North West Wales Dendrochronology Project Ty Mawr, Druid, Denbighshire

**EAS Client Report 2009/15
December 2009**

Ty Mawr, Druid, House and Barn

NPRN 28818 (House and Barn), 41742 (Barn)

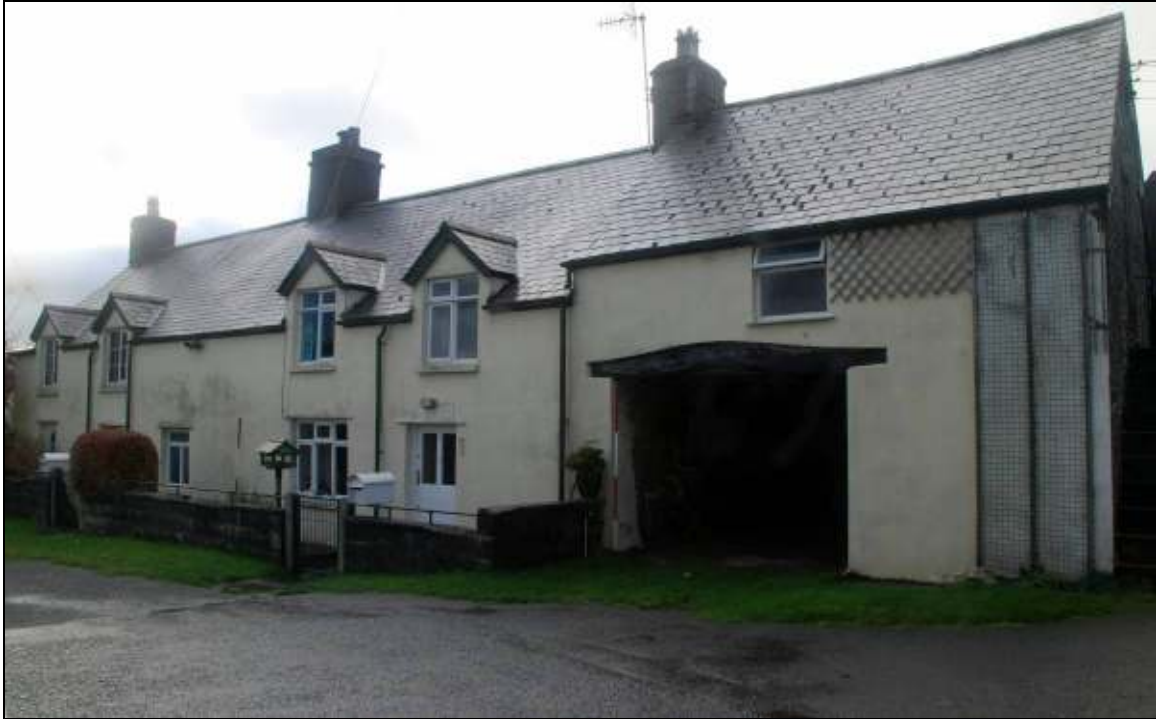
Plate 1: Front elevation looking SW.

Externally the house at Ty Mawr would appear to be an end terrace of a short row of houses (Plate 1). It is one and a half stories high, with rendered walls and a slate roof. Two chimneys are evident, one on the gable end and the other at the division between Ty Mawr and its neighbour. The windows and door are all modern replacements, the two upper front windows sitting within partial dormers with the windows partly below the eaves. Attached to the northern end of the house is an agricultural building, originally a cart shed, although now being used

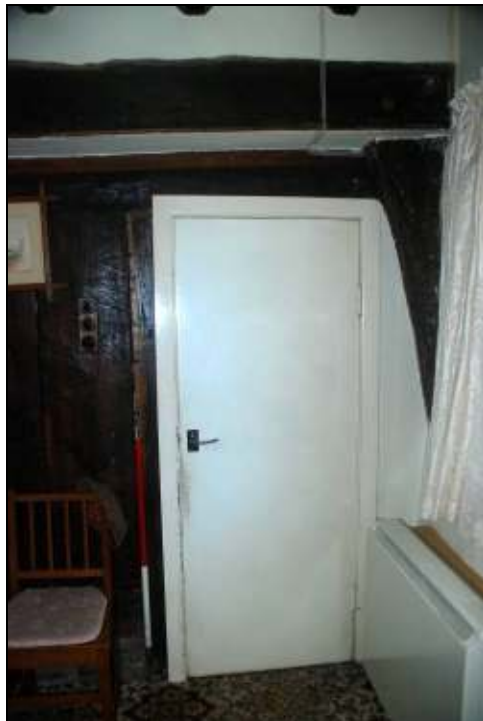
Plate 2: Base of the northern cruck frame, west side of house, looking NNE

The ground floor is divided into two principal rooms (a kitchen and parlour) with a small entrance hall from which the stairs to the upper floor are accessed (Figure 2). The kitchen has been improved and shows no features suggestive of an early date. The main room, however, has a number of features which demonstrate the development of the house. Along the northern wall of the room the foot of a cruck frame is evident which is partly embedded in the walls of the house (Plates 2 and 3, Figure 3). Both blades appear to extend up into the upper storey; however, they could not be easily traced in the wall dividing the southern bedroom from the stairwell. Set between the blades of the cruck is the remains of a post and plank partition (Plate 4, Figure 3). Each of the posts is approximately 0.30 m wide set with a separation of approximately 0.25 m. The posts and planks are set between two horizontal rails, the upper of which is jointed to the cruck frame. Two blocked slots in the upper corners of the partition and a number of empty peg holes may suggest the position of a dais canopy along this wall.

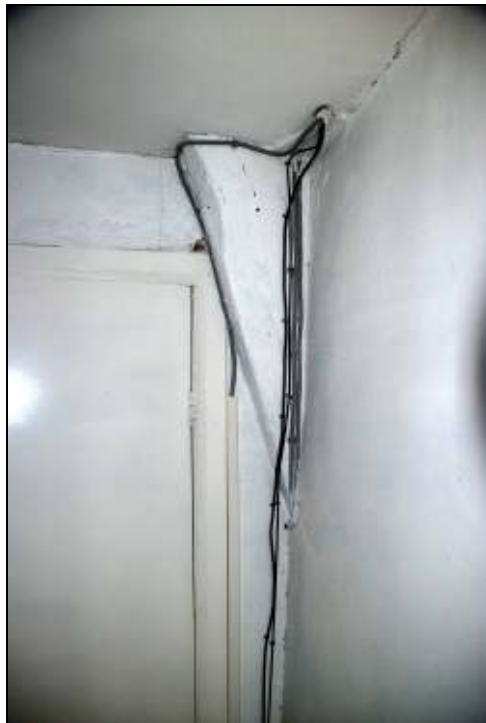
Plate 5: Base of the southern cruck frame, looking NNE

A second pair of cruck blades was located over the large fireplace in the southern end of the main room. Exposed on the ground floor in a corridor leading along the eastern side of the chimney breast (Plate 5), this frame was evident in a space over the chimney stack behind the southern wall of the southern bedroom. Here it could be seen that both blades of the cruck survive together with at least one pair of butt-purlins on the eastern side of the house (Figure 4, Plates 6-8) The purlins appear to have been truncated at the cruck frame, presumably this occurred when the roof was heightened and to allow for more room in the bedrooms.

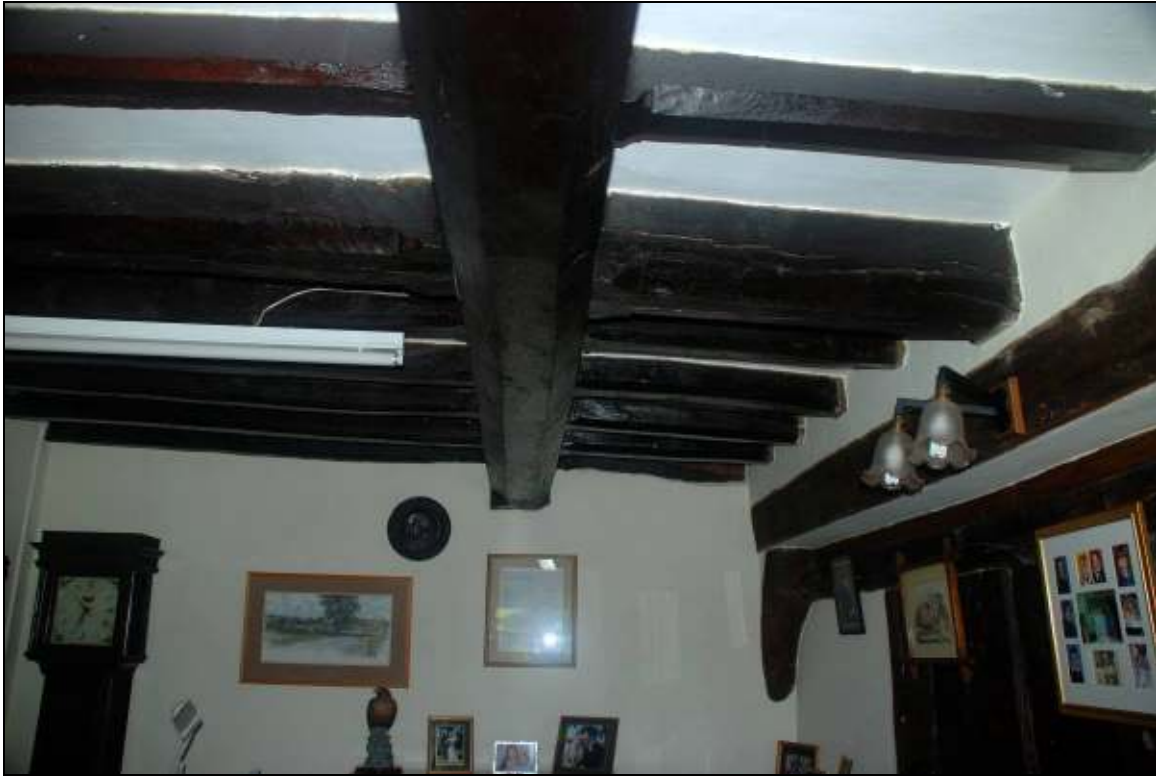
Plate 9: Beamed ceiling in the main ground floor room, looking NW

The main ground floor room has a beamed ceiling (Plate 9) consisting of a main cross beam running across the main axis of the house with a longitudinal beam running from the chimney breast to the wall containing the post and plank partition. The remaining space is further divided by a series of joists with bevelled housed joints into the main cross beam (Plate 10). Both beams and the joists are chamfered. The cross beam having curved stops at both ends of the beam. The longitudinal beam is only stopped at its joints to the cross beam and where it meets the northern wall of the room with stepped stops (Plate 11). The joists are stopped only where they meet the cross beam with curved and slightly stepped stops (Plate 12).

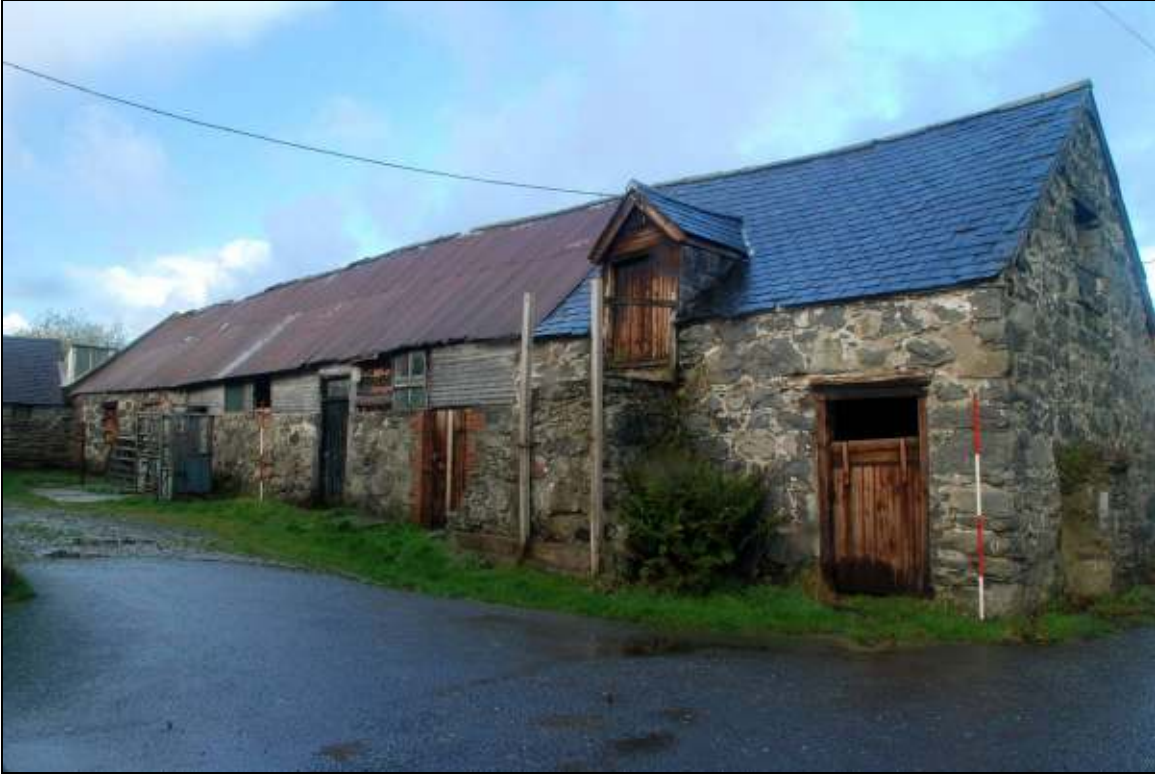
Plate 13: Barn looking west.

extending both to the west and east of the original building (Figure 5). Externally the barn is constructed of random stonework standing to a height of 1.8 m which is lower than the flanking buildings in the range (Plate 13). Currently it has a corrugated iron roof covering. Three doorways pierce the southern wall, the most easterly of which is clearly inserted as it has a modern brick casing. Two air vents are evident, externally in the northern wall of the barn (Plate 14). The barn attached to the north has an external stair leading to a hay loft. This also gives access to the gable end of the original building.

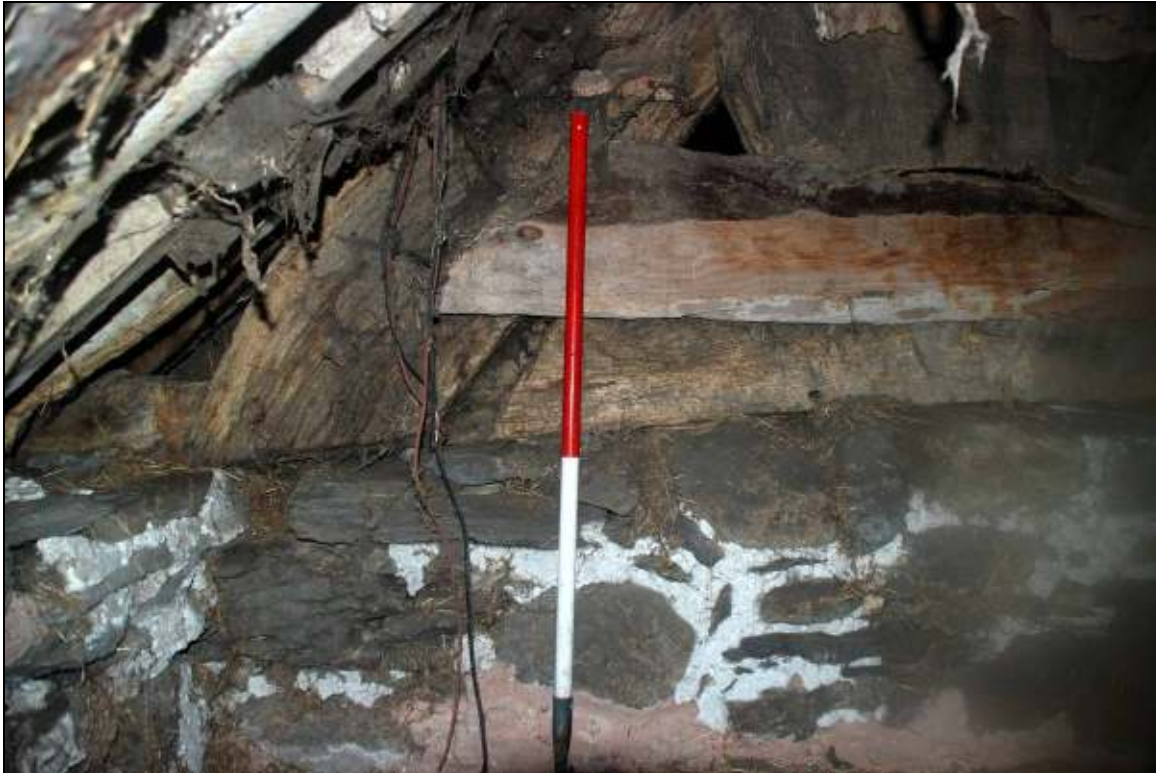
Plate 15: Half lap joint between the principal rafter and tie beam on the barn gable end truss looking SE

Three original trusses were located within the barn, two of which were sampled by Oxford Dendrochronology. The eastern gable end has a truss resting on the stone walling (Figure 6). The slight curving at the base of the principal rafters would suggest this may have originally been a cruck frame. There is a tie-beam sitting on the stone wall and a higher collar linked by queen struts. The tie-beam extends beyond the extent of the principal rafters, onto the side walls of the barn. It has half lap joints with the principal rafters which are pegged (Plate 15). The truss was obscured by a sacking screen; however it was possible to determine that there were cut outs for two pairs of purlins which are occupied by butt purlins, probably of a later date (Plate 16). There was also a ridge purlin.

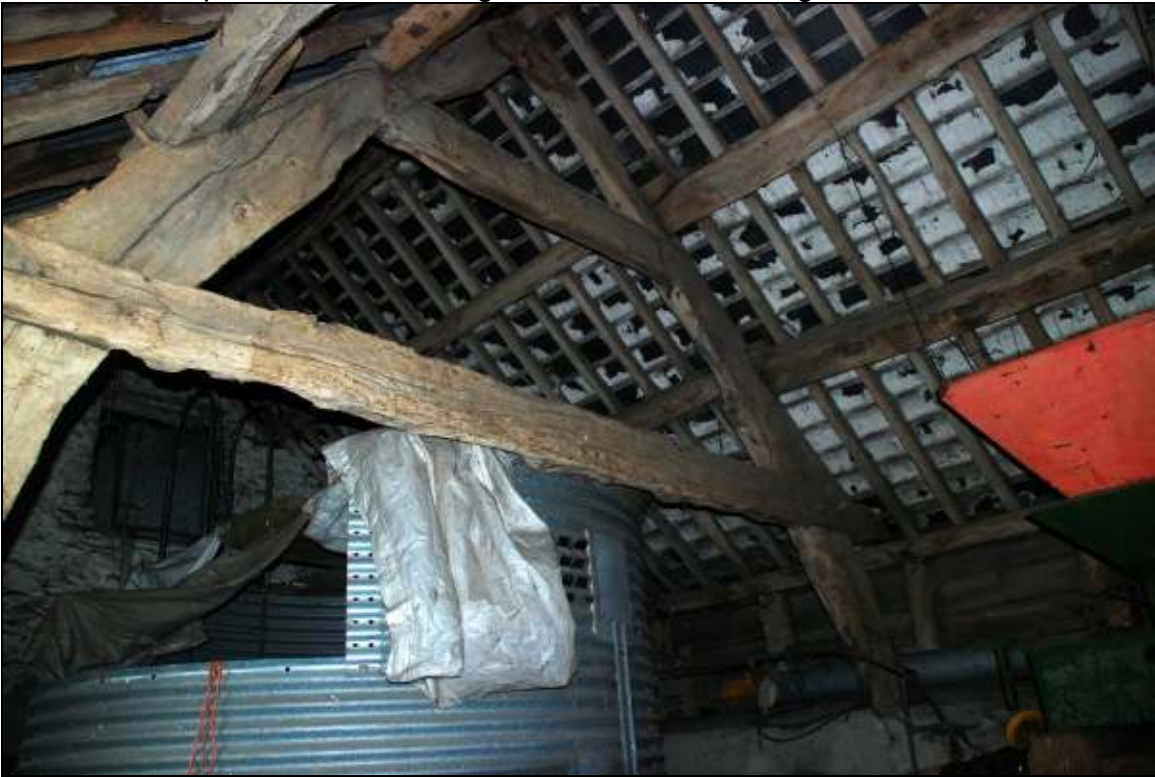
Plate 17: Barn truss 1 looking west

The internal trusses were clearly of cruck construction, both sitting on the dwarf stone walls. Truss 1 (Figures 5 and 7, Plate 17) has a collar and a wooden staple across the joint where the principal rafters join which are both assumed to be original. There is also a lower tie-beam which is clearly of a later date being only pegged to the face of the truss (Plate 18). The original (higher) collar is tenoned and pegged into the principal rafters and has two mortice holes and a series of dowel holes (Plate 19) on its underside suggesting the possible position of a division within the building. Similar dowel holes in the principal rafters also suggest this division extended above the collar.

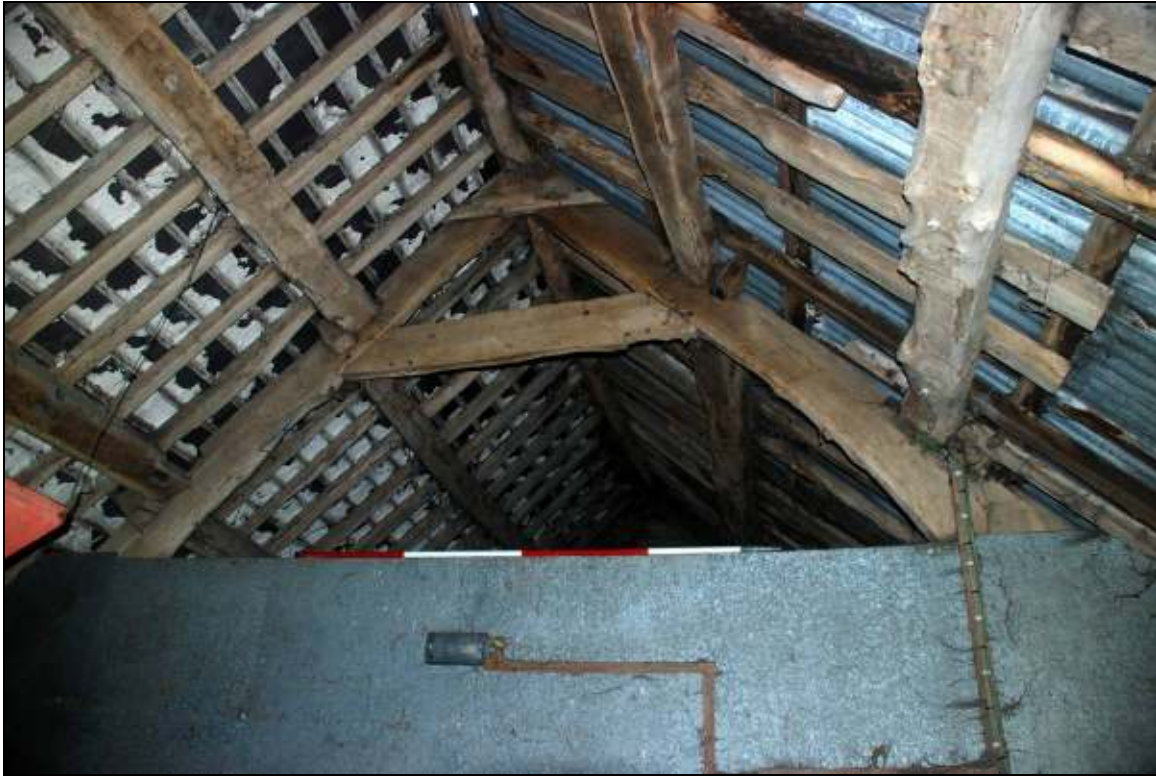
Plate 20: Barn truss 2, looking NE

Truss 2 (Plate 20) is similar to Truss 1. Its full extent is partly obscured by the insertion of a hay loft between Truss 2 and the gable end truss which is supported by a later tie-beam (Plate 21). Once again there are two mortice holes and a series of dowel holes on the underside of the collar suggesting a division within the building.
