North West Wales Dendrochronology Project Uchel Dref, Corwen, Denbighshire

**EAS Client Report 2009/20
December 2009**

EAS Client Report 2009/20

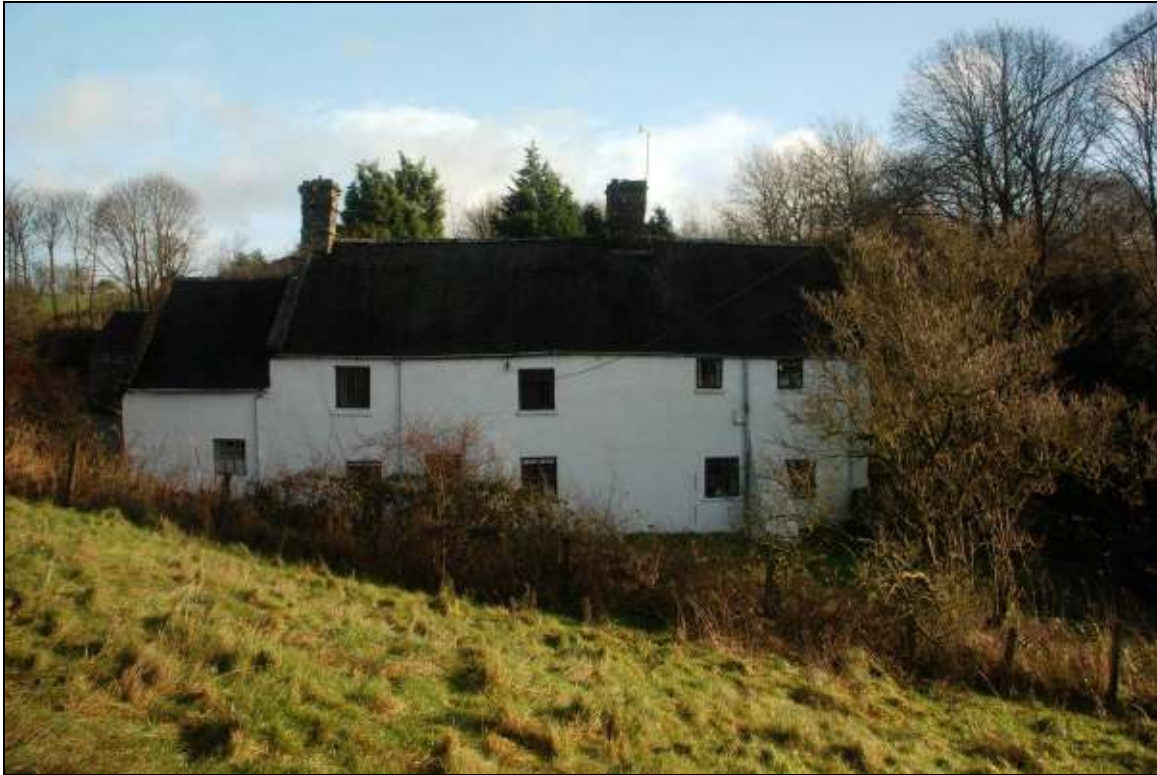
Plate 1: Uchel Dref, looking east

Uchel Dref is a large stone built winged gentry house approximately 1.3 km NNW from Rüg at a height of approximately 245 m OD (Figure 1). It is part of a small complex consisting of Uchel Dref itself, another cottage and a range of farm buildings which are assumed to have been a farmstead. The road runs along the western and northern sides of the house before running through the centre of the complex of buildings. In plan Uchel Dref has a “C” plan with a shorter northern wing and longer southern wing giving rise to an eastern courtyard between the wings. The main range is aligned NNW – SSE and is of two storeys (Plate 1) with a central chimney and a secondary chimney that clearly was on the northern gable end, but now sits at the junction between the original building and a linking structure to the northern wing. Both the walls facing onto the road and into the courtyard (Plate 2) are rendered and there are two large buttresses supporting the western side of the building. This wing is clearly stone built with random or semi coursed stonework as is seen at the junction between the main range and the south wing (Plate 3). The roof is covered with modern slate with stone ridge tiles and coping on the northern end.

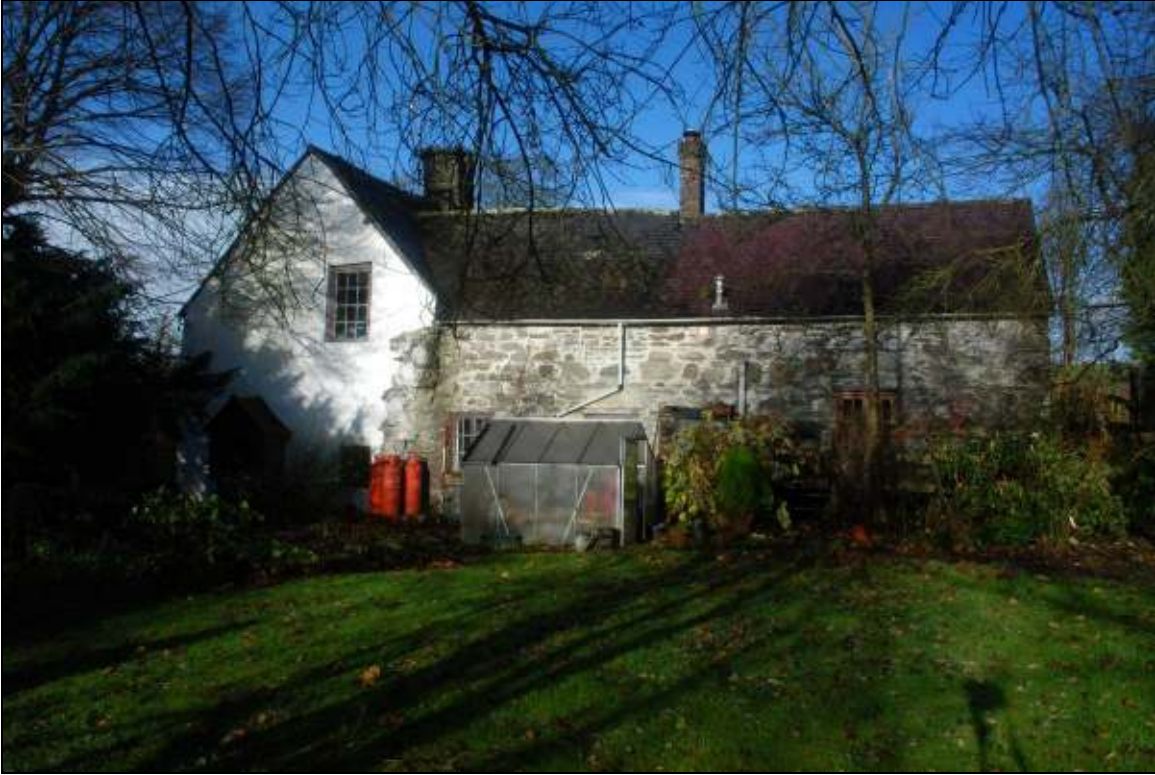
Plate 4: The south wing looking north

The long, south wing (Plate 4) is clearly an addition to the original building. It is one and a half storey high and constructed of semi-coursed stonework. There is

a single, slim, brick built chimney centrally placed on the ridge. The roof is covered in slate and the use of two different coloured slates on the roof would suggest that major repairs have been carried out at some point in its relatively recent history. Two blocked opening high on the southern face suggests there may have been dormer windows facing south (Plate 5). The general character of this wing would suggest it may have been partly agricultural in nature, however if there were dormer windows it is possible that there was servant accommodation in the roof space.

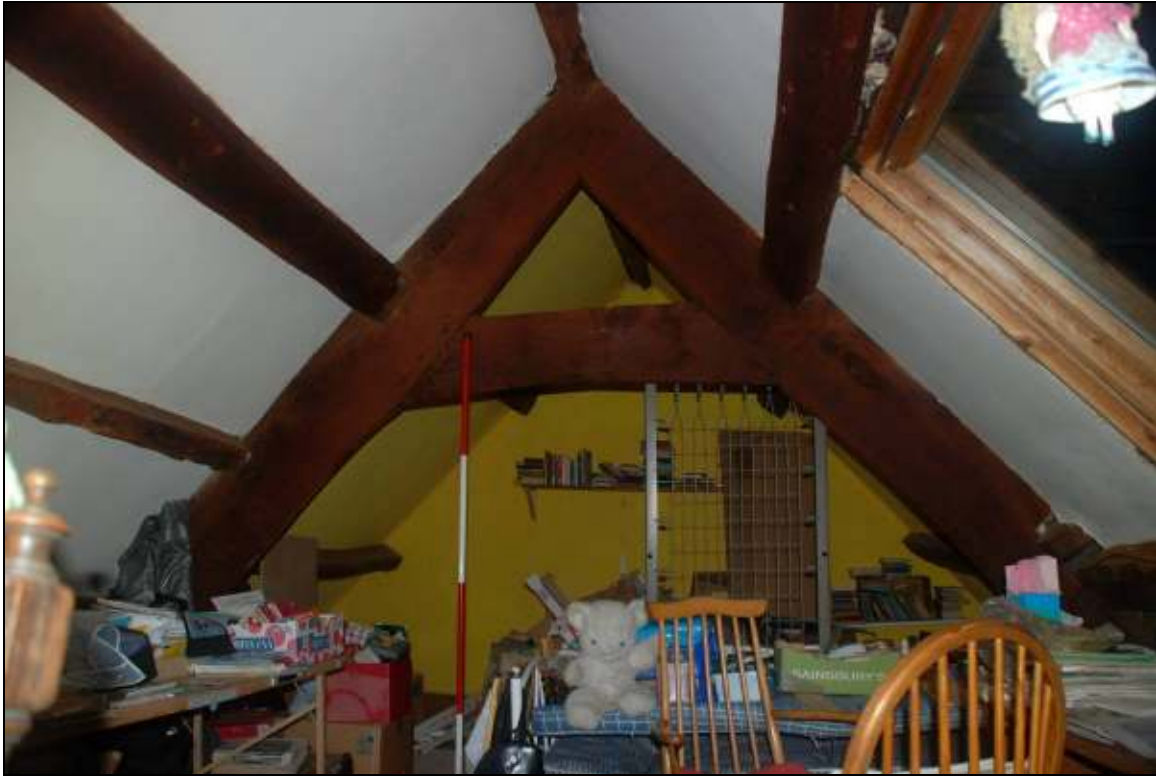
Plate 9: Main range, truss 1, looking north

Inside the property the recording concentrated on the areas of the building which were subjected to dendrochronological dating. Three trusses were located which related to what is assumed to be the original range. Two of these (Figure 3) were located in the attic in the central section of the range. Both trusses (Plates 8 – 10) have collars and are marked with carpenters marks. Truss 1 has a simple chisel mark on the collar (Plate 11) whilst Truss 2 has an inverted “y” (Plate 12). There is some indication of a possible partition below Truss 1 in the form of two slots cut into the southern side of the collar. The eastern side of both trusses have common purlins which are trenched. On the western side, however, whilst Truss 1 has trenched purlins, Truss 2 has an upper trenched purlin and a lower purlin in a blocking piece. The third truss is exposed in the upper storey room at the southern end of the range. It is far more complex in its design (Figure 4) and was clearly meant to be seen. The truss (Plate 13) has a tie-beam supporting queen struts to a high collar. Above the collar are two raking braces. The queen struts have a beam set between them, slightly above the tie-beam which has a series of mortice holes along its length (Plate 14). There are also five raking braces each side of the queen struts giving a decorative appearance to this truss. There is little sign of weather damage to this truss, suggesting it was never an external feature. The eastern side of the truss is supported by a post which can be traced, almost to ground level in the room below. Peg holes in the western end of the tie-beam would suggest that there was a matching post which has now been lost. Other peg holes on the tie beam suggest there may have been other vertical elements below the tie-beam which have also been lost.

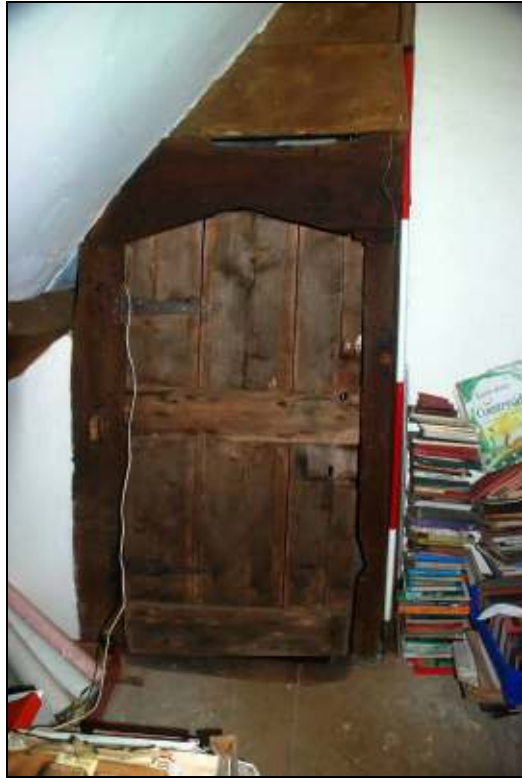
Plate 15: Attic door, looking south

Trusses 1 and 2 of the main wing sit on the other side of the main chimney from Truss 3 and access to the attic is via a short flight of stairs alongside the chimney breast. At the head of these stairs is a door with a flat pointed door head (Plate

15) of late sixteenth, or early seventeenth, century type (Alcock and Hall, 1994, 20).

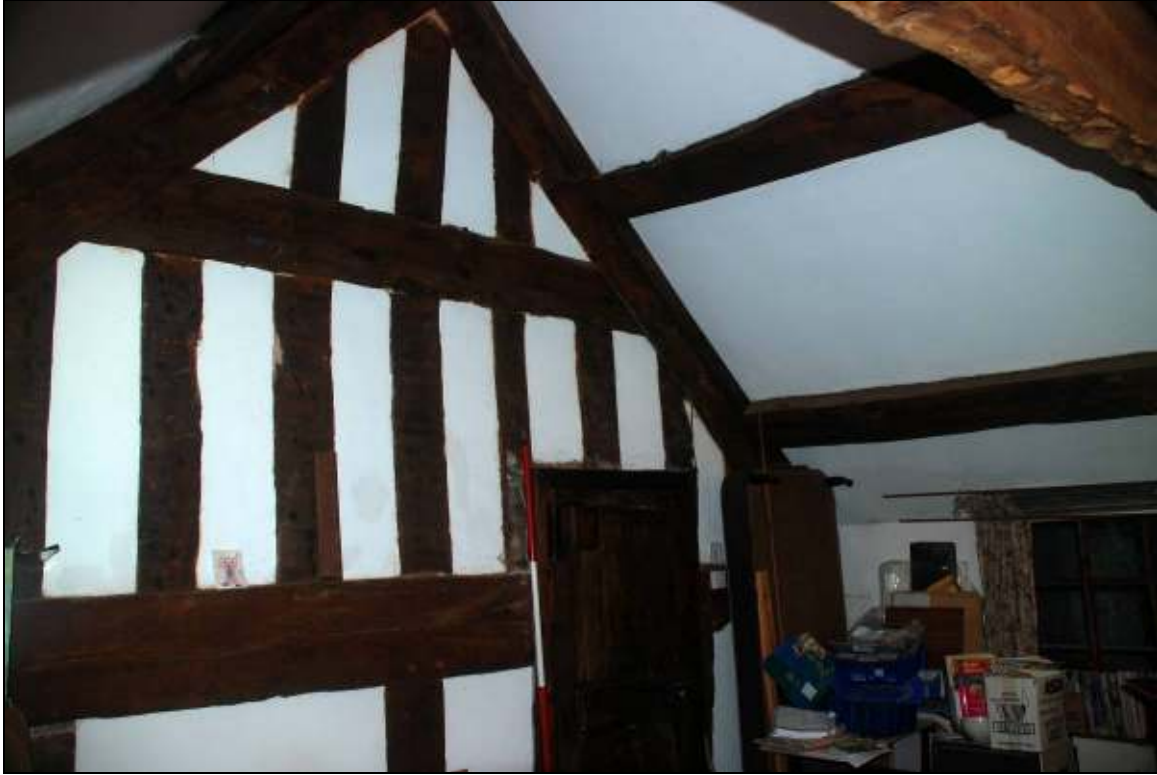
Plate 16: South Wing, Truss 1, looking NW

Two trusses were recorded in the South Wing, both in the first floor room at the western end of the wing. Indeed Truss 1 effectively marks the join between the South wing and the main range. Truss 1 (in the South Wing) has a tie-beam and a straight collar separated by a series of nine studs (Plate 16). There are also three studs above the collar and six below the tie-beam. At the northern end of the tie-beam the width of the beam has been reduced to produce a slightly curved door head. One of the studs below the tie-beam is clearly later as it blocks the door opening. The truss has been disturbed in more recent times with the insertion of a new door through the partition. Below Truss 1, of the South Wing, on the ground floor, is a wooden post and plank partition, dividing the main range from the South Wing (Plate 18). A slot in the middle portion of the partition would suggest that the western, ground floor room of the south wing was divided laterally (Plate 19). This slot continues on the underside of the ceiling beam in this room. Truss 2 is much simpler with a single collar and trenched purlins (Plate 17).

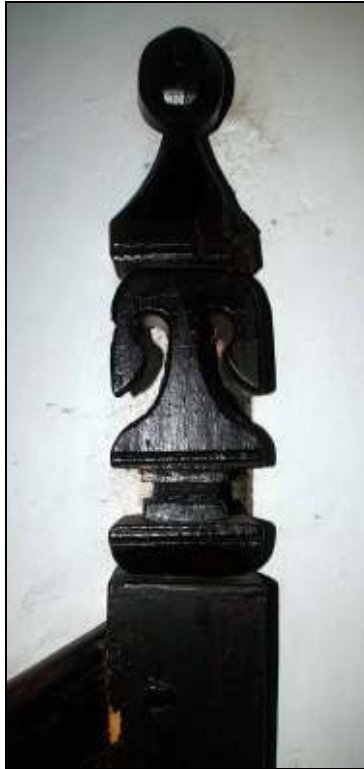
Plate 23: Carved newel post at head of stairs.

The two main rooms on the ground floor of the main range sit either side of the main chimney; the largest room is now used as a kitchen. Accessed through a door to the west of the fireplace in the current kitchen is an awkward space with a curved southern wall which appears to match with a similar space on the first floor. The function of this space is uncertain; however, it may have housed a staircase beside the chimney breast. The current staircase is on the eastern side of the main chimney (Plate 20). The staircase is dated to 1686 on the newel posts (Plates 21 and 22) it has a combination of lower splat balusters and upper turned balusters. The under stair cupboard has a pierced motif which appear to be contemporary with the staircase as does the carved newel post at the head of the stairs (Plate 23).

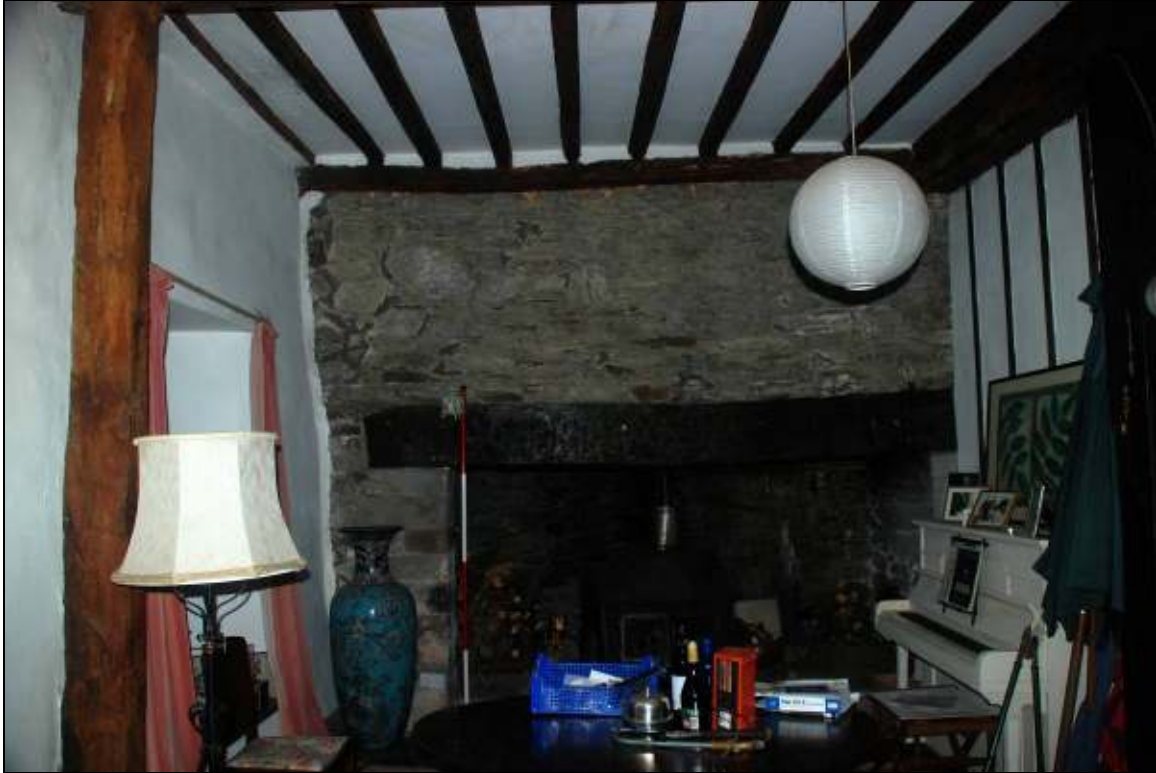
Plate 24: Large fireplace, looking north

The large fireplace in the southern, ground floor room (Plate 24) of the main range would suggest that this room may have originally been the kitchen. The ceiling has a longitudinal beam, partly embedded in the eastern side of the chimney breast and a lateral beam running from the longitudinal beam to the western wall. The majority of the joists run north-south, however a range of joist between the longitudinal beam and the partition run east-west. The longitudinal beam has two empty stopped lap joints towards its southern end suggesting the position of a partition (Plate 25). The lateral beam is chamfered by approximately 40 mm and has straight stops at both ends. The joists meeting this beam are slightly offset from one another (Plate 26).

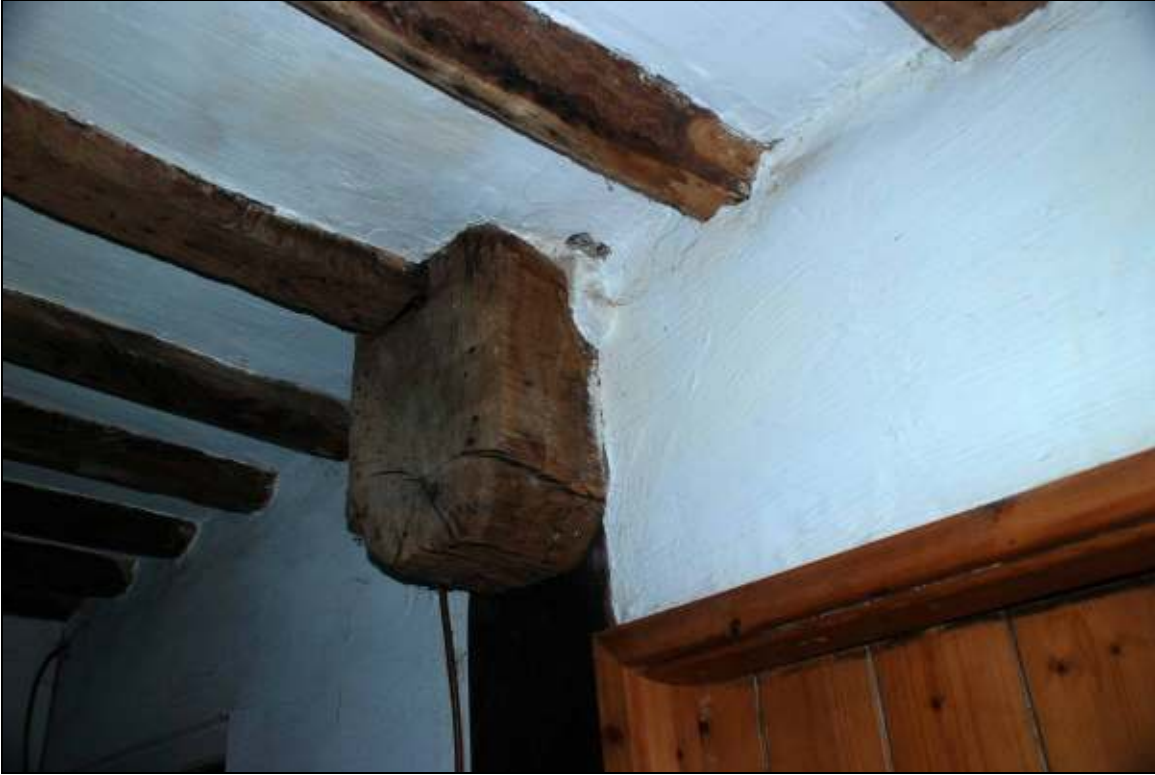
Plate 27: Truncated beam in hallway, looking SW

In the room now used as a kitchen the ceiling consisted of two lateral and one longitudinal beam together with a range of joists. Both of the lateral beams originally extended across the full width of the building, including the current hallway, although the southern beam has been truncated (Plate 27). The joists

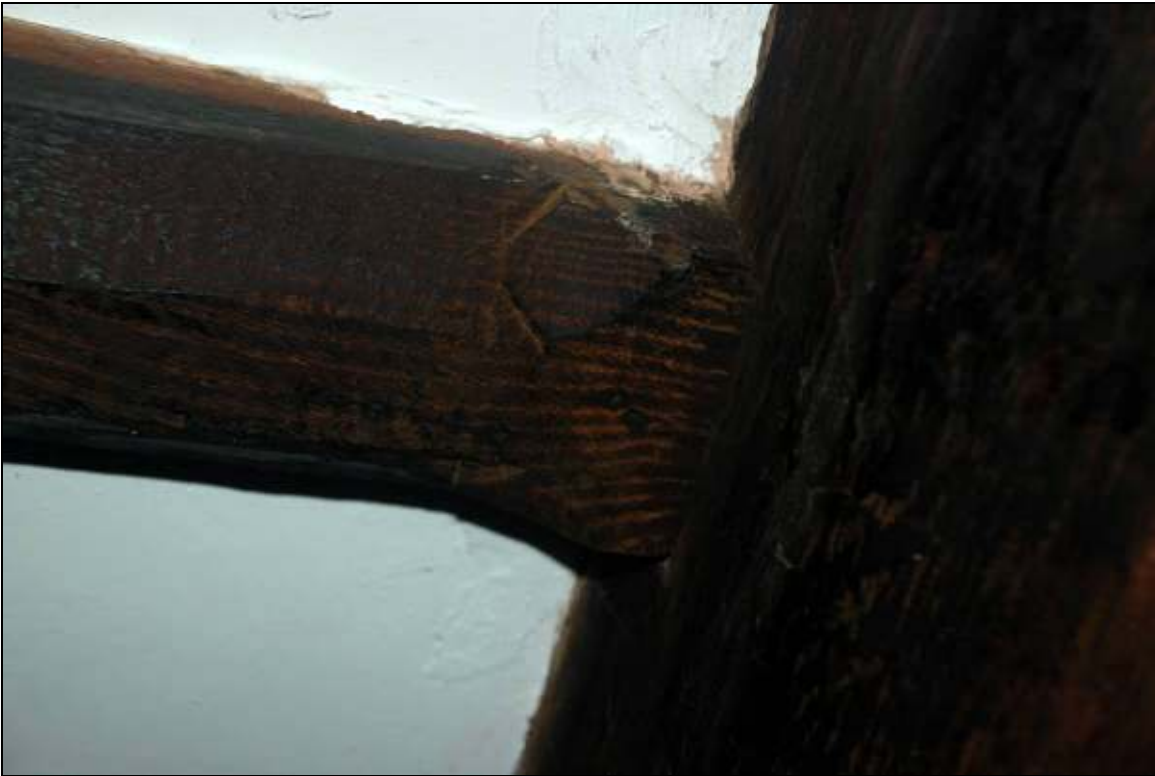
Plate 28: 'Spade' stop on joist in the kitchen

and beams have 'spade' stops and moderate chamfering (Plate 28). The northern lateral beam has a series of six mortice holes separated by groups of four dowel holes suggesting the position of a partition. To the north of this beam the joists are set longitudinally (at right angles to the rest of the joists in this room) and they are of a plain form. A trimming joist in the south east corner of this run of joist may suggest the position of an opening to the room above (Plate 29).

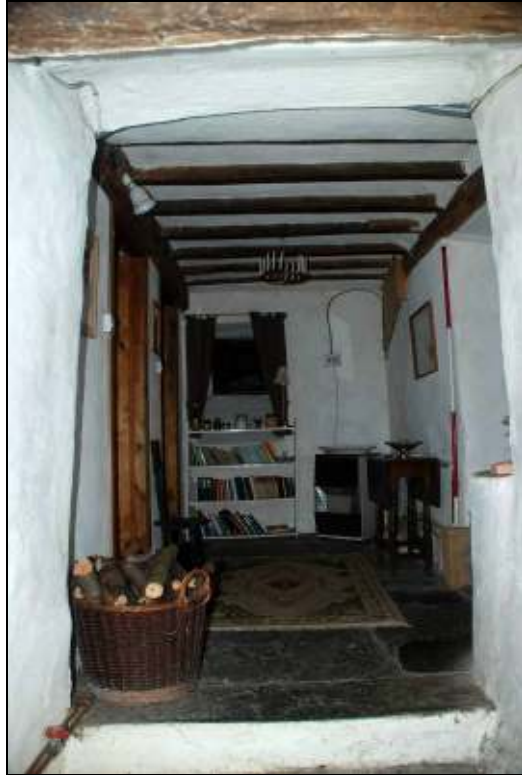
Plate 30: Corridor linking the main range to the North Wing, looking north

The ceiling of the passage between the main range and the northern wing was also sampled. Here a series of joists span the corridor (Plate 30) between two longitudinal beams into which they are trenched (Plate 31).

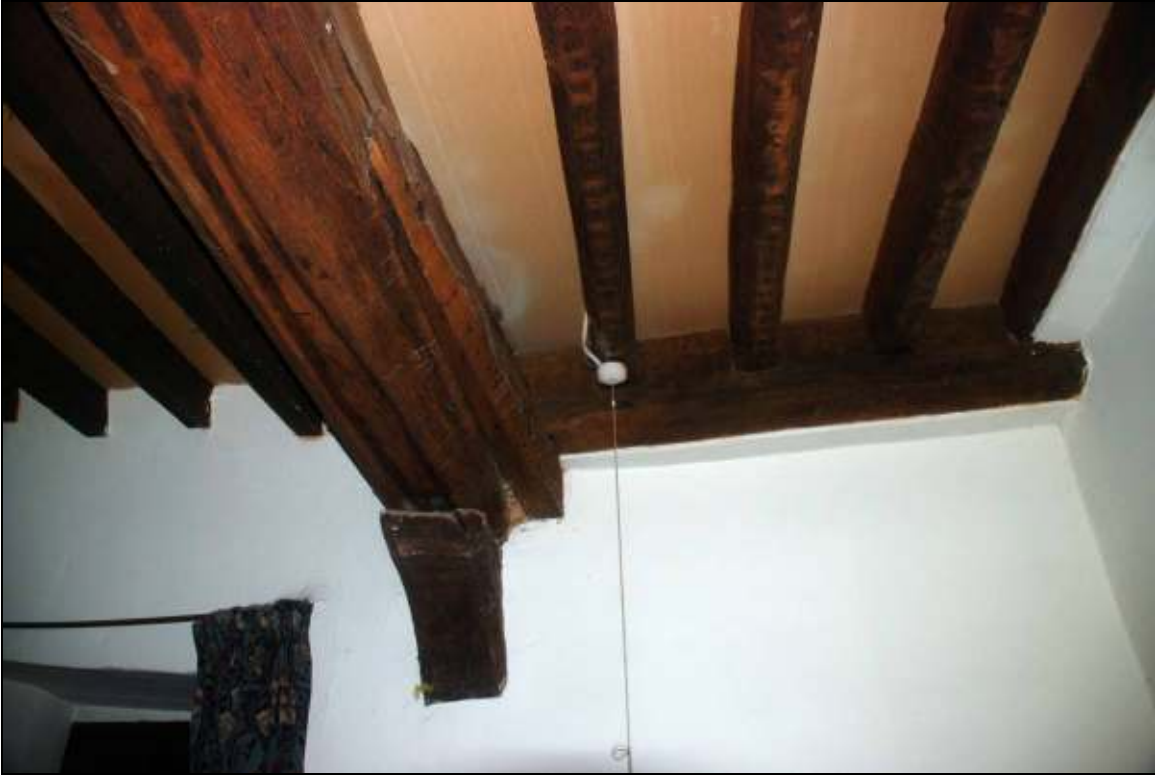
Plate 32: Beam resting on wooden supports in bedroom above kitchen, looking west

The bedroom above the kitchen has a ceiling with a beam resting on wooden supports (Plate 32). It is met by coffers which are tenoned into the main beam and have the joists trenched into their top surface (Plate 33).

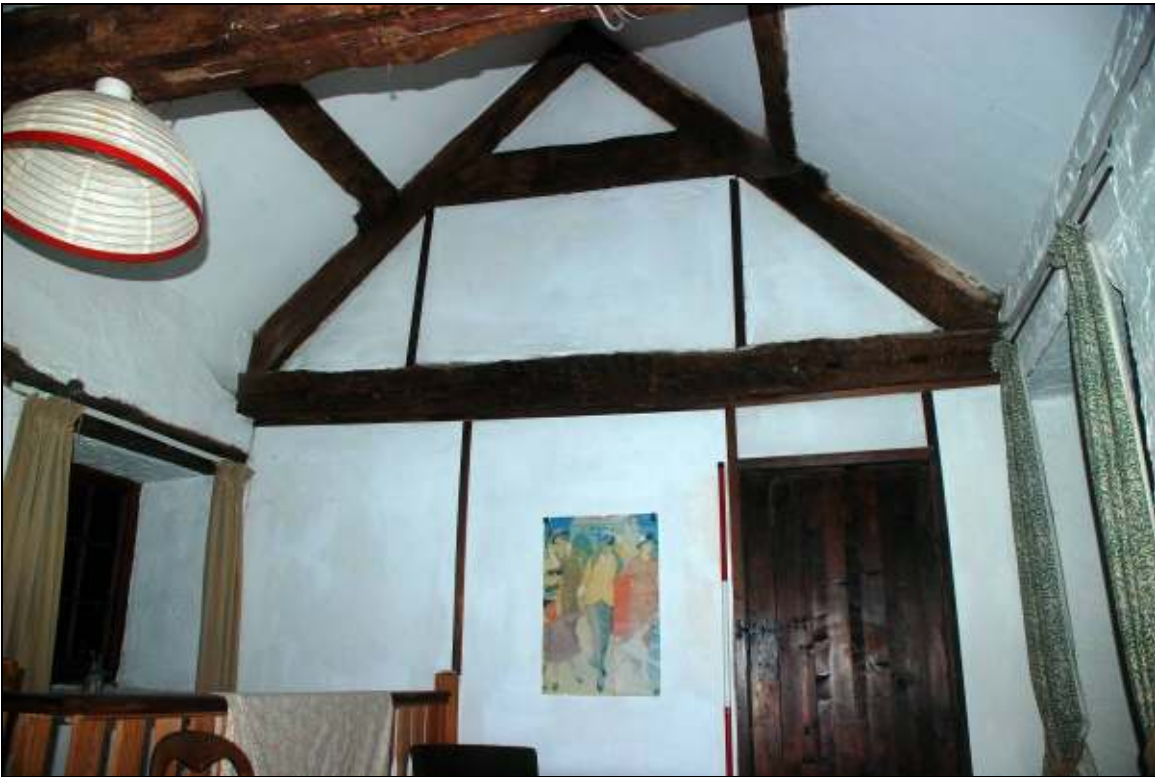
Plate 34: Truss in the North Wing, looking east

The trusses in the northern wing are relatively simple with tie beams and a collar pegged into the principal rafters. Mortice holes in the tie-beams suggest the presence of a floor at tie-beam height now lost (Plate 34). On the ground floor the timberwork appears to be rather rustic (Plate 35) and is probably relatively modern in date
