TWENTIETH CENTURY MILITARY SITES: AIRFIELDS – DISPERSED SITES AND DEFENCES

Final Report
A THREAT-RELATED ASSESSMENT 2013-2014
DAT 115A

DYFED ARCHAEOLOGICAL TRUST
RHIF YR ADRODDIAD / REPORT NO. 2014/21
RHIF Y PROSIECT / PROJECT RECORD NO. 103632
DAT 115A
Mawrth 2014
March 2014

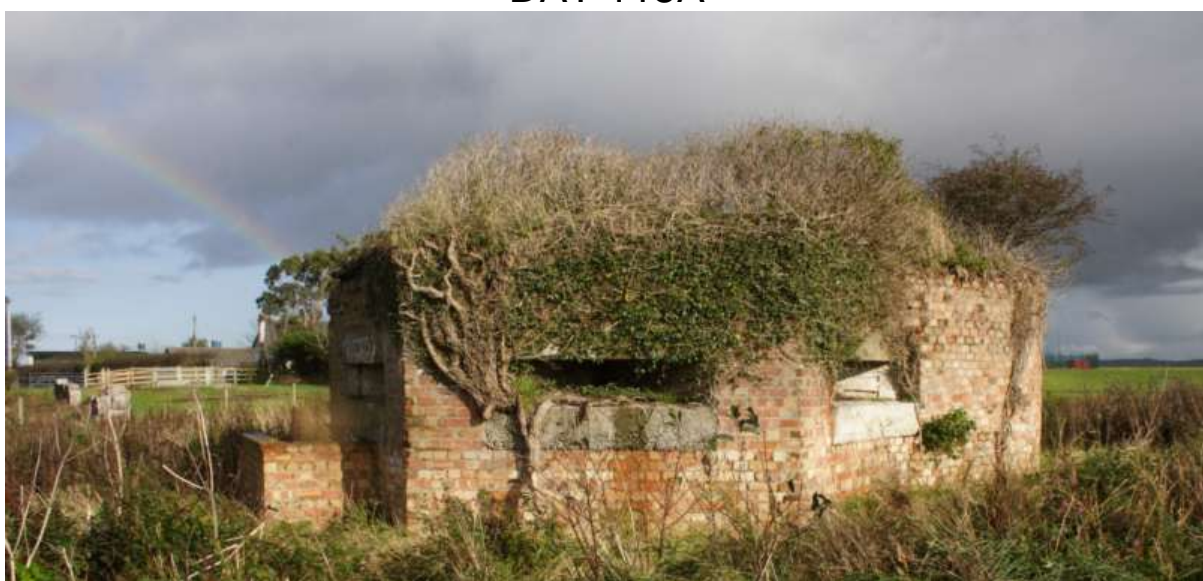
Pillbox, one of a ring which encircles Aberporth airfield

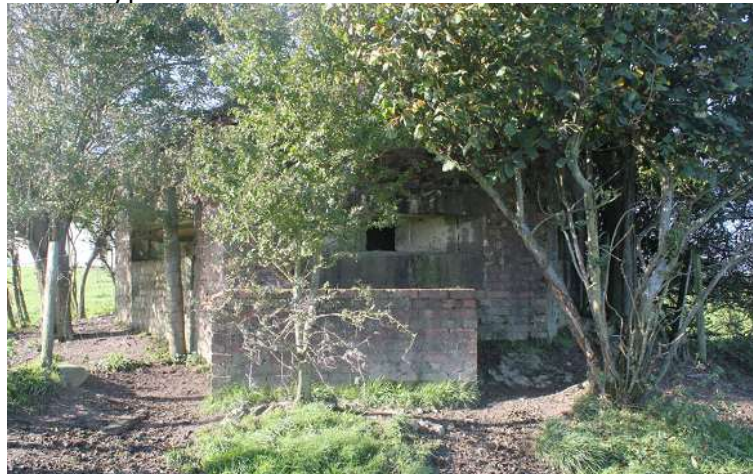
Figure 4: The easternmost pillbox tucked into the junction of two hedgerows

A hexagonal pillbox located at the junction of hedgerows. Built of concrete with brick shuttering. A D-shaped anti-aircraft emplacement is located to the northwest with a protected entrance to the southeast. One of series of scheduled pillboxes which encircle the airfield. A Pyper 2013

CONDITION DESCRIPTION / Pillbox in good condition, though woody vegetation encroaching upon it. A Pyper 2013

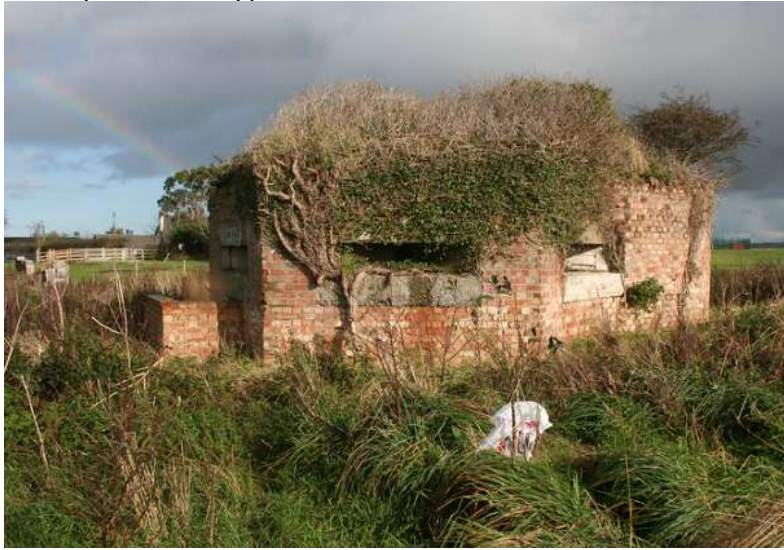
Figure 5: Pillbox on western perimeter of airfield now to the side of the extended runway

Type 24 pillbox, hexagonal in plan with a D-shaped annexe on its SE elevation and a flat concrete roof. Constructed in concrete with brick shuttering. Each wall except the SE has a centrally placed machine gun embrasure with Turnbull mountings for machine guns. Located within the D-shaped annexe is a Light Anti-Aircraft Machine Gun emplacement. The whole is part of a ring of 14 pillboxes encircling Aberporth Airfield. This pillbox is a scheduled ancient monument CD211L. Description based on Scheduling Description CD211L 2006. Visited in Nov 2011, A. Pyper.

CONDITION DESCRIPTION / Extensive ivy growth and some scrub vegetation growing from roof of pillbox. A Pyper 2012.

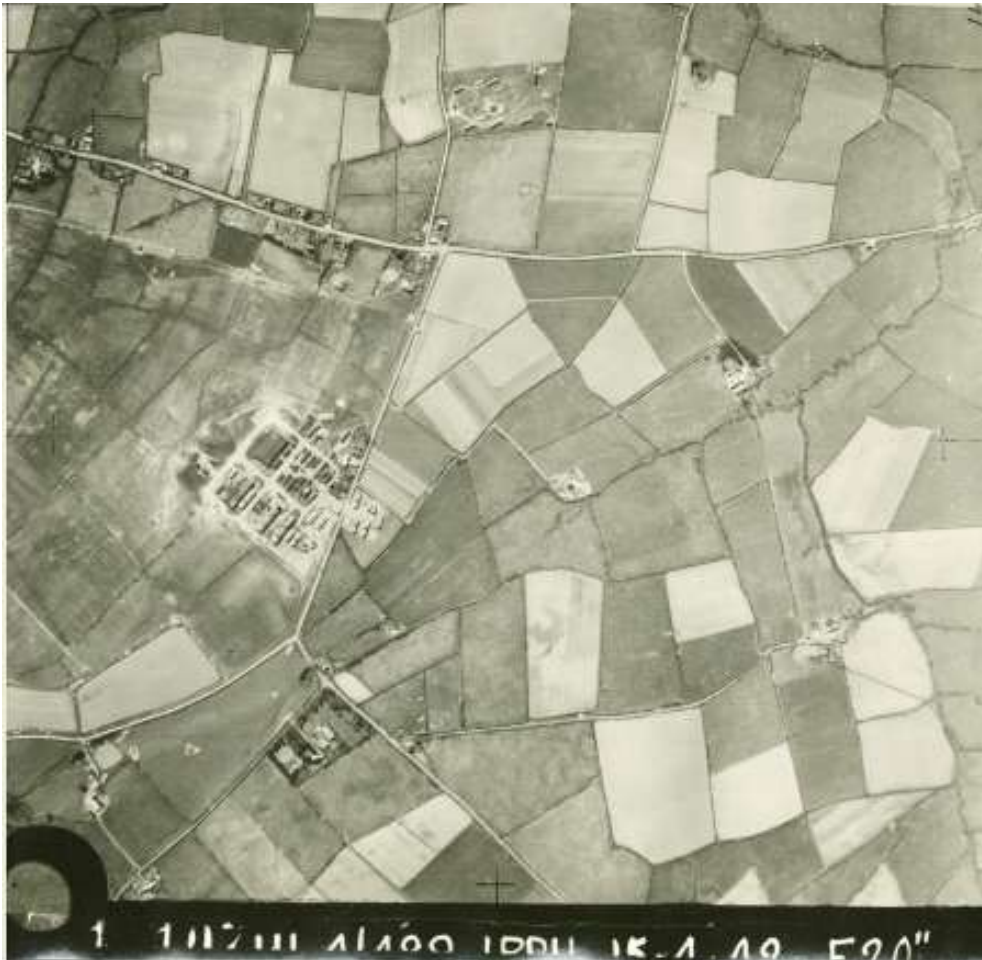
Figure 6: 1942 Aerial Photograph showing hut camp (M2324(1) 107 1942)

CONDITION DESCRIPTION When visited no trace of the structures were visible, but a concrete entranceway to the field. A Pyper 2014

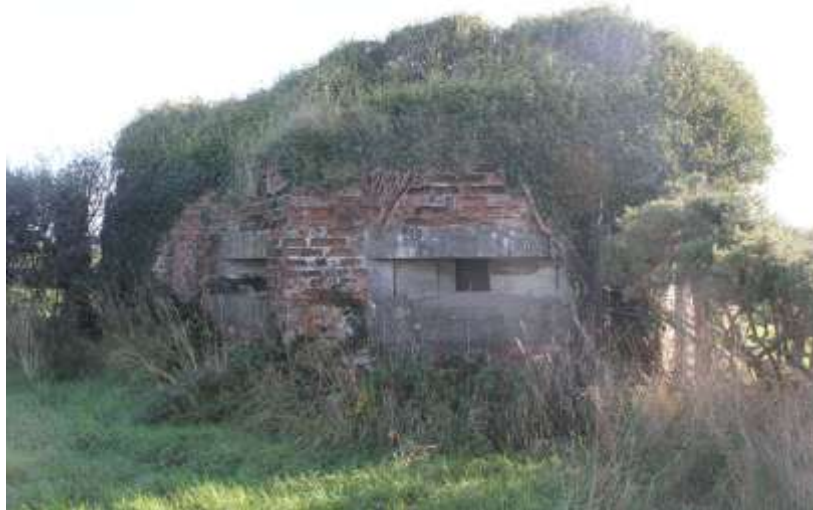
Figure 7: Pillbox to the south of the airfield at Aberporth

Each wall except the NE has a centrally placed machine gun embrasure with Turnbull mountings for machine guns. Located within the D-shaped annexe is a Light Anti-Aircraft Machine Gun emplacement. The whole is part of a ring of 14 Pillboxes encircling Aberporth Airfield. This pillbox is a scheduled ancient monument CD211J. Description based on Scheduling Description CD211J 2006. A. Pyper 2014.

CONDITION DESCRIPTION Pillbox is intact though the brick shuttering is very eroded and the cement pointing is standing proud of the brickwork. A Pyper 2013.

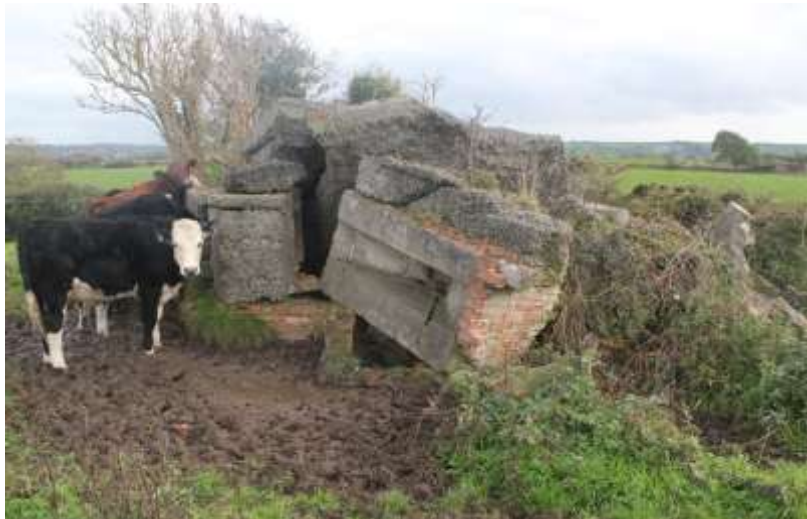
Figure 8: Remains of demolished pillbox

A partially demolished pillbox. Standing to the north of the airfield on a southeast facing slope. It is hexagonal with a D-shaped annexe for an anti-aircraft emplacement. Description based on Scheduling description. A Pyper 2013

CONDITION DESCRIPTION An attempt to demolish this pillbox was not entirely successful breaking up the roof slab and dislodging the walls which have been left in a tumbled state.

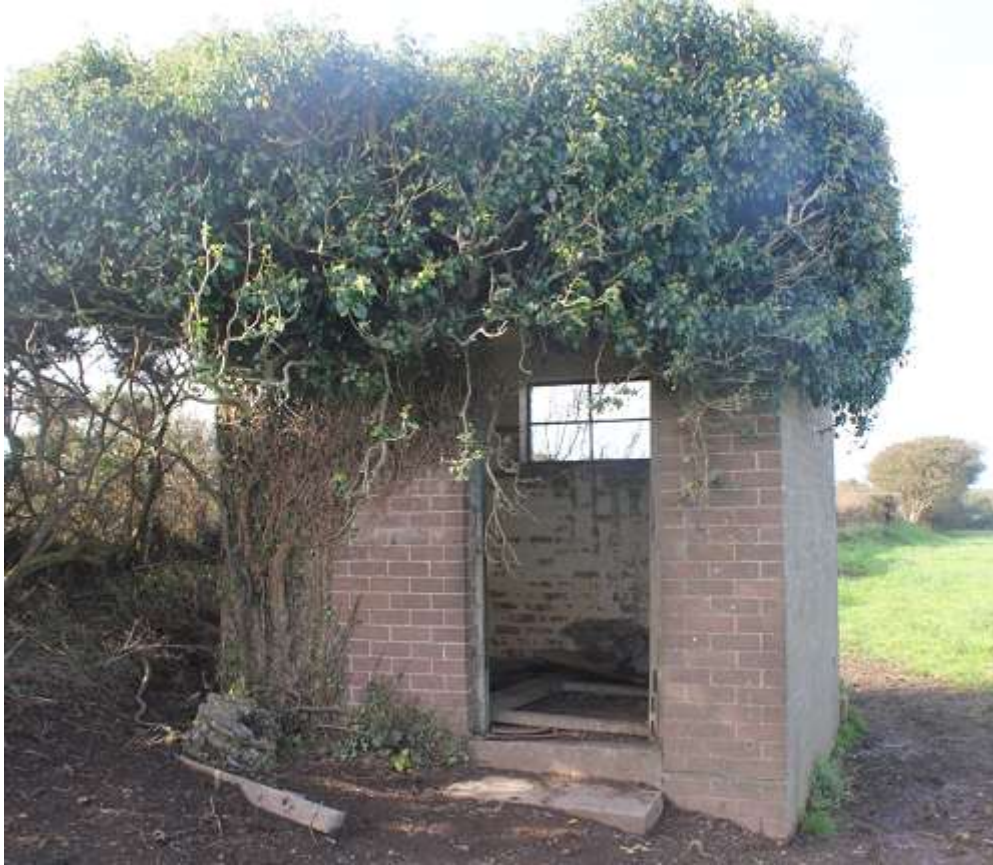
Figure 9: A small building located to the northeast of the airfield

CONDITION DESCRIPTION Intact building, roof very overgrown with ivy. Window glassless and door broken. A Pyper 2014

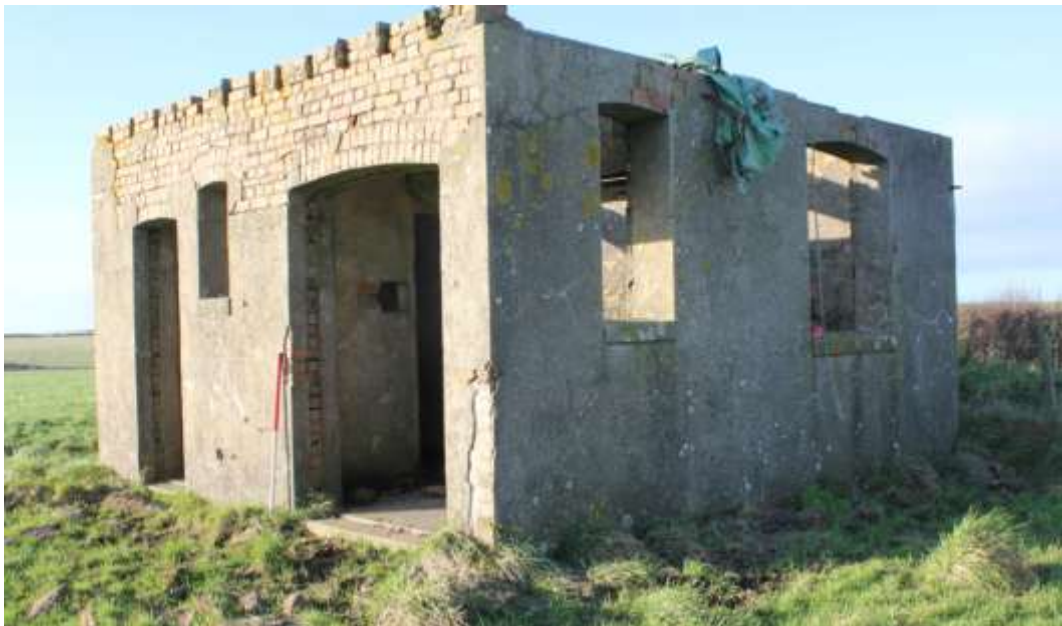
Figure 13: High Frequency Direction Finding building located to east of airfield.

CONDITION DESCRIPTION When visited in 2013 the building was roofless, and without windows and doors, but the walls still stood to roof level with roof timbers surviving. A Pyper 2013.

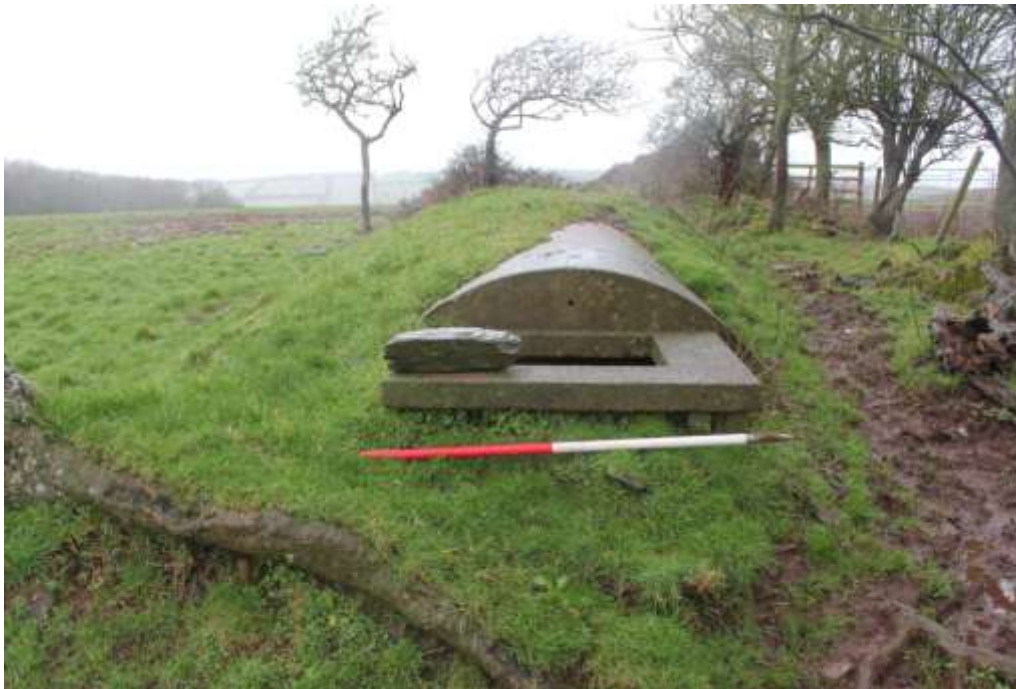
Figure 14: Air Raid Shelter now found on Hubberton Farm formerly Site No 5.

CONDITION DESCRIPTION In a stable condition near hedge line in farm, some bramble growing over north end. A Pyper 2013.

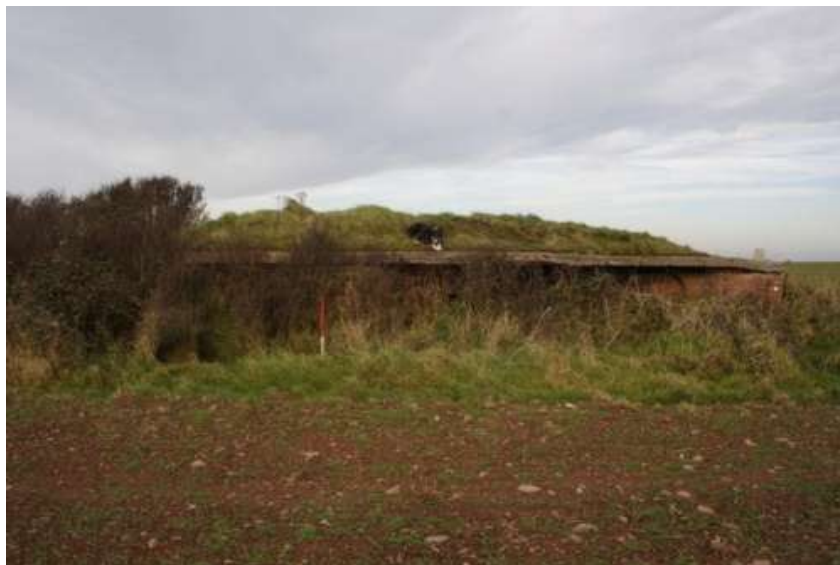
Figure 15: Modified pillbox to continue hedgeline to east of RAF Angle

Pillbox, located within hedge to the east of Angle airfield. Similar to pillbox located to the NW of the airfield except the roof is modified to carry the turf over the embrasures and continue the hedge line. Described by RJC Thomas as, "Semi-sunken, irregular hexagonal plan, integral 'D' shaped Anti-Aircraft Light Machine Gun pit against N wall, fair-faced brick, flat turf covered concrete roof on corrugated steel sheeting. Roof maintains line of hedge to the east. Wide splay embrasures fitted with Turnbull mountings." (Duplicate PRN 44601). A Pyper 2012.

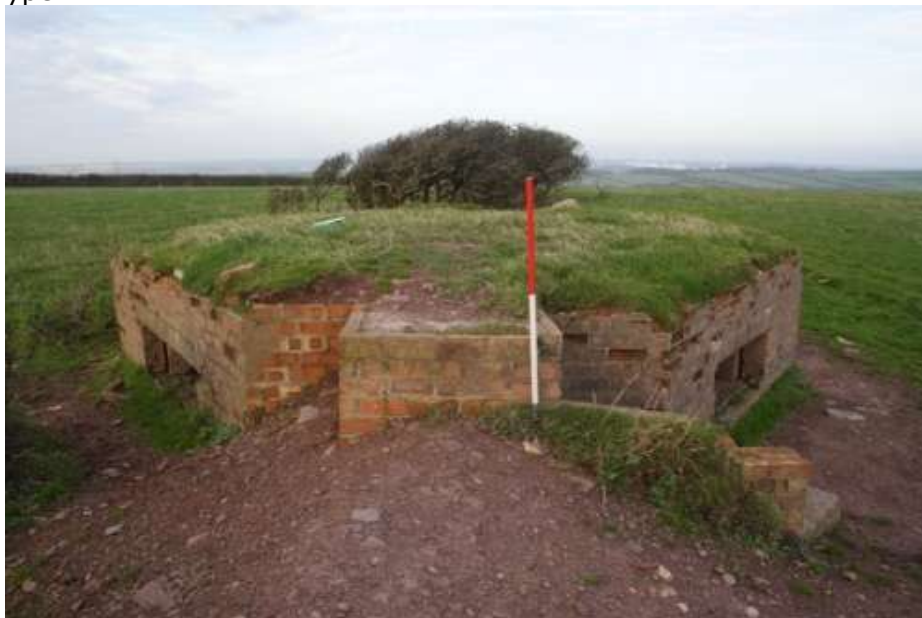
Figure 16: Pillbox to the northwest of Angle airfield

A brick and concrete pillbox located to the northwest of Angle airfield, within a hedgebank northeast of South Studdock Farm. Described by RJC Thomas as, "Semi-sunken, irregular hexagonal plan, integral 'D' shaped AALMG pit against N wall, fair-faced brick, flat turf covered concrete roof on corrugated steel sheeting. Protected entrance in S wall. 4 wide splay stepped embrasures fitted with Turnbull mountings."

Similar in construction to PRN 101389 at the eastern side of the airfield. Visited Nov 2011, A. Pyper.

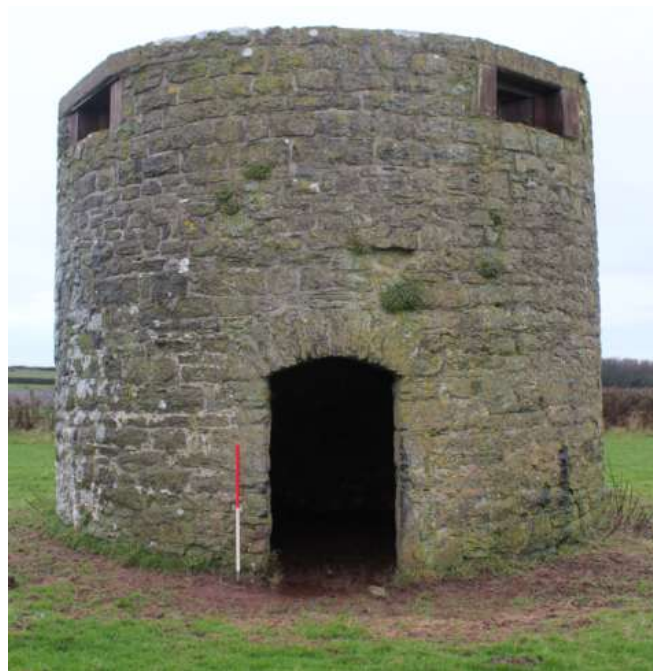
Figure 17: Former windmill modified for use as a gun emplacement, next to Battle Headquarters

CONDITION DESCRIPTION / Survives as roofless gun emplacement. Largely intact.

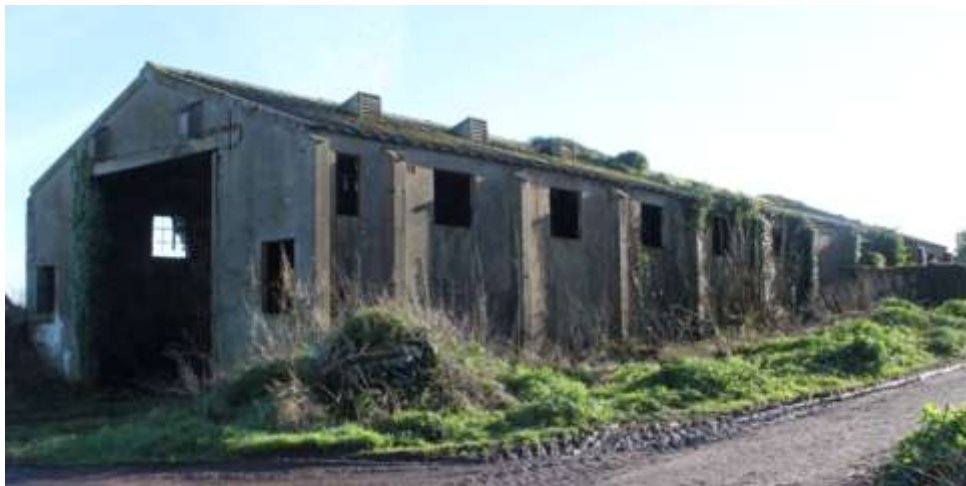
Figure 18: Ablutions block at the Communal site.

Ablutions block. Single storey, 9.5 bay rectangular plan, cement rendered temporary brick, corrugated asbestos cement sheeting gable roof. Twelve light standard steel windows. Combined water tower and chimney has been demolished. Built per A.M.W.D. drawing 14364/40 & 6530/42. When visited in 2013 the floor had been dug out and lowered, the roof missing at the southern end. Steps removed at the north gable end to make a large double doorway to allow access for machinery. A Pyper based on RJC Thomas 2013.

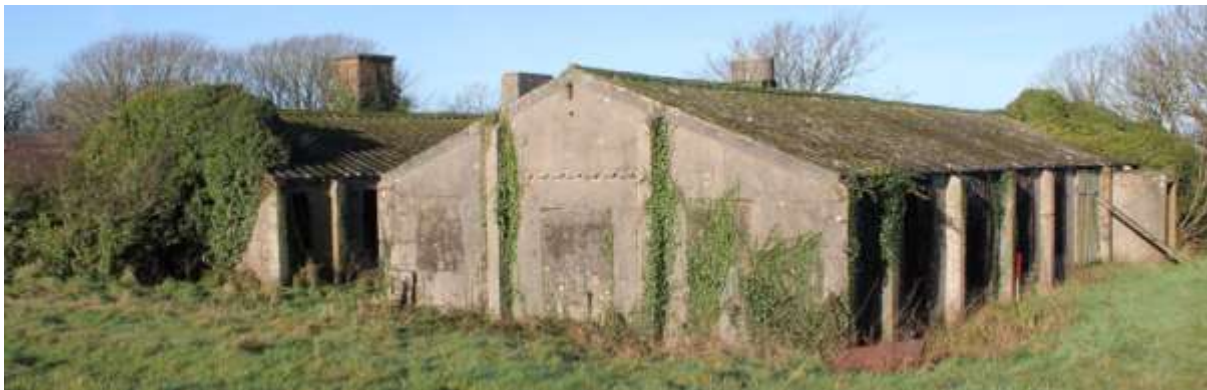
Figure 19: Remains of the institute at RAF Angle communal site

Linked parallel pair of temporary brick construction buildings 8.5 bays long x 3. Corrugated asbestos roof. Sixth bay of eastern range has a projecting porch on east side. West range has a brick built chimney in centre, otherwise interior has been cleared. Remains of a small latrine at south end. Latterly used as an agricultural store, though now little used. A Pyper 2013.

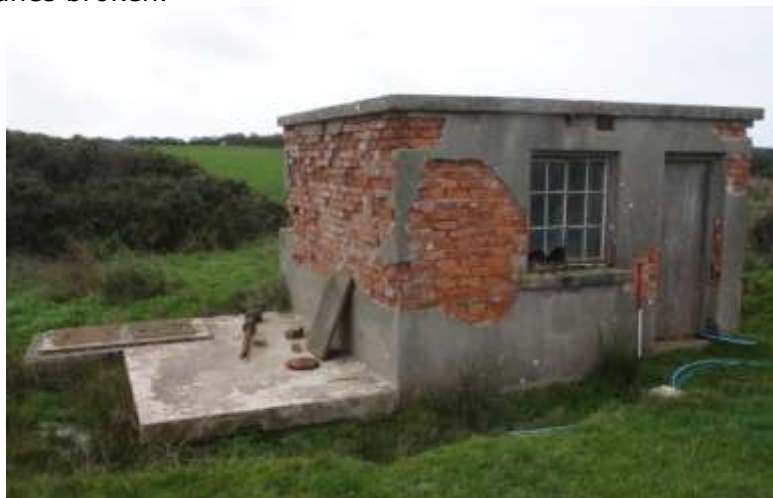
Figure 20: The pumphouse located near South Studdock Farm

Water pumphouse associated with Angle airfield. Largely intact with original windows, though some panes broken.

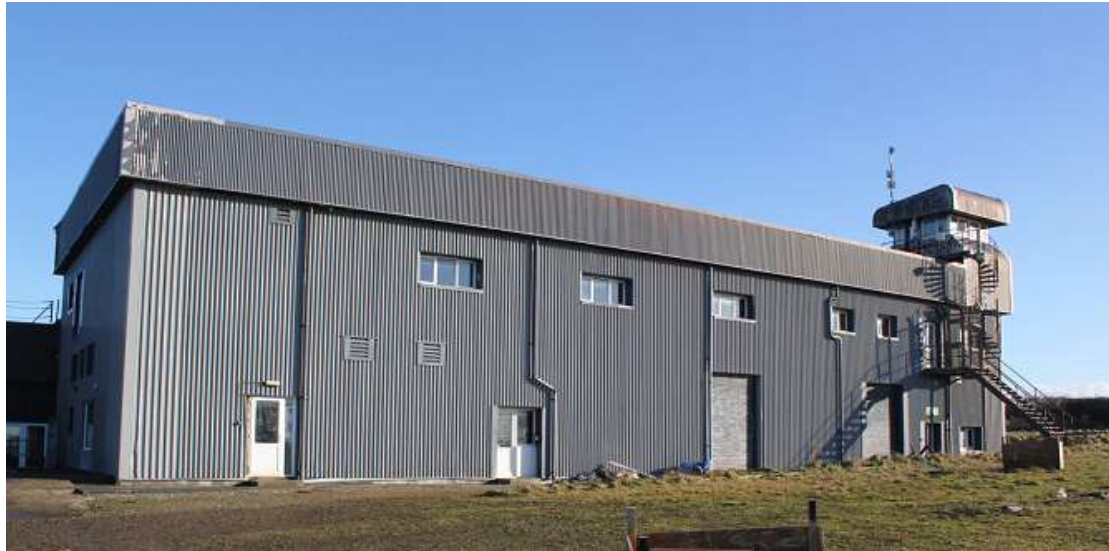
Figure 23: US Naval Facility building at Brawdy

CONDITION DESCRIPTION The complex which formed the NAVFAC Brawdy establishment appears largely intact when visited in December 2013. Though now reused by some businesses, some of the buildings appear to be abandoned and somewhat neglected.

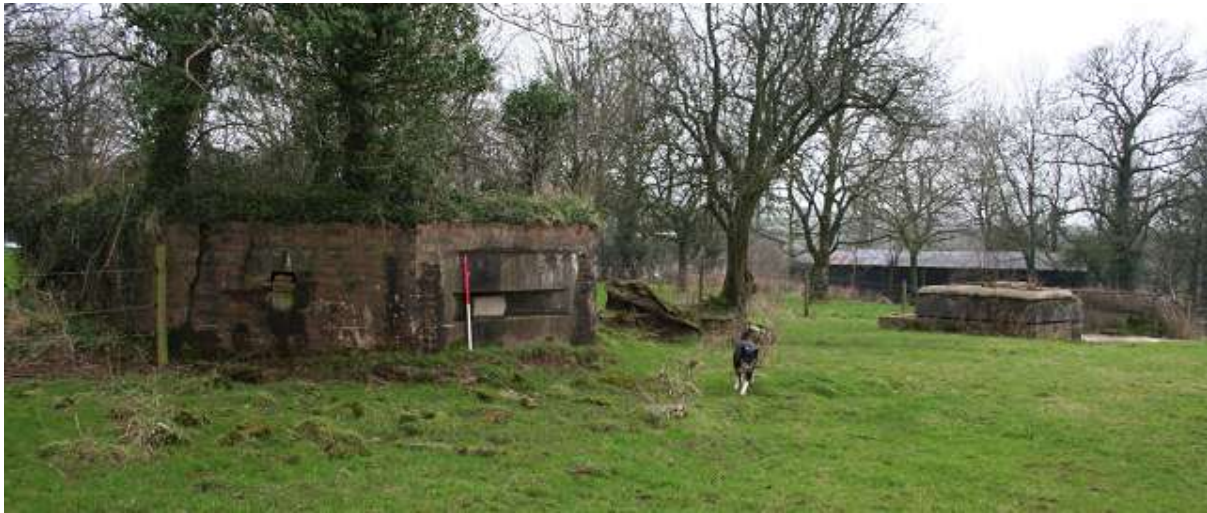
Figure 25: Battle Headquarters and nearby pillbox at Flemington Farm

CONDITION DESCRIPTION / Battle headquarters, still largely intact, part of the hand rails on the flight of steps missing, otherwise intact. Concrete cupola is showing signs of concrete failing, corner to NW has exploded and some of the concrete capping around the cupola disintegrating. Steps inaccessible due to dense bramble and scrub. A Pyper Jan 2014.

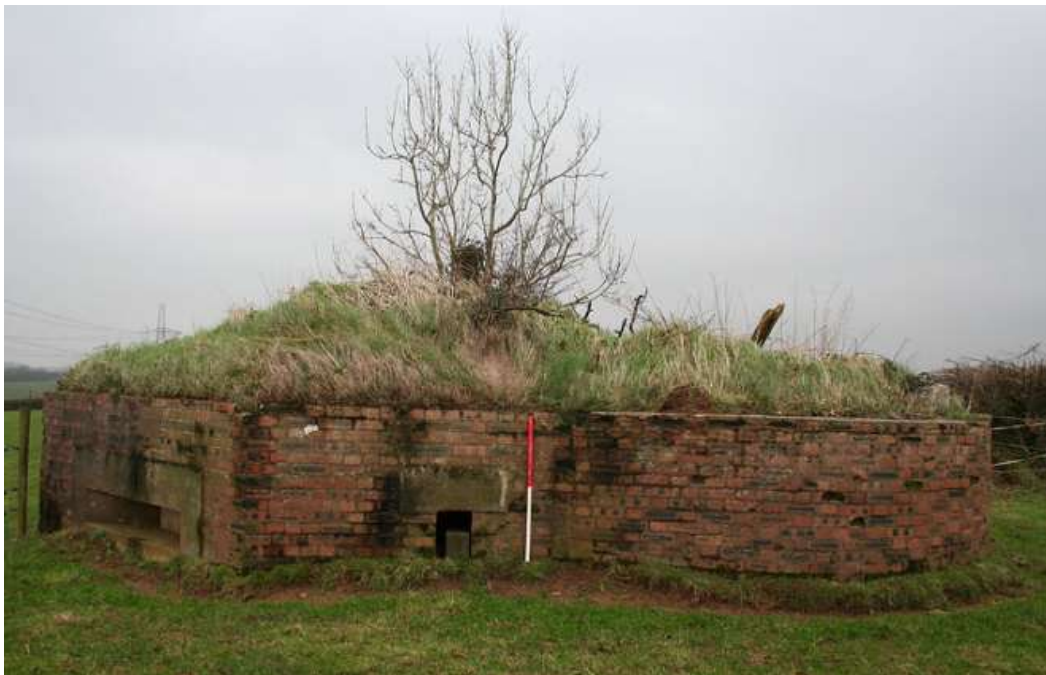
Figure 26: Pillbox to the east of the battle headquarters facing onto airfield

CONDITION DESCRIPTION / Pillbox situated at the junction of 3 hedges. Turf covered and sapling established on the roof of the structure. Otherwise in good condition. A Pyper 2014.

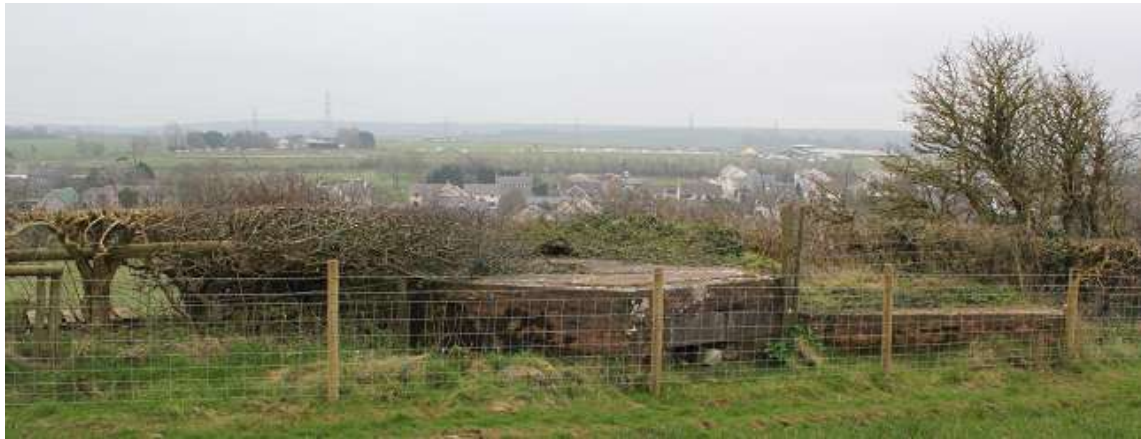
Figure 27: Pillbox overlooking airfield beyond

concrete flat earth and turf covered roof. Partially sunken and very overgrown with brambles. Appears to be slightly altered from standard form and irregular in shape but largely hexagonal. RJC Thomas's description identifies it with two wide splay embrasures with Turnbull mountings and two narrow embrasures. To the west, and within the hedge line is brick walled rectangular annexe. To the east, though not attached is a concrete gun post PRN 26161. A Pyper 2014

CONDITION DESCRIPTION / Intact pillbox, though very overgrown with brambles within hedge line. A Pyper 2014

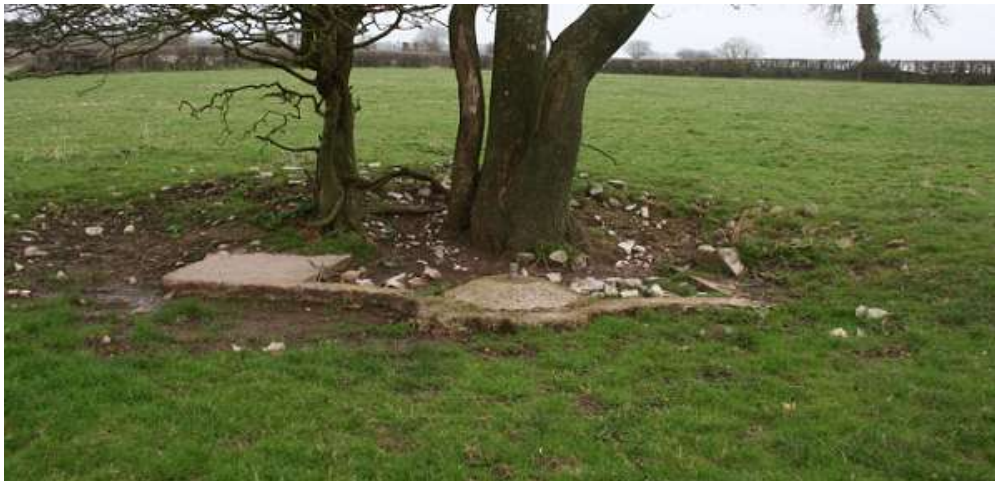
Figure 28: Spigot Mortar overlooking Milton Bridge

A spigot mortar gun emplacement, positioned in good vantage point overlooking the bridge across the river bridge at Milton which formed the old road. The concrete setting is visible below a hawthorn tree, with the steel pin standing proud of a concrete circular setting, to either side are concrete encased magazines. Now infilled, only the top of the cylindrical column is visible with the spigot and the tops of the concrete magazines. A Pyper 2014.

CONDITION DESCRIPTION Apparently intact structure subsurface so all cavities are infilled. A Pyper 2014

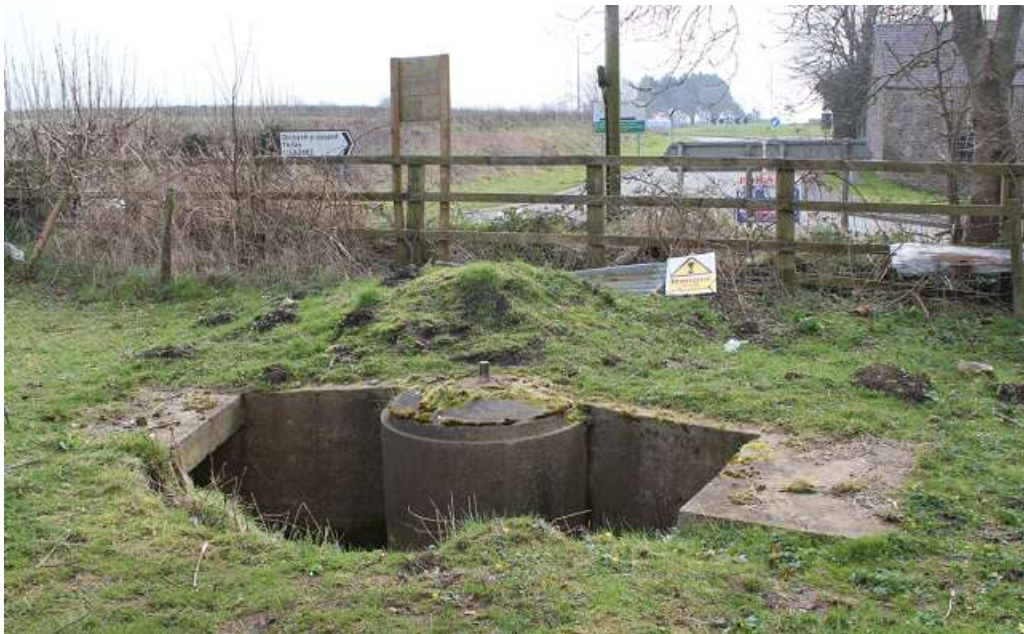
Figure 29: Spigot Mortar overlooking Sageston road junction

CONDITION DESCRIPTION Spigot mortar emplacement in excellent condition, having recently been dug out. Corrugated iron lines the circular part of the pit, this might be replaced when the emplacement was dug out. A Pyper 2014.

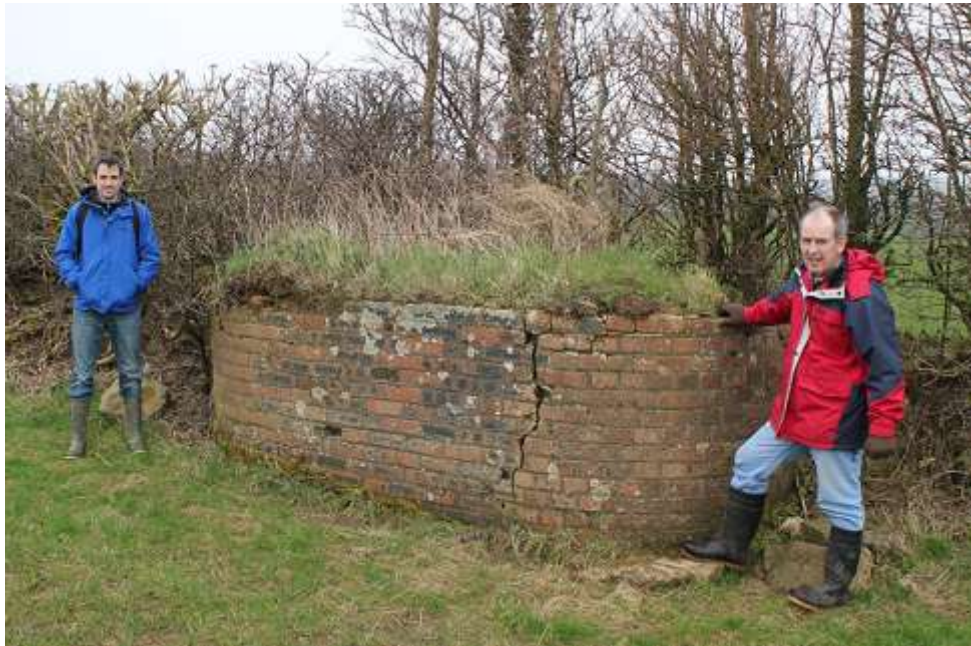
Figure 30: Motley stalk gun emplacement in the hedgeline to the north of RAF Carew Cheriton.

A light anti-aircraft gun emplacement, or motley stalk gun emplacement set into the hedge line running north between defences at PRN 26160 and PRN 105917. Consists of two precast concrete 'sewer pipes' set vertically side by side. The exposed edge on the west side has a brick built facade with wrapping around the curved ends. Earth has been backfilled between the pipes and brick facing with turf now covering. A Pyper 2014.

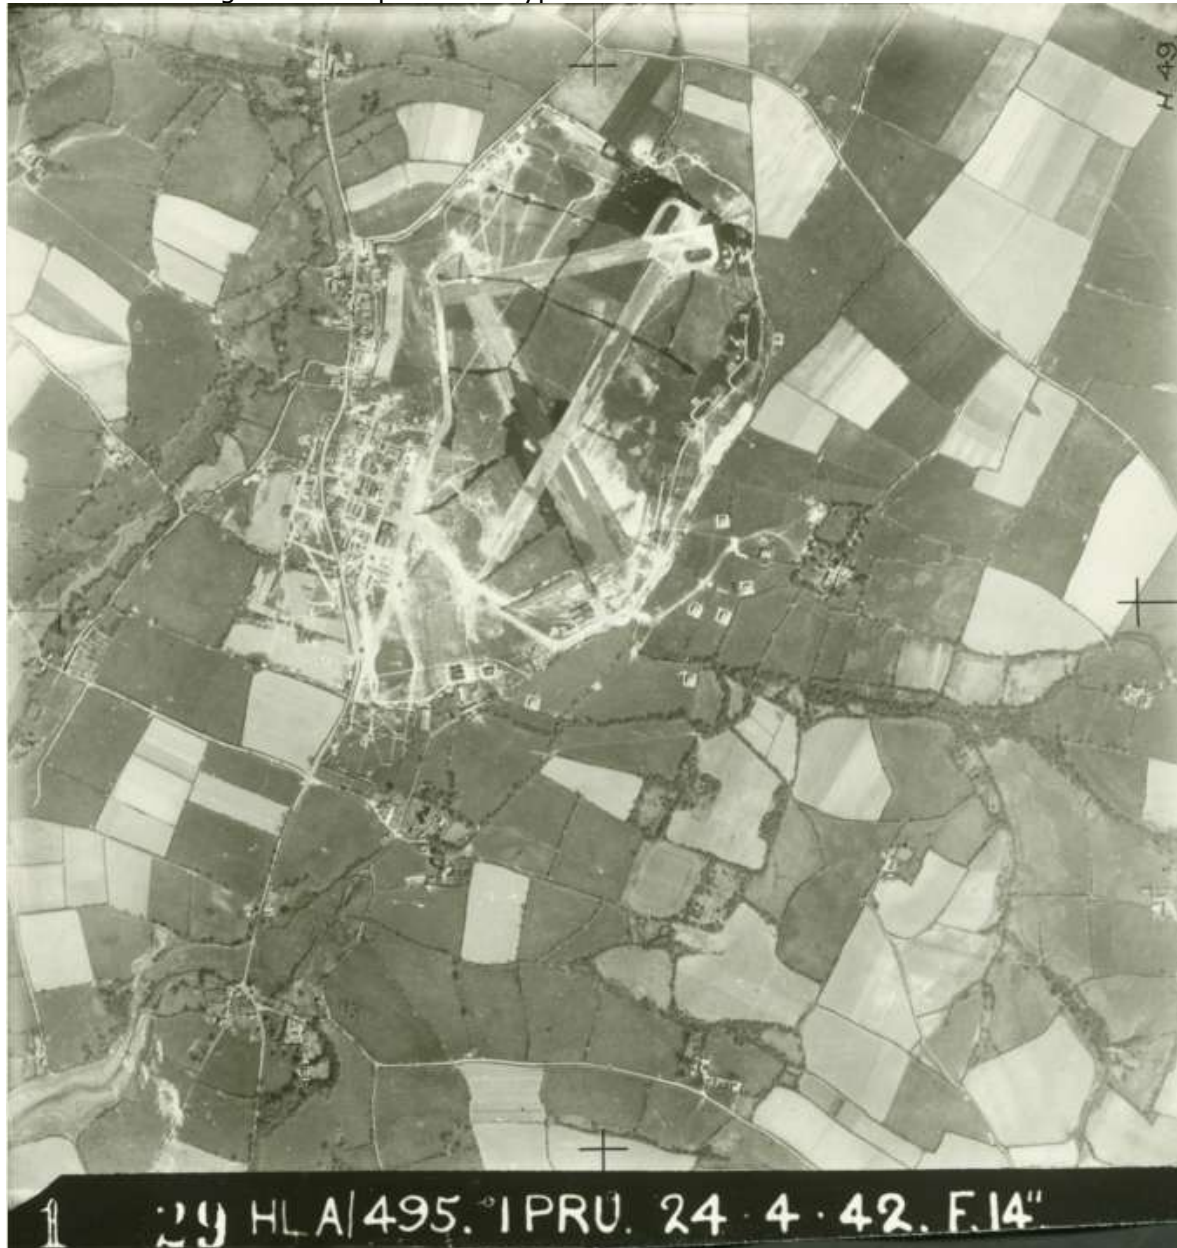
Figure 31: RAF AP showing hangar dispersals to the south of airfield (M 2330 1942)

Lying to the southwest of RAF Carew Cheriton Airfield boundary, as defined on the Air Ministry maps of 1945, though visible on the contemporary air photos of 24/2/42 (Medmenham collection M2330) are seven blister hangars dispersed across the fields between the airfield and Flemington farm. No longer visible at ground level, though access points across the stream exhibit concrete surfacing. A Pyper 2014.

CONDITION DESCRIPTION Site of former complex of blister hangars serving Carew Cheriton airfield. Now in pasture fields and little evidence at ground level, though concrete surfacing at access points. A Pyper 2014.

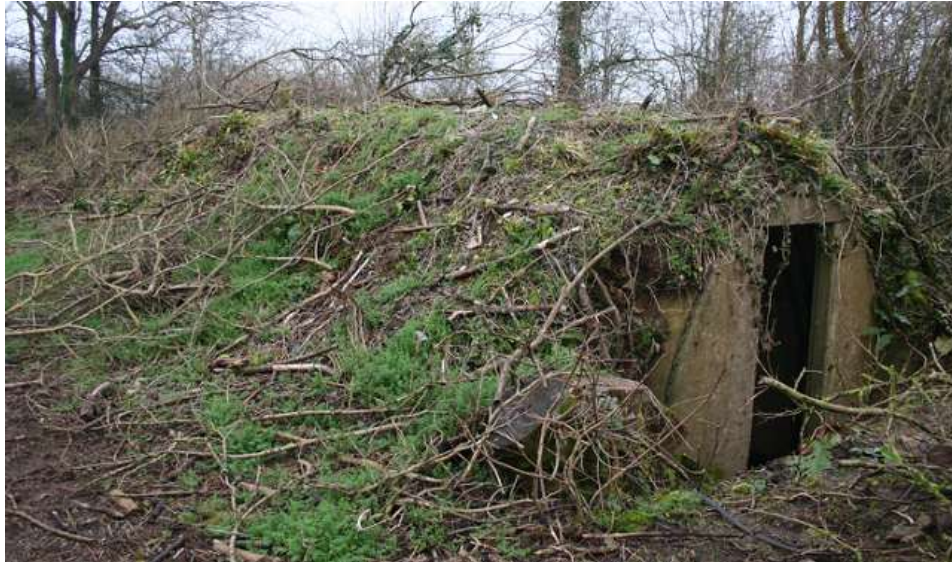
Figure 33: Air raid shelter beside pillbox and gun emplacement

CONDITION DESCRIPTION Although in a very overgrown piece of roadside waste land, this area has recently been subject to some vegetation clearance and the substantial saplings have been cut from the earth covering of the shelter. Alice Pyper Jan 2014.

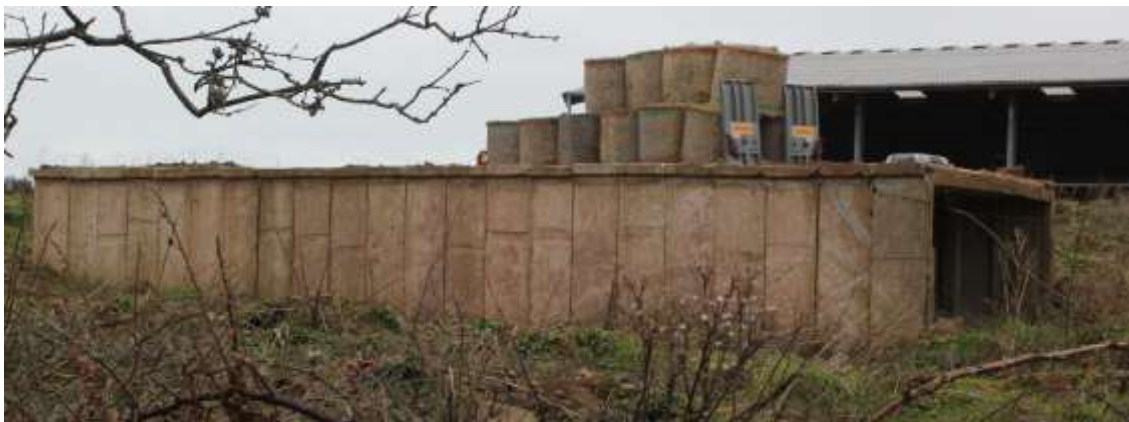
Figure 37: Remaining air raid shelter at the WAAF site

1941-47, Air Raid Shelter, now derelict. Semi-sunken, pre-cast concrete bolted panels, square in profile, entrance door in north wall, emergency exit hatch at south west corner. Whole structure covered and banked by earth. WAAF site, structure 235c, RAF Dale site plan 1464/44. RJC. Thomas, 23.02.93.

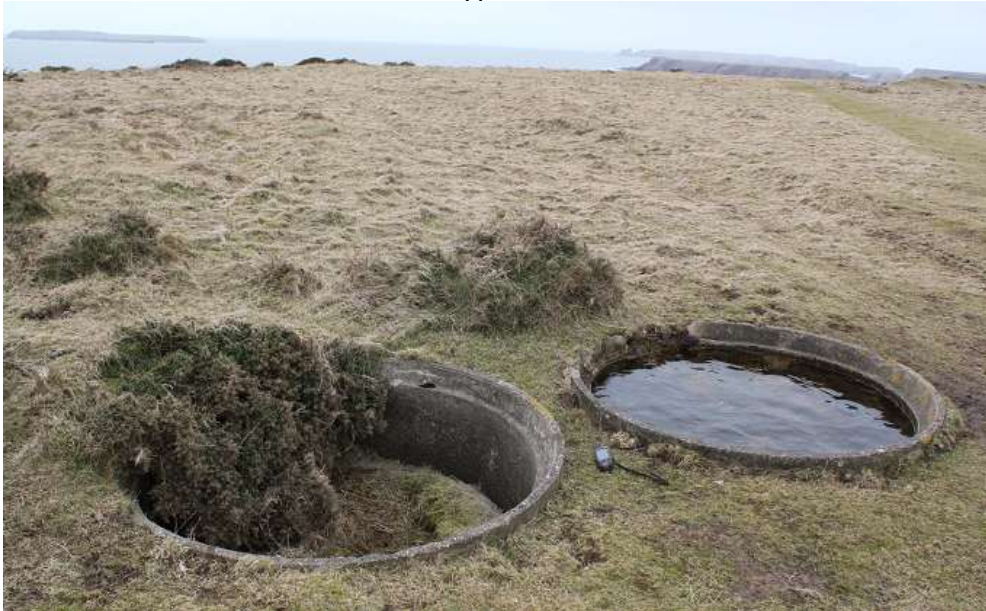
Figure 38: Motley stalk gun emplacement at the southwest corner of the airfield.

CONDITION DESCRIPTION / Two intact concrete rings side by side, sunk into the ground. intact when visited Feb 2014. A Pyper

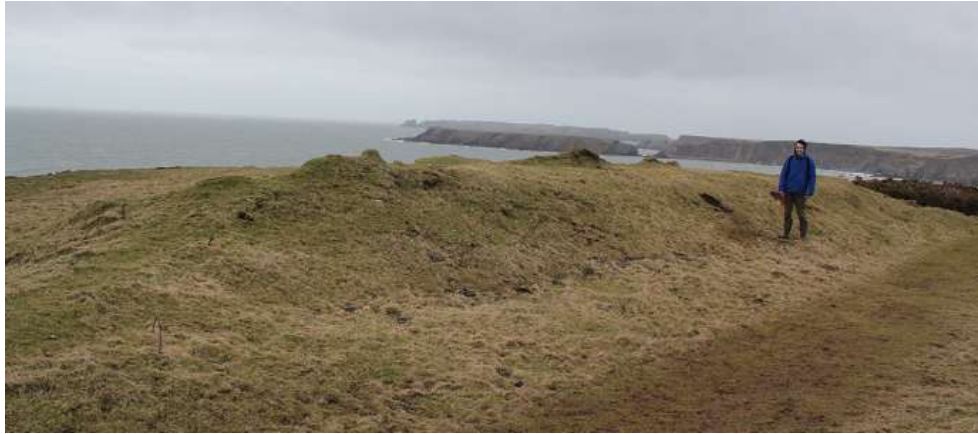
Figure 39: Earthen bank remains of a firing range

Firing range consisting of an earthen bank around 18.30m long and one metre high. A Pyper 2014

CONDITION DESCRIPTION / Grass covered bank, some erosion and bare patches. A Pyper 2014

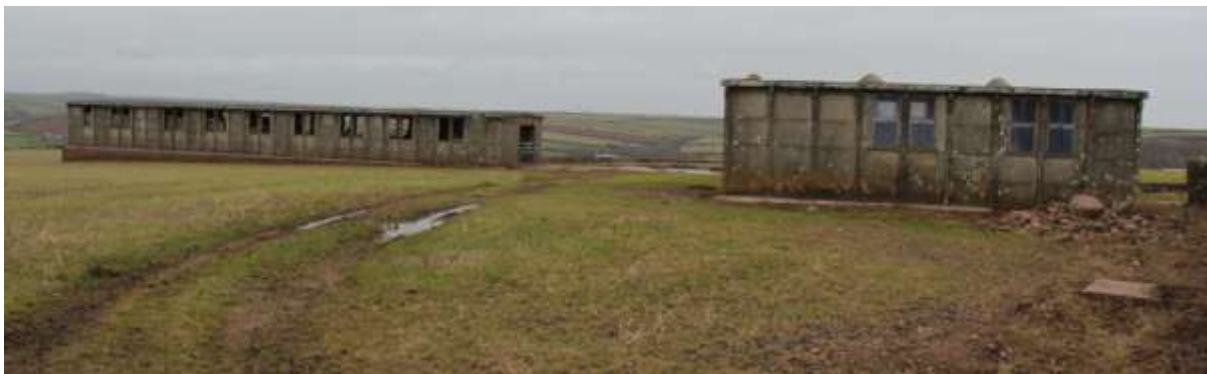
Figure 40: BCF huts, one Receiver block and picket post

Wireless Station, built 1943-47, present use seed potato store. Two BCF (British Concrete Federation) huts. RJC.Thomas, 29.01.93. Now used for low level storage. A Pyper 2014

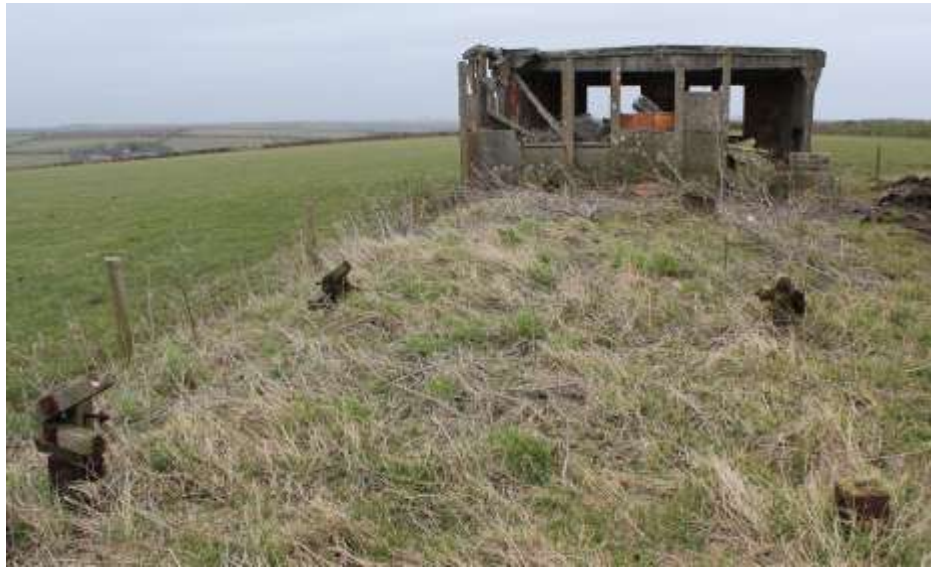
Figure 42: Mast fixing in the foreground and Transmitter block to the rear

Wireless Telegraph Transmitter Block, 1943-47, latterly used for agricultural use, now derelict. Single storey, pre-cast, re-fabricated BCF (British Concrete Federation) hut, bay length. No internal sub-divisions, doorway in south wall, standard steel windows. RJC.Thomas, 03.02.93. Part of a compound in occasional use for cattle housing. A Pyper 2014

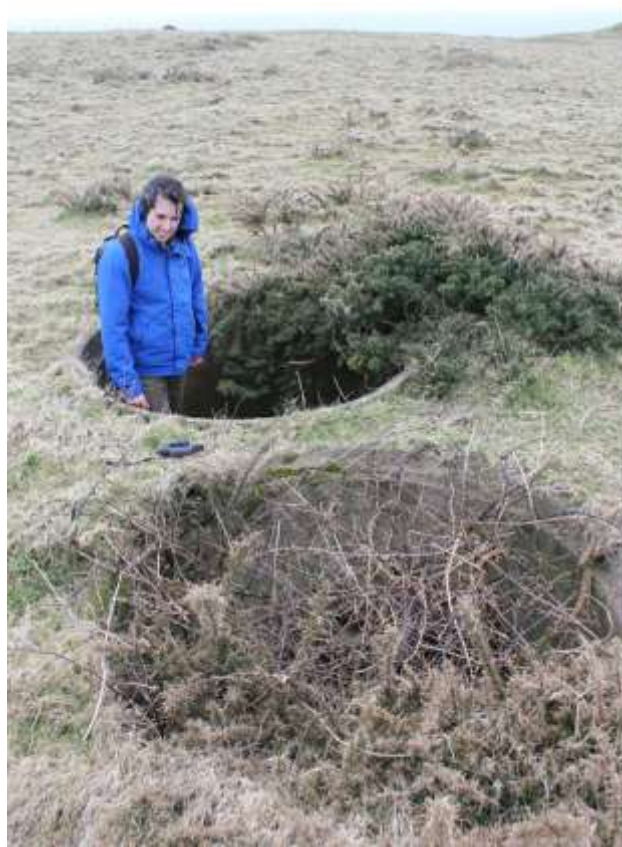
Figure 43: Second gun emplacement at the southwestern edge of airfield.

CONDITION DESCRIPTION Two intact concrete pipes sunk into the ground. Alice Pyper

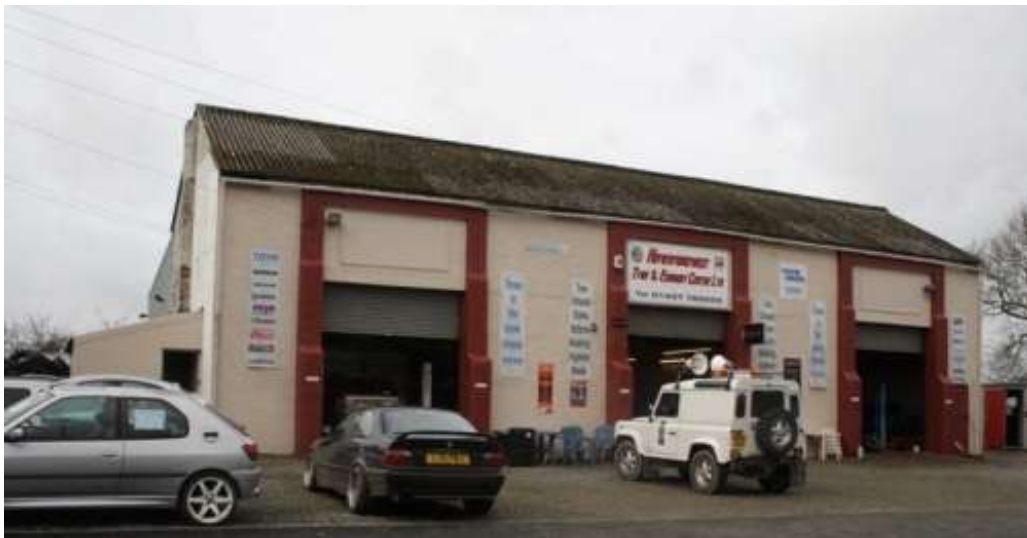
Figure 46: Turret Instructional Building at RAF Haverfordwest

Turret instructional building, Type 'A', with 3 bays. For the instruction of air crew in a simulated gun turret. When visited in Nov 2011 it was in use as a garage workshop. A. Pyper 2012.

CONDITION - Intact

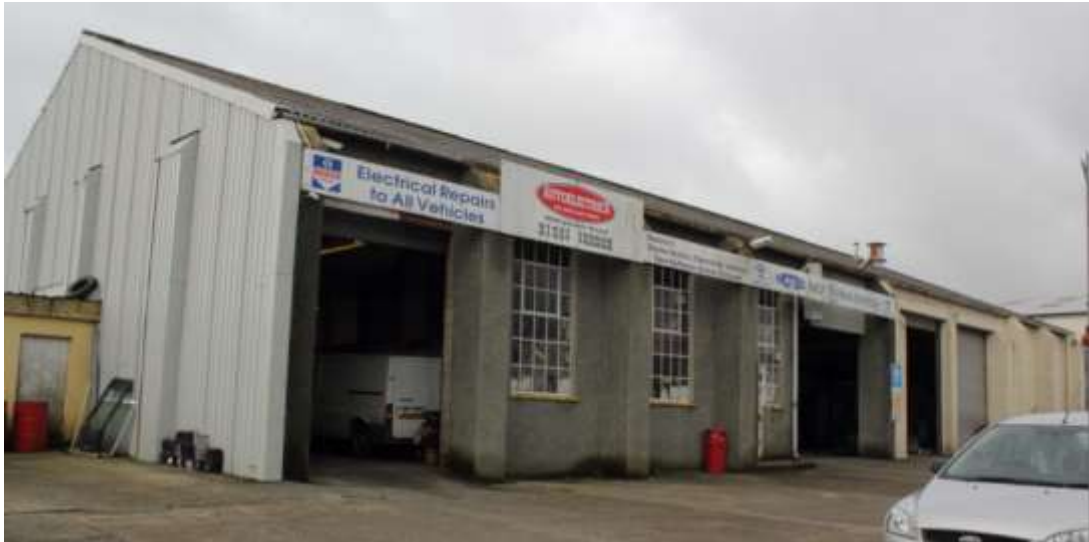
Figure 47: Gunnery and Crew Procedure Building

Recorded on the Air Ministry plan as a Gunnery and Crew Procedure Building. Nine by five bay temporary brick construction with a corrugated asbestos gable roof. Reclad with corrugated iron on the south gable. Tall 30 light windows in each bay. When visited in 2013 in use as a garage, and some bays have been broken through to create openings. A Pyper 2013.

1942-45, Gunnery and Crew Procedure Building, present use garage. One and a half storey, rendered 'temporary brick' construction, 9 X 5 bay rectangular plan, pitched corrugated asbestos gable roof. Tall 30 light standard steel windows per bay. Built per Air Ministry drawing 4597/41. RJC.Thomas, 22.01.93.

CONDITION -Intact

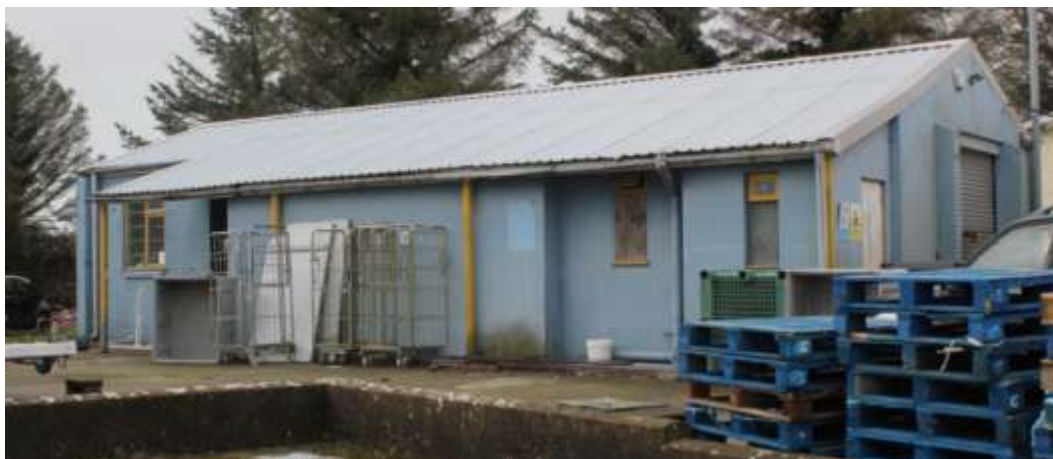
Figure 48: Link trainer building

CONDITION - Intact/ Near Intact

CONDITION DESCRIPTION / Still largely intact though re-clad corrugated iron roof and an extended roof over the front. A Pyper 2013.
