TWENTIETH CENTURY MILITARY SITES: AIRFIELDS – DISPERSED SITES AND DEFENCES

Final Report
A THREAT-RELATED ASSESSMENT 2013-2014
DAT 115A

DYFED ARCHAEOLOGICAL TRUST
RHIF YR ADRODDIAD / REPORT NO. 2014/21
RHIF Y PROSIECT / PROJECT RECORD NO. 103632
DAT 115A
Mawrth 2014
March 2014

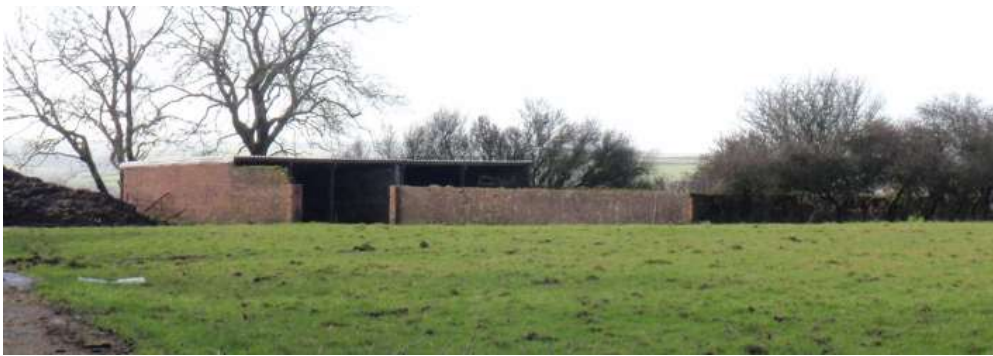
Figure 49: Main beacon at RAF Haverfordwest

A brick built enclosure which formed the Main Beacon for RAF Haverfordwest, part of a landing system to guide airplanes into Haverfordwest airfield and are associated with the Inner and Outer Beacons. Consists of a brick walled enclosure c 1.5m high with a concrete floor within. Converted for agricultural use when visited in 2013 with the southwest wall enclosed and roofed for stock. A Pyper 2013

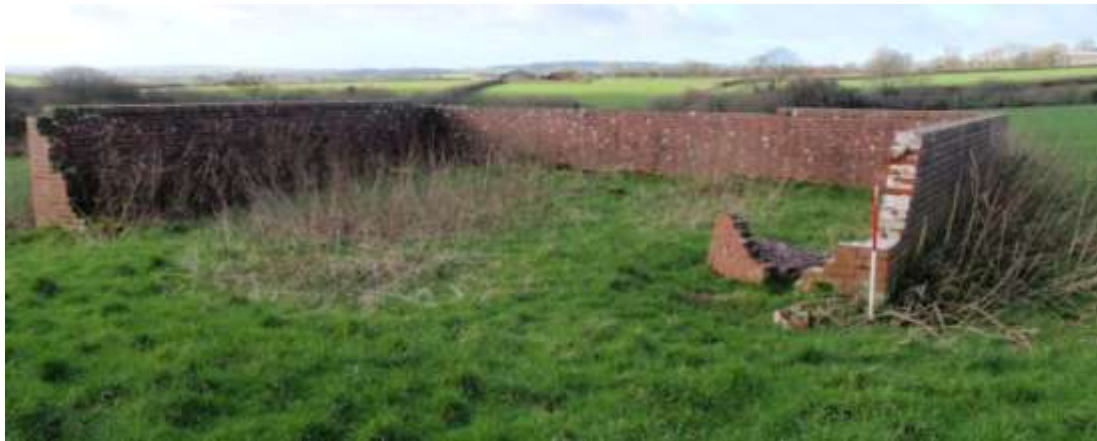
Figure 51: Outer navigational beacon for RAF Haverfordwest

CONDITION - Near Intact/ Damaged

CONDITION DESCRIPTION / The east wall of this structure has been demolished, but otherwise the walls are complete. Visited 2013 A Pyper.

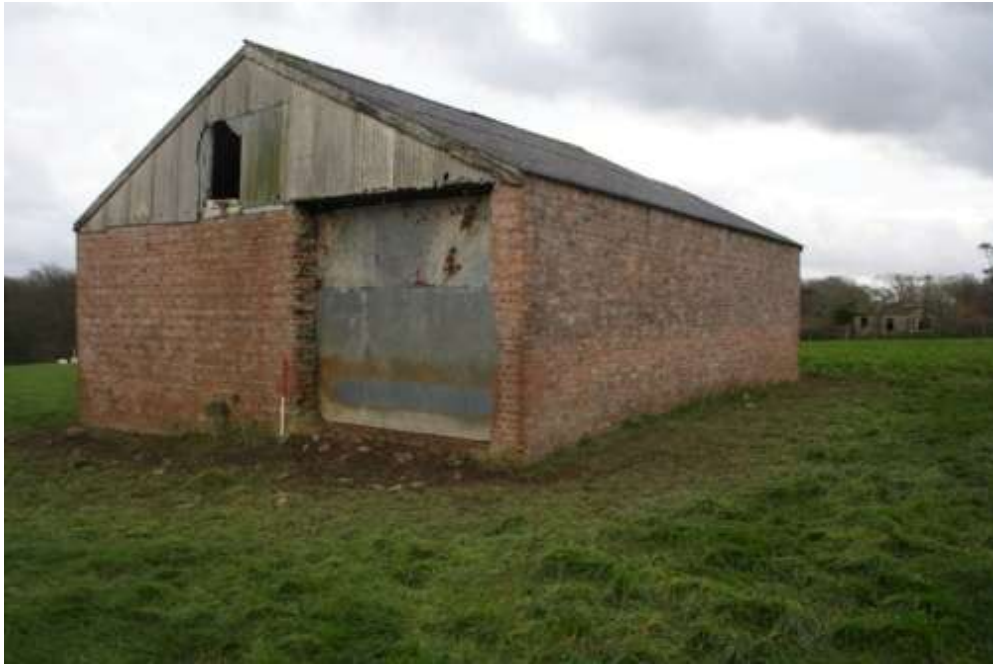
Figure 52: Inner beacon for the airfield at RAF Haverfordwest

Roof and walls appear intact. A Pyper 2012.

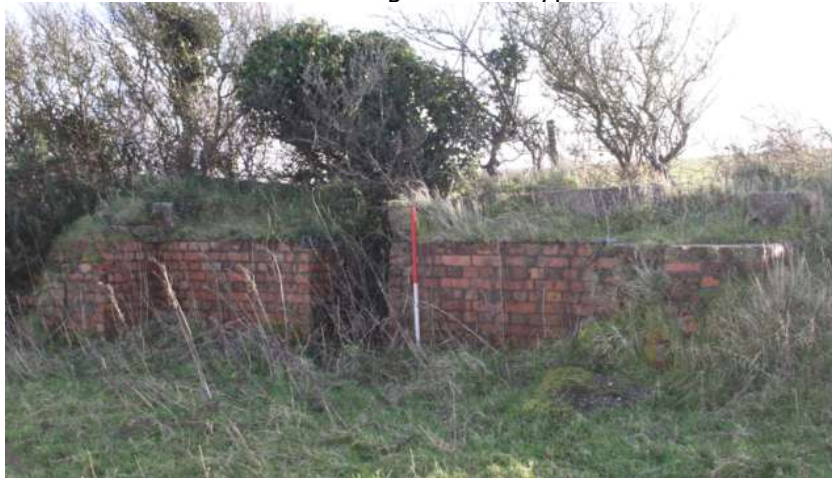
Figure 54: The remaining back wall of a pillbox

Within the hedge line are the remains of a Pillbox. Described by RJC Thomas in 1993 as, 'semi-sunken ,irregular hexagon, fair-faced brick, earth covered re-inforced concrete roof. Original wall thickness of 18 increased to 39. Structure predominantly destroyed, fragmentary section of S wall remains within a hedge line.' When visited in 2011 it was only visible from the north side of the hedge line. A Pyper 2014

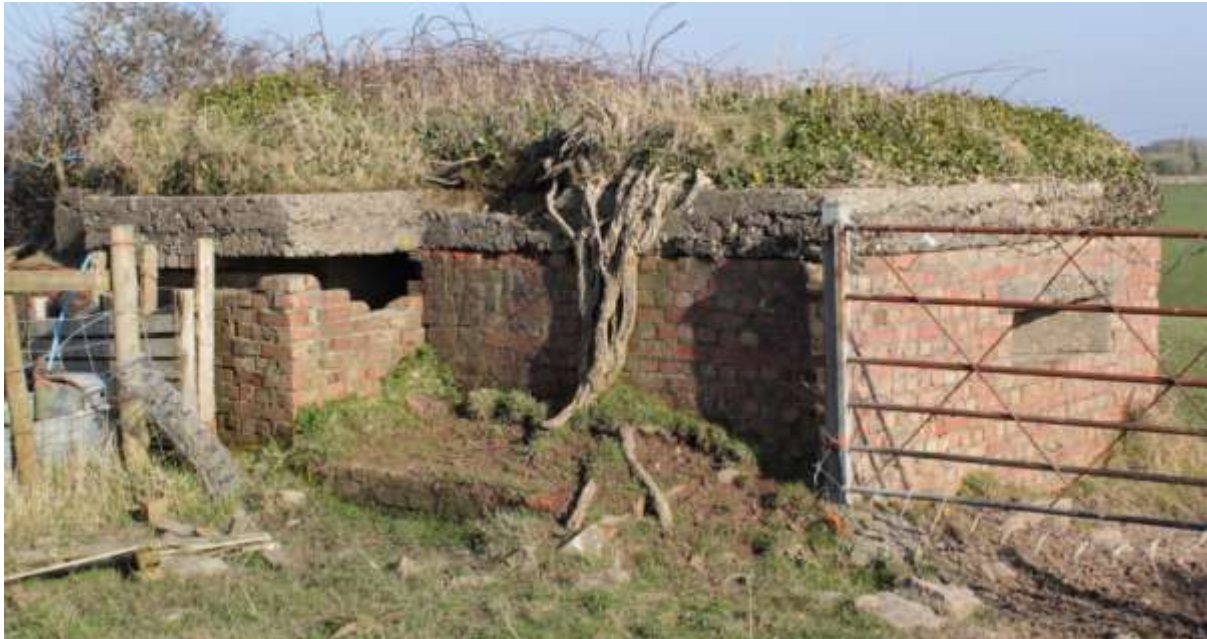
Figure 55: Last intact pillbox at RAF Manorbier

The site of a pillbox, described by RJC Thomas in 1993 as, Semi-sunken, irregular hexagon, fair-faced brick, earth covered 9 re-inforced concrete roof. Wall thickness of 18. Entrance in SW wall protected by a brick blast wall. All remaining walls fitted with wide splay concrete embrasures with 'Turnbull' mountings. Alice Pyper 2014.

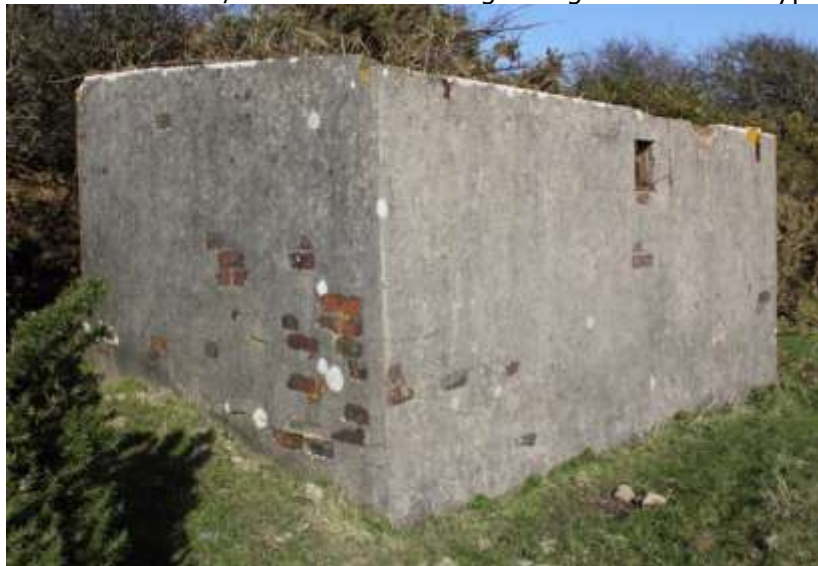
Figure 56: Remains of an ordnance store

Single storey, rectangular plan, approx. 12 x 6 ft., cement rendered 'temporary brick', mono-pitch corrugated sheeting roof carried on timber rafters {removed}. Doorway in north east wall, ventilation grilles set high and low in remaining walls. RJC Thomas 1993

CONDITION DESCRIPTION / Walls still standing though roofless. A Pyper 2013

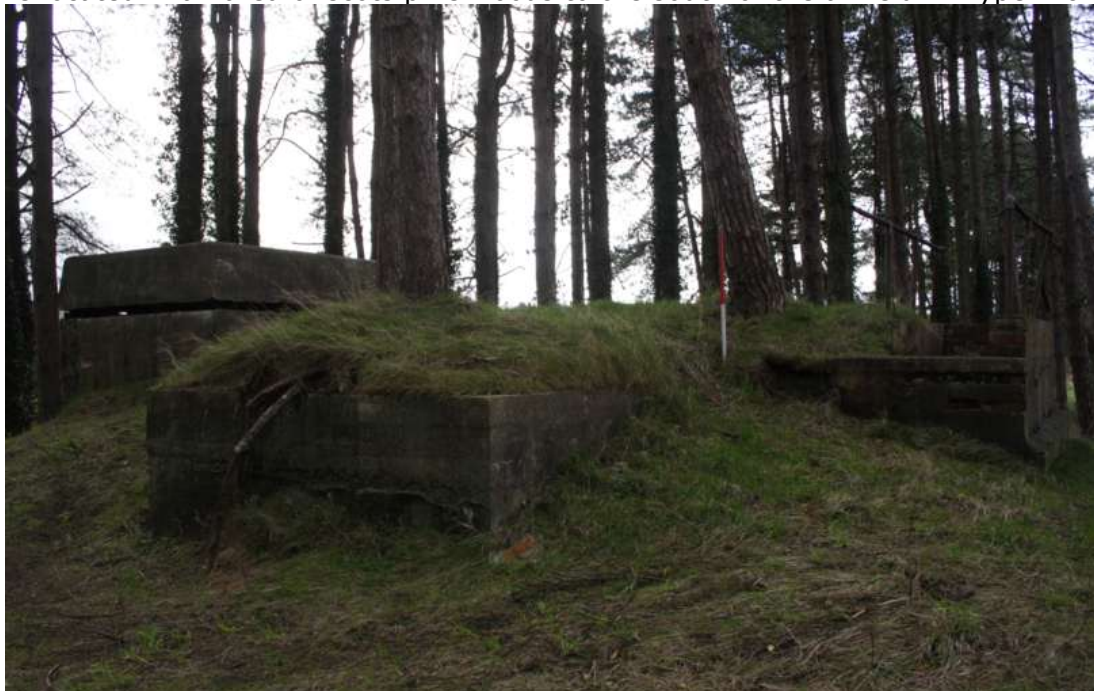
Figure 58: Pembrey battle headquarters

CONDITION DESCRIPTION Visited in 2012, the Battle Headquarters appears intact and is located in an area of scots pine woods to the south of the airfield. A Pyper 2012.

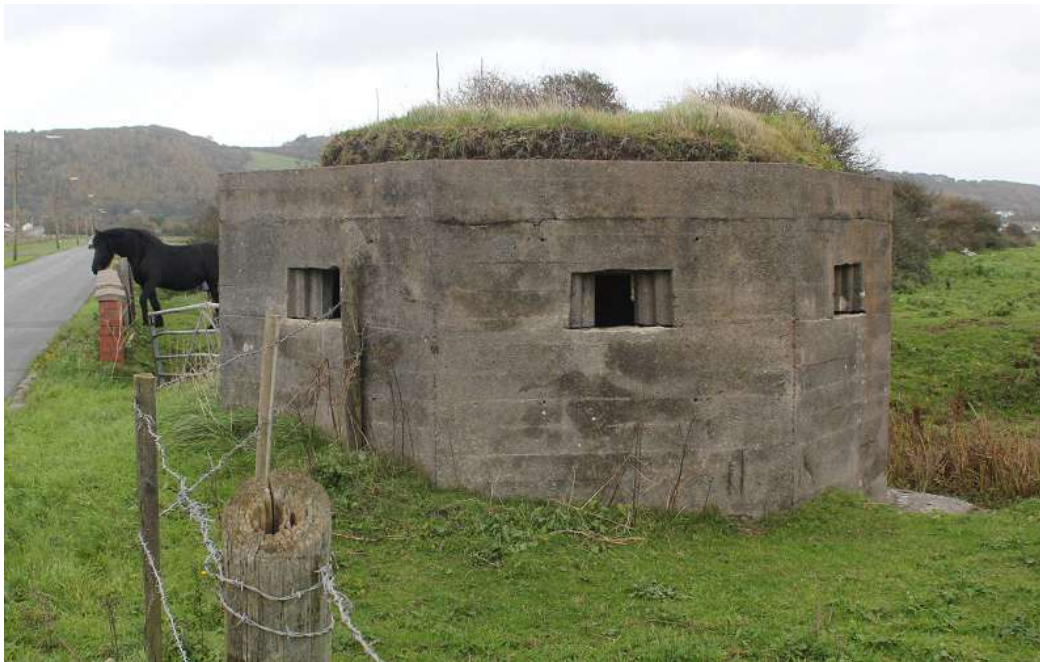
Figure 59: Pillbox to the east of the Factory road

CONDITION DESCRIPTION / Becoming slightly undermined on the northeast side by the Swan Pool drain. A Pyper 2014.

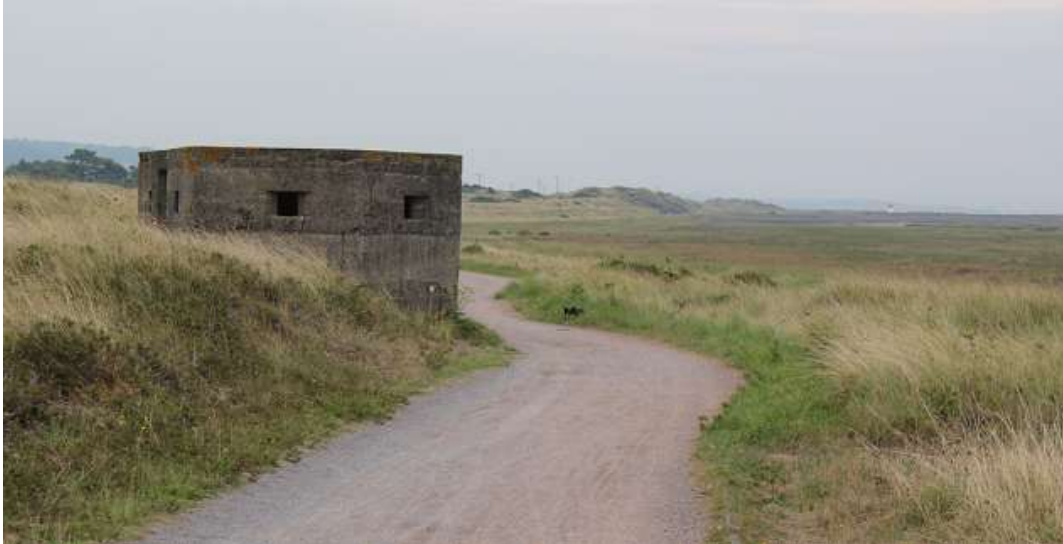
Figure 60: Pillbox at the southern end of the Carmarthen stopline

Irregular hexagonal (type 24) concrete pillbox located at the southeast corner of the Royal Ordnance Factory site and the southern end of the Carmarthen stop line. Facing southeast. Brick and concrete Y-shaped anti-ricochet wall inside. A Pyper 2014.

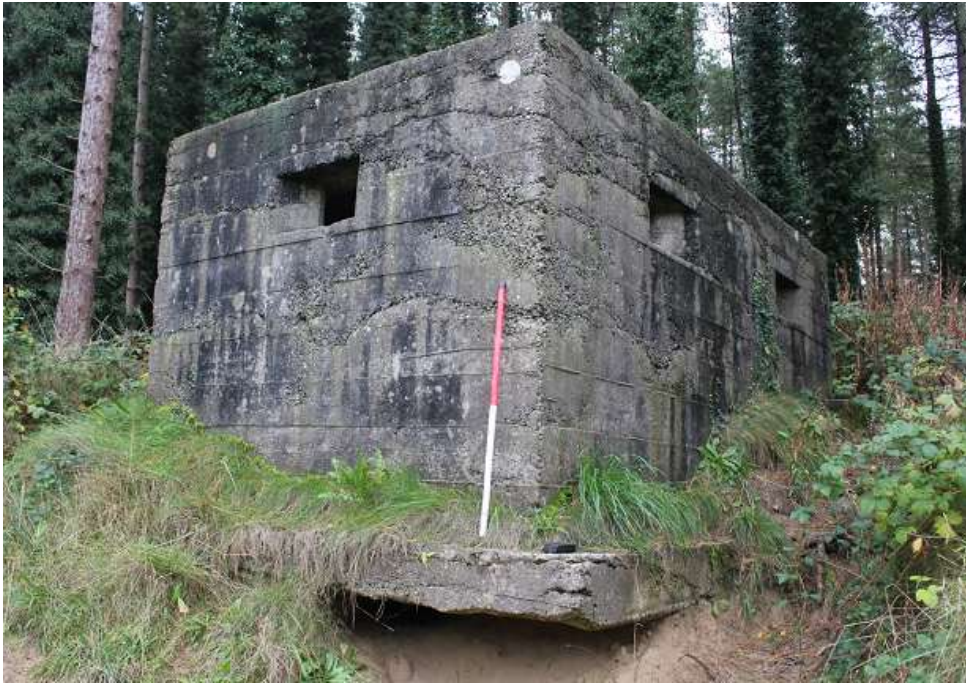
Figure 61: Pillbox overlooking Factory road at Pembrey

CONDITION DESCRIPTION / Intact pillbox though sand dune eroding underneath the northwest corner. A Pyper 2014.

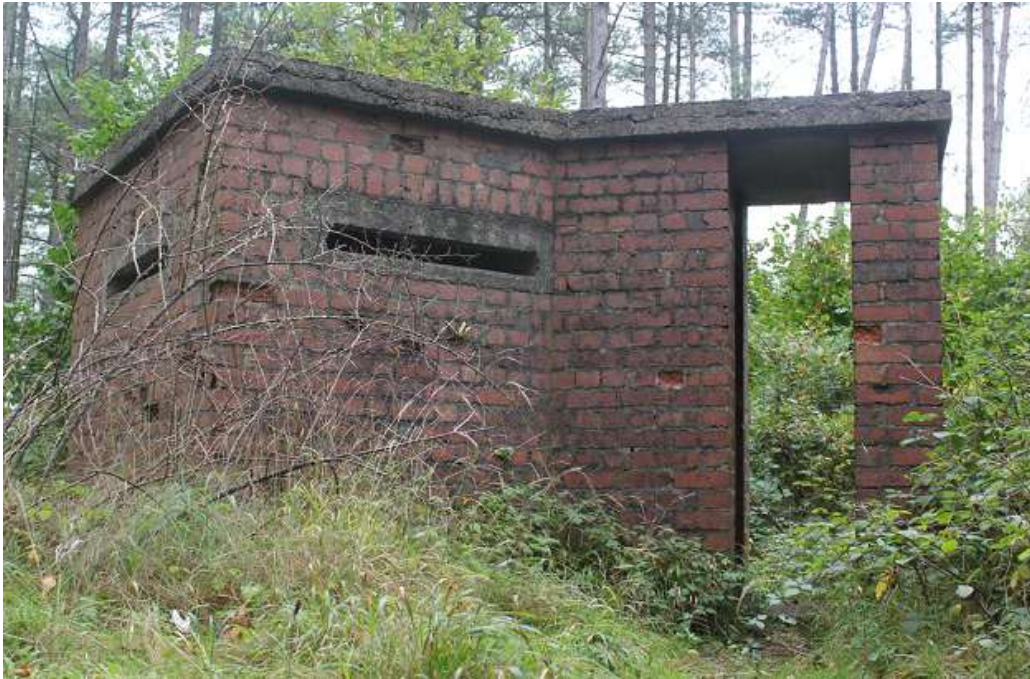
Figure 62: Observation post at Pembrey

CONDITION DESCRIPTION / Within pine forest and located on a dune. A Pyper 2014

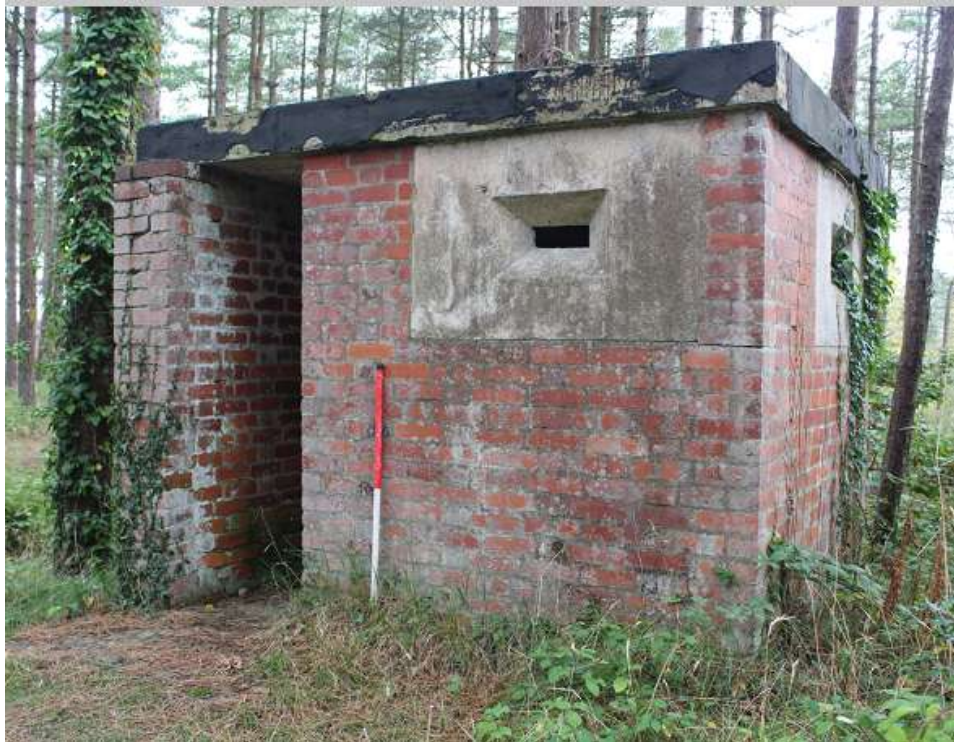
Figure 63: Observation post at Pembrey, part of protected entrance missing

Brick rectangular building with flat concrete roof. Protected entrance, though part of the blast wall has been lost. A Pyper 2014

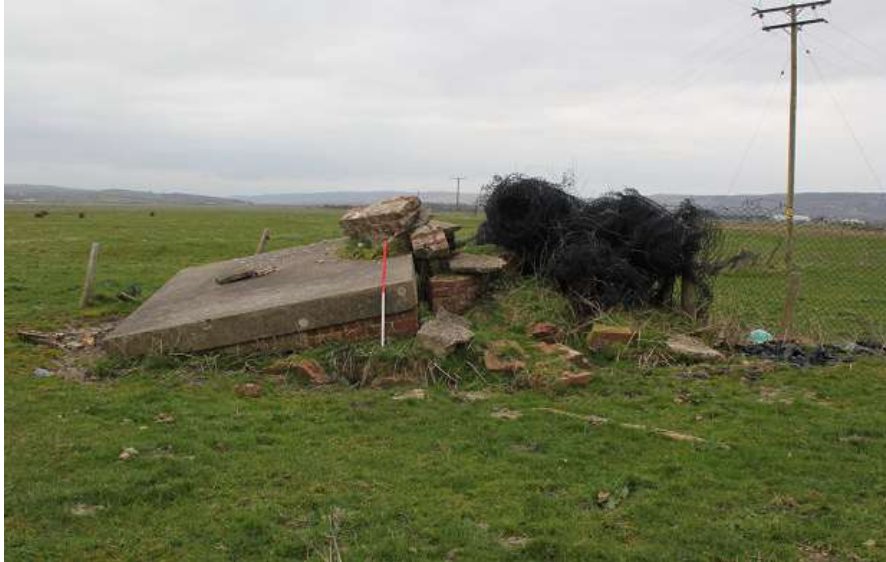
Figure 64: Remains of a pillbox at the southwest end of the sea wall

A demolished remains of a brick and concrete Type 23 pillbox. Part of a defensive line which runs along the sea wall, Banc-y-Lord protecting the airfield to the southeast from seaward attack. A Pyper 2013.

CONDITION DESCRIPTION / Although demolished (blown up?) at some point all the parts of the pillbox appear to survive where they fell, so it is possible to define the gun embrasures. A Pyper 2013.

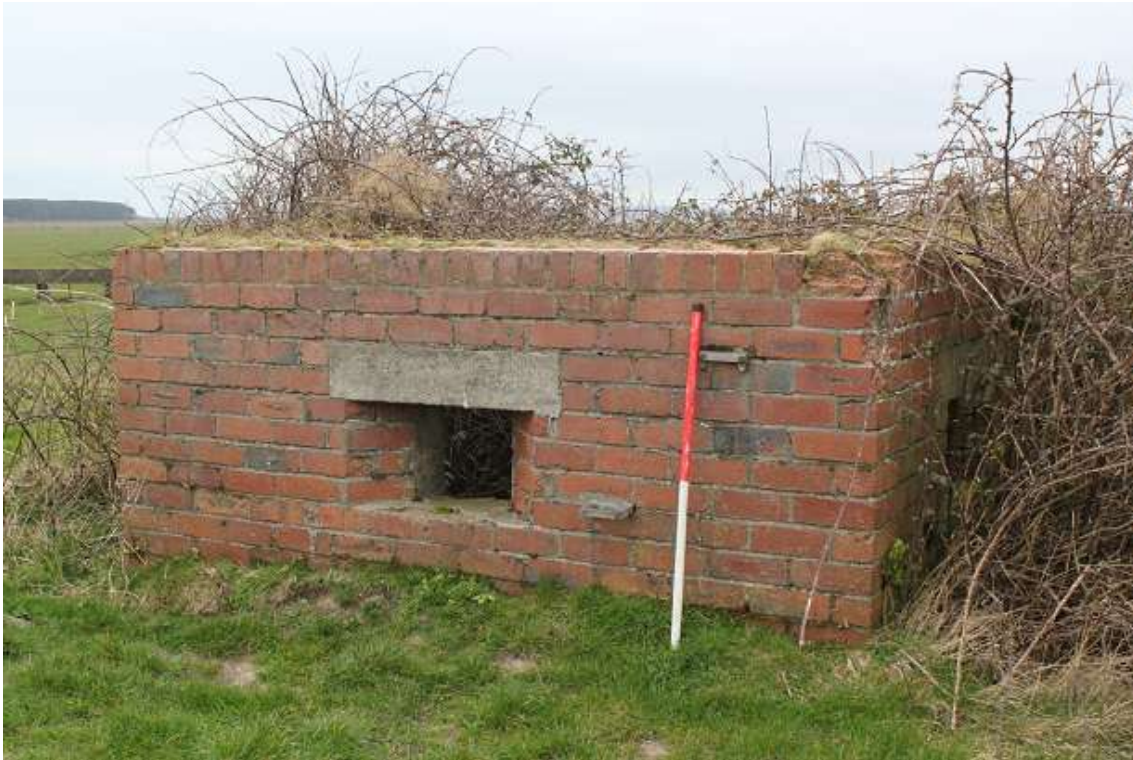
Figure 65: Pillbox on the sea wall at Pembrey, note metal access treads in brickwork

A brick and concrete pillbox located on the northwest side of the Bank-y-Lord sea wall, facing west protecting the airfield to the southeast. Type 23 in design (rectangular subdivided into one open, roofless section the other covered). Narrow gun embrasures with metal pivot mountings in the sill. Forms part of a defensive line of pillboxes which run along Banc-y-Lord. A Pyper 2014

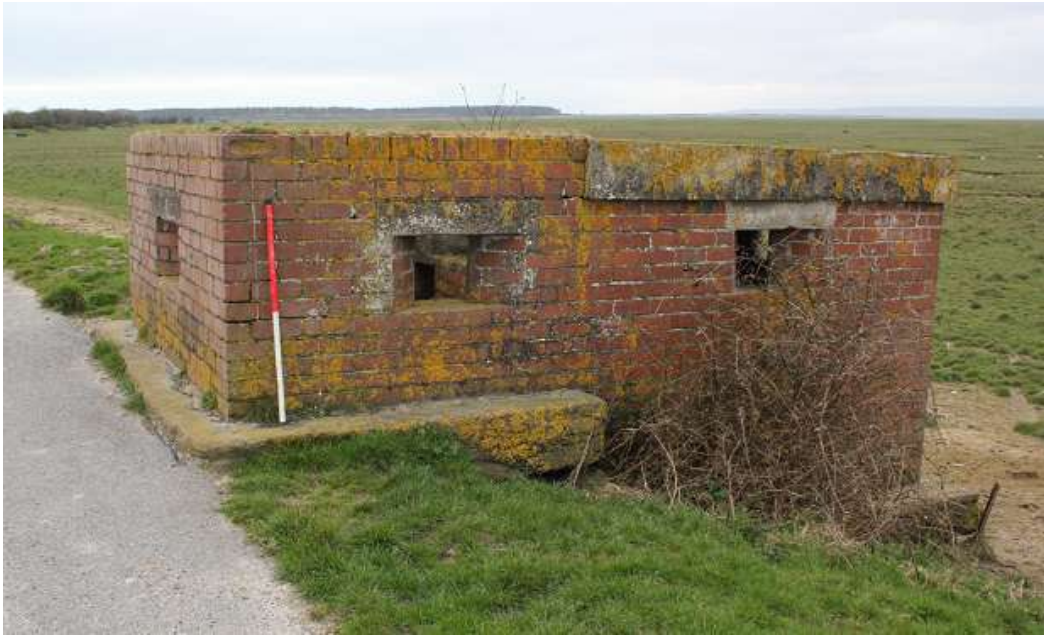
Figure 66: Pillbox built into the sea wall

A brick and concrete pillbox located on the northwest side of the Bank-y-Lord sea wall, facing west protecting the airfield to the southeast. Type 23 in design (rectangular subdivided into one open, roofless section the other covered). Narrow gun embrasures with metal pivot mountings in the sill. Forms part of a defensive line of pillboxes which run along Banc-y-Lord. A Pyper 2014

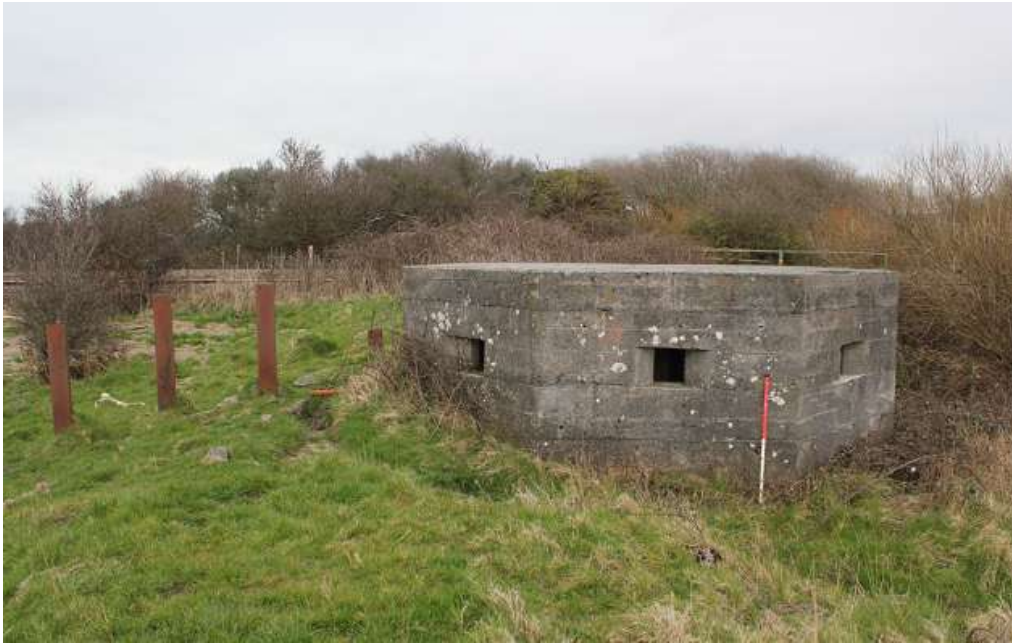
Figure 67: Pillbox with anti tank rails to the side

A pillbox built of shuttered concrete to the south of the railway and to the north of Banc-y-Lord. A strong point positioned on the stop line which consists of anti-tank blocks to the south and two parallel lines of vertically set railway rails to the north. The pillbox is facing west with the entrance in the east wall. Type 24 (rectangular with canted corners to the west), and with narrow gun embrasures. A Pyper 2014.

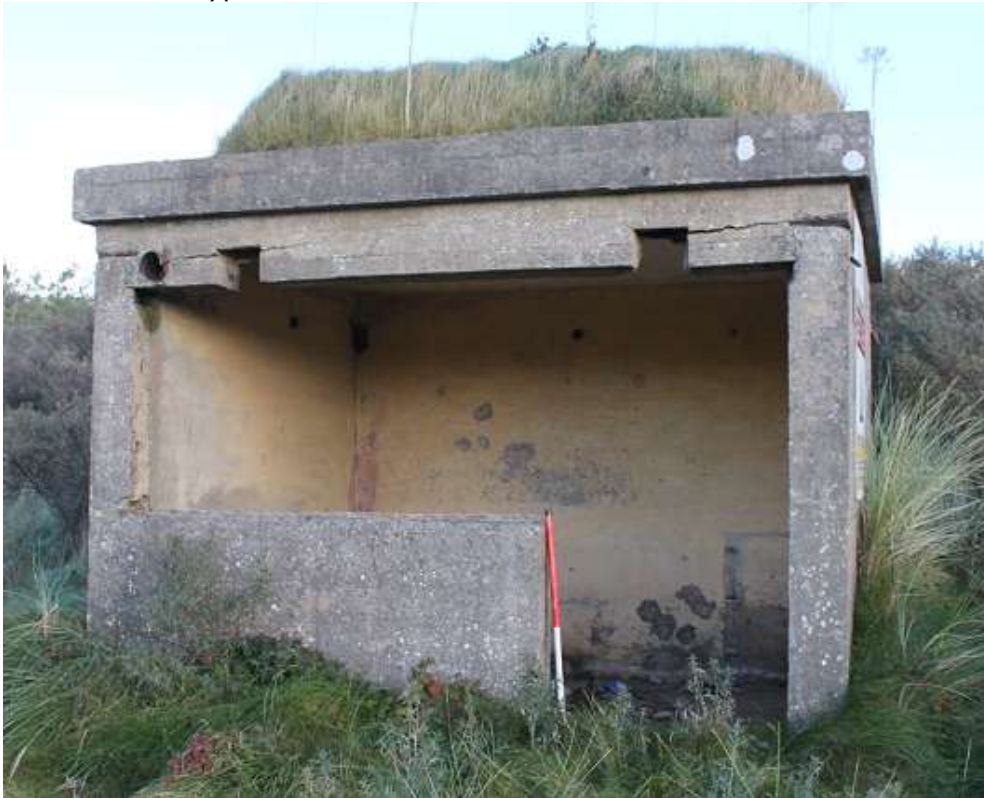
Figure 68: Gun emplacement overlooking Cefn Sidan beach

A gun emplacement built of reinforced concrete with turf on the flat roof. Rectangular in plan 3.05 x 2.4 m with openings facing southwest. One wide rectangular opening in southwest wall with doorway to side. Internally the walls are painted cream and a small concrete pad on the northeastern corner may form the base of stove. Other fixings and fixtures are traceable in the paintwork of the interior. Forms part of series of gun

emplacements built to defend Cefn Sidan beach from invasion or attack during the Second World War. A Pyper 2014

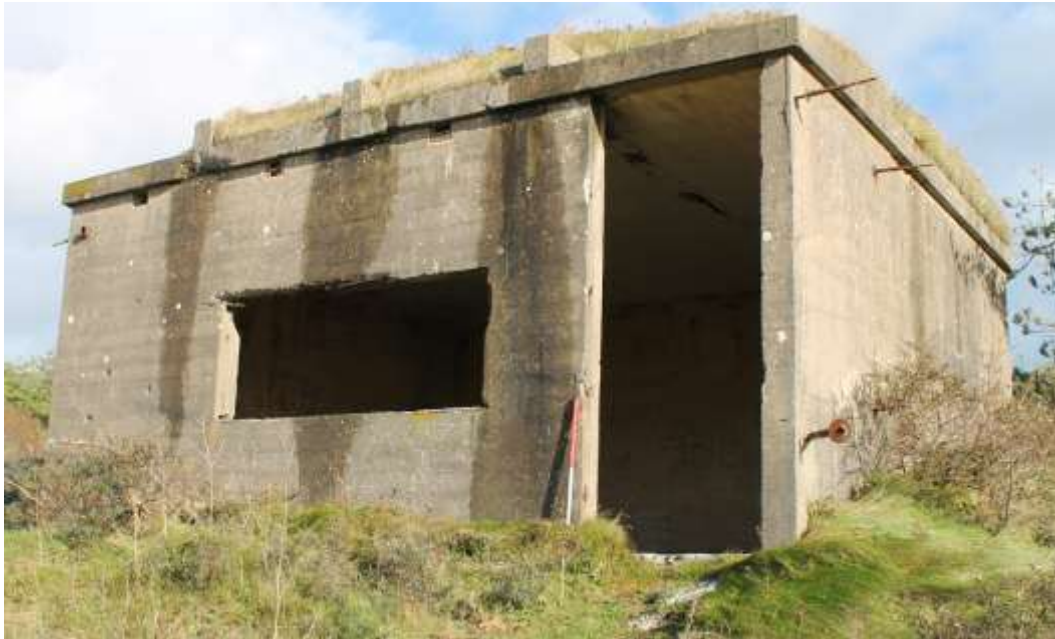
Figure 69: Gun emplacement, one of three overlooking Cefn Sidan

A gun emplacement built of reinforced concrete with turf on the flat roof. Rectangular in plan 6.4 x 7.3m with openings facing southwest. One wide rectangular opening in southwest wall with doorway to side. Internally the walls are painted cream and a small concrete pad on the northwestern wall may form the base of stove. Other fixings and fixtures are traceable in the paintwork of the interior. Forms part of series of gun emplacements built to defend Cefn Sidan beach from invasion or attack during the Second World War. A Pyper 2014

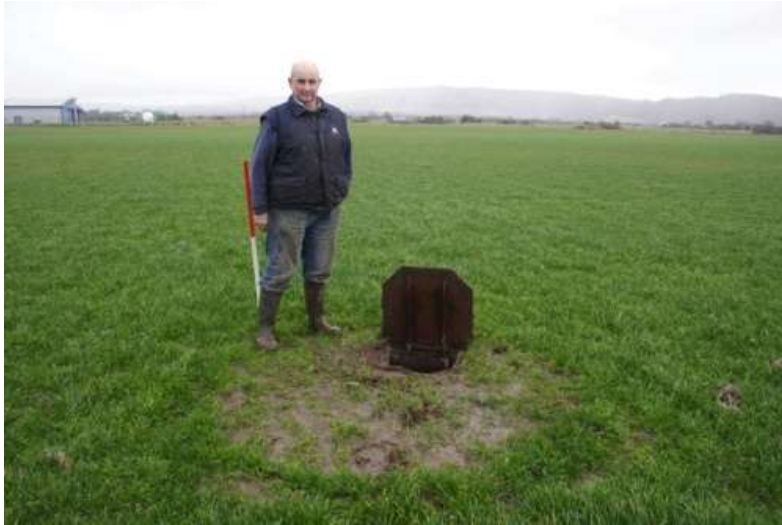
Figure 70: Pickett Hamilton fort to the east of the airfield

Concrete pad survives within reseeded field, and metal trap door is hinged. Interior is full of water, however allegedly it contains its internal mechanism and hydraulics. A Pyper 2012.

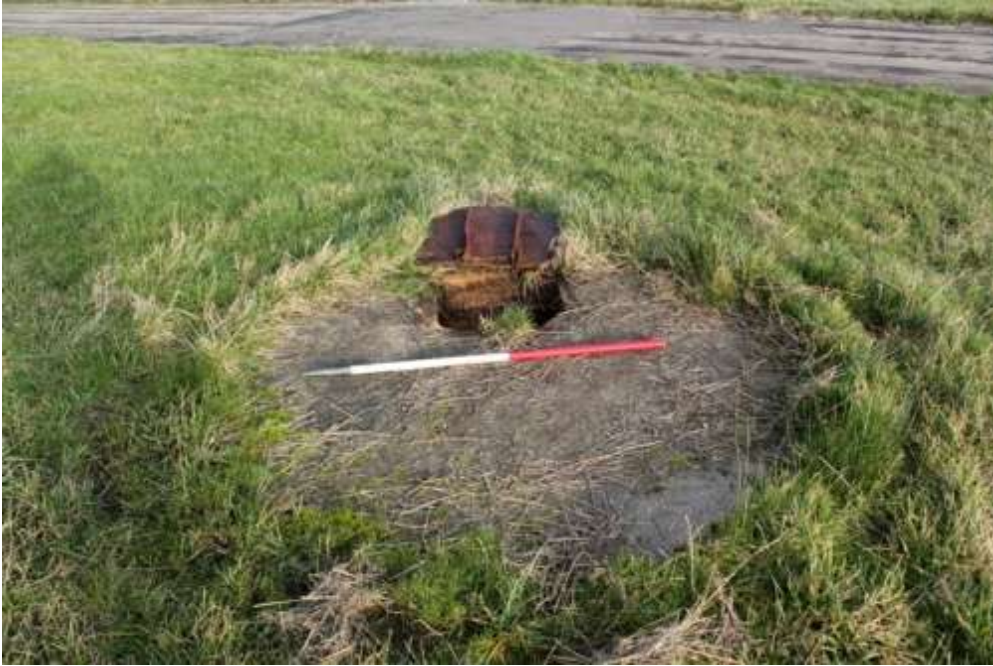
Figure 71: Pickett Hamilton fort at the north side of the airfield

Apparently intact, this Pickett Hamilton is one of two surviving examples which have been recorded at Pembrey airfield. This type of pillbox appears to be very rare in Wales. A Pyper 2012.

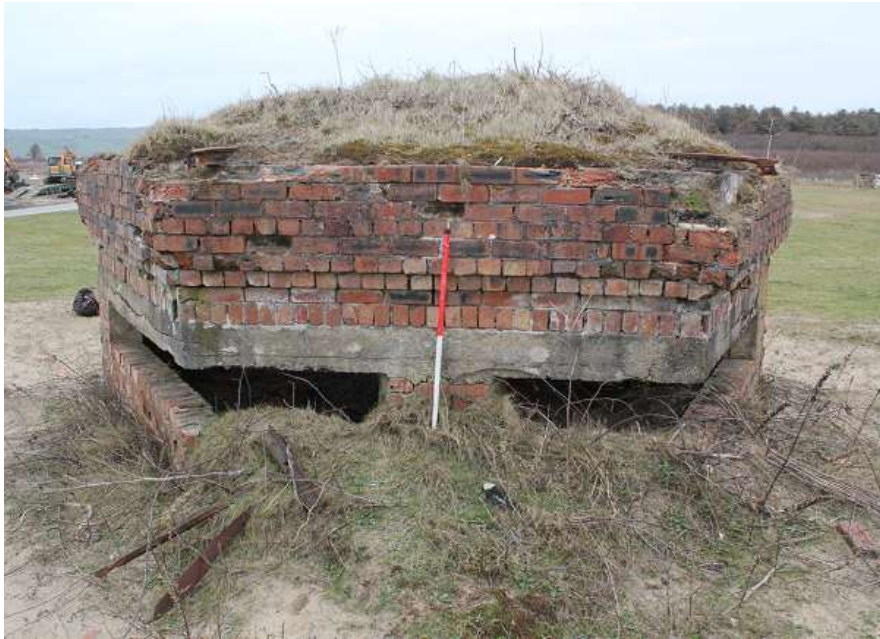
Figure 72: Pillbox overlooking Cefn Sidan beach

CONDITION DESCRIPTION Largely intact, though brick and concrete fracturing and eroding. A Pyper 2014

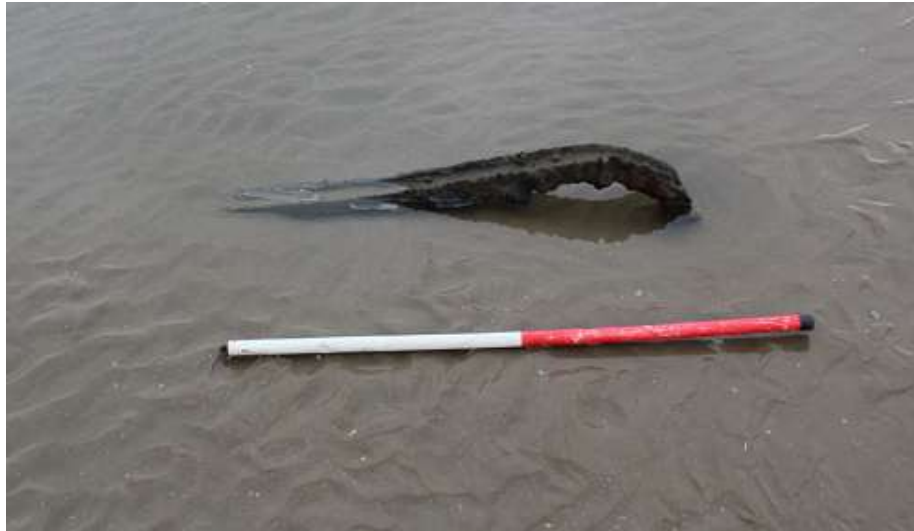
Figure 73: Anti-invasion defences in Cefn Sidan beach

Beach defences consisting of metal rails driven into the sand vertically or obliquely, to act as anti-landing obstacles. Apparently extending the length of Cefn Sidan beach. Rails vary in length and dimensions and may originate from the tramways and tracks at the Royal Ordnance Factory. A Pyper 2014.

CONDITION DESCRIPTION The coastal defences were being removed from an area south of the RAF Pembrey range tower in order to provide a safe temporary landing zone for aircraft training purposes. A section between SN3676902955 and SN3626803999 have been cleared. A Pyper 2014.

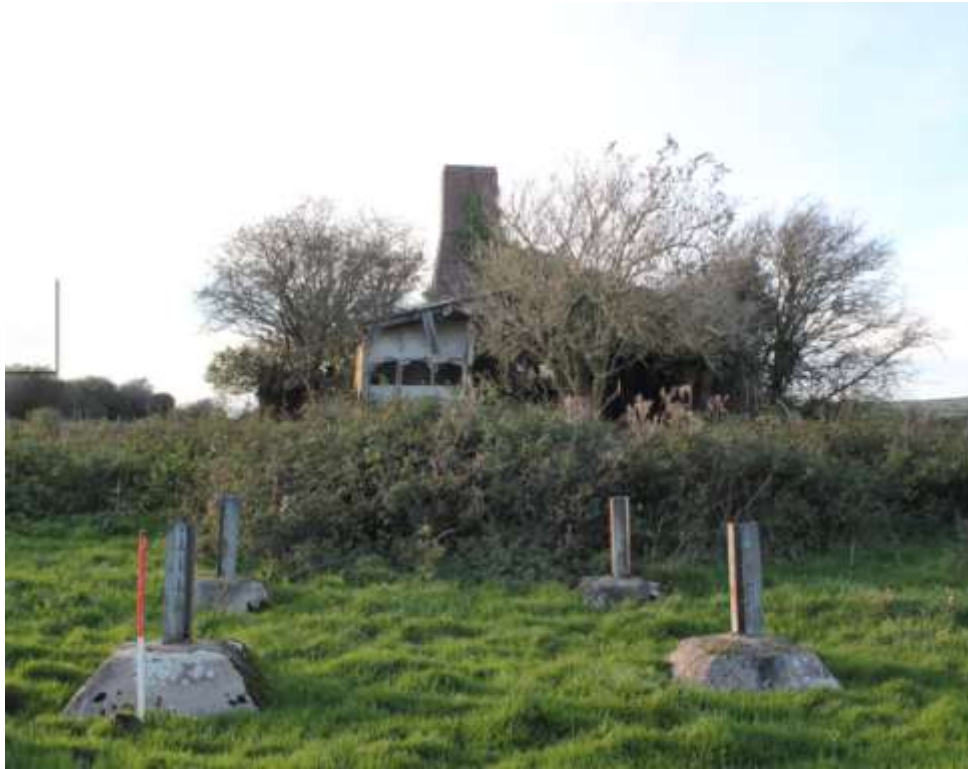
Figure 74: Radio station at RAF Pembrey, mast fixings in the foreground

CONDITION DESCRIPTION The timber building at the centre of the site is derelict and the timber walls collapsing. The blast wall is also fragmentary and vegetation is overgrowing it all. The air raid shelter survives to the west but is very overgrown. The mast bases survive well. A Pyper 2014

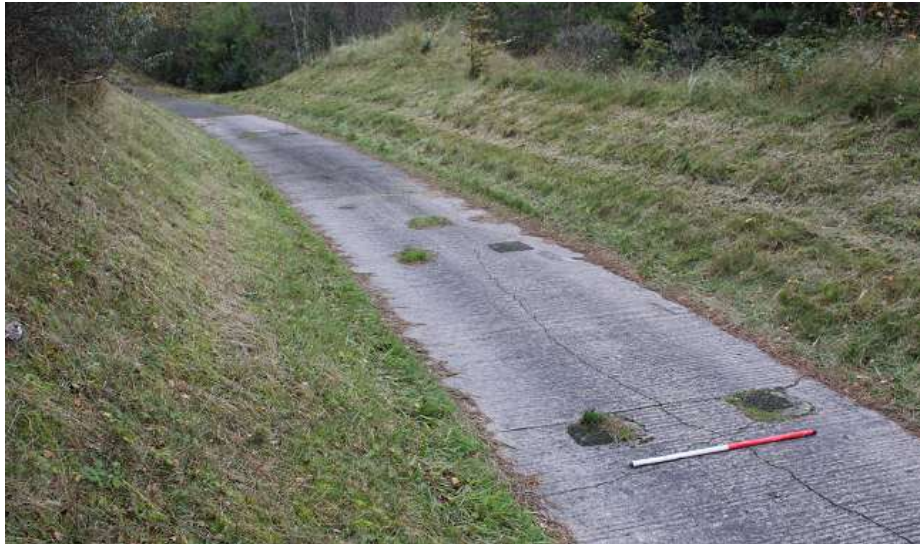
Figure 75: Traces of a road block

A road block is visible in the concrete road which runs southwest from RAF Pembrey. Identified as a pattern of square sockets (52x42-48cm) within the concrete now filled in with tarmac. Three pairs and one single socket. A Pyper 2014.

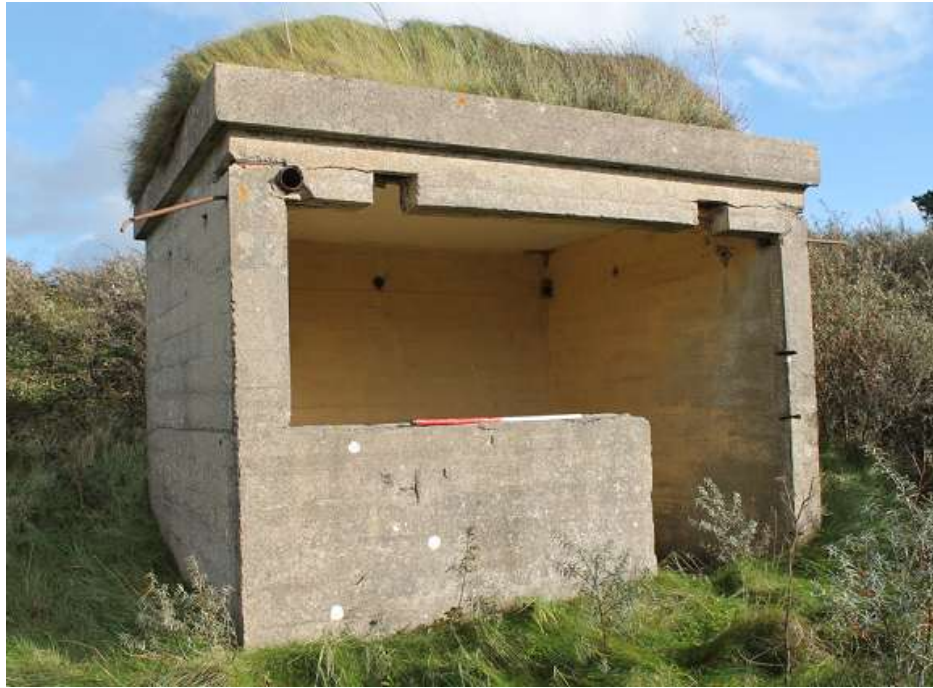
Figure 76: Gun emplacement overlooking Cefn Sidan beach

A gun emplacement built of reinforced concrete with turf on the flat roof. Identical in form to PRN 31414. Rectangular in plan 3.05 x 2.4 m with openings facing southwest. One wide rectangular opening in southwest wall with doorway to side. Internally the walls are painted cream and a small concrete pad on the northeastern corner may form the base of stove. Other fixings and fixtures are traceable in the paintwork of the interior. Forms part of series of gun emplacements built to defend Cefn Sidan beach from invasion or attack during the Second World War. A Pyper 2014

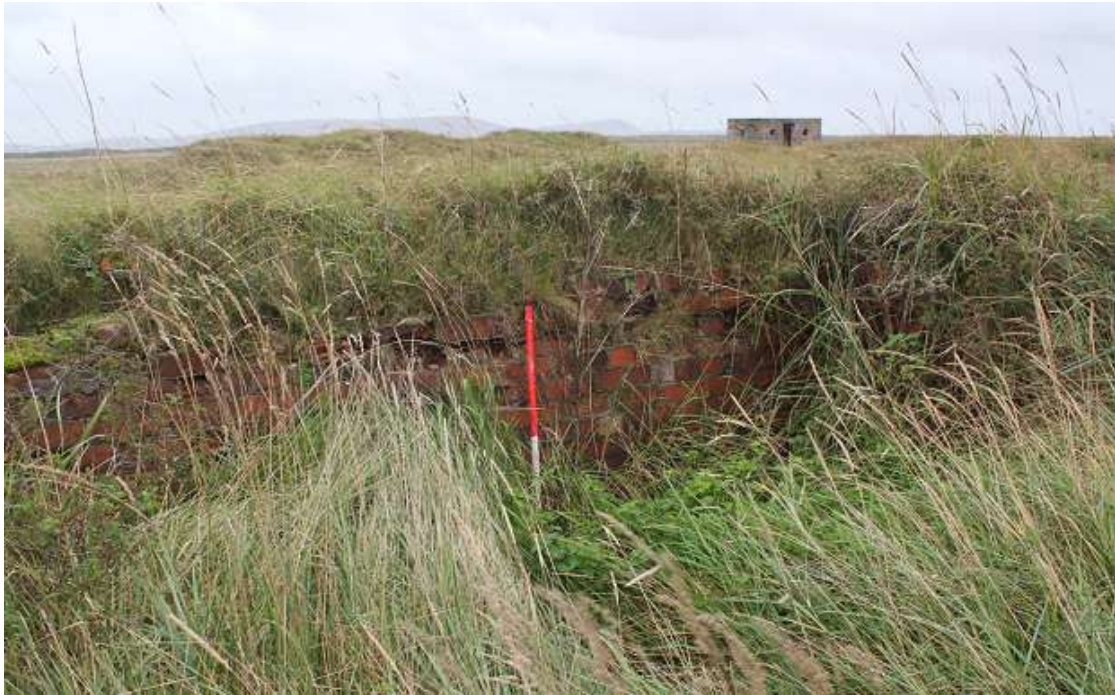
Figure 77: Weapons pit in the foreground and pillbox beyond

CONDITION DESCRIPTION Brick lined pit still identifiable though one side appears to have been moved or demolished. A Pyper.2014

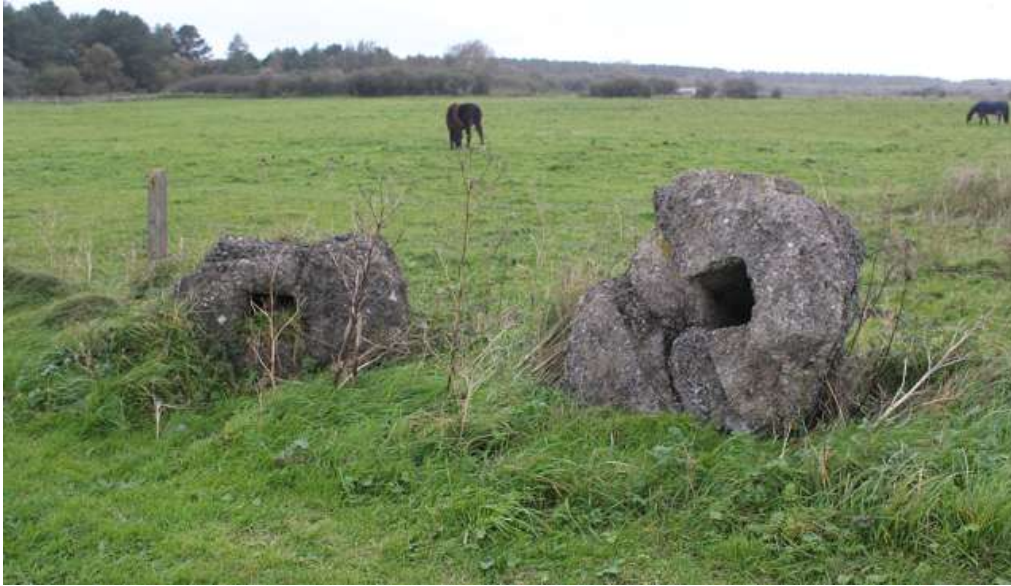
Figure 78: Remains of a dug out road block beside pillbox PRN 31365

CONDITION DESCRIPTION Two large lumps of concrete with square post sockets within them, removed from the road surface and lying on the roadside verge. One socket still in situ at the side of the road. A Pyper

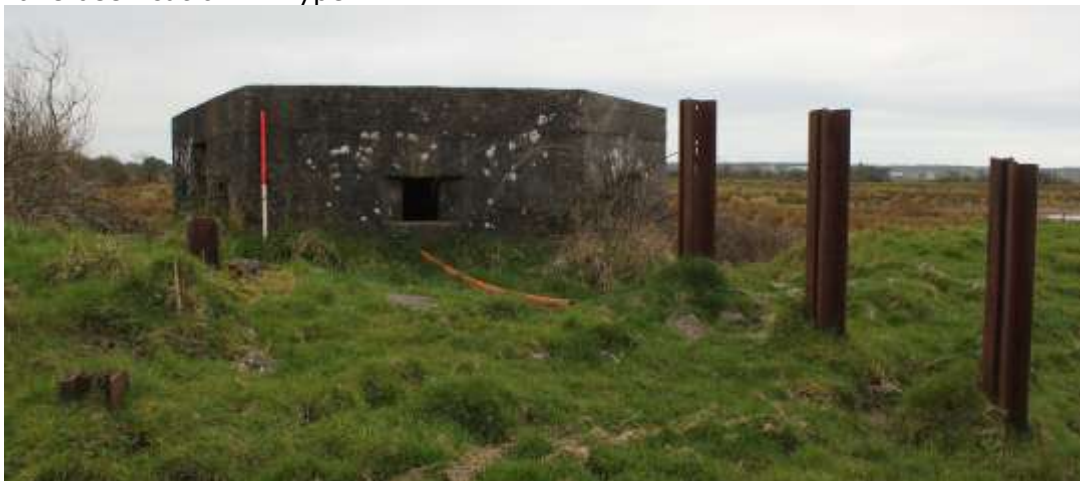
Figure 79: Anti- tank rails with pillbox

CONDITION DESCRIPTION Two parallel lines of anti-tank vertical rails, the eastern line have been cut off. A Pyper

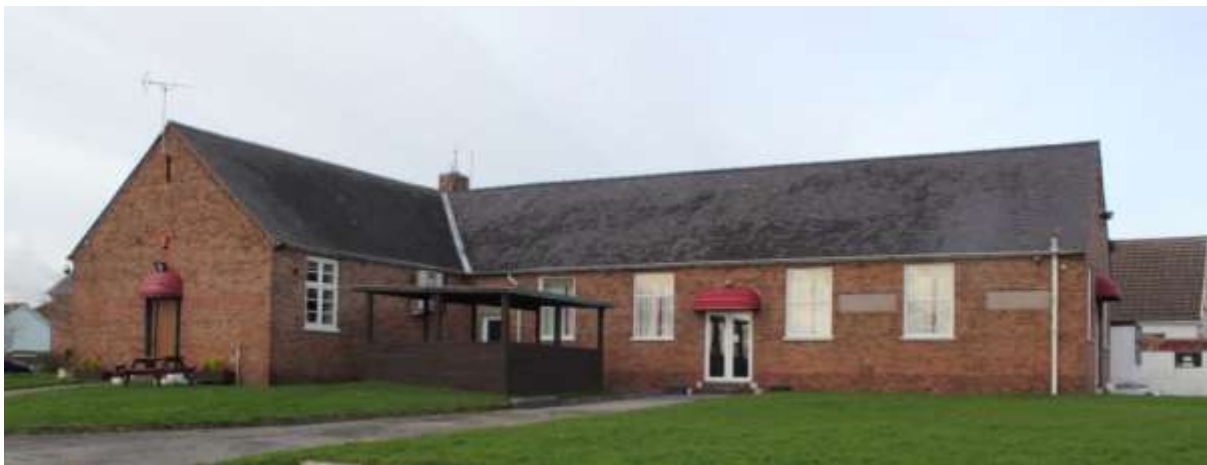
Figure 80: RAF Pembroke Dock radio station, now a Cricket club pavilion

CONDITION - Intact/ Near Intact

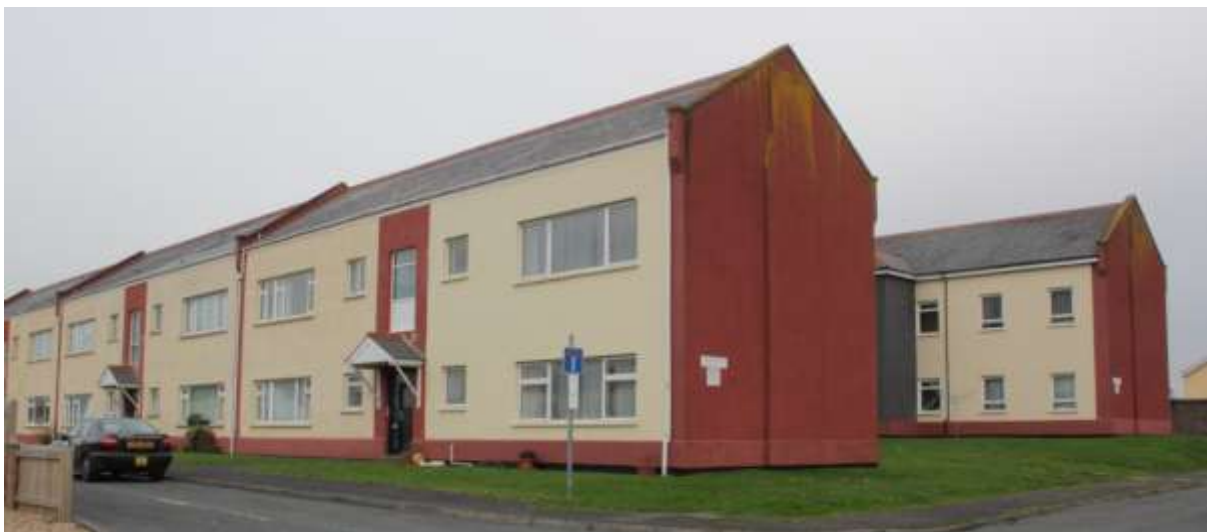
Figure 82: Former barracks also used by the RAF c1930 -59

1903-72, Soldiers Barracks, present use flats. Two storey, brick built, 28 bay, arranged in four groups of seven, doorway to ground floor set centrally in each seven bay range, front and back. Gabled slate roof. Substantially altered in appearance from original. Two storey verandah set against west wall. RJC.Thomas, 12.03.93.

CONDITION - Intact

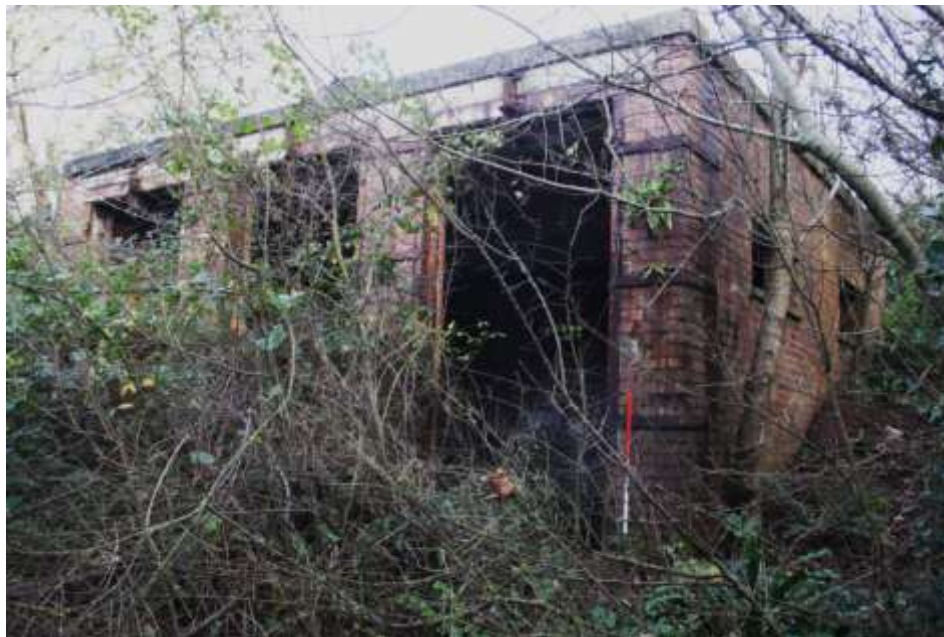
Figure 83: Brick built bomb stores for Pembroke Dock

Two single storey bomb stores behind blast wall PRN 28458. Brick built, square plan with flat concrete roof, set within earth banks. Some steel gantry survives to front, three doors to west now removed. A Pyper 2013

CONDITION - Intact

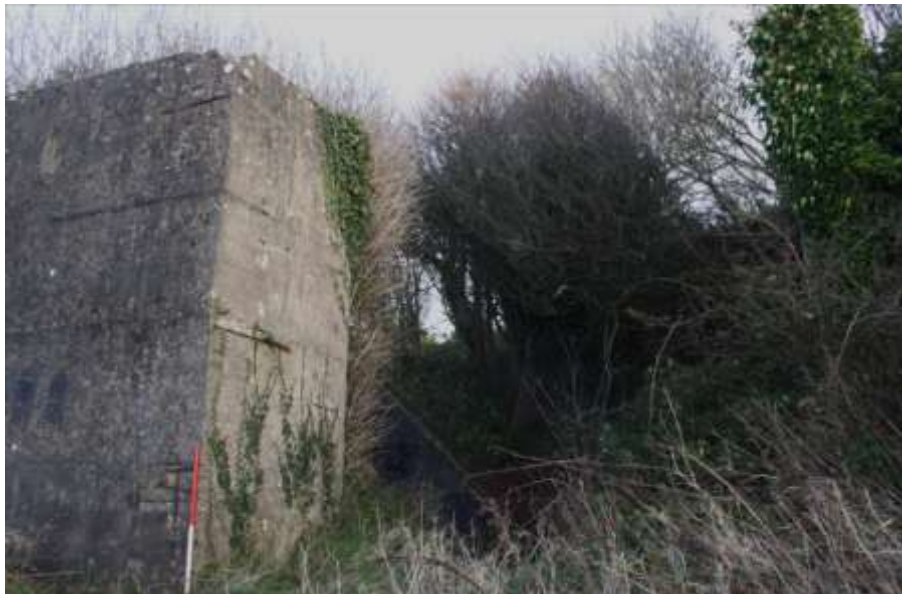
Figure 84: Blast wall in front of Bomb stores at Pembroke Dock

c1934, Flying Boat Base, Blast Wall, Bomb Dump, now derelict. Hollow re-inforced concrete wall, the space of which is infilled with coarse limestone rubble. RJC.Thomas, 14.12.93. Concrete blast wall for 28456. JH May 1998

CONDITION - Intact
