TWENTIETH CENTURY MILITARY SITES: AIRFIELDS – DISPERSED SITES AND DEFENCES

Final Report
A THREAT-RELATED ASSESSMENT 2013-2014
DAT 115A

DYFED ARCHAEOLOGICAL TRUST
RHIF YR ADRODDIAD / REPORT NO. 2014/21
RHIF Y PROSIECT / PROJECT RECORD NO. 103632
DAT 115A
Mawrth 2014
March 2014

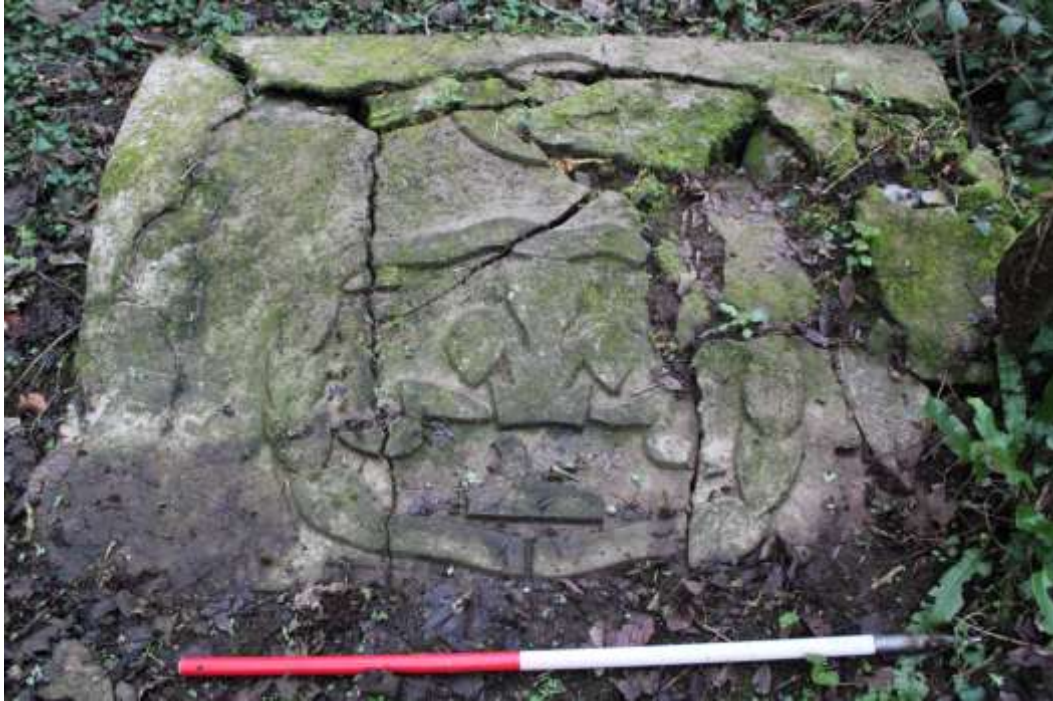
Figure 88: Commemorative plinth of the Manchester regiment

CONDITION DESCRIPTION concrete memorial cracked and broken. Lies within woodland and is quite overgrown. A. Pyper Jan 2013

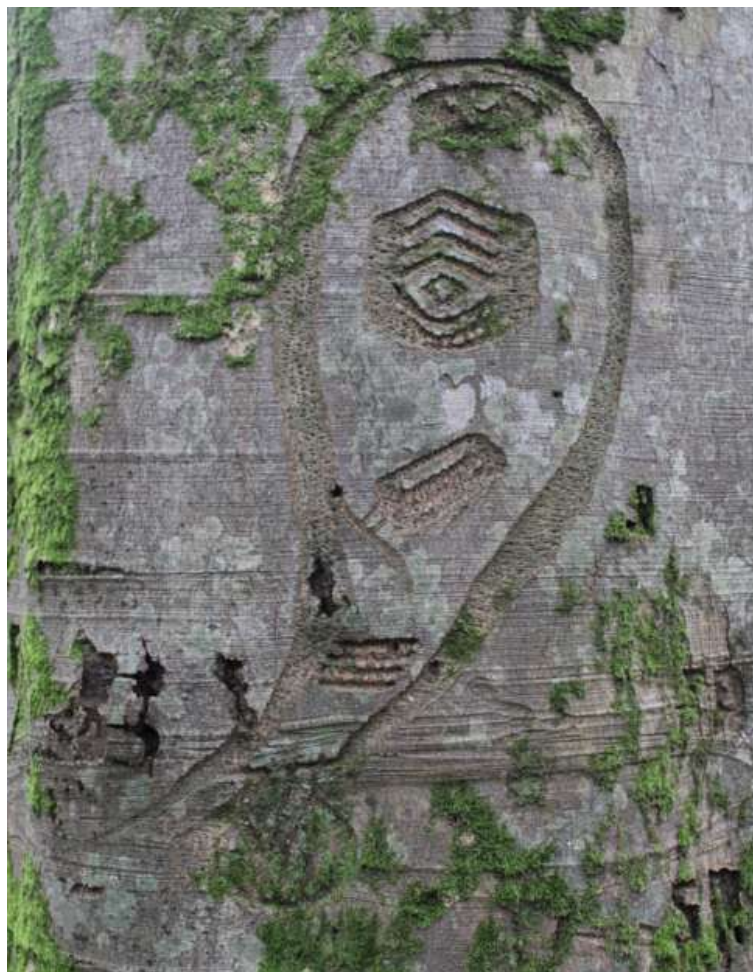
Figure 89: Beech tree graffiti by an American serviceman

Graffiti carved into a beech tree at the entrance to Lamphey Court. Representing the left sleeve of a U.S. Army NCO's service dress uniform, the insignia (or patches) are from top to bottom: Unit patch, representing the division, corp command or army to which the man is currently assigned. Rank insignia: First Sergeant. Service stripe (also called a hash mark) representing three years' service. Overseas bars, each bar represents six months overseas service, so it appears this man had already been overseas for two years. This would appear to date from 1943 when I and K companies of the 110th Infantry, 28th US Infantry Division were stationed at a site to the rear and to the left of Lamphey Court. A Pyper 2013.

CONDITION - Intact

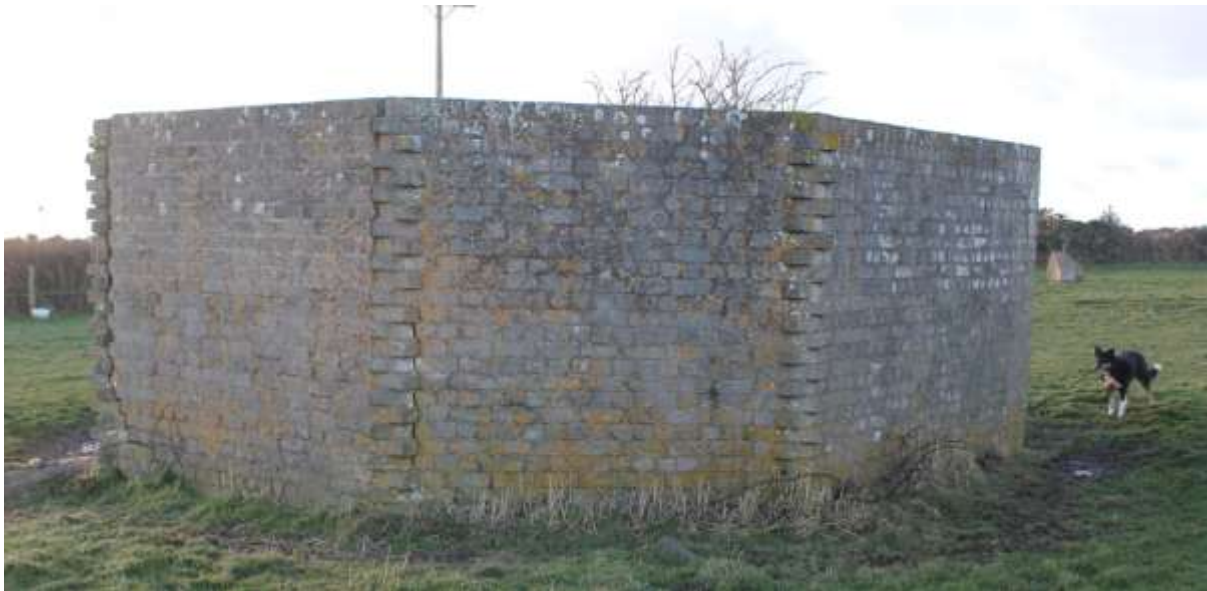
Figure 93: Octagonal wall formerly enclosing a HF/DF tower

CONDITION DESCRIPTION / Brick building intact to wall tops. Slightly overgrown with brambles inside. A Pyper 2013.

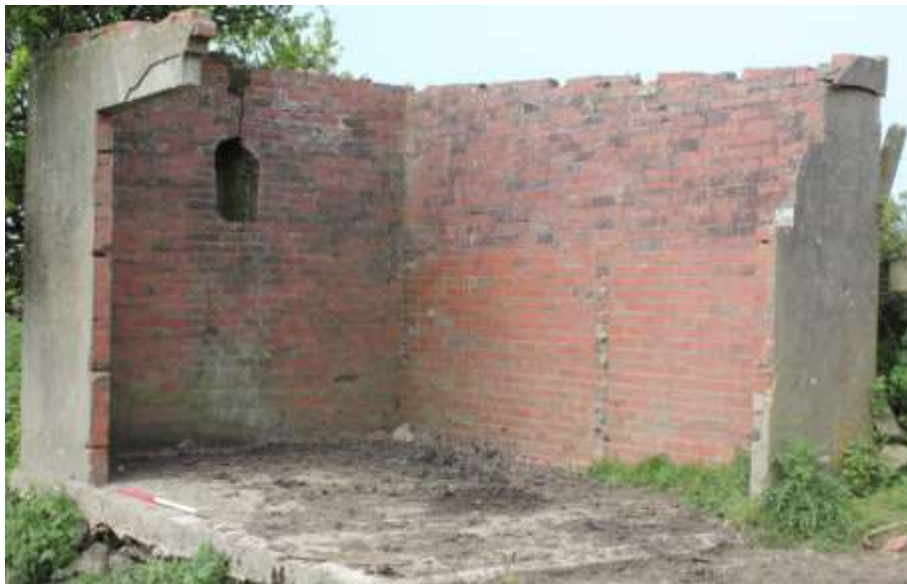
Figure 94: Destructor house south of St Davids airfield

Sited to the west of site no.7 and described on the Air Ministry plan as Destructor house. Single storey, rectangular plan, cement rendered 'temporary brick', corrugated asbestos cement mono-pitch roof (removed). Doorway in E elevation, north wall partially collapsed. Built per AMWD drawing 1189/43. Description based on Roger Thomas 1993. When visited in 2013; 2.25 sides of building survive. roofless, temporary red brick, with cement skim, concrete base, partially undermined. L.Meek May 2013.

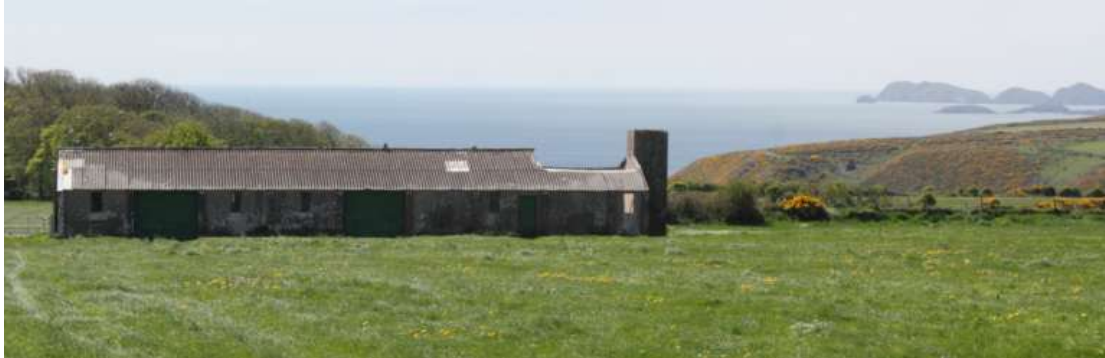
Figure 95: Ablutions block at St Davids

roof. Three light standard steel windows in all elevation. Cement rendered brick water tower to north wall. Built per AMWD drawing 16517/41. (Description based on Roger Thomas 1993). When visited in 2013; green doors have been added as it is now used for agricultural purposes. Half of the asbestos roofing has been blown off during the winter of 2012-2013. L.Meek May 2013.

CONDITION DESCRIPTION / Half of the asbestos roof was blown off in the winter 2012-2013. L.Meek May 2013.

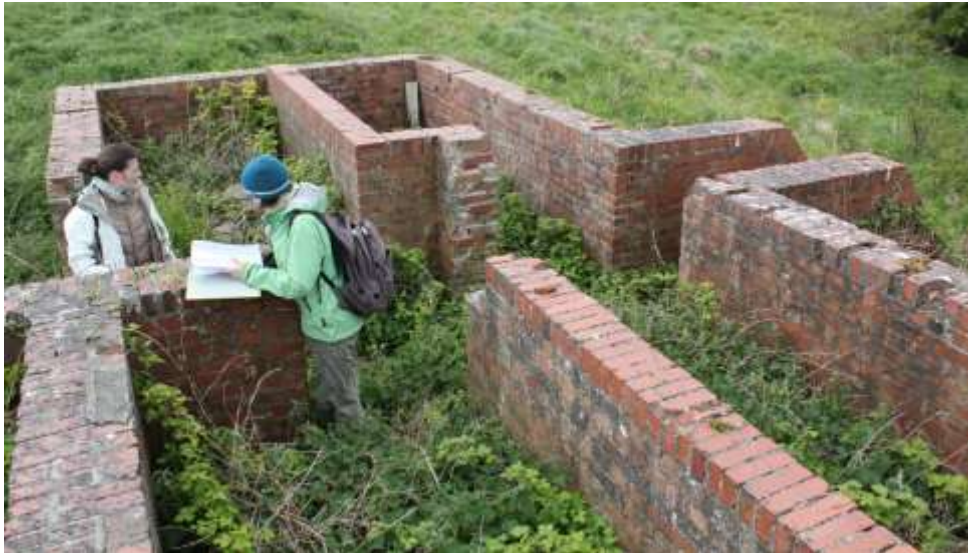
Figure 96: Blast shelter at the communal site

CONDITION DESCRIPTION / Tipping of concrete within feature. L Meek 2013

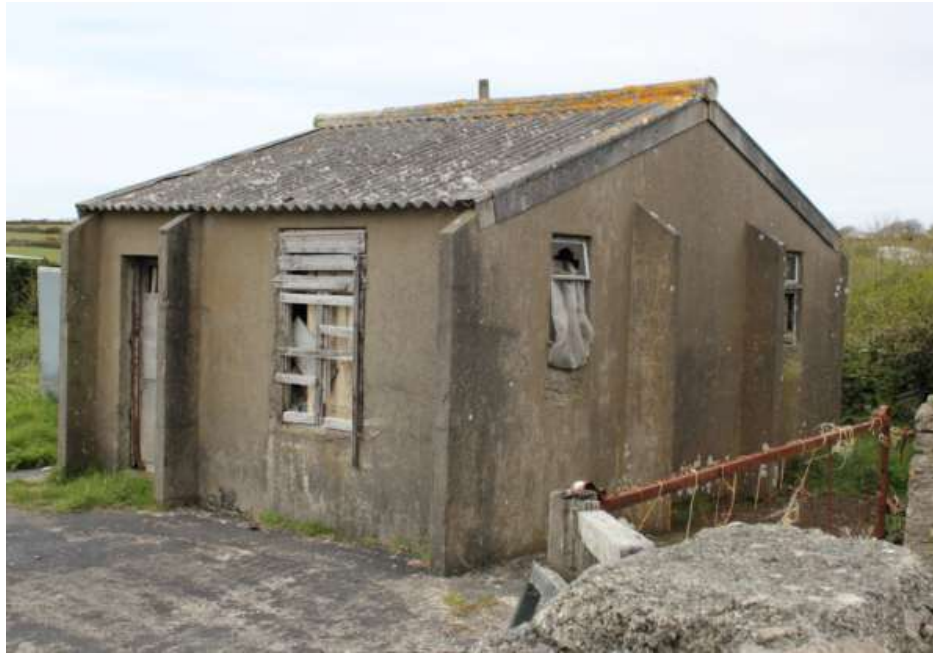
Figure 97: Remaining picket post

CONDITION DESCRIPTION / When visited in 2013; some windows and window frames still intact. Also remains of the door. L Meek 2013

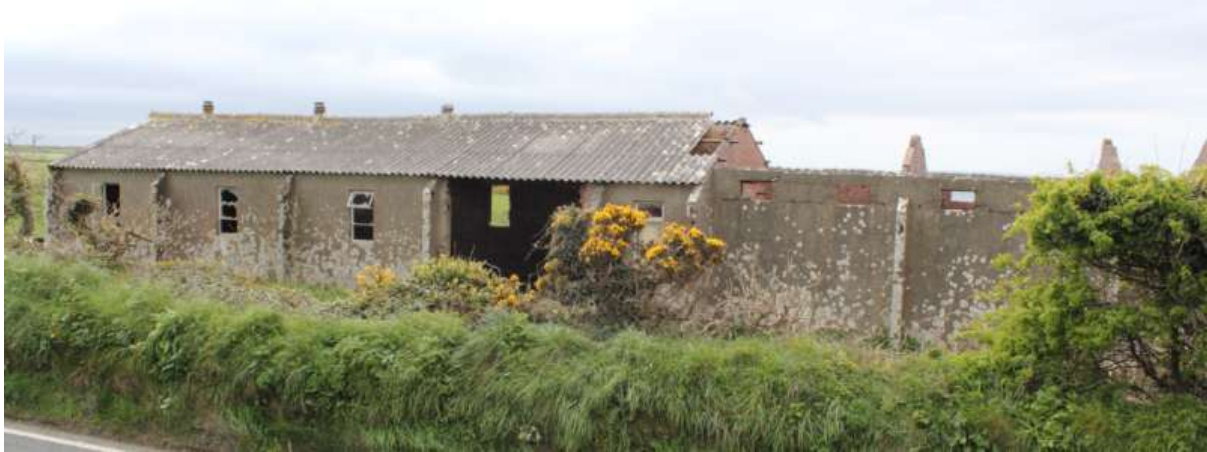
Figure 98: Partially roofless ablutions block

CONDITION DESCRIPTION / When visited in 2013; Some window frames and windows still intact. Roofless over the western end of the building. L Meek. 2013.

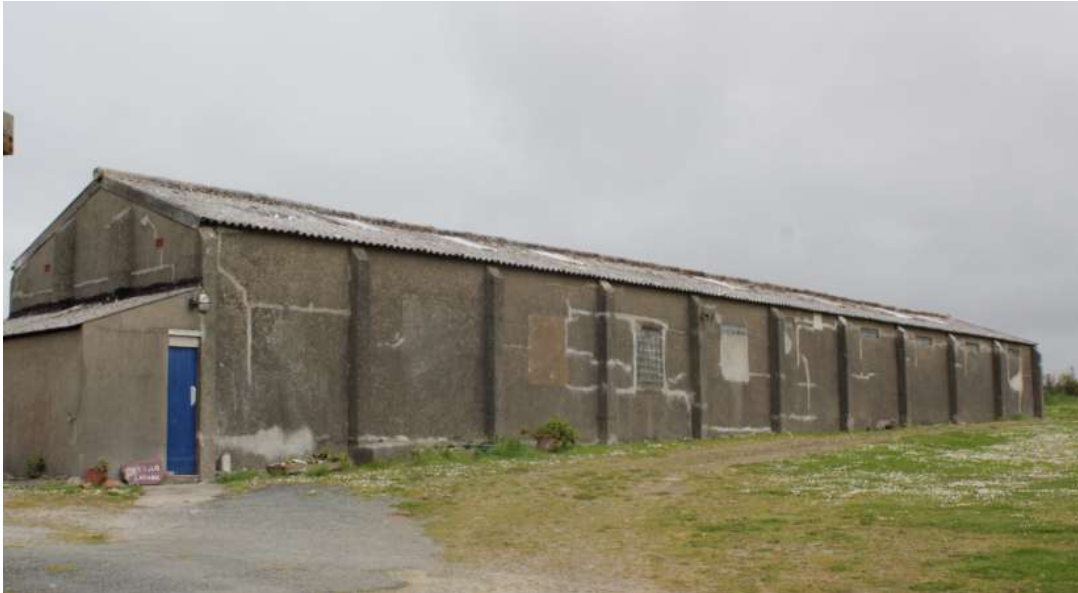
Figure 99: Remaining building at the wireless station

CONDITION DESCRIPTION Building survives, but no trace of the associated masts. A Pyper 2013.

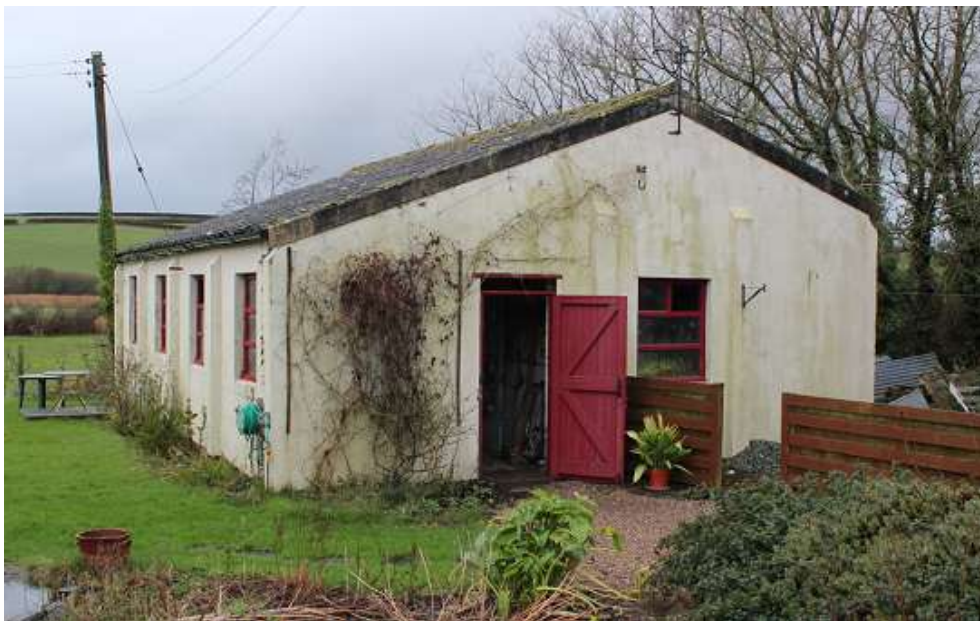
Figure 106: Pumphouse for RAF Talbenny

CONDITION DESCRIPTION / Pump house is intact and in use as a store and workshop. Paint scheme in the interior are still evident. A Pyper 2014.

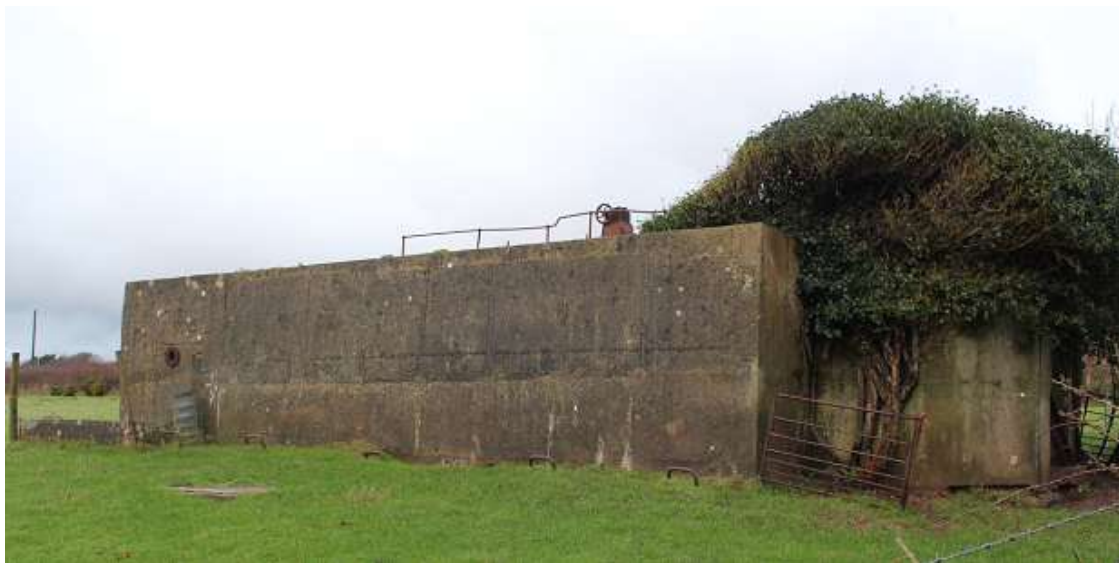
Figure 107: Water tank at Orlandon Kilns

Flocculating Tank, single storey, rectangular plan with projecting southern end wall, reinforced concrete, sub-divided open chambers with steel inspection catwalk over, accessed by steel ladder in southern projection. RJC Thomas 1993.

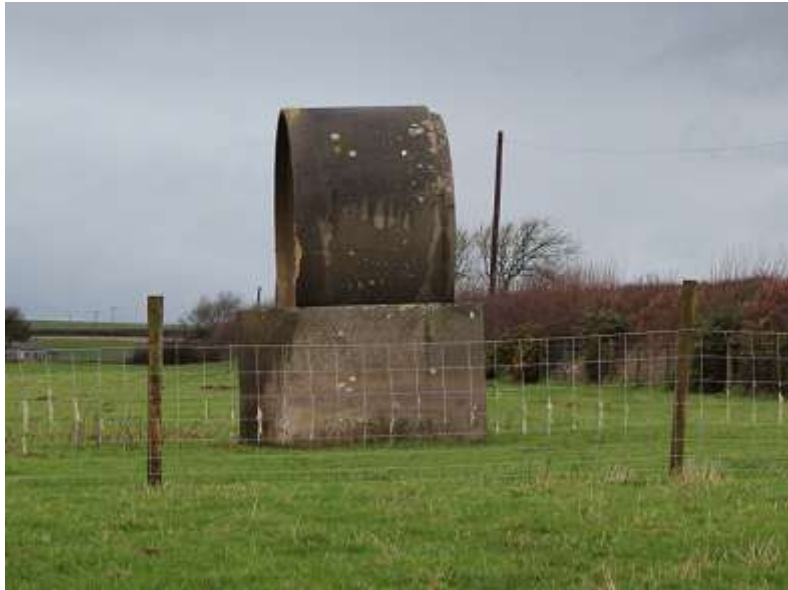
Figure 108: Motley stalk gun emplacement (since modified)

Two concrete sewage pipes. One has been lifted and now sits on top of the other, where originally they would sit side by side. Used as gun emplacement for light anti-aircraft machine guns. A Pyper 2014.

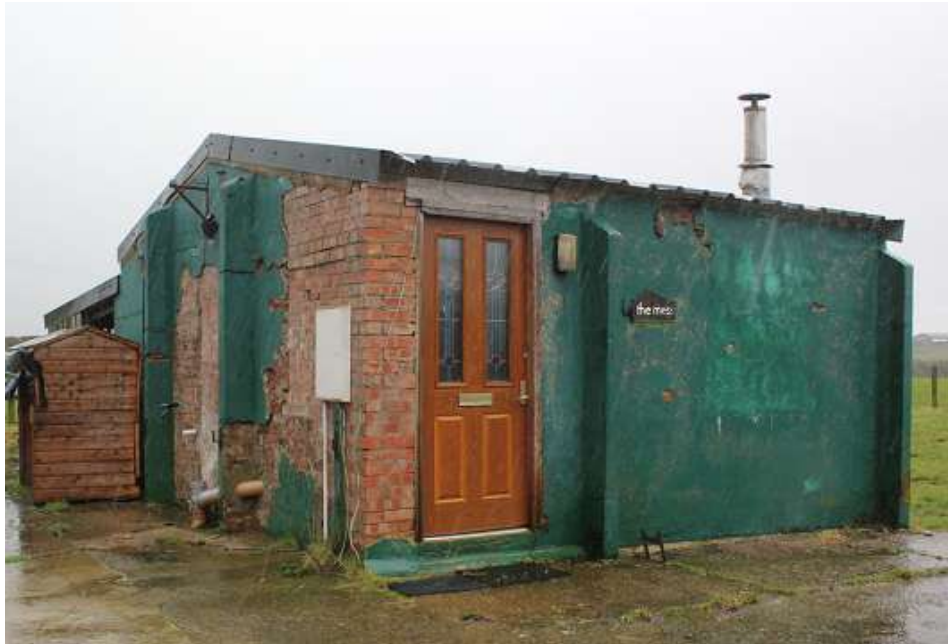
Figure 109: Converted picket post

Picket post part of dispersed site No.9. Single storey, square plan, cement rendered 'temporary brick', corrugated asbestos cement gable roof. Secondary timber framed, corrugated steel clad 'lean-to' against the NE wall. Built per AMWD drawing 7125/41. RJC Thomas 1993.

CONDITION DESCRIPTION / Picket post intact, greatly modified into a domestic building. Much of the cement skim has fallen off. A Pyper 2014.

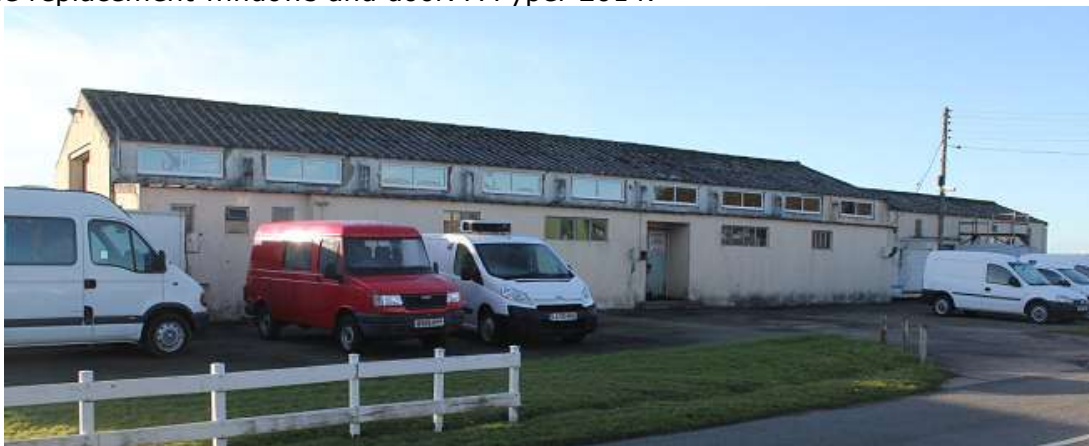
Figure 110: Former gymnasium and chapel

Communal Site. Single storey, rectangular plan, cement rendered 'temporary brick', corrugated asbestos cement gable roof. Built per AMWD drawing 4911/42. RJC Thomas 1993.

CONDITION DESCRIPTION / Building still in use and in good condition though it has some replacement windows and door. A Pyper 2014.

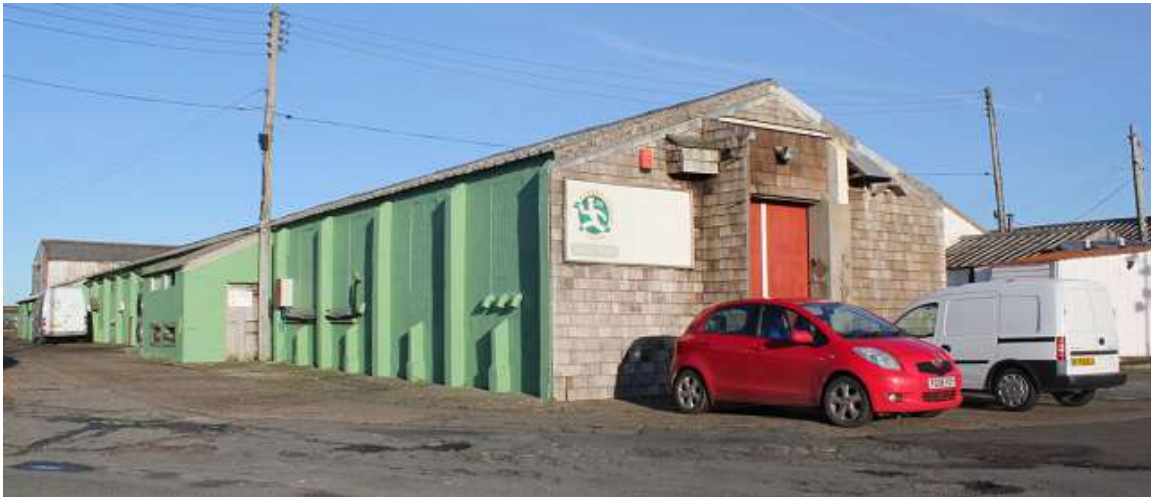
Figure 111: Former dining room at the communal site

Communal Site. Three parallel single storey ranges linked by a central cross range. Each range, rectangular plan, cement rendered 'temporary brick', corrugated asbestos cement gable roof. Built per AMWD drawing 7120/41. RJC Thomas 1993.

CONDITION DESCRIPTION / The dining room at the communal site at Talbenny is in use with a food company. In good condition. Modifications have been undertaken. A Pyper 2014

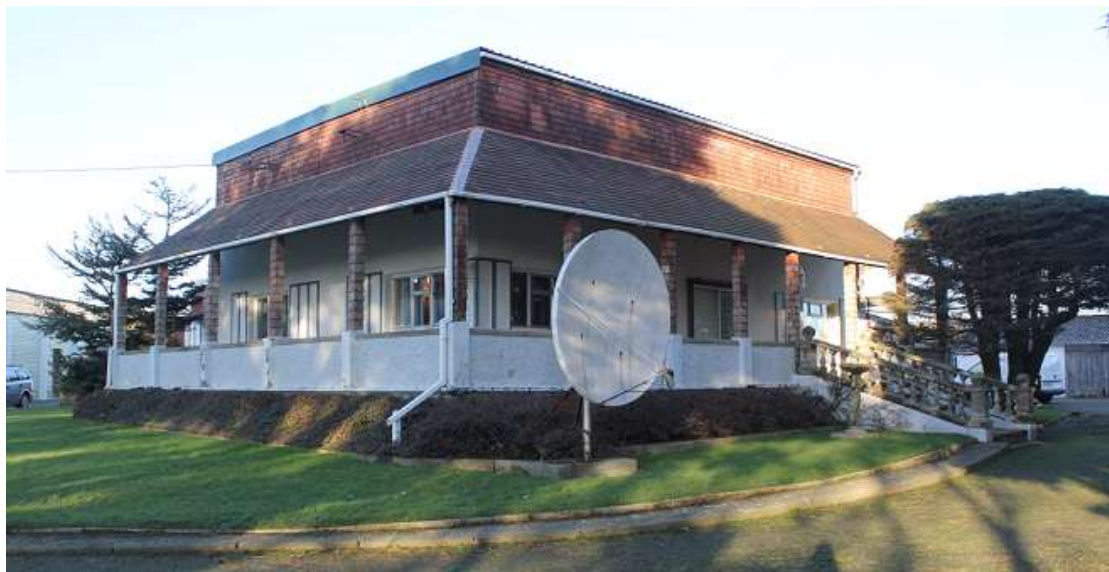
Figure 112: Former standby set house now converted

Communal Site. Single storey, rectangular plan, brick construction, flat re-inforced concrete roof. Radically altered into a house. Built per AMWD drawing 13244/41. RJC Thomas 1993.

CONDITION DESCRIPTION / Standby set house converted into a lavish bungalow with balconies around each side. A Pyper 2014.

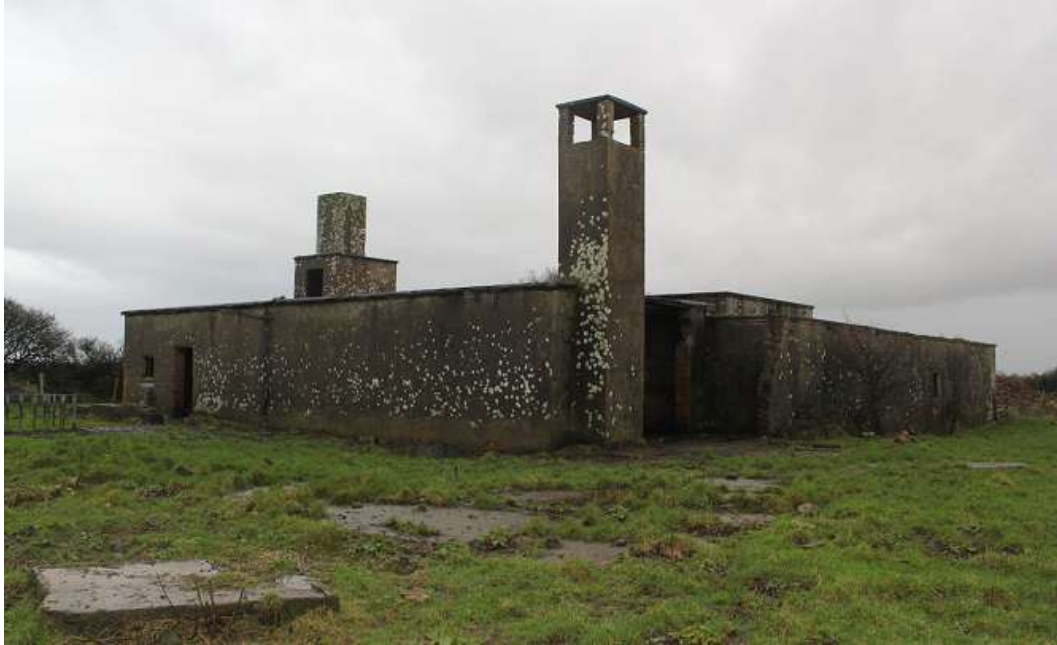
Figure 113: Derelict operations block

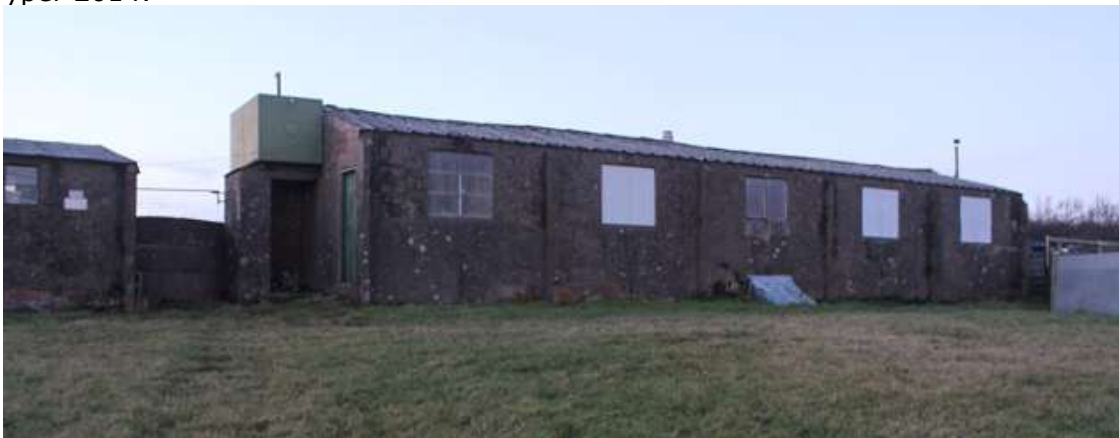
Figure 114: Former airmen's quarters

Identified on the Air Ministry plan as Airmen's quarters. Dispersed Site No.1. Single storey, rectangular plan, cement rendered 'temporary brick', corrugated asbestos cement gable roof. Built per AMWD drawing 7122/41. Based on RJC Thomas description A Pyper 2014.

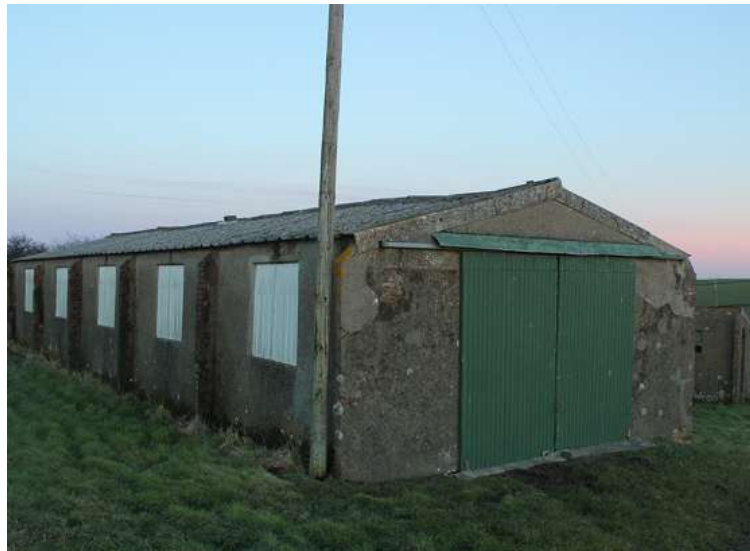
Figure 115: Former airmen's quarters

Identified on the Air Ministry plan as Airmen's quarters. Dispersed Site No.1. Single storey, rectangular plan, cement rendered 'temporary brick', corrugated asbestos cement gable roof. Built per AMWD drawing 7122/41. Based on RJC Thomas description. A Pyper 2014.

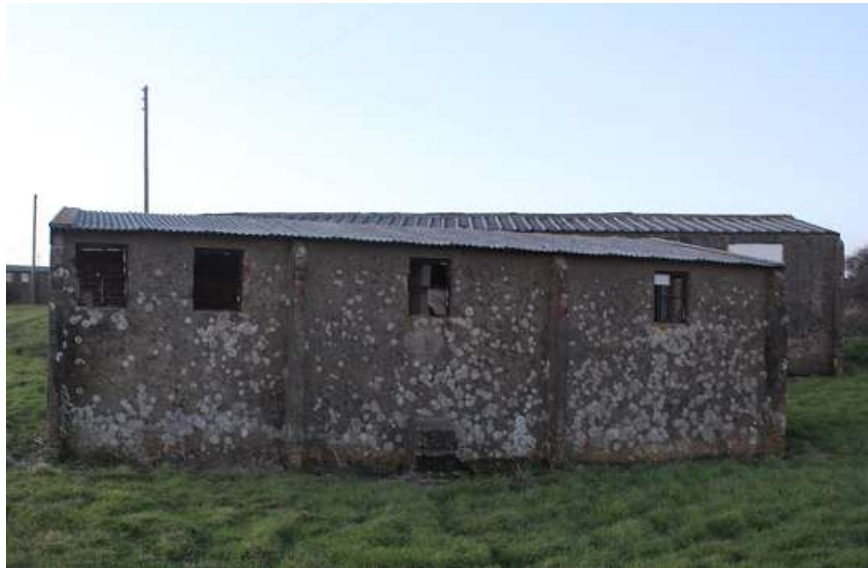
Figure 116: Former drying rooms associated with quarters

Identified on the Air Ministry plan as Airmen's quarters, drying rooms and latrines. Dispersed Site No.1. Single storey, 3 bay rectangular plan, cement rendered 'temporary brick', corrugated asbestos cement gable roof. Doorways in N & S walls. 4 light standard steel windows. Built per AMWD drawing 7125/41. Based on RJC Thomas description A Pyper 2014.

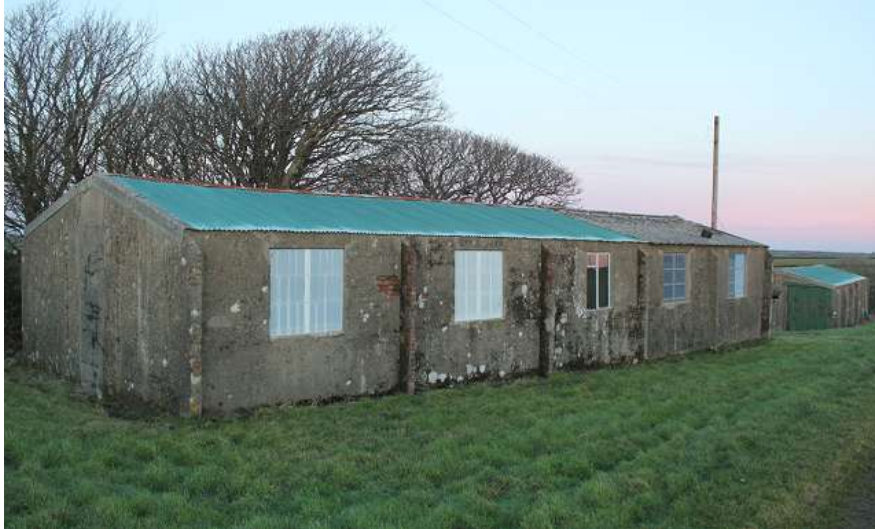
Figure 117: Former sergeant's quarters

Identified on the Air Ministry plan as Sergeants Quarters. Dispersed Site No.1. Single storey, 5 bay rectangular plan, cement rendered 'temporary brick', corrugated asbestos cement gable roof. Doorway in E & W gables, window per bay in N & S elevations. Built per AMWD drawing 9025/41. Based on RJC Thomas description. A Pyper 2014.

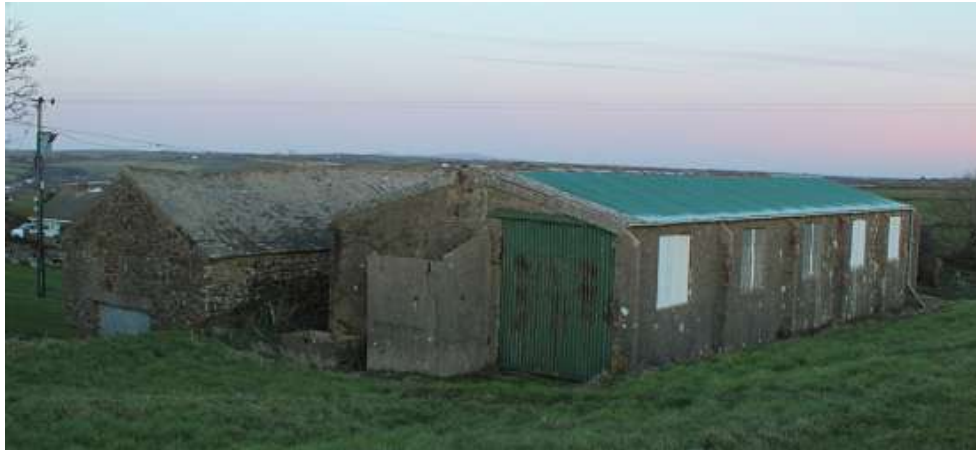
Figure 118: Former sergeant's quarters

Identified on the air ministry plan as Sergeants quarters. Dispersed Site No.1. Single storey, rectangular plan, cement rendered 'temporary brick', corrugated asbestos cement gable roof. Built per AMWD drawing 9025/41. Based on RJC Thomas description. A Pyper 2014.

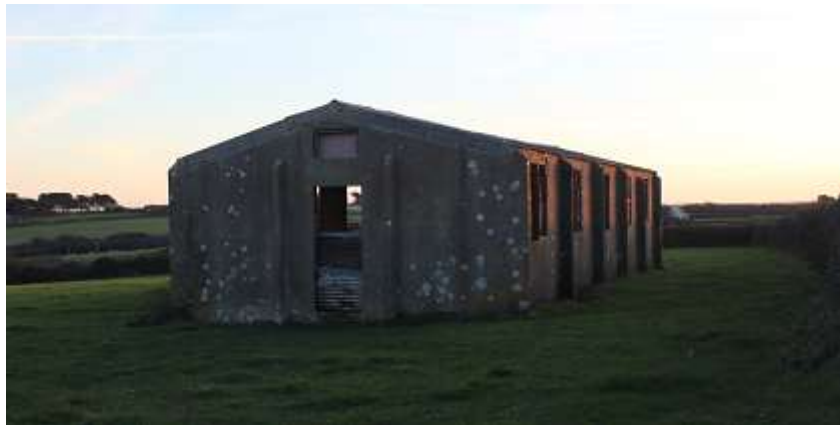
Figure 119: Former airmen's quarters

Airmen's quarters part of dispersed Site No.10. Single storey, rectangular plan, cement rendered 'temporary brick', corrugated asbestos cement gable roof. Built per AMWD drawing 7122/41. RJC Thomas 1993.

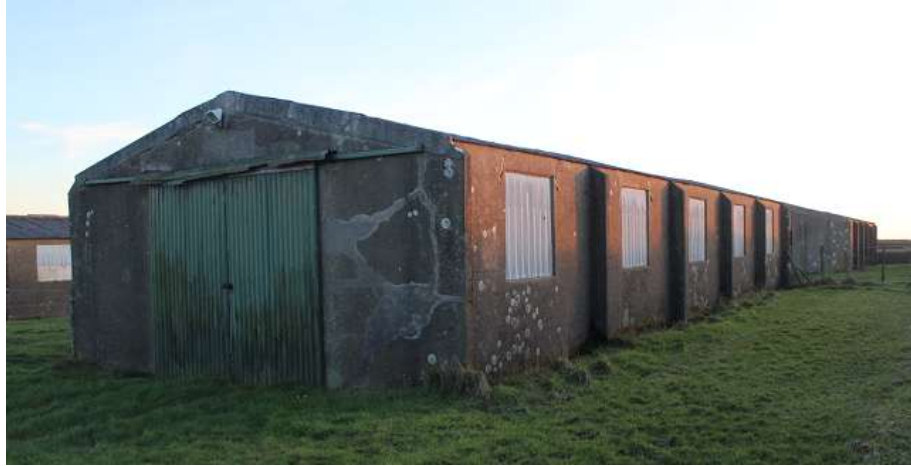
Figure 120: Former airmen's quarters

Dispersed Site No.10. Single storey, rectangular plan, cement rendered 'temporary brick', corrugated asbestos cement gable roof. Built per AMWD drawing 7122/41. RJC Thomas 1993

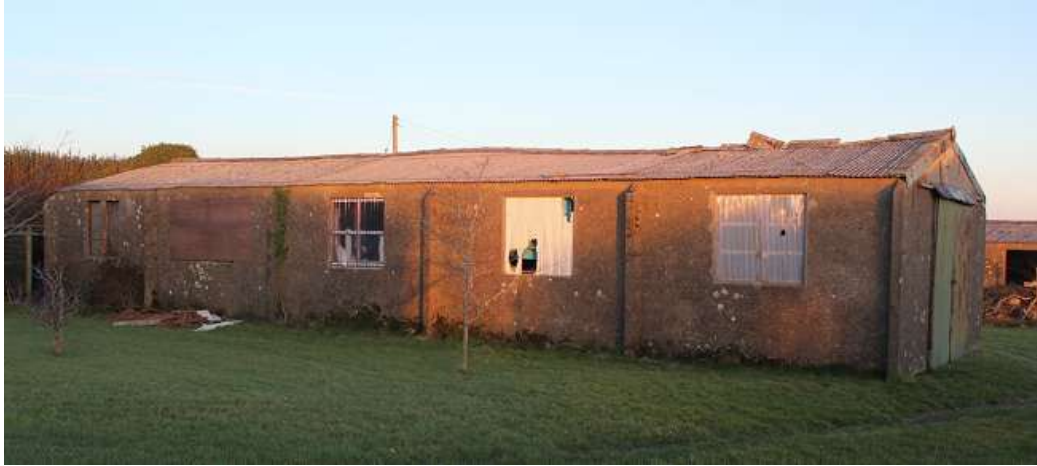
Figure 121: Former airmen's quarters

Airmen's Quarters, part of Dispersed Site No.10. Single storey, 5 bay rectangular plan cement rendered 'temporary brick', corrugated asbestos cement gable roof. Secondary double vehicle door in S gable. Built per AMWD drawing 7122/41. RJC Thomas 1993. Now becoming derelict. A Pyper 2014

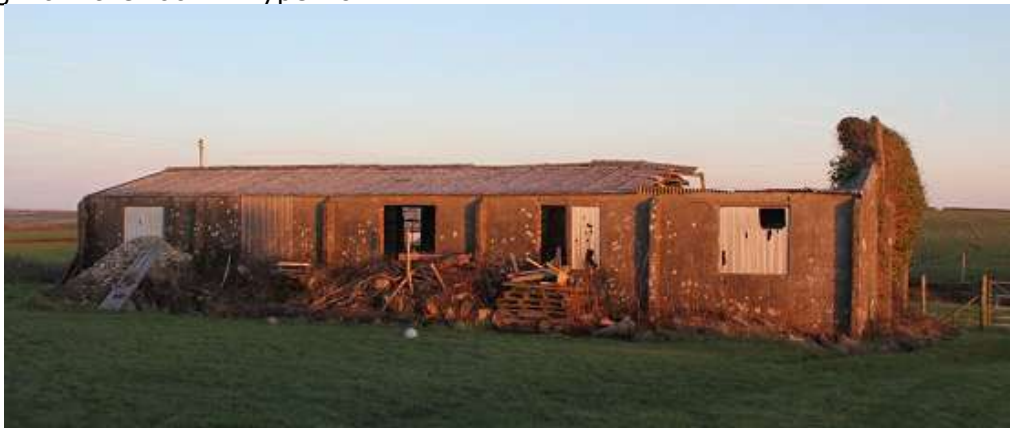
Figure 122: Former sergeant's quarters

Sergeant's Quarters, part of dispersed Site No.10. Single storey, 5 bay rectangular plan, cement rendered 'temporary brick', corrugated asbestos cement gable roof. Doorway in S gable blocked. Built per AMWD drawing 9025/41. RJC Thomas 1993.

CONDITION DESCRIPTION / Building in poor condition with some asbestos sheeting missing from the roof. A Pyper2014.

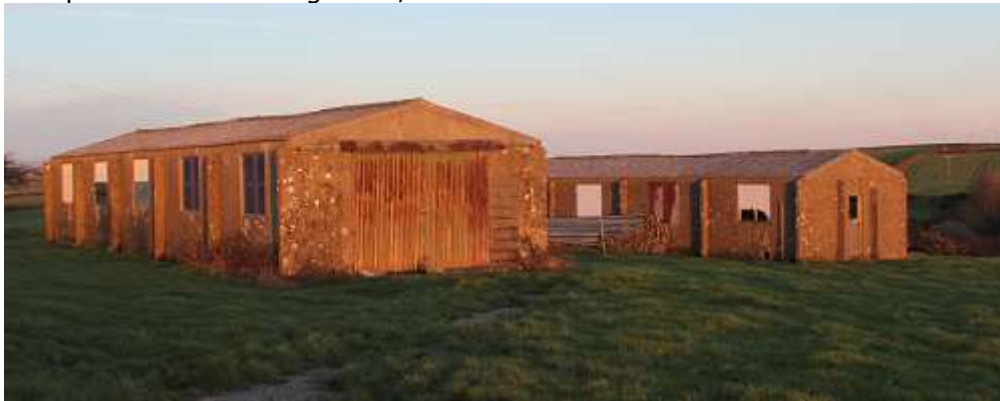
Figure 123: Former quarters PRNs 101557 & 101558

Dispersed Site No.10. Single storey, 5 bay rectangular plan, cement rendered 'temporary brick', corrugated asbestos cement gable roof. Secondary double vehicle doors in S gable. Built per AMWD drawing 9025/41. RJC Thomas 1993.

CONDITION DESCRIPTION / Quarters intact though much modified into a dwelling. A Pyper 2014.

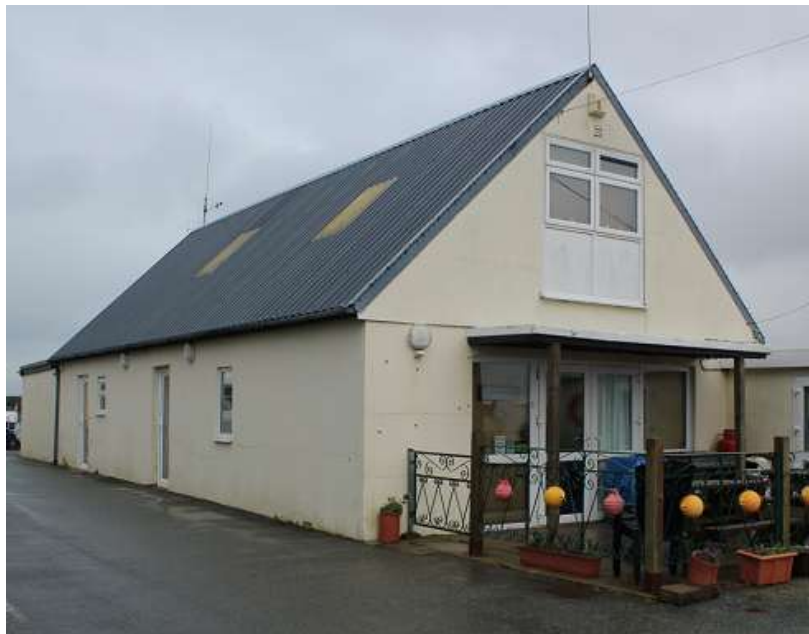
PRN 101561

Airwomen's and Sergeant's Quarters at the WAAF Site No.1. Single storey, rectangular plan, cement rendered 'temporary brick', corrugated asbestos cement gable roof. Rebuilt as a shop and workshop, radically altered in appearance with flat roof. Built per AMWD drawing 14423/41. RJC Thomas 1993.

CONDITION DESCRIPTION / Quarters have been much modified into a dwelling and shop A Pyper 2014.

Figure 124: Former sergeants and airwomen's quarters, now modified

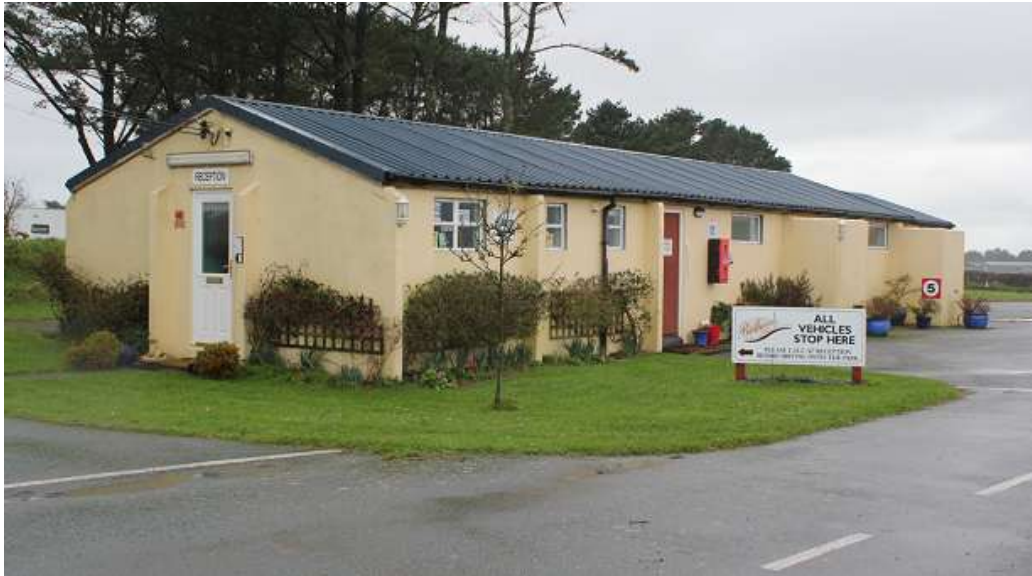
PRN 101564

Airwomen's & Sergeant's Latrine at the WAAF Site No.1. Single storey, rectangular plan, cement rendered 'temporary brick', corrugated asbestos cement gable roof. Built per AMWD drawing 13047/41. RJC Thomas 1993

CONDITION DESCRIPTION / Building in excellent condition and in use as part of the caravan park. A Pyper 2014.

Figure 125: Reused building on WAAF site

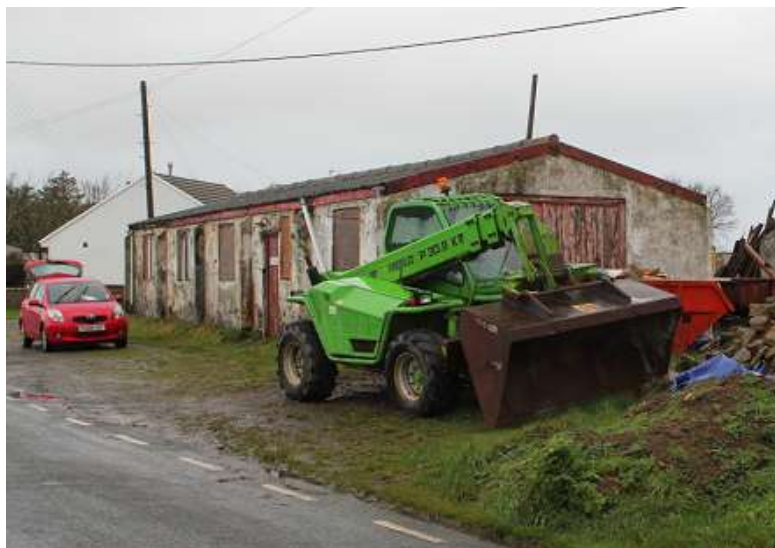
Airwomen's and Sergeant's Quarters at the WAAF Communal Site. Single storey, 5 bay rectangular plan, cement rendered 'temporary brick', corrugated asbestos cement gable roof. Porched doorway in W gable. Secondary fenestration and double vehicle door in E gable. Built per AMWD drawing 14423/41. RJC Thomas 1993.

Figure 126: Airwomen's and Sergeant's quarters

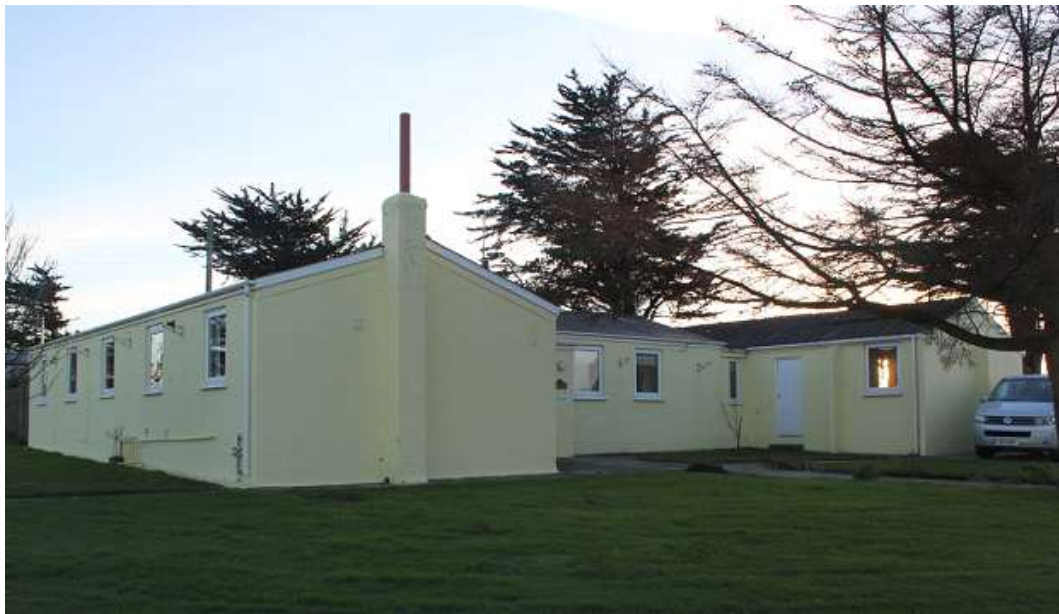
Officer's Quarters at the WAAF Communal Site. Single storey, 'H' plan, cement rendered 'temporary brick', corrugated asbestos cement gable roof. 7 bay S range, and 6 bay N range. Secondary garage door to S elevation of the S range. Built per AMWD drawing CCW No.57. RJC Thomas 1993.

CONDITION DESCRIPTION / Building now in use as part of the caravan park. Intact though modified. A Pyper 2014

Figure 127: Former quarters now converted

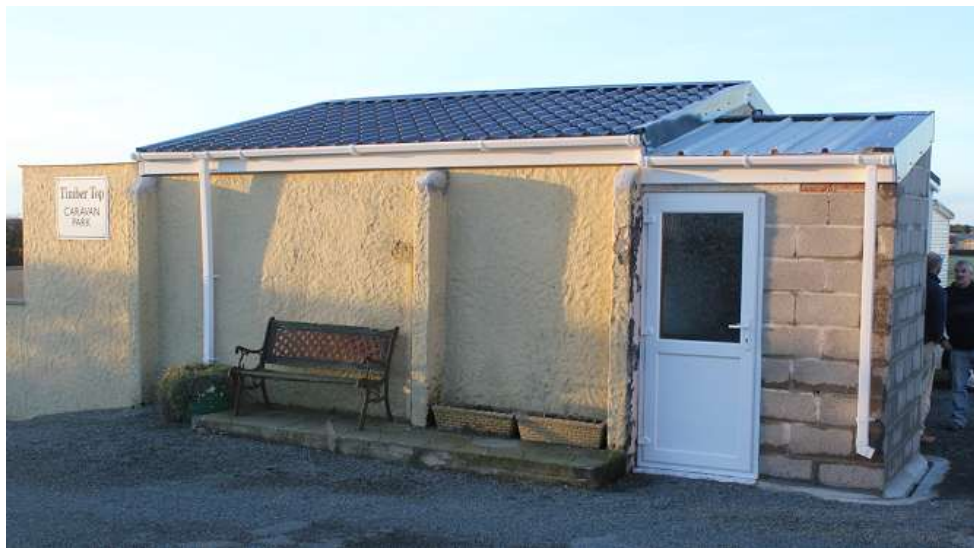
Picket post at the WAAF Communal Site. Single storey square plan, cement rendered 'temporary brick', corrugated asbestos cement gable roof. Built per AMWD drawing 7125/41. RJC Thomas 1993

CONDITION DESCRIPTION / Now the reception and living quarters for the caravan park. Modified. A Pyper2014.

Figure 128: Former picket post now converted

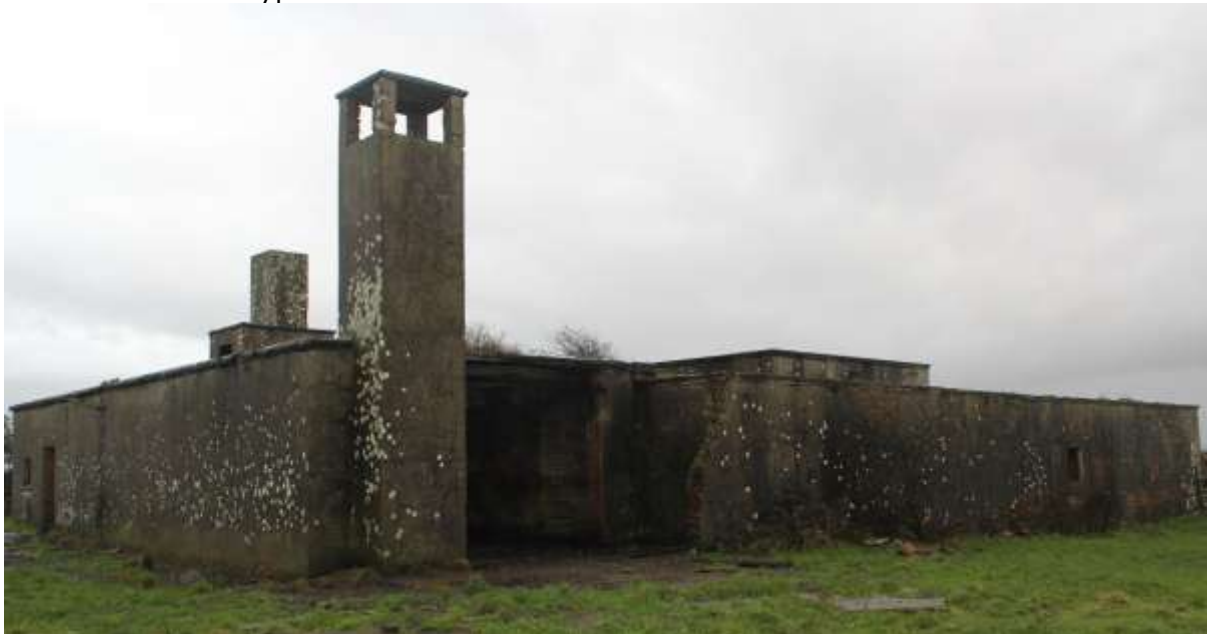
Identified on the Air Ministry map as the Operations Block site associated with RAF Talbenny. This consisted of a range of buildings including the Operations block, a Pigeon loft Airmen's Quarters. These were built in brick, timber and Nissen huts. When visited in 2014 only the operations block itself survives, the other buildings have been demolished to foundations. A Pyper 2014.

Figure 129: RAF Talbenny Operations block

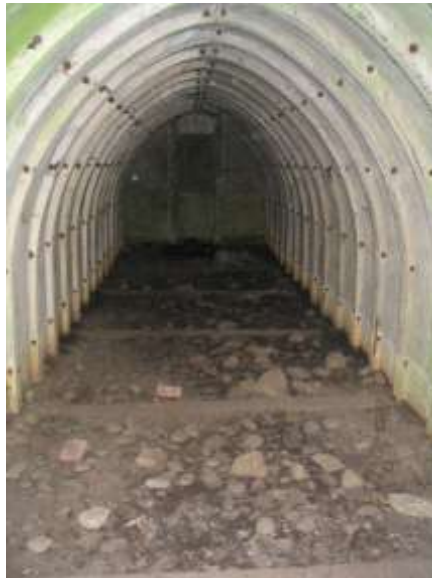
A "Stanton" air-raid shelter. Prefabricated design, consisting of sections which could be bolted together to form different lengths. A main entrance at one end flanked by a brick blast wall mounded up by earth. At the other end is a chimney-type structure, the escape hatch. Covered over by earth. The air raid shelter is currently covered with thorn trees on the main body of the building. A Pyper 2013

CONDITION DESCRIPTION The building appears to be in a reasonably stable condition.

Figure 133: Interior of the Stanton Air Raid Shelter

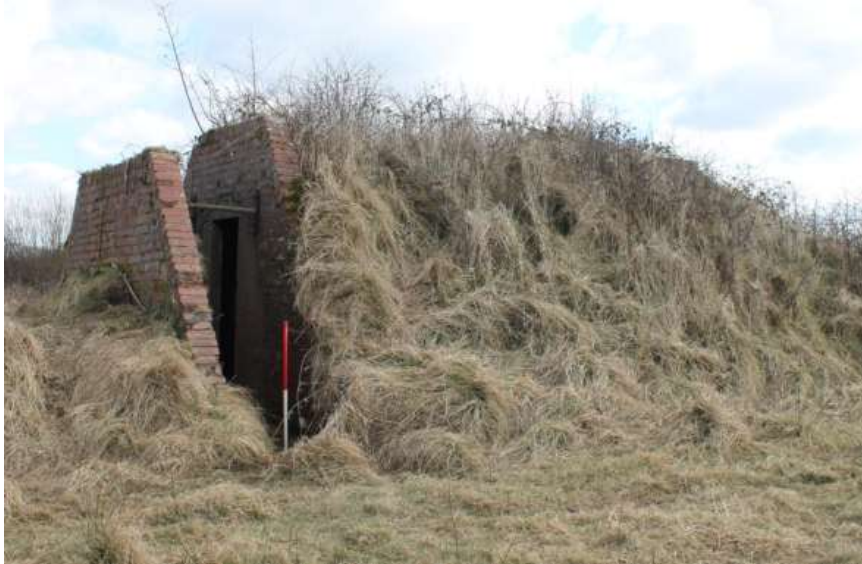
A "Stanton" air-raid shelter. Prefabricated design, consisting of sections which could be bolted together to form different lengths. A main entrance at one end flanked by a brick blast wall mounded up by earth. At the other end is a chimney-type structure, the emergency exit. Covered over by earth. The air raid shelter is currently covered with scrub on the main body of the building. A Pyper 2013

Figure 134: One of three air raid shelters which survive at Templeton

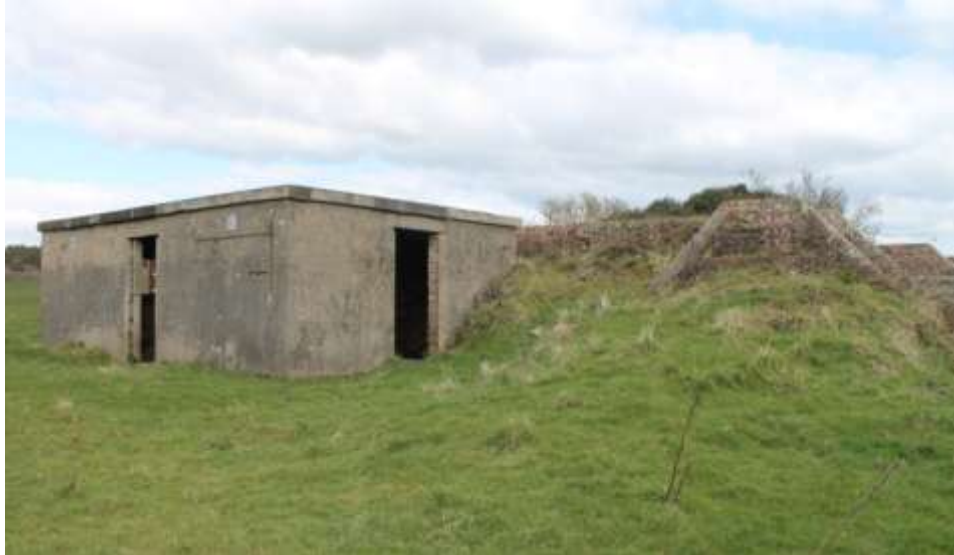
A bomb store or 'Pyrotechnic and incendiary store' identified on the Air Ministry plan. Described by Roger Thomas as, Parallel pair of single storey, rectangular plan, cement rendered brick, flat asphalted re-inforced concrete roofed stores. Ventilation grilles nr. floor & ceiling. Located within a 10 ft. high earth revetment enclosure. Built per AMWD drawing 18185/40. As described when visited in 2013, A Pyper.

CONDITION DESCRIPTION / Door-less and with trees growing around them, but essentially intact. A Pyper 2013

Figure 135: Remains of bomb stores at RAF Templeton
