TWENTIETH CENTURY MILITARY SITES: AIRFIELDS – DISPERSED SITES AND DEFENCES

Final Report
A THREAT-RELATED ASSESSMENT 2013-2014
DAT 115A

DYFED ARCHAEOLOGICAL TRUST
RHIF YR ADRODDIAD / REPORT NO. 2014/21
RHIF Y PROSIECT / PROJECT RECORD NO. 103632
DAT 115A
Mawrth 2014
March 2014

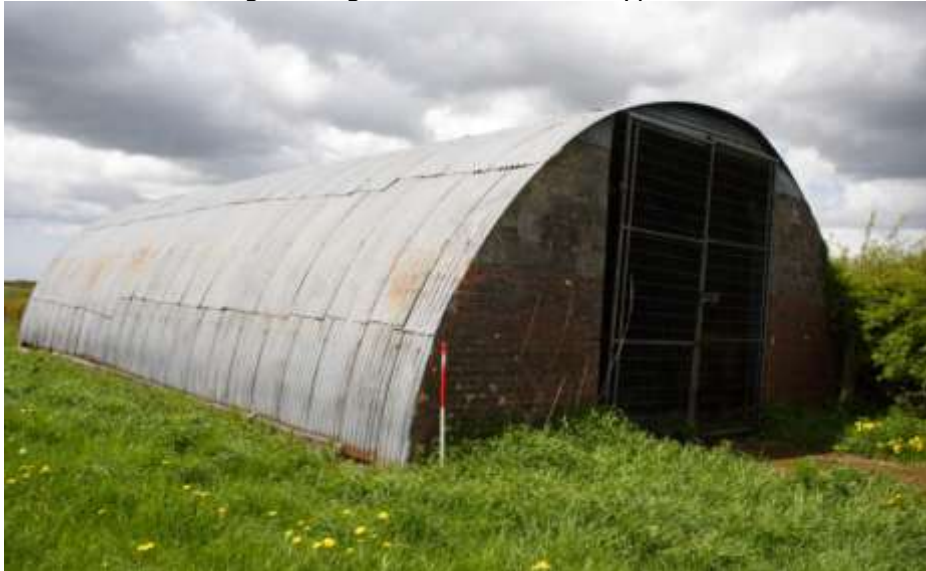
Bomb Fuzing Point Building. 24 ft. span Nissen hut, corrugated iron sections and brick and breeze block built gable walls with double sized entrances at either end. Blocked with breeze blocks at west end, metal gates (probably replacements) at east end. A concrete road loop passes through the structure via double width doors in each gable end. based on Roger Thomas's description. A. Pyper, 2013.

CONDITION DESCRIPTION Building appears intact - only seen from a distance, and appears to be in use as low grade agricultural store. A Pyper 2013.

Figure 136: Bomb fuzing building at RAF Templeton

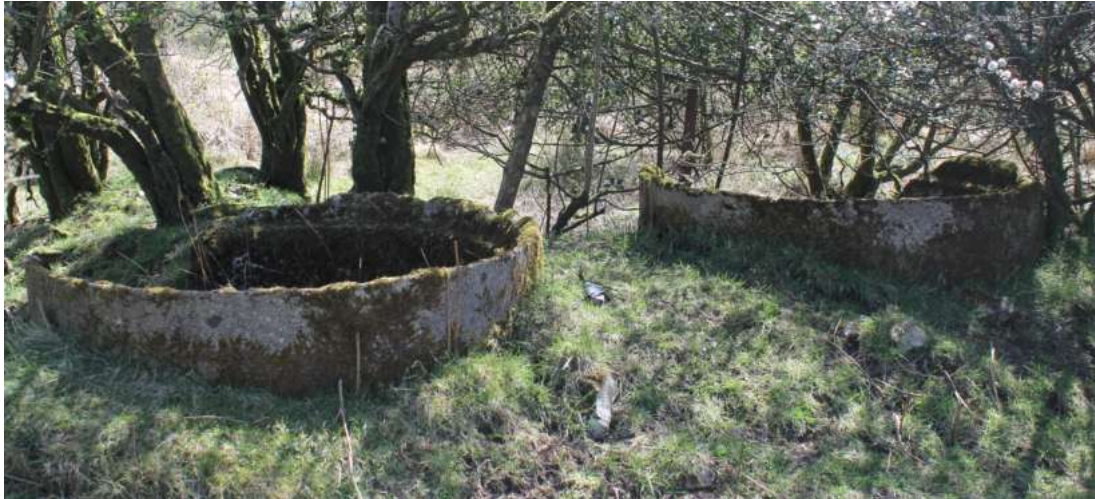
Two circular concrete rings placed side by side at the junction of two field banks. Also referred to as Motley Stalk gun emplacements, they are gun pits for Light Anti-Aircraft guns. Built within the field bank. Approx 1.60m deep and 0.9m across. The bottom is silted up. Located in thick blackthorn hedge. L.Meek May 2013.

CONDITION DESCRIPTION Both rings have broken down sides. The bottom of both rings are silted up and contain leaf litter. Surrounded by thick blackthorn. L.Meek May 2013.

Figure 137: Motley stalk gun emplacements in the hedgerow are RAF Templeton

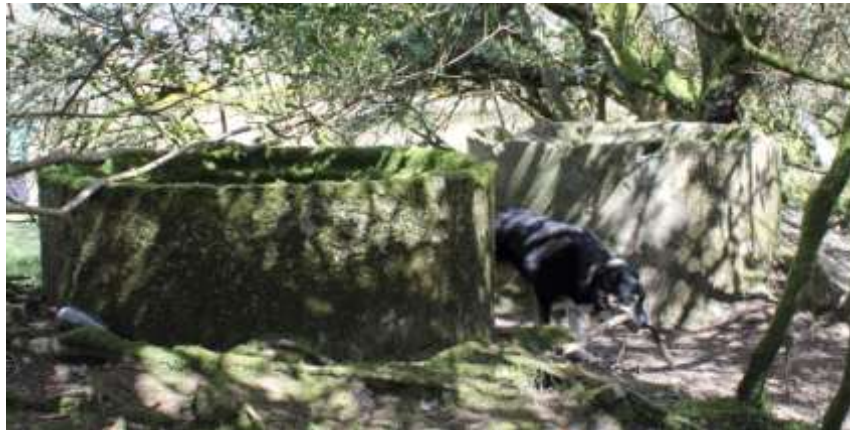
Two complete, circular, concrete rings. Situated on the hedgebank. Also referred to as Motley Stalk gun emplacements, they are gun pits for Light Anti-Aircraft guns. L.Meek May 2013.

CONDITION DESCRIPTION Both rings are intact but filled with water. L.Meek May 2013.

Figure 138: Remains of one of four Motley Stalk gun emplacements

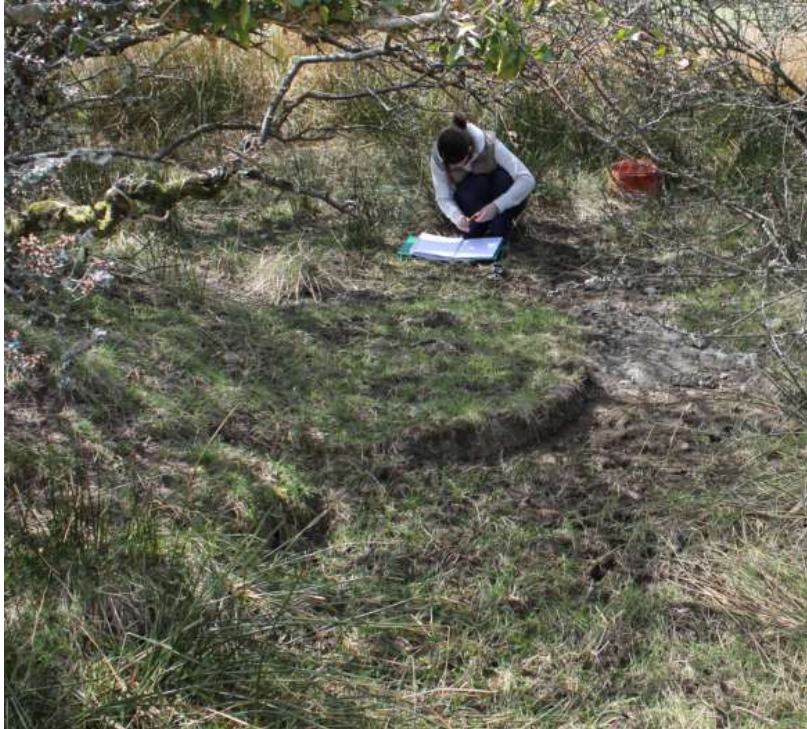
Figure 139: Fragmentary remains of a Motley stalk gun emplacement

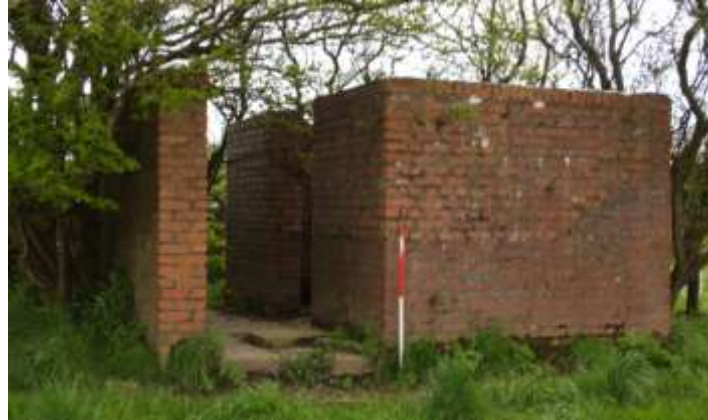
Square shaped, corrugated, red brick building, with a red brick blast wall parallel to it. No roof. Within the main section are two ceramic outlets and an indent on the floor. Also an iron bracket fitting on the floor, possibly for electrical purposes. Difficult to identify from site plan but may be Transformer plinth for the Main Beacon, which forms part of the Standard Beam Approach landing system for aircraft landing at night and in poor visibility. L. Meek May 2013.

Figure 140: Brick transformer plinth

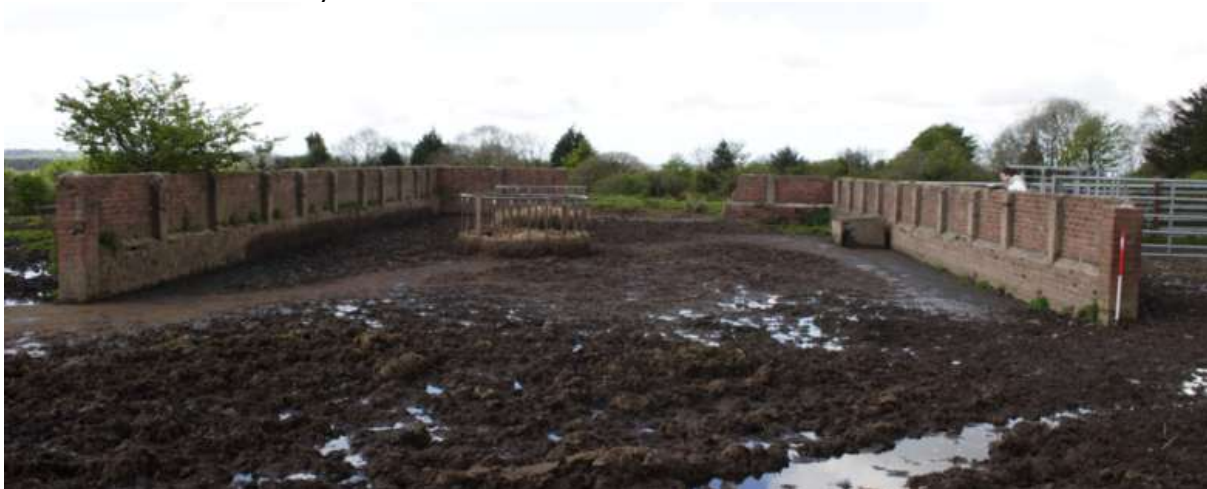
Main Beacon, a red brick, rectangular, concrete structure, now used for cattle. Height=150cm. North East end is open. South West end has a large entry; one pier has been demolished. The Main Beacon forms part of the Standard Beam Approach blind landing system to assist aircraft landing at night or in poor visibility. It forms part of three beacons lined up on the main runway (Inner Beacon PRN 102576, Outer Beacon PRN 105897). L.Meek May 2013.

CONDITION DESCRIPTION One pier on the South West end of the structure has been demolished. L.Meek May 2013.

Figure 141: Main beacon for the Standard Beam Approach blind landing system at RAF Templeton

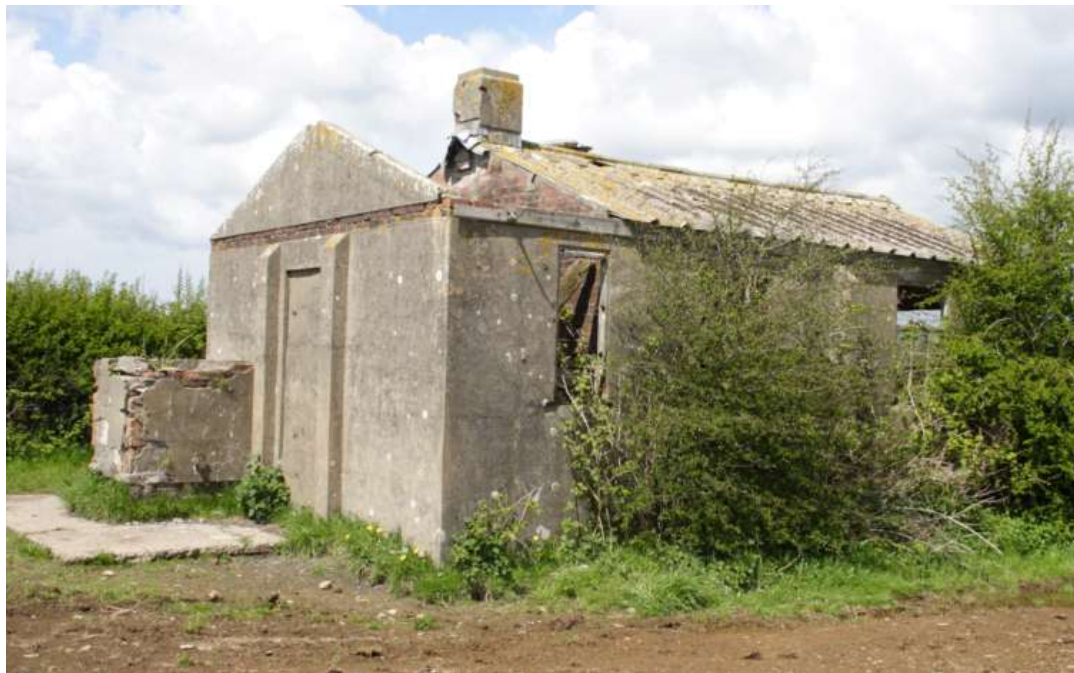
Rectangular, temporary red brick, concrete structure with corrugated asbestos roof. Some windows and their frames are still intact. Adjoining room on the South side. Entrance on the North side. Identified as 'Rest Hut' on the air ministry plan probably associated with the site of a High Frequency Direction Finding station nearby (PRN 105898). Interior walls cream paint finish still surviving. Switch gear and electrical cabling in the corner with 3 ceramic outlets in the floor. Remains of chimney flute and stove pipe. L.Meek May 2013.

Figure 142: Rest hut for High Frequency Direction Finding installation nearby.

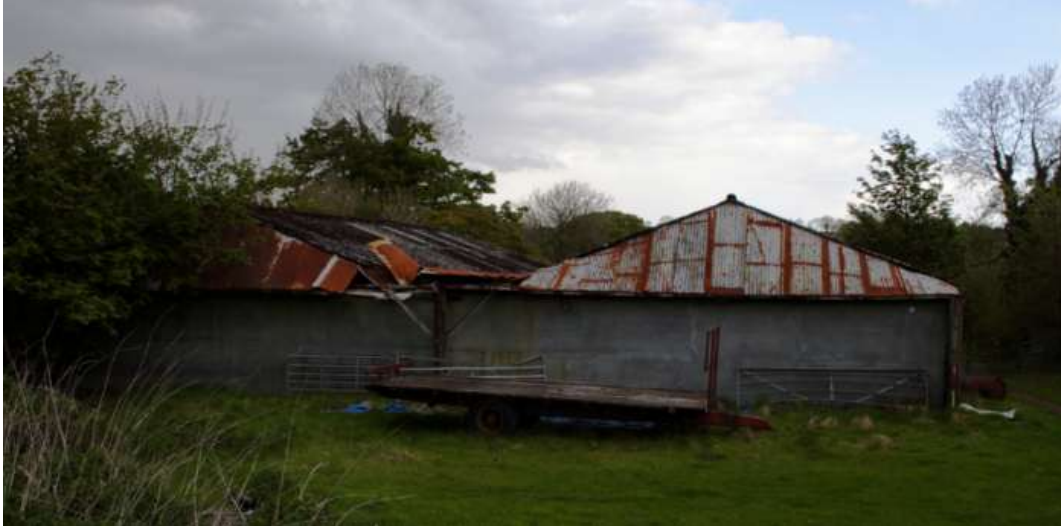
Figure 143: Only the concrete plinth from the beacon survives with a shed built over it

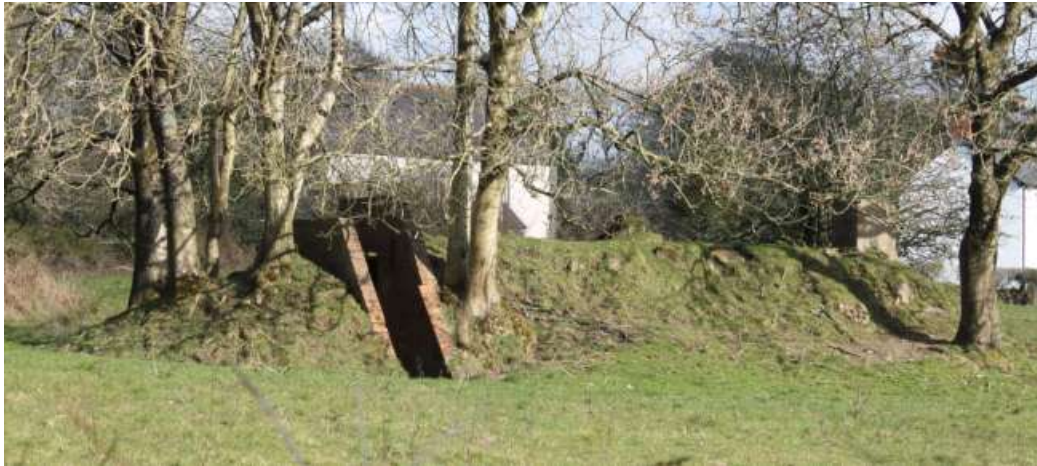
RAF TEMPLETON AIRFIELD No 1, located to the north edge of the airfield. Consisting, according to the Air Ministry site plan, of Officers, sergeants and airmen's quarters and associated latrines and picket post. These buildings were both temporary brick and Nissen huts and associated with Air Raid shelters. Site is now grazed and buildings removed, though two semi-sunken Stanton air raid shelters survive. A Pyper 2013.

CONDITION DESCRIPTION Though the buildings and hutting has been removed, there are two surviving Stanton Air Raid shelters surviving within the field. The air raid shelters have mature trees growing over the earth covered mounds. A Pyper 2013.

Figure 144: One of the remaining Air Raid Shelters

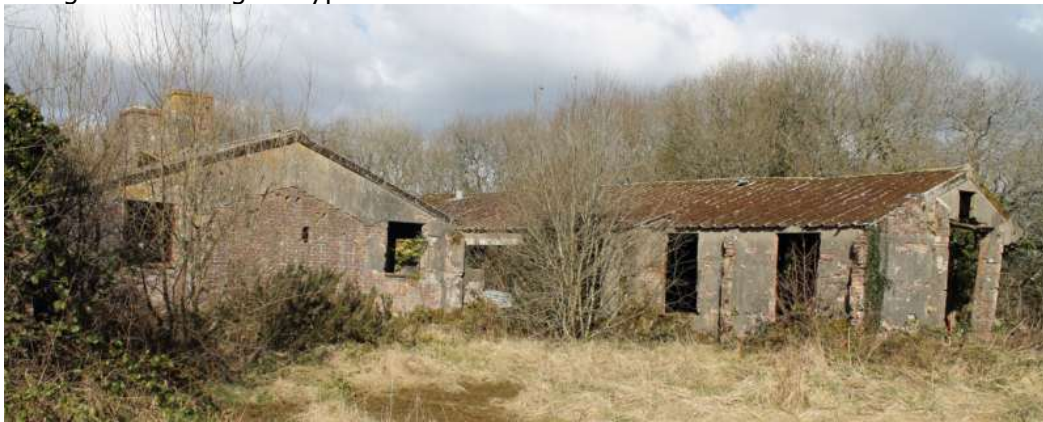
A range of three interconnecting parallel temporary brick buildings. Roofed in corrugated asbestos. Identified on the Air Ministry plan as a dining room. Central range were the kitchens and the outer dining rooms. A Pyper 2014.

CONDITION DESCRIPTION Dining room associated with airfield is in a poor condition, derelict with missing roof sheets, doors and windows missing, and vegetation and ivy penetrating the building. A Pyper 2014.

Figure 145: The remains of the dining room at the communal site

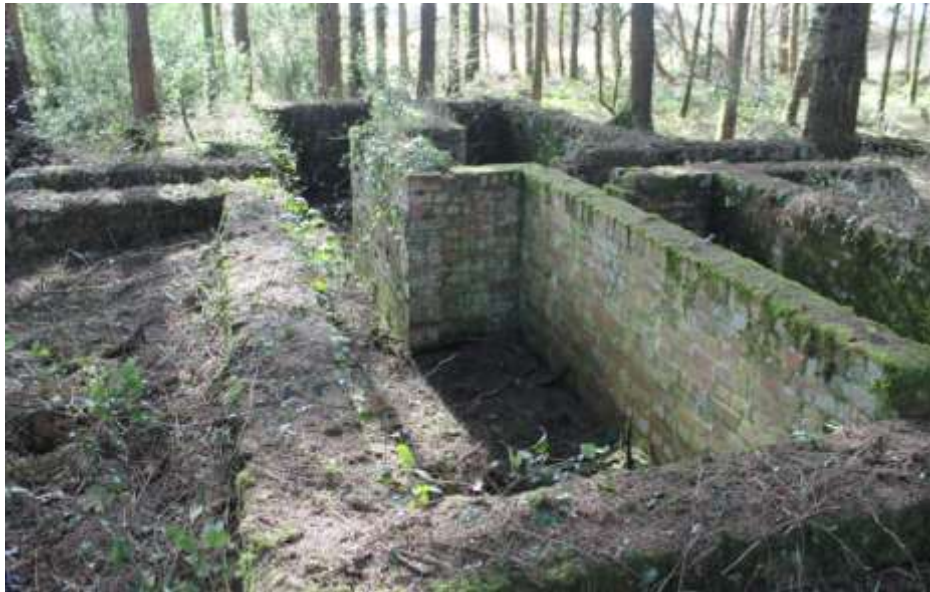
A brick built blast shelter, located within the communal site of RAF Templeton. Consisting of a rectangular structure within which are a series of doglegged walls with earth banked up around it. A Pyper 2014

CONDITION DESCRIPTION Surviving within conifer woodland, very good condition. A Pyper 2014

Figure 146: Blast shelter at the communal site

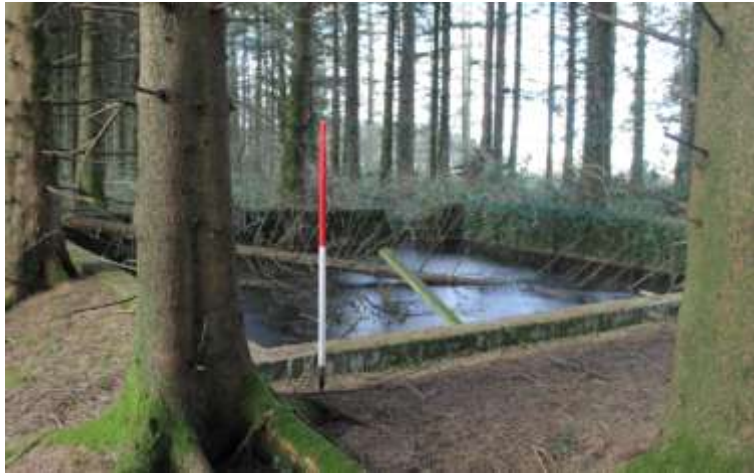
Concrete built water tank, identified on the Air Ministry plan and still surviving when visited in 2013. A Pyper 2013.

CONDITION DESCRIPTION Intact water tank - holding water!

Figure 147: Water tank on the communal site

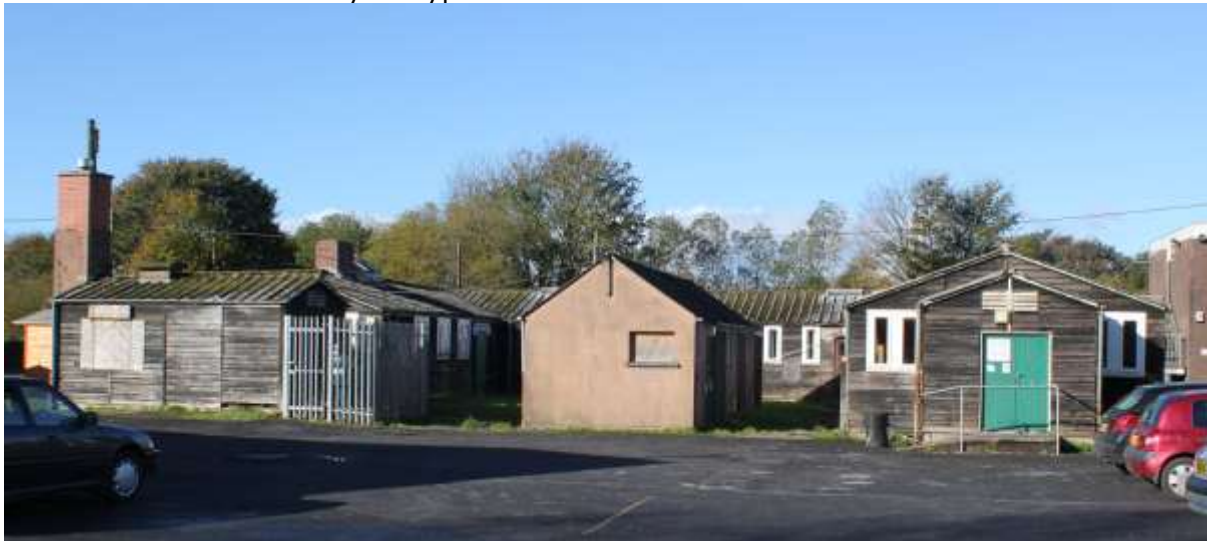
The timber huts and a single temporary brick building remain on the east side of the Carmarthen road. Likely to be the base for the RAF Air Sea Rescue established at Ferryside in the Second World War, using high speed launches to pick up crews that had ditched in Carmarthen Bay. A Pyper 2014.

Figure 149: Timber hutting associated with RAF Air Sea rescue base at Ferryside
