TWENTIETH CENTURY MILITARY SITES: AIRFIELDS – DISPERSED SITES AND DEFENCES

Interim Report

A THREAT-RELATED ASSESSMENT 2012-2013
DAT 115A

RHIF YR ADRODDIAD / REPORT NO. 2012/70

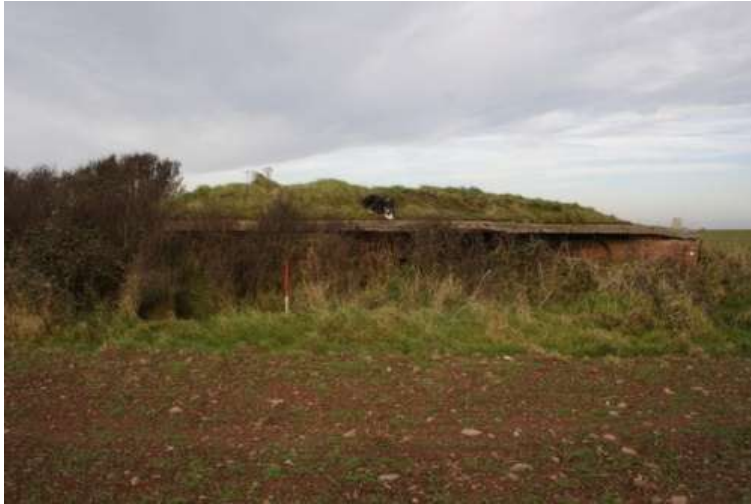
SITE DESCRIPTION

Pillbox, located within hedge to the east of Angle airfield.

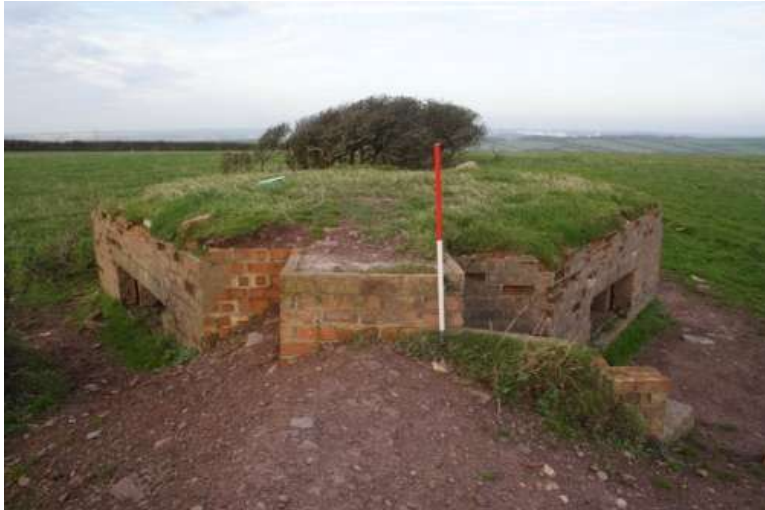
SITE DESCRIPTION

A brick and concrete pillbox located to the northwest of Angle airfield, within a hedgebank northeast of South Studdock Farm. Described by RJC Thomas as, "Semi-sunken, irregular hexagonal plan, integral 'D' shaped AALMG pit against N wall, fair-faced brick, flat turf covered concrete roof on corrugated steel sheeting. Protected entrance in S wall. 4 wide splay stepped embrasures

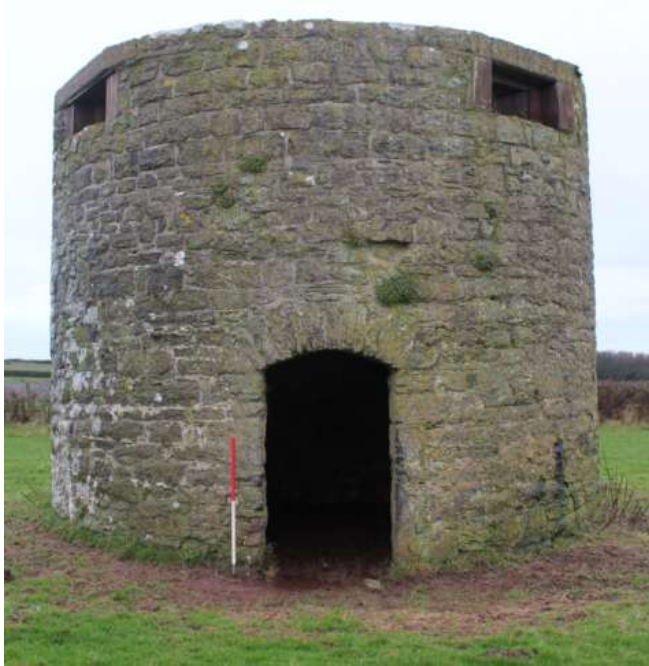
Circular stone tower, formerly a windmill (PRN 4386), converted into a defence post during the Second World War. Concrete floor inserted, with access to first floor gained via steel rungs set into wall and hatch. Five wide splayed concrete gun embrasures fitted with Turnbull mountings in first floor. Associated with the Battle Headquarters nearby to the east, PRN 34952. Intact when visited in 2013. A Pyper 2013.

CONDITION - Good/ Near Intact

CONDITION DESCRIPTION / Survives as roofless gun emplacement. Largely intact.

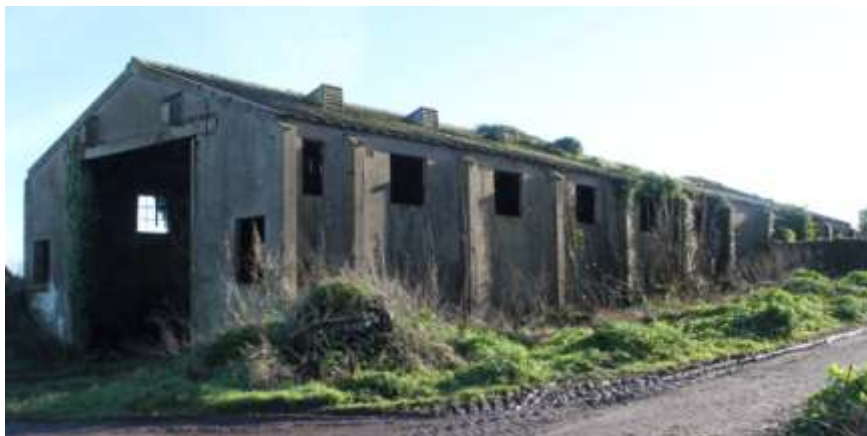
Ablutions block. Single storey, 9.5 bay rectangular plan, cement rendered temporary brick, corrugated asbestos cement sheeting gable roof. Twelve light standard steel

windows. Combined water tower and chimney has been demolished. Built per A.M.W.D. drawing 14364/40 & 6530/42. When visited in 2013 the floor and been dug out and lowered, the roof missing at the southern end. Steps removed at the north gable end to make a large double

doorway to allow access for machinery. A Pyper based on RJC Thomas 2013.

CONDITION - Damaged
CONDITION DESCRIPTION / None recorded

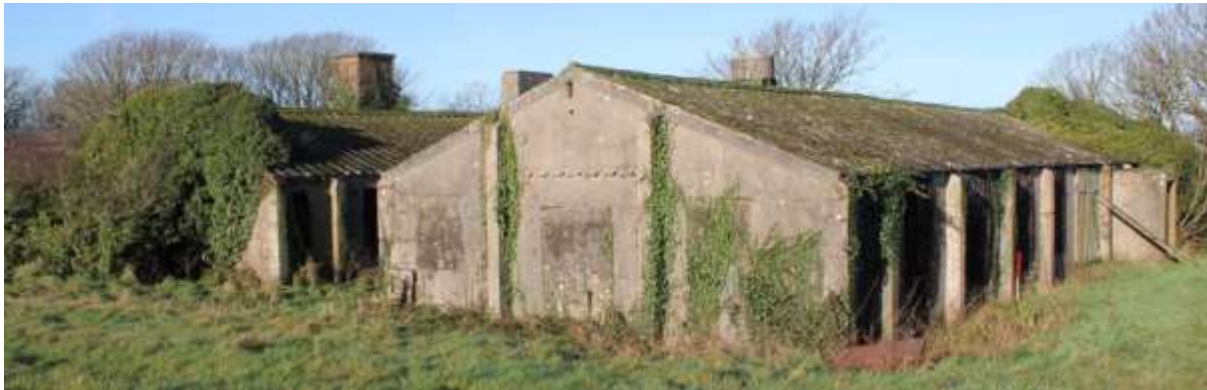
Linked parallel pair of temporary brick construction buildings 8.5 bays long x 3. Corrugated asbestos roof. Sixth bay of eastern range has a projecting porch on east side. West range has a brick built chimney in centre, otherwise interior has been cleared. Remains of a small latrine at south end. Latterly used as an agricultural store, though now little used. A Pyper 2013.

CONDITION - Damaged

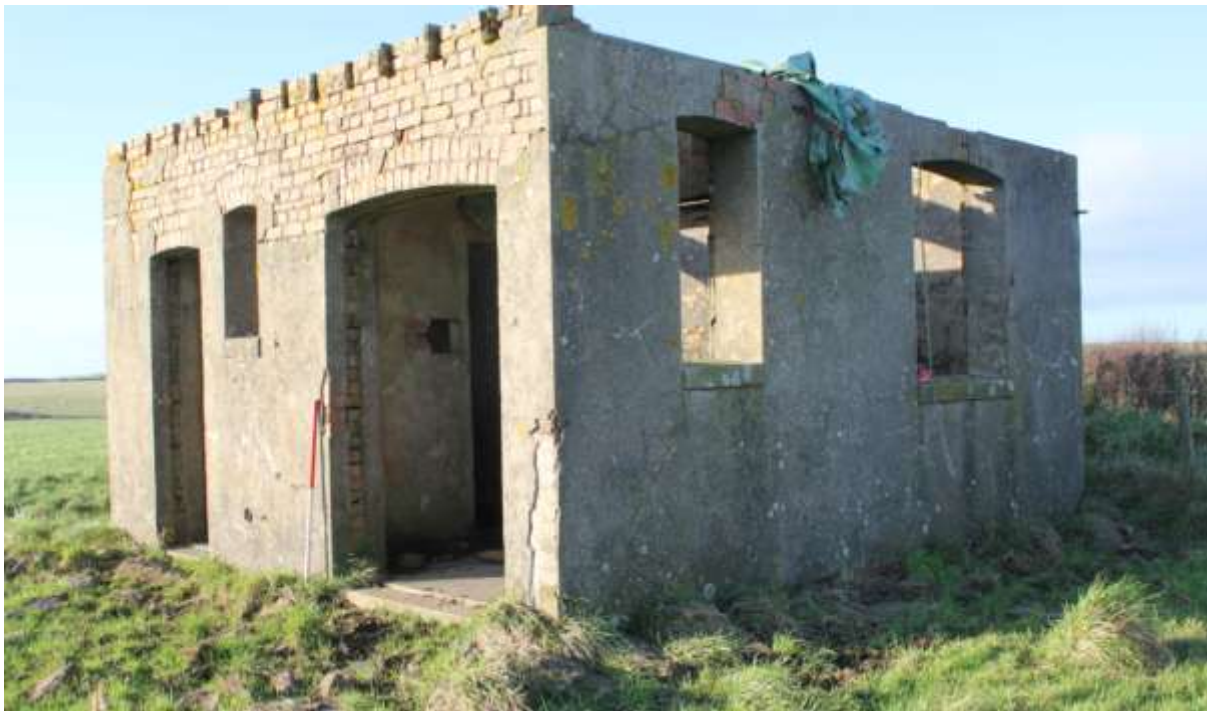
CONDITION - Damaged

CONDITION DESCRIPTION When visited in 2013 the building was roofless, and without windows and doors, but the walls still stood to roof level with roof timbers surviving. A Pyper 2013.

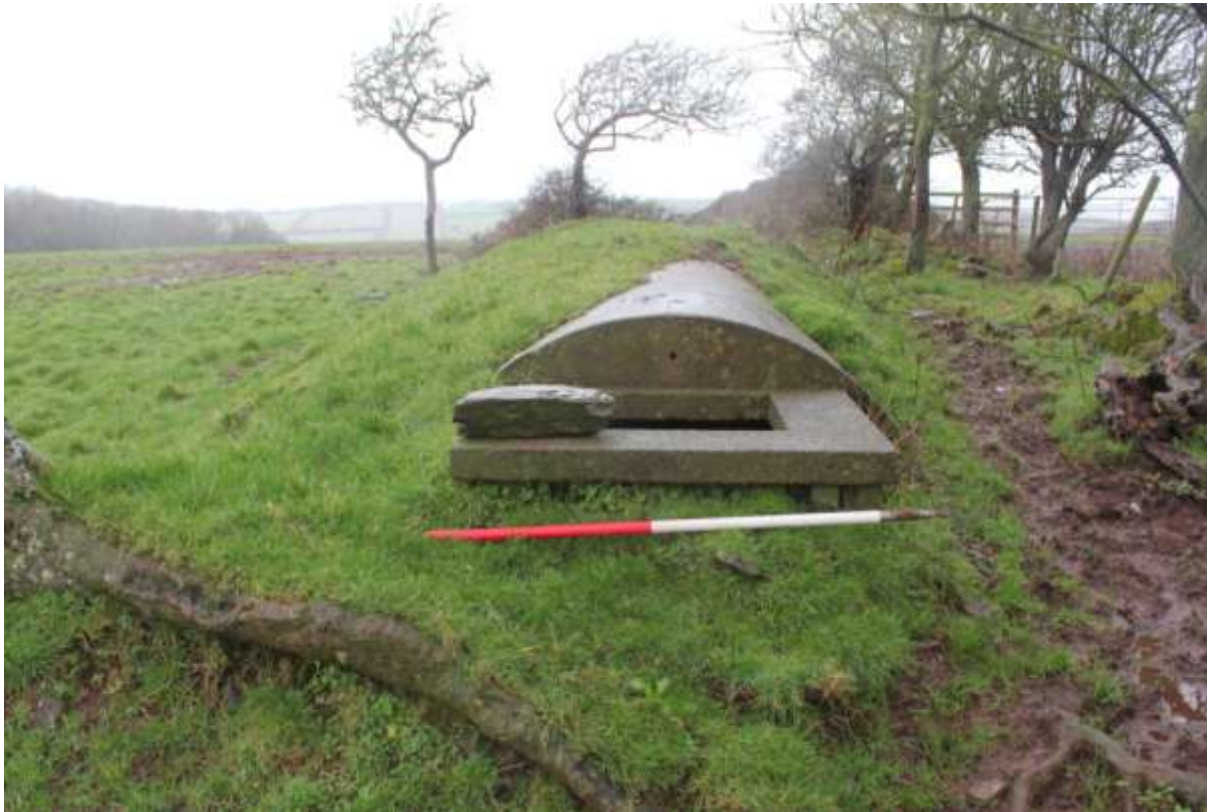
CONDITION - Near Intact

CONDITION DESCRIPTION In a stable condition near hedgeline in farm, some bramble growing over north end. A Pyper 2013.

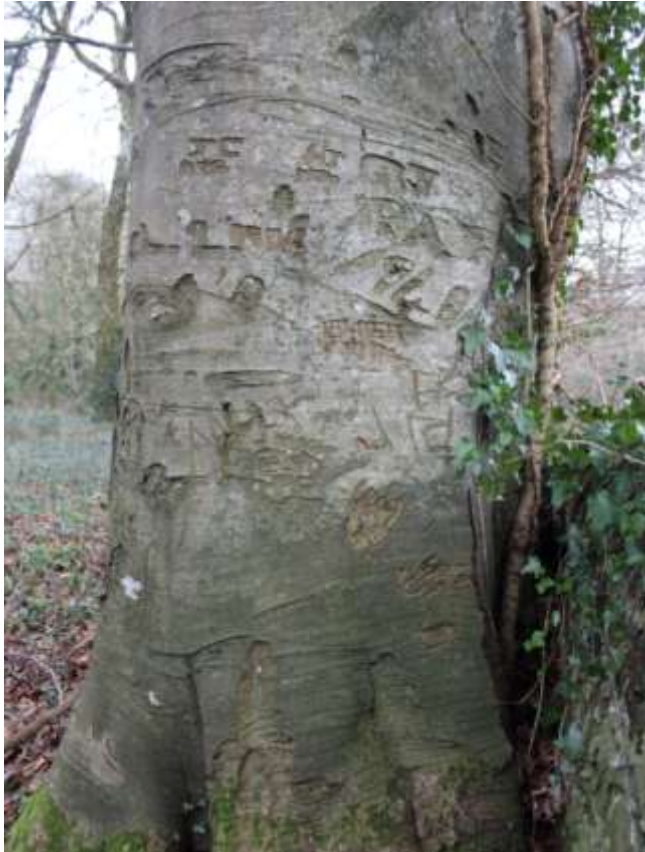
Graffitied Beech tree to the east of the enclosure in which the barrack huts for the personnel from RAF Pembroke Dock were stationed during the Second World War. Various initials inscribed and dates, one of which appears to be 'RAF 1940'. A Pyper 2013

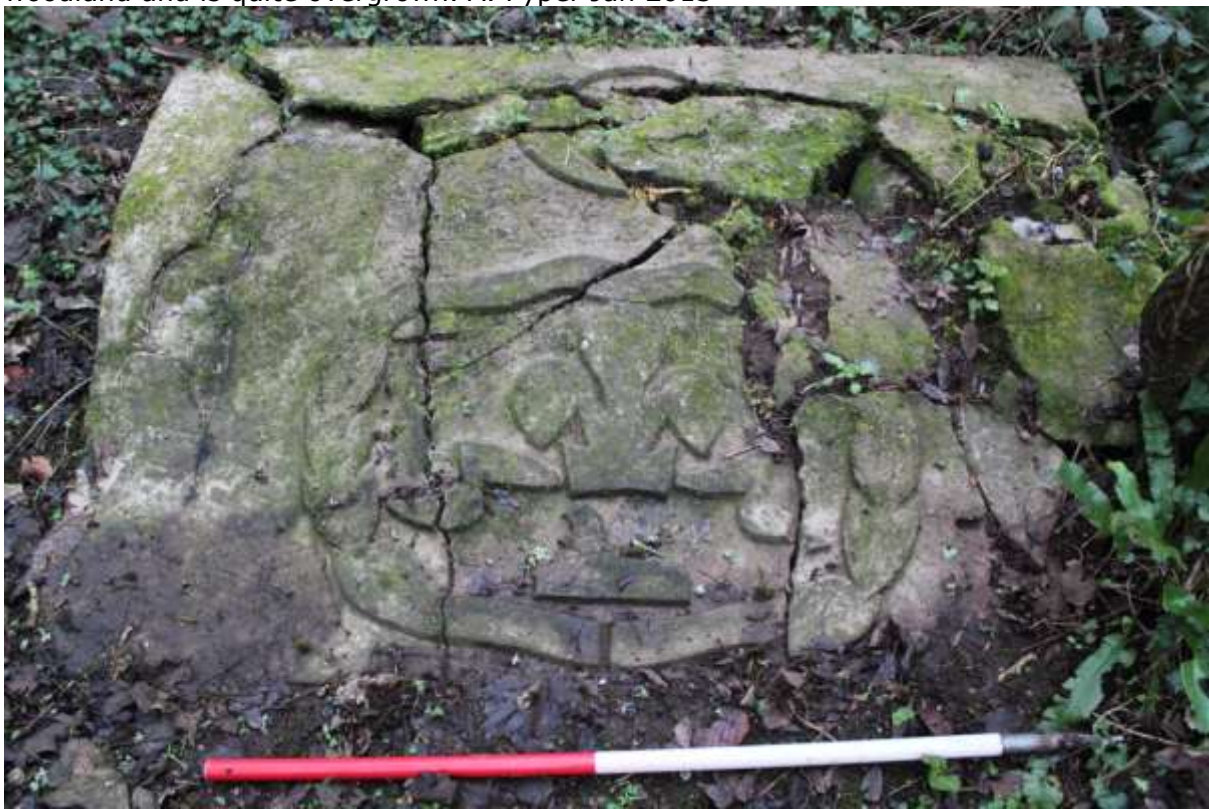
Concrete memorial slab located in woodland to the east of Lamphey Bishop's Palace. Concrete, cast with the Fleur de Lys within a wreath of laurels? This is apparently the badge of the Manchester Regiment. The cast concrete was fractured and broken and encroached on by self-seeded trees when visited in January 2013. A Pyper

CONDITION - Damaged

CONDITION DESCRIPTION concrete memorial cracked and broken. Lies within woodland and is quite overgrown. A. Pyper Jan 2013

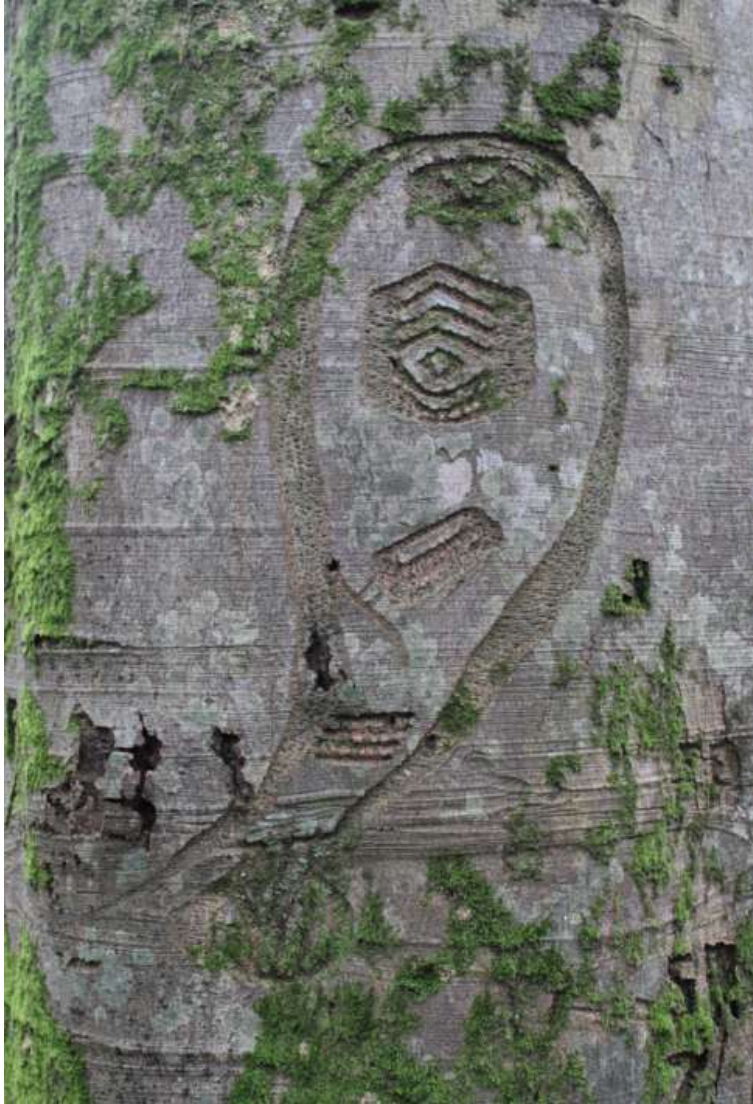
Graffiti carved into a beech tree at the entrance to Lamphey Court. Representing the left sleeve of a U.S. Army NCO's service dress uniform, the insignia (or patches) are from top to bottom: Unit patch, representing the division, corp command or army to which the man is currently assigned. Rank insignia: First Sergeant. Service stripe (also called a hash mark) representing three years' service. Overseas bars, each bar represents six months overseas service, so it appears this man had already been overseas for two years. This would appear to date from 1943 when I and K companies of the 110th Infantry, 28th US Infantry Division were stationed at a site to the rear and to the left of Lamphey Court. A Pyper 2013.

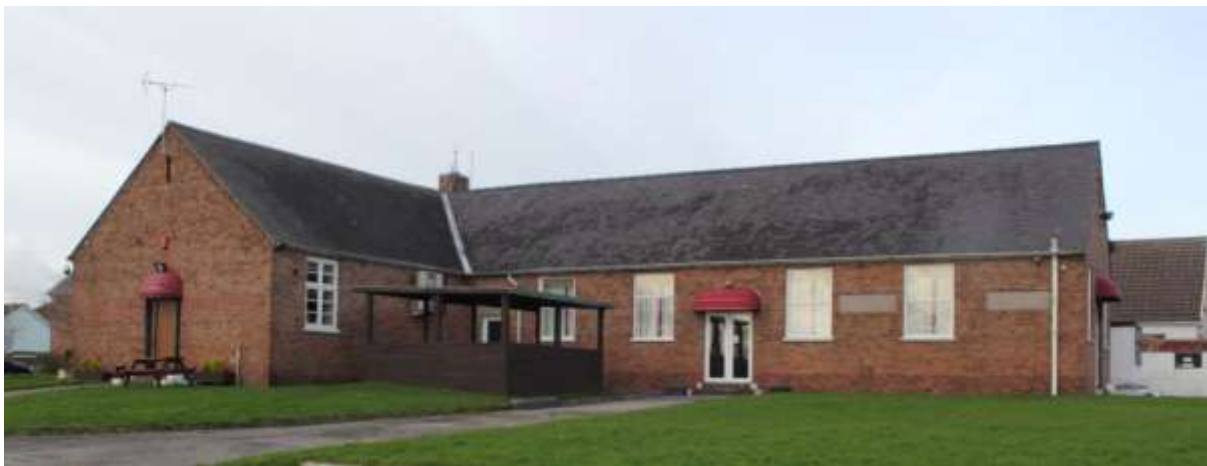
CONDITION - Intact/ Near Intact

CONDITION DESCRIPTION / None recorded

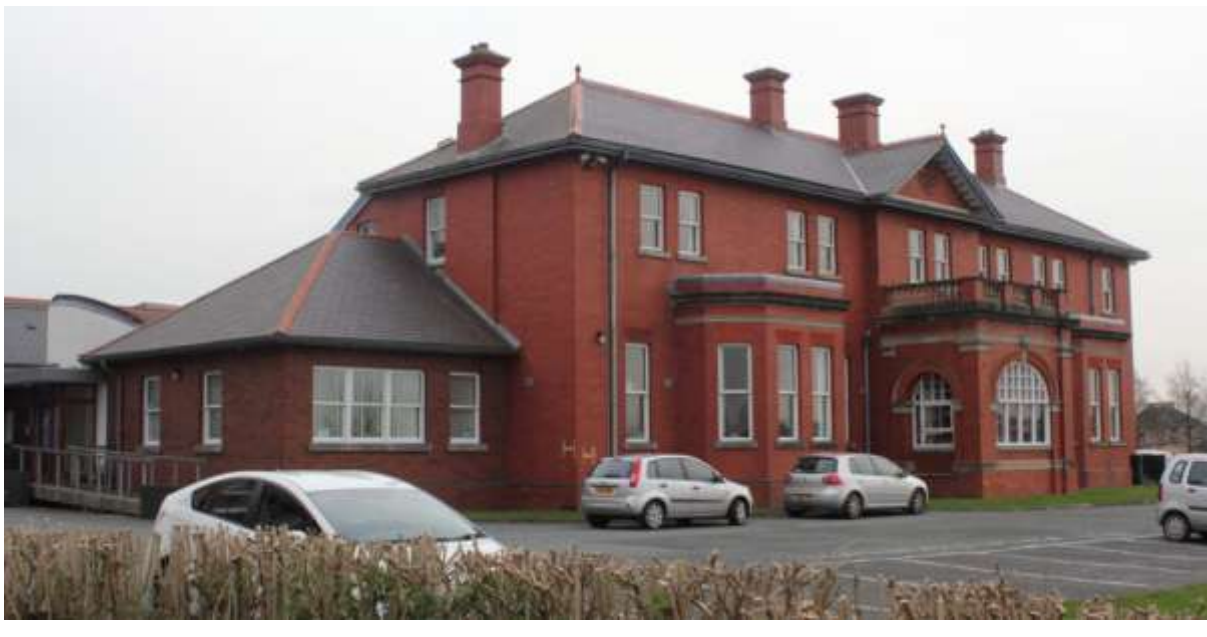
1903-72, Headquarters Building/Officers Mess, now council offices. A large, two storey, brick built, 'L' plan, hipped slate roof, with brick pedimented projections. 7 bay main elevations, 1st floor windows arranged 1-2-2-2-2-2-1. Ground floor brick porch with stone balustrade, two brick canted bay windows. Return range fenestration arranged 1-2-2-2-1-2-1. Central pediment dated 1904, Mosaic in hall dated 1905. RJC.Thomas, 12.03.93.

CONDITION DESCRIPTION / None recorded

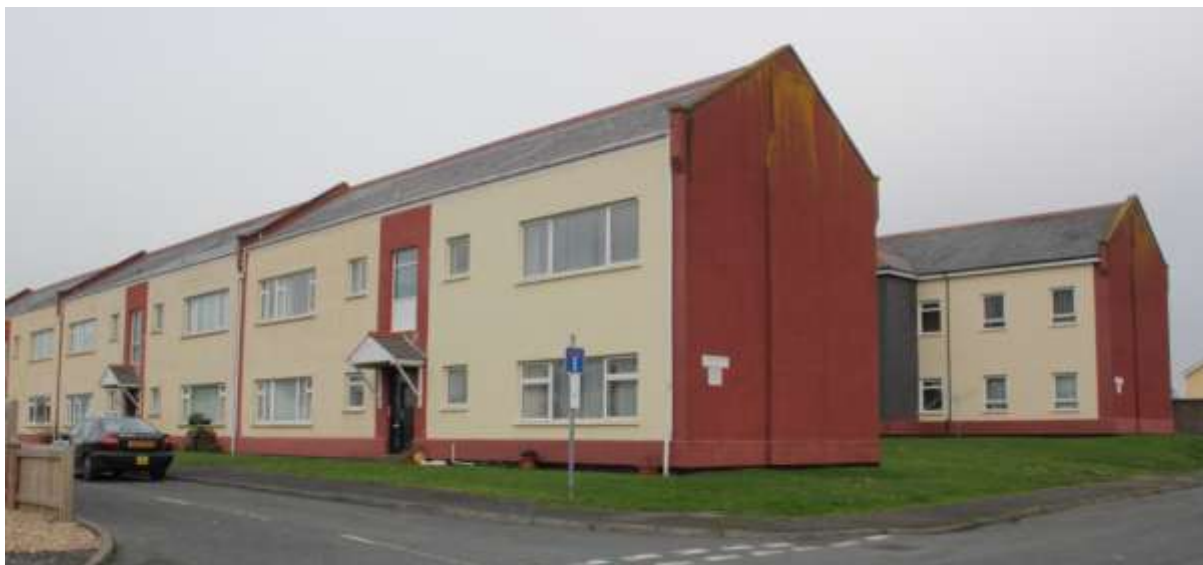
1903-72, Soldiers Barracks, present use flats. Two storey, brick built, 28 bay, arranged in four groups of seven, doorway to ground floor set centrally in each seven bay range, front and back. Gabled slate roof. Substantially altered in appearance from original. Two storey verandah set against west wall. RJC.Thomas, 12.03.93.

CONDITION - Intact

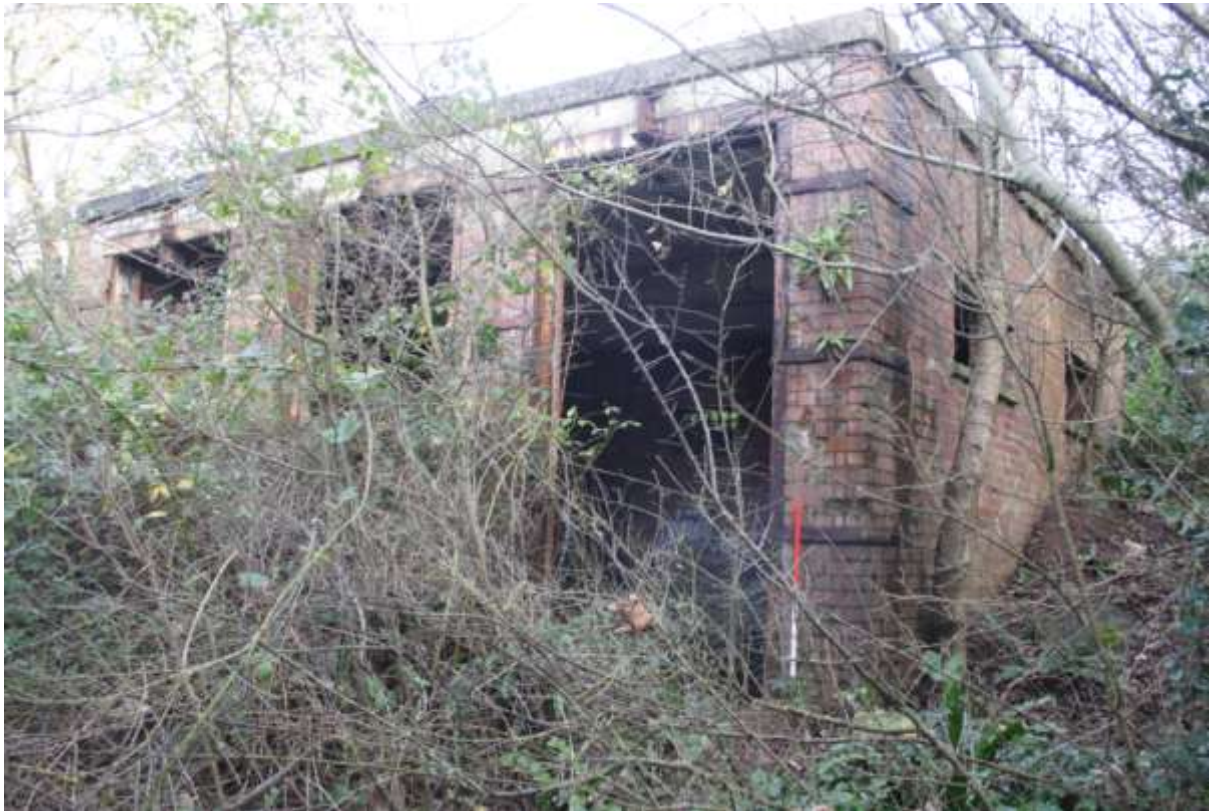
Two single storey bomb stores behind blast wall PRN 28458. Brick built, square plan with flat concrete roof, set within earth banks. Some steel gantry survives to front, three doors to west now removed. A Pyper 2013

CONDITION - Intact

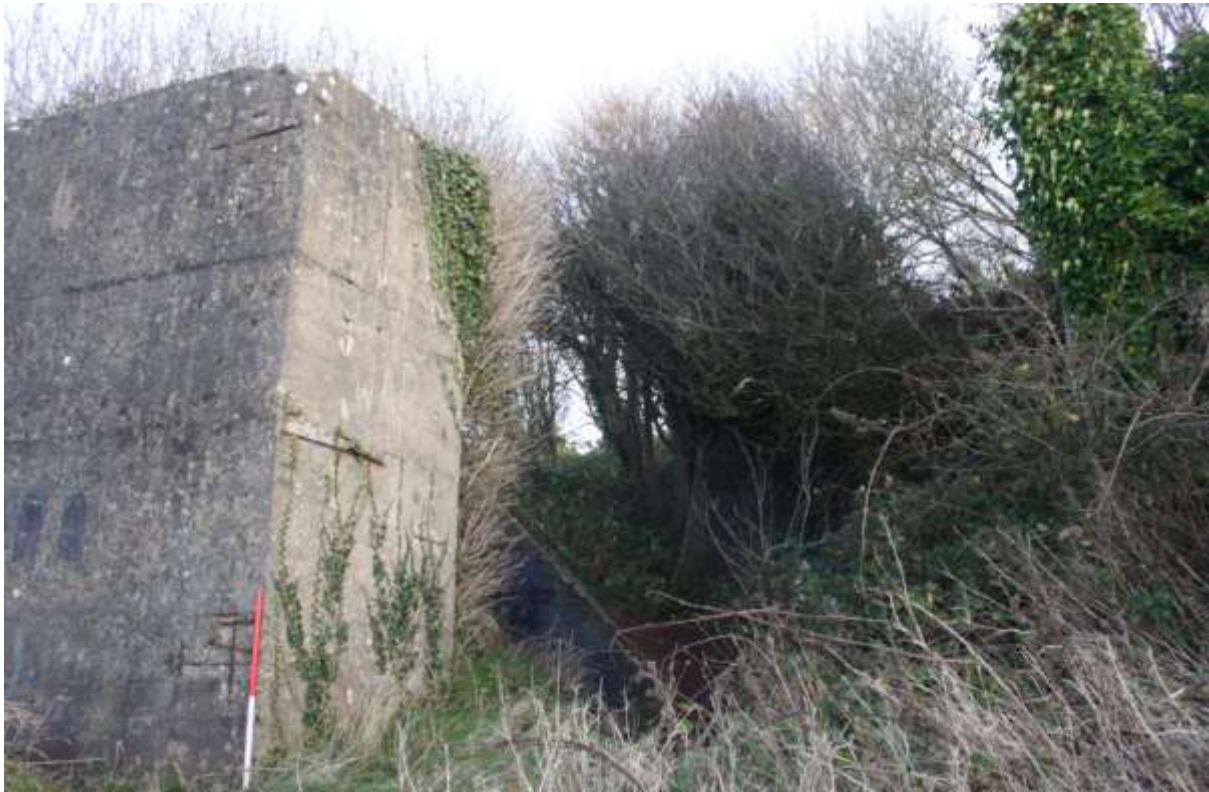
c1934, Flying Boat Base, Blast Wall, Bomb Dump, now derelict. Hollow re-inforced concrete wall, the space of which is infilled with coarse limestone rubble. RJC.Thomas, 14.12.93. Concrete blast wall for 28456. JH May 1998

CONDITION - Intact

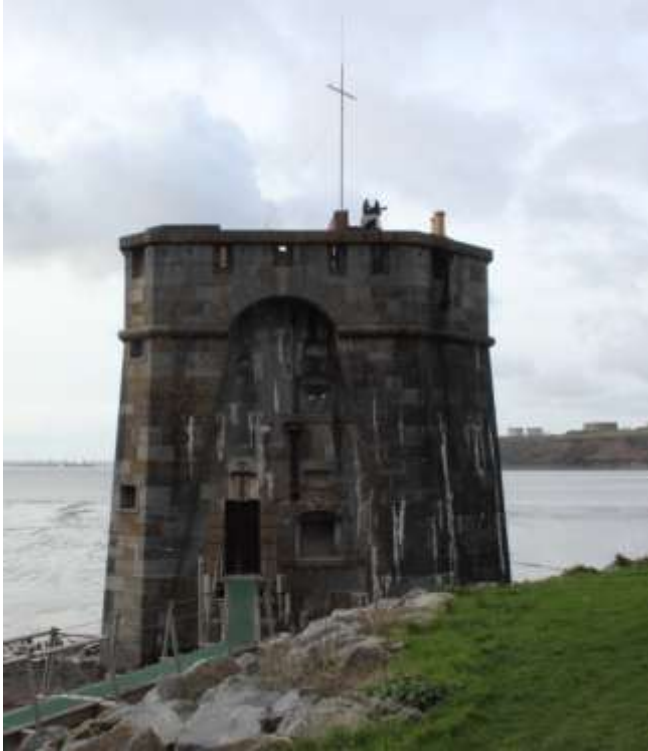
Martello tower of four storeys with a rooftop gun platform. Irregular octagonal plan, dated 1851, but reused in the Second World War. In private ownership when visited in 2013. A Pyper 2013.

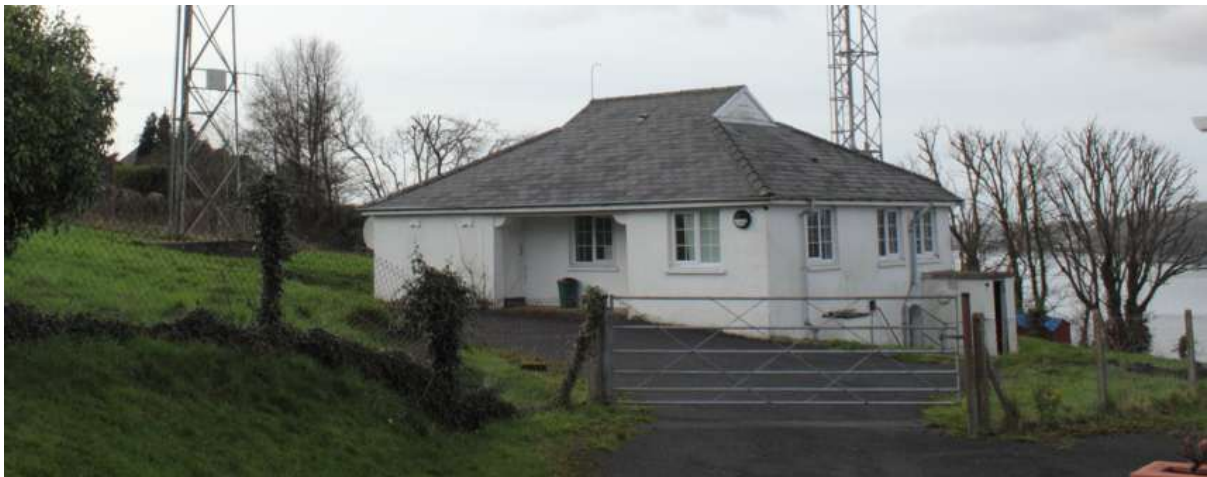
Wireless station identified by Roger Thomas, 328/000, with a square, single storey, three bay bungalow in the centre of the plot. Slate gabled roof. The earlier radio masts have gone, to be replaced by two communications masts. A Pyper 2013

CONDITION - Not Known/ Near Intact

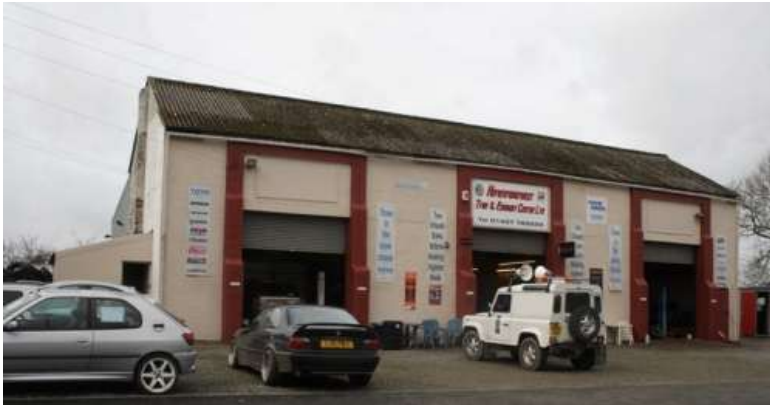
Turret instructional building, Type 'A', with 3 bays. For the instruction of air crew in a simulated gun turret. When visited in Nov 2011 it was in use as a garage workshop. A. Pyper 2012.

CONDITION - Intact

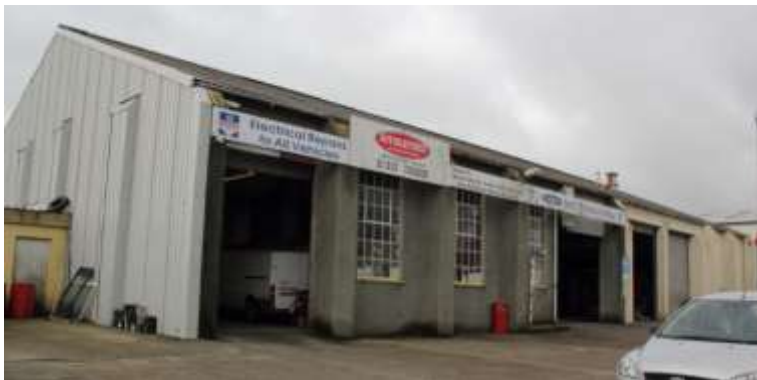
Recorded on the Air Ministry plan as a Gunnery and Crew Procedure Building. Nine by five bay temporary brick construction with a corrugated asbestos gable roof. Reclad with corrugated iron on the south gable. Tall 30 light windows in each bay. When visited in 2013 in use as a garage, and some bays have been broken through to create

openings. A Pyper 2013.

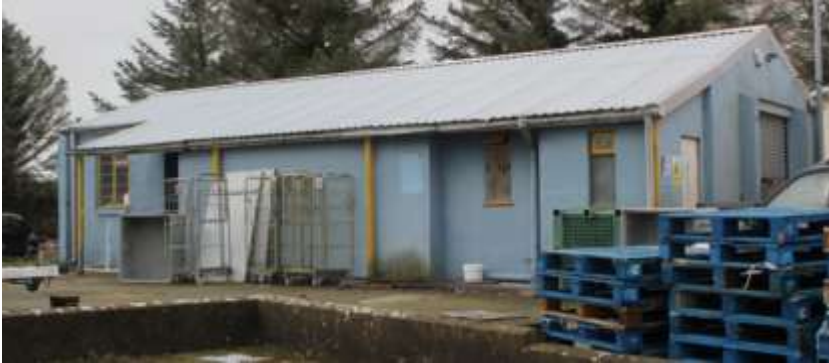
Identified on the Air Ministry plan of the Haverfordwest this single storey, temporary brick construction and re-clad corrugated iron roof. When visited in 2013 was in use as a store. A Pyper 2013.

CONDITION - Intact/
Near Intact

CONDITION DESCRIPTION / Still largely intact though re-clad corrugated iron roof and an extended roof over the front. A Pyper 2013.

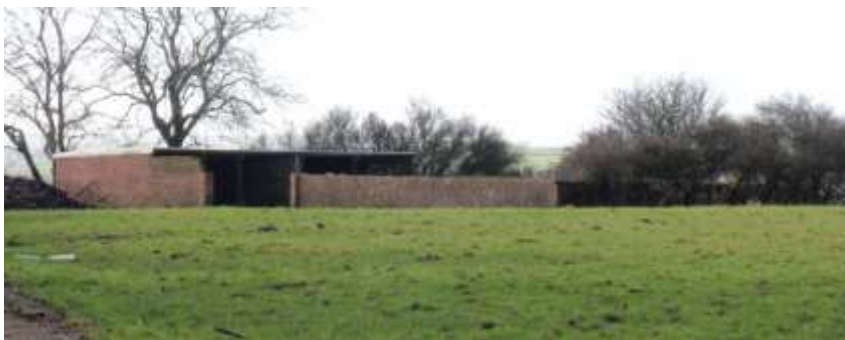
A brick built enclosure which formed the Main Beacon for RAF Haverfordwest. Consists of a brick walled enclosure c 1.5m high with a concrete floor within. Converted for agricultural use when visited in 2013 with the southwest wall enclosed

CONDITION - Near Intact/ Damaged
CONDITION DESCRIPTION / Modified for agricultural use though the brick enclosure appears reasonably intact. A Pyper 2013

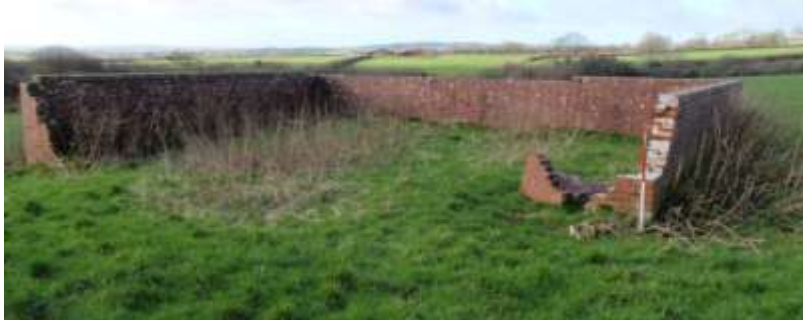
Outer navigational beacon for RAF Haverfordwest. Consists of a square brick walled enclosure measuring c 9m with walls 1.5m high. When visited in 2013, the east wall has been demolished but otherwise the walls are intact. A Pyper 2013.

CONDITION - Near Intact/ Damaged

CONDITION DESCRIPTION / The east wall of this structure has been demolished, but otherwise the walls are complete. Visited 2013 A Pyper.

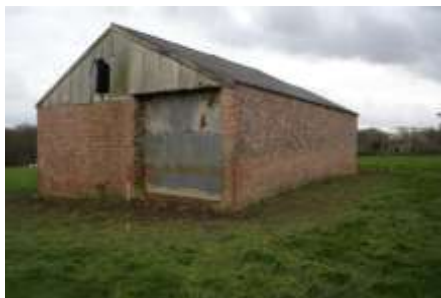
Rectangular red brick structure with a later pitched roof, pedestrian access in south wall and later double doorway inserted into north wall. Associated with the picket post (PRN 102487) to the south, these structures form the Inner Beacon, part of a landing system to guide airplanes into Haverfordwest airfield and associated with the Main and Outer Beacon.
