TWENTIETH CENTURY MILITARY SITES: AIRFIELDS

A THREAT-RELATED ASSESSMENT 2011-2012

RHIF YR ADRODDIAD / REPORT NO. 2011/48

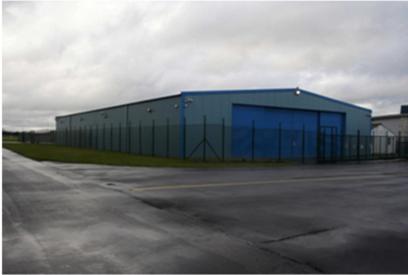
Hangar, Bellman type, one of two built as part of the Aberporth Airfield in 1941. This is the only one remaining. Now re clad, although apparently retaining original framework within and with modified doors. In use when visited in Nov 2011. A.Pyper 2012

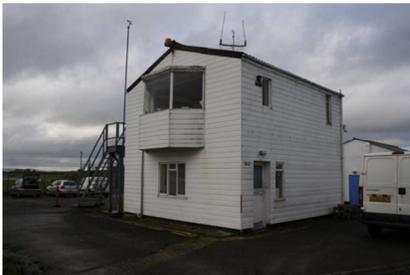
Two storey control tower. Replaced external cladding. Forms part of a group of three buildings which date from the establishment of the airfield in the Second World War. In use when visited in Nov 2011. A Pyper 2012.

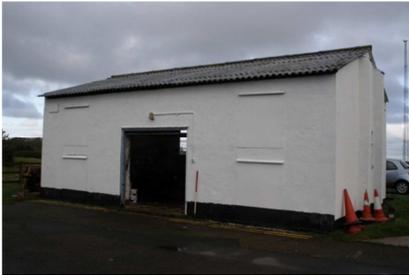
SITE DESCRIPTION

Three bay, temporary brick and corrugated asbestos roofed building. In a group around control tower. In use as workshop and store when visited in 2011. A Pyper 2012.

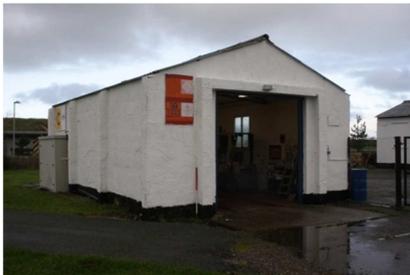
SITE DESCRIPTION

Temporary brick, 3 bay, corrugated asbestos roofed building, large double width door in gable end. In a cluster of Second World War buildings including the control tower at RAF Aberporth. When visited in 2011 in use as a fire tender shed. A. Pyper 2012.

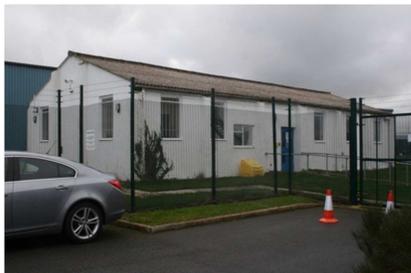
SITE DESCRIPTION

Six bay temporary brick, corrugated asbestos roofed building, adjacent and parallel to Hangar. One of the few remaining buildings that survive from the

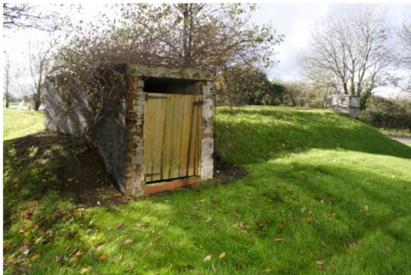
A Stanton semi-sunken concrete air raid shelter with an arched interior, covered externally with turf. The entrance is constructed from brick and concrete at the east end with a concrete 'chimney' escape hatch at the west end. Well preserved. Visited on 26th Oct 2011. A. Pyper 2012.

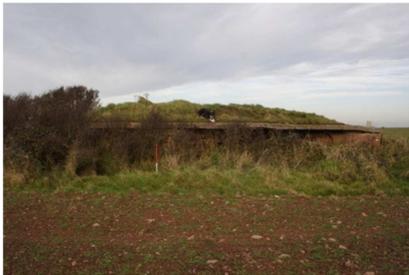
Pillbox, located within hedge to the east of Angle airfield. Similar to pillbox located to the NW of the airfield except the roof is modified to carry the turf over the embrasures and continue the hedgeline. Described by RJC Thomas as, "Semi-sunken, irregular hexagonal plan, integral 'D' shaped Anti-Aircraft Light Machine Gun pit against N wall, fair-faced brick, flat turf covered concrete roof on corrugated steel sheeting. Roof maintains line of hedge to the east. Wide splay embrasures fitted with Turnbull

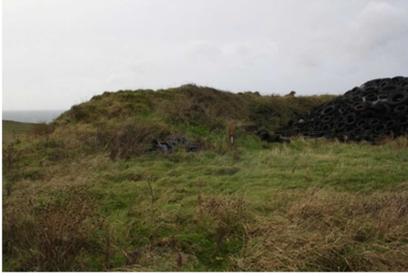
parabolic pre-cast concrete Stanton air raid shelter. Visited in 2011 when the concrete hardstanding was in use as a silage clamp. Last remaining dispersal pen on the airfield, originally there were 6, others remain as crop marks or slight depressions. A. Pyper 2012.

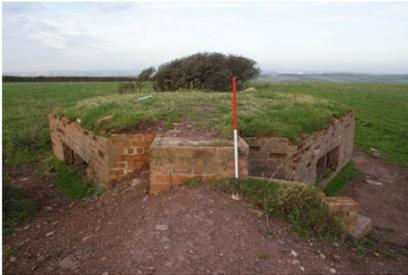
PRN - 101392
NAME - RAF ANGLE
TYPE - Pillbox
CONDITION - Good/ Intact
NGR - SM85610236
COMMUNITY - Angle
COUNTY - Pembrokeshire

A brick and concrete pillbox located to the northwest of Angle airfield, within a hedgebank northeast of South Studdock Farm. Described by RJC Thomas as, "Semi-sunken, irregular hexagonal plan, integral 'D' shaped AALMG pit against N wall, fair-faced brick, flat turf covered concrete roof on corrugated steel sheeting. Protected entrance in S wall. 4 wide splay stepped embrasures fitted with Turnbull mountings."

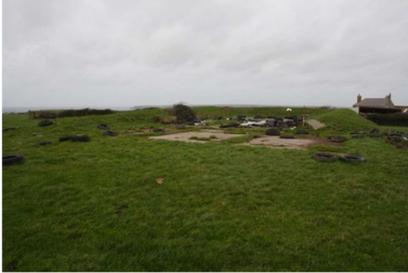
PRN - 102483
NAME - RAF ANGLE
TYPE - hangar
CONDITION - Near Destroyed
NGR - SM85370192
COMMUNITY - Angle
COUNTY - Pembrokeshire

Site of former blister hangar, now a U-shaped earthwork bank enclosing a rectangular concrete pad. Visited 2011, A. Pyper 2012.

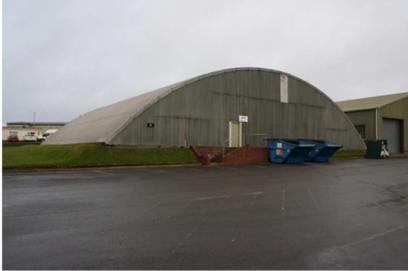
PRN - 102524
NAME - RAF BRAWDY / RNAS BRAWDY
TYPE - free gunnery trainer blister
CONDITION - Intact
NGR - SM84752449
COMMUNITY - Brawdy
COUNTY - Pembrokeshire

'Free Gunnery Trainer Blister', listed, no 5, on the Air Ministry plan of 1945. This building was used for the training of air to air gunnery, usually using projectors to project the images of attacking aircraft. In 2011 the blister was still intact and still has its number (5) on the front, south, elevation. A Pyper 2012.

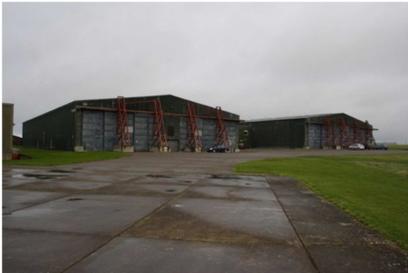
PRN - 102525
NAME - RAF BRAWDY / RNAS BRAWDY
TYPE - hangar
CONDITION - Near Intact
NGR - SM84922458
COMMUNITY - Brawdy
COUNTY - Pembrokeshire

Two T2 type hangars, linked by a later interconnecting 2 storey building. Listed on the Air Ministry plan of 1945. Full height sliding doors at south end. Large steel buttresses against the south end. Steel gantries to support sliding doors have been removed and structures reclad. A Pyper 2012.

Two T2 type hangars which have undergone various modifications including the later interconnecting 2 storey building. Full height sliding doors at south end. Large steel buttresses against the south end. Steel gantries to support sliding doors have also been removed. Otherwise in stable condition and in use. A Pyper 2012.

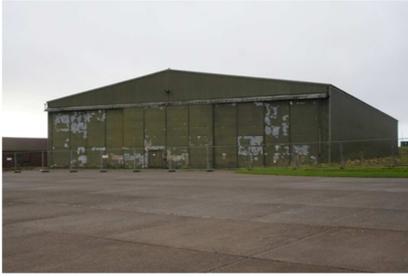
PRN - 102526
NAME - RAF BRAWDY / RNAS BRAWDY
TYPE - hangar
CONDITION - Damaged
NGR - SM84532469
COMMUNITY - Brawdy
COUNTY - Pembrokeshire

T2 type hangar, listed on the Air Ministry plan of 1945 for Brawdy airfield. Steel gantries for handling the full height steel doors at the west end are missing and the hangar has

been reclad. A Pyper 2012.

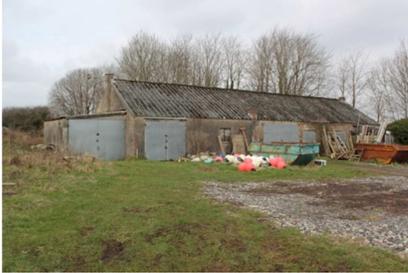
Identified as 'YMCA' on the Air Ministry Plan for Carew Cheriton Airfield. See RJC Thomas description, "1938-45, YMCA, present use store. Single storey, rectangular plan, rendered 'temporary brick' construction, gabled corrugated asbestos roof. Scarring on east wall indicates the former position of a timber extension." Three chimneys, one at each gable end and a further short chimney on the east elevation. In 2012 the building was still in use as a store by PCNPA. A Pyper 2012.

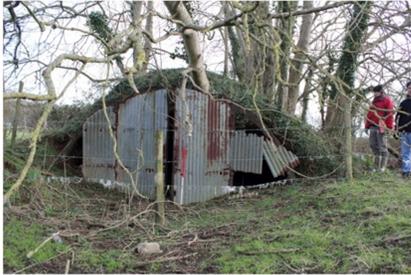
CONDITION - Damaged/ Near Destroyed

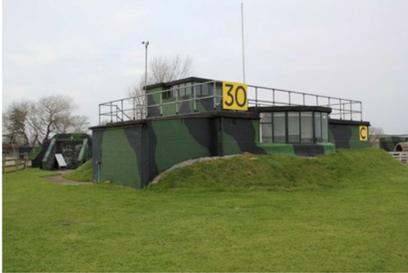
Control Tower at Carew Cheriton airfield. Between 2000 and 2004 local enthusiasts (The Carew Cheriton Control Tower Group) have renovated this uniquely designed, important building and restored it to its original specifications. It is now open to the public every Sunday between 1st July and 30th September and all Bank Holidays except Christmas and New Year, as both a visitor attraction and as an educational experience of WW 2 in the area. Richard Ramsey February 2011.

The Watch Office/Control Tower, is a square single storey, brick building with a flat concrete roof. Entrance in north east wall, metal framed bay window in south east wall. Small rectangular controller's post on roof. Stone and earth blast revetment against SW walls.

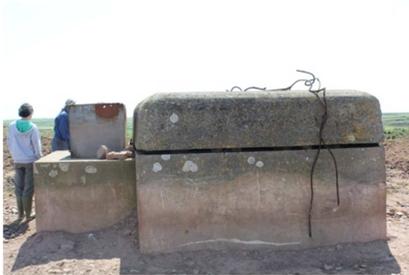
Battle Headquarters at Dale airfield. Underground bunker with a square concrete observational cupola projecting from the ground almost 2m high. "21'X 8'(6.40 X 2.44m)

underground complex of rooms 6' (1.83m) accessed by a flight of steps at southern end of structure. A 6'(1.83m) square concrete observation cupola rises 3' (.91m) above the roof of the main structure. A 360 degrees narrow observation slot in the cupola permits all round vision. An emergency exit hatch is adjacent to the east side of the cupola." (RJC Thomas). A Pyper 2012.

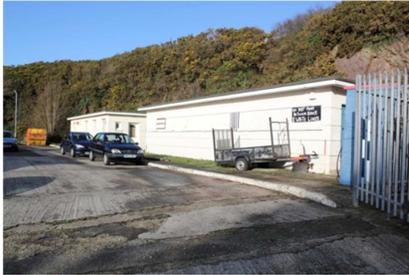
Group of five buildings comprising the pumping station for the RAF Fuel Reserve Depot at Haven's Head. This network of storage tanks and pumping station supplied high octane fuel to the military airfields of Pembrokeshire. Built in 1936 it continued in use supplying RAF Brawdy until the 1970s. Between the row of three single storey, concrete buildings which lie at the foot of the slope is a shelter with the pipelines connecting the fuel tanks at the top of the hill.

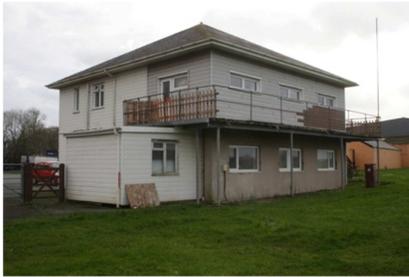
Former control tower for Haverfordwest airfield, numbered as 33 on Air Ministry Plan.

"Two storey, brick built, square plan, three bay main elevation with concrete balcony, flat concrete roof, beneath a secondary hipped slate roof " (Roger Thomas). Ground floor windows to west have been lowered. Visited in 2011 when it was still in use as showground office. A. Pyper 2012.

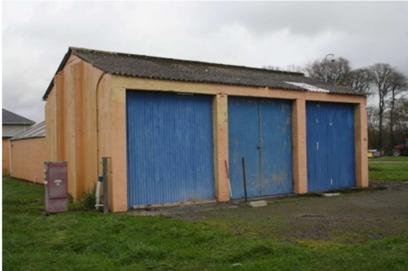
SITE DESCRIPTION

Former floodlight trailer and tractor shed at Haverfordwest airfield. One storey, though high sided, 3 and half bay temporary brick and corrugated asbestos shed. Three blocked windows in either side. Double doorway in north and south gable ends. When visited in Nov 2011 forms part of complex of Pembrokeshire showground buildings. A. Pyper 2012.

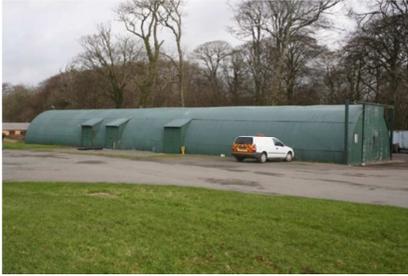
SITE DESCRIPTION

Former maintenance block at Haverfordwest airfield. A Nissen type hut, 24ft wide with curved corrugated iron sheeting. Three side entrances and a sliding double doorway at the south end. Painted green. Part of showground complex of buildings when visited in Nov 2011. A. Pyper.

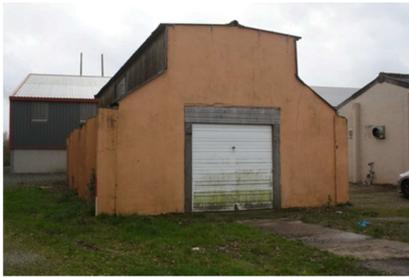
SITE DESCRIPTION

Former 'parachute store' at Haverfordwest airfield. When visited in Nov 2011 it had a replacement garage 'up and over' door in the north gable. A. Pyper 2012.

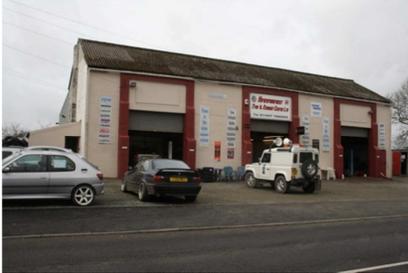
PRN - 28518
NAME - RAF HAVERFORDWEST
TYPE - turret instructional building
CONDITION - Intact
NGR - SM96101821
COMMUNITY - Rudbaxton
COUNTY - Pembrokeshire

SITE DESCRIPTION

Turret instructional building, Type 'A', with 3 bays. For the instruction of air crew in a simulated gun turret. "One and a half storey, rendered 'temporary brick' construction, 1/2--5--1/2 bay rectangular plan, pitched corrugated asbestos gable roof" RJC Thomas 1993. When visited in Nov 2011 it was in use as a garage workshop. A. Pyper 2012.

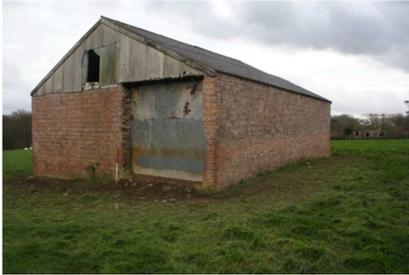
SITE DESCRIPTION

Rectangular red brick structure with a later pitched roof, pedestrian access in south wall and later double doorway inserted into north wall. Associated with the picket post (PRN 102487) to the south, these structures form the Inner Beacon, part of a landing system to guide airplanes into Haverfordwest airfield and associated with the Main and Outer Beacon. Visited Nov 2011, A.Pyper 2012.

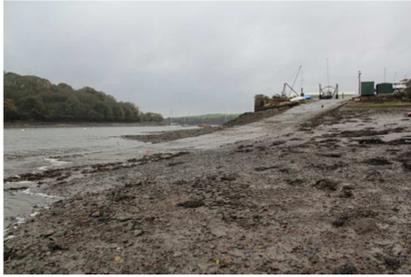
A slipway constructed for the establishment of the Royal Naval Air Station at Lawrenny Ferry (PRN 26201), also known as HMS Daedalus II established in 1941. The slipway was built 18ft wide (Fleet Air Arm, Handbook Royal Naval Air stations 1948-1955) and on aerial photographs appears approximately 80m long. It is constructed with concrete slabs. The winch has been dismantled in recent years. Now part of yacht club and still in use for winching boats. Visited in

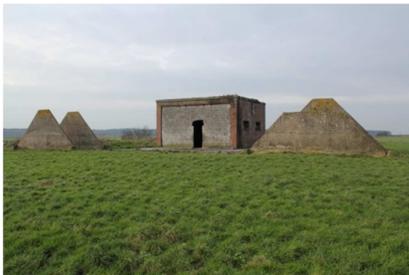
SITE DESCRIPTION

Bomb store located to the western extent of Pembrey airfield, listed on the Air Ministry plan of 1948 as type 3054/36. Consists of a building c 7m square built in brick with a flat concrete roof. The eastern side is infilled with blockwork, presumably large doors were located here. Reinforced glass small pane windows, 2 on each of the remaining three sides. To either side of the building - north and south are inverted V-shaped revetment walls, however the earth banks associated

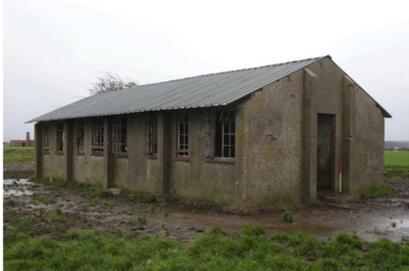
Identified on the Air Ministry plan as 'Barber, shoemaker and tailor's shop'. A rectangular 'temporary brick' construction 4 bays long with a new corrugated tin roof. Internally subdivided into three rooms with interconnecting doors. Some of the internal paint scheme survives; duck egg blue up to dado level. Electrical points also positioned at dado level. In 2012 the building had a new roof but no doors and no window glass remaining although metal casements survive. A Pyper 2012.

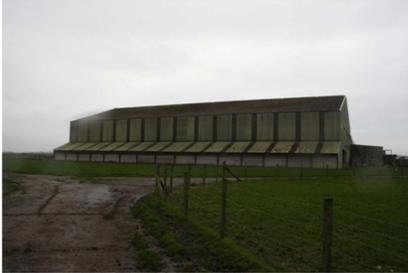
PRN - 31187
NAME - RAF PEMBREY
TYPE - Hangar
CONDITION - Destroyed/ Damaged
NGR - SN40490382

Described on the Air Ministry plan of 1948 as "'F' type shed' or aircraft hangar, one of four originally on the airfield. Originally identified on the drawings as 'Synthetic Trainer (3 screens)'. Dimensions approximately 33 x 63m with additional low level side extensions of which that on the north-eastern side was original. The hangar has been reclad in recent years and in 2011 was housing cattle. A Pyper 2012.

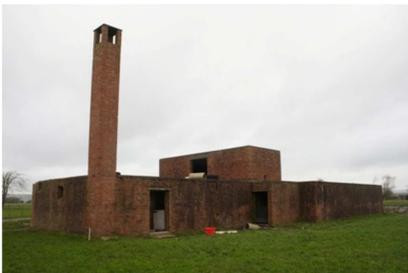
PRN - 31197
NAME - RAF PEMBREY
TYPE - Decontamination Building
CONDITION - Near Intact
NGR - SN40530391
COMMUNITY - Cefn Sidan
COUNTY - Carmarthenshire

SITE DESCRIPTION

Identified on the Air Ministry plan of 1948 as 'Decontamination Centre. Type H.' This is a large red brick complex designed to take both men and women through gas decontamination rapidly. In 2011 the building appeared remarkably intact with external hand rails and ventilation cowls. A Pyper 2012.

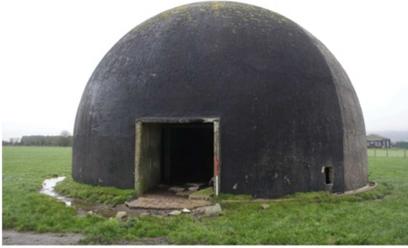
Dome Trainer built of reinforced concrete? with an external concrete skim. Approximately 8m in diameter and 8m high. The dome trainer was used to teach ground to air anti-aircraft gunnery. Visited in 2012. Ramped double width entrance. Drip gutter around the exterior. Inside partition composed of wire mesh infilled with sheep's wool, encloses a third of the interior together with the entrance. This is further subdivided by two partitions (one intact, one collapsed) which would have created a small entrance vestibule. Disused although some agricultural machinery stored inside. A Pyper 2012

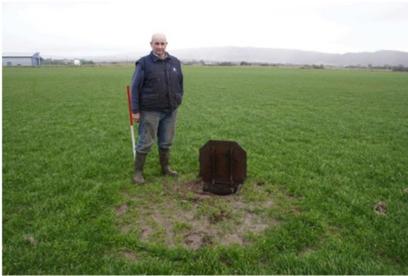
A sunken, circular, concrete pillbox, flush with the ground surface. Concrete top 2m in diameter with metal hinged trap door 0.56m square with canted corners. Located within the eastern intersection of the runways. In 2011 the interior was full of water and the field in which it is located was recently reseeded, A Pyper 2012. The Pickett Hamilton fort

would permit the free movement of aircraft, but if attack threatened, could be raised, hydraulically or by a counterbalance, and manned to give covering fire.

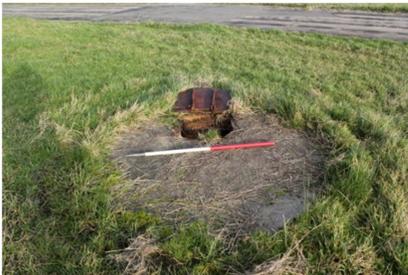
A sunken, circular, concrete pillbox, flush with the ground surface. Concrete top 2m in diameter with metal hinged trap door 0.56m square with canted corners. Located adjacent to the perimeter track at the northern extent of the runways. In 2011 the interior was full of water, however apparently it has been pumped out and the interior allegedly still contains hydraulics etc. Situated within mown grass. A Pyper 2012. The Pickett Hamilton fort would permit the free movement of aircraft, but if attack

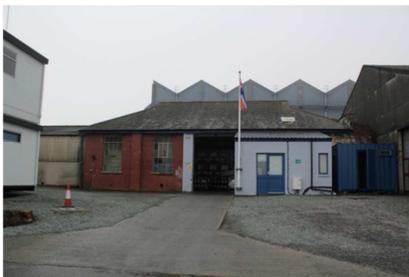
Pre-second World War Workshop located to the north of the seaplane hangars at Pembroke Dock. Single storey 5 bay red brick building with a gablet above the hipped slate roof, built against an earlier brick building. Each bay has brick piers and within each bay are large metal framed windows. Centre bay at the front is open and extensions have been added on the northwest and eastern gable. In 2011 the building was in workshop use. A Pyper 2012.

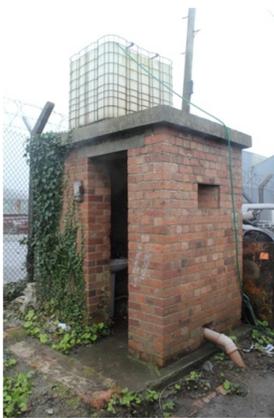
Defence post located within Pembroke Dock, rectangular small red brick building with a single doorway and embrasures in the remaining 3 walls. In 2012 it had latterly been used as a toilet, but now is disused. A Pyper 2012.

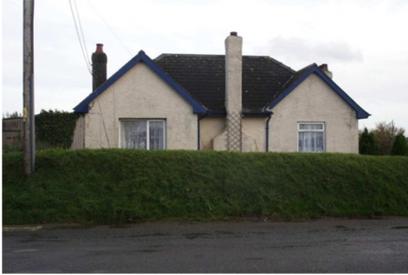
SITE DESCRIPTION

The watch office for the Rudbaxton Satellite Landing Ground. Single storey, 'H' plan, rendered brick, slate hipped main roof merging into gabled wing roofs. Tall rendered chimney stacks built against NW, NE and SE elevations. Southern cross range extended to SW. Secondary lean-to corrugated steel garage to NE wall. In 2011 it is in use as a dwelling. A Pyper 2012.

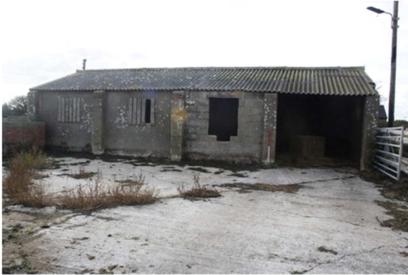
PRN - 101992
NAME - RAF ST DAVIDS
TYPE - Motor Transport Shed
CONDITION - Intact/ Near Intact
NGR - SM79262532
COMMUNITY - Solva
COUNTY - Pembrokeshire

SITE DESCRIPTION

Listed on Air Ministry schedule of 1945 as, 'MT shed' (Motor Transport). "Single storey, 4 bay rectangular plan, cement rendered 'temporary brick', corrugated asbestos cement gable roof. Double vehicle doors to each bay of the E elevation" described by RJC Thomas. Visited in 2011 when double doors to three bays survive, but the northern bay is missing. In agricultural storage use. A Pyper 2012.

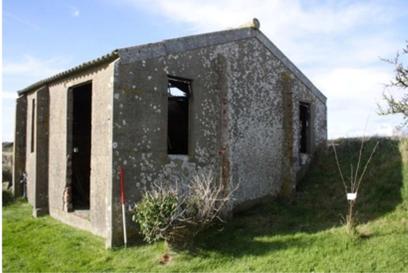
Listed on the Air Ministry site plan of 1945 as 'Picket Post'. Single store, square plan, cement rendered 'temporary brick', corrugated asbestos cement gable roof, RJC Thomas. When visited in 2011 it was used for low grade storage. No windows or doors survive. A Pyper 2012.

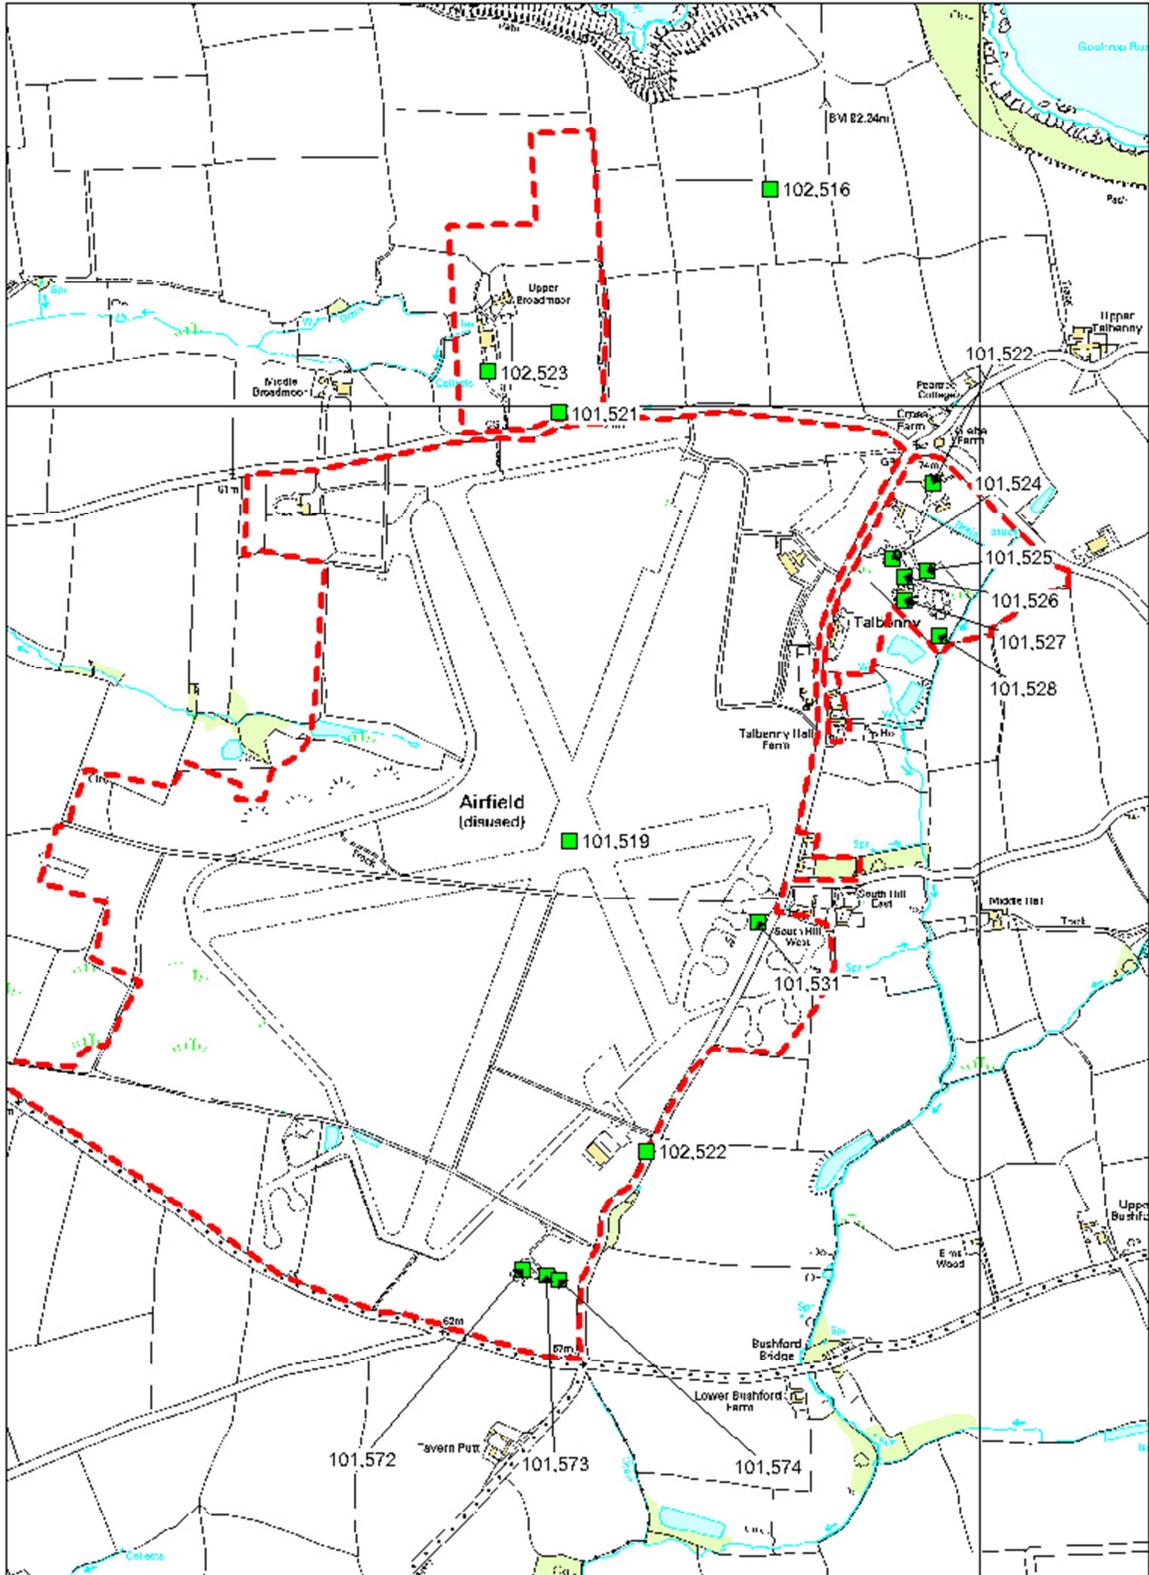
The runways have been largely removed, more so on the northern half of the airfield. A number of buildings to the northeast survive, though in quite poor condition. A Pyper 2012.

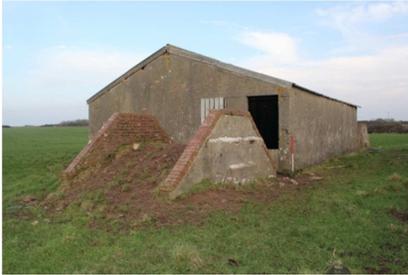
Bomb store, shown on Air Ministry plan as a square embanked revetment. In 2011 none of the earth bank survives, only three (of four originally) inverted V-shaped revetment walls located either side of a square temporary brick building. These revetments line up with double doors either side of the building to allow vehicle or trolley access through the building. The building has no doors and is open to the stock

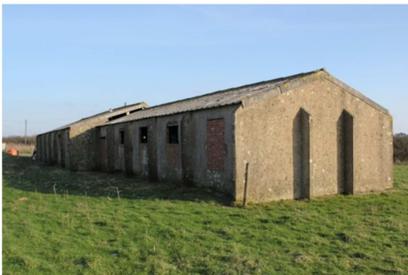
Listed on the Air Ministry schedule of 1945 as 'Station Headquarters Office'. As described by RJC Thomas in 1993. Internally the brick partitions survive, with a central corridor running the length of the building. Windows do not survive, but some internal doors intact. In occasional use for animal accommodation. A Pyper 2012.

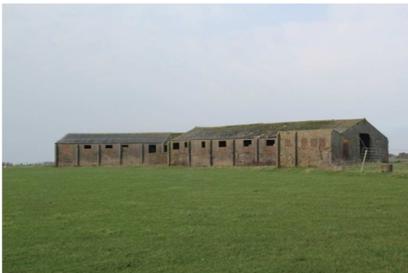
Recorded on the Air Ministry plan of 1945 as, 'Crew Rest, Locker and Drying Rooms'. Two parallel, inter-linked, single storey, 8 bay rectangular plan, cement rendered 'temporary brick', corrugated asbestos cement gable roof. Most doors and windows blocked or reduced in height - RJC Thomas description. In 2012 the building is used for animal accommodation. A Pyper 2012.

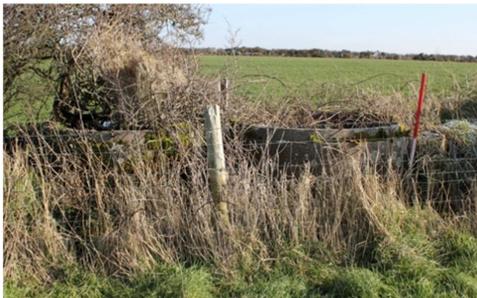
PRN - 102516
NAME - RAF TALBENNY
TYPE - gun emplacement
CONDITION - Near Intact
NGR - SM8364112372
COMMUNITY - The Havens
COUNTY - Pembrokeshire

A pair of precast concrete rings side by side located in a hedgeline to the north of Talbenny airfield. These are gun pits for Light Anti-Aircraft guns, and also referred to as 'Motley Stalk gun emplacements'. The rings are 1.5m in diameter and stand approximately 0.83m high with an internal flange. Located and fenced off within a hedgebank. A Pyper 2012.

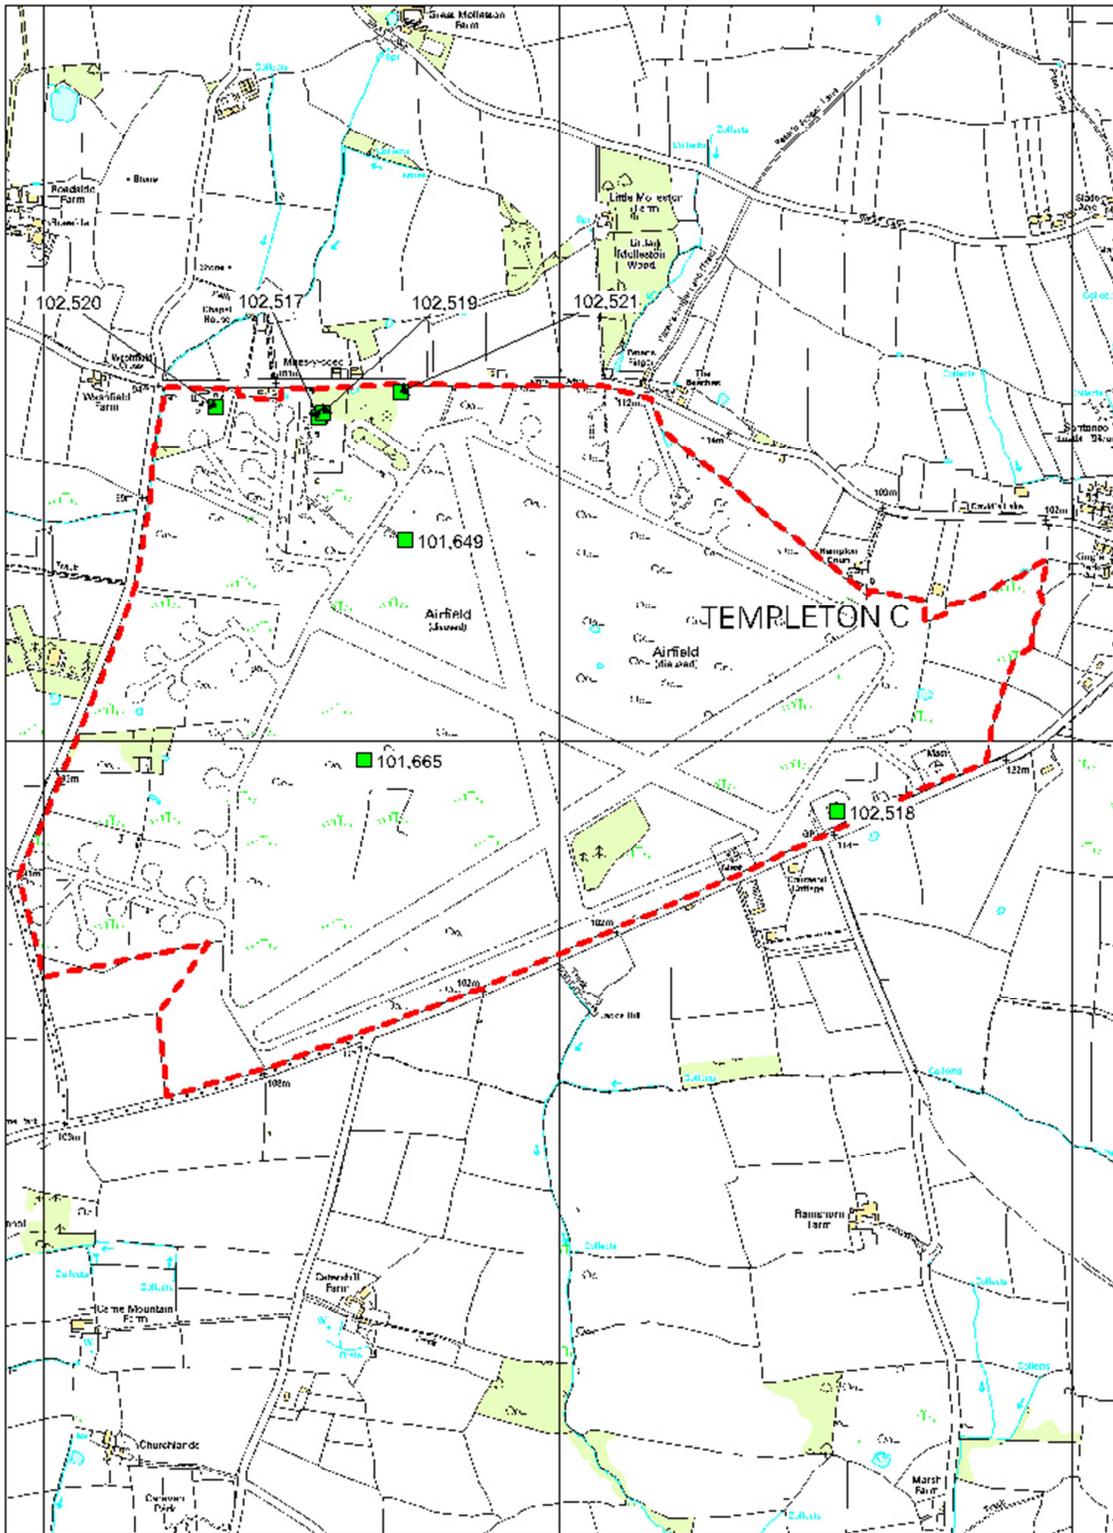
Notable structures which do survive are; the blast shelter PRN 102519, and a transformer plinth PRN 102521. The bomb sites lie to the south and west of the airfield and the living quarters to the north and west. The Uniter building located on the south side of the airfield with the two associated masts is a cold war military communication installation (PRN 102518). A Pyper 2012.

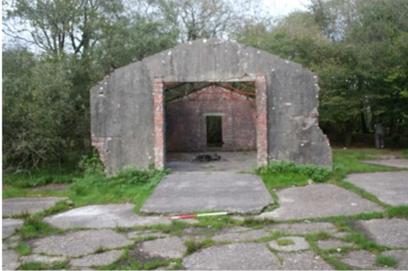
A roofless building of temporary construction, 4 bays long with a ramped entrance in the south gable wall and a doorway in the north. Although recorded on the Air Ministry schedule of 1951, it is difficult to read the schedule, so its function is currently unknown. In 2011 it is roofless though its trusses are intact. No doors or windows survive. A Pyper 2012.

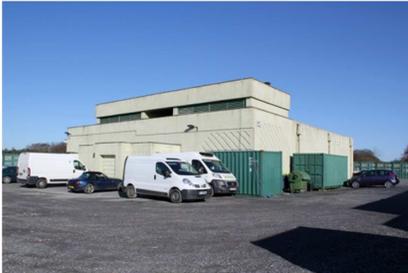
'UNITER' building, this is a 'hardened' building - one designed to resist the effects of conventional high-explosive bombs and nuclear weapons, and to remain functioning post strike. It formed part of a national military microwave communications system established during the early 1980s with a network of associated steel communication towers acting as relays and hubs. (Information from RJC Thomas pers. com). In 2012 the compound was in use as a storage facility and the building itself is a sandwich factory. A

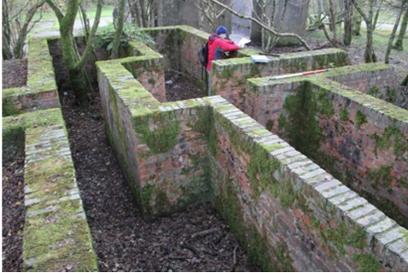
PRN - 102519
NAME - RAF TEMPLETON
TYPE - air raid shelter
CONDITION - Intact
NGR - SN09541164
COMMUNITY - Templeton
COUNTY - Pembrokeshire

Blast shelter / Air Raid Shelter located to the rear of the technical area at Templeton airfield. Consisting of brick built walls 1.5m high with earth embankments around the exterior. Approximately 9.4 x 9.6m, two entrances one to the west and one to the east. This is a well-preserved example of a blast shelter of which few are known to survive. In 2011 the structure was intact, though young trees are growing within the

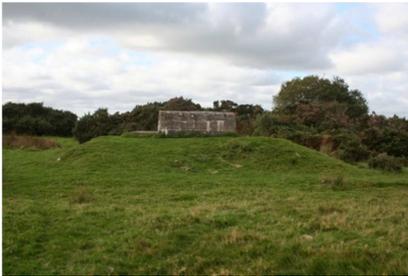
Battle Headquarters for Templeton airfield. Listed on the Air Ministry schedule of 1951. An underground bunker of rooms accessed by steps and a concrete cupola which sits above ground to provide a view of the whole airfield. See RJC Thomas description. In 2011 a density of gorse obscured the entrance but the concrete cupola is accessible. A Pyper 2012
