Dyffryn House and Gardens,
Vale of Glamorgan

Conservation Management Plan

Appendices

Teasdale
Environmental Design

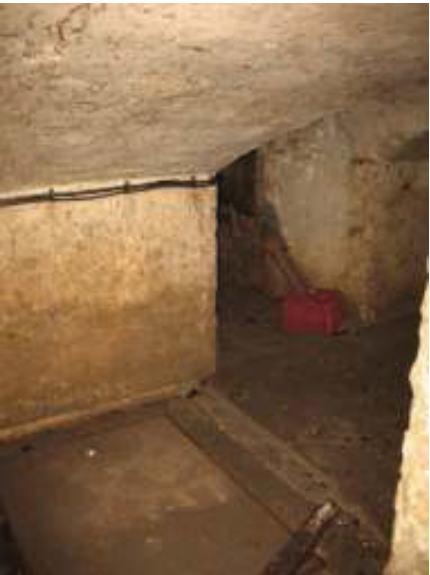
View Showing Manhole Cover

Floor: Solid floor; manhole in the southwest corner of the room.

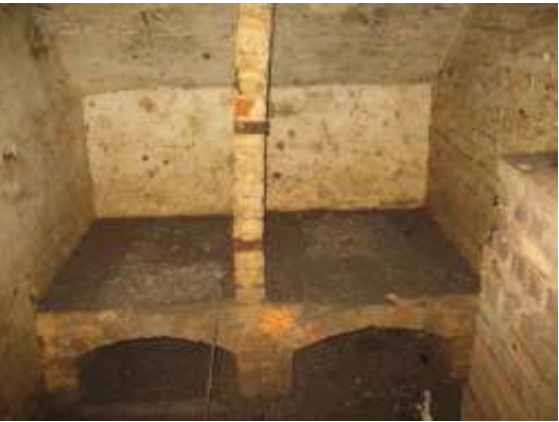
Wine Cellar – South Wall

Walls: Walls are of brick with a lime-washed finish. Opening between Bo5 and Bo6 partially bricked up (Bo5 IMG_1846.JPG) with modern bricks laid in English bond. The south wall has cellular low-level vaulted shelving, in brick with a concrete topping, divided into two compartments by a single skin brick fin wall. Presumably these were used for storage of wine, above floor level to allow for periodic flooding of the cellar. Mid way along the north wall, there is a light well, the reveals of which are of glazed white brickwork. The top of the light well is currently boarded over.

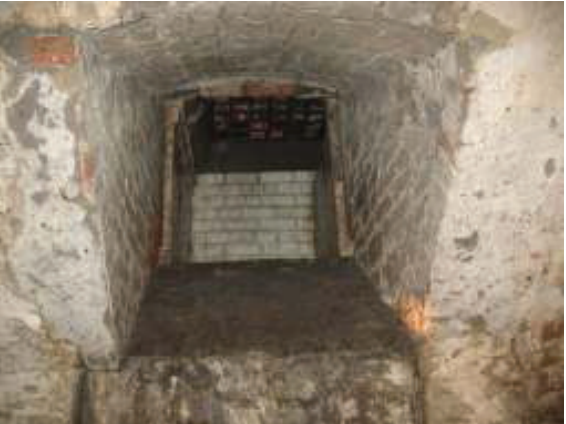
Light Well and Glazed Brickwork

Walls: Partially white-washed brick walls. Mid way along the north wall, there is a light well, the reveals of which are of glazed white brickwork. The top of the light well is currently boarded over. Cellular low-level vaulted shelving to north and south walls, in brick with a concrete topping, divided into two compartments by a single skin brick fin wall.

The glazed brick light wells and coal shaft could and should be repaired and, subject to security requirements, used to provide a degree of natural lighting into the basement.

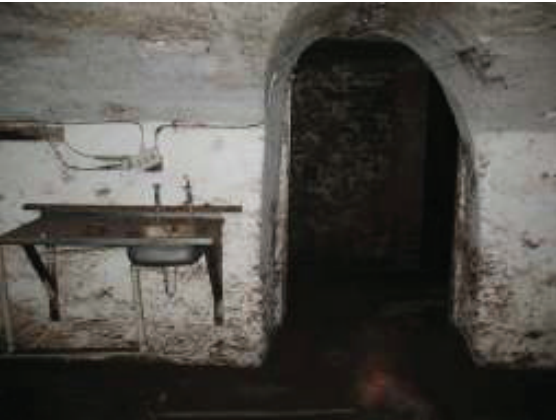
Opening Through North Wall

Floor: Stone flagged floor visible in photograph
Bo8 IMG_1882.JPG

(Fluorescent strip lighting not functioning at the time of inspection. Electrical sockets mounted on walls. Stainless steel basin and hot/cold water taps in north west corner.)

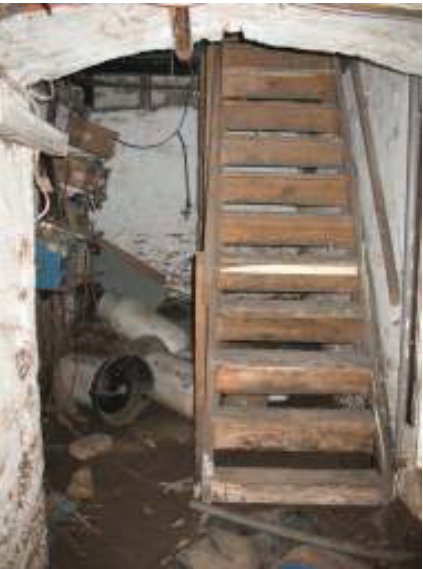
Room Bog – Timber Access Stair up to Ground Floor

Walls are rendered /whitewashed. A timber stair provides the principal access to and from the Ground Floor above. The floor was damp at the time of inspection, and strewn with rubbish.

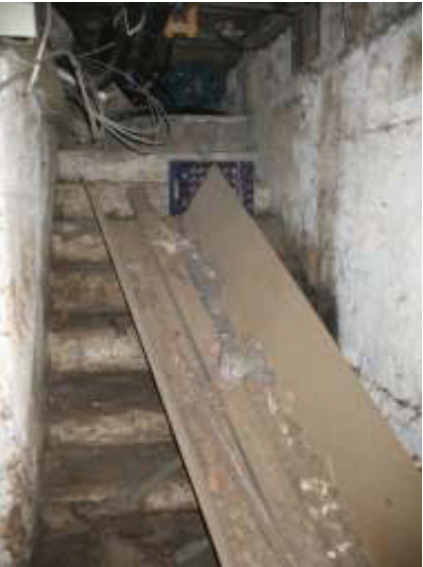
Redundant Solid Stair

There is an additional solid stair, running north to south, now out of use, possibly pre-dating the 1890s Lansdowne alterations. It would have provided access to and from the corridor, now incorporated into the Red Library.

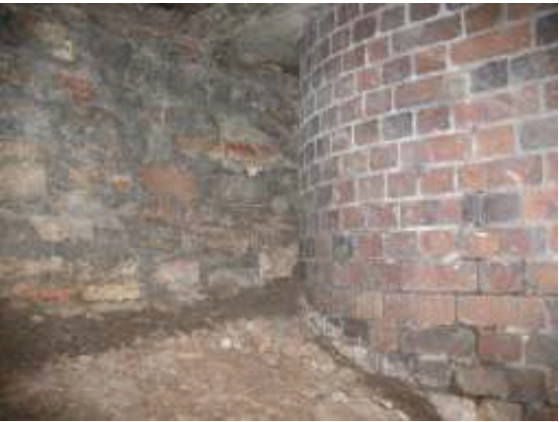
Room B10 – Masonry Junction in NW Corner

Walls: Exposed brick walls: the west wall appears to predate the other walls. There is a concrete beam and column insertion adjacent to the south wall.

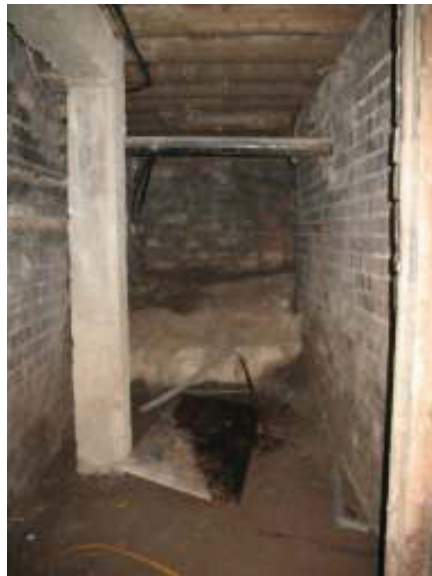
Concrete beam and column insertion adjacent to the south wall

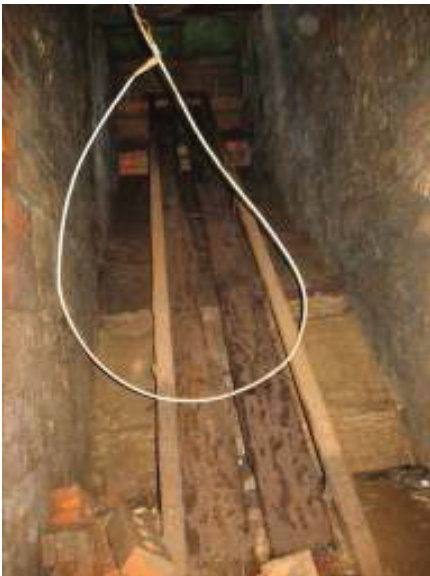
Coal Shaft

Walls: Un-plastered / un-painted. There is a rectangular masonry pier in the centre of the room. On the north wall there is an opening into a presumed coal shaft.

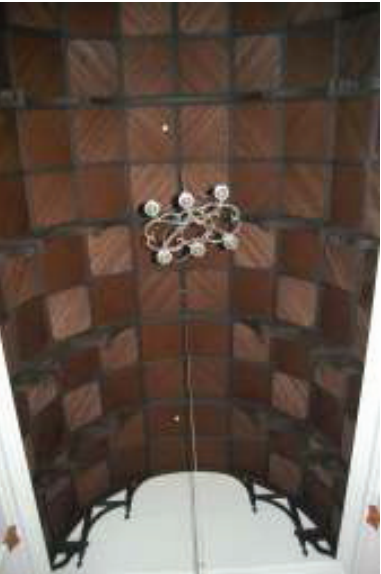
The Great Hall: Ceiling

The roof is a 5-bay false, double-hammer beam with herringbone pattern boarding. The floor is boarded form north to south.

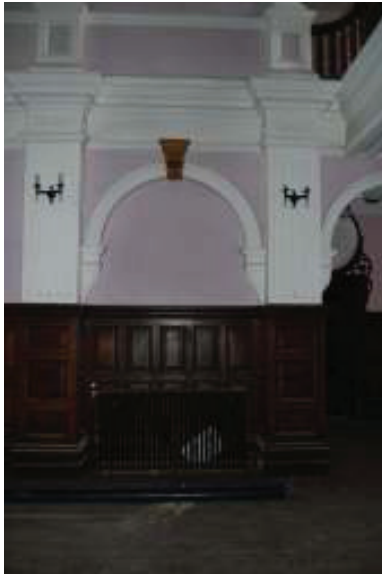
The Great Hall: Wall Detail

The east and west walls are enriched by two tiers of pilasters, rising above a high panelled dado, with Corinthian capitals and a deep dentil cornice. The upper section of the walls was hung with large, 17th century tapestries of the history of Titus and Vespasian. In the west wall is a full height niche with a dais on which stood the 1895 Brindley & Foster (Sheffield and London) two-manual electric organ with silvered pipes and 17 stops. At the south end a gallery is carried on large curved brackets; this connects the staircase with all the principal bedrooms. Below the gallery the doorways to the Billiards, Blue Drawing and Red Drawing Rooms are surmounted by circular, plaster, bas-relief, tondi set in timber frames with strapwork mounts.

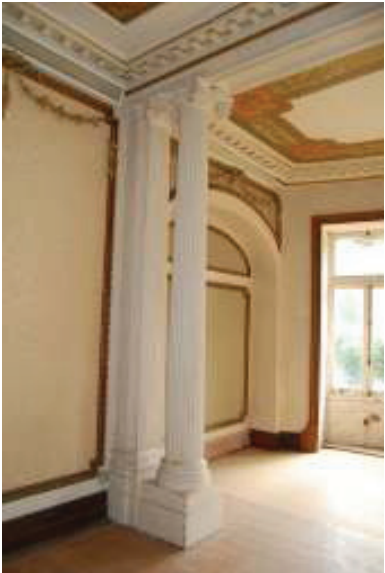
Blue Drawing Room: Column in antis

The room is approximately 42ft. 9ins. (approx 13m) long x 24ft (6.3m) wide and is divided into three compartments by columns *in antis*: the order is the composite but the acanthus decoration below the volutes has been omitted. Each section has a painted ceiling by T.W. Hay (see Appendix 6 of 2010 *Conservation Management Plan*) The outer sections of the ceiling have decorative borders of flowers and basket work with the initials 'JC' (John Cory) framed by 'C-scrolls'. The central ceiling has a similar border but the central panel is of a female figure carrying a basket of flowers set in the sky surrounded by three cupids carrying more floral paintings. This work is signed by the artist in the 'bottom' right corner. Below is a modillion and dentil cornice.

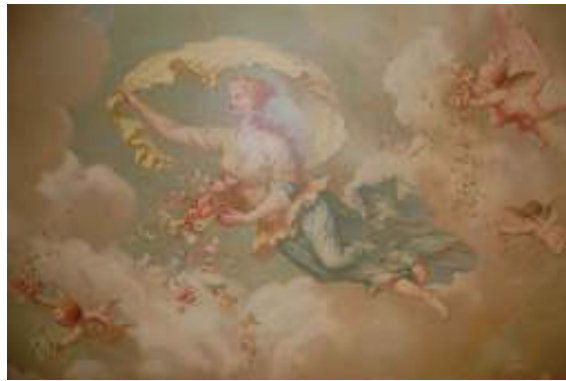
Blue Drawing Room: Ceiling

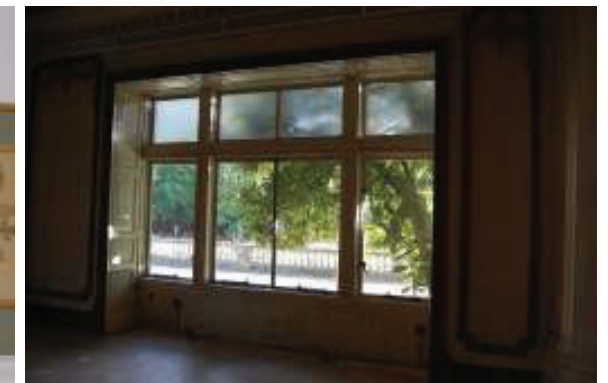
The garden (south) wall in the central part of the room has a later window: a three part mullion and transom window with plain recessed panels and steel windows. This alteration was probably made before 1923 as a watercolour by Edith Helena Adie, dated 11 July 1923, shows a similar window in the Boudoir (Lindley Library, Royal Horticultural Society). It is probable that Florence and Reginald Cory wished to improve their view of the gardens. The soffit and linings to the window have raised and fielded panels but the panel below the window has an unfinished appearance, probably because a large radiator has been removed.

Blue Drawing Room: South Window

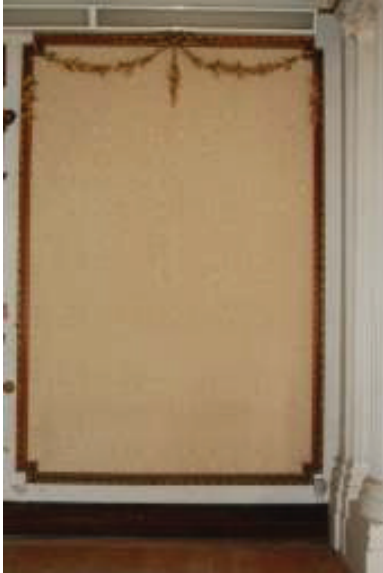
The walls of the room are decorated with framed by timber mouldings with bead and reel decoration, the central upper section of which is embellished with festoons of flowers and drops with ribbons tied in the centre. Within the frames there are modern, late C20 silk hangings.

Blue Drawing Room: Wall Panel

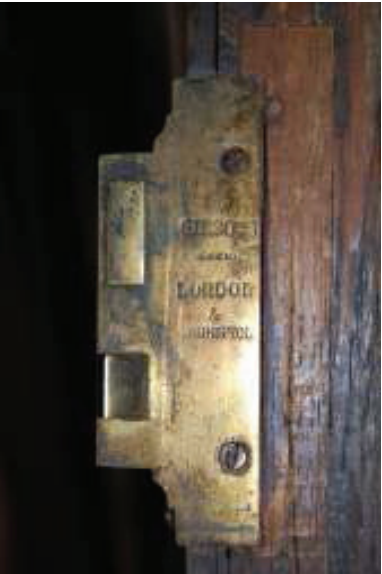
The Red Drawing Room is one of the suite of principal rooms on the south side of the house; it is the smaller of the pair of drawing rooms and is entered from the south west corner of the Great Hall. The oak entrance door has six panels (raised and fielded panelled oak door leads back) set with a flat architrave; it has an elaborate French-style lock made by Gibbons & Co, of London and Wolverhampton.

Red Drawing Room: Lock

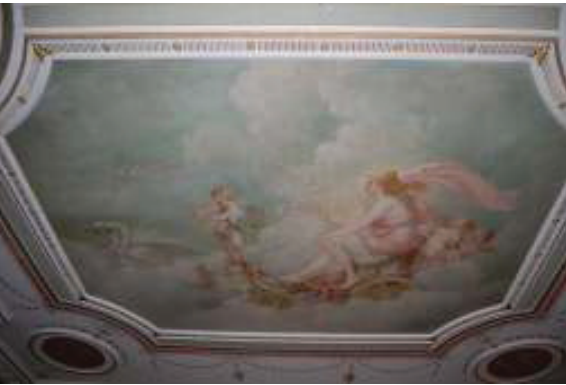
The room is approximately 22ft. 4in. (approximately 6.4m) long x 19ft. 0in. (approximately 5.9m) wide. The ceiling decoration is similar to that in the Blue Drawing Room – an allegorical scene by T.W. Hay (see Appendix 6 of 2010 *Conservation Management Plan*). Here the central panel has a goddess on a chariot being drawn by two swans, the reins on which are held by a standing winged cherub. Behind the goddess two other cherubs frolic and doves fly in the sky above. The border is neo-classical in style decorated with swags and drops with pairs of cherubs in the corner roundels. This work is signed by the artist in the 'bottom' right corner. As with the Blue Drawing Room there is a medallion cornice with paterae.

Red Drawing Room: Ceiling

Condition.
Generally the condition of the room is fair to good. There is, however, serious damage to the ceiling decoration and parts of the wall in the south west corner. This will require specialist consolidation, repair and retouching. The Paine & Stewart and Textile Conservation Ltd reports (October 2007. Bound as Appendix 3 and 5 of Caroe & Partners, 2008) provide specialist advice on the repair of the decorative scheme.

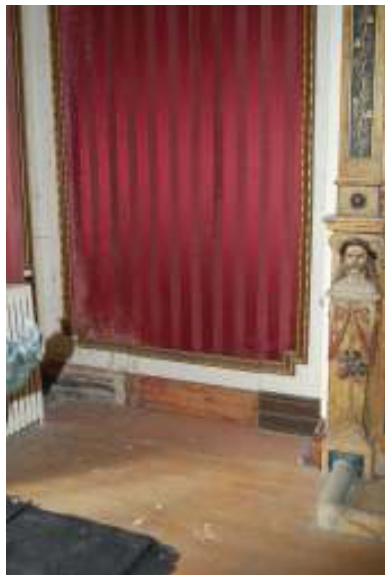
The walls of the room are decorated with timber mouldings with bead and reel decoration, the central upper section of which is embellished with festoons of flowers and drops with ribbons tied in the centre. Within the frames there are modern (probably 1960s') red striped silk hangings; where the silk is torn away it is set on hardboard. In the south west corner of the room, behind the silk there is a jib door which interconnected with the Morning Room to the west.

Red Drawing Room: Sealed Doorway

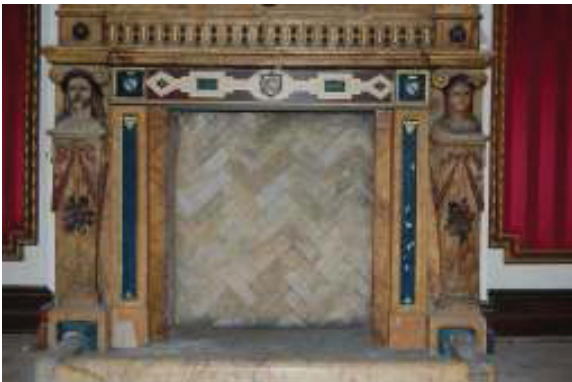
The principal feature of the room is the alabaster fireplace, in two sections, on the west wall. The history is established; the fireplaces were bought by Cory when they had been removed from Scarsdale House, Kensington, London. Originally it and the fireplace in the Blue Drawing Room had been designed for a west wing erected sometime after 1600 for Sir George More at his Surrey seat, Loseley. The wing included a Long Gallery and the two fireplaces may have heated this space. The Victoria County History (1911) suggested that the wing had been designed by John Thorpe: it was demolished c. 1835 and the fireplaces were bought and re-located to the drawing room at Scarsdale House in the 1850s by Edward Curzon. The fire surround has a pair of terms, one male and one female, supporting Ionic capitals. The overmantel panel has round and pyramidal bosses framing a central panel of a mounted knight, with a raised sword, riding through a fire. It has been suggested that the panel is an allegory of War. Curzon had the family mottoes painted onto the alabaster work. The mottoes, in gothic script, read as follows: (left) 'Let Curzon holde' (right) 'what Curzon helde'; and, (top) 'DIEU BENIT', (bottom) 'LE COURSON DE LA ZOUCHE' This very fine piece was bought by John Cory in 1892/3 after the Victorian & Albert Museum refused to take it and its sister piece in the Blue Drawing Room. It is a very important work, of Elizabethan/Jacobean interior decoration.

Red Drawing Room: Chimneypiece

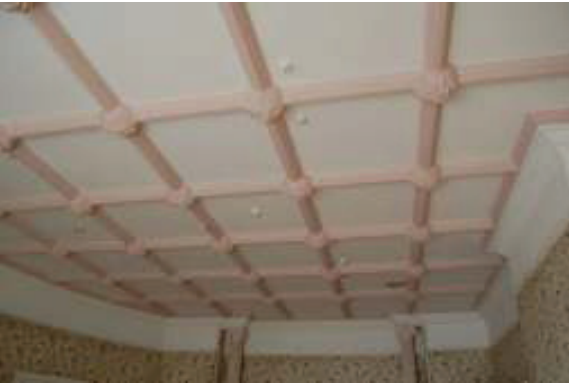
The Morning Room is 26ft 4in. (8.026m) x 32ft 2in. (9.8m) wide and its west wall has a shallow curve with two doors connecting to the Red Library and its passage on the north side. The Morning Room has Tudor-style ceiling divided by moulded beams (? plaster-covered) into square panels with carved bosses at the angles. Today it is painted pink with a white ground. There is a dentil cornice below.

Morning Room: Ceiling

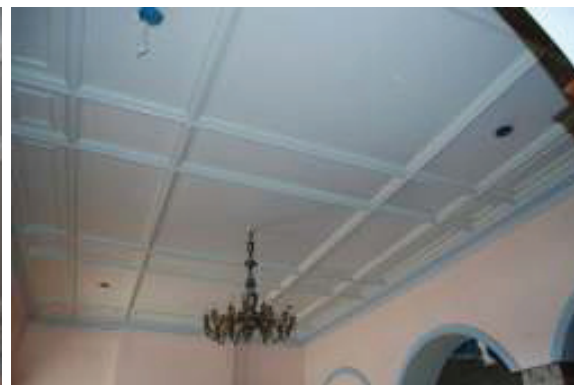
The panelling and the segmental arches above all appear to be work undertaken in the post WWII period. The 1937 sales particulars for the Duffryn estate describe the walls as being 'panelled in Mahogany to a height of 7ft. 6ins., with fine oval-topped Alcoves fitted with open book shelves'. The ceiling would appear to date from 1894; it is a panelled ceiling with shallow moulded, rib work forming squares and rectangles with a moulded cornice.

Red Library: ceiling

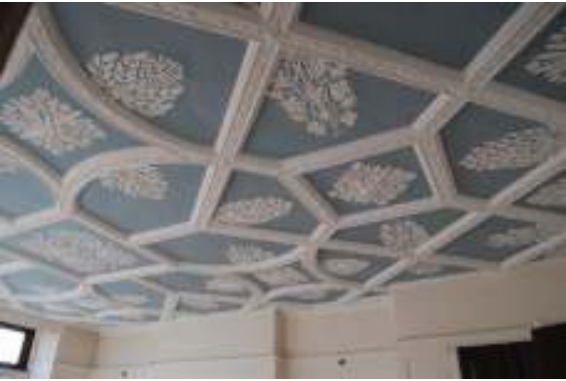
The ceiling is a very good piece of work in the Arts & Crafts style/Jacobean revival style at a lower level than the ceilings in the rooms to the east. Although the lobbies interrupt the decoration of the cornice, suggesting that the lobbies might have been inserted at a later date, there is no evidence of the cornice above the lobby spaces. The conclusion must be that the Boudoir ceiling and the panelling have been inserted (post 1893-4) into an earlier space. It is likely that the window was altered at the same date.

Boudoir: Ceiling

The ceiling is divided by broad ribs decorated with vine leaves and grapes, and the panels bear stylised plants, including thistles, roses, olives and vines, with a simple cornice. In 1937 the ground was described as olive green.

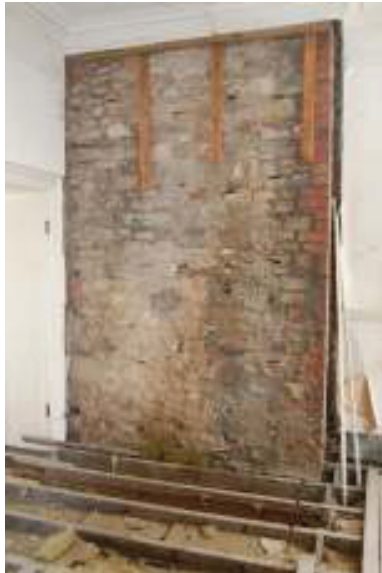
Breakfast Room: evidence of earlier house

Condition.
Generally the condition of the room is fair. It is important, however, to relay the floor and finish the exposed masonry sections. Skirtings and doorways need to be reinstated.

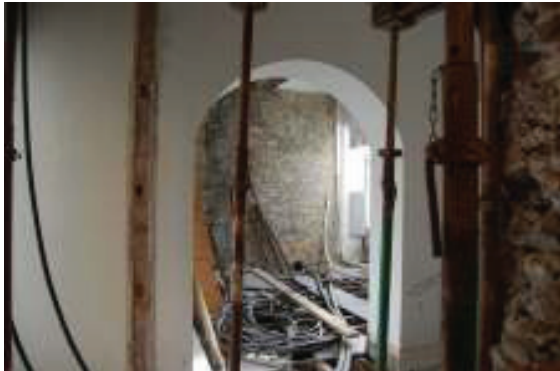
Breakfast Room: from internal passage

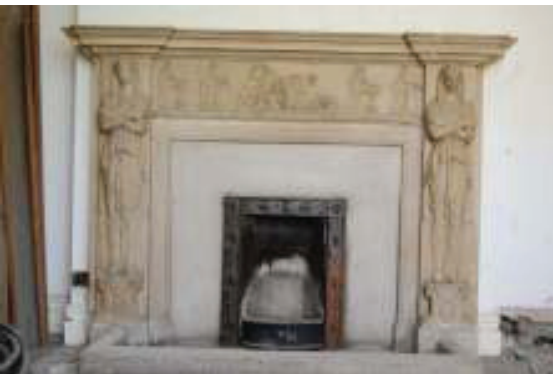
Breakfast Room: chimneypiece

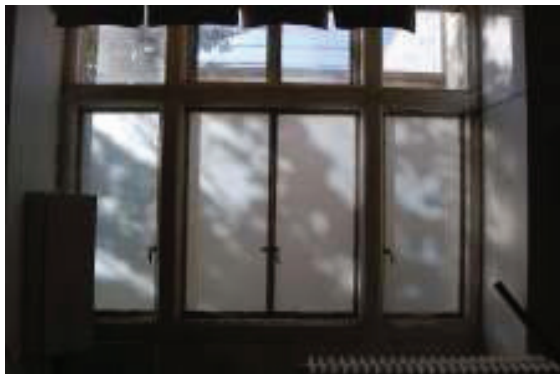
Breakfast Room: window

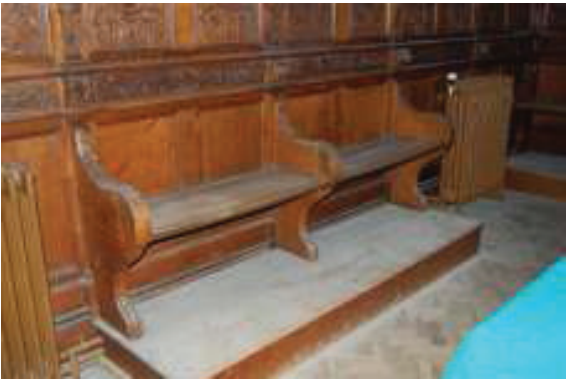
Billiard Room: Spectators' Bench

From floor to wallpaper the room is panelled in oak to a height of about 7ft. 6in. (approx. 2.28m). On the south, west and north walls there are seats, on raised platforms, for spectators. The seats are set on curved brackets and above them are *Francois Premier* -style carved panels with heads in roundels and griffins, surmounted by a frieze of scroll work with similar patterns. Between the individual panels are herms and carved heads. It is not yet been established whether this panelling, which has been made to fit the room, is genuine , French, 16th century work set in modern surrounds or whether it is a complete reproduction of the 1890s.

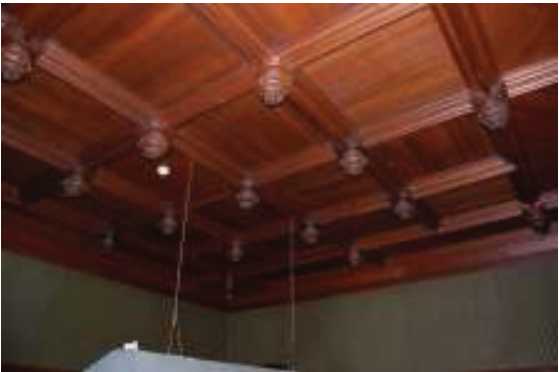
Billiard Room: Ceiling

The room is approximately 24ft. (approx. 7.32m) long by 22ft. 6in. (approx. 6.86m) wide . It has an elaborate, coffered, cedar wood ceiling with pendants with drops at the intercepting angles. The outer pendants are fitted with light bulbs. Below the ceiling is a moulded timber cornice. Below the cornice is a deep panel decorated with dark green wallpaper with fleur de lis. The date of the wallpaper is not known. The windows are all single pane, French windows dating from 1893-4 with raised and fielded panels to the linings and shutters.

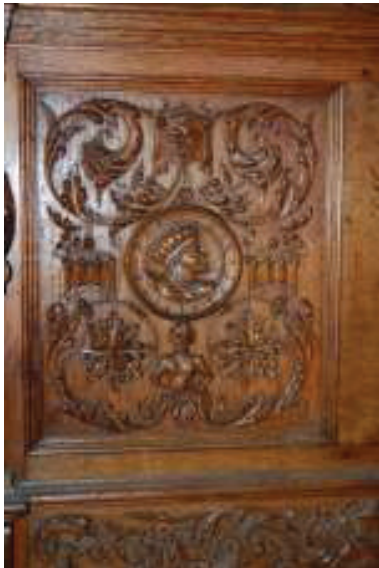
Billiard Room: Renaissance-style panel

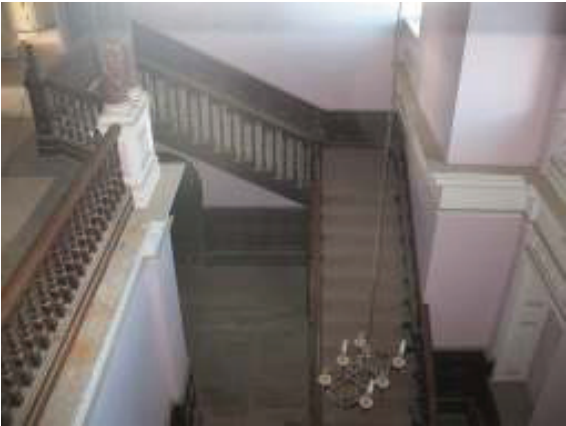
Staircase Hall: looking down

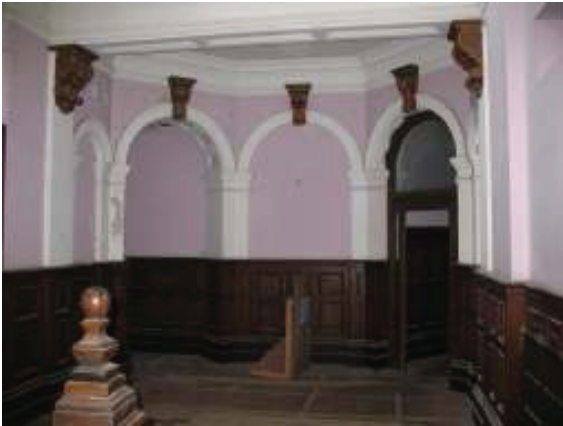
Staircase Hall: arcade

The Staircase Hall is a double height volume, though this extends to triple height up to ceiling level above the staircase to the second floor at the east end. At its perimeter, there is moulded plaster corncicing and two pairs of red, veined, marble columns punctuating the first floor balustrade, with Ionic capitals.

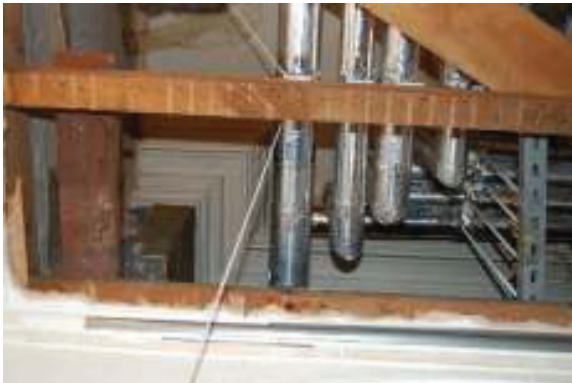
Corridor: former ceiling of White Library

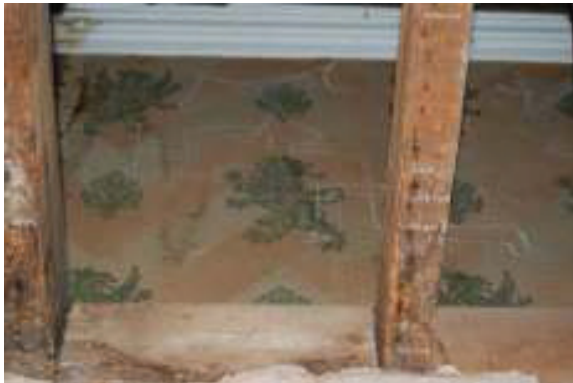
Corridor: former wall of White Library

Condition.
Generally the physical condition of the space room is fair to good but there are structural issue where part of the masonry wall has been removed in the area of the Boudoir/Breakfast Room.

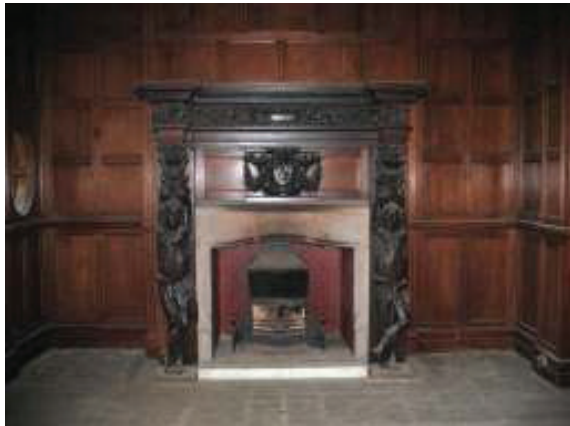
Dining Room: chimneypiece

The principal feature within the room is the fireplace with its carved oak canopy and figures, which is described in the Glamorgan volume of the *Buildings of Wales* as 'figures flank the chimneypiece, but these are even more bizarre: six-winged cherubim standing in cross-legged pose, probably made to adorn confessionals.'

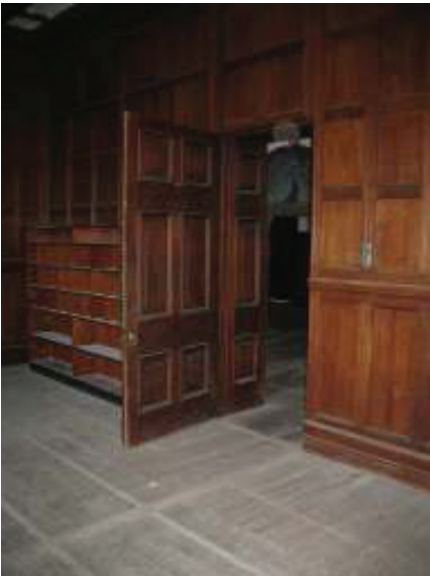
The Dining Room is one of the principal rooms on the north side of the house, and is entered from the south via a door from the Staircase Hall. The oak entrance door has six panels (raised and fielded panelled oak door) set within oak panelled linings on the staircase hall side. On the dining room side this door is detailed as a jib door incorporated within the panelling. The room is approximately 37ft 9ins.(11.5m) long x 20ft 0ins. (6.1m) wide. There is also access in and out of the room in the south-west

Dining Room: entrance door

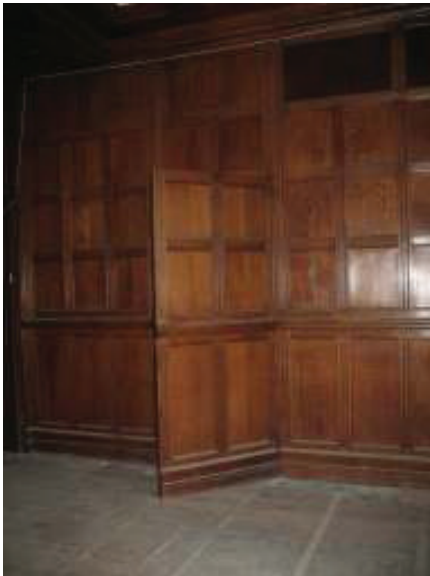
corner, leading under the staircase past the door down to the basement. Within the west wall, there is a secret door that formerly led to the White Library, but the opening behind this has been bricked up.

Dining Room: jib door to White Library

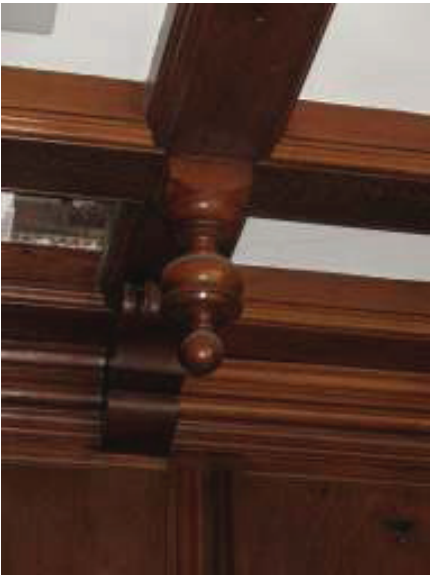
The ceiling is of oak with cross beams and 4 turned bosses. The recessed panels to the ceiling are damaged where previous electrical fittings have been removed and scaffolding supports for the roof works carried out in 2006/8. The recesses themselves are papered in textured wallpaper. The cornice is timber and moulded. The walls are panelled from floor to ceiling in small oak panels divided by narrow strapwork. Incorporated within the panelling, a dado rail runs round the perimeter of the room.

Dining Room: ceiling boss

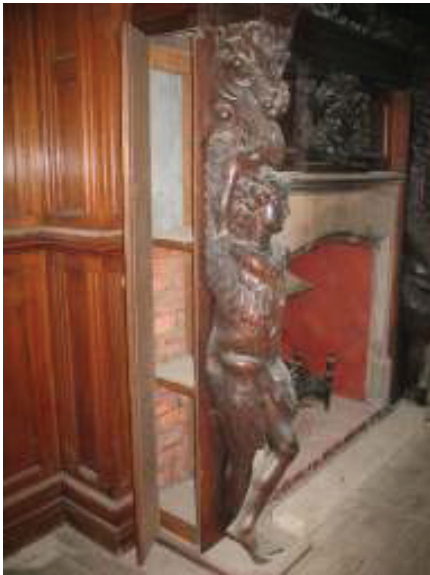
Dining Room: cherubim

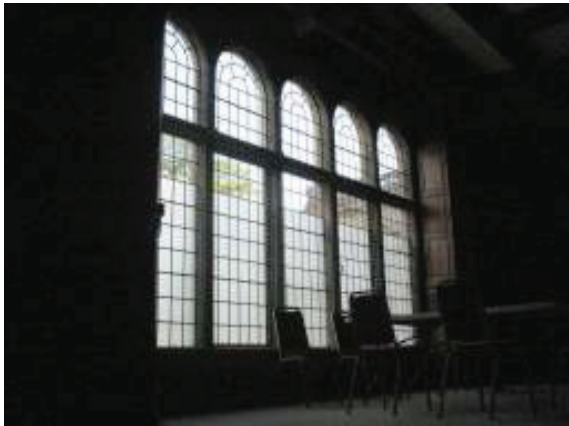
The north-facing window is located centrally on the north wall, and is arranged as a bay of five windows split into ten leaded lights. Window surrounds and transom are of stone. The top five lights above the stone transom are semi-circular fixed leaded lights, each of 27 panes of glass. The lower five are rectangular windows each of 54 panes of glass. Two of these lower rectangular windows are Crittal-style side-opening casement windows with leaded lights. All lower windows are obscured by applied film.

Dining Room: north window

The existing decorative scheme is consistent with that described in the South West Daily News of October 1911, when the room was still relatively new, and probably in its original condition. The obscure film on the windows is unsightly, and compromises the relationship of this room to the outside.

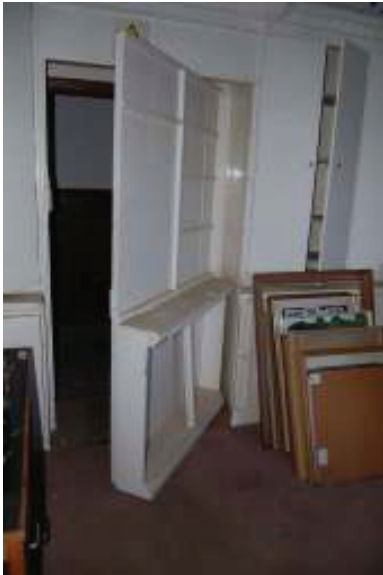
It is entered on the south wall out of the main axial corridor; the door is an oak six panel door with plain recessed panels as seen throughout the corridor. On the room side the door is hidden by an attached bookcase.

White Library: entrance door

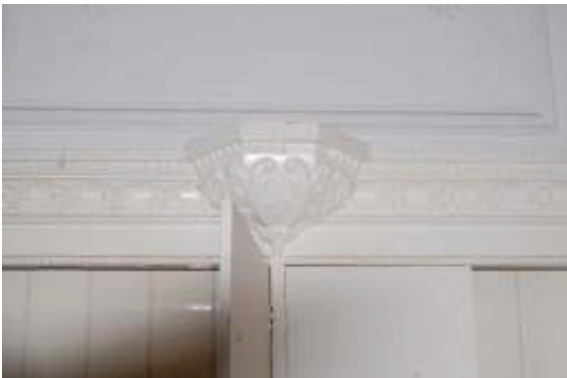
Although modern doors have been fitted the original moulded, egg and dart cornice, with a band of fleurons, and the projecting, decorated, dado-level shelf survive. The cornice has intermittent, 'corbel' projections on which would have been displayed bronzes or ceramics.

White Library: 'corbel' projection

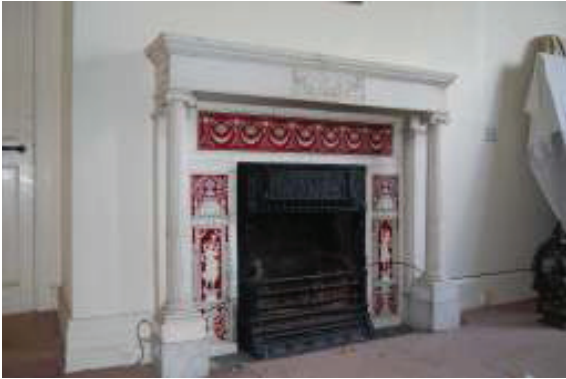
On the west wall is a marble chimney piece: Ionic columns support a full entablature with an ornamented central plaque; red and white neo-classical revival tiles decorate the opening. The doorway to the left is late 20th century insertion, replacing an earlier doorway in the north west corner of the room. On the east wall a jib door to the Dining Room has been sealed and papered over.

White Library: chimneypiece

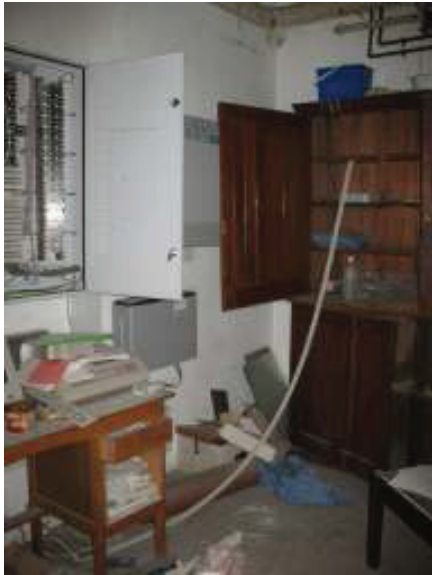
Currently entered from the corridor through a late 20th century modern doorway. There is a step up from the floor level from the corridor and the room currently has no natural light. Projecting structure in the north-east corner may be the remains of a fireplace but could be a change in the type and depth of wall construction. Currently some timber shelving is extant on the north wall. A large opening has been broken through the south wall at high level. In the north-west corner of the room there is a timber panelled opening, dating from circa 1894, into what is now a small room approximately 1.5 x 1.5 m.sq (the room should be labelled room G18A). The door lining indicates that the small room formed part of the Back Corridor, and that room G18 was entered from this point.

G18: south wall

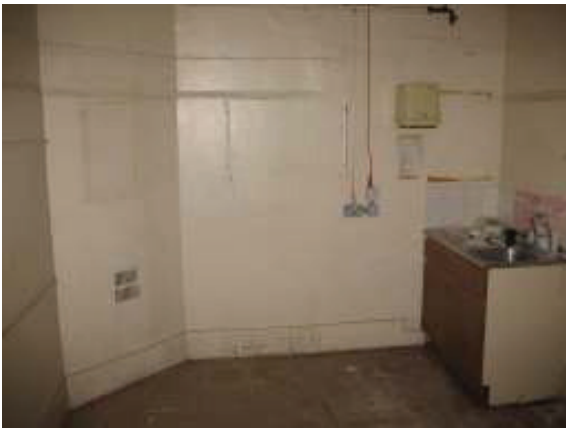
This room is entered through a modern door from the former Secretary's/Estate Room. The ceiling height is noticeably lower than in room G18 although there are several service penetrations running principally north-south through at ceiling level. In common with G18, there is no natural light. The angled wall and low level ventilation grill indicates a former fireplace in the southeast corner of the room. (G19 IMG_1917)

G19: former fireplace

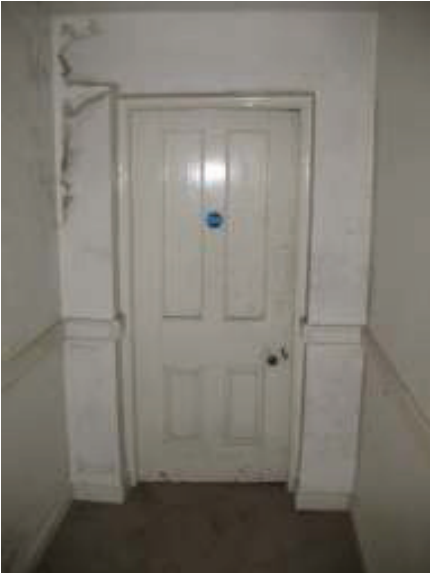
This room was formerly the northern end of the Back Corridor. It is entered from the north (the service corridor) through a doorway with a door of c.1894; four-panelled with round brass bun knob. The room has a stone flagged floor and a pitched ceiling with an arch at the south end of the room.

G20: Door

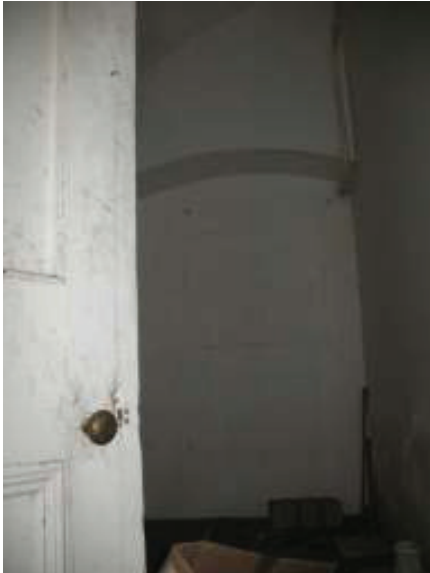
G20: south wall/arch

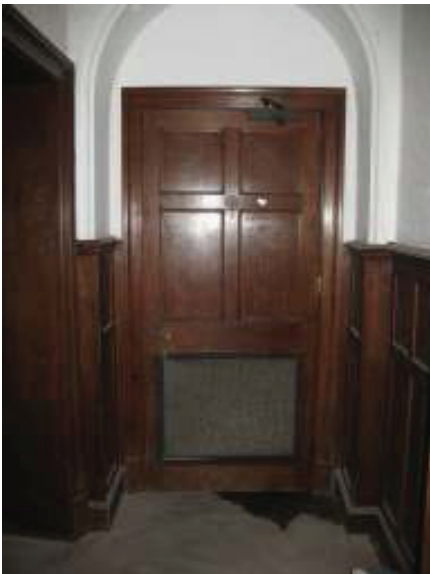
The men’s and disabled toilets are entered through a lobby that was formerly the southern section of the Back Corridor. The door to the male WCs is a six panelled timber door of c. 1894, modified to incorporate a large ventilation panel. The door to G21A has been modified in the same manner. Within the rooms there is nothing of interest.

G21: door

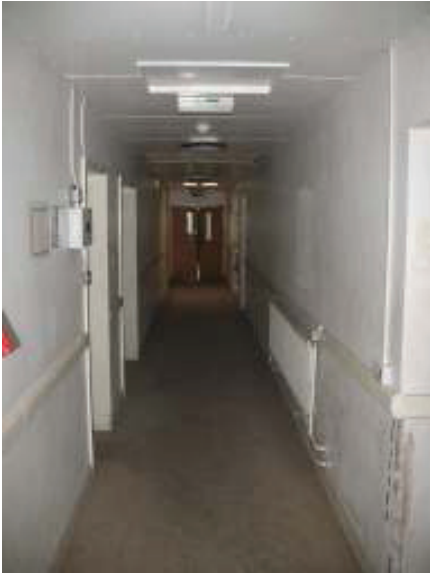
This long corridor runs east-west connecting the Back Corridor and former Secretary’s/Estate Room with the Domestic Offices. A modern lantern gives natural light at the east end. The ceiling is suspended and is original. The doors and light fittings are all late 20th century, except for the door to room G20. The plan of G20 is largely the same as 1911 but it provides access to the spaces created in the 1980s alterations.

G22: corridor

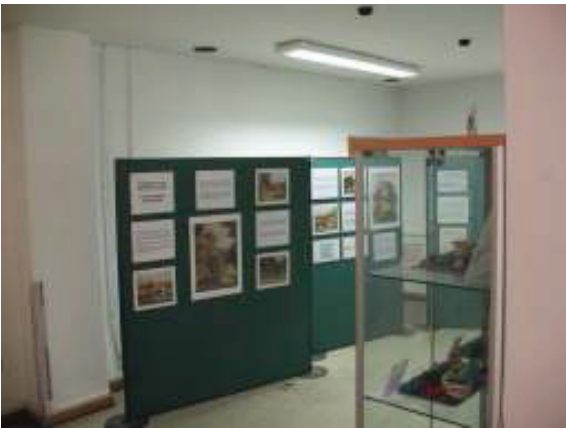
Go8A

This square space in the north-east corner of the exhibition area that was formerly two, or, perhaps, three rooms. The nib on the north wall and possibly the column directly to the south are evidence of the previous wall running north-south that divided two rooms. These might have been the Butler’s Pantry and Butler’s Bedroom, as referred to in the 1937 sales particulars.

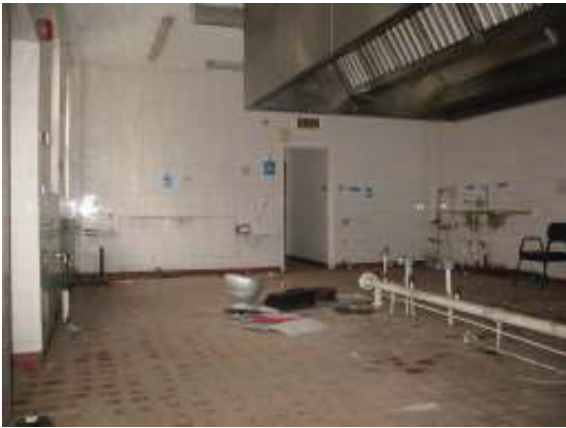
ROOM G23 (KITCHEN OR FITTED LARDERS?) is the current kitchen that, probably, was also the kitchen in 1911, although it was enlarged during the works in the 1980s.

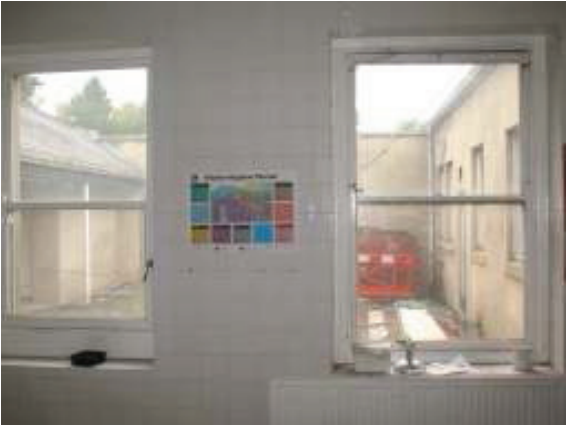
G27: windows

ROOM G27 is possibly the former scullery but the only surviving elements are the two north-facing sliding sash windows.

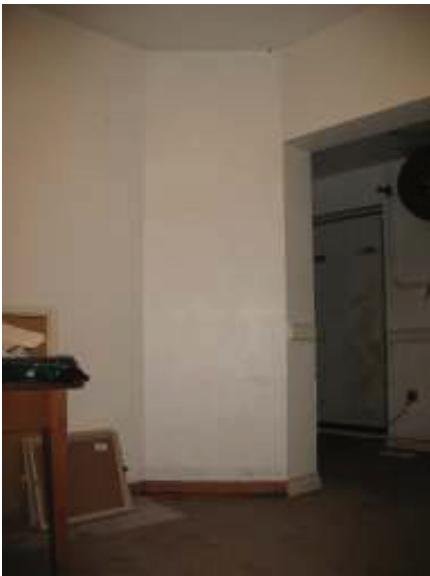
The southern walls of these rooms were external prior to the 1980s works at which time several windows were blocked. The rooms were part of the Domestic Offices that comprised the Butler’s Pantry, Butler’s Bedroom, Two Footmans’ Bedrooms and Housekeeper’s Room. Currently, G28 provides access into the exhibition space from the service corridor; G29 is a double height room occupied by large air conditioning plant for the former modern kitchen and restaurant; and G30 is used as a store room.

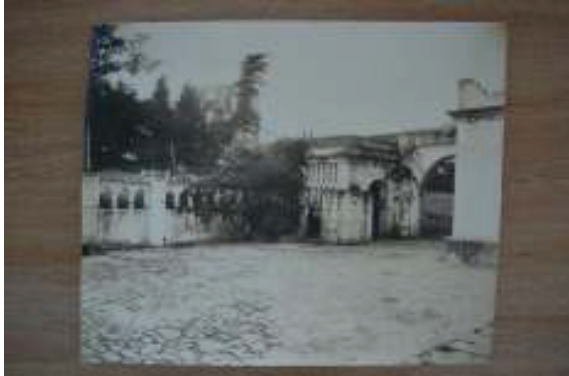
This was erected between 1900 and 1919, and most probably before 1911. It has been reduced in size as the wing on the east side of the courtyard is a 1980s addition.

Moorish Courtyard: c. 1937, looking north-west

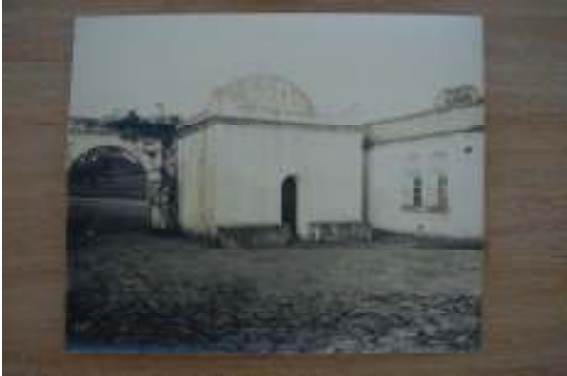
Moorish Courtyard: c. 1937, looking north-east

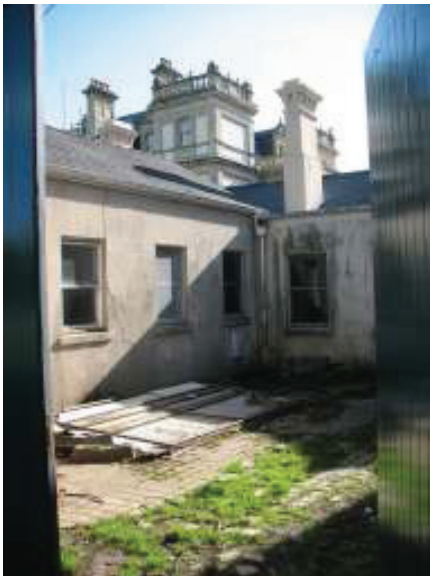
Moorish Courtyard: 2010

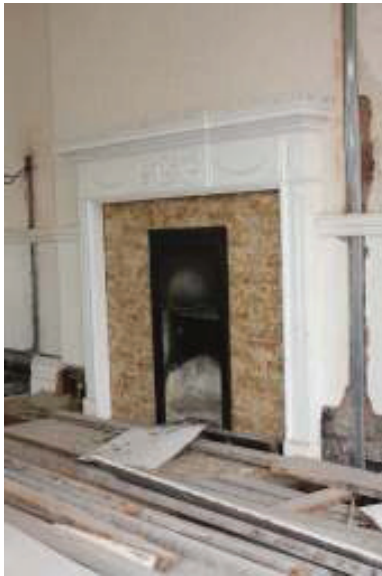
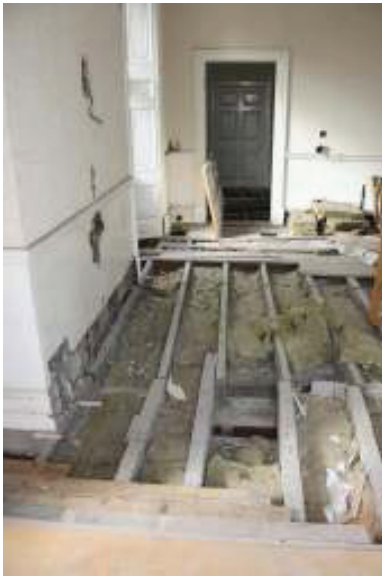
Bedroom Fo1

The south east corner bedroom with a late 20th century replacement ceiling and no cornice.

Floor: Temporary boarding/ sheeting laid to provide limited access.

Windows: 2 timber sash windows with two lights to the upper sash and a single pane to the lower. Panelled reveals which appear not to have been shutters.

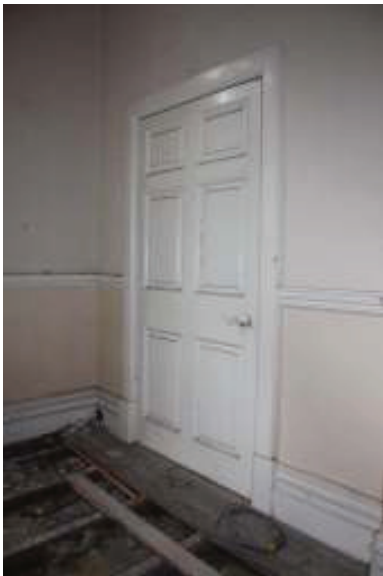
Dressing Room Fo2

Floor: Boards mostly lifted. Note that joists run into chimney-breast partition Fo2/Fo3 which, unlike the chimney-breast in Fo4, formerly was not a fireplace.

Windows: identical pattern to Fo1.

Doors: Variation in pattern - door in opening Fo1/Fo2 raised and fielded with recessed panels to reverse, no mouldings to frame.

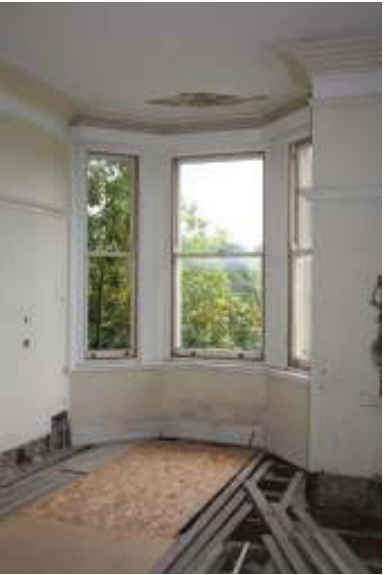
Bedroom Fo3

Windows: Raised and fielded panelled reveals to window openings. Bay window consists of three 2 x 2 sash frames, each sash consisting of a single pane. Adjacent window with upper sash of 2 lights, lower sash 1 light.

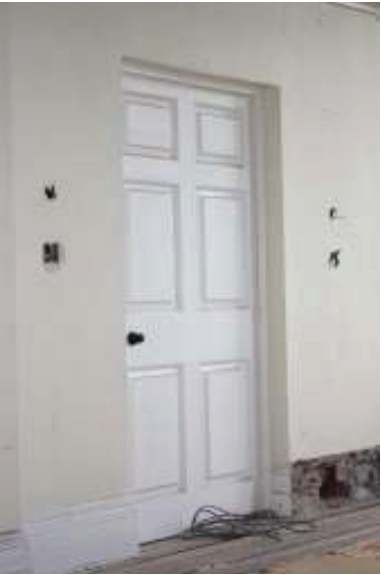
Doors: Moulded surround to *north* from landing.

Bedroom Fo3, door

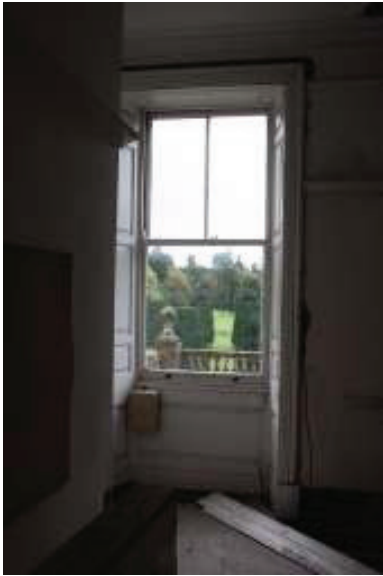
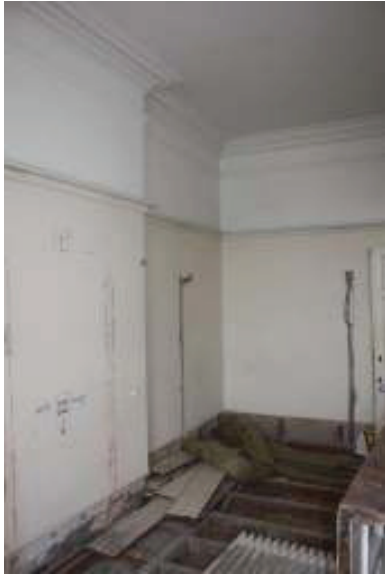
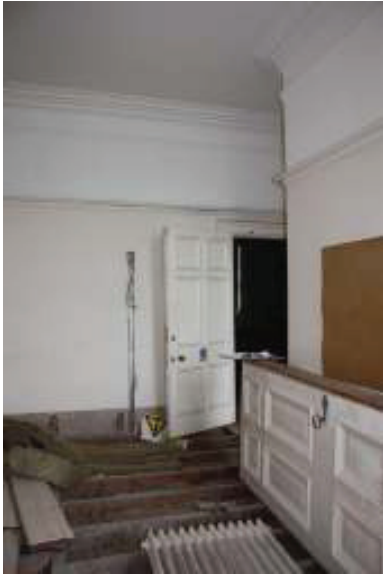
Dressing Room Fo4

Floor: Floorboards removed. Note brick corbel in trimmer in front of what must have been a fireplace opening prior to partition being installed.

Window: Raised and fielded panelled reveals to window.
Doors: Door Fo4/Fo5 missing.

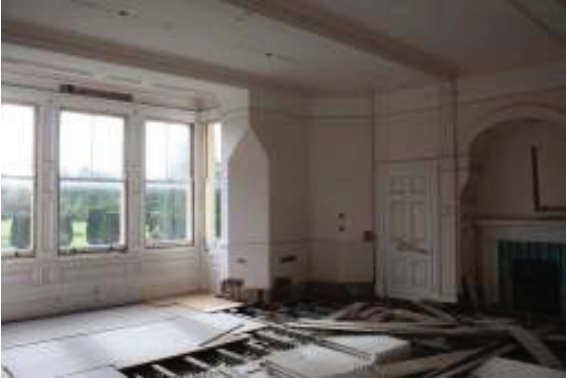
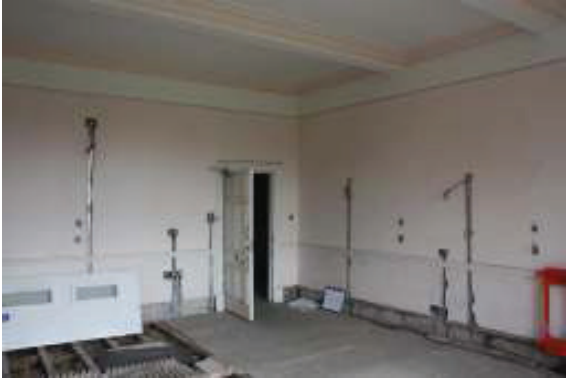
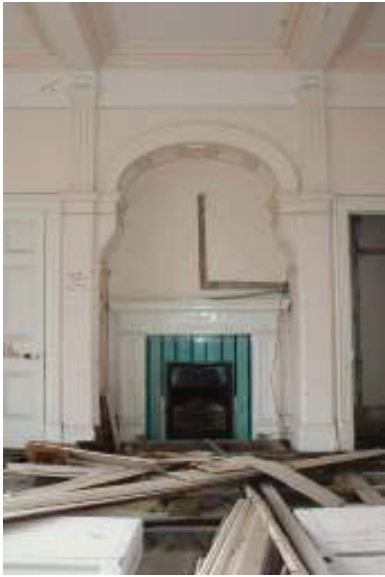
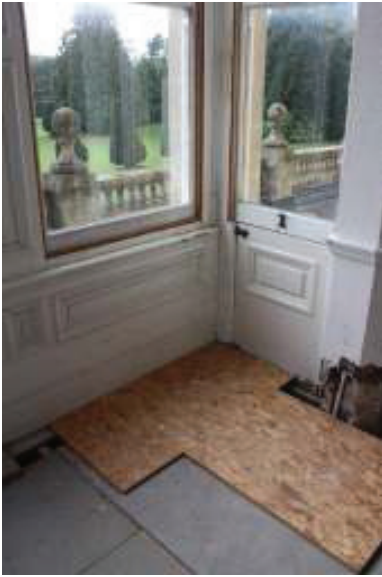
Bedroom Fo5

Fireplace: Simple fireplace surround of painted timber. Cast iron grate with marble inset panel. Plasterwork around fireplace of late 19th century.

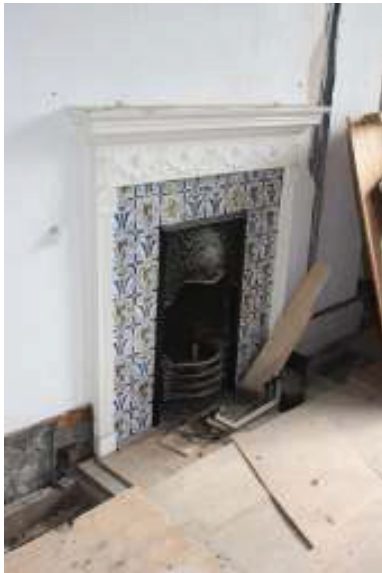
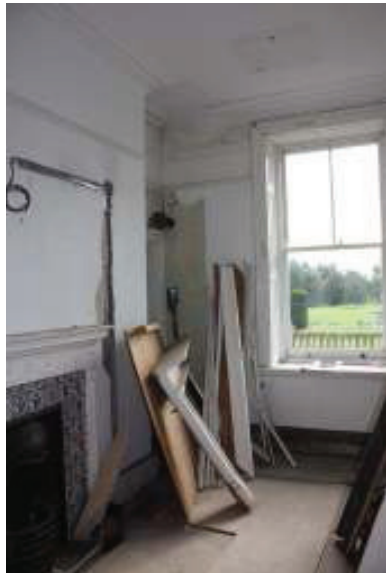
Dressing Room Fo6

Fireplace: Painted timber fire surround with cast iron grate flanked by tiling.

Doors: note that architrave moulding to blocked door in west wall does not match architrave moulding and joinery detailing generally from connecting door Fo5.

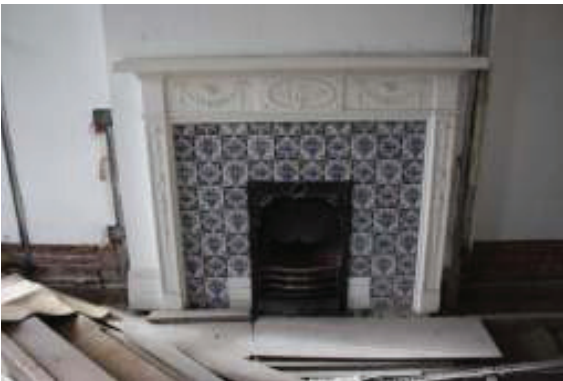
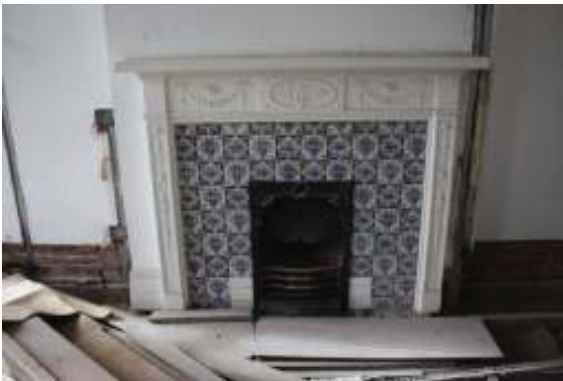
Bedroom Fo7

Doors: Two Dyffryn style raised and fielded panelled doors stored in room. Panelled fire door between Fo7 and corridor.

Fireplace: Painted timber surround with cast iron grate flanked by tiling.
