Dyffryn House and Gardens,
Vale of Glamorgan

Conservation Management Plan

Appendices

Teasdale
Environmental Design

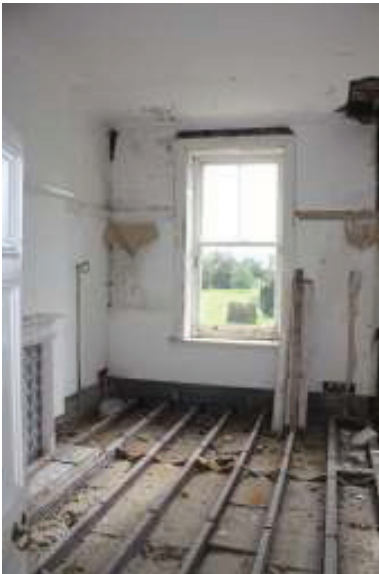
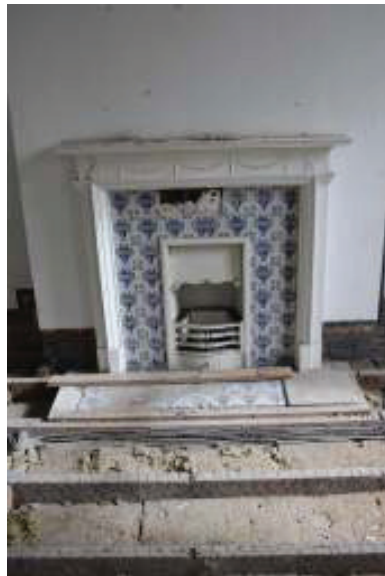
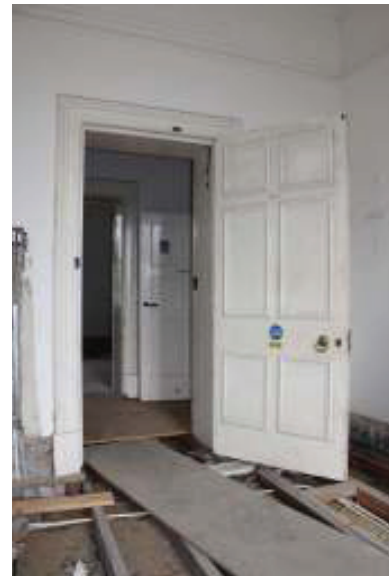
Bedroom Fo8

Door: Panelled fire door to corridor.

Fireplace: Painted timber fire surround with cast iron grate flanked by tiling.

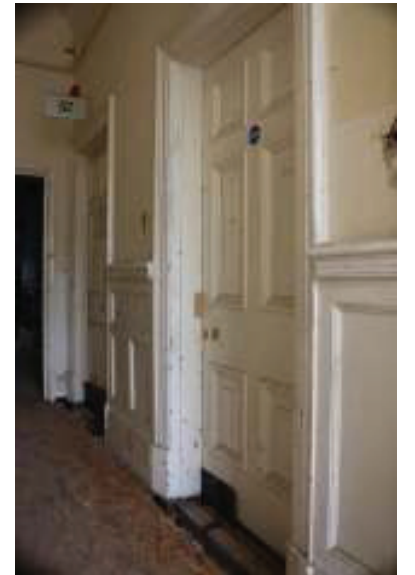
East Corridor

Window: East window formerly a fire escape with steps in situ.

Doors: Modern flush fire door to F1oB with chamfered architrave. This was, however, an opening previously judged by the detailing of the panelling.

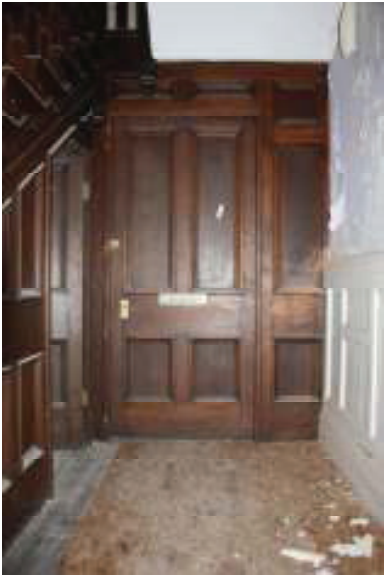
Lavatory off Staircase Landing F13

Walls: Tiled to approximately 1.6m with off-white “brick” tiles with a border of narrow blue tiles and a decorative frieze. Tiles have been damaged by modern fittings. These should, however, be restored to illustrate the hierarchy of this room.

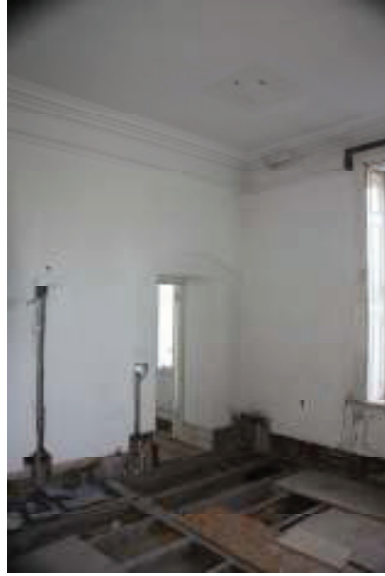
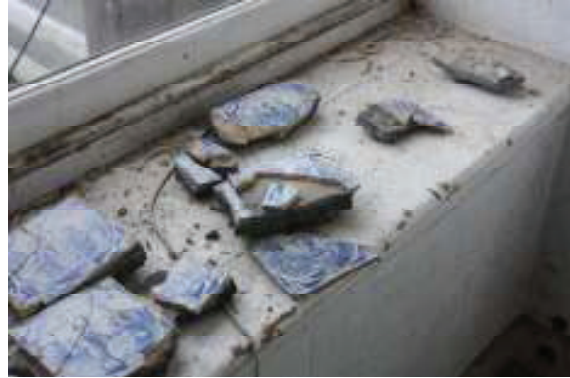
Room F14A

Window: Double hung sash window with 2 over 1 panes. Note: fragments of Delft-style fireplace tiles on window cill.

Door: Modern flush door.

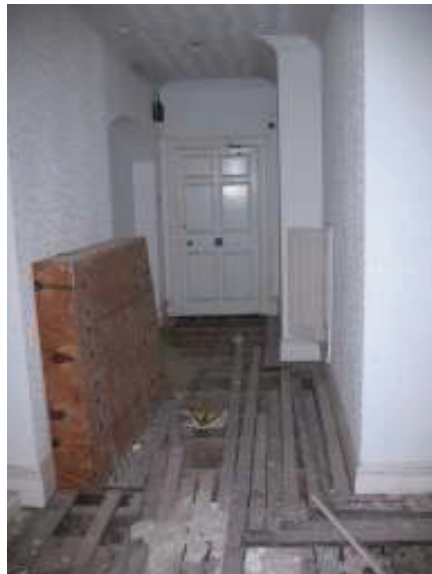
Room So1

Simple cornice, timber floor with boards approximately 80 x 27mm in section and joists that are approximately 50 x 275mm at 400mm centres. Sliding sash window on south wall overlooking gardens, upper sash of two lights. Six-panelled door upgraded for fire safety purposes. Fireplace covered by plywood boxing.

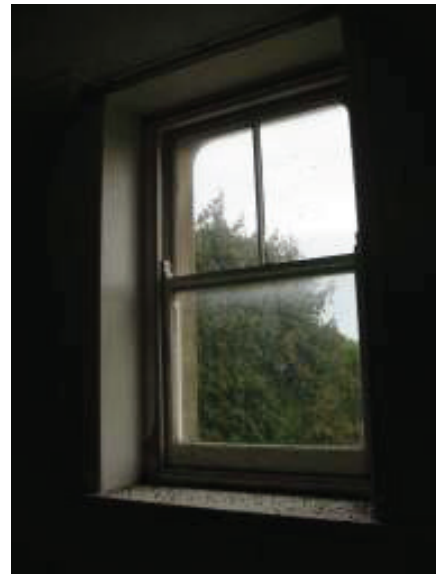
Room So1, sliding sash window

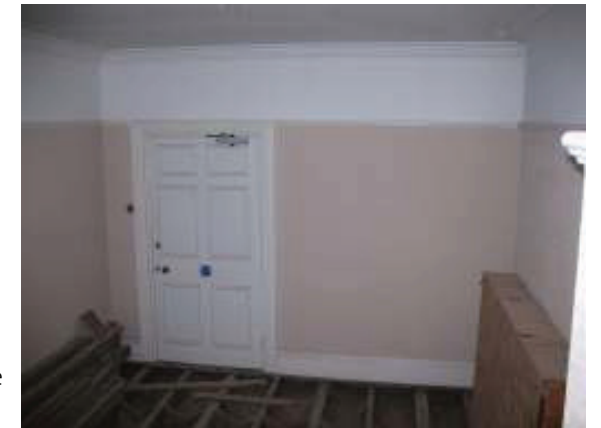
Room So3

Rectangular south facing bedroom with south facing sash window looking onto bay roof and stone parapet. Moulded plaster cornice, timber picture rail and skirtings (type So1): floor boarding taken up. Window as So1 with Windows: The window is vertical sliding sash timber window with two sashes. original sash fastener. The door is a fire door with brass round bun knobs and escutcheons with swing covers. The fireplace is covered by plywood boarding with part of the stone hearth exposed.

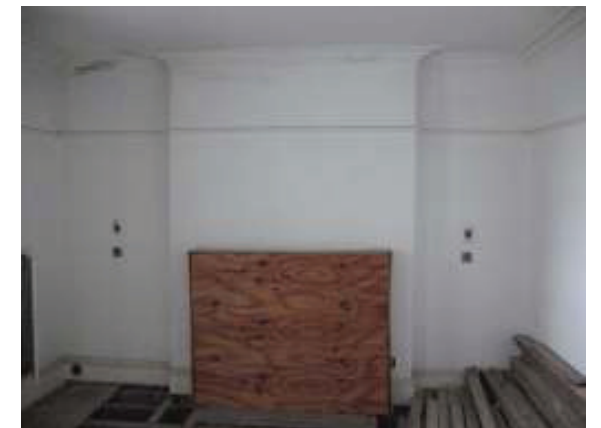
Room So4

Rectangular bedroom with two south facing windows.

Moulded cornice to perimeter, timber picture rail and timber skirting (type So1). Suspended timber floor with floorboards suitable for reuse. There is a timber access hatch to the roof void and there is a roof window beyond. Two windows as So1 with original sash fasteners present to both windows. Six-panelled upgraded fire door with brass bun knob and escutcheons with swing cover. Fireplace boxed in; part of the stone hearth is visible.

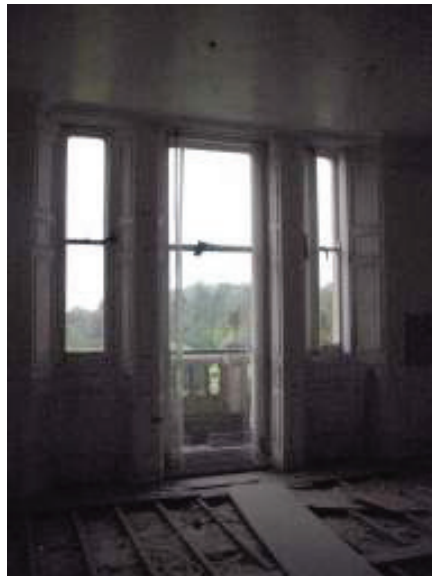
Room So5

This room has a much higher ceiling and grander proportions than all other bedrooms on the second floor. It is the largest second floor room and is centrally located on the second floor plan. It has a fine, south facing aspect towards the gardens, with large windows providing natural light, and access onto a roof terrace.

Plain plaster with moulded plaster cornice. Timber picture rail. The skirting is of a different profile to that seen previously (type So2) and the architrave to the entrance door is set on blocks. Suspended timber floor with steel beams providing primary support to the floor joists. Many of the floorboards have been removed. Three steel sections visible running east-west dividing the floor area into three bays of joists running north-south. Floor joists are approximately 50 x 170 timber set at approximately 420 centres. Steels are assumed universal beam sections 152 wide, depth unknown. Tripartite south facing sash window: central bay running from floor to ceiling flanked by two narrower side bays with painted timber panelling surrounds from floor to ceiling. Central window is a vertical sliding sash window split into three sliding sashes. Fire door – upgraded original six-panelled door with round brass bun knobs and brass escutcheons and swing covers. The fireplace surround, insert, bars and tiled hearth are complete see photograph.

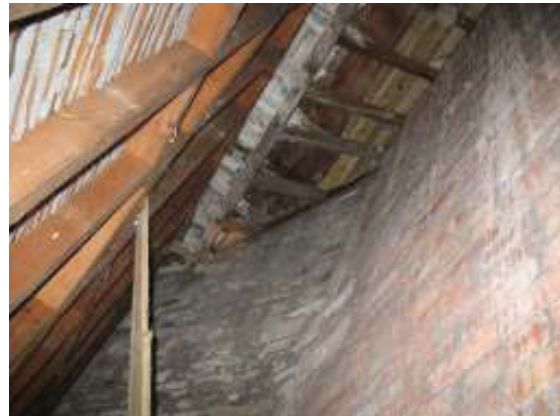
ROOM BETWEEN So5 AND So6 provides roof access with a hatch leading to a further space in which can be seen a canted length of what is probably pre-1894 stone walling.

Room Between So5 and So6 – Access Hatch

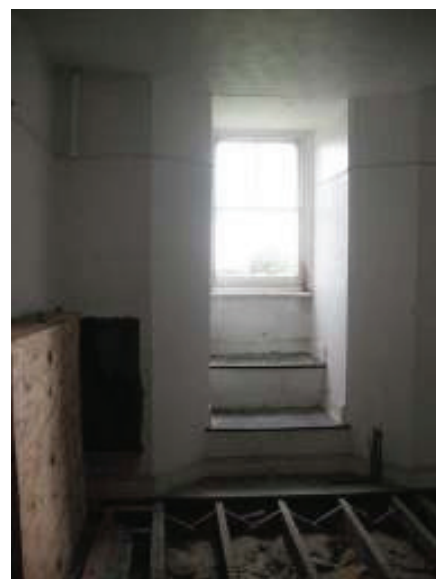
Room So6

South facing rectangular room with two south facing sash windows. No cornice, painted timber skirting (type So3), two south facing sliding sash windows. The fireplace is covered by plywood boxing. Upgraded six panel original door.

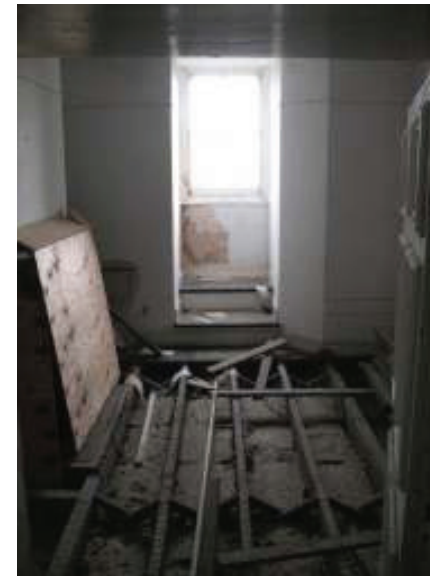
Room So8

Rectangular south facing room with 1 timber sash window, no cornice, simple bead at picture rail level as for So6, timber skirtings (type So3), 1 sliding sash window, as previously described, upgraded original six-panelled door. Fireplace: c.1890 cast iron grate and surround in good condition.

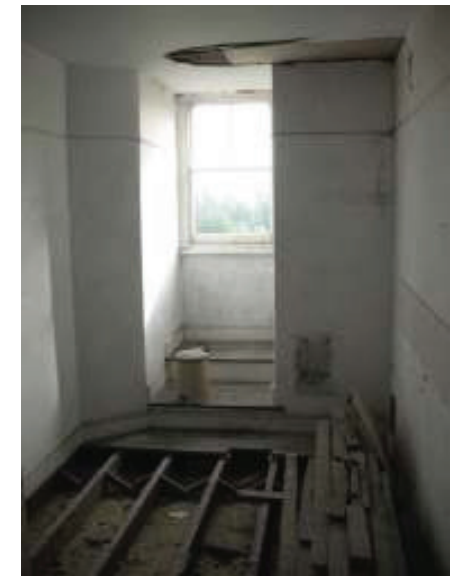
Room So9

Rectangular south facing room with 1 vertical sliding sash timber window, no cornice, semi-circular timber picture rail, and skirting type So3. A section of tiling extant at approx. dado height on west wall, 1 sliding sash window, upgraded original six-panel door.

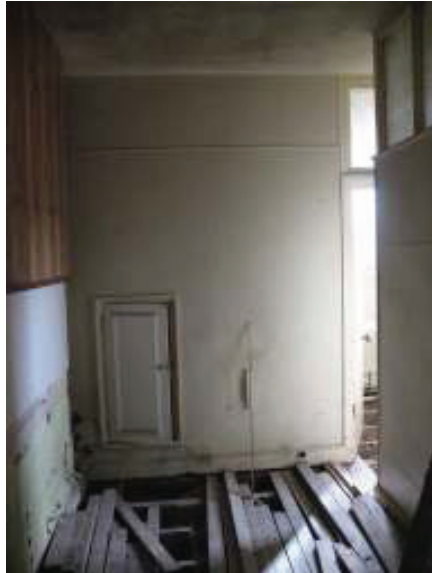
Room S10

The opening in the southwest corner leads to an L shaped space divided into two rooms, S10A, and S10B previously used as bathrooms. No cornice, simple timber picture rail, type S03 skirting, sash windows as previously room S01. Door has three lower panels and one large upper panel.

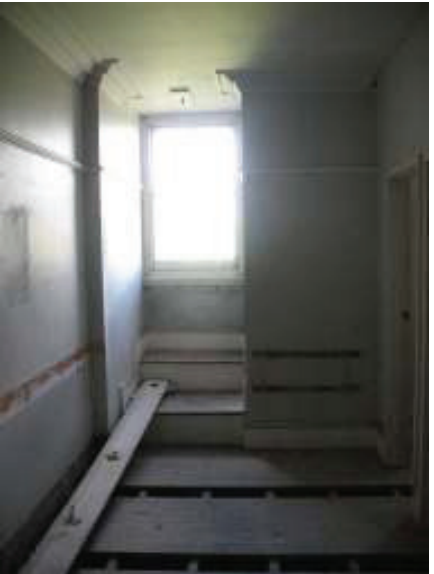
Room S12

North facing room subdivided into four rooms, numbered S12, S12A, S12B and S12C. Moulded cornice, simple picture rail, type 1 skirting, 1 north-facing timber sash as room S01, upgraded original six-panel door.

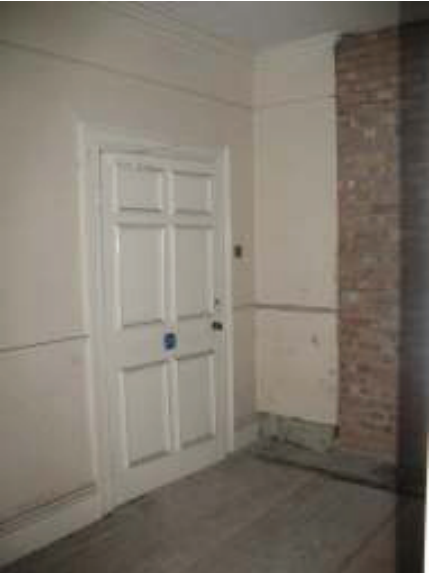
Room S13

Subdivided into two rooms, the north of which encloses a recently (2007-8) added escape staircase in timber, running down to ground floor level.

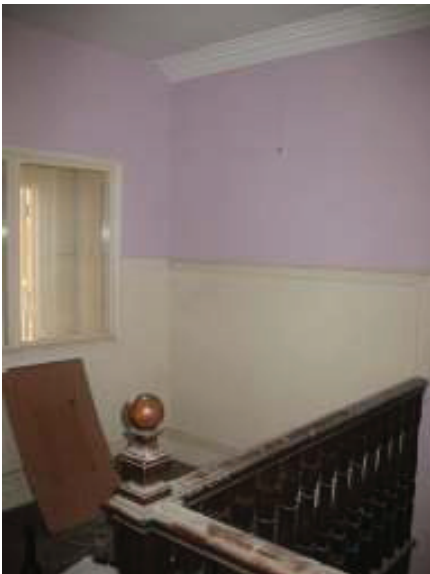
Room S14

This is the top floor landing to the main staircase down to first floor level. Moulded plaster cornice, modern partition wall (inserted for fire compartment purposes), timber dado rail. 1 north-facing timber sliding sash, modern fire door.

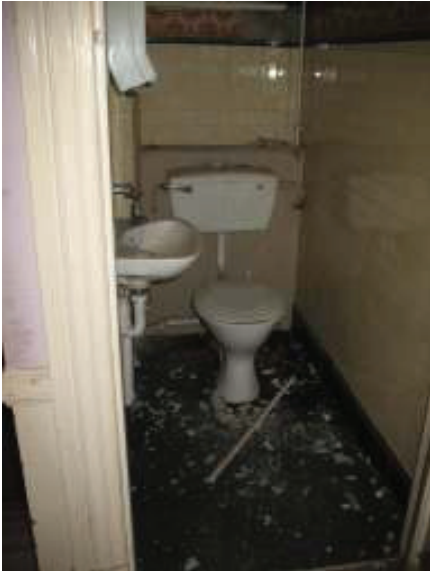
Room S14A

Walls are tiled, (circa 1895 tiles), up to approx. 1600 above floor level.

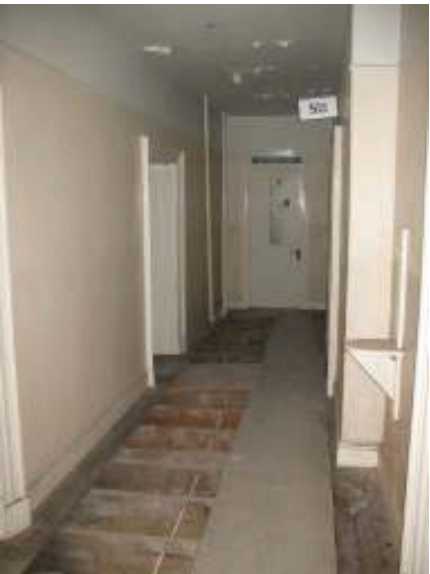
Room S15

This is a corridor space. Simple timber semi-circular picture rail, type S01 and type S03 skirting, eastern door upgraded fire door, western door is modern.

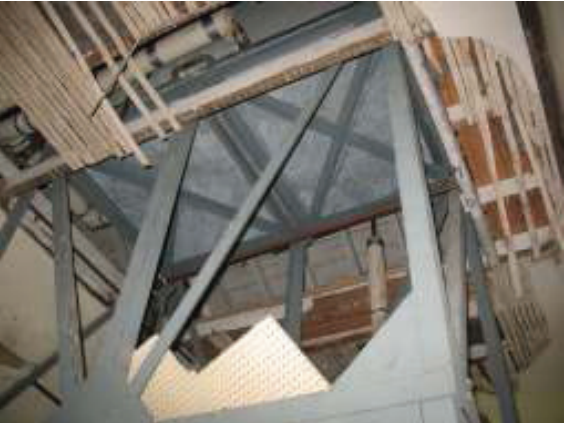
Room S16, ceiling

Type S03 skirting, 1 north facing sliding sash window as room S01, upgraded fire door.

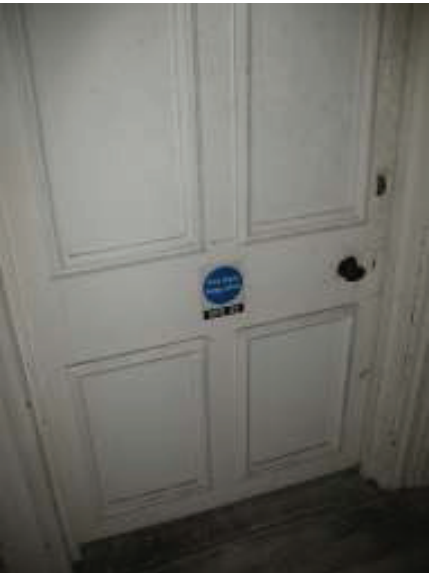
Room S17, door

No fireplace, no cornice, no picture rail, type S03 skirting, 1 north facing timber sash window as room S01, original upgraded six with oval door handle.

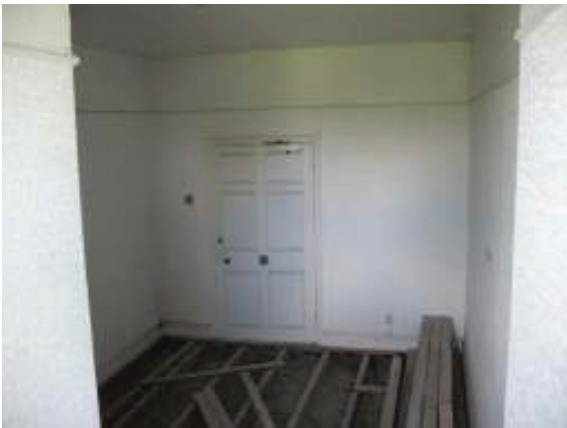
Room S18

Semi-circular picture rail, 1 no. north facing vertical sliding sash window, as room S01, fire.

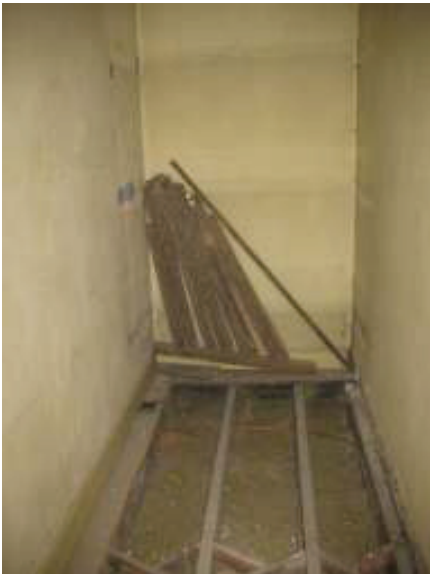
Room S19

Rectangular north facing rectangular store room, no window or fireplace, no cornice, type S03 skirting, upgraded original six-panel door.

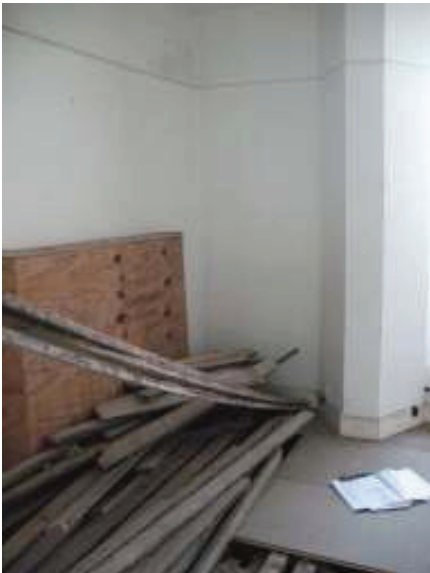
Room S20

Simple semi-circular picture rail, type S03 skirting running round perimeter of room. Timber grounds within east wall, single timber sliding sash window, presumed upgraded original door, fireplace covered.

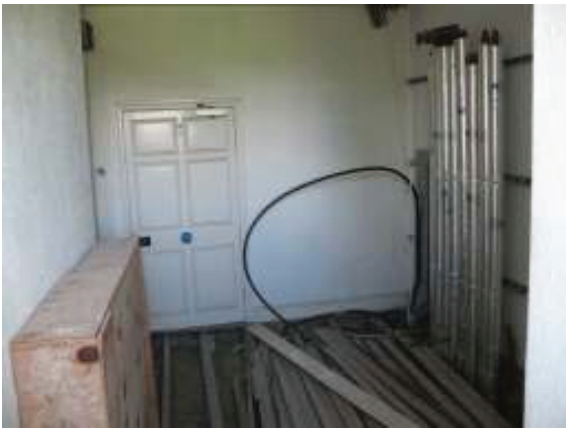
Room S21

No picture rail, type S03 skirting, 1 timber sliding sash window as described previously, assumed upgraded fire door, fireplace and hearth concealed.

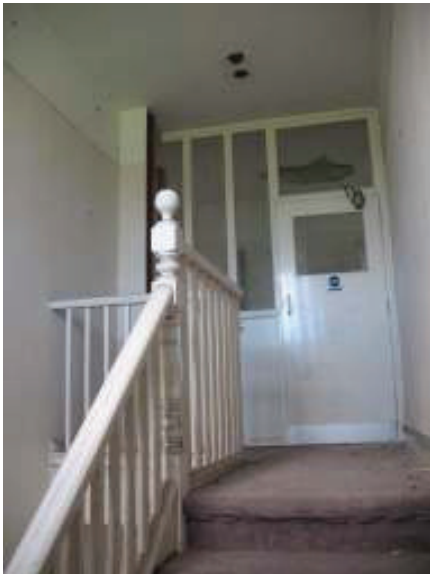
Room S22

Top floor of the stairwell. 1 timber sliding sash, no cornice, simple semi- bead at picture rail, type S03 skirtings, modern fire door.

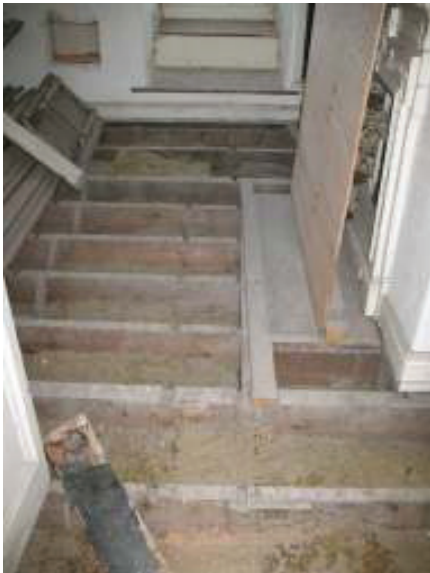
Room S23

No cornice, no picture rail, skirting type S03, north facing sash window, as room S01, upgraded original six-panel door, with brass ironmongery, fireplace boxed in.

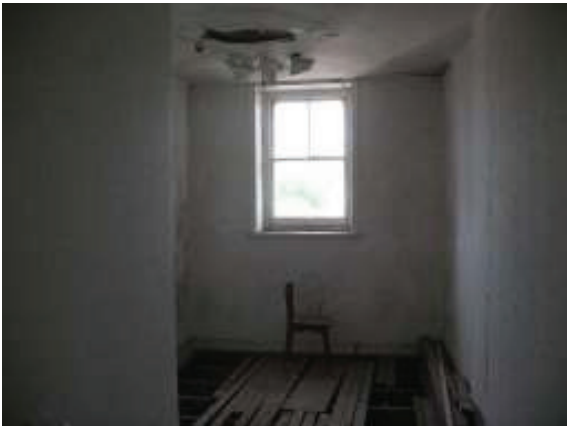
Room S24

Single sash window room S01, no cornice, no picture rail, type S03 skirting, upgraded original six-panel door, with brass ironmongery.

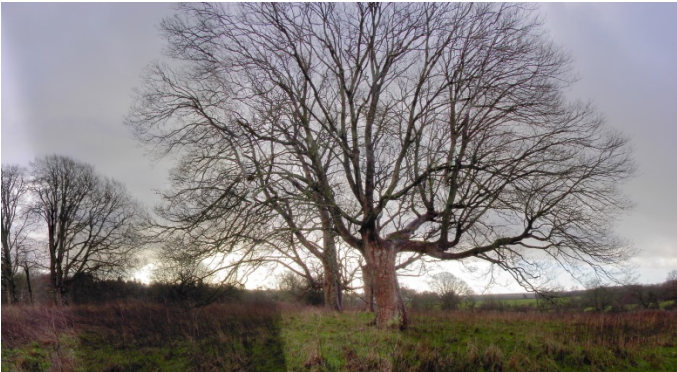
Row of mature sycamores on line of former hedgerow, 1878

The field boundary bordering the main drive is defined by a modern parkland railing. The western half of North Meadow is rough pasture; the eastern half appears to have been grazed or cut (winter 2013). A pond exists towards the SW border. The field hedgerows are in variable condition; the SW hedgerow is particularly thin.

A 10-year planting plan is needed for all the parkland (including North Meadow), to define new planting to replace (known) lost parkland trees but possibly planting more extensively to ensure a good stock of future parkland trees. Younger trees of inappropriate varieties (e.g. rowan and birch) should be replaced with more suitable parkland varieties such as oak, beech, lime or ash.

Ideally, the grassland sward of north meadow would benefit from being grazed by sheep and/or cattle (ideally a combination). To allow this, the field boundaries need to be strengthened, especially the thin hedgerow along the SW field boundary. Existing hedgerows need substantial management, by cutting and laying and replanting thin or missing sections. This would also contribute to the management of overland flow in prolonged periods of wet weather.

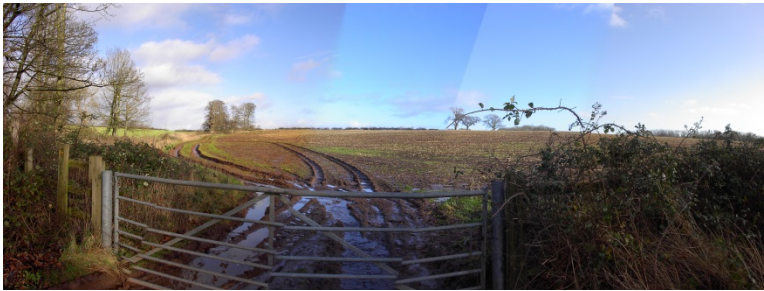
View along route of former track through mid-C19th parkland

Description of what survives:	Today the field is an arable field. It contains a few stag-headed oak trees marking the line of the old track.
Losses, removals and alterations:	The 19 th century track across the field is no longer visible.
Significance:	Little significance because the 19 th century track across the parkland is lost and only a few stag-headed parkland trees survive. However, it is significant as part to the historic estate of Dyffryn and, for a short time, as part of the parkland.
Recent investigations:	-
Condition and repairs:	The field is an arable field. Hedgerows are thin or (along the north boundary) almost completely lost.
Management issues and needs:	This field is not owned by the Vale of Glamorgan Council. However, the field has been used for overflow parking in the past and might be used again. Visitors would need to cross Dyffryn Lane but there is scope for choosing a safe crossing point. The possibility of leasing part of field L.6 for overflow parking should be explored , maybe initially on the basis of a short lease to allow a trial period for overflow parking.

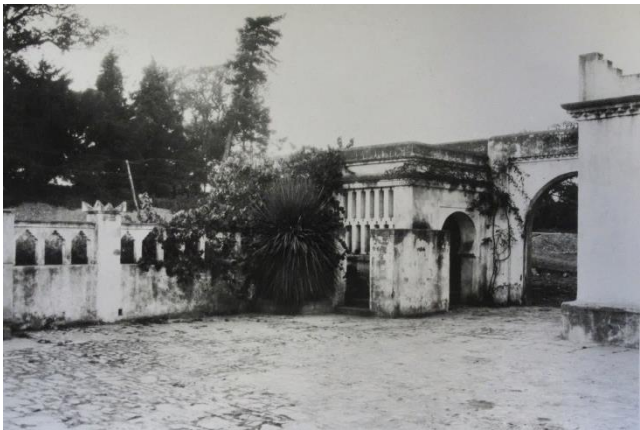
Moorish Courtyard in 1920

Description of what survives:	There is no visible trace of the Moorish Courtyard today.
Losses, removals and alterations:	-
Significance:	Little significance owing to its removal. Had it survived, the Moorish Courtyard would have been of Medium or possibly even High significance, owing to its association with the Grade II* listed house but also because of its association with the gardens created by Reginald Cory. The choice of design reflects Cory’s fascination with cultural styles found in southern Europe or, possibly, north Africa and his fondness for experimenting with them in his own gardens.
Recent investigations:	-

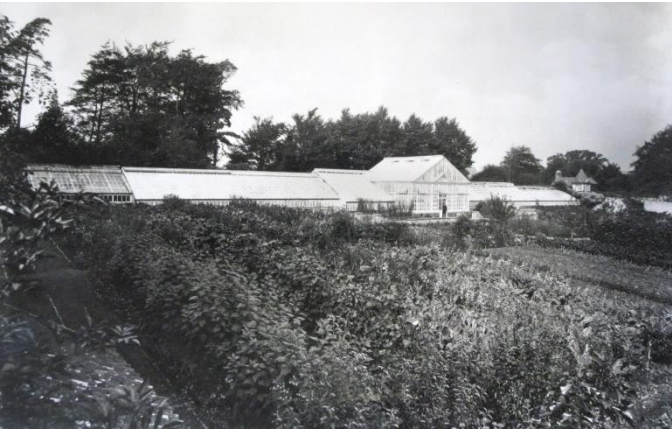
Main walled kitchen garden in 1910

Condition and repairs: The walled garden layouts, paths and dipping pools were restored with HLF grant aid from 2004 - 2011. The new glasshouse range in the west garden was completed in 2011.

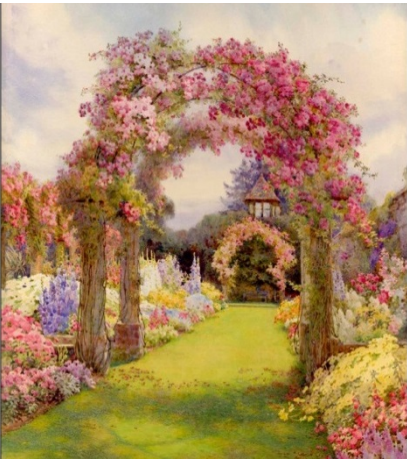
Painting by Edith Adie, 1923

The small turret-like summer house at the west end of the herbaceous borders, described in 1911 and shown in a watercolour in 1923 by Edith Adie, no longer exists. There is no visible sign even of the turret base in the grass area beyond the west wall but buried foundations may still exist.

- Investigate the site of the lost garden tower shown in the painting by Adie at the west end of the garden to establish whether it existed and, if so, the characteristics of the foundation.

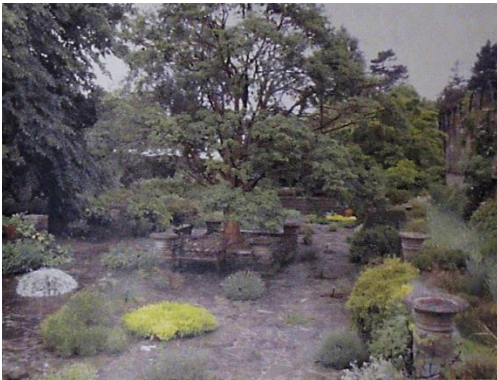
Dutch Garden, 2008⁴⁴

<p>create symmetry when looking along the length of the garden from the west end. A raised border runs along the north side of the garden, beneath the supporting wall of the adjoining, but higher Herbaceous Border garden: this now contains a collection of bearded irises.</p> <p>A photograph of the garden published in The Gardeners' Chronicle in 1914 shows a summer house standing mid-way along the south side of the garden. It has a raised veranda facing north, giving an elevated view. The photograph shows series of small raised beds arranged along the north and south sides of the central area, to either side of a central gangway.⁴⁷ These may have been temporary beds built to accommodate dahlias grown as part of the 1913 and 1914 'Duffryn Trials' of garden dahlias. An article published in The Gardeners' Chronicle in 1920 describes an area known as the Narcissus Garden, which appears to correspond to the photograph of 1914. It describes '<i>many raised beds enclosed by wooden borders. Japanese Acers are a feature of this garden in summer, and the low retaining stone wall is gay with Roses, among them the new Rosa Moyesii, which is covered with its numerous dark red single blossoms.</i>'⁴⁸</p> <p>The Dyffryn estate sales particulars of 1937 describe a sunken Dutch Garden with terrace and garden house: is assumed that referred to this area.</p> <p>The garden became known as the Mediterranean Garden after the Corys' time - possibly since the 1950s - when new head gardeners began to take advantage of the warm shelter space to grow plants of Mediterranean climate provenance. In 2008, a large mature <i>Acer griseum</i> stood in the centre of the garden.</p>

Recent investigations:	-
Condition and repairs:	<p>The small masonry viewing platform with shelter beneath (at the SE corner of the garden) was repaired in the late 1990s. The display of small Mediterranean sub-shrubs in the crazy paving is uninspiring.</p>
Management issues and needs:	<ul style="list-style-type: none">Ensure that the paving, steps and walls are maintained in a safe and clean condition.Selectively prune surrounding trees and shrubs to re-open views to west, south and east from the small viewing platform at the SE corner.
Future character & presentation	<ul style="list-style-type: none">Consider either<ul style="list-style-type: none">re-creating the Dutch Garden that is shown in the photograph published in The

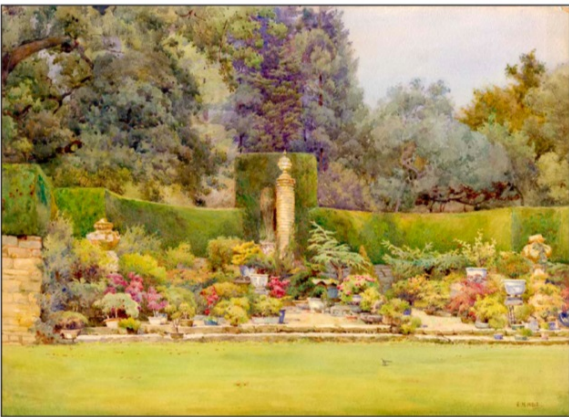
Description of what survives: The shape of the theatre garden and its enclosure with yew hedges remains much as originally designed. The stage remains although it has been extended forwards and is now paved with stone flags. The central pillar survives although the finial is a similar, but not identical replacement of the original.

Losses, removals and alterations: Today, at both north and south ends of the stage there are two sets of curved steps, marking entrances from neighbouring gardens. However, the photograph of 1920 only shows one small flight of steps at the north end of the ‘stage’ and no others. It is not known when the other three flights of steps were added. The two lower plinths which supported stone finials - one on either side of the ‘stage’ – are no longer there. The original finial on the top of the central column (thought to have been Coade stone) was removed and replaced in the 1990s.

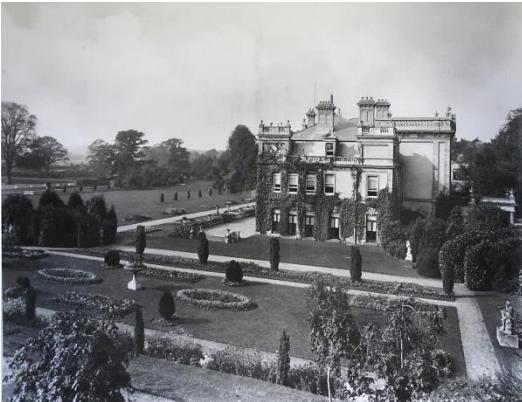
Panel Garden, 1910

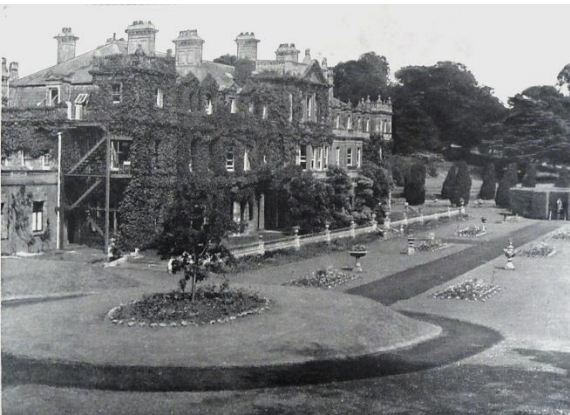
South Front, 1957 ⁹⁹

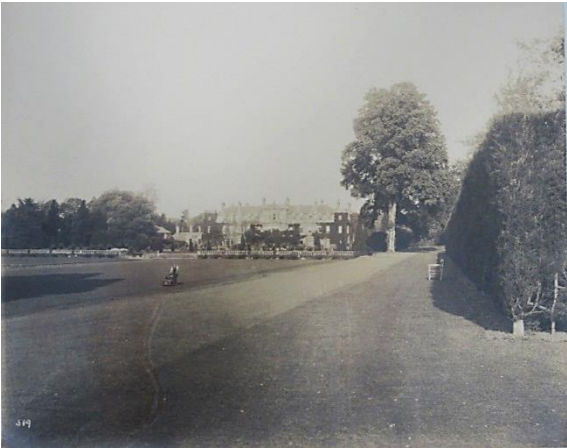
Great Lawn, 1920

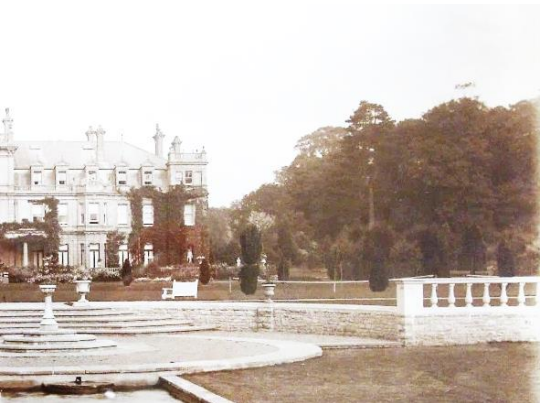
The Rookery (right hand side), c.1910

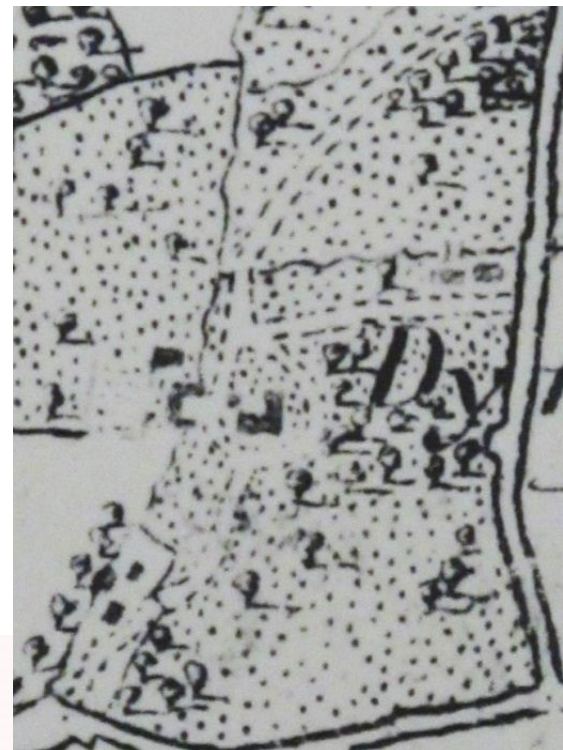
Extract Ordnance Survey Two Inch Drawing, 1811
Source: Glamorgan Archives

The map of 1826 – 27 that also shows an L-shaped house is Greenwood's Map of Glamorgan, Brecon and Radnor. Maps were quite often made by a combination of surveying and copying previous maps: it is possible that the shape of the house shown on this map was out-of-date even when the map was made.

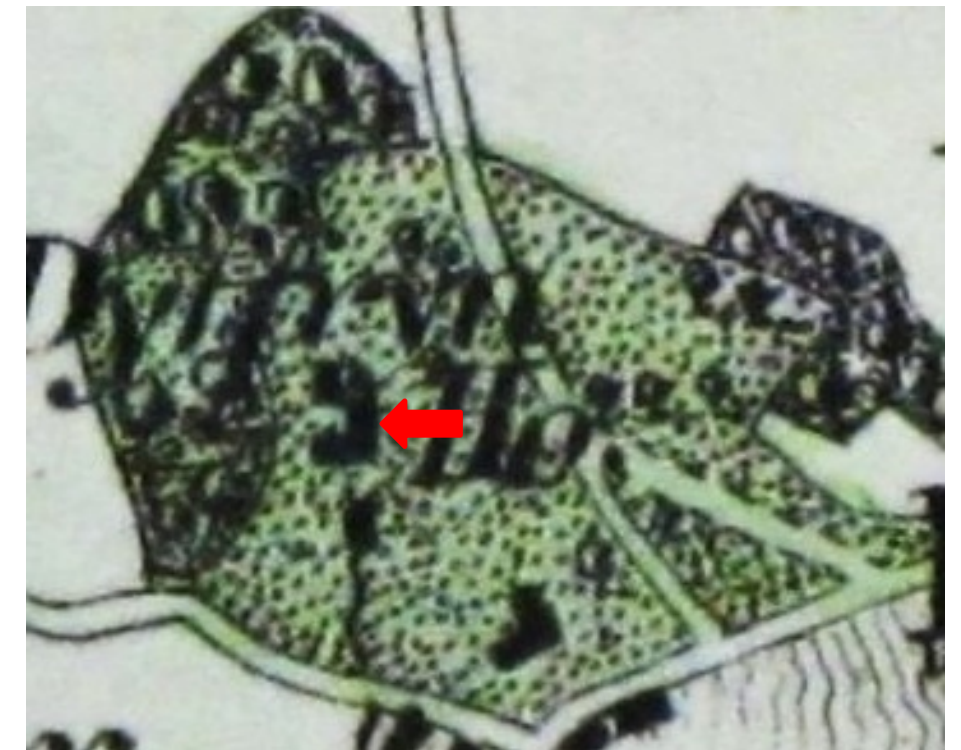
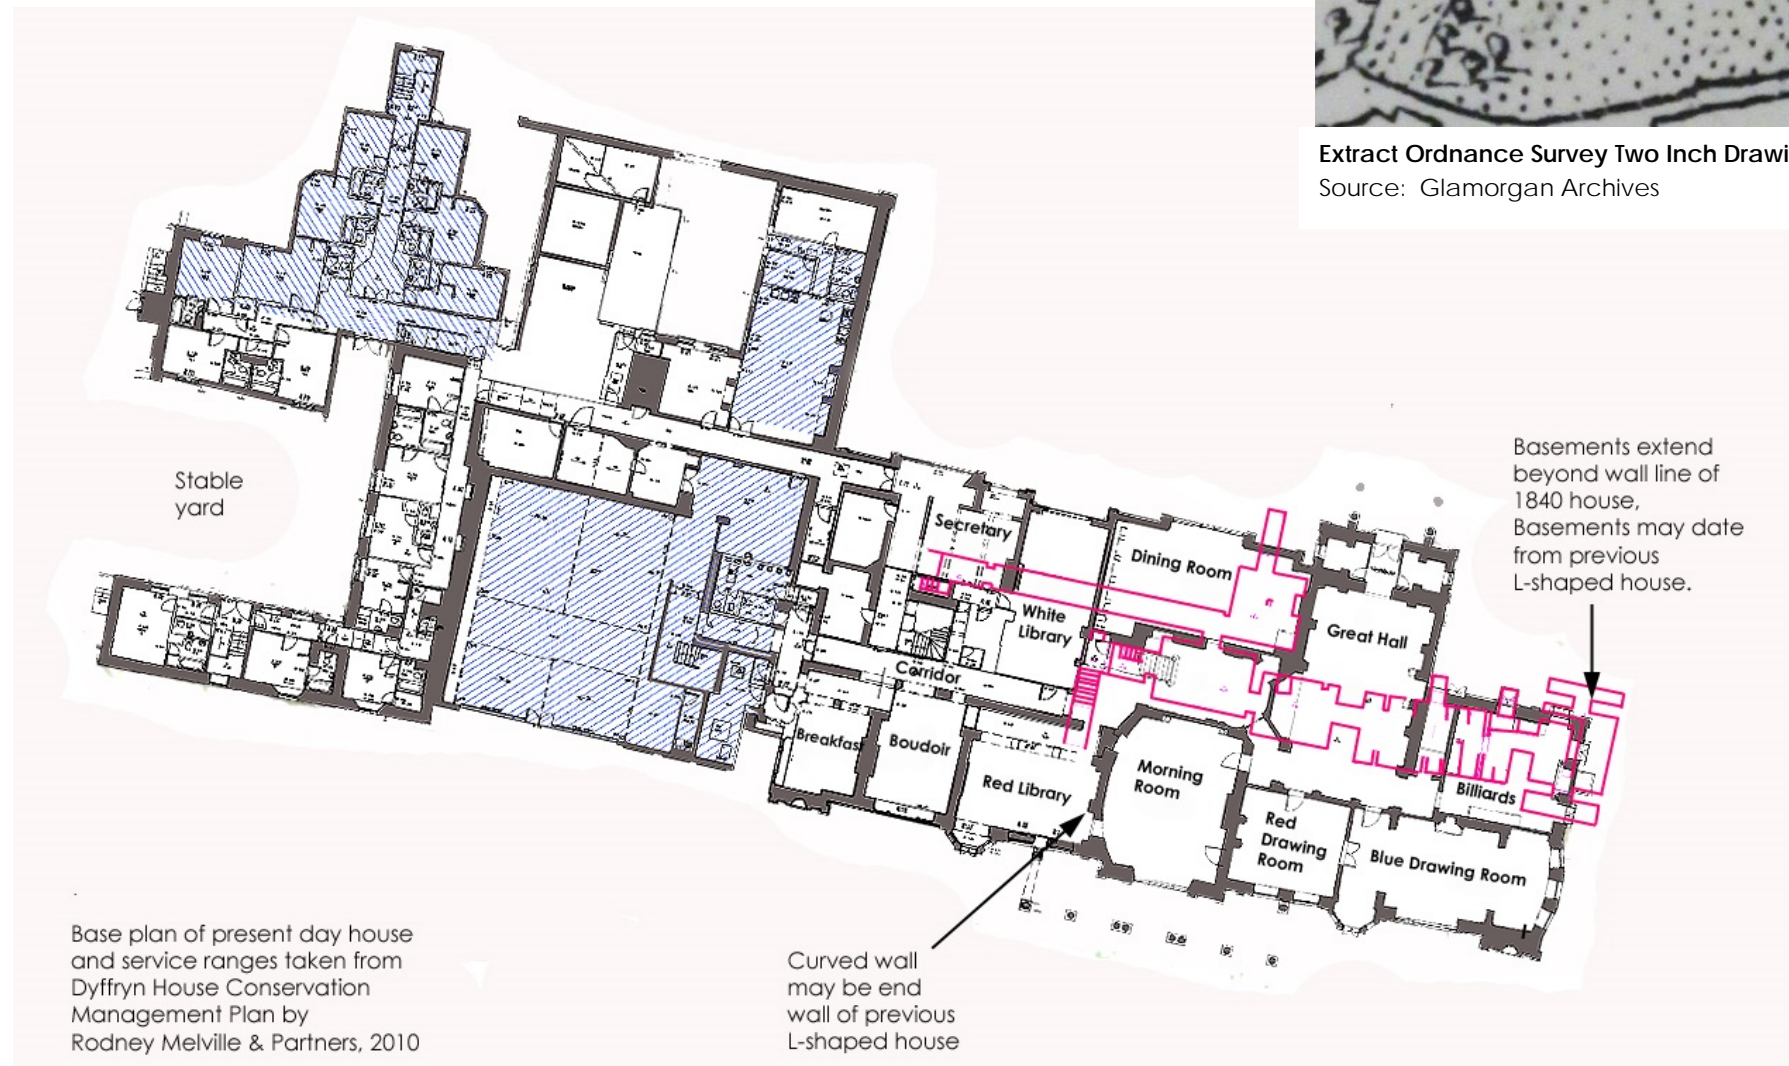
Base plan of present day house
and service ranges taken from
Dyffryn House Conservation
Management Plan by
Rodney Melville & Partners, 2010

Curved wall
may be end
wall of previous
L-shaped house

The curved west wall of the ground floor Morning Room (thick enough to be an outer wall) and the curved east wall of the Blue Drawing Room are suggestive of the end walls of an earlier house – possibly this L-shaped house of the early 19th century.

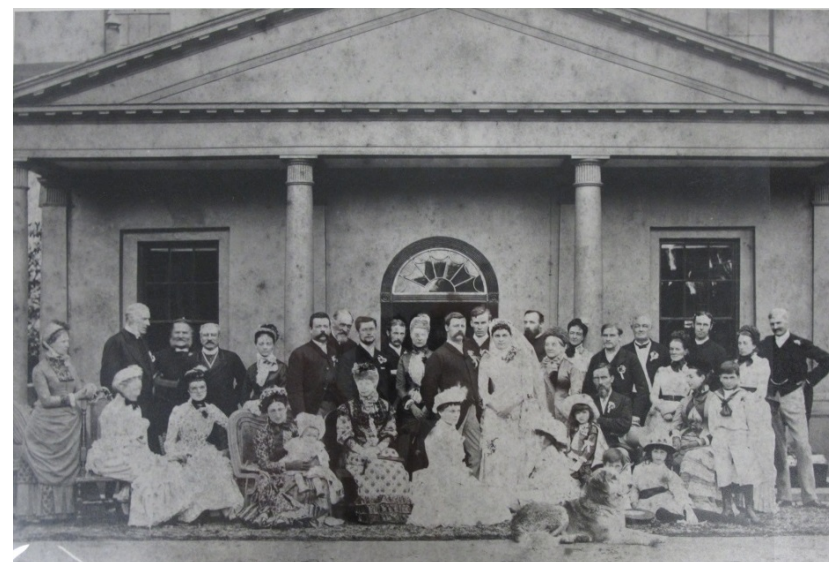
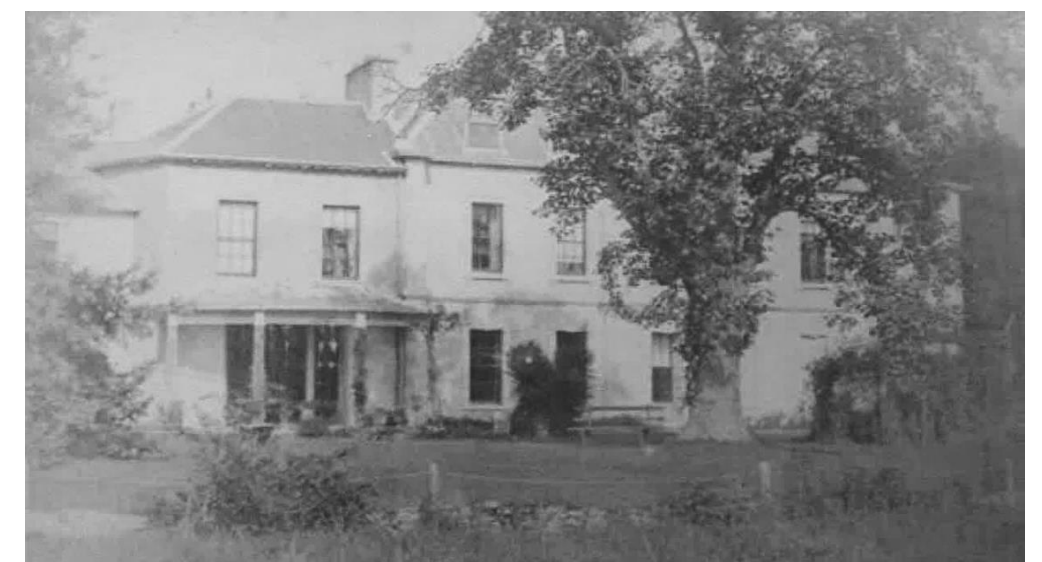
Old Dyffryn House, viewed from the south, un-dated – possibly c.1870?
Source: Glamorgan Archives, ref. D19/59/6

A photograph of the south side of the house (date uncertain) shows the tallest part of the house, with 3 storeys extending along the portion of the house that contains the Red and Blue Drawing Rooms. Attached to the west end of this is a two storey section which appears to correspond to the existing Morning Room. The main room of this section has large full-height windows with a canopied veranda. The west wall, which is only partially visible in the photograph, appears to be bowed but not as a smooth curve: instead the curve is formed by three straight wall panels and the hipped roof has a corresponding articulation. To the west again is a third section to the house, also of two storeys although the floor-ceiling height appears to be lower.

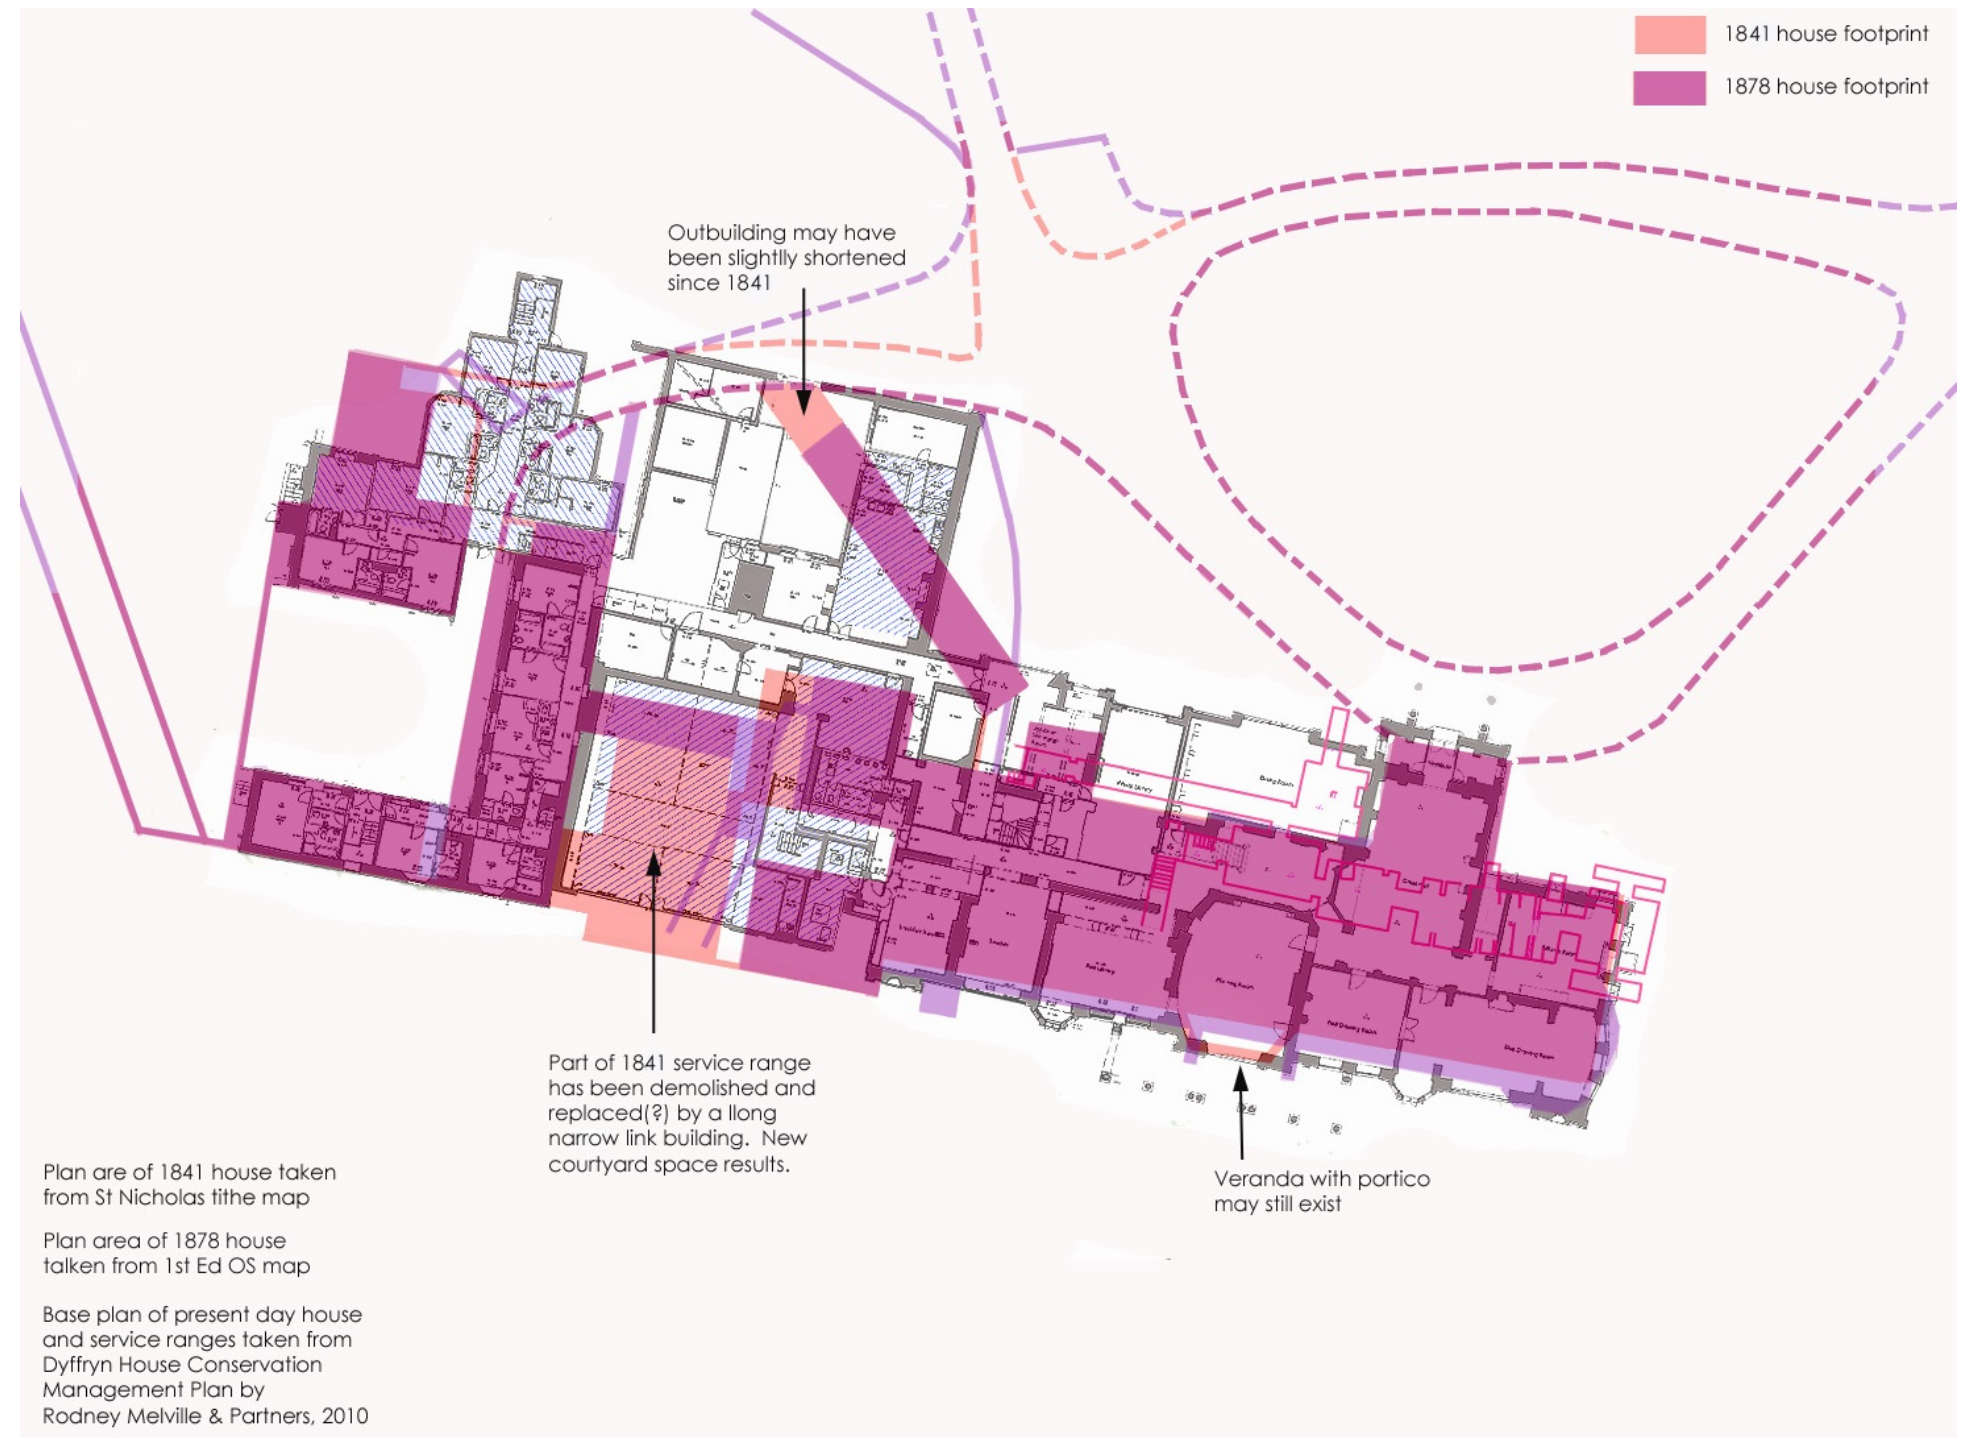
The footprint of the 1878 house and adjoining service ranges corresponds closely with that of 1841. The plans reveal only two changes of any size, both to the service ranges. A substantial portion of the service ranges between the main house and the stables appear to have been either completely demolished or substantially reduced, leaving two long narrow buildings defining a courtyard space on the site of the Traherne Suite restaurant. A long narrow outbuilding to the north, running at a 45° angle to all the other buildings appears to have been slightly shortened.
