Dyffryn House and Gardens,
Vale of Glamorgan

Conservation Management Plan

Appendices

Teasdale
Environmental Design

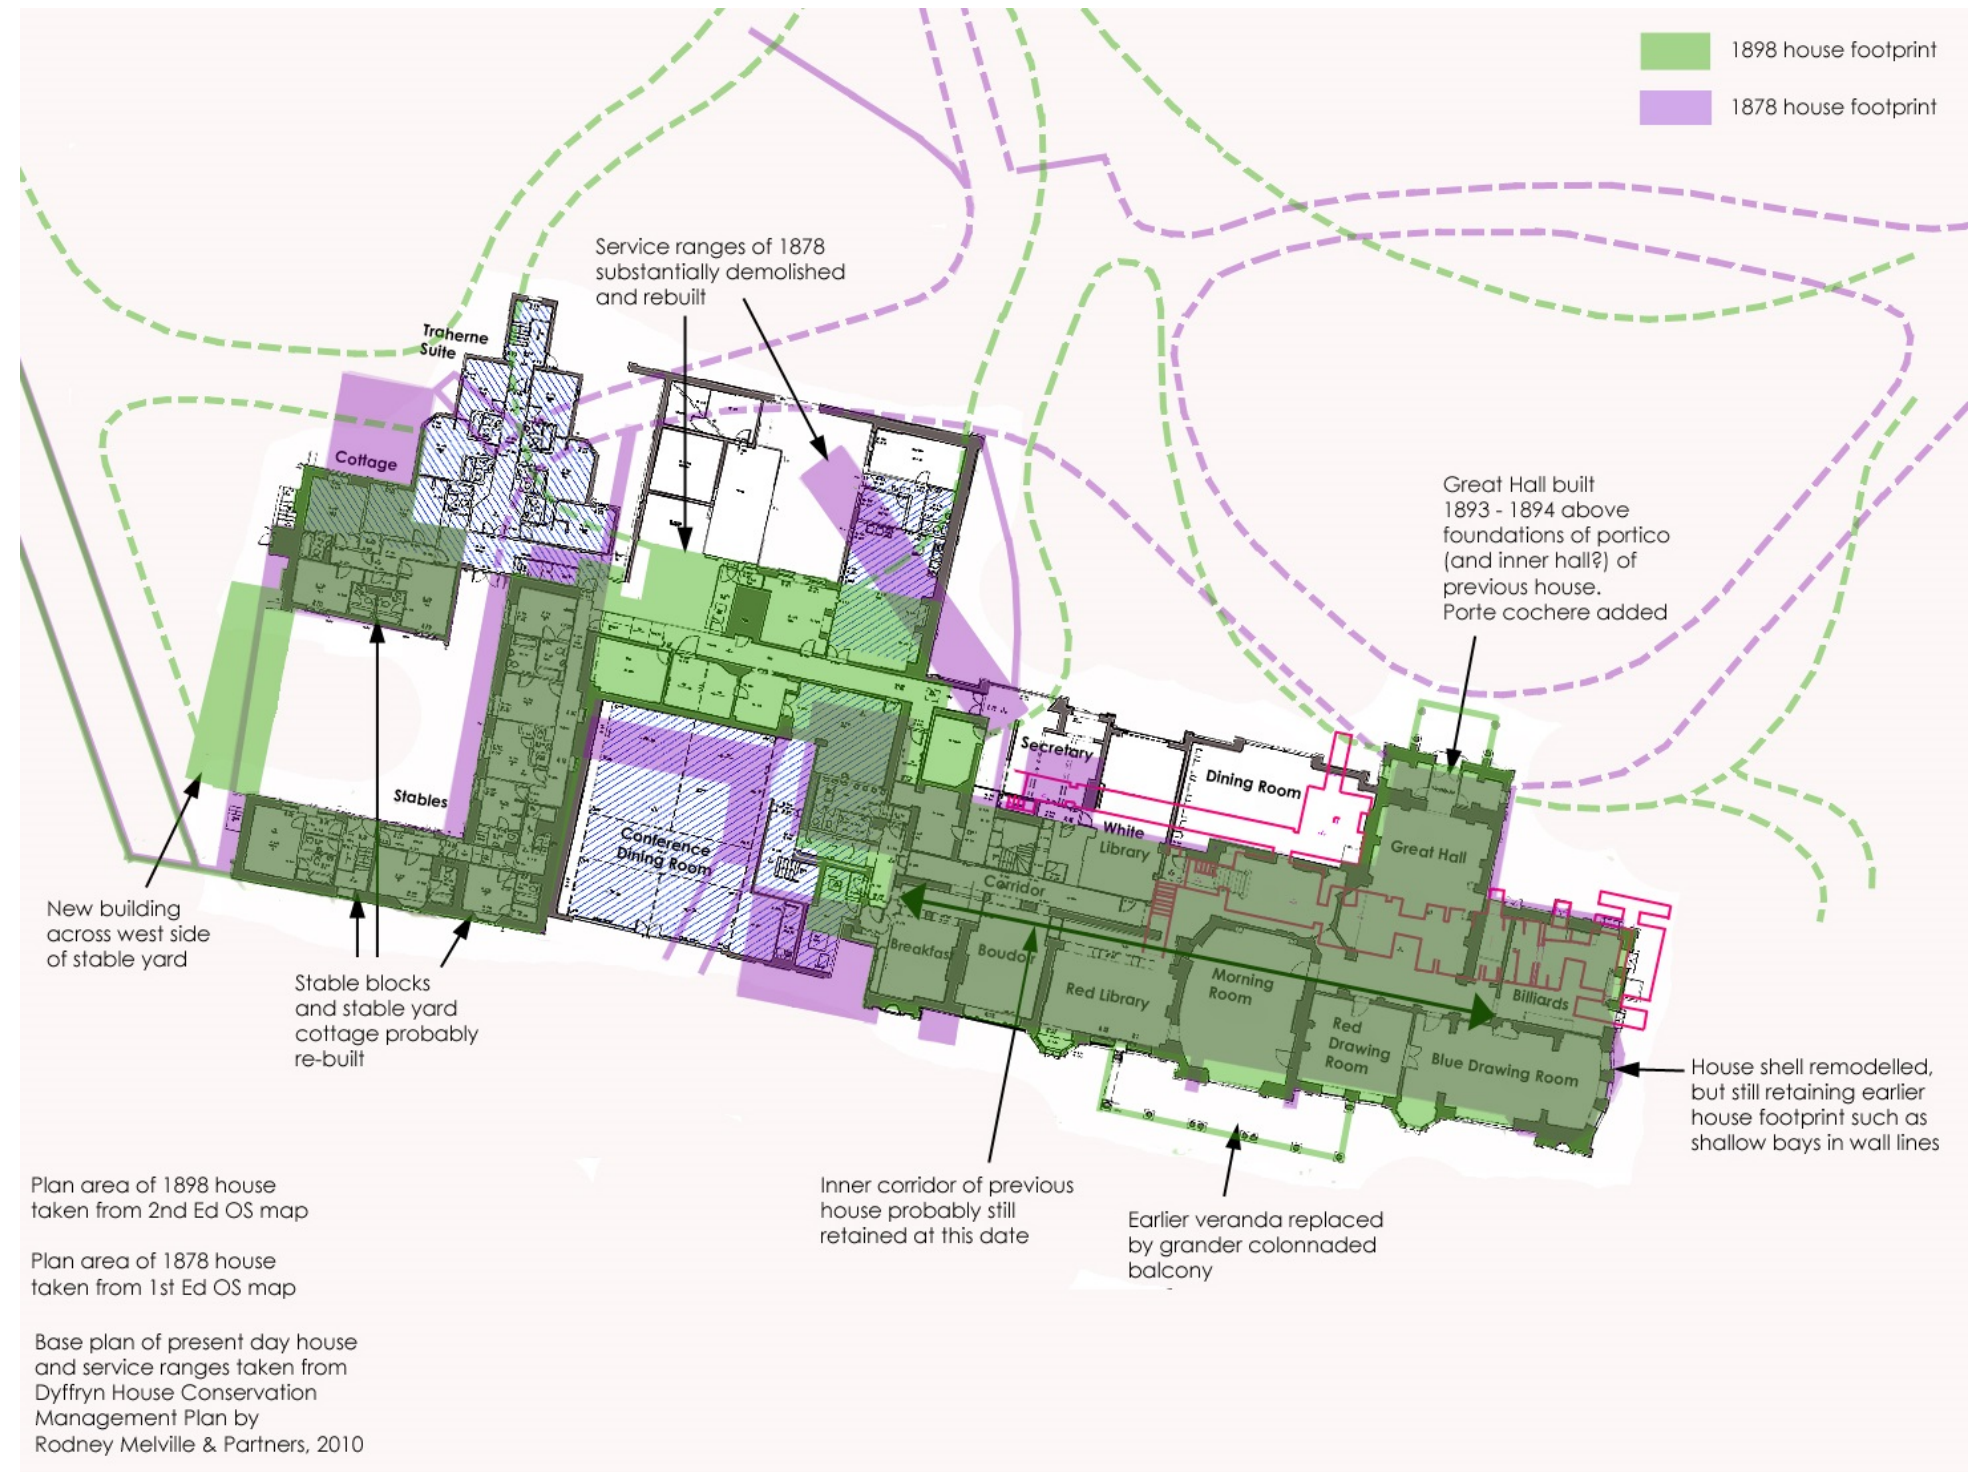
House footprints of 1898 and 1878, superimposed on present day house plan

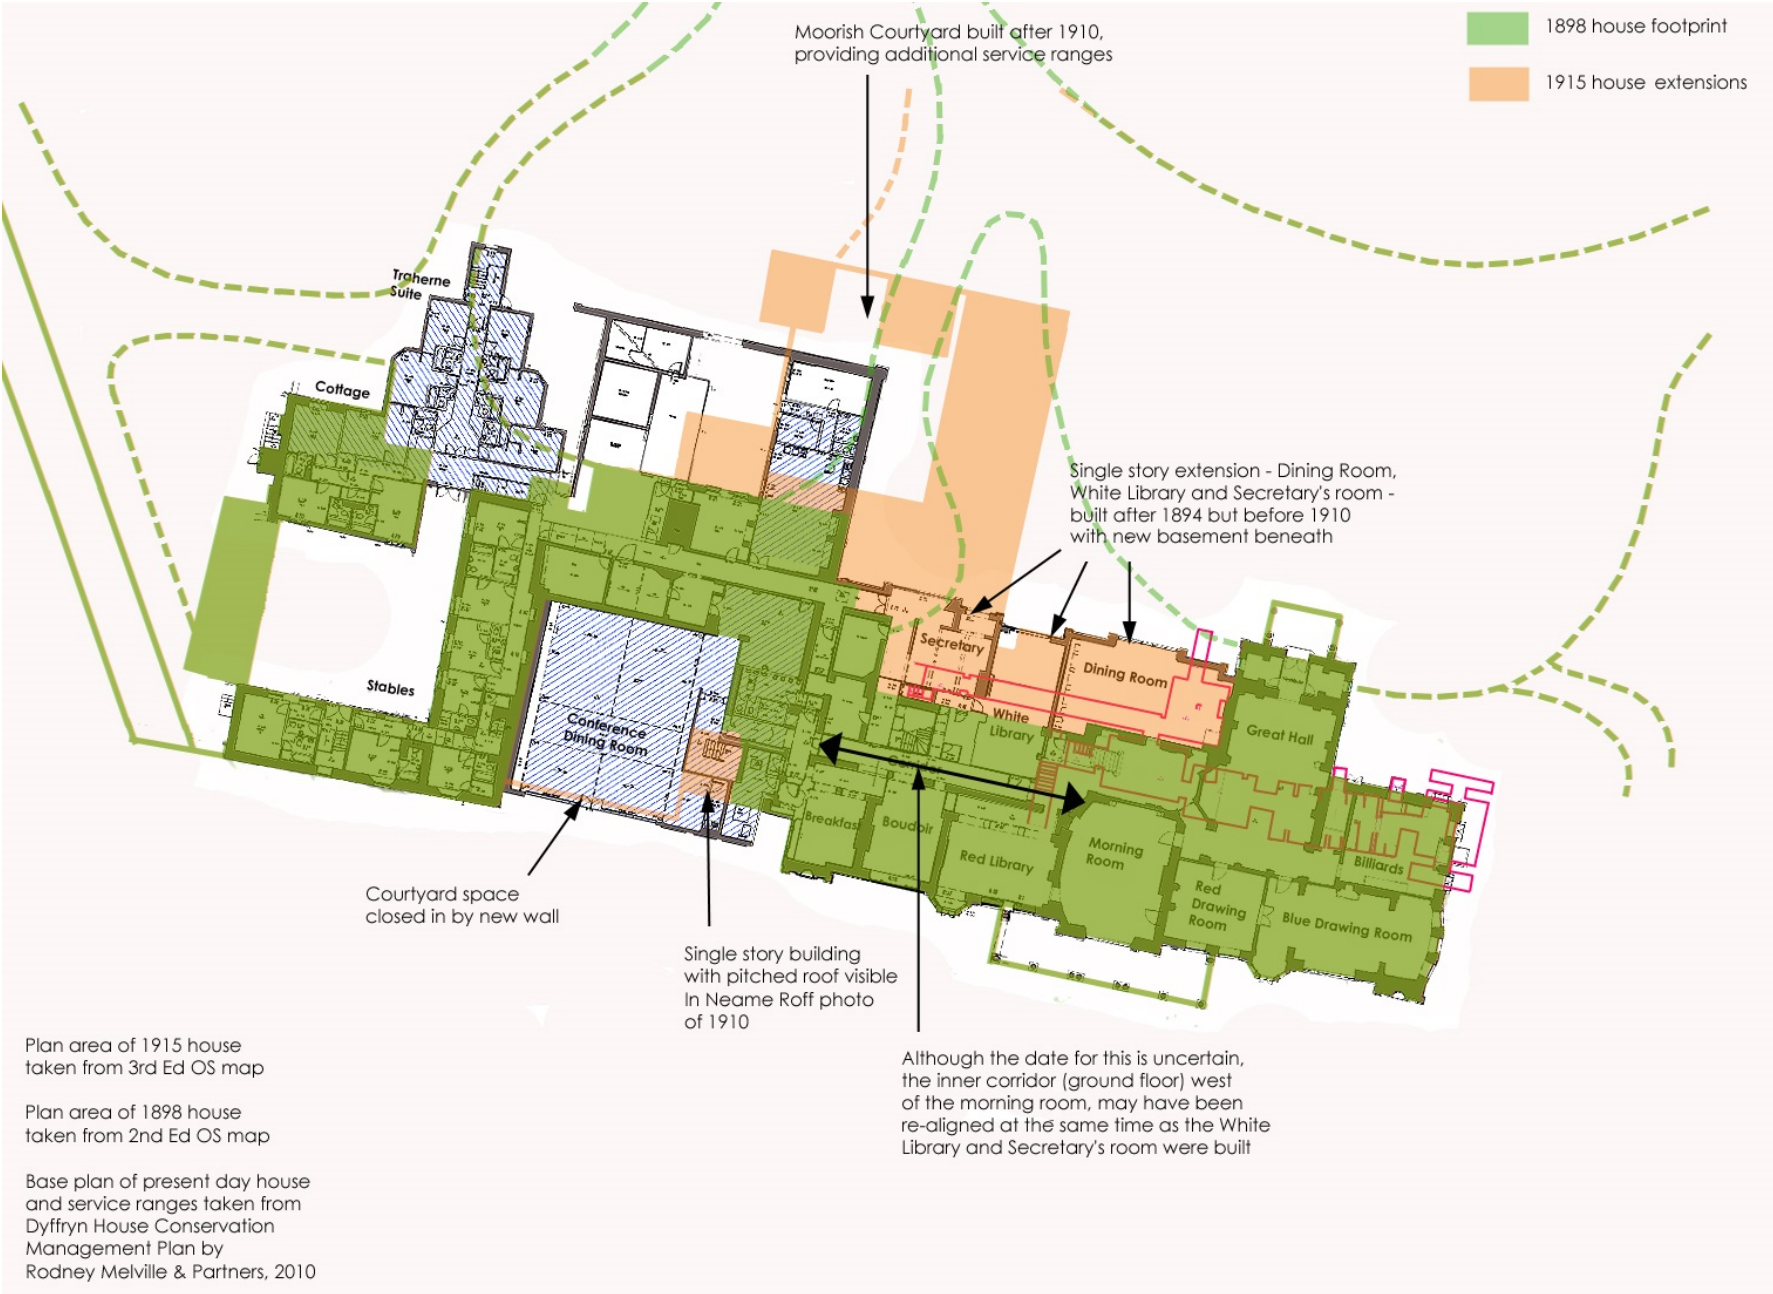
1898

Dyffryn was bought by John Cory in 1891. Work on remodelling the house began in late 1893 and was probably completed by December 1894, when the Cory family moved in. The Great Hall - built on the site of an earlier projection with portico - was completed in advance of this and opened for a function in early May 1894. The hall may have been built above the earlier foundations and may have even incorporated parts of the lower walls of the projecting structure. However, in view of the much larger, heavier structure of the great hall, it seems probable that the walls would have needed to be largely rebuilt.

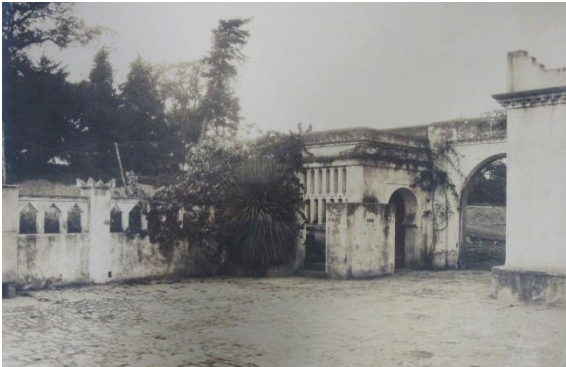
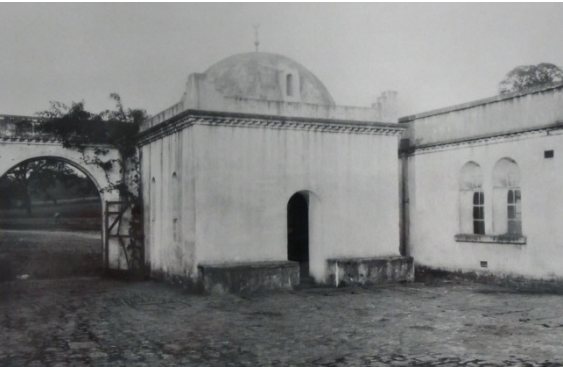
Two views of the Moorish Courtyard, 1920

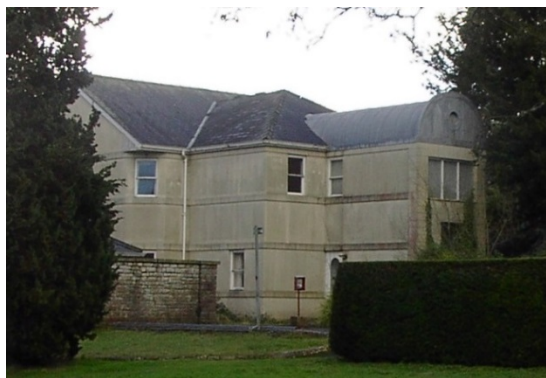
Traherne Suite wing opened 1985

The Traherne suite comprises the stable yard cottage and the stable block - altered or converted to provide delegate bedrooms and en-suite bathrooms - and a new building added to the immediate north of the stable block and designed to connect with both. This new wing completely blocked the original north entrance into the stable yard.
