Malefant Castle (GM626), Llanmaes, Vale of Glamorgan CF61 2XR

Archaeological Building Investigation & Recording and Watching Brief

June 2024

HRS Wales
Report No: 274
(V1)

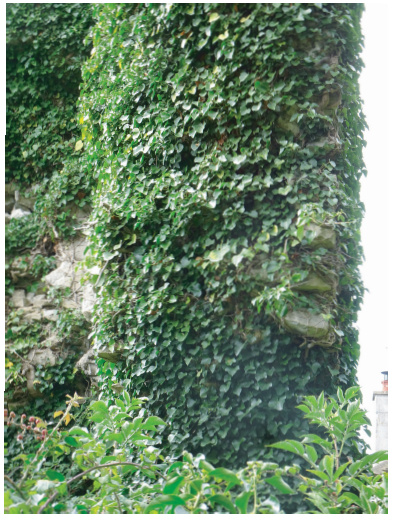
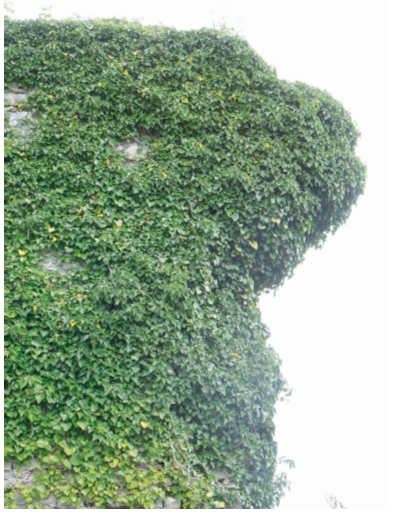
Photos of Malefant Castle, Llanmaes showing density of ivy growth covering monument prior to proposed remediation work in August 2023 *(Copyright Mann Williams)*.

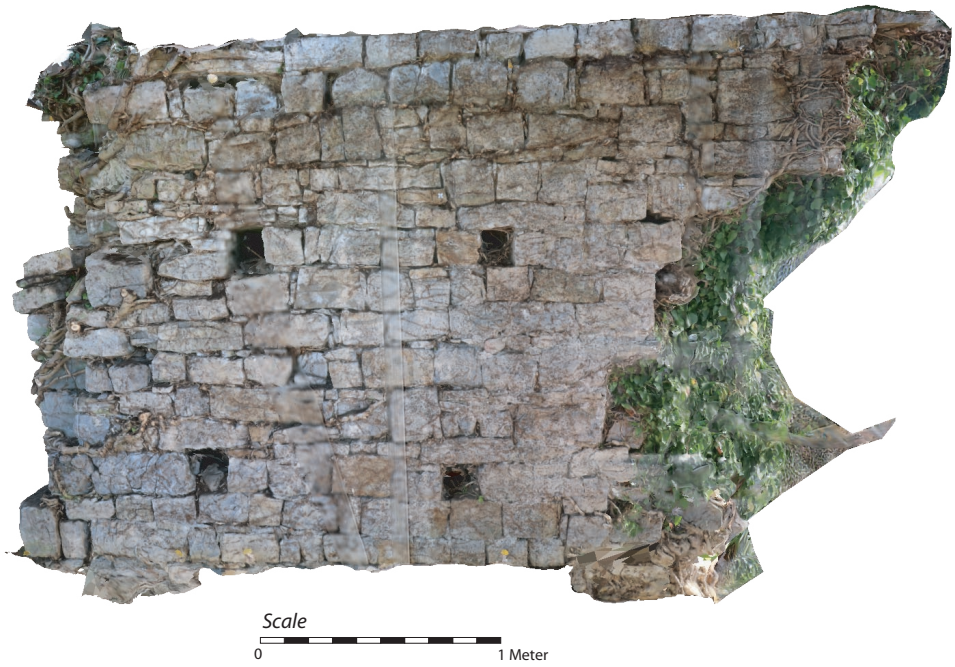
Plate 24. Malefant Castle - Screen shot of generated 3D model of second scaffold level from top of SW facing external elevation following ivy removal. Looking NE.

Plate 25. Malefant Castle - View of third level of scaffold from top of SW facing external elevation following ivy removal. Looking NE.

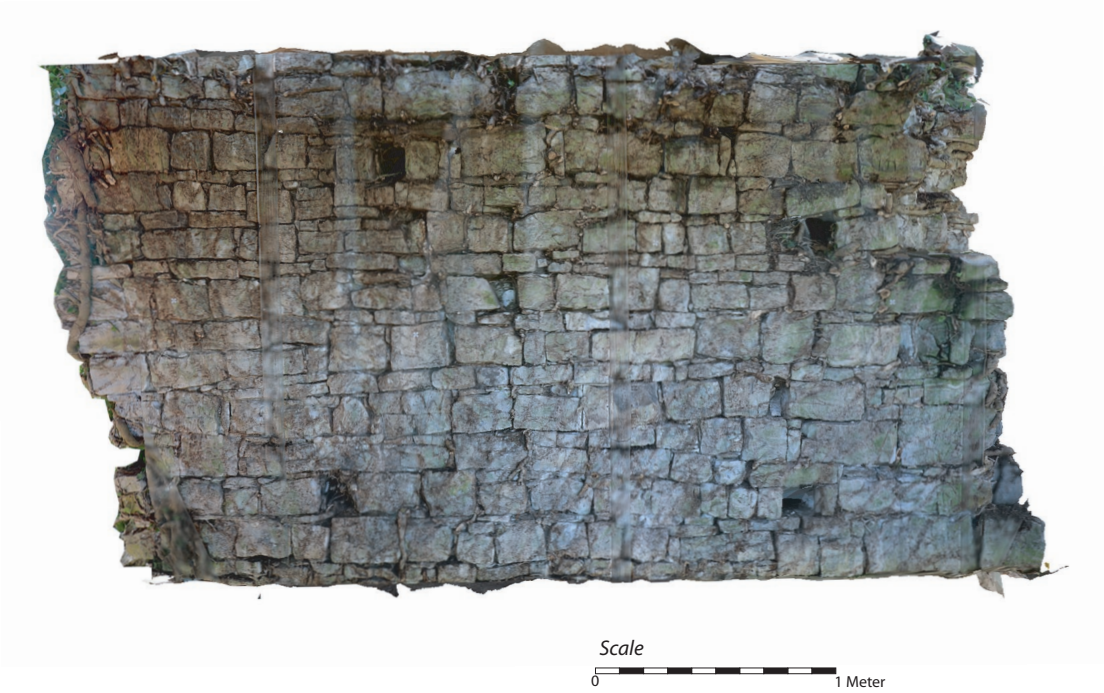
Plate 26. Malefant Castle - Screen shot of generated 3D model of second scaffold level from top of NW facing external elevation following ivy removal. Looking SE.

Plate 27. Malefant Castle - View of third level of scaffold from top of SW facing external elevation following ivy removal. Looking NE.
