BENARTH ROAD RETAINING WALL, CONWY

Archaeological Watching Brief

Prosiect Rhif / Project No. G2527

Adroddiad Rhif / Report No. 1402

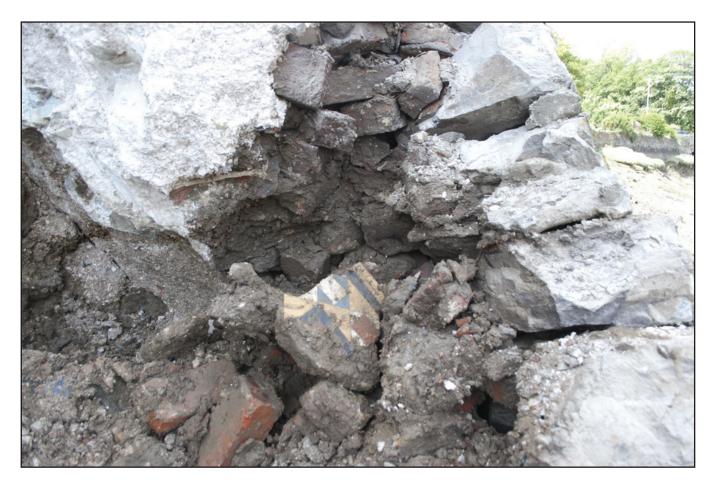
Plate 42: Late 19th century Minton style floor tiles fragment recycled within rubble backfill behind the retaining wall (no scale, archive image ref G2527_077).

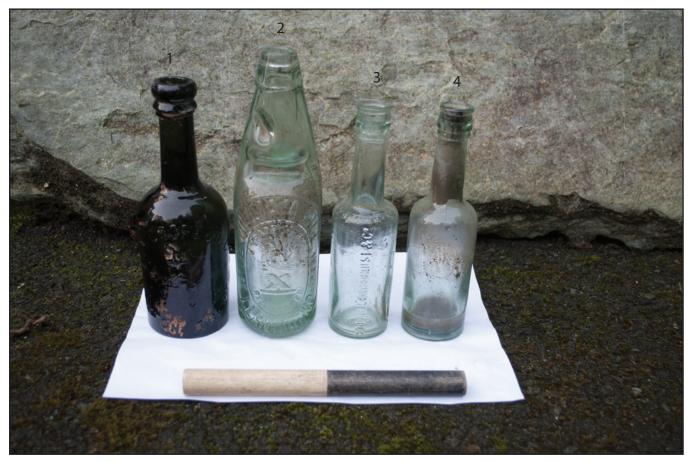
Plate 43: Nineteenth to early twentieth century bottles recovered from material behind the revetment wall (scale: 0.20m, archive image ref G2527_094).

1 = Green glass beer bottle, emobossed with "Ind Coope & Co Ltd Burton on Trent"

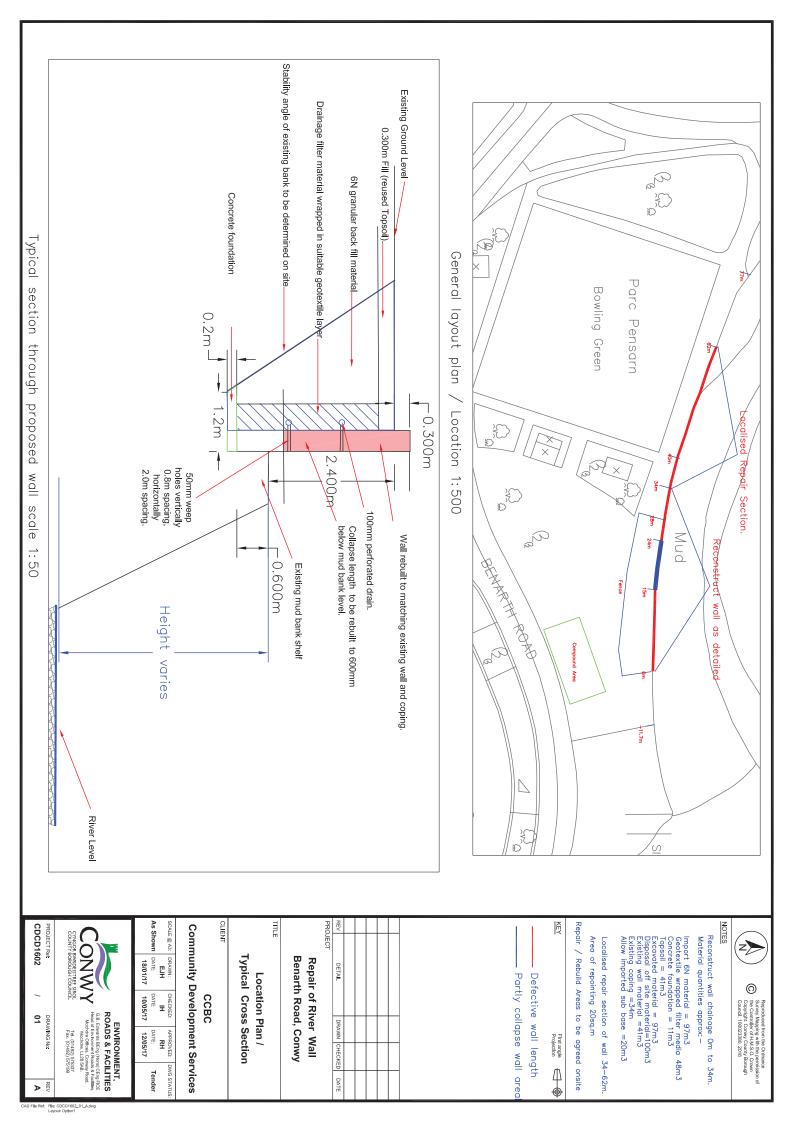
FIGURE 01

Reproduction of Conwy County Borough Council Drawing CDCD1602/01 REV A

The ground level was reduced in spits using a mechanical excavator fitted with a flat, toothless bucket and the excavations were monitored to the proposed 3.2m maximum dig depth required to carry out the repair works (Figure 01).

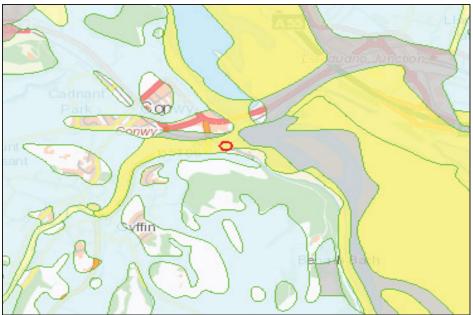
Figure 2 – Superficial Geology Map Extract (Tidal Flat Deposits shown as yellow)

2.4.1 The British Geological Survey map for the area shows that the drift deposits at the site comprise Tidal Flat Deposits of silt and clay (Figure 2). The bedrock below the site comprises mudstone of the Llandovery Formation.

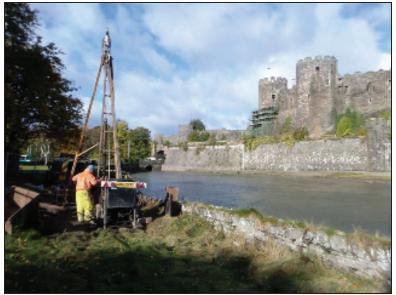
Plate 2 – Borehole Location

3.4.1 Borehole and trial pit locations are indicated on Plate 2 and Figure 3 below.
