## **Church House Farm, Llandeilo Graban, Powys**

### **Desktop Study, Archaeological Evaluation and Building Recording**

Report No. 1572

May 2017

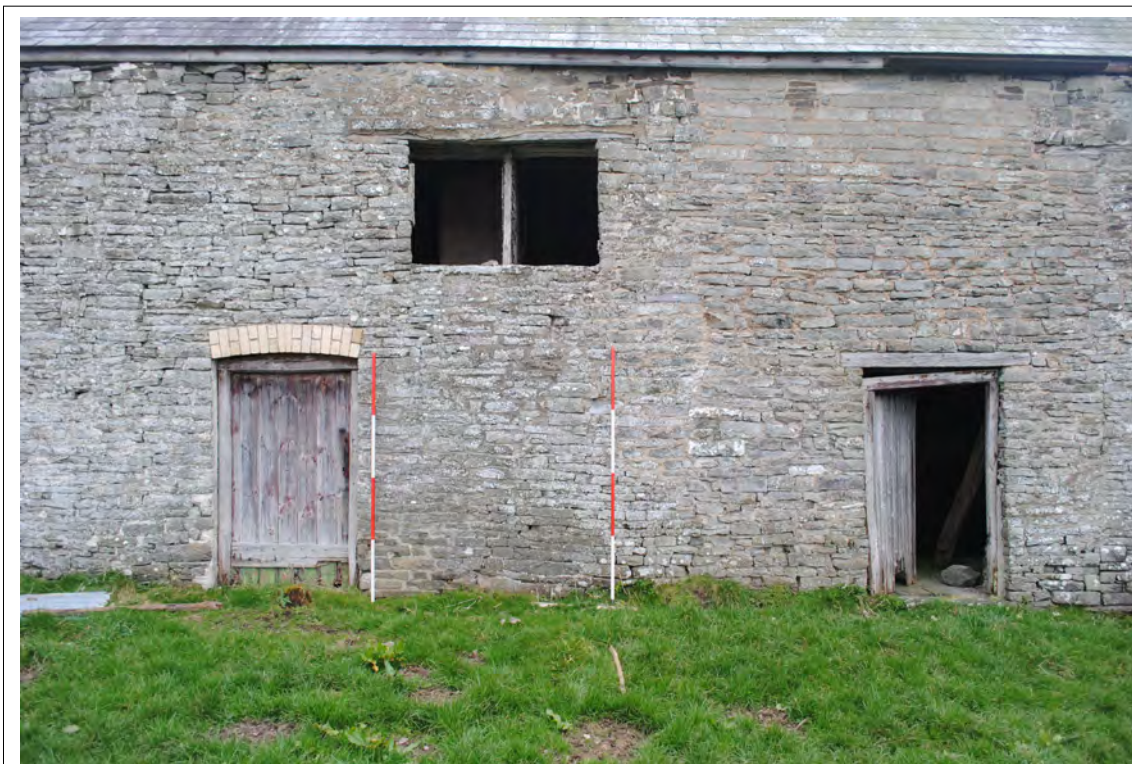
Plate 28. Front windows of the western part of the farmhouse, showing rebuilt stonework (southern elevation). Looking north.

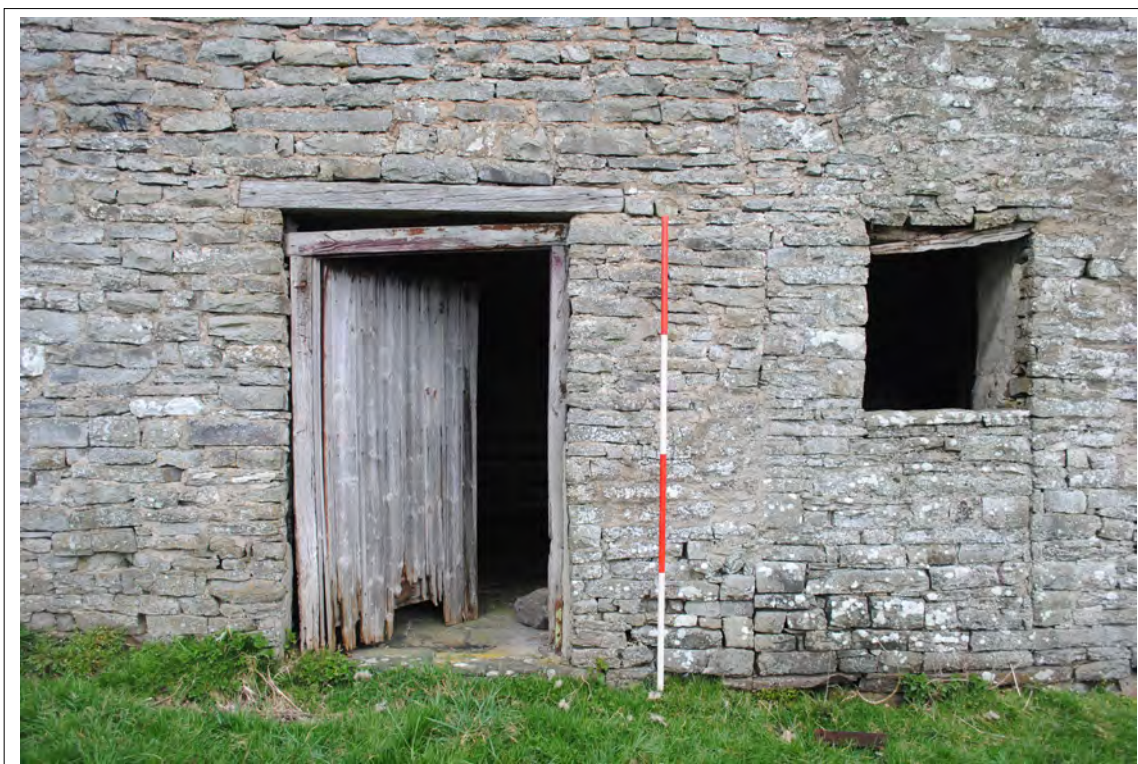
Plate 31. View of different phases of stonework on the southern elevation, between the two doorways, with rebuilt sections above the right (east) entrance and above both upper windows. Looking north.

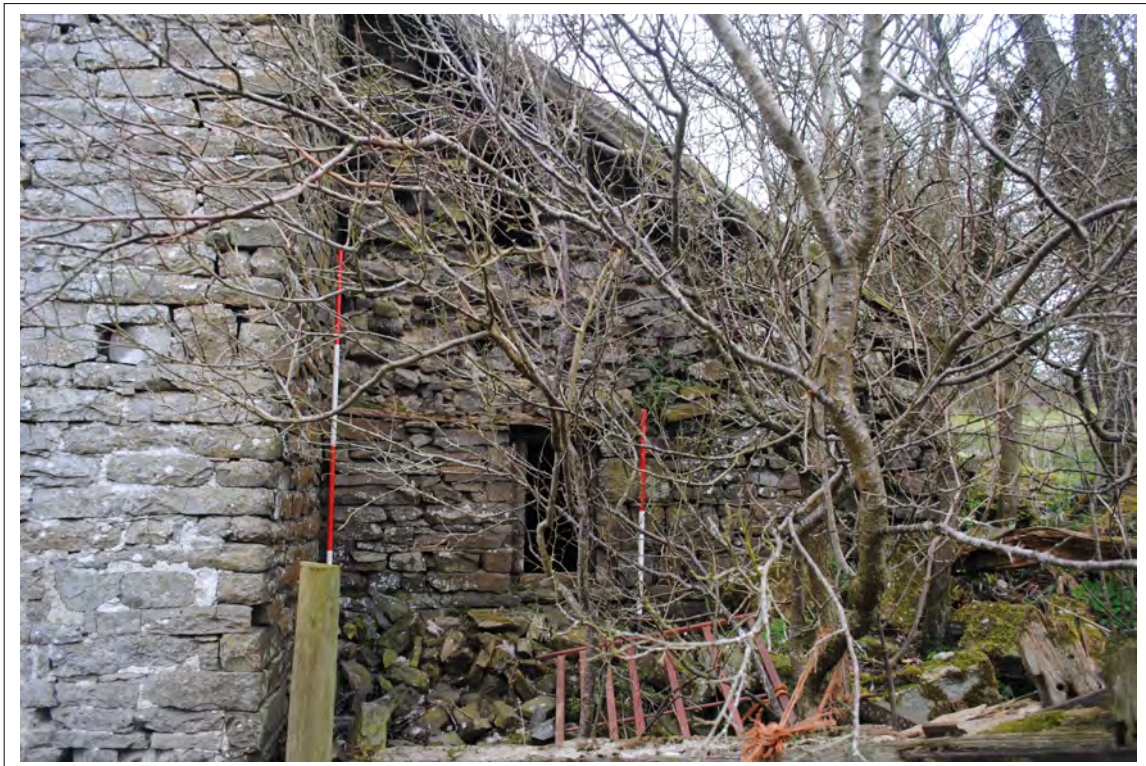
Plate 39. Oblique view of the partly collapsed eastern wall of a lean-to on the the northern elevation. Looking south-southwest.

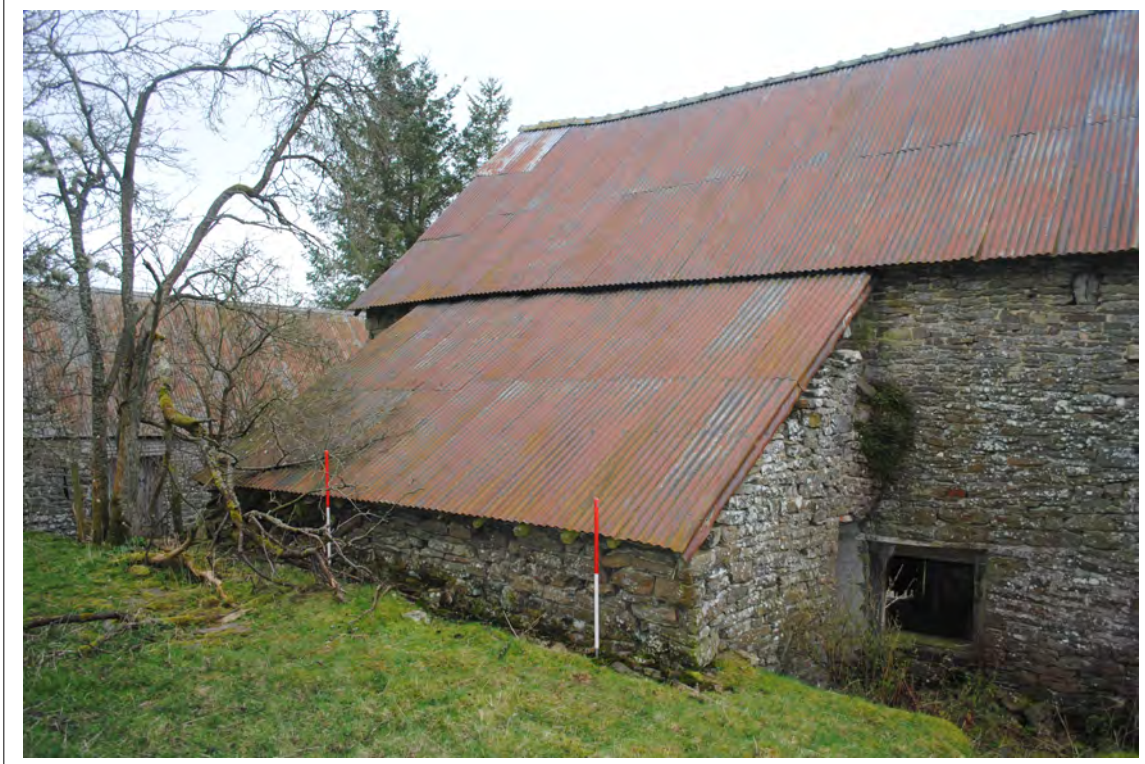
Plate 40. The lower ventilation slit and collapsed upper opening on the eastern side of the lean-to. Looking west.

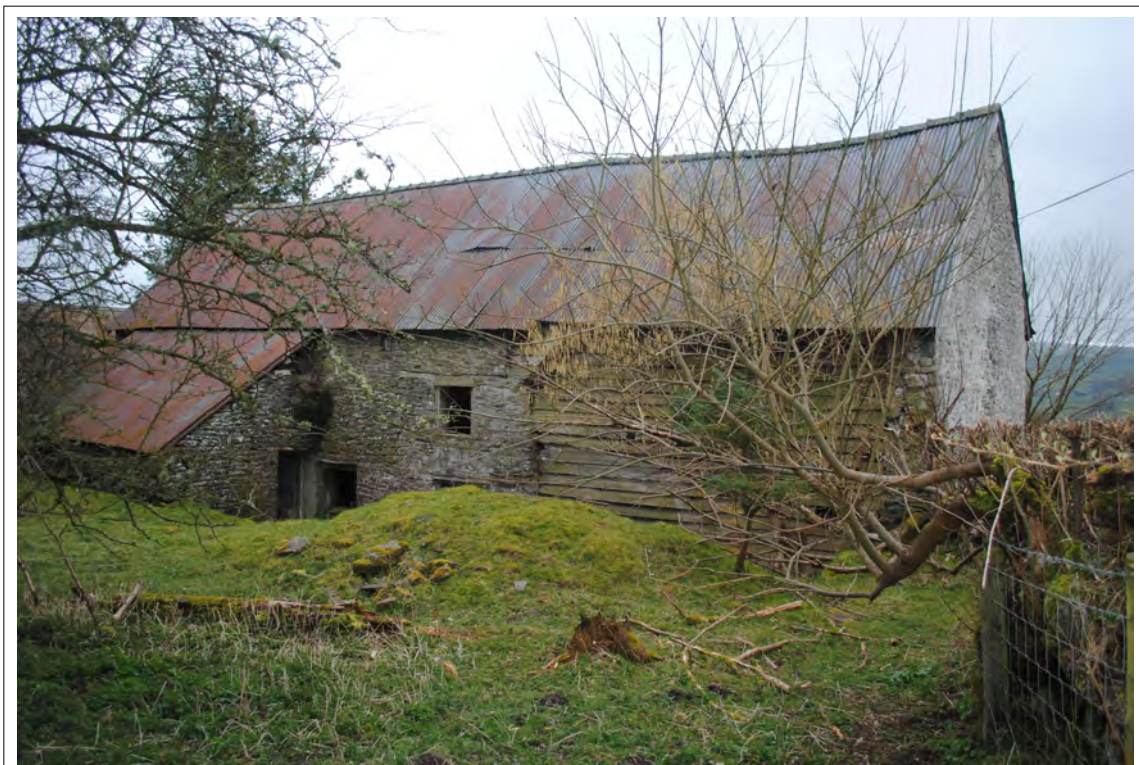
Plate 42. Detail of collapsed walling at the northeast corner of the lean-to (viewed along the northern elevation). Looking southeast.

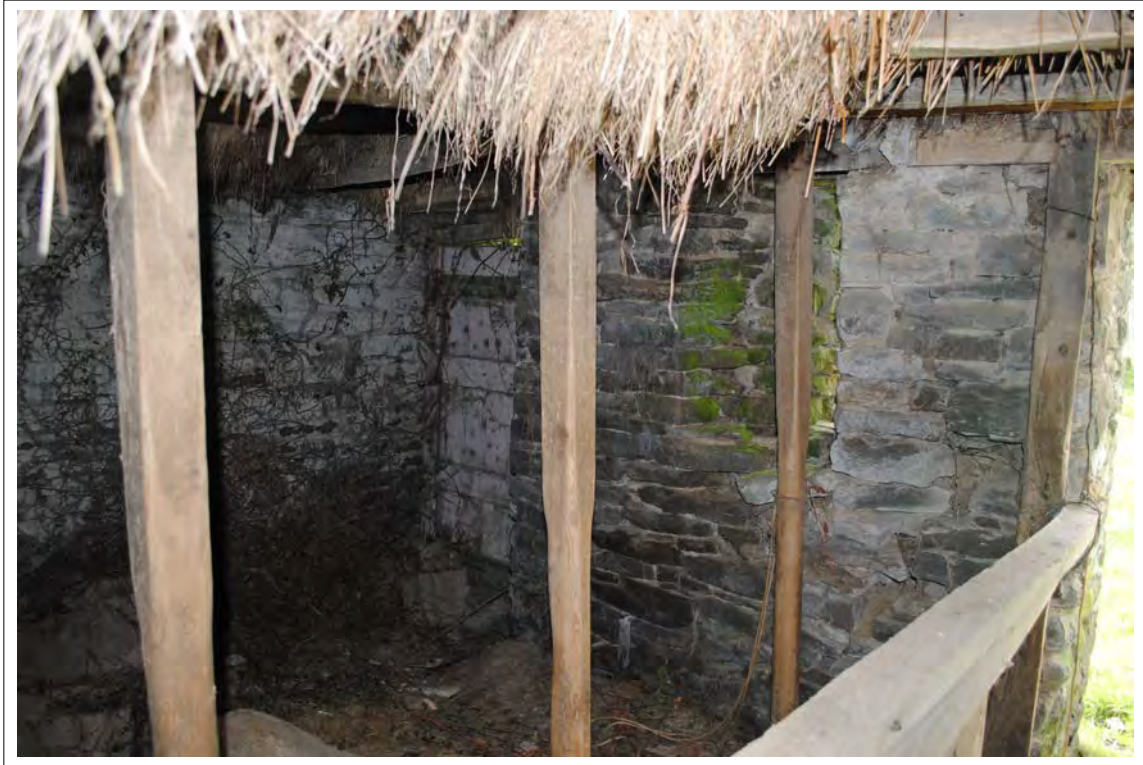
Plate 181. Oblique view of the doorway and ventilation slit along the western wall of Bays F and G. Looking southwest.

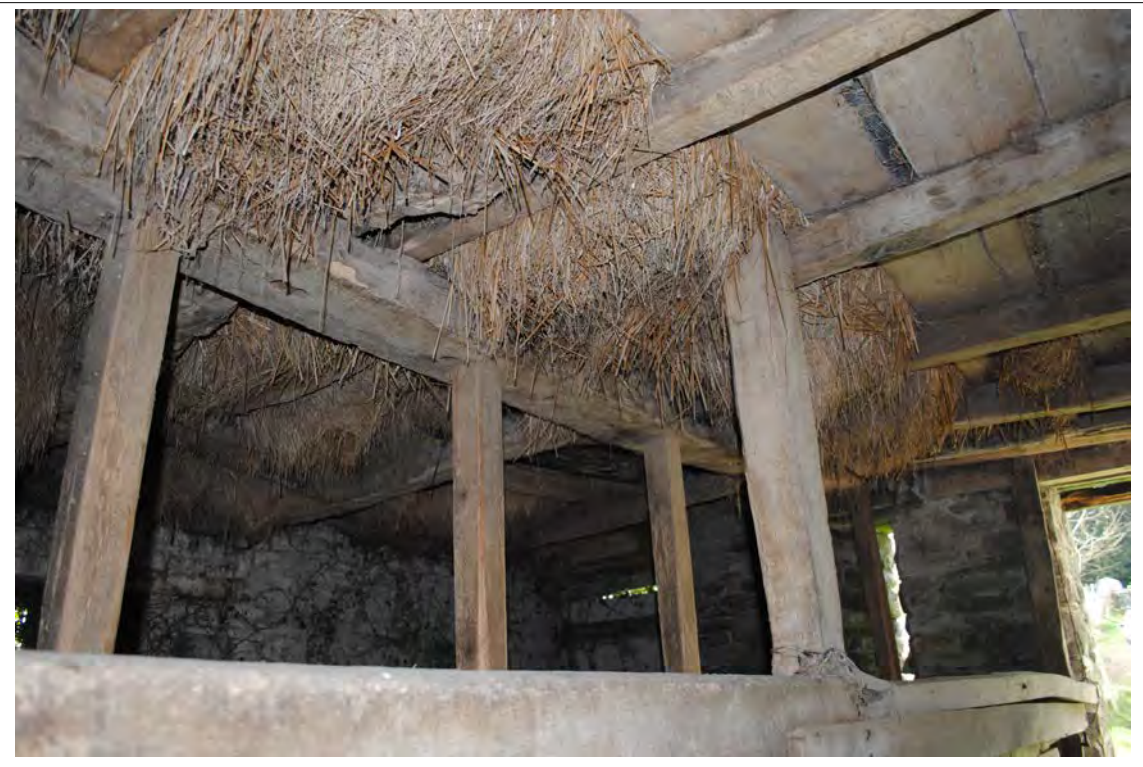
Plate 182. Detail of the timberwork for the hayloft above the probable cowhouse (Bays F & G).

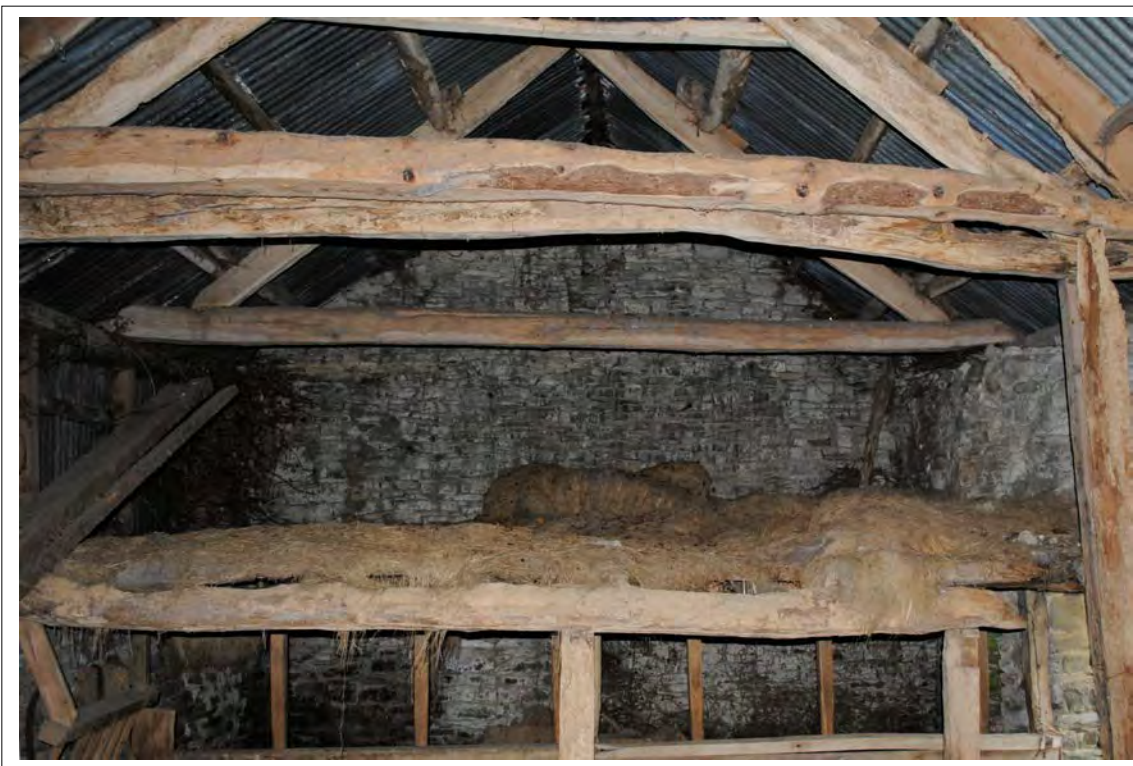
Plate 183. General view of the hayloft within Bays F and G. Looking south-southwest.

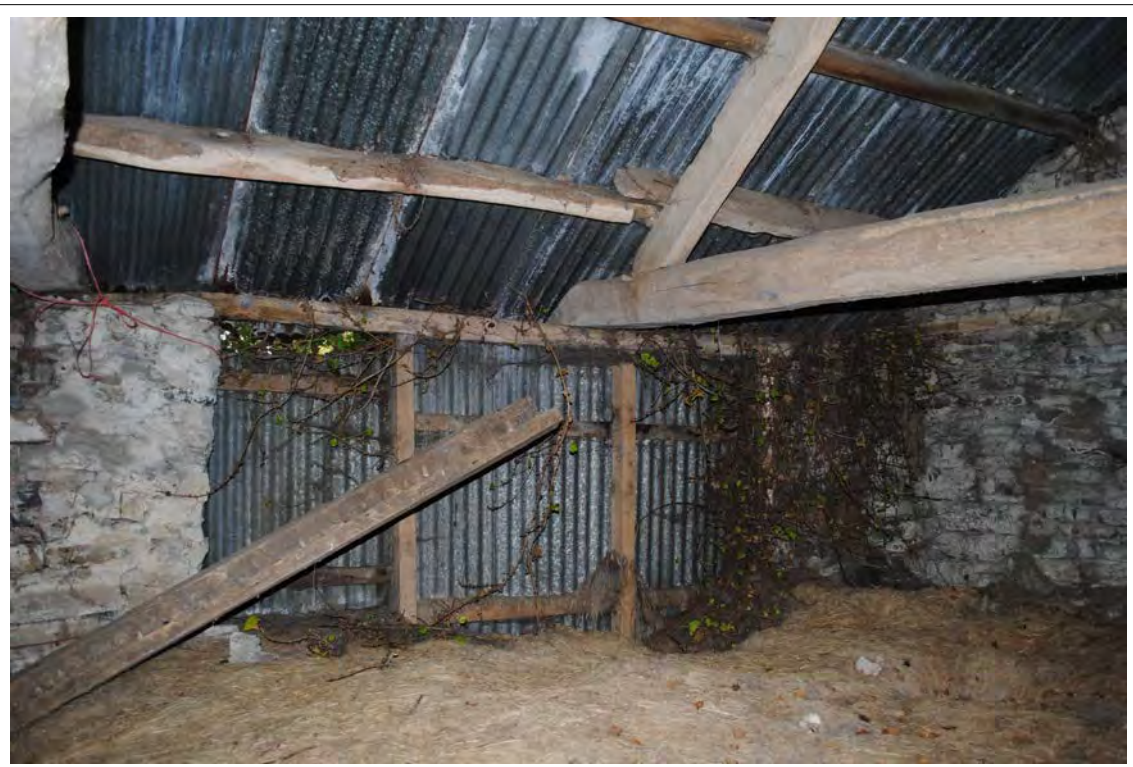
Plate 184. Oblique view of the eastern wall of the hayloft, showing modern timberwork (Bays F & G). Looking southeast.

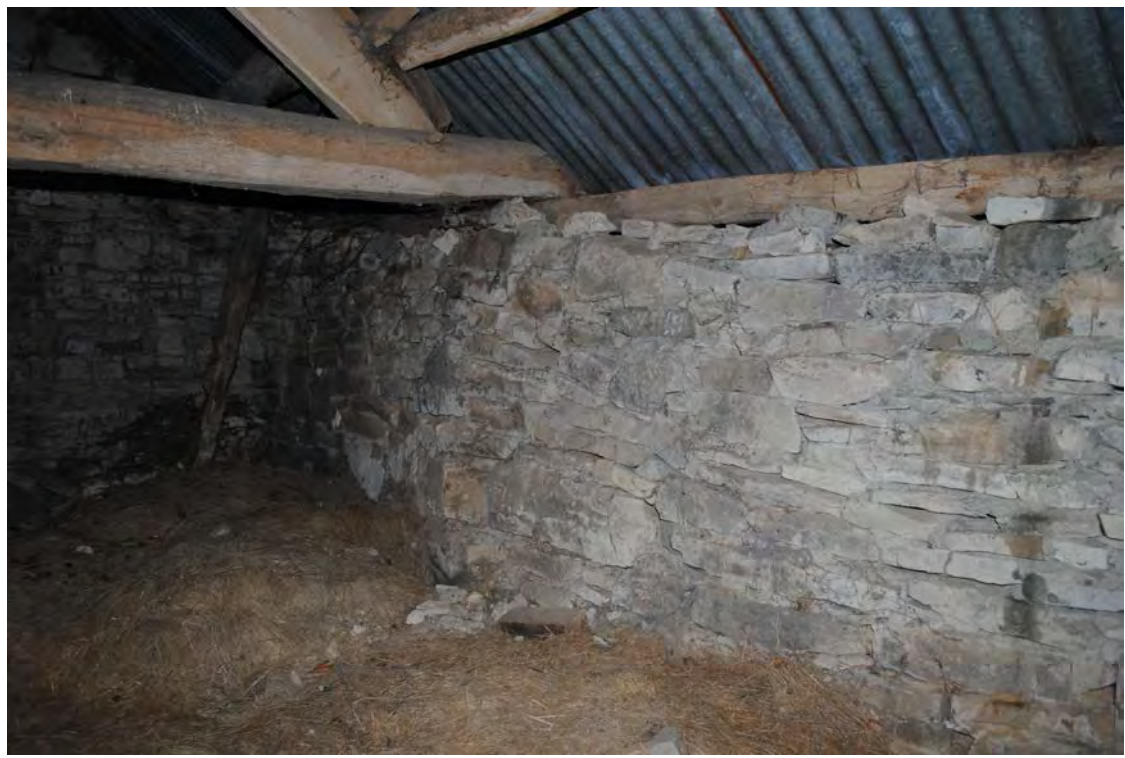
Plate 185. Oblique view of the western wall of the hayloft, showing bowing masonry (Bays F & G). Looking southwest.

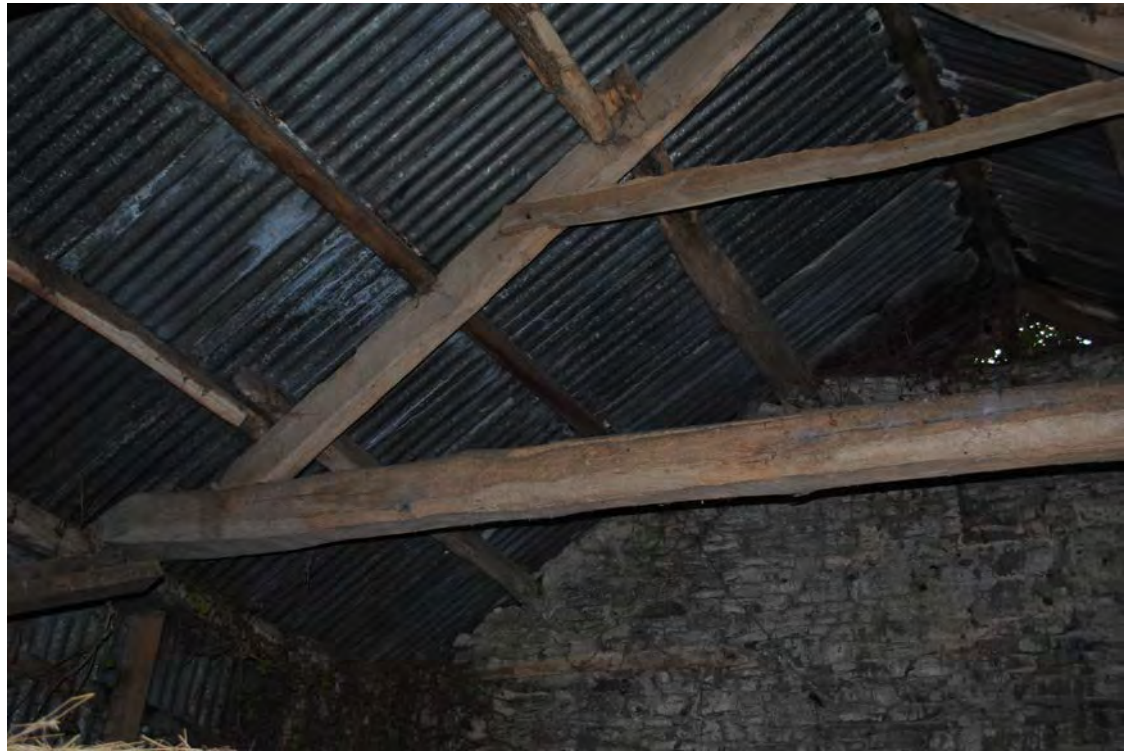
Plate 211. Eastern side of Truss F, with the tie-beam supported by modern timber-framing. Looking south.
