Cathays Library Refurbishment

Pre- Development Tree Inspection and Report

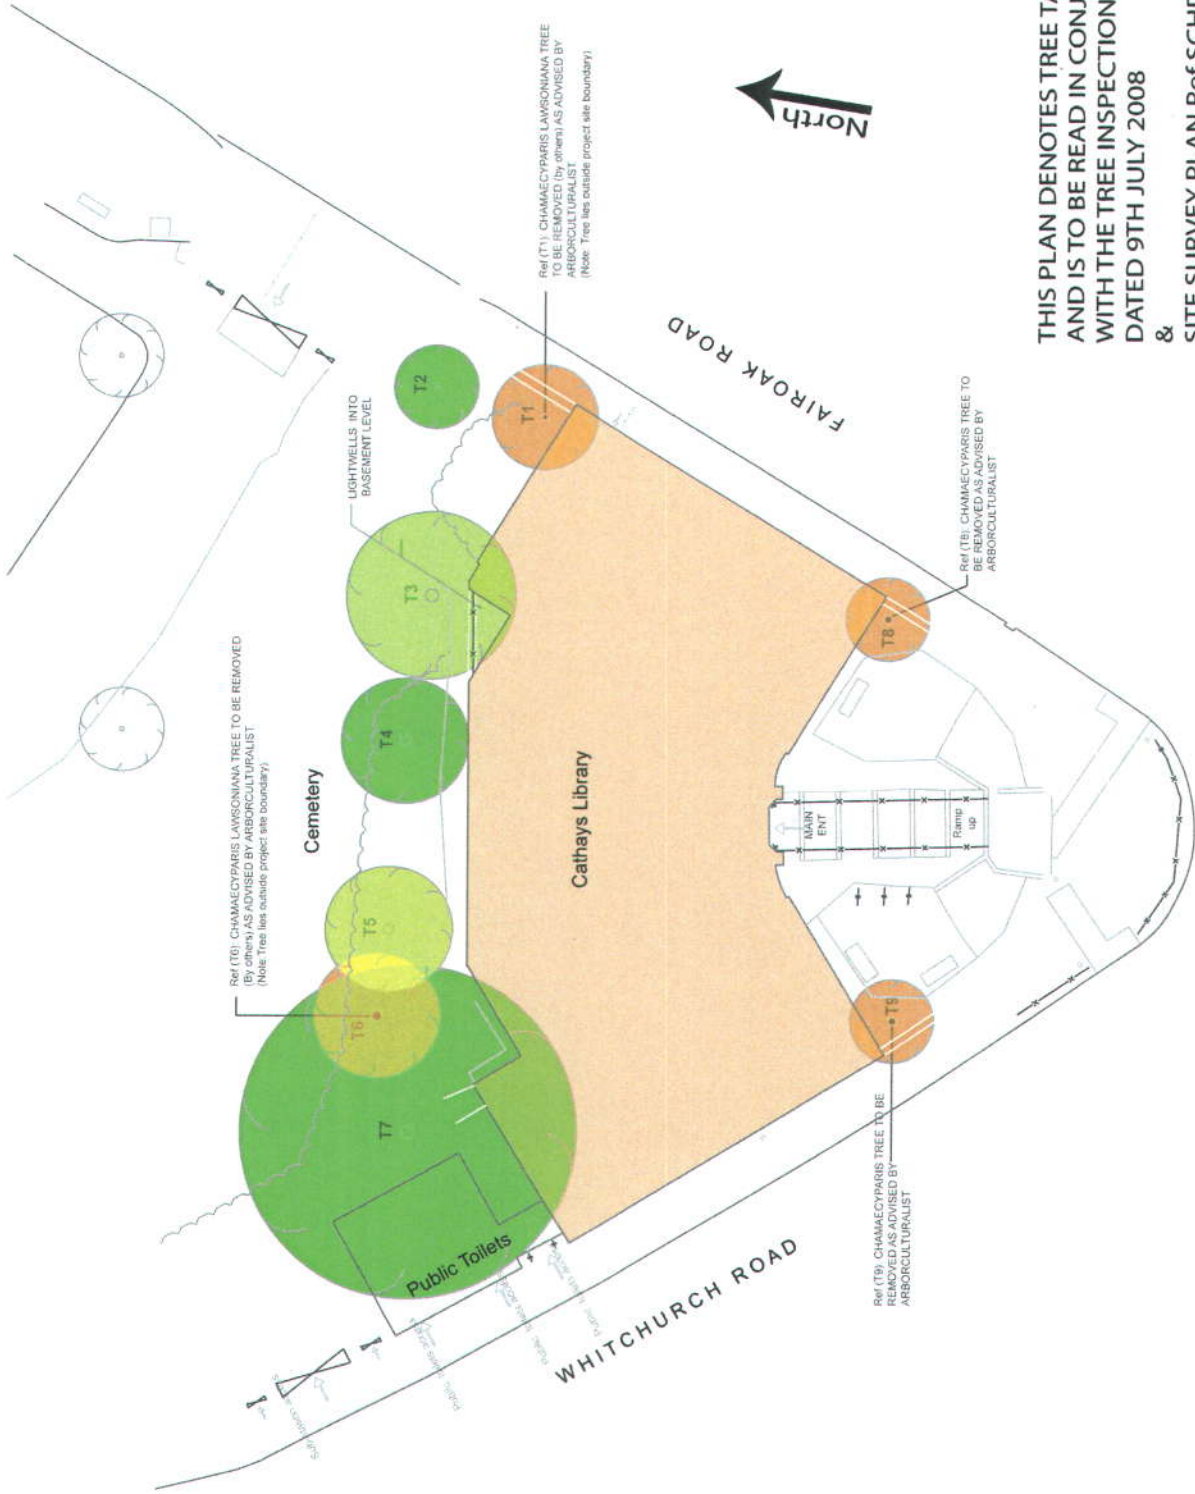
Tree No.	Species	Age	Hgt mtr	Ca t	DB H cms	Crow n Spread (M)	Life exp t	Condition	RPA (m2)	Protection Radius (m)
T1	Chamaecyparis lawsoniana (Lawsons Cypress)	M	12	B	31	Avg 2m	M	Single stemmed conifer, healthy condition, situated within the cemetery approx. 5 m from the corner of the building and adjacent to the road. Compact crown with moderate growth. Very stable tree with a moderate life span, unlikely to develop much bigger. Holds one main side limb which has slight impact on building.		
T2	Pyrus chanticleer (Ornamental pear)	s/m	10	B	19	2 N 2.5 S 1.5 W 3 E	L	Healthy young tree, full well developed crown, long life expectancy, growing in cemetery		
T3	Pinus nigra (Black Pine)	M	25	A	68	4 N 5 S 4 E 4 W	M	Very fine dominate tree, full healthy well balanced crown formed on single main stem. Reasonable life expectancy. Minor deadwood evident in upper crown. Crown overhangs building which will require pruning back. Growing in cemetery, 1.6m from rear of building. Important to retain

T4	Chamaecyparis lawsoniana	M	16	B	53	3 N 3 S 3 W 3 E	M	Fine healthy tree, single stem holding well balanced crown of good density, extensive ivy growth developing along main stem. Growing in cemetery, approx 3m from rear of building		
T5	Chamaecyparis lawsoniana	M	15	B	51	Avg 2m	M	Reasonable condition, dense crown of moderate growth, ivy developing in crown. Growing in cemetery, approx 4m from rear of building, lower branches overhang building

T6	Chamaecyparis lawsoniana	M	14	C	47	2 N 3 S 1 W 2E	S	Moderate to poor condition, extensive ivy growth as subdued crown with only lower live growth remaining, very limited life. Situated in cemetery
T7	Tilia platyphyllos (Lime)	s/m	12	B	58	6 N 6 S 5 W 5 E	L	Very fine multistemmed tree with full dense crown arising from three main limbs from base. Very healthy young tree with long useful life expectancy. Situated within cemetery to rear of toilets, upper branches impacting on building. Some crown lifting, pruning back required. A tree of good quality and high amenity value.
T8	Chamaecyparis species	M	10	BB	19	1- 1.5m	S	Small compact crown arising from 3 main stems at ground level, situated in corner of building to front of library. Slow healthy growth. Other limbs have previously been removed from base. A tree of limited life with some aesthetic value. Could be removed and replaced if required

T9	Chamaecyparis species	M	10	BB	22	Avg 2m	S	Similar tree to the above, situated to corner of building to front of library. Again could be removed if required and replaced. Both of these trees have limited value providing some landscape impact with the area. The trees within the cemetery, apart from T6, form a very important row of trees, visually providing a backdrop to the building from the cemetery. They have a medium to long life expectancy and all should be retained with minimal pruning required to prune back from the building. All require adequate protection during period of renovations.

- 3.2 As advised by the Arborculturalist Officer and recommended in the property condition report, the adjacent trees are to be pruned back away from the building lines, climbing ivy is to be removed and fallen foliage and leaves adjacent to the building are to be taken up.
