STANAGE PARK, KNIGHTON, POWYS
 OUTLINE BRIEF AND SPECIFICATION FOR REINSTATEMENT OF ORNAMENTAL LAKE

STANAGE PARK, KNIGHTON, POWYS
OUTLINE BRIEF AND SPECIFICATION FOR WORK IN
RELATION TO THE SILTED UP LAKE TO BE EXECUTED AS PART OF A
GLASTIR AGREEMENT

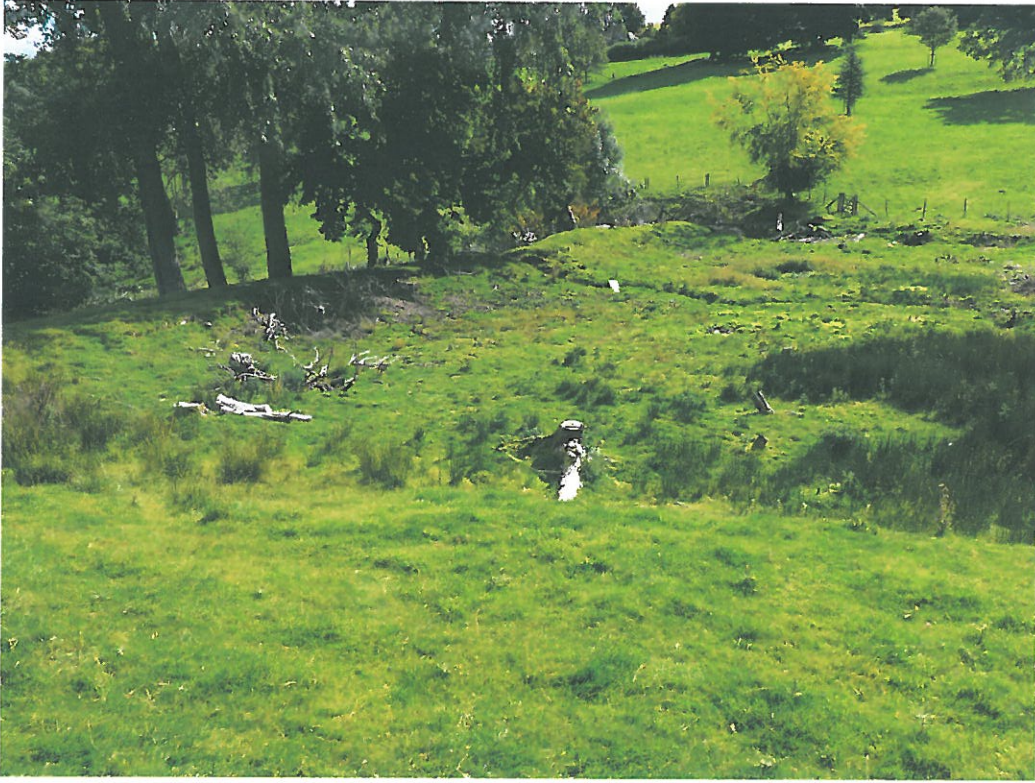
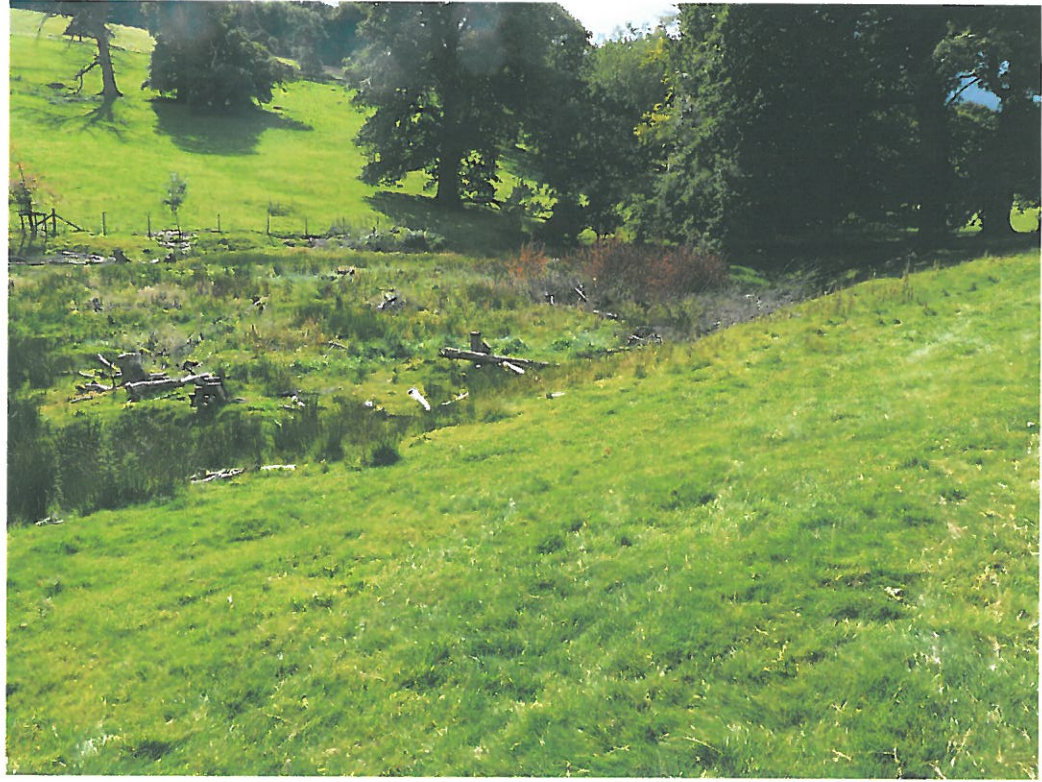
4530 Stanage Park – Lake

- 3.3 The concrete block overflow structure is in poor condition. The blocks at the base of the outlet channel are disintegrating but the upper blockwork is relatively sound. The two 225mm diameter concrete pipes are inadequate to accommodate sudden downpours. Water has eroded under the blockwork at the east end of the overflow structure. Larger volumes of uncontrolled overflowing water at this point have deeply eroded the bank and the south end of the dam

- 4.1 Engage a Conservation architect and engineer with experience of working on earth dams and ornamental historic lakes to design, specify, tender and oversee the repairs and act as CDM co-ordinator
