# NEUADD, LLANON, CEREDIGION, BUILDING RECORDING & COMMUNITY ARCHAEOLOGICAL EXCAVATION 2013

## VOLUME I

RHIF YR ADRODDIAD / REPORT NO. 2013/57  
RHIF Y PROSIECT / EVENT RECORD NO. 105803

Medi 2013  
September 2013

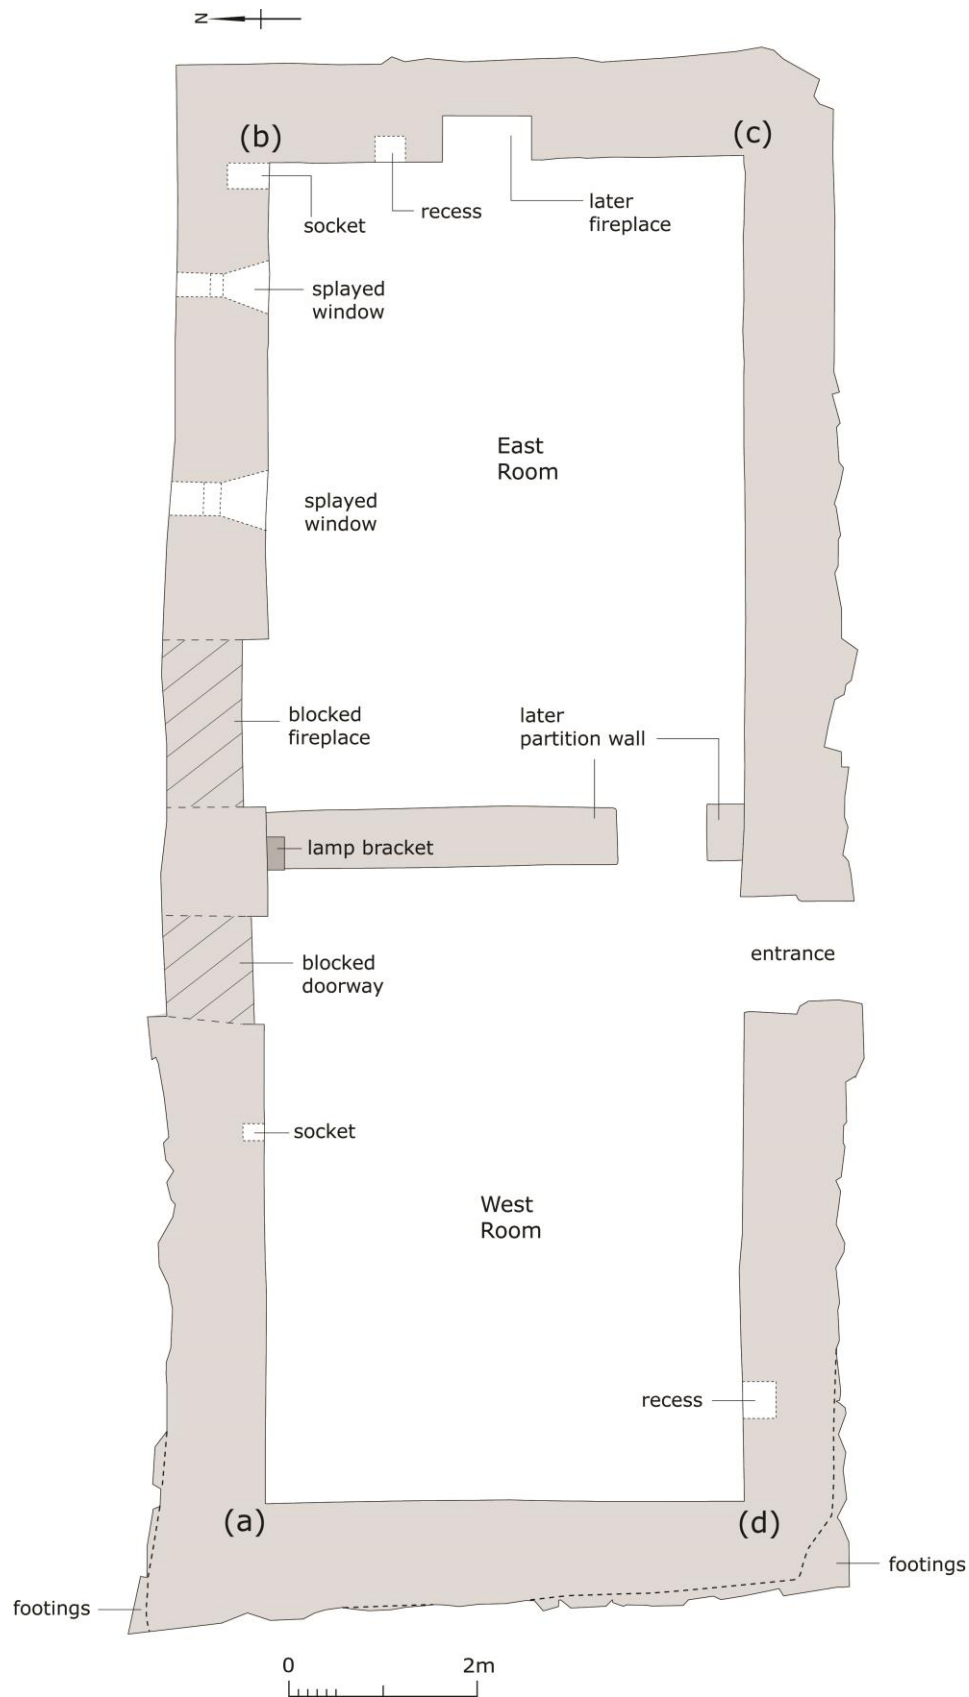
**Figure 6:** Plan drawn in 2013 of the Neuadd ruin labelled with identifiable architectural features. The lower case letters refer to the drawn elevations.

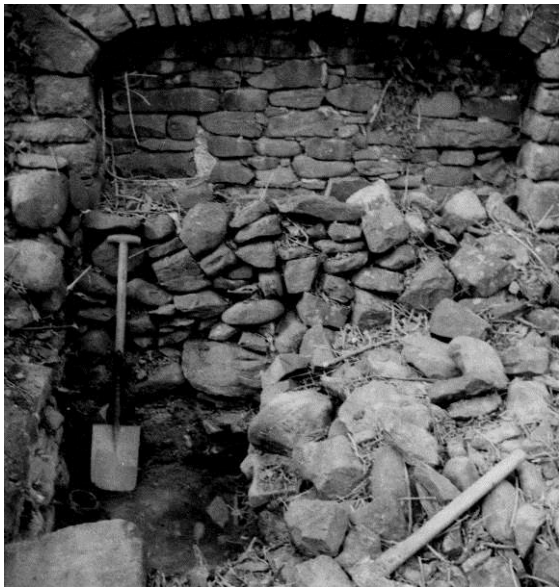
- 5.3 In Photo 8 the photographer was facing the fireplace. Within the area of the blocked up fireplace the excavated trench reveals large stones firmly stacked up against the blocking stonework, not the disordered rubble one would expect from a general accumulation over the years.

**Photo 8:** (left) A trench excavated in the 1970s in the east room in the area of the blocked fireplace. Note the stones firmly stacked up against the blocking stonework. Facing north. **Photo 9:** (right) The same 1970s trench viewed from above looking west. Note the small iron saucepan found on the stone flag floor.

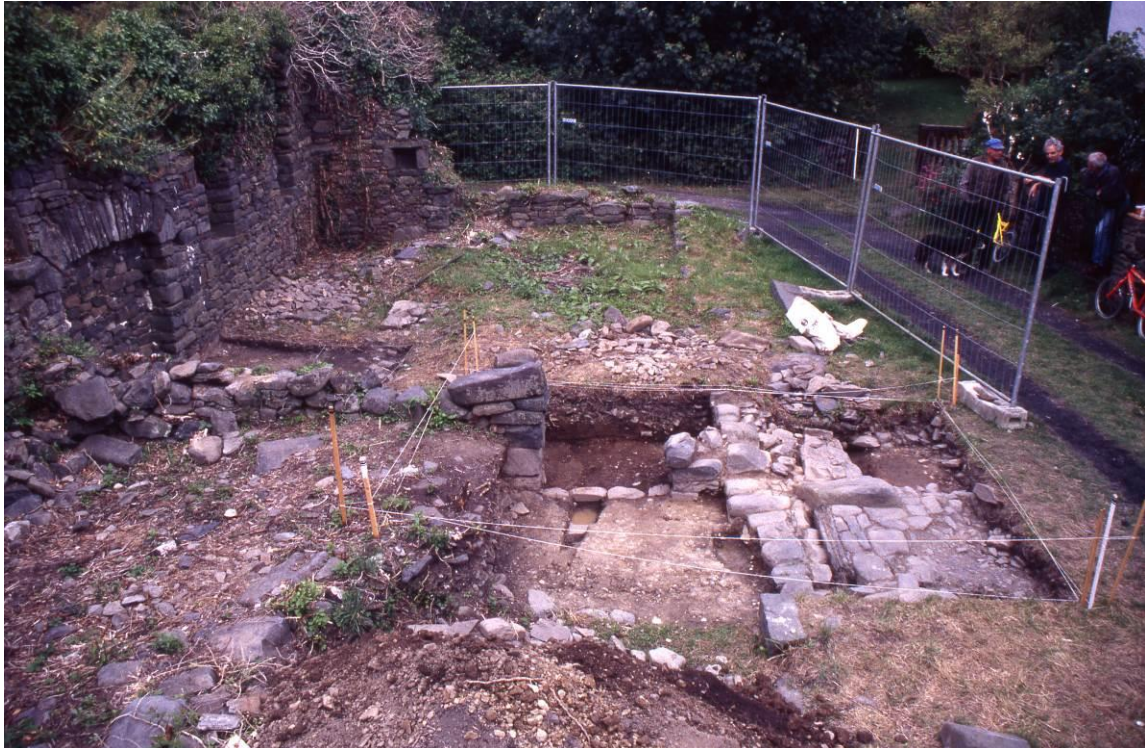
- 5.5 In July 2000 two small trenches were excavated (Figure 7 & Photo 10) on behalf of Ceredigion Museum under the direction of Elena Isayev with the help of local volunteers. The excavation revealed the substantial amount of rubbish that had accumulated over the site since it was last used. Nevertheless it was felt that some archaeological stratigraphy survived. After the removal of modern 19<sup>th</sup> and 20<sup>th</sup> century overburden, a rubble

layer containing stones, pieces of mortar, brick, and chunks of clay was excavated. This lay above a more solid clay layer that was interpreted as the original floor and ground level of the site into which the foundations of the walls were dug.

**Photo 10:** Photograph of the trench excavated in 2000 within the area of Neuadd south doorway. Looking east. (Amgueddfa Ceredigion Museum).

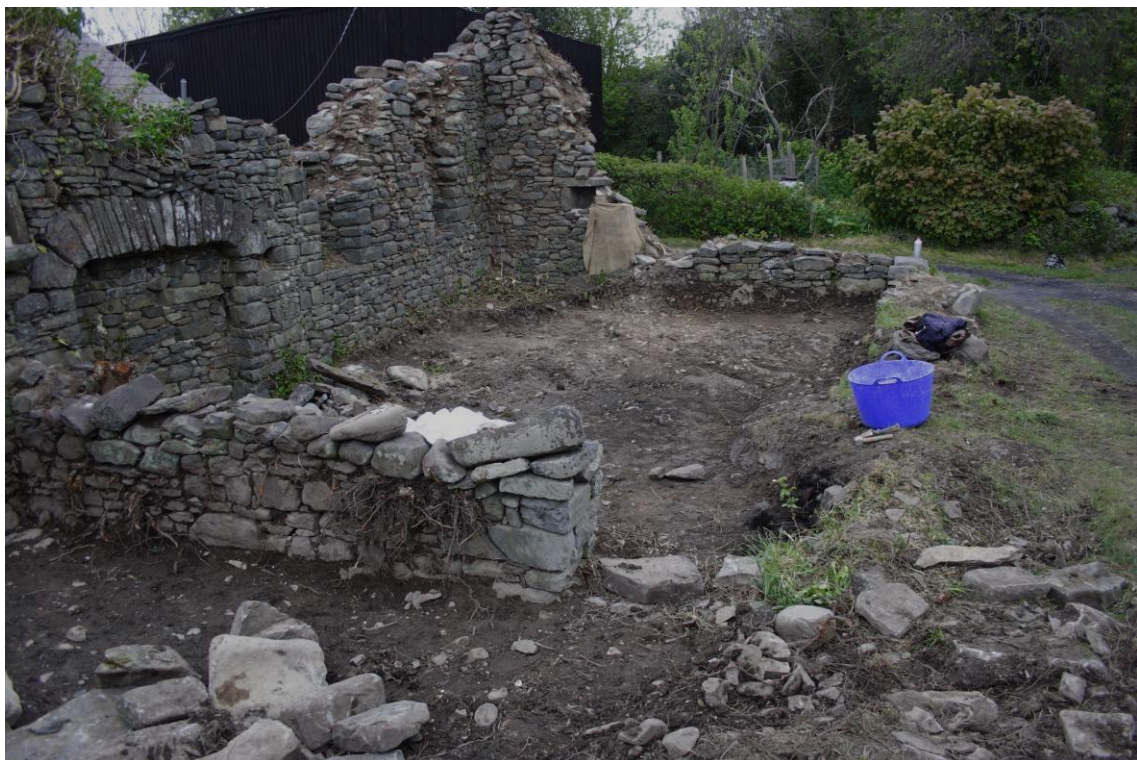
**Photo 16:** *Neuadd interior after the majority of the accumulated overburden had been removed by machine.*

- 7.1.8 Once the machining was completed, the conservation building team continued to rebuild and repoint the walls. The tops of walls were made safe in order that the archaeological excavation could start in early July.

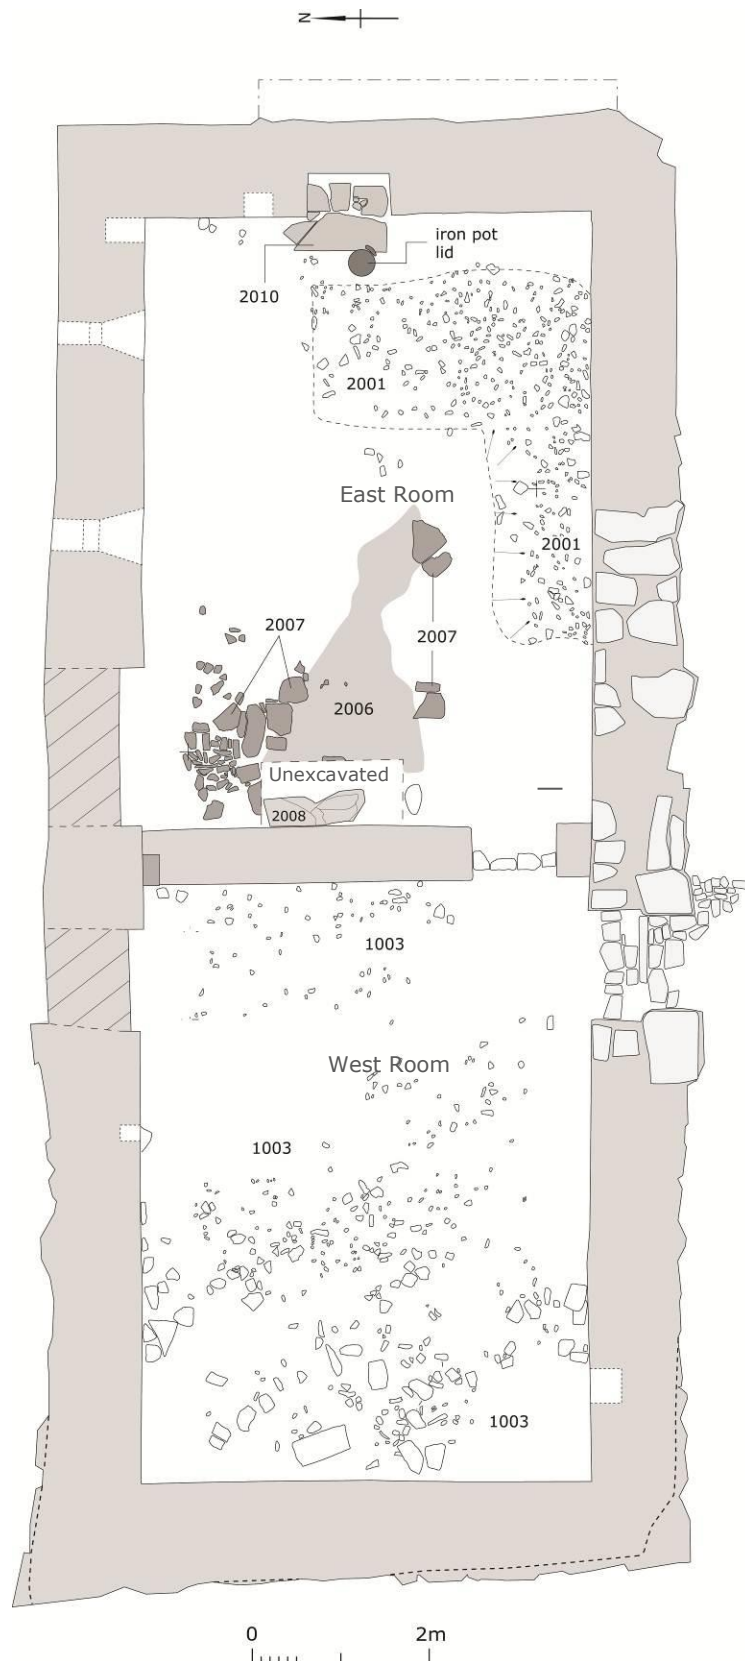
**Figure 8:** Plan of the 2 rooms of Neuadd showing the floor surfaces and associated archaeological contexts revealed after the removal of rubble layers.

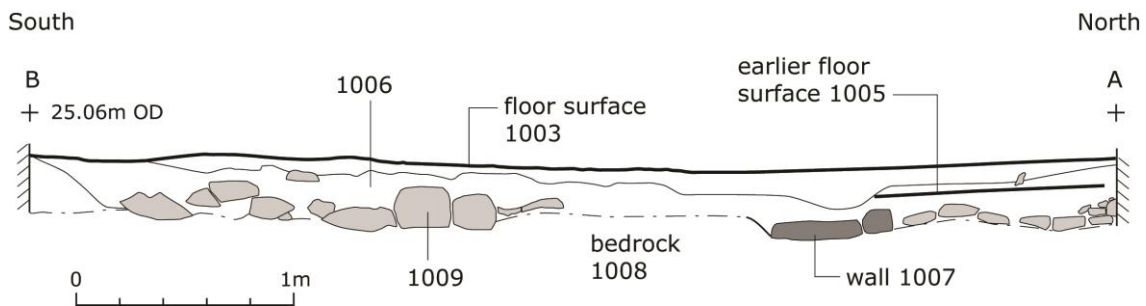
7.3.8 Figure 10 shows the east facing section (A-B) of the north-south trench. Below floor surface [1003] a small fragment of an earlier compressed clay floor surface [1005] could be seen in section at the north end of the trench, although it was not visible when excavating the trench. One piece of pre 19<sup>th</sup> century pottery (Dyfed gravel tempered ware) came from just above this floor layer. Below [1005] and running below [1003] was a very clean and compacted grey/brown silty clay layer. It was very similar to the natural boulder clay [1008] but between it and [1008] were a number of large and medium sized flat stones [1009]. At first it was thought that these stones were a natural deposit but on investigating them further and cutting the edge of the section back a little more at the northern end of the section, the base of a wall [1007] was discovered running in an approximate east-west direction (Photo 20).

**Figure 10:** East facing section of the north-south trench excavated in the Neuadd west room, showing the layers below floor surface [1003].

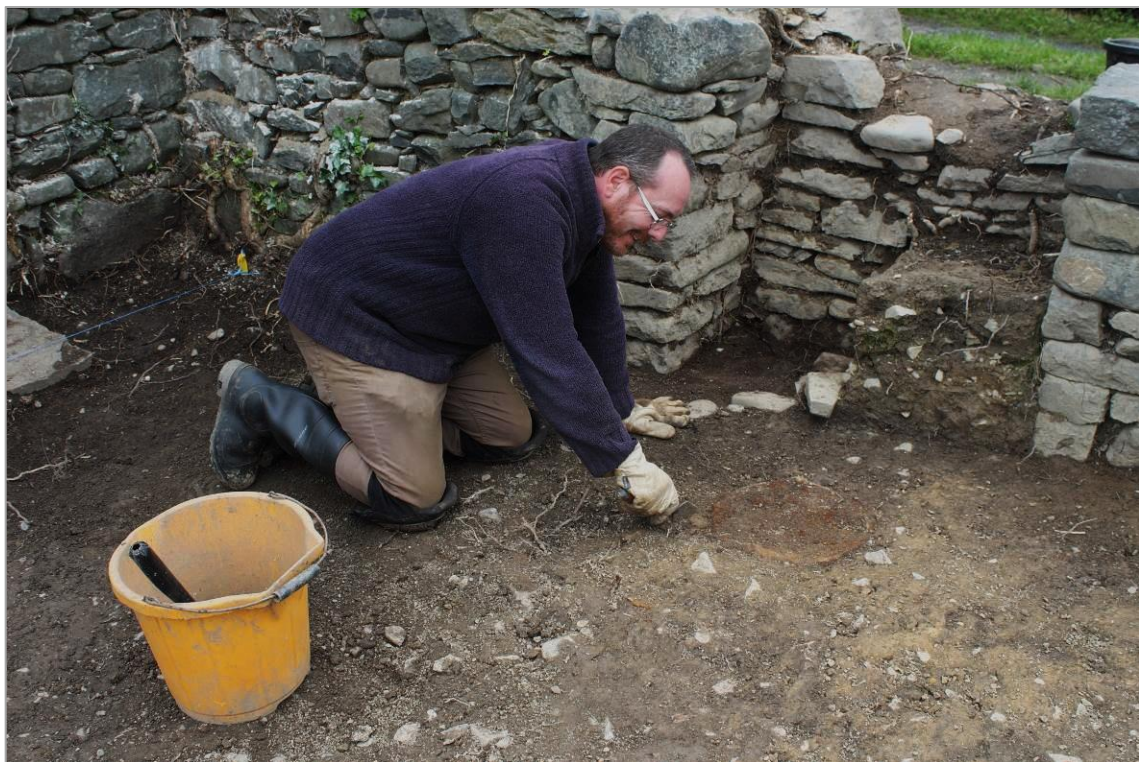
**Photo 22:** *The large iron pot lid being uncovered in front of the east wall fireplace. The pot lid lay within clay layer [2001].*

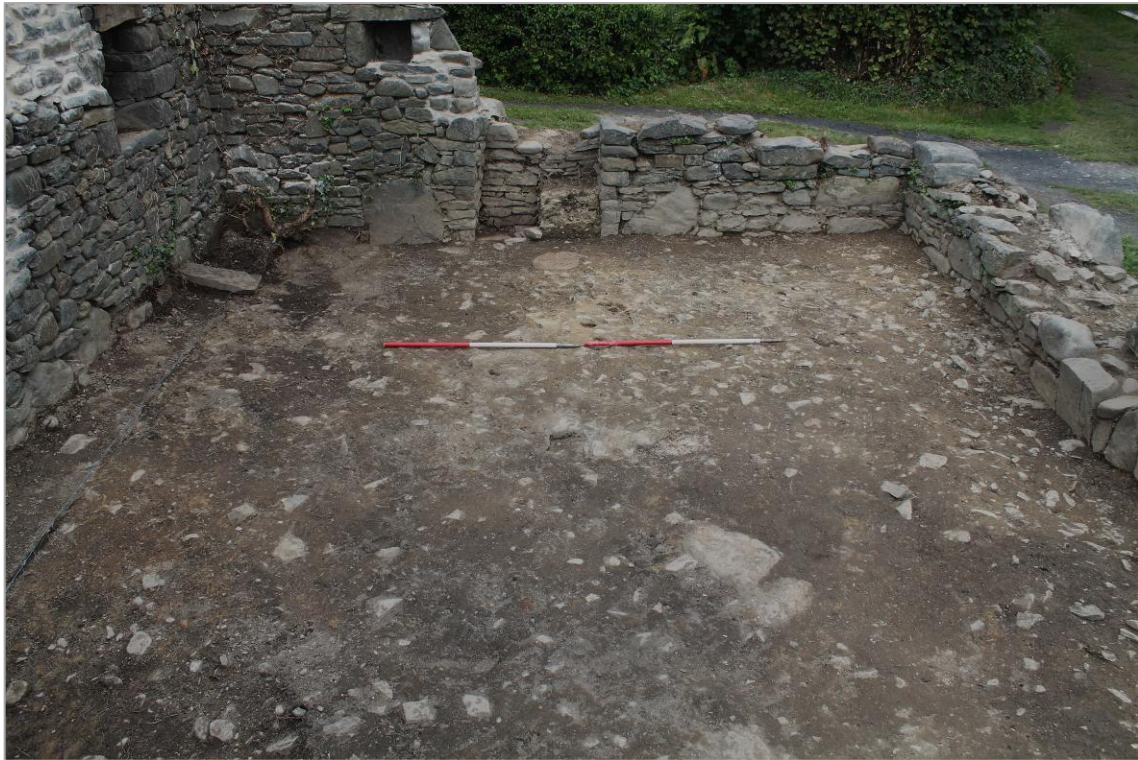
- 7.4.4 The edges of the spread of clay layer [2001] (Figure 8 & Photo 23) were very distinct and possibly represent an internal barrier or division that once existed in the east room.

**Photo 23:** Looking east at the Neuadd east room after all overburden [2000] had been removed and the area trowelled.
