# Vivian Engine House, Hafod-Morfa Copperworks

## Archaeological Watching Brief & Building Record

**City and County of Swansea**

**- BLACK MOUNTAINS ARCHAEOLOGY -  
- ARCHAEOLEG MYNYDD DU -**

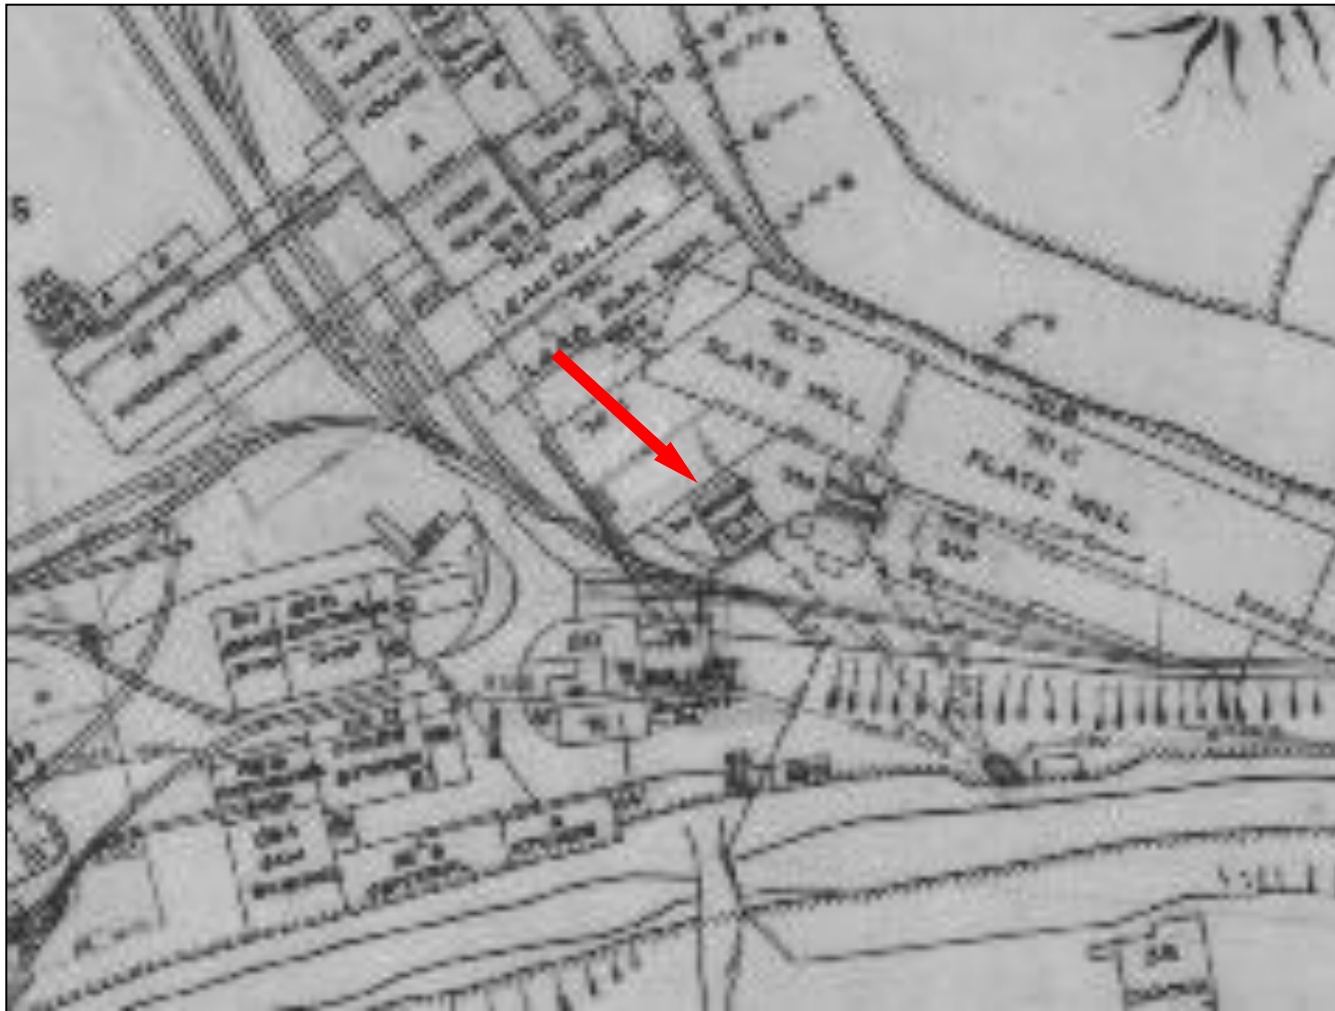
Figure 4. Detail from an ICI plan of unclear date (labelled as 1951). The outlet pipe from the former canal basin is feeding a network of pipes through the Hafod Copperworks, including the basement culvert uncovered in the watching brief. © Swansea Museum Collections

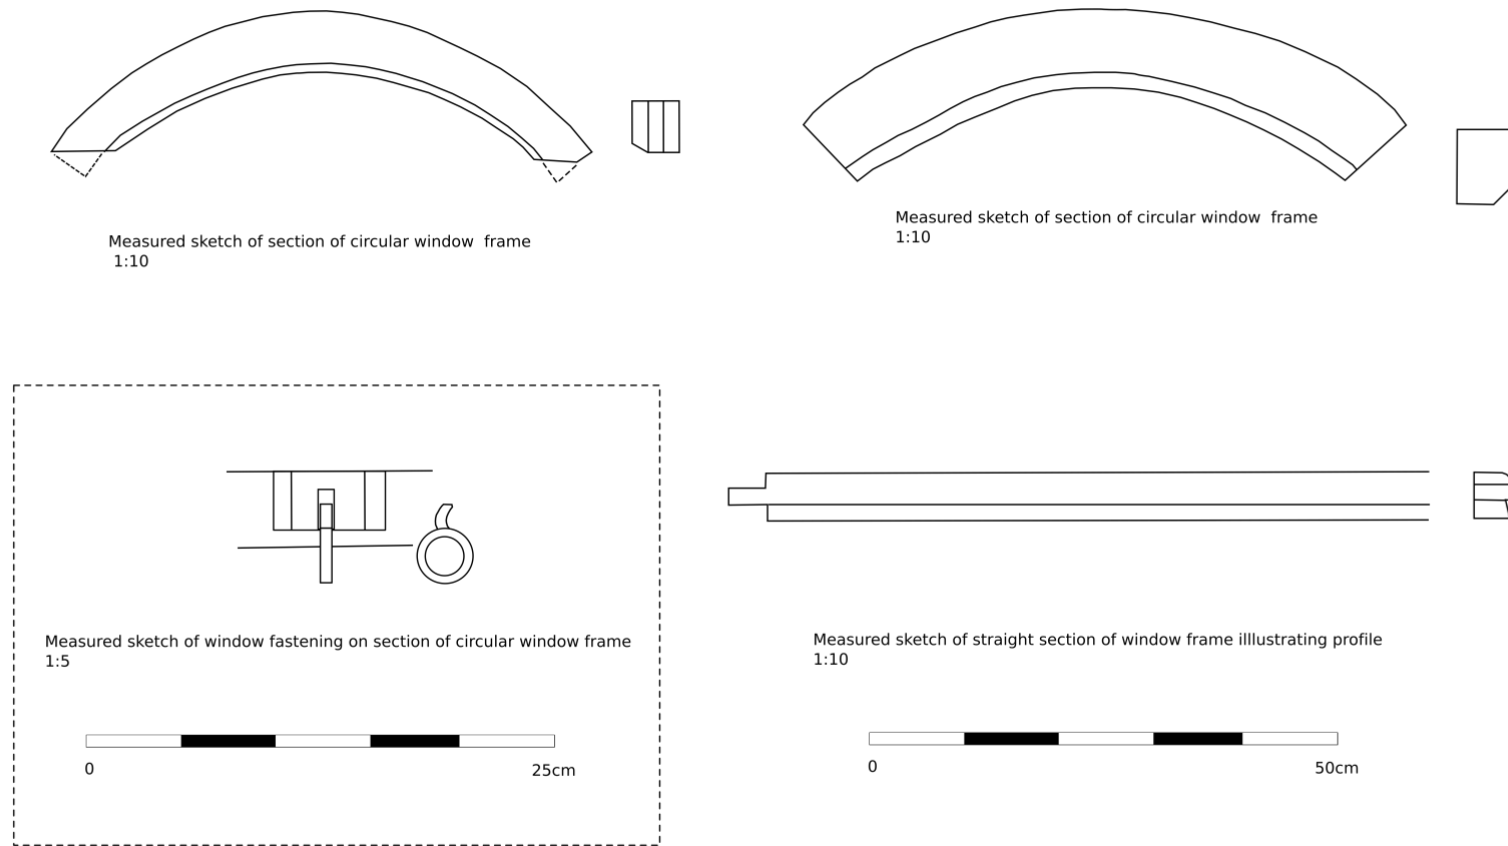
Figure 11. Measured sketches of sections of window frame recovered from the Vivian Engine House

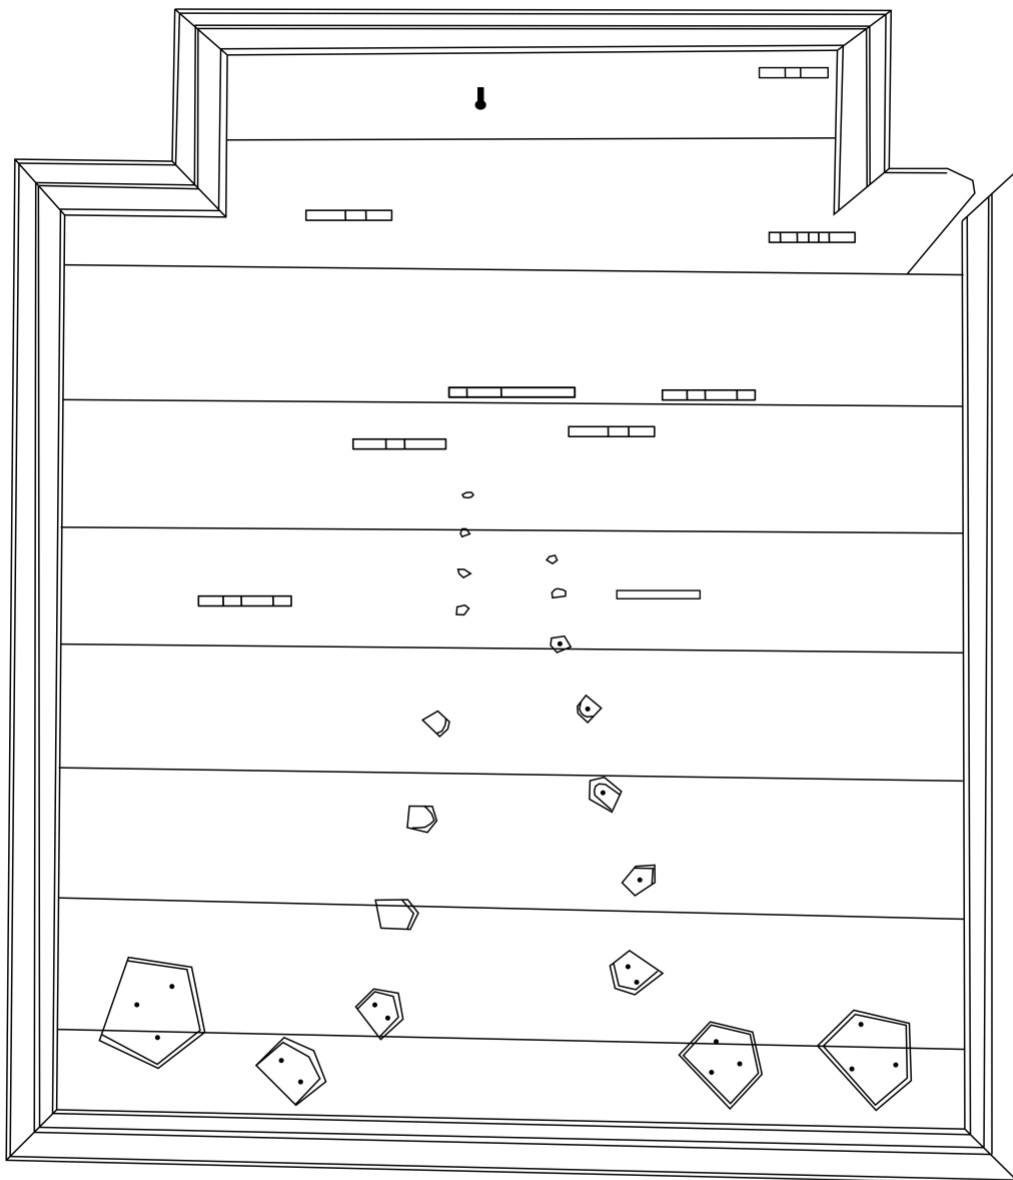
Figure 12. Measured drawing of the timber spanner board recovered from the Vivian Engine House

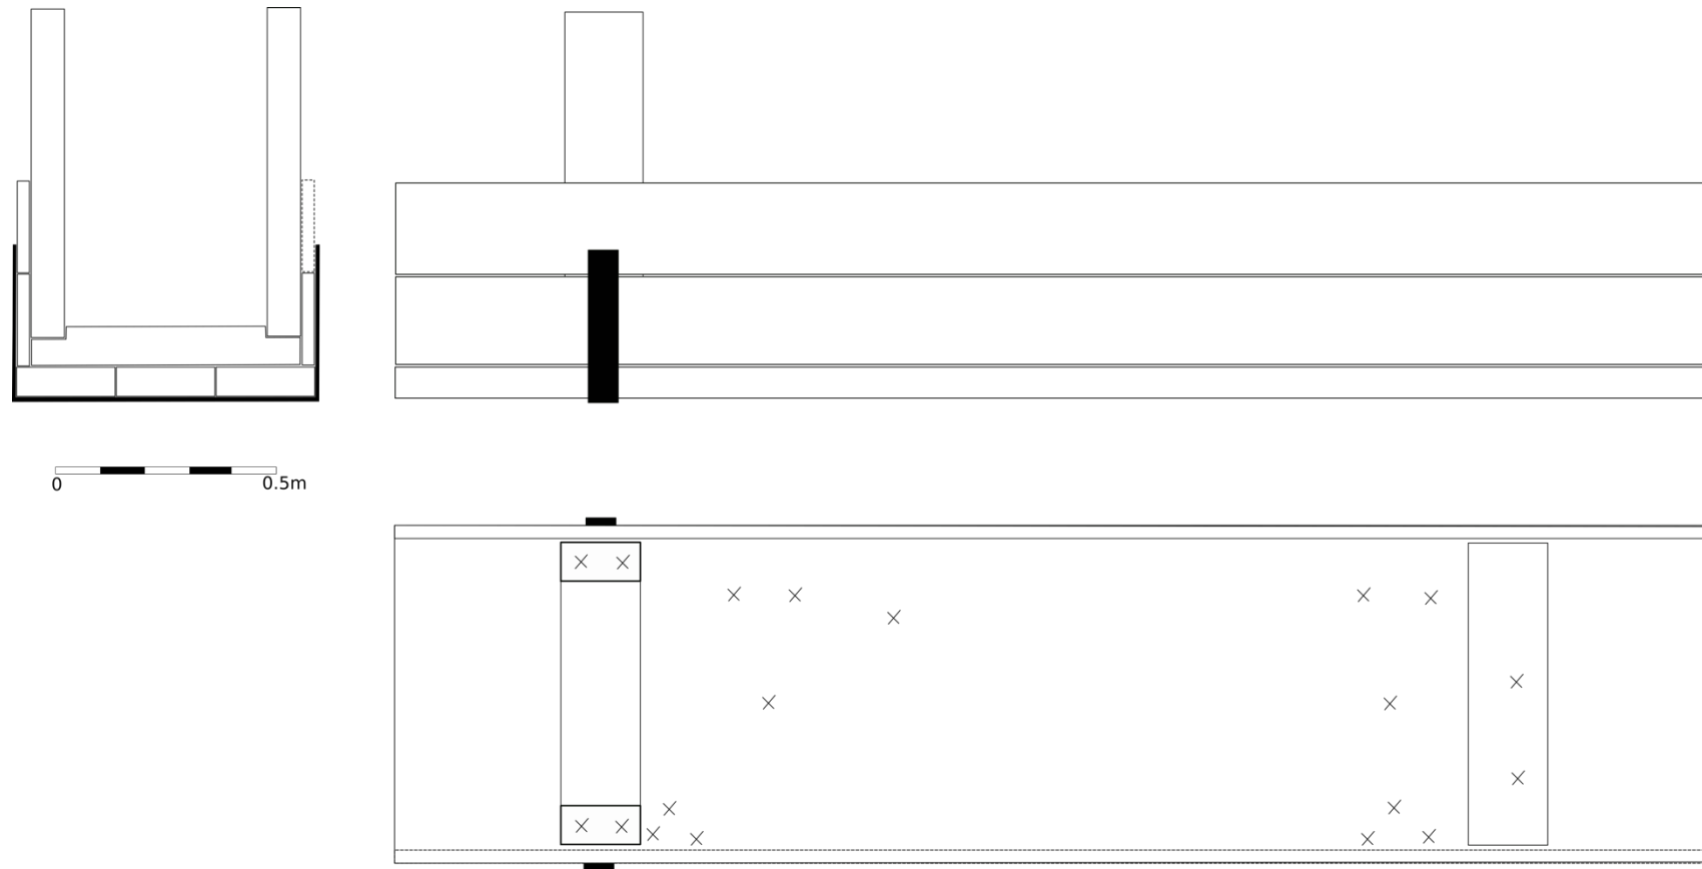
Figure 13. Measured drawing of the section of timber leat

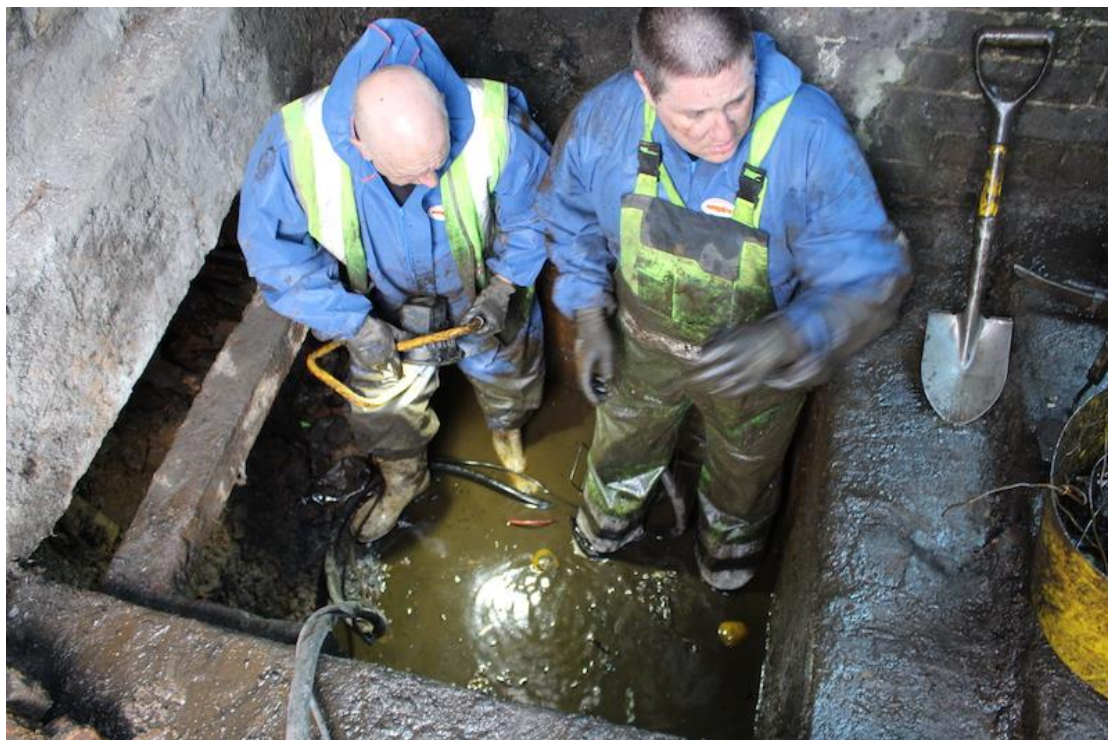
Plate 13. Working shot during the excavation of sump [103] showing water ingress.

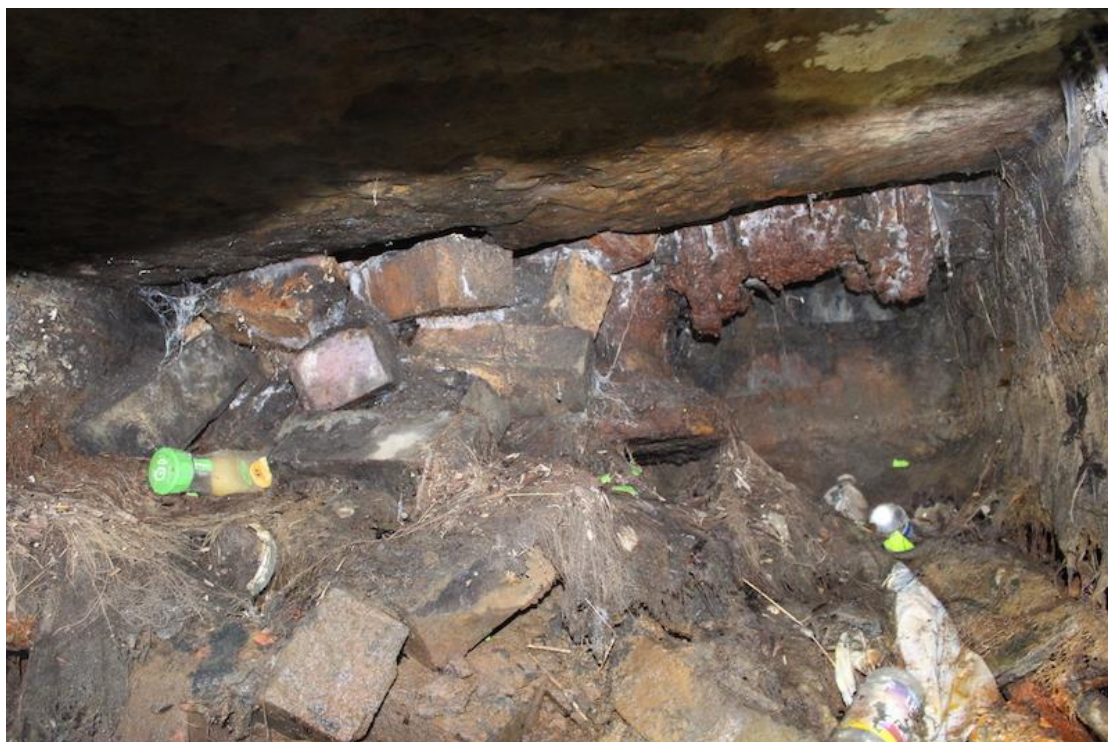
Plate 14. Working shot during the excavation of sump [103] showing the back wall and in situ pipe work. It also shows brick backfill (102).

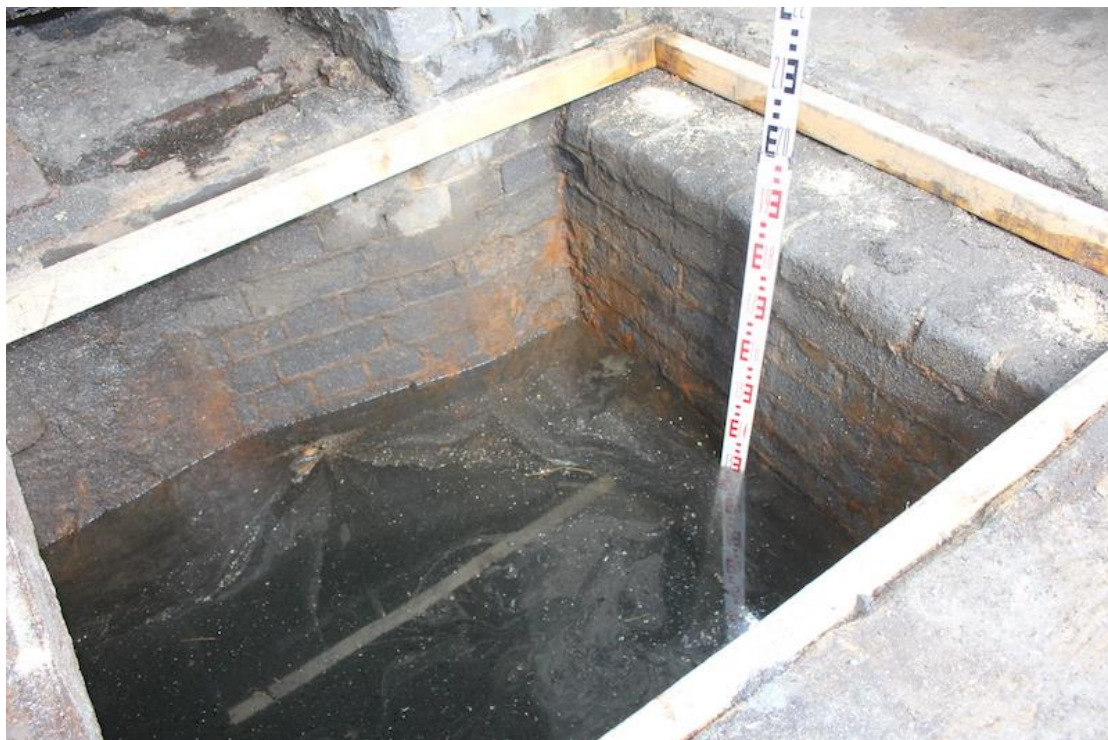
Plate 15. West facing post-excitation photo of sump [103] which was excavated to a depth of 1.6m but not bottomed. Also shows water ingress.

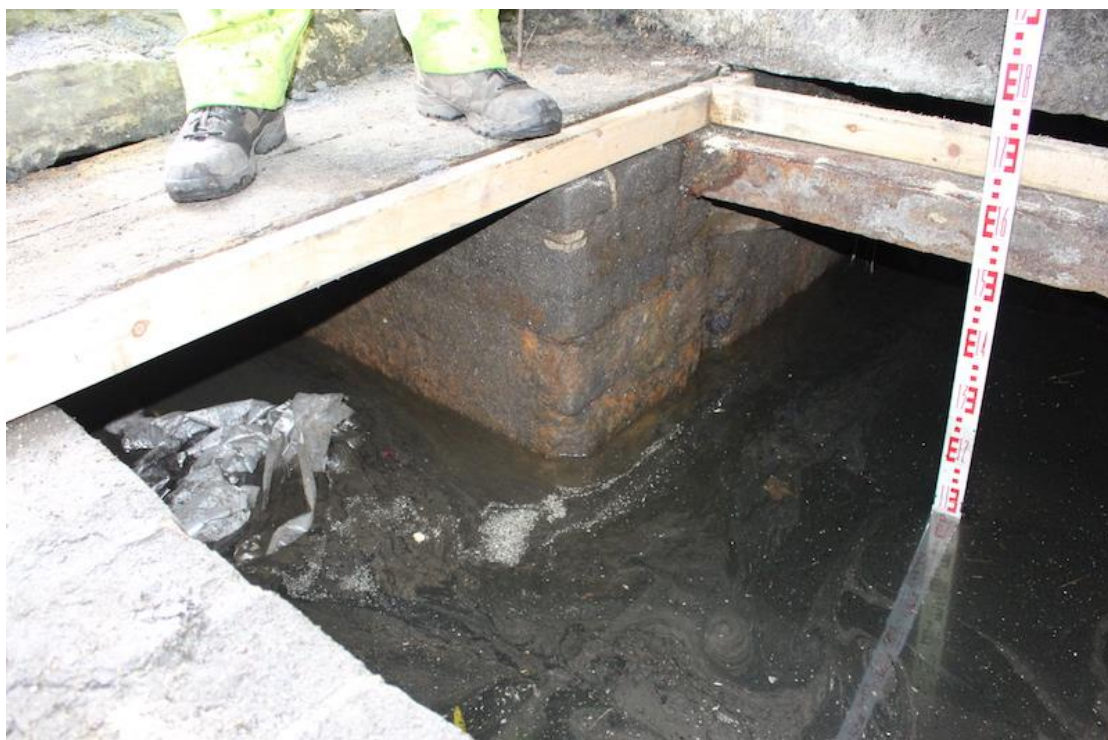
Plate 16. South facing post-excitation photo showing sump [103] to right and culvert [104] running beneath the east doorway. Also shows water ingress.

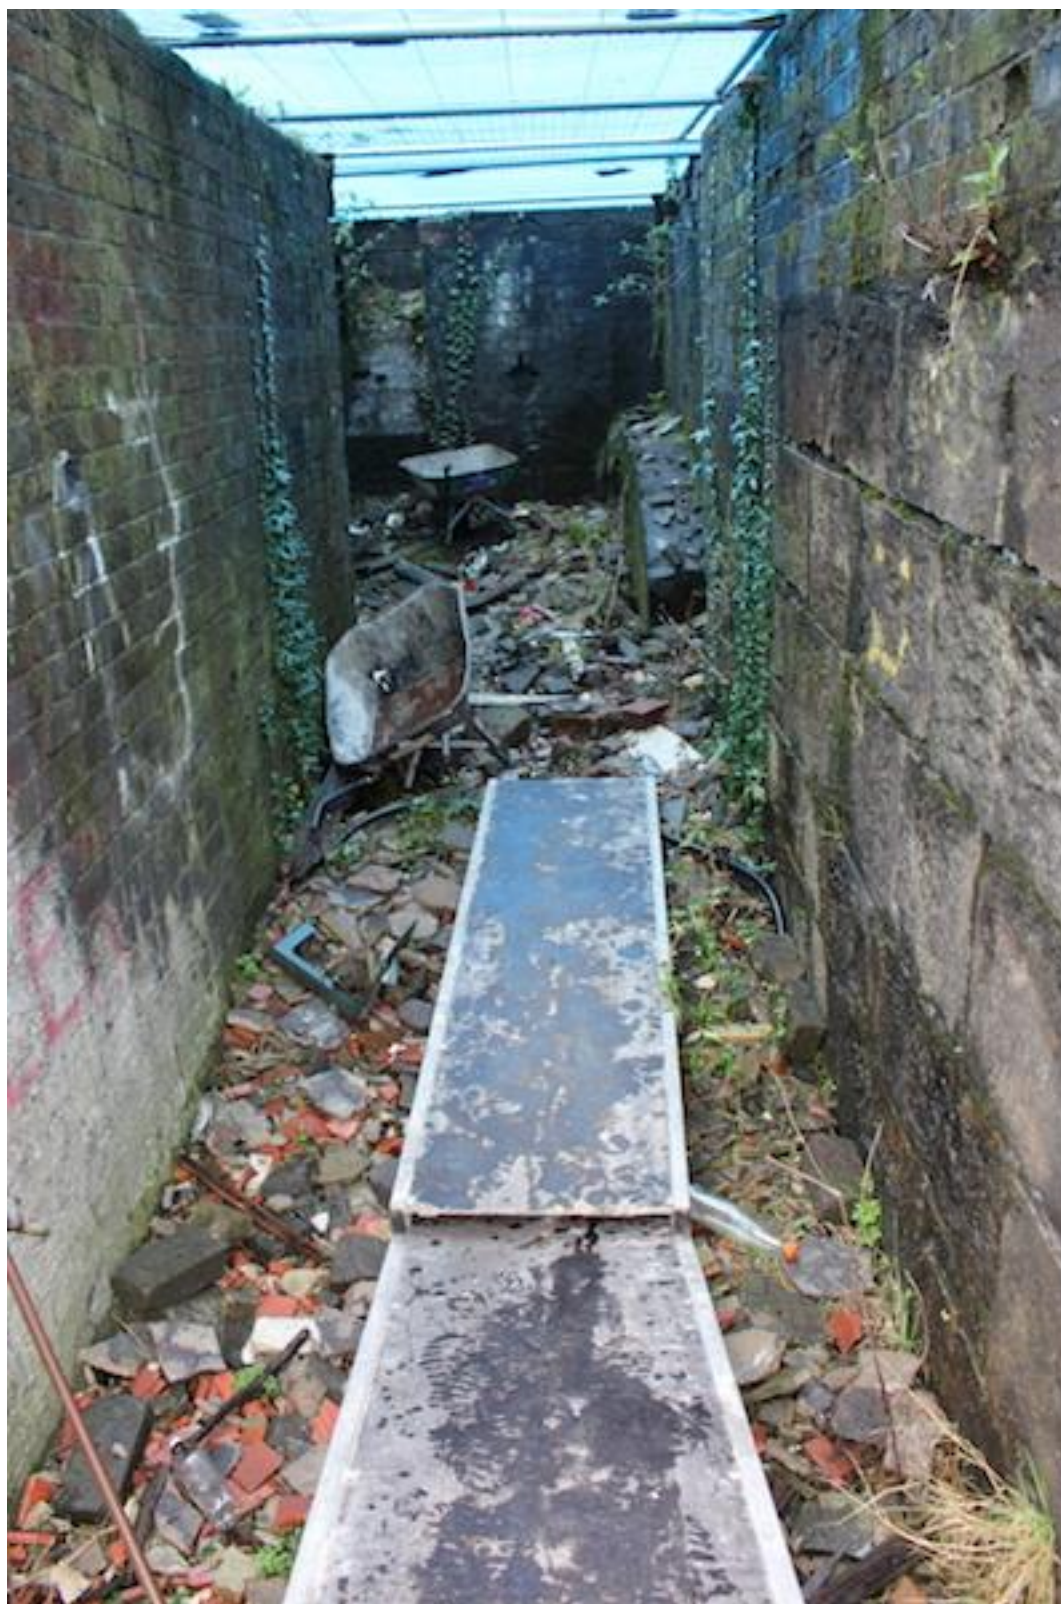
Plate 18. West facing pre-excitation photo showing deposit (201) within wheel pit [206] and inspection platform area [207] situated to the rear.

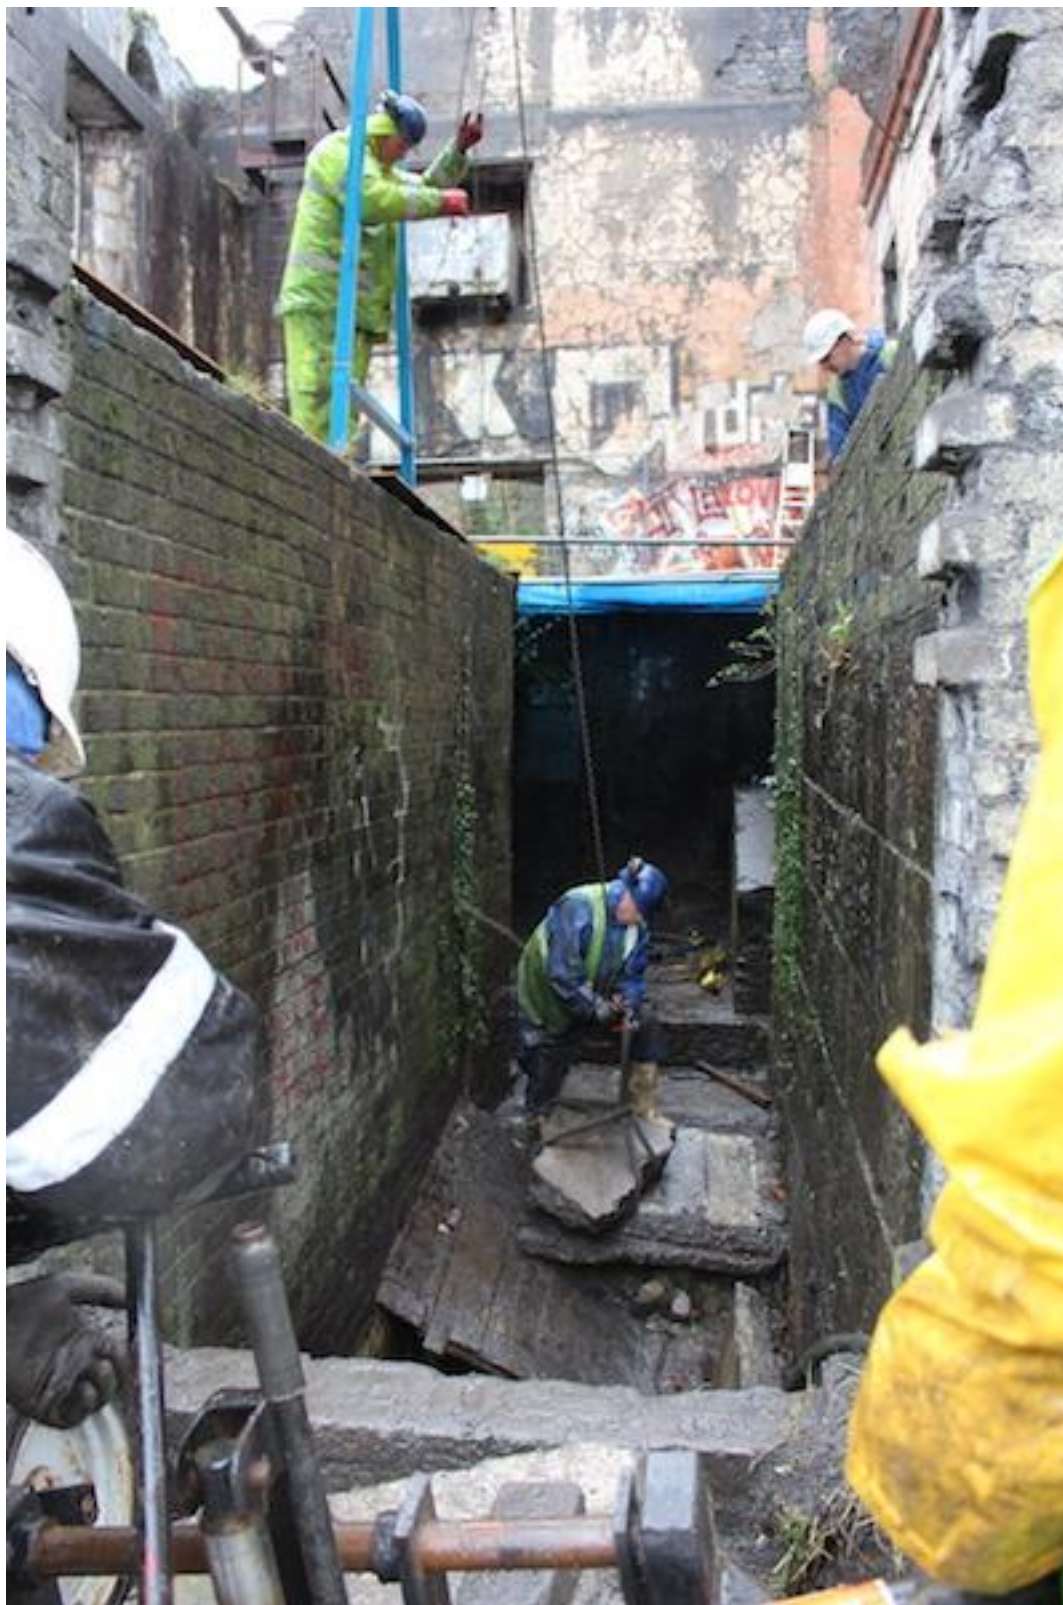
Plate 20. West facing working shot showing removal of concrete slabs using gantry hoist. Spanner board can be seen beneath slabs.

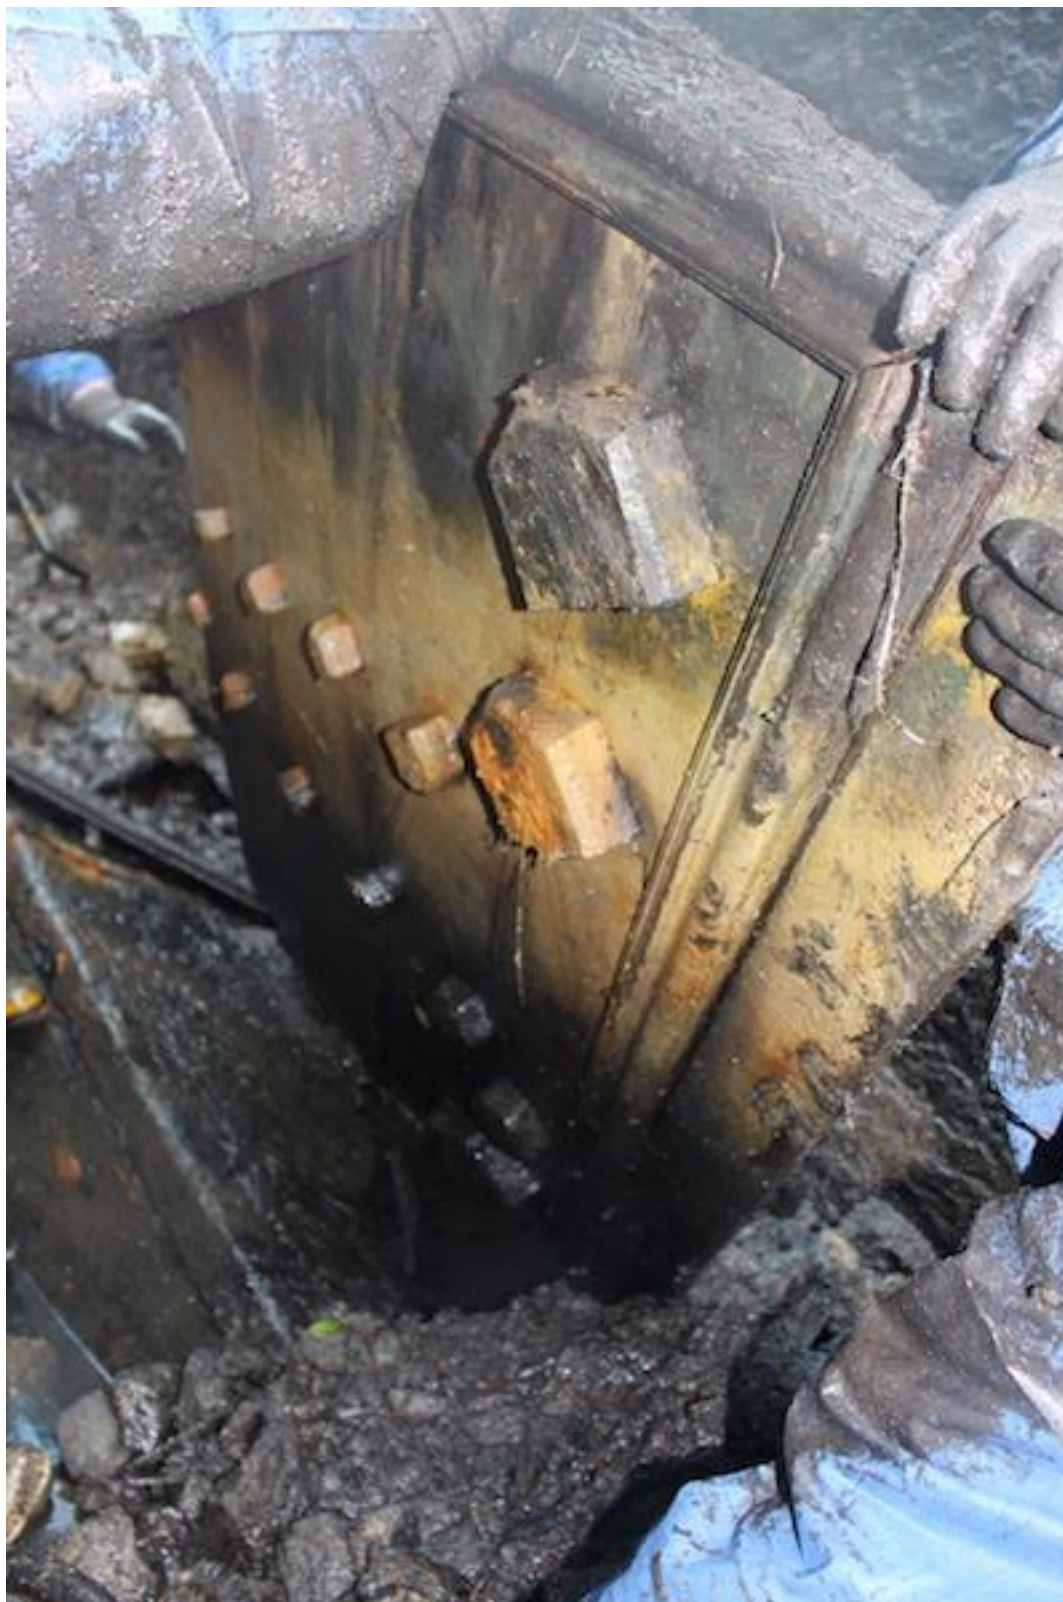
Plate 21. Working shot showing moment of discovery of the spanner board which lay face down beneath concrete slabs (202).

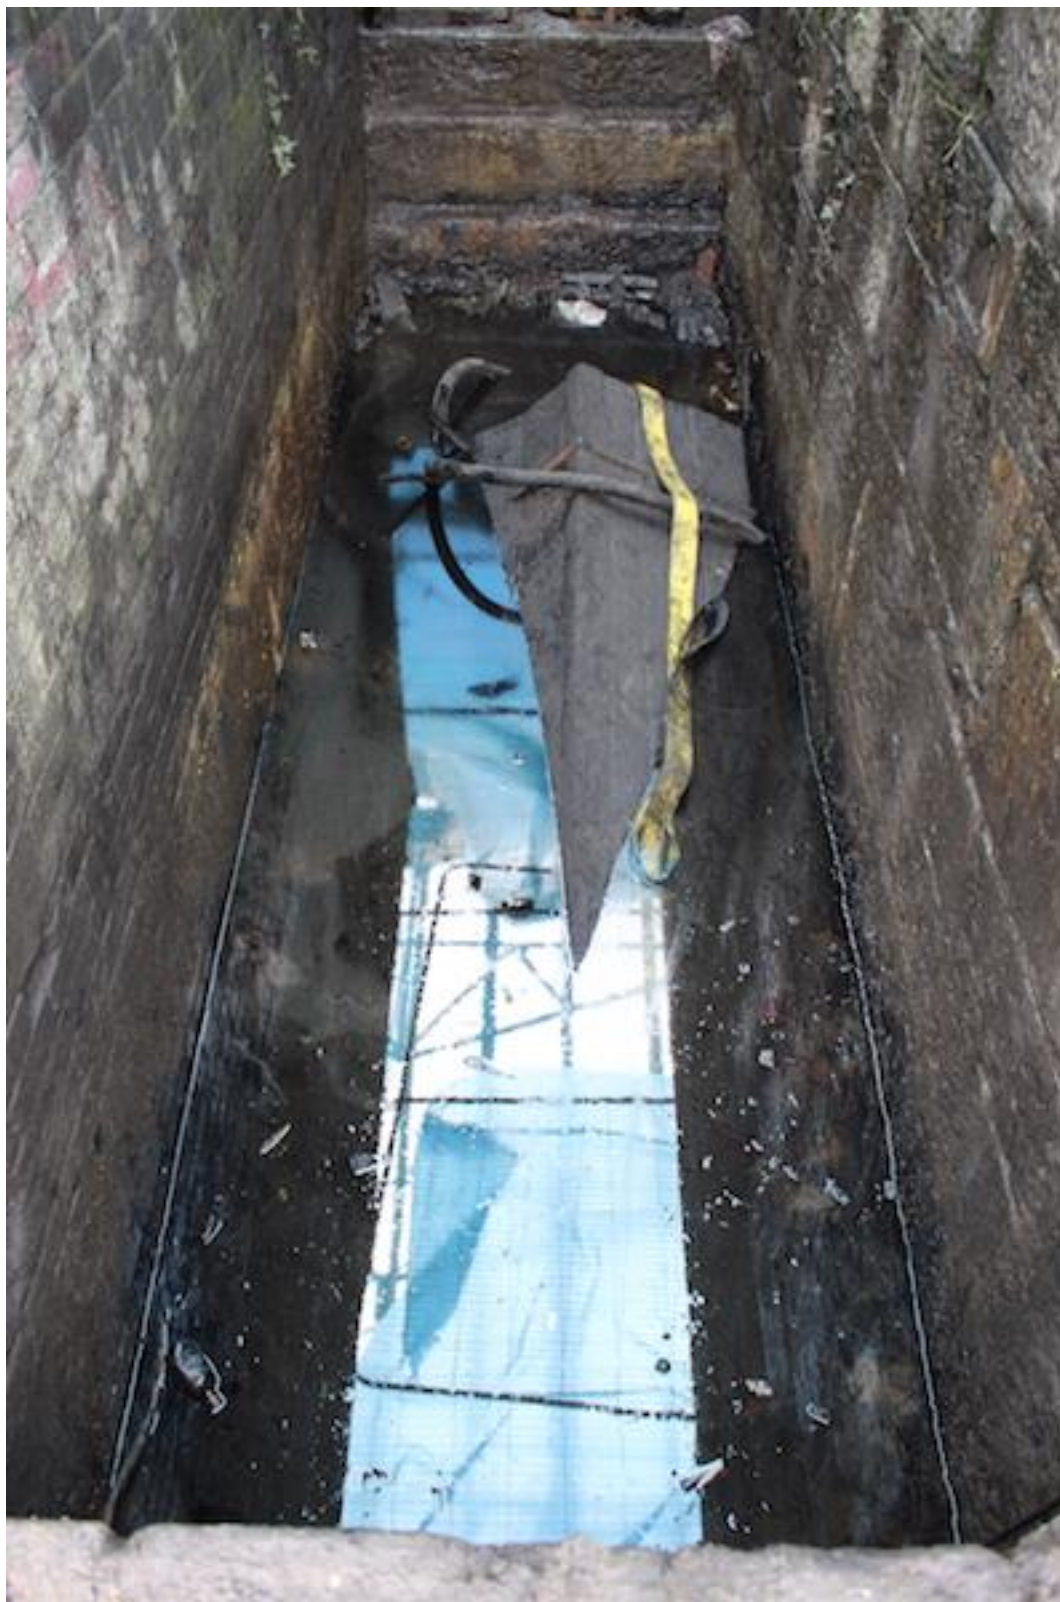
Plate 22. West-facing photo showing timber section of leat within wheel pit [206], prior to removal.

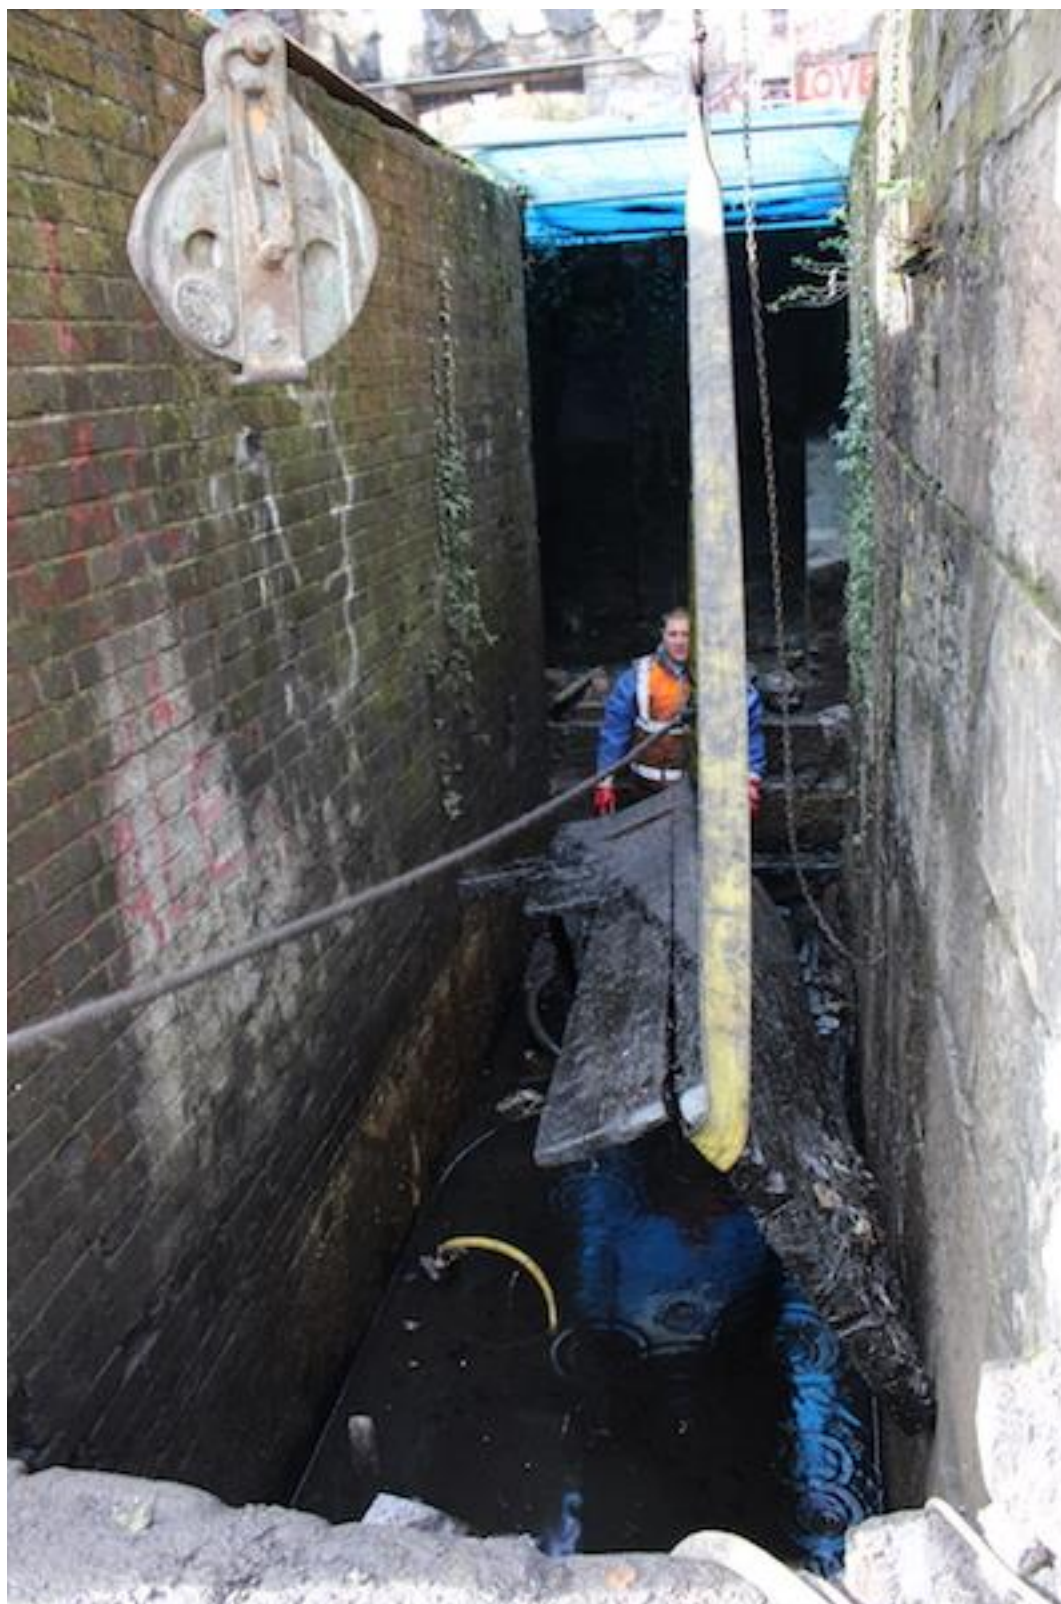
Plate 23. Working shot showing the removal of the timber leaf from wheel pit [206] using a gantry hoist.

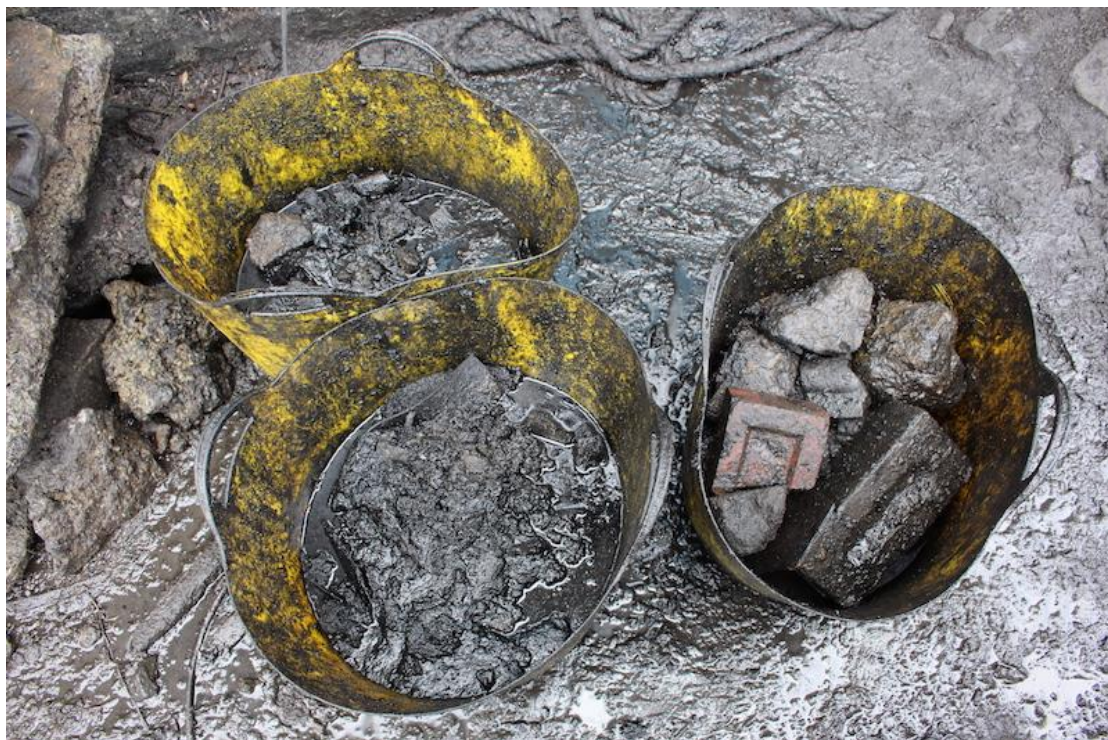
Plate 25. Detail shot showing contamination of lower deposit (203).

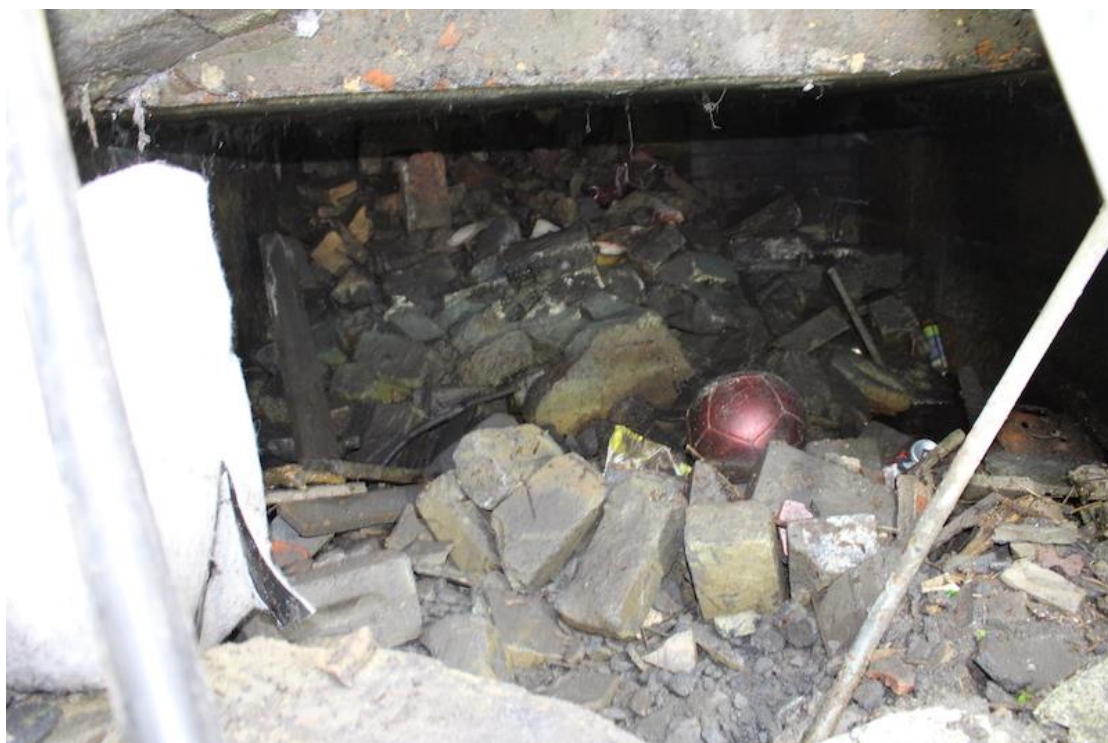
Plate 26. Working shot showing rope chamber [205] and brick backfill (204) before excavation.

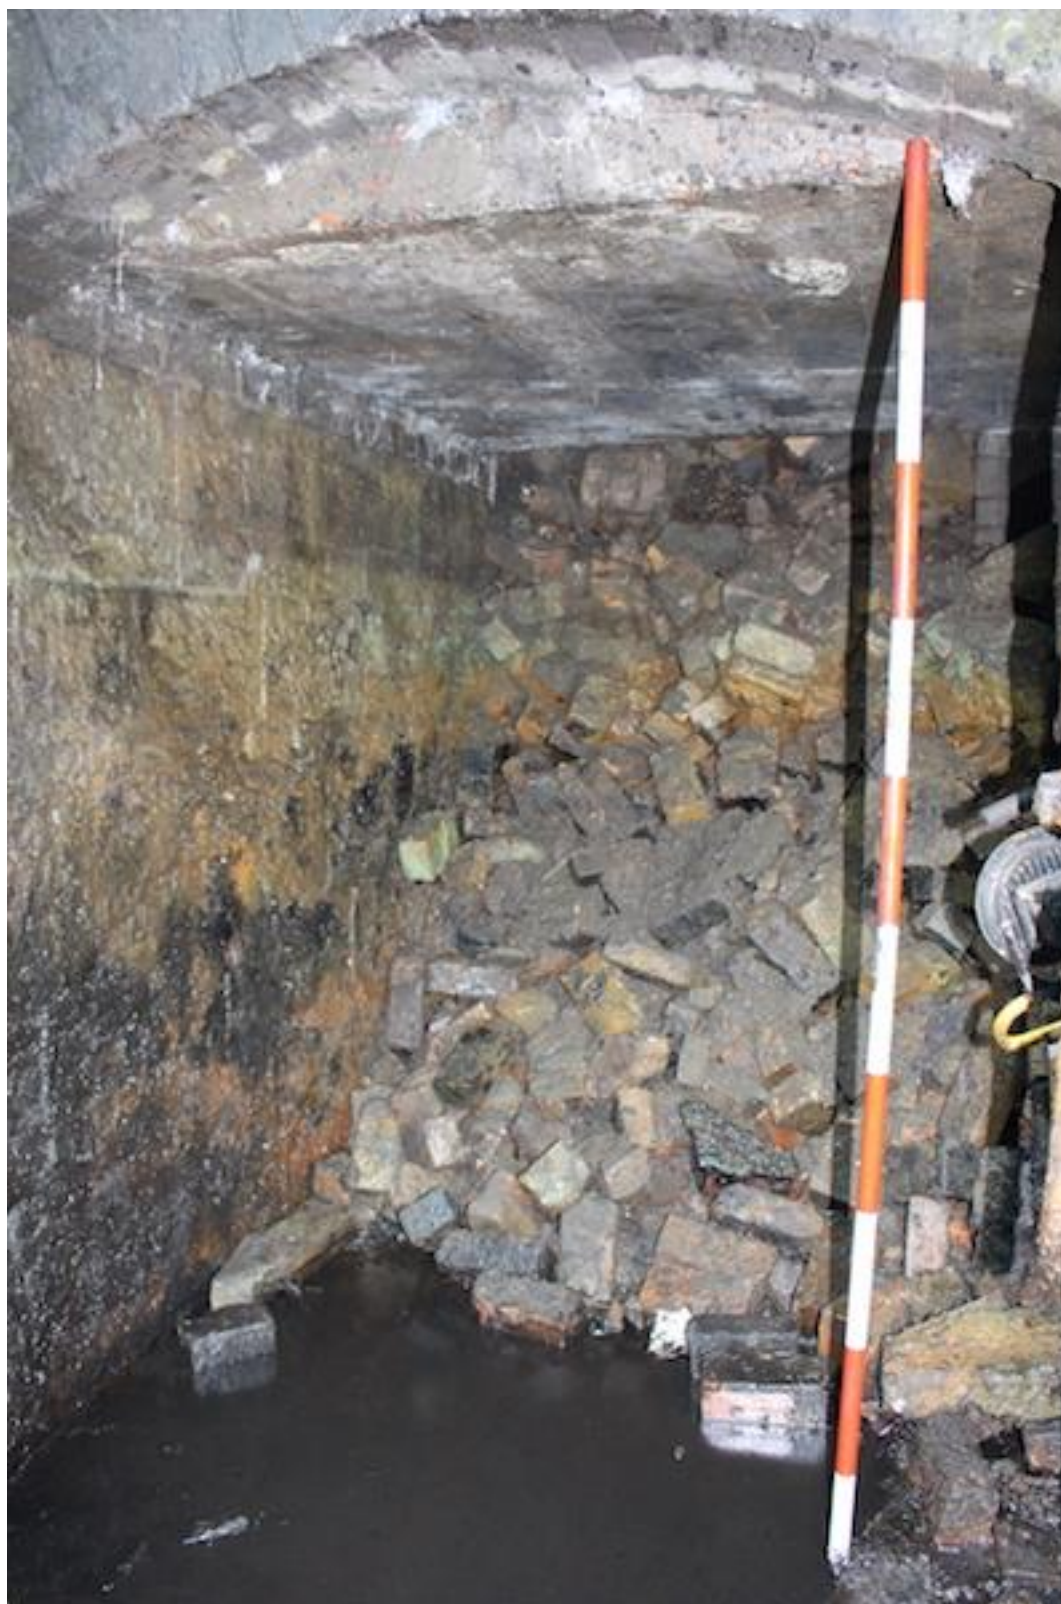
Plate 28. East-facing photo showing pennant stone north wall of rope chamber [205].

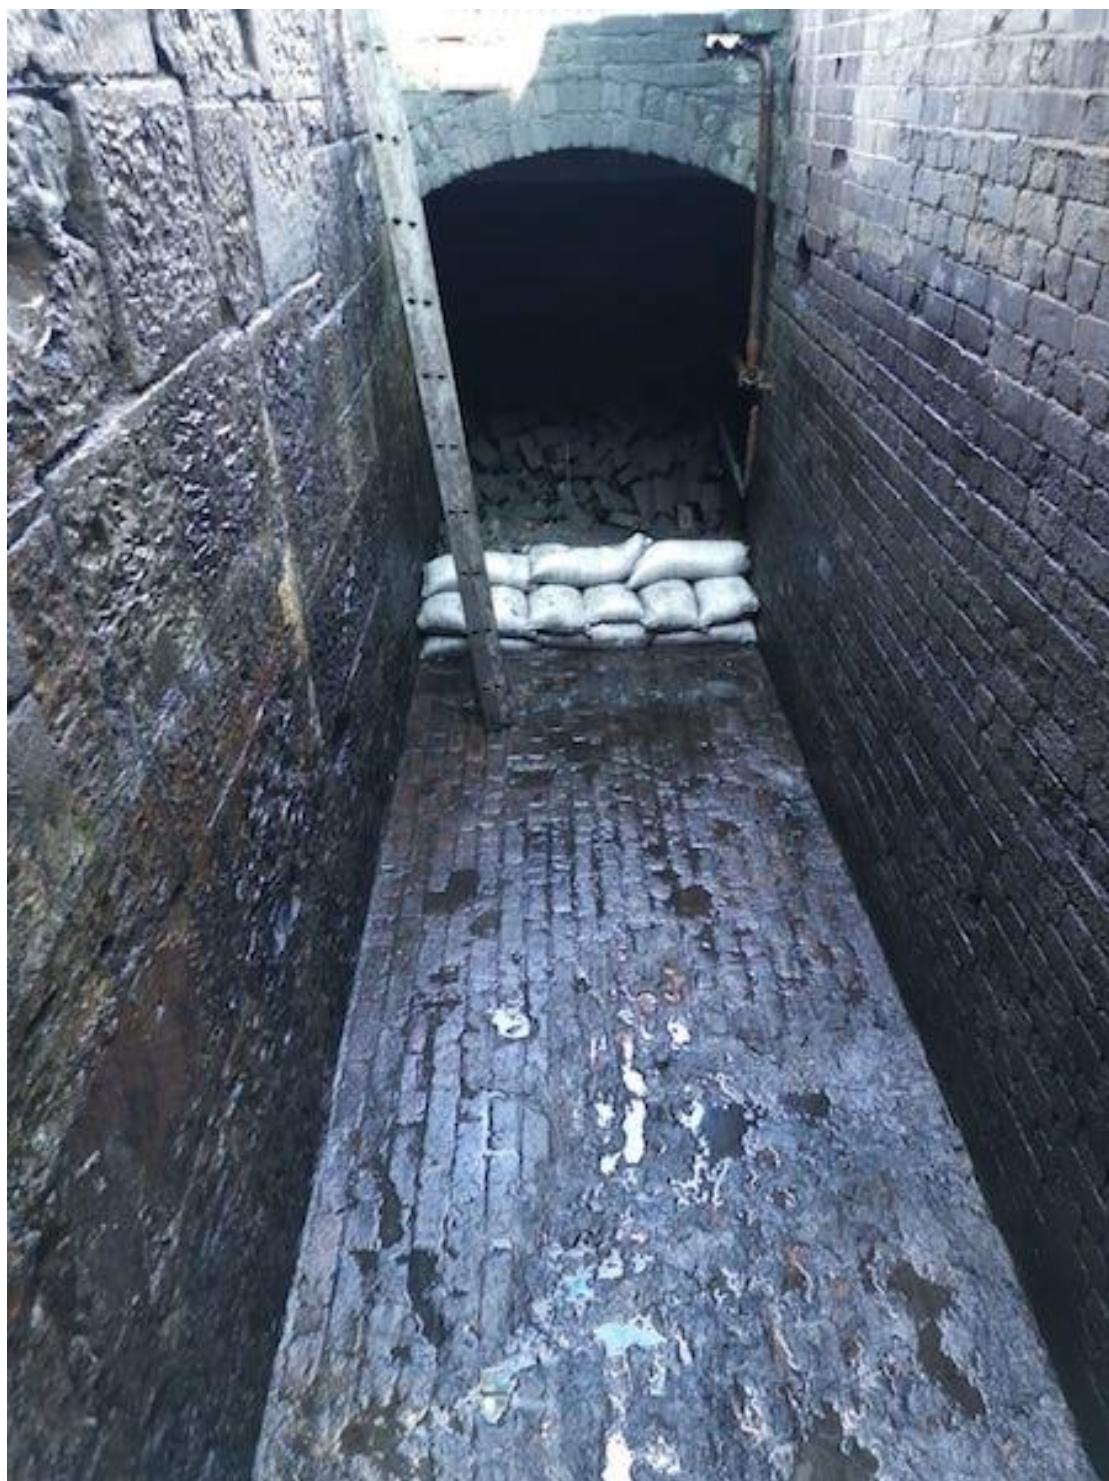
Plate 29. East-facing working shot showing the brick-lined floor of wheel pit [206].
