# Vivian Engine House, Hafod-Morfa Copperworks

## Archaeological Watching Brief & Building Record

**City and County of Swansea**

**- BLACK MOUNTAINS ARCHAEOLOGY -  
- ARCHAEOLEG MYNYDD DU -**

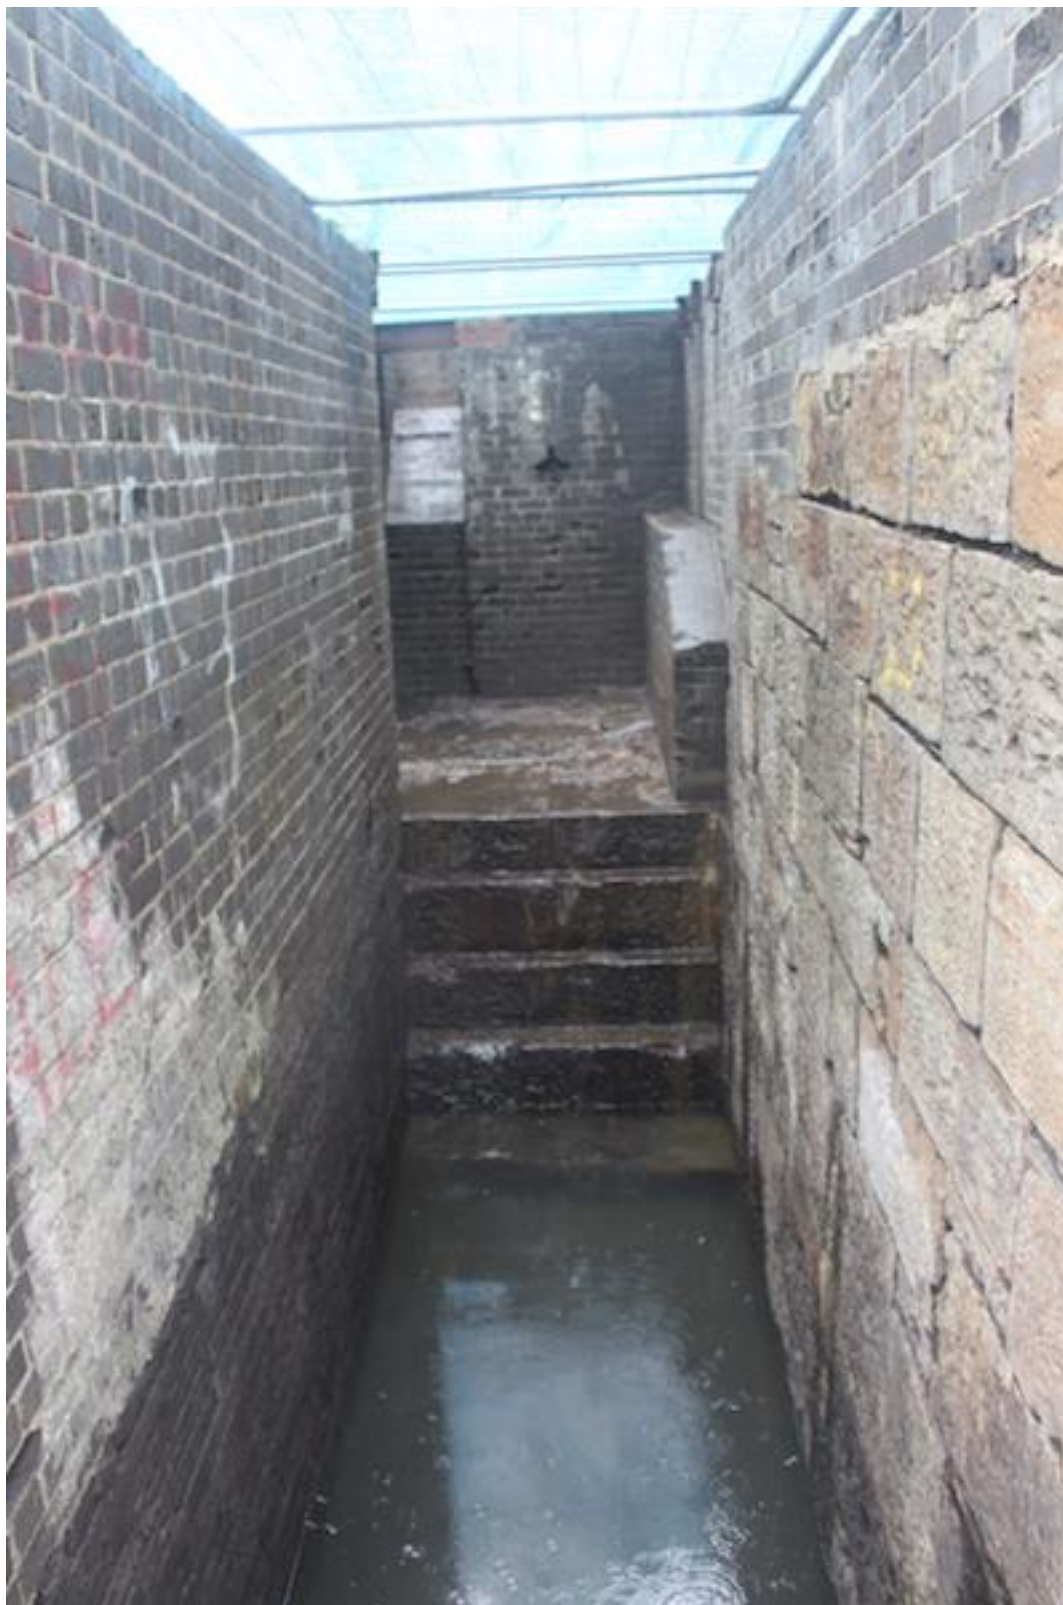
Plate 31. West-facing photo of machine pit showing wheel pit [206] and inspection platform [207] to rear. Also shows steps to the base of the wheel pit.

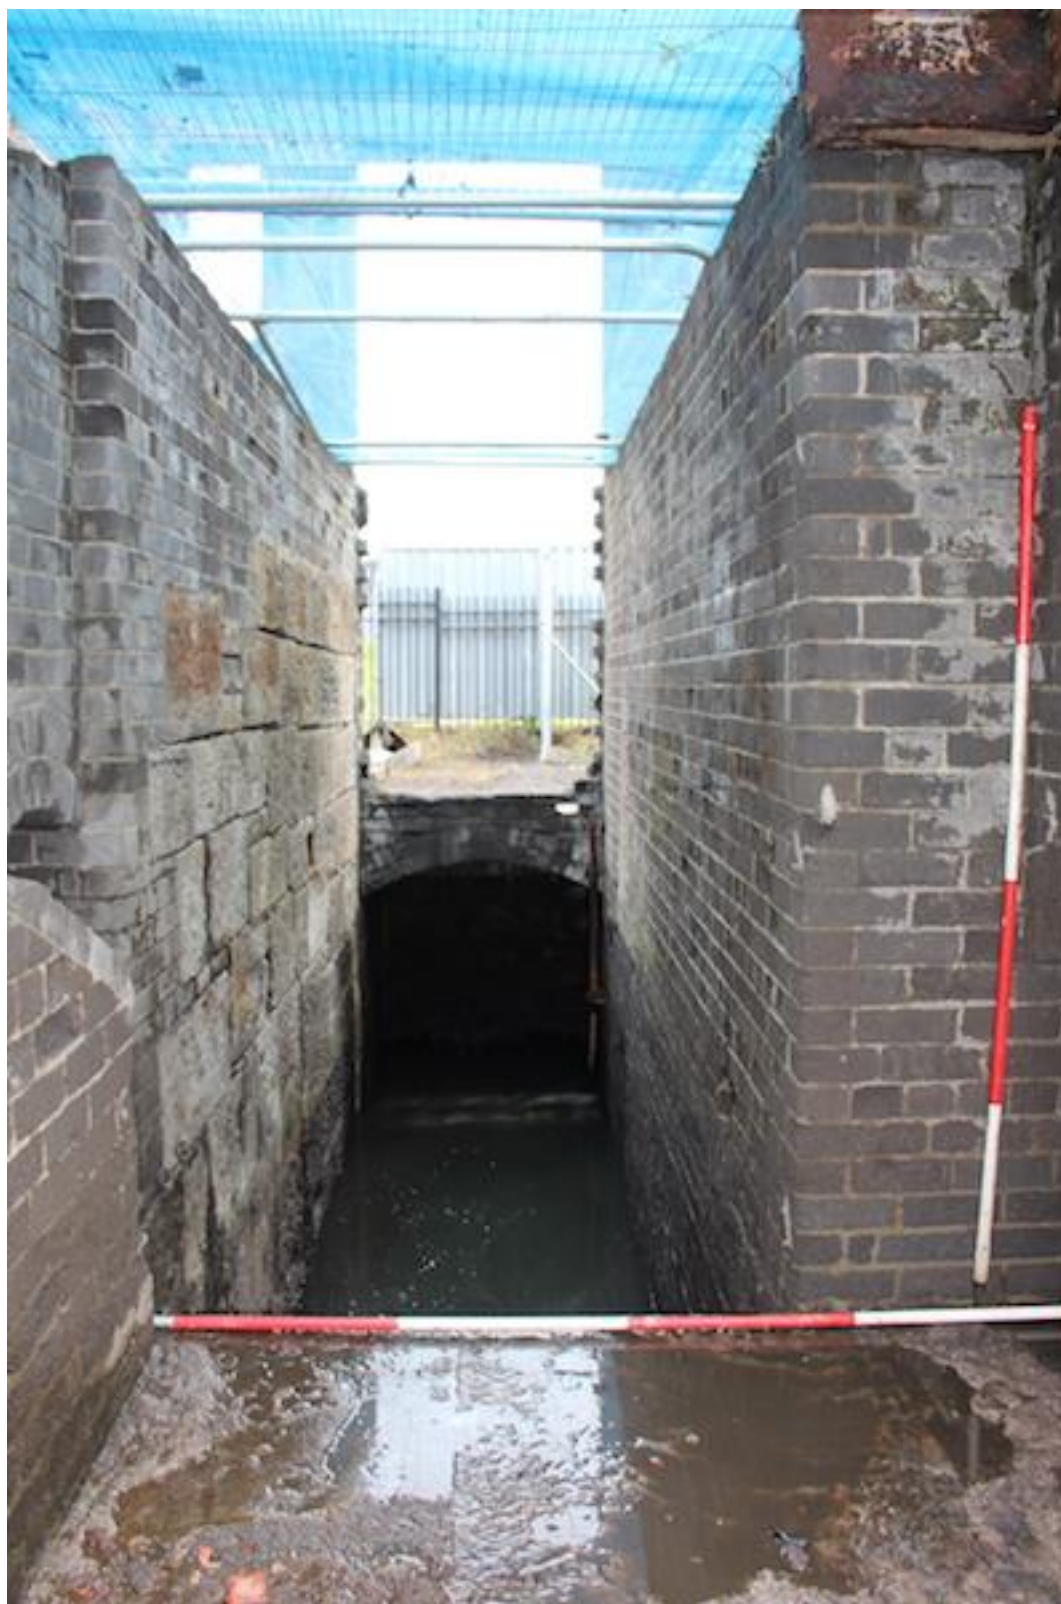
Plate 32. East-facing photo from inspection platform [207] showing wheel pit [206] and rope chamber [205].

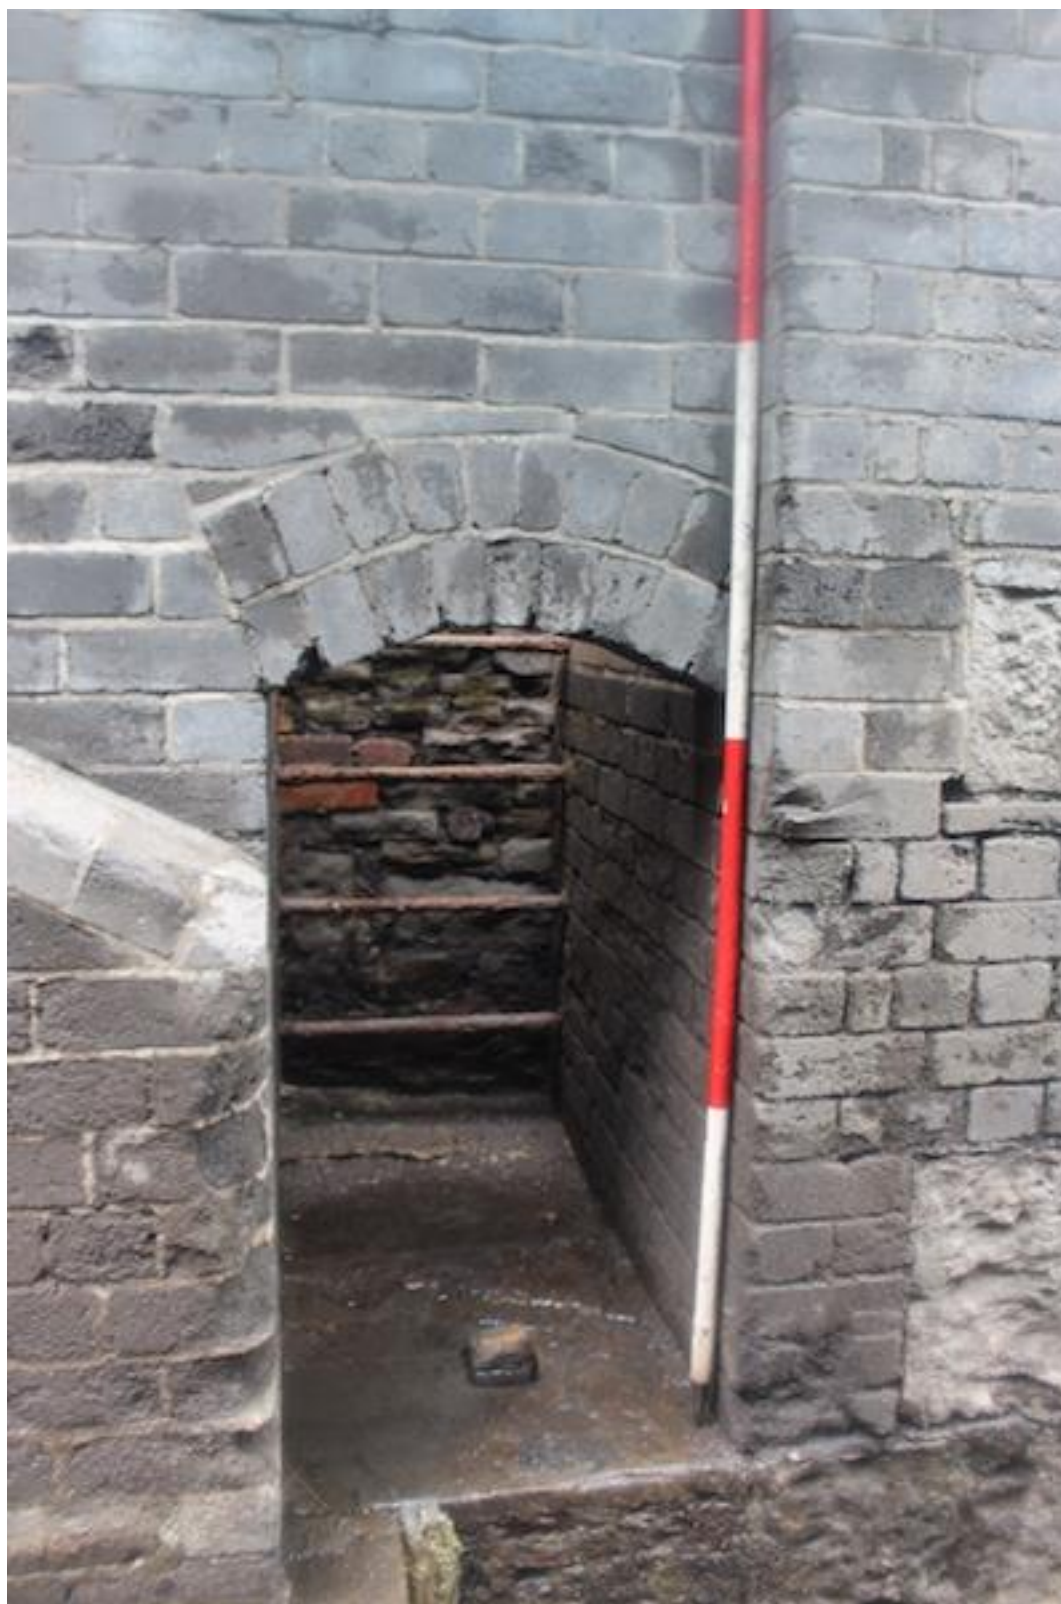
Plate 33. North-facing photo from inspection platform [207] showing access to manhole tunnel.

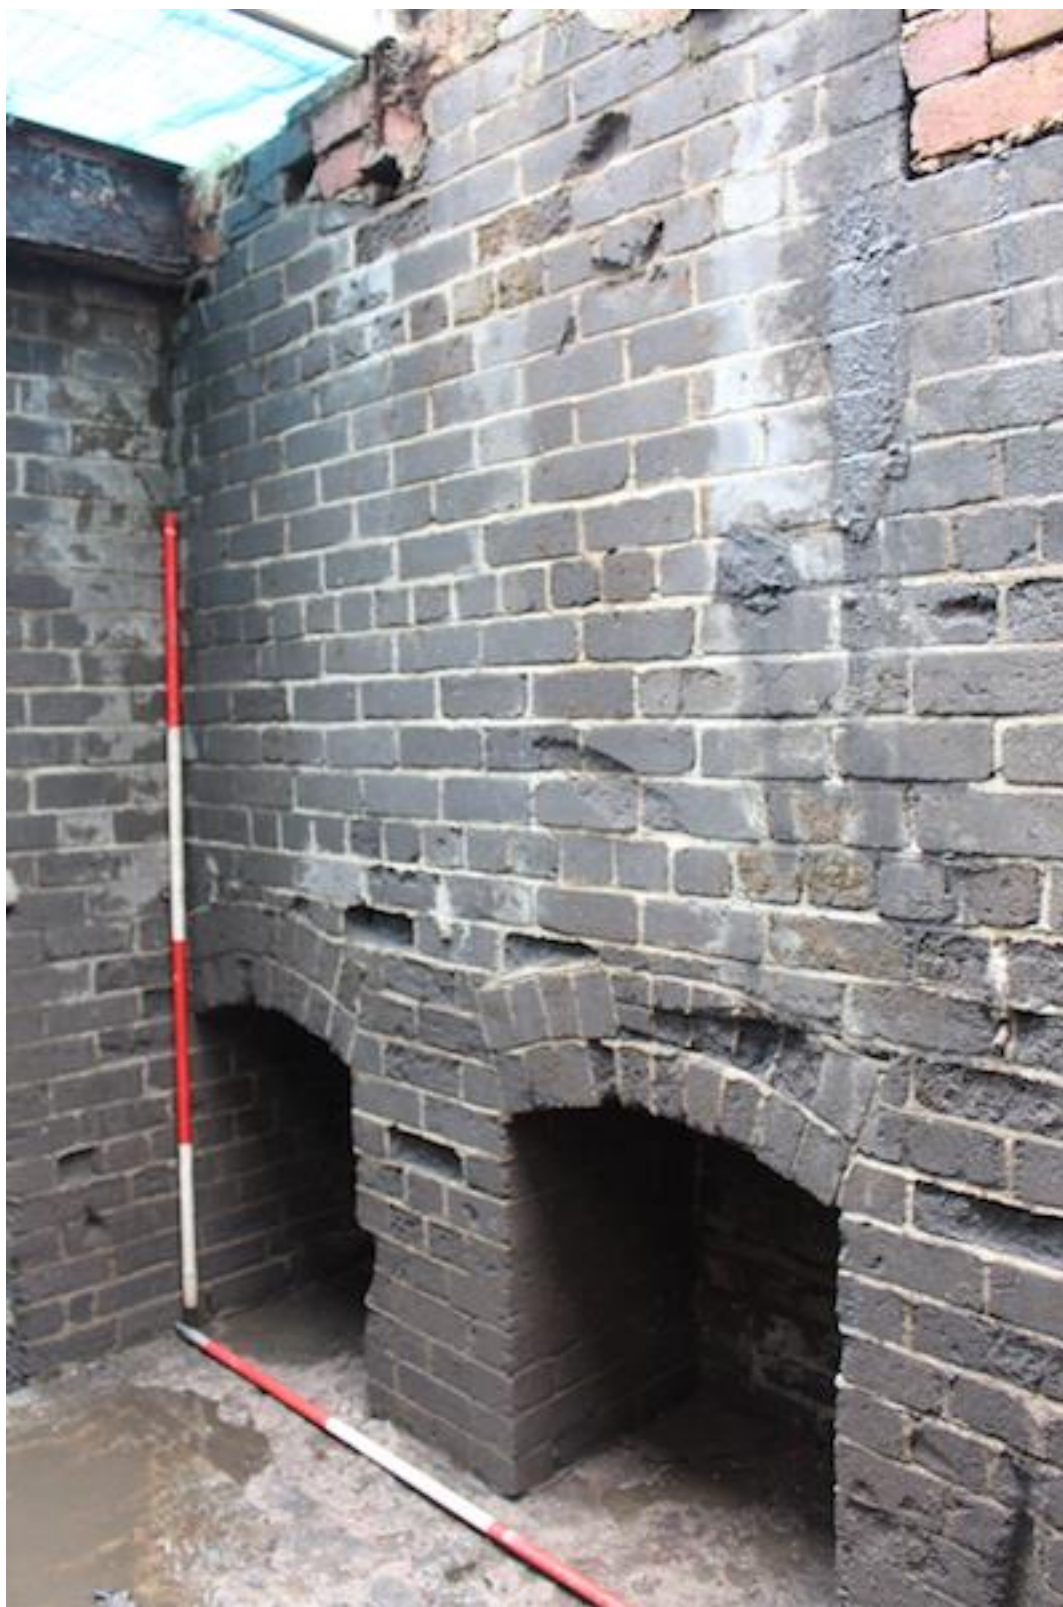
Plate 34. South-facing photo showing two of three brick arched recesses in south wall of inspection platform [207].

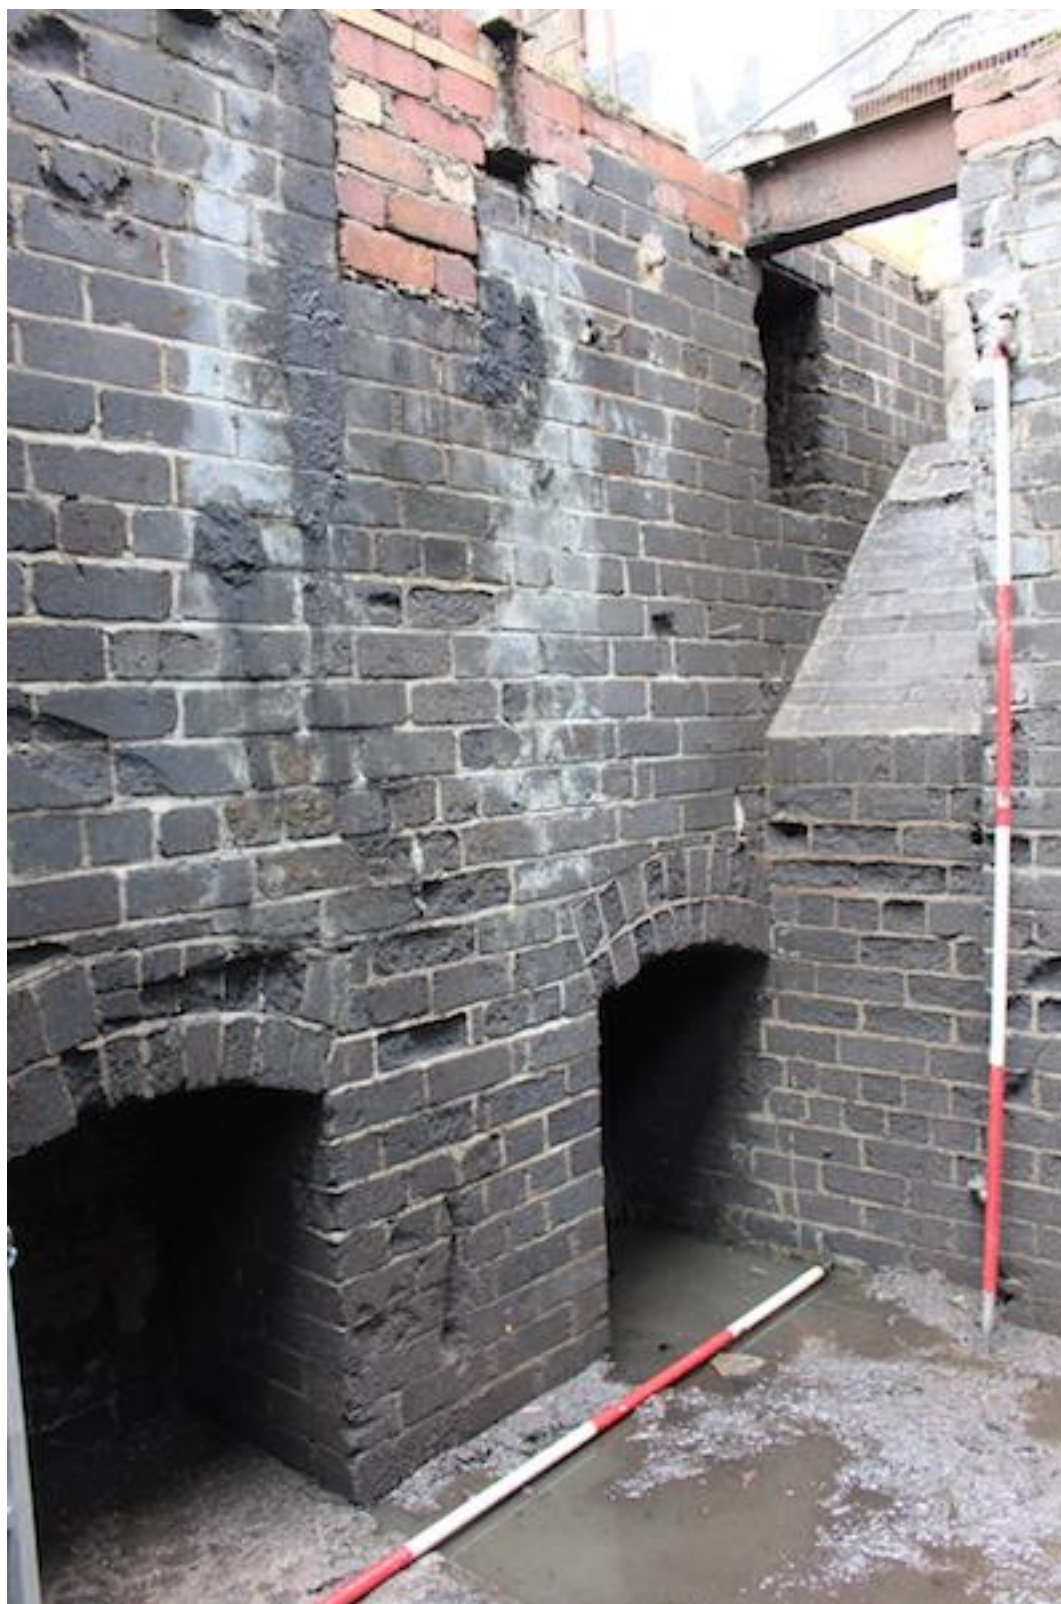
Plate 35. South-facing photo showing two of three brick arched recesses in south wall of inspection platform [207]. Also showing chute from machine floor.

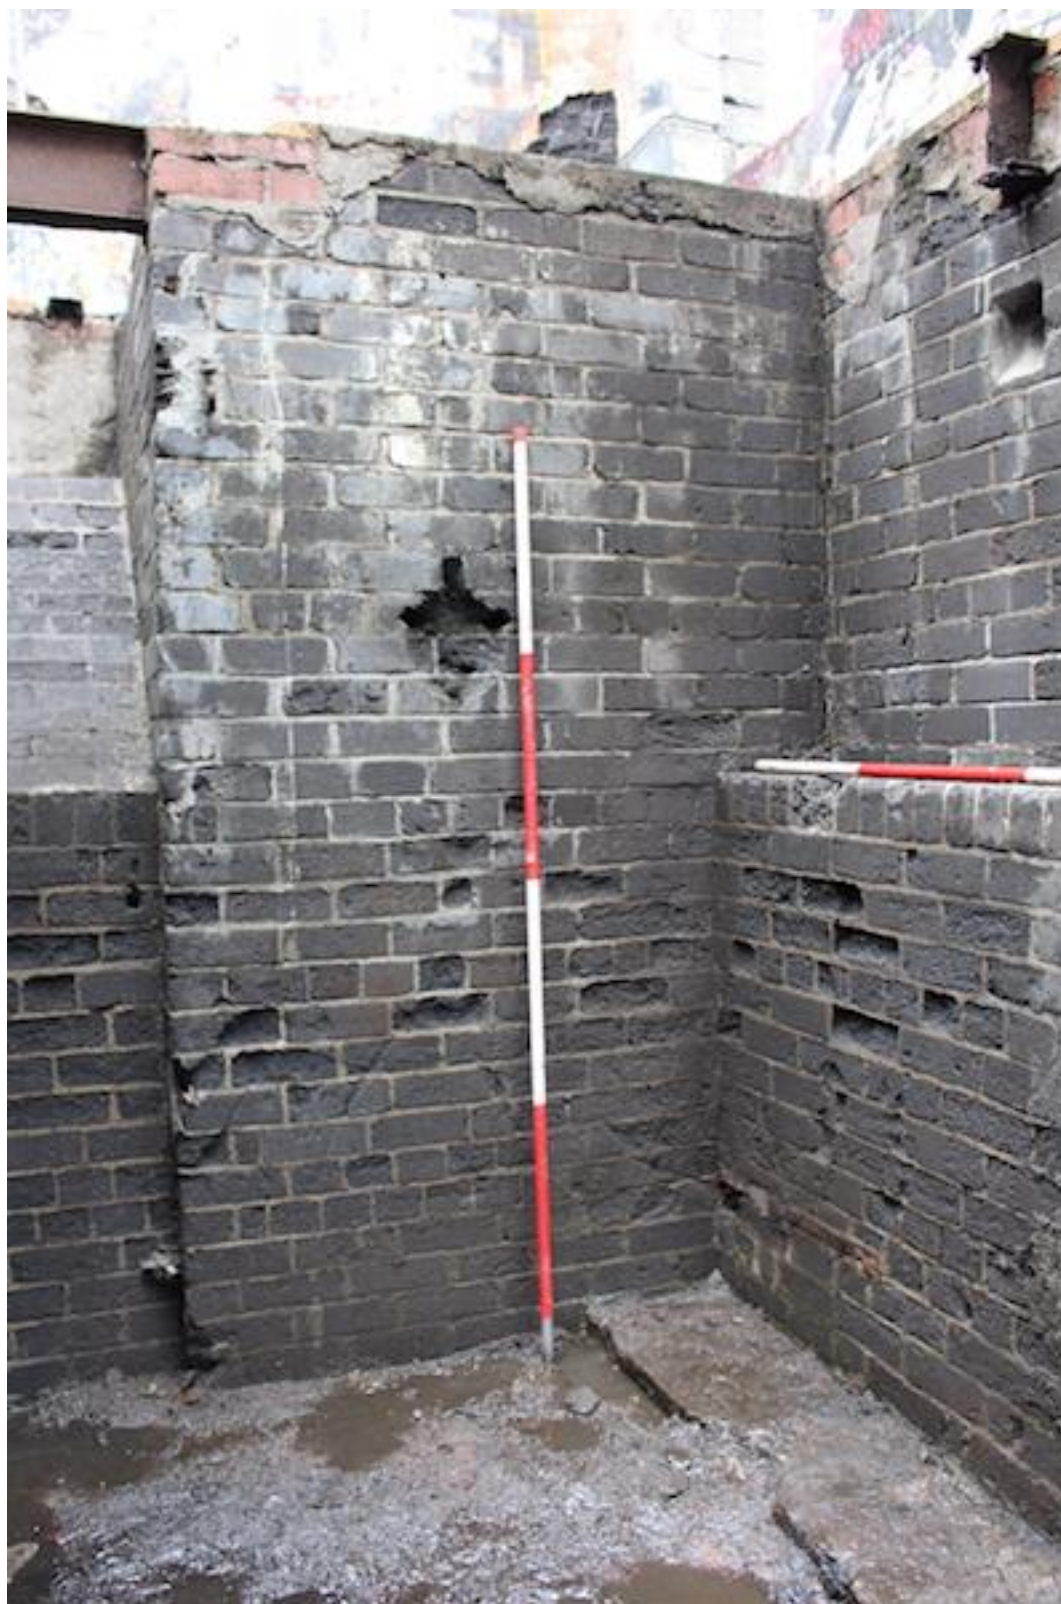
Plate 36. West-facing photo showing west wall of inspection platform [207].

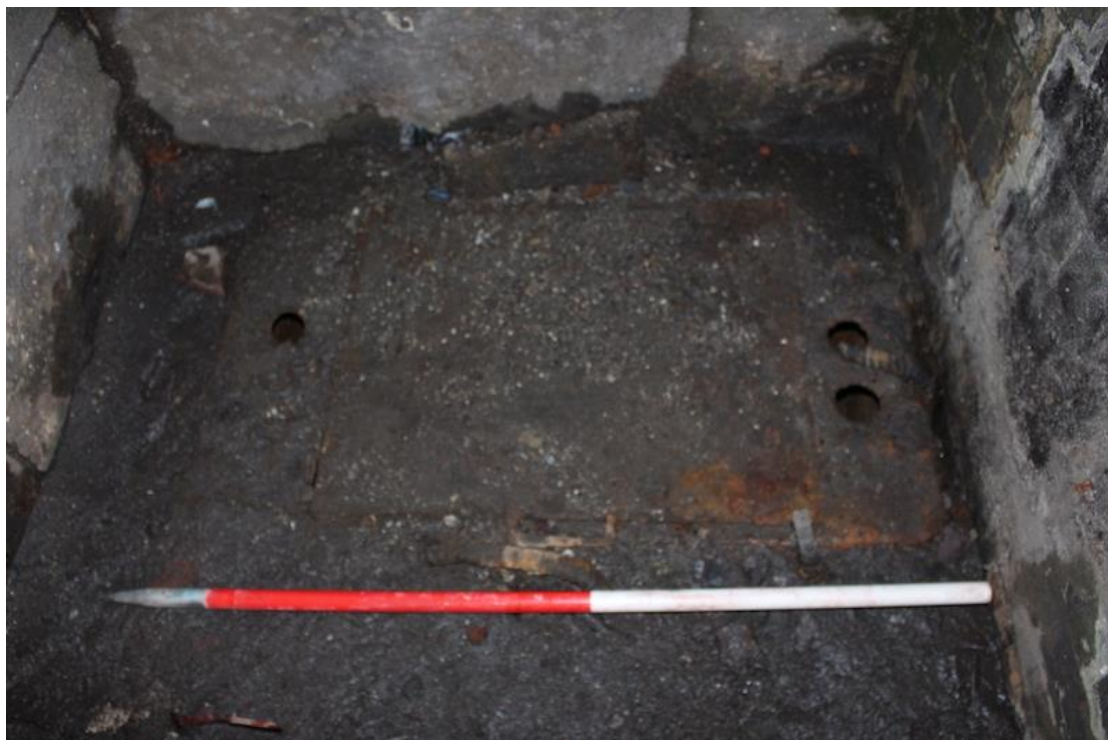
Plate 40. Detail photo showing a steel-lined sump located at the west end of main basement [105].

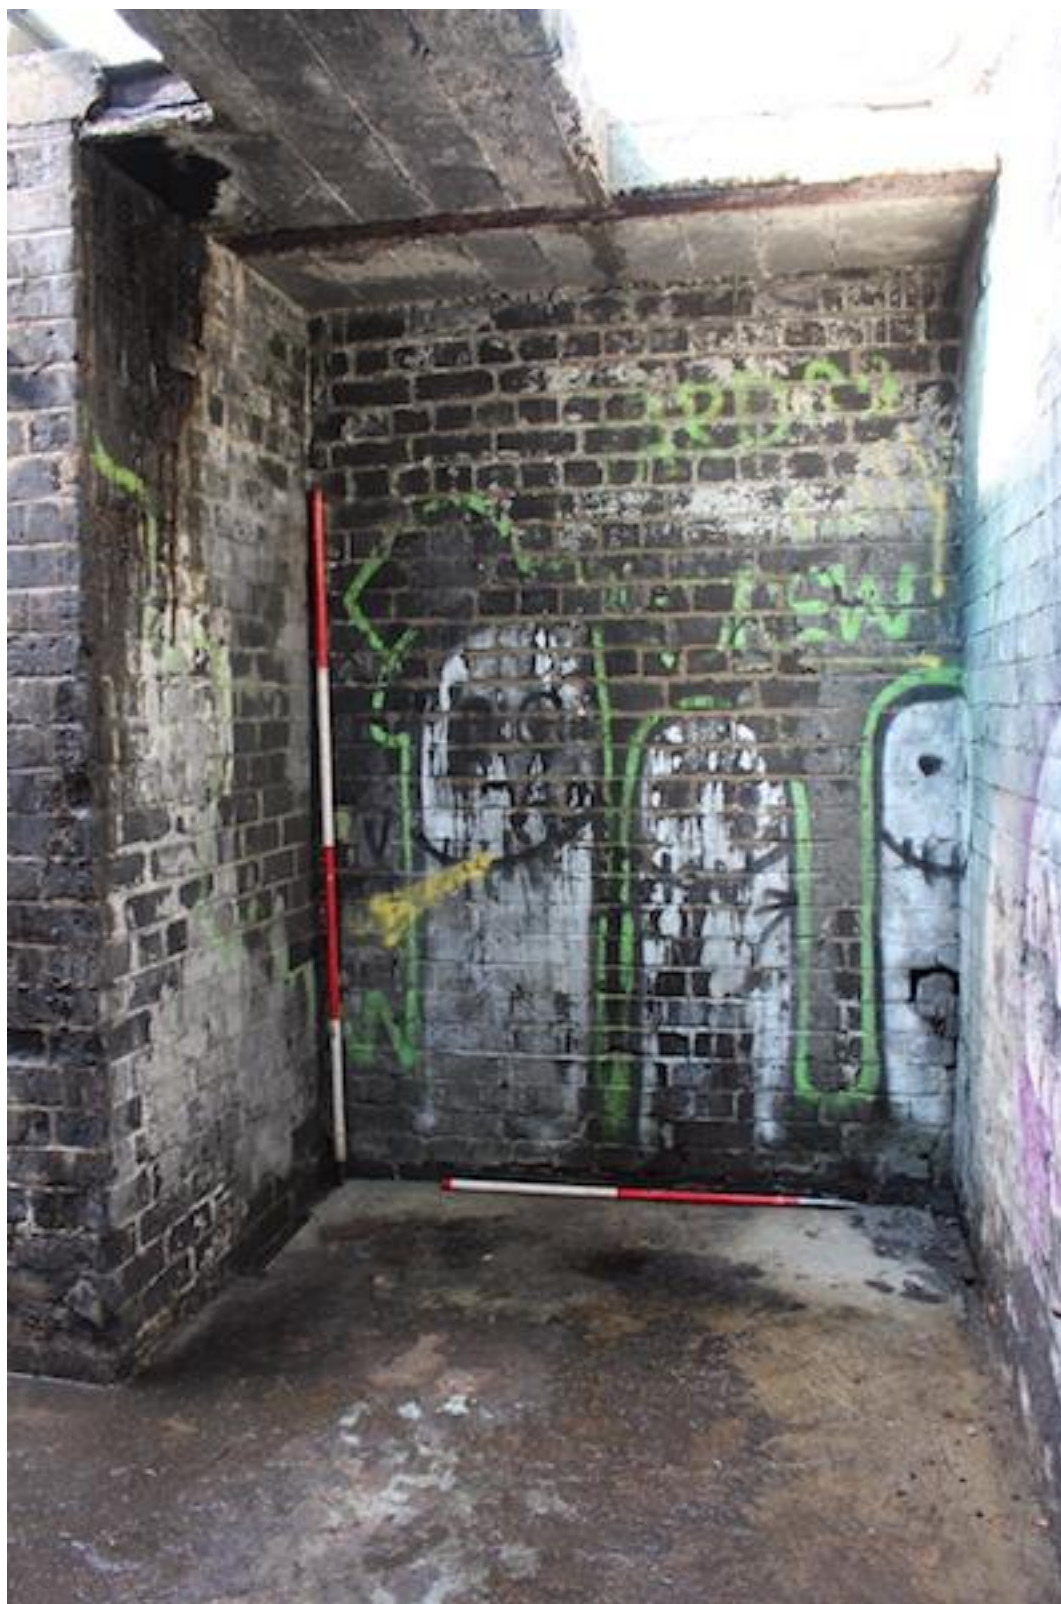
Plate 43. North-facing photo showing recessed north wall of stairwell [106].

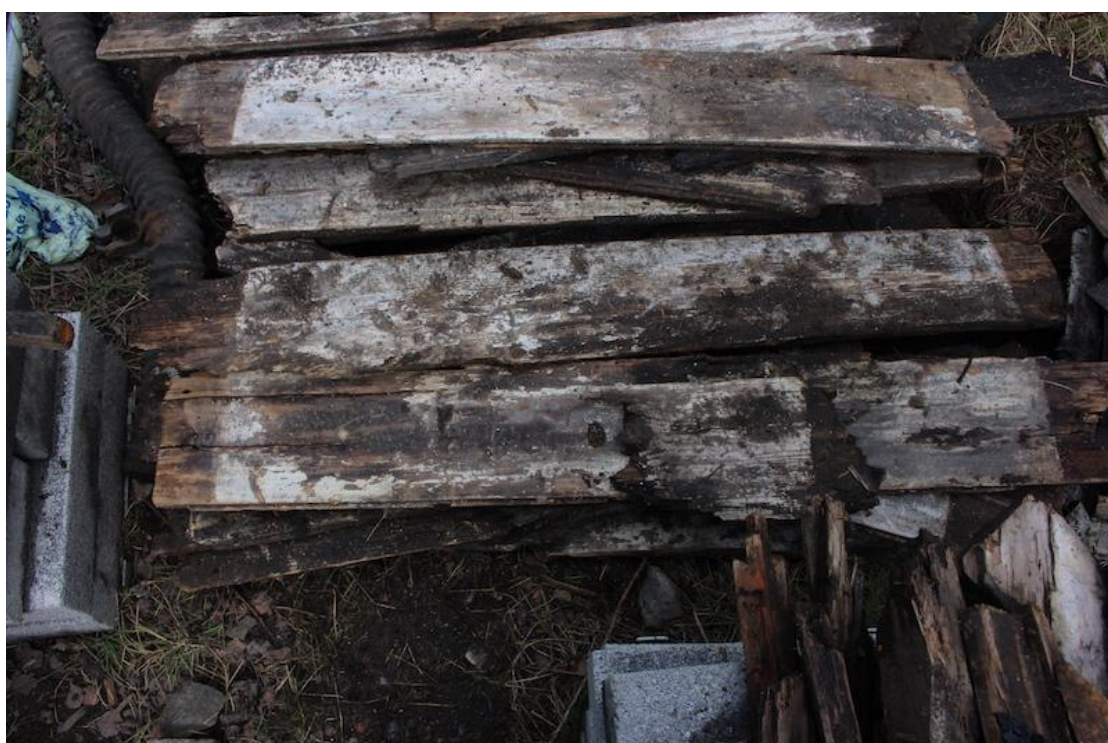
- 5.1.7 A total of 11 lengths of white painted tongue and groove pine timber majority in poor condition and rotten at edges with dimensions of 1.4m x 19cm x 2cm (Plates 45 and 46). These timbers may originate from a timber Vivian Engine House roof, and if so the unpainted ends would suggest that they were fixed at their ends immediately behind steel joists before being painted internally. However, their position in un-stratified deposits means that we cannot be certain of their origin, particularly considering the nature and scale of the re-deposited material that must have come from the wider Hafod site.

Plate 48. White-painted timber tongue & groove boards recovered from both main basement [105] and wheel pit [206].

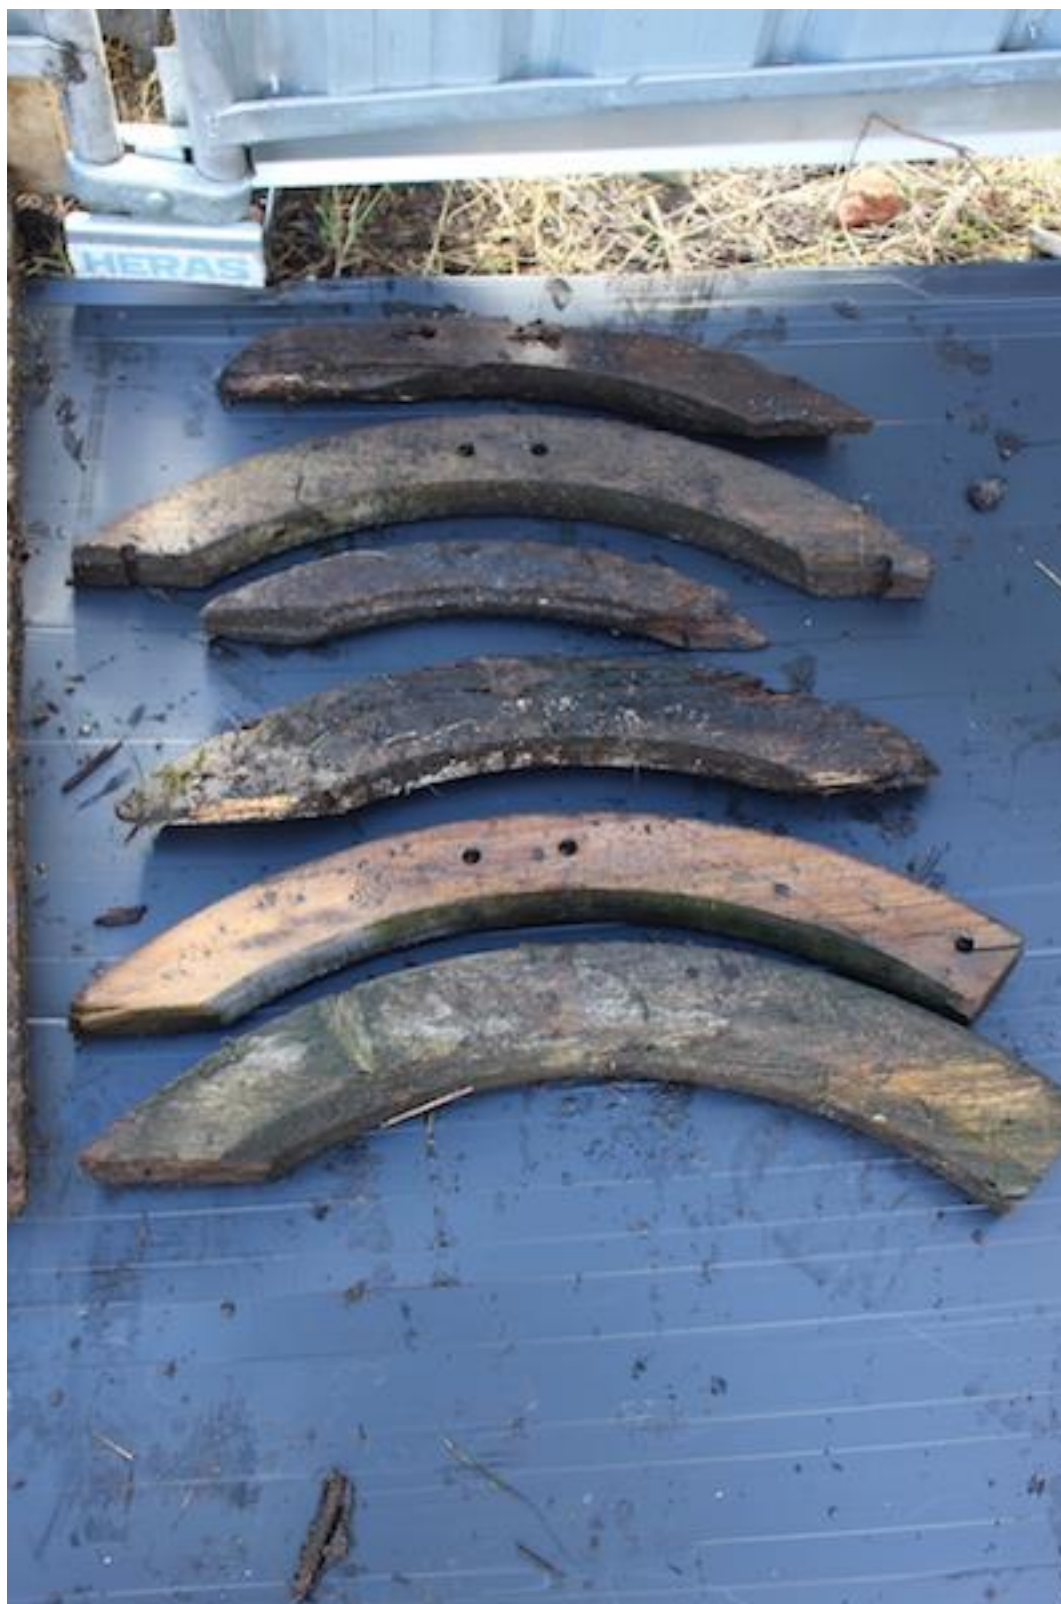
- 5.1.4 Timber window frame sections were recovered that are consistent with existing ocular window openings (Plate 47 and 48). These consisted of quarter circle timber sections, four of which made a complete frame. The glass frame sections, all in very poor condition, showed evidence of caulking as a means of fixing the glass into the frame, at least in their latest phase. Interior faces were painted white. Two fragments featured elements of a brass window catch (Plates 49 and 50, Figure 10).

Plate 49. Examples of sections of timber ocular window frames recovered from both main basement [105] and wheel pit [206].

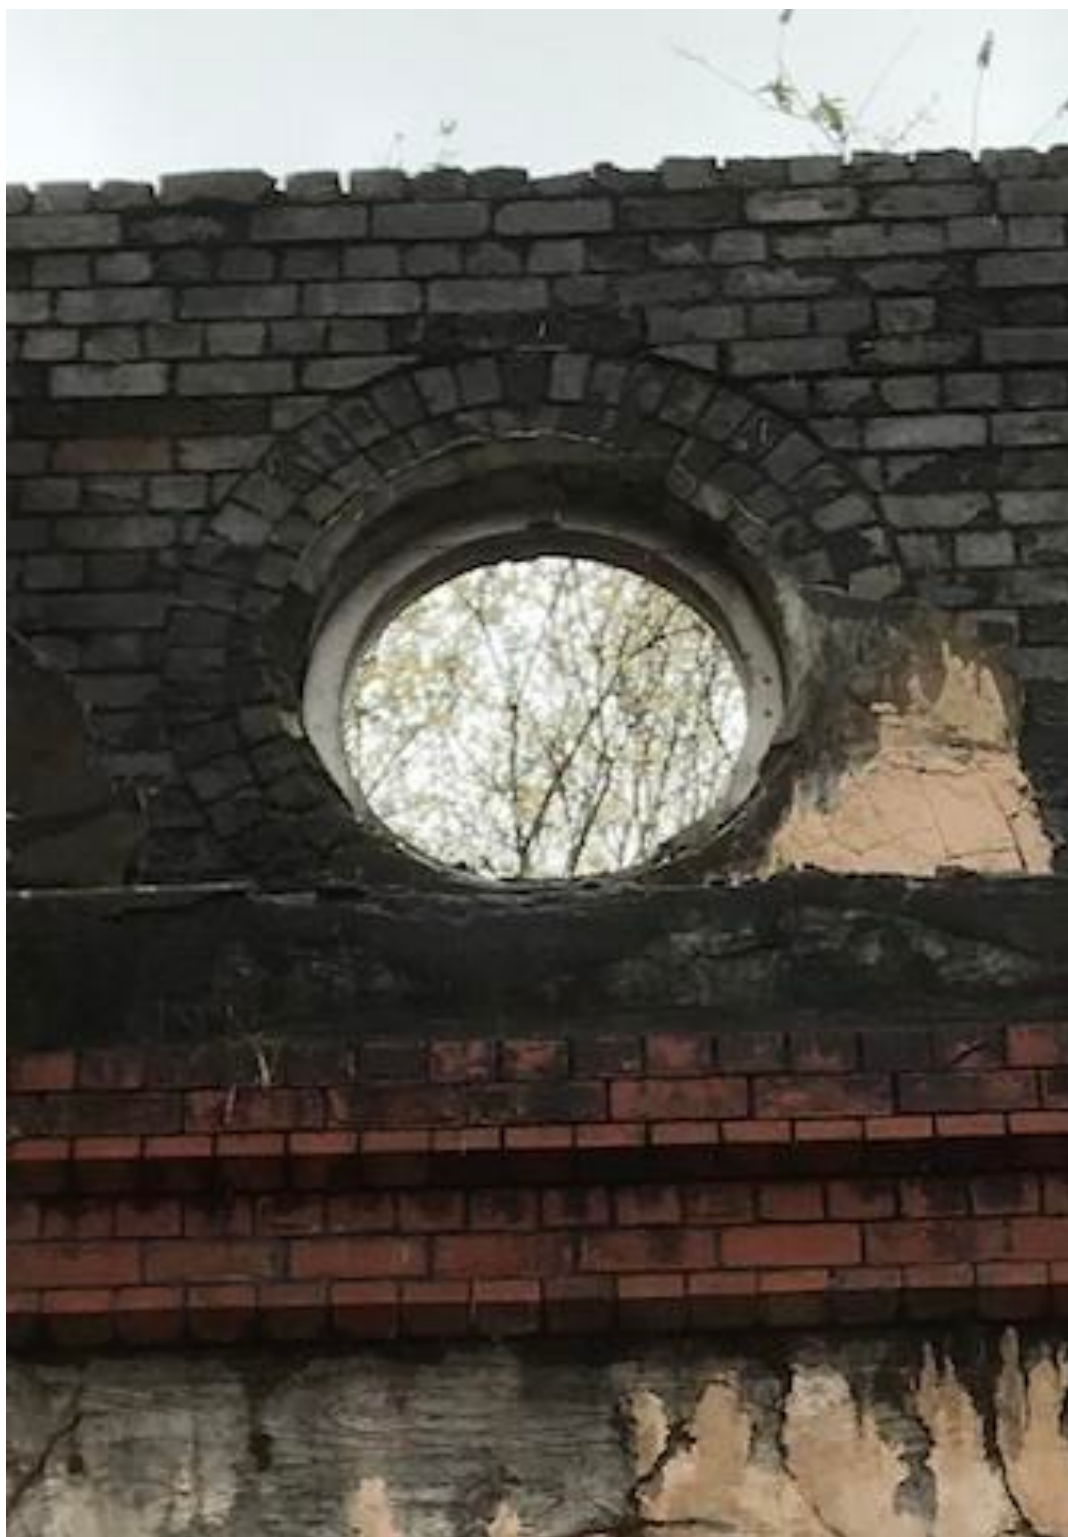
- 5.1.5 There is one *in situ* ocular window frame (Plate 51) that has a catch hook fixture at its top informing us that the window would have clasped at the top and opened inwards. This *in situ* window frame also reveals the method of construction with internal and external frames being each constructed of four quarter-circle sections and then offset and secured with two bolts at the join. No obvious bolts were recovered.

Plate 53. North-facing photo showing in-situ ocular window frame.

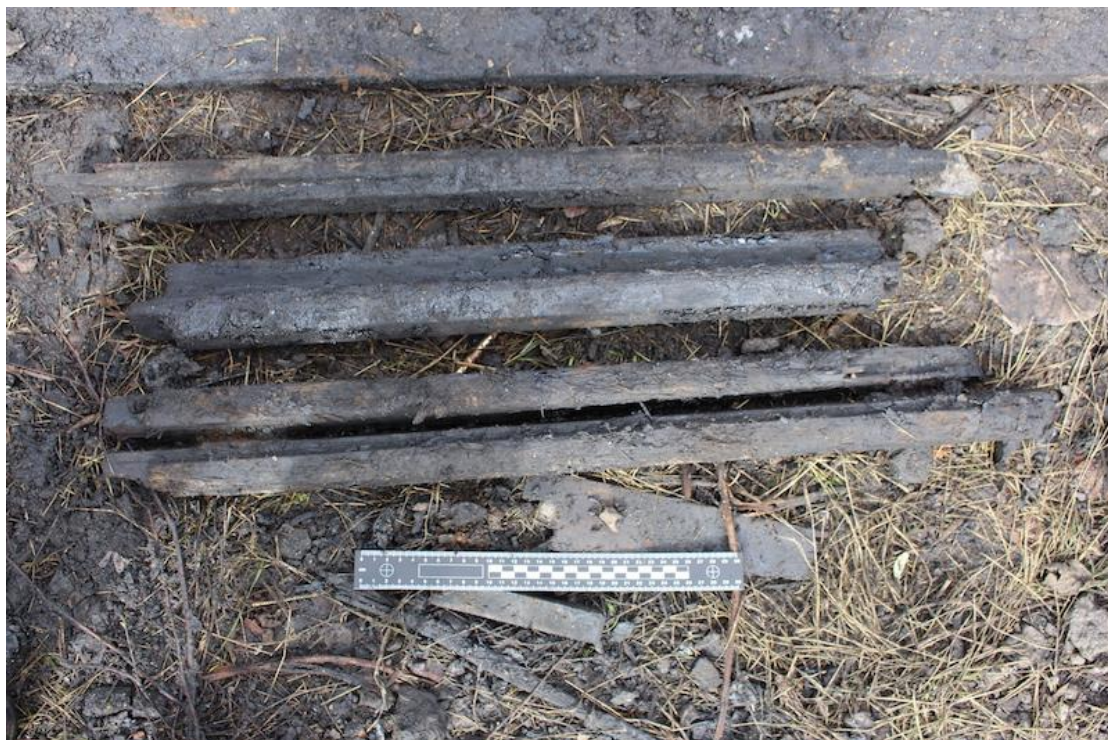
- 5.1.6 Small number of windowpane components that may represent elements of existing rectangular openings but uncertain due to un-stratified nature of backfill (Plate 52). Window frames fragments with identical profile can be found as debris elsewhere on the Hafod-Morfa site.

Plate 54. Sections of timber window frame recovered from main basement [105].

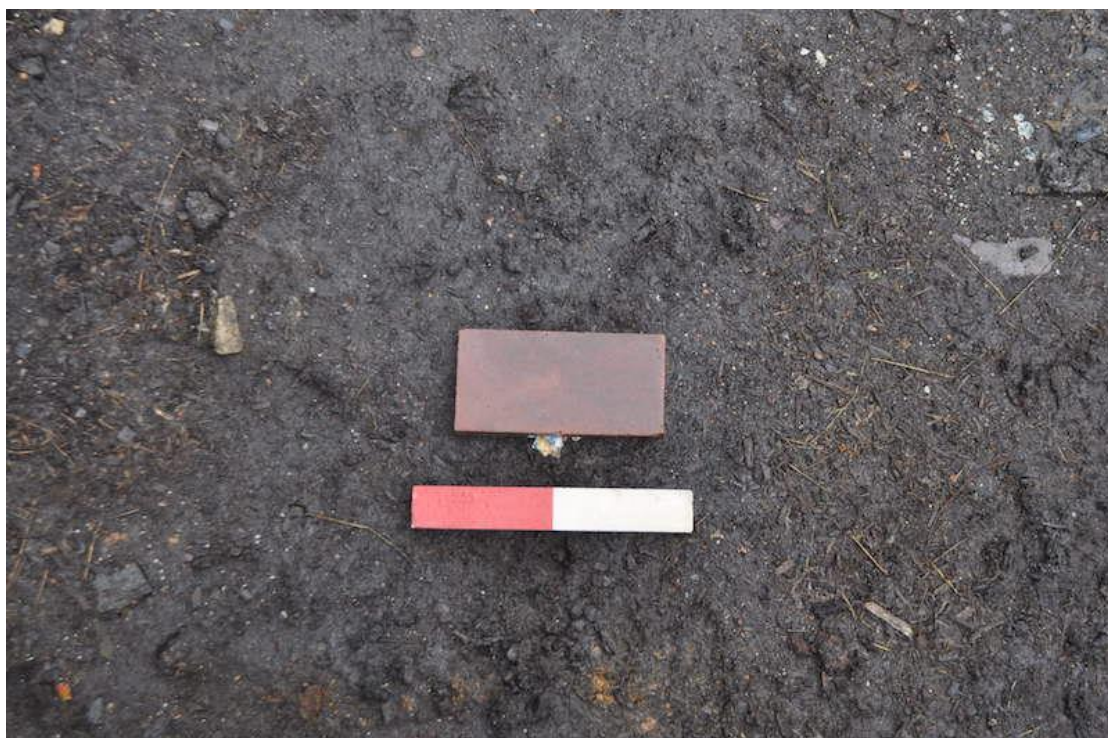
Plate 69. Quarry tile. These remain in situ in the machine floor of the Vivian Engine House.

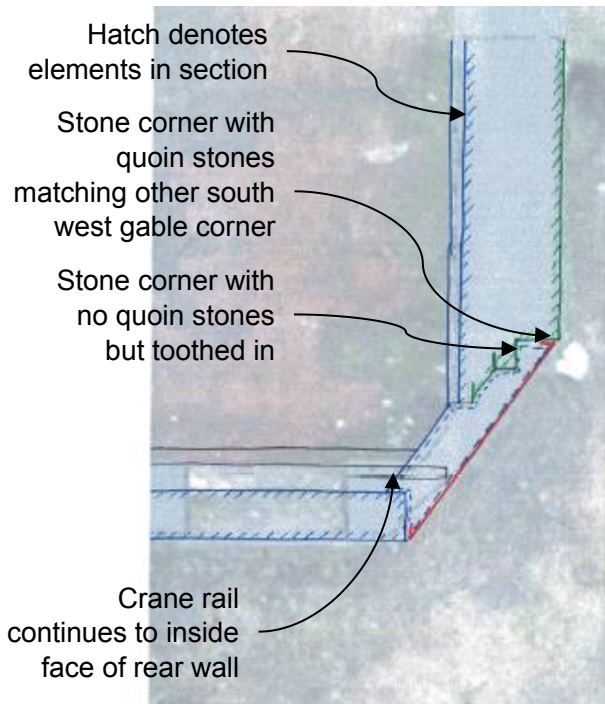
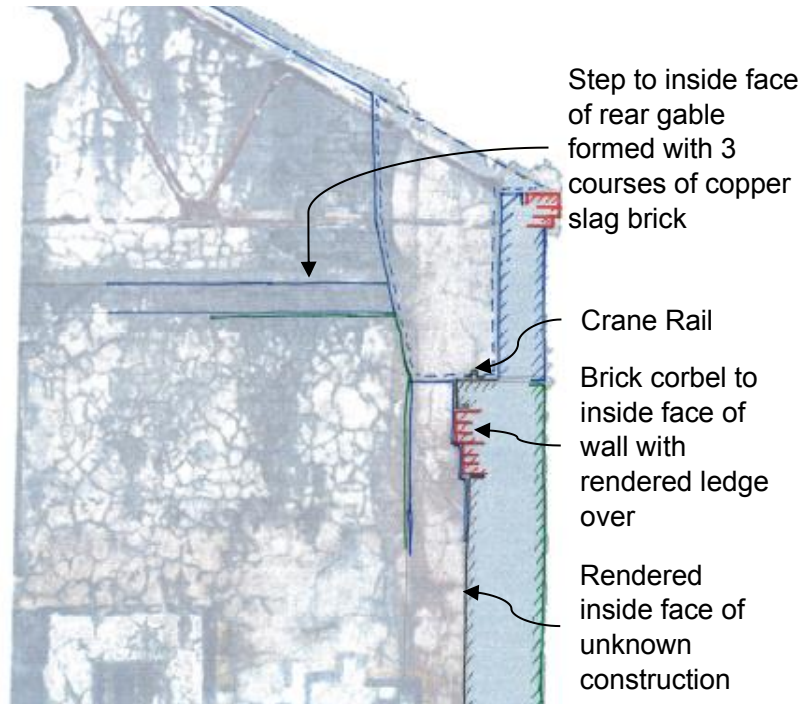
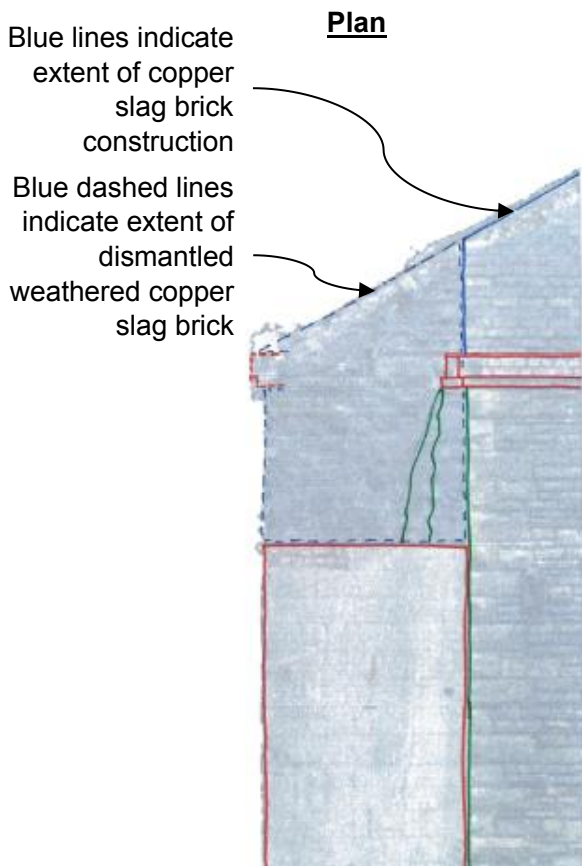
**South West Internal Elevation / Side Wall Section**

2.5 The following sketches record the current materials of this corner of the building

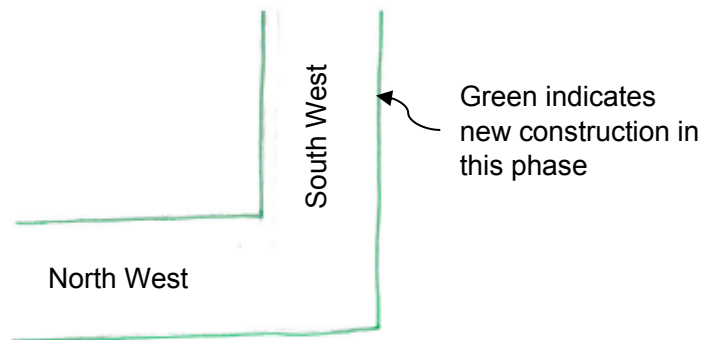
3.3.1 The oldest portion of the building remaining is the south west elevation and half of the south east side wall. This suggest a roughly square original building with the north west side wall on the line of the existing quoins at the edge of the chamfered corner.

3.3.2 This is supported by the line of stone quoins, the variation in wall thickness, the symmetry of the south west elevation and the lack of consistency of openings in the south east side wall. This north west wall position appears to line through with the north west side of the "wheel pit".

3.3.3 The only discrepancies with this are the lack of a scar or straight joint on the inside of the rear elevation and the tothing in of the doglegged section of rear elevation.

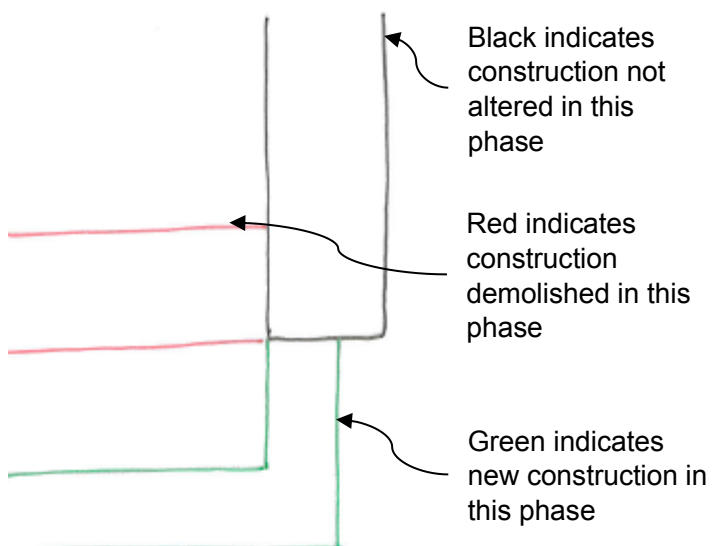
3.4.2 This is mainly evidenced by the portion of stone walling now uncovered and the crane rail which has been shown to extend to the inside face of the rear wall.

3.4.3 There is a discrepancy in wall thickness between the dogleg section at 550mm and the side wall at 650mm. There is also a question as to what was gained by this dogleg.

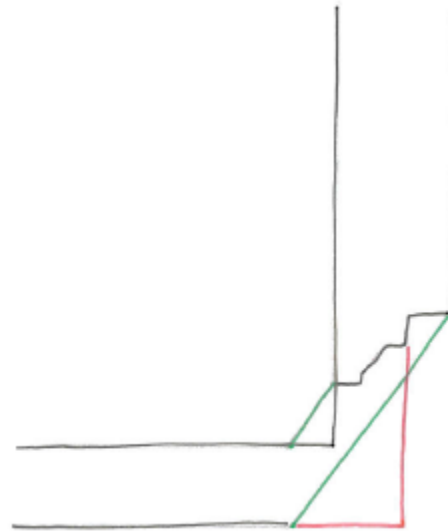
3.6.2 The eaves level brick corbel detail continues onto the dogleg section of rear gable which with the crane rail length suggest the chamfer was a later alteration. There is also a slight change in appearance and weathering of the chamfered panel of copper slag brick in comparison to the side elevation, there is less variation in degradation and more projecting mortar joints.

3.6.3 The most significant discrepancy is the render to the red brick which is cement based in contrast to the masonry underneath being in lime mortar.
