Historic Building Recording at

**LOWER FARM
BOWLING BANK**

Client:	Tony Walsh
Local Authority:	Wrexham County Borough Council
NGR:	340913, 350545
Planning App:	P/2021/0604
Author(s):	E Ellis
Doc Ref:	LP4028C-HBR-v1.1
Site Code:	LP4028C / PRN 166988
Date:	September 21

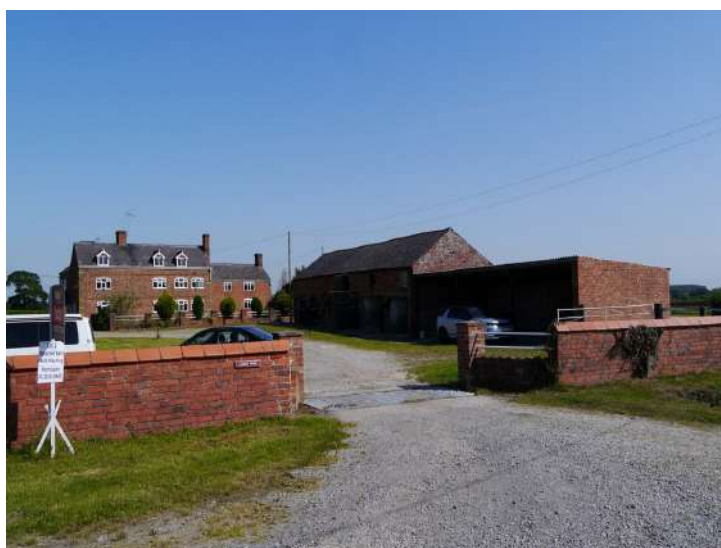
Plate 1 - General shot in context

- 6.3.1. The building is located directly north of Lower Farm Road, part of a series of similar agricultural buildings including a dwelling, set within a large open forecourt and comparatively level plain site, which presents extensive vistas over the surrounding agricultural landscape (PLATE 1).
- 6.3.2. The complex sits on a north-west to south-east axis with access into each floor level made via the south-west elevation. The fabric consists primarily of brick and mortar with timber framing, and a pitch slate gable rooftop with plain ceramic ridge tiles (PLATE 2).
- 6.3.3. The brick course is of english garden wall style, and although generally uniform breaks in formation can be seen, with random rows of stretchers between each row of headers.

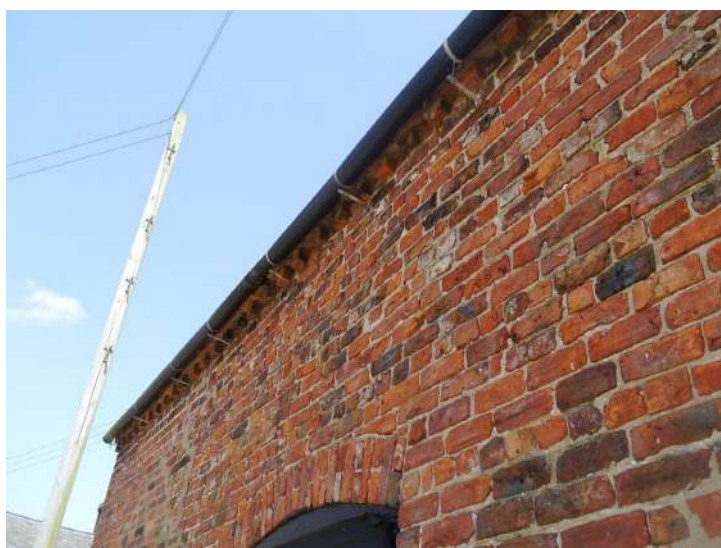
Plate 4 - Dentil top course south- west elevation

6.3.4. The south-west elevation functioned as the front facade and main access point into the building (PLATE 3). Protruding brick end top coursing decorated in dentil fashion, were featured below the slate roofline (PLATE 4).

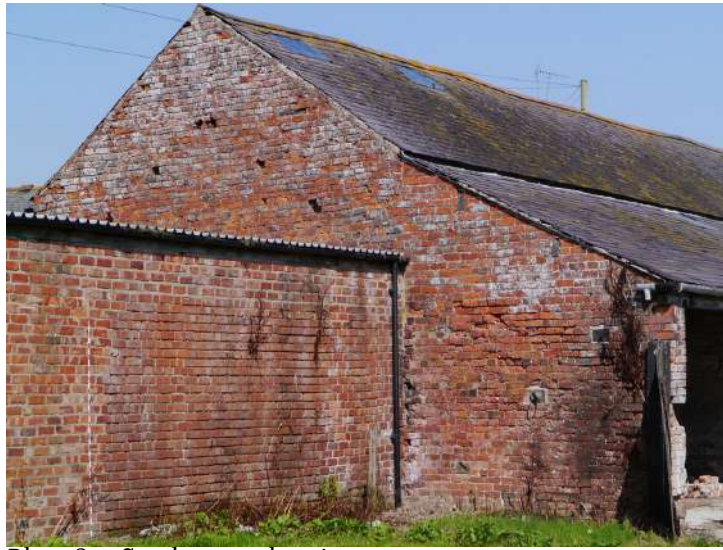
Plate 8 - South-west elevation

- 6.3.13. Ghosting of a previous building marked the south-east elevation wall, which appeared to have resembled a pitched roof. Timber beam slot holes chased the impression in a triangular fashion, further indicating an earlier structure (PLATE 8).

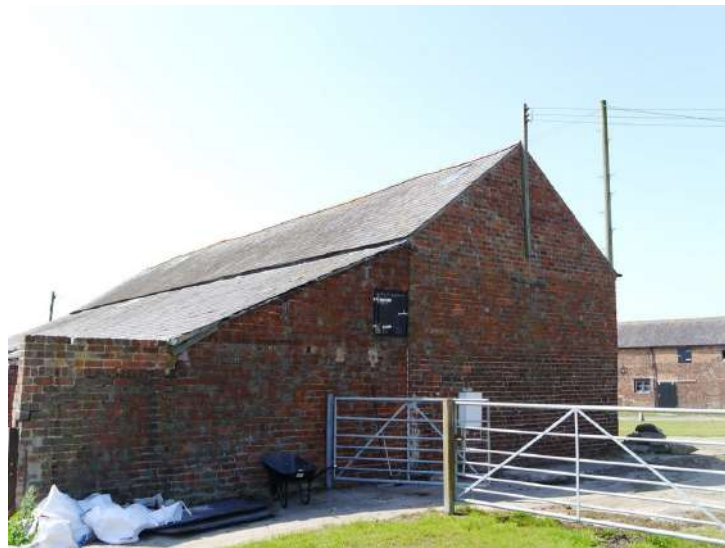
Plate 9 - North-west elevation

6.3.18. The gable end was fashioned in english garden wall bond, with rows of stretchers between each row of headers (PLATE 9).

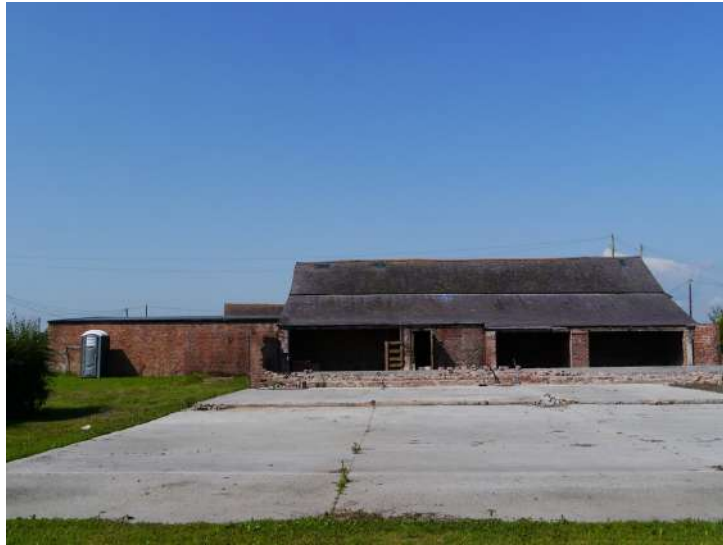
Plate 11 - North-east elevation

6.3.26. The extent of the north-east elevation comprised of a later extension phase, which consisted of three large open planned barns and one internal barn accessed via a single doorway (PLATE 11).

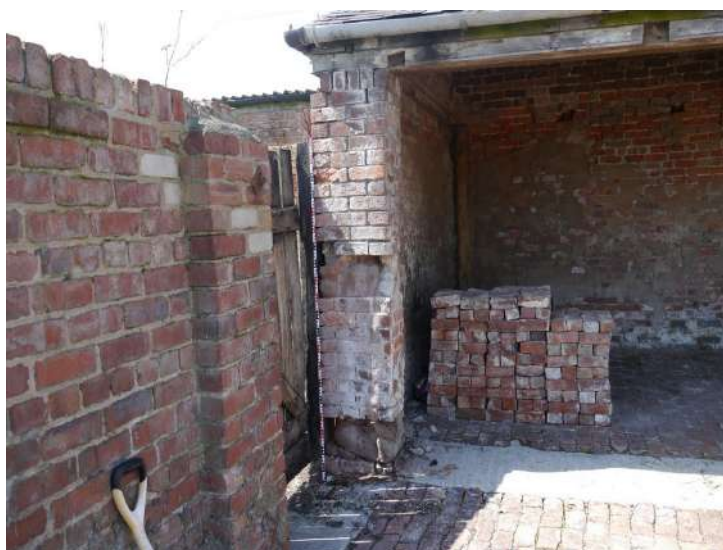
Plate 12 - Sandstone with imbedded iron hinges room B4

6.3.27. Room B4, located on the south-west most elevation, was the widest of the three open barn features. The supporting south-east wall of room B4 had two sandstone blocks with iron hinges still imbedded, which would have functioned as the support for a barn door (PLATE 12). The adjacent north-west division wall had similar parallel features, but masked with a cement coating to the lower section of the wall. The threshold was made of concrete in a linear fashion separating the internal and external brick floor. A recycled structural timber frame with exposed lapped joints, functioned as the joist below the roofline.

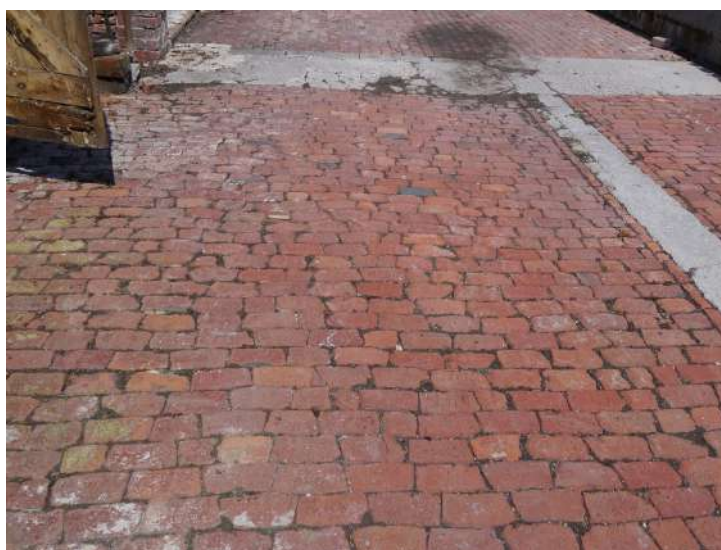
Plate 14 - Brick floor

6.3.36. The forecourt was decorated in red brick (PLATE 14).

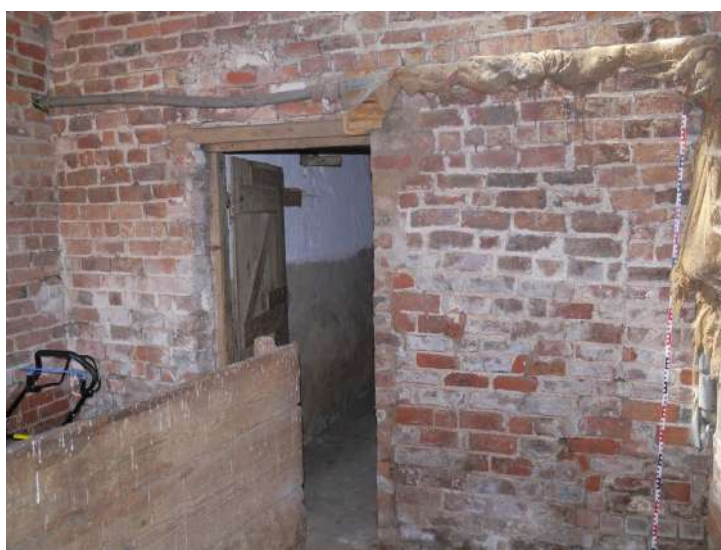
Plate 20 - Threshold south-west elevation room B3

to accommodate the threshold, suggesting the doorway was inserted at a later phase and not part of the original design (PLATE 20).

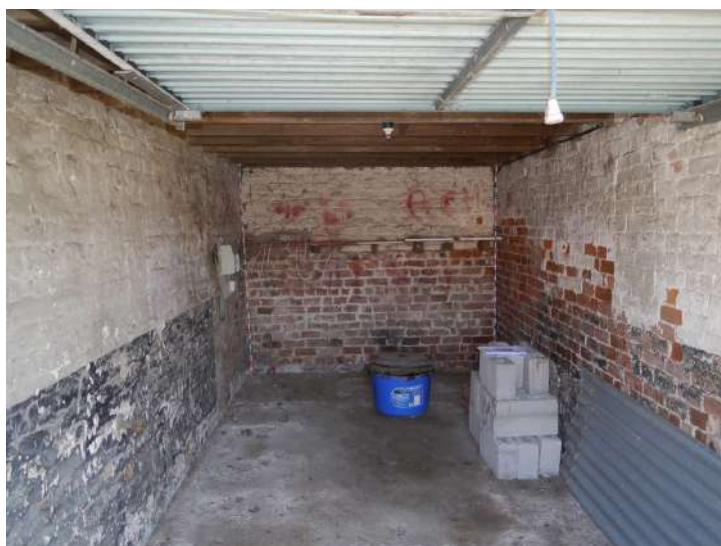
Plate 23 - Room B5

6.4.30. The internal north-west, north-east, and south-east walls consisted of brick material in English garden wall style. A remnant of white paint was present on the upper brick surface and black paint on the lower section, which partially concealed reconstruction marks made from later structural modifications (PLATE 23).

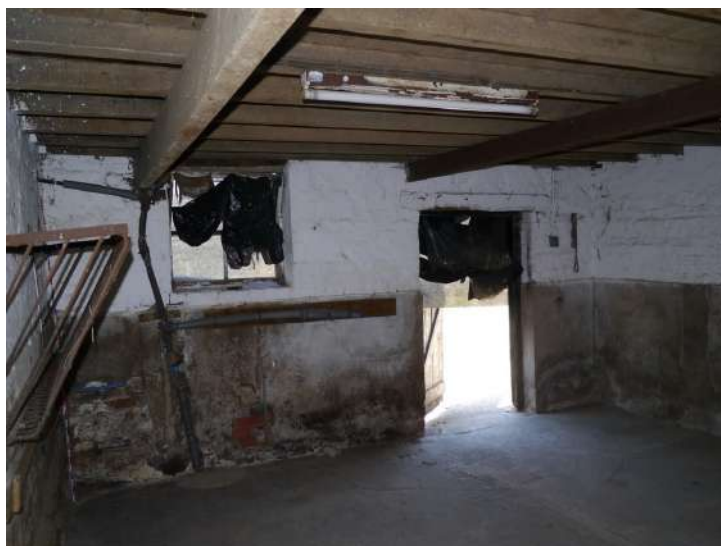
Plate 25 - Threshold and Window on south-west elevation in room B6

6.4.38. A later phase of reconstruction was evident where a central positioned steel joist, and south-east positioned modern timber framed joist, fused to the north-east and south-west elevation walls (PLATE 25). A series of modern timber framed hanging beams positioned in a north-west to south-east alignment above the steel and timber joists, were fused either end into the north-west and

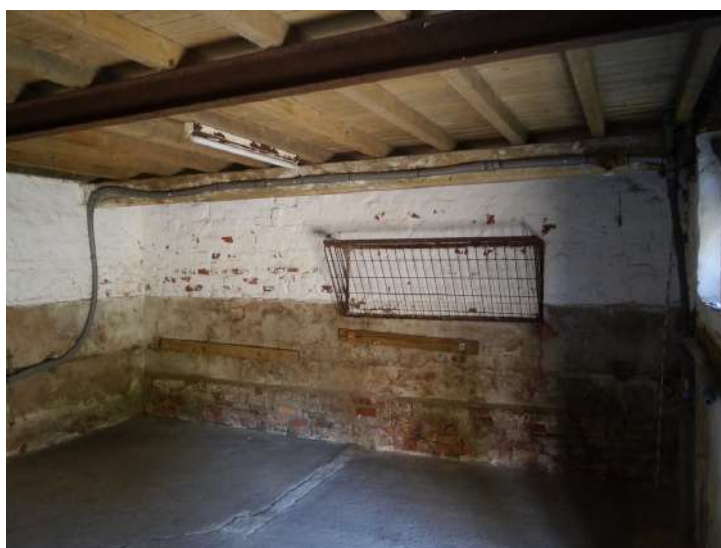
6.4.39. The floor consisted of modern concrete which featured structural outlines extending from both the north-west and south-east walls, where stall partitions for the segregation of horses may have originally stood (PLATE 26).

6.4.40. A cast iron hay rack was fused to the south-east wall and another to the north-west wall.

Plate 26 - An iron cast hey rack and concreted stall foundation

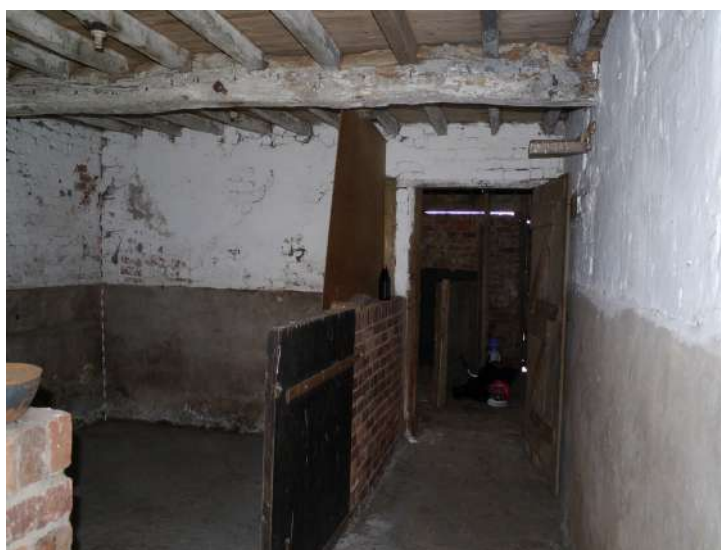
Plate 27 - Room B7

6.4.43. The area was subdivided by two fifteen course high brick walls in english garden wall stretcher bond style, and complete with a top course of headers. One divider stemmed from the south-west elevation and directly north-west of the doorway, and the other from the north-east elevation directly north-west of the B3 doorway (PLATE 27). The two walls formed an open centre where a timber swing gate was fixed.

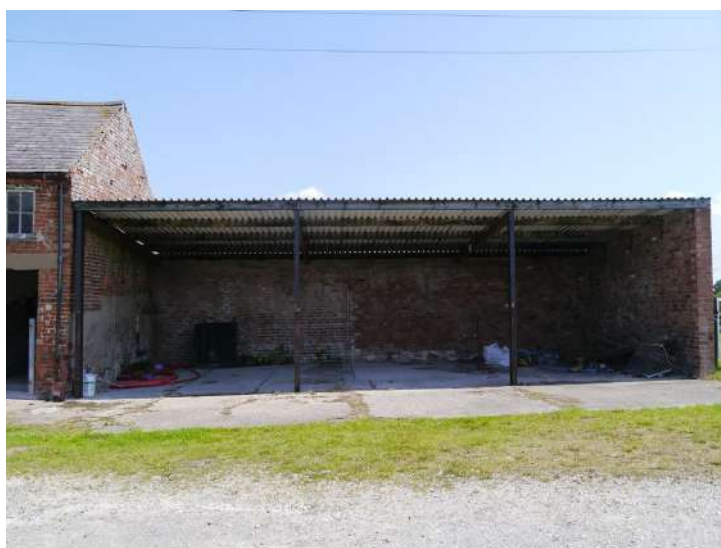
Plate 32 - Room B10

6.4.62. B10 was a contemporary addition, completely open with exposed steel supporting beams which held up the corrugated metal roof sheeting. The roof gradually sloped north-eastwardly towards the ridge of the north-east brick wall (PLATE 32).

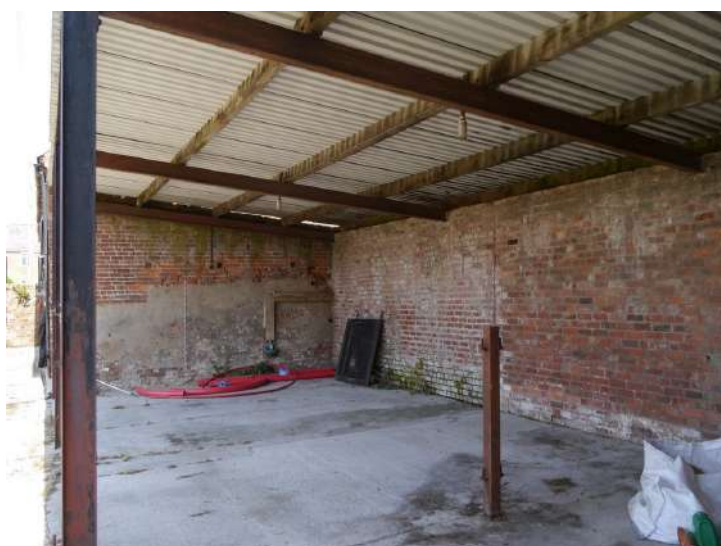
Plate 33 - Internal space room B10

6.4.63. The floorspace consisted of modern concrete and utilised for storage during the time of survey (PLATE 33).

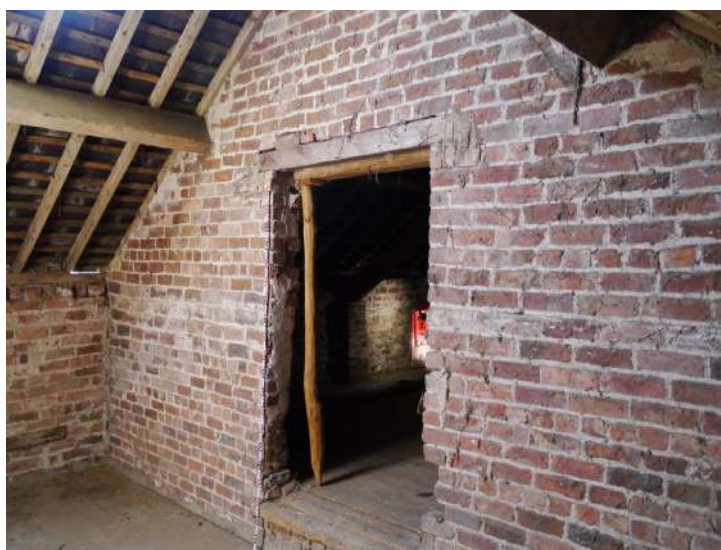
Plate 34 - Threshold south-east wall room F1

- 6.4.66. Situated on the south-east elevation wall was a threshold implemented at a later phase, evident from the outline of the doorway which appeared to have disrupted the fabric of the brick. The doorway consisted of timber lintel and threshold (PLATE 34).

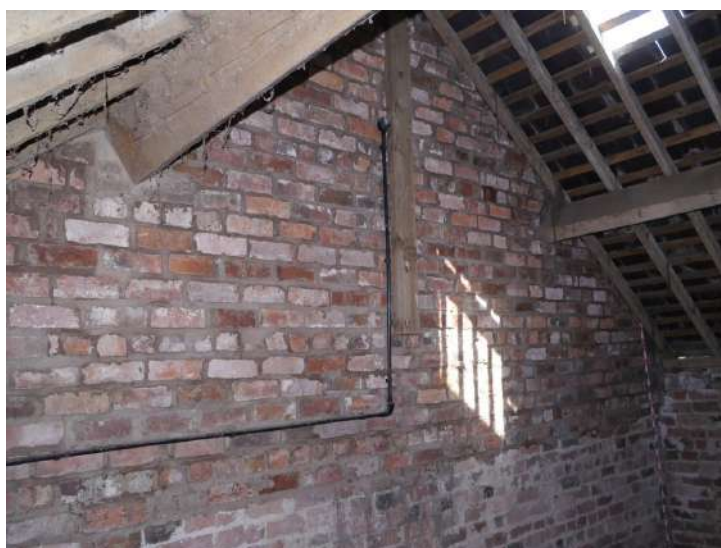
Plate 35 - North-west wall room F1

- 6.4.67. The threshold stepped down into F1 from B2 by a height of two brick courses, onto a contemporary timber floorboard surface.
- 6.4.68. The upper north-west brick wall had been restored at a later phase from the thirteenth course brick, which was evident from the discolouration of mortar (PLATE 35). The fabric appeared to have accommodated the contemporary timber purlins that protruded in a north-west to south-east fashion, indicating the wall had been reconstructed in conjunction to the restoration of the roof.

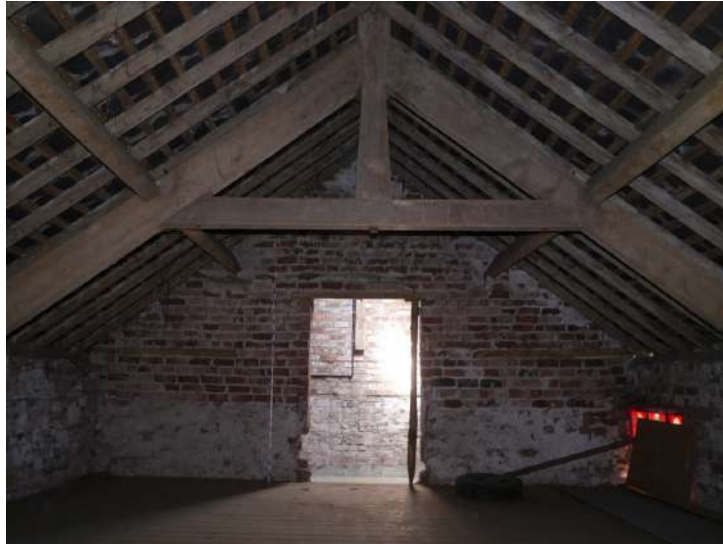
Plate 37 - Room F2

6.4.73. The ceiling comprised of the open roofline with exposed timber structural framing and slate rooftop. Two protruding brick wall posts, two course wide and eleven course high, were visible in the centre of the room which bore the timber central timber principle rafters above. Two timber purlins were fixed from the north-west to south-east walls, which rested above the principle rafters, whilst a collar beam further supported the central principle rafters. A series of common rafters rested above the purlins, extending in a declining fashion from the ridge of the open roof, to the timber wall plate located on the south-east and north-west walls (PLATE 37).

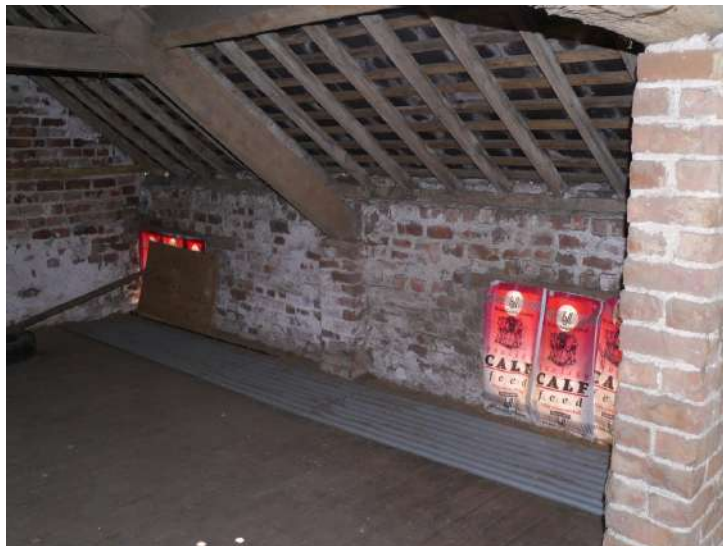
6.4.74. Two rectangular windows with timber lintels were positioned on the north-east wall, directly above the floor surface (PLATE 38).

Plate 38 - Two window features and brick wall post

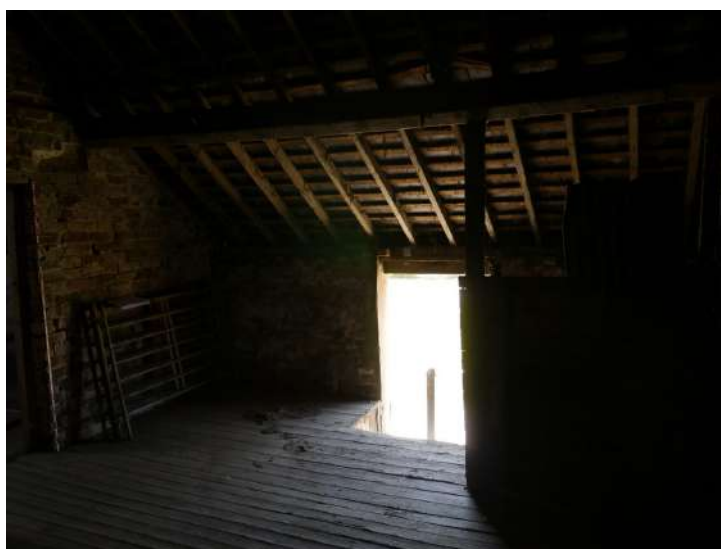
Plate 39 - Threshold south-west elevation room F3

6.4.76. The short narrow threshold, positioned on the south-west elevation in room F3, functioned as the main and only access route into the first floor level from the external staircase (PLATE 39).

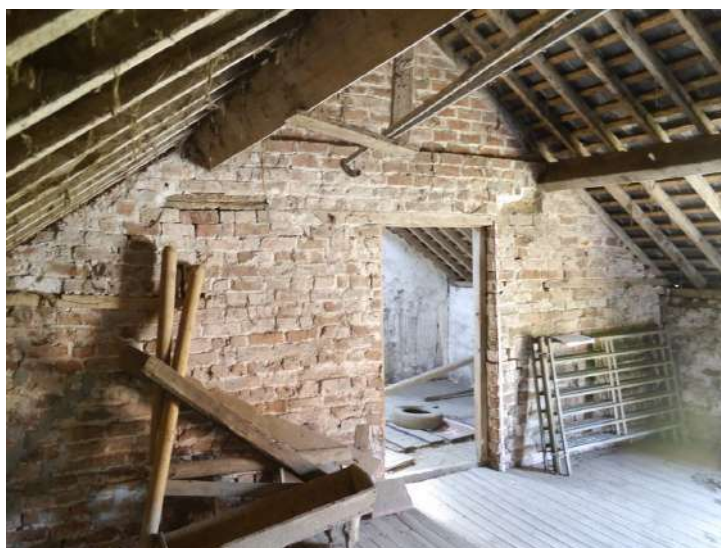
Plate 40 - South-east elevation room F3

6.4.77. Room F2 was assessable via a wide open threshold on the north-west elevation, and room F4 via a much narrower threshold on the south-east elevation (PLATE 40).

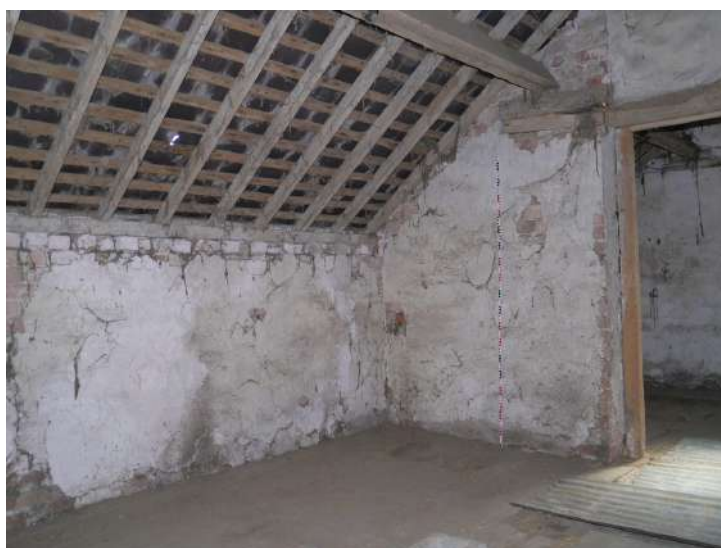
Plate 41 - Room F4

6.4.83. The walls were coated in a layer of white wash cement render, and the floor consisted of timber floorboards (PLATE 41).

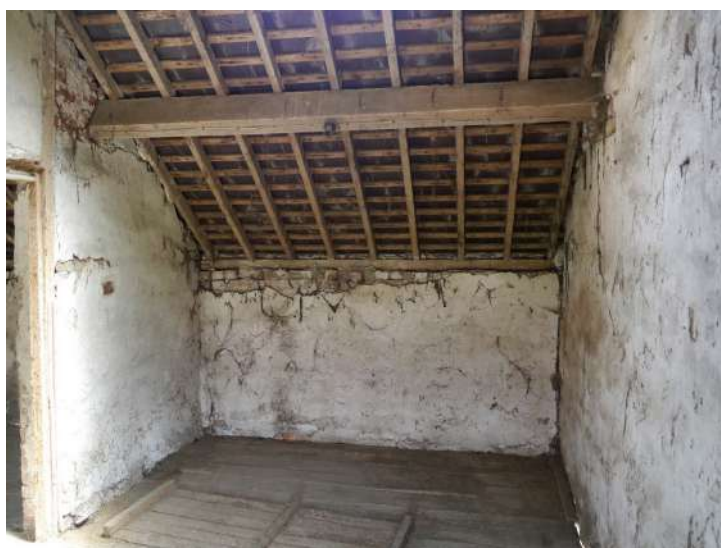
Plate 43 - Room F5

6.4.86. Room F5 was positioned on the south-east most side of the complex, consisting of a small rectangular floorspace accessible via room F4 (PLATE 43).

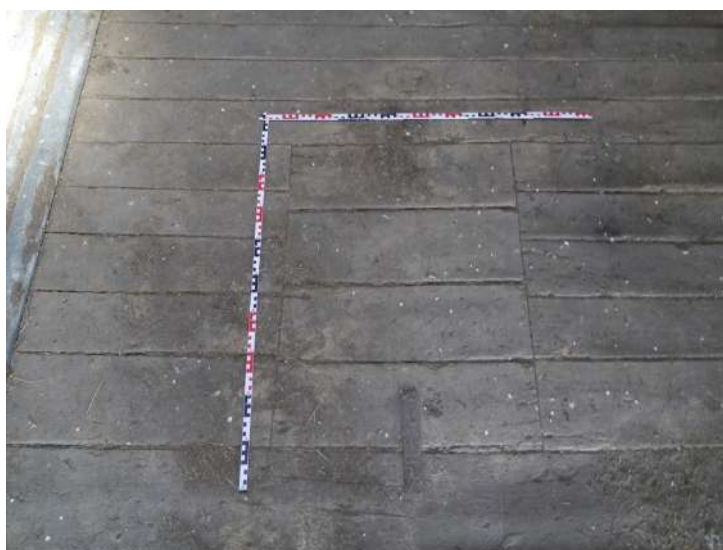
Plate 44 - Floor hatch room F5

floorboards. A square hatch door was visible in the centre of the floor (PLATE 44).

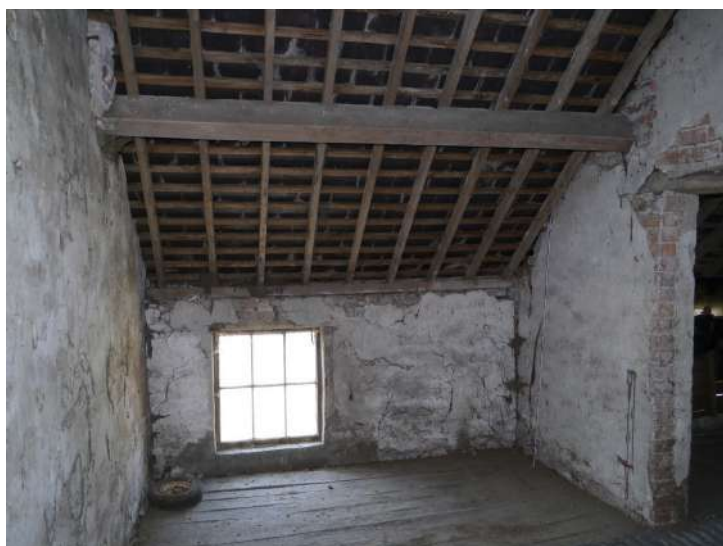
Plate 45 - Window feature south-west elevation room F5

6.4.88. A small square window was positioned on the south-west elevation wall, in similar dimension to the window in F4 (PLATE 45).

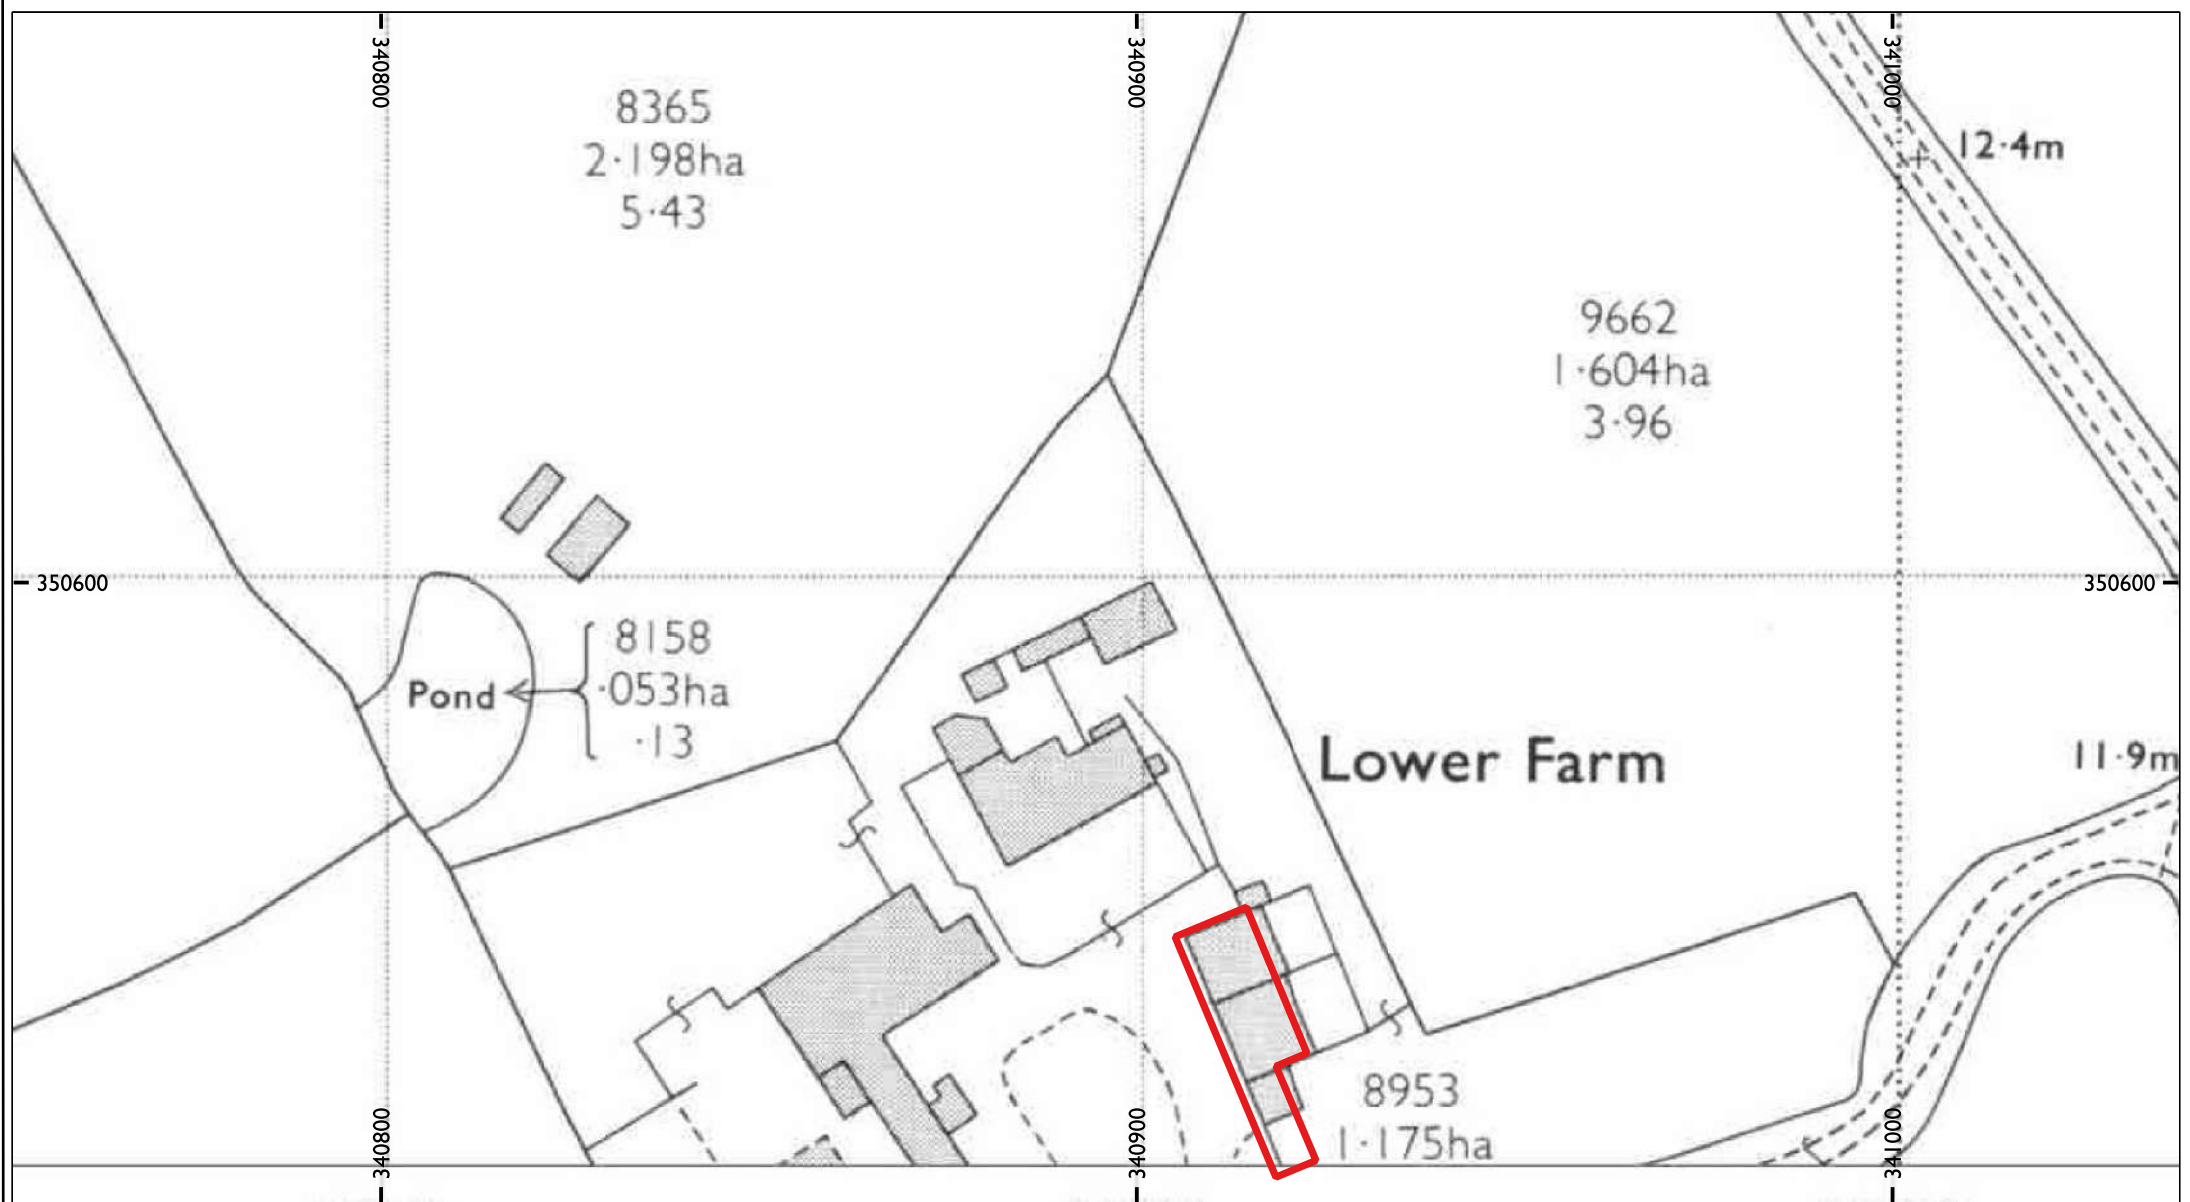
FIGURE 11 // 1970 OS Map

- 4.1.7. The 1970 OS Map edition (FIGURE 11) depicts a small extension to the north most corner of the complex, and another extension on the south most corner. The south-east expansion had been extended further in the 1993 OS Map (FIGURE 13), while another rectangular complex appears to the north-east, parallel to the barn building, where it is seen on the 2001 OS Map (FIGURE 14).

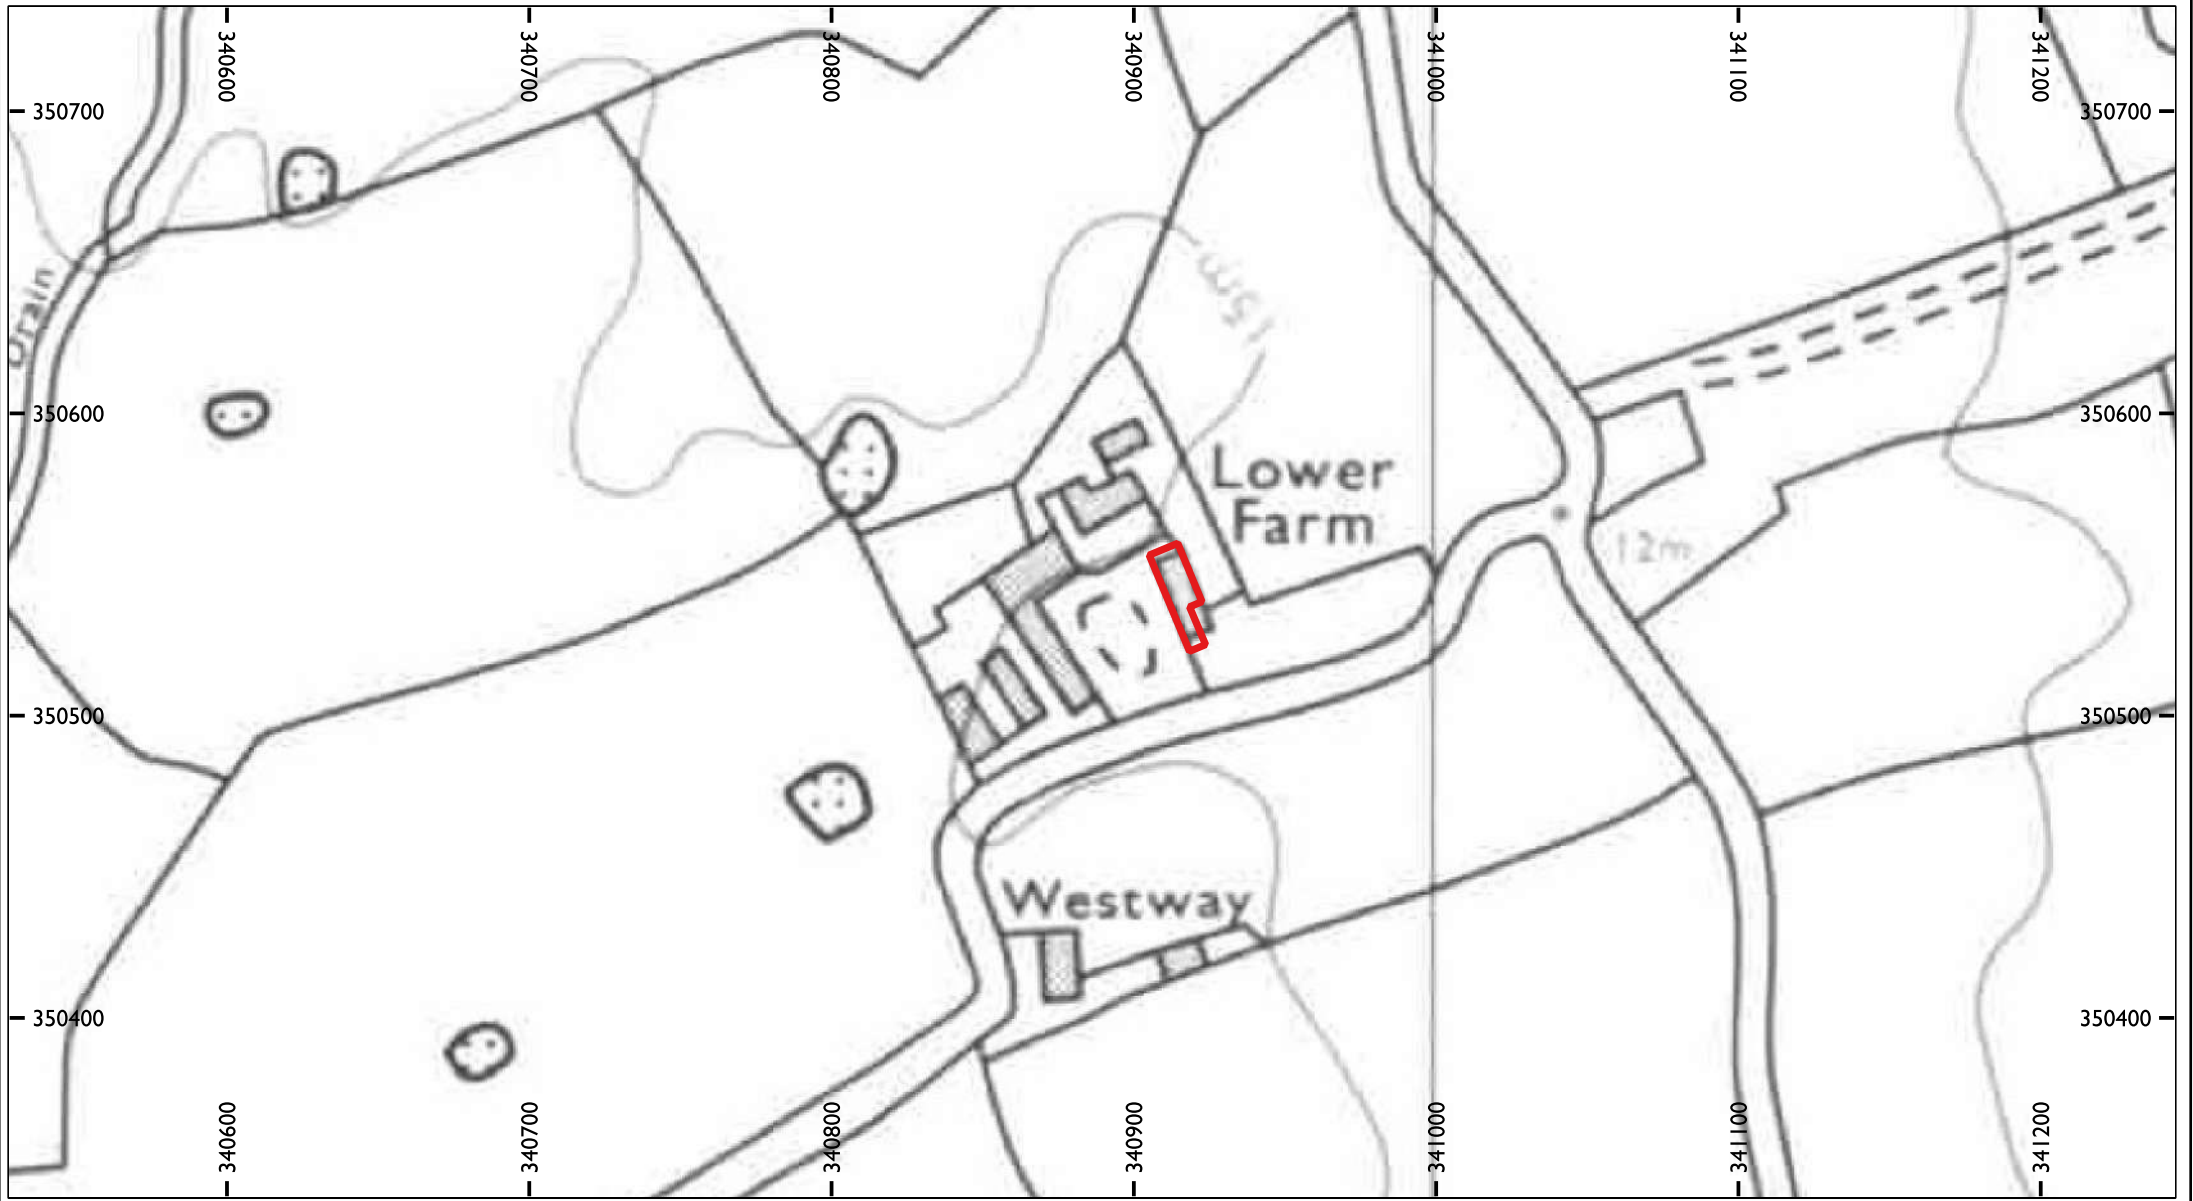
FIGURE 12 // 1976 OS Map

- 4.1.8. During the time of survey, the 1970 and 1976 (FIGURE 12) expansions, including the 1993 building to the north-east, were absent, while the main 1843 illustrated building complex was present.
