Historic Building Recording at Springfield Farm Marford Hill

Report No. 22/4602C

A level 2 building survey was carried out at Springfield Farm, Marford Hill, Marford, LL12 8TD in December 2022 by Ethan Ellis and John Baker of MOLA on behalf of the client Blueprint Architectural Services Ltd.

The survey was requested by Clwyd Powys Archaeological Trust (hereafter CPAT) prior to the conversion of the barn into office buildings and took the form of a photographic and drawn survey in line with Historic England best practice and an agreed methodology, as laid out in a written scheme of investigation (Ellis 2022).

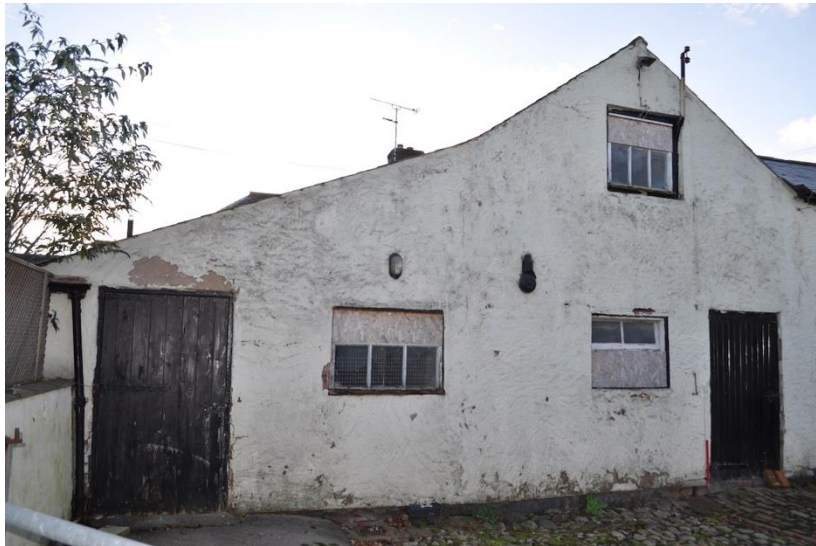
6.2.1. The north west facing elevation the external façade is covered in a white render which obscures the brickwork (Plate 1). There is a slate roof which, according to the owner, was replaced in the 1980's. Towards the north east there is a single story lean to extension (Plate 2). Towards the south west, there is a single story cart shed which forms a further extension to the building (Plate 3).

Plate 2 - Lean-To Extension on North West Elevation

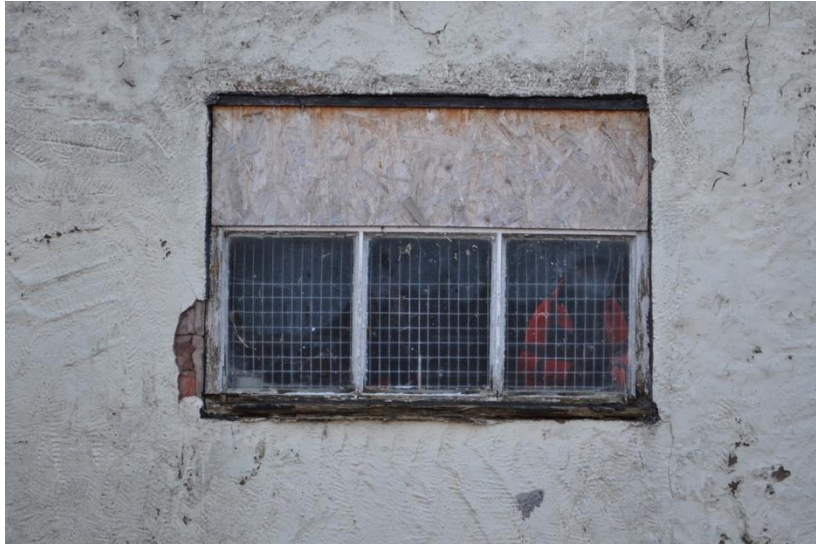
6.2.2. There are five windows visible; to the north east of this elevation, three windows are rectangular and partitioned on the lower pane into three, and the upper pane into two (Plate 4, 5 & 6). The upper pane is hinged at the bottom in a hopper light style. The windows are single glazed, and timber framed, with a timber lintel and sill. On the first floor towards the south west of this elevation, the window is covered with a wooden shutter door (Plate 7). It is square, single hinged and timber framed. This window likely permitted access into the hay loft on the first floor. On the ground floor, and towards the south west, there is a single ornate window with an ogee arch (Plate 8). This is typical of the style and character of the Marford area. The window has a metal casement but a more modern sill of brick suggesting a later date for its inclusion.

Plate 4 - Ground Floor Window on North West Facing Elevation

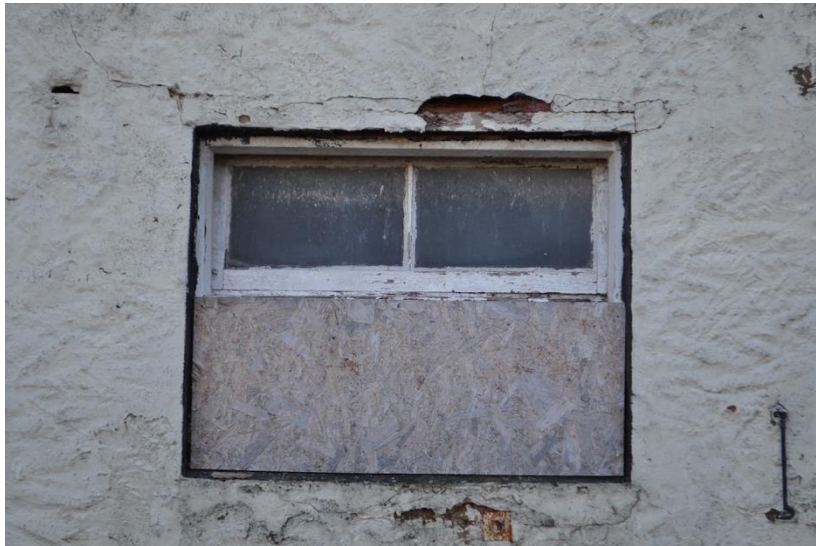
Plate 5 - Ground Floor Window 2 on North West Facing Elevation

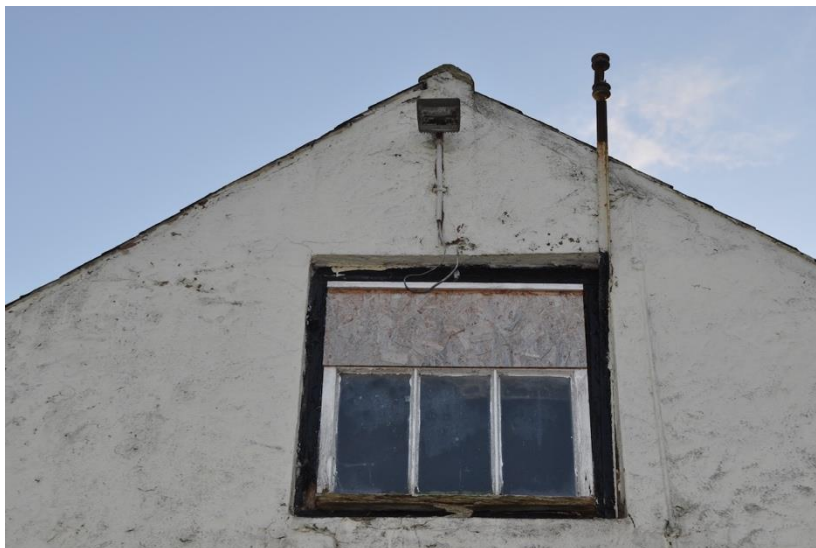
Plate 6 - Upper Window on North West Facing Elevation

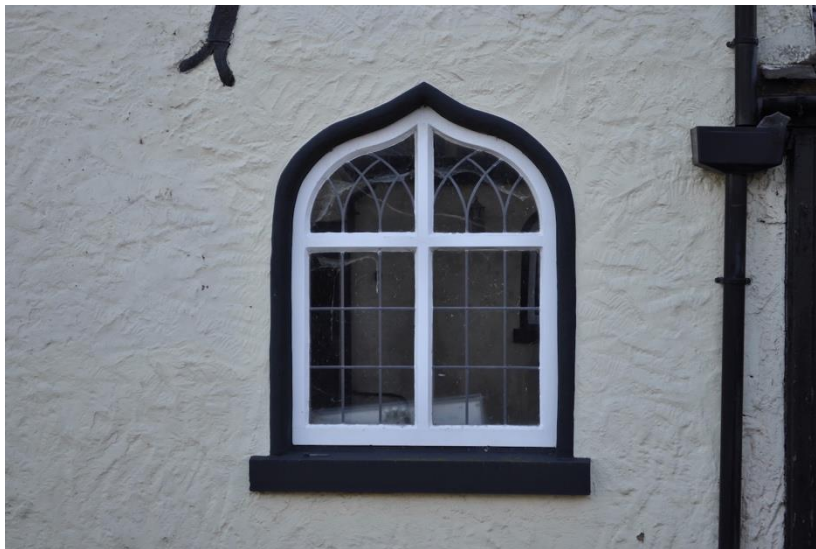
Plate 8 - Ogee Window, Ground Floor, North West Facing Elevation

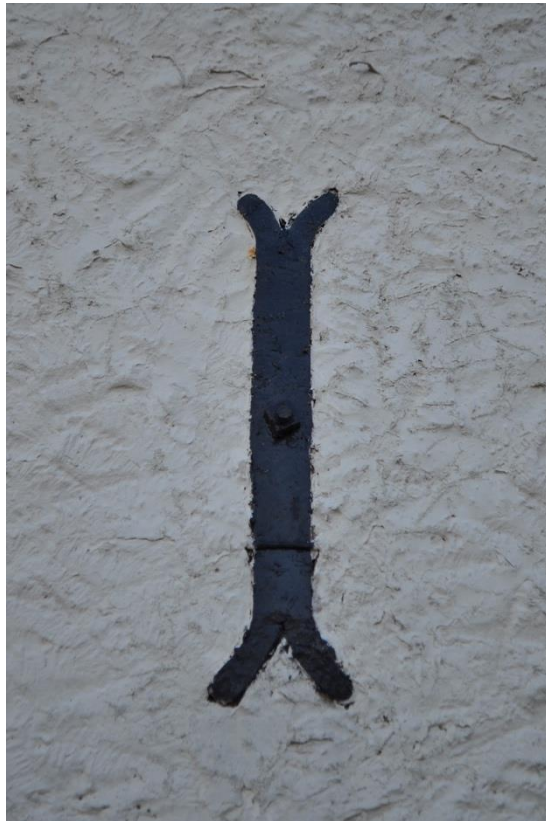
6.2.4. In detail, there is a fire bell attached to the wall on the ground floor level between the first and second windows on the north east side (Plate 13). The inscription on the bell reads 'TANGENT'. Towards the south west side there are two metal wall ties between the ground and first floor which serve to reinforce the structural integrity of the building (Plate 14 & 15).

Plate 14 - Detail Shot, Patress Plate, North West Facing Elevation

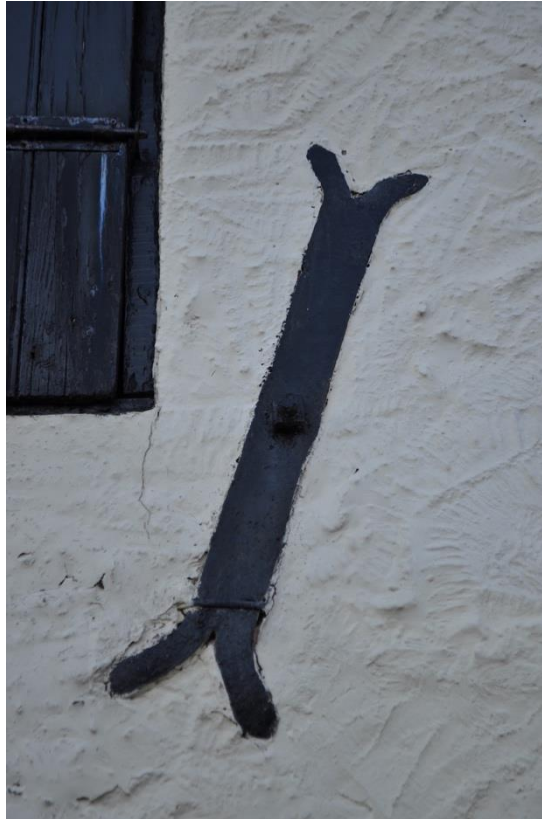
Plate 15 - Detail Shot, Patress Plate, North West Facing Elevation

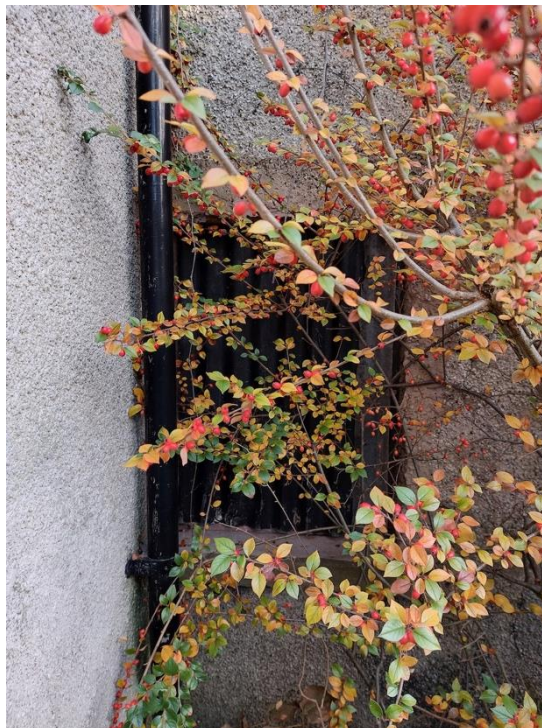
6.3.6. There are two further windows on this portion of the elevation. The first is small, with a stone sill and presently boarded up (Plate 21). The second appears much higher up towards the centre of the façade. It is single glazed and has a wooden sill and lintel. The lower pane is divided into three and the upper is as a single piece (Plate 22).

Plate 21 - Boarded Window on South West Facing Elevation

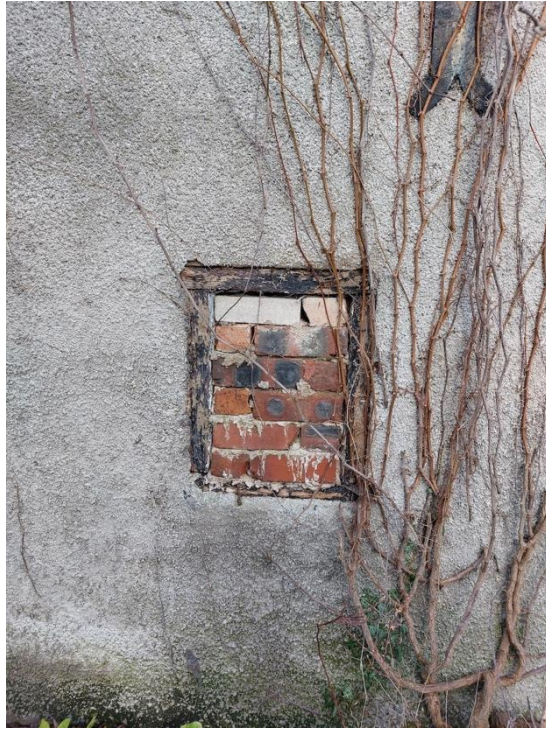
6.4.2. There is a small window to the south west which has been bricked up with machine made brick suggesting a post, mid 19th century modification. It is timber framed and has a timber sill (Plate 25). Adjacent to it is a larger rectangular window which is also timber framed with a wooden sill (Plate 26). The lintel is obscured by the render. Towards the north east end, there is an arched window that is largely obscured by foliage. The arch has been formed in brick and there is a wooden sill still partially extant. This window has also been boarded up (Plate 27).

Plate 25 - Bricked up window, South East Facing Elevation

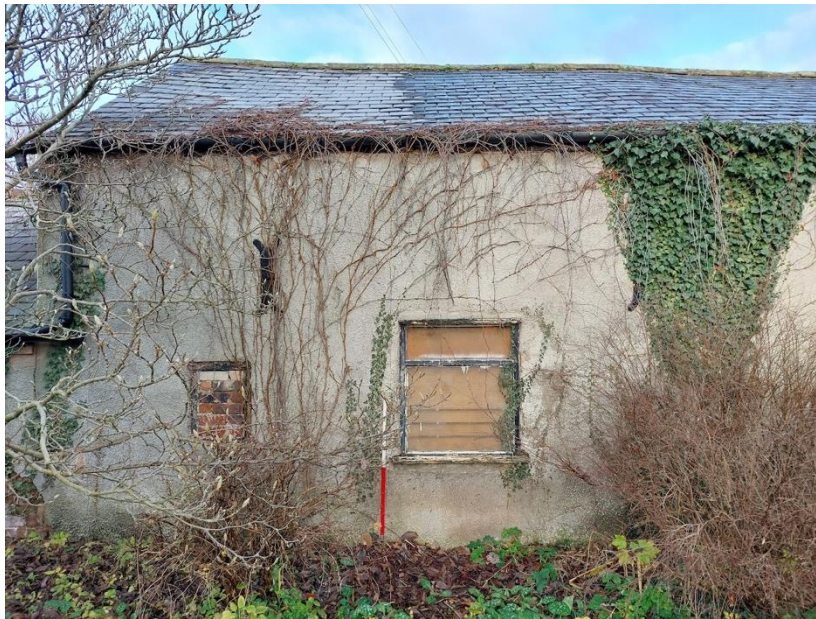
Plate 26 - South East Facing Elevation, Close Up

6.4.3. There are two braces evident on this elevation which compliment those seen on the north west elevation (6.2.4) (Plate 26). There is a wooden batten seen just below the roofline of the cart house, this appears to be modern and supporting the modern UPVC drainage.

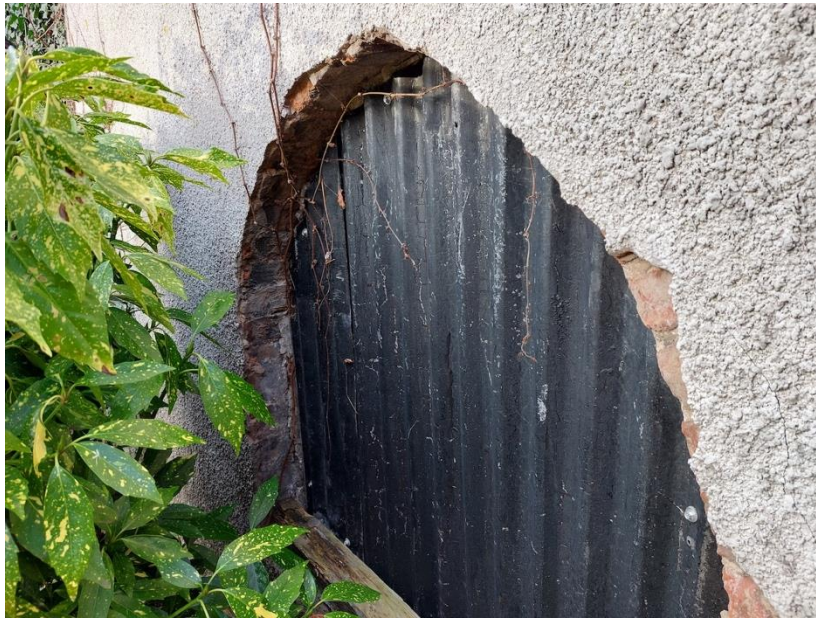
Plate 27 - Boarded Up Arched Window, South East Facing Elevation

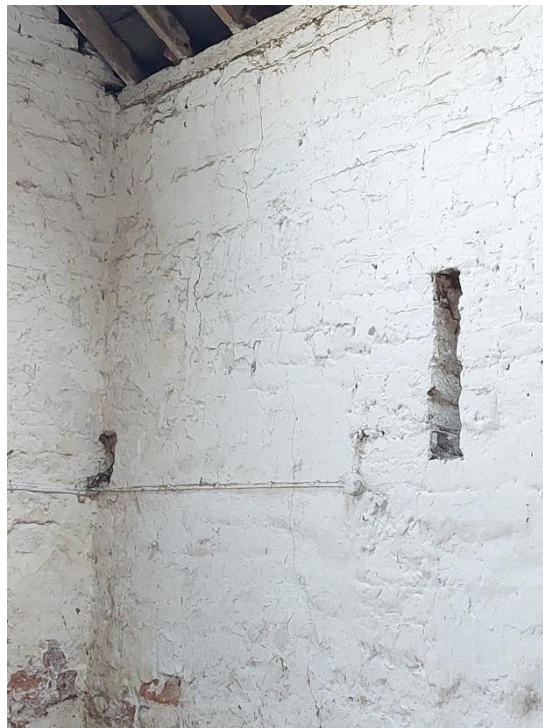
6.7.4. The south west facing elevation is double height and has been whitewashed and rendered (Plate 39). The elevation is made up principally of brick which looks to be handmade. Two air vents are visible in the upper portion of the wall as discussed in 6.6.6. There is also a beam slot in the middle of the elevation in the north west corner (Plate 40). This implies that there was once an upper floor which may have served as a hay loft for the cattle housed below. The air vents on this elevation also suggest its use as a hay loft and the square opening on the north west elevation of this room may have served as access

Plate 40 - Detail Shot Showing Beam Slot and Air Vent on South West Facing Elevation of Room G2

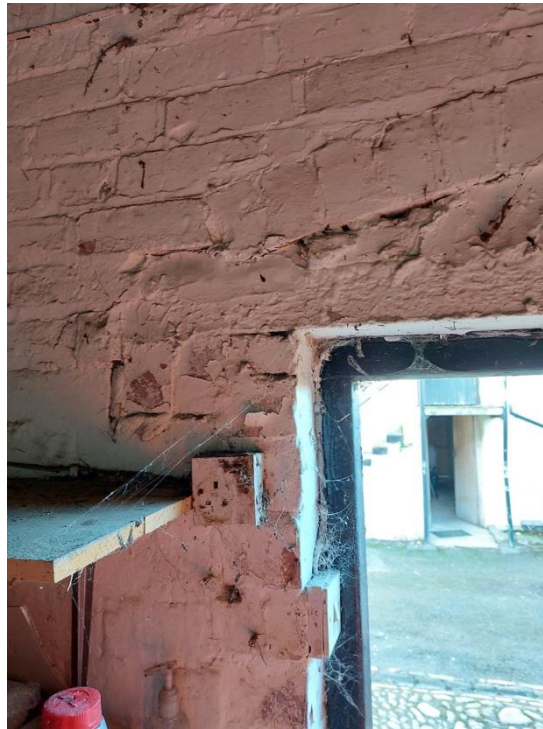
Plate 55 - Detail Shot Showing Modern Brick Used to Narrow the Doorway in G4

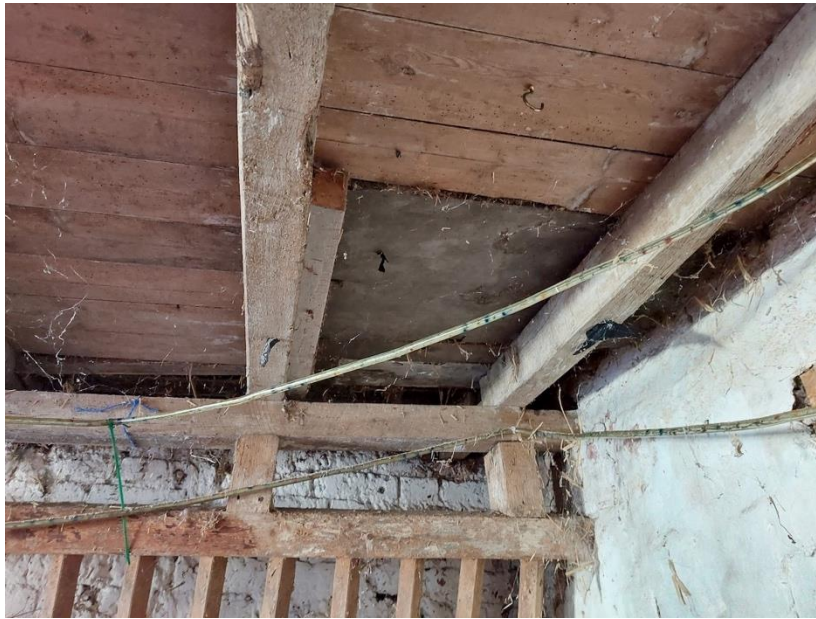
6.10.1. The ceiling of room G5 looks to be original (though see 6.10.4 and 6.10.6 below). The thick wooden beams are not machine saw cut and the floor-boards look to be contemporary (Plate 57). Towards the east corner of the room, there is a section of the floor above which has been replaced by a modern piece of compound wooden board (Plate 58). This may indicate the presence of a previous access to room F1 above.

Plate 58 - Boarded Opening in Ceiling of Room G5

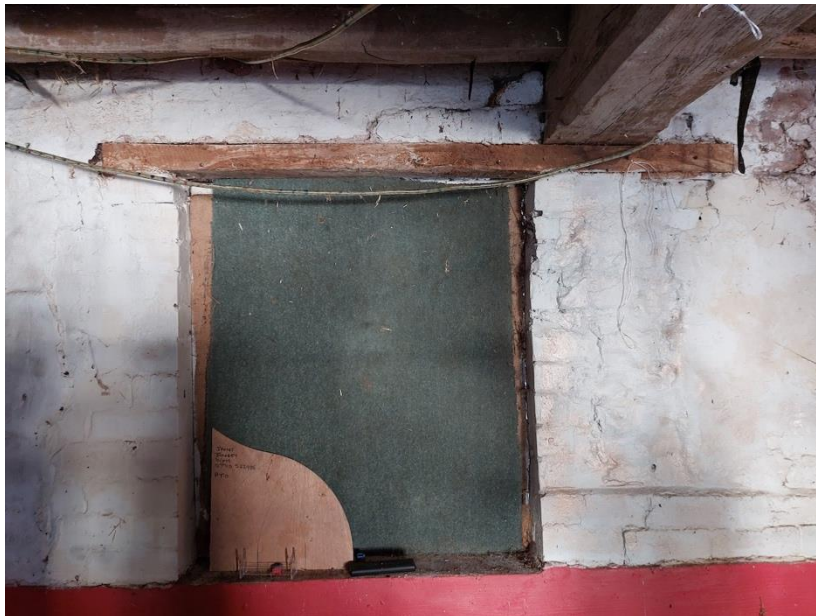
Plate 60 - Detail Shot of Boarded Window on North West Elevation of Room G5

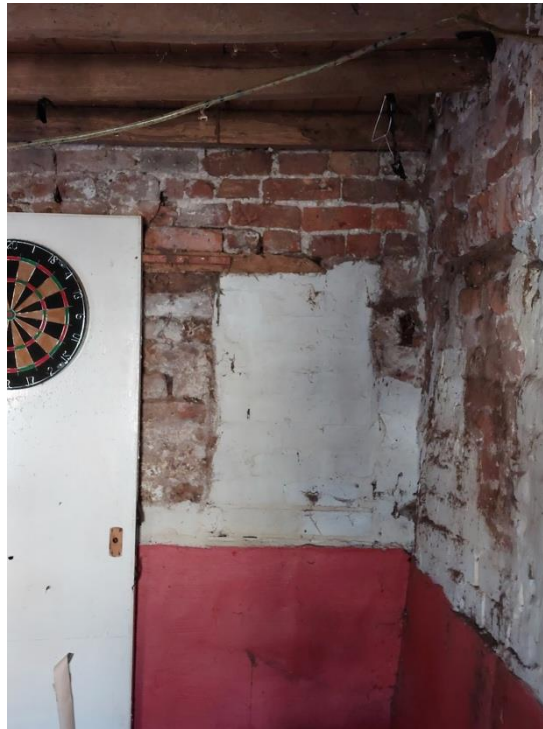
Plate 61 - Detail Shot of Bricked up Window on North West Facing Elevation of Room G5

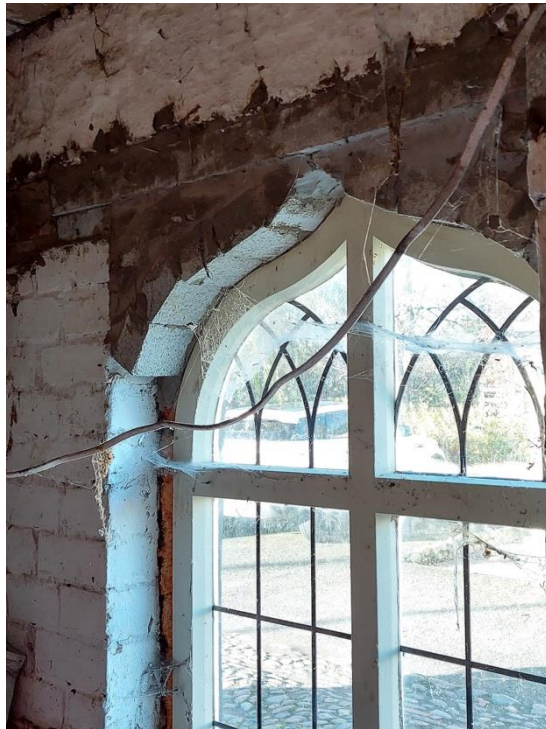
Plate 65 - Detail Shot Showing Modern Materials Used to Fit Ogee Window

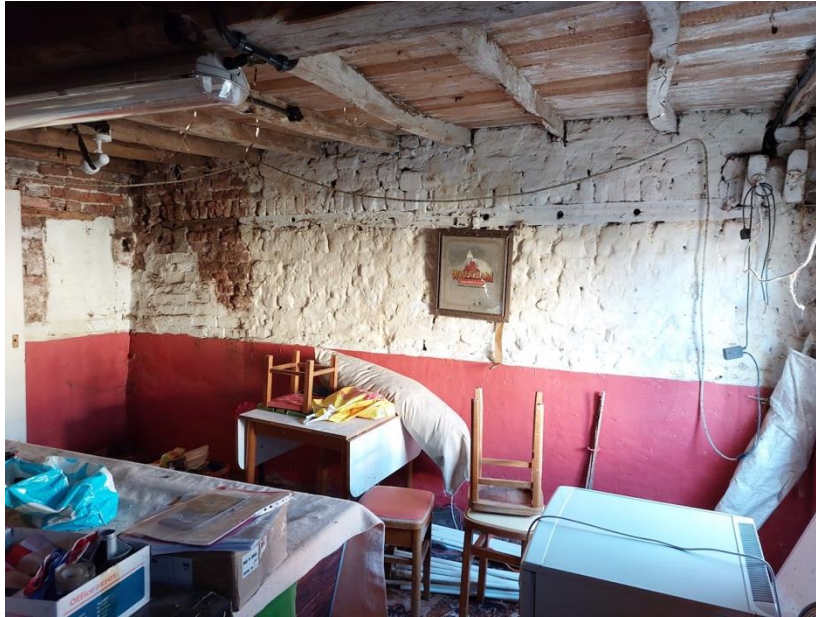
6.10.6. North east facing elevation of G5 is constructed of handmade brick which has been painted and rendered. Running across this elevation is a wooden insert capped with a row of headers, likely used to aid in tackle storage for livestock (Plate 66). There are also two beam slot holes that have been filled with

modern brick (complimenting those on the south west elevation). This suggests that the roof was once lower and the ceiling may not be entirely original.

Plate 66 - North East Facing Elevation of Room G5

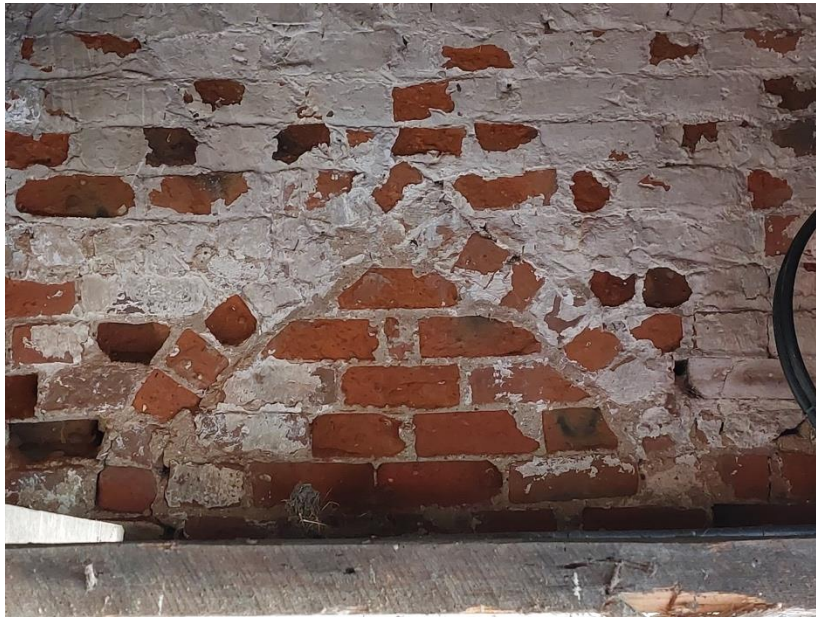
6.11.6. The north east facing elevation of G6 is built of handmade brick which has been painted white (Plate 71). The blocked ogee window is visible in the upper portion of this elevation, however, it appears an additional wall has been built in front of this window after it had been bricked up (Plate 72). There is also evidence of a wooden extension towards the north west of this elevation.

Plate 72 - Detail Shot of Bricked-Up Ogee Window on North East Facing Elevation of Room G6

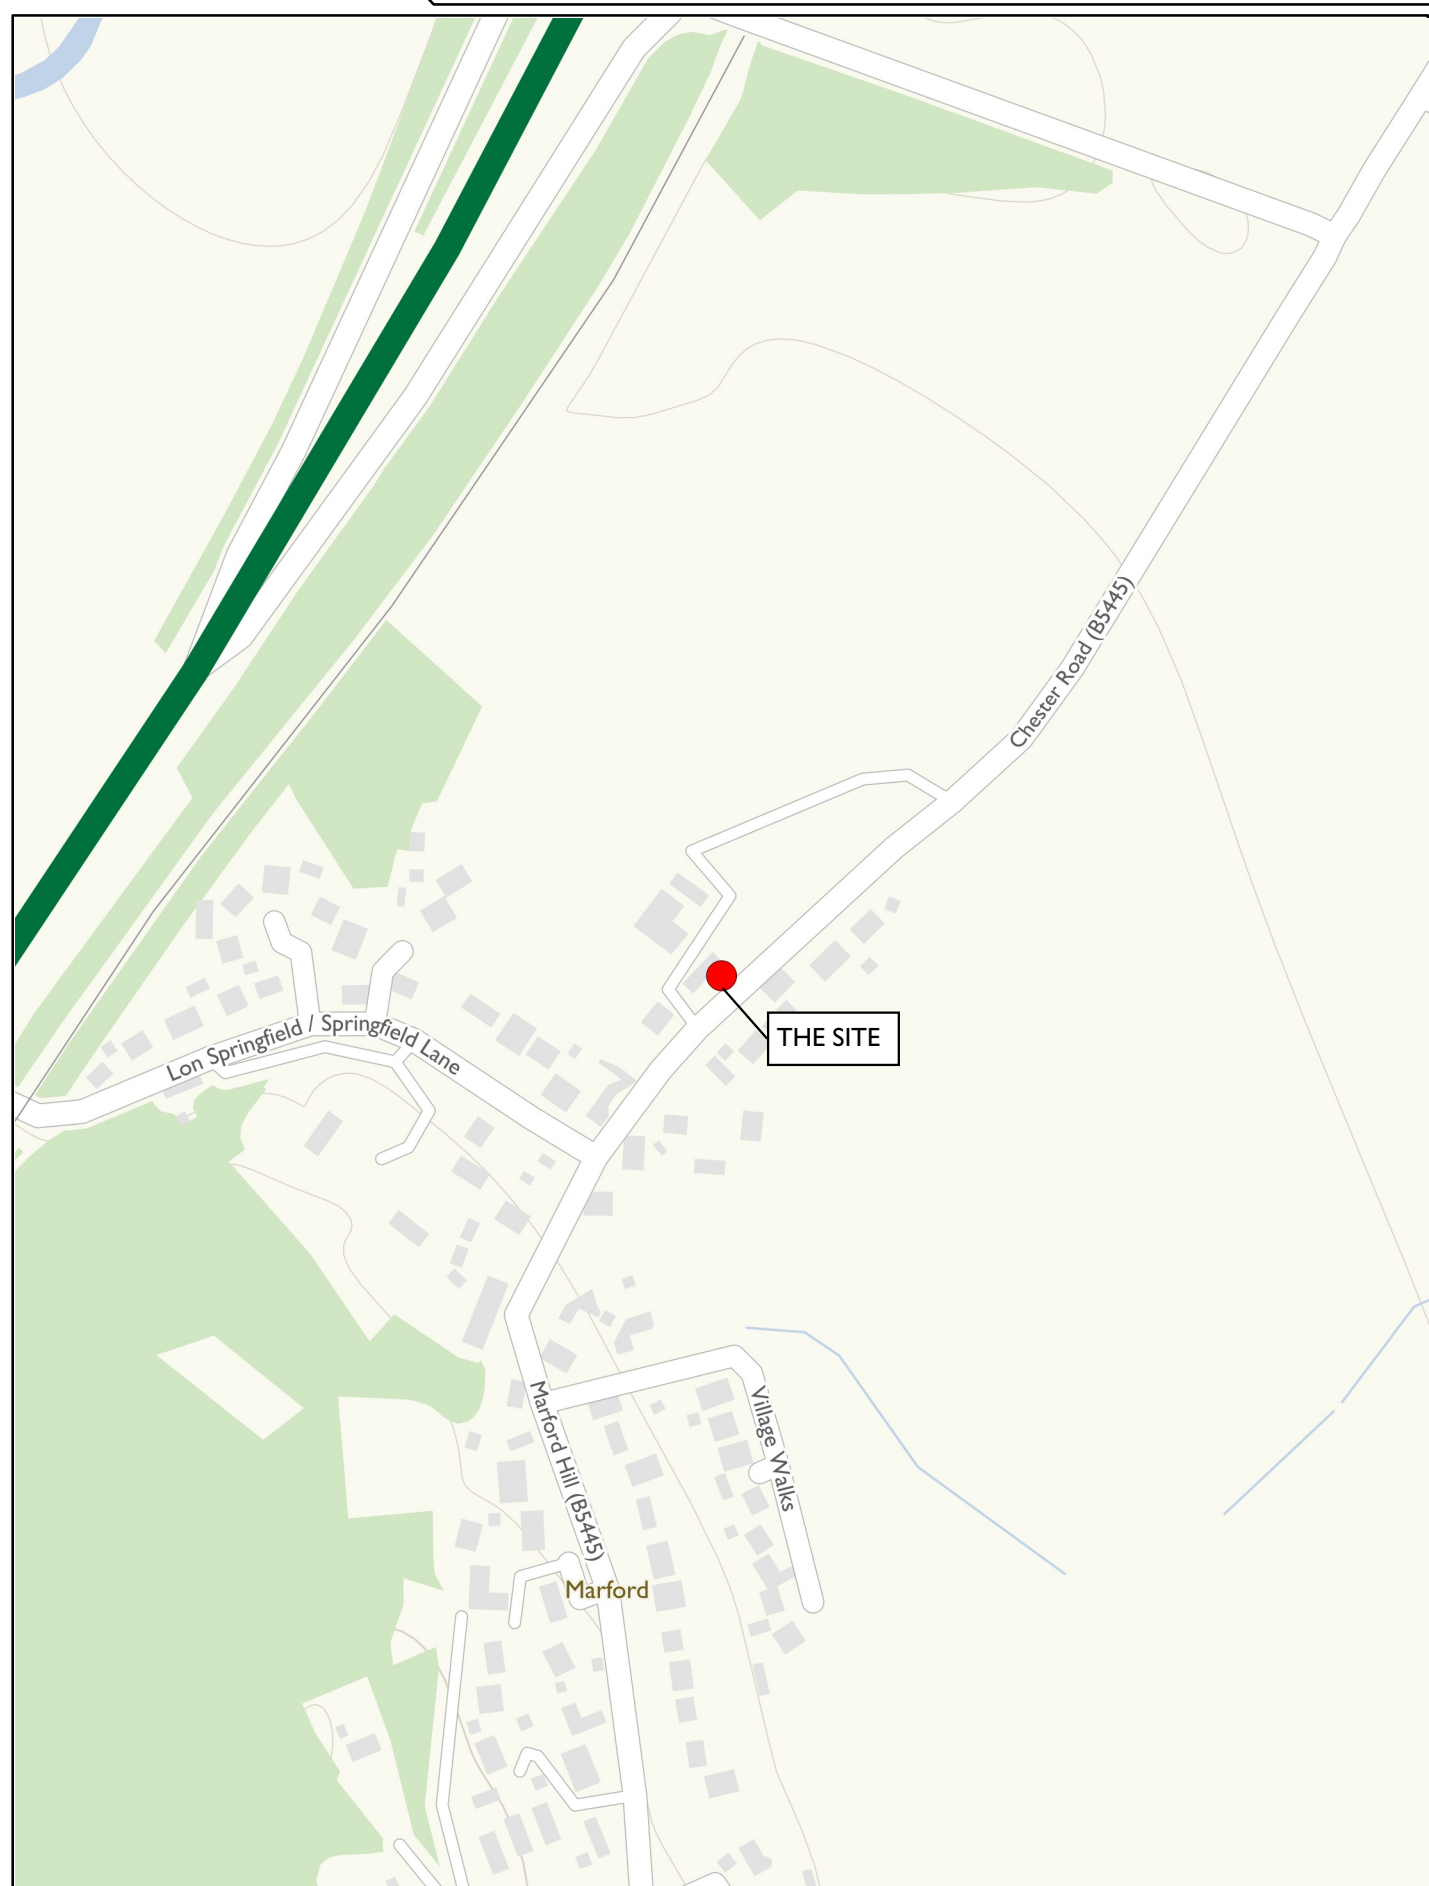
FIGURE I // Site Location - General

- 1.2. The fieldwork was carried out by Ethan Ellis and John Baker on the 7th December 2022.
- 1.3. The site location is at Springfield Farm, Marford Hill, Marford, Wrexham, LL12 8TD (Figure 1 & Figure 2). The site centres around National Grid Reference (NGR) 336026,356410.

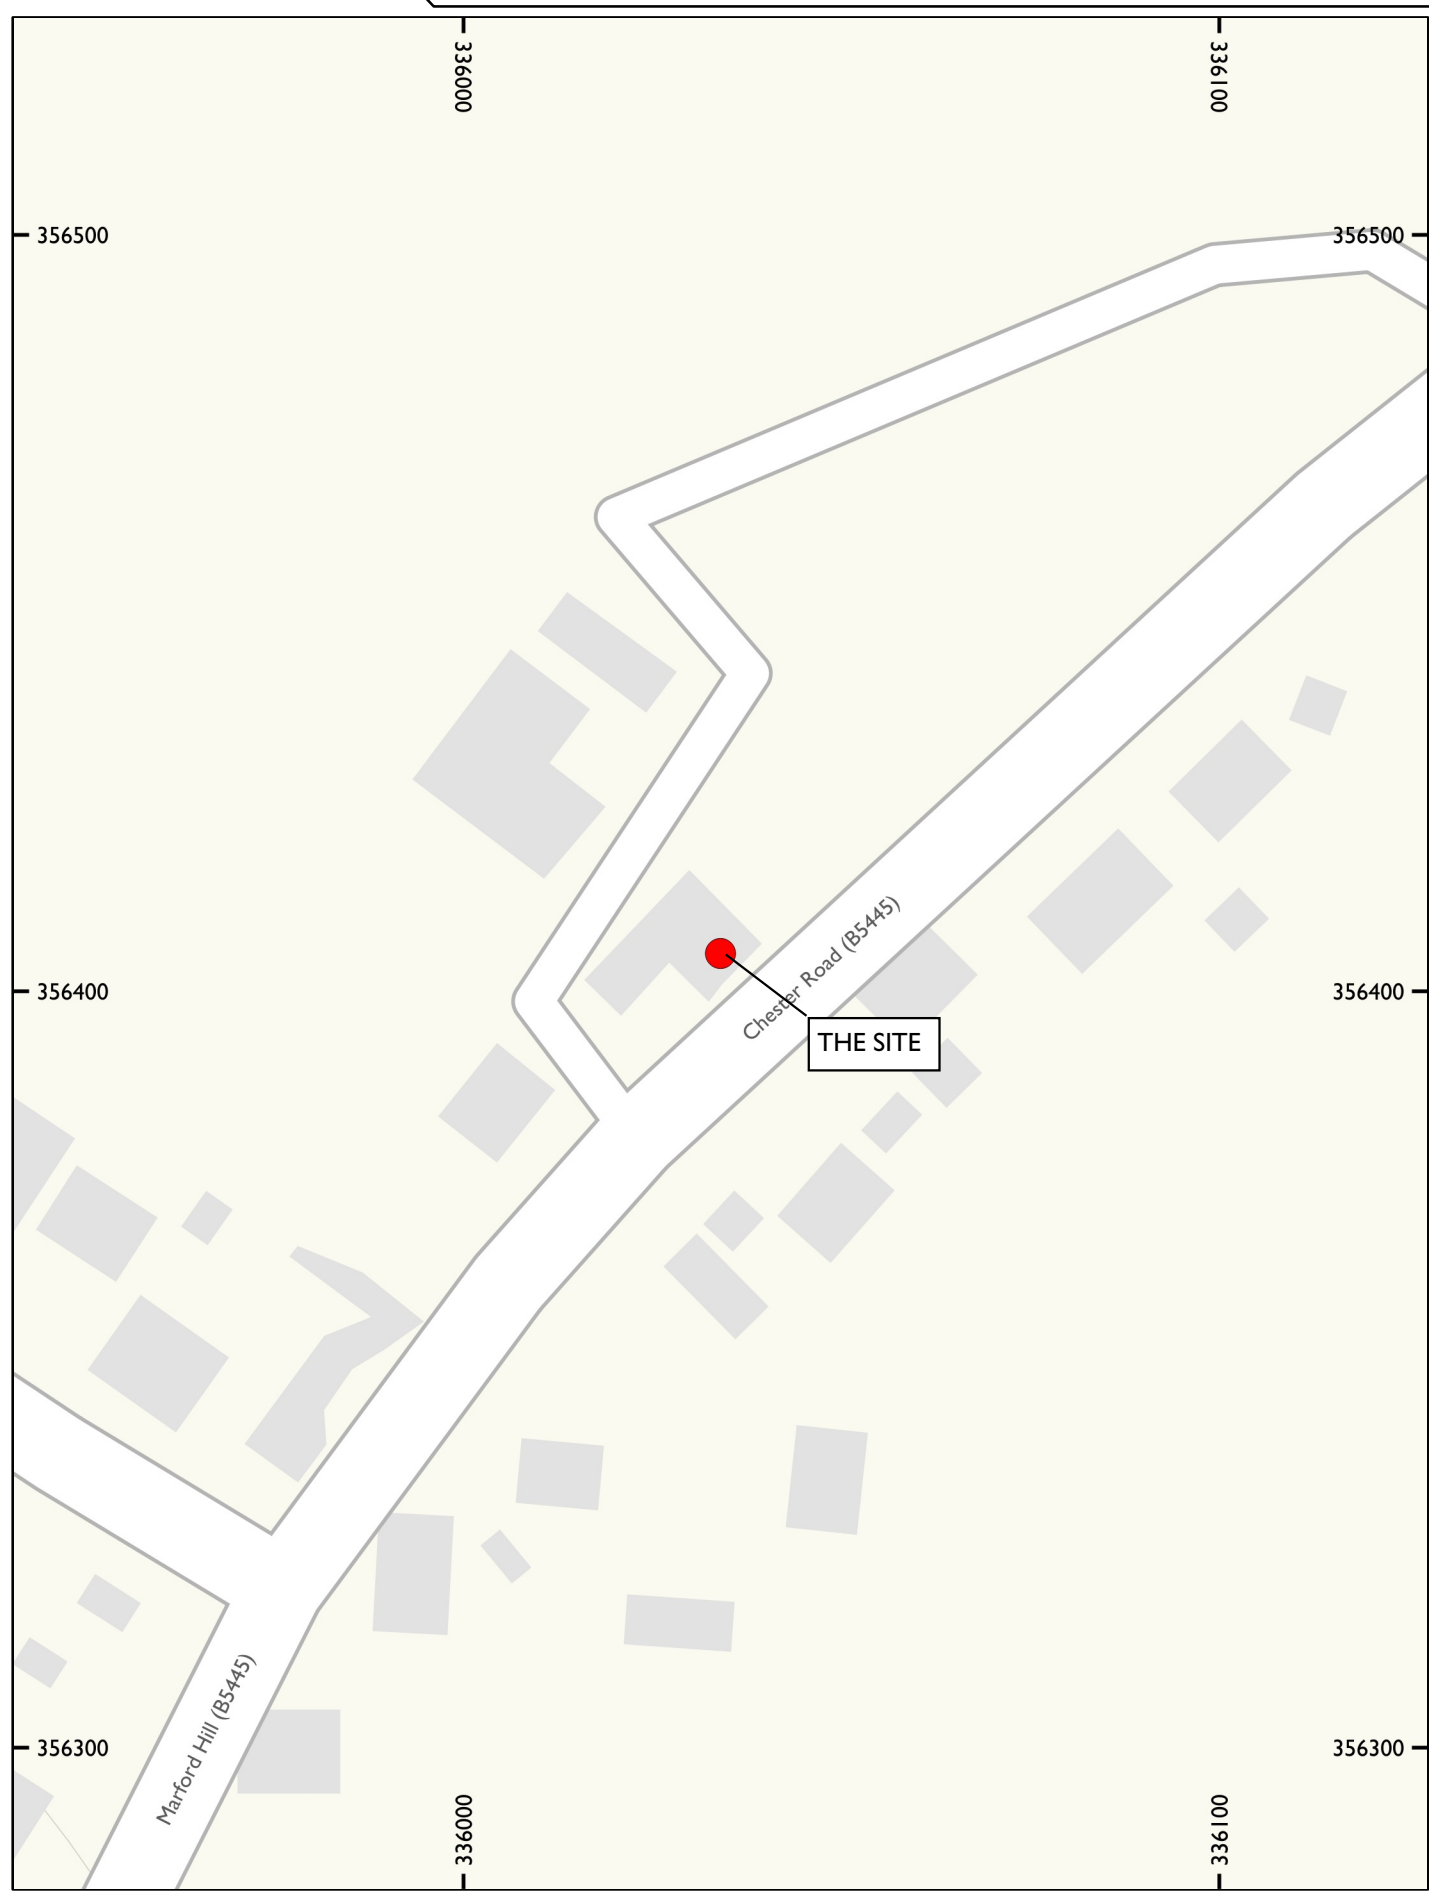
FIGURE 2 // Site Location - Detail

- 2.2.1. The bedrock geology of the site is thought to be of Kinnerton Sandstone with superficial deposits of Devensian sand and gravel (BGS, 2020).
- 2.2.2. The site is set on a farmstead directly off Chester Road on sloping terrain at 26 mOD (Figure 2).

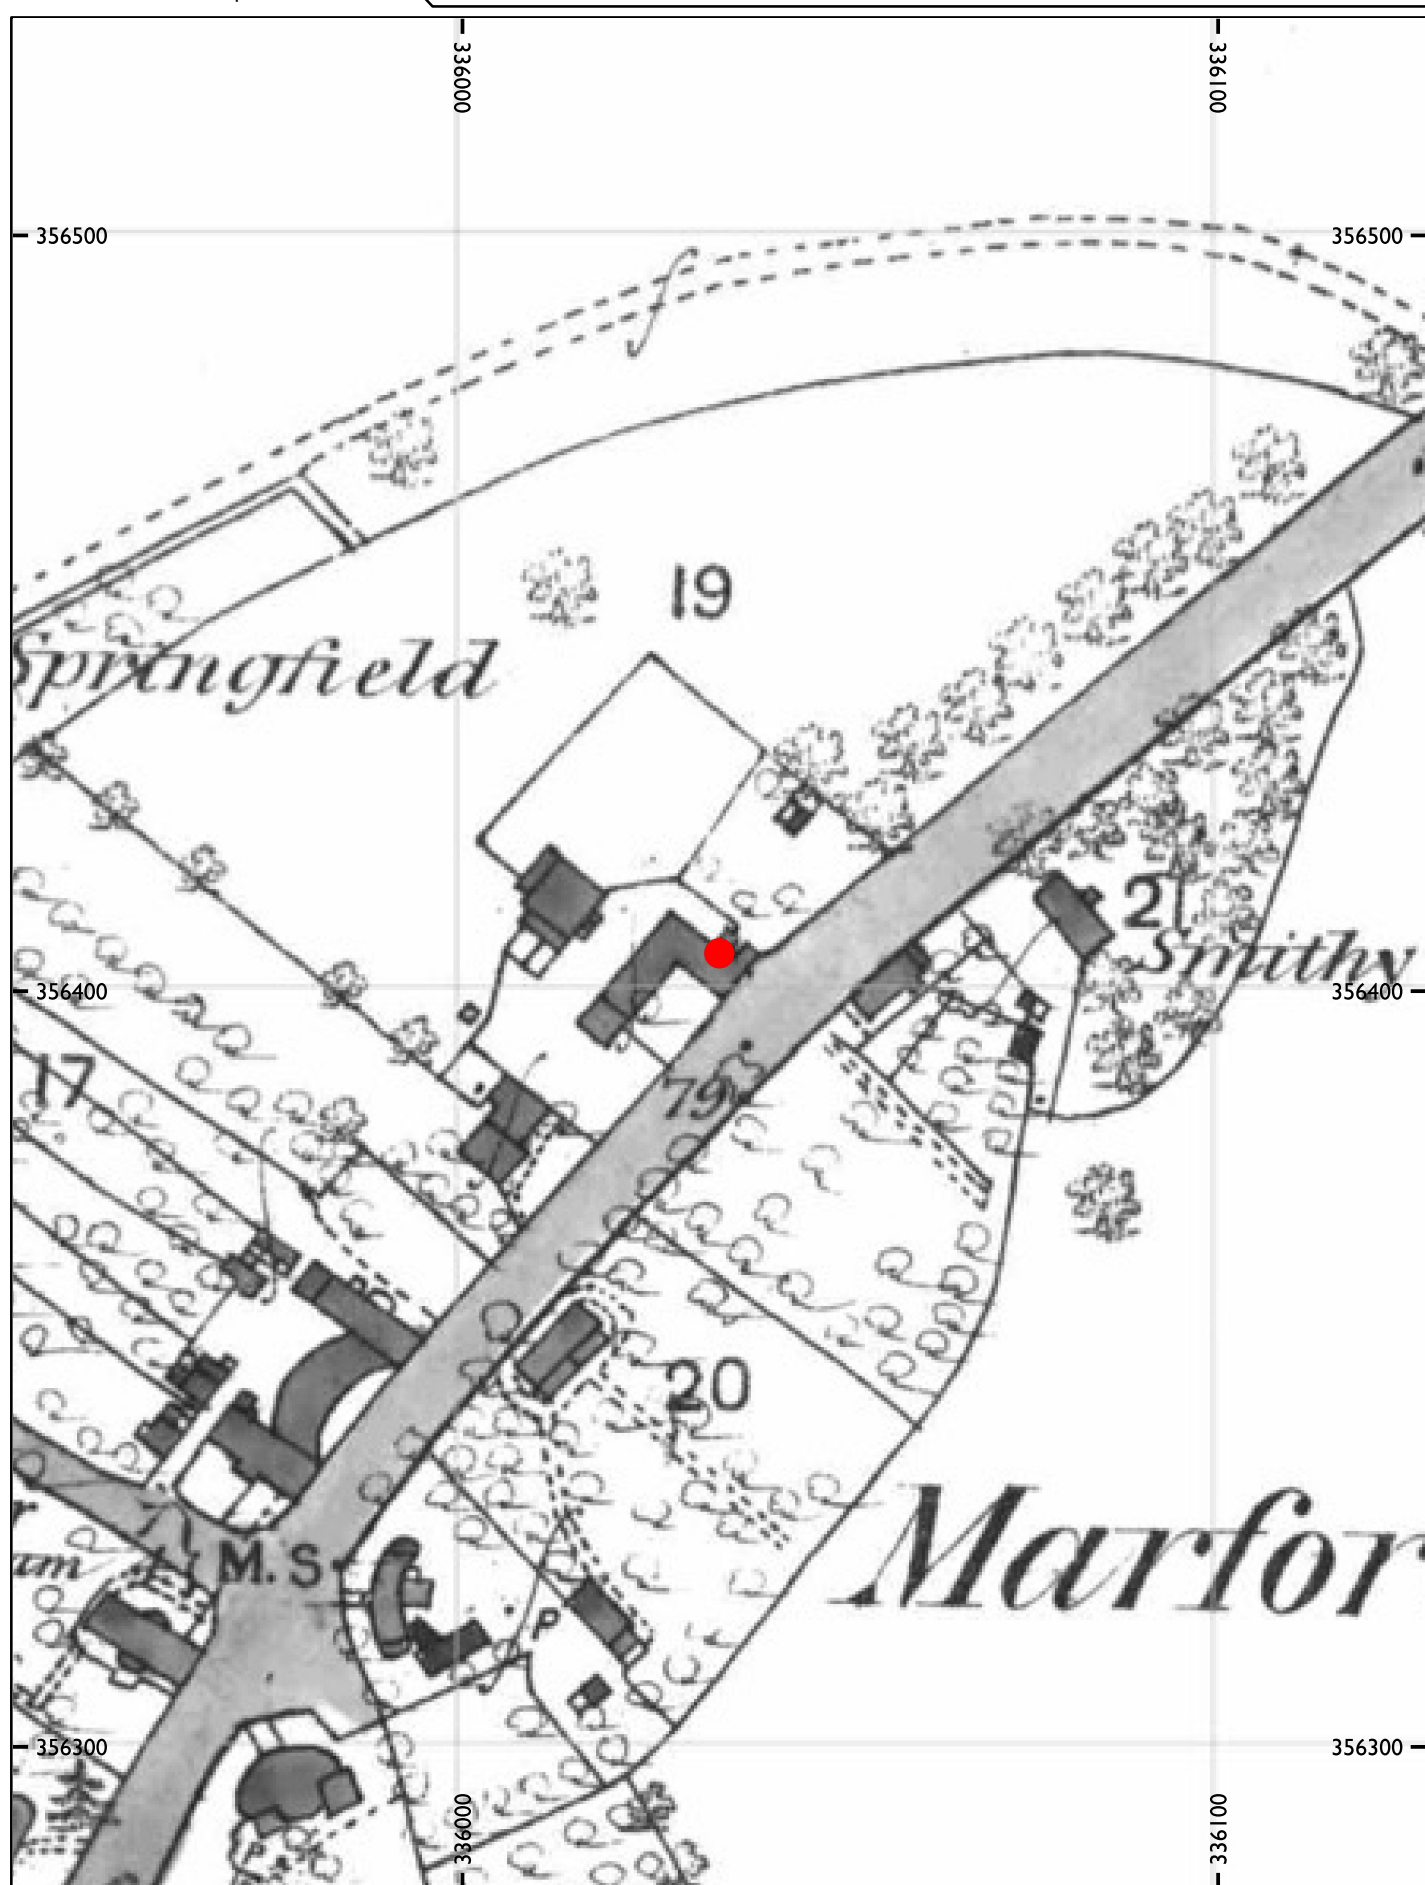
FIGURE 3 // 1873 OS Map

- 4.2.2. The OS map from 1873 (Figure 3) shows the barn as an 'L' shaped complex with a clear division on the south western end. This division could represent the addition of the cart shed (now garage) that currently stands as part of the building.

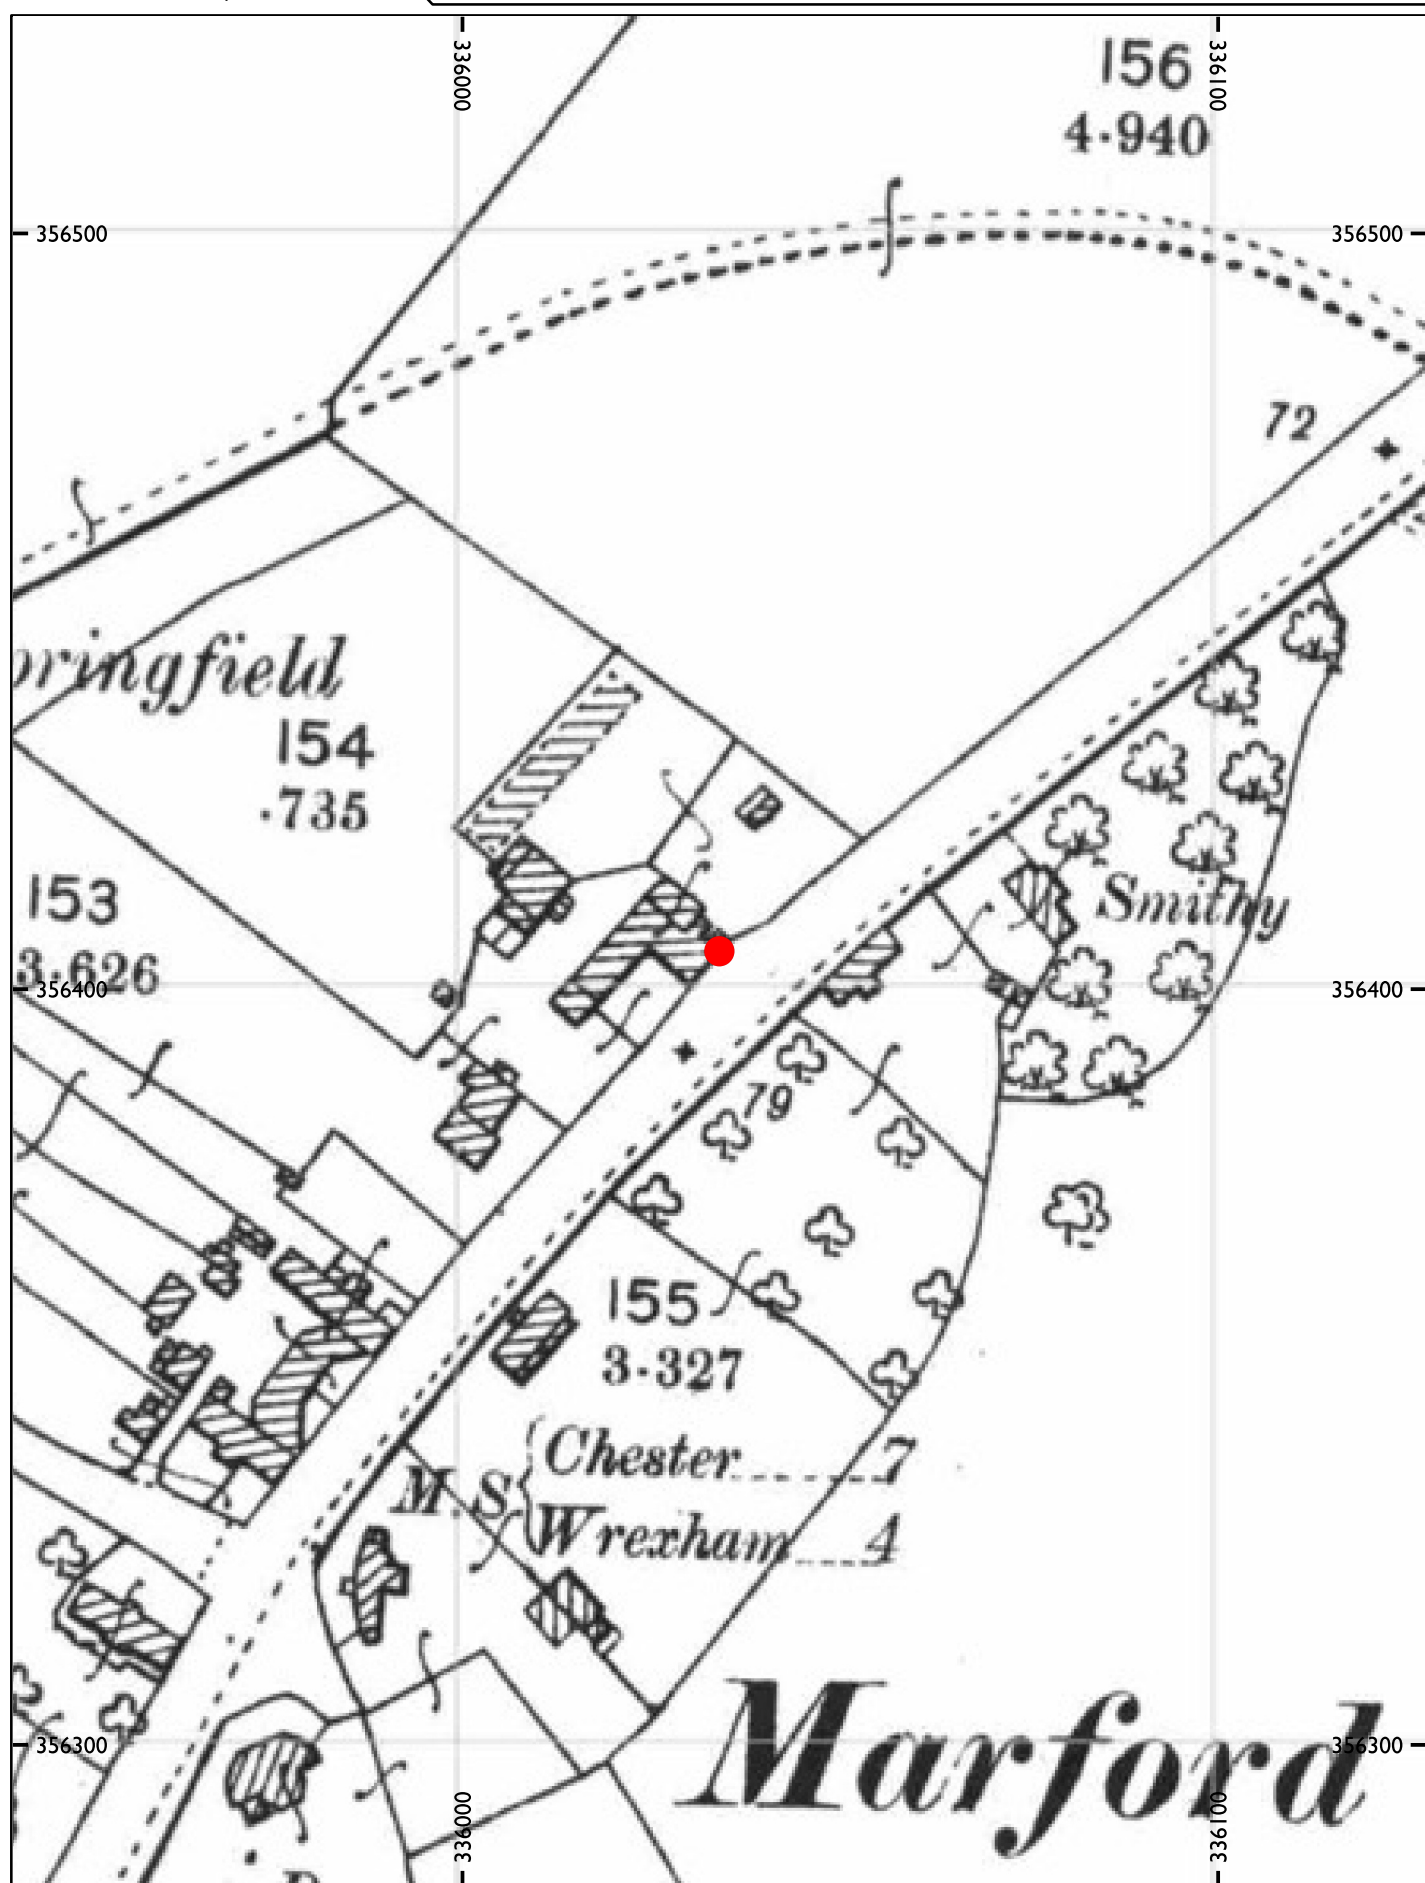
FIGURE 4 // 1899 OS Map

- 4.2.3. The OS map from 1899 (Figure 4) shows an additional division on the north eastern corner of the 'L' shape of the barn complex. This likely represents the lean to extension discussed below.
