Historic Building Recording at Springfield Farm Marford Hill

Report No. 22/4602C

A level 2 building survey was carried out at Springfield Farm, Marford Hill, Marford, LL12 8TD in December 2022 by Ethan Ellis and John Baker of MOLA on behalf of the client Blueprint Architectural Services Ltd.

The survey was requested by Clwyd Powys Archaeological Trust (hereafter CPAT) prior to the conversion of the barn into office buildings and took the form of a photographic and drawn survey in line with Historic England best practice and an agreed methodology, as laid out in a written scheme of investigation (Ellis 2022).

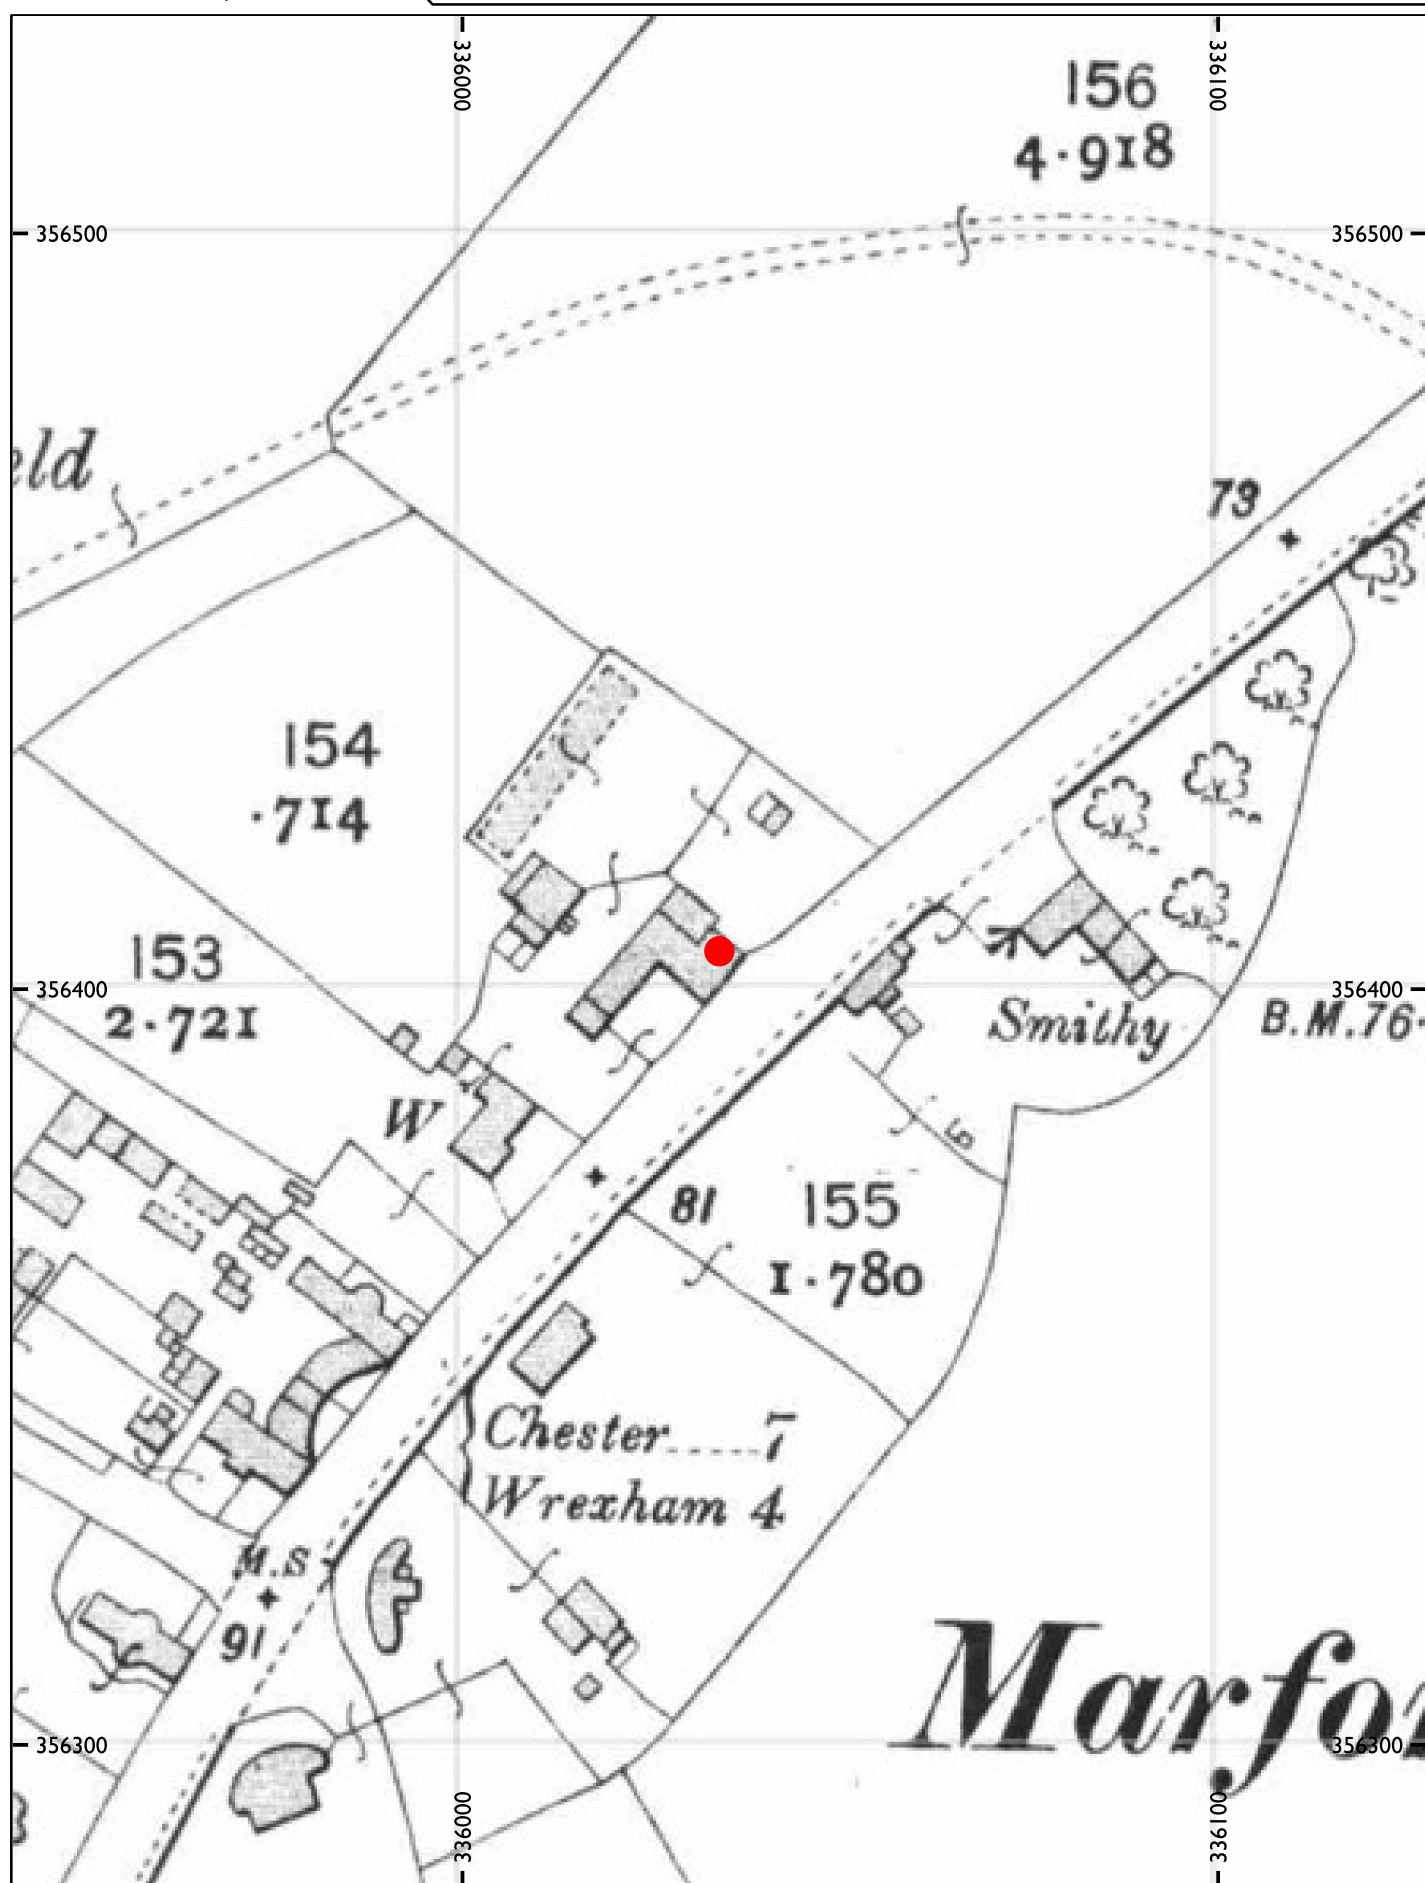
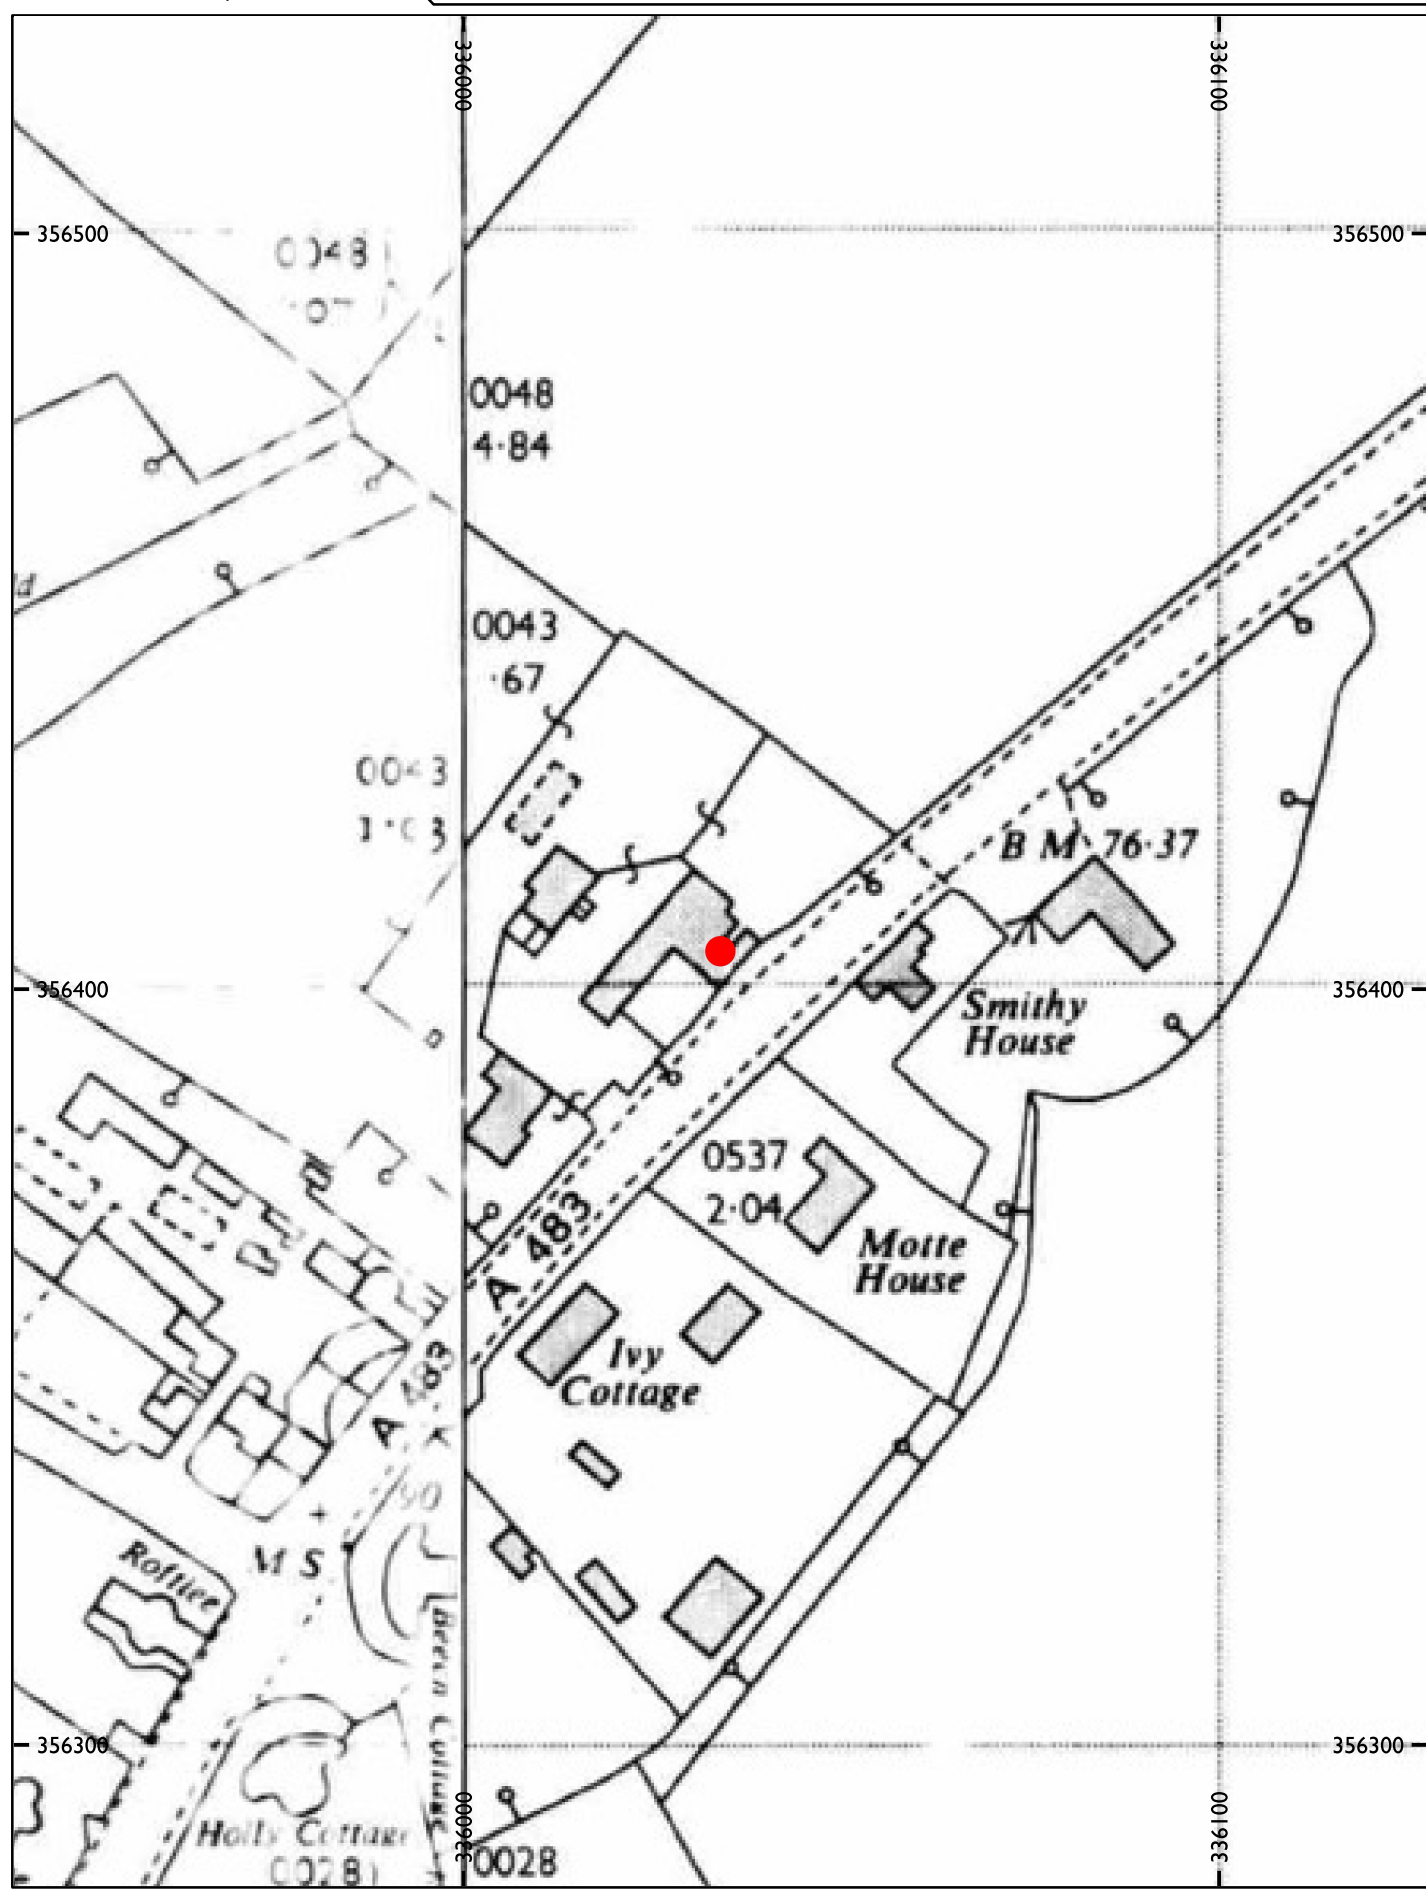
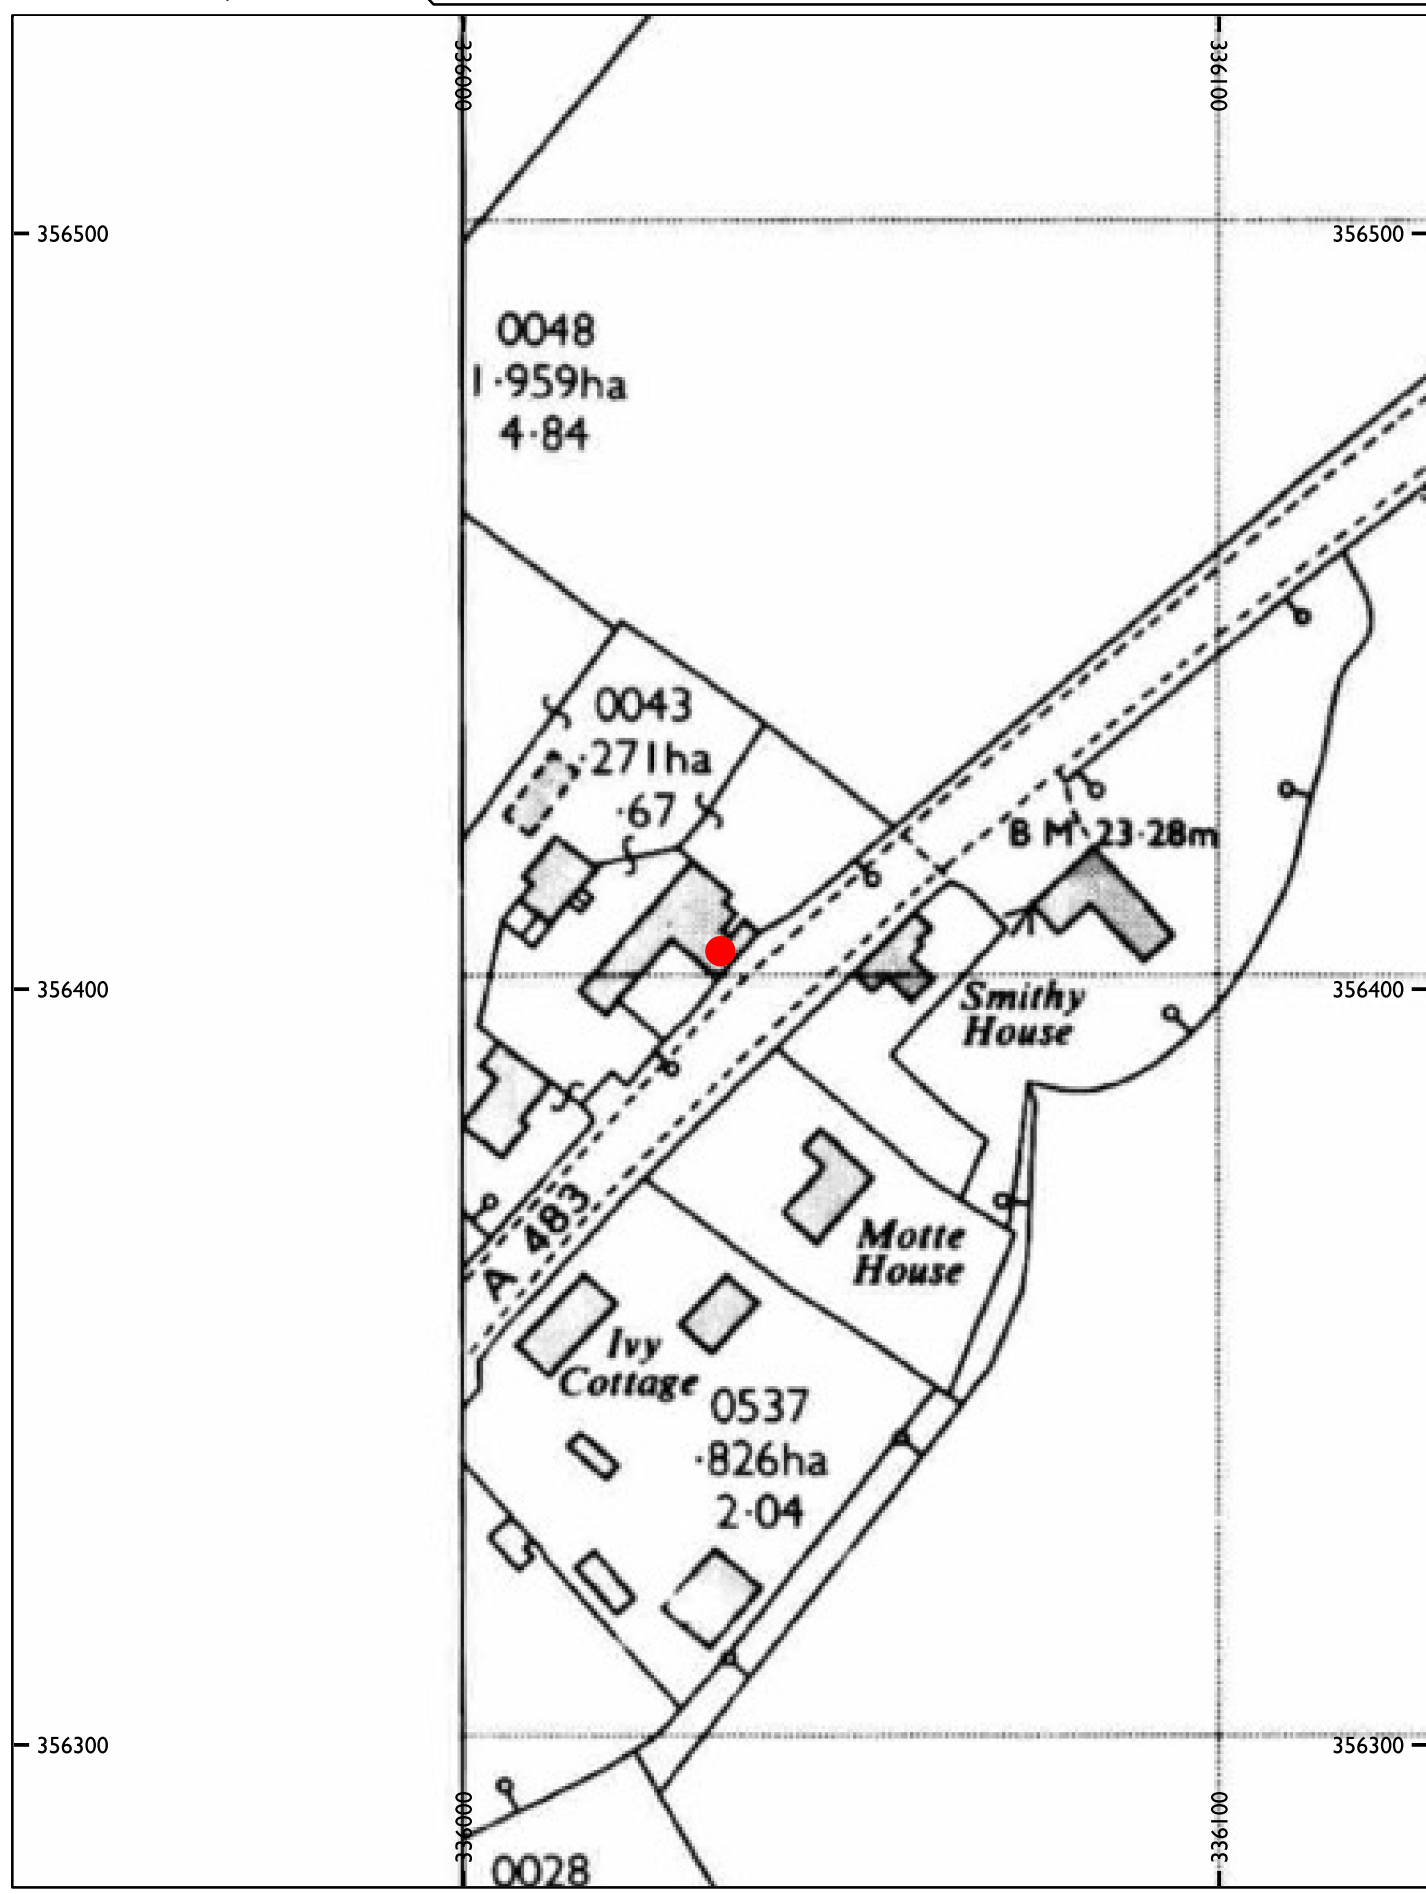
- 4.2.4. The OS maps from 1911 through to 1977 (Figures 5,6 & 7) show little to no change in the overall plan of the building in question.
- 4.2.5. There is a slight change on the north western side of the complex though it appears to be associated with the adjoining Springfield Cottage in 1987 (Figure 8).

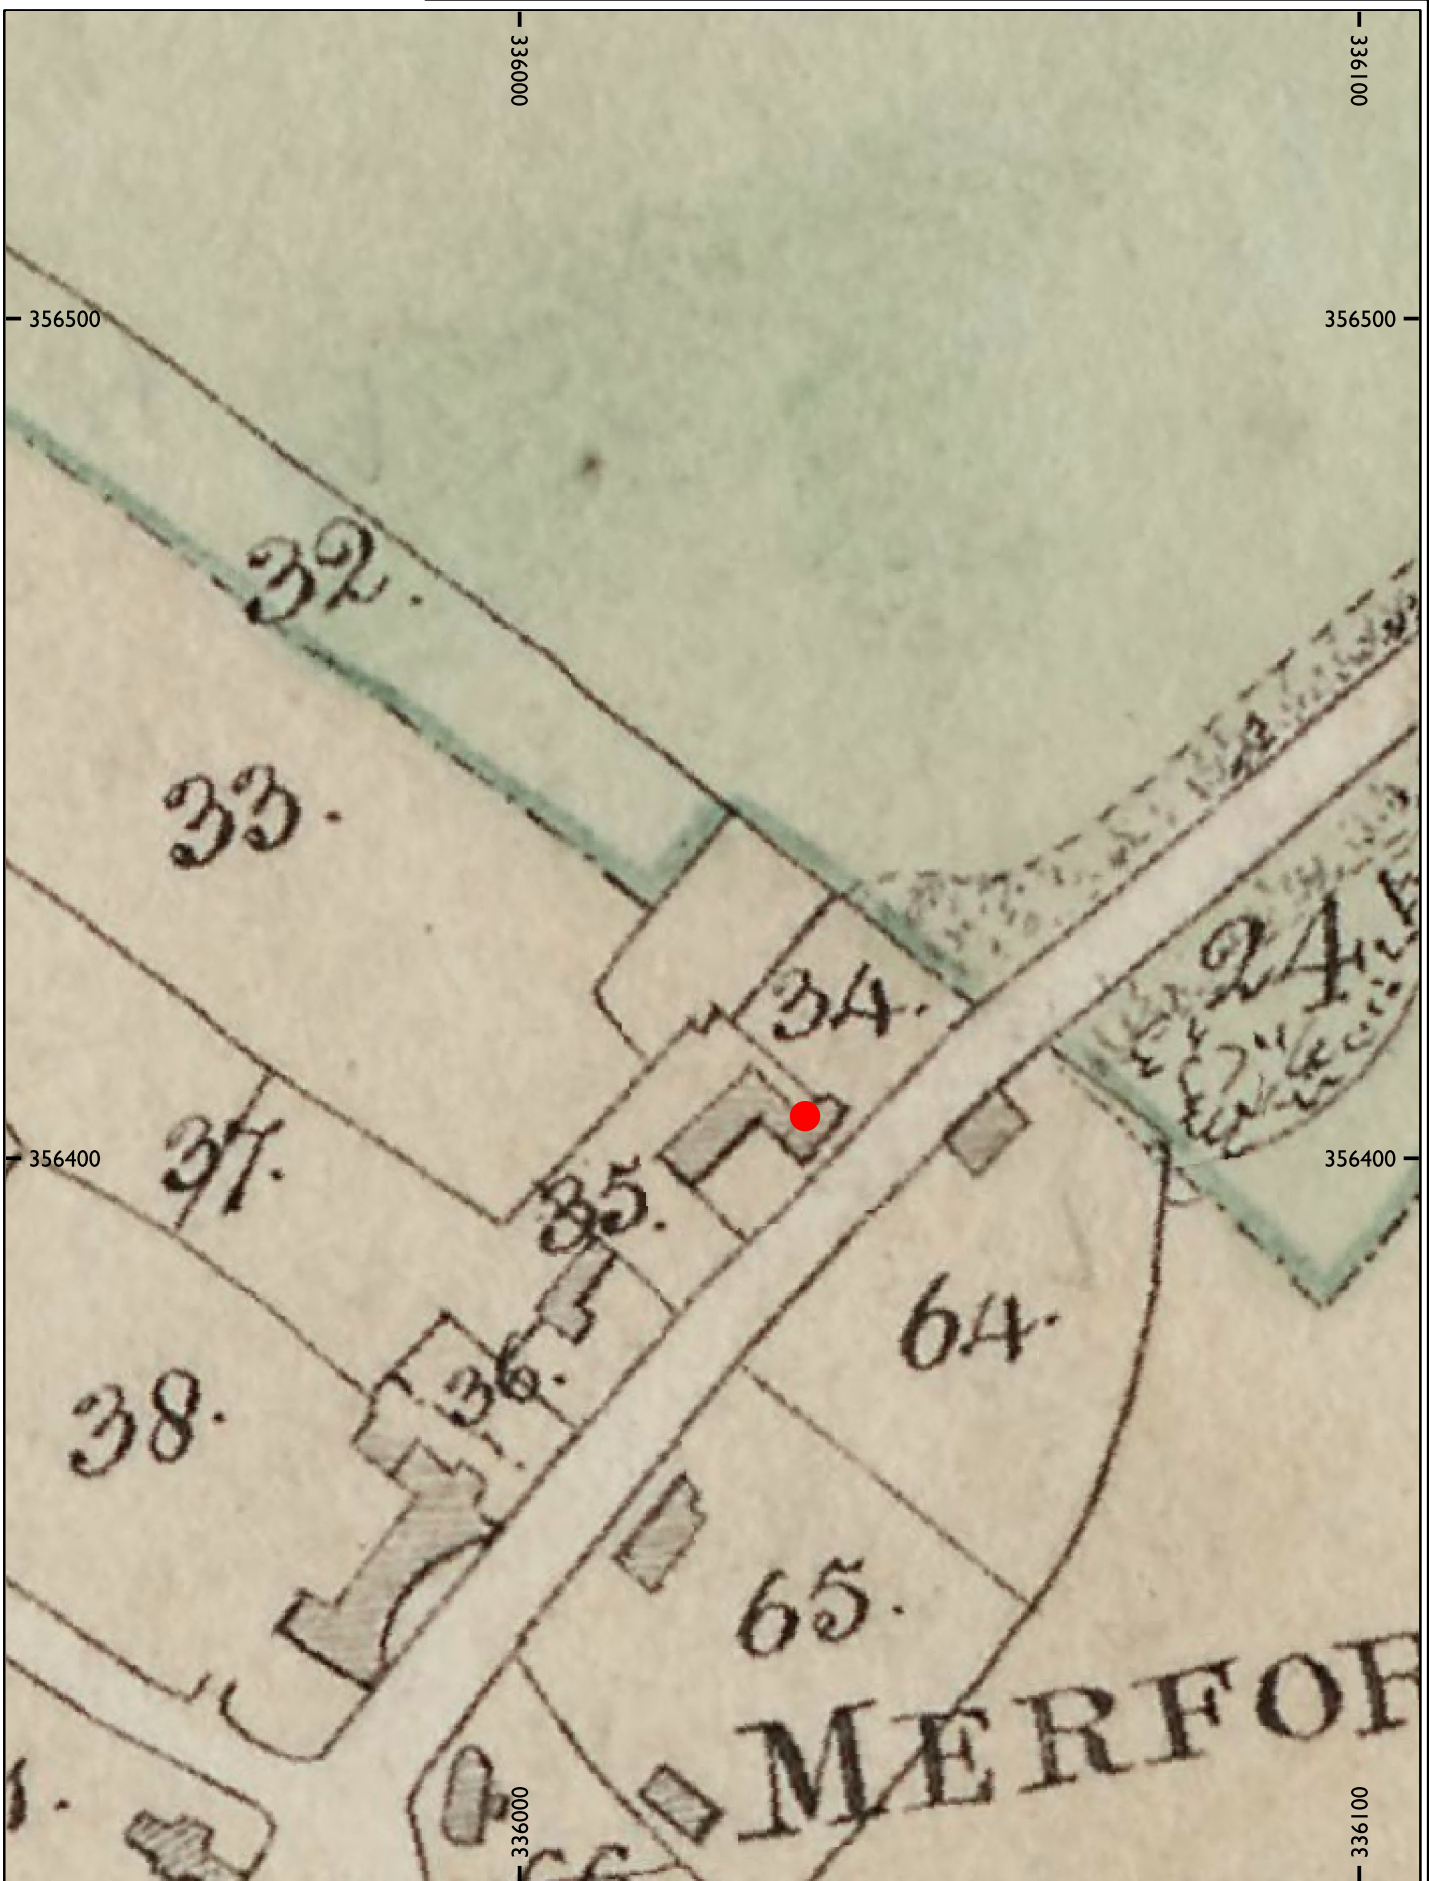
FIGURE 11 // 1844 Tithe Map

- 4.2.1. The tithe Map for the area, dated to 1844, (Figure 11) shows the plan of the present building in an L shape with an addition on the north eastern end which is presently Springfield Cottage.
