# **GREEN FARM HIGHER KINNERTON**

Historic Building Recording at

Client:	Daniel Rowland
Local Authority:	Flintshire County Council
NGR:	333761, 361094
Planning App:	064050
Author(s):	E Ellis and J Baker
Doc Ref:	LP4509C-HBR-v1.3
Site Code:	LP4037C / PRN 213811

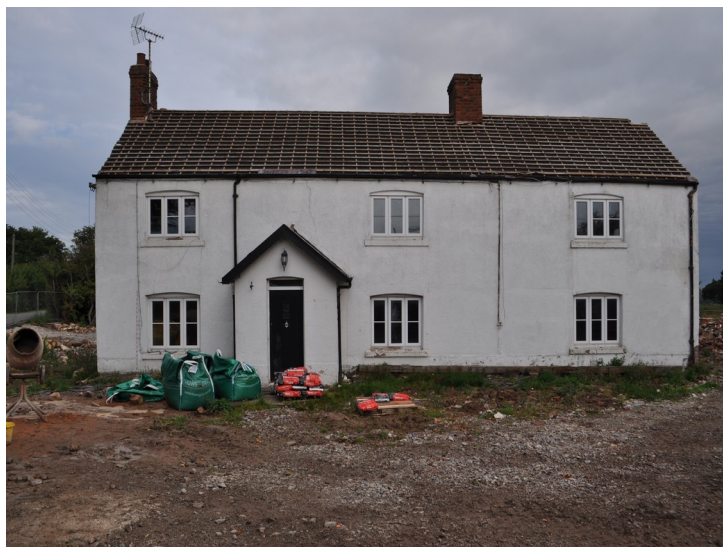
Plate 7- Southeast Facing Elevation

6.13. The southeast facing elevation functioned as the front facade and main access point into the complex. Similarly to the southwest elevation, the front facade is entirely masked in a white wash render, concealing the building fabric beneath (PLATE 7).

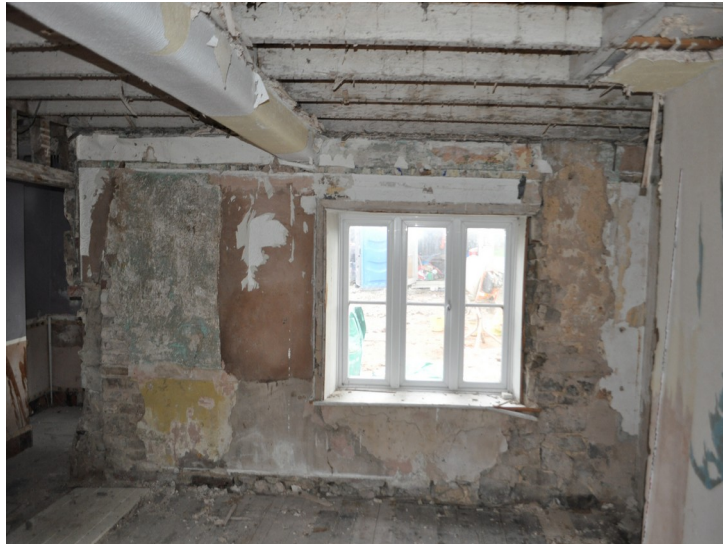
Plate 12: Northwest Facing Elevation of Room G1

6.23. The exposed ceiling in room G1 (PLATE 10) located on the ground floor, southeast most side, is a timber construction. A load bearing timber beam extended on a northwest-southeast alignment in the centre of the ceiling, with a series northeast-southwest aligned joists resting above. Modern timber floorboards of the first floor sit above the series of (PLATE 12).

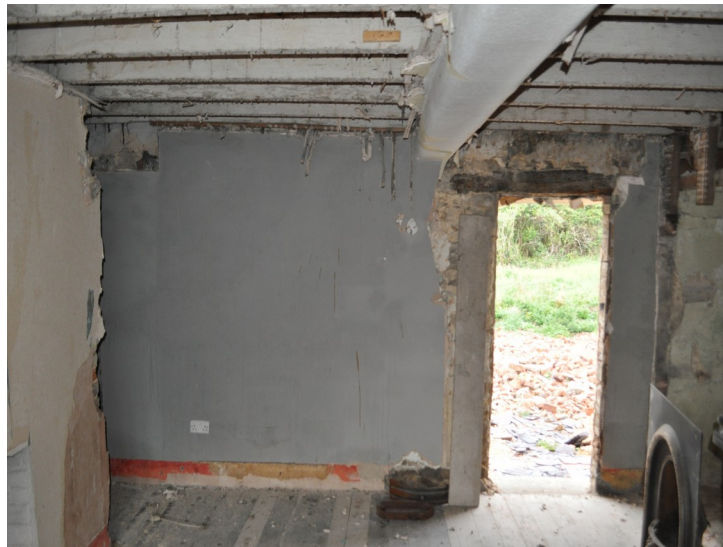
Plate 14- Southeast Facing Elevation of Room G1

6.28. The southeast facing elevation of room G1 is of stone and mortar construction, most of the elevation is plastered and so obscured. There is a doorway in the northeast corner leading to the outside. This has a timber lintel above which appears to be contemporary to the surrounding stonework (PLATE 14).

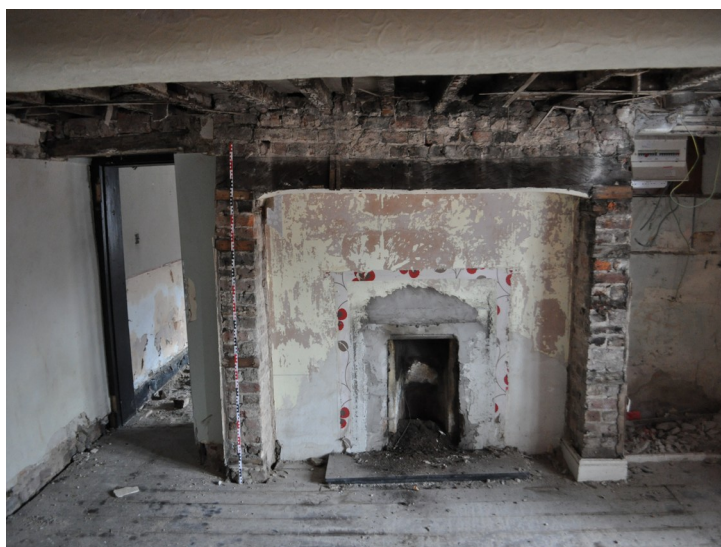
Plate 17- Southwest Facing Elevation of Room G2

6.32. The southwest facing elevation of room G2 consists of machine made brick construction in a common bond form. Centrally, there is a large open fire place with a wooden manteltree. Positioned on the northwest end of the elevation, there is a doorway that leads into room G3 (PLATE 17). This doorway is supported by a wooden

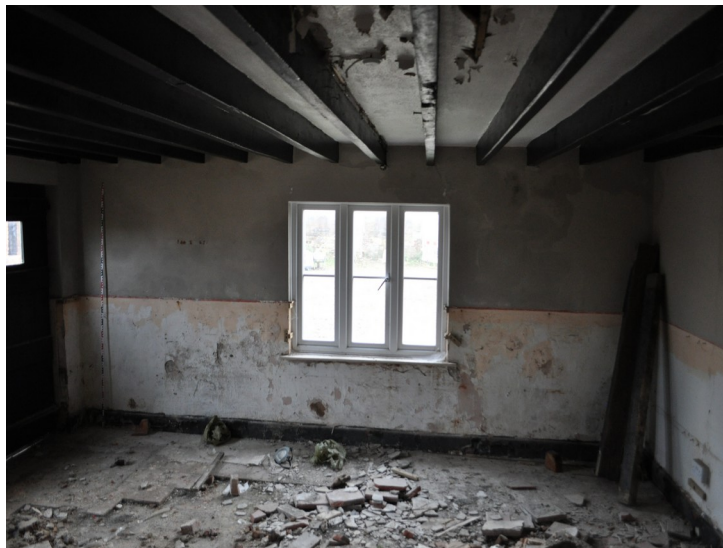
Plate 20- Northwest Facing Elevation of Room G3

6.34. The ceiling in room G3 is made up of timber joists which run perpendicular to those seen in rooms G1 and G2 (i.e. running northwest – southeast, rather than north east to south west). The plaster has been left between the joists (PLATE 20, 21) so the first floor floorboards were not visible.

6.36. The northwest facing elevation of room G3 is again entirely covered in plaster. There is a modern UPVC window in the centre of this elevation. As the brickwork is obscured it is not possible to say if this was a later addition or contemporary to this building phase (PLATE 20)

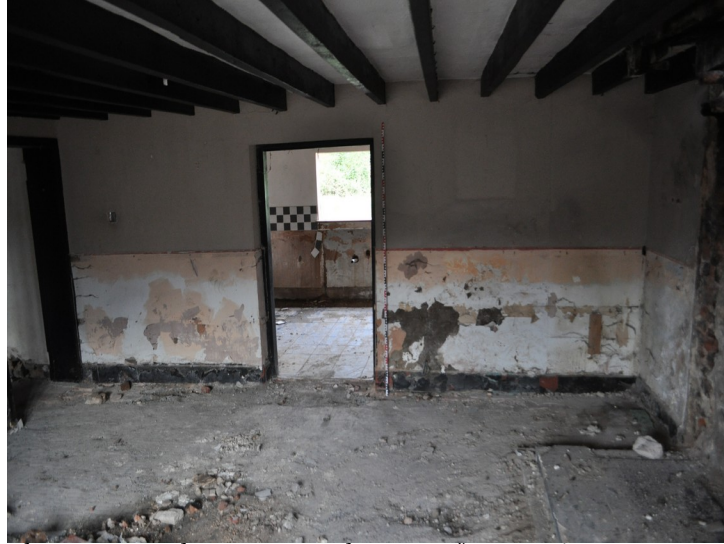
Plate 21 - Southeast Facing Elevation of Room G3

6.39. The southeast facing elevation of room G3 was covered in plaster rendering the fabric indeterminable. A doorway was positioned in the centre of the elevation leading to room four. (PLATE 21)

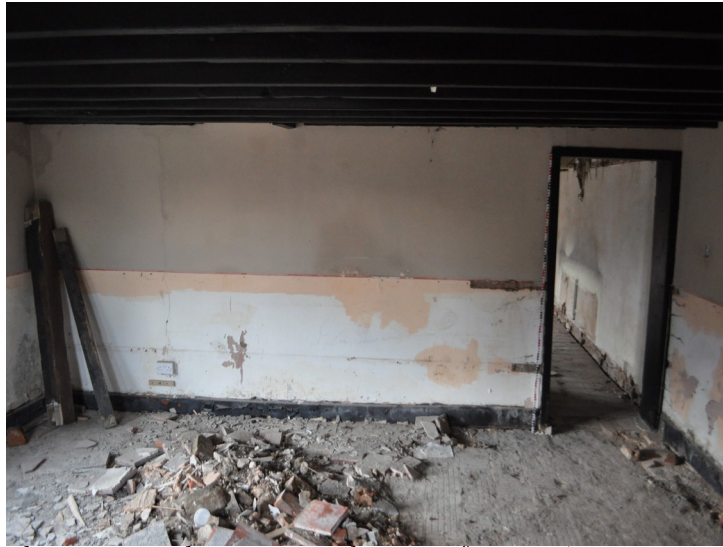
Plate 23- Northeast Facing Elevation of Room G3

6.35. The northeast facing elevation of room G3 is entirely covered in plaster, concealing the fabric beneath, preventing a detailed analysis of the buildings skeletal structure in order to date. On the north west edge of the elevation there is a doorway leading into room G2 (PLATE 23).

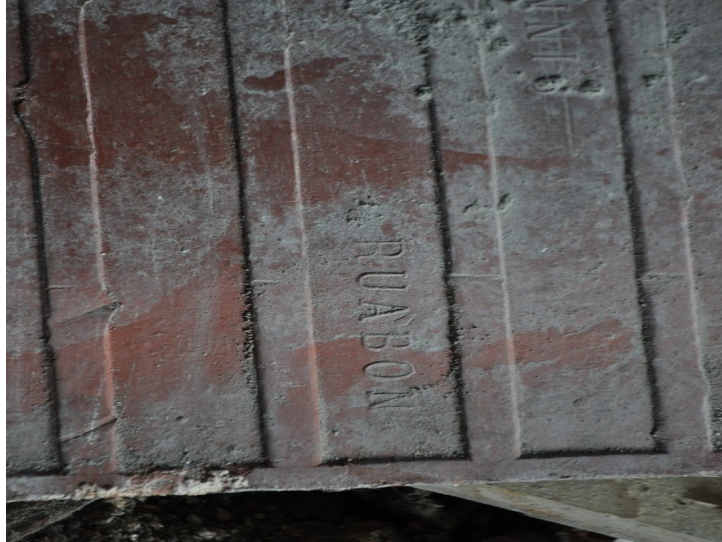
Plate 24- Detail of Obverse Side of Floor Tiles in Room G3

6.34.1. The floor is made up of timber floorboards and tiles, which are present in-situ in the southeast corner of the room (PLATE 22). The same tiles have been lifted in the centre of the room which appear to be modern from the fabric and the stamp on the obverse side (PLATE 24).

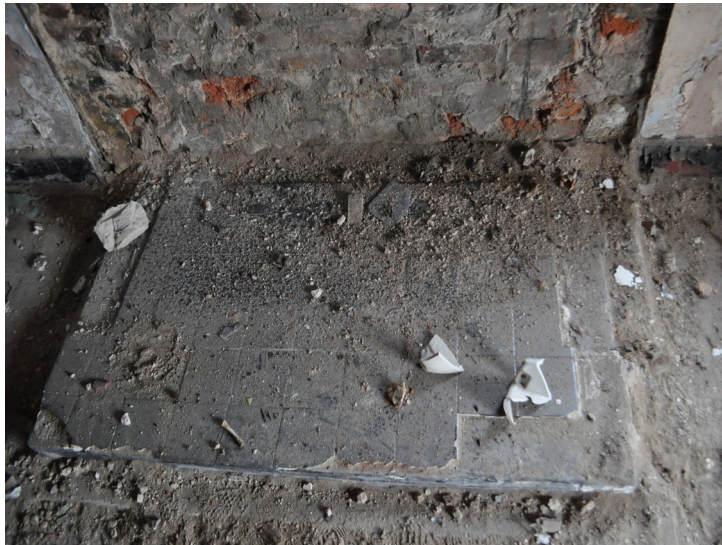
Plate 25- Detail of Tiled Hearth in Room G3

6.37. The fabric of the southwest facing elevation of room G3 was largely obscured by the plastering. There is a section of exposed brickwork and a tiled hearth where a fireplace and chimney were once housed (PLATE 25). The bricks are machine made and in a common bond design (PLATE 26).

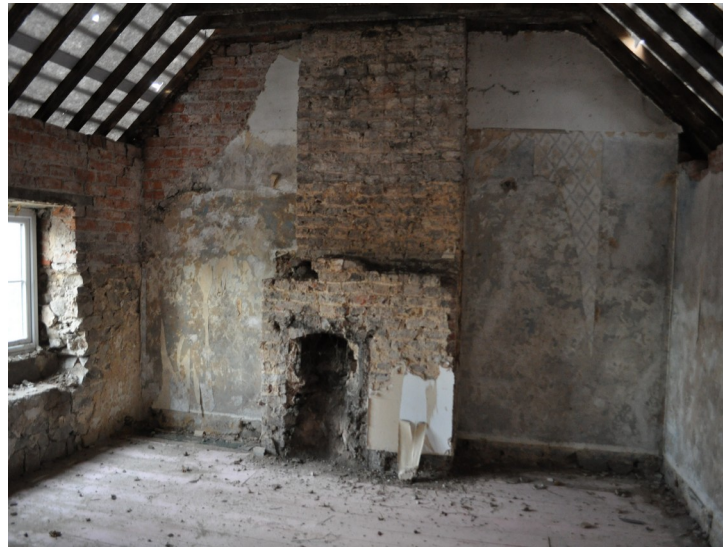
Plate 32- Northeast Facing Elevation of Room F1

6.47. The floor was made up of timber boards running north east – southwest (PLATE 32).

6.48. The north east facing elevation of room F1 is a mixed fabric of stone and mortar and brickwork. The stonework is visible near the base of the elevation, the extent is obscured by plaster. The top southeast corner shows the brick fabric – this is machine made brick given the finish and regularity of the size and shape, in a common bond. There is a central brick chimney breast – a continuation of the one seen in room G1. The brickwork for the chimney is exposed, machine made and in a stretcher bond (PLATE 32).

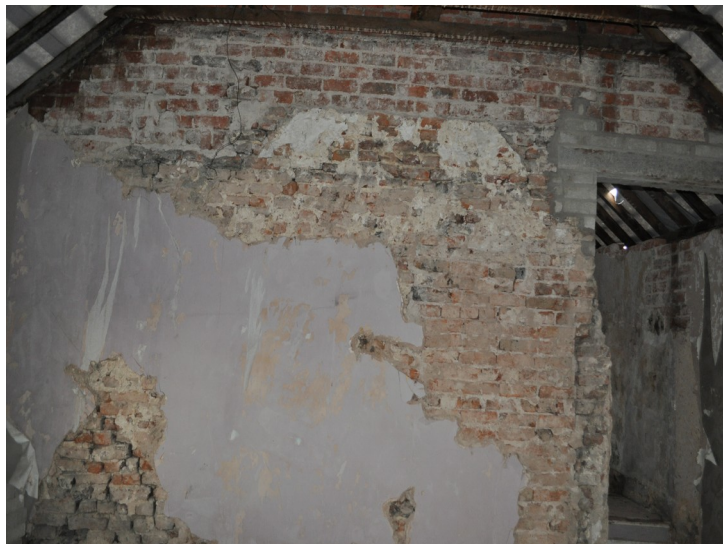
Plate 34- Northeast Facing Elevation of Room F2

6.51. The fabric of the southwest facing elevation was entirely of machine made modern brick in a common bond. A continuation which is seen in room G1 (PLATE 13) and the rear side in room F2 (PLATE 34). There was a doorway in the north east corner leading into room F2.

6.54. The northeast facing elevation was constructed entirely of machine made brick in a common bond. There is a doorway on the northwest edge of this elevation. The doorway was recently reinforced with modern breeze blocks. There are some remnants of plaster over the brickwork (PLATE 34).

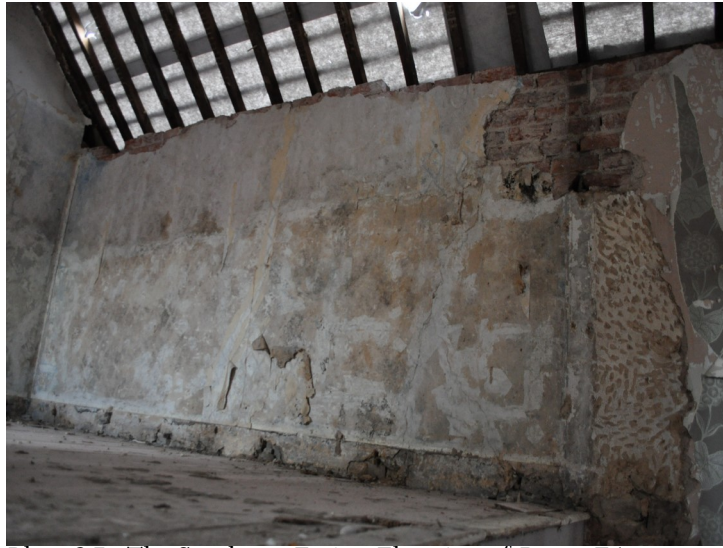
Plate 35- The Southeast Facing Elevation of Room F1

6.52. The southeast facing elevation of room F1 is largely obscured by plaster. Although, machine made brick in a common bond was visible on the upper northeast section

of the elevation (PLATE 35).

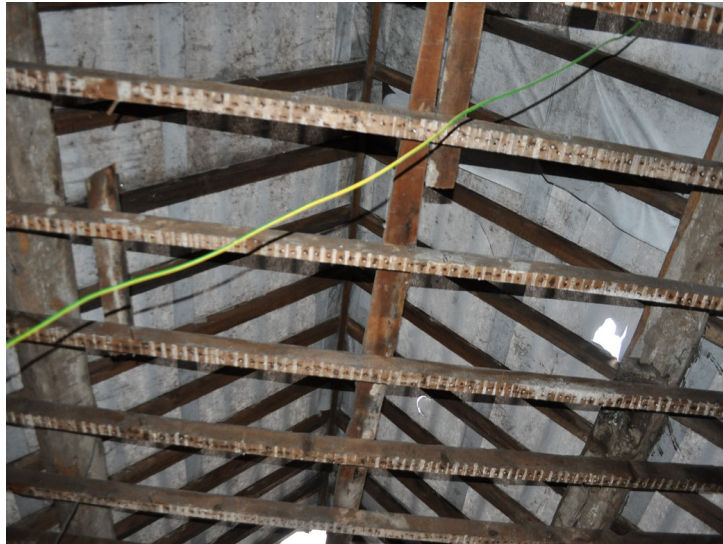
Plate 40- Ceiling in Room F3

6.58. The ceiling and flooring in room F3 is identical to that seen in rooms F1 and F2 (PLATE 40, 41). With recycled northeast-southwest aligned support beams and modern joists, rafters and a waterproof membrane. The floor consisted of timber boards.

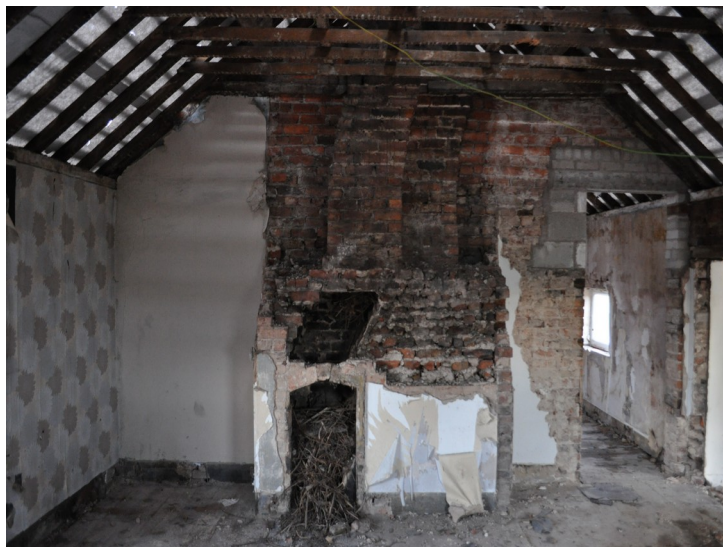
Plate 41 - Northeast Facing Elevation of Room F3

6.59. The northeast facing elevation is made up of brickwork – this is exposed on the northwest side. The bricks are machine made and in a common bond. There is a doorway on the extreme northwestern edge of this elevation, which leads to room F2. The top of this has been reinforced as described in section 6.52. The southeast side of the elevation is covered by plaster. In the centre, there is a large chimney and open fireplace constructed of brick. The brick is regular and consistent in its finish and size and therefore machine made. The chimney is built in stretcher bond (PLATE 41).
