THE GREEN FARM BARN

Author Ethan Ellis MA

Client: Rowlands Contracting

Doc Ref: LP4037C-HBR-v1.4

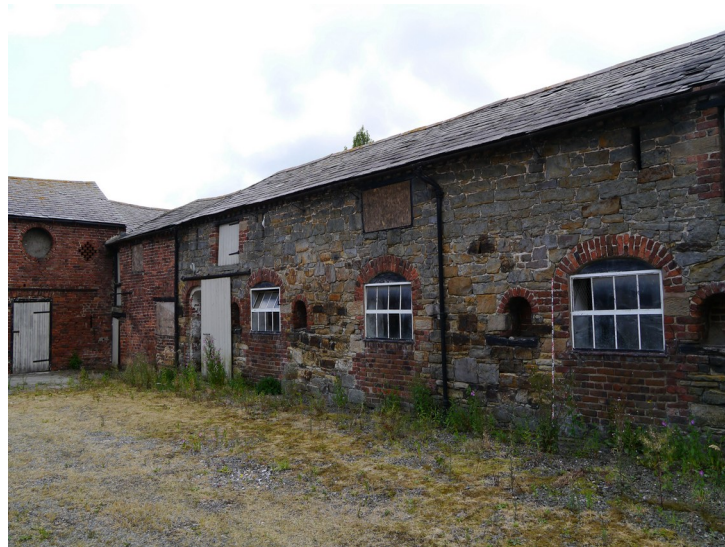
Plate 1 - North-west elevation of Phase 1

6.4.1. The north-west elevation of phase 1 and phase 2 functioned as the primary access route into the building from the main forecourt. The front facade comprised of stone and mortar structural fabric with red brick detail encompassing the doorways and window features. Sculpted stone ends protruded in dentil fashion along the top course of the building directly below the roofline of Phase 1 (PLATE 1). The gable end of Phase 2 projected north-westwardly forming a clear recess and a narrow north-east elevation. A series of brick headers were visible along the top course of the north-east the Phase 2 built in dentil fashion, and a row of iron features imbedded into the stone work which supported the drainage pipe (PLATE 2).

6.4.2. A total of six narrow flat arched lintels of similar dimensions were positioned along the extent of the elevation. Five evenly spaced doorways on phase 1, and one on the north-east most side of the marginally protruding north-west gable

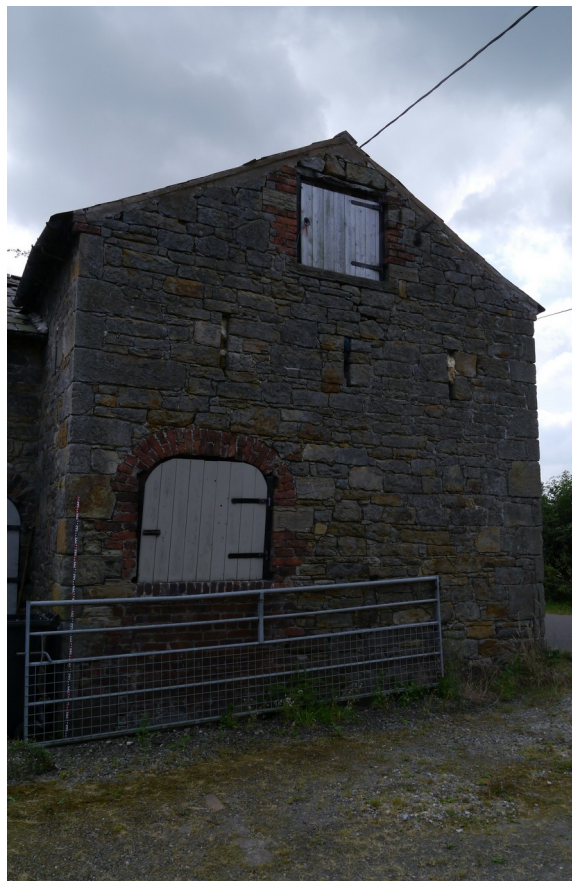
Plate 2 - North-west elevation of Phase 2

6.4.3. The three central previous doorways of Phase 1, and the singular doorway on Phase 2, were bricked from the foundation to the centre of the doorway, which created a rectangular void positioned above. Identically fashioned, with thirteen course high brick in english garden wall bond, three stretchers below a row of headers on the lower area, four stretchers to a row of headers in the centre, and three stretchers below the top course of headers. The three central doorways of Phase 1 were complete with contemporary eight pane windows, whilst the Phase 2 doorway had a fixed swing gate. The two outer doorways of Phase 1 functioned as entrance points into the building, the north west most doorway consisted of an external sliding door, and south-west doorway fused with a swing gate (PLATE 3).

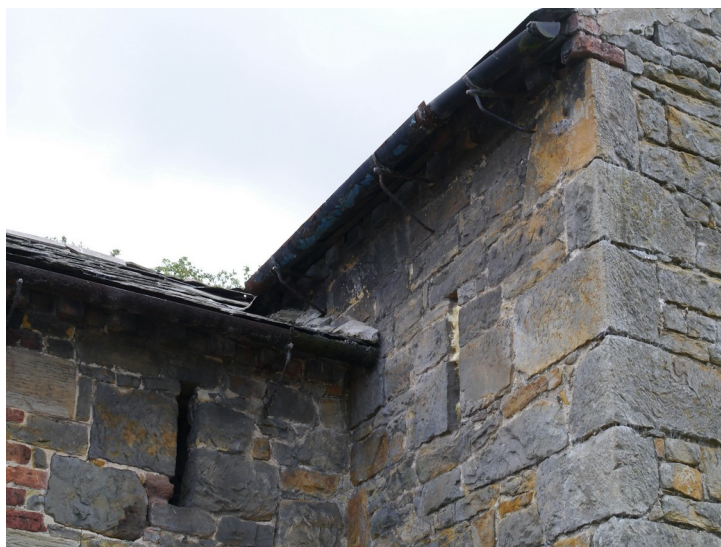
Plate 5 - Joining roofline of Phase 1 and Phase 2

- 6.4.8. Collectively, the phase 1 features were designed in a symmetrical fashion.
- 6.4.9. The south-west most doorway on Phase 1 had been truncated by the north-west to south-east aligned Phase 2 building (PLATE 4), indicating a later phase of construction to the original Phase 1 complex. The extended ridge line of the roof from Phase 1 to Phase 2 is a clear later inclusion, in an attempt to fuse the two buildings, which were characterised by two various styles of slate. A lens of cement render was fixed to the lower Phase 1 roofline to the north-east wall of Phase 2 (PLATE 5).

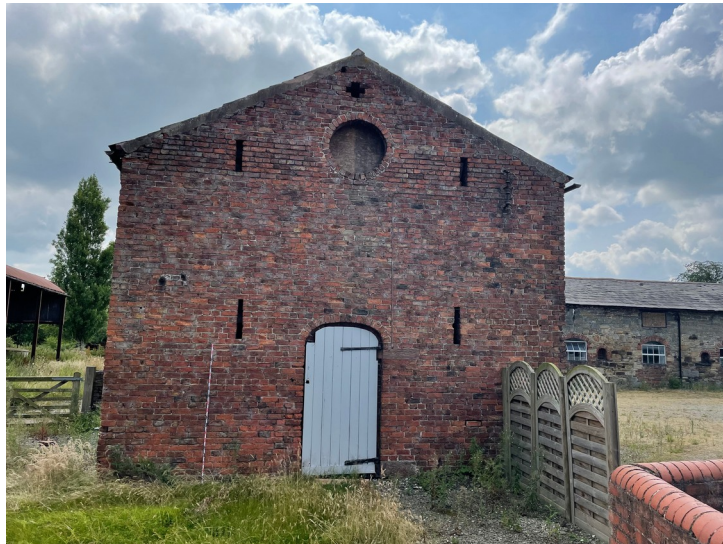
Plate 7 - North-west elevation of Phase 5

6.4.22. Two parallel air ventilation slits were positioned on the upper area of the building directly below the sloping roofline, and two further narrow parallel air ventilation slits were situated either side of the doorway on the lower area.

6.4.23. Extending from the centre of the foundation was a flat arched doorway, decorated in brick ends and two sandstone hinge blocks on the south-west side of the doorframe.

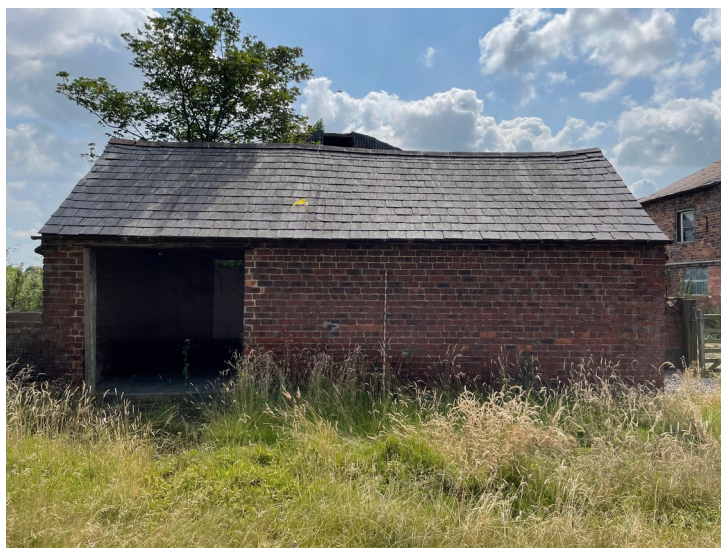
Plate 8 - North-west elevation of the outbuilding

6.4.24. Brick and mortar formed the extent of the north-west elevation wall, decorated in english garden wall bonding course (PLATE 8).

6.4.25. A wide timber framed doorway was positioned on the north-east most area of the elevation, extending from the foundation to the roofline. A lighter shade of mortar chased the brick doorway outline indicating a later insertion. An attempt was made to maintain the brick course bonding.

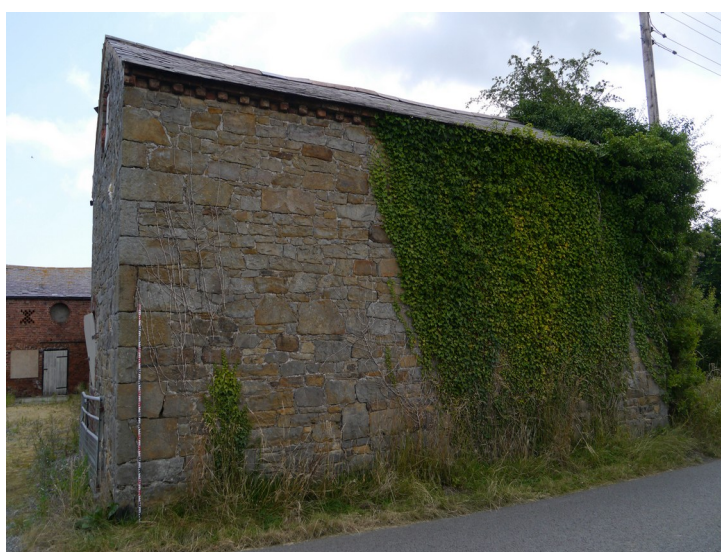
Plate 9 - South-west elevation of Phase 2

6.4.27. The fabric of the south-west elevation of Phase 2 consisted of stone material with red brick dentil top course. Large quoin stones, identical to the main fabric of Phase 1 were present at the edges of the facade (PLATE 9). Undergrowth concealed the south-east extent of the elevation.

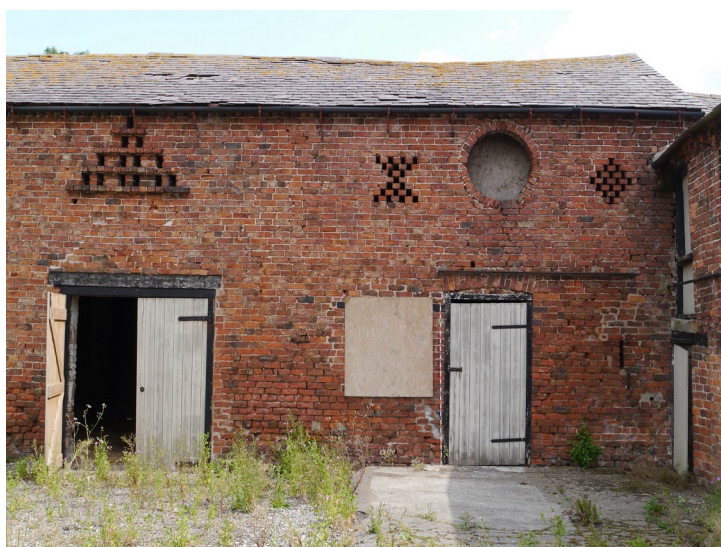
Plate 10 - South-west elevation of Phase 5

6.4.29. Red brick in english garden wall bonding formed the south-west elevation of Phase 5. Although mainly uniform there were areas with breaks including various rows of stretchers between each row of headers (PLATE 10). Protruding brick ends decorated the top course below the roofline in dentil fashion.

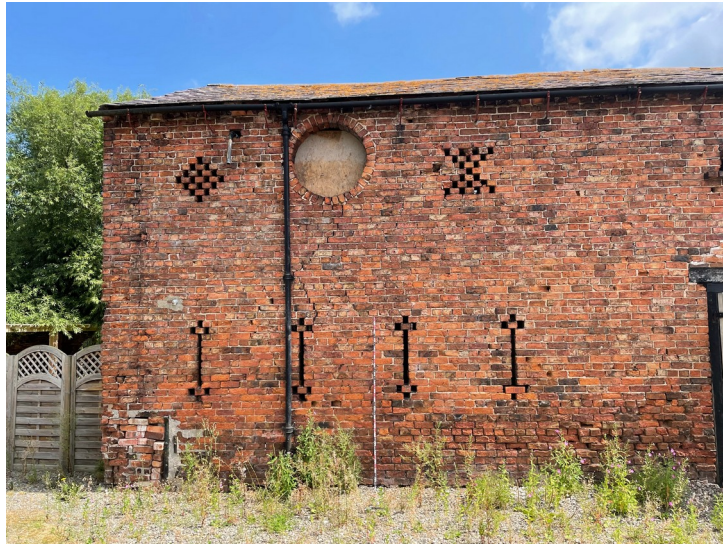
Plate 11 - Air ventilation holes and pitching eye south west elevation of Phase 5

6.4.33. Four air ventilation holes, eight courses vertical with three removed bricks in triangular formation either end were evident along the lower north-west most side of the elevation wall (PLATE 11).

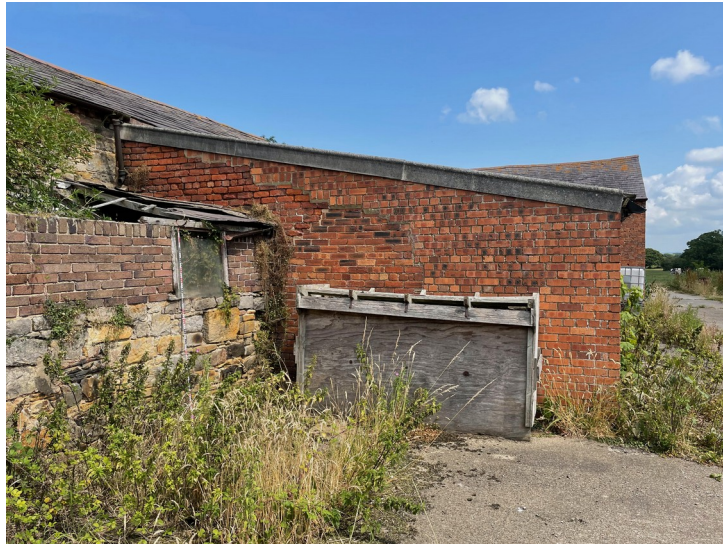
Plate 13 - South-west elevation of Phase 7

6.4.40. Consisting of modern brick material and mortar in english garden wall bonding style, with a sloping felt roofline that descended south-eastwardly, the south-west elevation of Phase 7 butted against the Phase 3 build. An interruption to the brick bond arrangement which had been chased by a discolouration in mortar and broken course bond was evident, where the build fused against the Phase 3 building (PLATE 13). Possibly the building had been extended further south-eastwardly at a later stage to form a larger internal floor space.

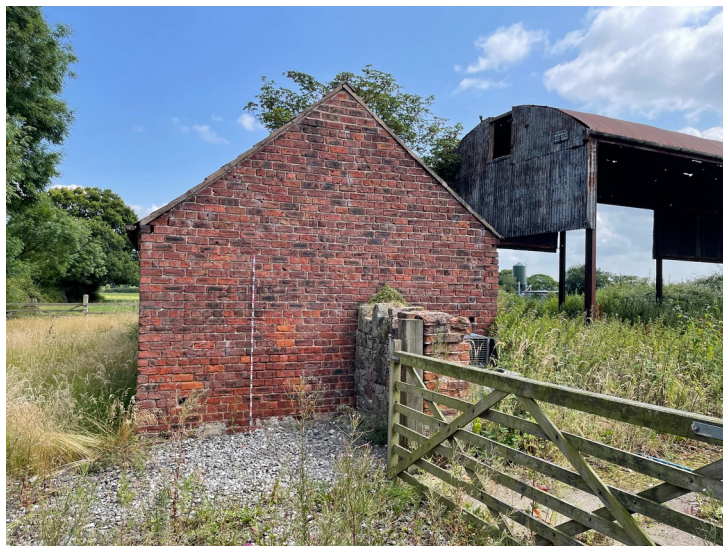
Plate 14 - South-west elevation of outbuilding

6.4.41. The south-west elevation of the outbuilding comprised of gable end in brick and mortar, styled in english garden wall bonding course.

6.4.42. A low stone wall which functioned as an enclosure to the rear east section of site, which butted against the elevation.

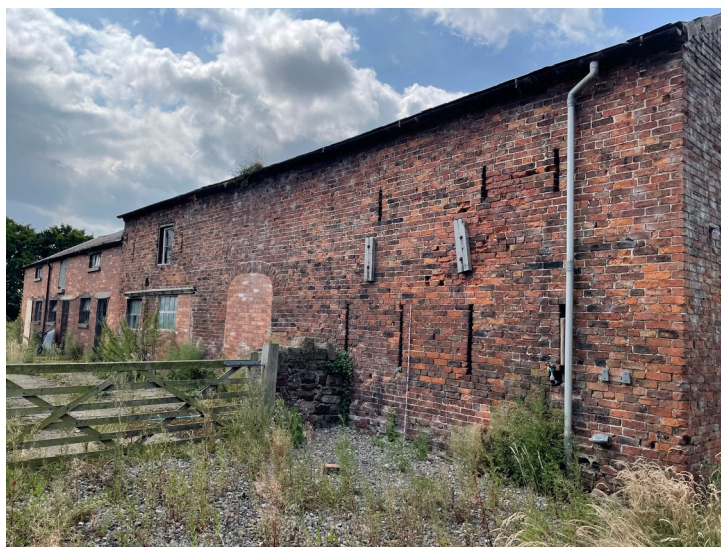
Plate 15 - North-east elevation of phase 5

6.4.43. The fabric of the north-east wall was decorated in english garden wall brick bonding style, with various rows of stretchers between each row of headers. Protruding brick ends decorated the top course below the roofline in dentil fashion (PLATE 15).

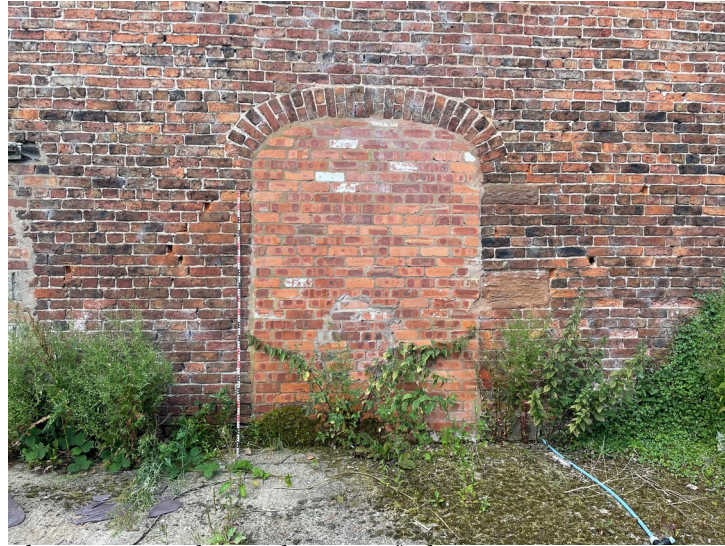
Plate 16 - North-east doorway of Phase 5

6.4.44. Situated in the lower, central area of the elevation was a brick arched doorway of similar dimension to the parallel doorway seen on the south-west elevation. Originally, the two doorways would have formed a fluid entrance point throughout the phase 5 building. Although, the north-east doorway had been sealed at a later stage with contemporary brick material (PLATE 16). Evident from the variation in brick dimension and colour. A large sandstone block was evident on the lower north-west most side of the doorway, and another smaller in sandstone block in comparison positioned six brick courses above, possibly where the original door was fused.

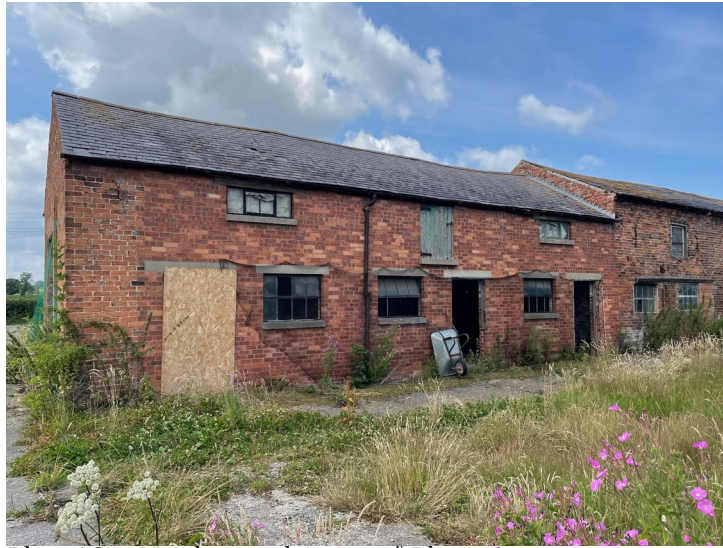
Plate 18 - North-east elevation of Phase 6

6.4.51. The roofline of Phase 6 was marginally lower than that of Phase 5 by eight courses of brick. The fabric of Phase 6 appeared to have been fused into the

original fabric of Phase 5 (PLATE 18).

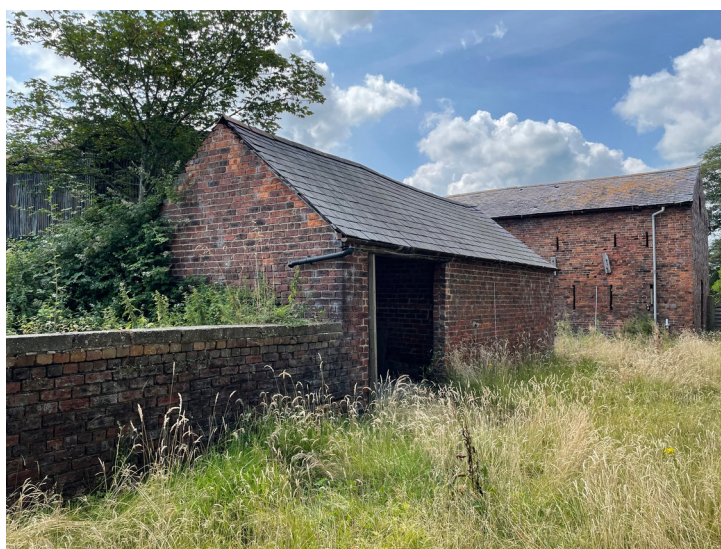
Plate 19 - North-east elevation of the outbuilding concealed by vegetation

6.4.57. The gable end of the north-east elevation was decorated in english garden wall brick course bond. Undergrowth partially concealed lower elevation (PLATE 19).

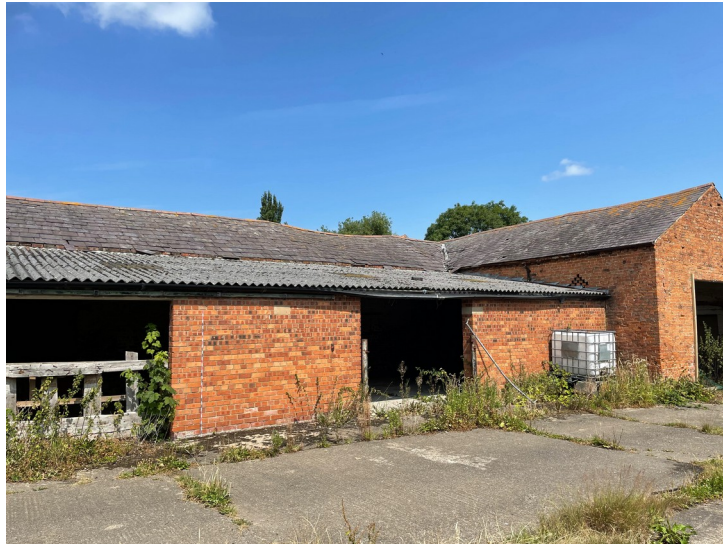
Plate 20 - Rooftop of Phase 1,6, and 7

6.4.59. The view from the south-west elevation presented the best prospective of the rooftop of Phase 1, 6, and 7, which were diverse in material and dimension (PLATE 20). Phase 1 consisted of disproportionate large blue slate, whilst Phase 6 was similar in material and colour but comprised of much smaller and equally sized slate, and the sloping rooftop of Phase 7 consisted of corrugated metal roof sheeting.

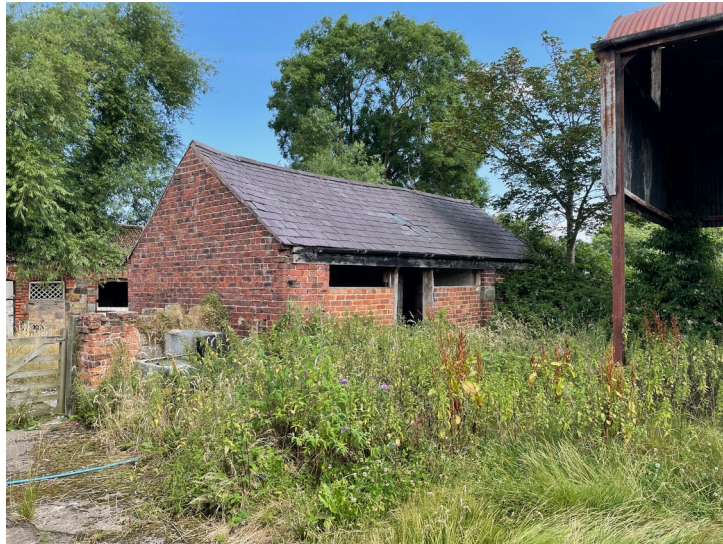
Plate 25 - South-east elevation of the outbuilding

6.4.69. An original wide bay doorway was located on the south-west most elevation wall. An alternate brick material sealed the doorway which contained a narrow doorway in the centre, with a four brick course high window feature positioned each side, descending from the timber load bearing beam (PLATE 25).

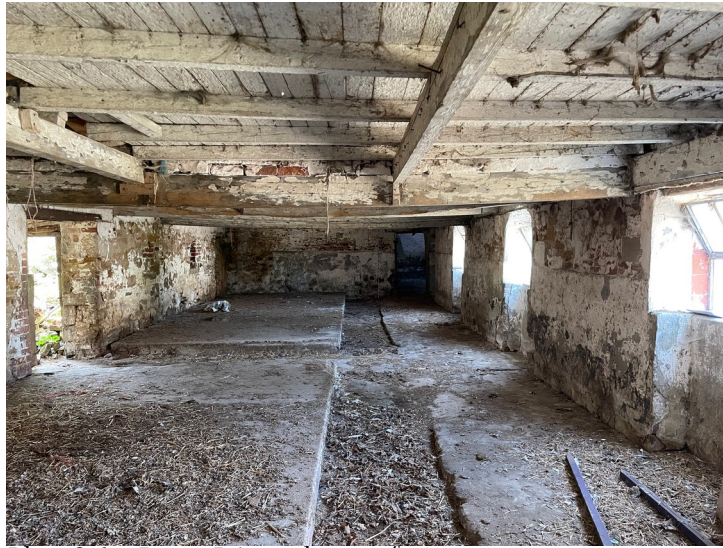
Plate 26 - Room B1 south-west facing

- 6.5.1. During the time of survey, B1 consisted of a large open floor space with a concrete floor surface and a north-east to south-west aligned drainage channel (PLATE 26).
- 6.5.2. The white wash brick walls made it difficult to detect possible reconstruction scars to the fabric.
- 6.5.3. Exposed timber beams formed the low ceiling, which comprised of four north-west to south-east aligned joists that were fused into the north-west and south-east support walls. A series of north-east to south-west load bearing beams were fixed into the main structural timber joist. The timber floorboards of the upper first floor were exposed.

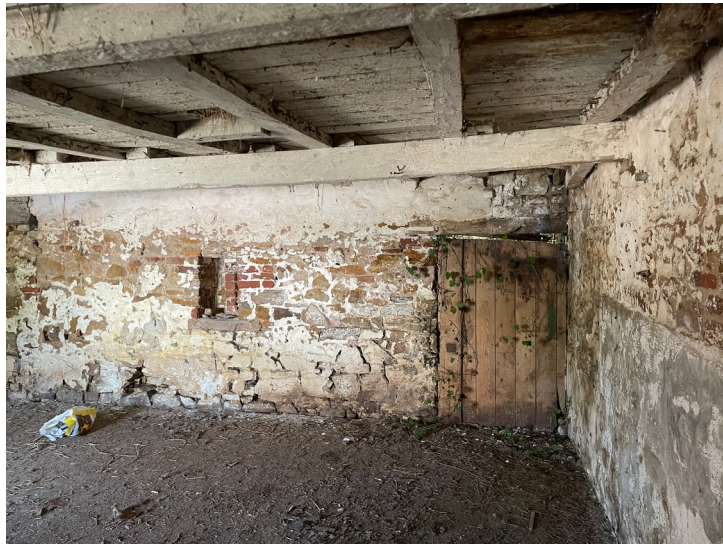
Plate 27 - doorway on south-east elevation wall of Room B1

- 6.5.4. A small doorway comprising of a timber sill was positioned on the south-west most end of the south-east wall, which appeared to compliment the

surrounding stone fabric (PLATE 27).

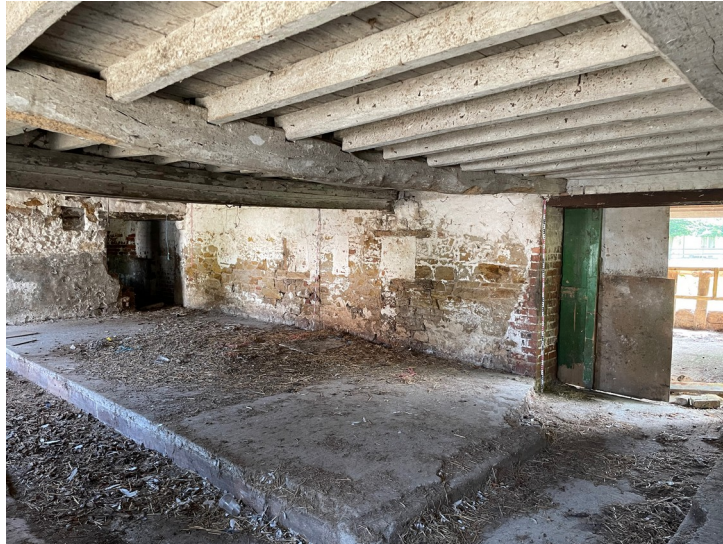
Plate 28 - Three sealed air ventilation holes on south-east elevation in Room B1

6.5.5. The outline of three small rectangular window features were evident along the north-east most side of the elevation. Each were dissimilar in dimension but equally positioned within the centre of the wall, and sealed with brick. The east most feature bore a timber sill, the centre was a narrow two course wide feature, whilst the west most comprised of a timber lintel. Two further bricked features were evident along the west most side of the south-east wall which

comprised of stone sills (PLATE 28). Originally, the features would have functioned as an air ventilation system to maintain a continuous flow of air throughout the complex (HISTORIC ENGLAND 2017, 9).

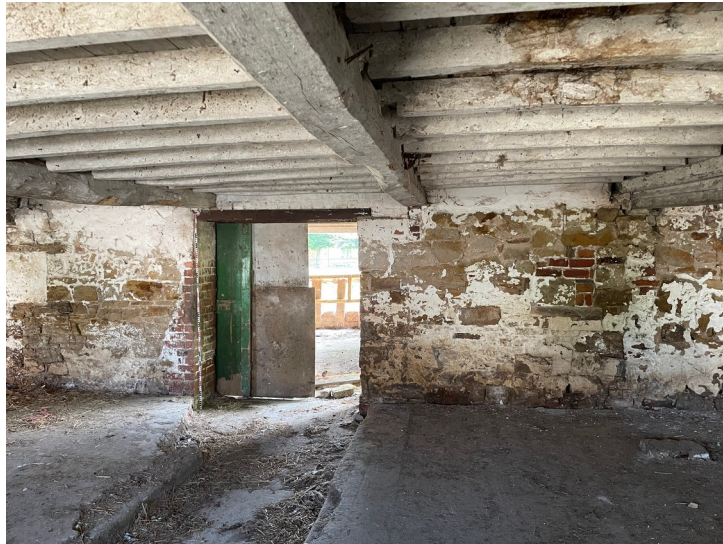
Plate 29 - South-east doorway Room B1

6.5.6. A wide doorway was positioned in the centre of the south-east wall which consisted of an iron lintel. The doorway created an entrance point into the adjacent Phase 7 build. The stone fabric on the south-west side of the doorway appeared to compliment the doorway, whilst the east most side was made of modern brick, indicating the doorway was inserted or widened at a later stage (PLATE 29).

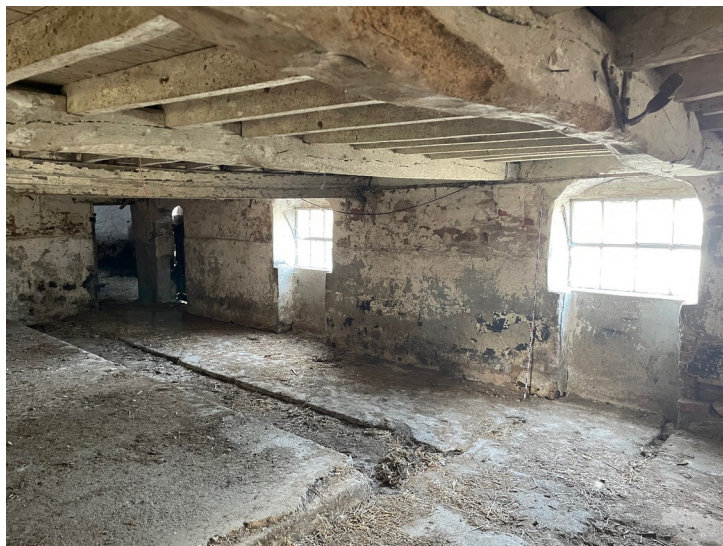
Plate 30 - North-west doorways Room B1

6.5.7. Five doorways were evident along the north-west elevation wall (PLATE 30). The north-east most doorway was arched and consisted of typical vertical sides, whilst the lower area of the four other doorways were narrowed, representative of a horse stable or byre.

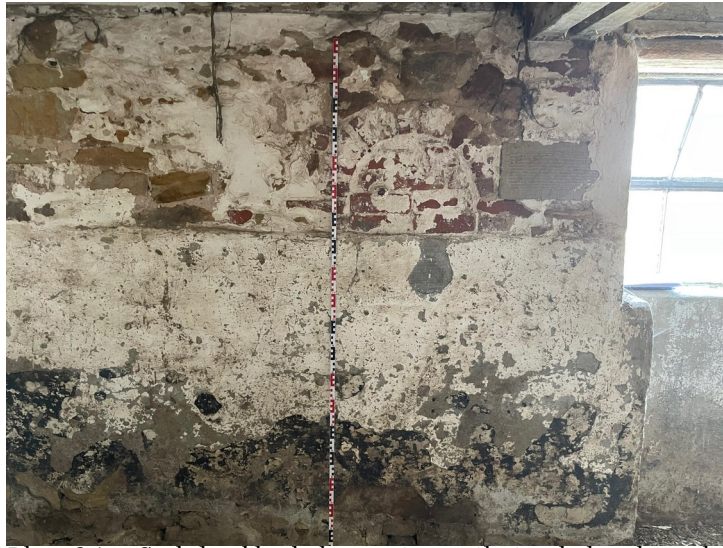
6.5.8. Either side of both the second and fourth doorways were small arched windows, or cubby holes which had been sealed in brick (PLATE 31). The same

Plate 31 - Sealed cubby holes or air ventilation holes along the north-west elevation in Room B1

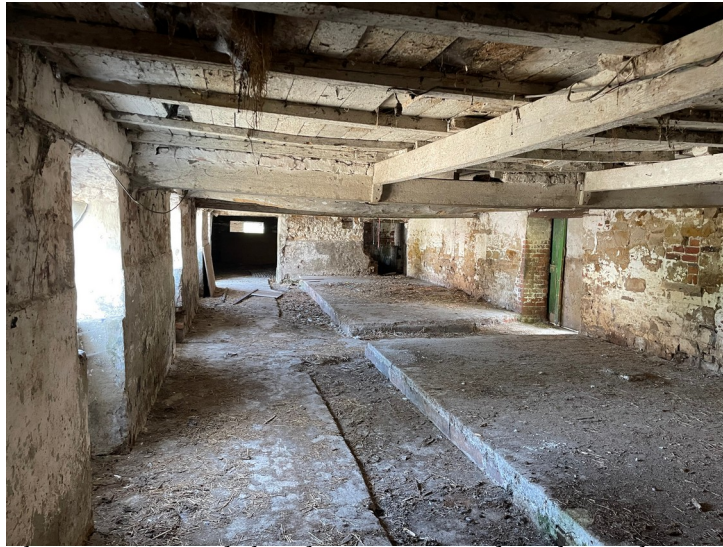
6.5.10. Positioned either end of the north-east elevation wall where two wide doorways with solid timber lintels which lead to the Phase 4 build (PLATE 32). Originally, the elevation would have been a solid stone wall but had been reconstructed during the construction of the Phase 4 build to create a fluid internal access route throughout the entire Phase 1, 2 and 4 complex.

Plate 32 - Two wide bay doorways situated on the north-east elevation of Room B1

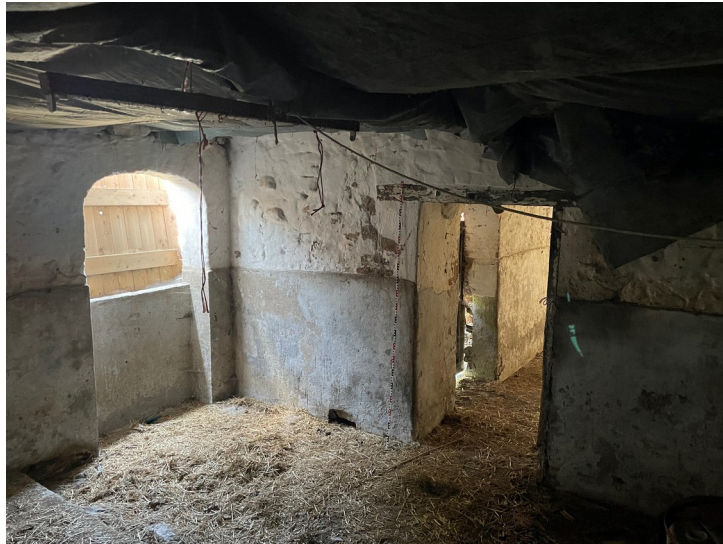
Plate 33 - Two doorways Room B2

6.5.11. Room B2 comprised of a large rectangular floorspace which was assessable from B1 via a doorway located on the south-east elevation, and another arched doorway upon the north-west elevation (PLATE 33). The floor consisted of concrete with a north-west to south-west aligned drainage channel, and an elevated stepped level along the extent of the south-east wall (PLATE 34).

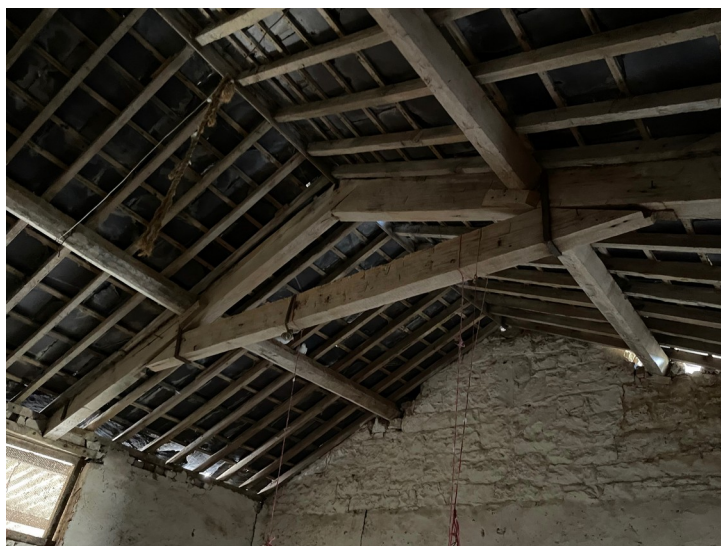
Plate 35 - Timber structural roof Room B4

6.5.19. The exposed rooftop featured a single north-east to south-west aligned ridge beam and two purlin beams which were fused into the north-east to south-west walls. A ridge beam was fixed above the centre of the north-west and south-east wall, which were fixed to the ridge beam above. A tie beam was fused to the two principal rafter beams. A series of common rafters rested above the two purlin beams, extending in a declining fashion from the ridge beam to the top course of the north-west and south-east wall (PLATE 35).

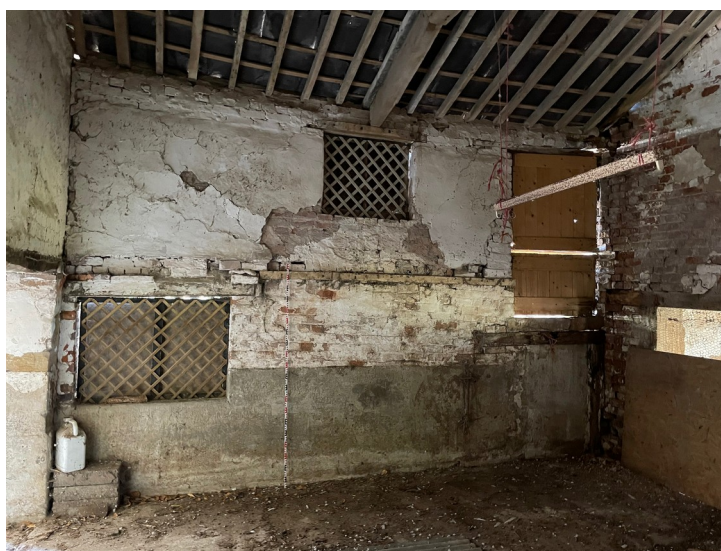
Plate 36 - North-west elevation Room B4

6.5.20. The north-west internal elevation was made of brick and mortar which had been coated in plaster and white wash. Cement render was evident along the lower boarder of the wall (PLATE 36).

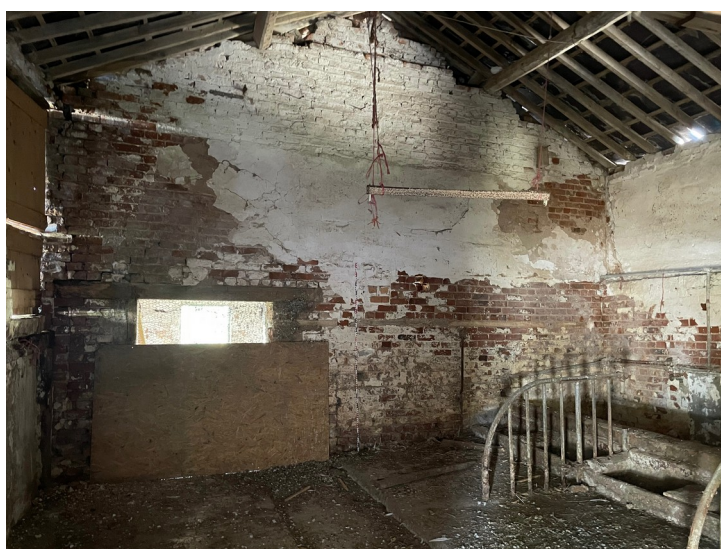
Plate 37 - North-east elevation Room B4

6.5.27. A doorway was positioned on the lower north-west side of the north-east wall which bore a timber lintel that was imbedded into the brick fabric (PLATE 37). Above the lintel was a row of brick headers. The doorway was likely implemented at a later phase due to the disturbance in the surrounding brick fabric.

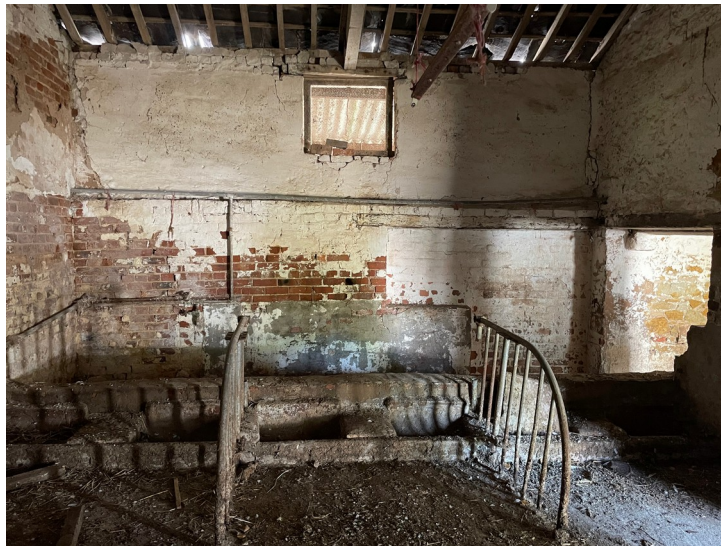
Plate 38 - South-east elevation of Room B4

6.5.30. An outline of a wide bay doorway was evident on the north-east lower end of the south-east wall which had been sealed by brick (PLATE 38). A timber lintel

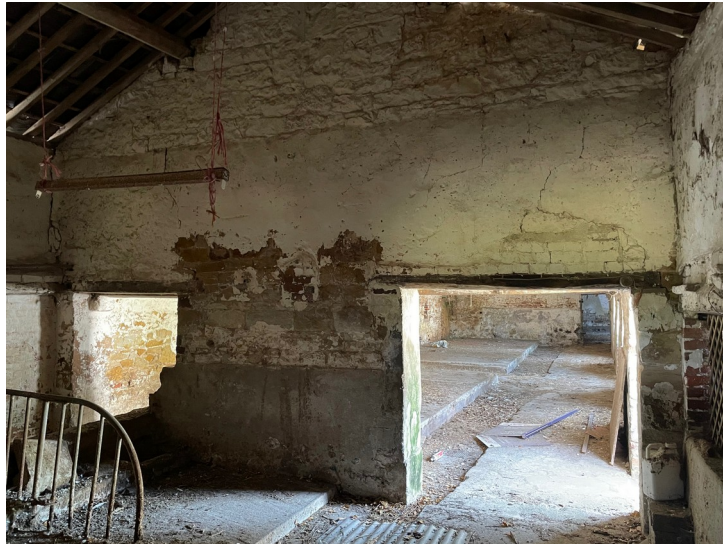
Plate 39 - South-west elevation Room B4

6.5.33. Two wide doorways were positioned on the south-west elevation which consisted of timber lintels (PLATE 39). Implemented at a later phase, possibly during the construction of the Phase 4 build.

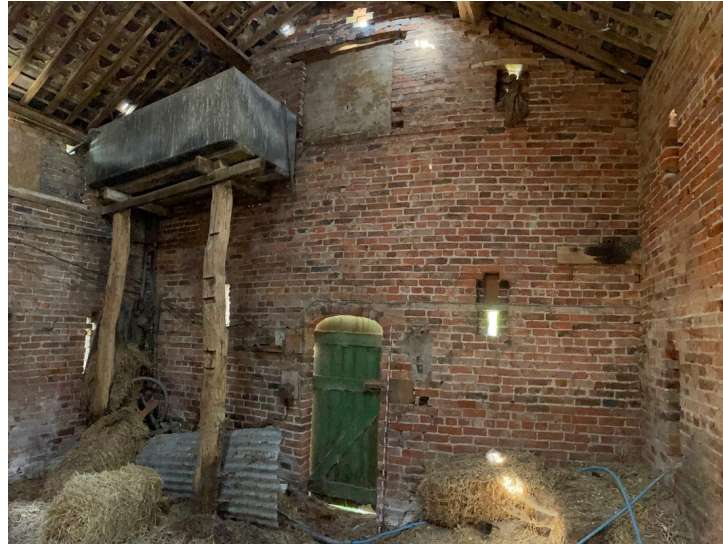
Plate 40 - North-west elevation Room B5

6.5.38. A square boarded window feature was positioned on the upper area of the

north-west elevation, the same feature visible from the external north-west elevation. A cross shaped owl hole was located directly above, with two flanking air ventilation slots on either side (PLATE 40).

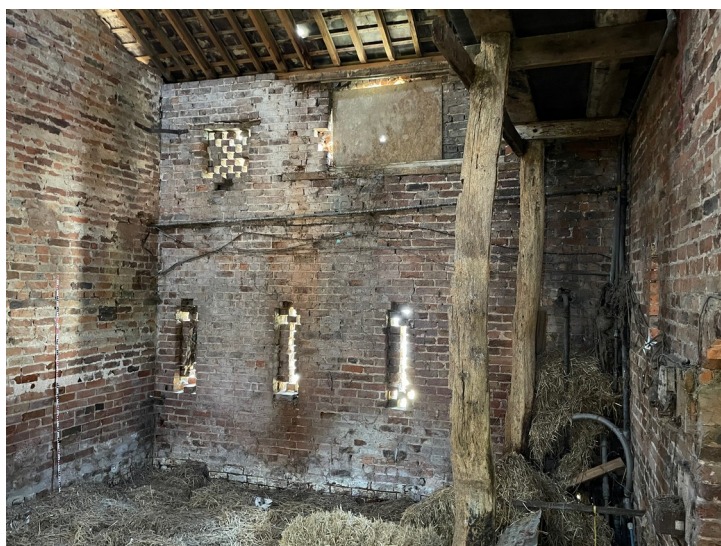
Plate 41 - South-west elevation Room B5

6.5.42. Four horizontal air ventilation slits in an equally consecutively spaced fashion, were positioned on the lower area of the south-west wall (PLATE 41). The same features evident on the external south-west elevation. A boarded rectangular window feature was located directly below the top course of the south-west

elevation, central to the wall which bore a timber lintel and sill. The feature appeared to compliment the surrounding brick fabric, indicating an authentic feature. Two square intruding honeycomb air ventilation features, six course by six course brick in dimension, were positioned either side of the window feature.

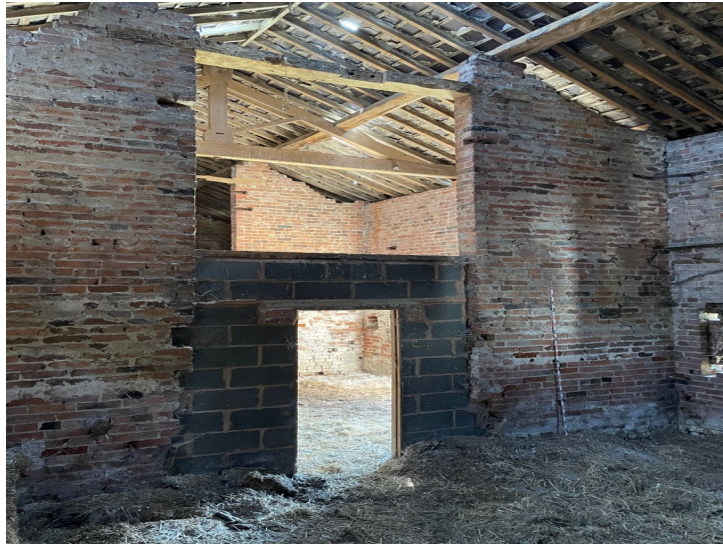
Plate 42 - South-east elevation Room B5

6.5.43. A large wide bay doorways was positioned on the south-east elevation which extend from the foundation to the top course (PLATE 42). A later, eleven course high breeze block wall with a smaller doorway within, was implemented at a later phase. A recycled timber support joist was fused into the upper brick fabric of the two division walls.

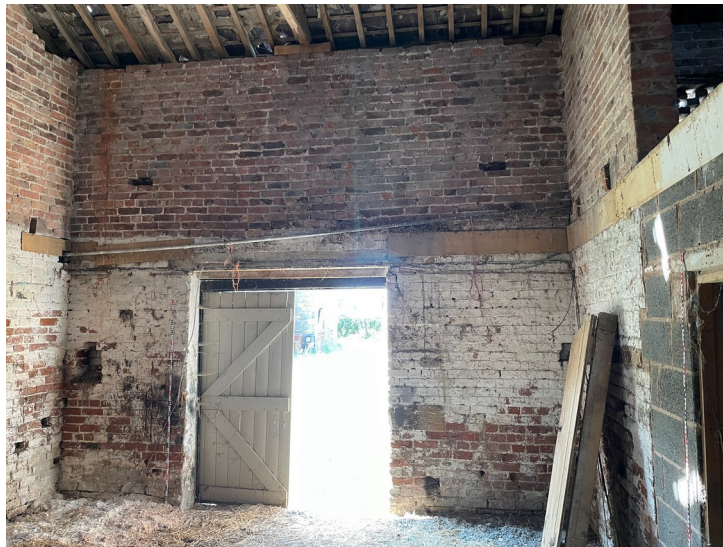
Plate 43 - South-west elevation Room B6

6.5.46. An original wide bay doorway was located on the south-west elevation, marginally positioned south-eastwardly from the centre of the wall (PLATE 43). The doorway contained a timber lintel and a sandstone block, ten brick courses from the foundation on the north-west most frame.

6.5.47. A five brick course high and two course wide cubby hole was located four brick courses south-east of the doorway and fifteen courses up from the

foundation.

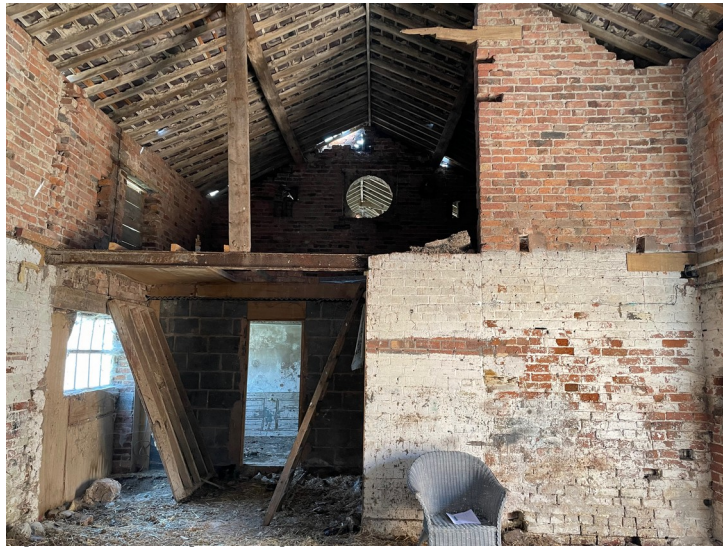
Plate 44 - South-east elevation Room B6

6.5.48. The north-east end of the division wall between B6 and B7 had been removed, whilst the lower south-west side of the division wall had been extend north-eastwardly by five brick courses and thirteen brick course high, evident from the break in brick coursing. A horizontal steel joist was fused to the sub divided room B7 to the north-east elevation, a vertical support timber post rested above the steel joist which held the north-west to south-east aligned purlin above (PLATE 44).

6.5.49. A broken timber joist was evident within the south-west brick fabric, four courses down from the top course. Most likely removed during the removal of the north-east most side of the south-east division wall.

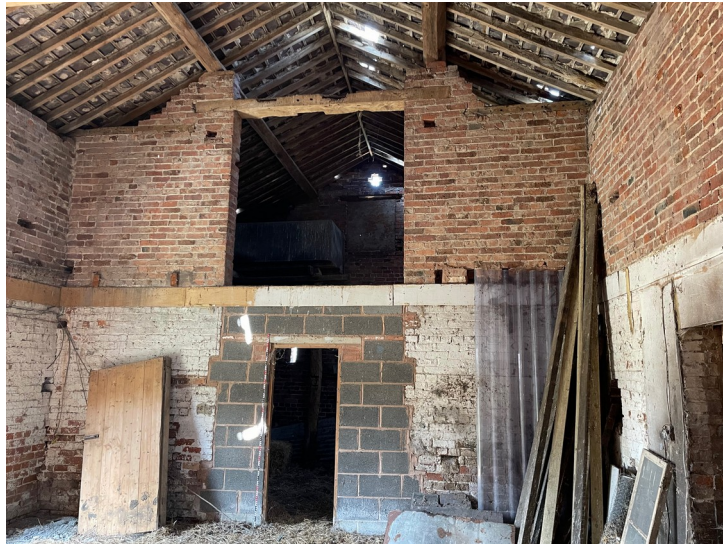
Plate 45 - North-west elevation Room B6

6.5.53. Slot holes for a floor surface were evident in a consecutive horizontal fashion along the central area of the north-west division wall (PLATE 45). The lower open doorway had been sealed with breeze blocks and a narrow doorway with a timber lintel positioned within. A recycled timber joist was fused to the upper north-east to the south-west division walls of the north-west elevation.

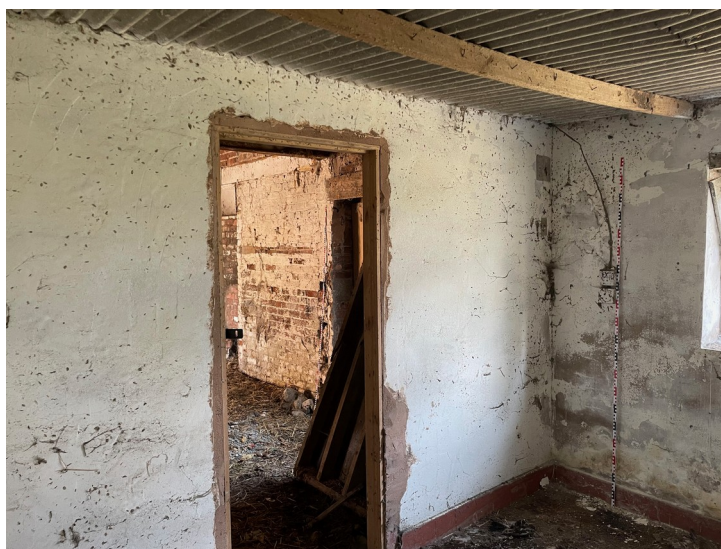
Plate 48 - North-west elevation room B7

6.5.63. A timber framed doorway was positioned in the centre of the north-west wall, presenting access into the adjacent Room B6 (PLATE 48).

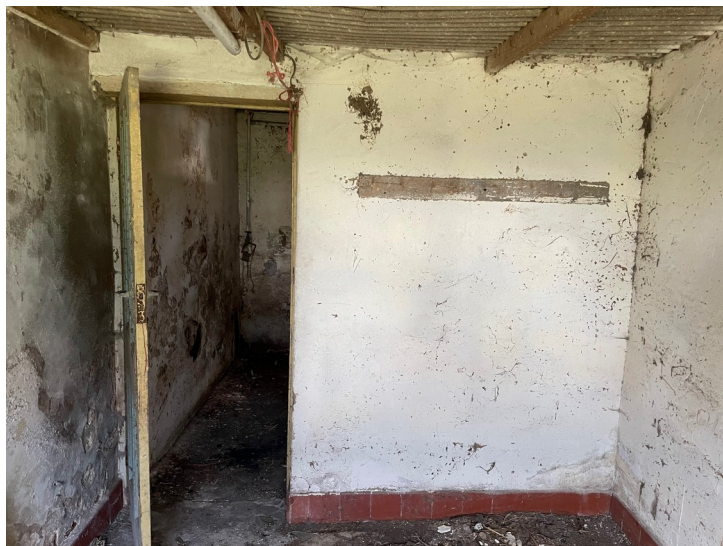
Plate 50 - South-west elevation Room B7

6.5.66. A doorway was positioned on the south-east most end of the south-west wall which comprised of a timber lintel. Imbedded into the fabric of the south-west wall, adjacent the doorway in a horizontal fashion, was a timber frame, which possibly functioned as a fixture for a feature (PLATE 50).

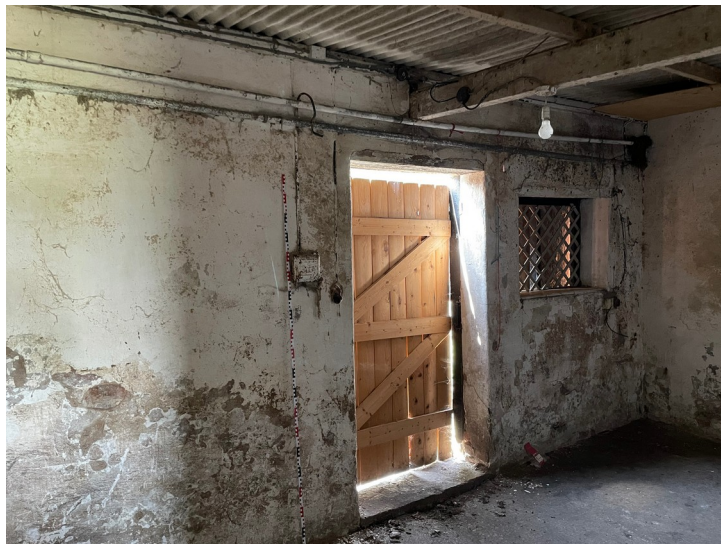
Plate 51 - South-west doorway Room B8

6.5.71. A doorway with a stone threshold was positioned in the centre of the south-west elevation wall, presenting access to the front facade of the Phase 5 building. A small squared window feature with a timber lintel was evident north-west of the doorway (PLATE 51).

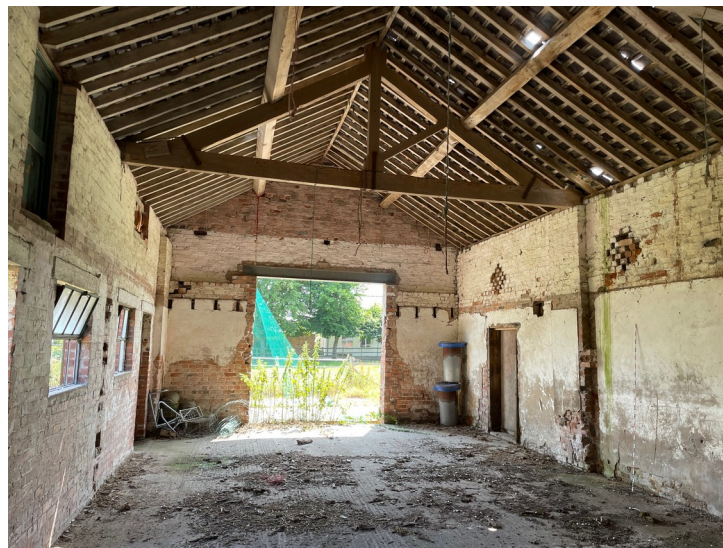
Plate 52 - Timber structural beam Room B9

6.5.73. A timber framed ceiling support joist extended from the top course of the south-west brick post, to the top course of the north-east wall. A king post extended vertically from the ceiling support joist to the ridge beam. Two diagonal brace beams were fixed to the ceiling support joist to the king brace above (PLATE 52). Another identical feature was positioned to the north-west.

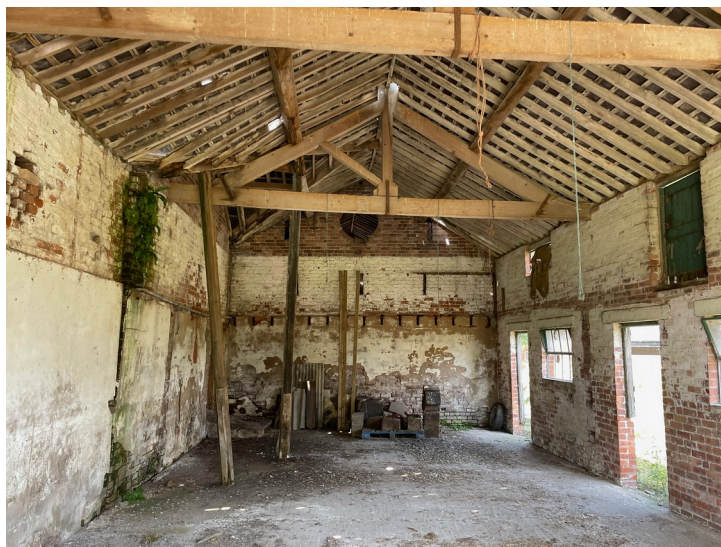
Plate 53 - North-west elevation Room B9

6.5.77. Positioned in an equally dimensioned, consecutive horizontal fashion along the centre elevation wall, was a series of small vertical slots holes which had previously accommodated timber joists of an upper first floor level. White wash paint was applied to the seventeen courses of brick above the original first floor joist fittings.

6.5.78. Plaster render applied to the lower area concealed any possible reconstruction scars to the original brick fabric.

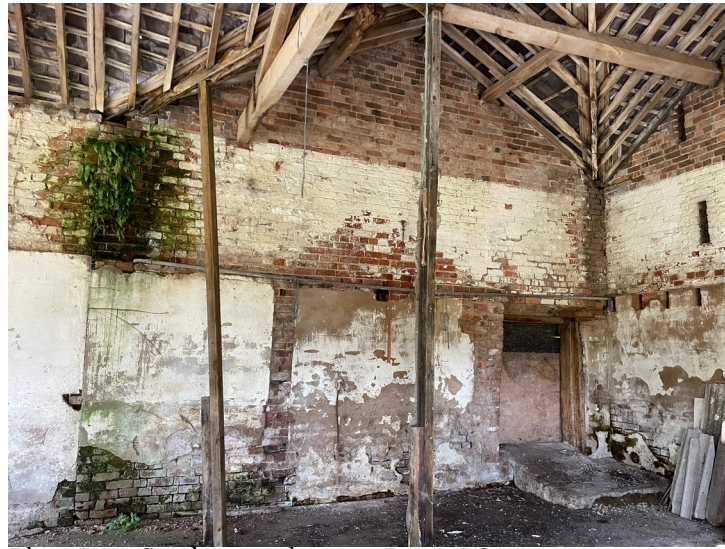
Plate 54 - South-west elevation Room B9

6.5.79. The external north-east elevation of the gable end Phase 4 build, functioned as part of the internal fabric of the south-west internal wall of room B9. There was a clear vertical break in the brick bonding course where the continuation of the south-west wall of room B9 extended south-eastwardly (PLATE 54). The

continuation wall butted against the original Phase 4 build, confirming that Phase 6 was later than Phase 4 in date.

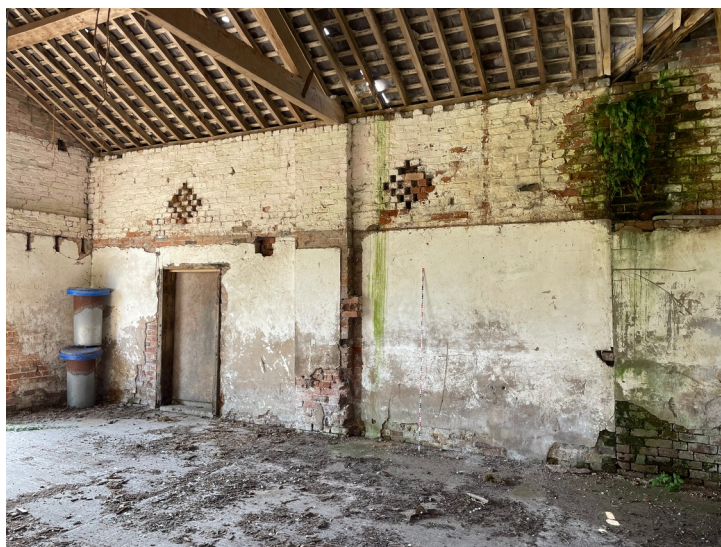
6.5.81. Situated on the south-east end of the south-west elevation wall was a timber framed doorway with a stone doorway (PLATE 55). The surrounding brick had been plastered, concealing any reconstruction scars to the fabric to clarify whether the feature was an original architectural feature or a later adaption.

6.5.83. A protruding brick wall post extended from the foundation to the top course, situated directly north-west of the doorway air ventilation feature by six stretcher brick courses wide. The brick post measured at three stretcher course wide and one brick end in depth. The feature supported a timber ceiling joist above.

6.5.84. Two courses north-west of the protruding brick post was another seven by seven course air ventilation feature fashioned in a diamond design, equally levelled to the adjacent air ventilation above the doorway located to the south-east.

Plate 55 - Doorway and two air ventilation features along south-west elevation Room B9

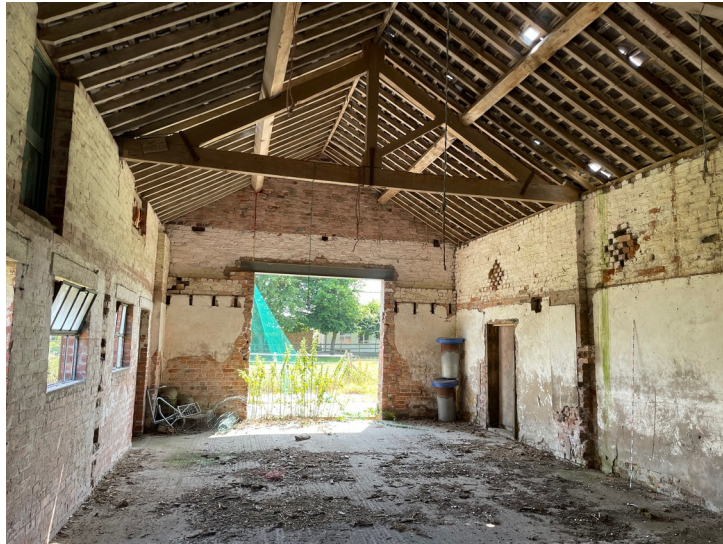
Plate 56 - South-east elevation doorway Room B9

6.5.86. A wide bay doorway consisting of a steel lintel was positioned in the centre of south-east elevation (PLATE 56). Reconstruction to the surrounding brick fabric was evident, with a break in course bonding that was chased by a discolouration in mortar. Situated either side of the doorway in a consecutively horizontal fashion, were four beam slot holes which had previously supported a floor surface.

6.5.87. The lower area of the elevation, exactly five brick courses down from the steel joist, protruded outward north-westwardly by a single brick end.

6.5.88. Three small square holes were evident in a horizontal fashion along the upper elevation.
