THE GREEN FARM BARN

Author Ethan Ellis MA

Client: Rowlands Contracting

Doc Ref: LP4037C-HBR-v1.4

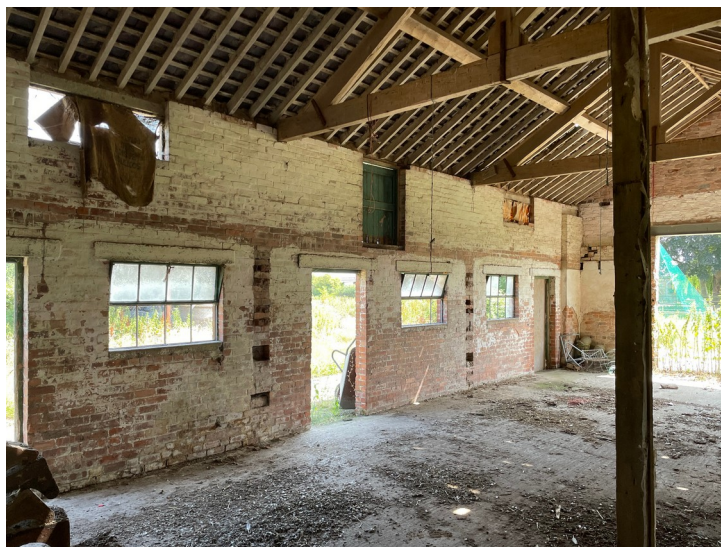
Plate 57 - North-east elevation Room B9

6.5.89. Three doorways of similar dimensions were evident along the north-east elevation wall, comprising of stone lintels (PLATE 57). One positioned on the centre of the wall, another near the north-west most end, and a further on the south-east most side.

6.5.92. A ghost vertical outline was evident between the central doorway and the adjacent north-west window, where a previous single brick stretcher course dividing wall extended south-westwardly. Another similar outline was visible between the two windows situated on the south-east side of the elevation wall.

6.5.93. In the south-east most corner of the north-east elevation was a protruding brick wall post which extended from the foundation to the fourth lower course of the top course.

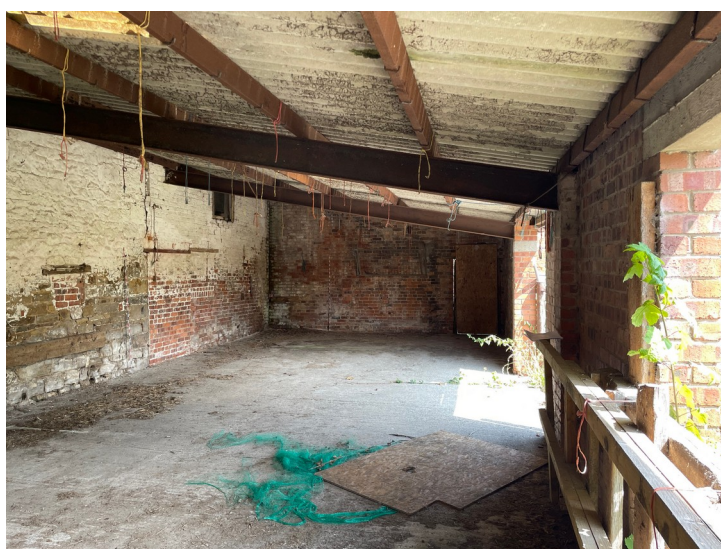
Plate 58 - North-east elevation Room B10

6.5.96. Brickwork formed the north-east elevation in english garden wall course bonding. A boarded doorway with a timber lintel occupied the south-east most end of the elevation, which presented access into the adjacent room B9 of the Phase 6 complex (PLATE 58).

6.5.97. A steel hay rack was fixed to the wall directly north-west of the doorway, implying the complex was utilised for a horse barn or cattle house at some point.

6.5.98. Situated above the hay rack, directly below the roofline, and north-west of the doorway, was a small rectangular outline of mortar around three brick header courses of brick, contrastive to the encompassing original fabric. Possibly a former support slot for a structural feature, or simply restoration work.

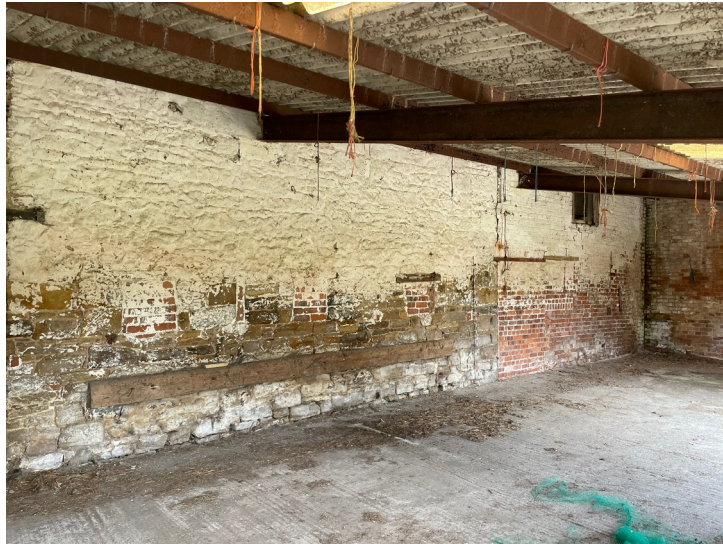
Plate 59 - North-west elevation Room B10

6.5.100. The south east external elevation of Phase 1 and 4, functioned as the north-west internal wall of room B10. Subsequently, there was a clear vertical break in the structural framework, distinguishable by the stone fabric of Phase 1 and the brick fabric of Phase 4. The brick structure of Phase 4 butted against the original Phase 1 stone complex (PLATE 59).

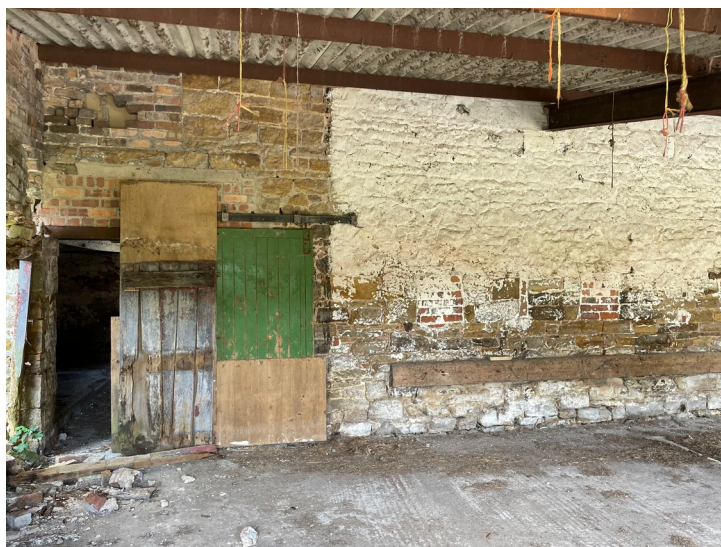
Plate 60 - North-west doorway Room B10

6.5.104. A wide bay doorway was located on the lower south-west most end of the elevation wall, comprising of a steel lintel (PLATE 60). An iron rail was attached to the fabric directly above which would have accommodated a sliding door. Clear restoration work was evident above the doorway which comprised of brick material.

6.5.105. Against the south-west most side of the brick fabric was a doorway and a window feature directly north-east of the doorway. Both features comprised of a timber lintel and were sealed with modern brick. Evident from the discolouration of mortar and break in coursing bond. The alternate brick material used differed from the encompassing main fabric in both dimension and colour.

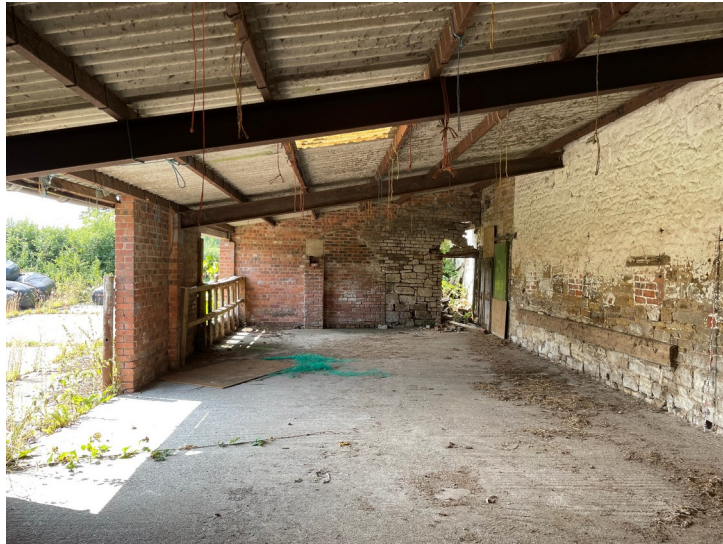
Plate 61 - South-west elevation Room B10

6.5.107. The stone fabric of the north-east external elevation of the Phase 3 building, functioned as the internal south-west elevation of room B10. A timber framed doorway was situated on the north-west most side of the south-west elevation (PLATE 61). The south-east stone doorframe appeared to compliment the doorway, indicating an original architectural feature of the Phase 3 complex.

6.5.108. The remainder of the south-east area of the elevation wall, comprised of three alternate brick materials in english garden wall course bond. Distinguishable from the break in bonding course, and the variation in colour and brick dimension.

6.5.109. A protruding brick post, fourteen courses in height and two stretcher course wide, was evident directly south-east section of the elevation wall, possibly the original extent of room B10.

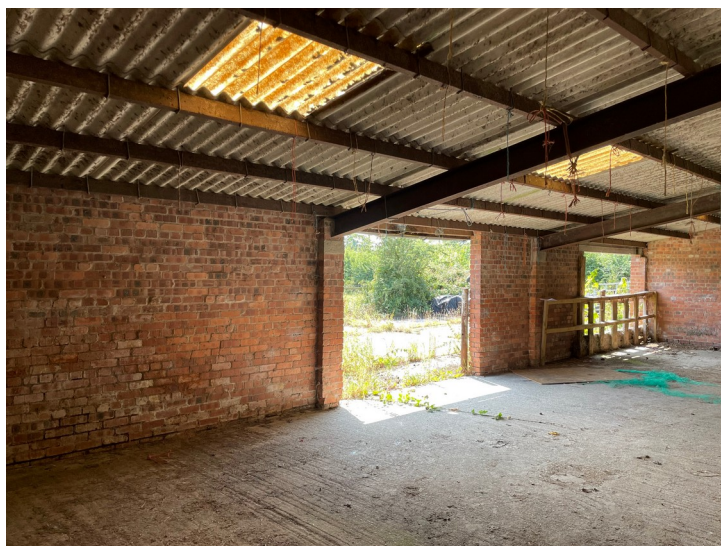
6.5.110. The extent of the south-east elevation consisted of brick material in english garden wall coursing. Two wide bay doorways of similar dimension extended from the foundation to the roofline. One situated on the south-west most end of the elevation, and the other positioned in the central wall (PLATE 62).

6.5.111. A protruding brick post extended from the foundation to the roofline of the north-east frame of the central doorway, which supported the north-west to south-east aligned steel roof joists. Another protruding post of similar characteristics was located in the centre of the two doorways which supported another steel roof joist.

Plate 62 - Two doorway positioned along the south-east elevation Room B10

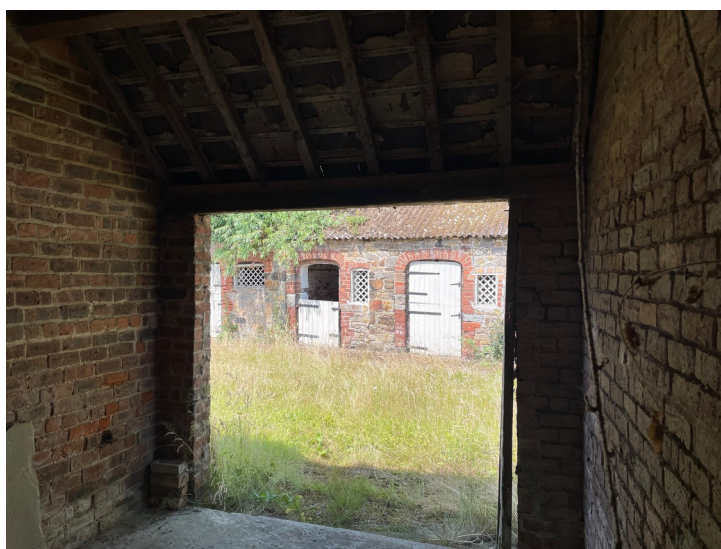
Plate 63 - North-west elevation Room B11

6.5.114. The wide bay doorway positioned on the north-west elevation functioned as the main form of access into the building. The lintel comprised of a solid timber beam (PLATE 63).

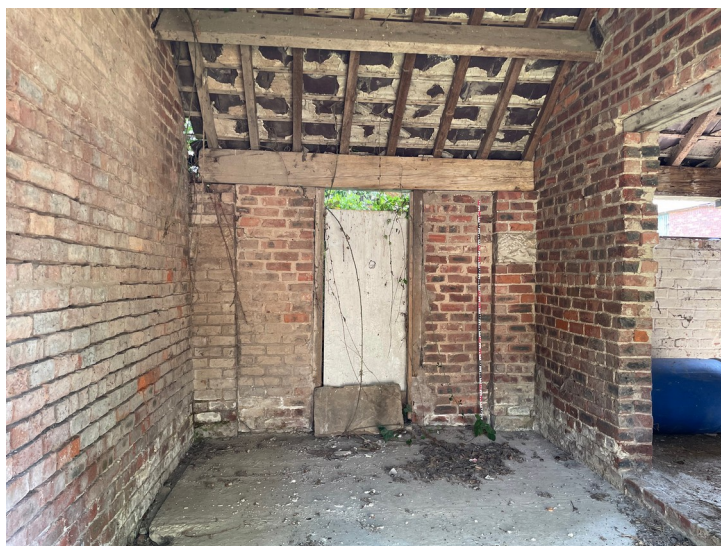
Plate 64 - South-east elevation Room B11

6.5.117. Brick post, two brick wide, protruded outward either side of the south-east elevation. A stone block was fixed into the upper south-east most post. A narrow timber doorway was positioned in the centre of the wall (PLATE 64).

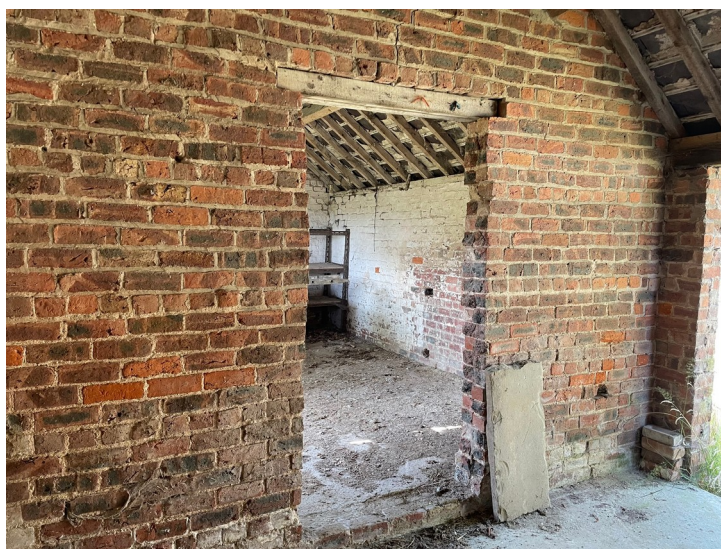
Plate 65 - South-west elevation Room B11

6.5.118. A wide doorway was positioned in the centre of the south-west wall which appeared to disrupt the surrounding brick fabric, indication a later insertion. The doorway consisted of a timber beam lintel and brick threshold (PLATE 65).

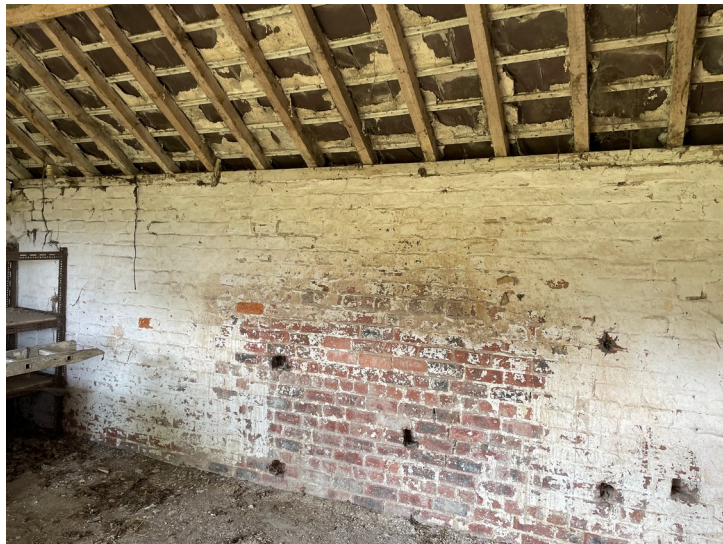
Plate 66 - North-west elevation Room B12

was likely fused to the wall (PLATE 66).

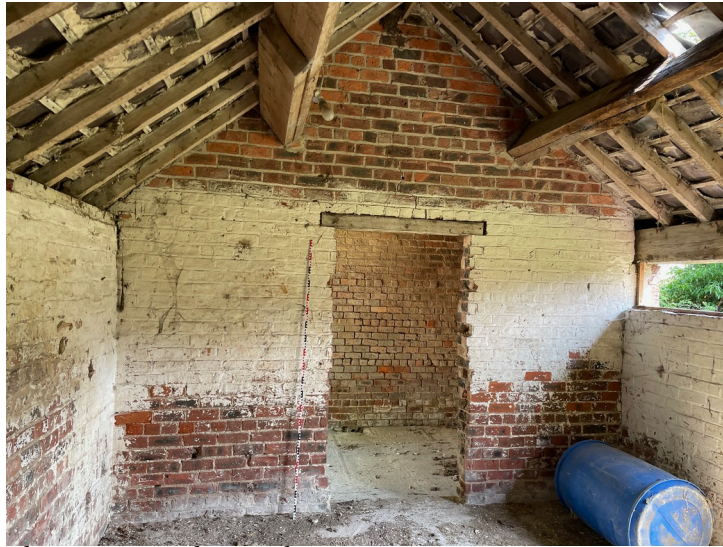
Plate 67 - North-east elevation Room B12

6.5.122.A later doorway was positioned in the centre of the north-east elevation wall, evident from the disrupted surrounding brick, which formed an access route into the adjacent Room 11 (PLATE 67).

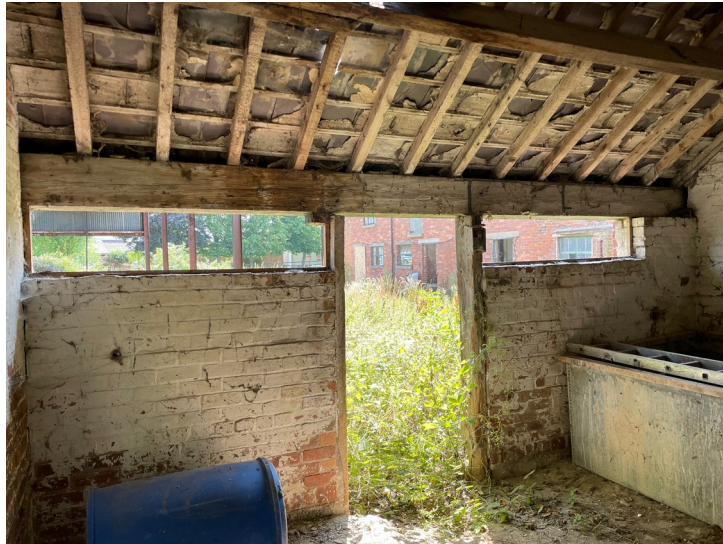
Plate 68 - South-east elevation Room B12

6.5.123.A timber doorway was positioned in the centre of the south-east elevation, with two narrow windows of similar dimension, one positioned either side of the doorway on the upper most elevation, directly below the roofline (PLATE 68).

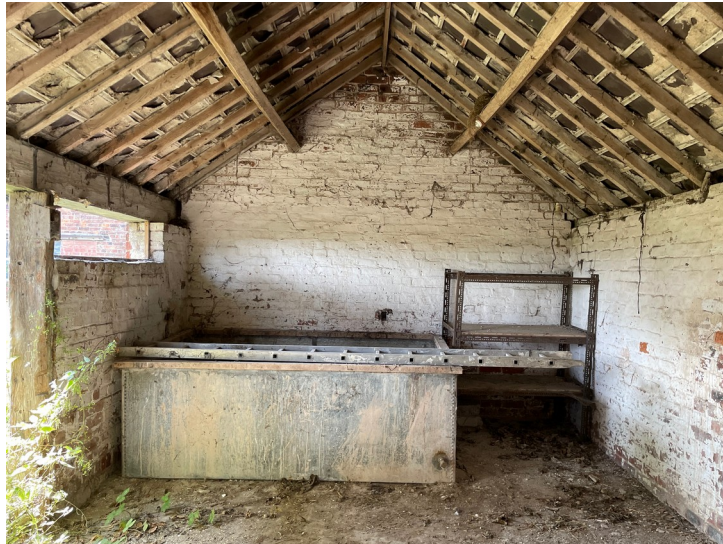
Plate 69 - South-west elevation Room B12

6.5.125.A steel tank and shelf was fused to the south-west gable end elevation wall (PLATE 69).

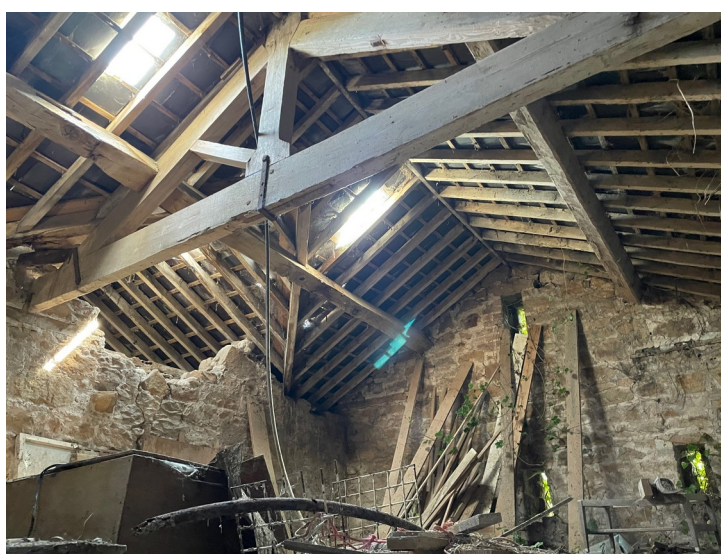
Plate 70 - Timber structural beams Room F2

6.5.128. The four elevation top course walls comprised of stone and mortar fabric. The open structural roof consisted of a combination of modern and recycled timbers, with a ridge beam and two extending from the north-west elevation to the south-east elevation wall. A series of common rafters declined from the ridge beam to the wall posts above the north-east and south-west walls (PLATE 70).

6.5.129. A timber framed ceiling support joist extended from the top course of the central north-east elevation to the top course of the south-west wall. A king post extended vertically from the ceiling support joist to the ridge beam. Two diagonal brace beams were fixed to the ceiling support joist to the king brace above.

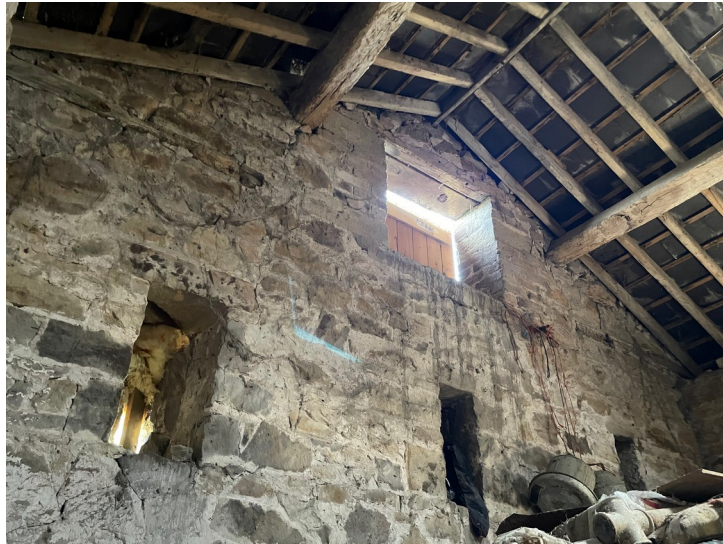
Plate 71 - North-west gable end Room F2

6.5.131. Three consecutive air ventilation slits were positioned along the lower area of the north-west elevation wall, parallel to the three similar features on the south-east elevation. A large square pitching hole was evident above the central air ventilation feature, located directly below the top course of the gabled wall. The pitching feature bore a timber lintel and stone sill (PLATE 71).

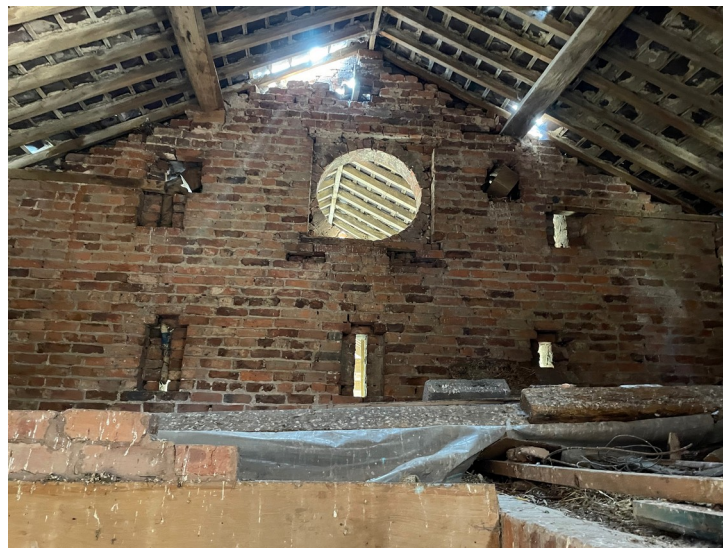
Plate 72 - South-east elevation Room F3

6.5.135. Three air ventilation slots were evident along the lower area of the south-east elevation, positioned in a consecutive fashion. A circular pitching hole was located above the lower central air ventilation hole, directly below the top course of the gabled wall. Adjacent the pitching hole on either side was an air ventilation slit (PLATE 72).
