**LEVEL 3 BUILDING RECORDING OF
A FORMER BARN AT
LLAN Y NANT, LLANISHEN,
TRELLECH GRANGE, NP16 6QN
PLANNING APPLICATION:
DM/2019/00998 (Monmouthshire)**

April 2021

Trysor Project No. 2020/746

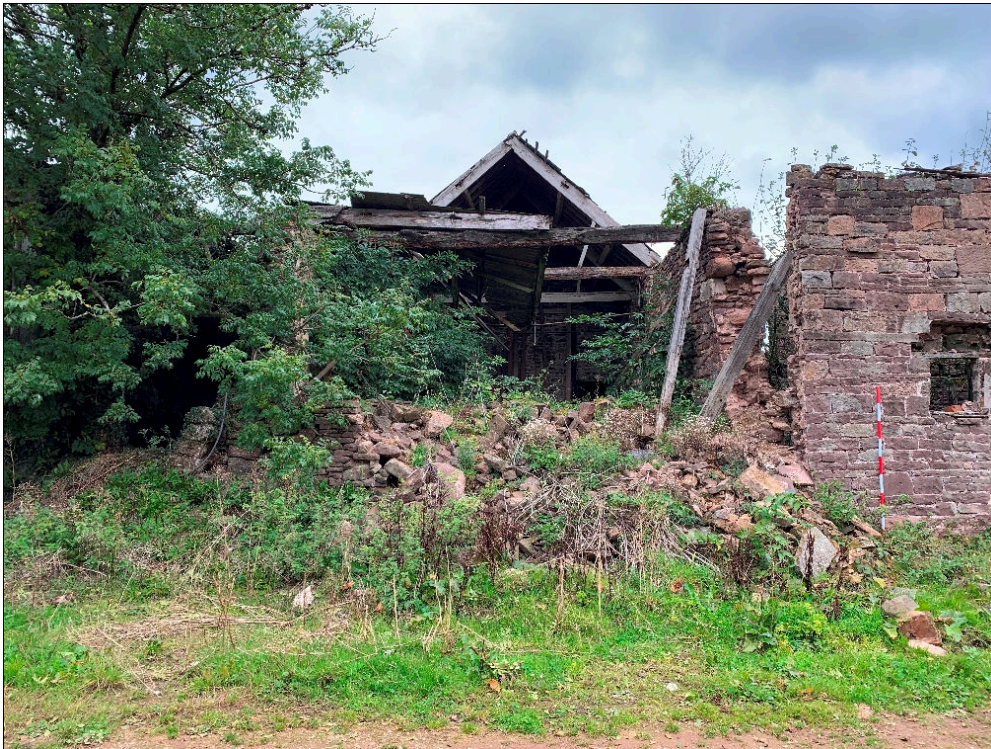
8.3.5 The southern gable wall of the barn has collapsed, and its rubble lies to the south of the building (Plates 1 & 55). No features survive, although it is thought that this wall was not the original gable wall of the barn as it appears to have been inserted between the lateral walls of the barn (Plates 4 & 5). During the 19th and 20th centuries an extension, now lost, stood attached to the outside of this wall and it is possible that the original gable wall was replaced when this extension was constructed.

Plate 1: LLN2020_001 - A view of the now collapsed southern end of the barn at Llan y Nant. Looking north.

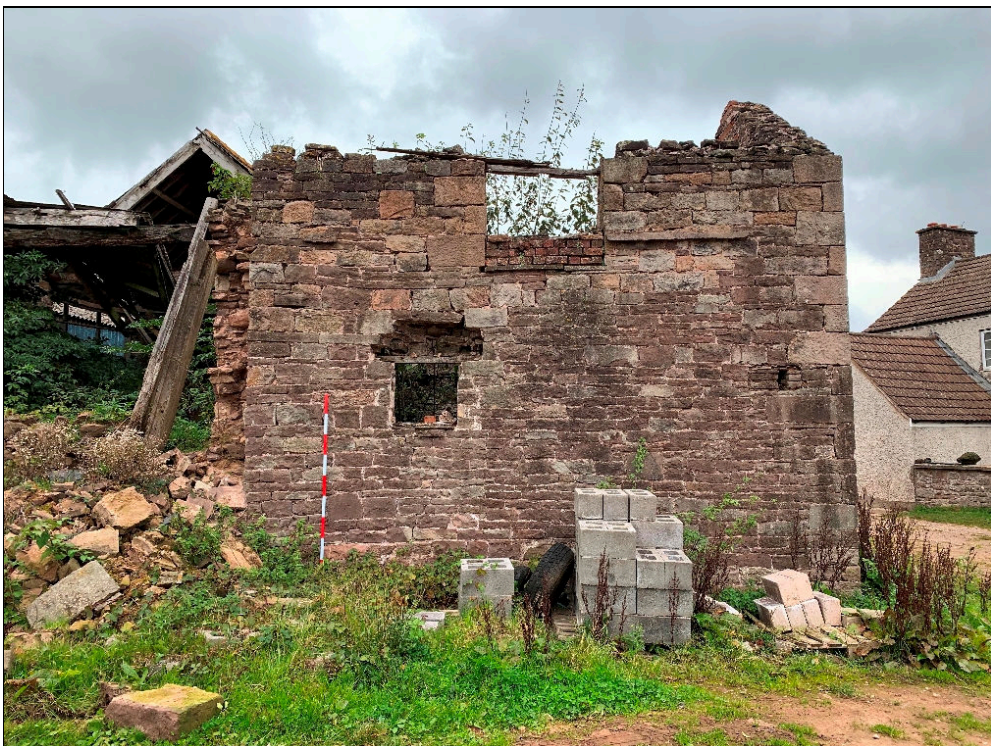
8.5.3 The southern wall of the annexe (Plate 2) there is a small window on the ground floor to the west of centre (Plate 7). A larger, central window is seen in the upper floor (Plate 6). This latter window is partially bricked up. Some concrete attached to the external face of the wall appears to mark the roof line of a lean-to structure which stood against the wall until the later 20th century (Plate 6). There is no trace now of the small red-brick lean-to which is shown on the aerial photograph of the farmyard taken around 1970 (seen Figure 6). Internally, the holes for the joists which supported the upper floor are visible along the length of the southern wall.

Plate 2: LLN2020_002 - A view of the southern wall of the eastern annexe attached to the barn. Looking north.

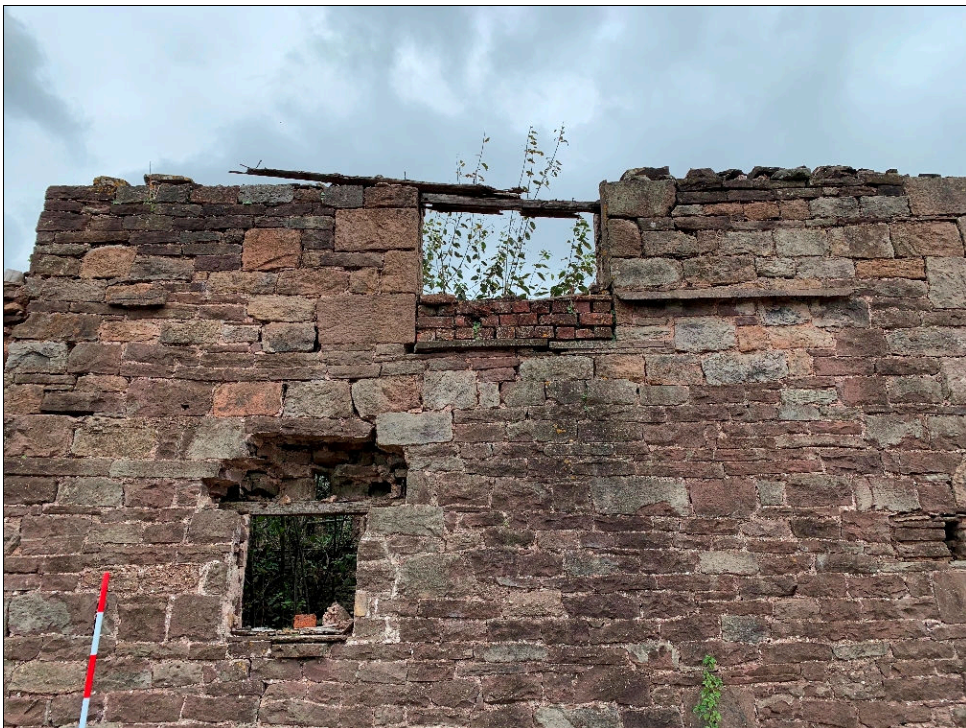
Plate 6: LLN2020_006 - A view of the windows in the southern side of the eastern annexe. The concrete line visible to the right of the upper window is thought to be the roof line of a lean-to which stood against this wall until the later 20th century. Looking north.

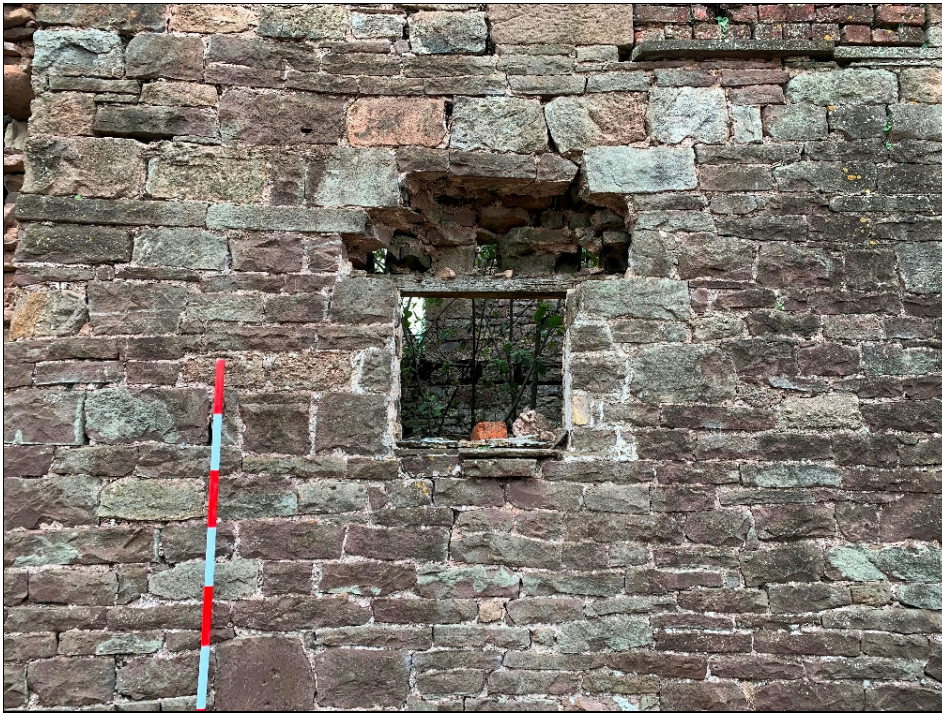
Plate 7: LLN2020_007 - A view of the small ground-floor window in the southern wall of the eastern annexe. The lintel has been removed. Looking north.

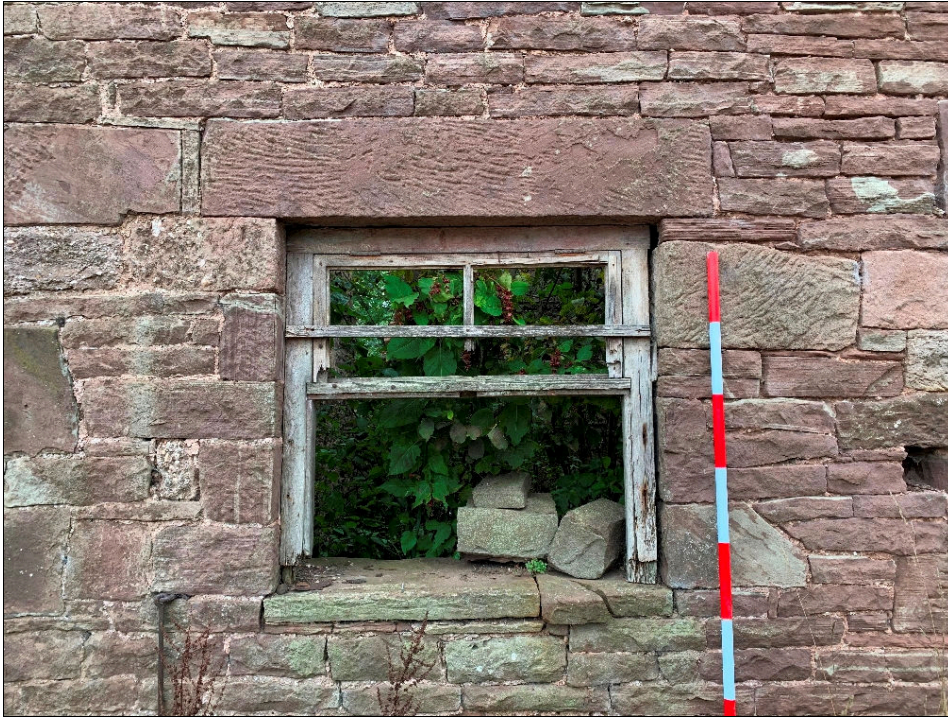
Plate 9: LLN2020_009 - A view of the ground-floor window in the eastern wall of the eastern annexe, showing the remains of the wooden window frame. Looking west.

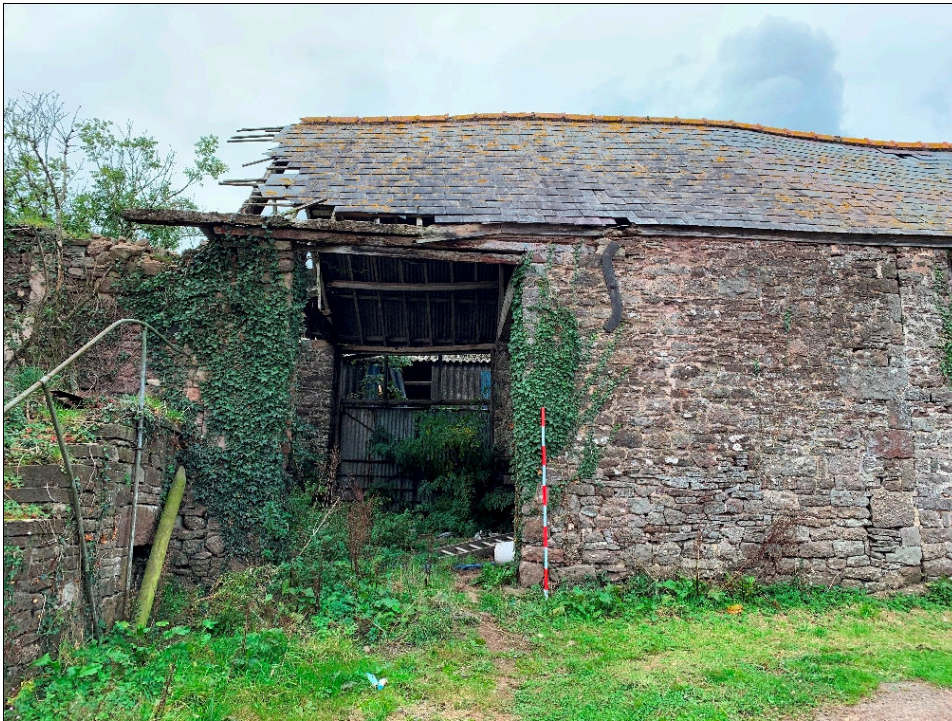
Plate 15: LLN2020_0015 - A view of the large doorway in the eastern side of the barn, with the western doorway visible through it. Note the straight joint to the right edge of the photograph where the cow house is attached to the barn. Also note the break in the slate roof where the southern part of the roof has collapsed. Looking west.

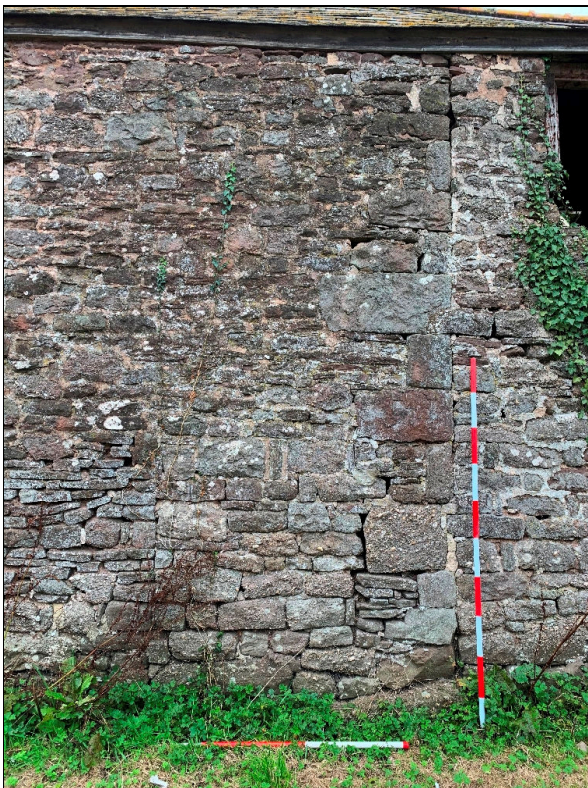
Plate 16: LLN2020_0016 - A view of the blocked-up doorway at the northern end of the eastern wall of the barn, with the straight joint between the barn and cowshed to its right. Looking west.

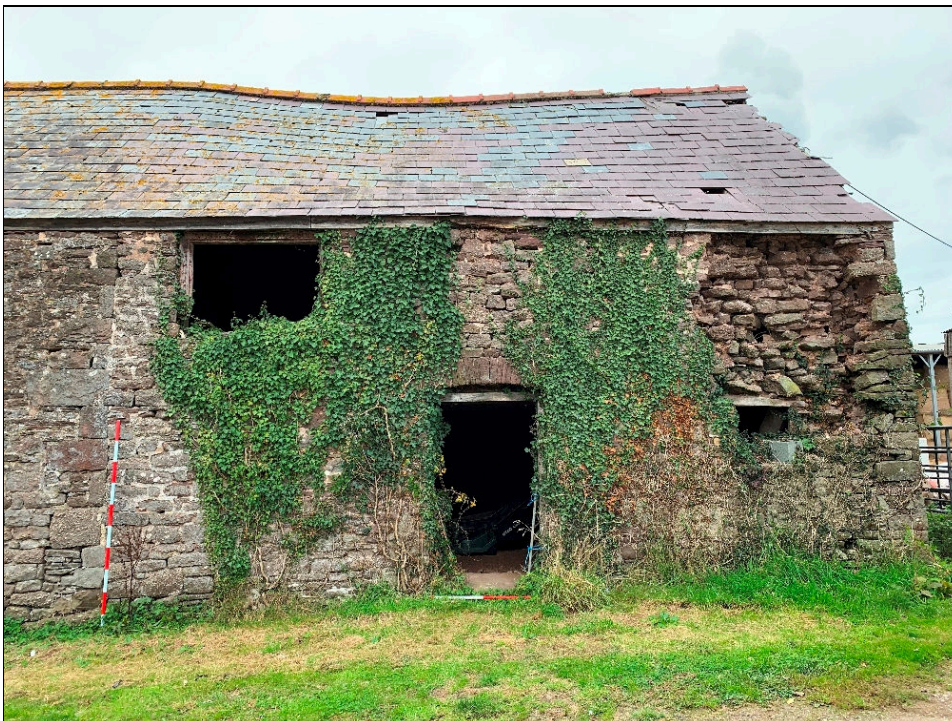
8.4.5 The eastern lateral wall of the cow house currently has a central doorway on the ground floor (Plate 20), with a small window to its northern side. There is a larger window to the southern end of the wall at first-floor level (Plate 18). A large part of the outer stone facing of the wall has fallen away at first floor level at the northern end of the building, revealing the core of the wall (Plate 19). A blocked-up doorway is visible to the north of the present doorway (Plate 84). The small window at ground floor level was cut through the northern side of this former doorway at some time after it had been blocked up (Plate 89). There is also a blocked-up doorway at the southern end of this wall (Plate 82), which is opposed by a doorway through the western lateral wall of the cow house.

Plate 18: LLN2020_0018 - A view of the eastern wall of the cow house. Note the loss of the outer face of the wall in the upper floor at the northern end of the building. Looking west.

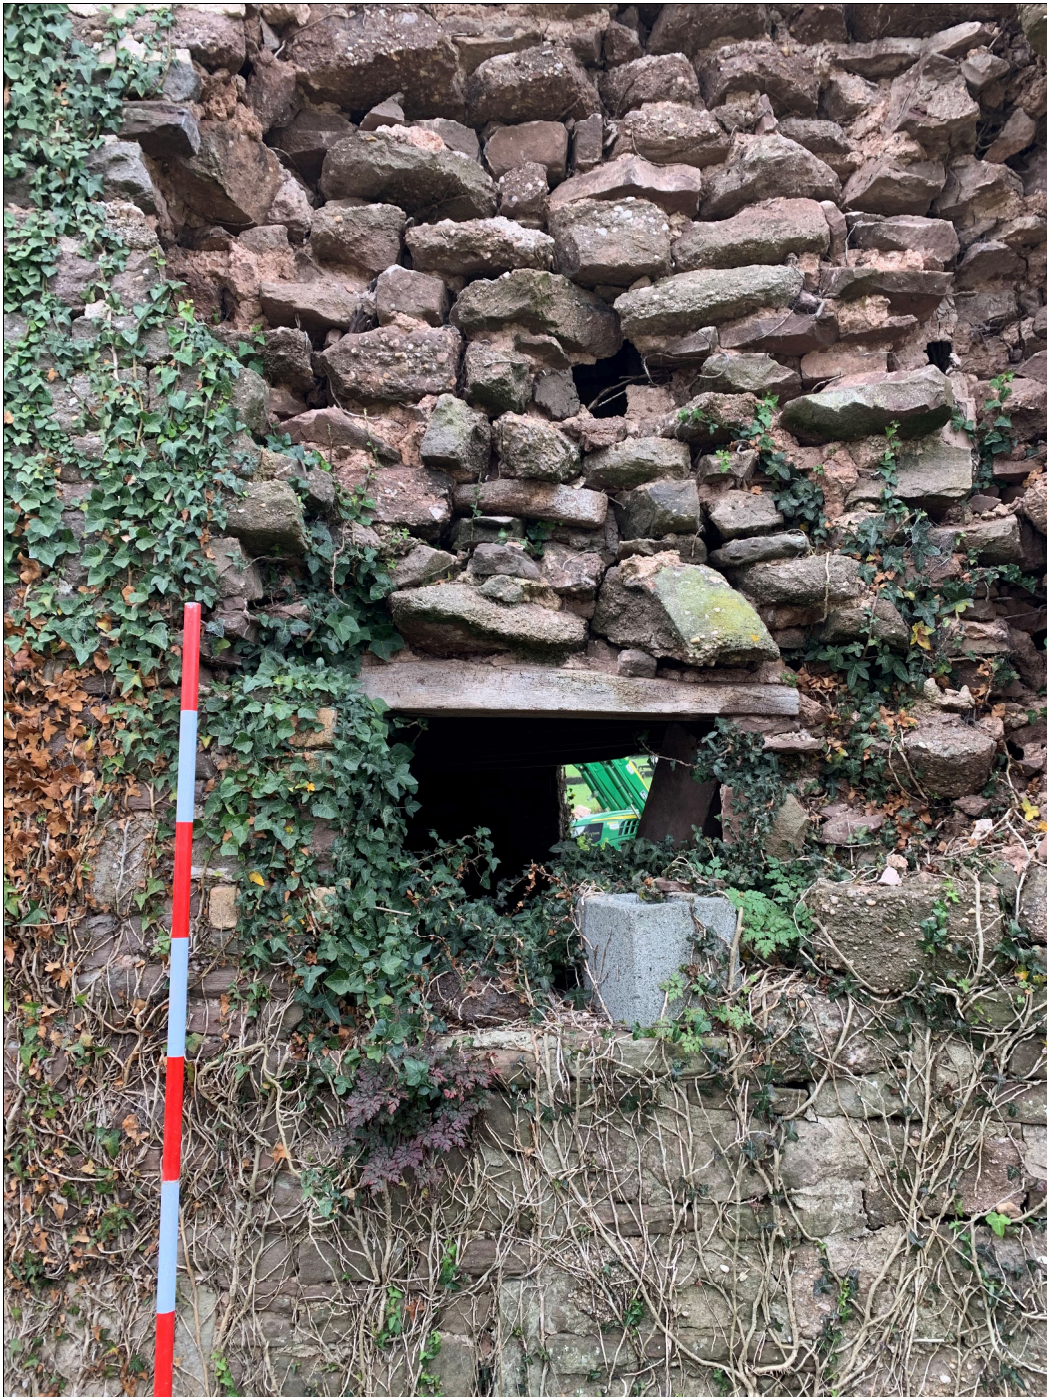
Plate 23: LLN2020_0023 - A view of the small window inserted through the eastern wall of the cow house towards its northern end. This appears to be a later feature partially cut through an earlier, blocked-up, doorway. Looking west.

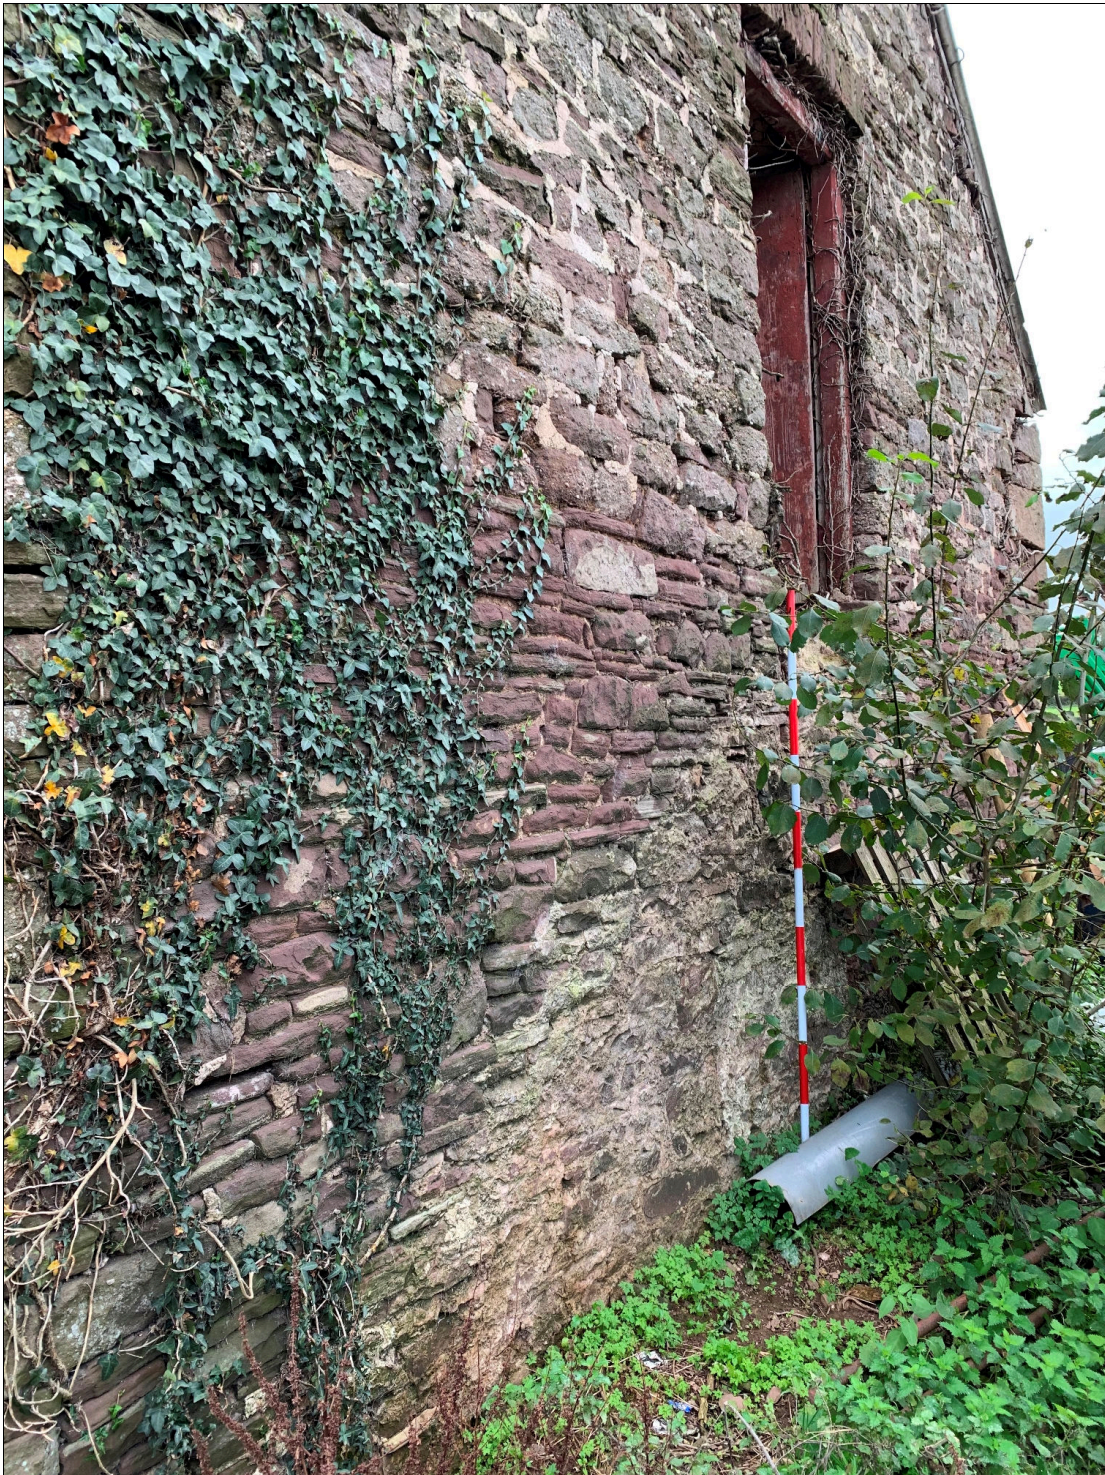
8.4.4 The northern gable wall had no features at ground floor level, but central door is still in place at first floor level. This would have been accessed via an external staircase, which no longer survives, make the first floor inaccessible. The scar of the external stairs is still visible on the external face of the wall, however (Plates 21, 22, 24 & 25). Devonian quartz conglomerate is more evident in the upper part of this wall than any other part of the complex.

Plate 24: LLN2020_0024 - A view of the northern gable end of the cow house. The stair to the doorway in the upper floor has been removed but the scar of the structure is still visible on the wall. Looking southwest.

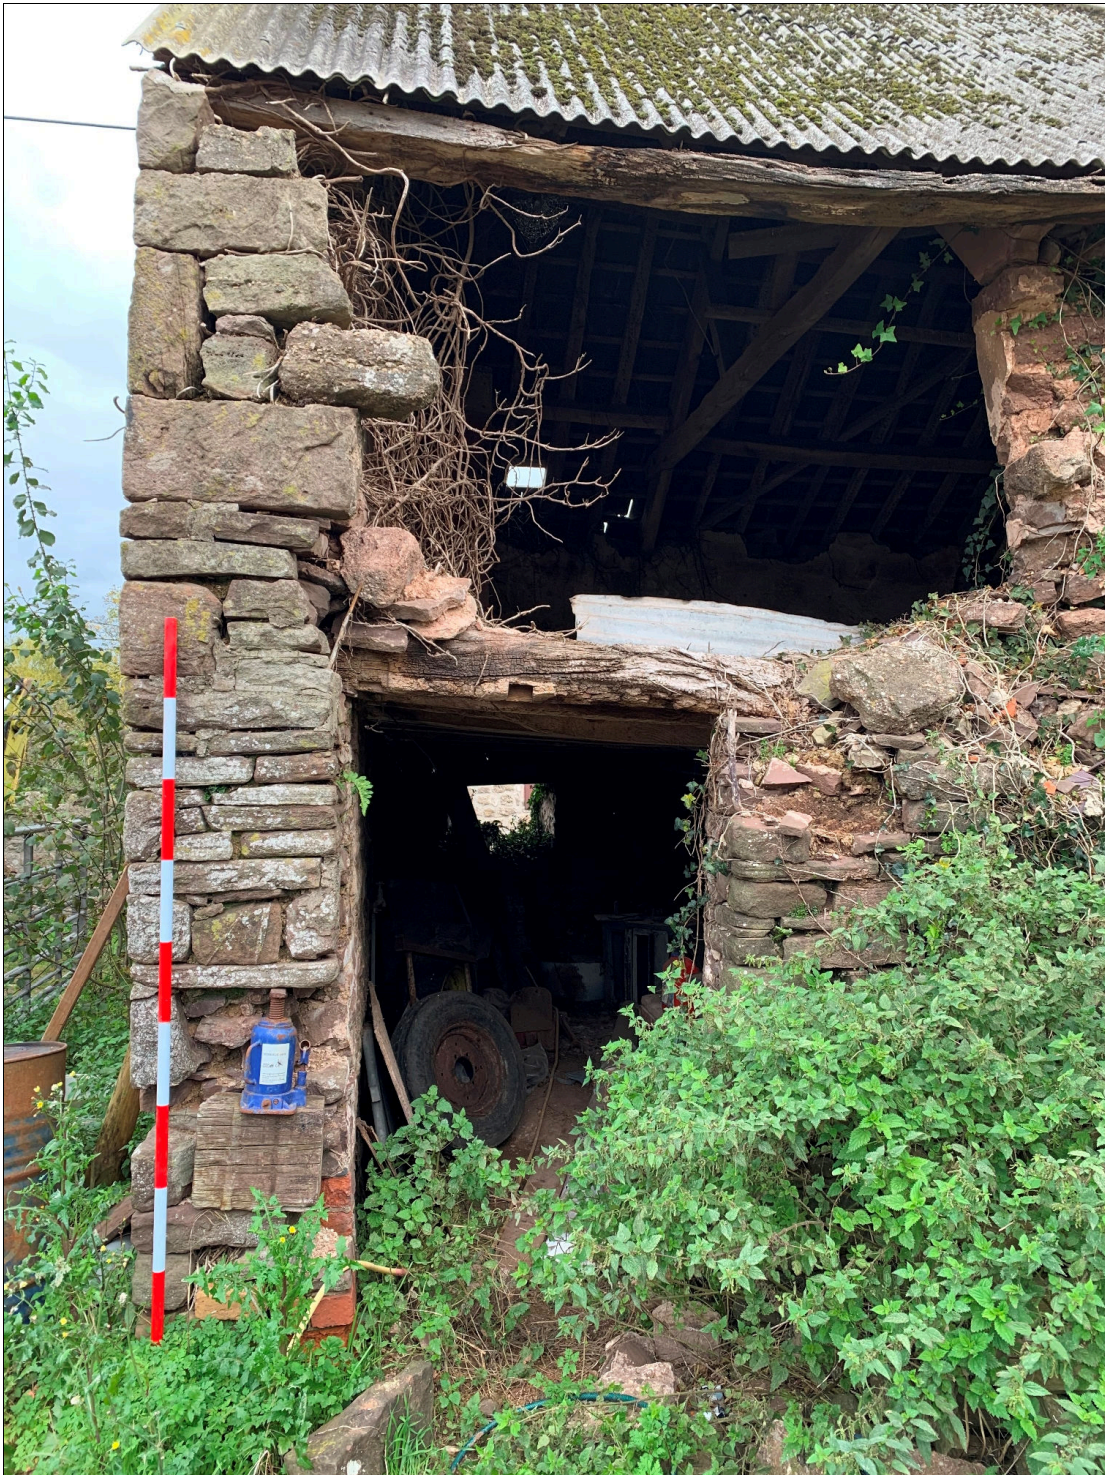
8.4.7 The western lateral wall of the cow house has doorways at its northern and southern ends which are still in use (southern door Plates 69 & 70, northern door Plates 27 & 28). The stone walling above the northern door is in a poor state and has fallen, leaving the timber lintel of the door exposed. It appears that there was a window above this doorway but only the reveal at its southern side survives (Plate 28). The wall to the southern side of the southern door has also fallen leaving part of a timber frame of unknown purpose exposed (Plates 71 & 72). There is a blocked up, central door in this wall on the ground floor (Plates 86, 87 & 90) which opposes the present central door through the eastern lateral wall of the cow house.

Plate 28: LLN2020_0028 - Another view of the doorway at the northern end of the western wall of the cow house. The timber lintel was probably originally hidden behind a sandstone arch – the angled stonework seen to the left of the lintel was probably shaped to allow the stones of the arch to be fitted in place. Looking east.

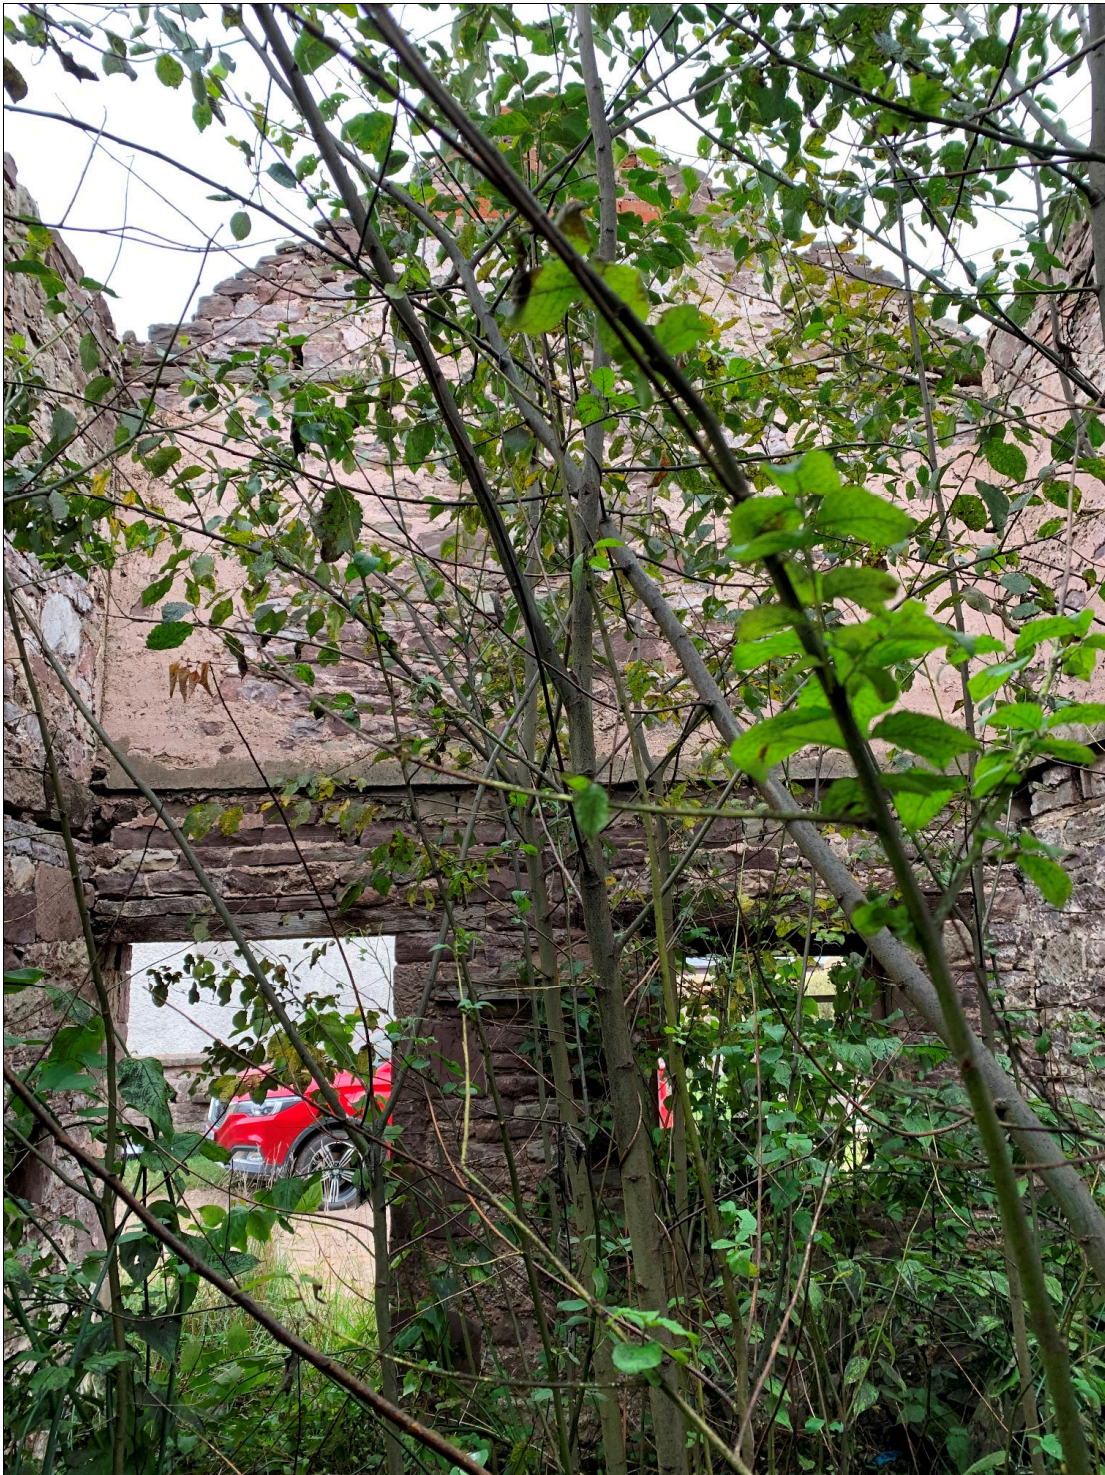
8.5.4 The western wall of the annexe is formed by the eastern wall of the barn, against which it was built (Plate 31). The only features of note on the eastern face of this wall are four of the barn's ventilation holes which can still be seen. Two ventilation holes on the ground floor remain open, but the two which are seen in the wall in the upper floor have both been blocked in the past, with sandstone blocks pushed into them. The wall of the upper floor appears to have been plastered at some point and traces of the plaster can still be seen.

Plate 31: LLN2020_0031 - A view of the western wall inside the eastern annexe. The wall is the eastern wall of the earlier barn. The gap to the left has been caused by the collapse of the southern gable wall of the barn. Looking west-southwest.

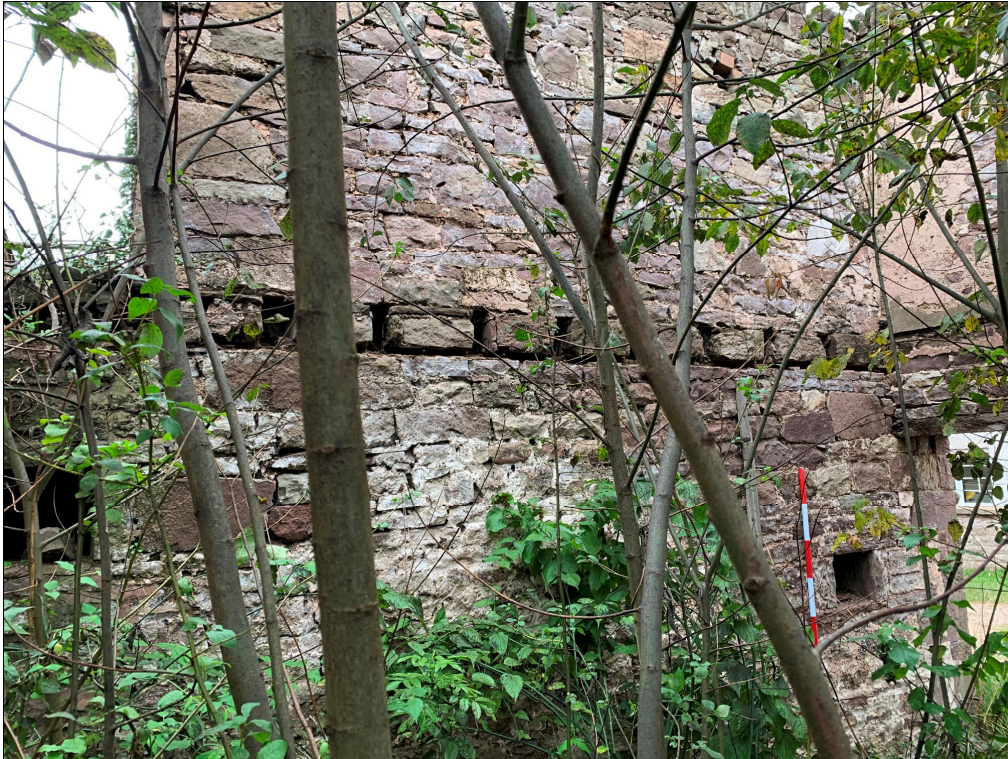
8.5.1 The northern wall of the annexe has few features. The holes for the 11 joists which supported the floor of the upper story are visible internally (Plates 35, 36 & 39). At each end of the wall there is a small stone storage box, or cubby holes, built into the wall (Plates 36-39). There is a single door at first-floor level at its western end. This is reached via a stone stair, built against the outside of the wall, which has a flight of 13 steps which lead to a platform outside the doorway (Plates 12, 13 & 95). A small chamber has been created beneath the stair, below the platform, which is accessed from the north (Plate 14). The entrance has a large stone lintel comparable with those above the door and window in the eastern elevation. The chamber may have been intended as a shelter for dogs or fowl, or as a simple store box.

Plate 35: LLN2020_0035 - A view of the joist holes in the northern wall of the eastern annexe. Looking north-northeast.

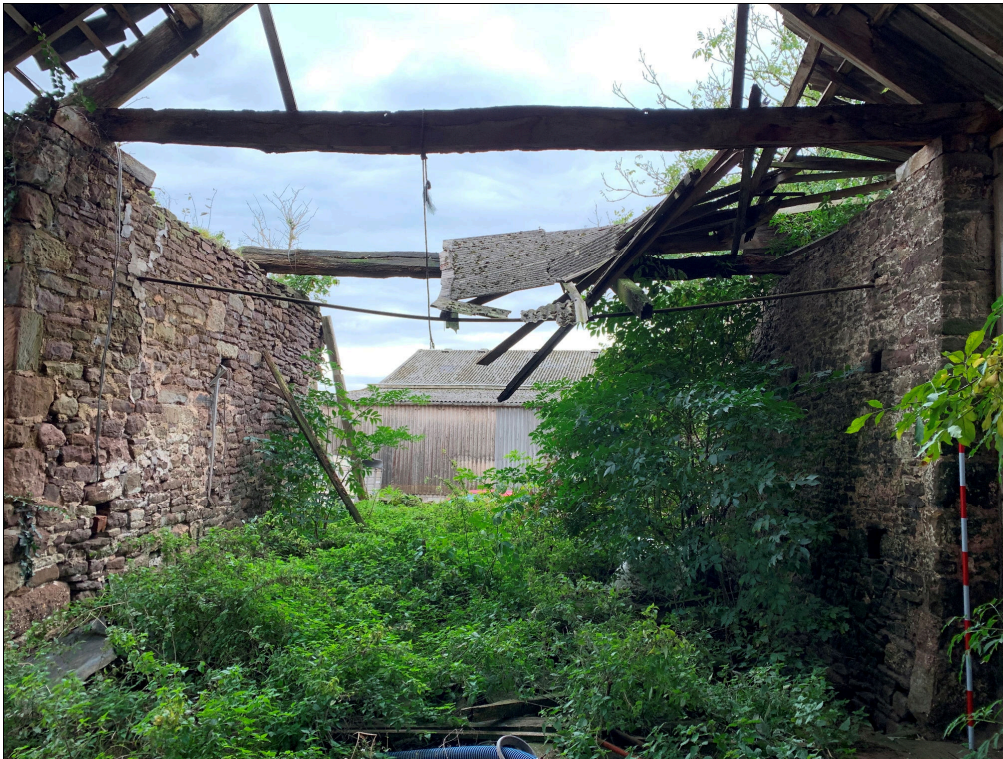
Plate 39: LLN2020_0039 - A view of the niche at the western end of the northern wall inside the eastern annexe, with the doorway into the upper floor above. Looking north-northwest.

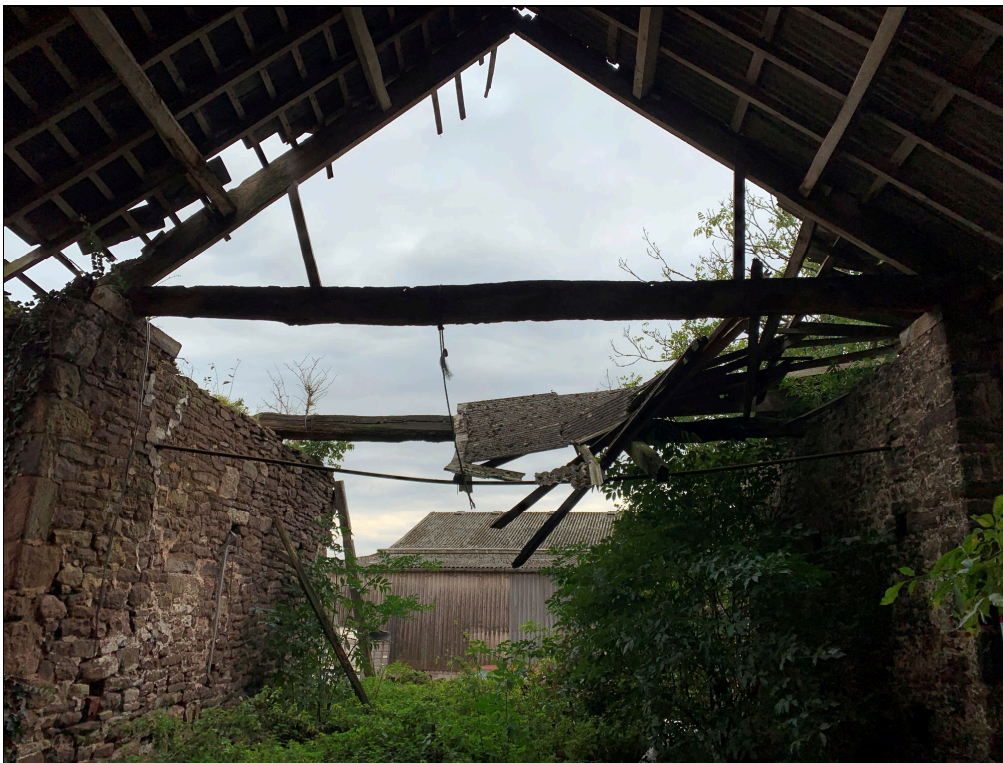
Plate 40: LLN2020_0040 - A view inside the barn, showing the collapsed southern end of the roof and the gap left by the collapse of the southern gable wall. Looking south.

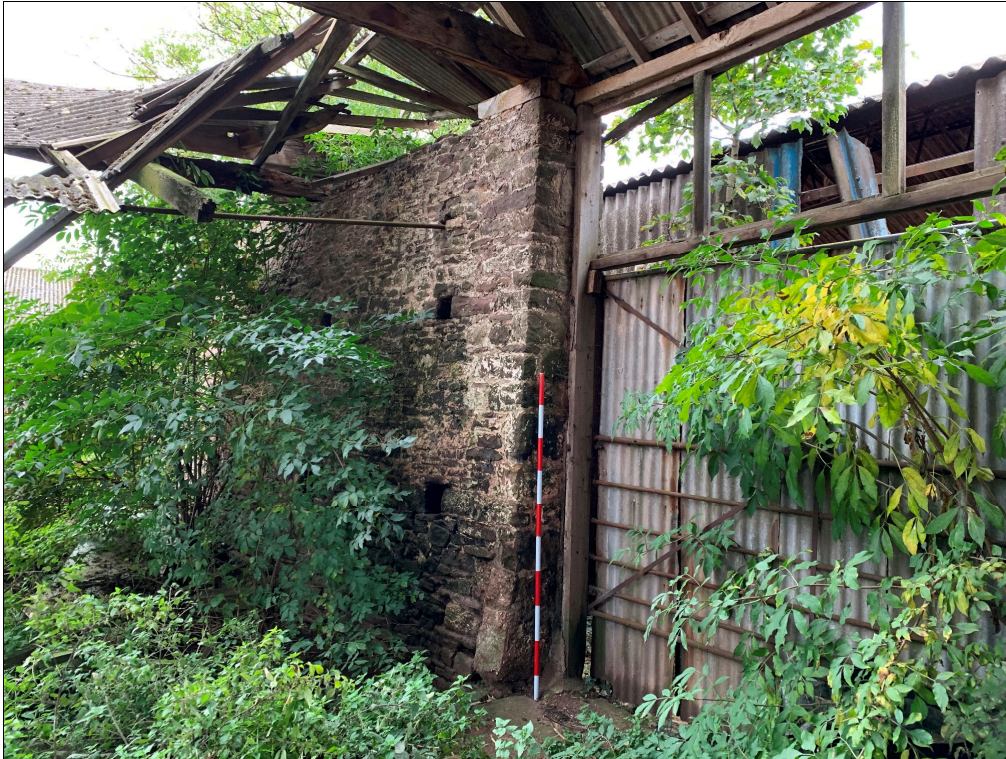
Plate 41: LLN2020_0041 - A view inside the barn, showing the collapsed southern end of the roof and an original roof truss still in place. Looking south.

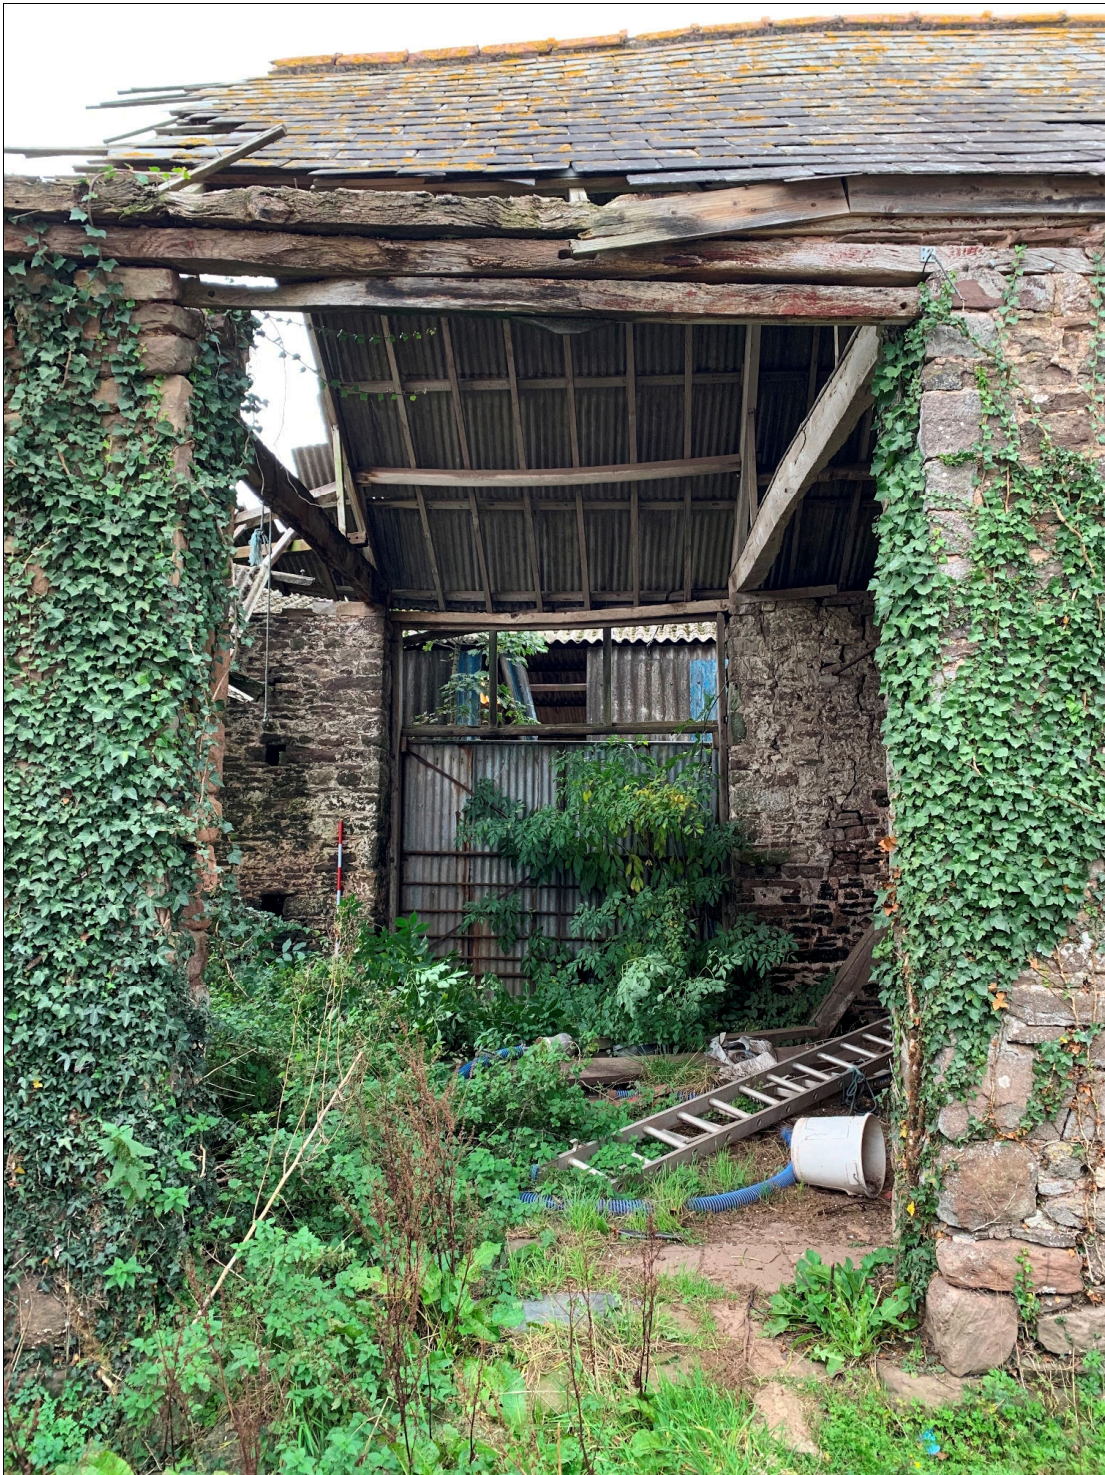
8.3.6 The western wall of the barn reflects the detail of the eastern wall to a large extent. There is a large doorway, 3.10 metres wide, opposite the eastern door (Plates 22 & 56). There are also five ventilation holes through the wall to the south of the barn door, facing those in the eastern wall (Plate 43). It is not clear if there was a sixth ventilation hole as a later window has been inserted approximately where the upper ventilation hole of the southern pair would be (Plates 53 & 55). At the northern end of this wall a short timber "lintel" 0.73 metres long, of unknown purpose, is visible just over 1 metre above floor level (Plate 66).

Plate 43: LLN2020_0043 - A view of the western wall inside the barn showing two of the three pairs of ventilation holes in the wall. Looking southwest.

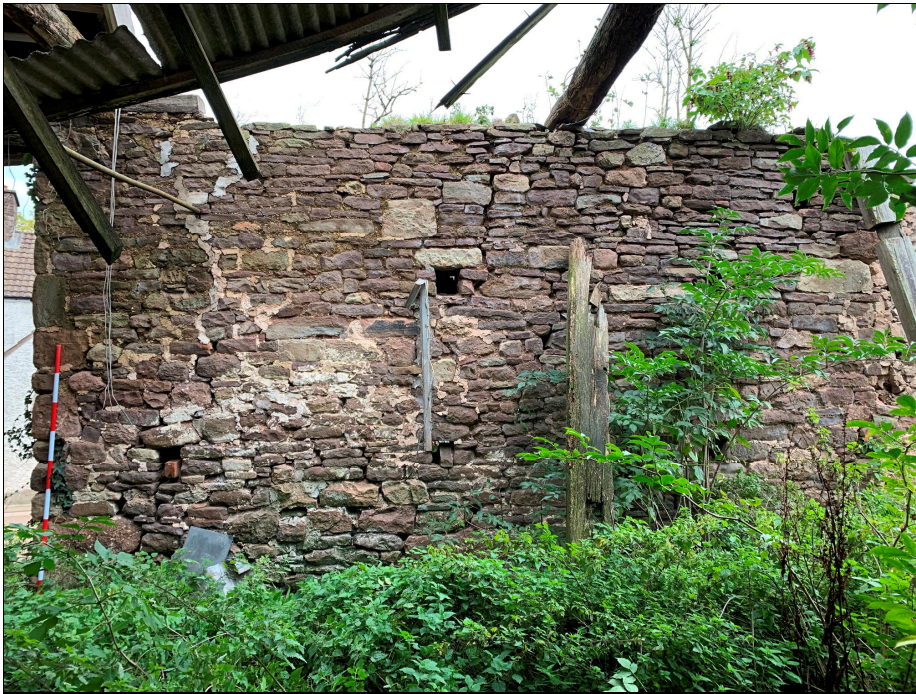
8.3.4 The eastern wall of the barn has a large doorway to the north of centre, which measures almost 2.5 metres wide and rises to wall plate level (Plate 44), which is approximately 3.9 metres high at this point. This doorway faces an opposing doorway in the western side of the barn. The door has been removed and now only the lintel below the wall plate remains of the doorframe. The wide, opposed doors are features typical of a traditional threshing barn. Between this doorway and the original northeastern corner of this building is an infilled doorway. It has been infilled with lime-mortared stonework and is now represented by parallel straight joints with a timber lintel above (Plate 17). It was a little over 1 metre wide and over 2 metres high (Plates 62 & 63). Other features of note in this wall are three pairs of square ventilation holes spaced out in the southern part of the wall (Plates 45-47). These measure about 0.20 metres square, with the lower vent in each pair just over 1 metre above floor level and the upper vent approximately 2.5 metres above floor level. Each has a long stone slab acting as a lintel. The upper ventilation hole of the northern pair has been blocked with mortared stone in the past. There are no ventilation holes to the north of the main barn door.

Plate 44: LLN2020_0044 - A view through the eastern door of the barn towards the opposing western door. The large, opposed doors are typical of a post-medieval threshing barn. Looking west.

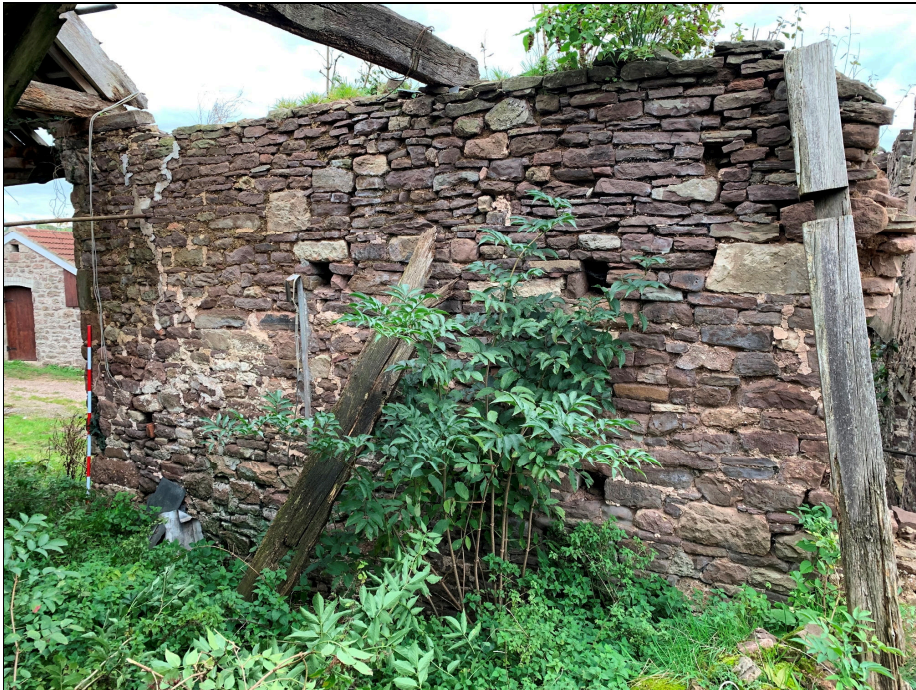
Plate 45: LLN2020_0045 - A view of the eastern wall inside the barn, showing the ventilation holes, some of which have been blocked in the past. Looking east.

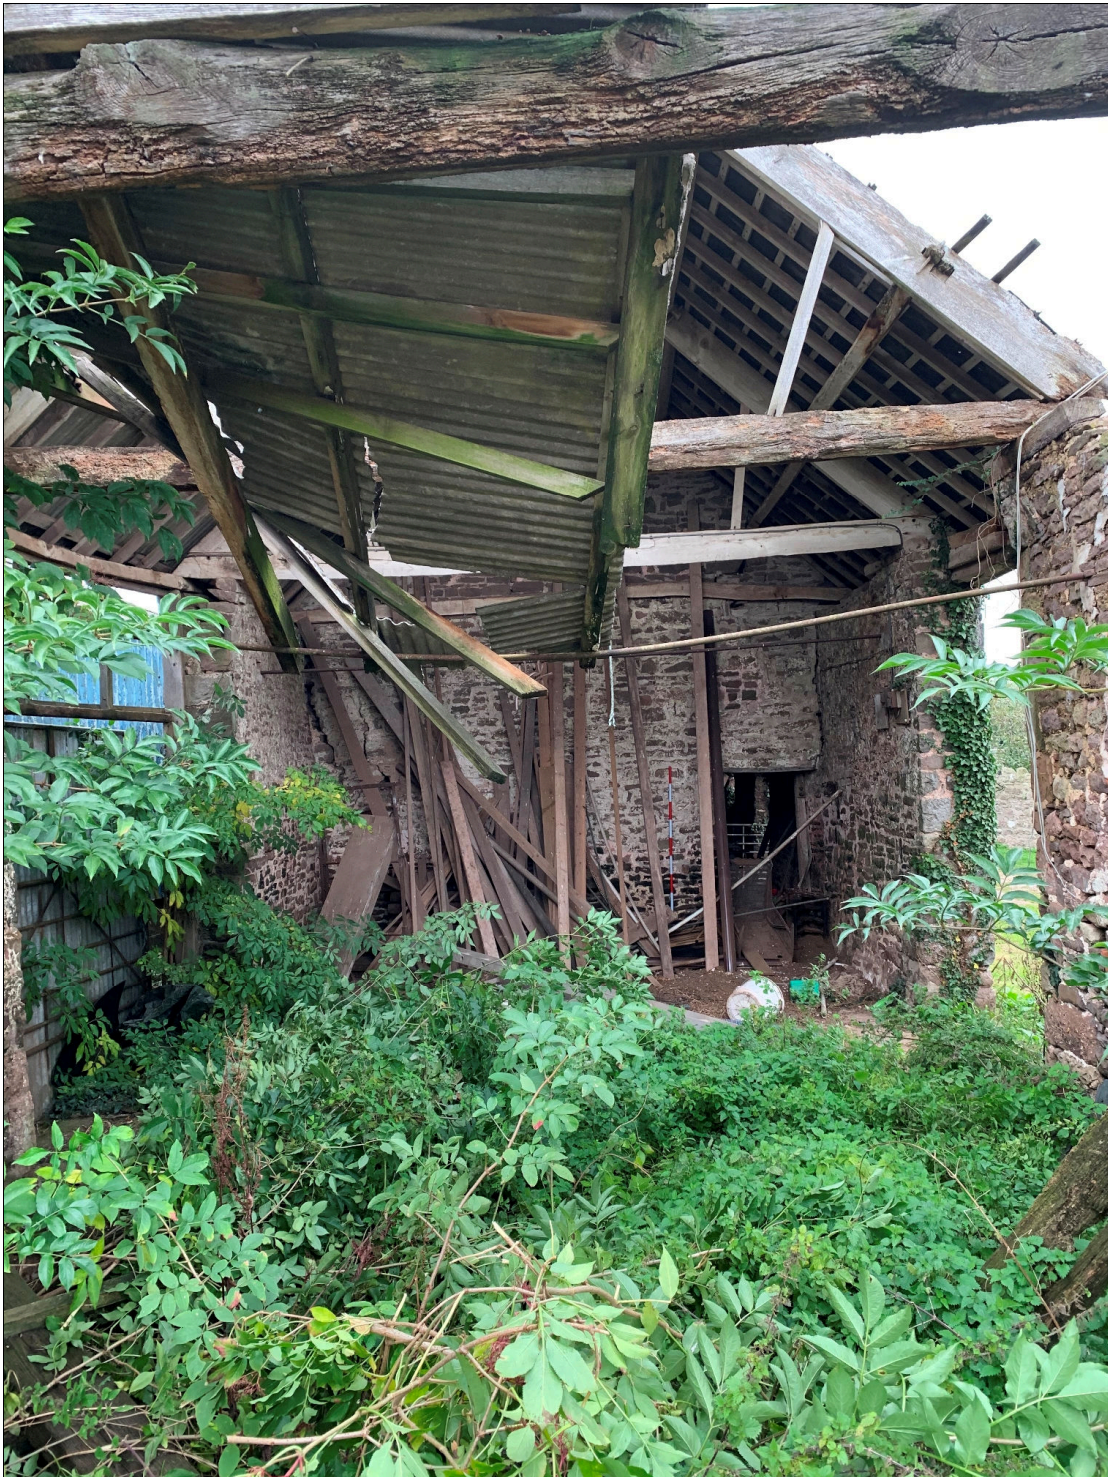
Plate 50: LLN2020_0050 - A view showing more detail of the broken roof truss, which had wooden pegs connecting the timbers. Looking north.

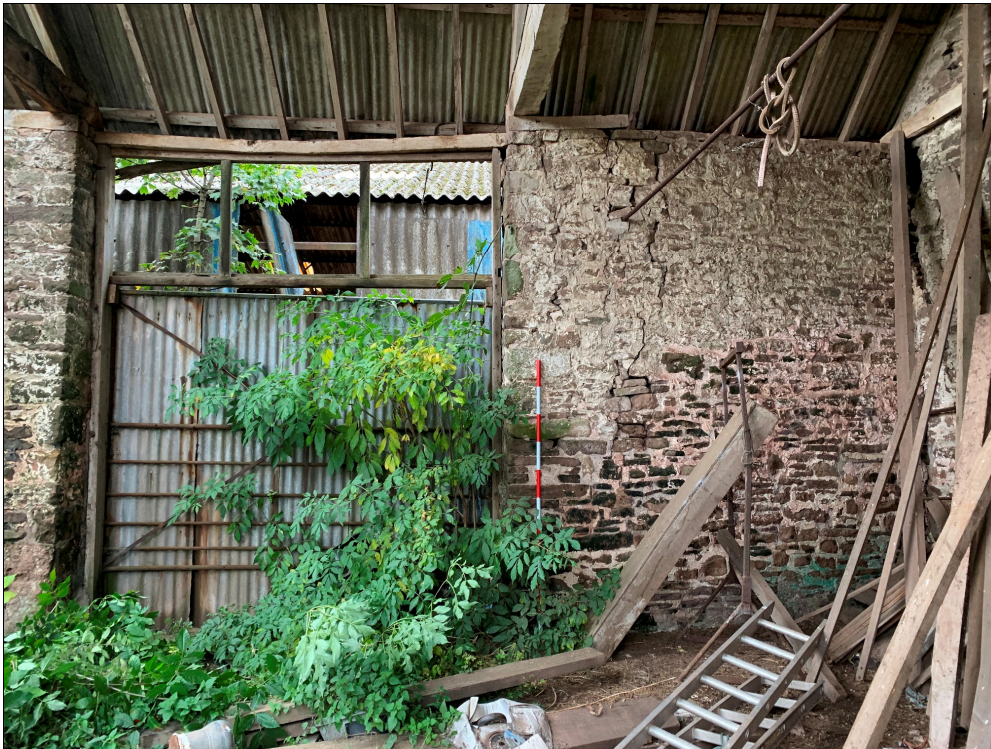
Plate 55: LLN2020_0055 - A view of the rubble marking the line of the southern gable end of the barn. This view seems to suggest that the gable wall which collapsed was not the original gable wall but was a later insert which did not bond with the lateral walls. Looking west.
