**LEVEL 3 BUILDING RECORDING OF
A FORMER BARN AT
LLAN Y NANT, LLANISHEN,
TRELLECH GRANGE, NP16 6QN
PLANNING APPLICATION:
DM/2019/00998 (Monmouthshire)**

April 2021

Trysor Project No. 2020/746

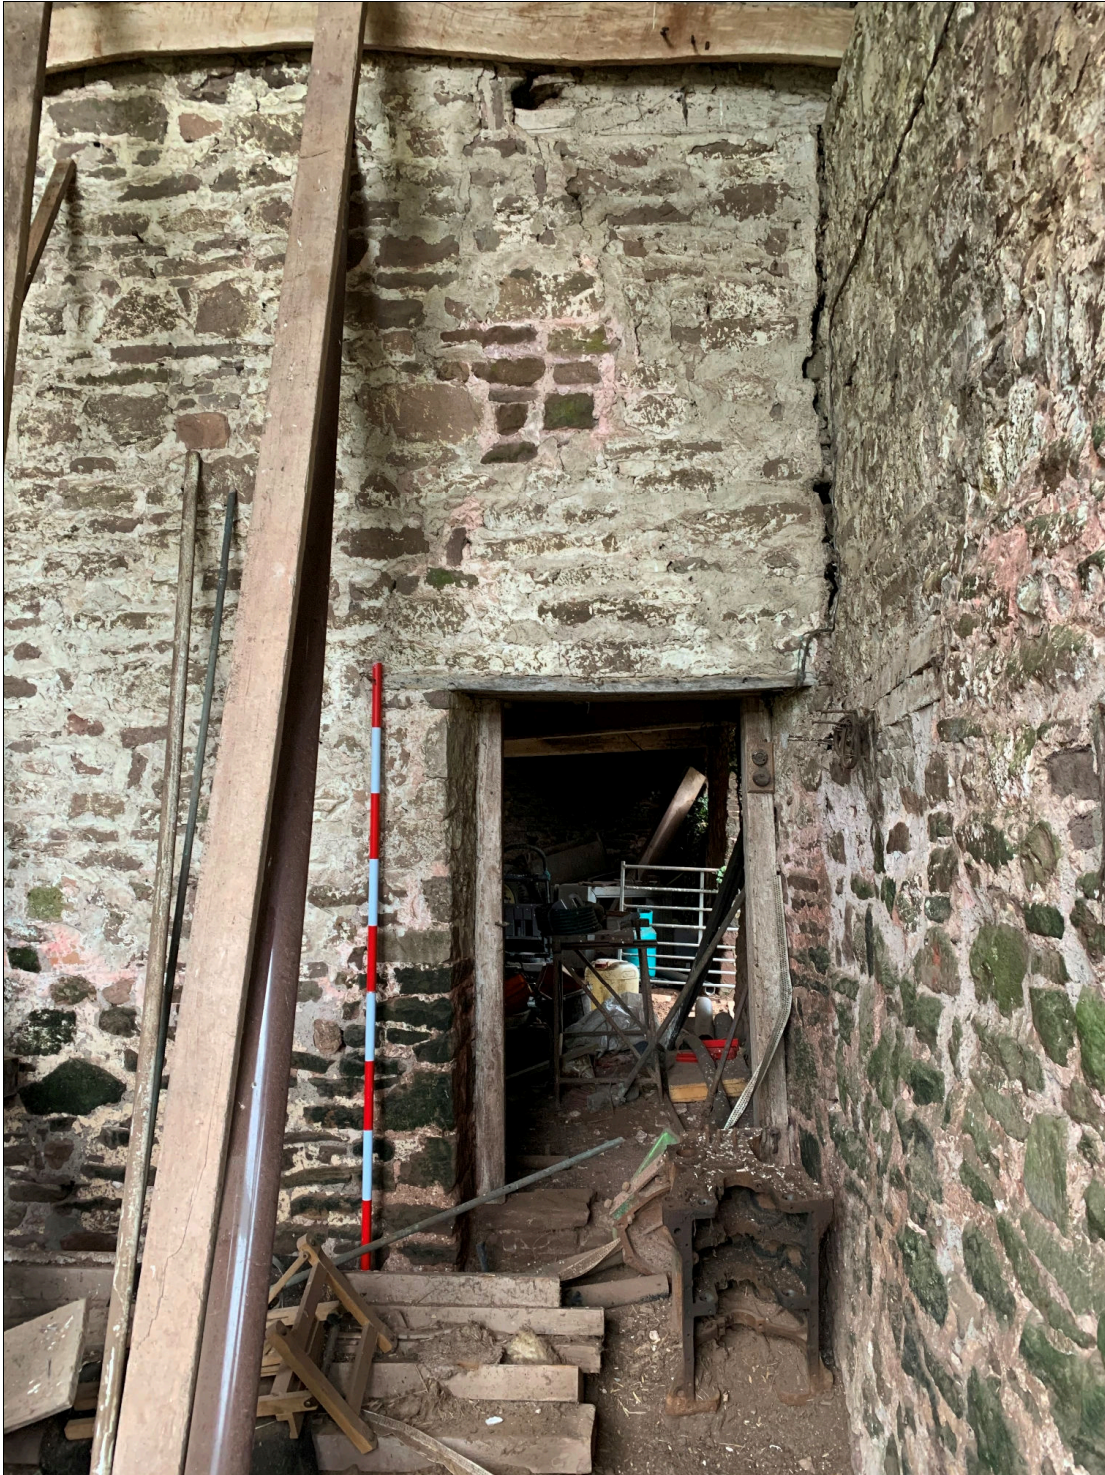
8.3.3 The northern wall was originally the gable end of the barn but now serves to divide it from the later attached cow house (Plate 58). The wall is lime-washed but some features of interest are still visible. It has a doorway through it at its eastern end which is not an original feature but is currently in use (Plates 59-62). An earlier door, now blocked up, is visible to the west of centre in this wall (Plates 73 & 74). It was 1 metre wide and circa 1.8 metres high. There is also a blocked-up

Plate 58: LLN2020_0058 - A view of the northern gable wall inside the barn. Note the blocked-up door in the centre of the upper part of the wall. The doorway to right the may original as it is a constructed feature and has not been cut through the wall. Its reveals are splayed slightly. The rip joint where the gable wall meets the eastern lateral wall to the right may be evidence of a repair or partial rebuild of the gable wall allowing for the doorway to be inserted when the adjacent cow house was added. There is also a blocked-up doorway left of centre of the wall on the ground floor, hidden by the planks stacked against the wall. Looking north.

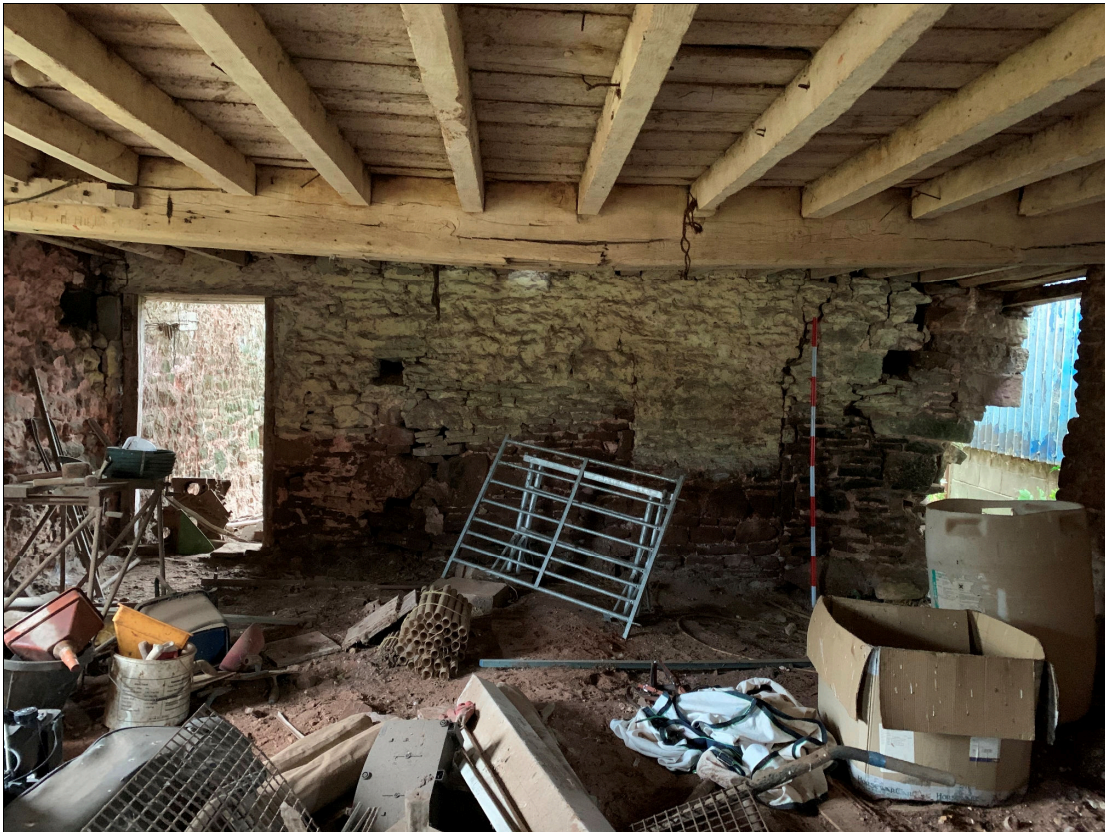
Plate 72: LLN2020_0072 - A view of the damaged wall at the northwestern corner of the barn. Looking south.

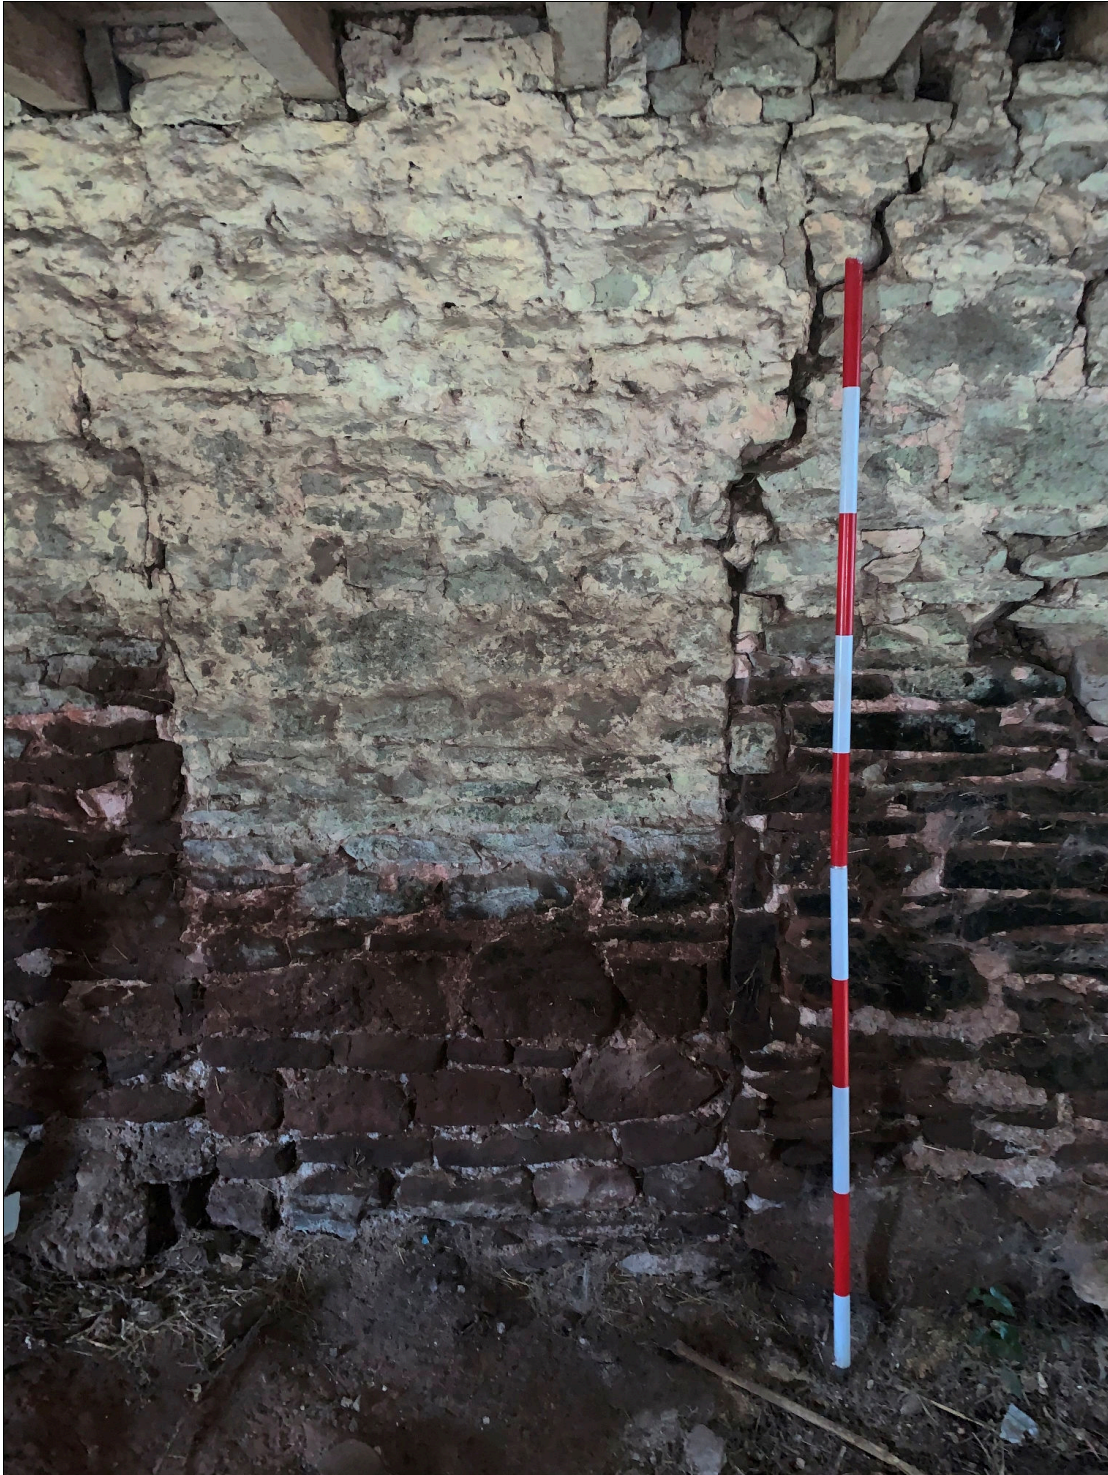
8.4.6 The southern wall of the cow house is formed by the northern gable wall of the adjacent barn. An earlier door, now blocked up, is visible to the west of centre in this wall (Plates 73 & 74). It was 1 metre wide and circa 1.8 metres high. There is also a blocked-up window higher up in the centre of this gable wall.

Plate 73: LLN2020_0073 - A view of the southern wall of the cow house from inside the building. The doorway into the barn is to the left, a blocked-up doorway is seen right of centre and an external doorway to the right. Note the beam, joists and floorboards of the upper floor. Looking south.

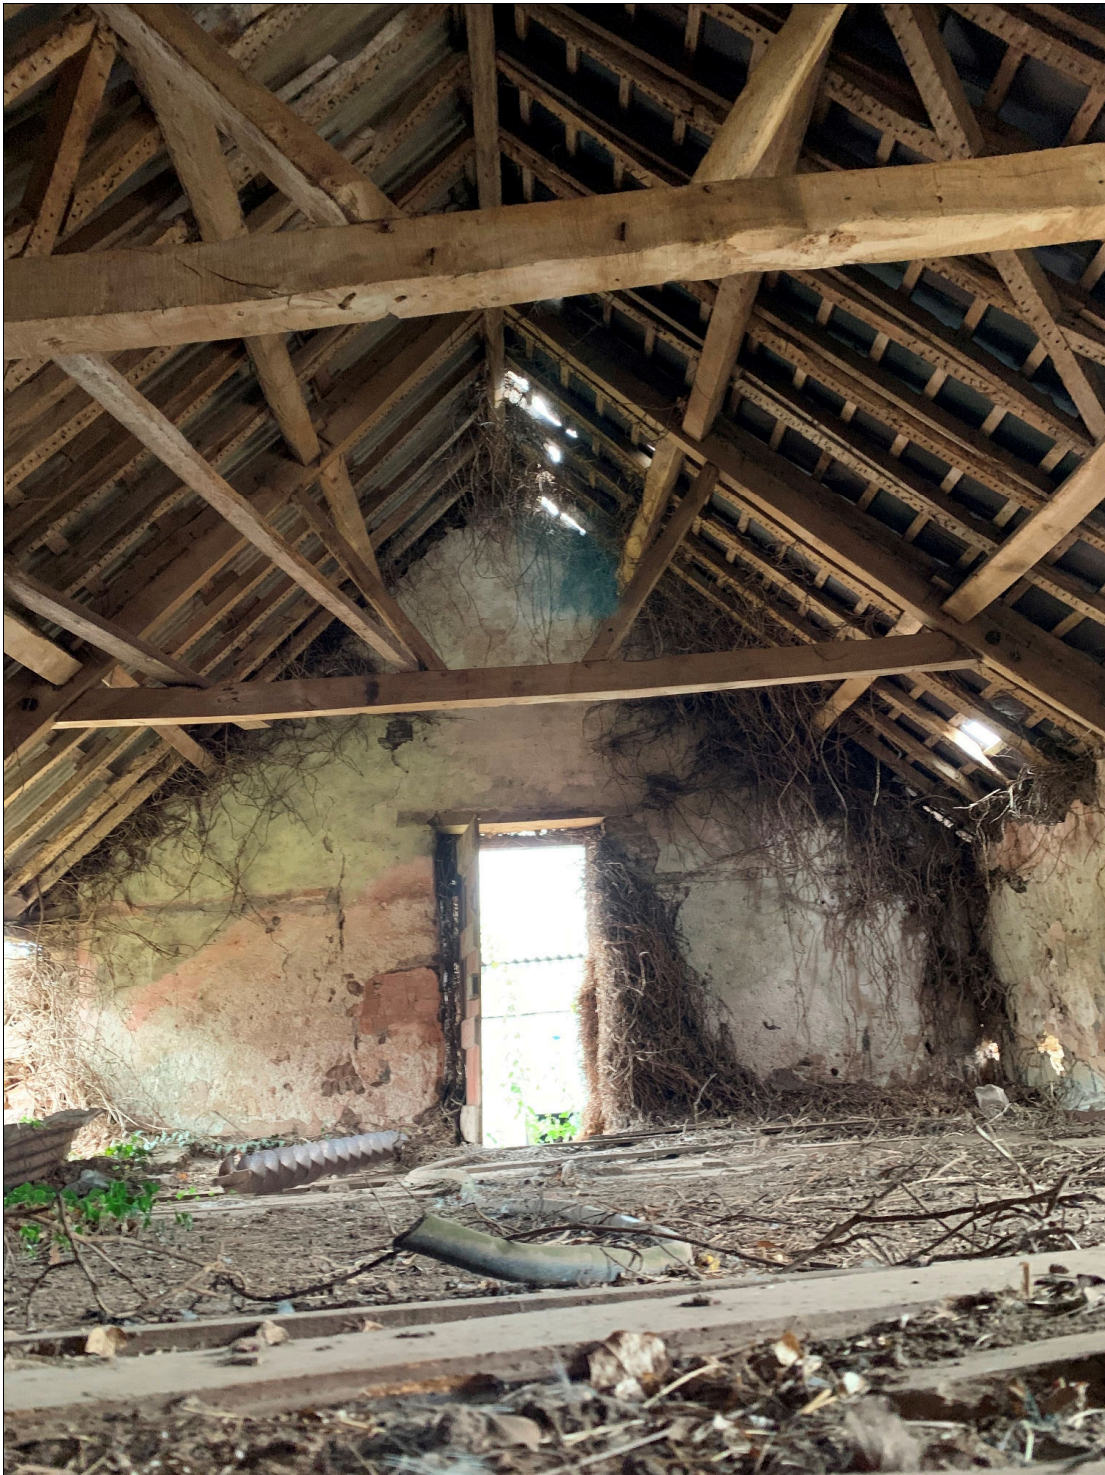
Plate 74: LLN2020_0074 - A view of the blocked up doorway through the southern wall of the cow house. Looking south.

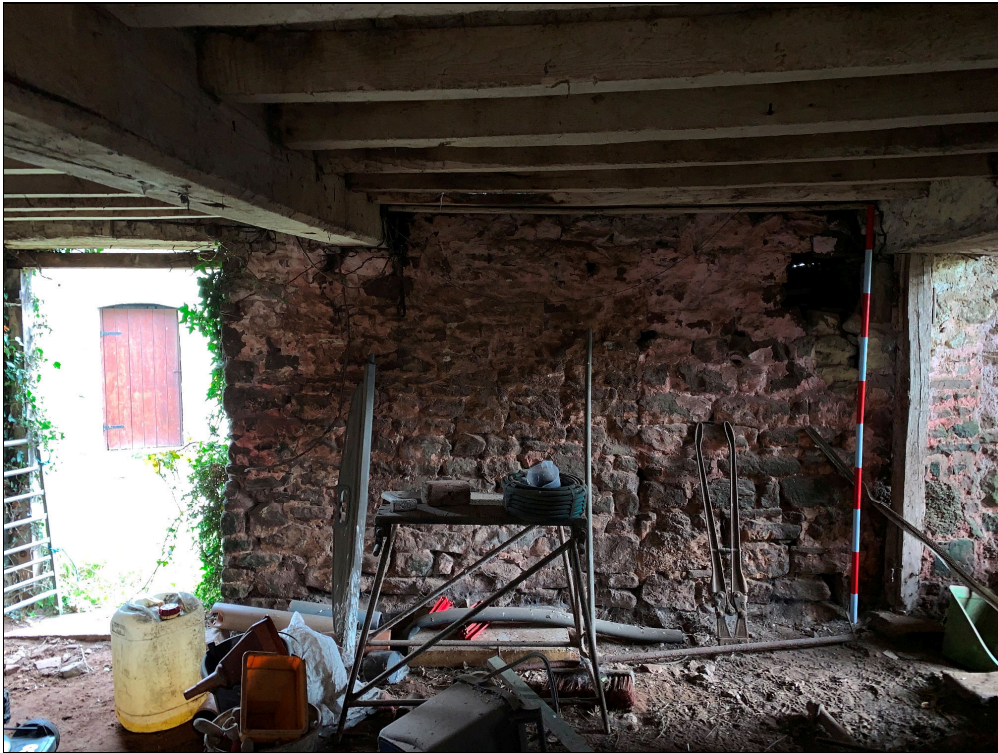
8.4.5 The eastern lateral wall of the cow house currently has a central doorway on the ground floor (Plate 20), with a small window to its northern side. There is a larger window to the southern end of the wall at first-floor level (Plate 18). A large part of the outer stone facing of the wall has fallen away at first floor level at the northern end of the building, revealing the core of the wall (Plate 19). A blocked-up doorway is visible to the north of the present doorway (Plate 84). The small window at ground floor level was cut through the northern side of this former doorway at some time after it had been blocked up (Plate 89). There is also a blocked-up doorway at the southern end of this wall (Plate 82), which is opposed by a doorway through the western lateral wall of the cow house.

Plate 82: LLN2020_0082 - A view of the eastern wall inside the cow house. The blocked-up central door can be seen. Note the beams and joists of the floor above. Looking east.

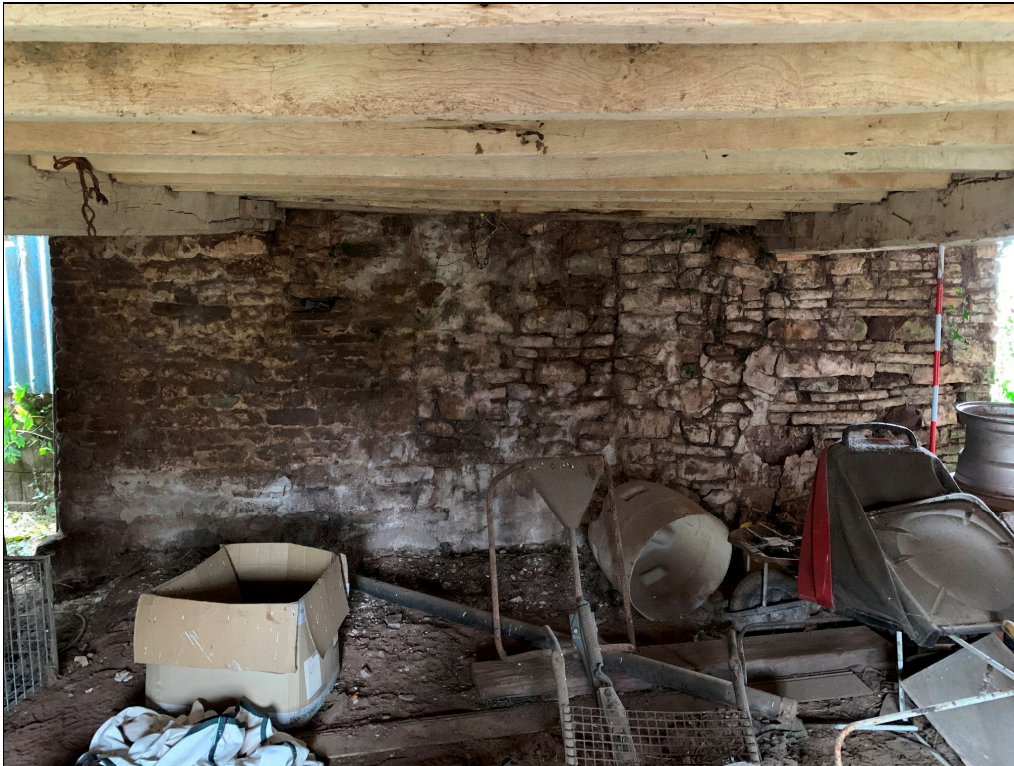
8.4.7 The western lateral wall of the cow house has doorways at its northern and southern ends which are still in use (southern door Plates 69 & 70, northern door Plates 27 & 28). The stone walling above the northern door is in a poor state and has fallen, leaving the timber lintel of the door exposed. It appears that there was a window above this doorway but only the reveal at its southern side survives (Plate 28). The wall to the southern side of the southern door has also fallen leaving part of a timber frame of unknown purpose exposed (Plates 71 & 72). There is a blocked up, central door in this wall on the ground floor (Plates 86, 87 & 90) which opposes the present central door through the eastern lateral wall of the cow house.

Plate 86: LLN2020_0086 - A view of the blocked-up central doorway in the western wall of the cow house. Looking west.

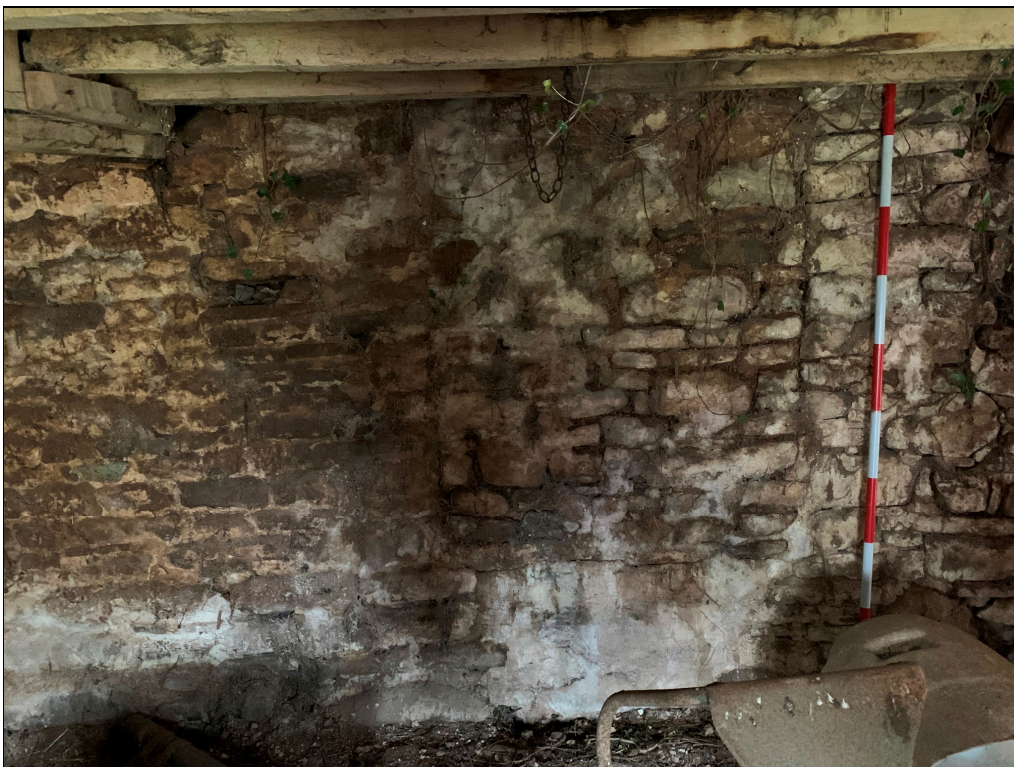
Plate 87: LLN2020_0087 - A view of the blocked-up central doorway in the western wall of the cow house. Looking west.

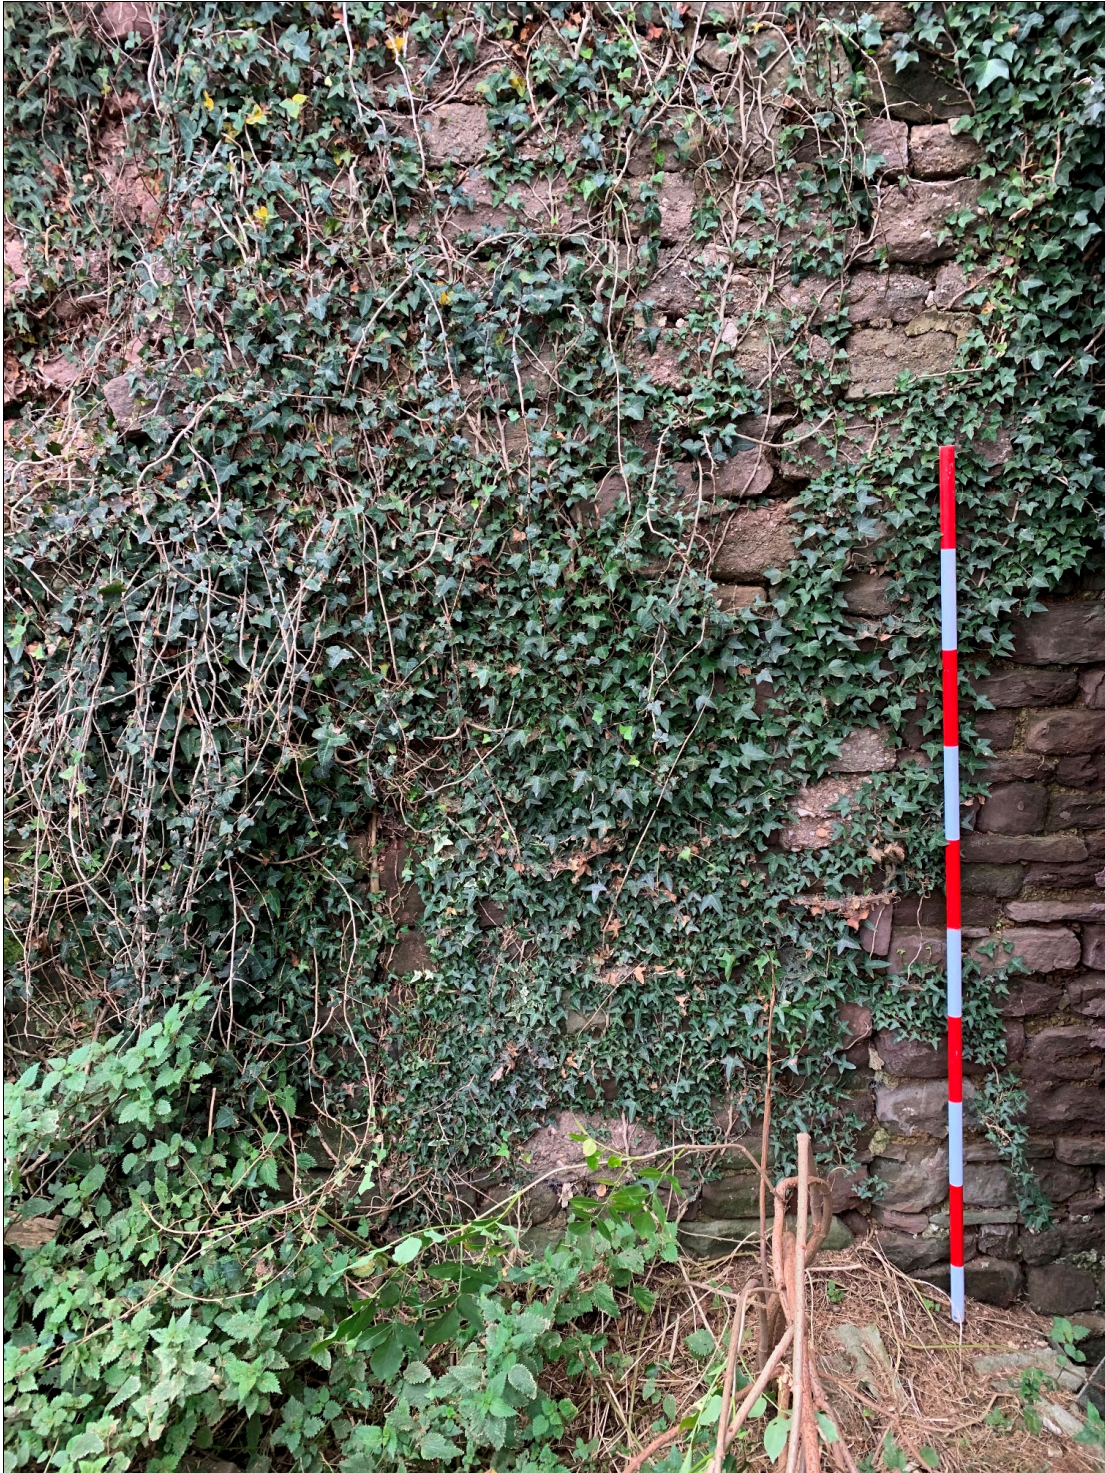
Plate 90: LLN2020_0090 - A view of a the blocked-up central doorway through the western wall of the cow house, seen through the ivy outside the building. Looking east.
