Llanishen Reservoir, Cardiff

Building Recording Level 2

Report No. 1742

April 2019

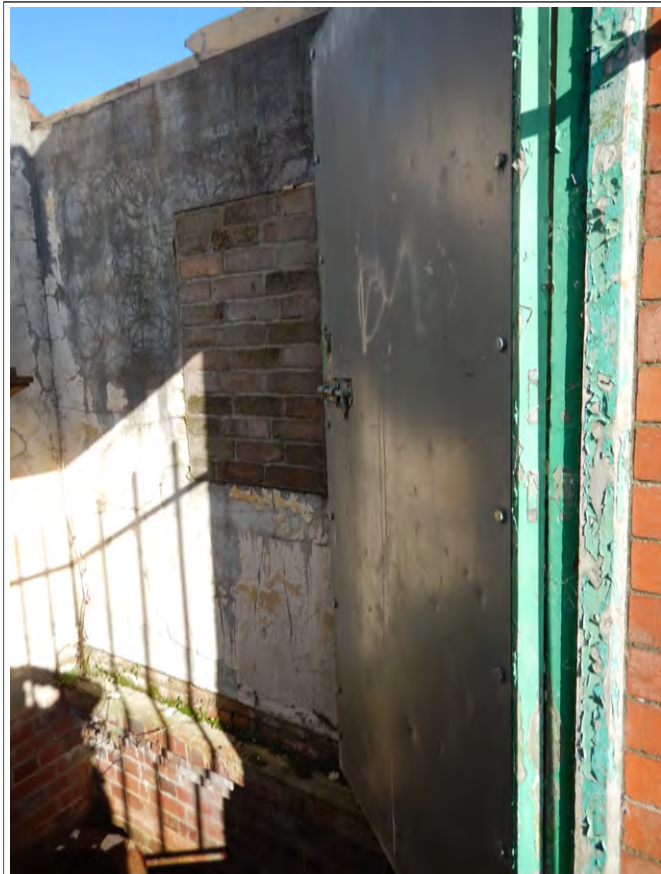
Plate 58. Door and interior wall of Gauging Station building.

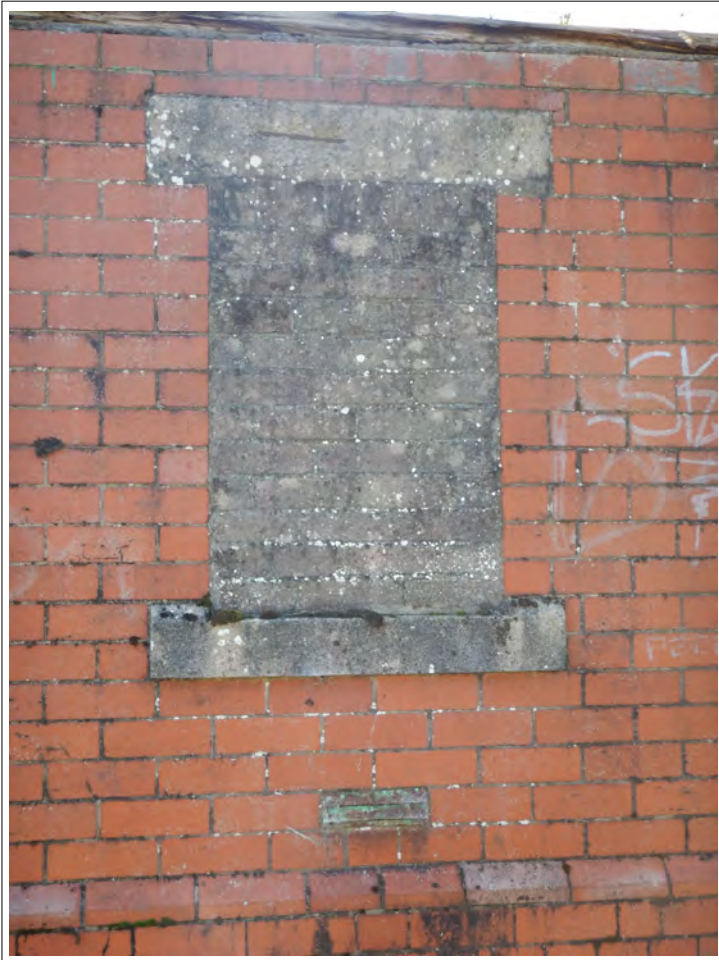
Plate 59. Blocked-up window on the north-east elevation of the Gauging Station building.

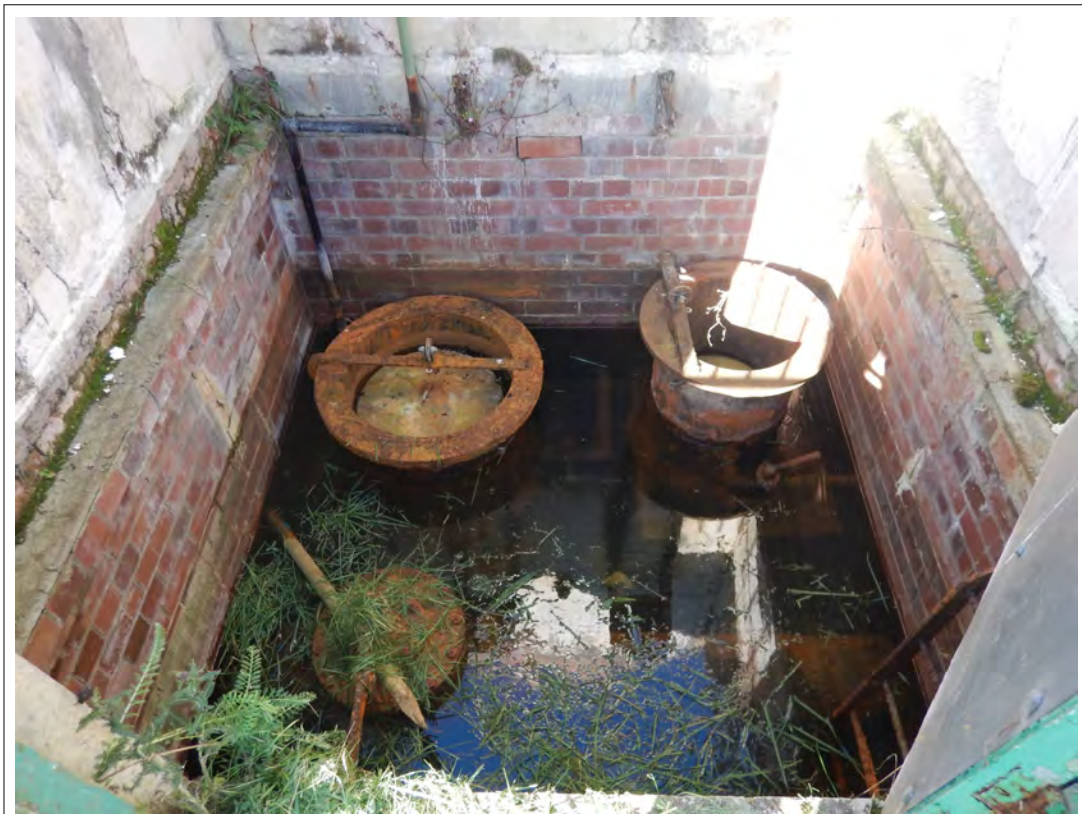
Plate 60. Interior of the Gauging Station building.

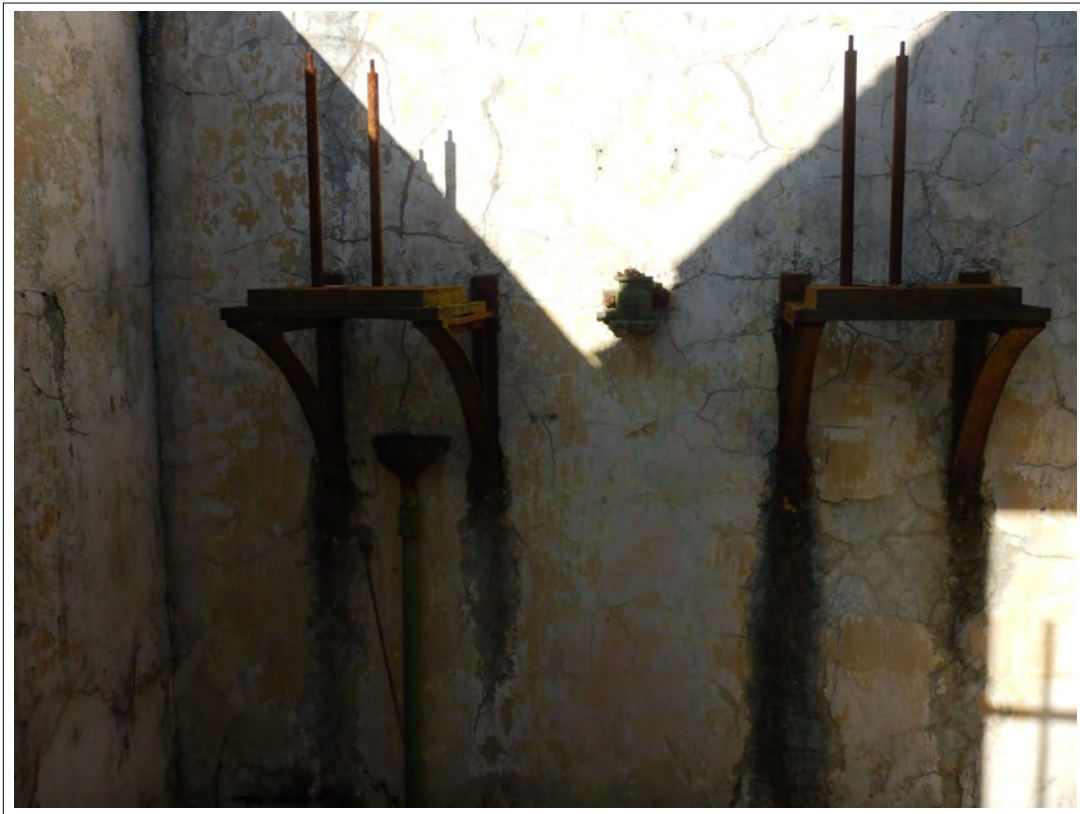
Plate 61. Gauging Station building showing brackets for the water meter.

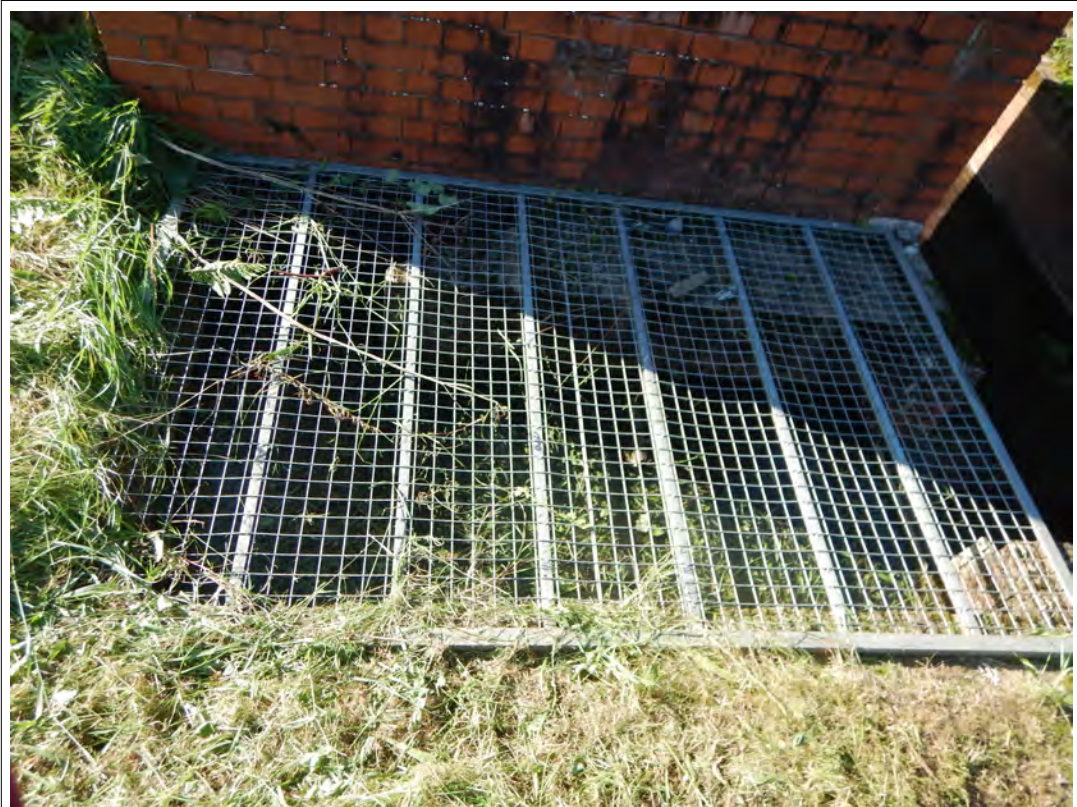
Plate 62. Tank to the north-east of the Gauging Station building.

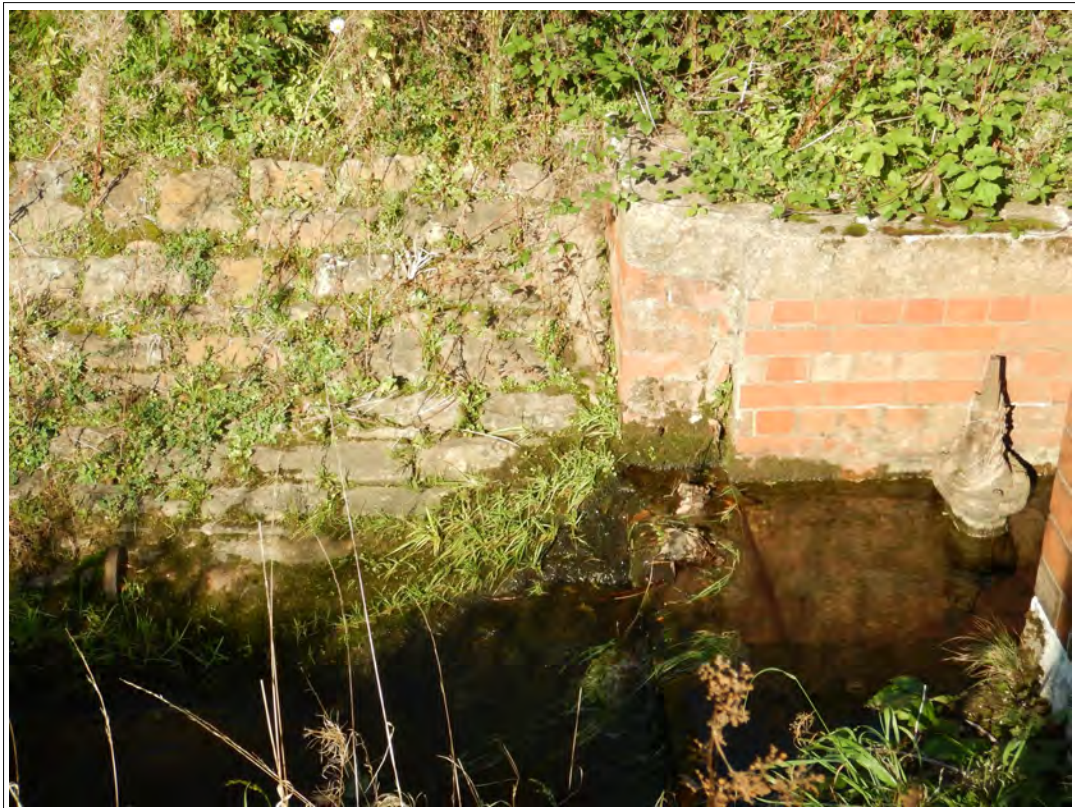
Plate 64. South-west of the modified section of the by-wash channel by the Gauging station building showing small stone step weir, looking west.

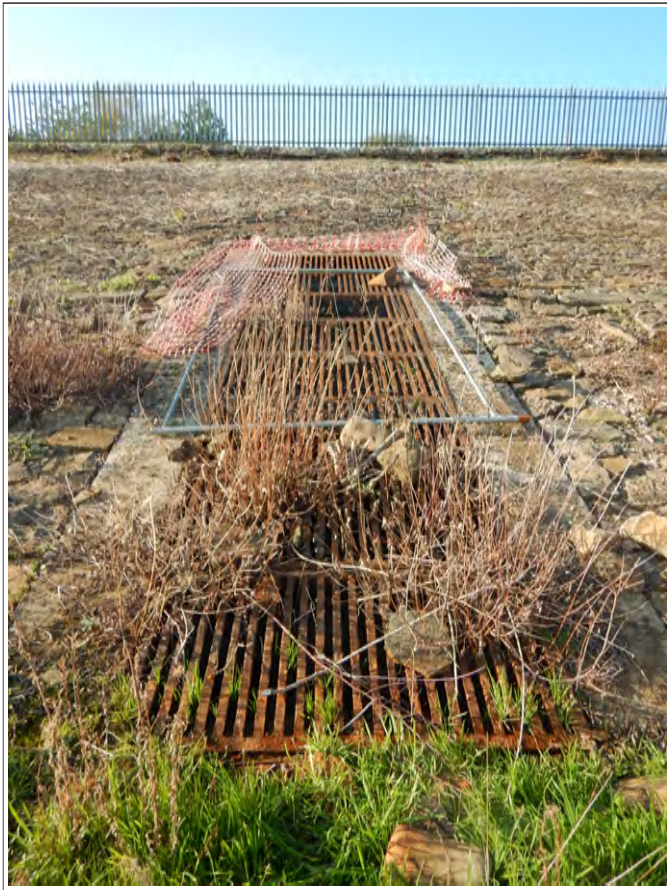
The outlet is not mentioned specifically in the listing text. It was a later addition to the reservoir, and detailed plans for it, dated to 1936, are available (Figure 6; Plate 65).

Plate 65. Outlet situated on west bank of the reservoir, looking west.

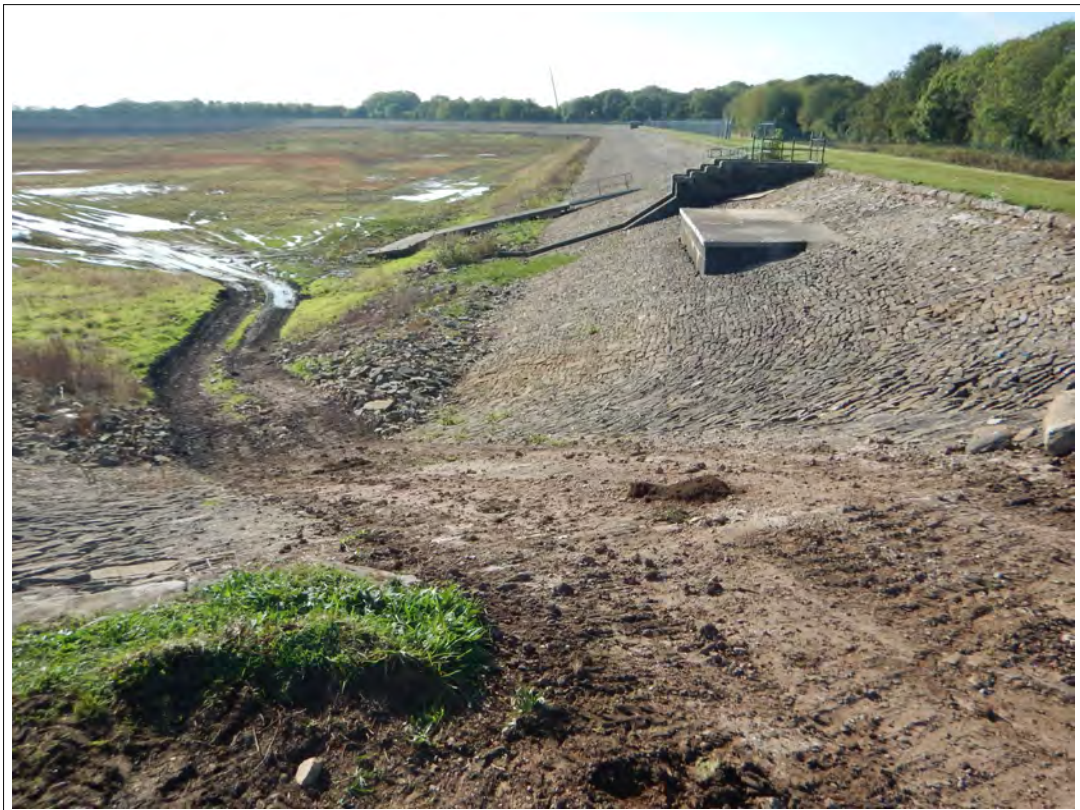
The jetty and slipway are not noted in the listing text. Architects' drawings for both features date to 1977 (Figure 22) indicating they were built in the late 1970s. They relate to the reservoir's recreational use. The jetty is a rectangular, flat topped structure built into the reservoir embankment, constructed from concrete blocks (Plate 66). The slipway consists of a concrete surface made by pouring concrete on top of the pitched stone of the reservoir embankment.

Plate 66. View south-west from the north-west corner of the reservoir, showing the Inlet Gauge Chamber, Jetty, and in the foreground the Slipway.

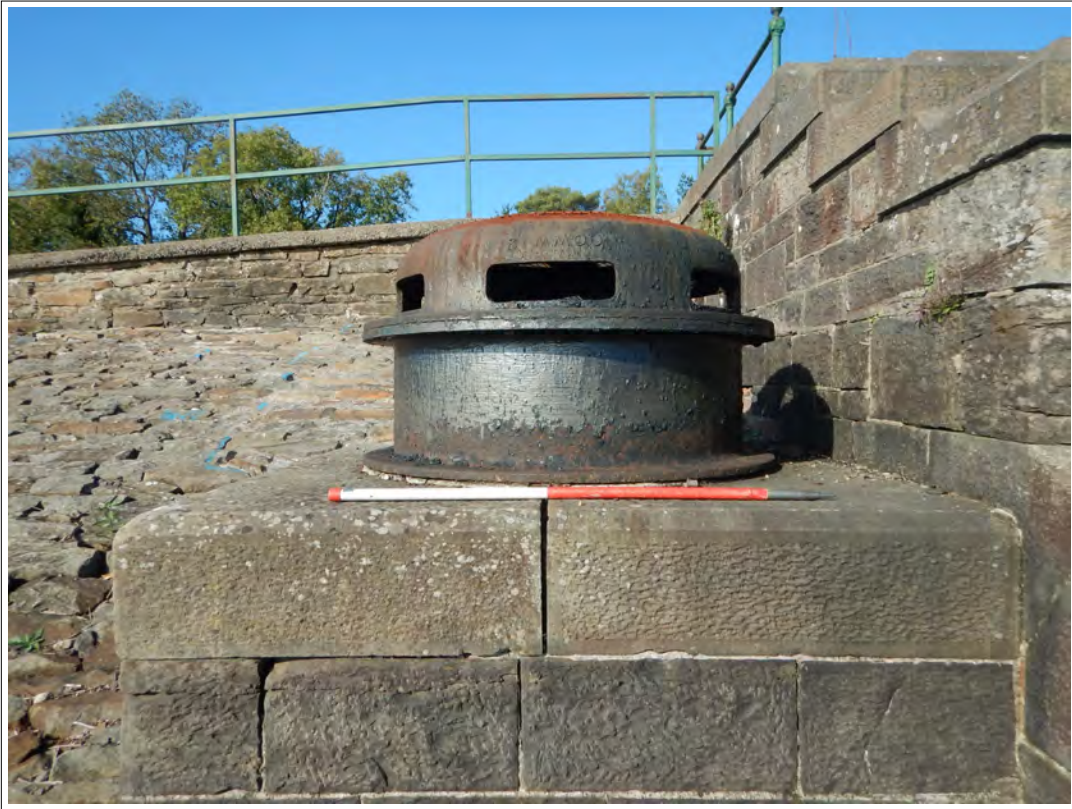
Immediately to the south-west of the south-western wall is a small platform two stone block courses high constructed from roughly-finished ashlar with rusticated coping stones (Plate 67). A large capped metal overflow valve is situated on top of it.

Plate 67. Overflow valve to the south-west of the Inlet Gauge Chamber, and the south-western wall. Scale 1m.

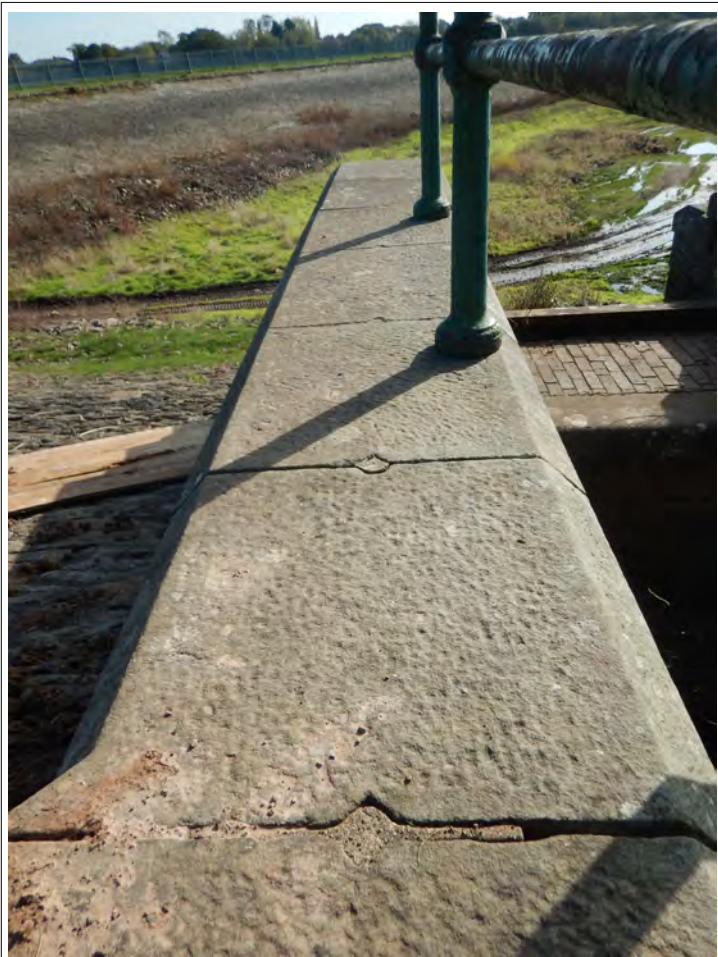
The structure is built into the interior of the reservoir embankment. It consists of two parallel walls extending into the reservoir with an internal perpendicular wall that forms a deep chamber (Figure 21). The exterior walls are constructed from randomly coursed roughly-finished ashlar blocks. These external walls initially extend out at the ground level of the top of the reservoir, before stepping down three steps and then continuing into the reservoir as a low sloping wall following the slope of the pitched stone embankment (Plate 66). The walls are topped by coping stones of rough pointed work with chiselled margins and chamfered edges (Plate 67). Diamond-shaped holes to the top of the coping stones were for vertical cramps or dowels used in the placement of the stones (Plate 68). The wall is topped by a cast iron fence of the design shown in the original architect's drawing.

Plate 68. Coping stones on the top of the Inlet Gauge Chamber walls, showing the mortar plug joints and cast iron fence.

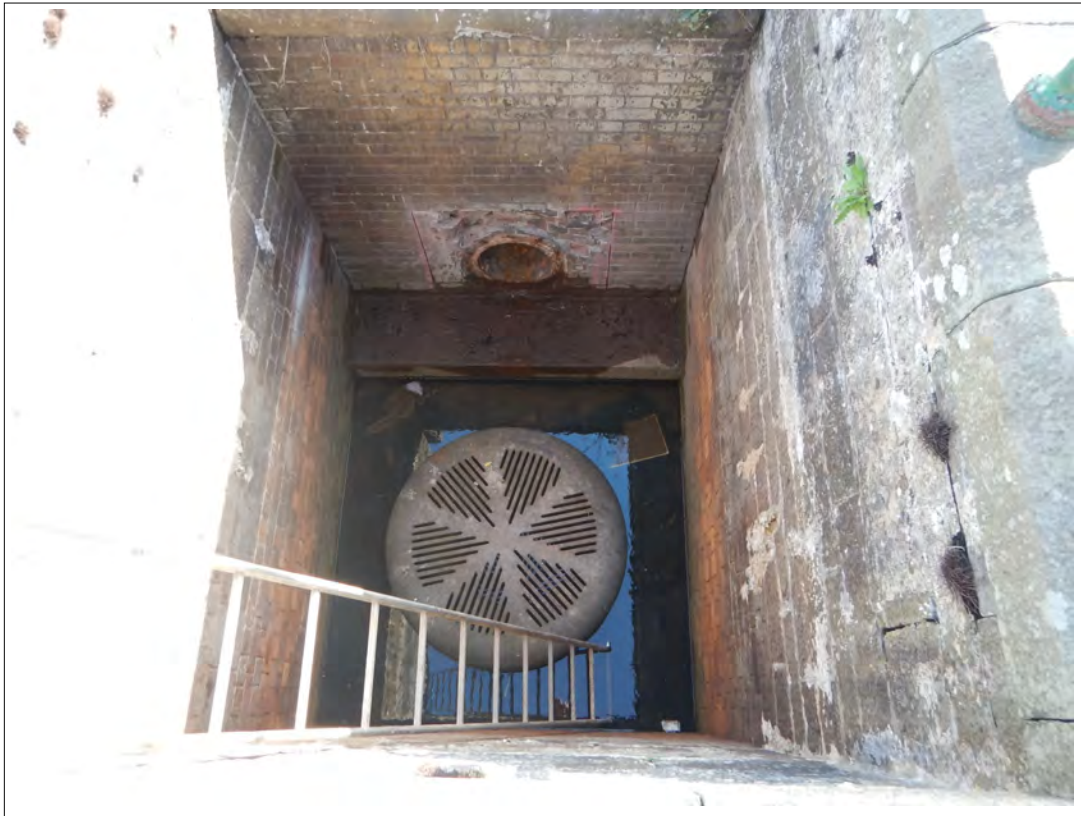
The interior chamber was inaccessible due to depth. The walls on the south-west, north-west and north-east sides were constructed in stone as described above to a depth of 2m from the top of the walls, and below this they were brick built in an English garden bond (Plate 69). The whole of the south-east wall was brick built. Towards the base of this wall was a large outlet pipe. In the bottom of the chamber is a large metal cover over the inlet pipe rising from the floor. The base of the chamber was not visible due to standing water.

Plate 69. Interior chamber of the Inlet Gauge Chamber.

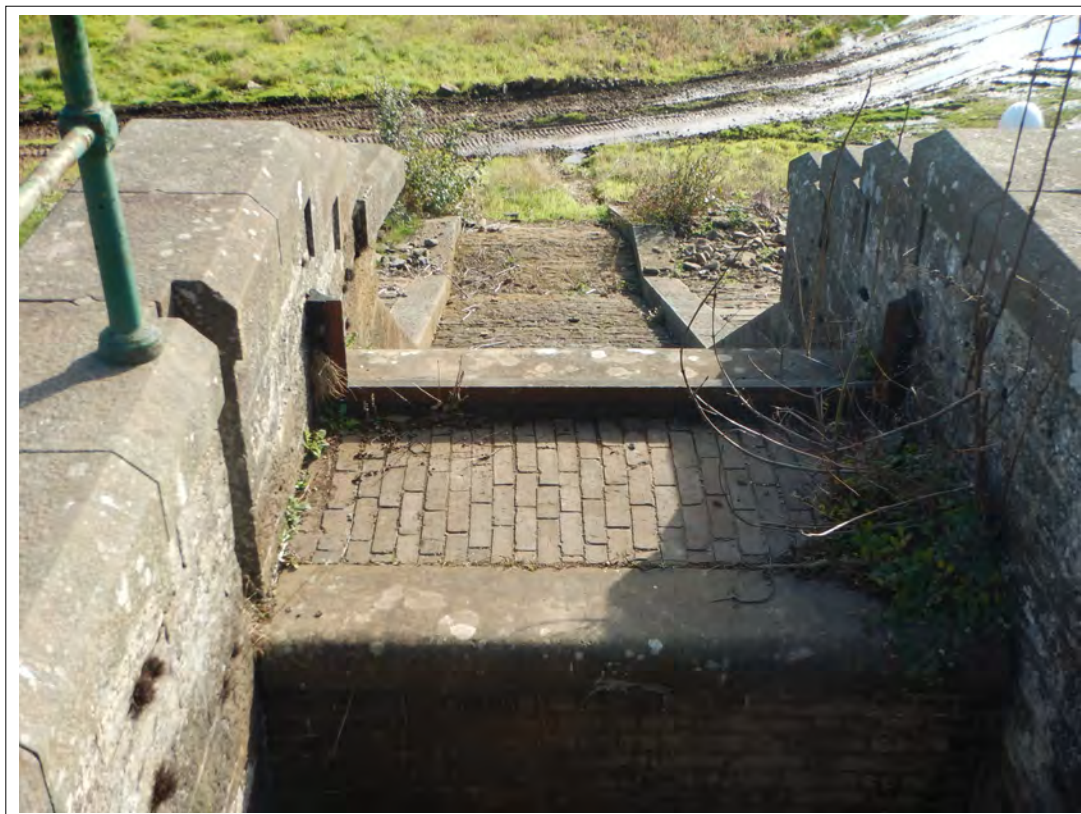
The south-east wall of the chamber was much thicker but also lower than the other walls (Plate 70). It was topped by brick with stone edging. A metal bracket indicates

Plate 70. South-east wall of the Inlet Gauge Chamber, looking south-east down the outlet flow channel into the reservoir.

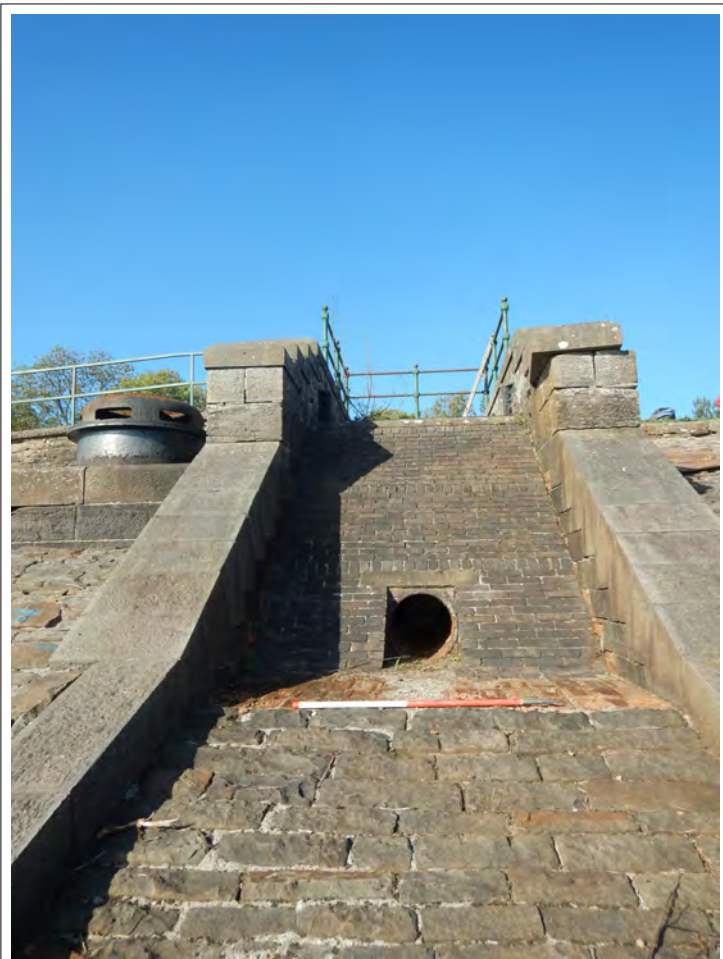
there may have been some kind of sluice gate or removable panel on the top. When viewed from the reservoir interior it is possible to see that this wall slopes at an angle of about 60° from horizontal (Plate 71). The outlet pipe discharged from the base of this wall into the reservoir (Plate 72).

Plate 71. South-east elevation of the Inlet Gauge Chamber showing the outlet pipe, looking north-west. Scale 1m.

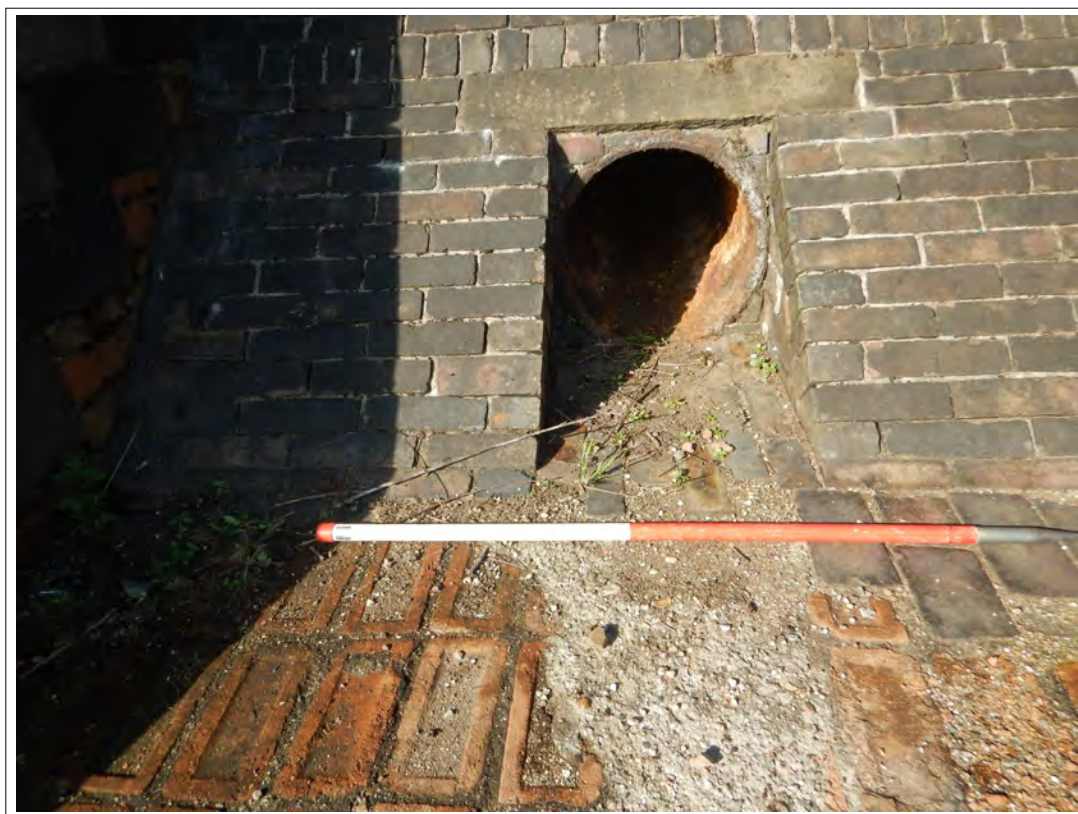
Plate 72. Close-up of the outlet pipe on the Inlet Gauge Chamber, looking north-west. Scale 1m.

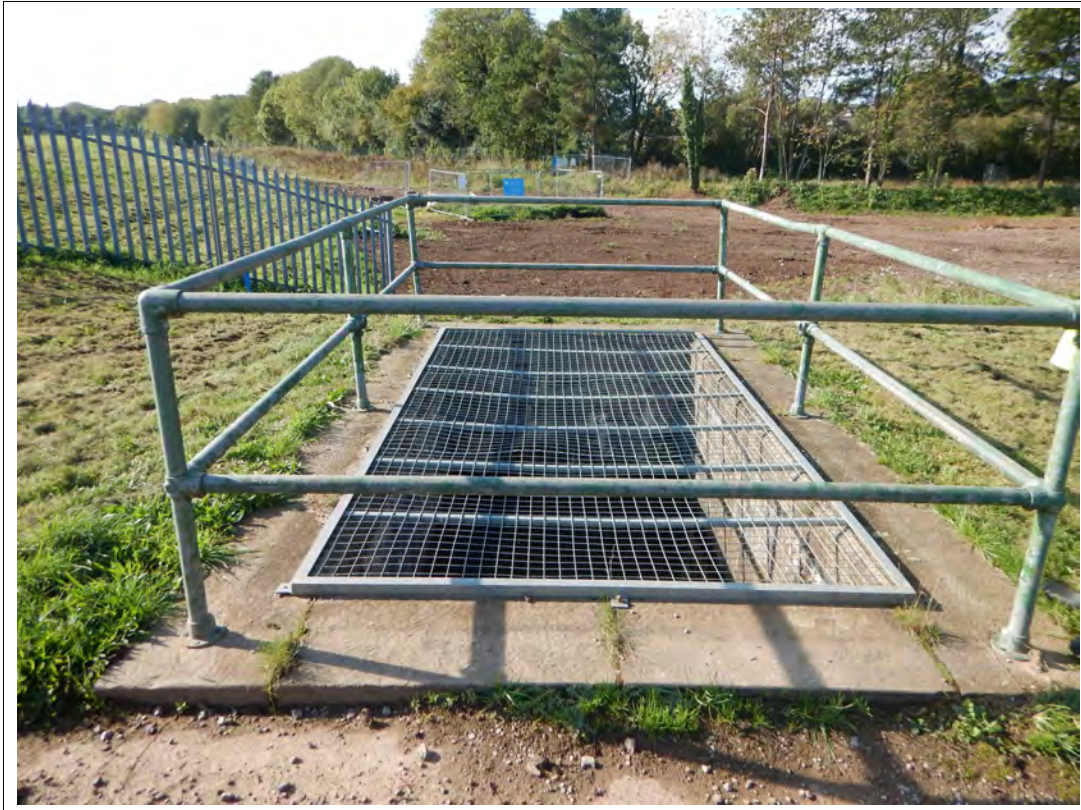
The inlet and gauge basin are situated on the north-west corner of Llanishen Reservoir just to the north of the embankment (Plate 73). Although not mentioned in the listing text they should be considered as Grade II Curtilage Listed due to their operational link to the Reservoir. They are both key components of the original reservoir, with architect's drawings available from 1884 (Figure 21).

Plate 73. Gauge Basin from Lisvane Reservoir, looking south-west.

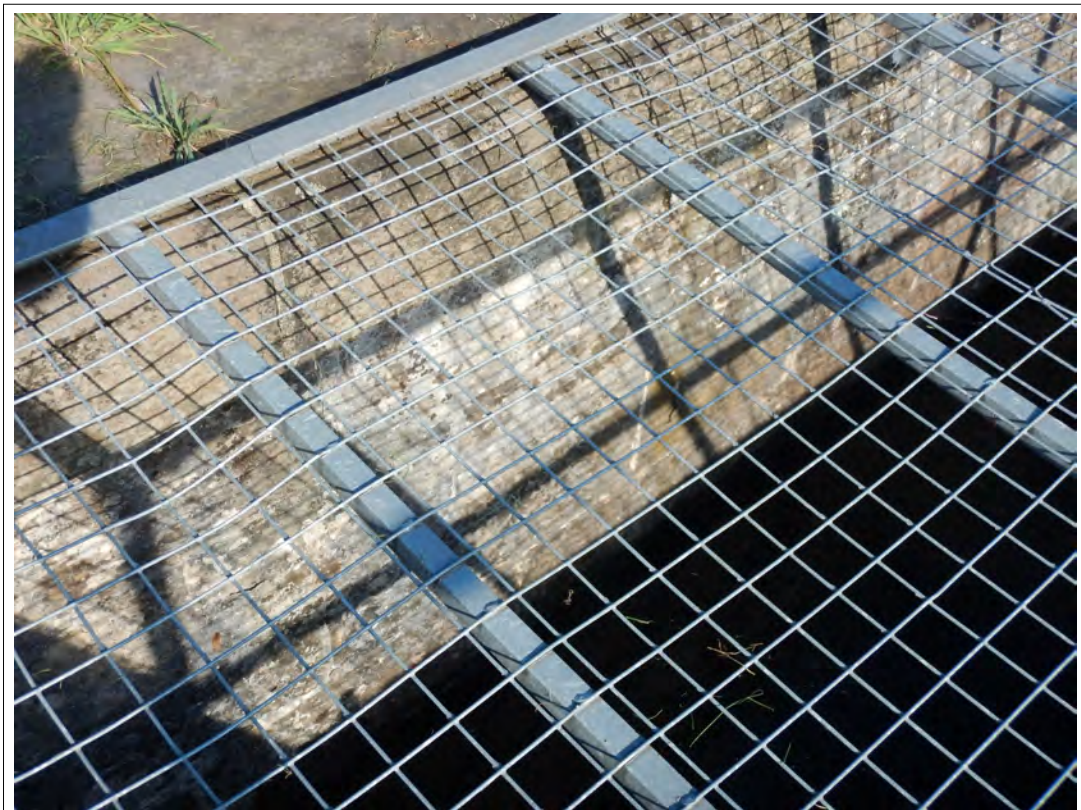
The gauge basin is a simple rectangular basin sunk into the ground, measuring 2.65m by 4.29m. It is now covered by a metal mesh which makes visibility difficult. The chamber is stone lined by well finished ashlar blocks (Plate 74). The chamber's north-east side is open to an inlet channel from Lisvane reservoir. The coping stones have vertical dowel holes visible to the top.

Plate 74. Interior stone lining of the Gauge Basin.

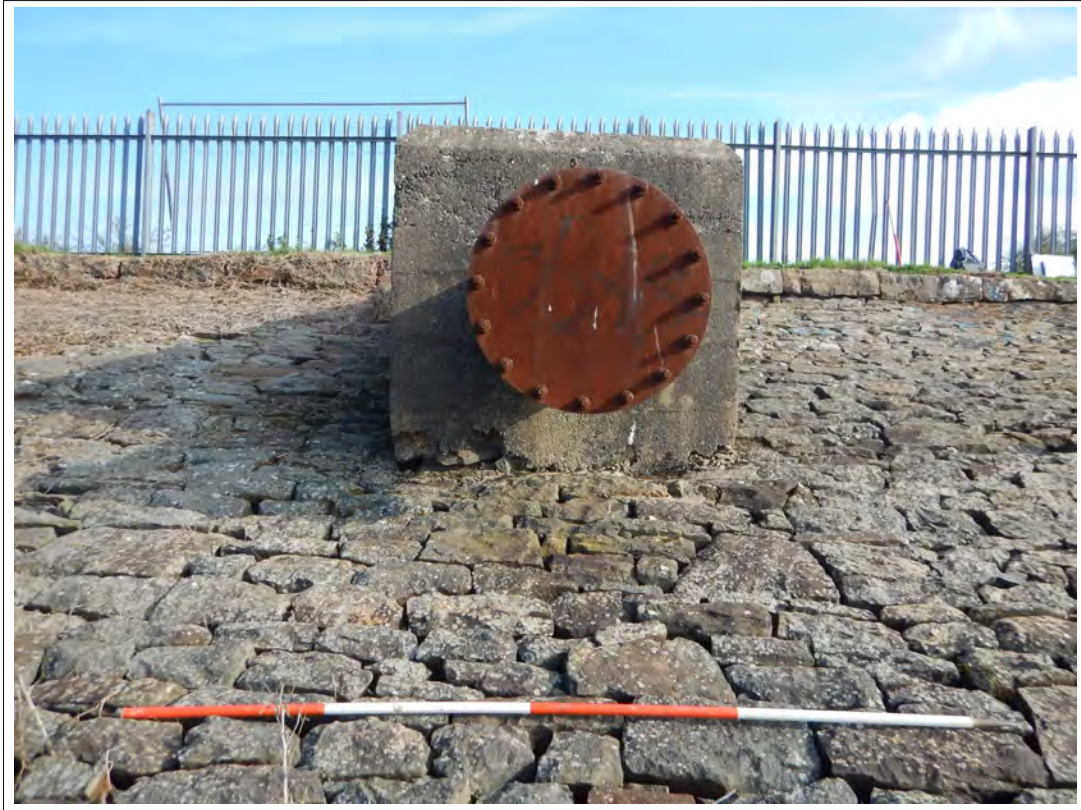
The structure is a single piece of poured concrete which had been poured directing onto the pitched stone (Plate 77). It extends 3.36m into the reservoir from the edge of the embankment, is 1.6m wide, and at its highest point is 1.47m from the pitched stone surface. The concrete bears the impression of the wooden slats used to form it. It has chamfered edges in the style of the Victorian stonework. The pipe exits into the reservoir. It is capped with a circular plate attached with bolts that is 0.83m in diameter and is slightly off centre.

Plate 77. Pipe penetration, looking east. Scale 2m.
