MAESTEG TOWN HALL
HISTORIC BUILDING RECORDING
ISSUE 01: OCTOBER 2019

MAESTEG TOWN HALL: HISTORIC BUILDING RECORDING

Purcell was commissioned to carry out a Level 3 historic building recording (HBR) to Maesteg Town Hall to fulfill condition 12 xiii of consented application P/18/761/LIS for the renovation and extension to the building to create a sustainable future use as a cultural arts centre.

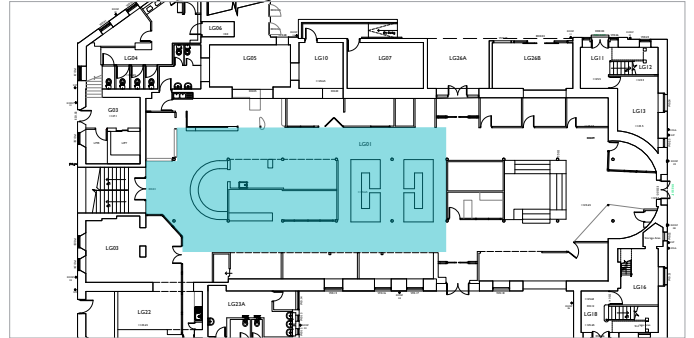
3.1 FORMER PLAIN LATH AND PLASTER CEILING TO MARKET HALL (LG01)

The 1980s tin tile matt black ceiling was removed from the market hall, revealing the original 19th century plain lath and plaster ceiling that was hidden above. Large areas of this plasterwork were damaged or hollow and a grid of battens that the tin ceiling was fixed to was acting as support for the plaster and securing it in place.

The battens and the lath and plaster were retained, with a new ceiling suspended beneath.

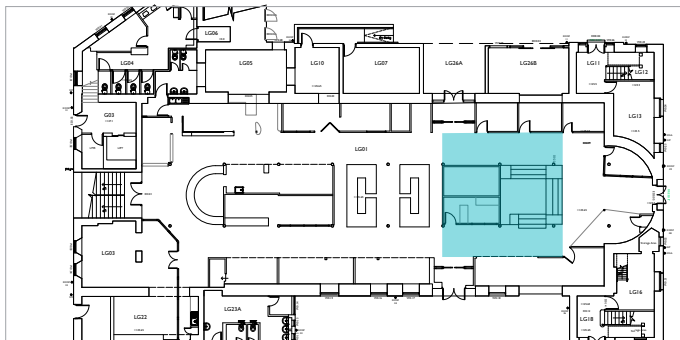
3.2 MARKET HALL CEILING HATCH (LG01)

Upon revealing the original ceiling noted above, a hatch was revealed within the separating floor between the Market Hall and the Main Hall above. This is assumed to be a historical means of transferring goods from one floor to the other.

The ceiling hatch between the Market Hall and the Main Hall.

The hatch was retained along with the historic plasterwork and has been re-concealed above the new suspended ceiling.

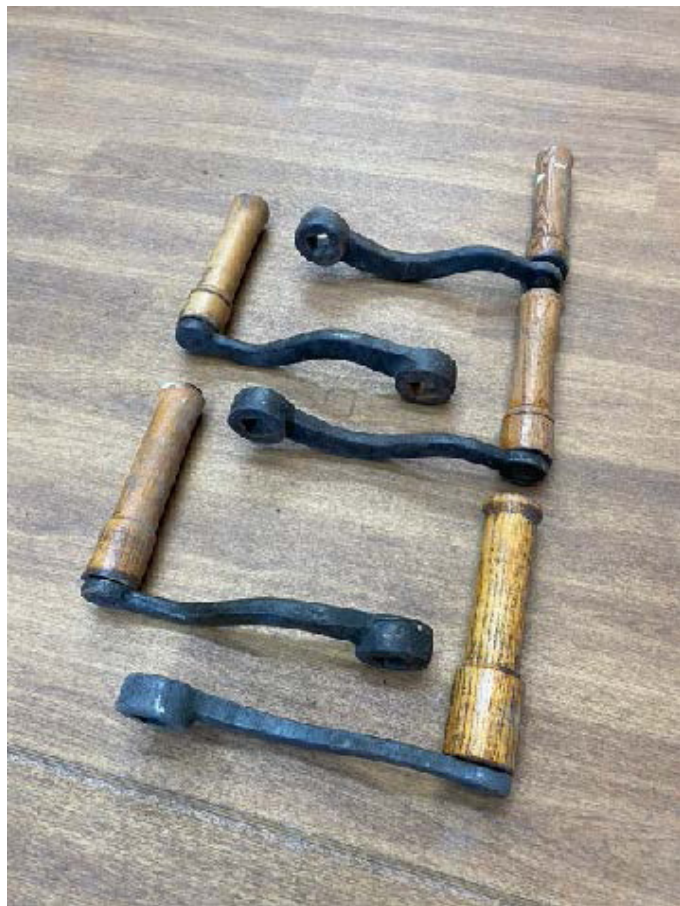
Four wrought iron and hardwood rotary handles were found resting loose on top of an existing stone wall in the Market Hall. Their original use is unknown, but it is assumed that they are associated with the manual operation of a wound system within the building.

The four wrought iron and hardwood rotary handles found within the Market Hall.

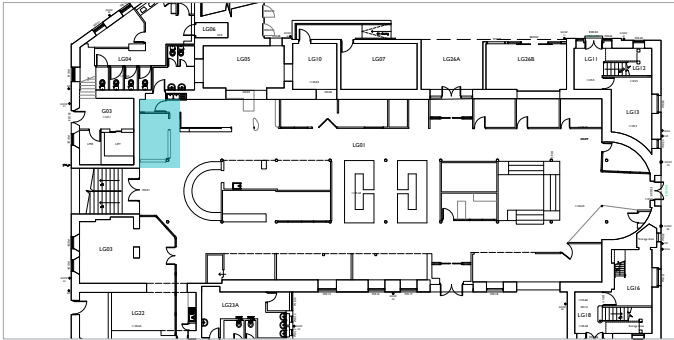
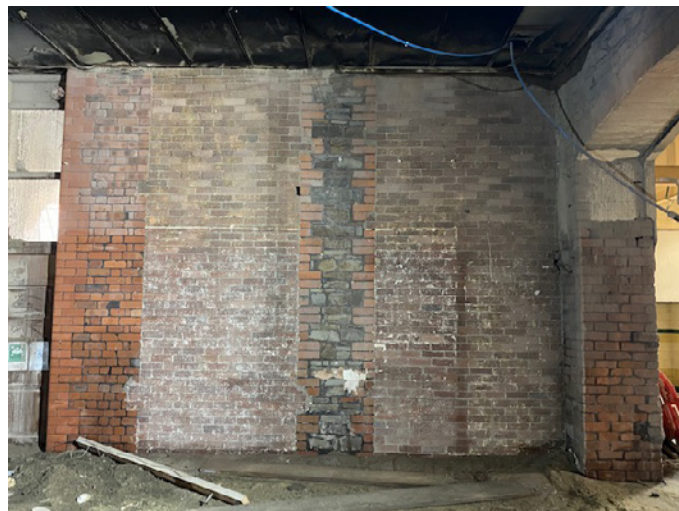
3.4 FORMER 19TH CENTURY OPENINGS TO THE NORTH OF THE MARKET HALL (LG01)

Two large former 19th century door openings were uncovered once multiple layers of masonry paint were removed from the original historic fabric. These doorways would have led into a northern room located below street level to the north-east of the Market Hall. This would have mirrored a similar room on the north-west side of the Market Hall. The north-east room was partly infilled with concrete in the 20th century to provide access from street level and is now in use as a plant room.

The scarring of the two infilled doors on the north side of the Market Hall.

The infilled openings have been retained and are visible within Market Hall with the masonry walls exposed in the new scheme, revealing the legibility of the previous planform.

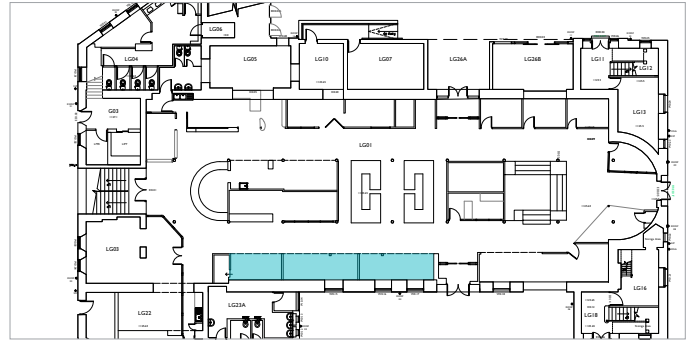
3.5 FORMER 19TH CENTURY OPENINGS TO THE WEST OF THE MARKET HALL (LG01)

Two 19th century infilled door openings were found in the western external wall to the Market Hall which were also uncovered once multiple layers of masonry paint were removed.

The infilled openings have been retained and are visible within Market Hall with the masonry walls exposed in the new scheme, revealing the legibility of the previous planform.

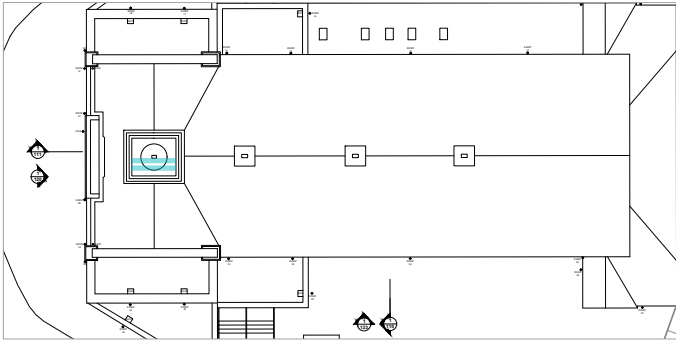
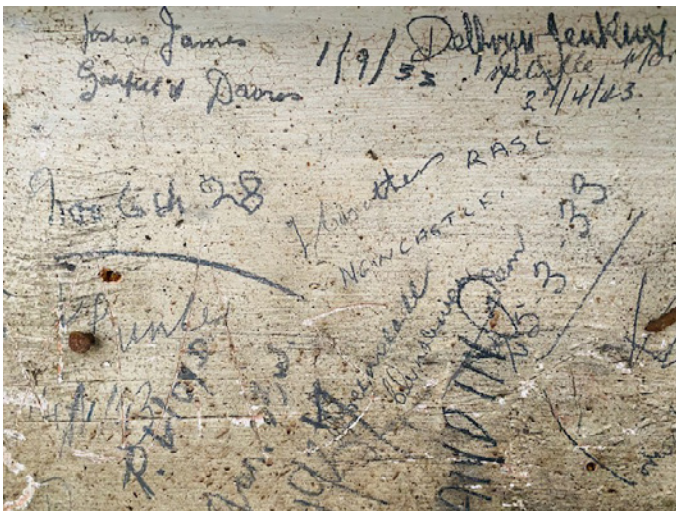
3.6 SIGNATURES WRITTEN AND ENGRAVED ON STRUCTURAL TIMBER BEAMS WITHIN CLOCKTOWER

A large collection of signatures have been inscribed onto the structural beams behind the clockfaces of the clocktower dating from early 1900's to the 1980s. Predominately the signatures originate from between 1920-1945; it is understood that the graffiti dating from World War II was inscribed in the beams when the clocktower was reportedly used as a look-out point for air raids.

An extract of the signatures written and engraved on the structural beams of the clocktower.

The beams and signatures have been retained and are accessible to view within the clocktower structure.

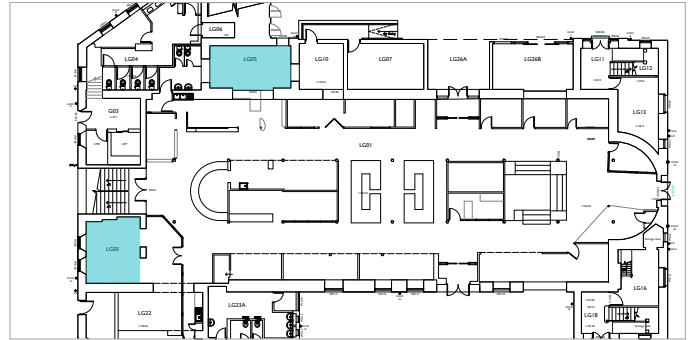
3.7 HALF-LEVEL TILES TO ROOMS OF OFF MARKET HALL (LG03 AND LG05)

Decorative green, cream and yellow glazed tiles were revealed after wall drylinings were removed to LG03 and LG05 adjacent to the Market Hall. It is not known what the historic function of these room were to warrant the decorative tiling.

The tiles were retained to LG05 and will remain visible in the completed scheme. The tiles to LG03 were removed as they had been extensively damaged.

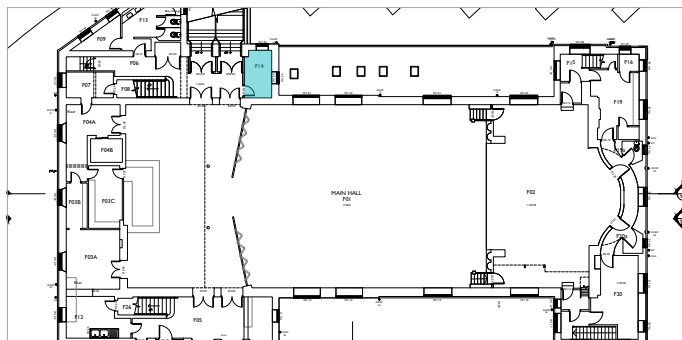
3.8 HISTORIC CORNICE TO STAFF OFFICE (F14)

A plaster cornice and plain ceiling was revealed within staff office. Unfortunately, sections of this plasterwork had deteriorated and had been damaged, however the cornice was repaired and reinstated to a matching decorative scheme.

The damaged cornice and plaster ceiling to the staff office which was repaired to a matching decorative scheme.

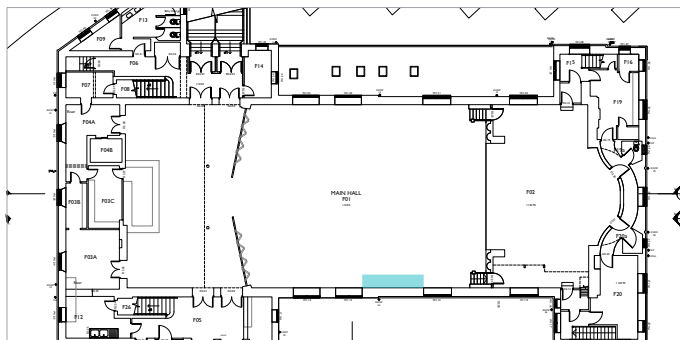
3.9 19TH CENTURY WAINSCOTING TO MAIN HALL (F01)

A 19th century scheme of decorative timber wainscoting was revealed in the Main Hall after the removal of 1970s panelling that had been obscuring the original feature.

The original wainscoting was retained and extensively repaired with matching profiles and replacement sections.

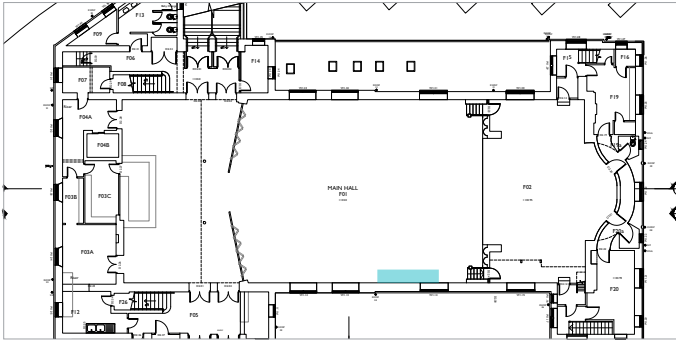
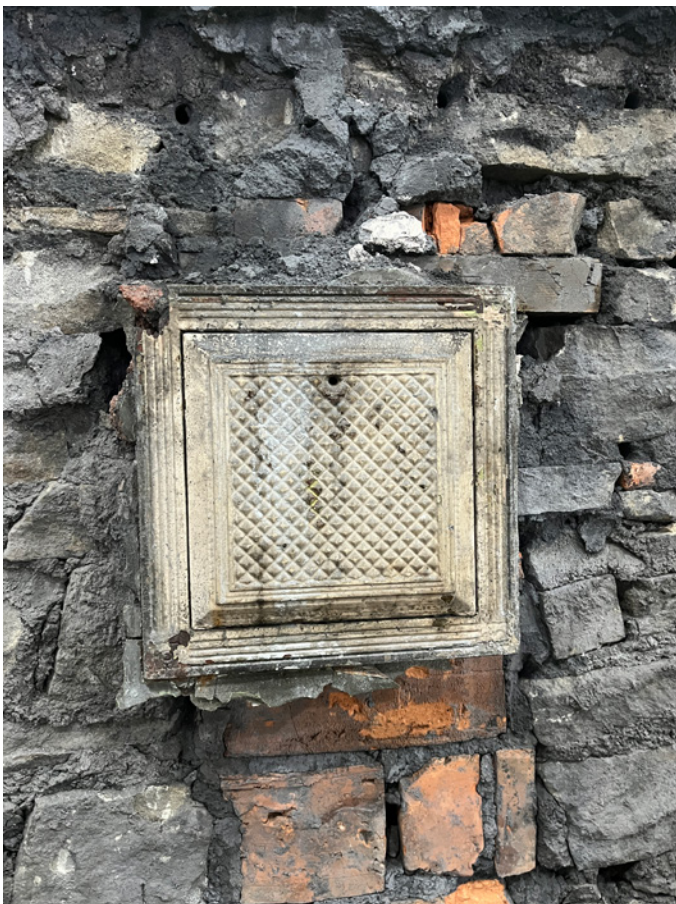
3.10 CAST IRON WALL VENTS WITHIN 19TH CENTURY WAINSCOTING TO MAIN HALL (F01)

Cast iron wall vents were revealed within the Main Hall once the 1970s panelling was removed.

The wall vents revealed from behind the 1970s panelling in the Main Hall.

The cast iron vents were retained and redecorated within the Main Hall.

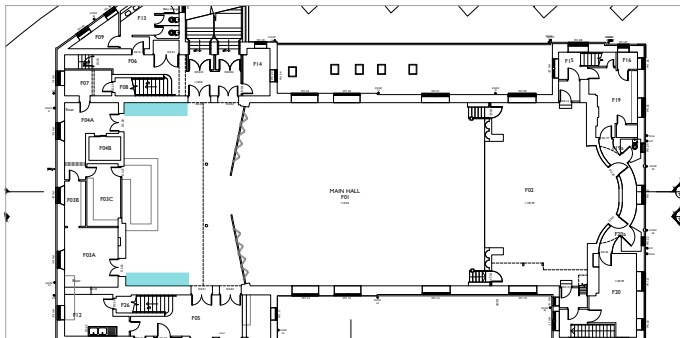
3.11 FORMER 19TH CENTURY WINDOWS TO EAST/ WEST OF MAIN HALL BENEATH BALCONY (F01)

Four timber framed multipaned 19th-century fixed casement windows, two on the east elevation and two on the west elevation, were revealed within the Main Hall beneath the balcony canopy. These were previously obscured behind 20th century wall linings.

The four windows were repaired and retained as features within the Main Hall.

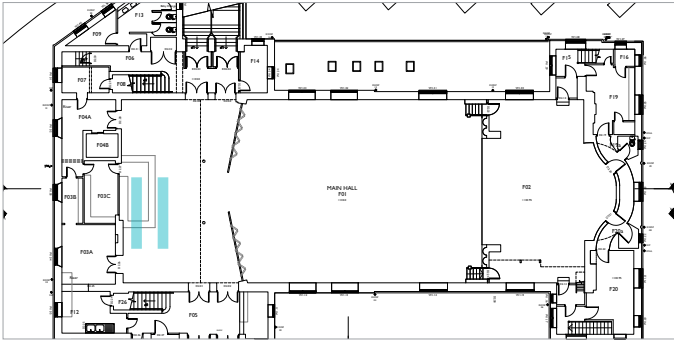
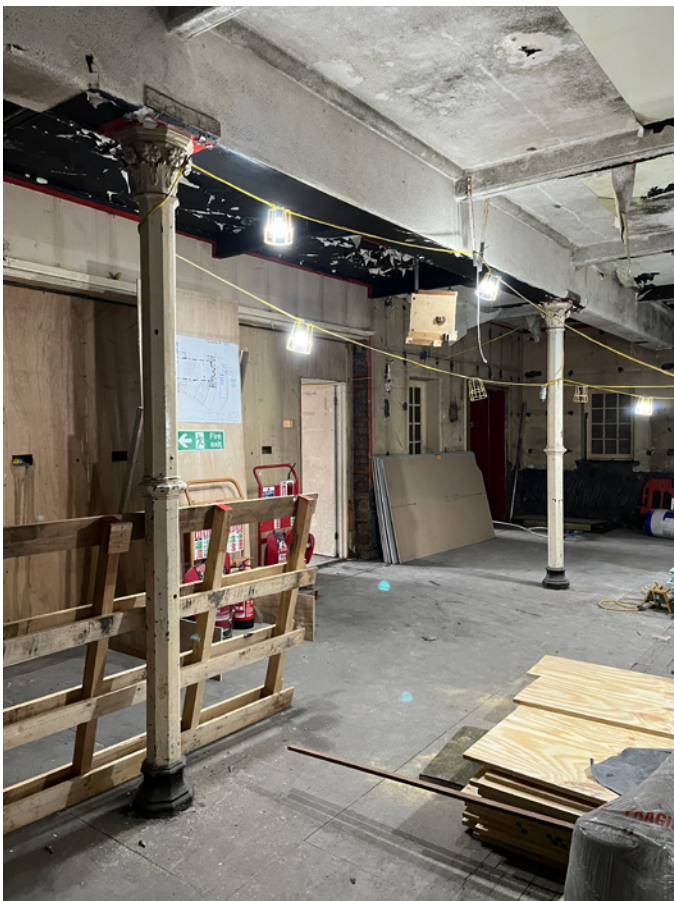
3.12 2NO. ORNATE CAST IRON COLUMNS TO MAIN HALL (F01)

Two ornate cast iron columns were revealed in the Main Hall once the former bar servery was removed.

The cast iron columns in the Main Hall.

The columns have been retained, redecorated and are now visible in the Main Hall.

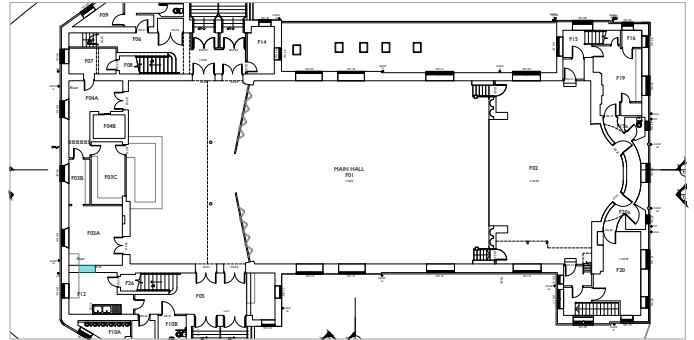
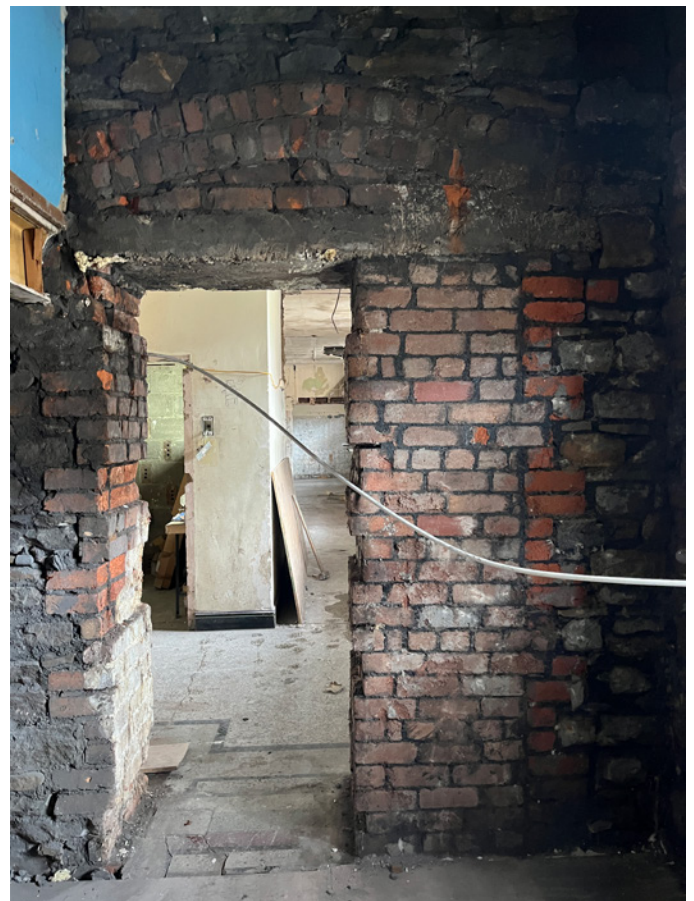
3.13 FORMER 19TH CENTURY OPENING TO EAST OF KITCHEN (F03)

An adapted opening partially infilled with bricks within the masonry wall was revealed once the modern wall linings were removed from F03. The historic opening was shown to have had a segmented brick arch head, similar in style to other openings visible across Maesteg Town Hall.

The adapted opening partially infilled with brick, with a segmented brick arch above, previously obscured behind modern wall coverings.

The opening has been re-incorporated within the plan form of the building to provide access between front of house and back of house. The surrounding masonry walls have been plastered over.

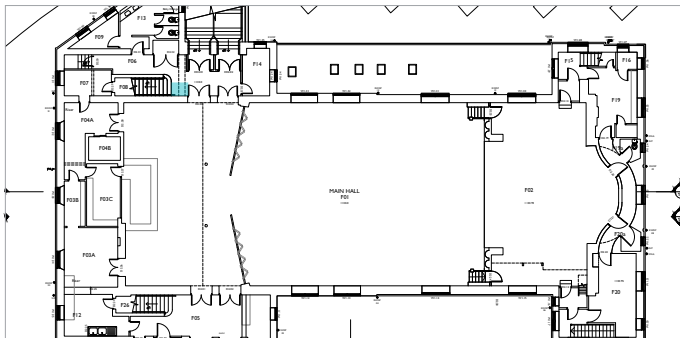
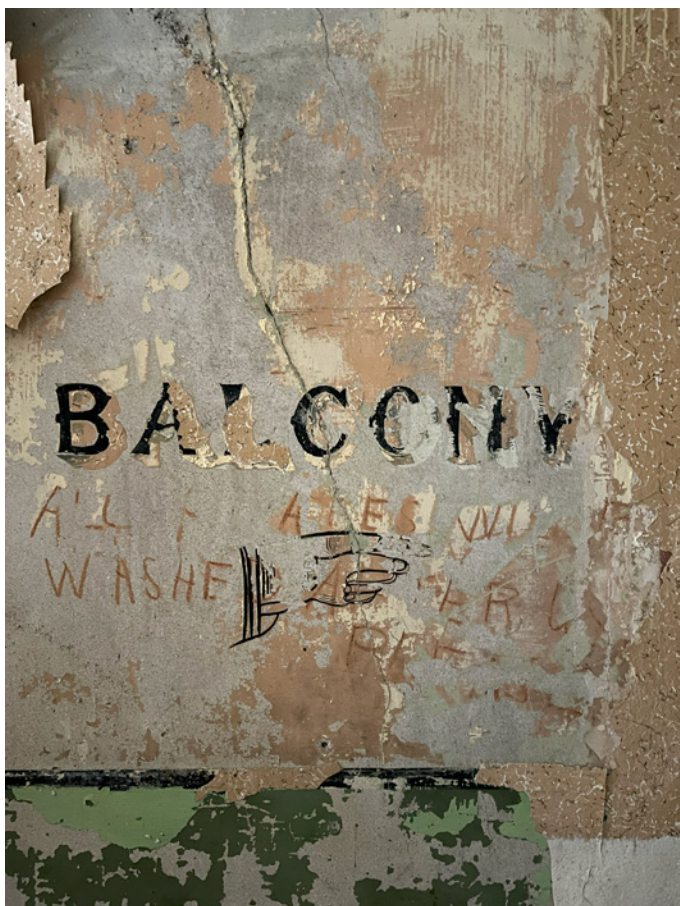
3.14 HAND PAINTED WAYFINDING IDENTIFIED TO ONE LOCATION WITHIN EASTERN STAIR WING (F06)

A hand-painted wayfinding sign was revealed behind flaking paint within the eastern stair wing. The sign depicts a hand pointing right underneath the word 'Balcony'.

The hand painted signage found on the eastern stair wing.

The signage has been recorded by photographs (as above) but has been re-covered behind new paint.

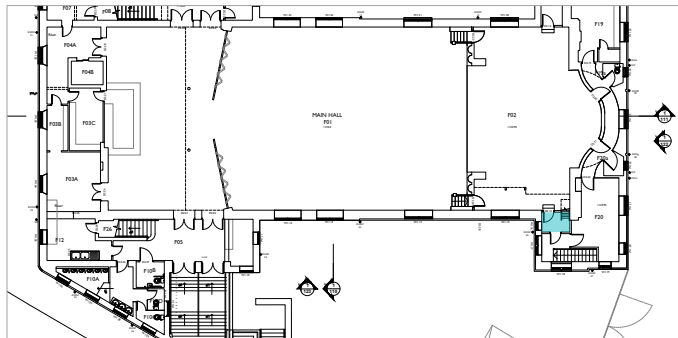
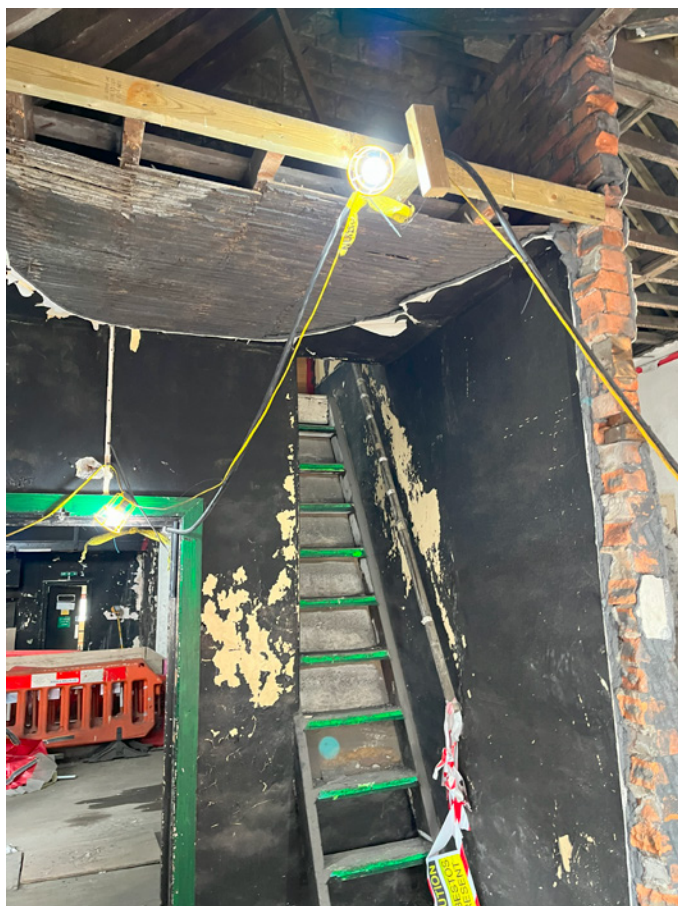
3.15 LADDER ACCESS TO 19TH CENTURY STAGE LEFT GANTRY (F28)

A single width ladder was uncovered behind modern wall coverings within the Main Hall. The narrow and steep ladder provided access to the stage left gantry prior to being blocked over.

The narrow ladder to the stage left gantry.

The stage left gantry was removed as a part of the renovation works to Maesteg Town Hall, and as such the ladder was also removed as part of works within the building.

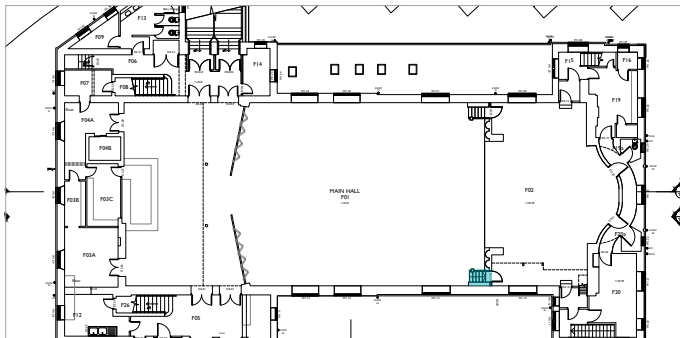
3.16 FORMER BALUSTRADE TO STAGE FRONT STEPS CONCEALED BEHIND PLYWOOD CLADDING (F01)

A historic balustrade to the front steps of the stage in the Main Hall was revealed upon the removal of modern plywood cladding that had been obscuring it. The uncovering of this feature has also revealed a previous decorative scheme to the Main Hall.

The balustrade has been retained and repaired where necessary with matching profiles. The repaired balustrade has been redecorated to be incorporated within the new decorative scheme within the building.
