LEVEL 3 BUILDING RECORDING OF A FORMER BARN AT GETHLEY BARN, LLAN Y NANT FARM, TRELLECH GRANGE, NP16 6QN

Report by: Trysor

June 2021

Trysor Project No. 2020/770
GGAT HER EVENT PRN : E009532

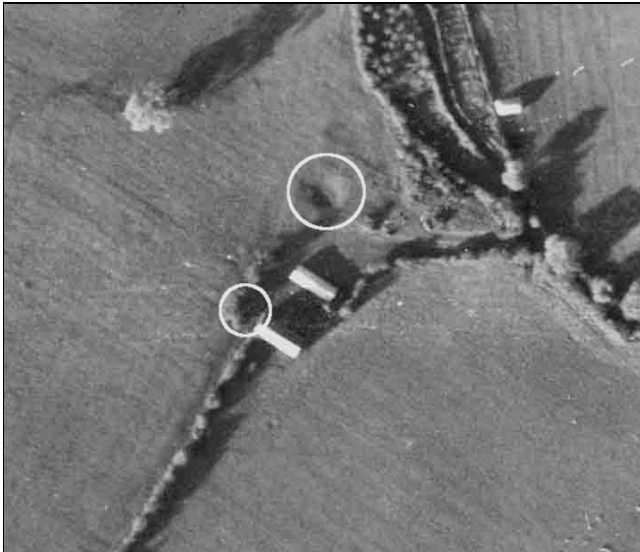
7.10 The present owner provided information that the barn was damaged during the Second World War, when it was hit by a German bomb and the western gable wall was “destroyed”. This incident is mentioned in the parish history (Burton, Heath & Williams, 2001, p.45). The 1946 RAF aerial photograph shows that the barn was still roofed at that time, which suggests repairs were rapidly undertaken. The owner recalls that the damaged western end was rebuilt with concrete blocks during the 1960s, but this wall also decayed. The building remained in use into the late 20th century but in the 1990s the slate roof had been stolen, leaving the walls unprotected and susceptible to further deterioration. Following this the mid-20th century concrete block walling has been replaced by stone walling which is more sympathetic to the original structure and sits on the original footprint of the barn. The building remains roofless in 2021.

Figure 8: The 1946 RAF aerial photograph with the location of two of the bomb craters identifiable from a series of five created during a Second World War bombing raid. A third was made to the south and another two were reported as being closer to Gethley cottage to the north. (Welsh Aerial Photography Unit, 1946, 4650 RAFCPEUK1828 3301).

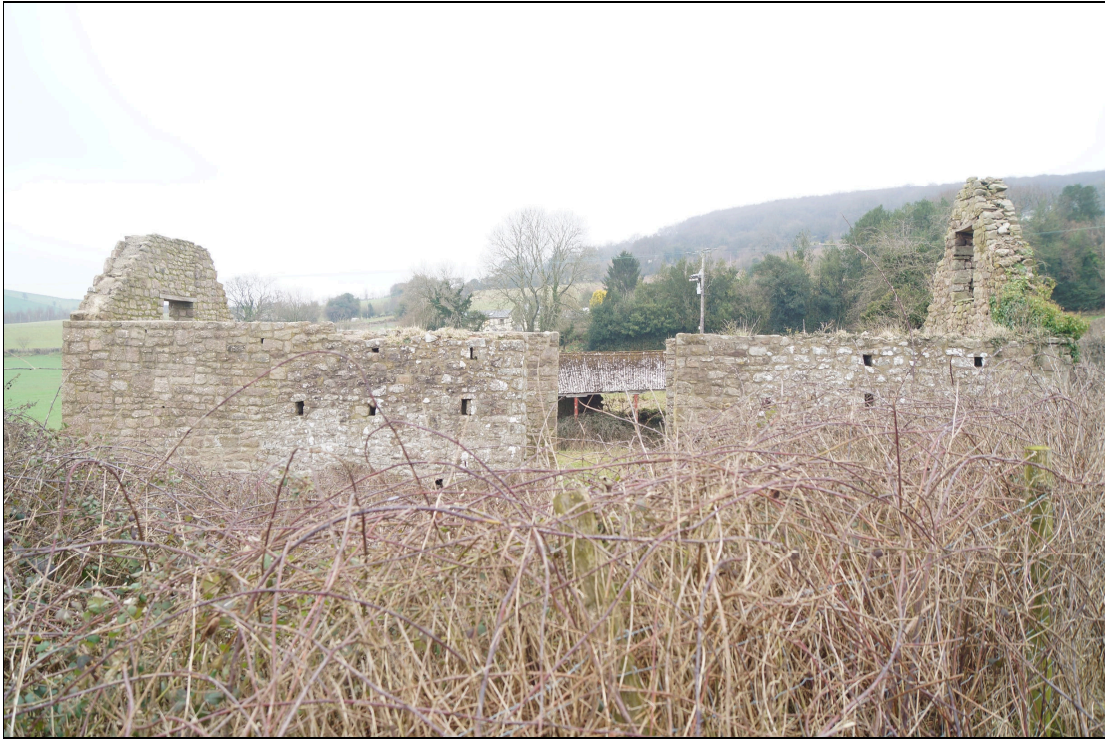
8.3.5 The southern wall of the threshing barn has a large doorway to the east of centre, which measures 2.72 metres wide and rises to wall plate level (Plate 3). This doorway faces an opposing doorway in the northern side of the barn. No doorframe or associated fixings survive.

Plate 3: GTB2021_003 - A view of the threshing barn from the adjacent trackway. Looking north-northeast.

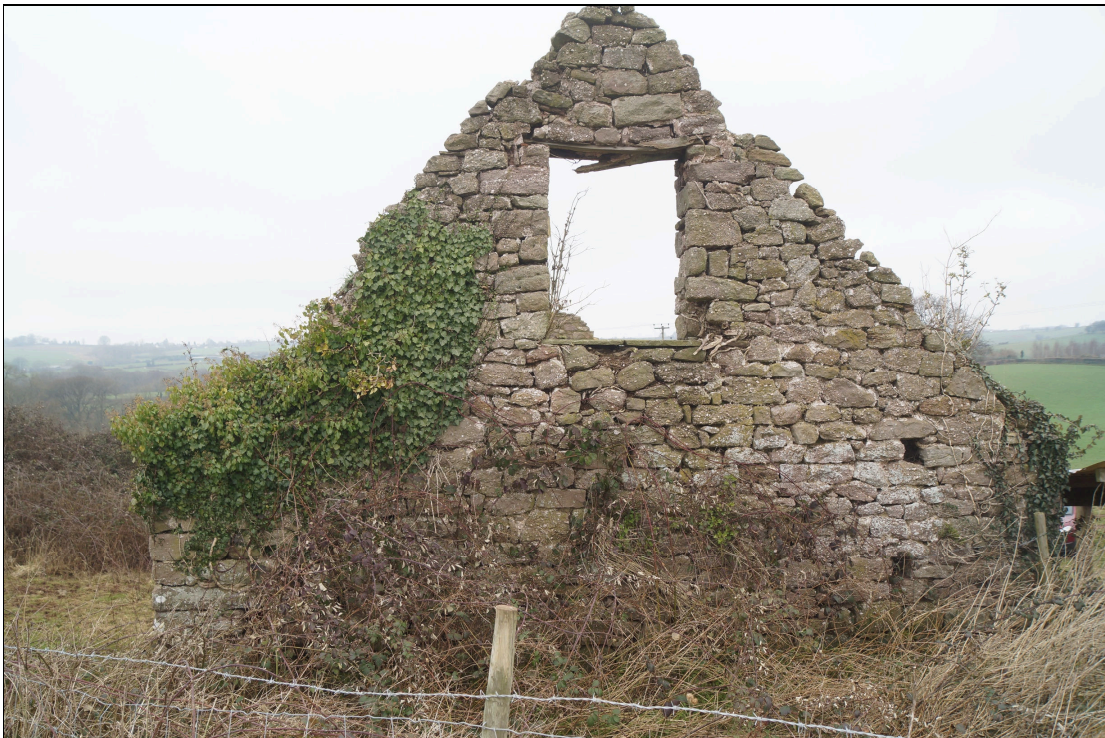
8.3.4 The threshing barn stands on a levelled terrace, with the lower part of its eastern gable wall revetted into the slope. This wall has a central window in the upper part of the gable (Plates 4 & 37). A wooden lintel and stone cill remain in place in this window. This wall also has three pairs of square ventilation holes above external ground level and two similar apertures of unknown purpose in the lower part of the wall, below external ground level. The bottom of the window is over 3 metres above the present internal floor level. Two mortar samples were taken from the eastern gable. D was of the core mortar (Plate 57) and E was of the pointing (Plate 56). Both are likely to be of 18th century date and the pointing closer to the construction date than later in 19th or 20th century.

Plate 4: GTB2021_004 - A view of the external face of the eastern gable wall, showing the pitching window and a pair of ventilation holes on the right, the other four are obscured by vegetation. Looking west-northwest.

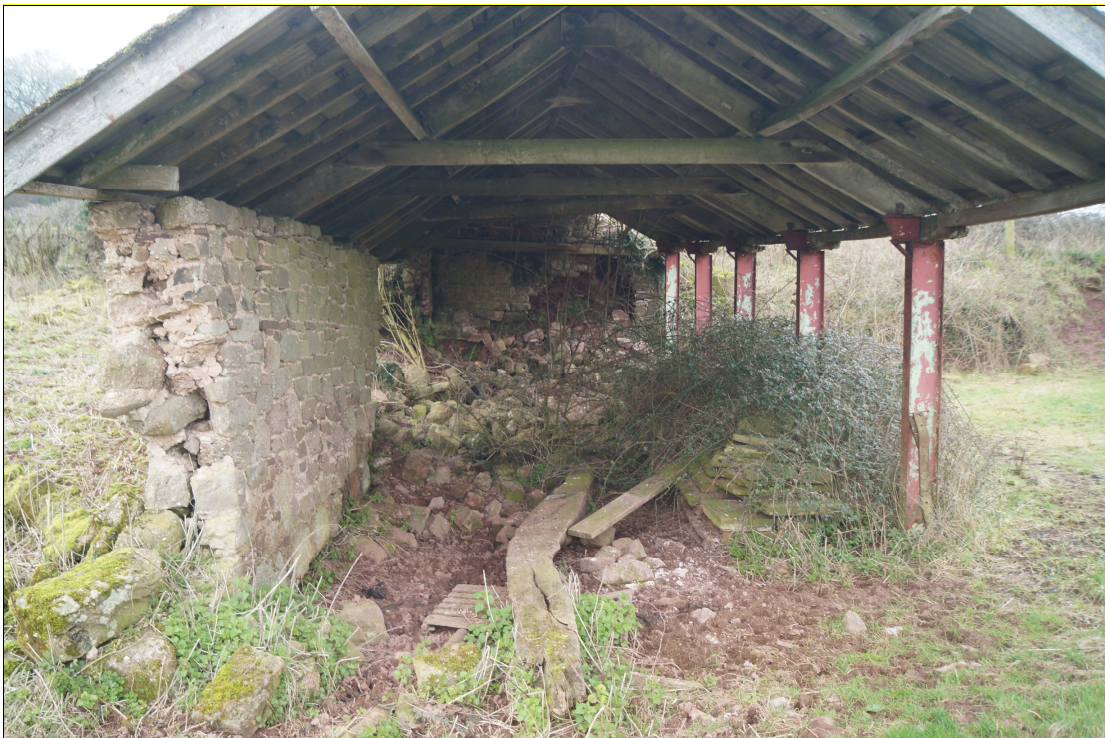
8.3.2 There is presently no roof on the building. At least one roof beam from the barn is currently stored in the neighbouring storage shed (Plate 14).

Plate 14: GTB2021_014 - A view inside the open-sided storage shed north of the threshing barn. Note that part of a roof truss from the threshing barn lies on the floor, and stone flagstones are also stacked here, source unknown. Looking east-southeast.

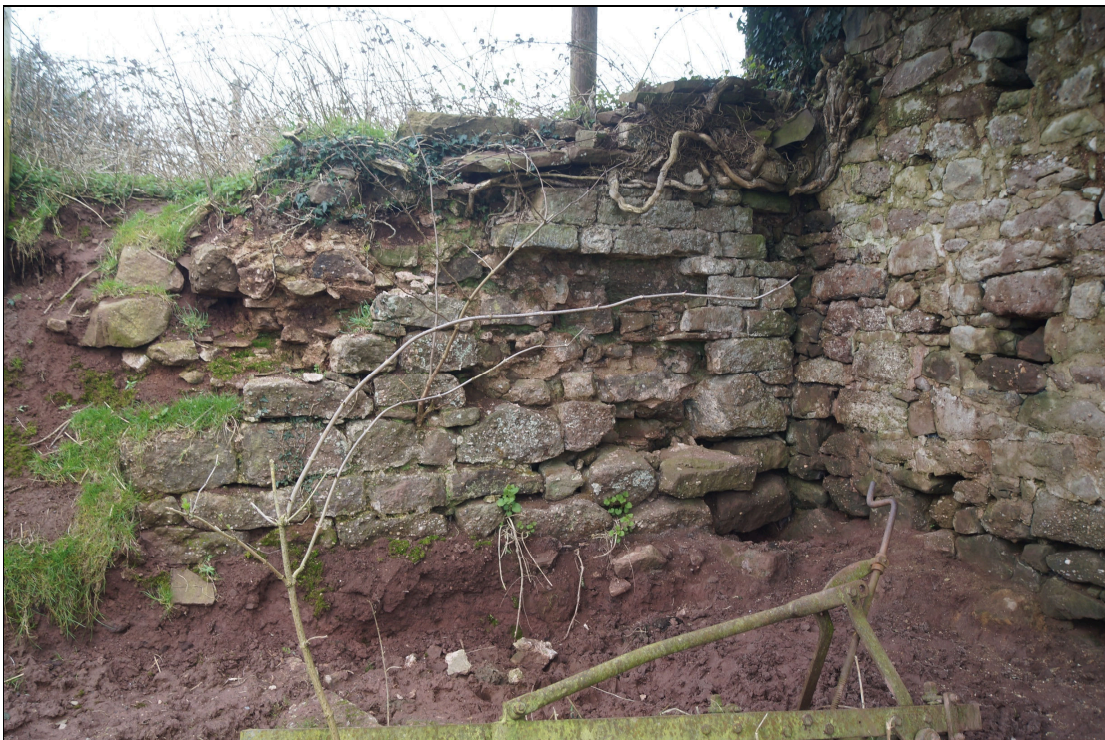
Plate 20: GTB2021_020 - A view of the ruinous remains of a former boundary wall which springs off the northeastern corner of the threshing barn. Looking south-southeast.

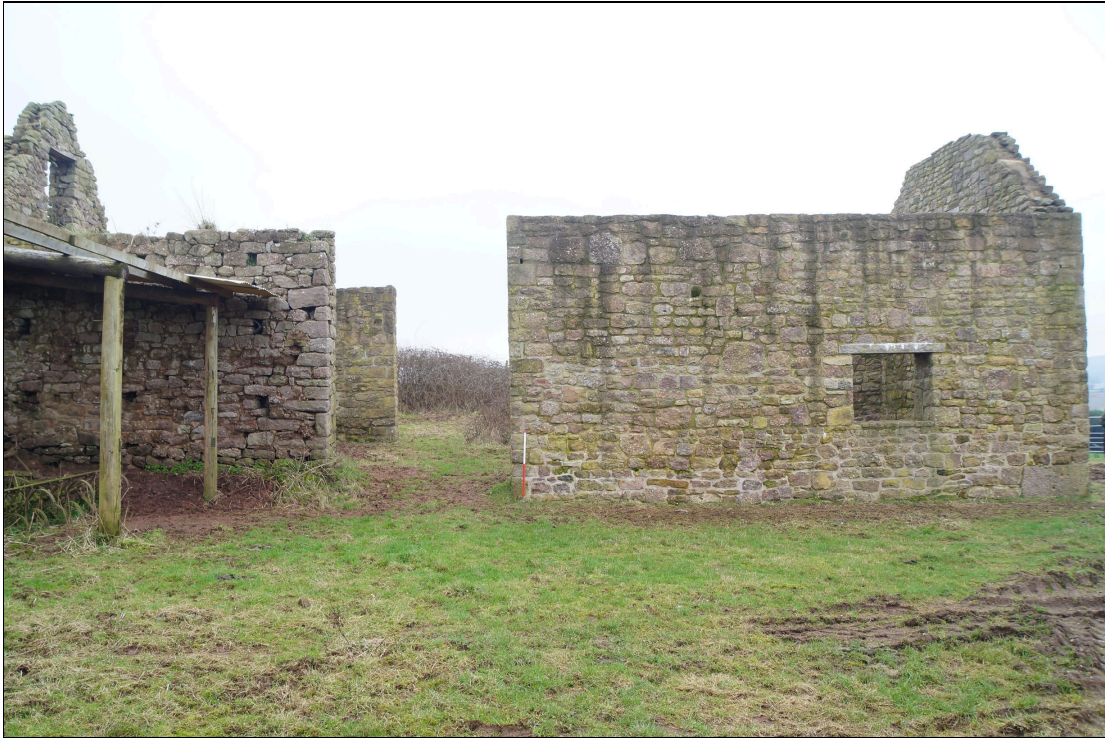
Plate 27: GTB2021_027 - A view of the threshing barn, showing the opposed doors through the lateral walls. Looking south-southwest.

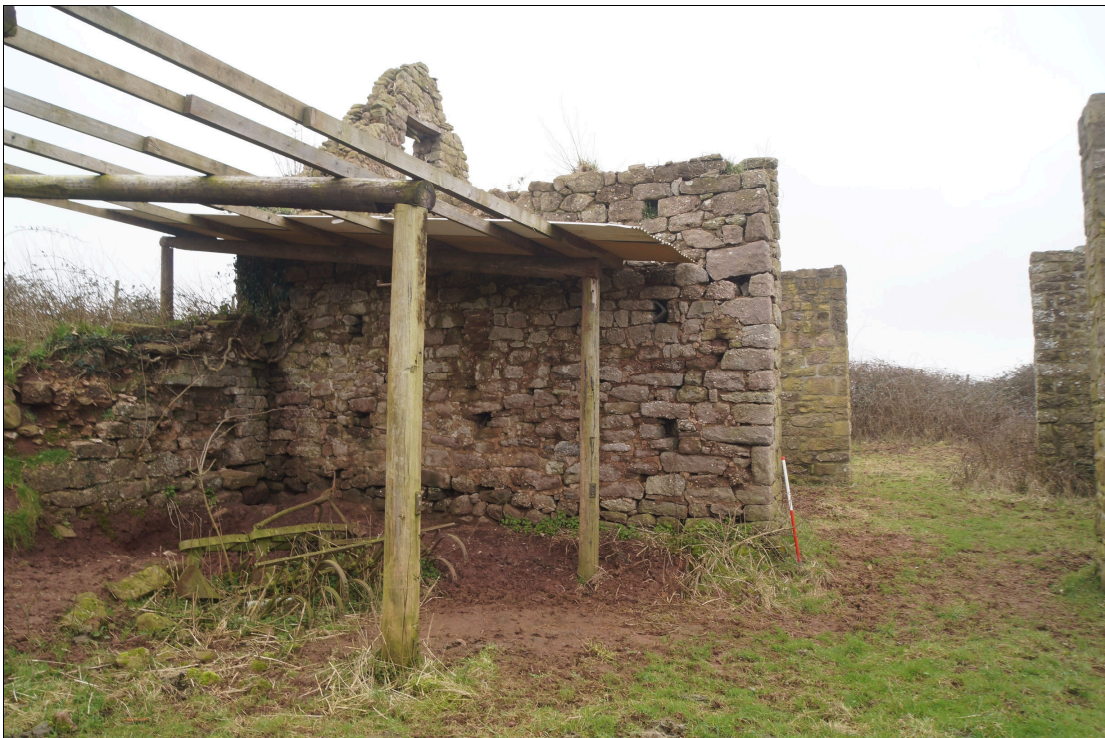
Plate 30: GTB2021_030 - A view of the threshing barn, showing the largely unaltered walls at the eastern end of the building and the opposed door. Looking south.

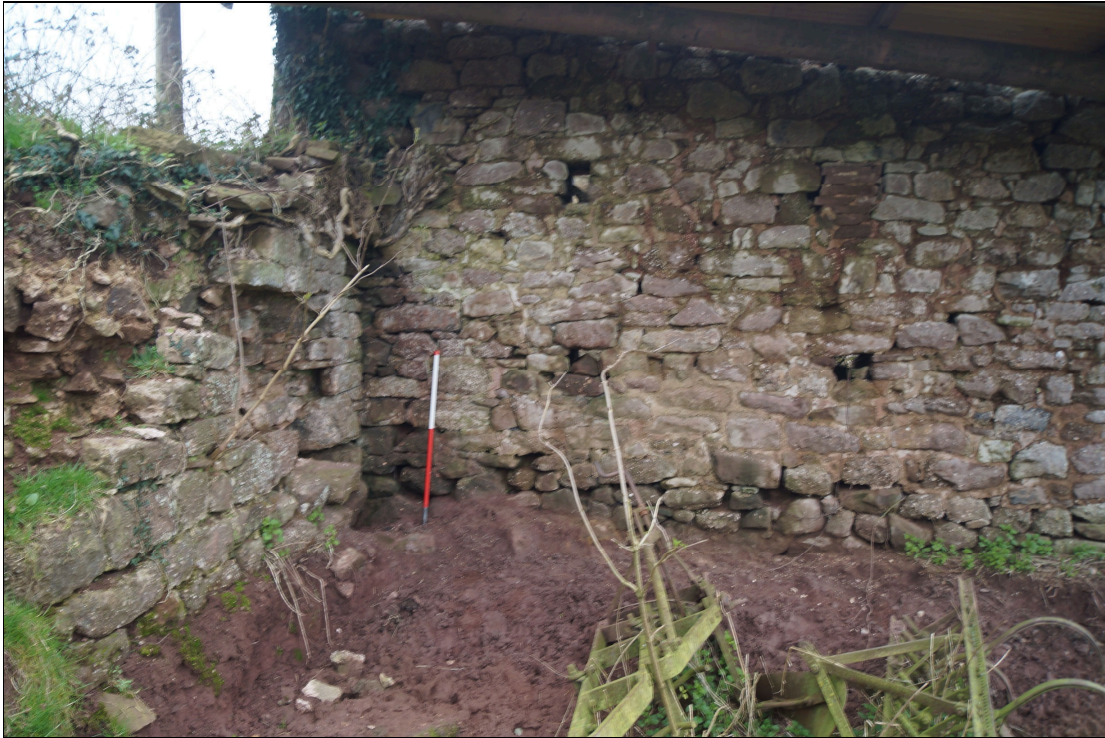
Plate 31: GTB2021_031 - A view of the eastern end of the northern lateral wall. A surviving section of the revetment wall which enclosed an associated enclosure around the three buildings at Gethley Barn is visible on the left of the photo. Looking south-southwest.

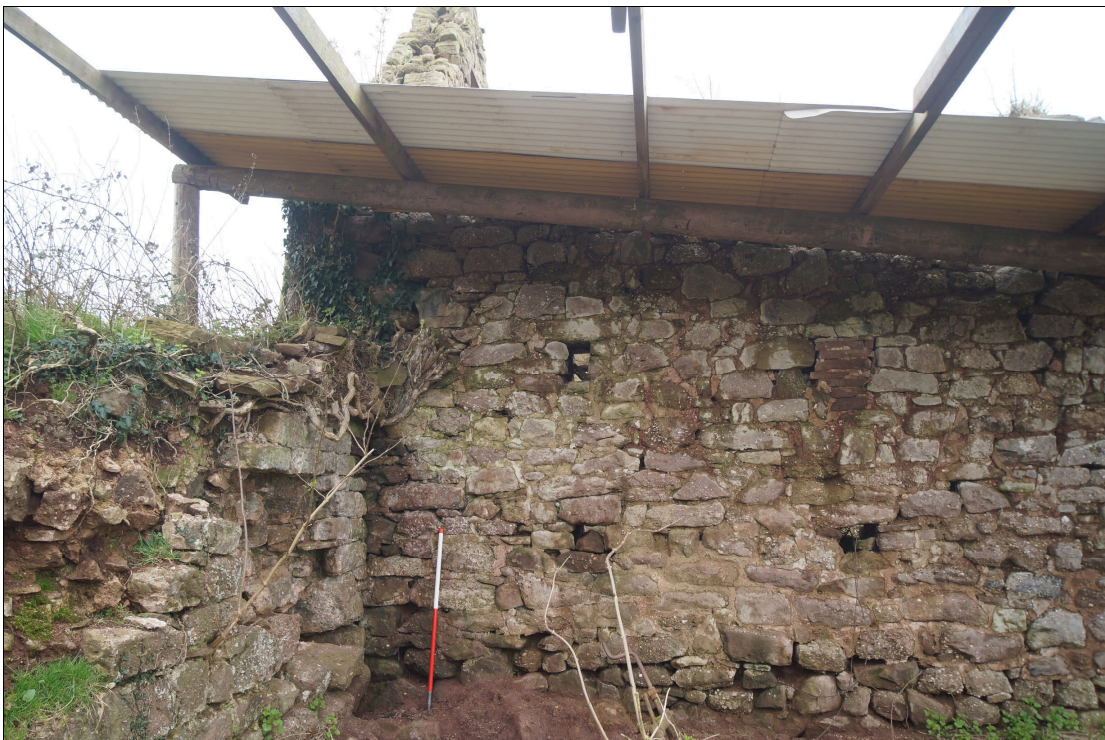
Plate 32: GTB2021_032 - A view of the eastern end of the northern lateral wall. A surviving section of the revetment wall. Note the ventilation holes of the threshing barn. Looking south-southwest.

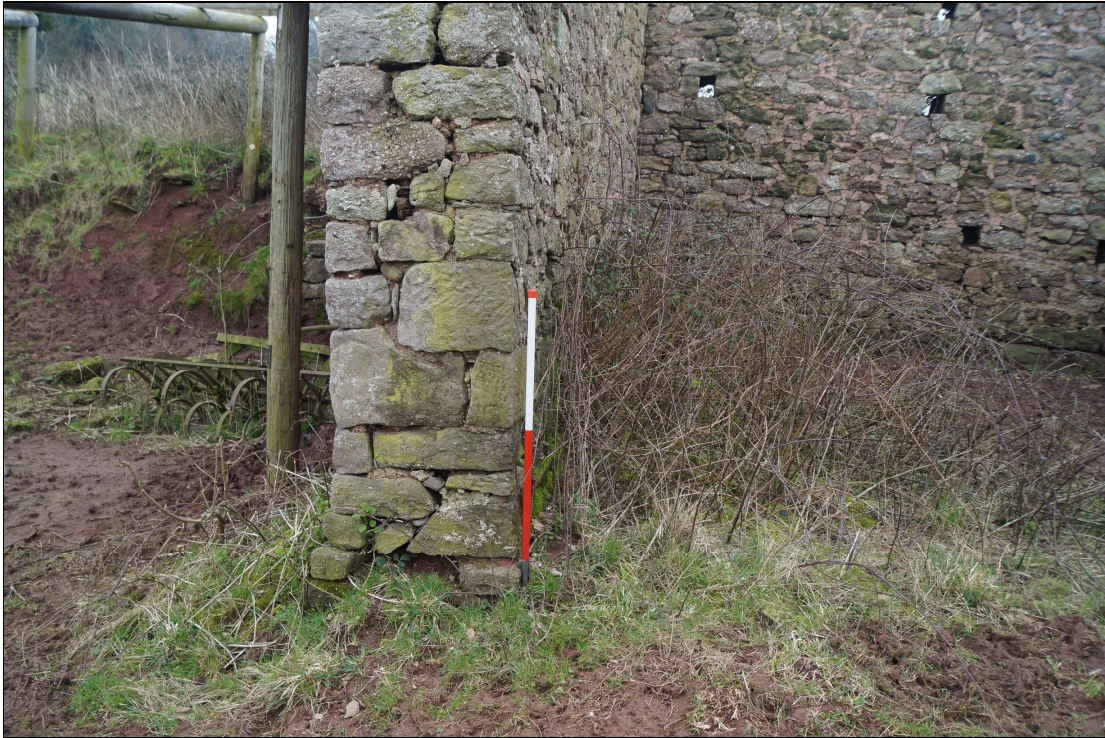
Plate 33: GTB2021_033 - A view of the door reveal at the eastern side of the northern doorway into the tithe barn. This is an original wall. Looking east-southeast.

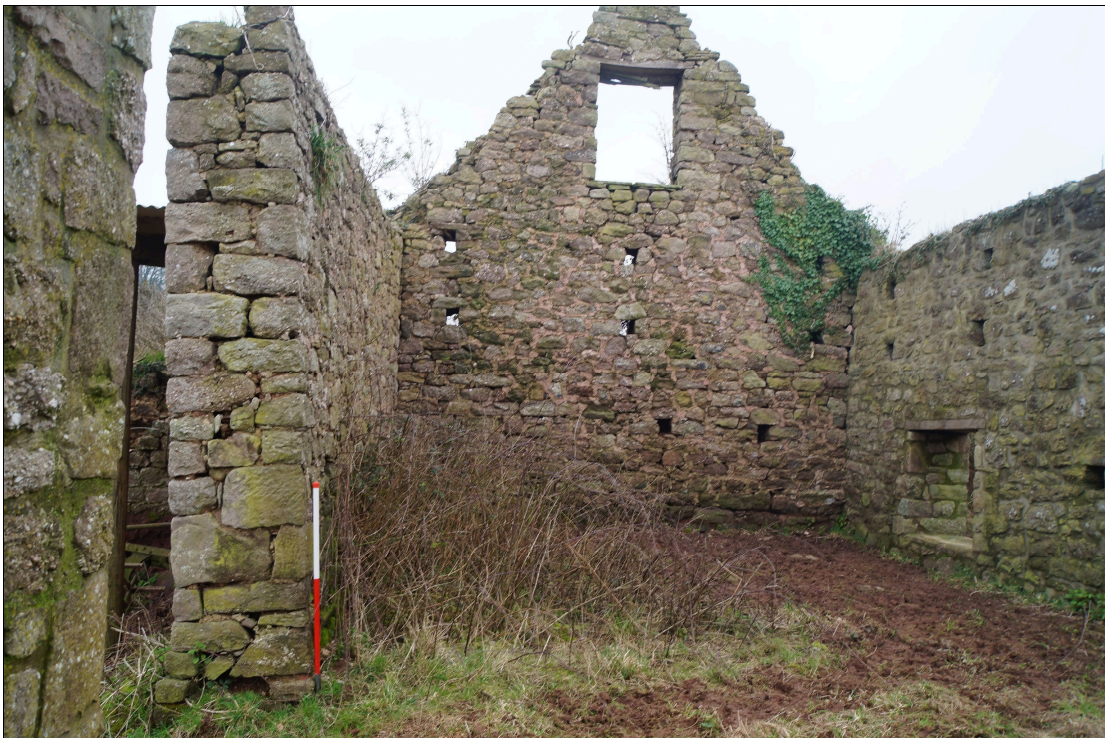
Plate 34: GTB2021_034 - A view inside the eastern end of the threshing barn, showing largely original walls. Looking east-southeast.

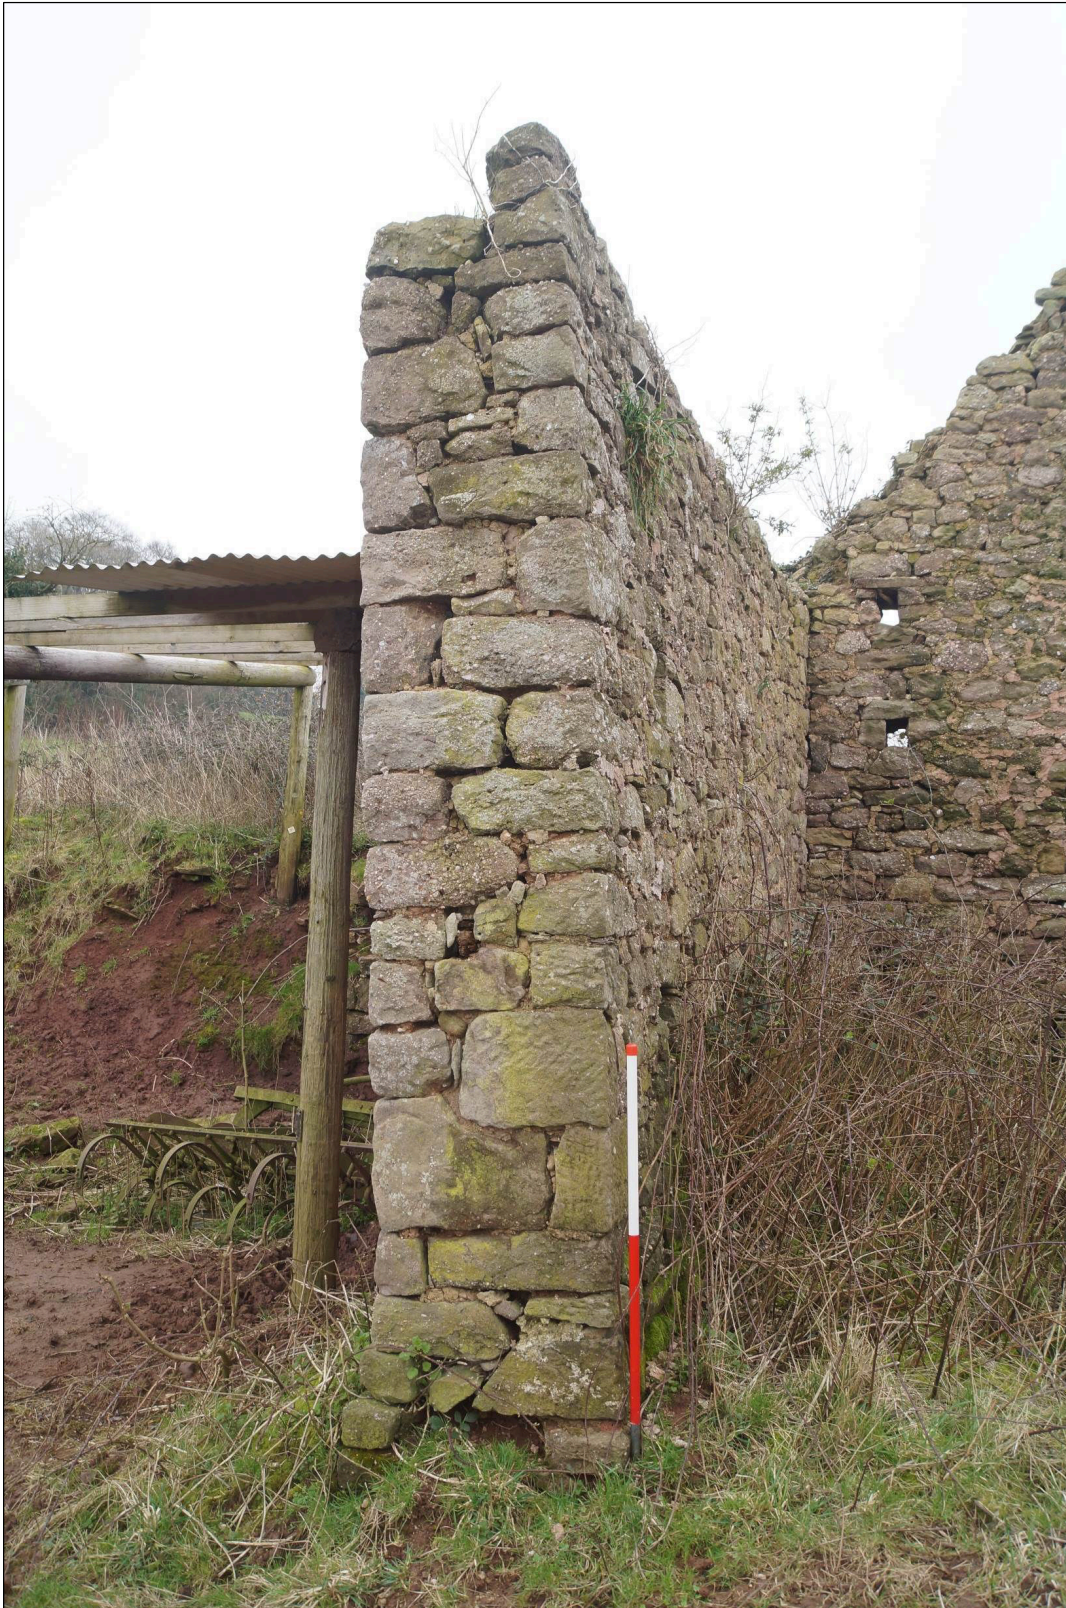
Plate 35: GTB2021_035 - A view of the door reveal at the eastern side of the northern doorway into the tithe barn. This is an original wall. Looking east-southeast.

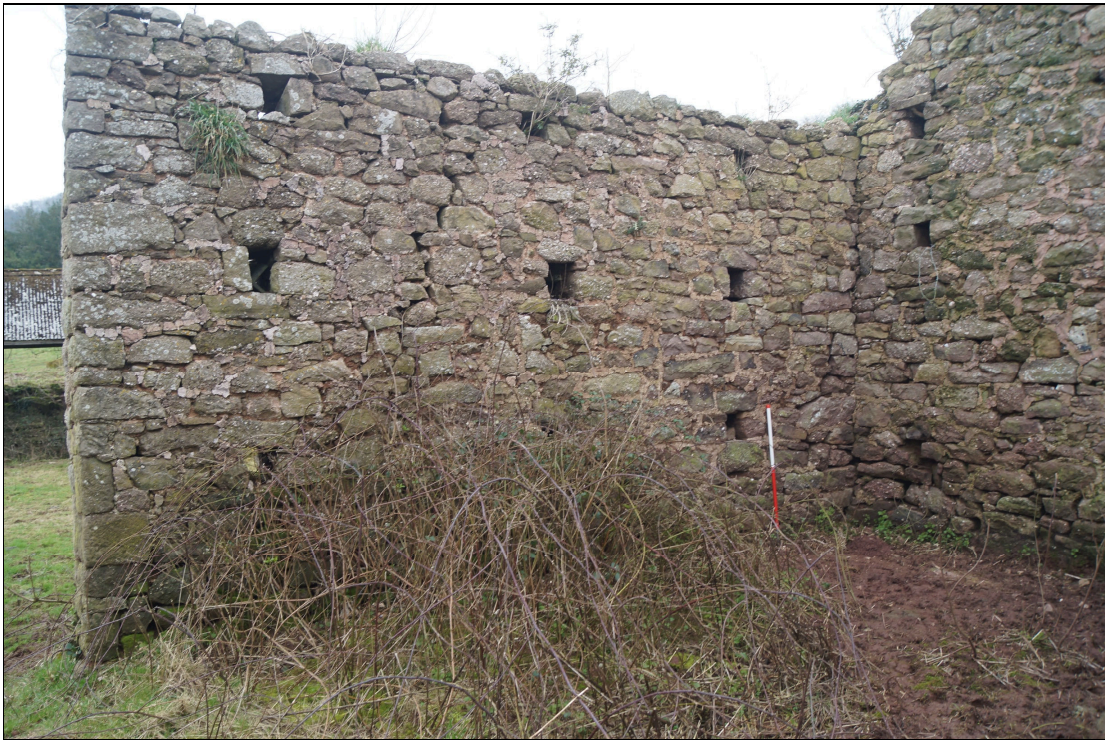
Plate 36: GTB2021_036 - A view inside the eastern end of the threshing barn, showing the original eastern end of the northern lateral wall. Looking east.

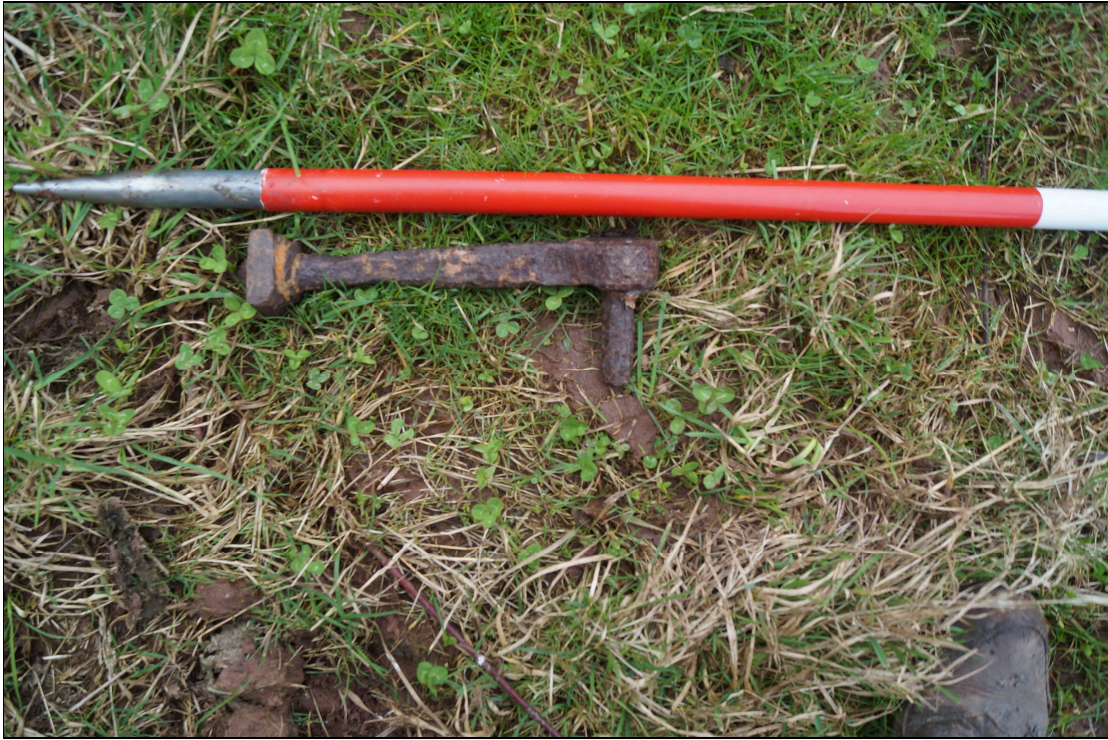
Plate 44: GTB2021_044 - A view of a large iron hinge found on the ground surface outside the southern side of the barn.

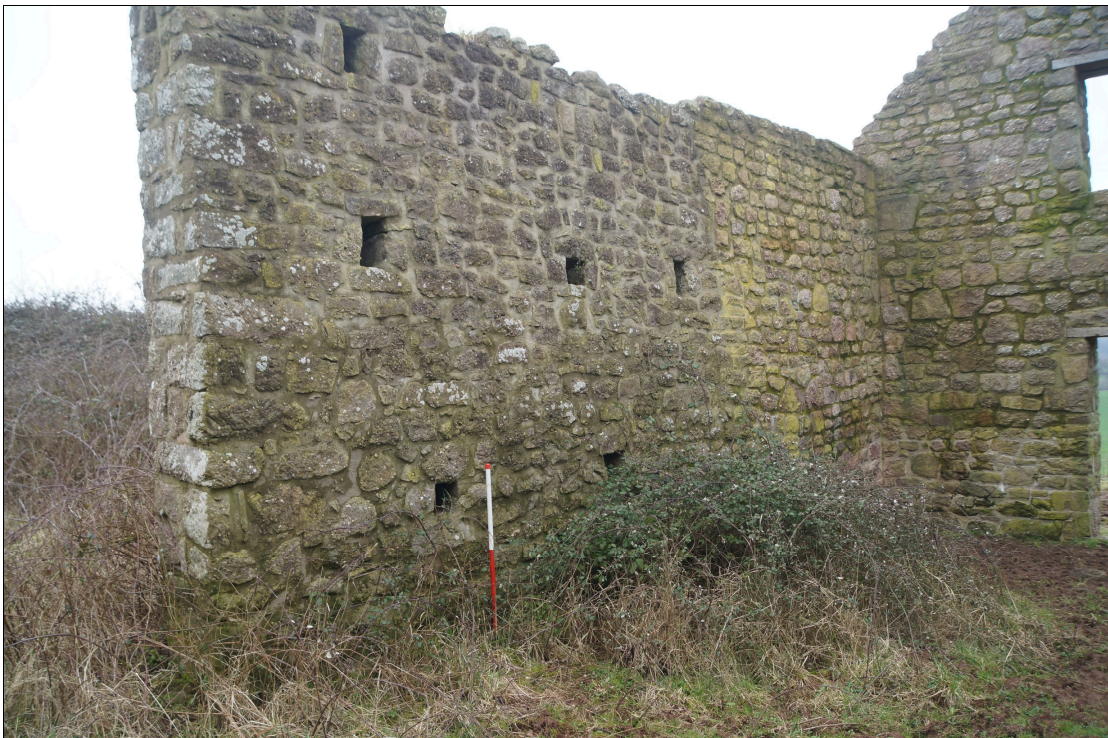
Plate 45: GTB2021_045 - A view inside the western end of the threshing barn, showing the western end of the southern lateral wall. Looking west.

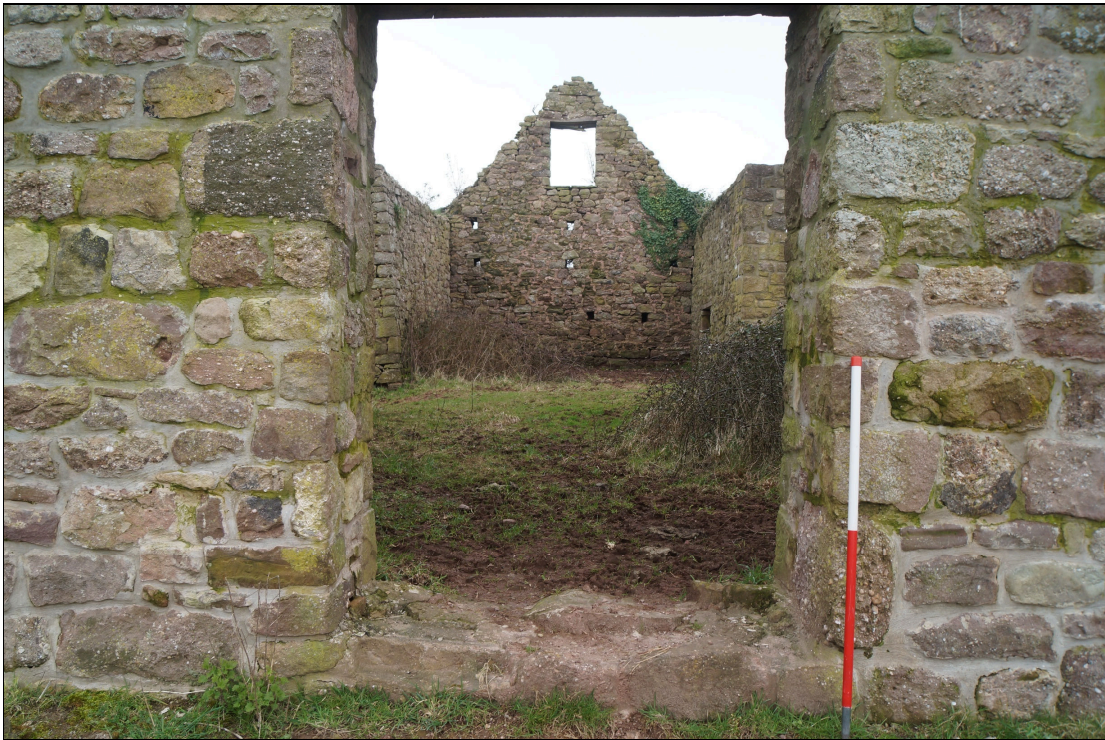
Plate 50: GTB2021_050 - A view through the modern doorway through the southern gable wall into the threshing barn with the eastern gable end facing. Looking east-southeast.

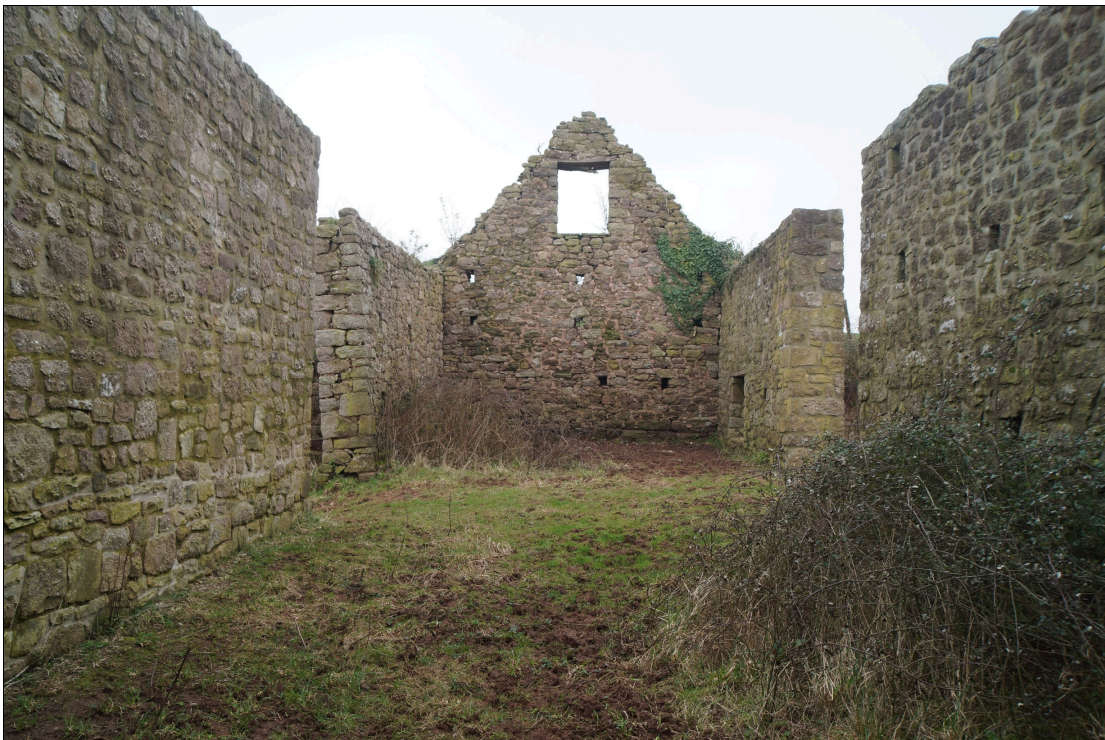
Plate 51: GTB2021_051 - A view from inside the western gable wall of the threshing barn with the eastern gable end facing. Looking east-southeast.

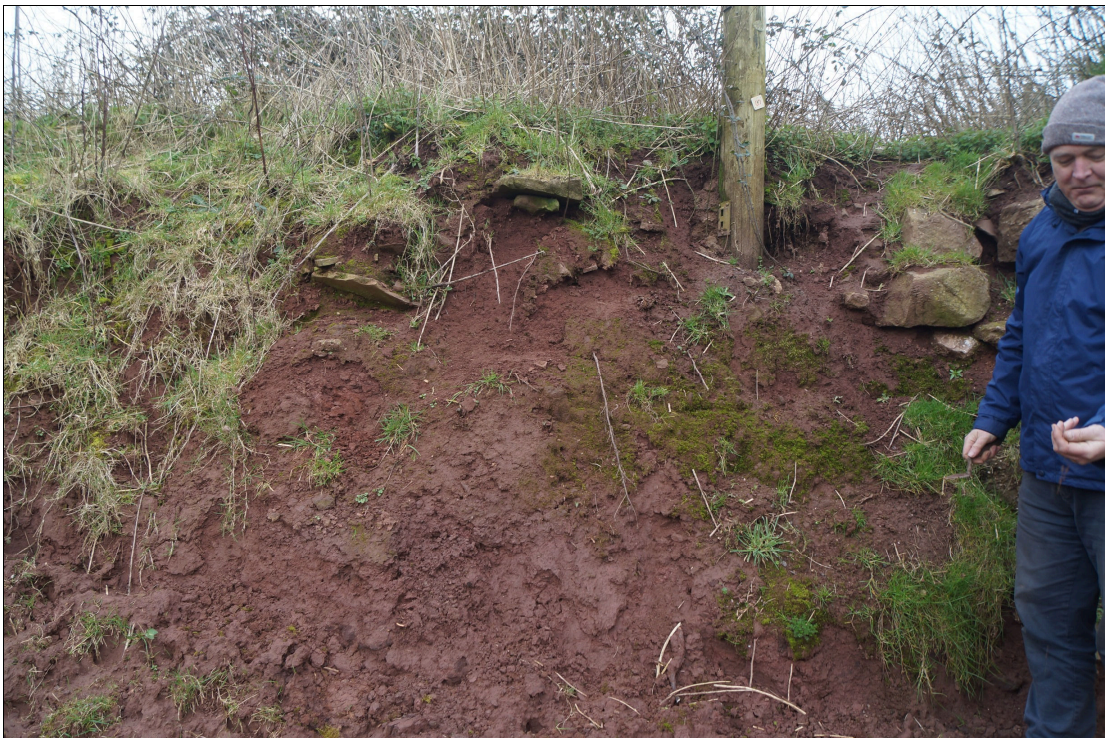
Plate 53: GTB2021_053 - A view showing Martin Locock taking a sample of the subsoil from an exposure alongside the revetment wall to the north of the threshing barn. Looking east-southeast

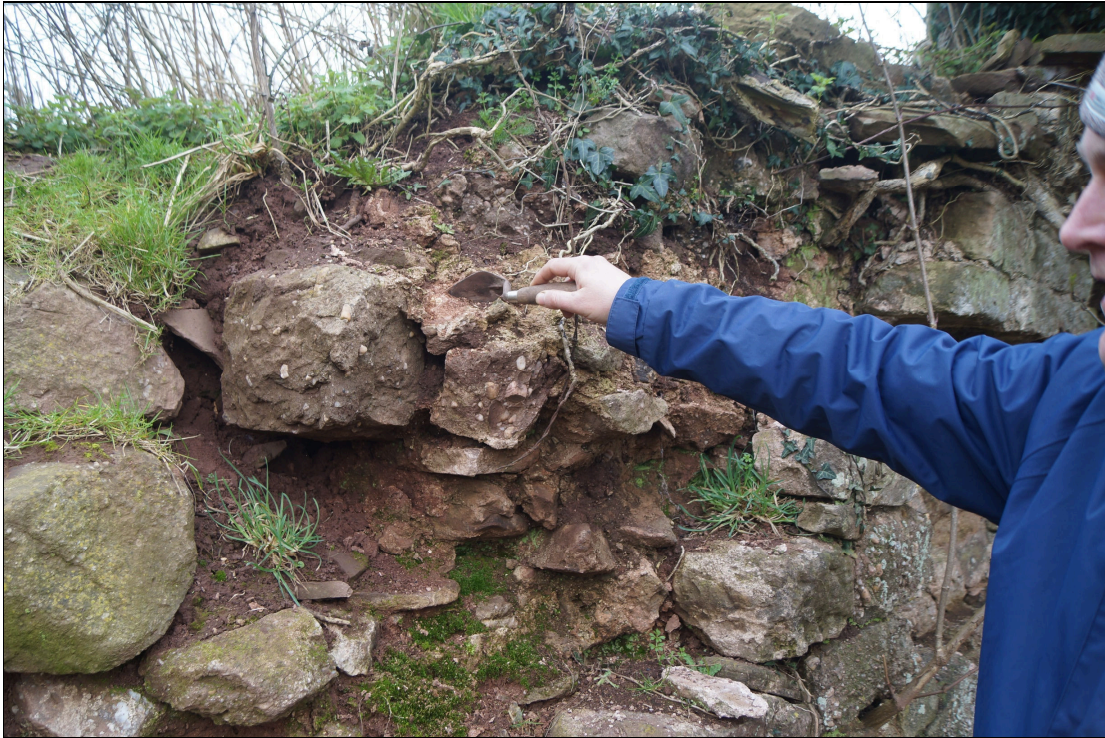
Plate 54: GTB2021_054 - A view showing Martin Locock taking Mortar Sample A from the revetment wall to the north of the threshing barn. Looking south-southeast

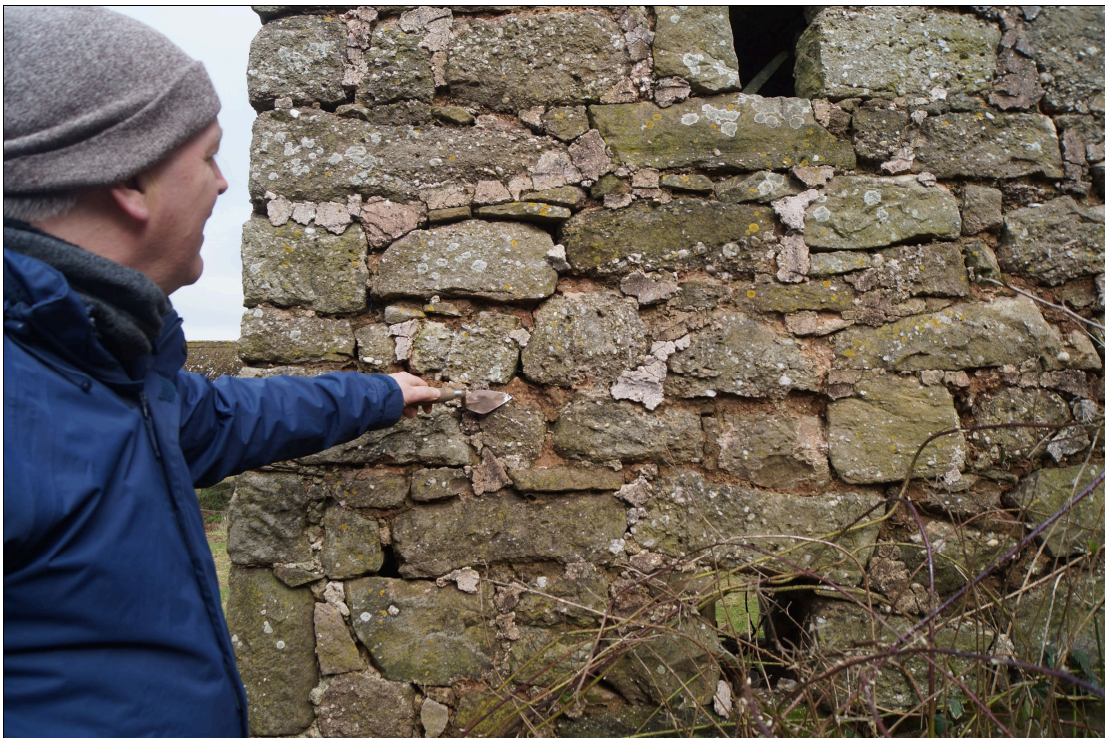
Plate 55: GTB2021_055 - A view showing Martin Locock taking Mortar Sample B from the eastern end of the northern lateral wall of the threshing barn. Looking north-northeast

Sample	Description	Aliquot Gross wt g	Residue wt g	Lime wt g	% lime	Residue notes
B Eastern part of northern wall of threshing barn – core, Plate 55	Hard pale red brown lime mortar with lime lumps	15.44	3.99	11.45	0.74	Red brown sandy silt
C Eastern part of northern wall of threshing barn - pointing	Soft red brown earthen mortar	7.14	1.99	5.15	0.72	Red brown sandy silt
D Eastern gable wall of threshing barn – core Plate 57	Hard pale red brown lime mortar with lime lumps	9.65	1.24	8.41	0.87	Red brown sandy silt
E Eastern gable wall of threshing barn – pointing Plate 56	Soft red brown earthen mortar	23.11	11.86	11.25	0.49	Red brown sandy silt
F Eastern part of southern wall of threshing barn core Plate 58	Hard pale red brown lime mortar	10.7	4.47	6.23	0.58	Red brown sandy silt
G Western side of southern wall of threshing barn – core Plate 59	Soft red brown earthen mortar	7.82	4.03	3.79	0.48	Red brown sandy silt

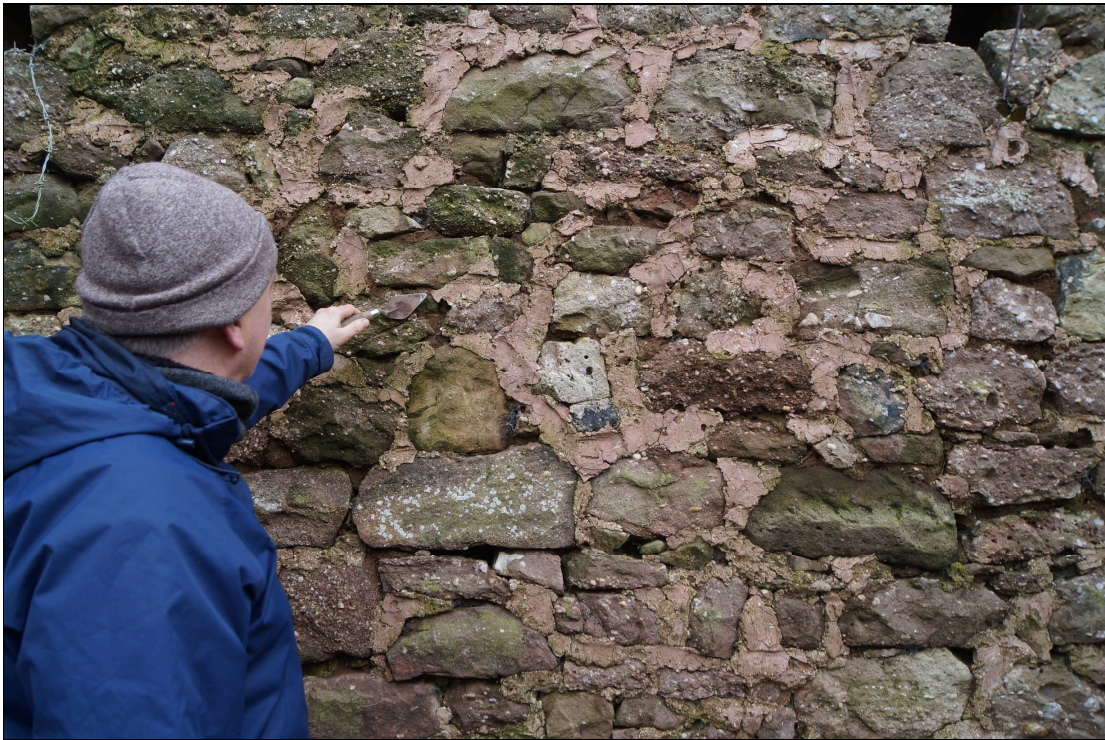
Plate 56: GTB2021_056 - A view showing Martin Locock taking Mortar Sample E from the eastern gable wall of the threshing barn. Looking east-southeast

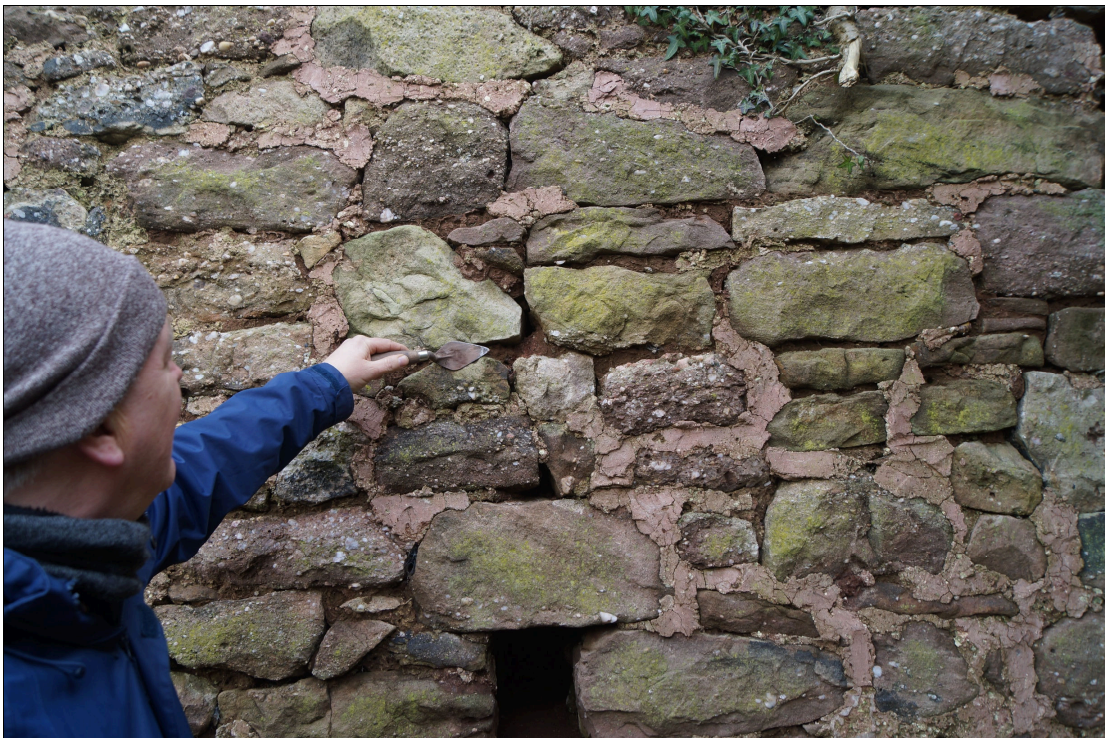
Plate 57: GTB2021_057 - A view showing Martin Locock taking Mortar Sample D from the eastern gable wall of the threshing barn. Looking east-southeast.

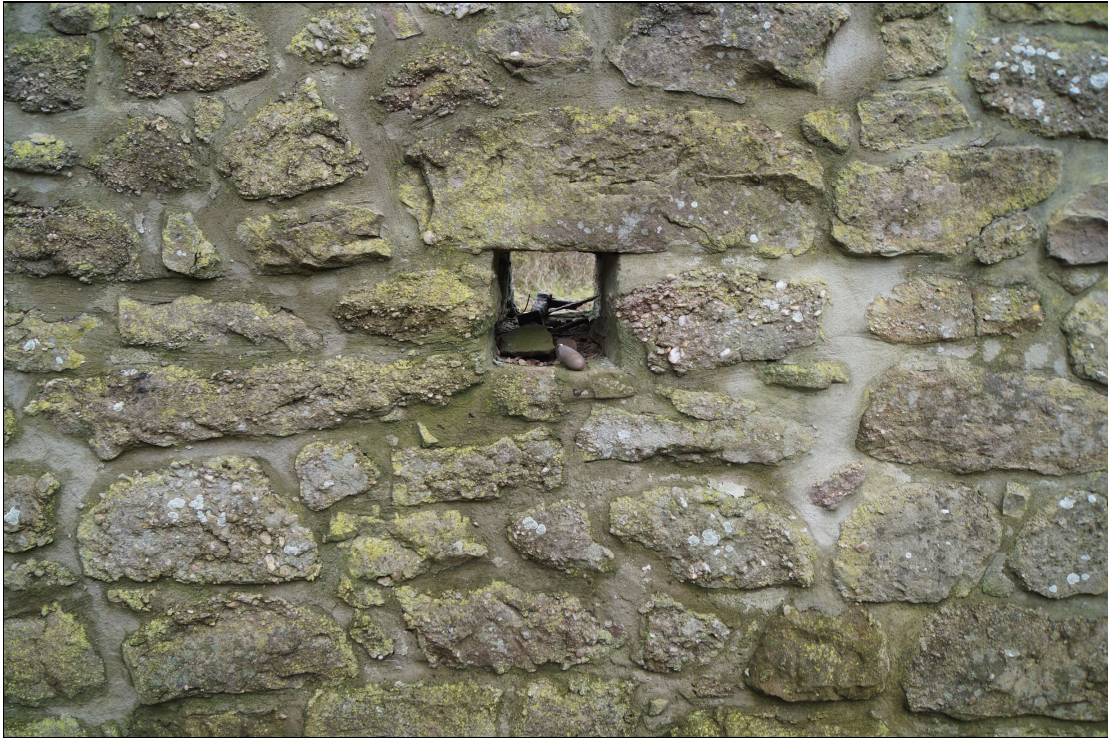
8.3.6 The eastern door reveal has been repaired in modern times, but undoubtedly corresponds to the position of the original door frame as it matches the position of the opposing door reveal in the northern wall. The rest of the wall to the east of the doorway is original but repointed in modern times. A window had been inserted towards the eastern end removing two ventilation holes, leaving six ventilation holes in this section of wall. A mortar sample, G (Plate 59), from the core of the wall taken from within a ventilation hole is likely to be of 18th century date.

Plate 58: GTB2021_058 - A view of the lowest ventilation hole to the east of the doorway through the southern lateral wall. Looking south-southwest. Mortar sample F was taken from the core of the wall within the ventilation hole

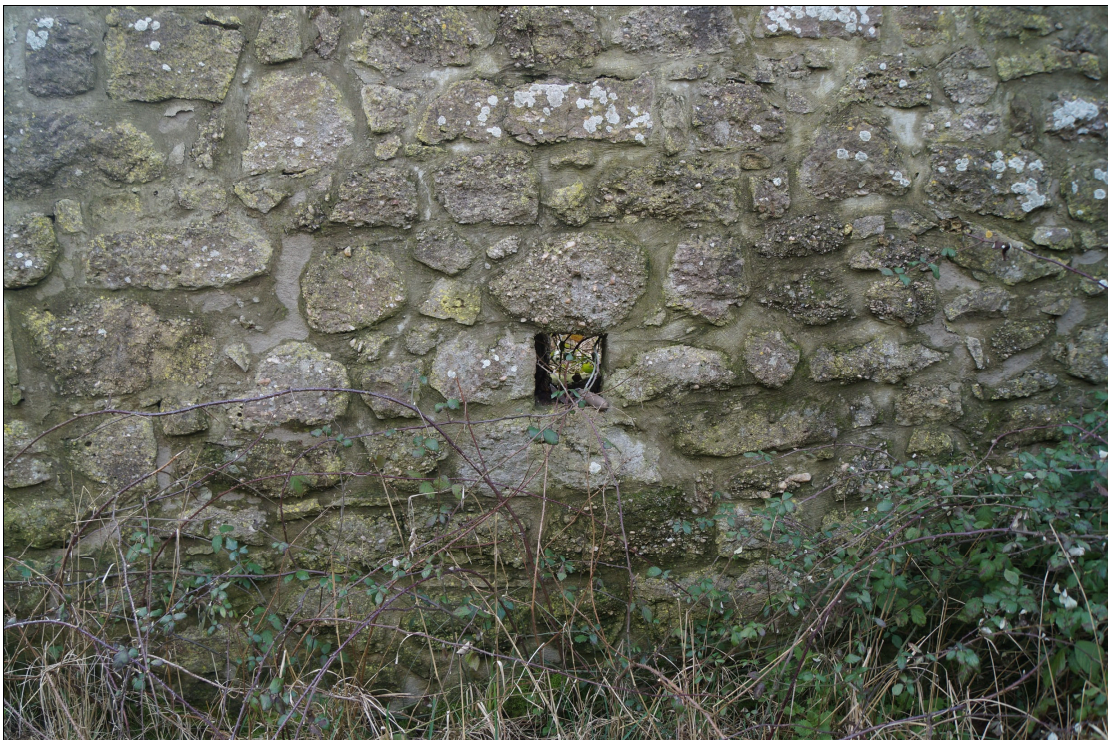
8.3.7 The first section of wall to the west of this southern doorway, including the door reveal, is original but repointed in modern times (Plate 45). It includes seven ventilation holes (Plate 43). There are no ventilation holes in the western end of the wall as that section of walling has been rebuilt in modern times (Plate 47). A mortar sample, F (Plate 58), from the core of the wall taken from within a ventilation hole is likely to be of 18th century date.

Plate 59: GTB2021_059 - A view of the lowest ventilation hole to the west of the doorway through the southern lateral wall. Looking south-southwest. Mortar sample G was taken from the core of the wall within the ventilation hole.
