LEVEL 3 BUILDING RECORDING OF A FORMER BARN AT GETHLEY BARN, LLAN Y NANT FARM, TRELLECH GRANGE, NP16 6QN

Report by: Trysor

June 2021

Trysor Project No. 2020/770
GGAT HER EVENT PRN : E009532

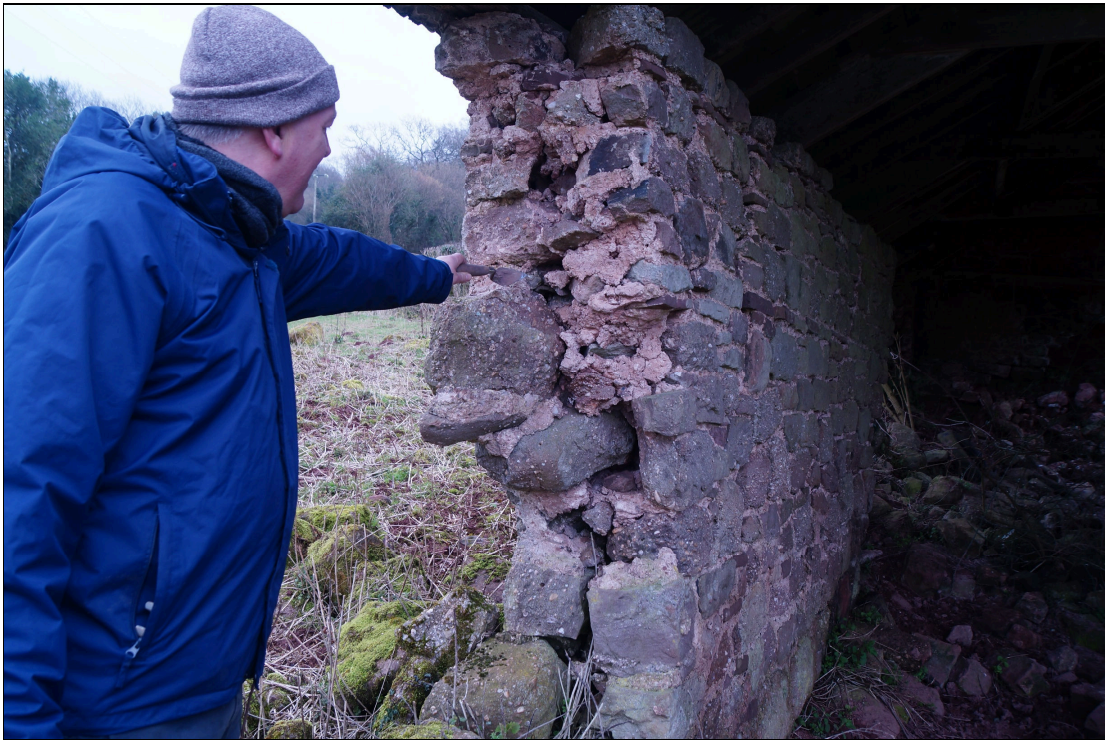
Plate 60: GTB2021_060 - A view showing Martin Locock taking Mortar Sample H from the core of the northern wall of the roofed storage shed to the north of the threshing barn. Looking east-southeast.

H Open-sided barn wall – core Plate 60	Hard very pale red lime mortar	8.02	2.17	5.85	0.73	Red brown sandy silt
I Northern barn – core Plate 61	Hard pale red brown lime mortar	14.1	3.69	10.41	0.74	Red brown sandy silt

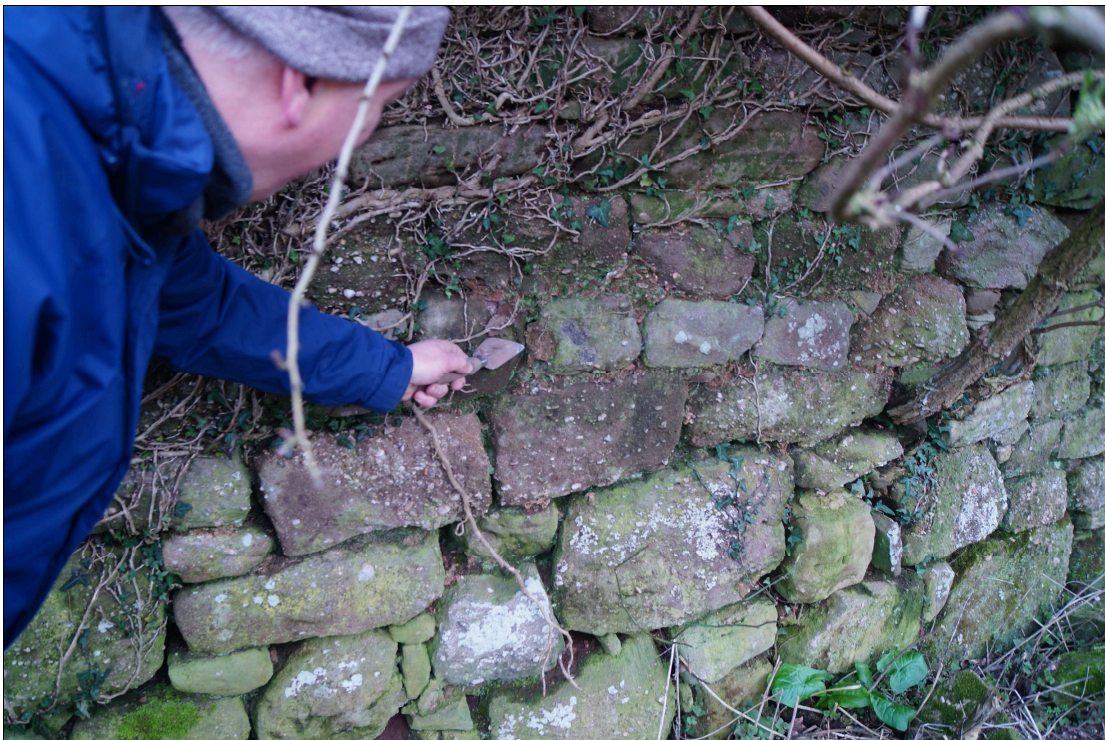
Plate 61: GTB2021_061 - A view showing Martin Locock taking Mortar Sample I from a surviving fragment of walling from the largely lost northern building in the complex at Gethley Barn. Looking southeast.
