Historic Building Recording

Hillside, Erbistock

Report Number: 24-1087

Client: T Walker
Author(s): Blair Poole
HER Event No: PRN 220224
Planning Application: P/2023/0574
Document Ref: 24-1087-HBR-v1.1
Date: 5 December 2024
NGR: 335112,342100

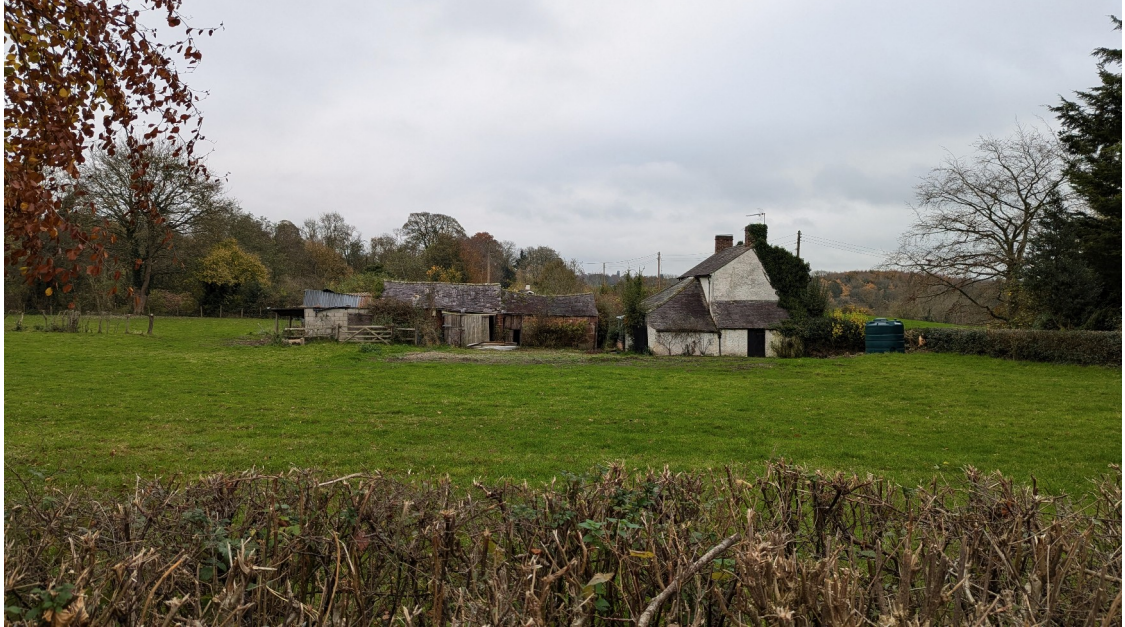
Plate 1: The setting of the structure, looking east

6.1 A site visit was undertaken on the 7th November 2024 by Blair Poole of DAS on behalf of T Walker. The study structure is located to the north of Hillside in a rural setting and only visible from the road to the west and southwest (Plate 1).

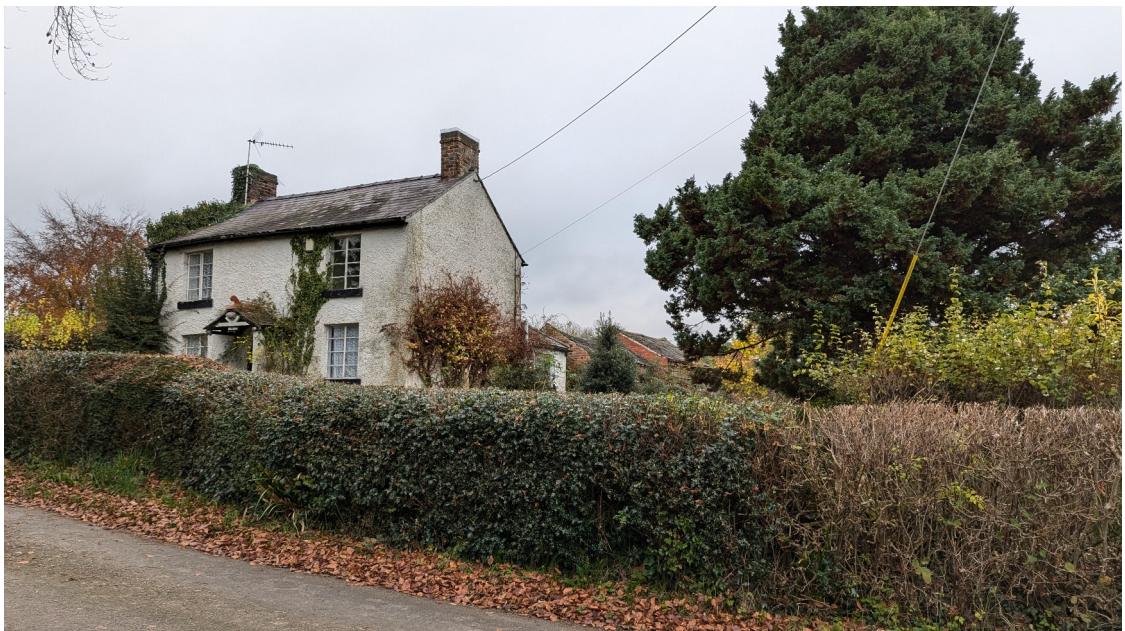
Plate 2: The setting of the structure, looking northwest

6.2 The view of the site from the south allows for some view of the roofline of the structure, with the bulk of it obscured by the house and garden hedge (Plate 2).

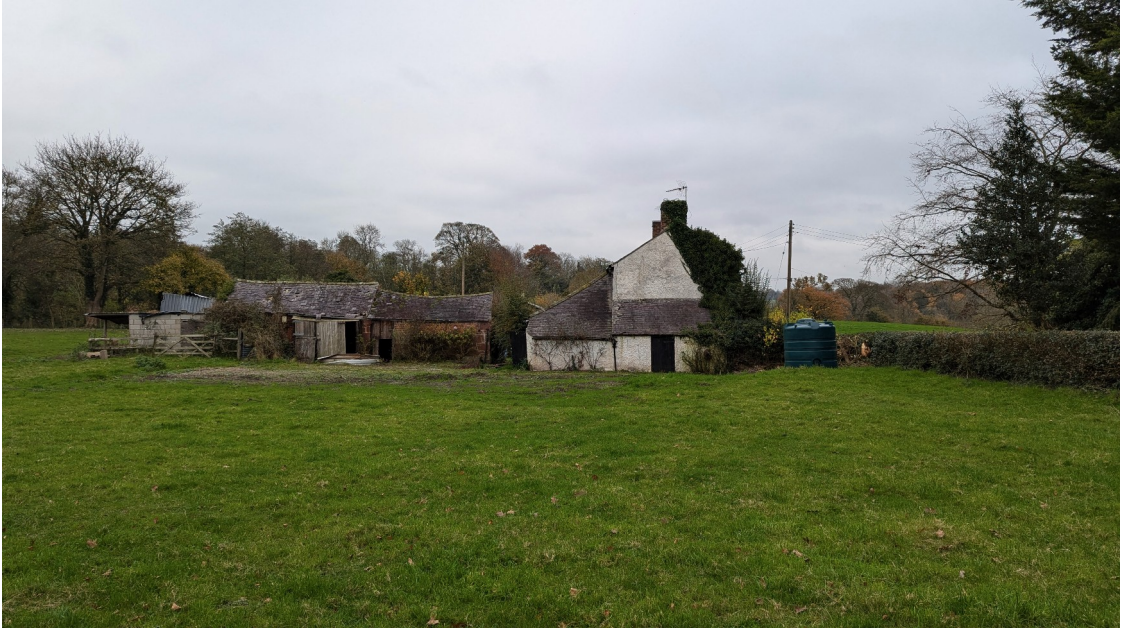
Plate 3: The west elevation

6.4.1 **The western elevation** (Figure 11) is the most visible of all the elevations, as it is overlooked by the field to the west and the roads (Plate 3). The siting of the structure, close to the rear of Hillside, is apparent from this viewpoint. The extension of Hillside, established between the 1872 and 1898 OS maps, can be seen in the fabric of the building from this viewpoint as well, forming the northern single storey bay.

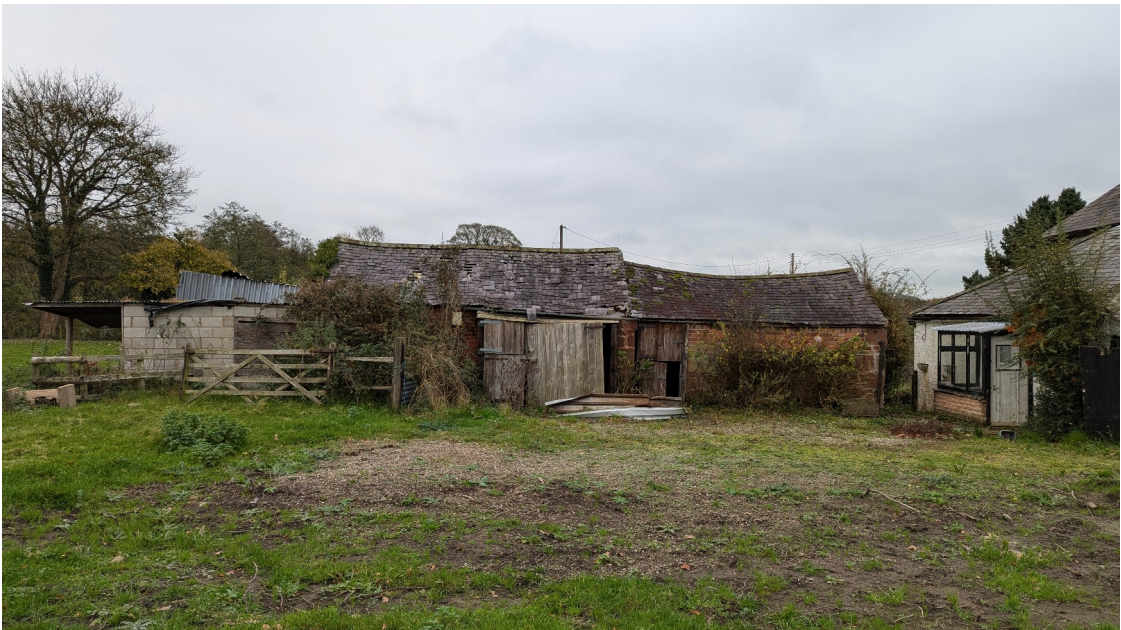
Plate 4: The west elevation showing bays C, D and E

6.4.2 The western elevation comprises three bays that reflect the internal layout, Rooms C, D and E, respectively.

6.4.3 The southern bay (C) is a single storey sandstone and brick construction with slate pitched roof. The central bay (D) is a single storey brick structure with slate roof, and the northern bay (E) is a concrete block, single storey, metal roofed pig sty (Plate 4).

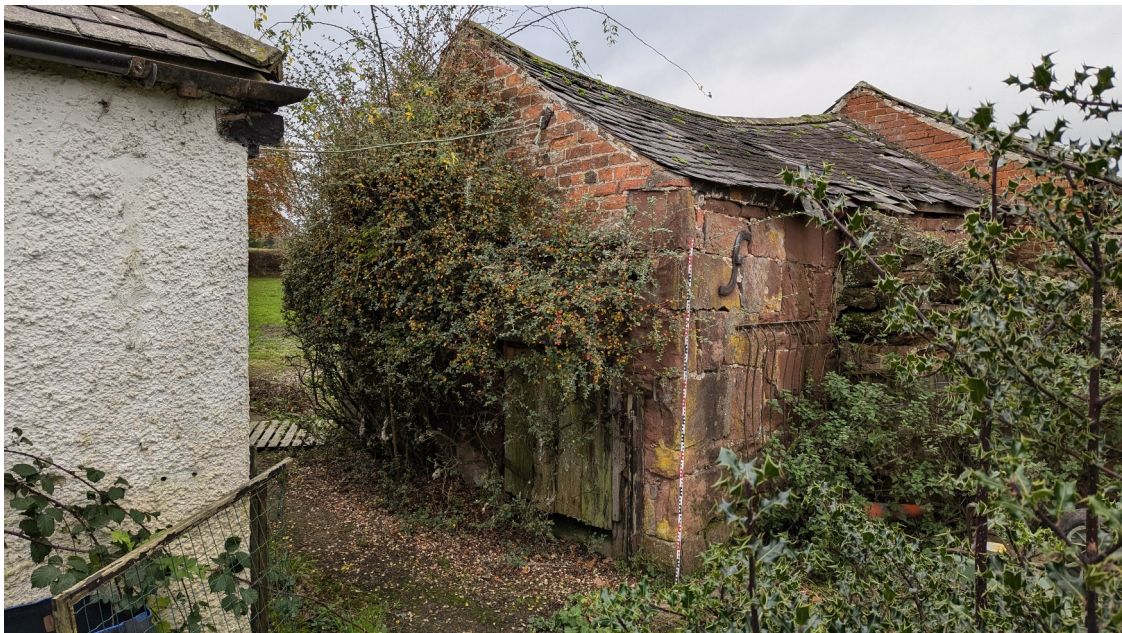
Plate 11: Southern elevation, looking west

6.4.12 **The southern elevation** (Figure 12) was a single bay sandstone and brick construction, forming the gable end of the outbuilding (Plate 11).

6.4.13 Although the majority of the elevation was obscured by vegetation, the construction form and materials could be determined and modifications were visible. The east and western edges of the elevation were of sandstone blockwork and represented the original construction form and material. The gable wall was of the same brickwork as seen on the western elevation for this bay, differing from the brickwork of the central area (Room D).

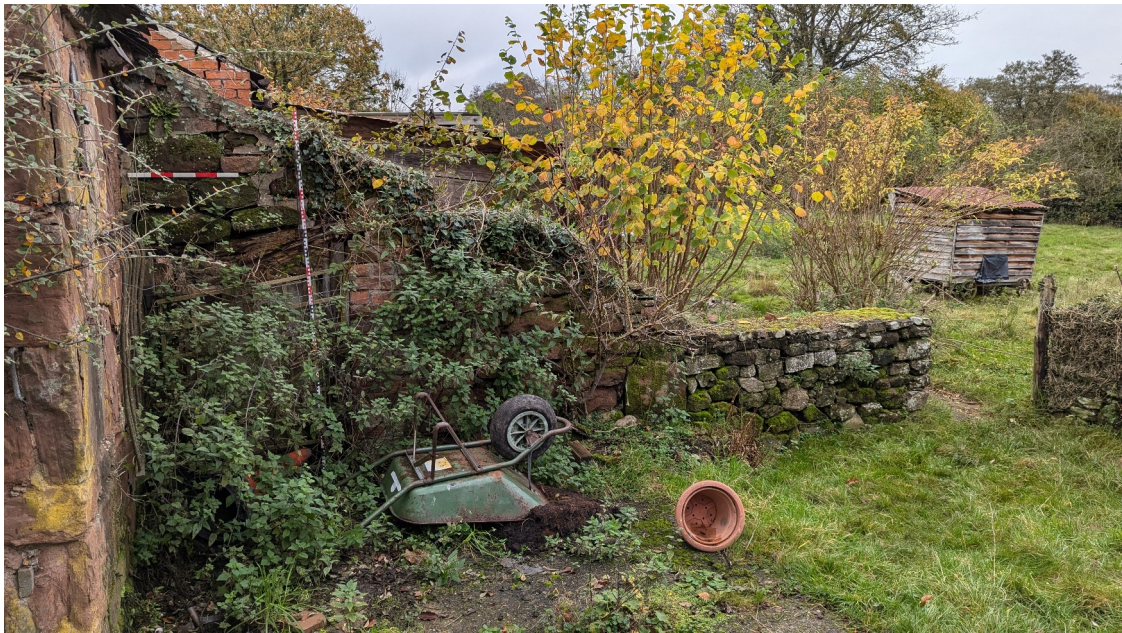
Plate 14: Southern elevation, showing Room A and garden wall

6.4.16 To the east of Room C were the remnants of two previous extensions (Figure 16) including a rough brick and stone lean to (Room A) butting the eastern wall of the main outbuilding, dating from between 1872 and 1898 and forming the third phase of development of the building. Attached to the east of this extension was a

rough, random coursed, sandstone wall 800mm high dating from the mid 20th century, pre dating the 1962 OS map (Plate 14).

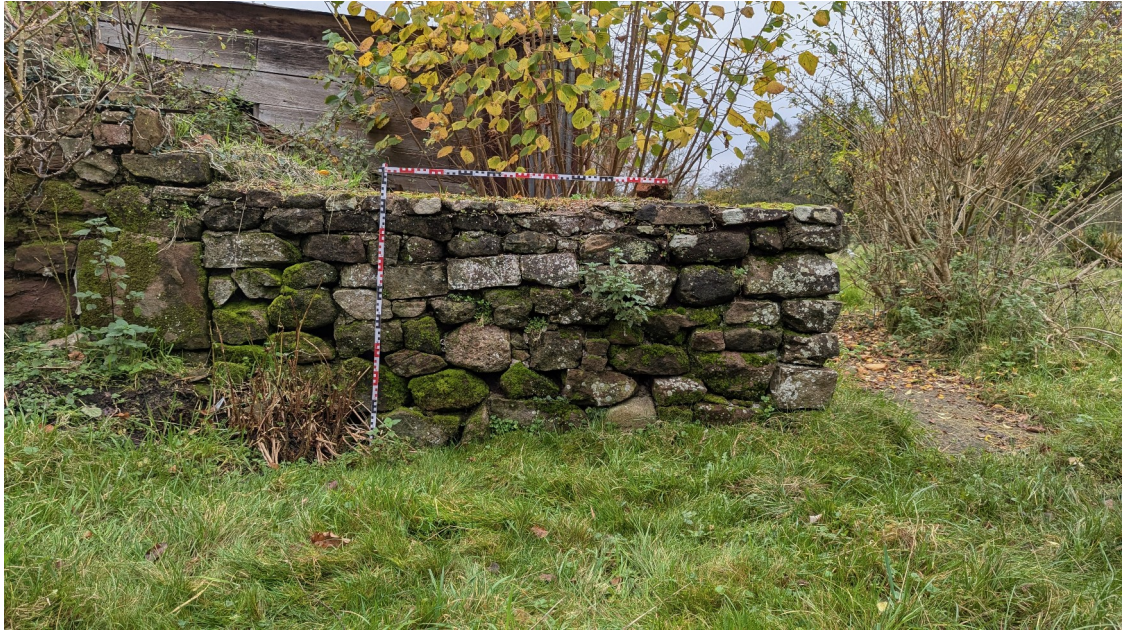
Plate 16: Southern elevation, showing garden wall

6.4.18 To the east of the lean to, the single stretch of garden wall can be seen to have been part of the mid 20th century series of extensions to the structure (Figure 8). It is likely that this particular area was used as a pen and open to the elements (Plate 16).

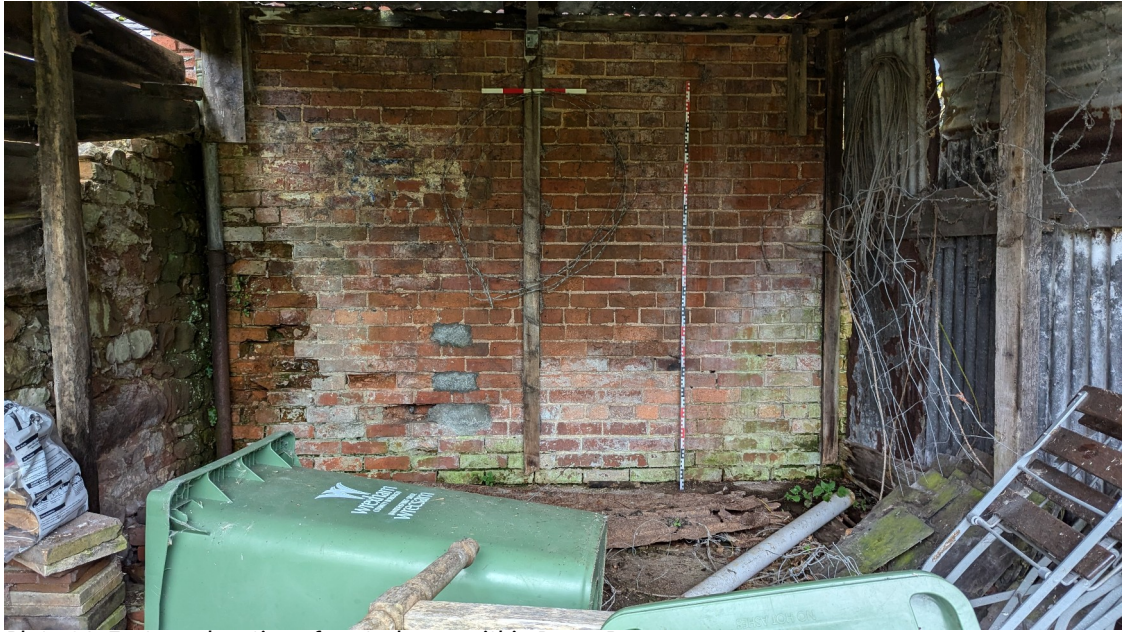
Plate 21: Eastern elevation of central area within Room B

6.4.22 The central bay was of brick construction in English Garden Wall bond. This was most visible within the area of the lean to forming Room B (Plate 21).

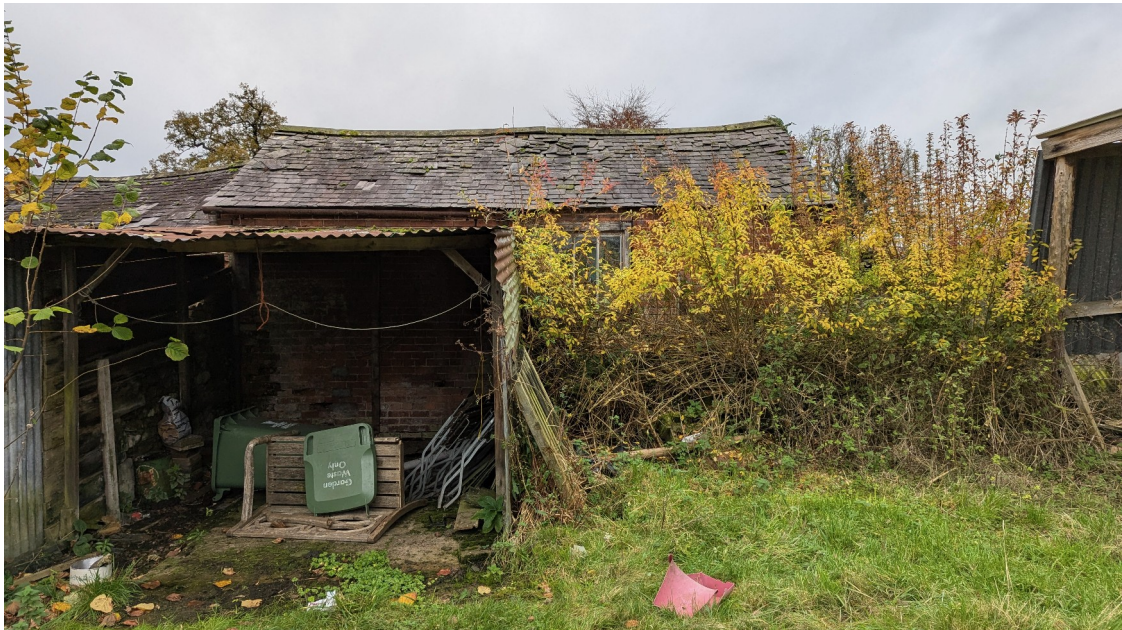
Plate 22: Eastern elevation, central bay

6.4.23 To the north of the lean to a window was present on the central bay, with wooden framework including lintel and cill, and fine wooden vertical muntins creating long upright panes (Plate 22). This is described in more detail from the interior assessment below.

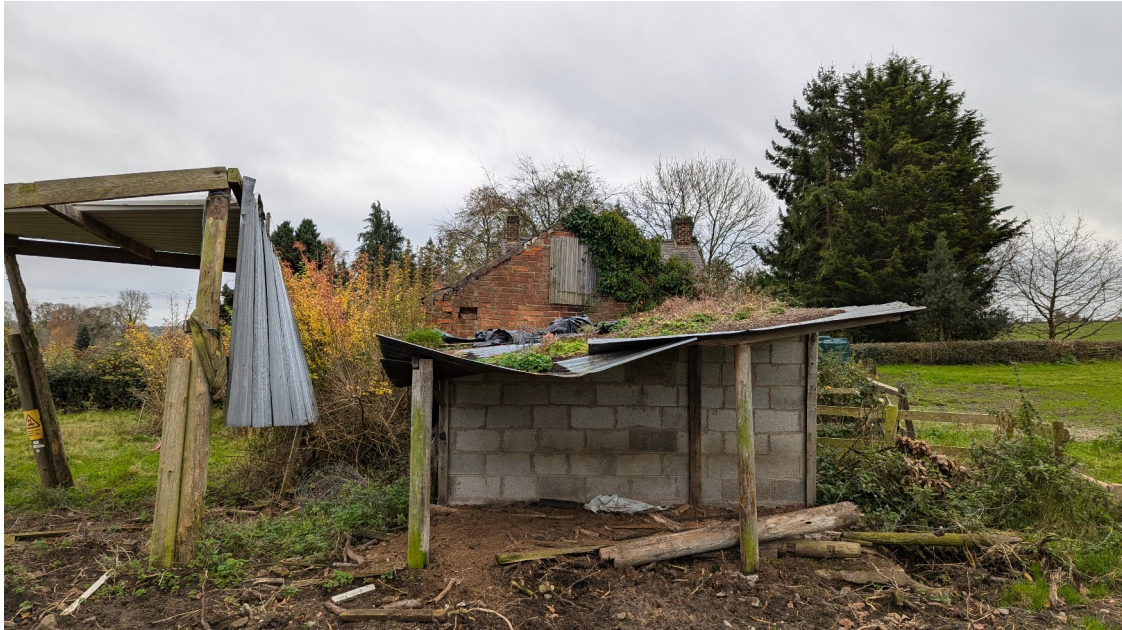
Plate 23: Northern elevation

6.4.24 **The northern elevation** (Figure 14) was mainly taken up by the concrete block pig sty, however, above this the brickwork for the gable wall of the central bay was visible (Plate 23).

6.4.25 The gable brickwork was of brick in English Garden Wall bond, and located centrally within the gable was a loading door that had been blocked by asbestos and plastic corrugated sheet.

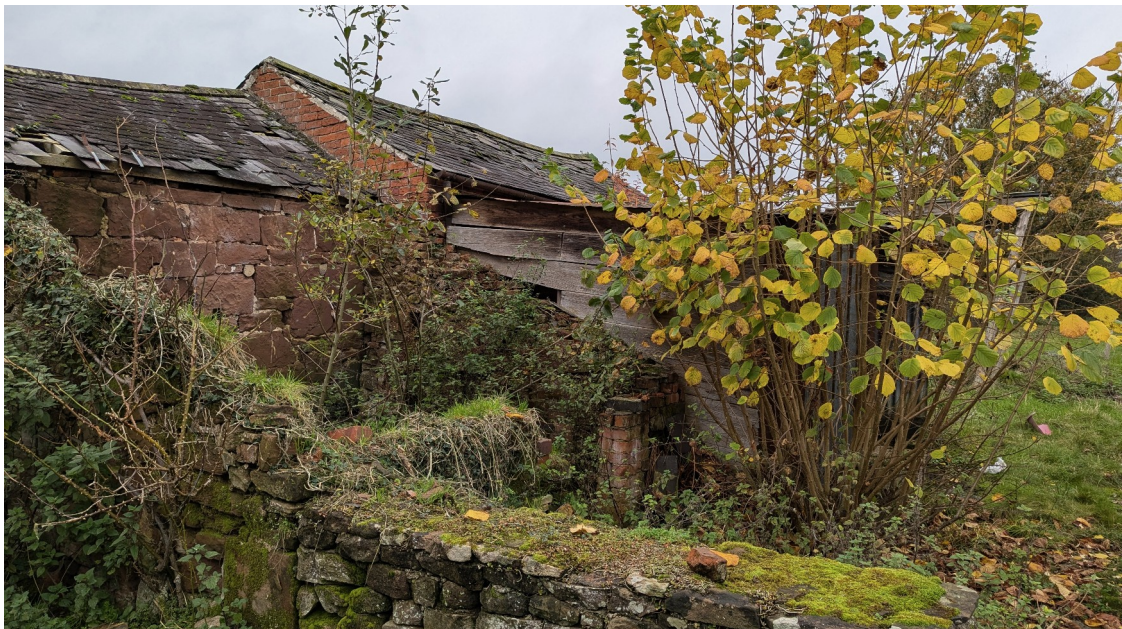
Plate 24: Room A looking northwest

6.5.2 **Room A** (Plate 24) was an external space at the southeast of the structure that had originally been a lean to extension. This dates from between 1872 and 1898 (Figure 16) and was a low storage area with sloping roof extending from the eaves of the main structure to approximately 1.2m above ground level at the eastern end.

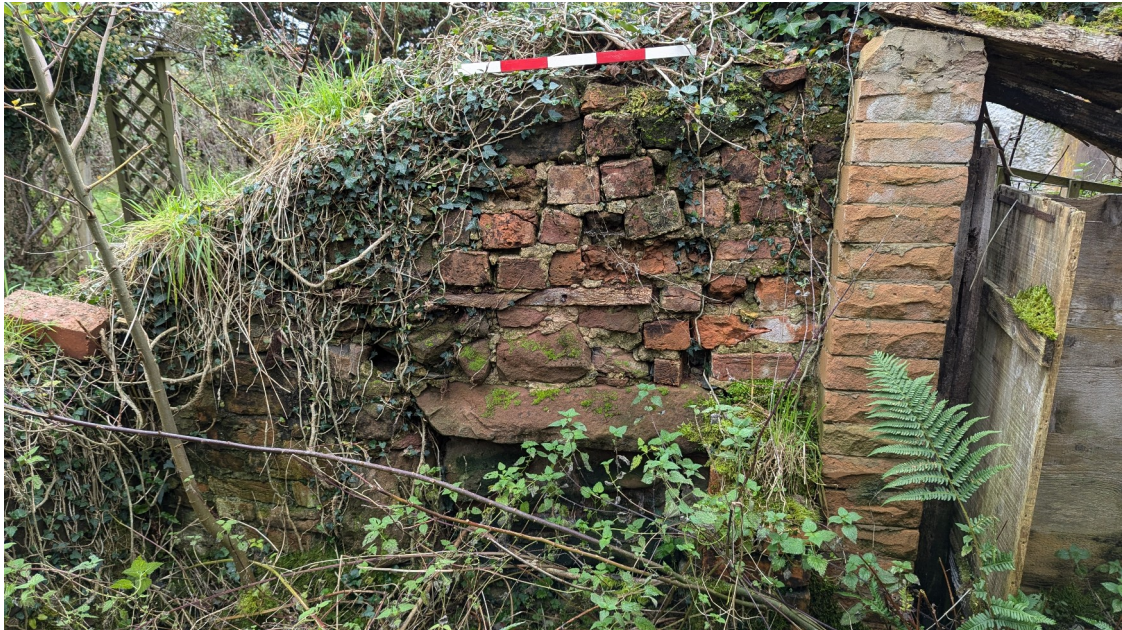
Plate 25: South wall of Room A

6.5.4 The southern wall of Room A contained later brick infill and an inserted door of 20th century orange brick at the southwestern corner (Plate 25).

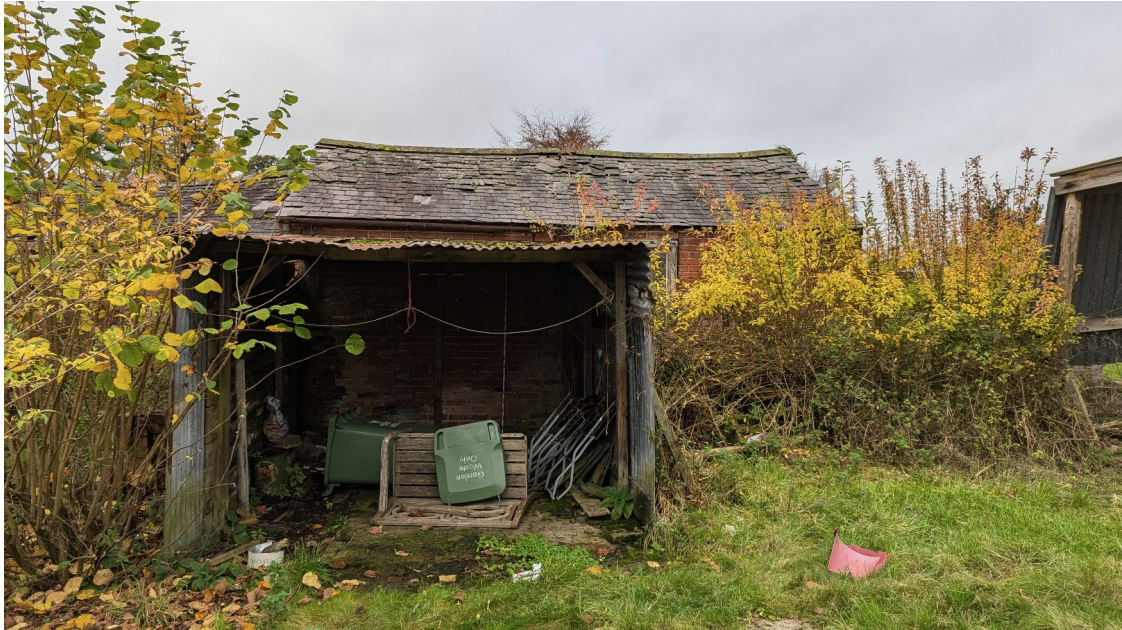
Plate 26: Room B looking west

6.5.5 **Room B** was located to the north of Room A, dating to between 1962 and 1994, and comprising a covered storage area (Plate 26). The western wall of the room was formed by the eastern wall of Room D and was of brick in English Garden Wall bond (Plate 21). The eastern side of the room was open, looking out onto the garden area.

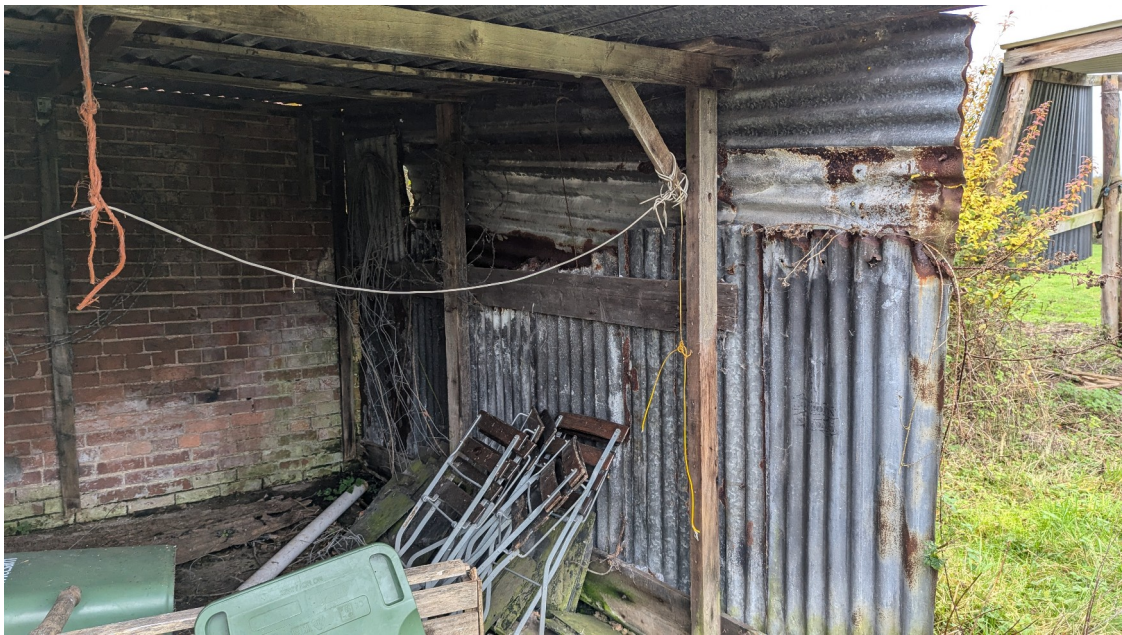
Plate 27: North wall of Room B

6.5.6 The north wall of Room B was of corrugated metal sheet on a wooden framework (Plate 27).

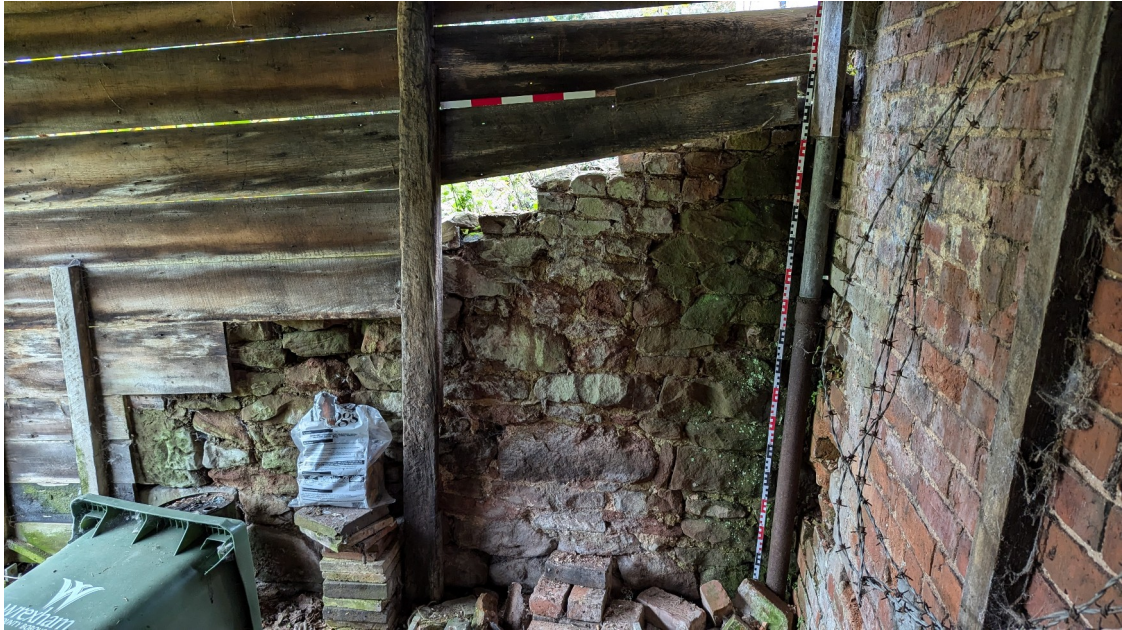
Plate 28: South wall of Room B

6.5.7 The southern wall of Room B was formed by a composite of the north wall of Room A, dating from the late 19th century, and a late 20th century wooden upper section. The earlier wall followed the sloped lean to roof line and the late 20th century wooden frame was clad in wooden planks to raise the roof level (Plate 28).

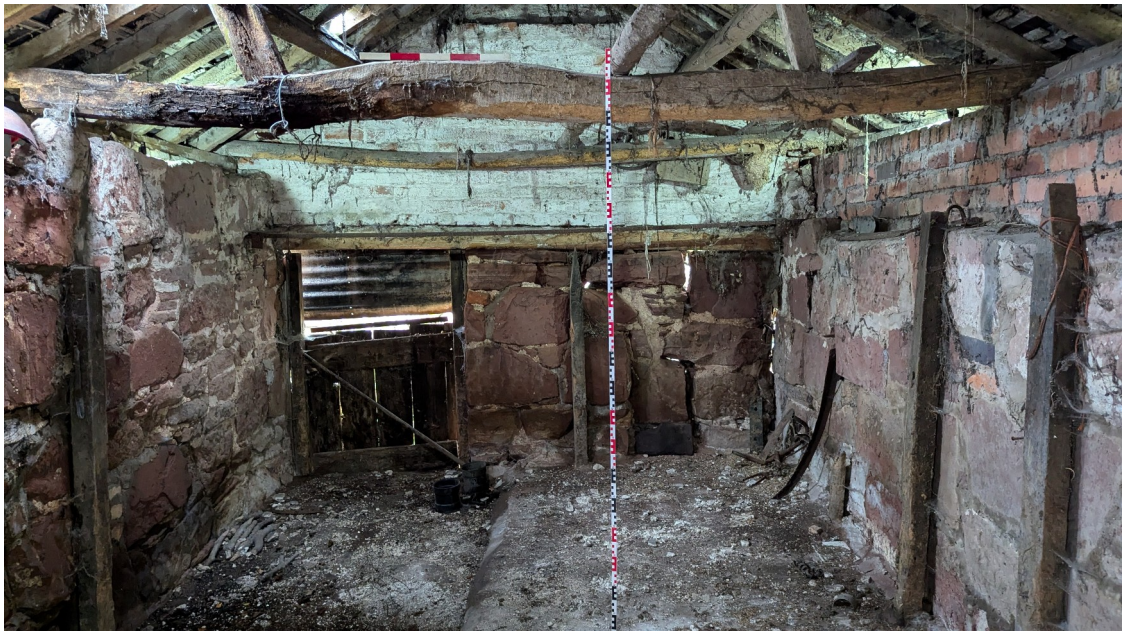
Plate 29: Room C looking south

6.5.9 **Room C** was the earliest part of the structure dating from pre-1843, possibly originally late 18th century in date (Figure 15 & Figure 16). The room had been used as a barn and appears to have been constructed for that function, with single skin sandstone walls, low roof and rough brick floor forming the earliest elements still in situ (Plate 29).

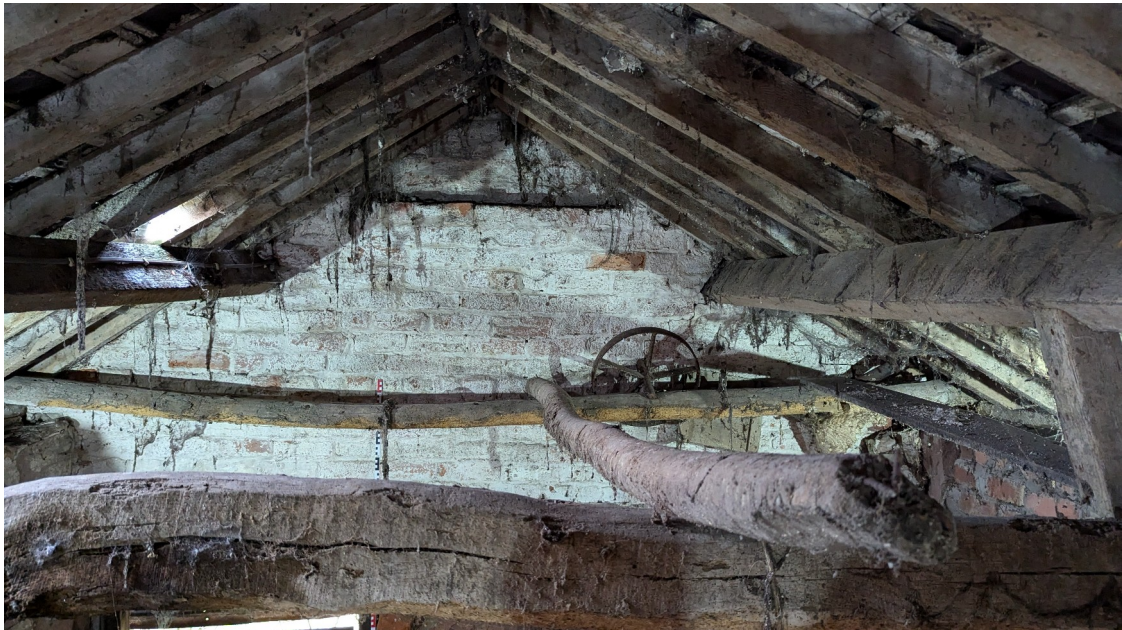
Plate 31: Room C upper section of southern wall

6.5.12 A wooden summer beam sits above the sandstone fabric, above which brickwork in English Garden Wall bond forms the gable wall (Plate 31).

6.5.13 Within the top section of the gable a recess was present suggesting a void or access hatch would have been present in the past. The roof structure obscures part of this recess, indicating the roof is a later replacement. This is supported by the upper brickwork seen on the western wall.

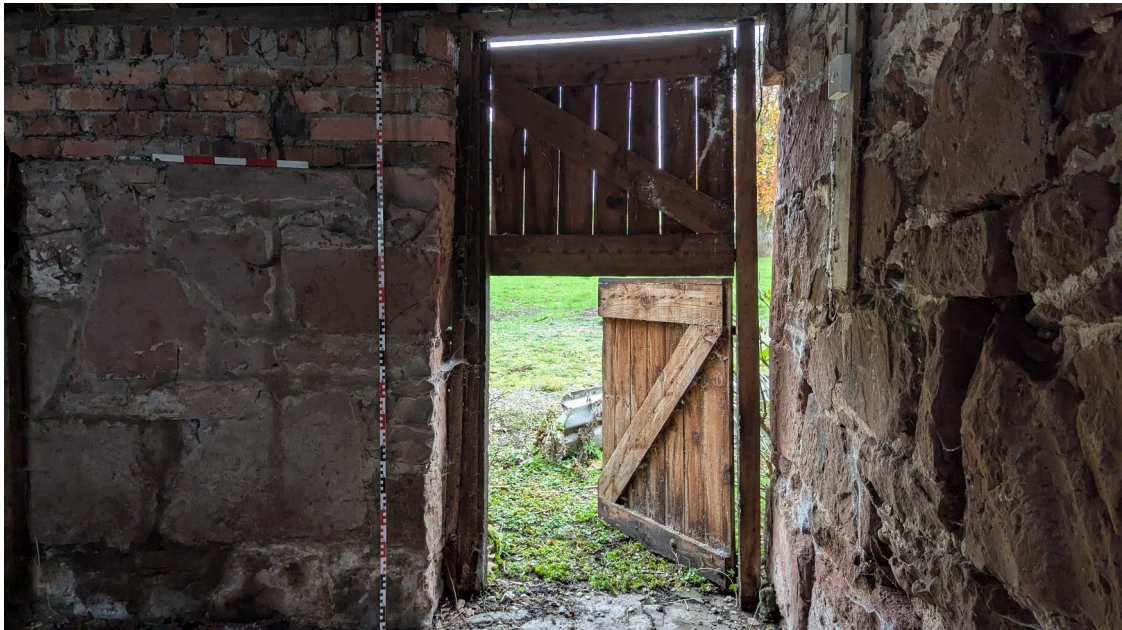
Plate 34: Room C access

6.5.16 At the northern end of the western wall the doorway to Room C was present (Plate 34). The aperture for the door appears to be the original access location, with facing on the stonework indicating a deliberate edge. The door and frame are a late 20th century wooden insertion.

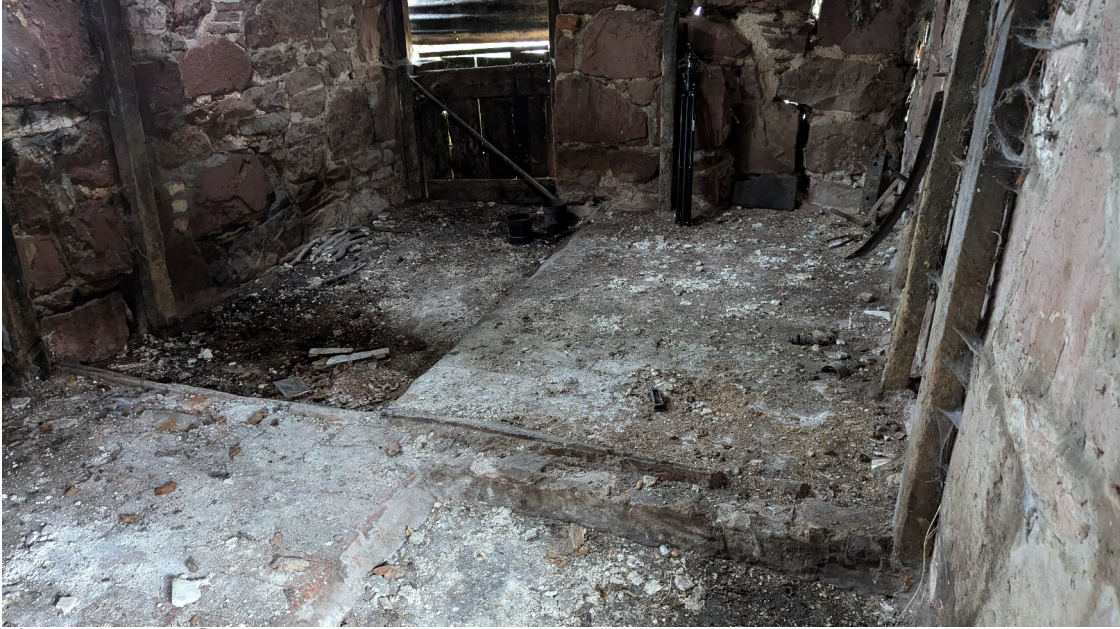
Plate 37: Room C floor

6.5.21 The floor of Room C was of brick stretcher courses divided centrally by a narrow east-west alignment of on edge stone to create two distinct zones. Within the southern zone the eastern half had been removed, and in the northern zone the western half had been removed. Mortar along the edge of the broken brick edges indicate this was a later deliberate modification to create high and low areas typical of byres.

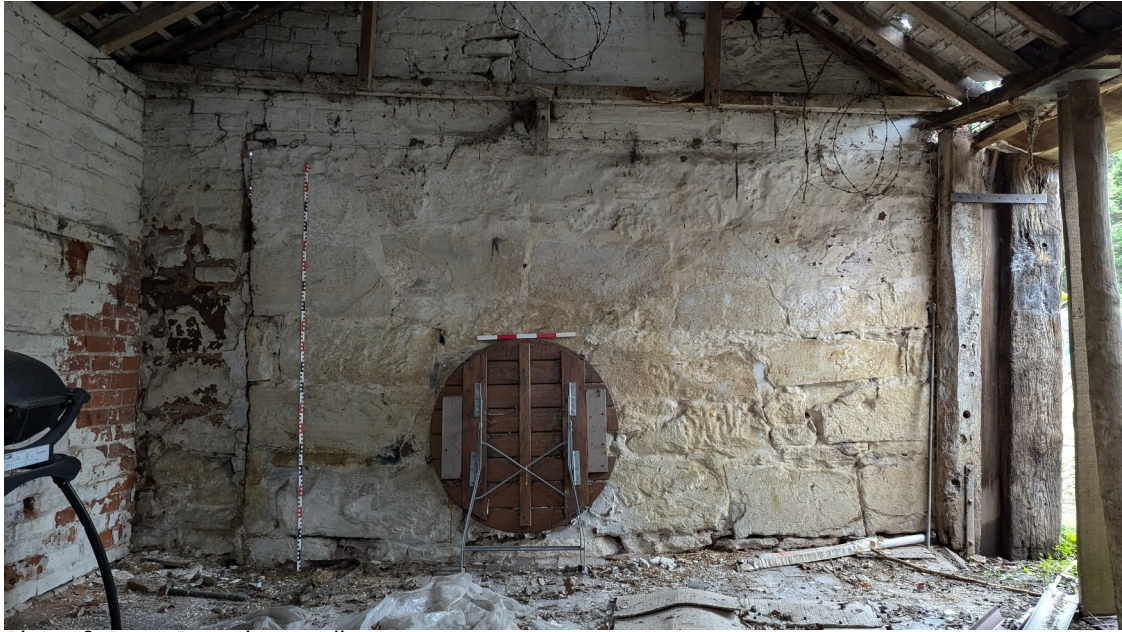
Plate 38: Room D southern wall

6.5.23 The southern wall of Room D was the dividing wall for Room C and contained much of the original phase 1 sandstone fabric (Plate 38). Room D was 400mm wider than Room C and this extension is apparent at the eastern edge of the wall, where stone material has been used to fill the gap. The gable section of the wall is of brick, matching the brickwork forming the rest of the room construction. The recess seen in the wall from Room C is not visible on this face.

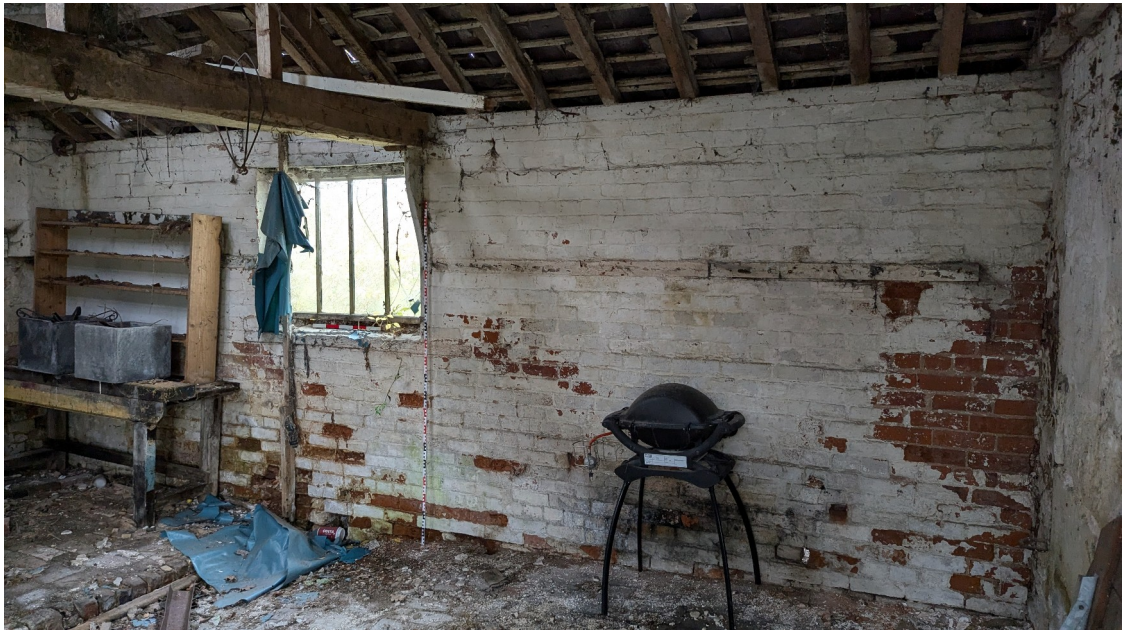
Plate 39: Room D eastern wall

6.5.24 The eastern wall of Room D was of brick, in English Garden Wall bond, painted white and is a single construction phase (Plate 39).

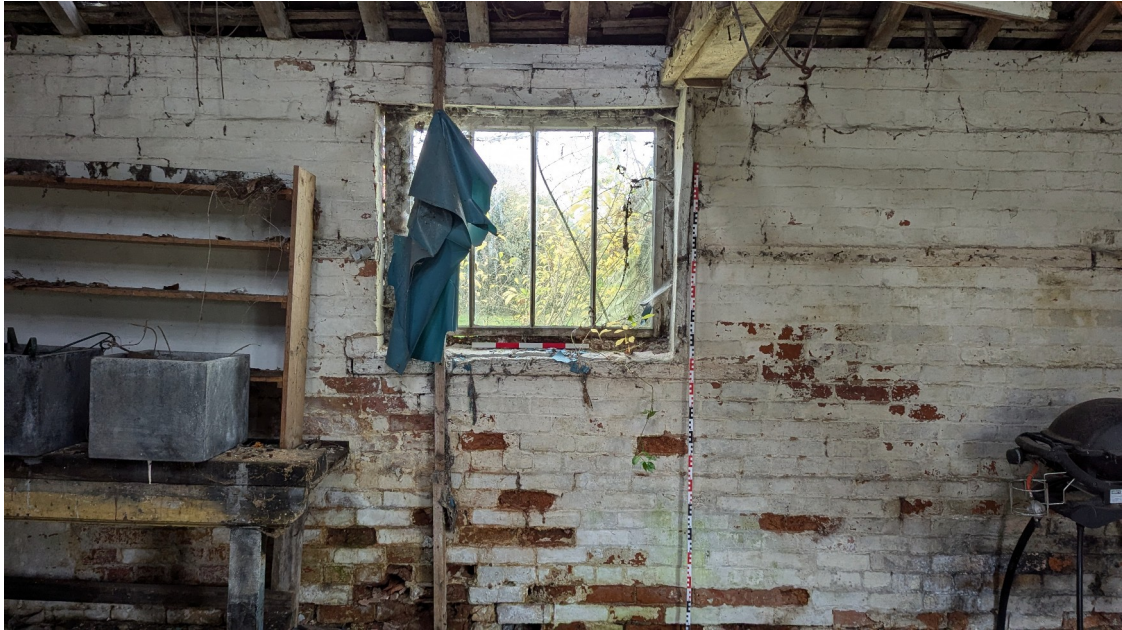
Plate 40: Room D eastern window

6.5.25 Located in the northern part of the eastern wall was a window set in a wooden frame, with wooden cill and lintel. The window had four long vertical panes separated by thin wooden muntins (Plate 40).

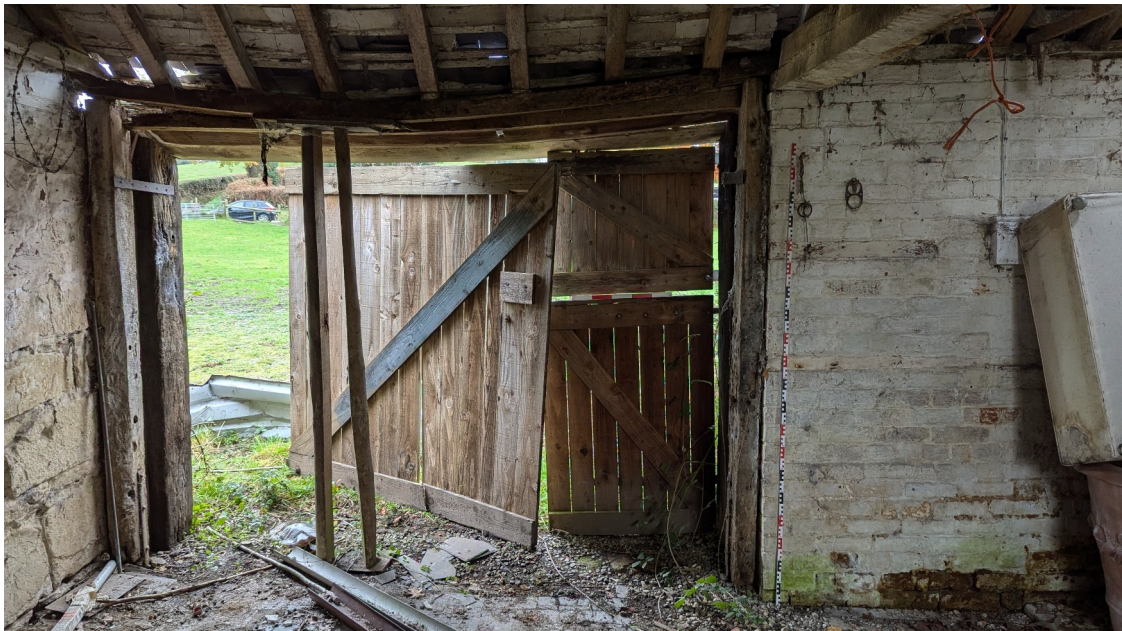
Plate 43: Room D access

6.5.29 The access to Room D was via a wide doorway at the southern end of the western wall (Plate 43). The aperture for the doorway appears to be an original design, however, the wooden frame and door were late 20th century replacements.

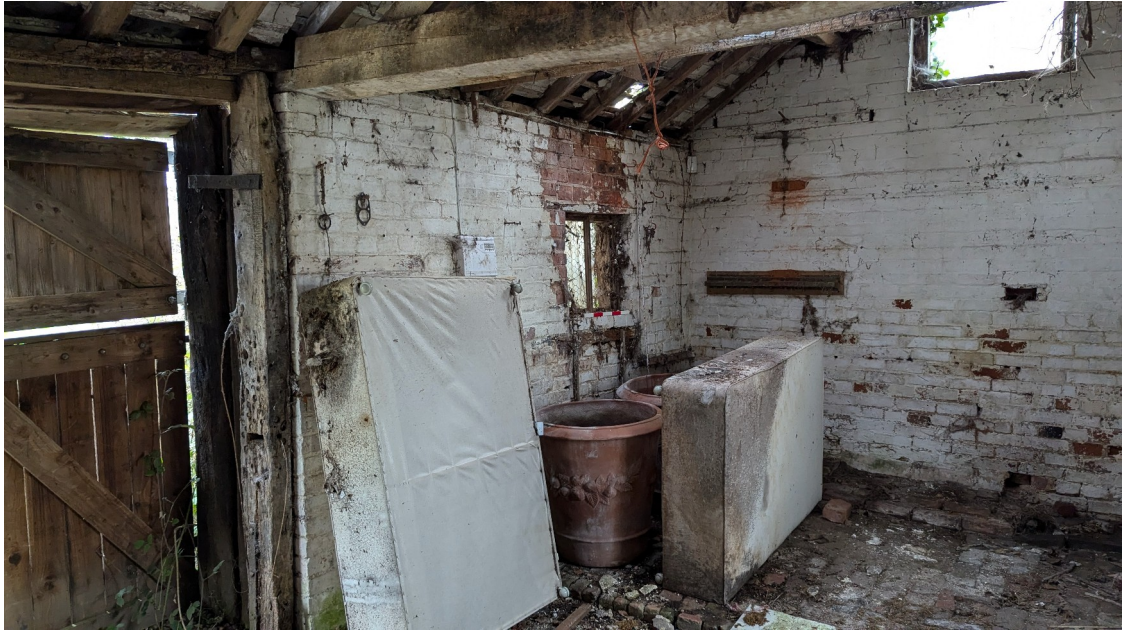
Plate 44: Room D western wall

6.5.30 North of the doorway the structure continued as brick in English Garden Wall bond, with a small square window towards the northern end (Plate 44).

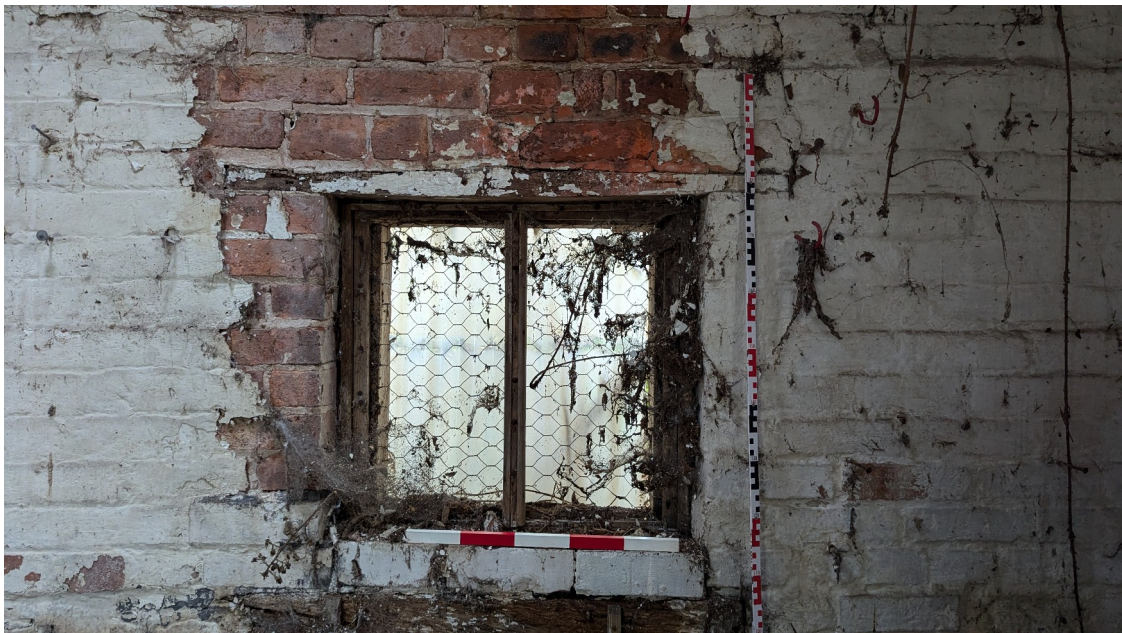
Plate 45: Room D western window

6.5.31 The window aperture is an original element with stone lintel and brick cill. However, the wooden frame casement window was a late 20th century addition (Plate 45).

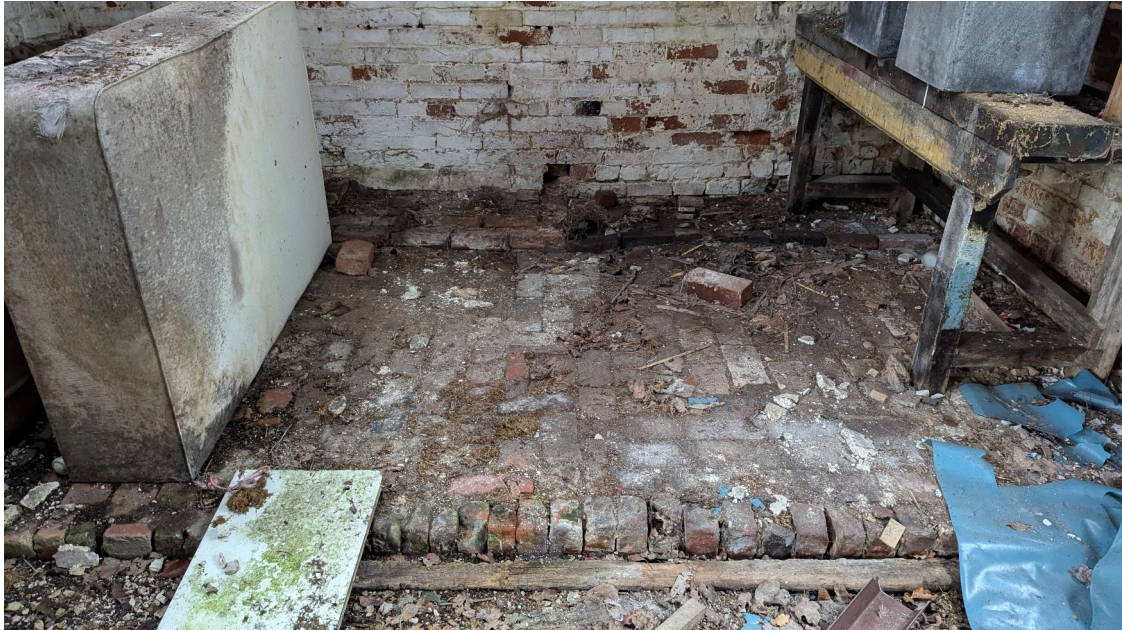
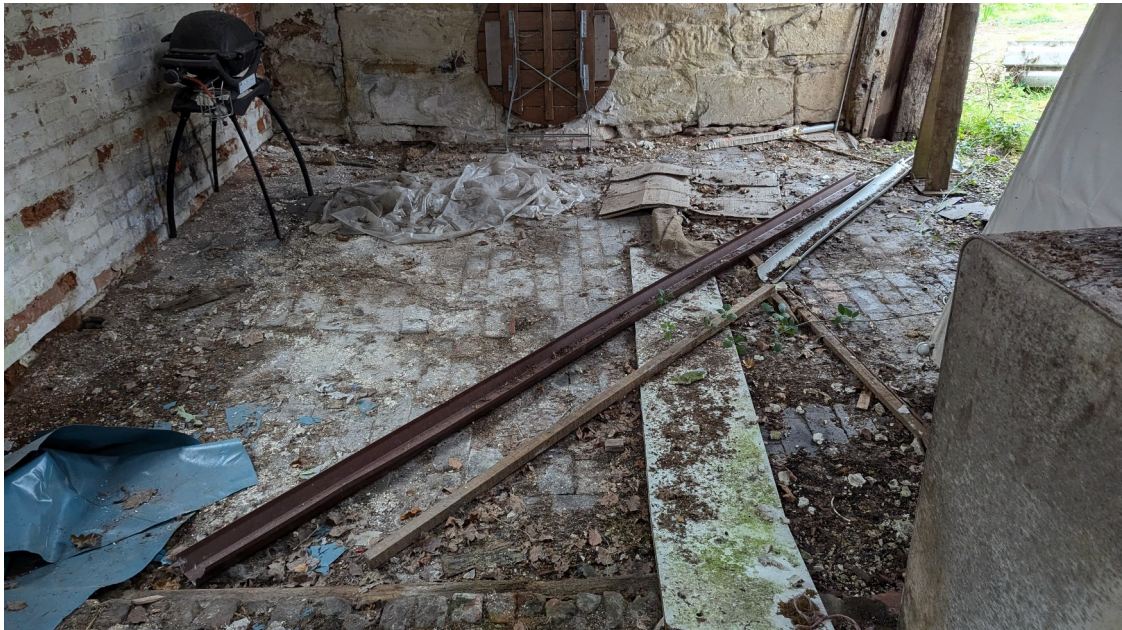
6.5.32 The floor of Room D was of stretcher course brick with a raised platform towards the north wall marked by a row of on end bricks (Plate 46 & Plate 47).

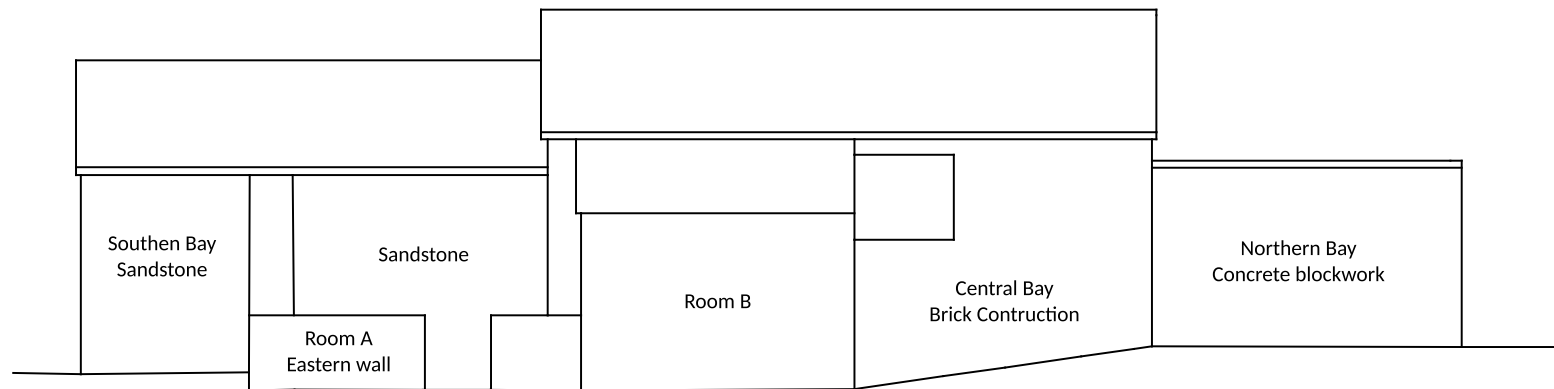
Figure 13: Eastern Elevation

6.4.19 **The eastern elevation** (Figure 13) of the outbuilding comprised the three bays noted above, with the southern bay the earliest phase of construction, central bay forming the second phase, and northern bay being the 20th century concrete block pig sty. In addition to this, Rooms A and B extended east from the elevation towards the garden area (Figure 15).
