Historic Building Recording

Hillside, Erbistock

Report Number: 24-1087

Client: T Walker
Author(s): Blair Poole
HER Event No: PRN 220224
Planning Application: P/2023/0574
Document Ref: 24-1087-HBR-v1.1
Date: 5 December 2024
NGR: 335112,342100

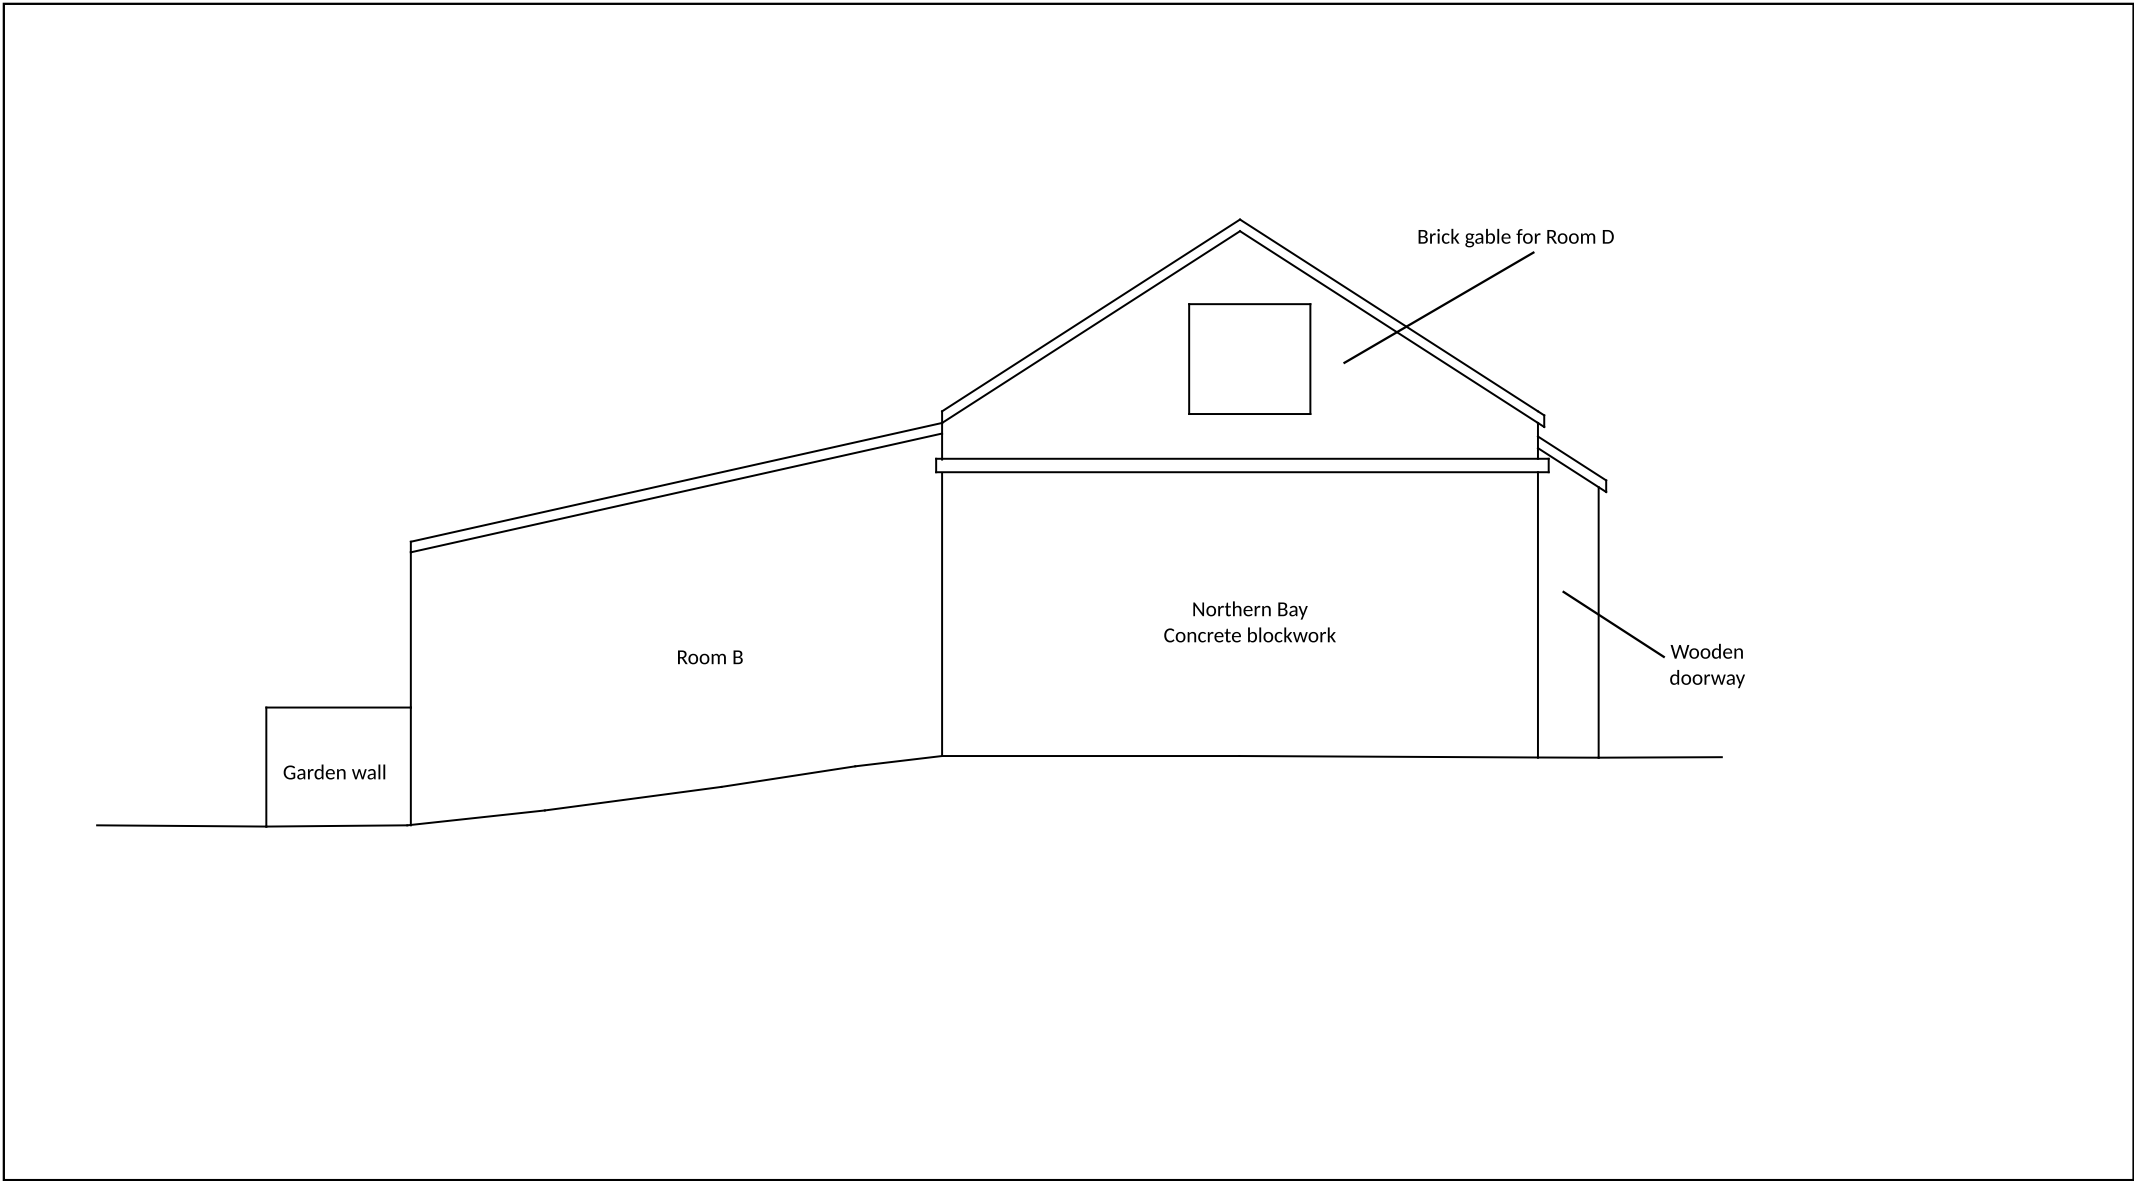
Figure 14: Northern Elevation

6.4.24 **The northern elevation** (Figure 14) was mainly taken up by the concrete block pig sty, however, above this the brickwork for the gable wall of the central bay was visible (Plate 23).

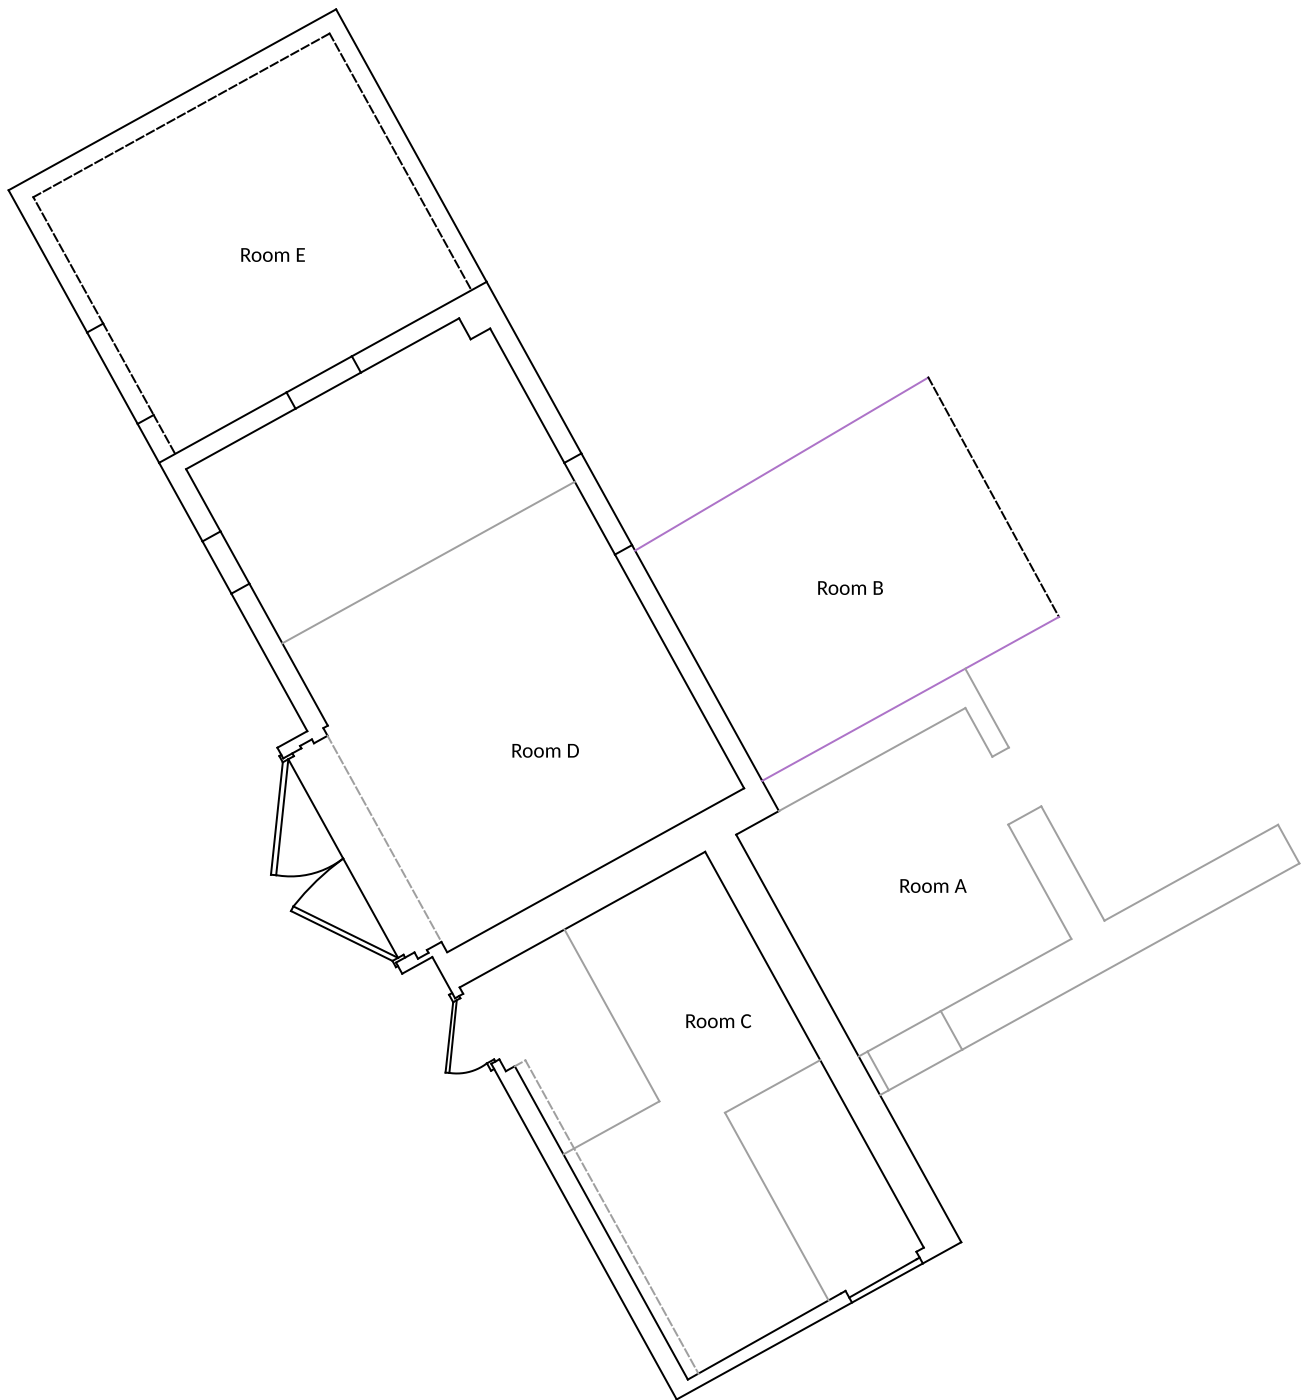
Figure 15: Plans

6.5.1 The structure comprised a series of five distinct rooms, all accessed via external doors with no access between rooms (Figure 15). These divisions reflect the construction phasing and function of the rooms.

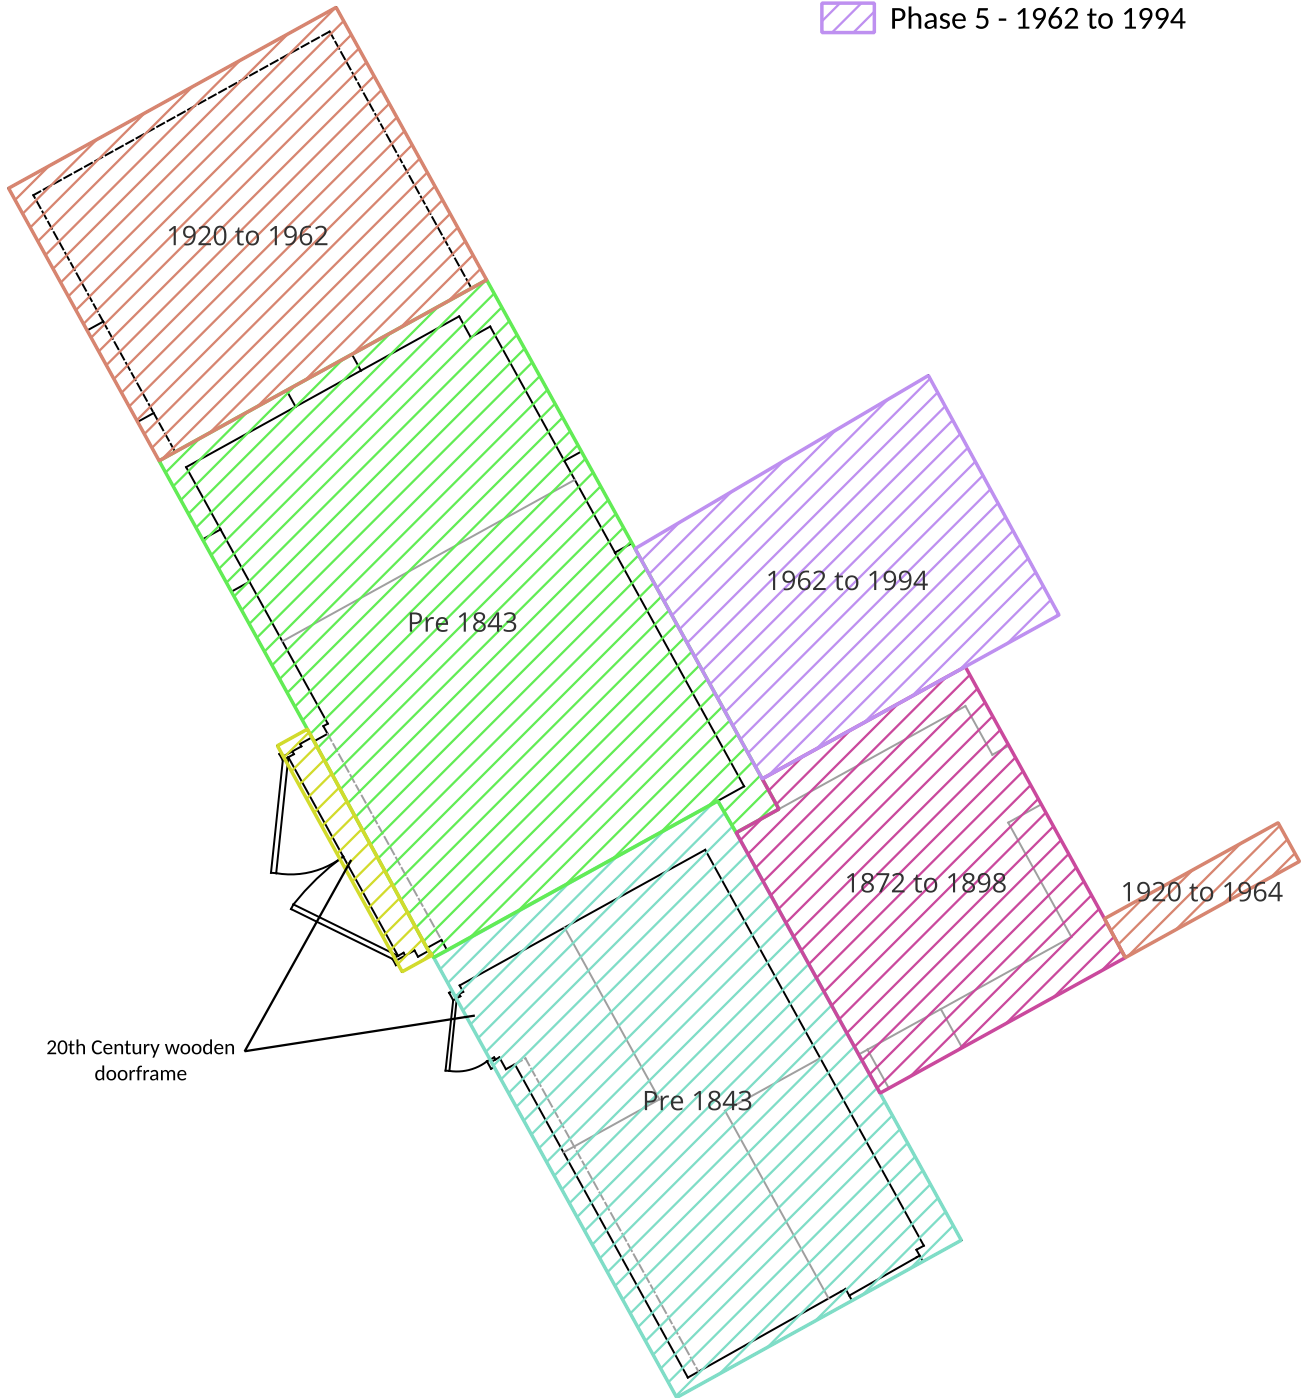
Figure 16: Phasing

6.4.16 To the east of Room C were the remnants of two previous extensions (Figure 16) including a rough brick and stone lean to (Room A) butting the eastern wall of the main outbuilding, dating from between 1872 and 1898 and forming the third phase of development of the building. Attached to the east of this extension was a

6.5.2 **Room A** (Plate 24) was an external space at the southeast of the structure that had originally been a lean to extension. This dates from between 1872 and 1898 (Figure 16) and was a low storage area with sloping roof extending from the eaves of the main structure to approximately 1.2m above ground level at the eastern end.
