Mulberry House, Pen Y Pound, Abergavenny

Archaeological Level 3 Building
Recording

Report No. 1846

October 2019

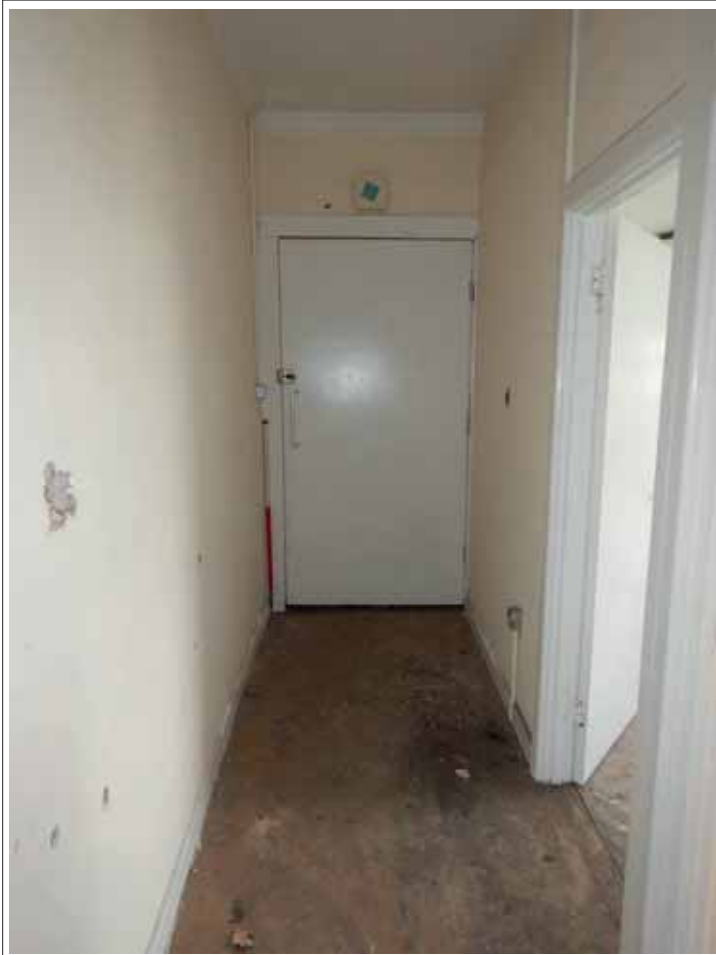
Plate 47. Room 1.3, looking south. 1m scale.

Room 1.3 is a corridor reached through the north door of the main landing (Plate 47). It is a later addition and would originally have formed a single room with Rooms 1.4 and 1.5. It measured 5.58m by 1.16m.

It has a painted plaster ceiling with a section of original moulded coving visible only on the south wall (Plate 47).

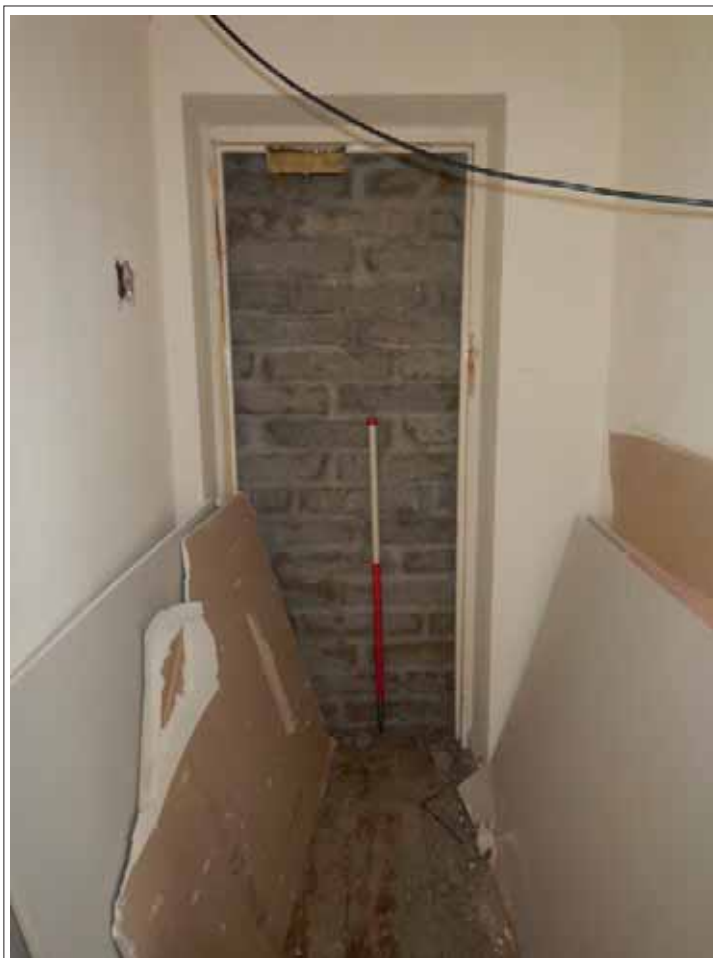
The walls are also painted plaster with bull nose skirting boards. As well as the door through to the landing there are four doorways off of the corridor: two on the west to Rooms 1.4 and 1.5, one on the east to Room 1.2 and one to the north to the north annex, now blocked up (Plate 48). All of these doorways are standard height modern doors with a plain wooden surround.

Plate 48. Room 1.3, looking north, showing blocked doorway through to north annex. 1m scale.

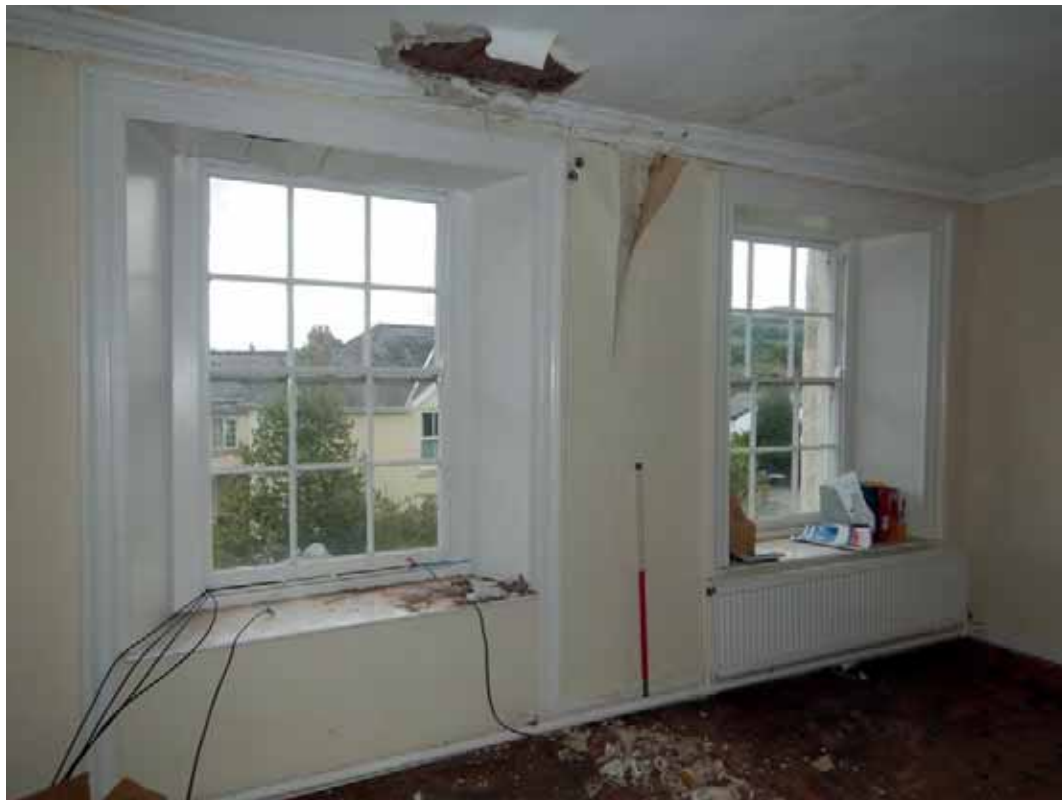
The ceiling is painted paper over plaster with a moulded cornice (Plate 49). It is in poor condition, showing water damage in places. There is a hole in the plaster near the east wall which reveals the original lathe and lime plaster construction (Plate 50).

The walls are painted plaster with bull nose skirting boards. There are two windows to the east wall (Plate 49). They are both six- over six-light sash windows with plain wooden reveals and a flat arch architrave that extends down to the floor.

Plate 49. Room 1.2, looking south-east. 1m scale.

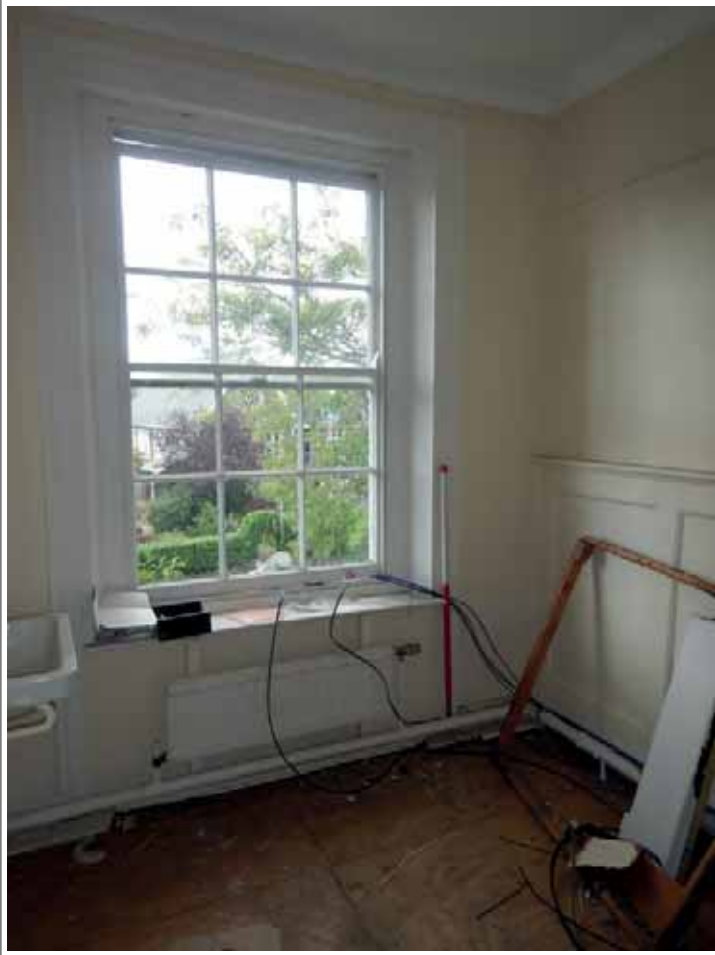
Plate 51. Room 1.4, looking north-west. 1m scale.

The ceiling is of painted plaster with a plain cornice to the west and north walls (Plate 51).

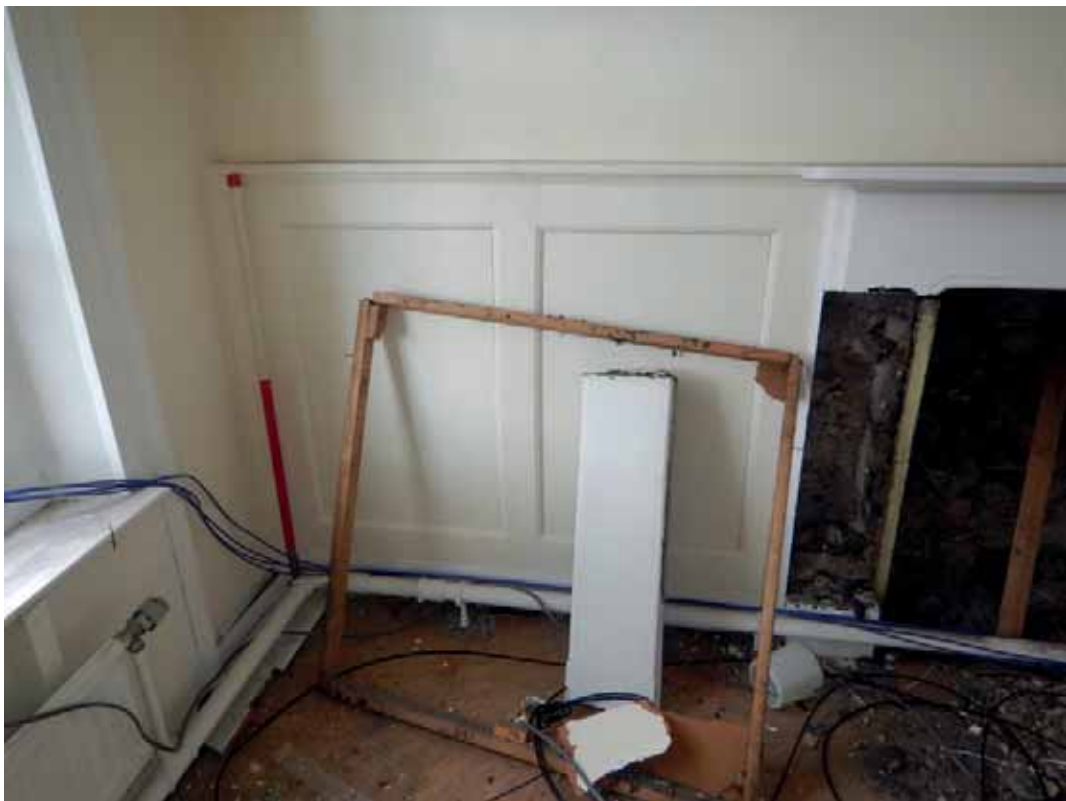
Plate 52. Room 1.4 showing wall panelling, looking north. 1m scale.

The walls are of painted plaster. The north and west walls would have formed part of the original room while the south and east walls are later additions to sub-divide the original room into two rooms and a corridor. The later stud walls are plain with bull nose skirting boards. The north wall has half height framed panelling and a dado (Plate 52). There is modern plumbing, including a radiator to the west wall and a sink to the south wall.

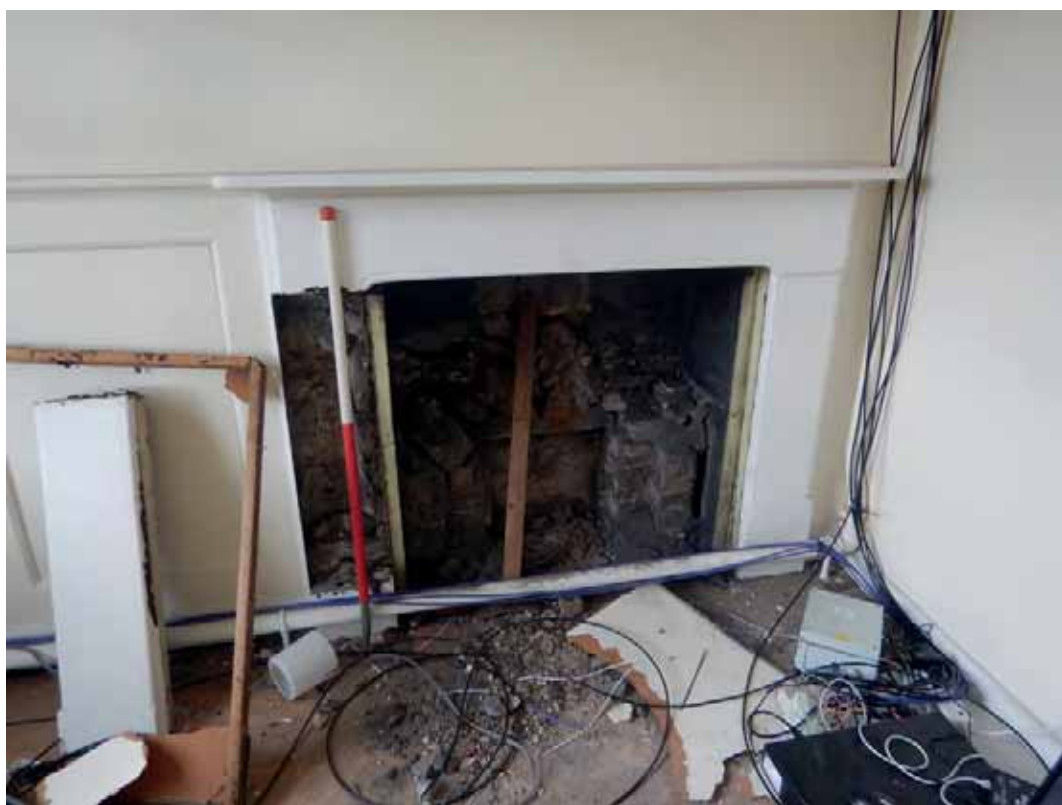
Plate 53. Fireplace in Room 1.4, looking north. 1m scale.

There is a fireplace to the north wall (Plate 53). It has a wooden mantel and a simply moulded painted stone surround, 1.22m high and 1.48m wide. It was in poor condition, with the western upright having come away and the grate having been removed.

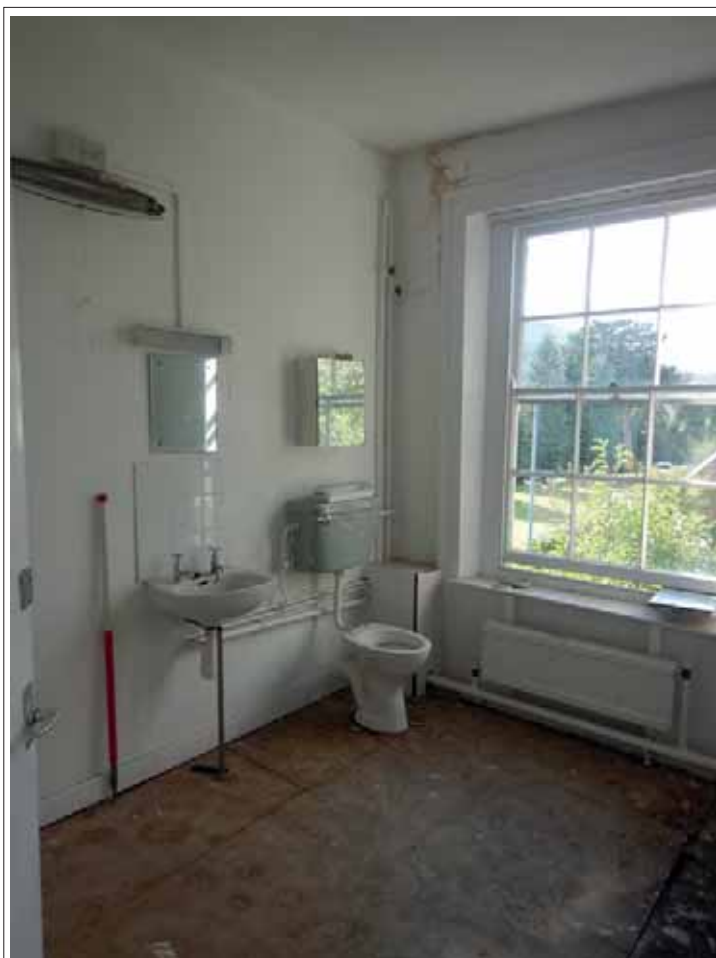
Plate 54. Room 1.5, looking south-west. 1m scale.

The walls are painted plaster, showing water damage in places (Plate 54). They have bull nose skirting boards but otherwise no decorative elements. Recent additions to the south wall include a toilet, sink, lights and mirrors.

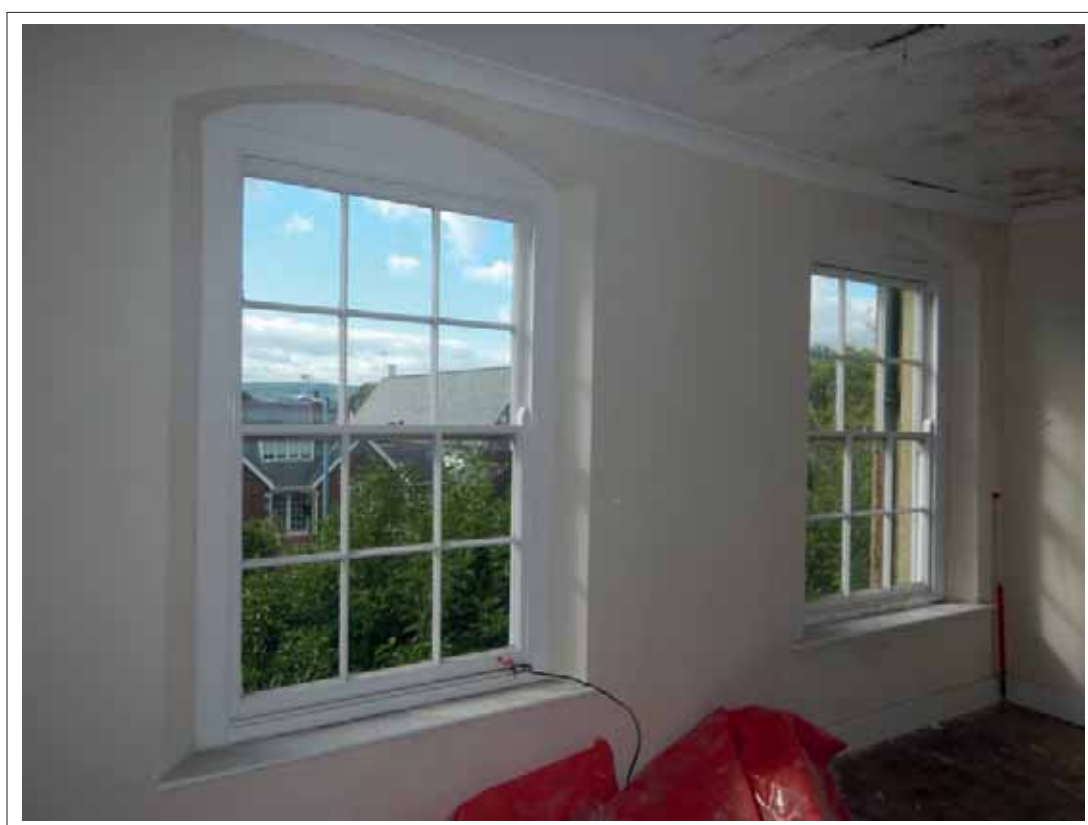
Plate 56. Room 1.7/1.9, looking north-west. 1m scale.

The room has a painted plaster ceiling in moderate condition with some evidence of damp (Plate 56). It has plain coving to all sides that is a modern addition (Plate 57).

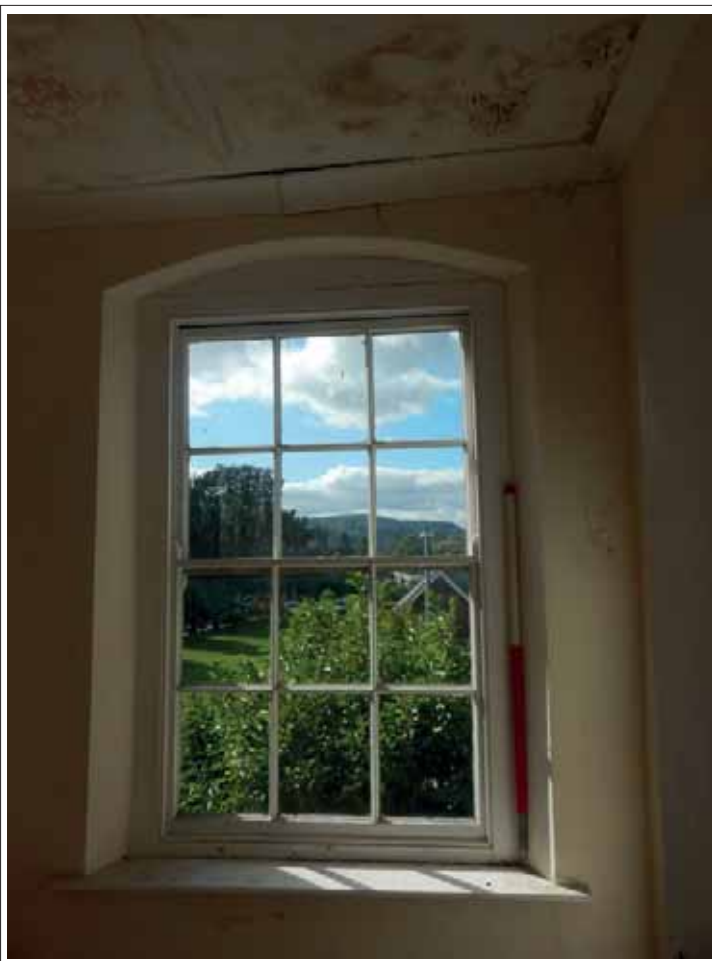
There are two windows to the front (west). The windows themselves are as those to Rooms 1.4 and 1.5, being six- over six-light sash windows. Unlike the other first floor front windows, they do not have an architrave, instead having a plain plaster recess (Plate 58). It is likely that the original architraves had been removed at an earlier period.

Plate 58. Sash window on west wall of Room 1.7/1.9, looking west. 1m scale.

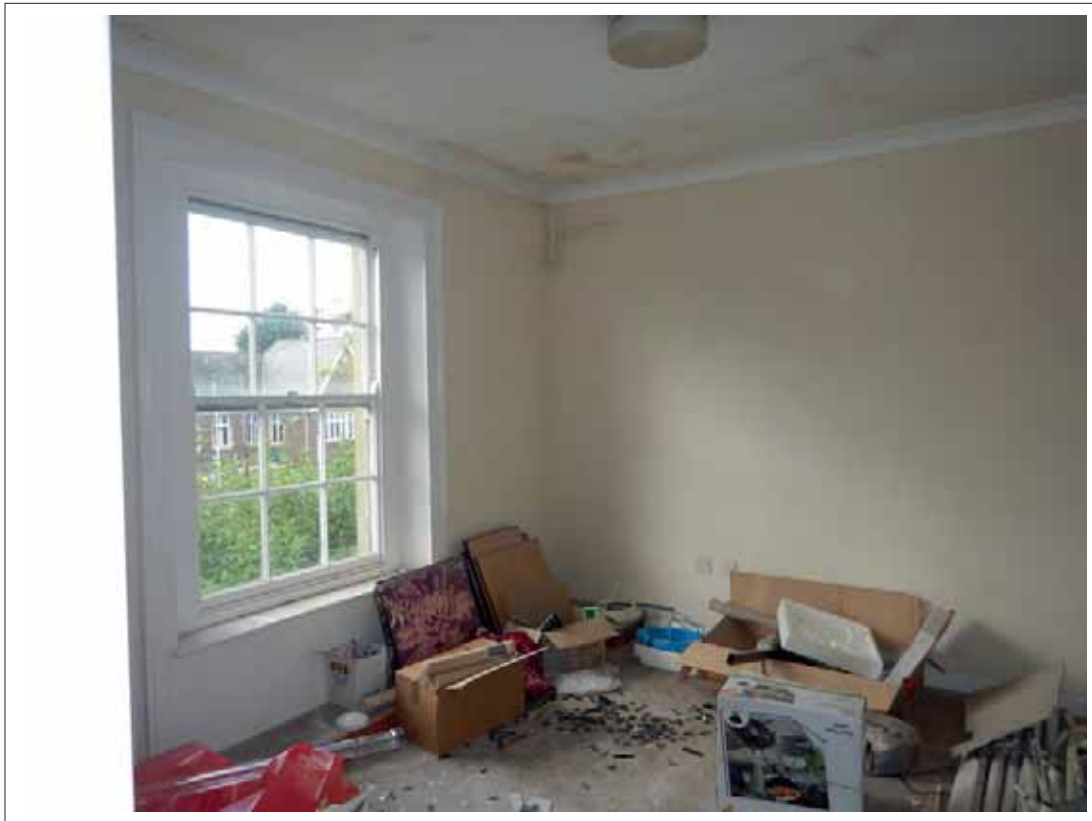
Plate 59. Room 1.6, looking north-west.

The ceiling is painted plaster with plain coving to all sides (Plate 59). There is some evidence of damp.

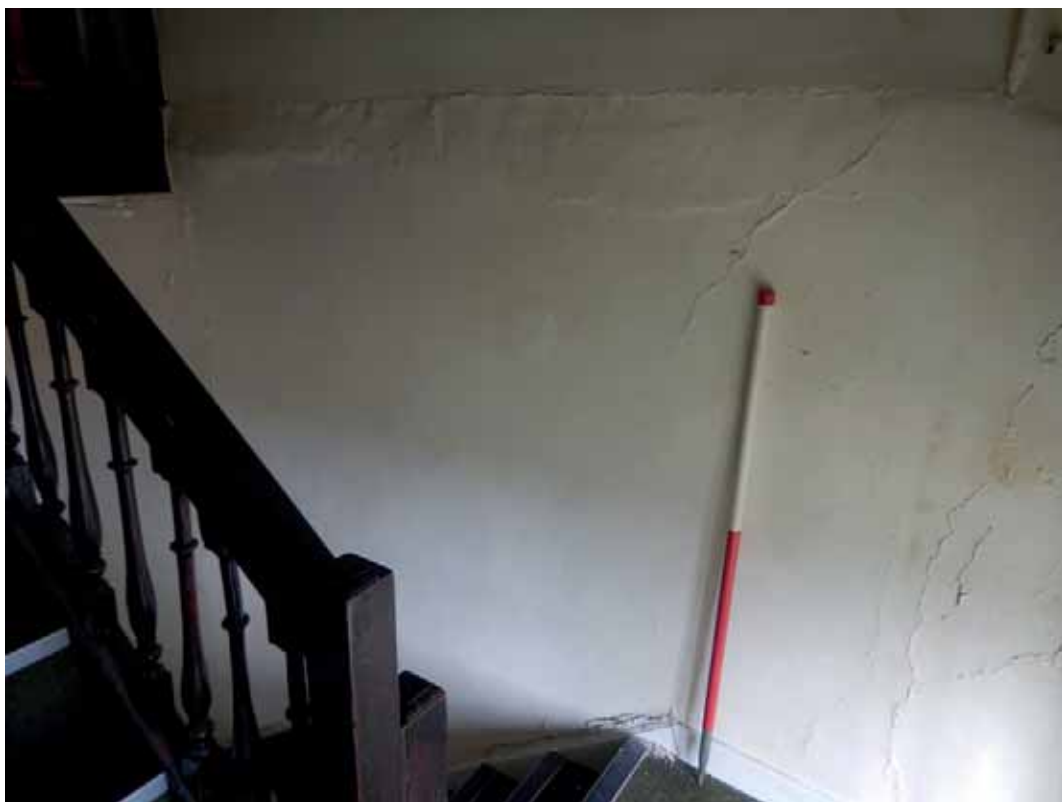
The room has no ceiling as the stairs lead to the attic. However, scars on the wall at attic floor height indicate that there was originally a ceiling (Plate 61). This was probably removed to create the stairway when the attic was converted to rooms for the convent in the early 20th century.

Plate 61. North wall of Room 1.13, showing scar of removed first floor ceiling to the top of the image. 1m scale.

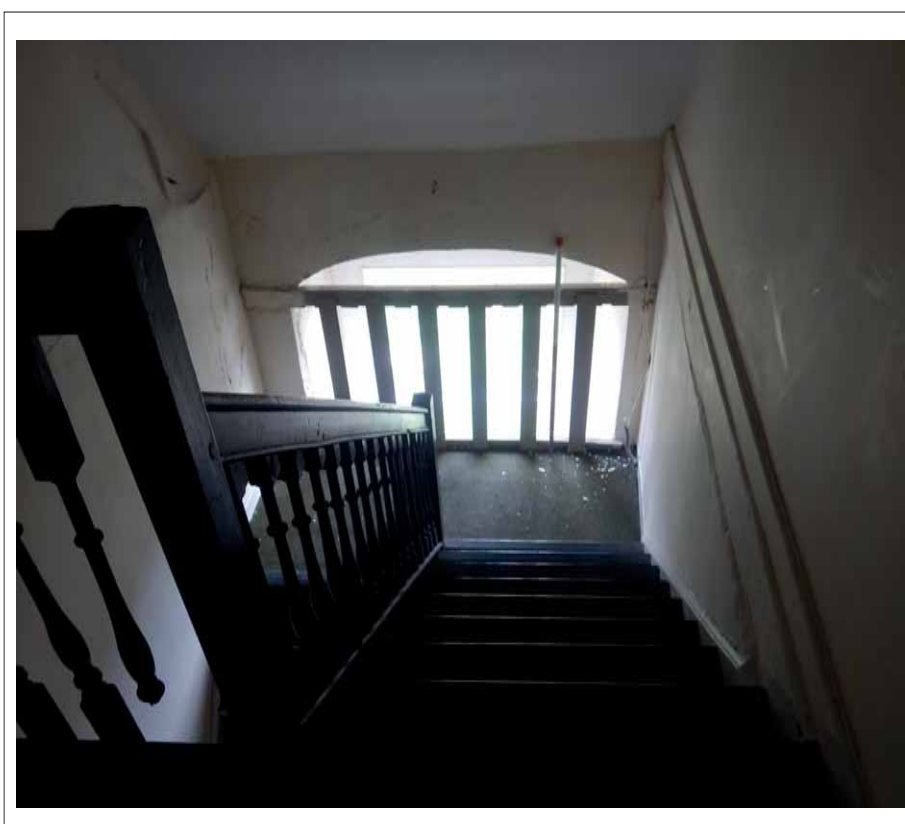
Plate 62. Room 1.13, looking down and east from second floor landing. 1m scale.

The stairs are as described in Room 0.4. Several balustrades are missing (Plate 62).

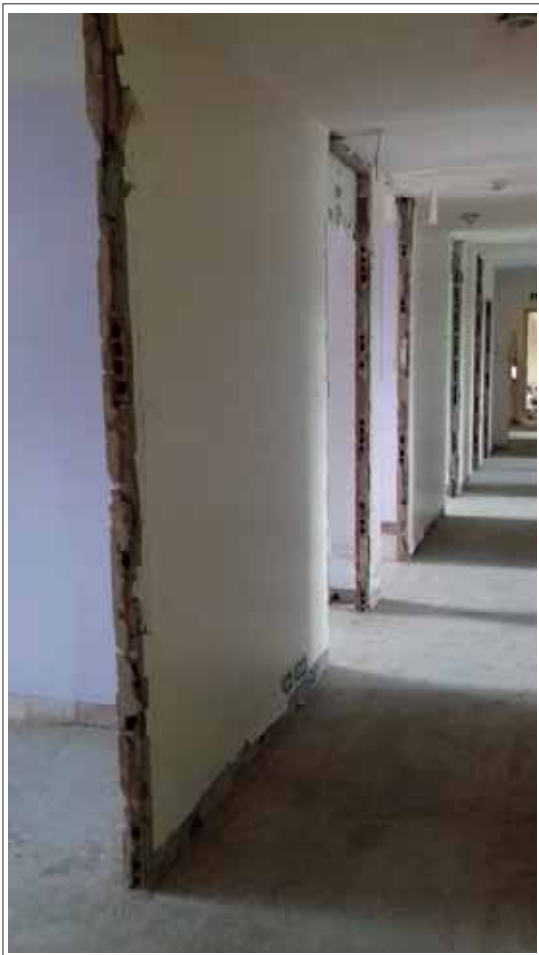
Plate 213. Dormitory Area 1 to second floor, showing room partitions. Looking north-west.

The walls are painted plaster in poor condition, with evidence of removed skirting (Plate 213). There are nine three light windows, four in the east wall, four in the west walls and one in the north wall (Plate 214). All the doors and frames have been removed from each room exposing brick. There are two doors one on both the north and south walls. The northern door is a narrow lite wooden door, with wooden frame and modern fittings. The door on the south has been removed along with the frame.

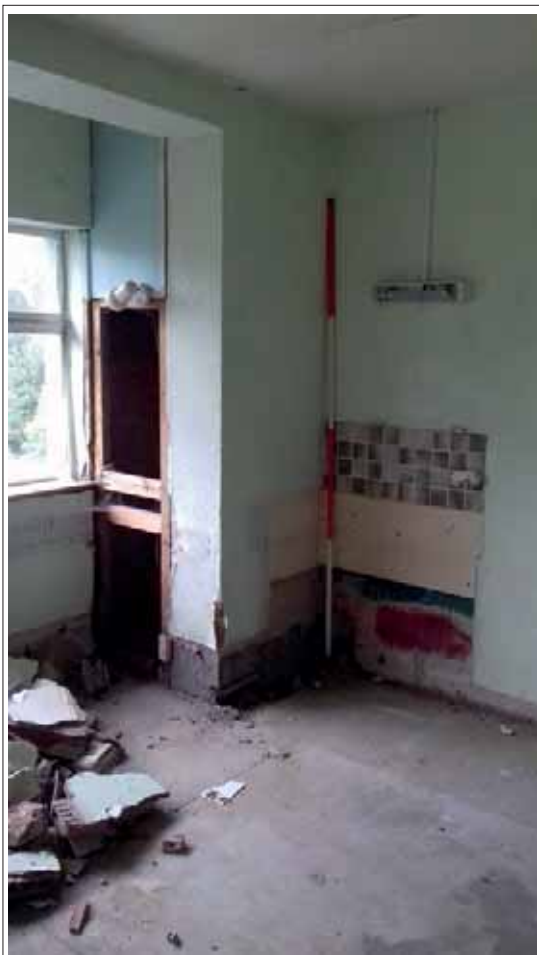
Plate 215. Central bedroom, looking north-west. 2m scale.

The walls are painted wallpaper in very poor condition. There are several holes and the wallpaper is peeling in places. The plaster has been removed on both walls of the recess exposing the wooden frames (Plate 215). There is one eight light single pane window on the western wall (Plate 216). The door on the south has been removed along with the frame, exposing the brick.

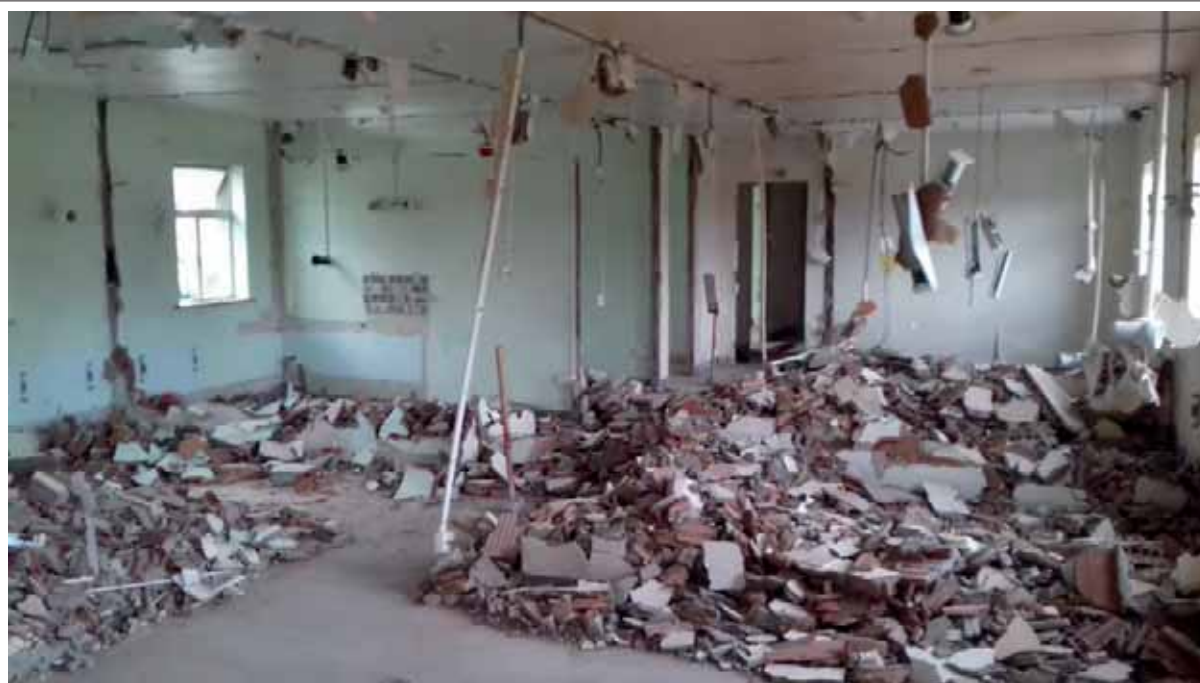
Plate 222. Dormitory Area 2, second floor, looking north-west.

The walls are painted plaster in poor condition, with evidence of removed skirting and partition walls (Plate 222). There are nine three light single pane windows, four on the east, four on the west walls and one on the south wall. There are two doors one on both the north and south walls. The southern door is a narrow lite wooden door, with wooden frame and modern fittings. The door on the north wall has been removed along with the frame.

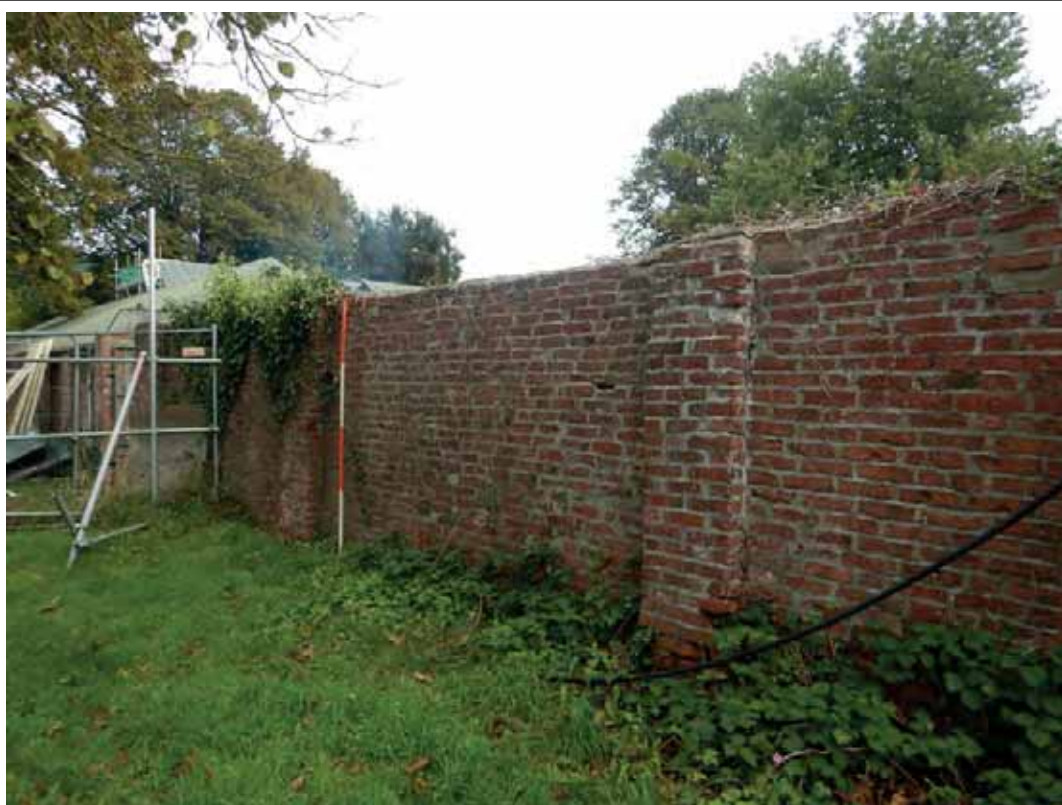
Plate 224. East wall of the walled garden, looking north-east. 2m scale.

The east wall has been subject to later disturbance. The upper part of the wall has been removed so that the tops of the arches are no longer present (Plate 224). The wall stands around 2m high and has no cap stones. To the north end of the wall a modern shed has been abutted against it (Plate 229), utilising it as the rear wall of the shed (Plate 230). A corrugated iron roof rises from the wall with a timber board and metal guttering and drainpipe (Plate 231).

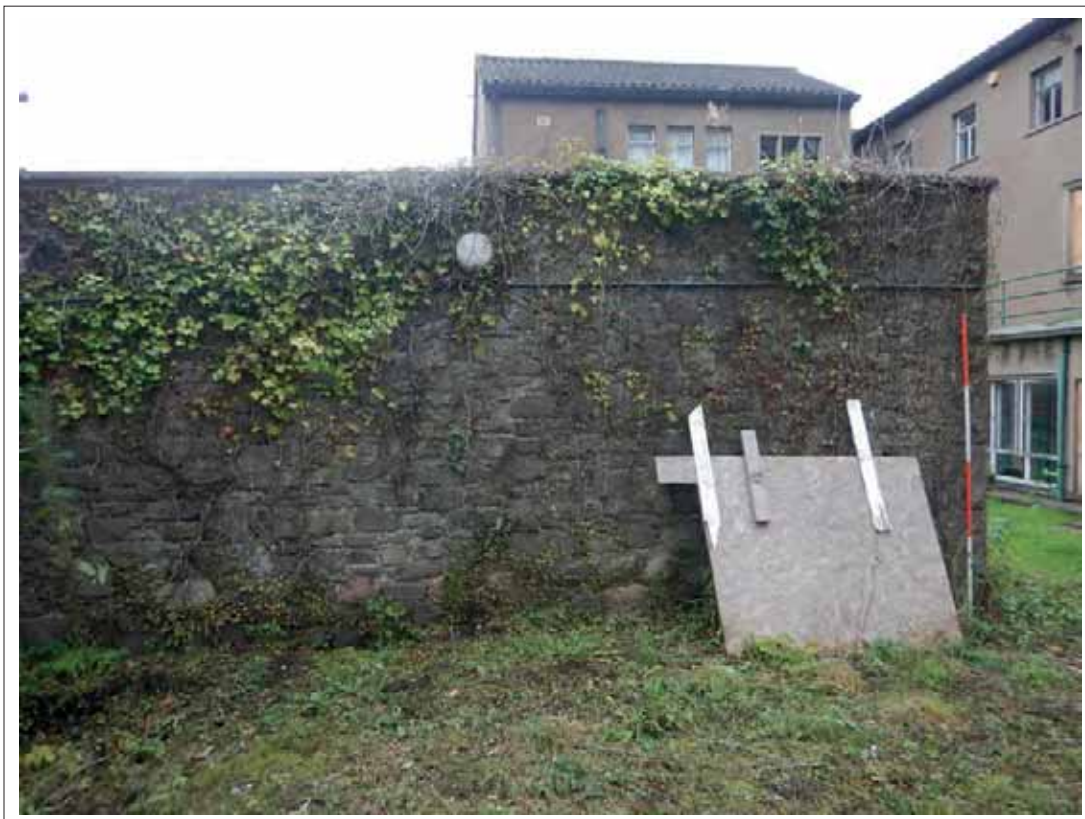
Plate 225. Exterior of the north section of the walled garden, looking south. 2m scale.

The interior of the wall is of red brick in stretcher bond with lime mortar (Plate 224). In places it has been repointed with cement mortar. The exterior of the wall is random rubble course sandstone (Plate 225).

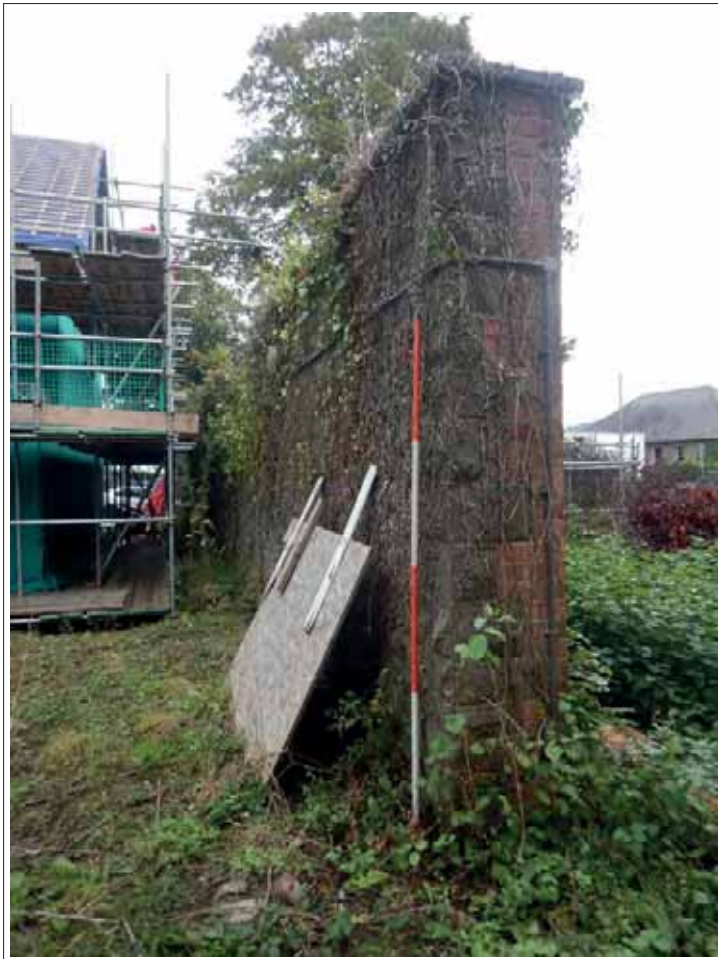
Plate 227. West end of the north section of the walled garden, looking east. 2m scale.

The north section of wall, which is orientated east-north-east to west-south-west, is the best preserved. Its height averages 2.9m. To the interior it has six wide arched recesses with brick voussoirs (Plate 226). It has been capped with a later addition of concrete capstones. At its western end, where the 1950s demolition ended, it has been finished with squared rock-faced stone (Plate 227).

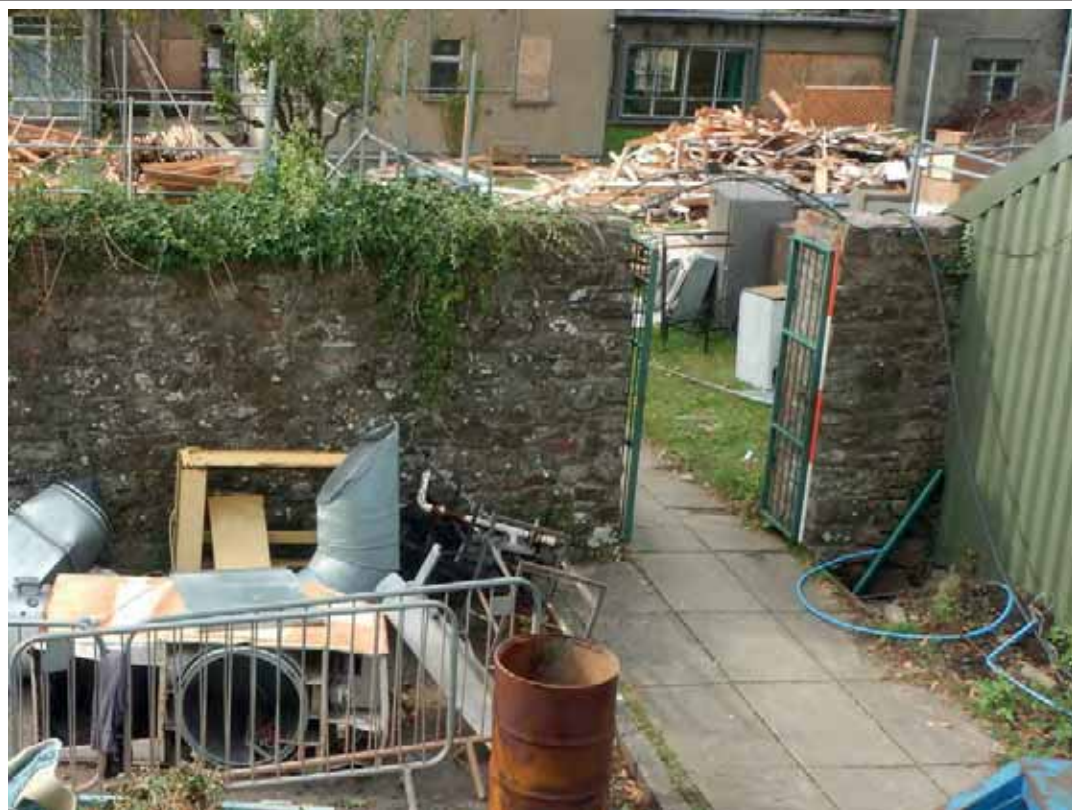
There is a gateway to the centre of the extant wall (Plate 232). This gap is not observed on any of the historic mapping. It has centre-opening metal bar gates and an arched metal overthrow.

Plate 232. Gateway in east wall of walled garden, looking north-west. 2m scale.

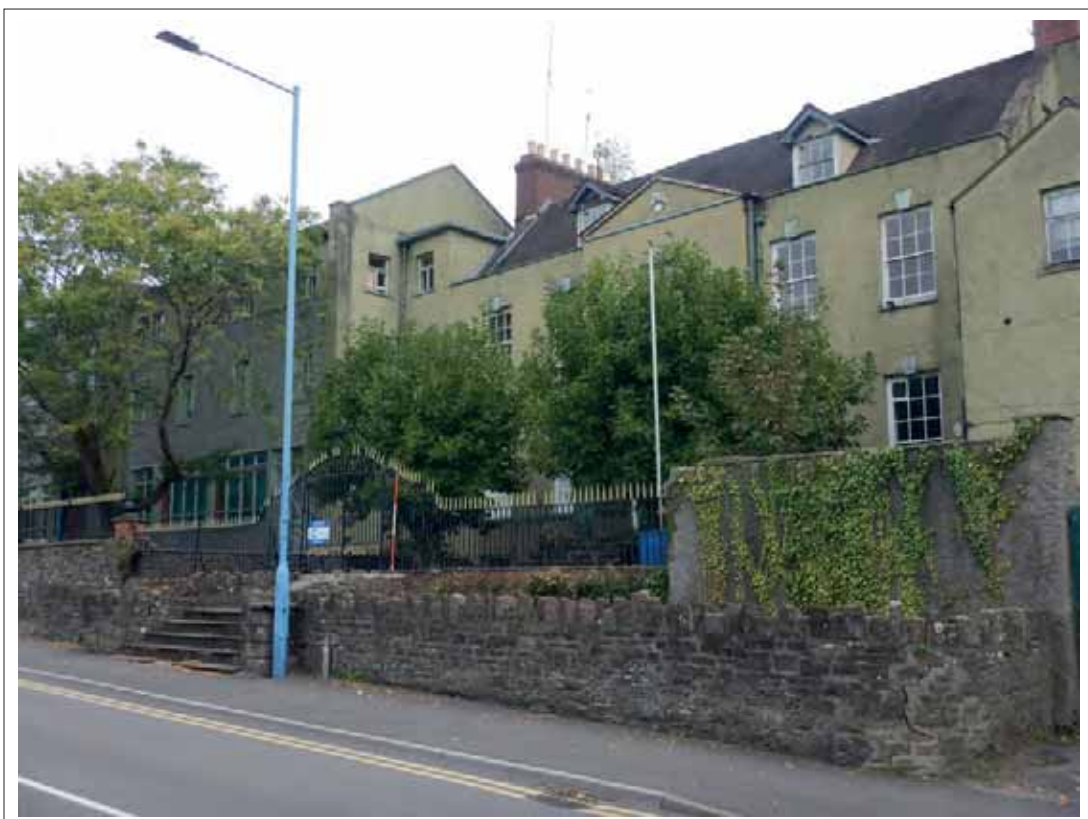
The boundary wall at the front of the property along Pen Y Pound is constructed in uncoursed rubble. The southern projecting section, in front of the original house, has roughly squared vertical rubble coping stones (Plate 236). It is identical to that shown on the photograph of circa 1900 shown in Appendix 1 (Bradney, 1906, 182). It projects around a stone culvert that runs along the front of the building (Plates 237 & 238) and is shown on the 1880 map (Figure 4). The culvert is lined with river pebbles (Plate 239).

Plate 236. Front of Mulberry House showing exterior wall projecting around the culvert, looking north-east. 2m scale.

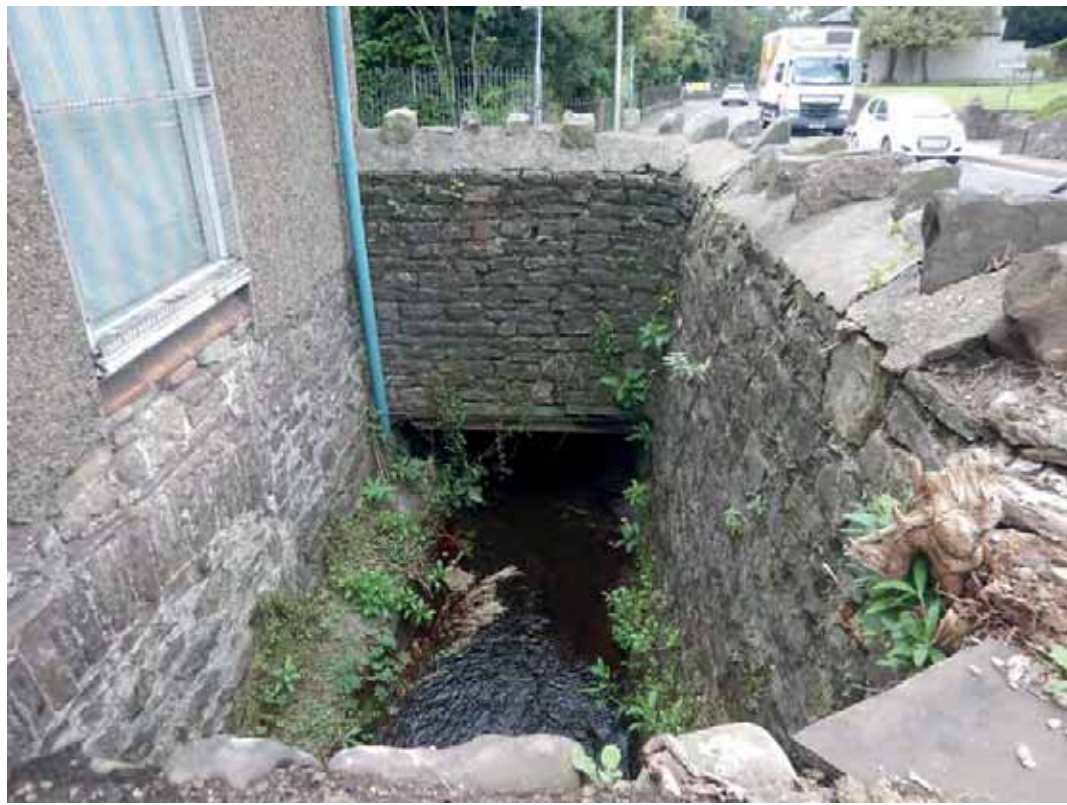
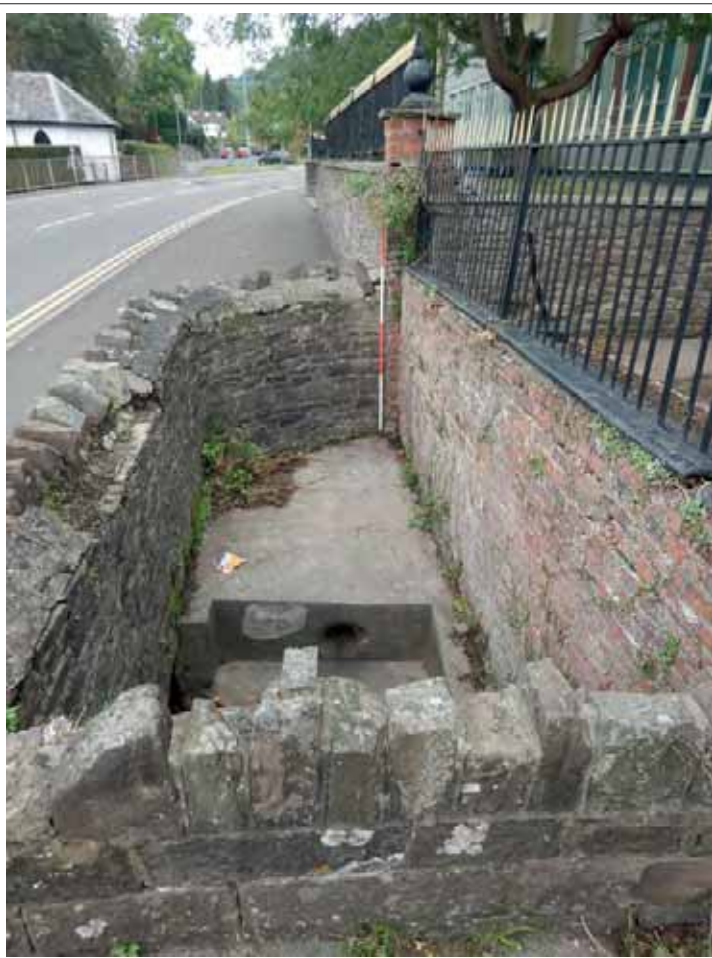
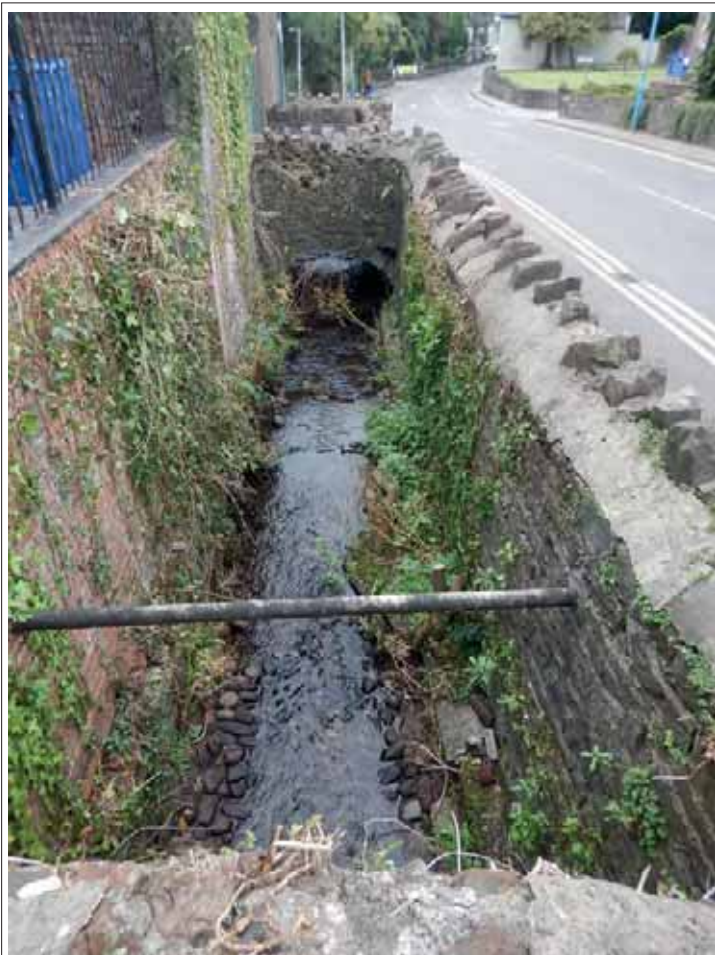
Plate 237. Culvert to the front of the out-building to the south-west corner of the curtilage, looking south.

Plate 238. Culvert to the front of Mulberry House, looking north. 2m scale.

Plate 239. Culvert to the front of Mulberry House, looking south.

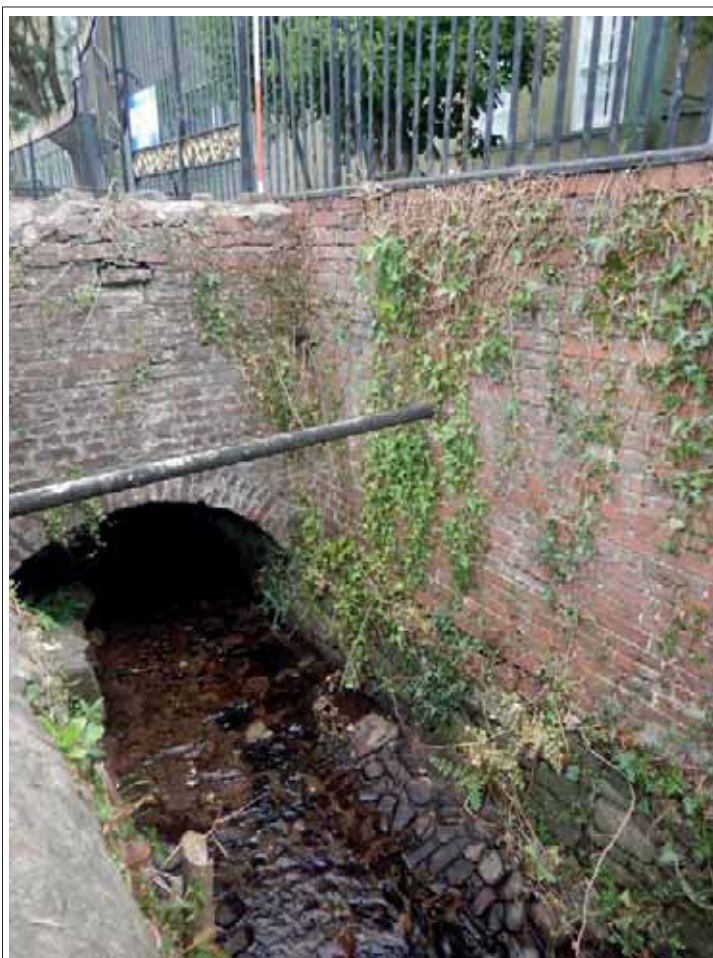
The current iron entrance gate and railings are also shown on the circa 1900 photograph (Appendix 1). The gates are Grade II listed and may be contemporary with the original house. They are accessed via a stone steps from the street level (Plate 4) via a brick arch over the culvert (Plate 240). The gates are wrought iron, sweeping up twice from the railings to a spiked arch with an overthrow and lamp bracket with a half-height panel band of curlicues (Plate 241). The railings are set on top of a low red

Plate 240. Brick arch over culvert to the front of Mulberry House, looking north-east.

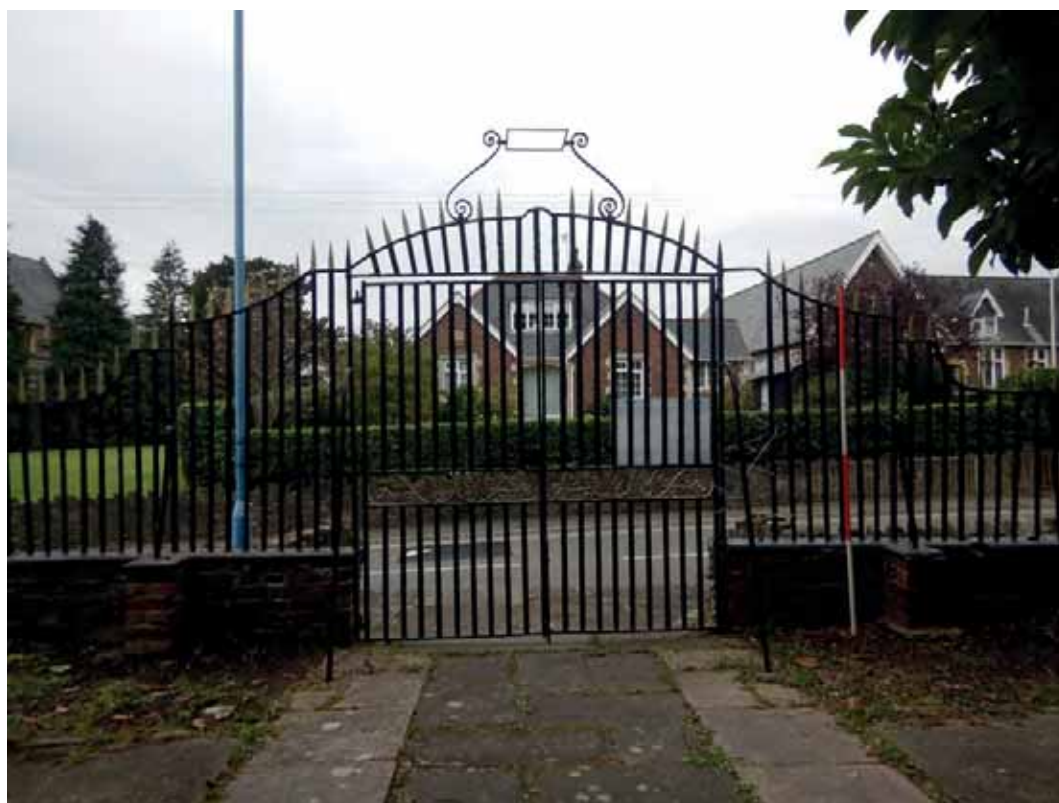
Plate 241. Original gates to front of Mulberry House, looking west. 2m scale.

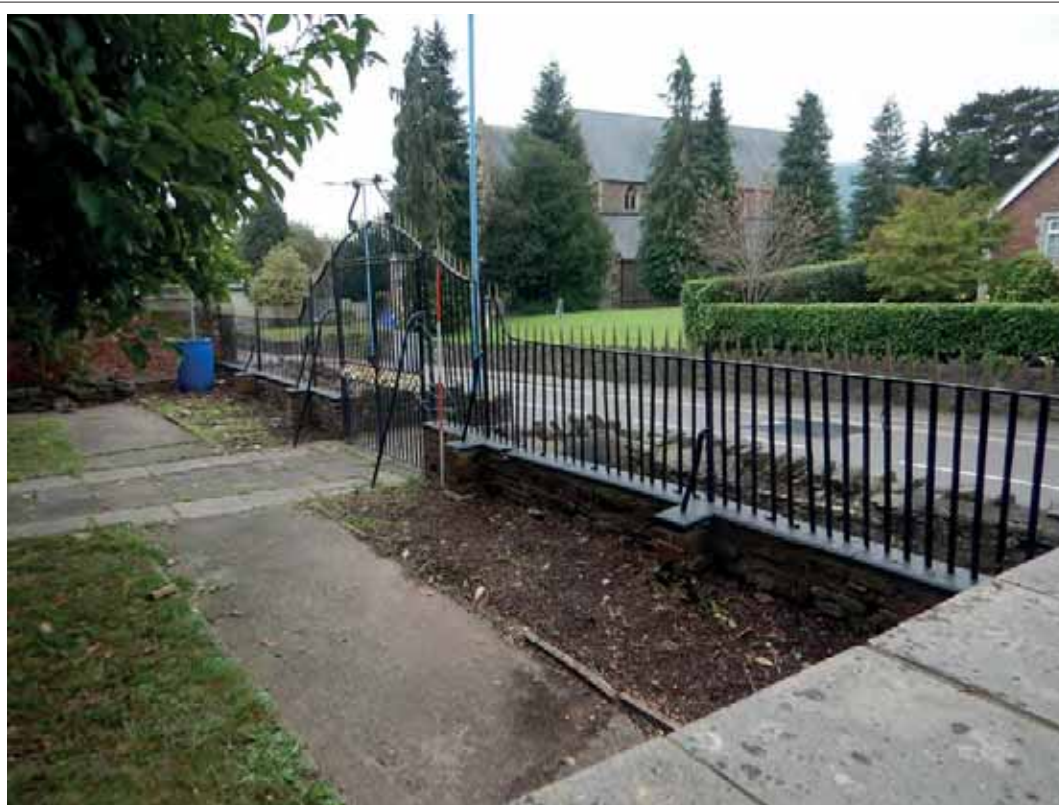
brick wall in stretcher bond (Plate 242), which to the exterior reaches down to the culvert (Plate 240).

Plate 242. Original gates and fencing to front of Mulberry House, looking south-west. 2m scale.
