Mulberry House, Pen Y Pound, Abergavenny

Archaeological Level 3 Building
Recording

Report No. 1846

October 2019

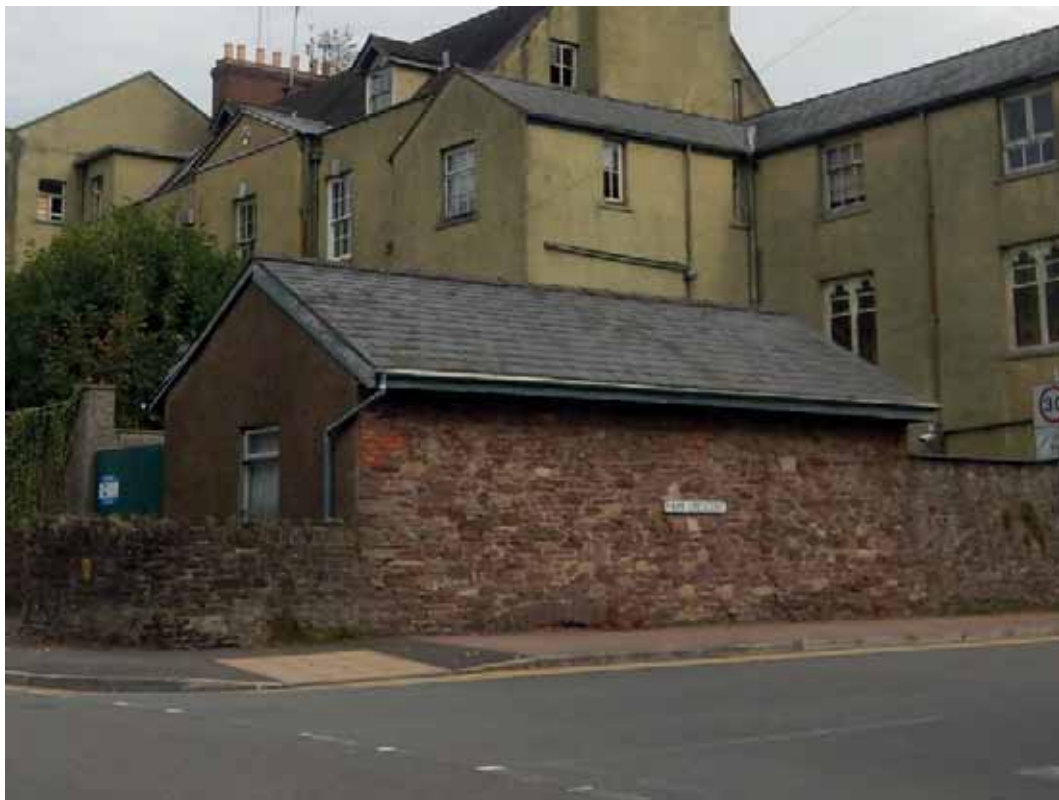
There is a single-storey outbuilding located in the south-west corner of the curtilage (Plate 243). Its external (south) wall, fronting on Park Crescent, is of uncoursed sandstone rubble. There is a blocked rubble sandstone arch near ground level externally on Park Crescent marking the former exit of a culvert that ran around the front of the property (Plate 244). A vertical line of former rubble quoins also indicate that this outbuilding has been extended to the east, possibly during the 1956 renovations (The extended form is first visible on the 1965 OS Plan; Figure 6). The remaining walls of the outbuilding are of rough cast render. The roof is of slate, gently pitching with gable ends and painted bargeboards. The openings are plain with no visible surround and the windows are modern.

Plate 243. Out-building to south-west of Mulberry House, looking north-east.

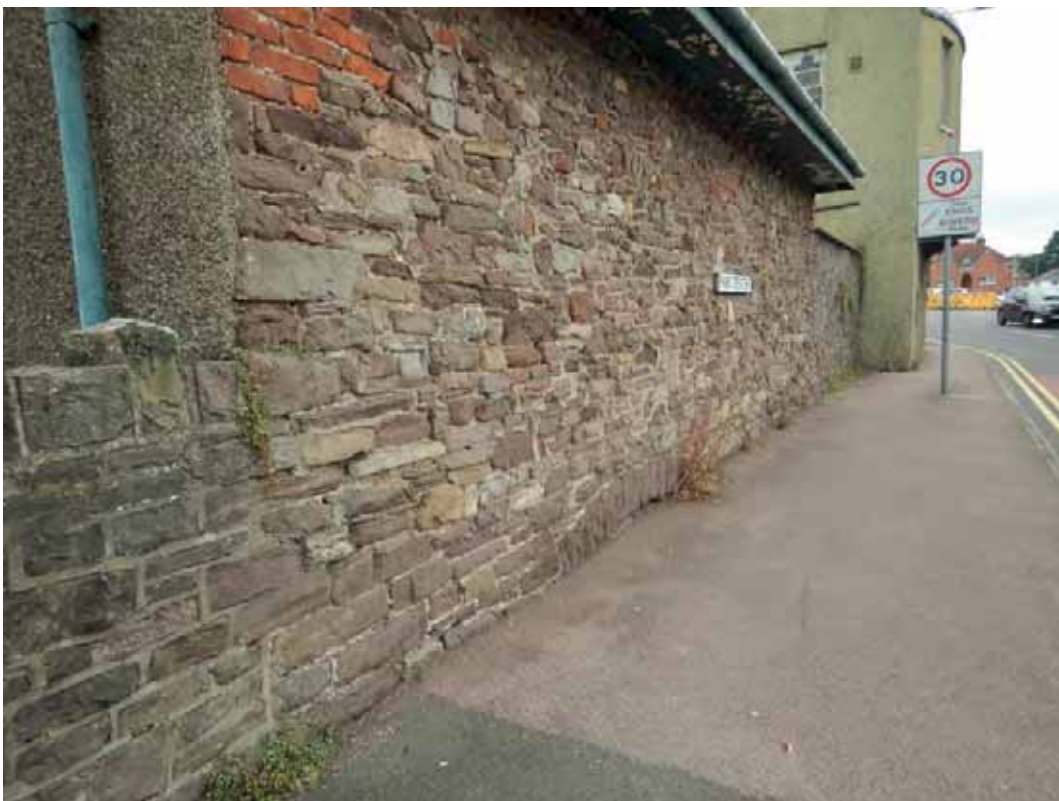
Plate 244. South wall of out-building showing the arch of a former culvert to the lower part of the wall. Looking north-east.

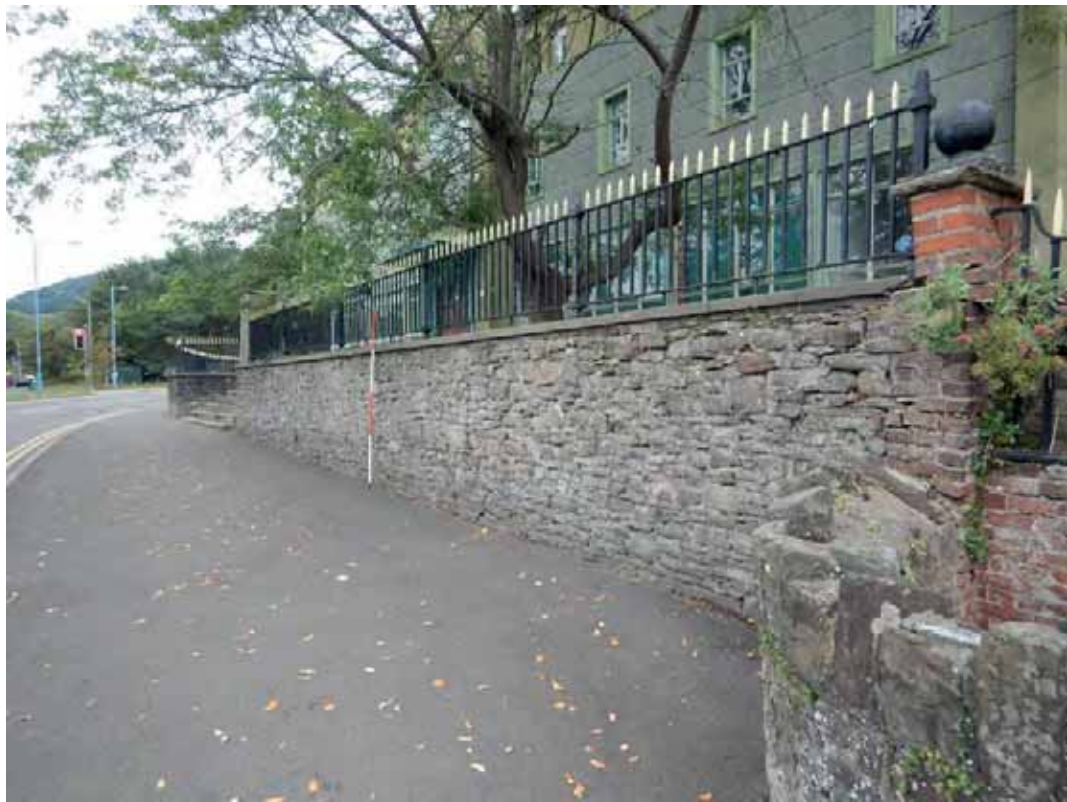
The north section of the front boundary wall, in front of the north annex, is also of uncoursed rubble stone but it is capped with concrete flat tiles (Plate 245). It follows the line depicted on the 1801 map and may be original with a modern coping added after the construction of the north annex. It is topped by wrought iron spiked railings which imitate those to the original gate, but which are modern (Plate 246).

Plate 245. Curtilage wall to the front of the north annex with modern railings, looking north-east. 2m scale.

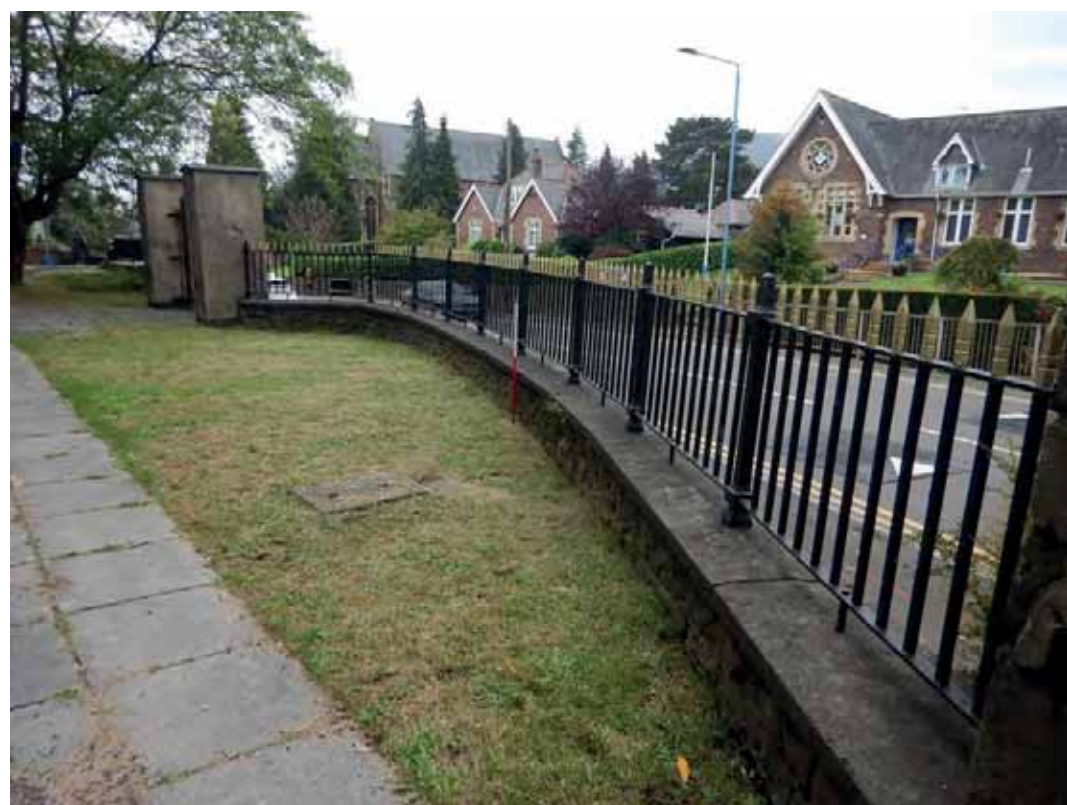
Plate 246. Modern railings to the top of the north-west of the curtilage wall, looking south-west. 2m scale.

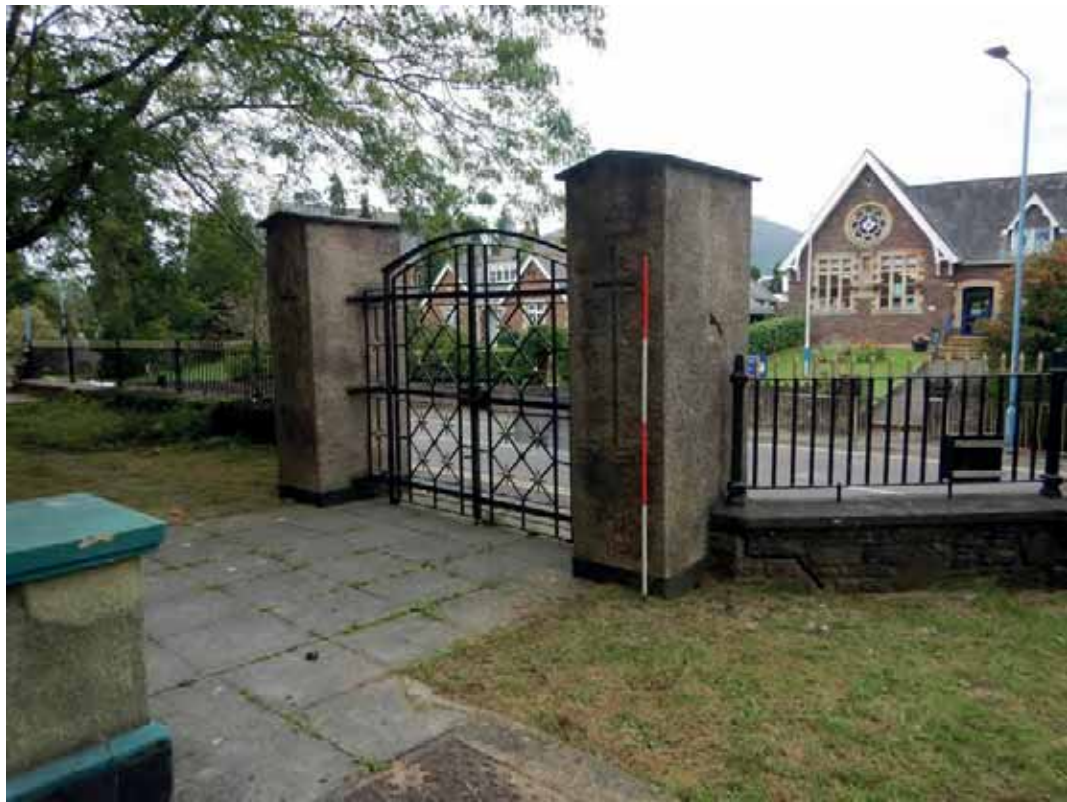
The entrance gate to the north Annex reflects the design of the original gate, but dates from the mid-20th century (Plate 247). It is of wrought iron with a depressed arch with diamond panels with stars to the corners. The gate posts are 2.5m high rough rendered rectangular pillars with pitched coping. They have a cross motif to each.

Plate 247. Gateway to the north annex, looking south-west. 2m scale.

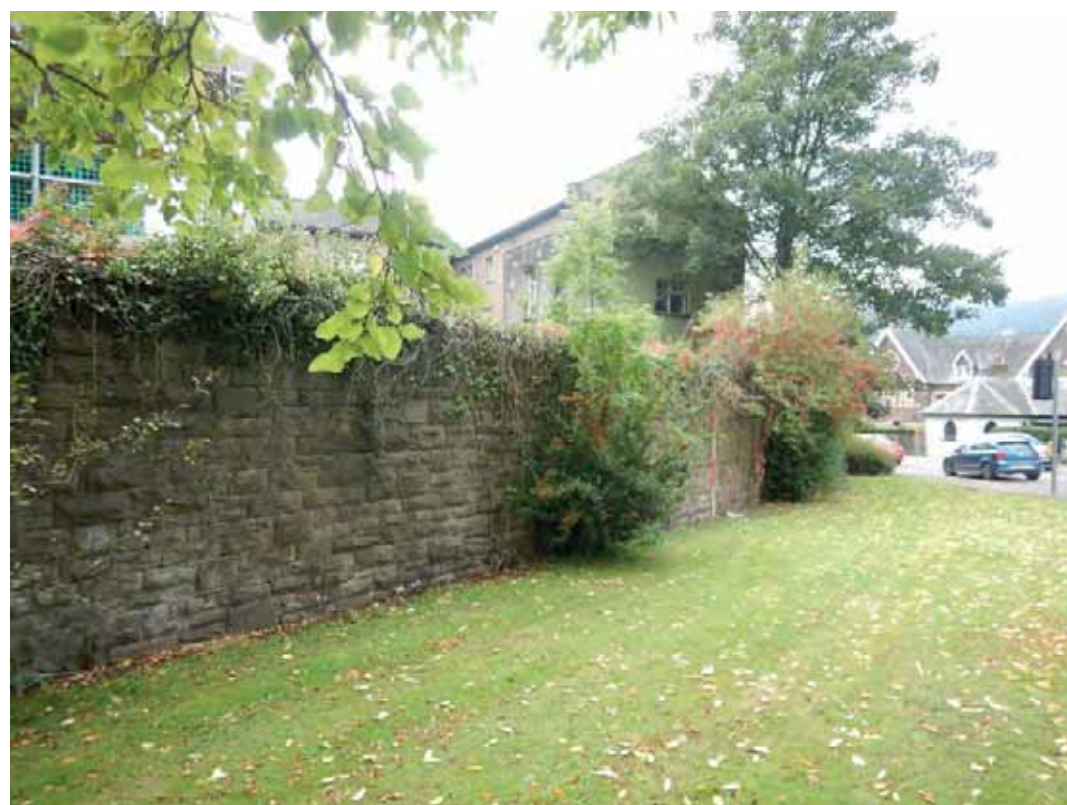
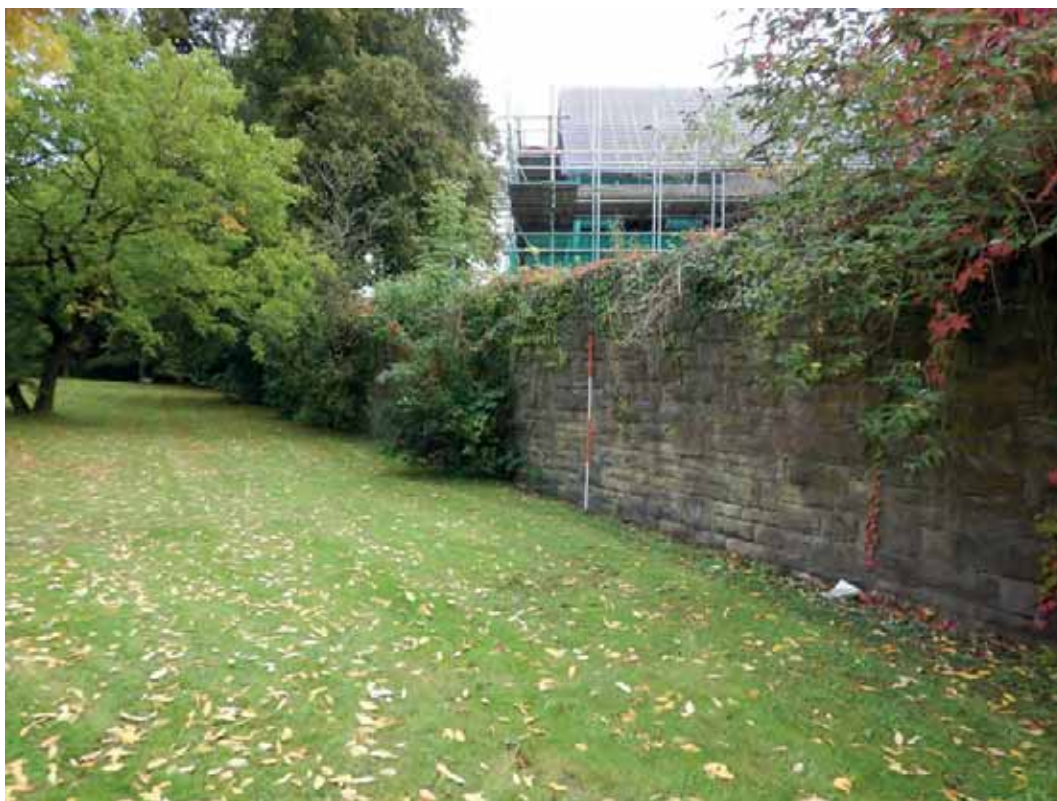
The curtilage wall continues to the north of the Mulberry House complex (Plates 248 & 249). It appears to follow the boundary between the orchard and Hereford Road depicted on the 1801 map, although from the map it appears that at that point the boundary was a hedgerow (Figure 3). It is clearly depicted as a wall on the 1880 town plan (Figure 4). It is very overgrown with bushes and vegetation. Unlike the wall to the front, which is of uncoursed rubble stone, the northern perimeter wall is of randomly coursed squared rock-faced ashlar stone. It seems unlikely therefore that this was dates to the original building of the house and it is probably a 19th century addition.

Plate 248. North section of the curtilage wall, looking south-west. 2m scale.

Plate 249. North section of the curtilage wall, looking south-east. 2m scale.

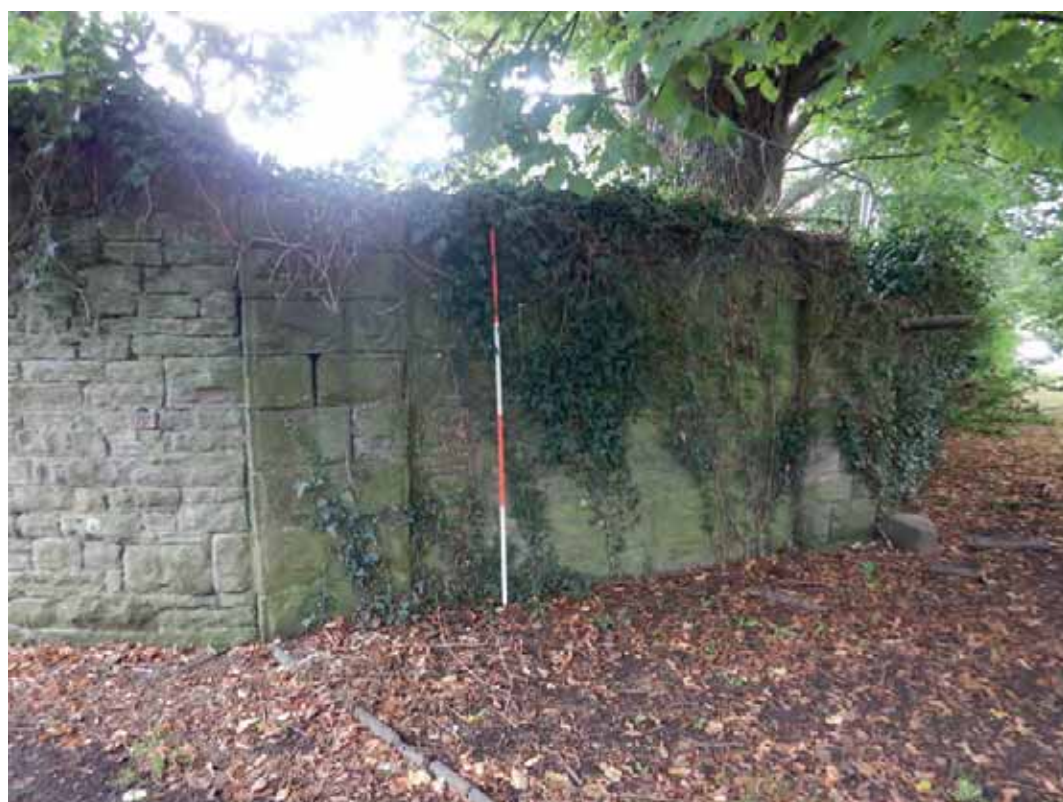
At the north-east corner of the curtilage wall there is a blocked gateway (Plate 250). The location of this corresponds to a gateway depicted on the 1880 town plan. It is noted on the 1901 OS map but not the 1920, therefore it was probably closed in connection with the founding of the convent. The gateway, which was probably contemporary with the rest of the curtilage wall, was flanked by large pillars of large squared rock-faced ashlar stone with dressed margins. The infilled section is of randomly coursed rubble stone.

Plate 250. Blocked gateway to the north-east corner of the curtilage wall, looking south-west. 2m scale.

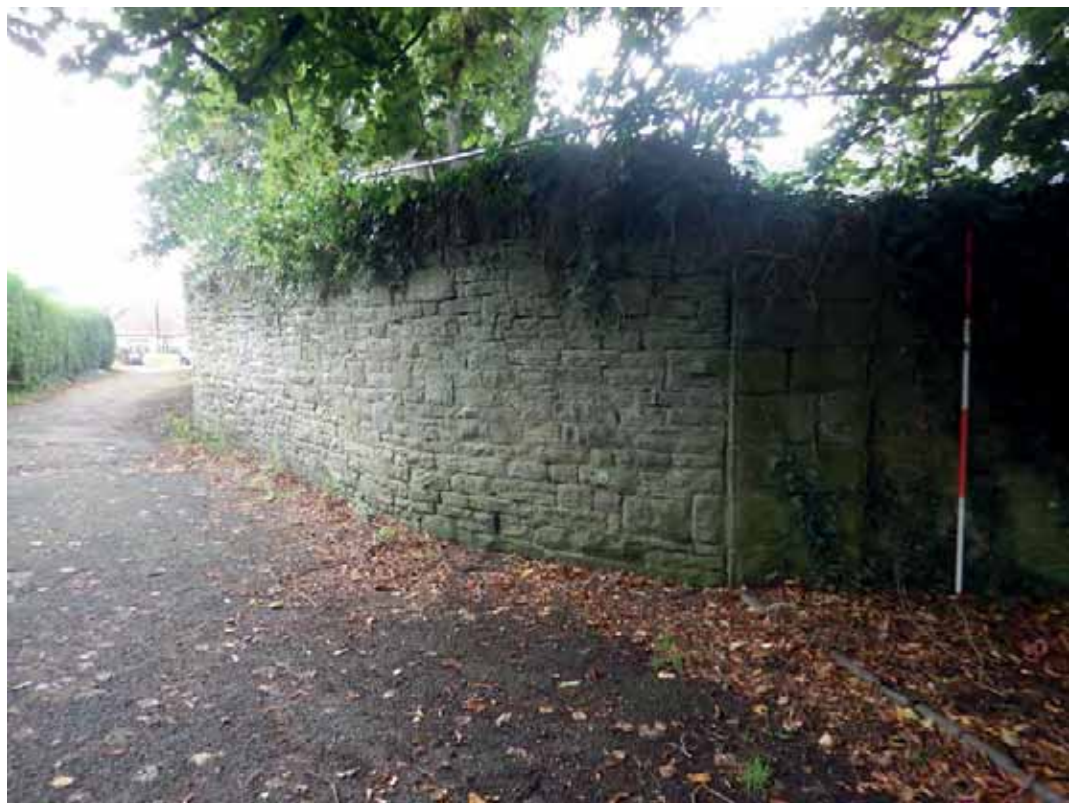
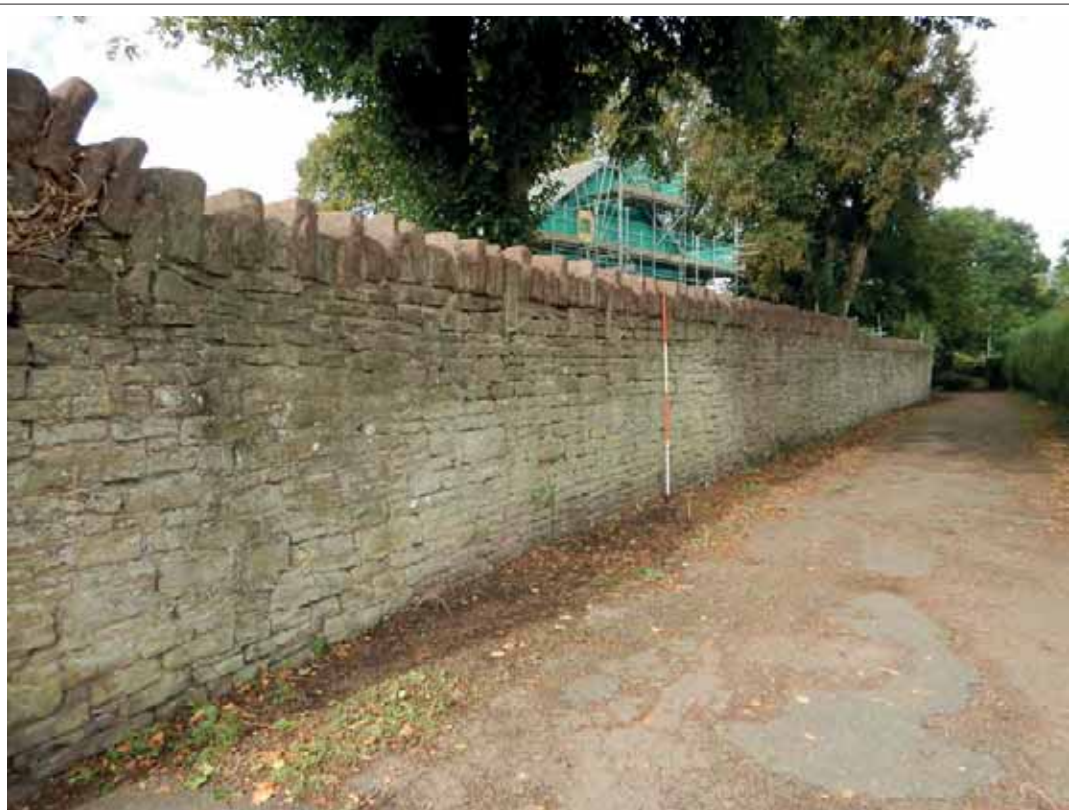
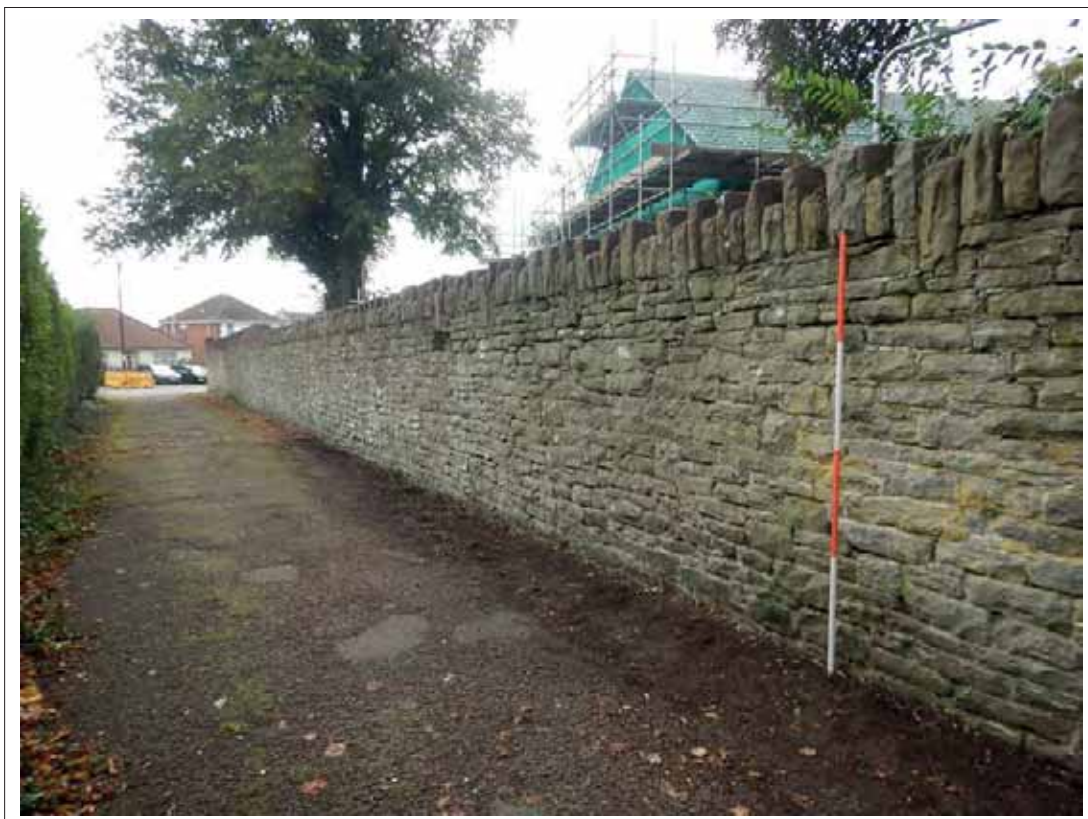
The curtilage wall curves to the south-east from this gateway (Plate 251). This section of wall, which runs along an alleyway (Plate 252), was also depicted on the 1880 town plan. Its construction differs from the northern section. It is of randomly coursed squared rubble stone with vertical rubble coping stones (Plate 253). It resembles the style of the front wall more than the north.

Plate 251. North-east corner of the curtilage wall, looking south. 2m scale.

Plate 252. East section of the curtilage wall, looking north. 2m scale.

Plate 253. East section of the curtilage wall, looking south-west. 2m scale.

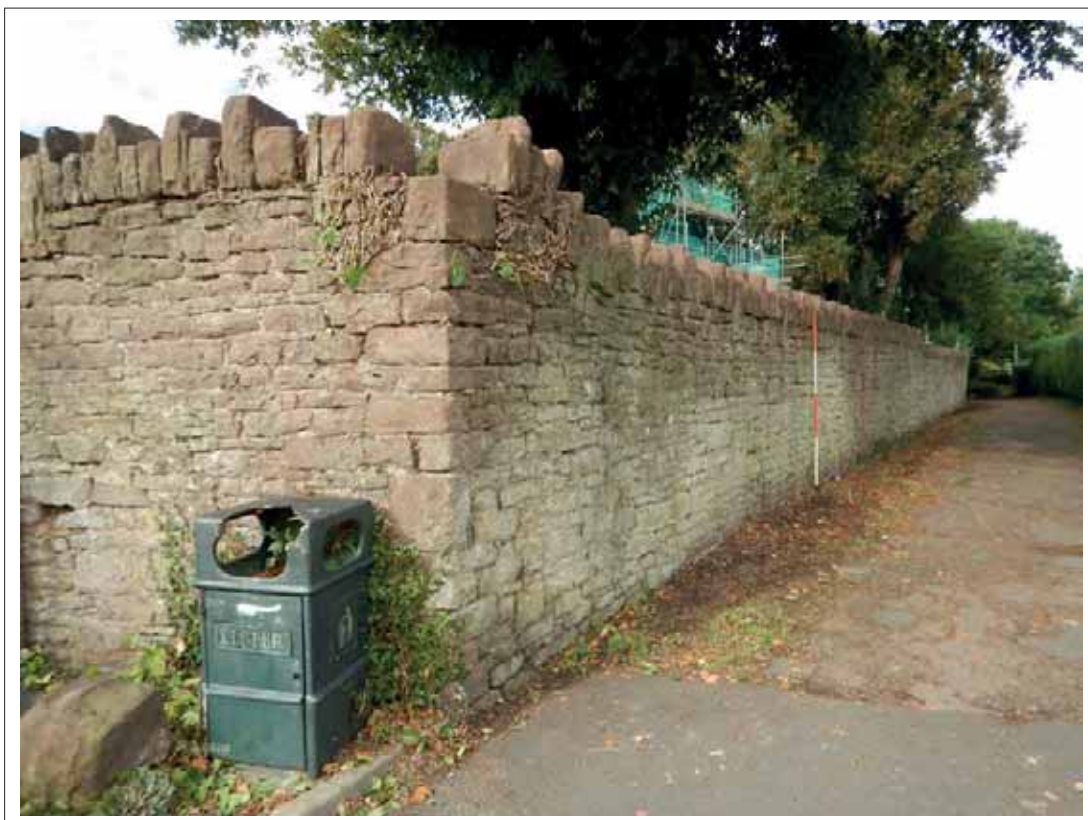
The south-west corner of the curtilage is a sharp corner at an angle of slightly over 90 degrees (Plate 254). Again, this is as depicted on the 1880 town plan. There is a gateway in the south-east wall, 3.5m from the corner. This is depicted on none of the historic maps and must have been created after the production of the 1970 - 1976 OS map. The wall, which on the 1880 town plan joined with the east wall of the walled garden, was present for another 10m to the south-west, after which it was replaced by a modern wooden fence. It seems likely that the original wall was demolished at the time of the construction of the houses on Park Crescent.

Plate 254. South-east corner of the curtilage wall, looking north. 2m scale.
