Barmouth Viaduct, Abermaw, Gwynedd

Desk Based Assessment and Site Visit

Report No. 1903

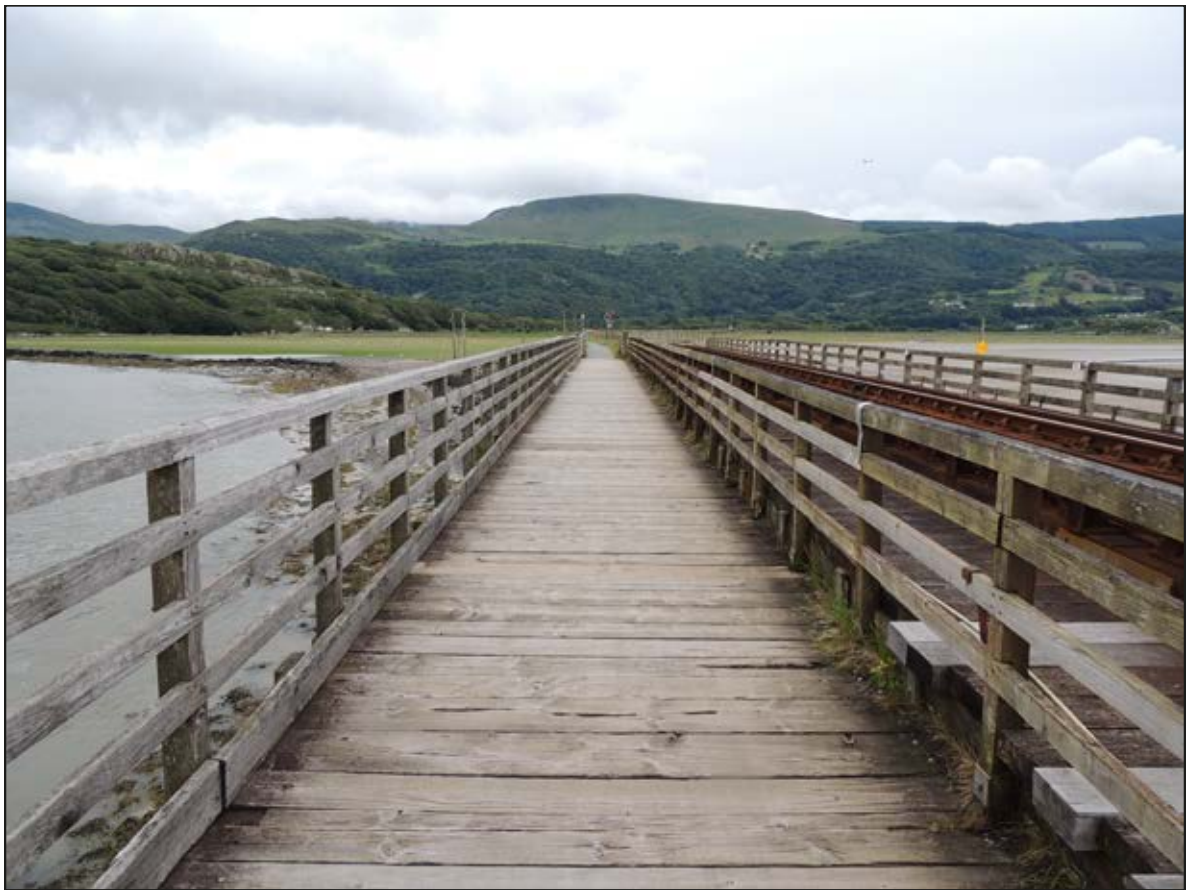
Plate 13. SE facing shot of viaduct walkway from between trestle 7.

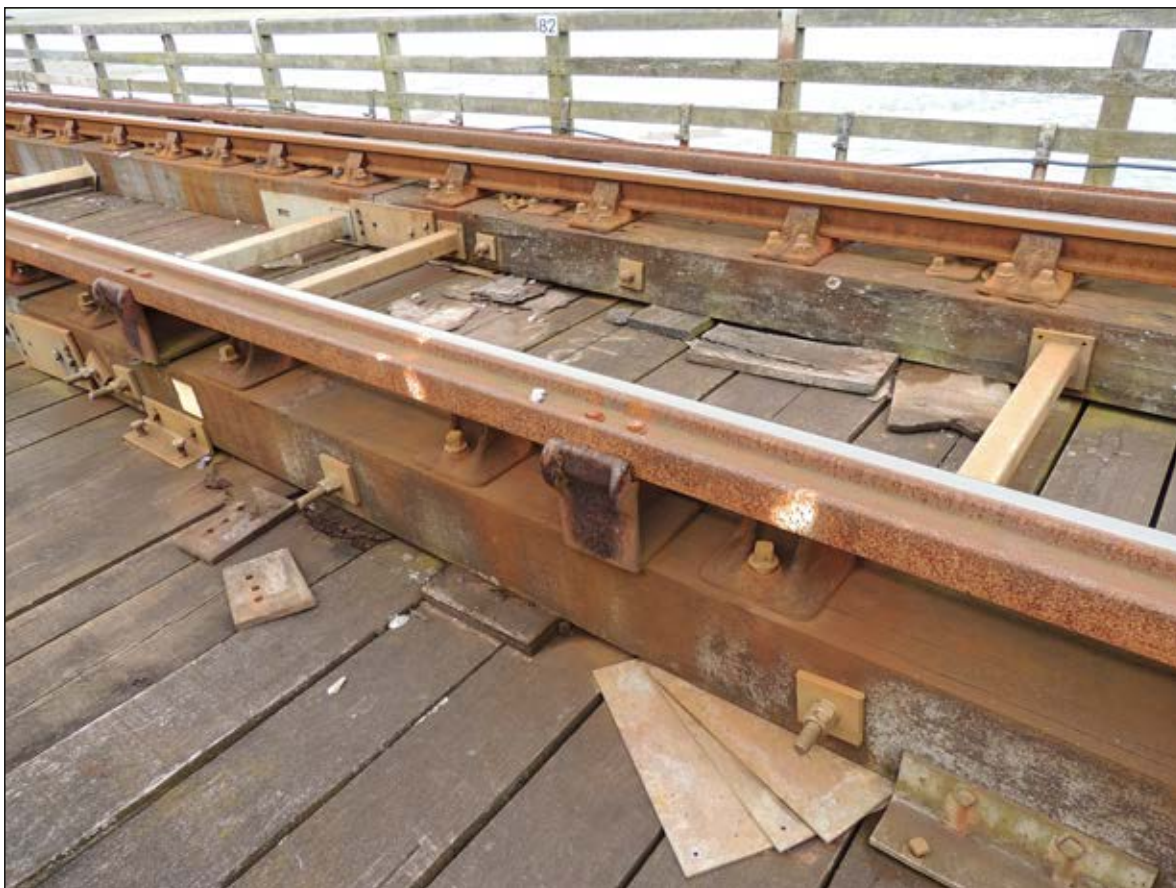
- 7.3.5. Other notable areas that were observed on the railway track were the transverse deck planks at trestle 81 and 82, where a number of planks that the track lies upon are sagging. It appears measures have been taken to prop up the track with metal plates and timber boards to keep the track level. The sagging of these deck planks are most probably due to the horizontal beam atop of the trestle beneath being weakened over time (See plates 24 and 25).

Plate 24. SW facing shot of metal plates supporting the track due to slumping of the transverse deck planks at trestle 81 and 82.

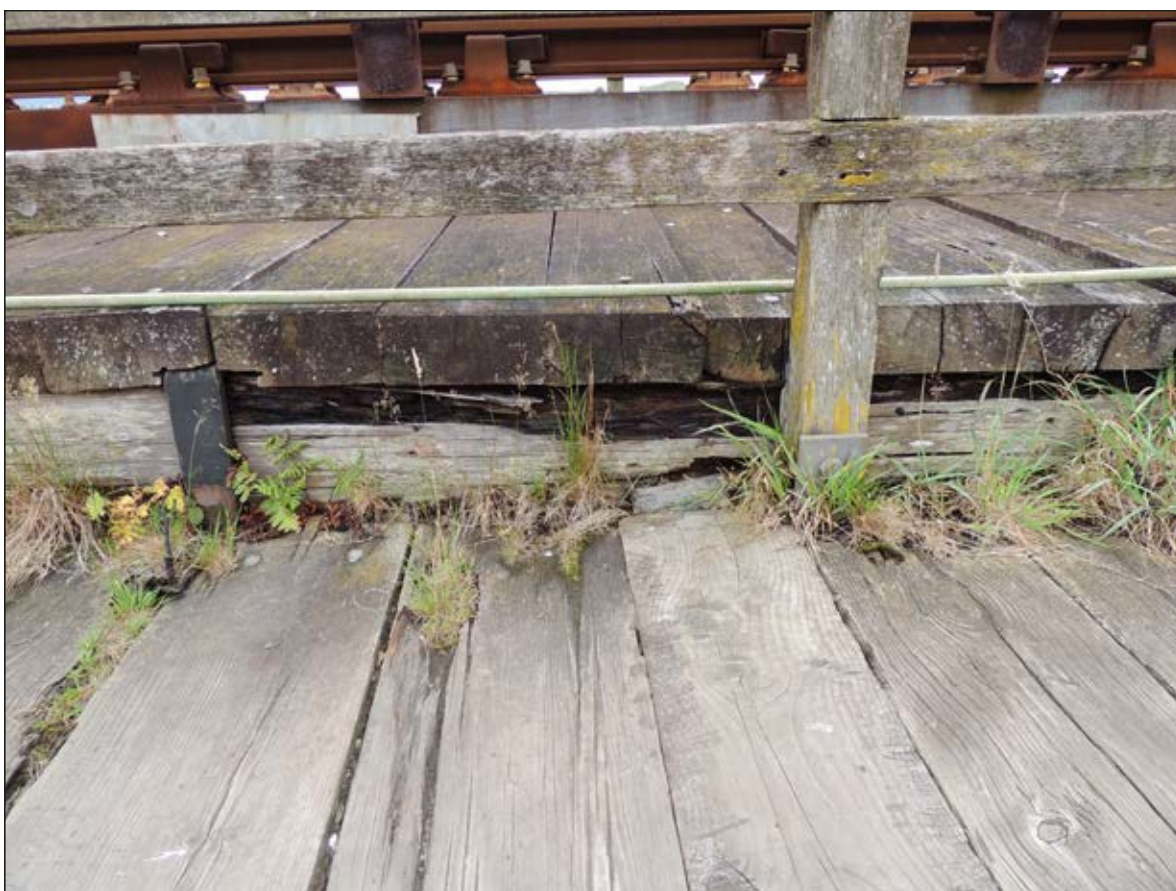
Plate 25. SW facing shot of metal plates and wooden boards supporting transverse deck planks at trestle 82.

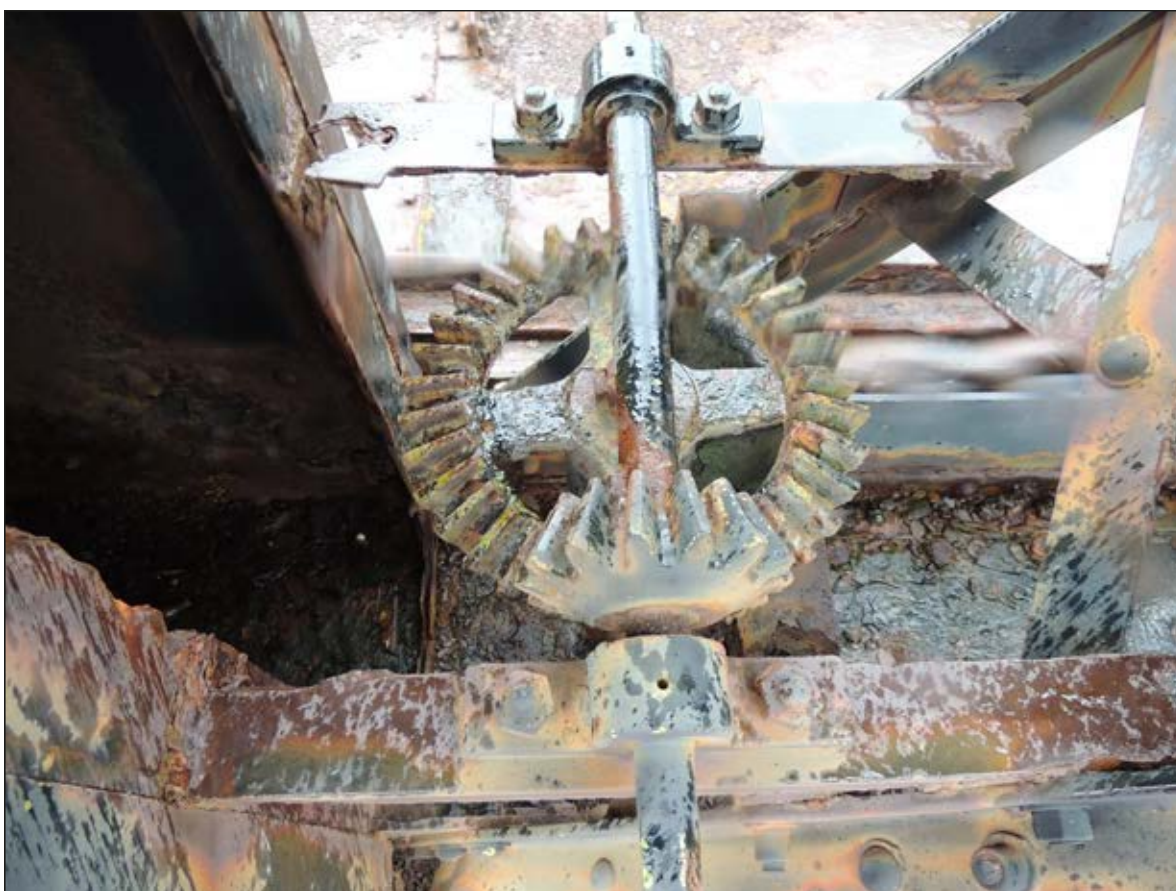
as part of the mechanism to pivot the bridge into position (See plates 37 - 38). The hand crank appeared to be in a good state of preservation and is an original feature of the swing bridge.

Plate 37. SW facing shot of hand crank mechanism of the swing bridge on NE elevation of hogback lattice trusses on the spans of the viaduct.

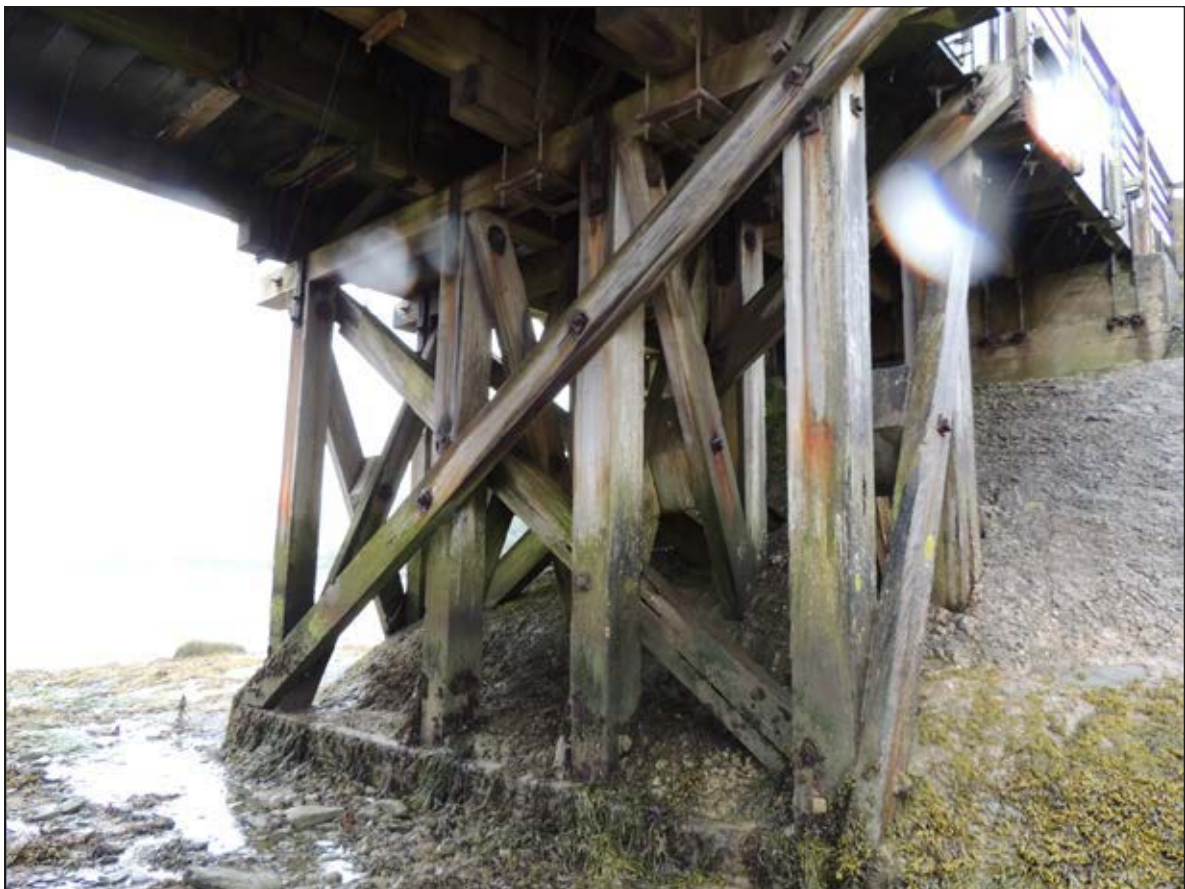
- 7.4.2. The first notable alterations to the underside of the viaduct were on trestle 2, where the metal straps that brace the cross-head beams to the central beam on the underside section of the railway track have been replaced. The replacement straps are made from galvanised steel with a square frame attached via nuts and bolts to hold the beams firmly together (See plates 43 – 44 and 48). The galvanised steel straps are quite noticeable compared to other metallic fittings observed on trestle 2, as all other fittings appeared older in date and had signs of corrosion. According to the engineer who was in attendance during the visit, noted that the galvanised steel straps were probably added during the 1990s, however engineering plans detailing the straps are not available. All other metallic fittings on trestle 2 correspond to engineering plans from the 1980s.

Plate 43. Shot of steel galvanised straps attached to support beams for transverse deck planks at trestle 2.

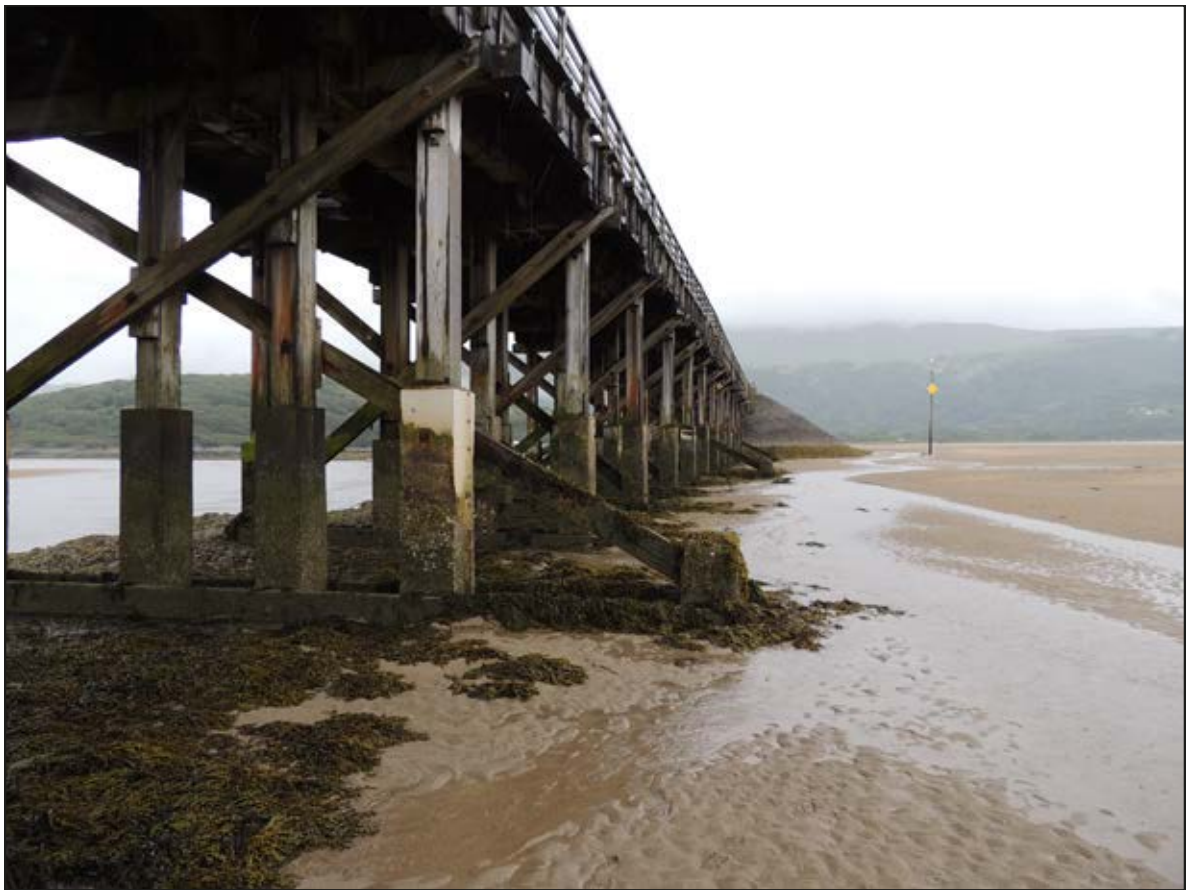
- 7.4.4. Reinforced concrete casings were observed on a majority of piles on the viaduct and were added as part of the alterations of the 1980s. The casings were added to protect the timber piles at the foot of the trestles from *Teredo Navalis*. However, water erosion has caused significant damage to the concrete casings and stripped them down to the rebar beneath (See plate 46). The worst affected by the water erosion are the piles on the seaward side of the viaduct. Observed on trestle 14 and 32 are what appears to be white plastic PVC coverings clipped together on two sides by metal fixings (See plates 47 and 50). Again, engineering plans could not be obtained to determine the date of when these were added, however the engineer who was present noted that they were probably from the 1990s.

Plate 46. ESE facing shot of damaged reinforced concrete pile casing with exposed rebar of trestle 13.

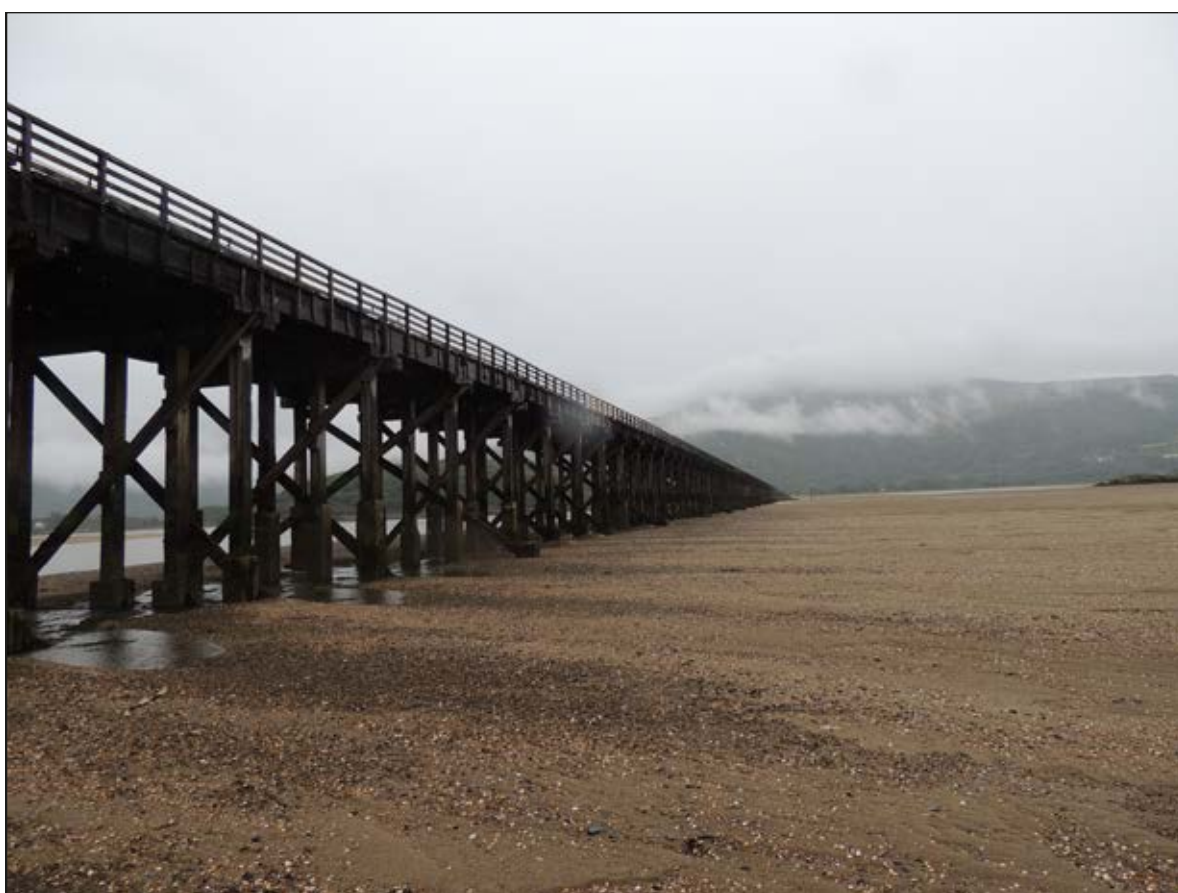
Plate 51. N facing shot of trestle 39 showing erosion of verticle piles and concrete pile casing.

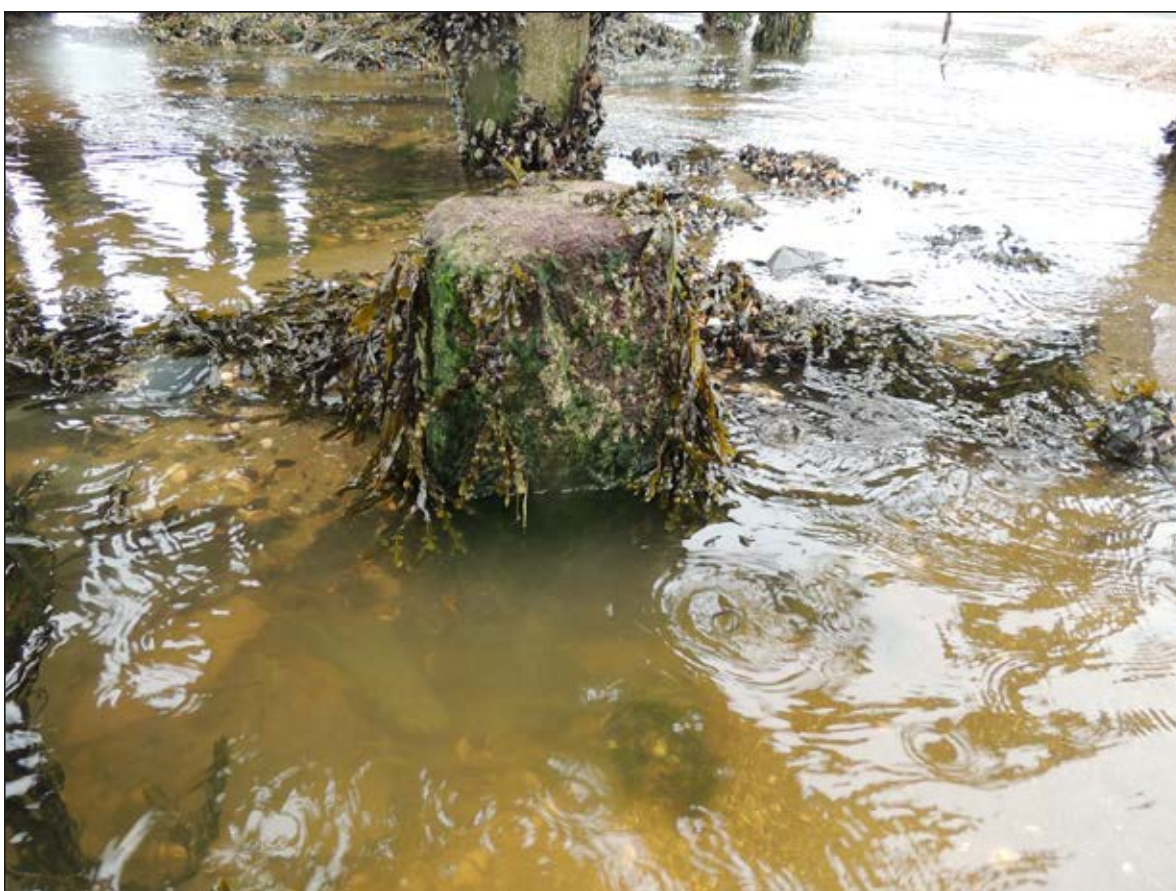
not be ascertained if they were of timber or concrete, as access to them was impeded by fairly deep water in these areas (See plates 53, 54, 56 and 57). The stumps at trestle 55 were in the best state of preservation and were approximately 1m in front of the dividing trestle of 55 and 56 and aligned perfectly with the functioning piles behind. The stumps of the suspected older piles under trestle 55, 86, 87 and 88 are at a section of the viaduct where there is no reno mattress on the estuary bed and appears the reno mattress ceases at trestle 54 (See plate 55). The reno mattress at trestle 54 is approximately 0.50m thick and has a heavy covering of seaweed. It is unclear if the reno mattress in the sections of the viaduct where the pile stumps are located has been removed, or if there was ever any laid on the estuary bed at these sections of the viaduct. Notwithstanding, the 1980s renovation plans included the placement of reno mattresses in pier 55, and indicated the existence of older mattresses in 86, 87 and 88. The absence of these structural elements may suggest alterations postdating the 1980s.

Plate 53. NNE facing shot of remains of verticle pile stumps under trestle 55.

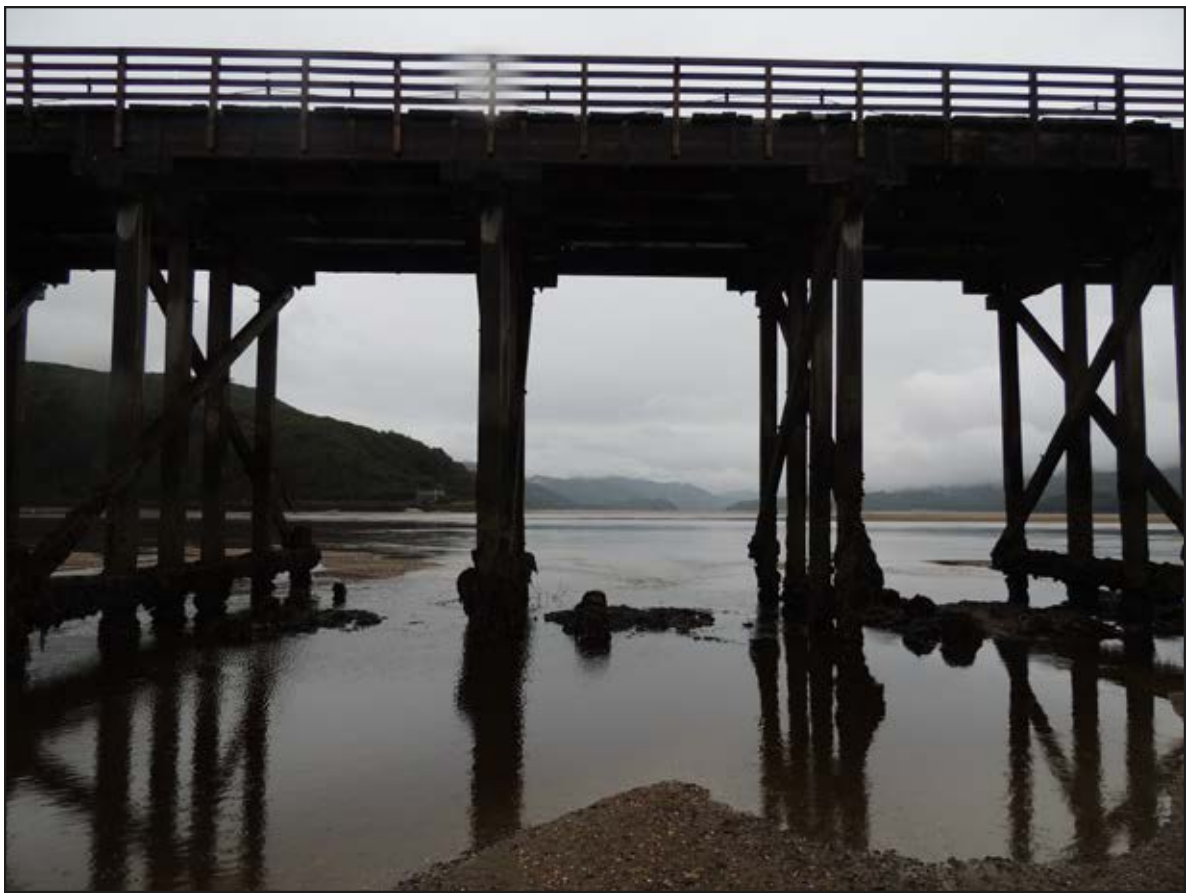
Plate 56. NE facing shot of the remains of old verticle pile stumps under trestle 87.
