Sea View Labour Club, Barry

Level 2 Building Survey

Report No . 1967

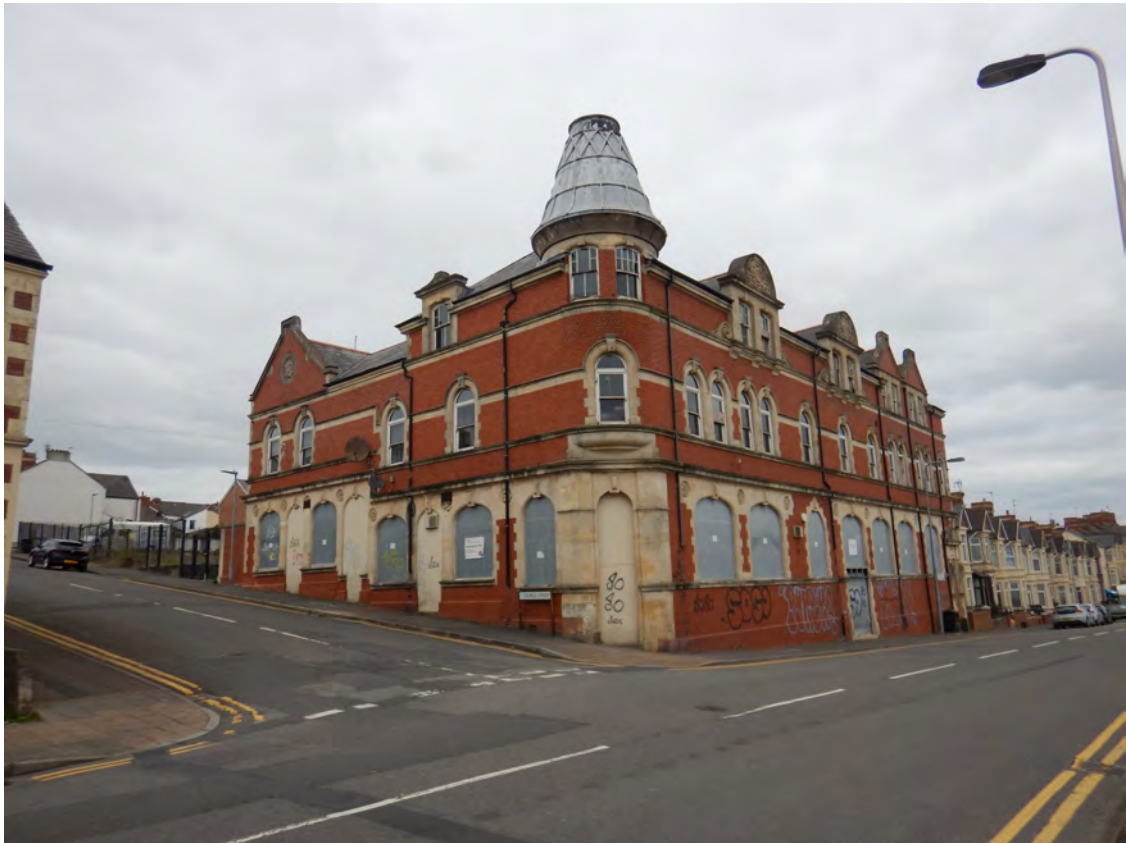
- 5.1. The Sea View Labour Club building is a 2 ½ storey, L-shaped building orientated north-east – south-west along Dock View Road (Figure 2; Plate 1). The north-east end is gabled while the south-west is hipped. There are two cross-gable projections to the rear of the building. The smaller, to the north-east end, is square to the main building,

Plate 1. Seaview Labour Club, looking north

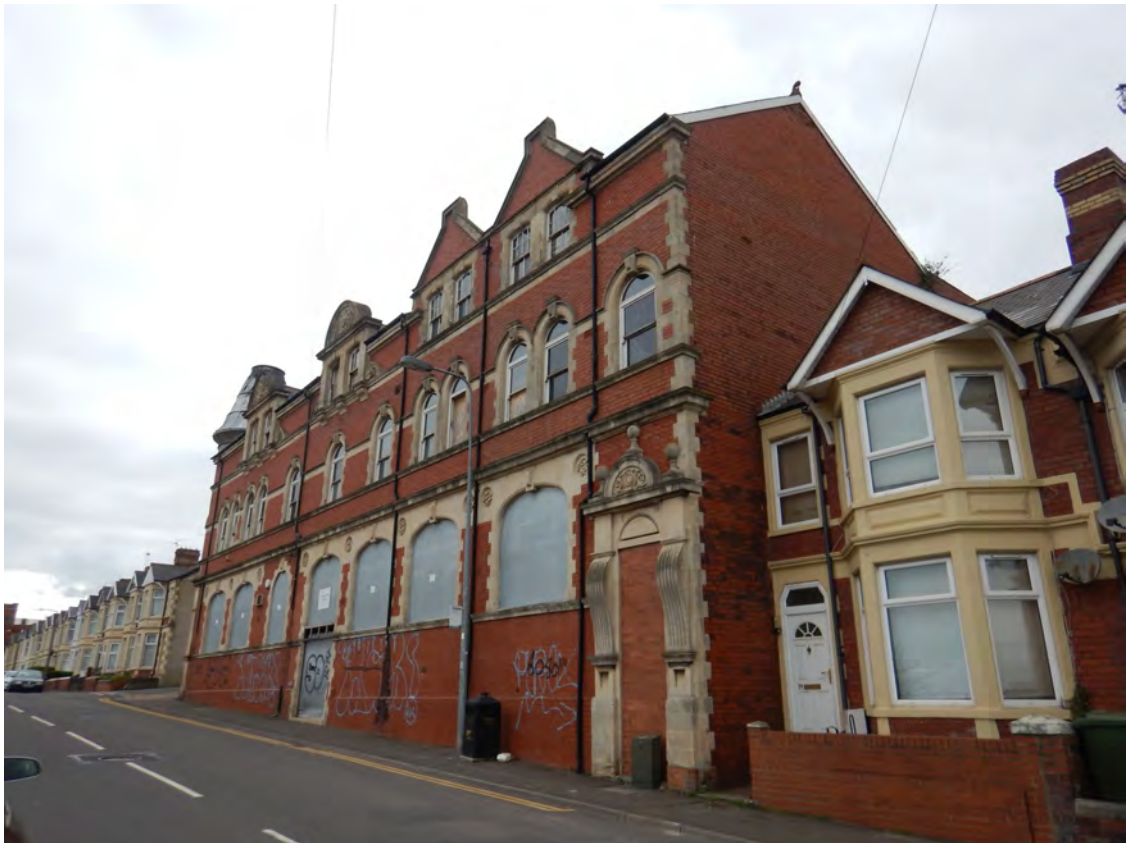
- 5.4. The front elevation is two and a half storeys high and nine bays wide (Figure 3; Plates 2 and 3). There is also a partially exposed basement, as Dock View Road slopes down to the north-east. The façade has the broad appearance of symmetry, which is jarringly contradicted by notable asymmetric elements, possibly intended to give the appearance of phased development.

Plate 2. Front elevation of Seaview Labour Club, looking north-west

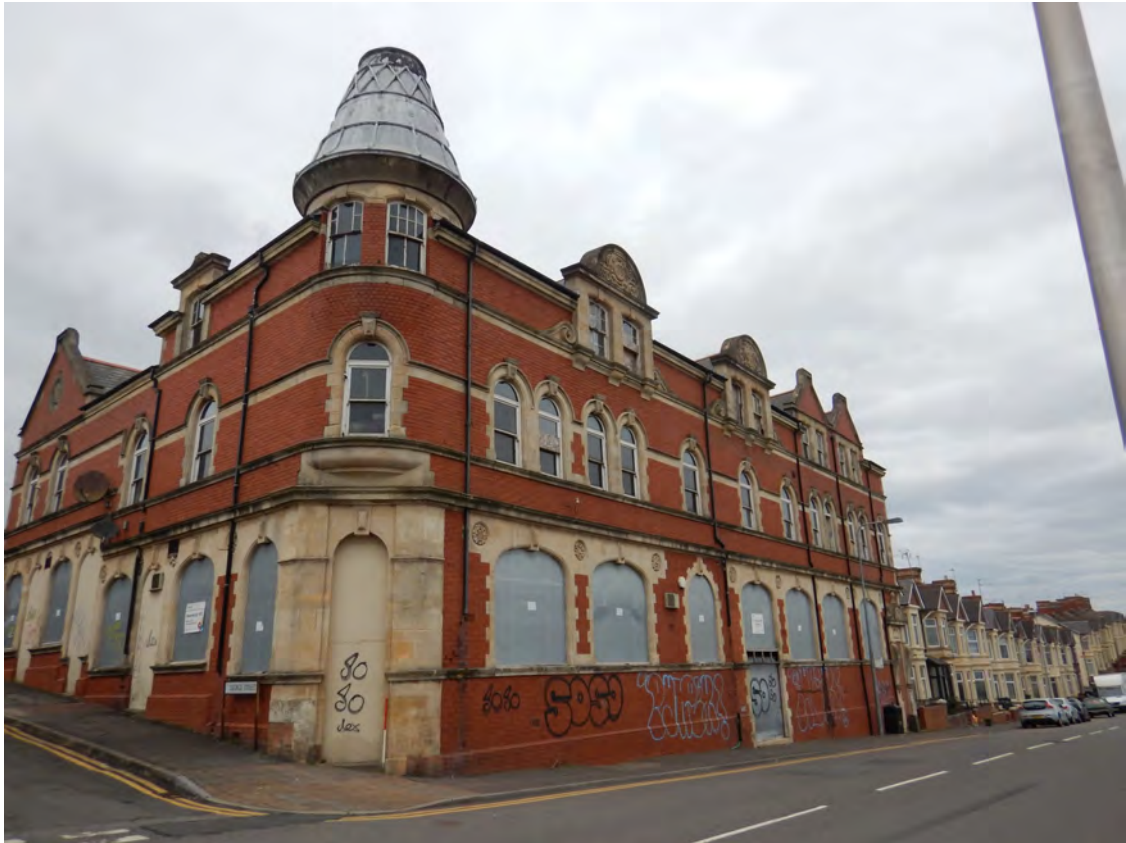
Plate 3. Front elevation of Seaview Labour Club, looking north-east

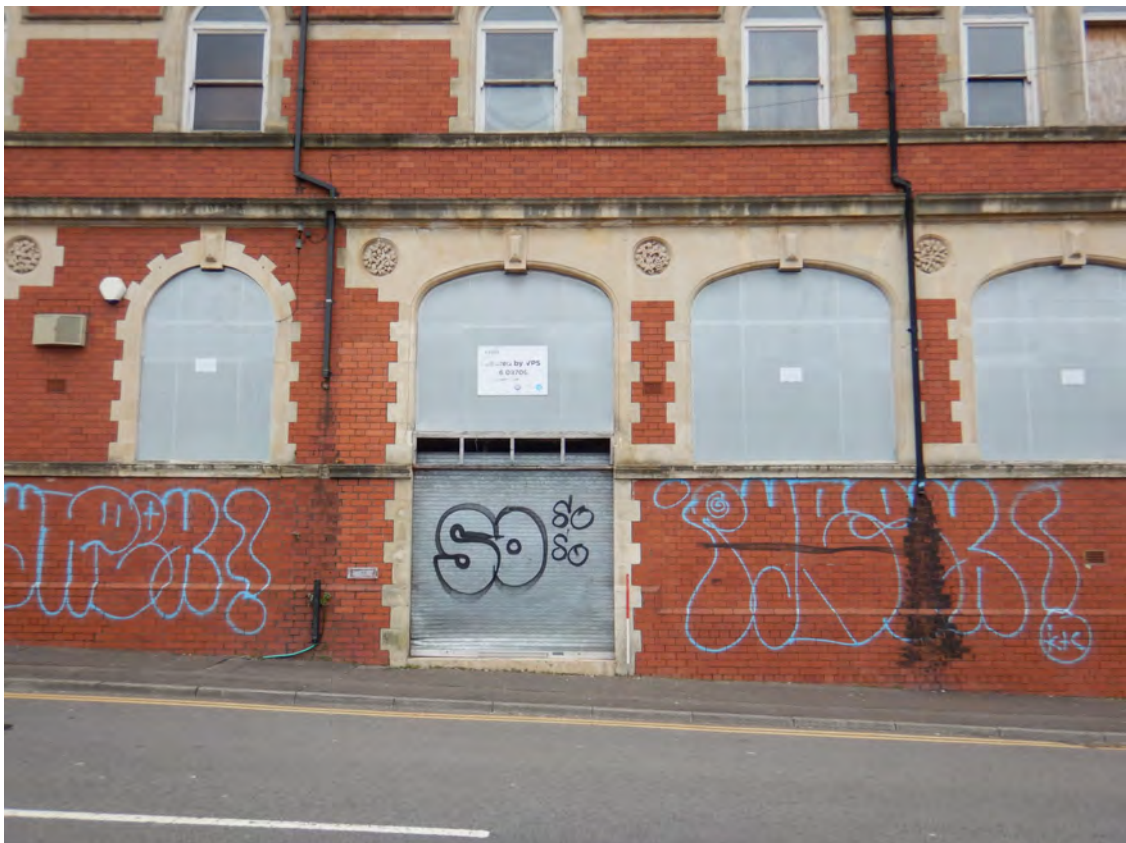
- 5.7. The main entrance is to the centre of the façade (Plate 4). The door is now covered by a metal roller door and security grill. The three-centred arch surround is of limestone ashlar block quoins, which have moulded interiors to the upper part, in the same style as the ground floor windows, and are square to the lower part. There is a slightly projecting dropped keystone.

Plate 4. Main entrance on the front elevation, looking north-west

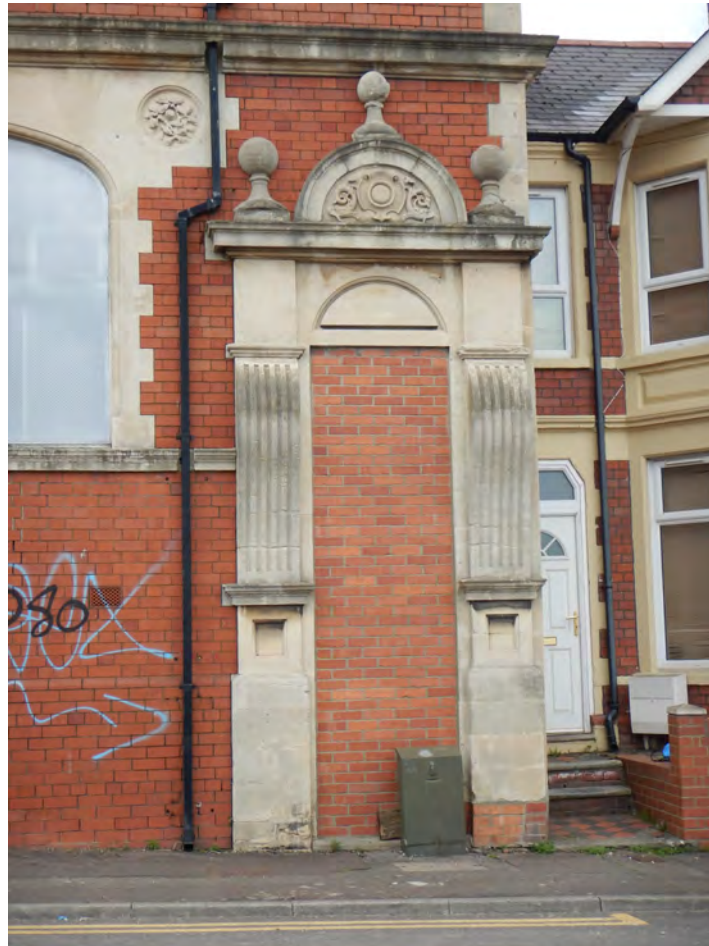
- 5.8. The entrance to the north-east end of the façade has a tall, narrow, flat arch doorway that has been bricked up with reddish-orange bricks and cement mortar in a stretcher bond (Plate 5). It has a Neo-Classical style limestone surround with blocked pilasters

Plate 5. Blocked doorway to the north-east of the front elevation, looking north-west

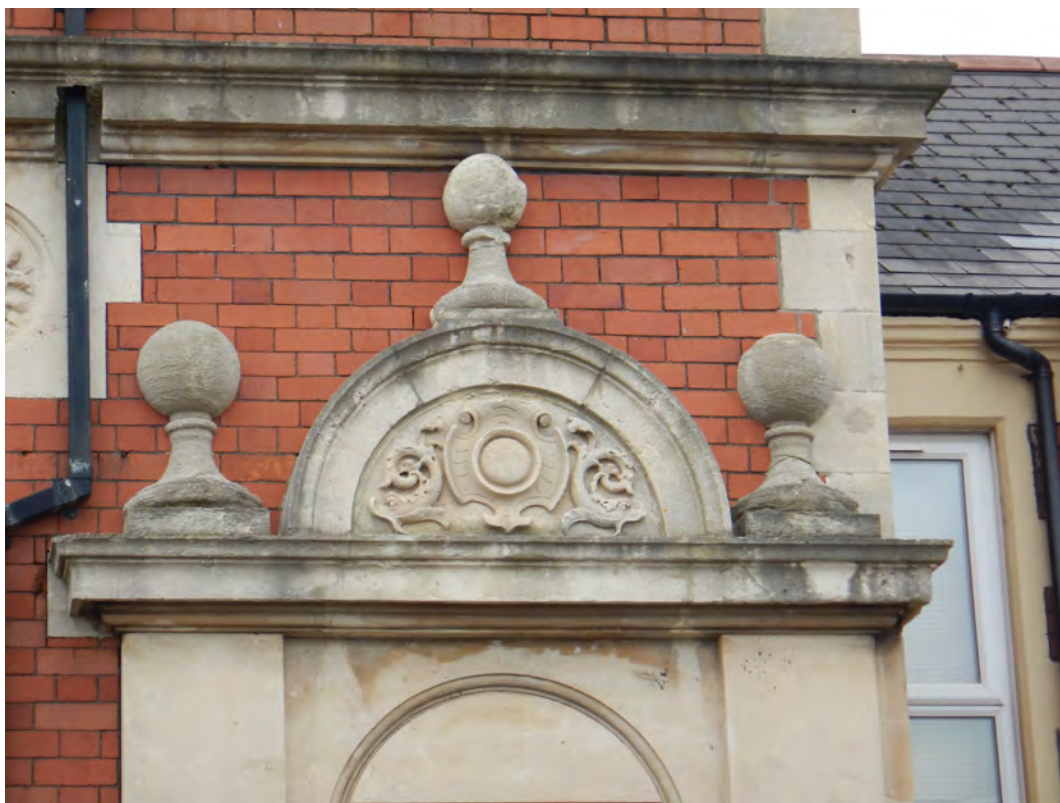
including a curving, fluted section and a rounded pediment. The tympanum is decorated with a crest flanked by fish (Plate 6). To the top and either side of the pediment are ball finials.

Plate 6. Detail of the pediment above the blocked doorway, looking north-west

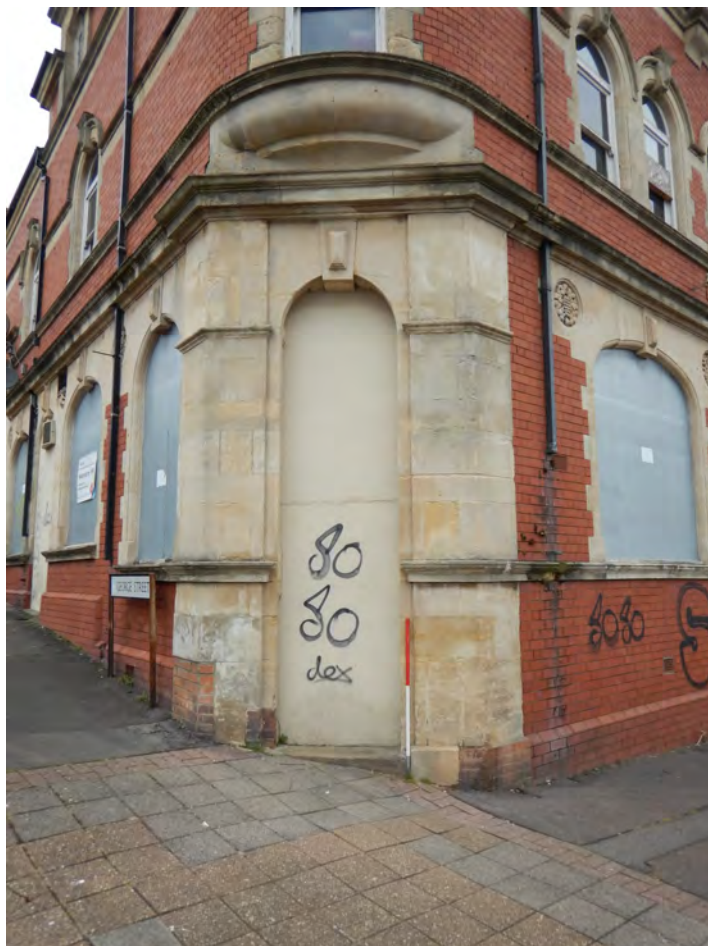
Plate 7. Blocked doorway to the southern corner of the Seaview Labour Club, looking north-west

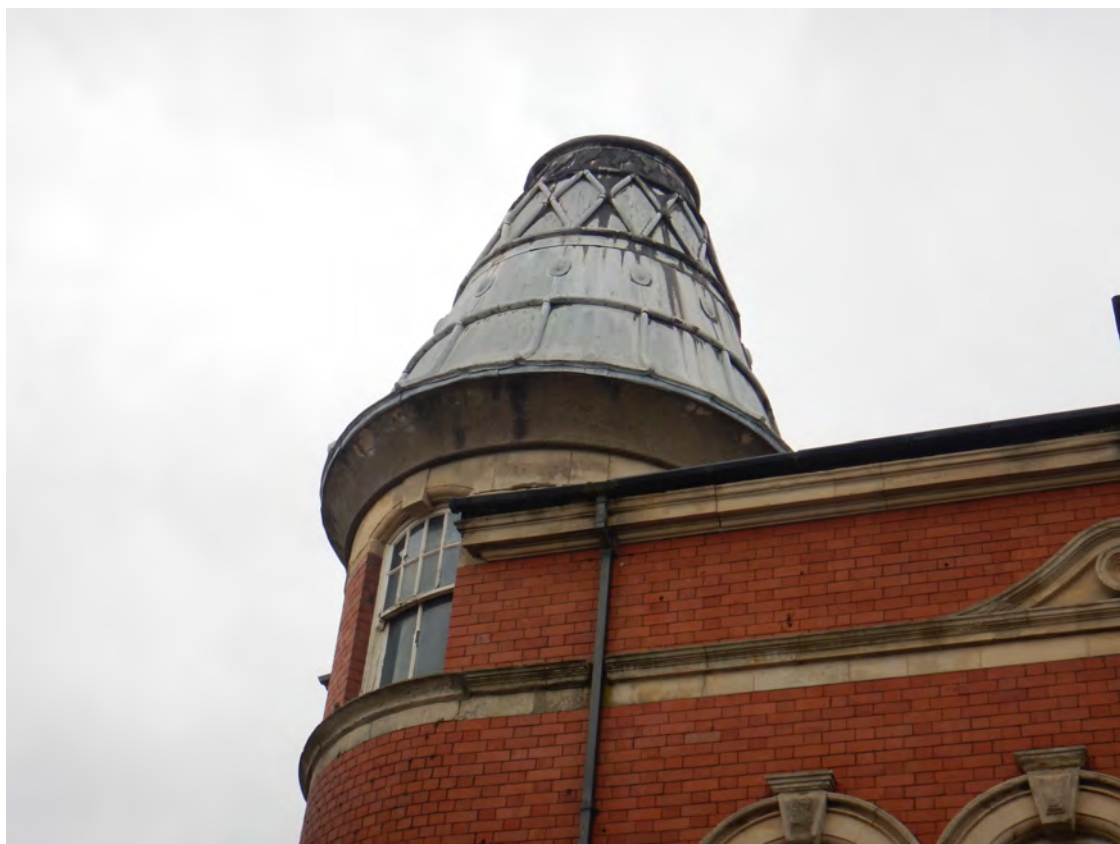
- 5.16. The circular corner tower to the south corner of the building is a flat topped, conical lead covered structure with limestone base (Plates 18 and 19). It has applied lead decoration of banding, small roundels, and diamonds.

Plate 18. Circular lead-roofed corner tower, looking west

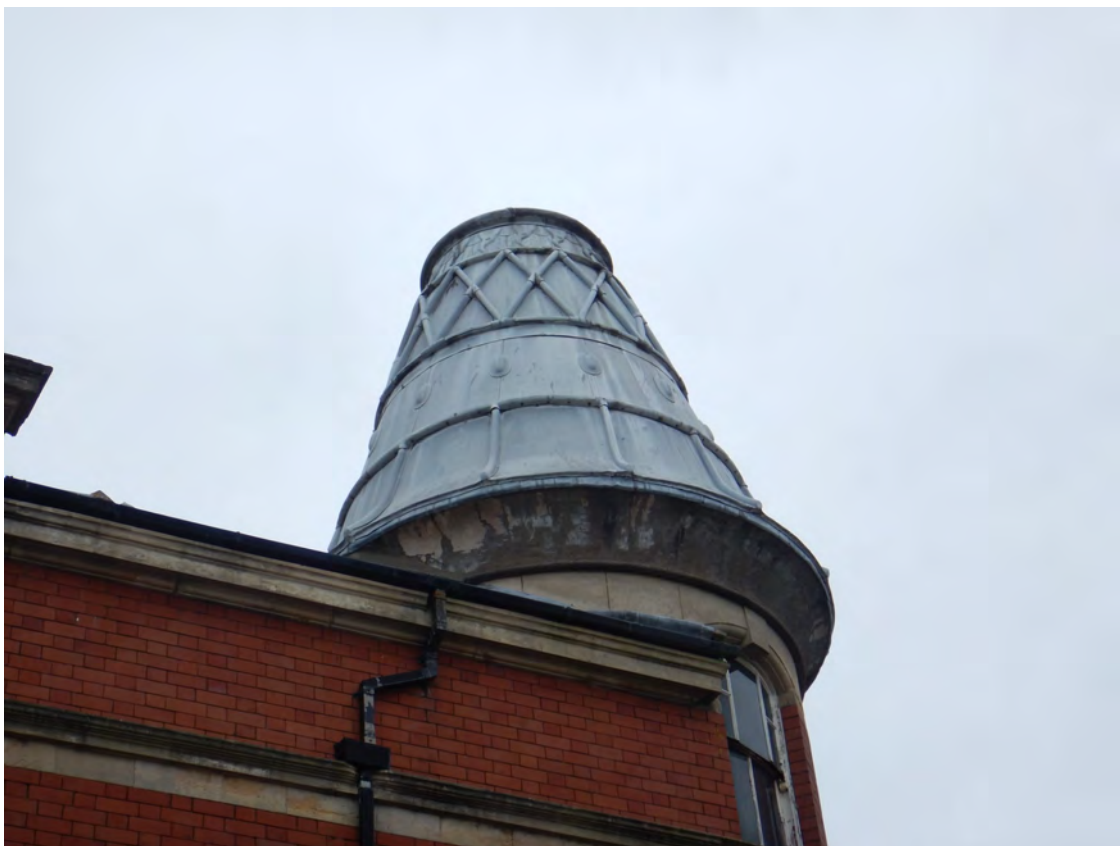
Plate 19. Circular lead-roofed corner tower, looking east

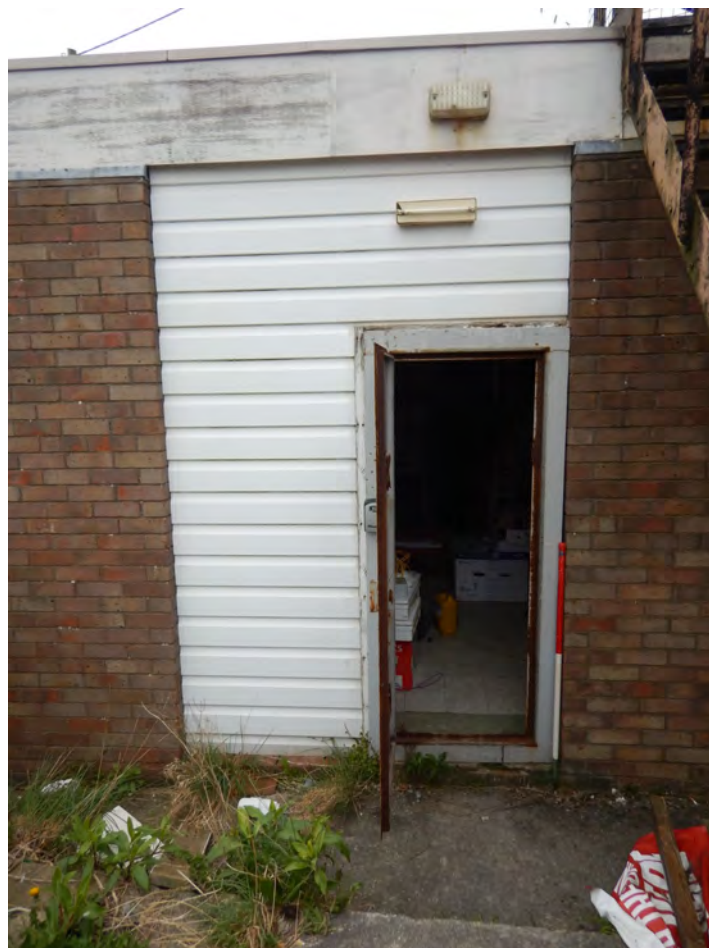
Plate 25. Door to the south-west facing elevation of the 1970s extension, looking north-east

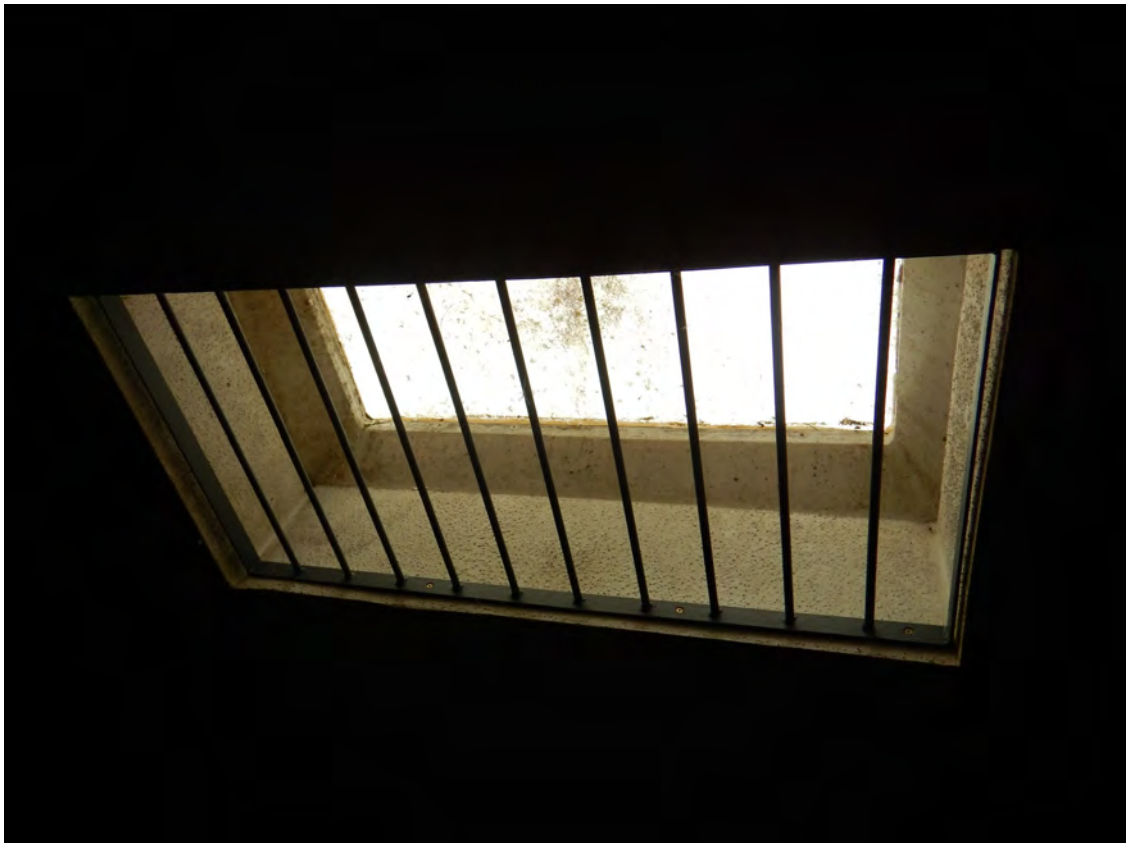
- 5.39. Room 2, the Club Committee Room, has green carpet. The walls are painted yellow over textured paper, with a decorative paper band to the top (Plate 44). The ceiling is white painted plaster with two electric strip lights. Both walls and ceiling show signs of damp, with large amounts of mould growth. There are two skylights in the ceiling, covered with metal bars (Plate 45). A door on the north-east wall leads to Room 3. The door is a plain white painted wooden door in a blue painted wooden frame (Plate 46). It has a plate inscribed with "SEA VIEW LABOUR CLUB OFFICE."

Plate 44. Room 2, looking north-east

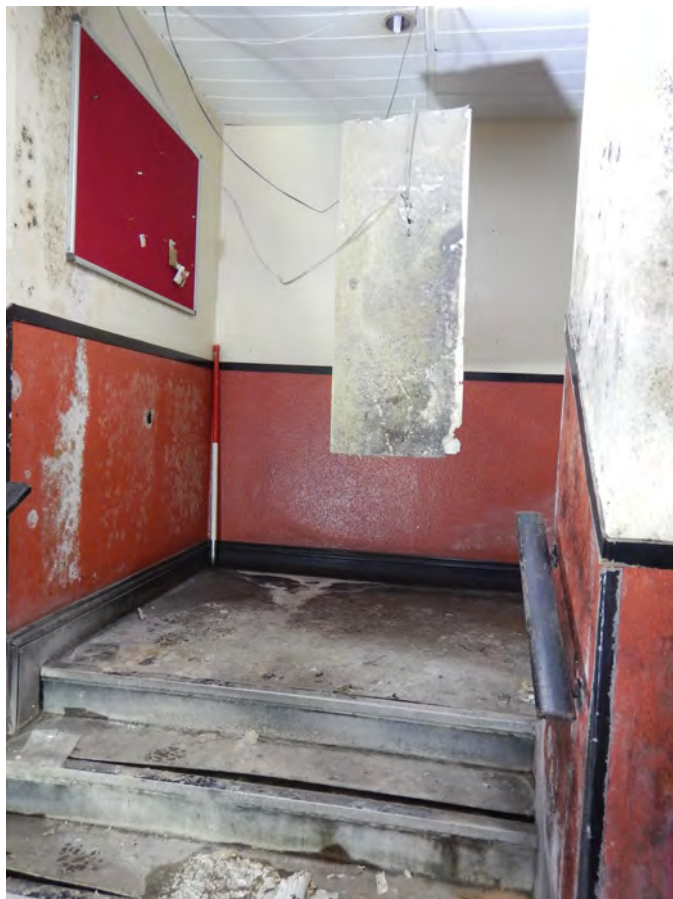
- 5.44. Room 5 has suffered damage from a roof leak (Plate 56). The floor is exposed concrete. The walls are textured paper with moulded skirtings and picture rail. The ceiling is suspended plastic wooden plank effect tiles with electric spotlights. The remains of upholstered benches are on the south-west and east corner walls. There is a metal door in a wooden frame on the north-east wall which leads out to the courtyard area.

Plate 56. Room 5, looking north

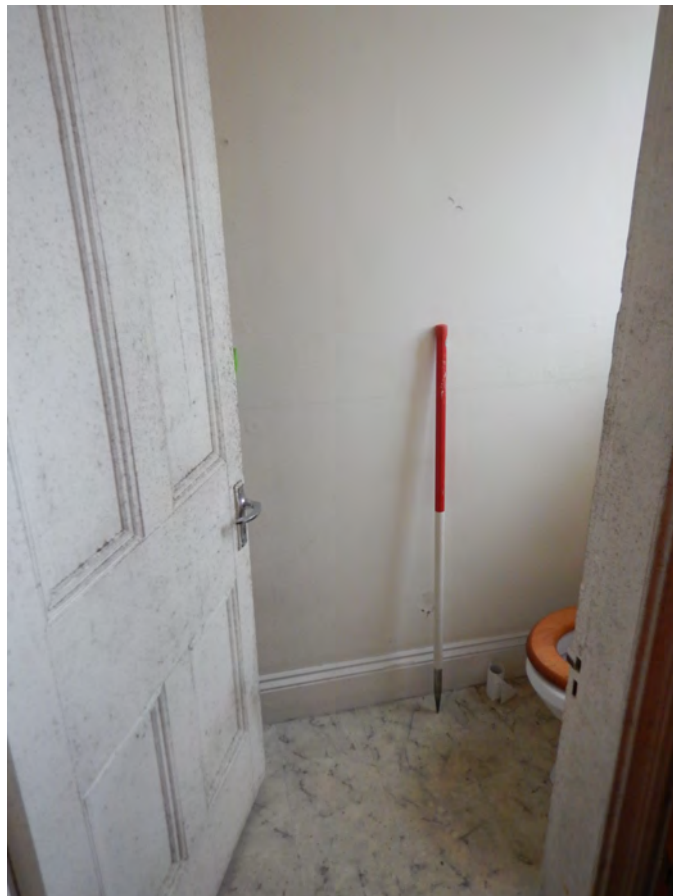
Plate 116. Door to toilet, looking south

white-painted solid wood with four fielded panels (Plate 116). There is a small one-over one-light with awning transom uPVC window and plastic sill on the north-west wall (Plate 117).

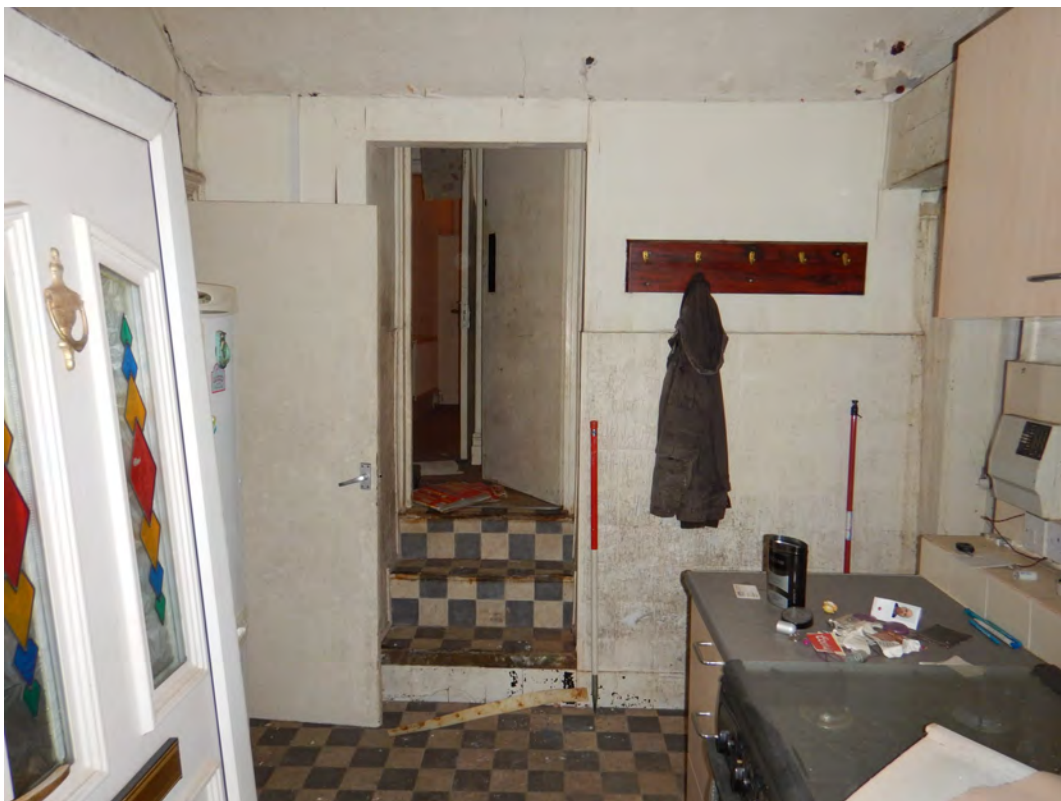
Plate 118. Accommodation area Kitchen, looking south-west

- 5.62. The kitchen is accessed from the Corridor down a flight of three steps (Plate 118), meaning both it and the neighbouring Lounge are at the same level as the main building First Floor. The two rooms occupy the smaller north-west – south-east orientated cross-gable. It has chequered tile pattern lino flooring and painted plaster walls and ceiling (Plate 119). The doors to the Corridor and Lounge are both solid wood in wooden frames (Plate 120). There is a fire escape door on the north-west wall. There is a one-over one-light awning transom uPVC window on the north-west wall (Plate 121) and a one-light casement uPVC window on the north-east wall. The kitchen has modern fixture and fittings.

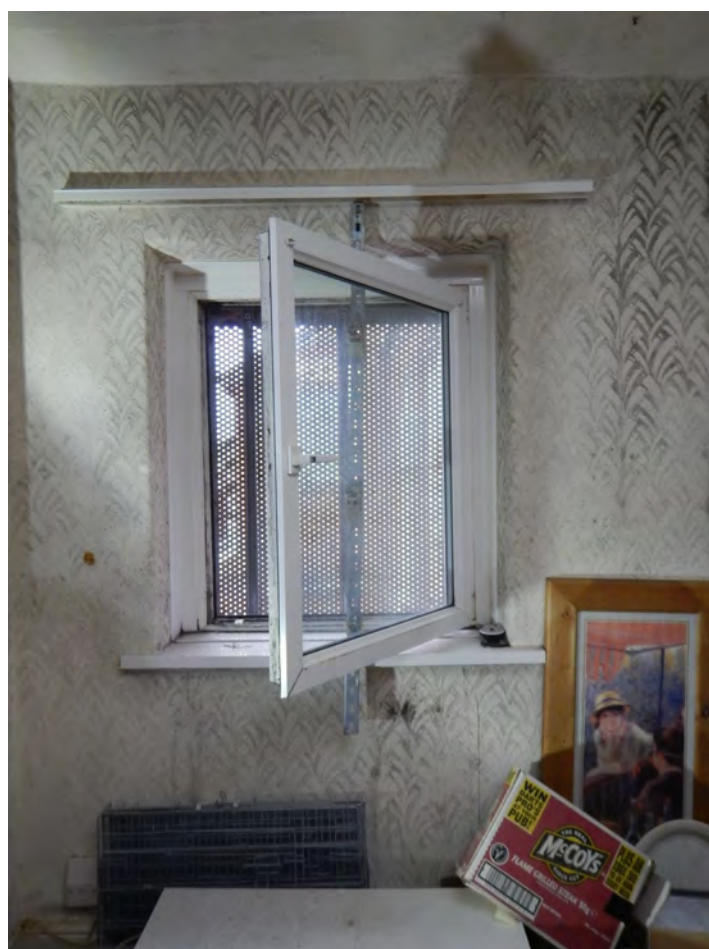
Plate 124. Window on north-east wall of Lounge, looking north-east

- 5.63. The Lounge has brown pattern carpet, white-painted moulded skirting boards and textured foliage pattern wallpaper (Plate 122). The ceiling is painted plaster and slopes slightly on the north-east and south-west sides due to the roof gable. There is a small ceiling hatch to access the roof with moulded wooden surround. On the south-west side the ceiling has partially collapsed, probably due to water ingress along the valley with the main cross-gable, revealing the wooden rafters (Plate 123). A one-light uPVC casement window is slightly recessed in the north-east wall (Plate 124).

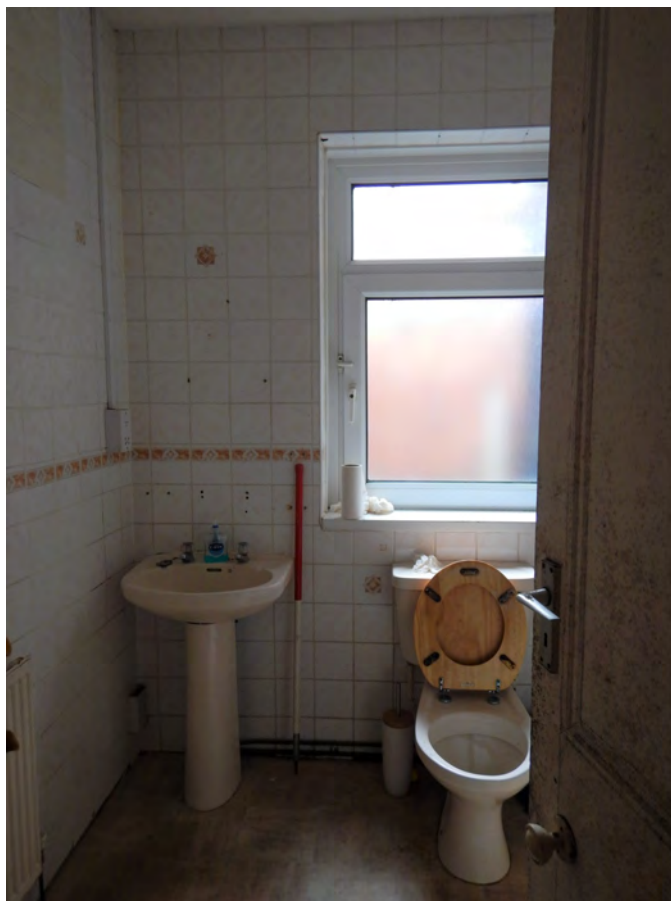
Plate 125. Accommodation area Bathroom, looking north-east

- 5.64. The Bathroom is accessed from the Corridor at the south-east end. It has lino flooring, patterned ceramic tiles to the walls with a decorative band at dado height, and painted plaster ceiling (Plate 125). The door is white painted wood with four fielded panels (Plate 126). There is a one-over one-light uPVC window with the bottom light casement opening. The bathroom fixtures are modern.

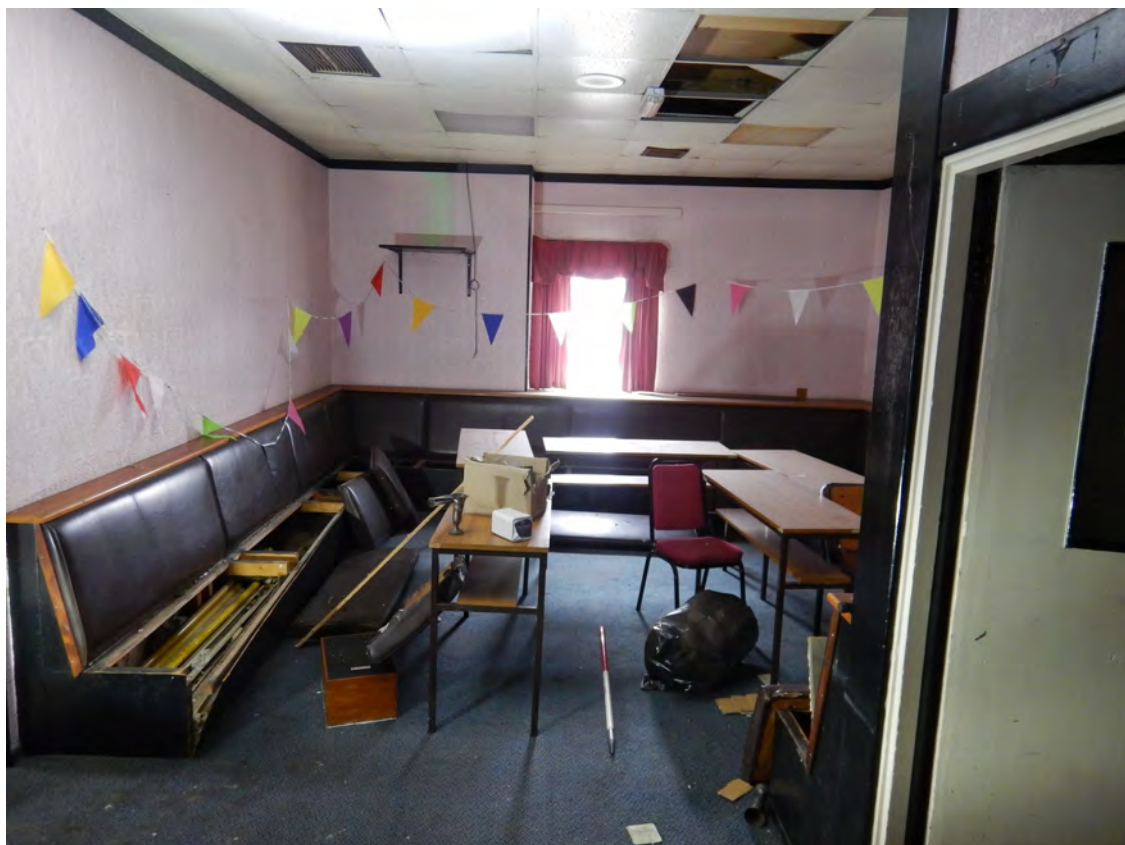
Plate 127. Seating area in First Floor Concert Room, looking south-west

- 5.65. The First Floor Concert Room is a single open room that takes up almost the entire area of the main building and north-west cross-gable and floating extension. It includes a seating area in the southern corner (Plate 127), a bar on the south-east wall (Plate 128) and a dance floor and stage at the north-east end (Plate 129). The floor is carpeted with blue carpet in the south-west half of the room and around the sides of the dance floor. The dance floor itself is wood, and along the front of the bar is a strip of grey lino. The walls are pink painted textured patterned wallpaper (Plate 130). The ceiling is suspended tile with occasional air conditioning vent panels. In places tiles have been removed revealing the original painted plaster with moulded panels (Plate 131). There are two exposed plastered beams orientated north-east – south-west and one perpendicular beam in the north-west half of the area. There is one supporting column on the dance floor and another by the bar area (Figure 9; Plate 132). The door to the stairs to the Second Floor is located to the centre of the room on the north-west wall (Plate 132). It is a white painted solid wood door with black and white painted frame. There is a door to the female Toilets on the north-west wall and a door to the Kitchen in the southern corner in the same style and a fire door in similar style on the north-west wall to the right-hand side of the Toilets (Plate 133).

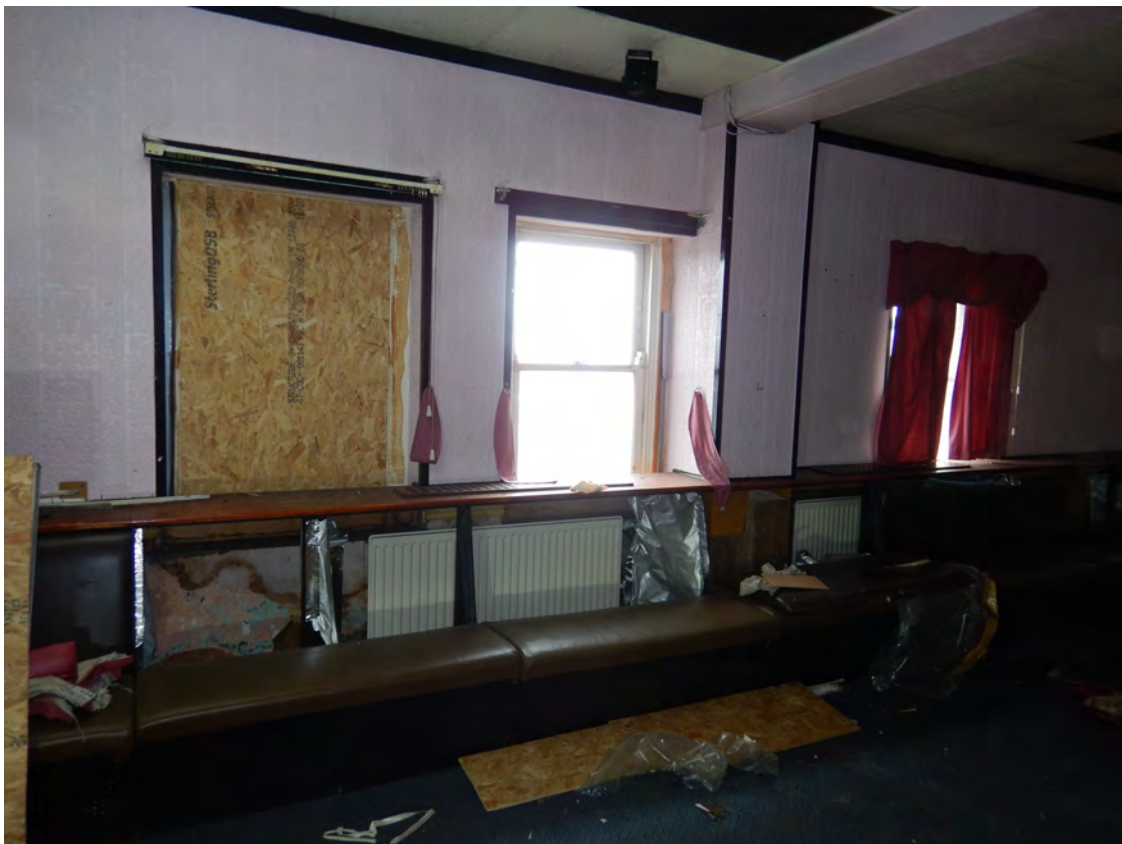
- 5.66. There are ten windows on the south-east wall, most of which have been recently boarded over with plyboard (Plate 134). The uncovered windows are white painted wooden framed one- over one-light sash windows (Plate 135). There are six windows on the north-west wall, which have been covered by metal grills (Plate 136). They are all wooden framed two-light mullion windows. There is a single window to the south-west wall, which is a white painted wooden framed one- over one-light sash window.

Plate 134. Windows on south-east wall of Concert Room, looking south

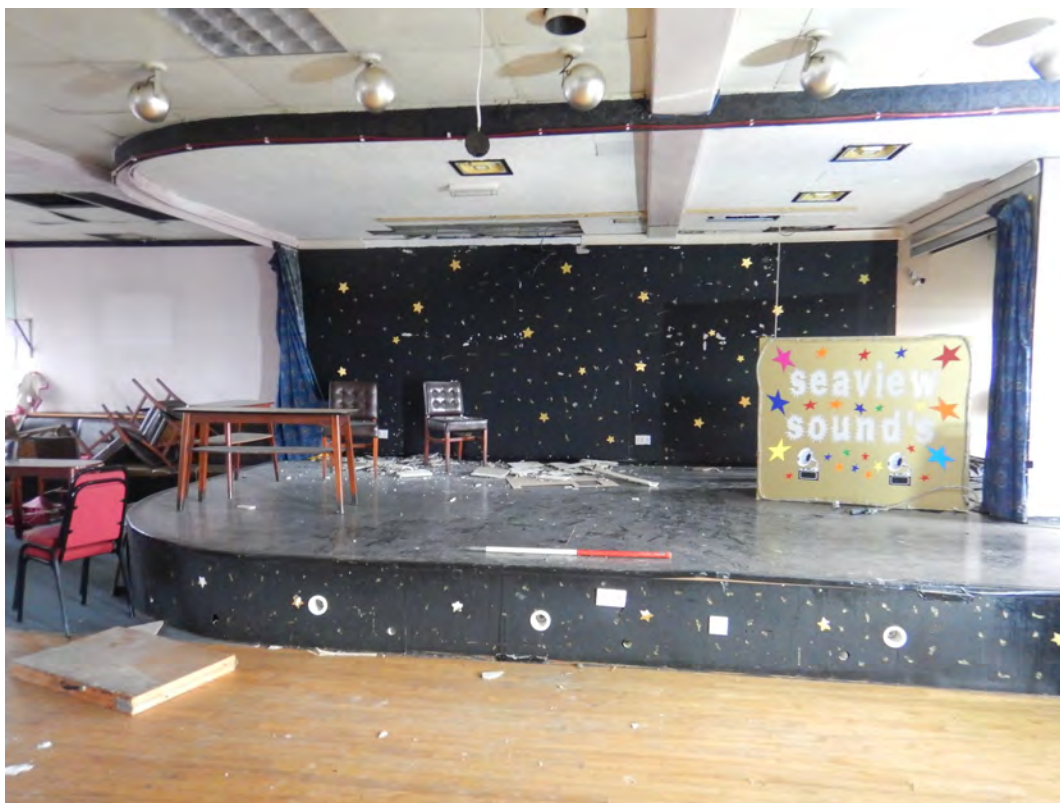
Plate 137. Stage in Concert Room, looking north-east

- 5.67. The stage area is situated at the north-east end of the building. It is a low, black-painted wooden platform with a curved west corner (Plate 137). There is a corresponding curtain rail to the ceiling electric spotlights in front. In the east corner is a second curtain to screen the technical area and spiral staircase to the Second Floor (Plate 138). The staircase is metal-framed and open, with wooden stair treads and a spiralling metal handrail (Plate 139).

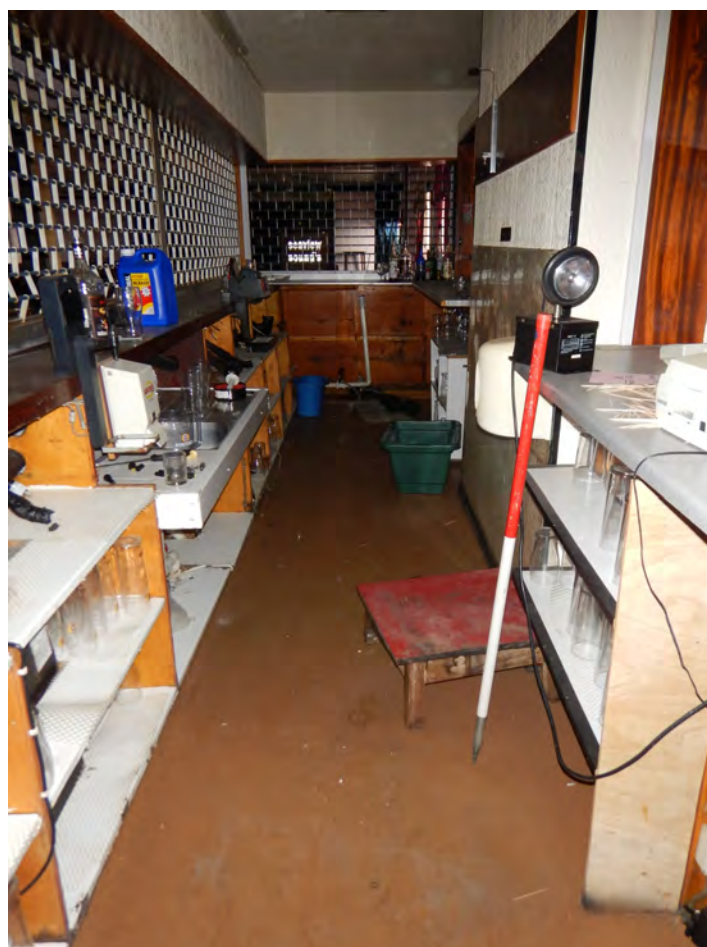
Plate 140. Concert Room bar, looking north-east

- 5.68. The bar exterior has metal geometric-patterned panels to the lower wall and dark stained wood above and to the bar top (Plate 140). There is a metal roller grill covering the bar opening. The bar interior has brown lino flooring, cream-painted textured wallpaper, and a suspended tile ceiling (Plate 140). There are various modern fixtures and shelving to both long sides.

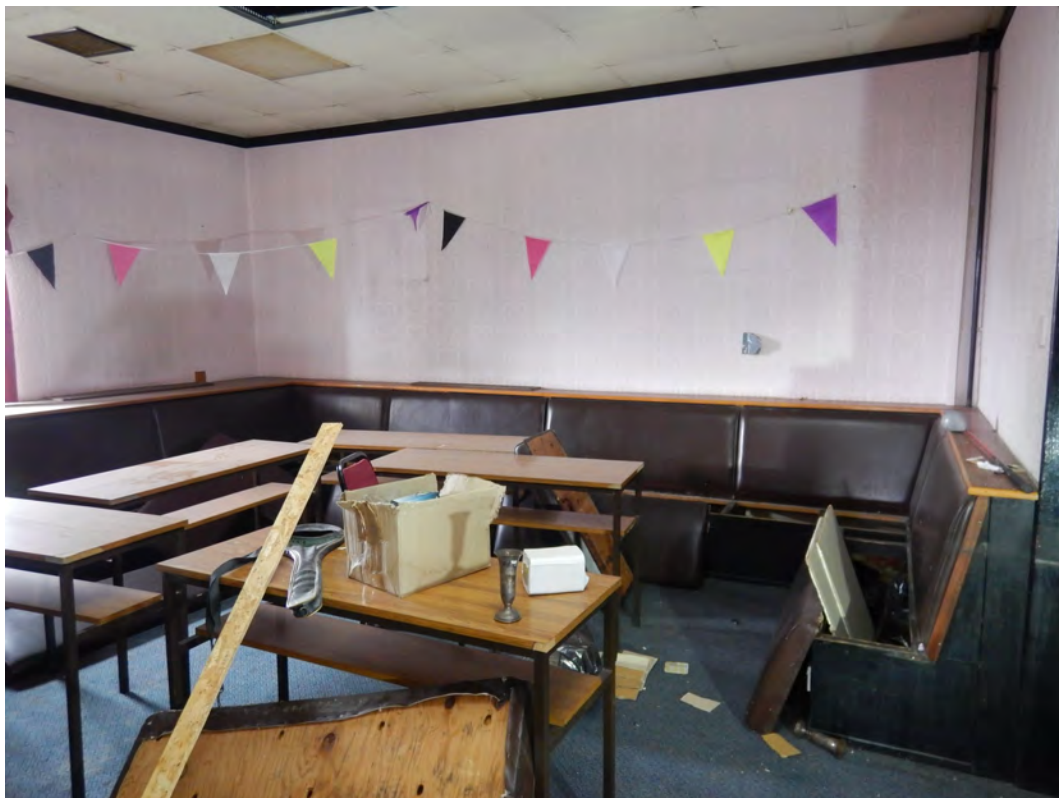
Plate 141. Concert Room seating area, looking west

- 5.69. The seating area in the south-west end of the room has built-in seating around the walls with wooden frames and faux leather cushions (Plate 141).

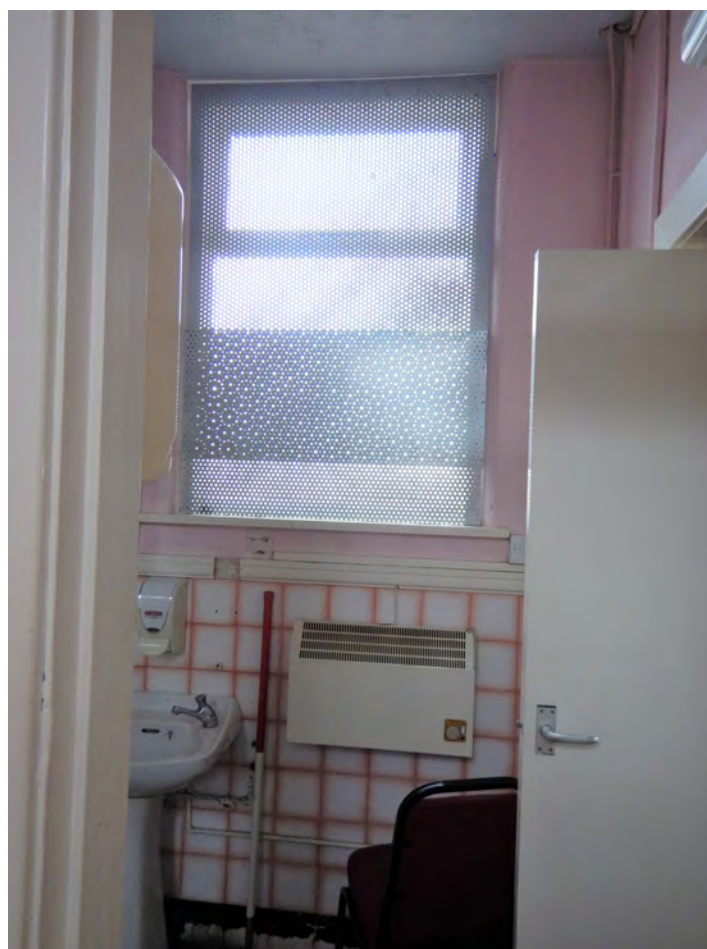
Plate 142. Ladies toilet, looking north-west

- 5.70. The female Toilets, on the north-west of the dance floor, have blue lino flooring, ceramic tiles to the lower walls, a moulded wooden, white-painted dado, pink painted plaster walls above and a painted plaster ceiling (Plate 142). The interior doors are solid, white-painted wood in wooden frame. There is a on both the north-east and south-west walls, both of which have been covered with metal grills. They appear to be one- over one-light wooden frames transom windows. There are modern toilet fixtures and fittings.

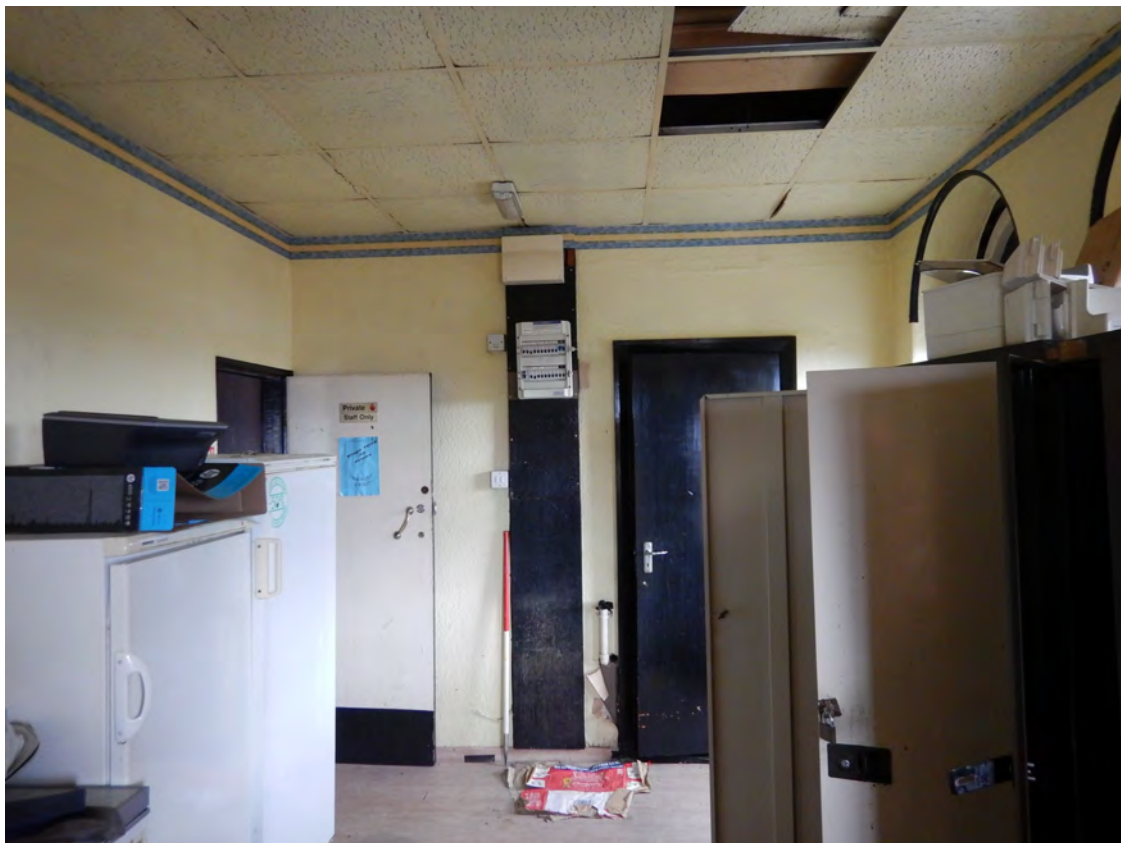
Plate 143. Concert Room Kitchen, looking north-east

- 5.71. In the southern corner of the area is a separate Kitchen, through which the bar is accessed (Plate 143). The room has red lino flooring, yellow wallpaper with a blue and yellow band to the top of the walls, and a suspended tile ceiling (Plate 144). Elements of the original plaster ceiling are visible where ceiling tiles have been removed (Plate 145). There are two windows on the south-east wall. They are both white-painted, one- over one-light wooden sash windows with a blocked semi-circular transom above (Plate 146). They are recessed, with painted wallpaper to the reveals and a wooden sill. The edge of the reveal arch is painted black. There is a larger window in the same style on the south corner, which is on the curved section of wall below the tower.

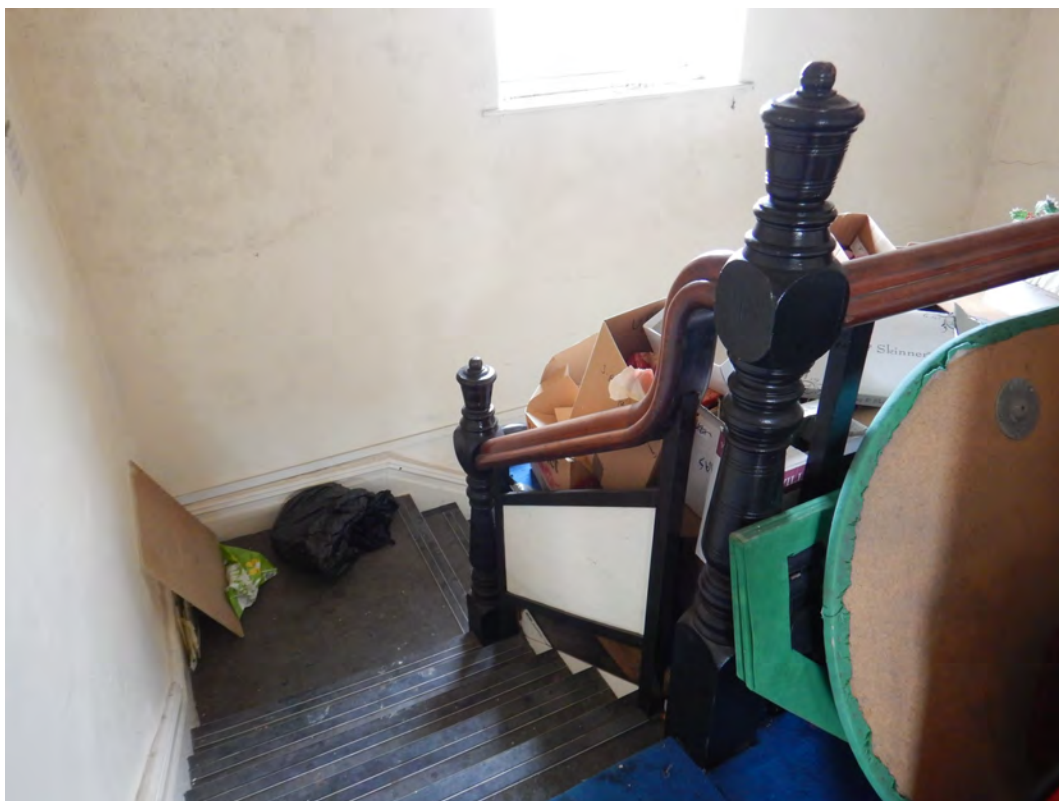
Plate 147. Stairs from Second Floor to First Floor, looking north-west

- 5.72. The main access to the second floor is via the stairwell from the centre of the Concert Room on the First Floor. The staircase is a quarter turn with landing (Plates 147 and 148). The treads are carpeted with rubber edges (Plate 149) while the risers are
