Sea View Labour Club, Barry

Level 2 Building Survey

Report No . 1967

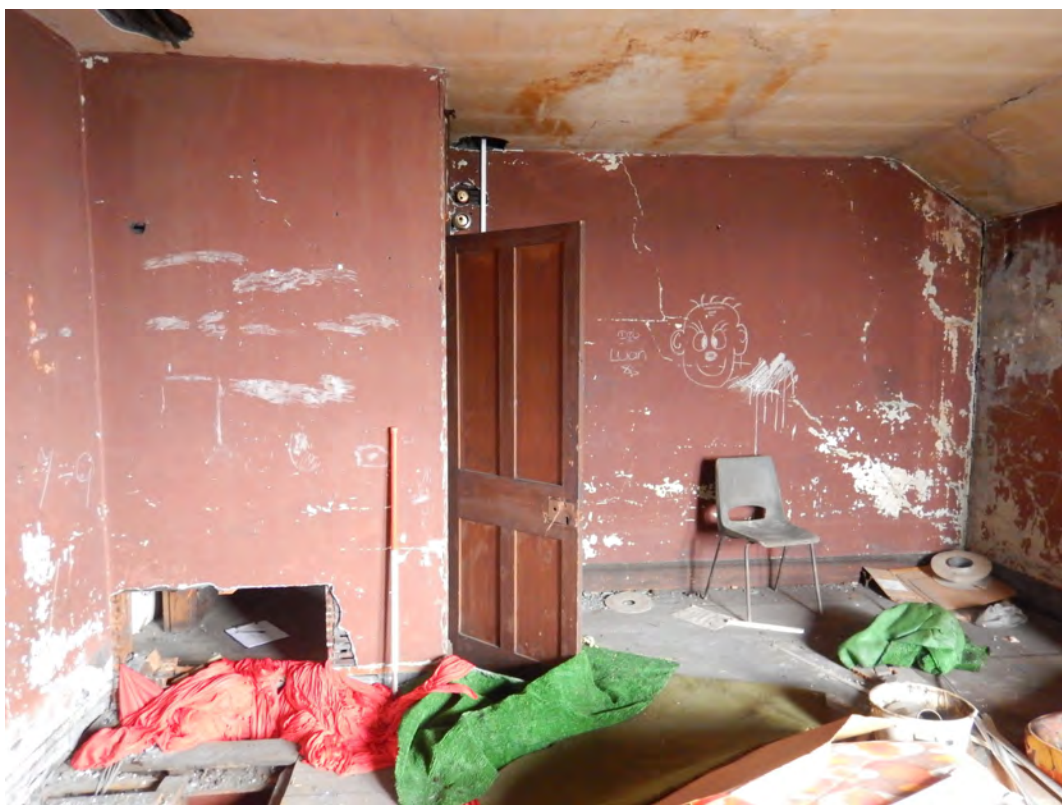
Plate 162. Room 3, looking north-east

- 5.76. Room 3 is located in the south corner of the building. It has wooden floorboards, moulded wood skirting boards, brown painted plaster walls and plaster ceiling in poor condition (Plate 162). The ceiling slopes to the south-east side, and there are two exposed beams with plastered sides (Plate 163). A large area of the ceiling plaster has

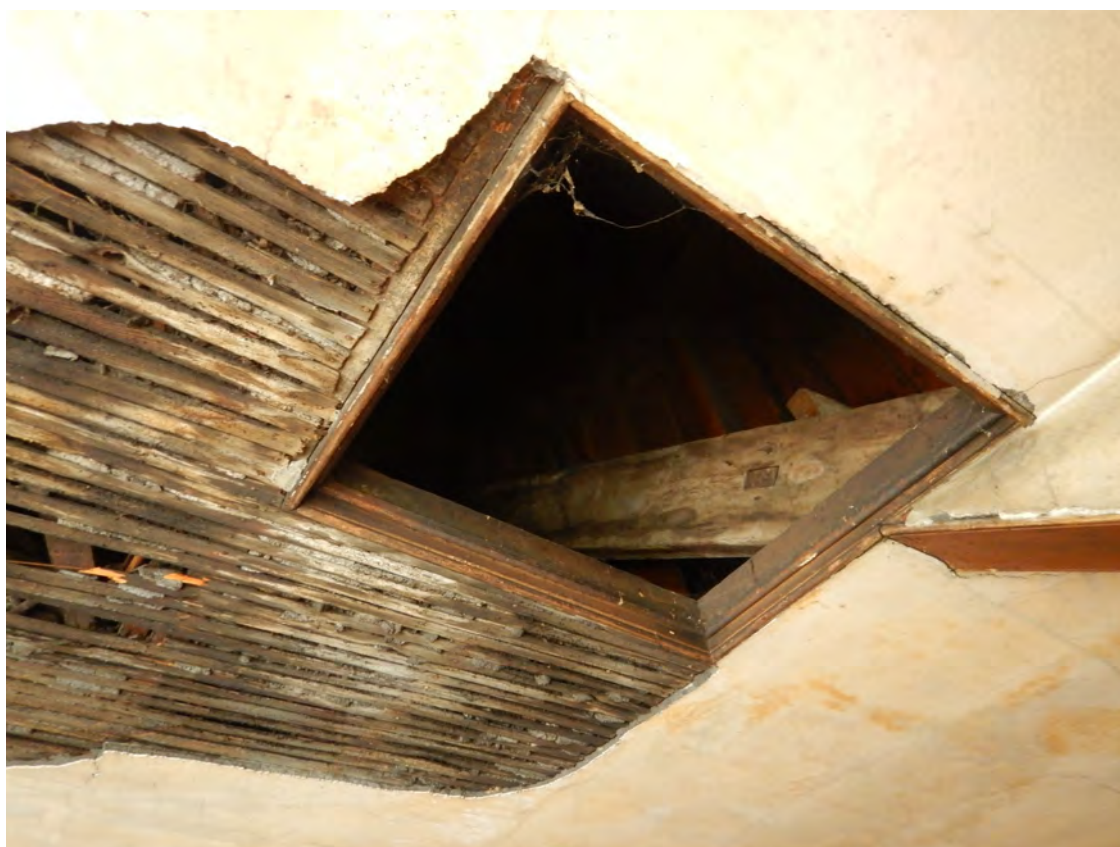
Plate 164. Looking into loft area from Room 3, looking north

come down, revealing the lathe structure. There is a hatch in the southern corner of the ceiling that provides access to the tower and through which it is possible to see the continuation of the rafter (Plate 164). The southern corner of the room is curved. There are two recessed, wooden framed sash windows with a segmental arch to the top (Plate 165). The one to the left has four-over-four lights to the upper half and a two-light mullion to the lower. The one to the right is the same except that there is a large central pane to the upper centre instead of four small lights. The windowsills and reveals are of wood. There is a fireplace to the centre of the south-west wall (Plate 166). A single piece cast iron surround with floral decoration has been removed. The door is in the north corner of the room. It is a two-over-two fielded panel door in a moulded wooden frame (Plate 167).

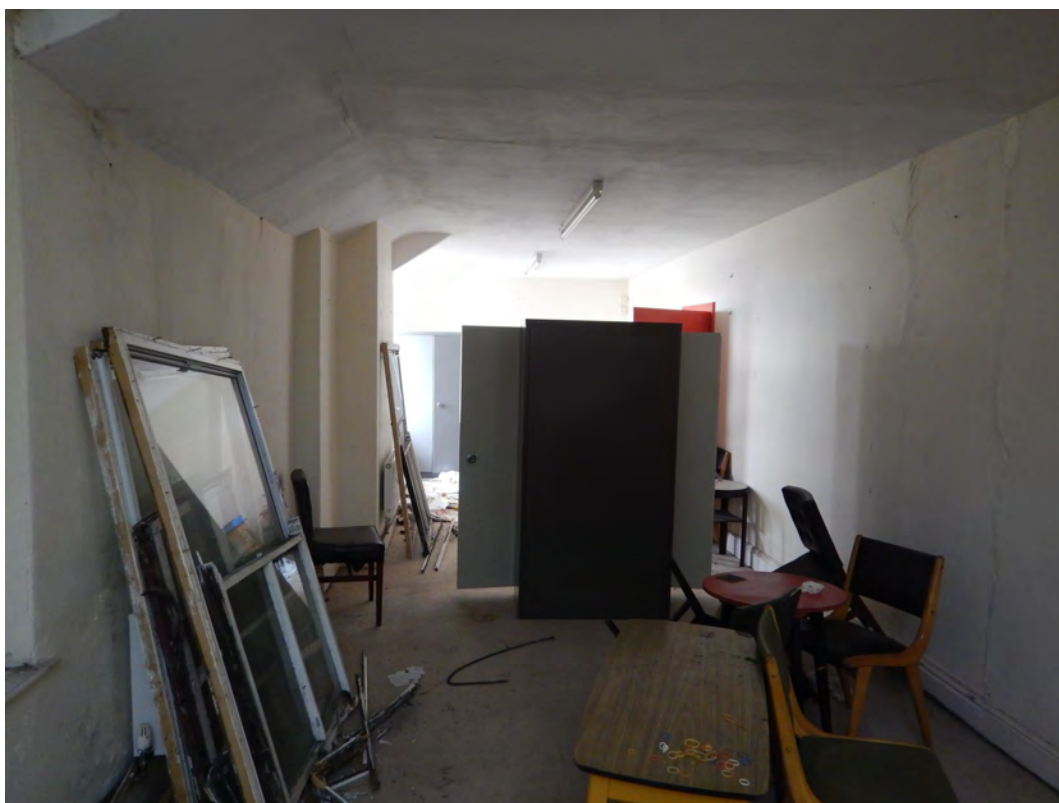
Plate 168. Room 4, looking south-west

- 5.77. Room 4 is a long rectangular room that runs along the majority of the front of the building. It was probably originally two rooms. An uneven area on the walls to the centre of the room may be evidence of an earlier wall removal (Plate 168). It has a carpeted floor, white painted skirting boards, cream painted plaster walls and white painted plaster ceiling, in good condition (Plate 169). The roof slopes down at the front of the building and there are three exposed rafters. There are electric strip lights to the centre of the ceiling. The south-east wall has four windows in pairs. They have all been boarded up with plyboard (Plate 170). The window openings are recessed, with painted plaster to the reveals, and wooden sills. There are two doors to the north-west wall. They are modern red painted wood panel doors with a square light to the upper centre in a moulded wooden frame (Plate 171).

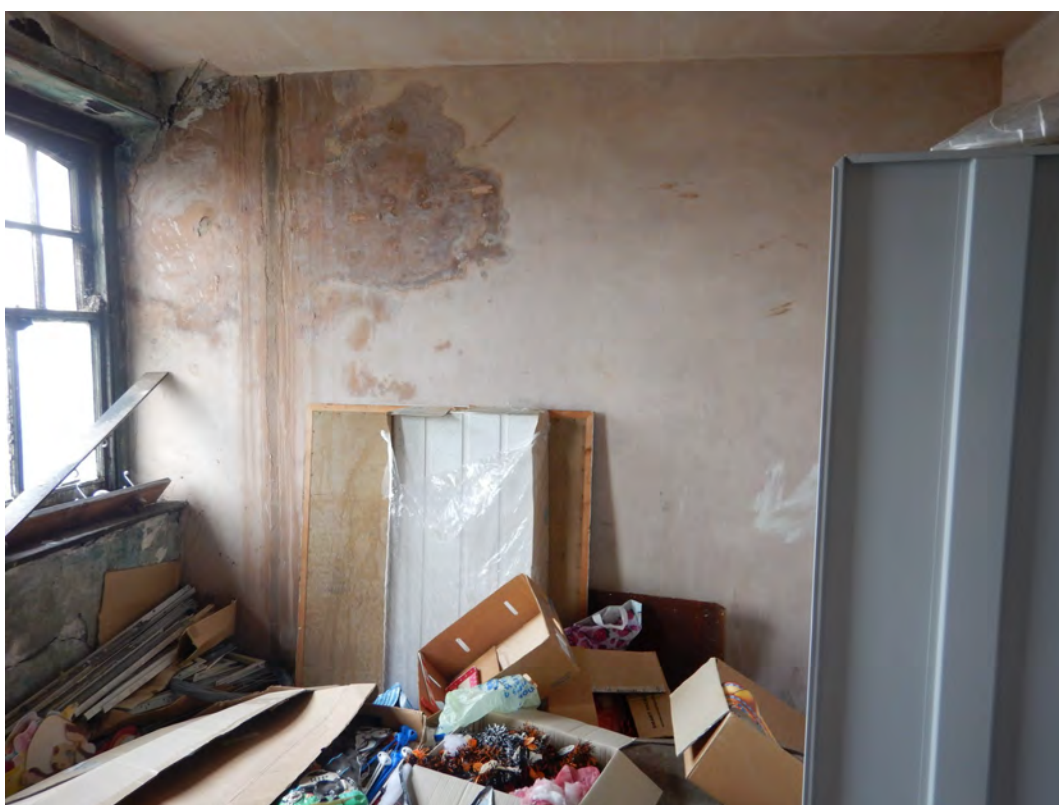
Plate 172. Room 5, looking south

- 5.78. To the north-east of Room 4, Room 5 is a small, square room. It appears a start has been made at replastering the room before the building went out of use. The floor is exposed boards. The walls and ceiling are exposed plaster (Plate 172) with the exception of the exterior (south-east) wall, which has patches of earlier painted plaster and exposed rubble stone wall (Plate 173). There is a pair of windows on the south-east wall, in the same style as Room 3. The door is a modern wood veneer door in white painted frame (Plate 174).

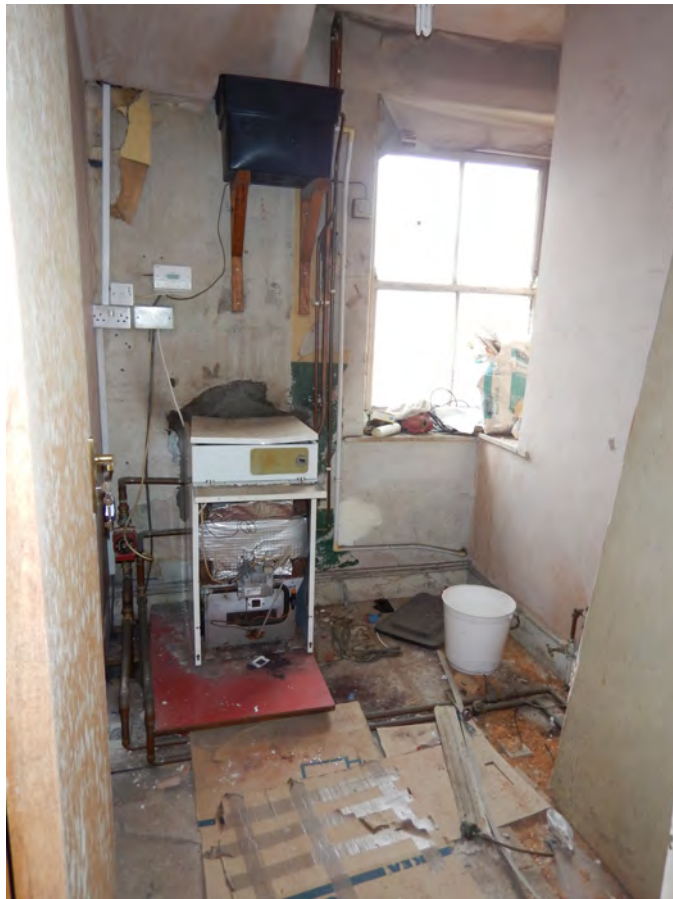
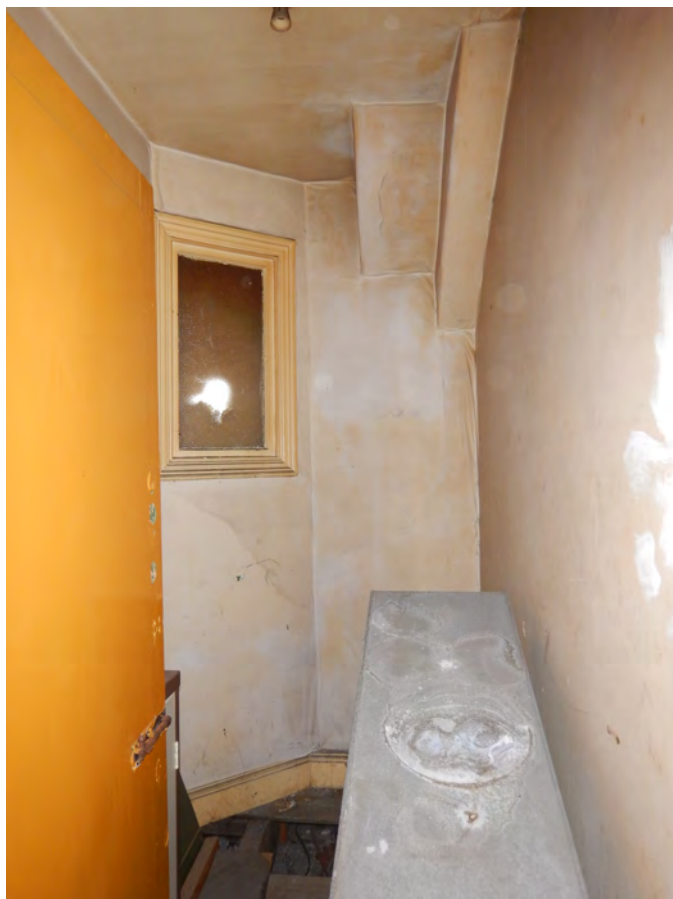
- 5.79. Immediately to the north-east of the stairs are two small rooms, Room 6 and 7, which were being renovated when the building went out of use. They have exposed floorboards and plaster walls and ceiling (Plates 175 and 176). The dividing wall between the two covers an external window and is a later stud partition, while the exterior walls are lathe and plaster, indication that these two rooms were originally one. The window is a two-over-two light sash window, recessed, with a wooden sill. In the west corner of Room 7 the partition wall is angled to cover the exterior window, and a small, one light textured glass window in moulded wooden frame has been added. The doors of both rooms are modern wood panel doors in a moulded wooden frame (Plate 177).

Plate 175. Room 6, looking north-west

Plate 176. Room 7, looking north-west

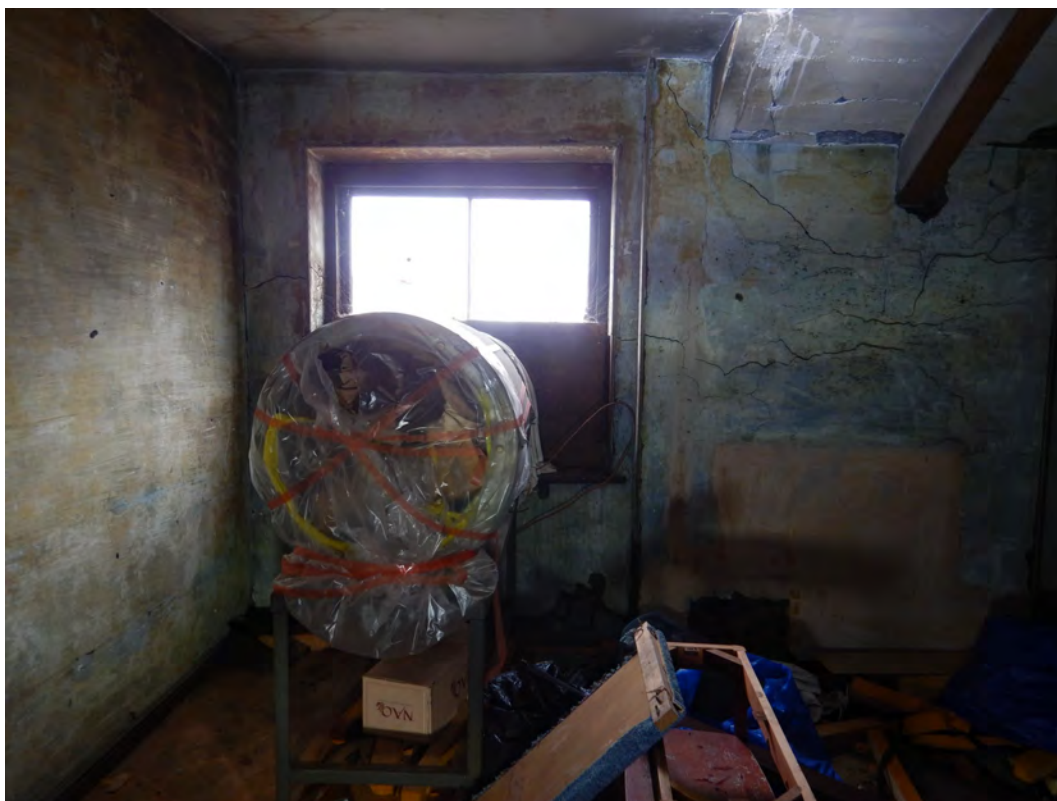
exposed in some places (Plate 178). There is an exposed rafter to the centre of the exterior wall (Plate 179). A section of the wall in the southern corner has been recently replastered (Plate 180). There is a window to the north-west wall, which has been partially blocked to allow the fitting of a fan unit (Plate 181). The window is wooden framed, and two lights remain unblocked. It is recessed, with wood to the reveals. The door to the corridor on the south-east wall is missing but there is a moulded wooden frame (Plate 182).

Plate 181. Partially installed air vent, Room 8, looking north-west

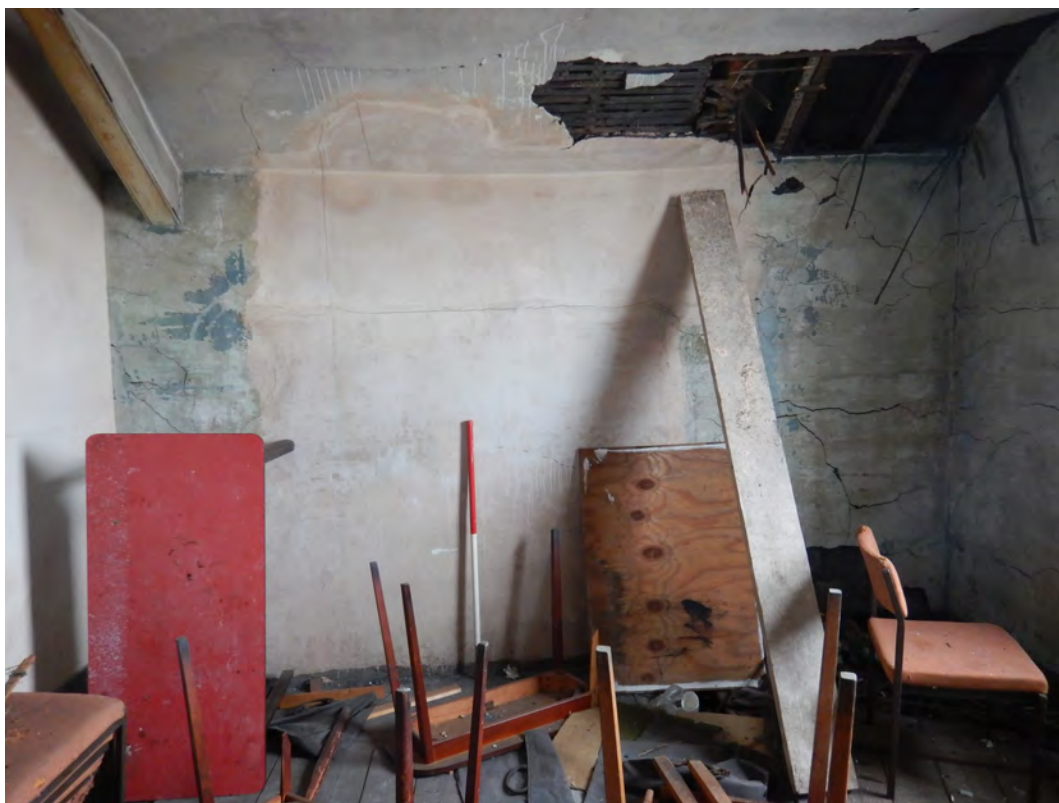
Plate 184. Room 9, looking south-west

- 5.82. At the north-west of the corridor is Room 9. It has exposed floorboards, old painted plaster walls with modern plaster patches, and a painted plaster ceiling with exposed lathes in places (Plate 184). The ceiling slopes to the south-west edge. There is one exposed rafter. There is a window to the north-west wall which is a two-over-two light sash window with wooden sill and reveals (Plate 185). The door, in the south-east corner, is missing but there is a wooden moulded frame (Plate 186). To the floor against the centre of the south-west wall, is a tile hearth (Plate 187) and the modern plaster above this is clearly covering a blocked fireplace.

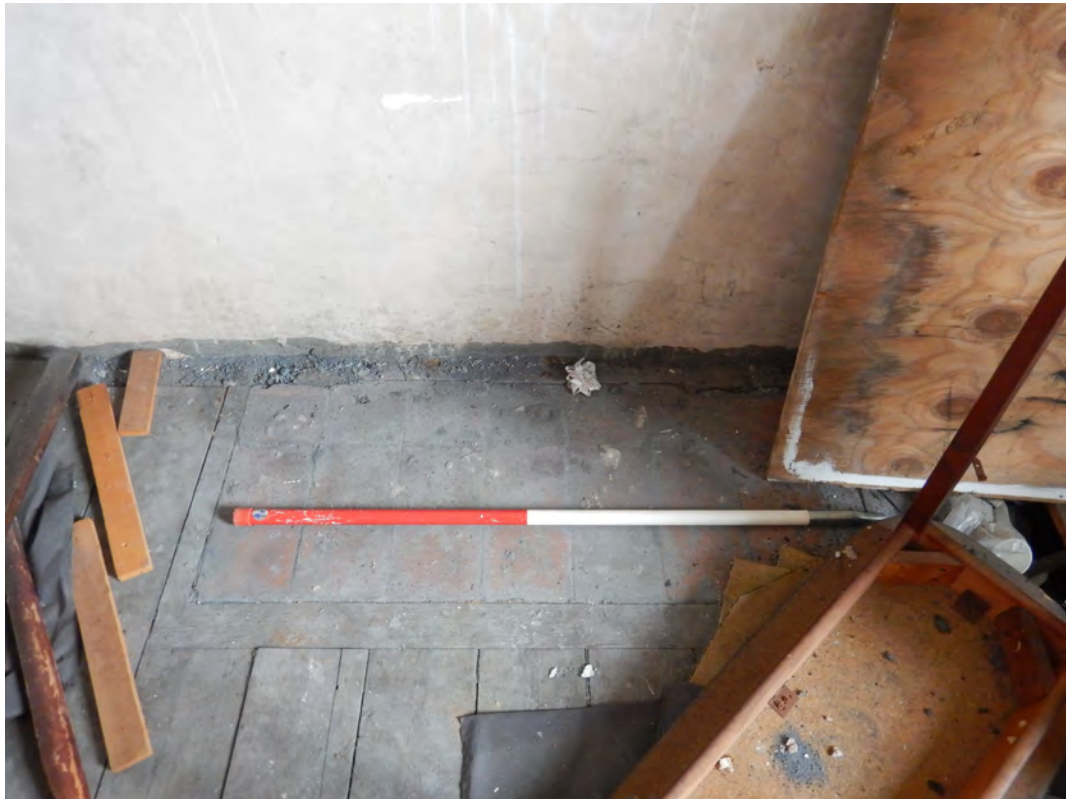
Plate 187. Hearth to south-west wall of Room 9, looking south-west

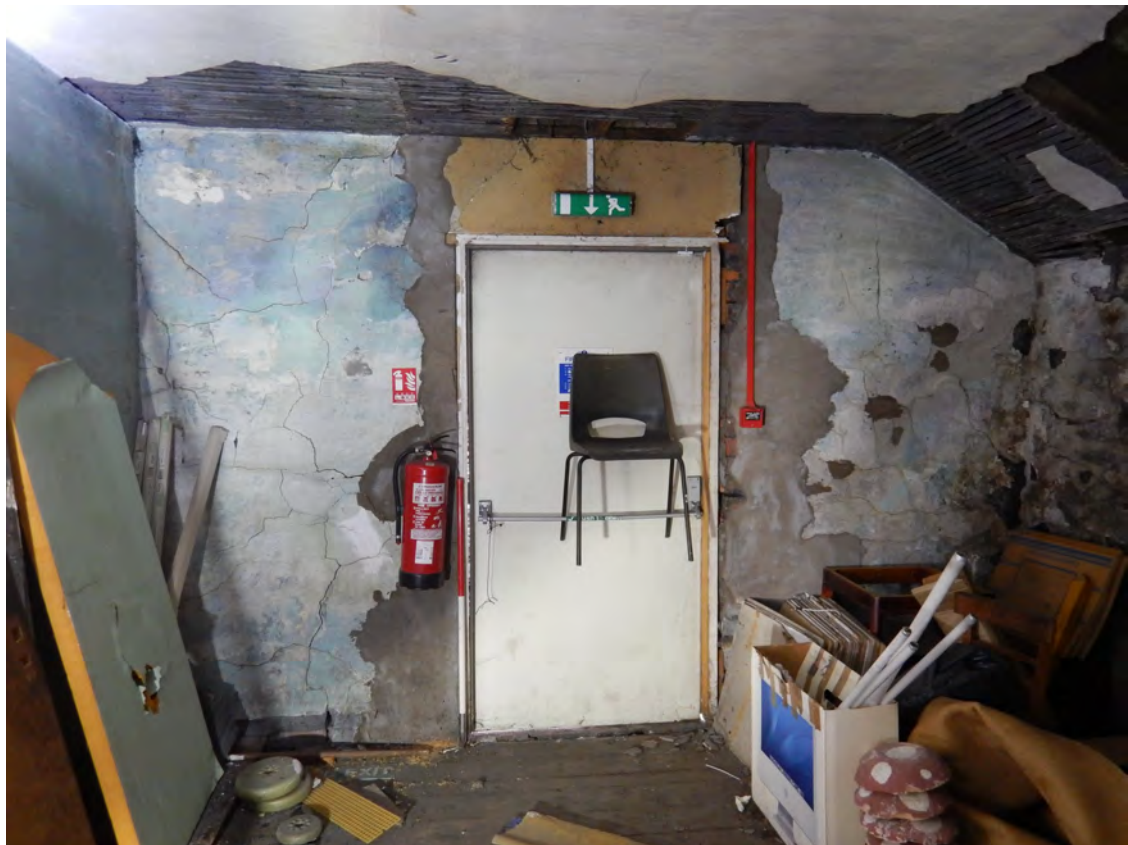
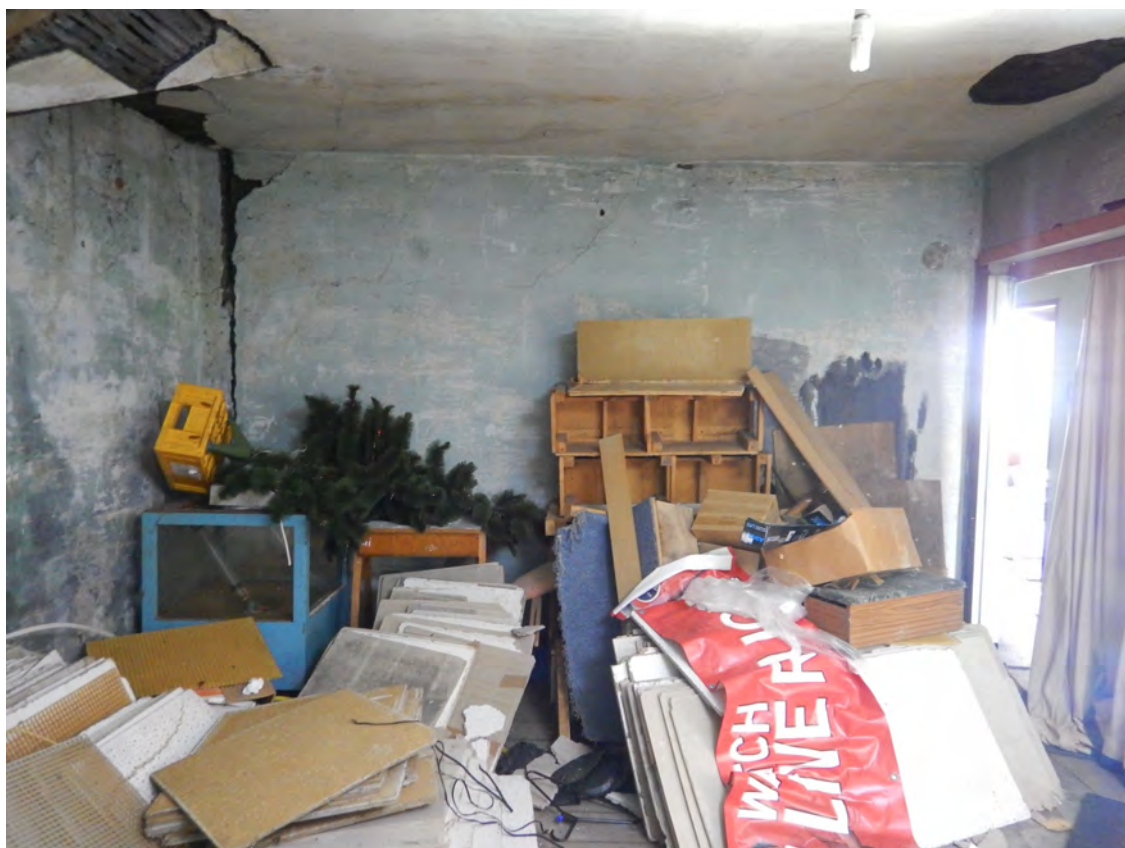
- 5.84. Room 10 is at the north corner of the building. It has a large, flat arch opening from the corridor covered by a blue curtain (Plate 189). It has exposed floorboards and painted plaster walls and ceiling in very poor condition (Plate 190 and 191). The ceiling slopes down to the north east edge (Plate 192). To the left of the north-east wall is a fireplace with exposed brick chimney breast (Plate 193). To the north-west wall is a modern wooden fire door in plain wooden frame (Plate 191).

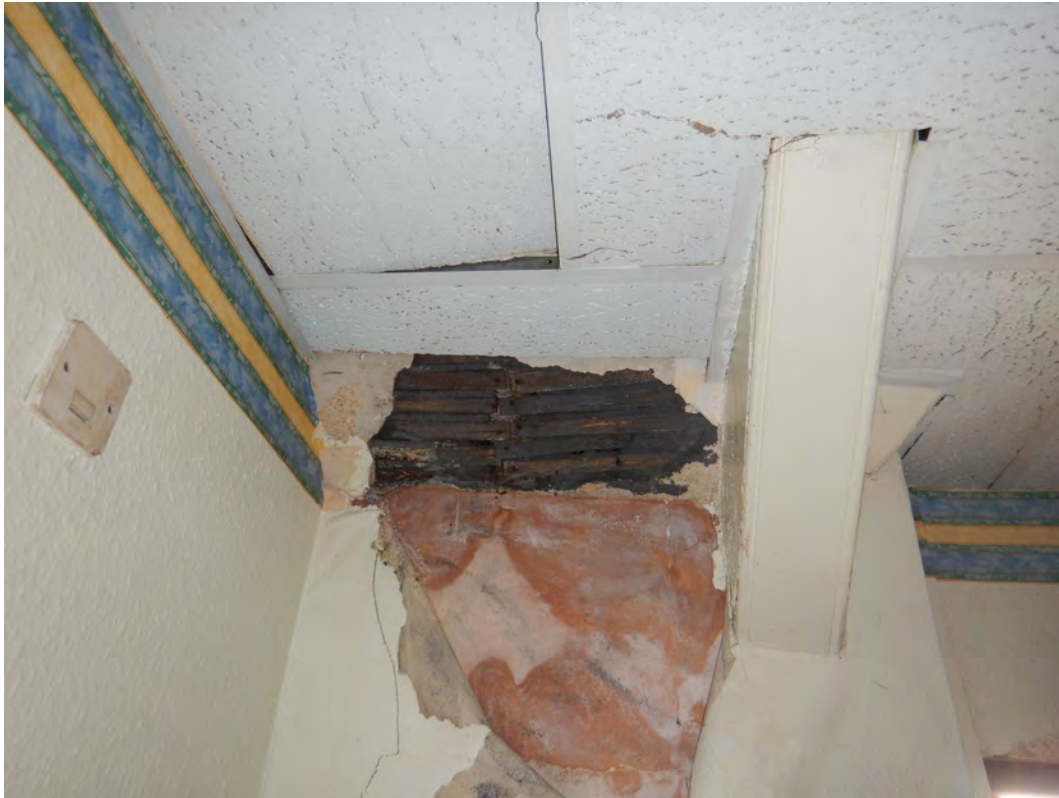
- 5.85. Room 11, the Artist's Room, is in the east corner of the building. It has red vinyl floor tiles, dark brown painted skirting boards, painted wallpapered walls with a decorative band to the top and suspended tile ceiling with electric strip lights (Plate 194). There is an exposed rafter to the south-east wall (Plate 195). The window on the south-east wall was blocked, probably during the late twentieth century (Plate 196). Part of the plasterboard blocking the window has recently been removed revealing a sash window with four-over-four lights to the upper half and two-light mullion to the lower. It is recessed and has a wooden sill. There are three doors to the room, one to the small north-west – south-east corridor, one to the spiral staircase and one to a cupboard room in the south-west corner. All the doors are modern white painted

Plate 195. Exposed lathes in the east corner of the Artist's Room, looking east

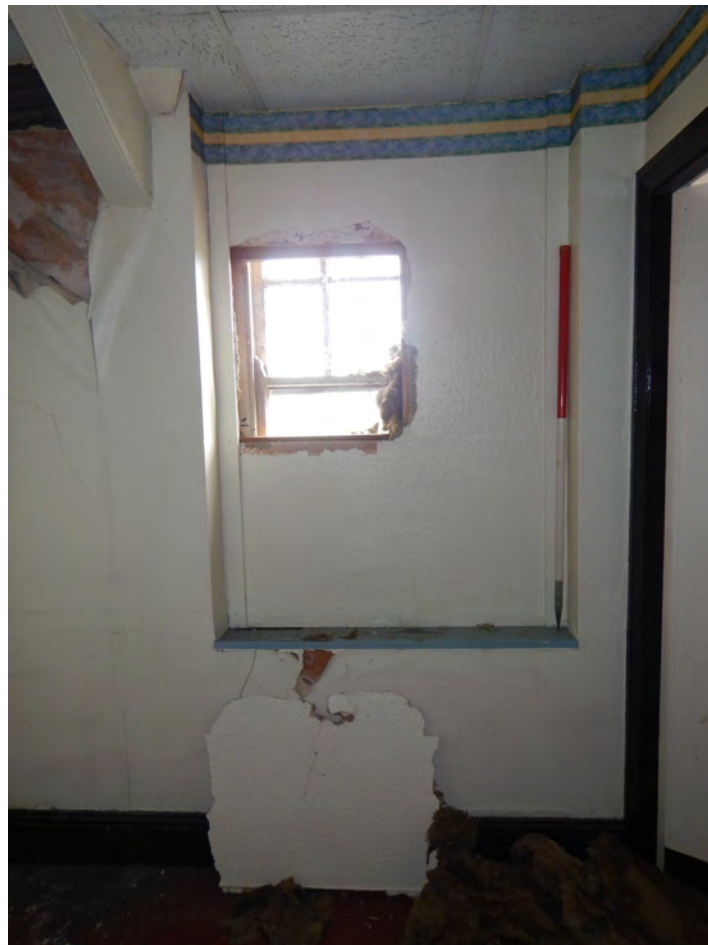
Plate 196. Blocked window on south-east wall of Artist's Room, looking south-east

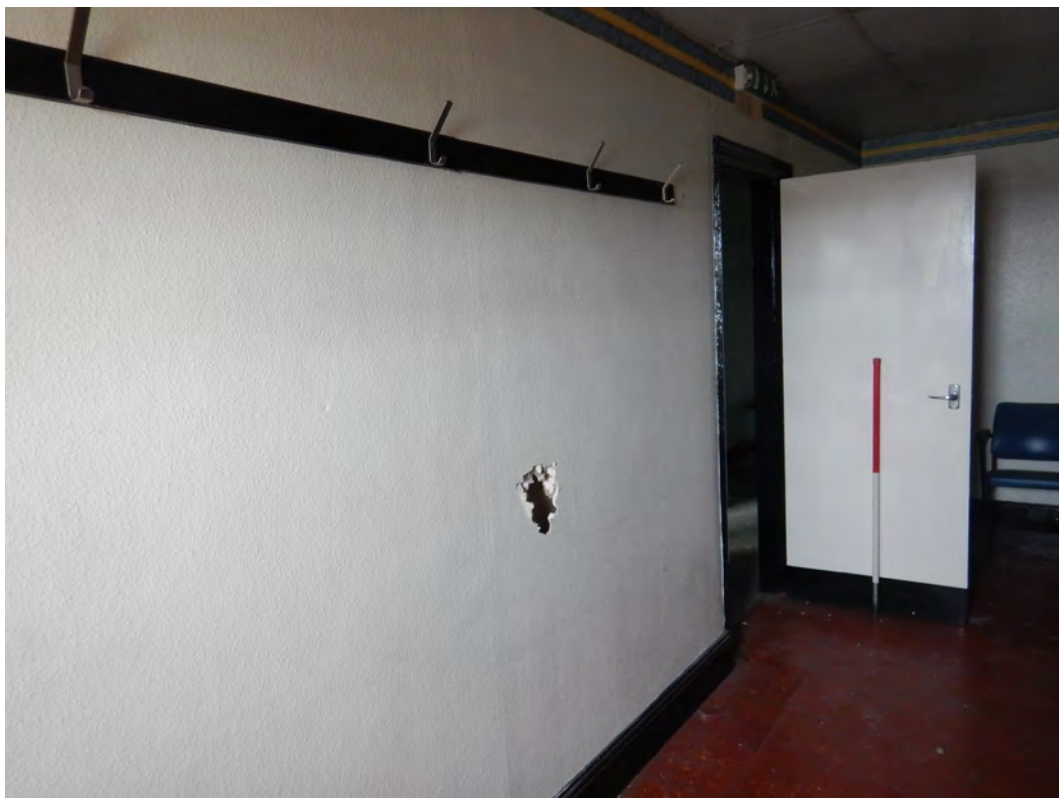
panel doors with a dark brown painted frame (Plate 197). The door to the spiral staircase has an 'ARTISTS ROOM' sticker (Plate 198).

Plate 197. Artist's Room, looking west

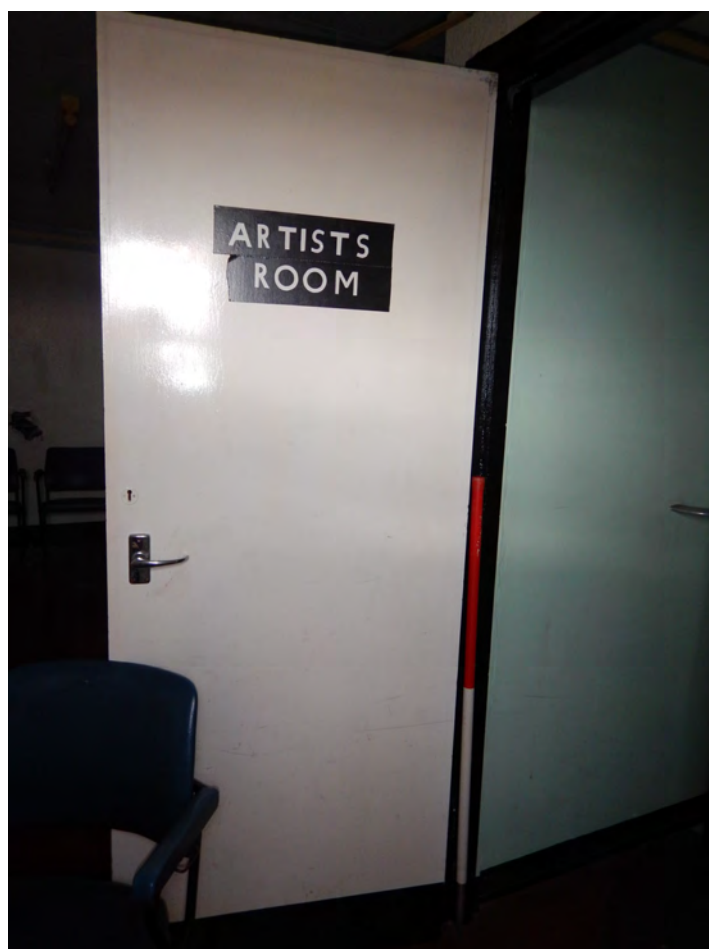
Plate 198. Door to Artist's Room, looking north

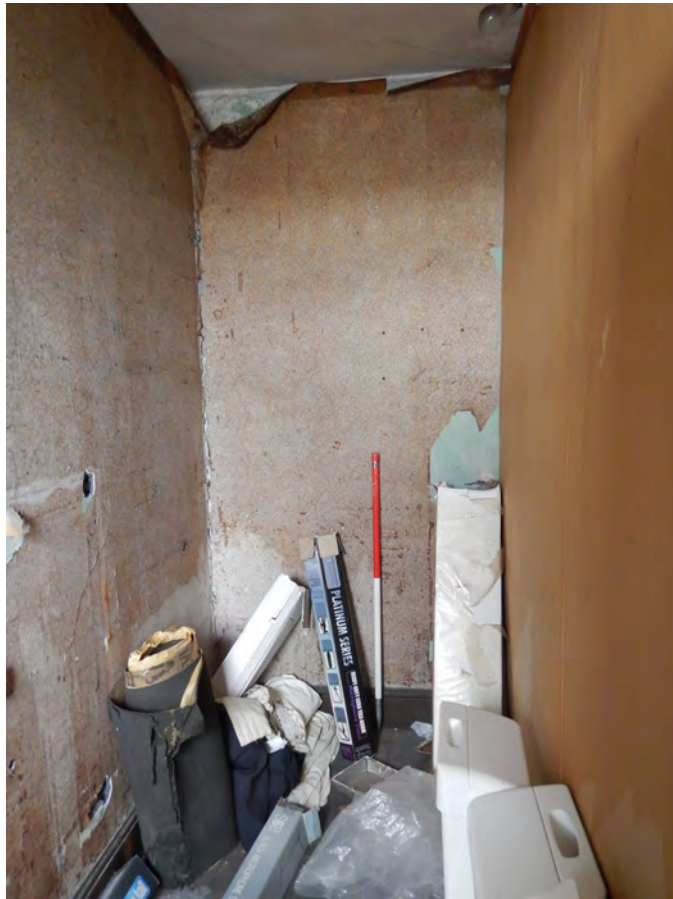
- 5.86. The cupboard room has carpet underlay over the floorboards. The north-east wall is a modern stud wall, probably added in the late twentieth century, dividing it from the rest of Room 11 (Plate 199). The other walls have wooden skirting boards and are papered with patterned paper over plaster. The ceiling is painted plaster. There is a window to the south-east wall which has been boarded over to the lower half (Plate 200). The window is a wooden framed sash window with segmental arch, and the upper half is four-over-four light. It is recessed with wooden reveals and sill.

Plate 199. Cupboard off of Artist's Room, looking north-west

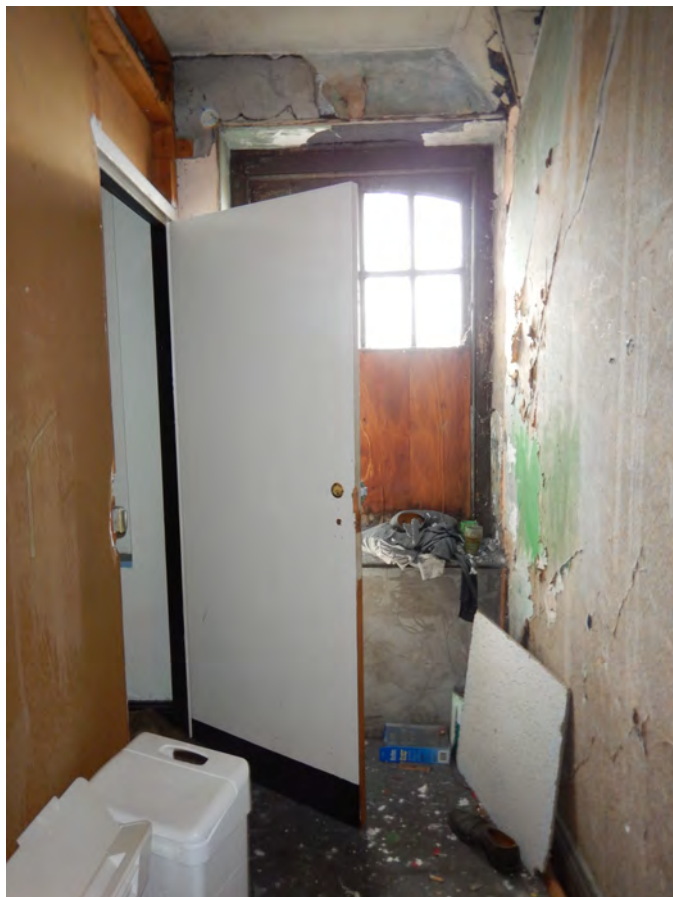
Plate 200. Cupboard off of Artist's Room, looking south-east

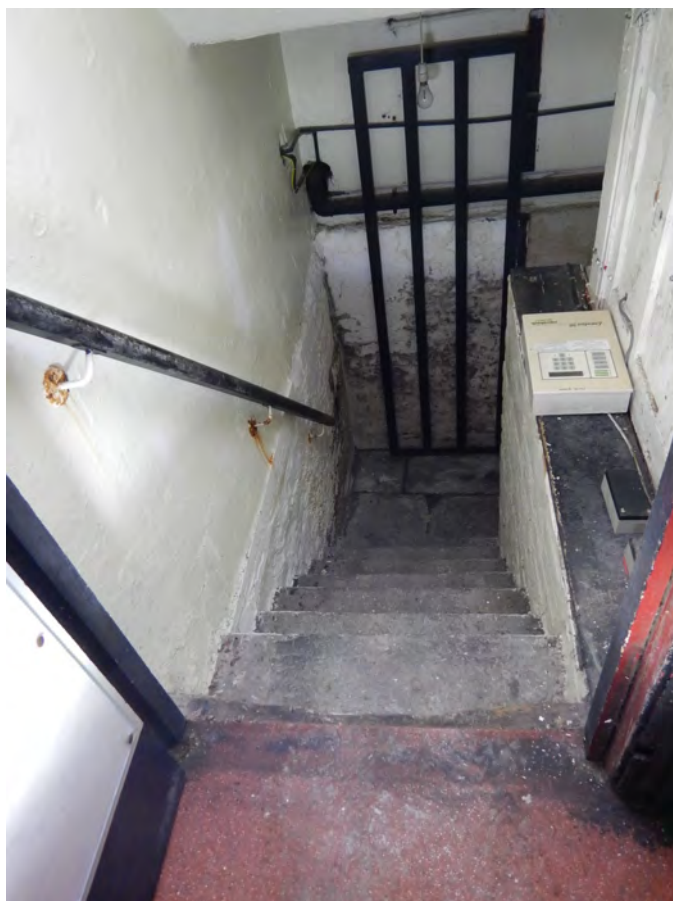
- 5.87. Access to the basement is via a flight of steps under the Ground Floor Main Stairwell (Figure 8). The stairs are a quarter turn with landing. The steps are cement while the landing has flagstones (Plate 201). There is a plain metal handrail on the outer wall. The upper part of the stairwell wall is painted plaster, but below Ground Floor level it is white-painted brick (Plate 202).

Plate 201. Stairs down to Basement, looking north-east

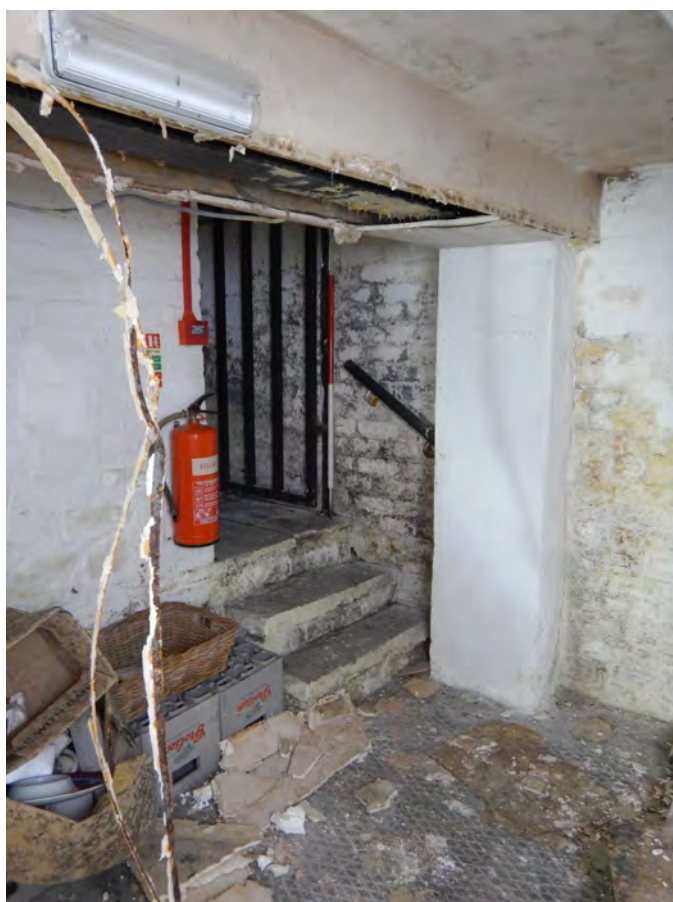
Plate 202. Stairs up from Basement, looking north

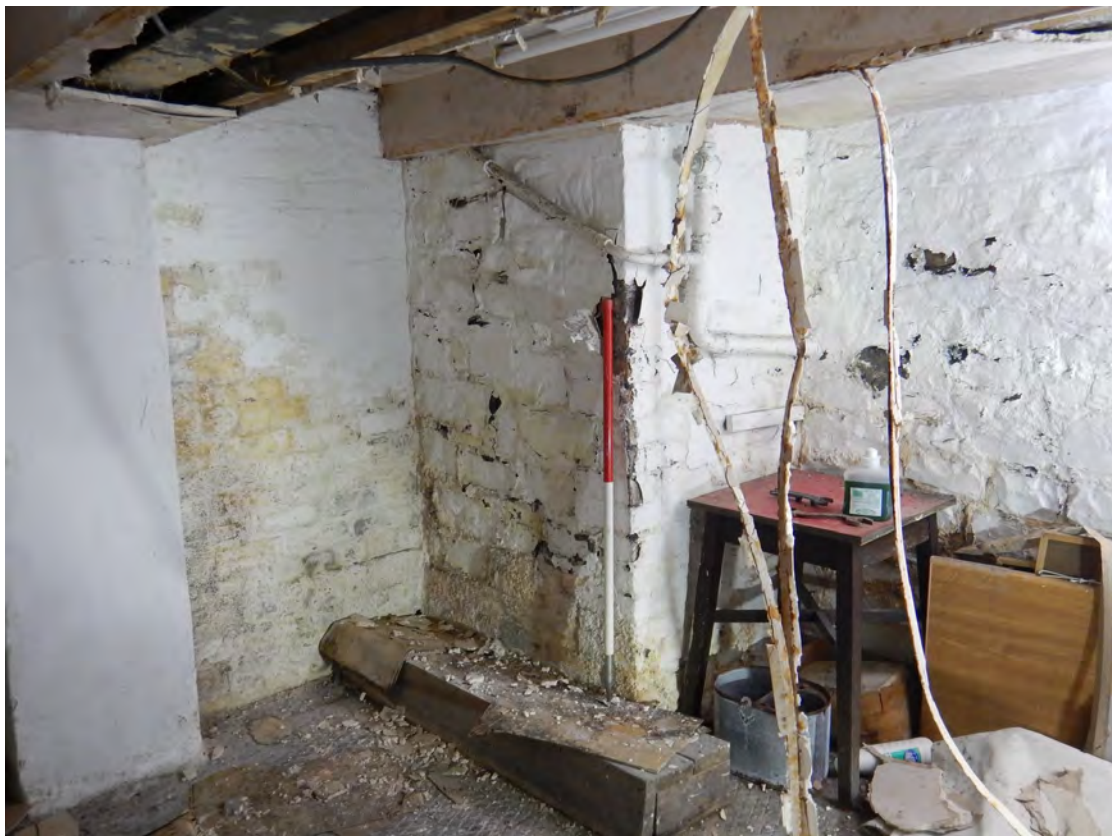
- 5.88. Room 1 is a small room with a low ceiling. The flooring is diamond-pattern texture brick, and the walls are white-painted rubble stone with the exception of some brickwork at the north-east end (Plate 203). The ceiling is plasterboard, including around the two north-east – south-west orientated metal rebar beams. There are electric strip lights. There is an open, flat arch doorway through to Room 2.

Plate 203. Basement Room 1, looking north-east

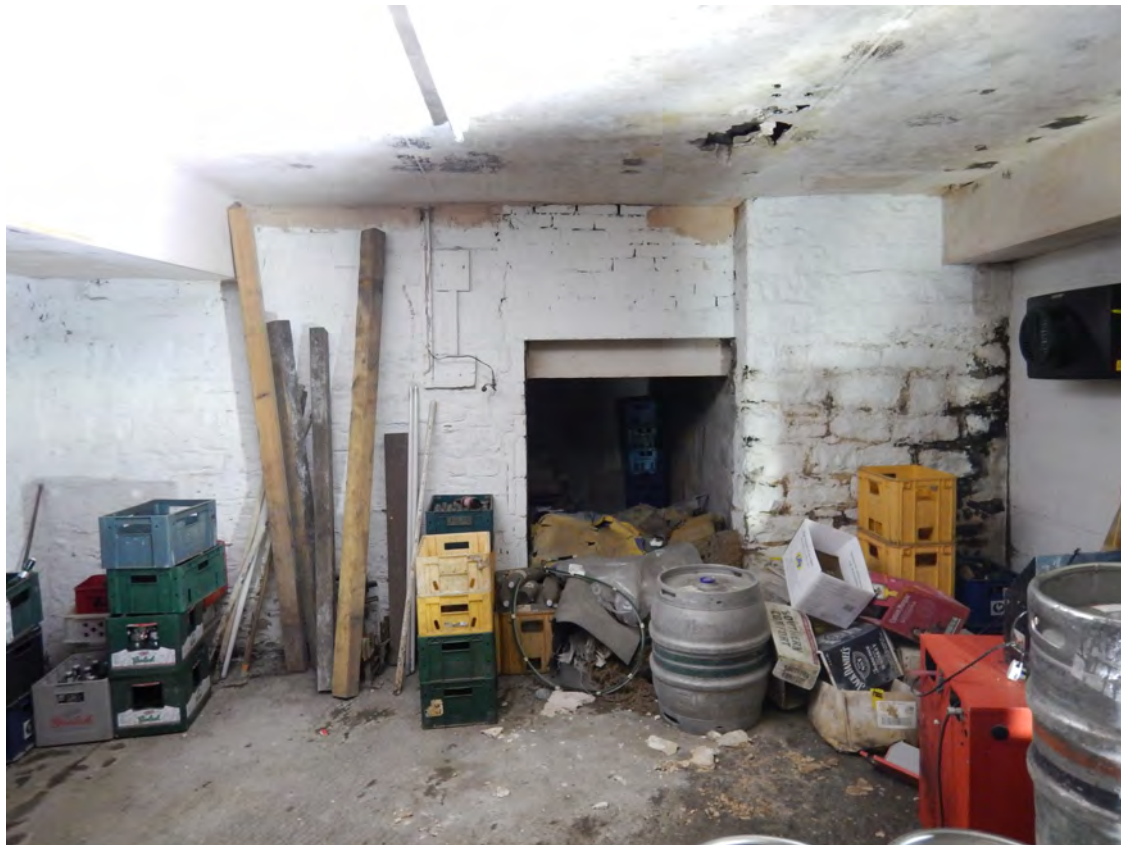
- 5.89. Room 2 is a larger space with a low ceiling to the north-east half which then steps up to the south-west (Plate 204). As Room 1, the flooring is diamond-pattern texture brick, and the walls are mainly white-painted rubble stone (Plate 205). The north-east wall with Room 1 seems to be a later addition, with stonework-like scoring in the plaster wall (Plate 206). The north-west wall has also been covered with plasterboard and is probably a later stud wall division (Plate 207). The ceiling is plasterboard with electric strip lights. There are two brick pillars in the room (Plate 208). Both appear to be very recent brickwork, but it is not clear whether they replace earlier pillars or are new additions. There is a barrel chute with central metal steps in the west corner (Plate 209). There is a low opening through to the store on the south-east wall (Plate 206). The doorway to Room 4 on the north-west wall has a PVC strip curtain (Plate 209).

Plate 204. Basement Room 2, looking south-east

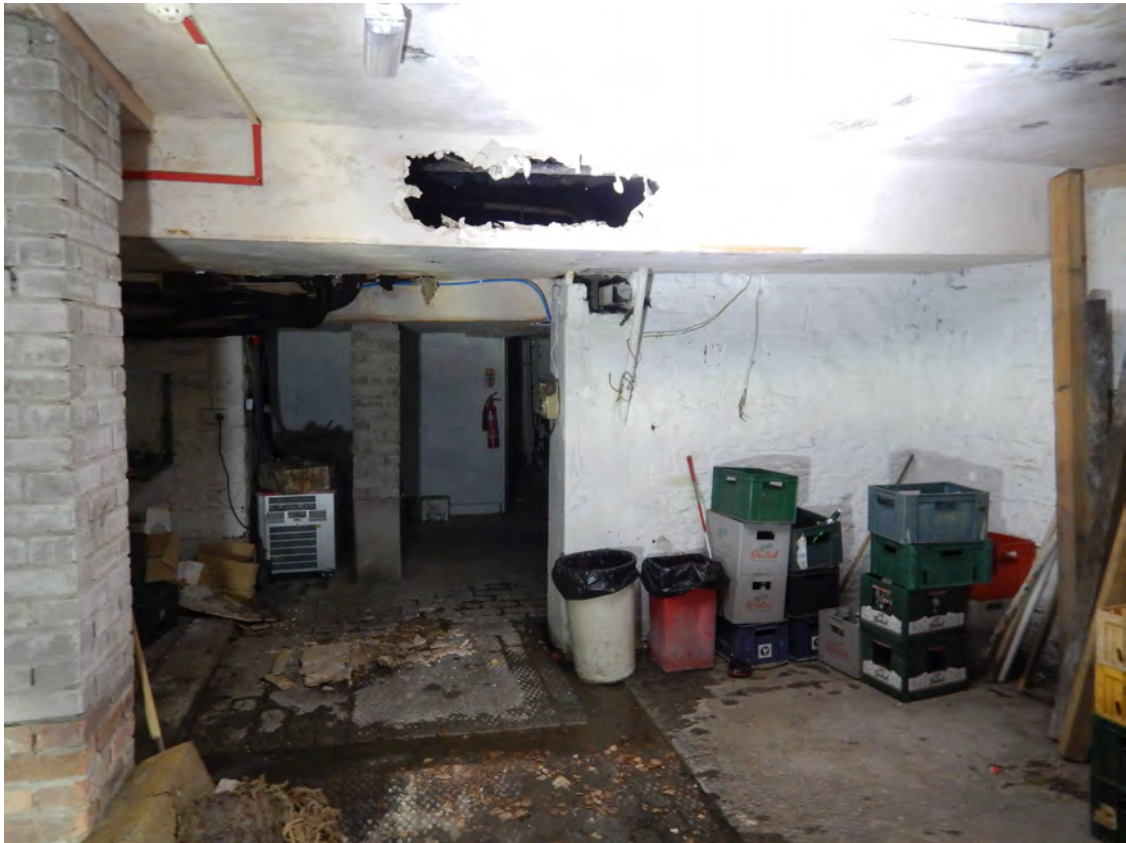
Plate 205. Room 2, looking north

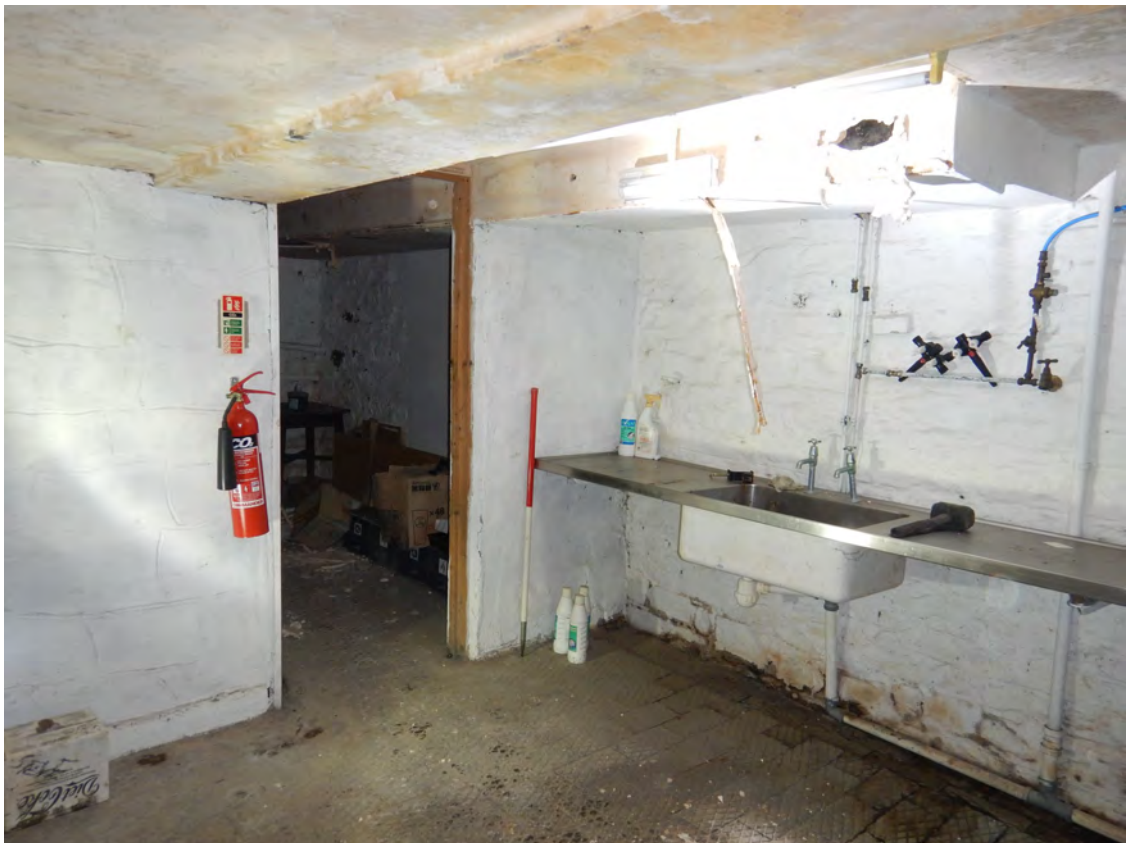
Plate 206. Room 2, looking east

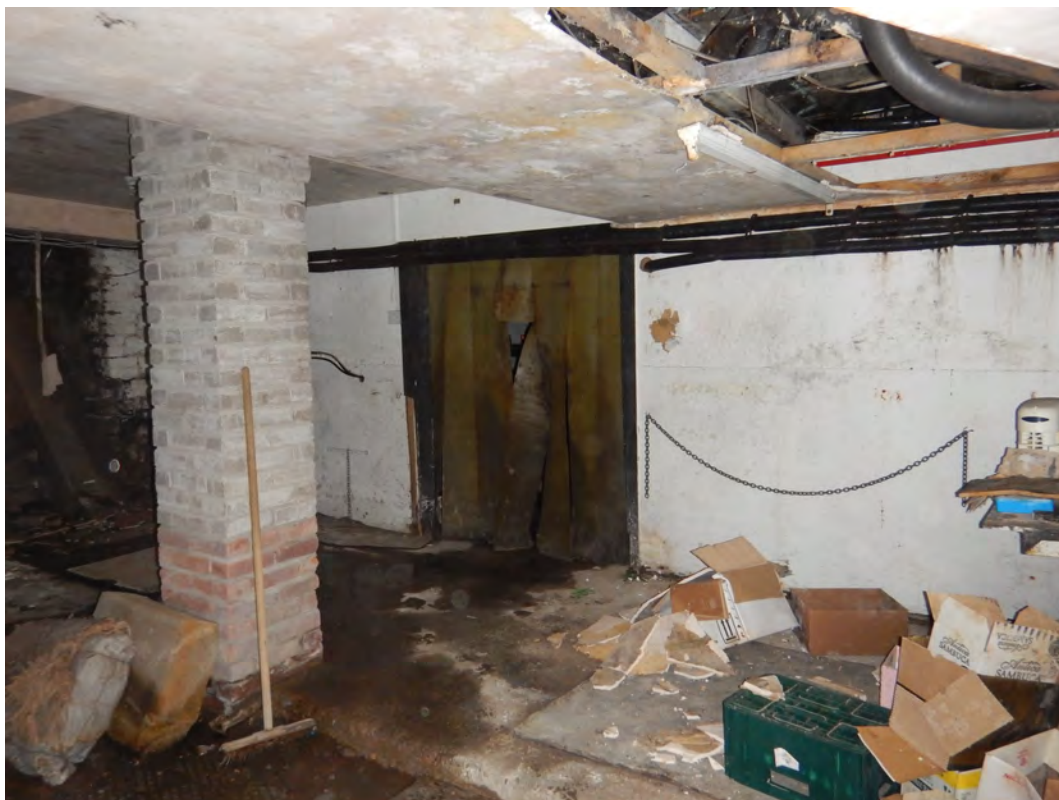
Plate 207. Room 2, looking west

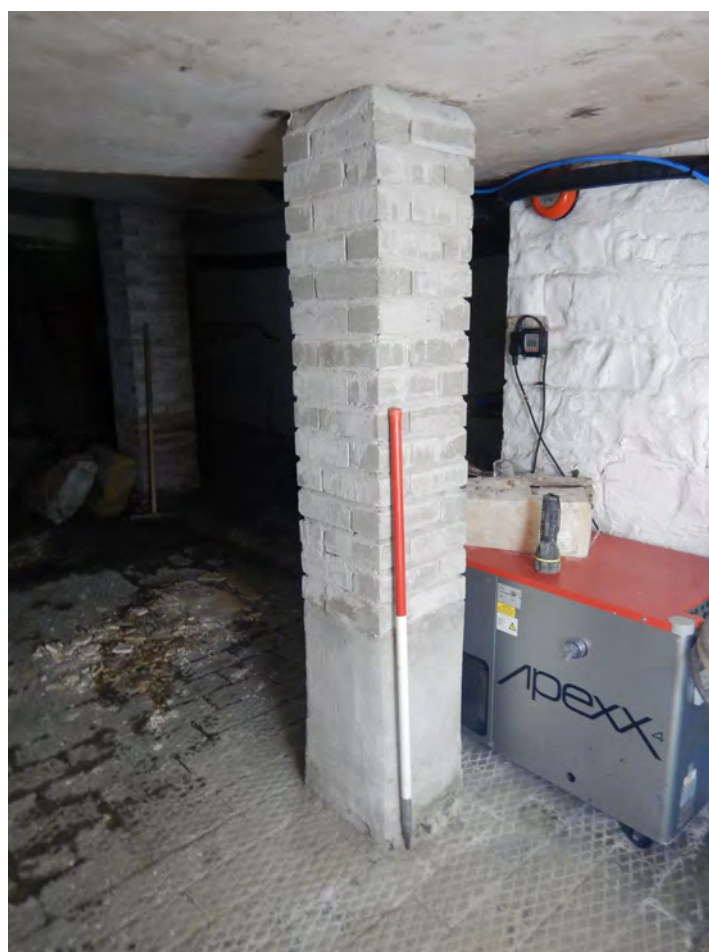
Plate 208. Newly built column in Room 2, looking west
