Sea View Labour Club, Barry

Level 2 Building Survey

Report No . 1967

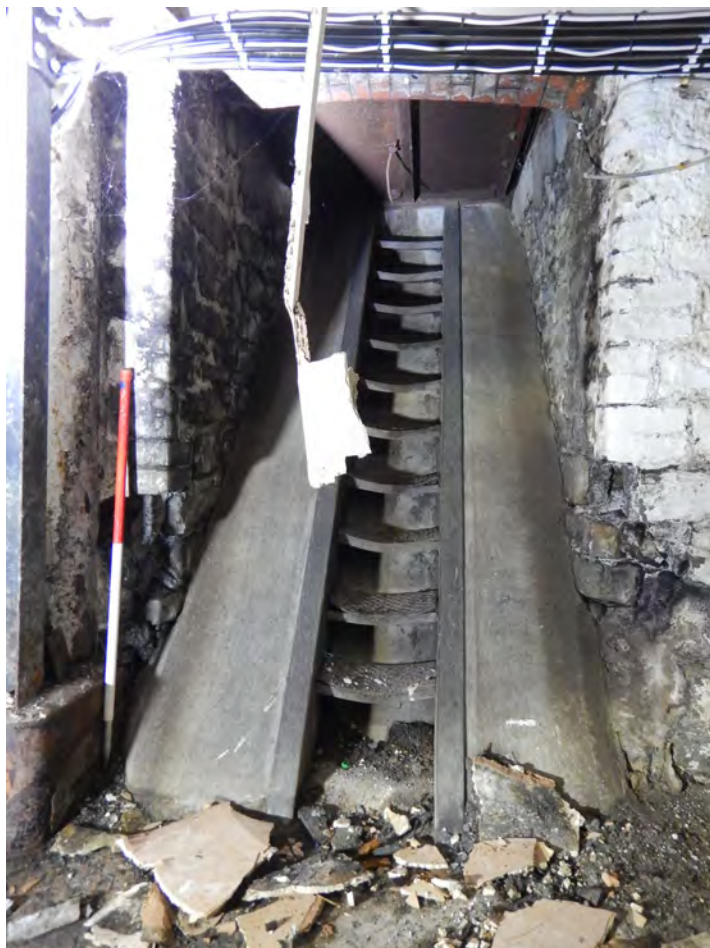
Plate 209. Barrel chute, Room 2, looking south-west

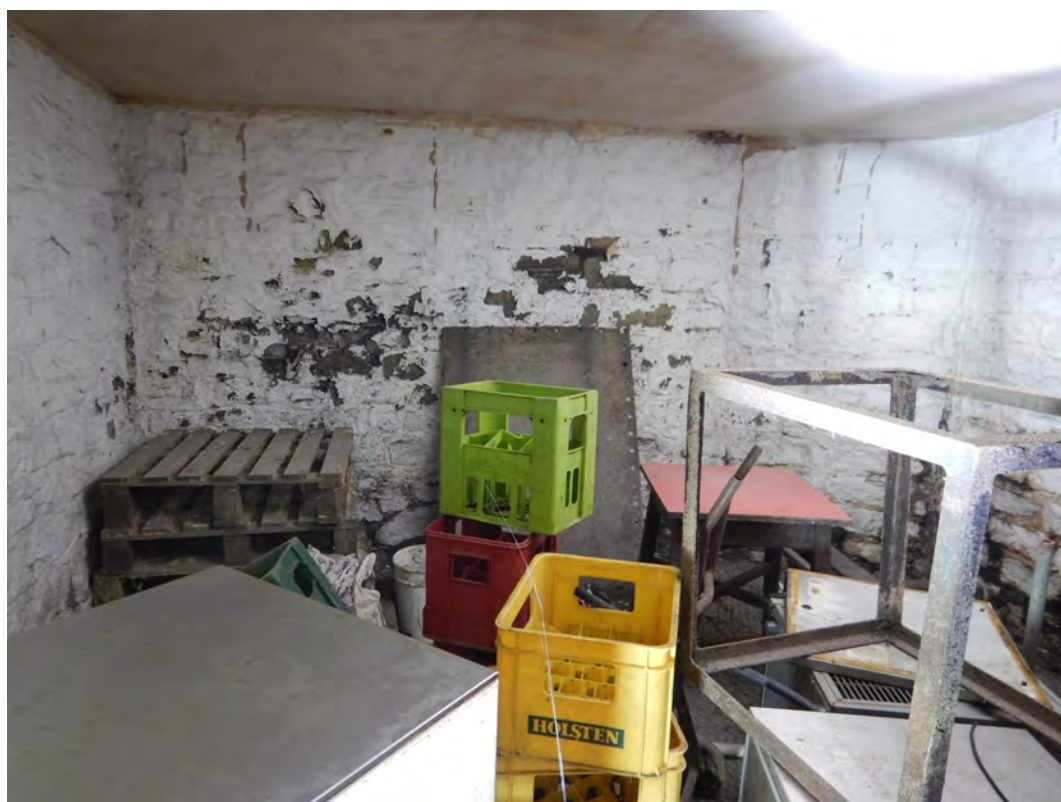
- 5.90. Room 3 is a small room to the south-east of Room 2. Floor, walls, and ceiling are as the other Rooms (Plate 210). The doorway to Room 2 is a flat arch opening with plastic curtain (Plate 211). There is also a low opening to the Store from this room (Plate 212).

Plate 210. Room 3, looking east

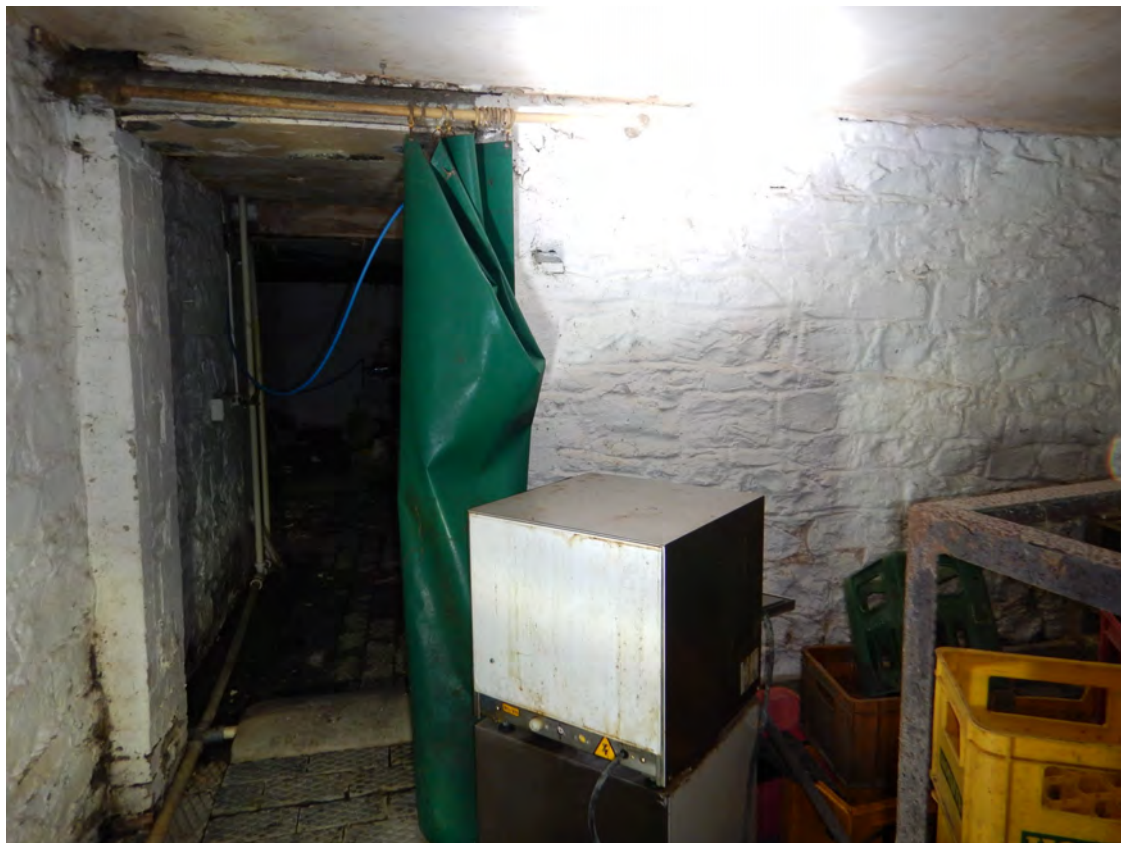
Plate 211. Room 3, looking north-west

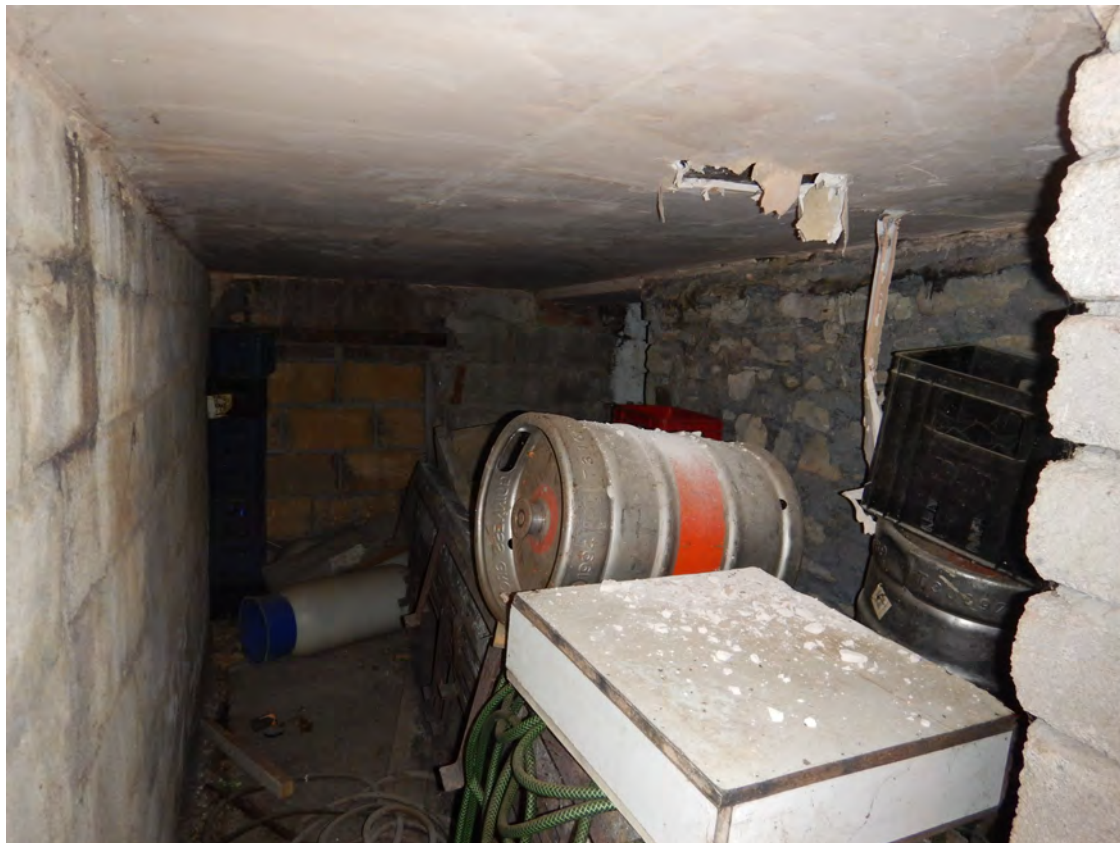
Plate 212. Store area from Room 3, looking south-west

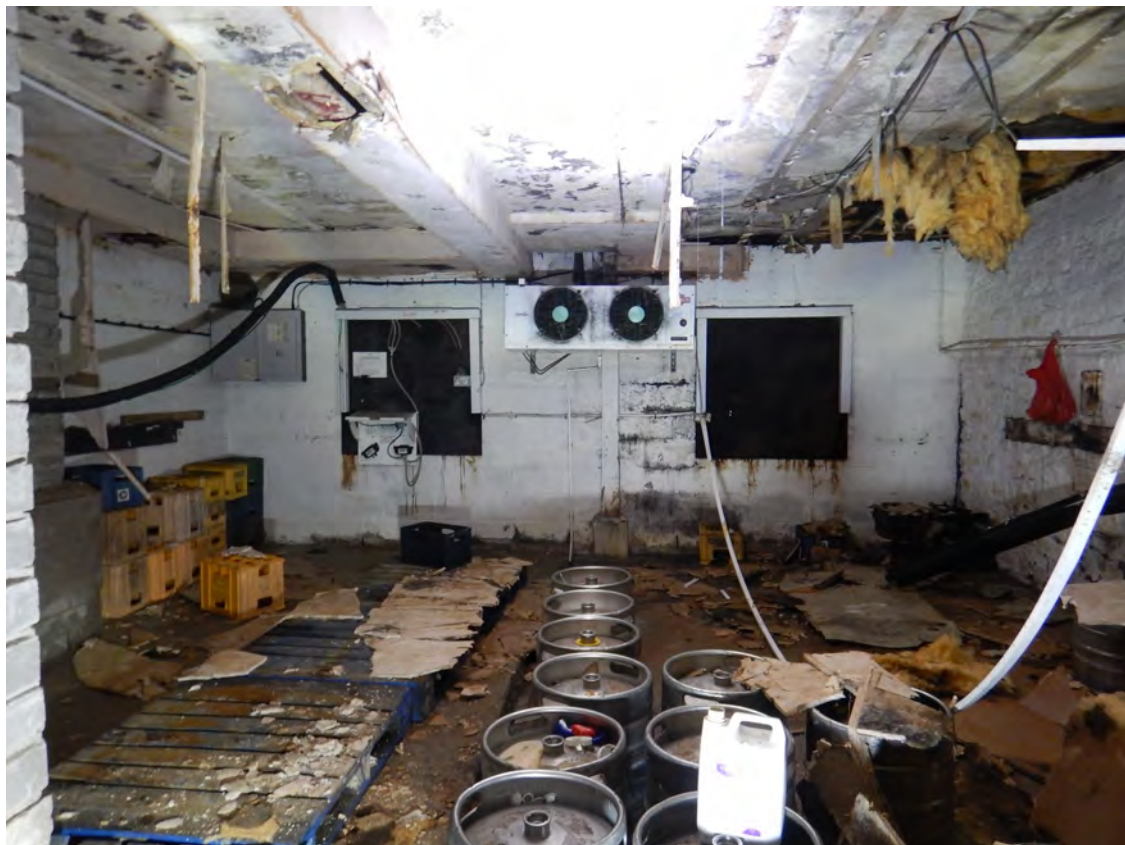
- 5.91. Room 4 is largely as the other Basement rooms (Plate 213). Its north-west and south-west walls are breezeblock rather than rubble stone (Plate 214). Along the north-east wall are the fittings and pipes for beer barrels (Plate 215). As in Room 2, there are recently built or replaced brick pillars (Plate 216).

Plate 213. Room 4, looking north-west

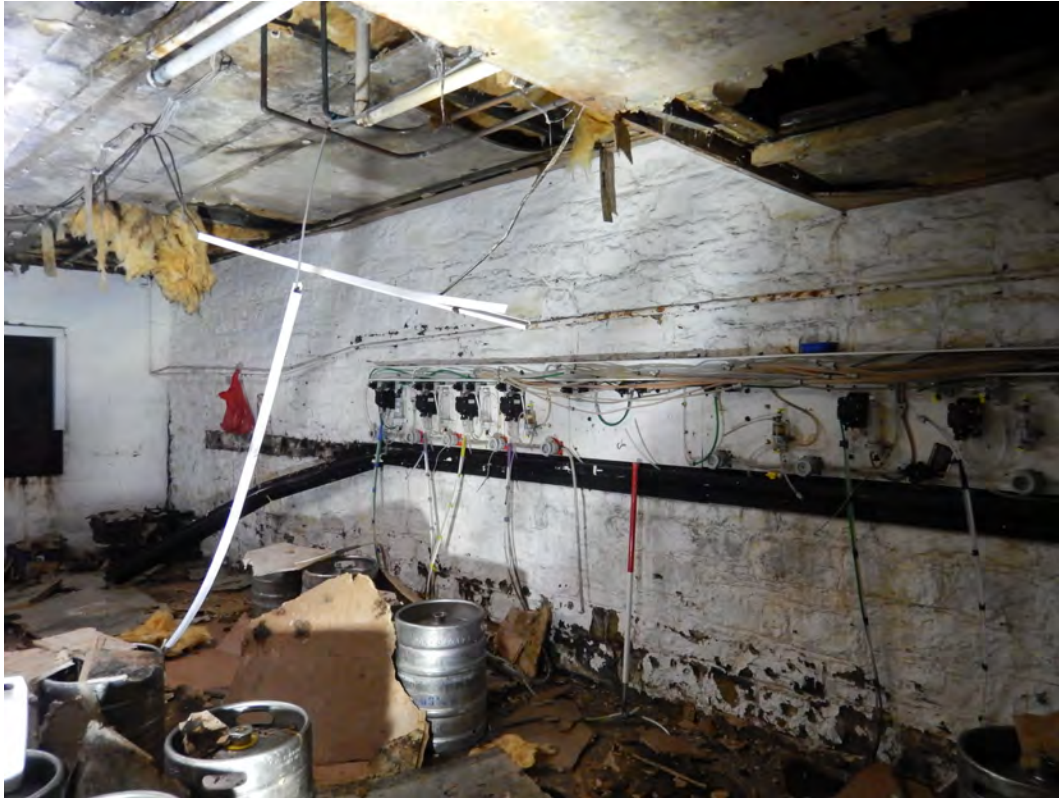
Plate 215. Room 4 , looking north

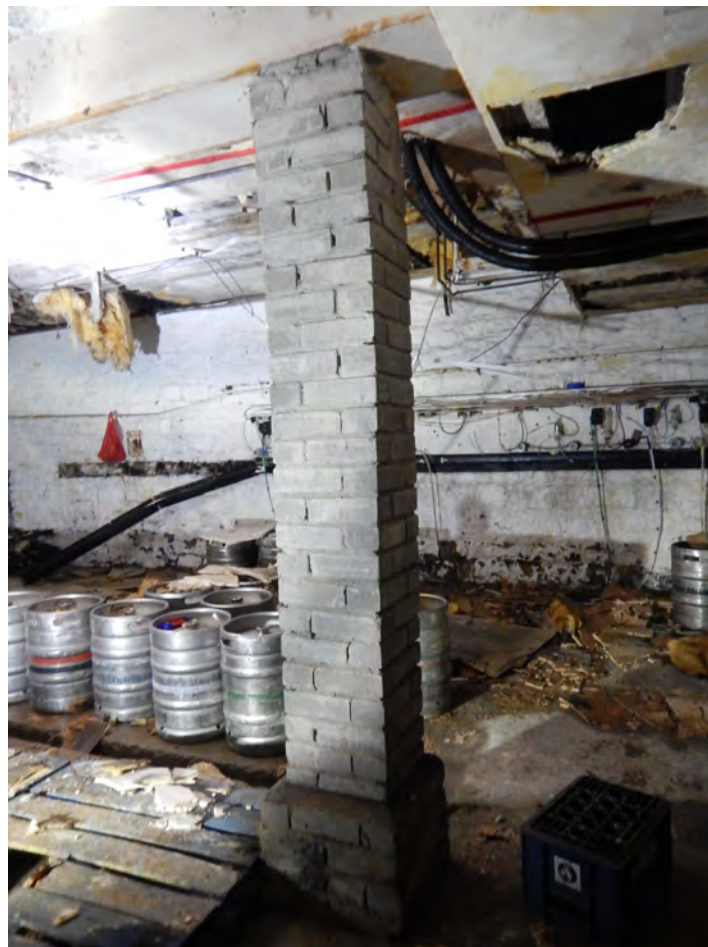
Plate 216. Newly built column in Room 4, looking north
