The Hanbury Arms Caerleon, Newport

Historic Building Recording

CA Project: CR1416

November 2023

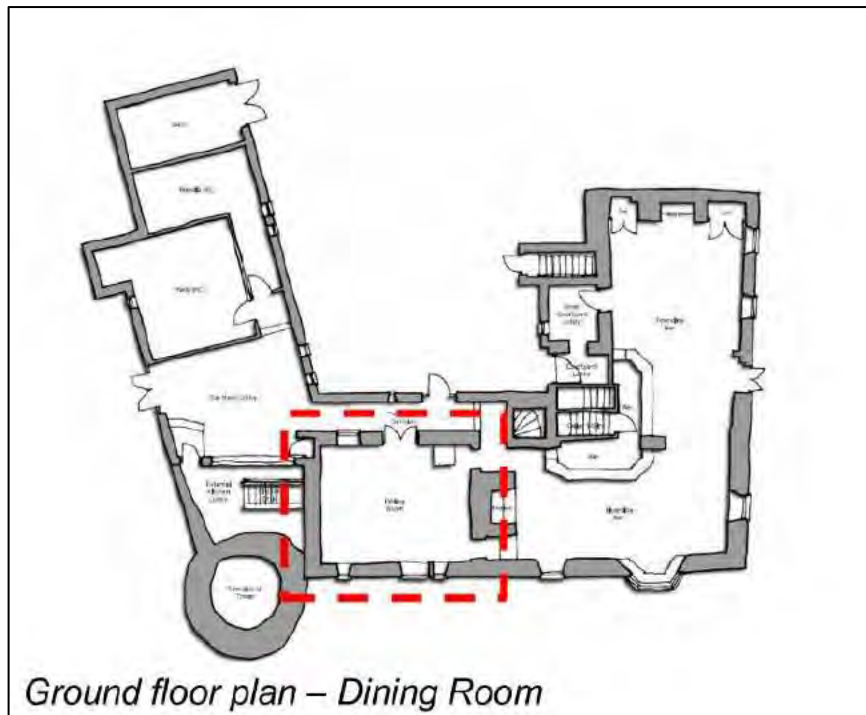
Fig. 6 Ground floor plan, with area of works outlined (courtesy of Mann Williams)

- 5.3. The affected areas for recording are located in the westernmost section of the historic building and both mapping (Figs. 2 to 5) and historic images suggest this section is either original to the construction of the building, or at least 17th century in date. The cohesive group of three 3-light mullioned windows to the first floor suggest the former. The affected area in relation to the overall building footprint is annotated on Figure 6 below.

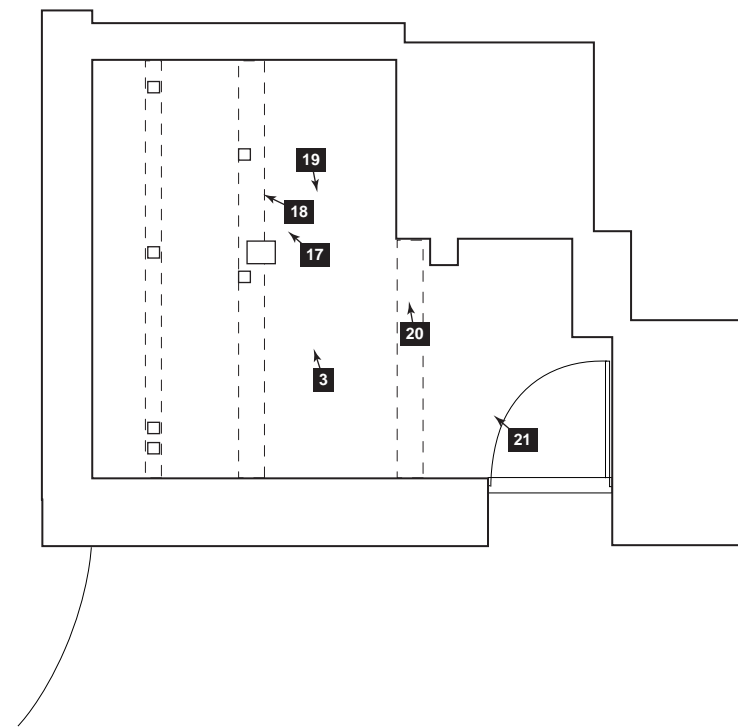
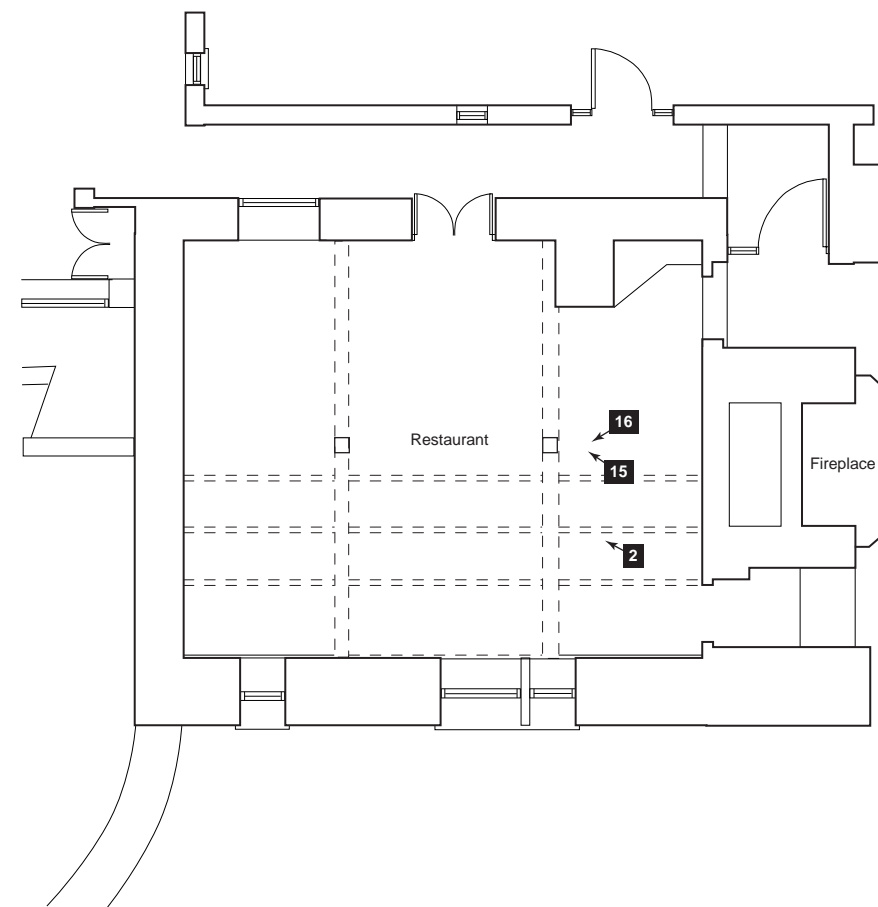
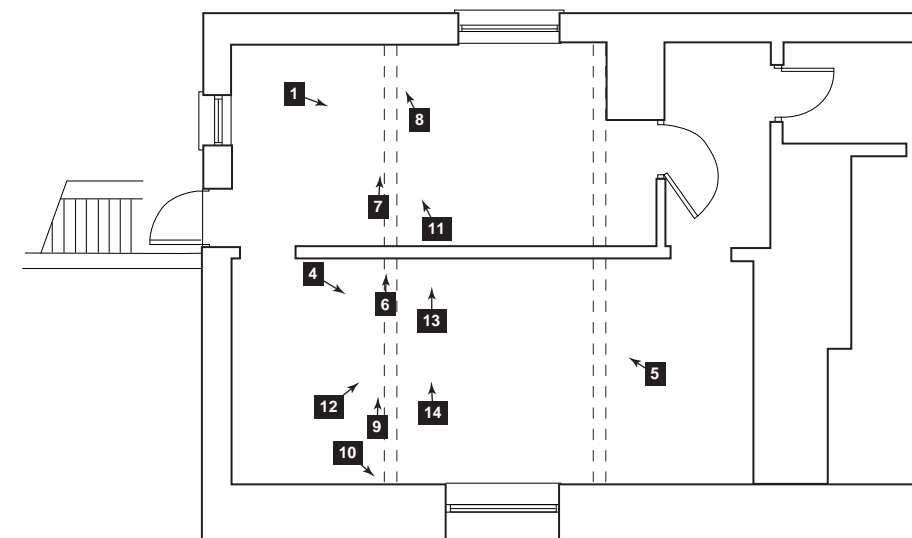
Floor plans with photograph locations

- 5.4. Figure 7 below provides floorplans of the affected areas with photo locations for orientation.
- 5.5. Photos 1 to 4 illustrate the rooms prior to the consented works. As can be seen in Photo 1, the first floor space is a commercial kitchen area. This is subdivided by a modern stud wall as annotated on Figure 7 (Floorplans). Photo 2 depicts the ground floor restaurant with oak piers *in situ* whilst Photo 3 illustrates the concrete block pier in the basement area.

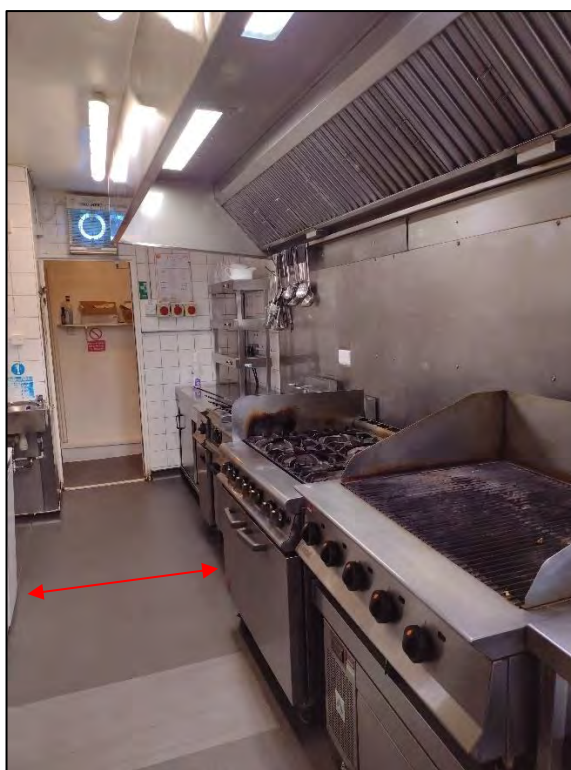
Photo 1 View looking east in the first-floor kitchen (approx. location of eastern beam arrowed)

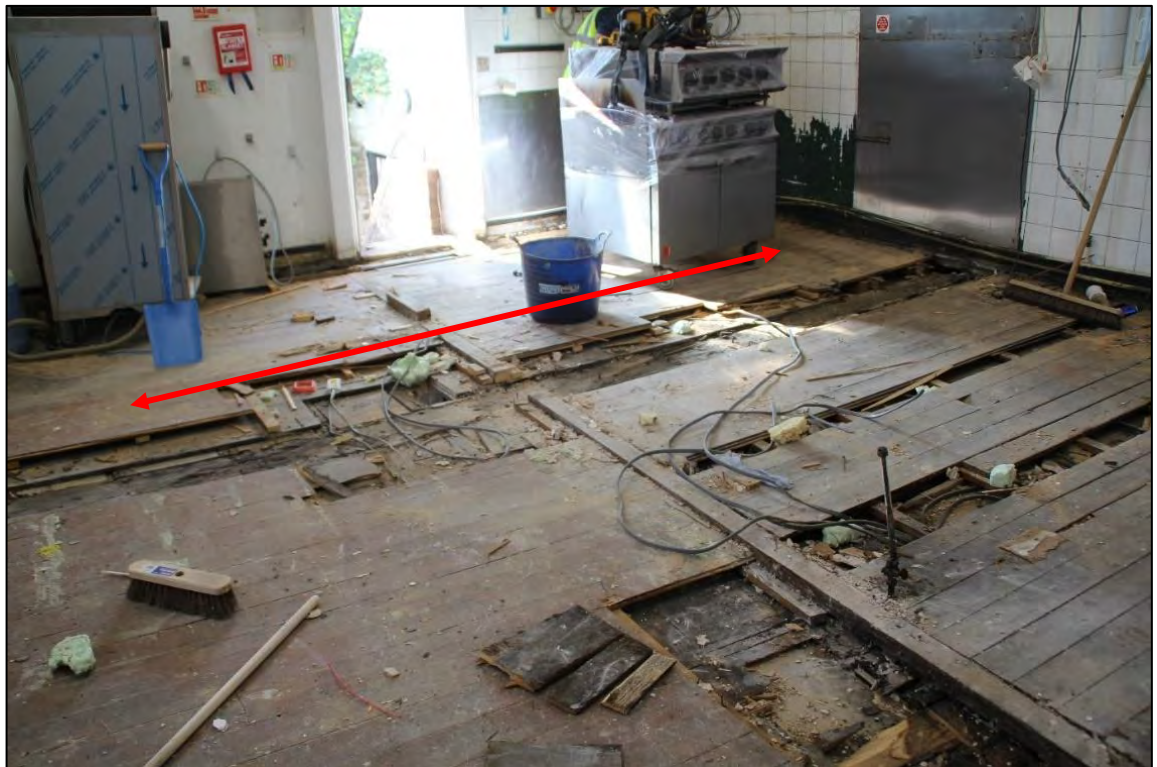
- 5.6. As part of the consented work, the commercial kitchen equipment and the modern subdividing stud wall was removed to reveal the extant flooring, which was covered in a linoleum surface commonly seen in commercial kitchens. The areas of lino are laid over a flat plywood surface comprising a floating floor over two other layers of timber flooring. This is best illustrated in Photos 4 and 5, with the floating floor being laid on .10m x .05m joists resting on what appears to be a late 19th or 20th century pine tongue and groove floor surface. The pine boards are .10m wide and sit flush to the central thin transverse joist which supported the stud wall subdividing the kitchen. The nature of the relationship of the transverse joist and the tongue and groove pine flooring suggest they were inserted contemporaneously. The pine boards are varnished, which suggests they were a visible floor surface.

Photo 5 Following removal of the plywood layer and showing the pine tongue and groove layer with areas of removal to reveal the two beams (arrowed)

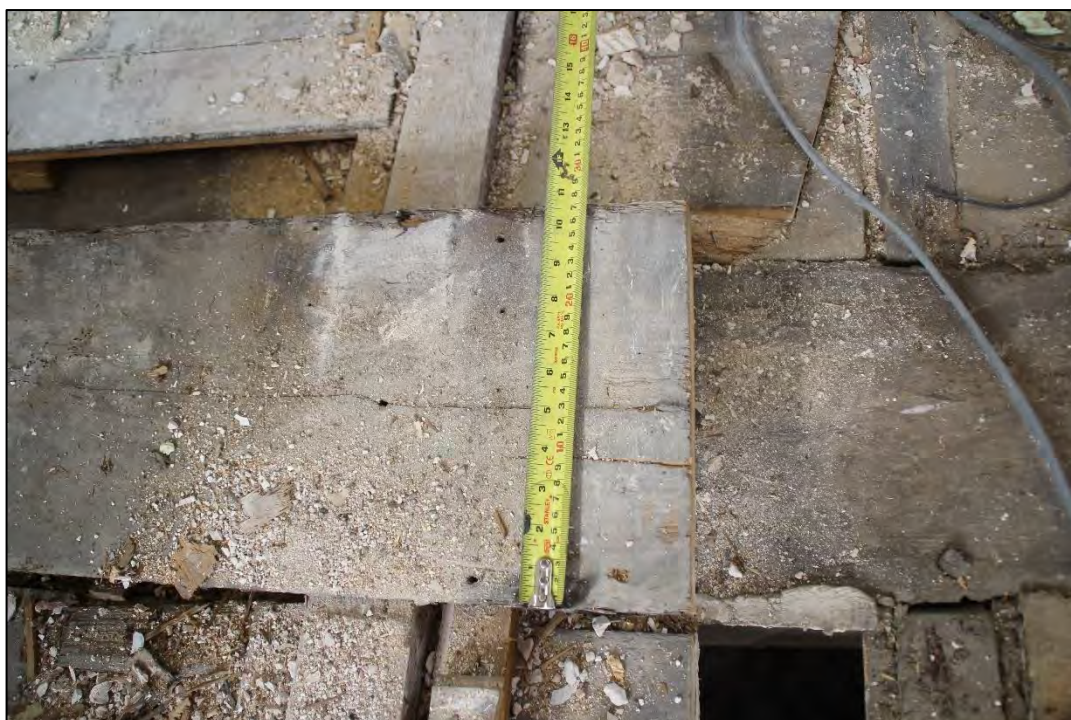
- 5.7. Directly below, also bearing on transverse joists .05m x .02.5m, this middle layer rests on wider oak floorboards of 0.28m width which are likely the original boards or at least of some considerable antiquity (Photo 6). Only areas over the two main beams which are subject to the works were fully uncovered.

Photo 6 The oak floorboards present as the first layer over the beams and joists

-
- 5.9. The historic wide oak floorboards (Photo 6) have a typical pit sawn character, with rough edges and a relatively flat surface. There is evidence of changes over time such as nail holes and some cutting to facilitate new flooring being laid on top.
- 5.10. The removal of sections of the flooring to reveal the two beams subject to the remedial works revealed that the beams are .28m wide and .28-.30m deep. The beams, which appear to be oak, are rough hand cut and there is no evidence to suggest they are not original to the early phases of the building. As illustrated in Photo 7, the beams have been subject to some alterations over time. These include notching for joists, some ironwork additions, presumably for structural strengthening (Photo 8), and some insect and environmental damage, including an area of blackening which is suggestive of minor fire damage.

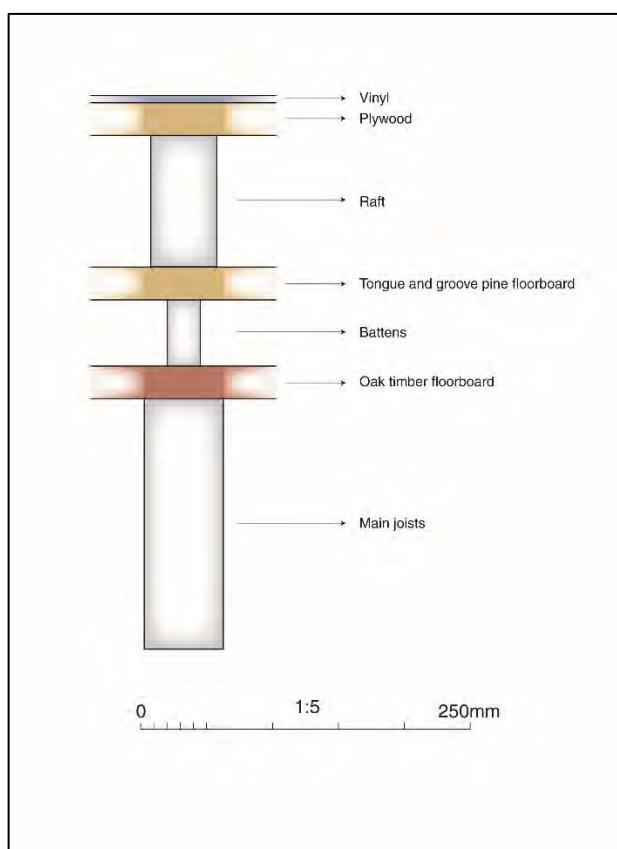
Fig.8 Section of floor build up

- 5.8. This floating floor build up is illustrated in Figure 8 below. Joists increased in height towards the centre of the bowing to level up the uneven surface and may have been used to conceal surfaces.

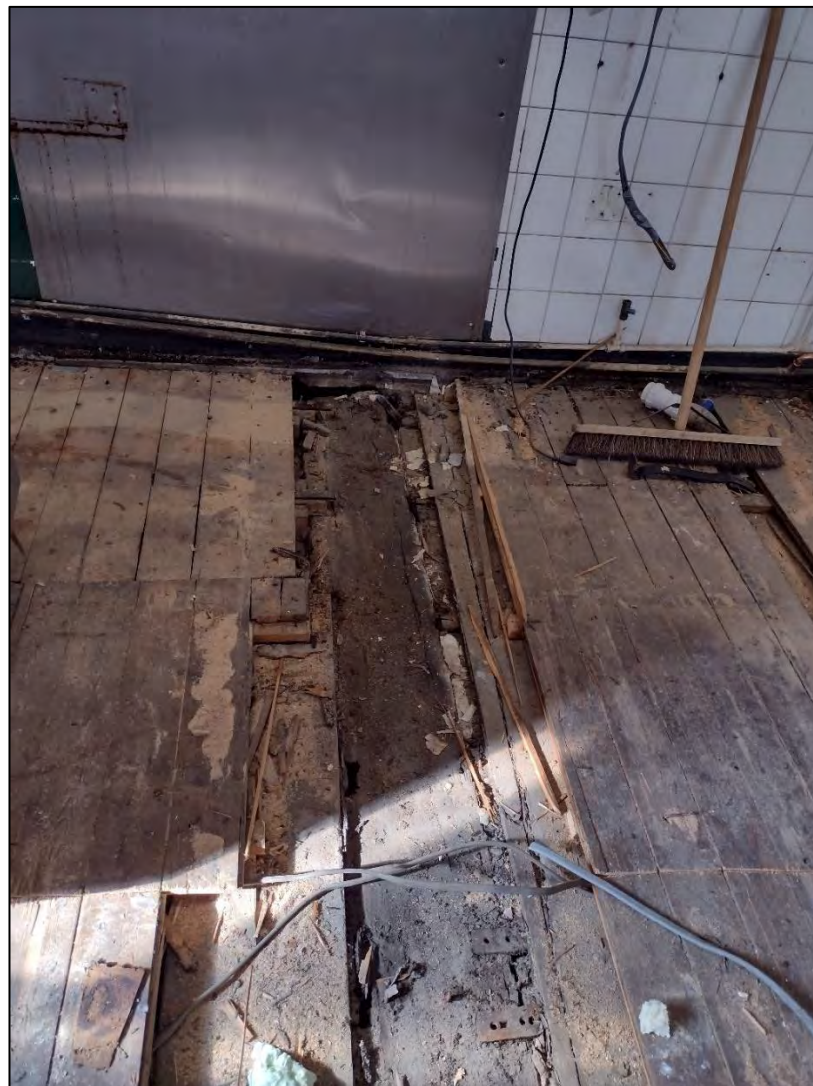
Photo 7 The westernmost beam, uncovered

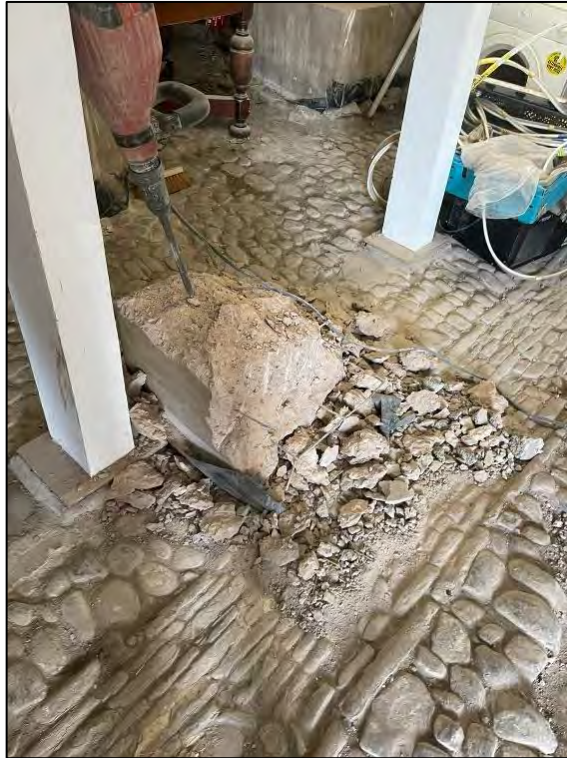
- 5.18. The piers to be removed as part of the consent (annotated in Photo 17, all other supports are part of previous consented works) was removed as a final stage to the project. The ground floor is supported on two primary beams, one of which is partially built into a supporting wall (Fig. 7), with three bays of joists. The central primary beam has been found to be not supported on masonry (Mann Williams 2019 et al) and is now propped with steel posts and concrete footings as part of previous consented works as is the secondary beam in the west of the space. Historic cobbles are extant throughout most of the basement floor surface; they show drainage channels and likely relate to the earlier phases of the building as a house and possible trading depot.

- 5.19. The unauthorised piers were formed of concrete blockwork laid on a poured concrete pad over DPM. Photos 18-21 illustrate the removal of the piers, the uncovering of a chamfered ground floor timber beam and the subsequent making good following removal. As can be seen the historic cobbles were undisturbed by both the 2016 installation and removal of the piers and the historic walling was also undisturbed. The chamfered central beam (Photo 19) was observed to be a substantial timber

Photo 17 Part way through removal of the concrete pad

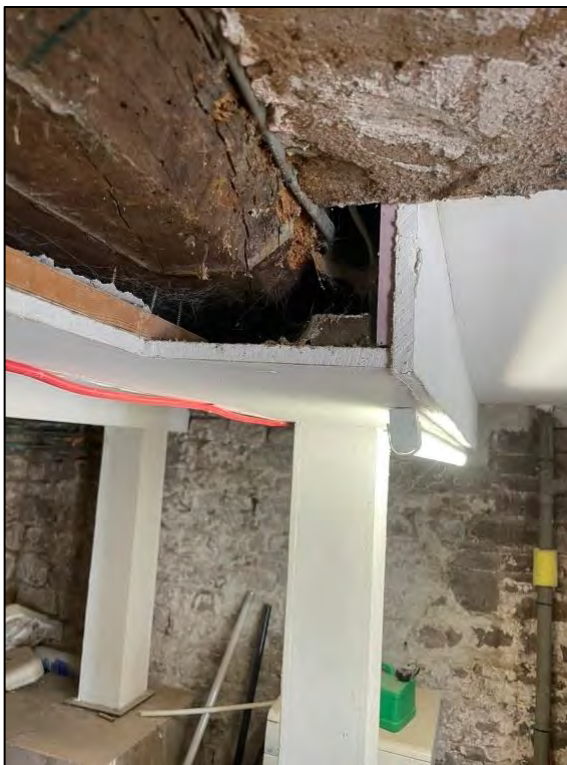
commensurate with those seen at first floor level and is therefore highly likely to be original building fabric. In the section that was exposed there was evidence of beetle infestation and nail holes from previous works.

Photo 18 View of the chamfered western beam uncovered as part of the removal

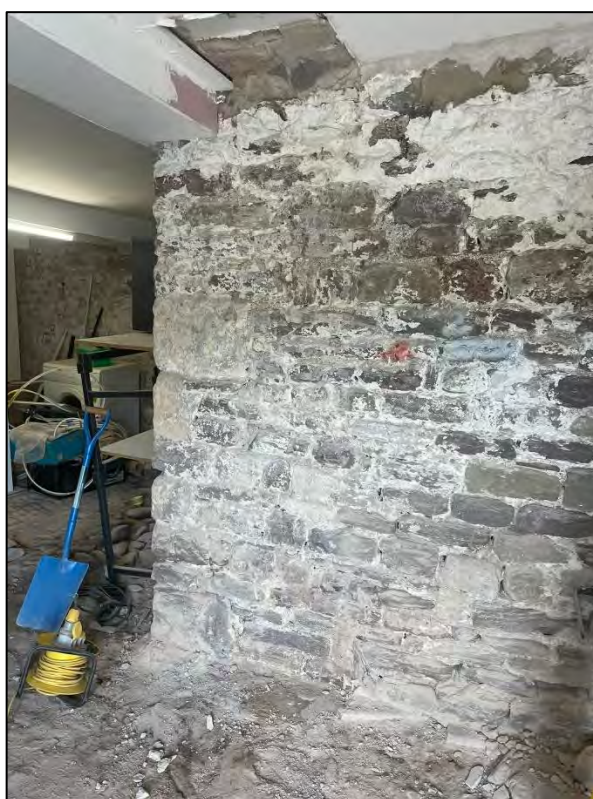
Photo 20 **The undisturbed cellar wall after the concrete pier was removed**
