Ruperra Castle (Castell Rhiw'r Perrai) Caerphilly Glamorgan

Historic Building Recording

CA Project: CR1627

CA Report: CR1627_1

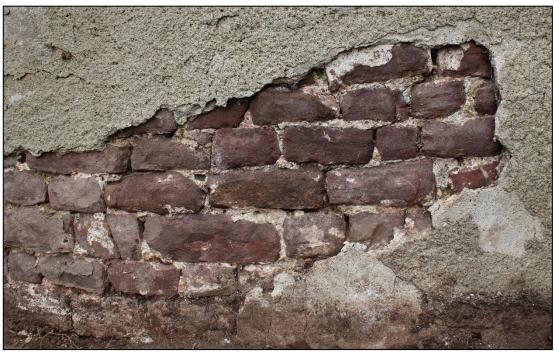
Photo 3: Exposed course of old red sandstone, south-west tower

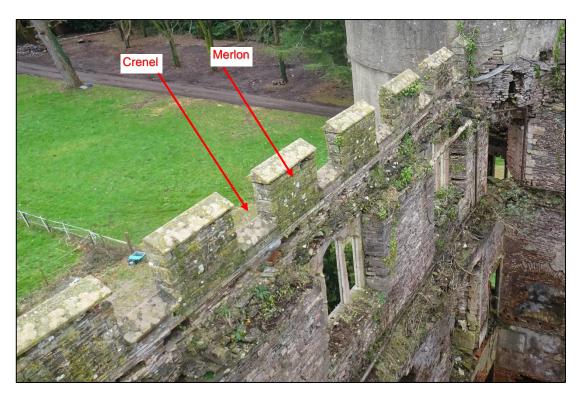
4.14. Prior to the fire of 1941, each elevation and tower was originally topped by a continuous band of crenelations (Photo 9), however, these features have been largely lost on the north and west elevations in the years following the 1941 fire. According to both Dineley's 1684 sketch and the anonymous 1770 sketch (Figs. 2 and 3), the original configuration of the building featured crenelations on the towers only. As such, the crenelations atop each facing elevation were added following the fire of 1785. It is likely, however, that due to the appearance and consistency of form across all the wallheads, the crenelations on the towers may have also been renewed following the 1785 fire. The merlons across the building incorporate a consistent moulding for both elevation and tower embattlements whereby the stone coping features an asymmetric cross section akin to a bolection mould, facing outwards. This was likely intended to bolster the visible elements of the coping without necessary repetition of the mould on the roof facing side. The coping at the base of each crenel is simple in its form and is sloped inwards, towards the roof, likely to direct rainfall away from the face of the elevation.

Photo 9: Section of crenelations atop south elevation

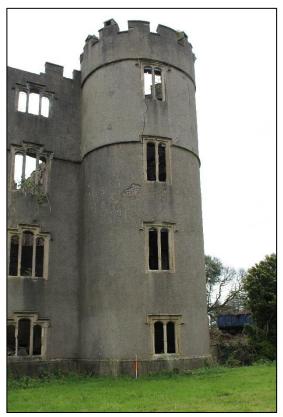
- 4.16. The south-east tower partially collapsed in 1982, leaving the internal elevations exposed (Photo 11). This event followed the emergence of cracks along the length of the tower that precipitated the failure. Cracks of similar nature are also apparent within each of the other three towers, which are currently all still standing.

Photos 10 and 11: Overview of south-west tower, looking south-east, and south-east tower, looking north-west

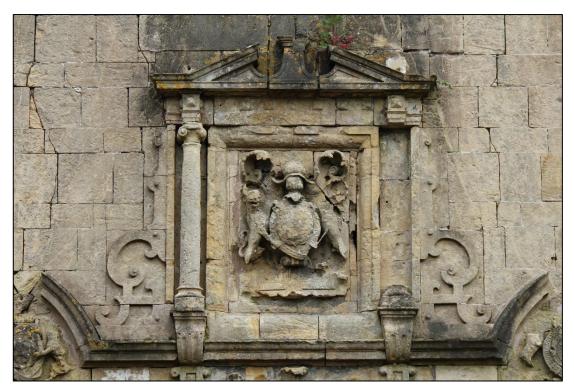
RCAHMW 1981). Each panel is set beneath a cornice that is, in turn interrupted by regularly spaced corbels, and a broken pediment above each panel. Since the interpretation of the panels, as documented in the RCAHMW analysis in 1981, the panels have all experienced noticeable weathering and are now, consequently, difficult to decipher. Conversely, other features, such as the broken pediments and dentils are relatively intact, suggesting a possible intervention by Hardwick during his repairs of the 1780s.

Photo 15: Detail of Charles I heraldic panel

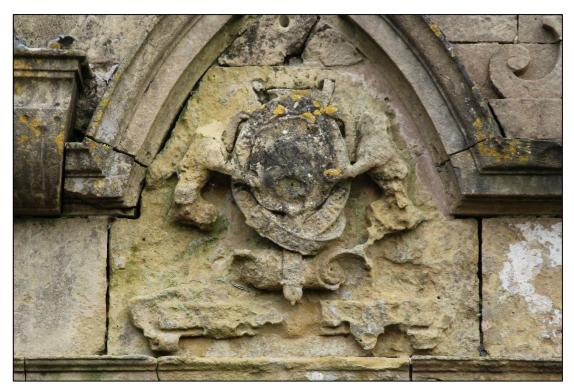
Photo 16: Detail of west panel

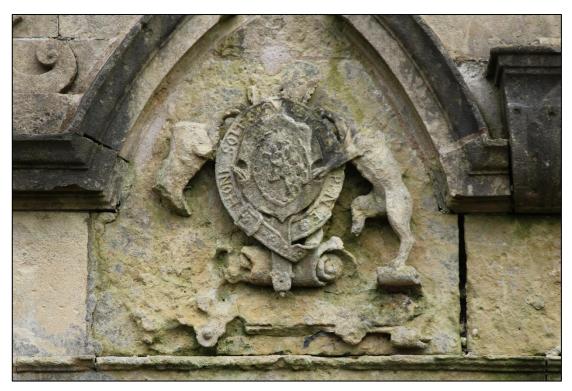
Photo 17: Detail of east panel

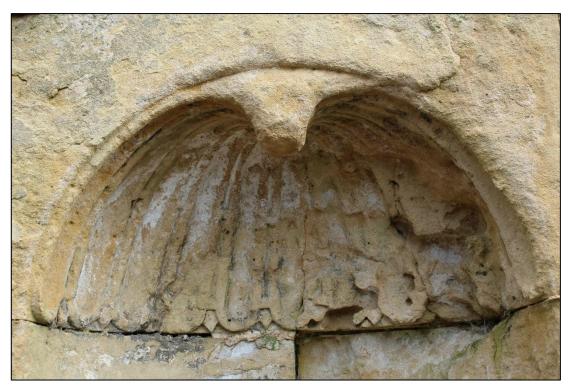
- 4.24. To either side of the door are two identical niches which incorporate semi-circular shell motif heads, both heavily weathered (Photo 19). Above each niche is a band of strapwork that is moulded to follow the curve of the niche below. Above these are two further panels, both blind (Photo 18). Further embellishment is provided through the incorporation of dentils as part of a shallow cornice, directly above the door surround. The door is approached via a set of stone steps that appear to be a relatively recent addition.

Photo 19: Example of shell head within west niche

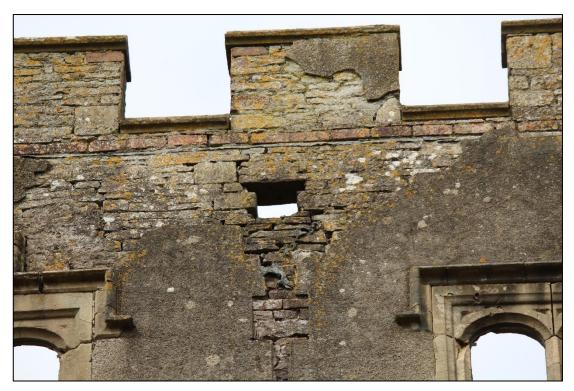
4.26. There are areas at parapet level where the cementitious render has fallen away, revealing the masonry structure beneath (Photo 21). This affords an interpretation of possible phasing where the visible old red sandstone composition of the walls gives way to coursed rubblestone and a levelling layer of red brick to form the crenelations. This is possible visible evidence for the alterations carried out following the 1785 fire and may have prompted an early application of roughcast to hide the variations caused by these interventions, as suggested in the engraving by JP Neale in 1821 (Fig. 11). The exposed masonry does not provide any clear evidence for the shape of the former gables, however.

Photo 21: Detail of exposed masonry at parapet level

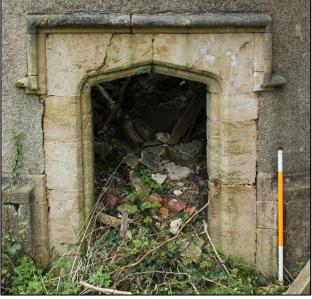
4.36. The symmetry of the north elevation is compromised by the inclusion of a small doorway into the vaults at the eastern extent of the elevation (Photo 31) and an adjacent doorway providing access into the north-east tower (Photo 32). The doorway to the vaults appears to have been inserted through the truncation of an existing window in this position. The mullion and surround of the window have been shortened and made good whilst a stone door in the perpendicular style has been inserted beneath. The junction between the two elements is awkward and has resulted in a slightly wider door surround than the corresponding window surround above. The aperture is not symbolised as a doorway on the 1780s plan (Fig. 37) but is suggested as a doorway on the 1909 plans (Figs 38) so it was likely installed in the intervening years, possibly to facilitate a more convenient entry to the vaults for both cooking ingredients and coal/coke for the central heating system.

Photos 31 and 32: Detail of doorways to vaults (left) and north-east tower (right), north elevation

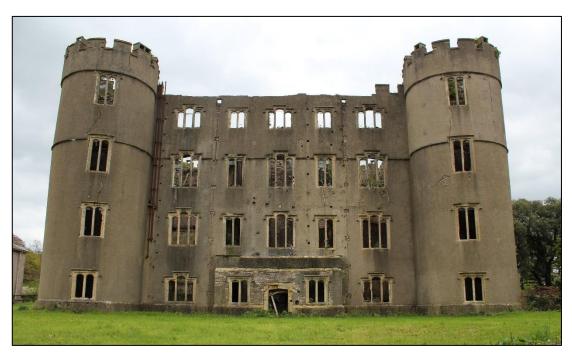
Photo 33: West elevation

4.40. The west elevation of the building (Photo 33) broadly mirrors the east elevation in terms of fenestration arrangement, incorporating alternate three, two, three light window configurations. The west elevation differs, however, in its incorporation of a row of apertures serving the lower ground floor. As with the north elevation, the west elevation is also missing the majority of its crenelations. Whilst these features initially survived the 1941 fire (Fig. 15), they were subsequently removed, perhaps implying that the north and west elevations suffered more from the effects of the fire.

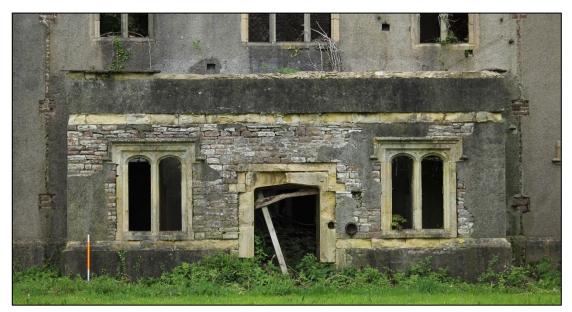
Photo 34: Porch, west elevation

4.41. The distinguishing feature of the west elevation is the single-storey porch, providing access to the ground floor of the building. The porch (Photo 34) consists of roughly

coursed rubblestone with two-light, stone window apertures of an identical style to the rest of the building. The doorway of the porch comprises a stone surround with ovolo mouldings, incorporating a pseudo 4-centred arch at its head, badly eroded (Photo 35). There are the remains of a stone hood mould above the door surround which is also badly eroded and missing its facing decoration.

4.42. The porch is a later addition to the castle. It was not present on the 1780s plans (Fig. 27) but had appeared by the 1909 plans (Fig. 28). Furthermore, a small projection on the west elevation is identifiable on the Tithe and historic OS maps from as early as 1839 (Fig. 11) but this is certainly an earlier wooden porch as depicted in a photograph of the 1890s (Friend 2018). Ultimately, the style and appearance of the porch, coupled with identification of the porch as contemporary with the early 20th-century refurbishment of the house by several secondary sources (Cadw 1999a; CA 2001; Friend 2018) asserts that the porch was probably constructed contemporaneously with the east porch, in, or shortly after, 1909. The incorporation of near identical window stone and tracery within the later porch may suggest that other windows within the remainder of the building were possibly repaired or replaced at the same time, as suggested by different rates of weathering within the same unit at certain points (e.g. Photos 12 and 22).

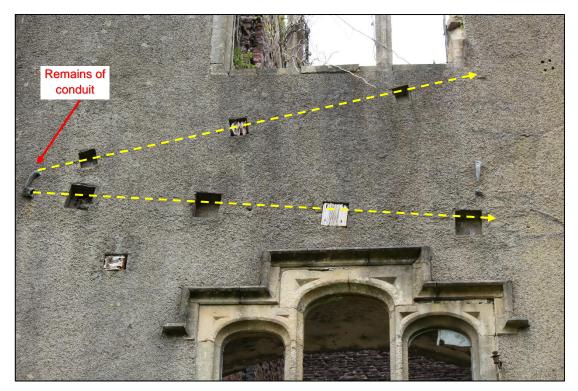
Photo 36: Example of square indentations in west elevation

4.43. Notably, the west elevation (and a vertical portion of the north-east tower) incorporates a series of shallow square indentations with the fabric (Photo 36). Although broadly equally spaced, the indentations exhibit no clear relationship with the external features of the castle and appear to route in seemingly random directions. In all likelihood, these indentations were made either during or after the Second World War. Their purpose is, initially, unclear, however some of the indentations retain a square section of timber within the slot. The most likely hypothesis is that the indentations were made to secure apparatus to the exterior of the castle. This is clearer on the north-east tower where the path between indentations shows evidence of scarring and the alignment breaches through the preexisting stringcourse, indicating that a feature, pipe or cable was routed along the wall, secured onto the timbers within each indentation. Furthermore, a vestige of a conduit junction remains on the west wall with outlets that align with the direction of the indentations (Photo 36), suggesting that a series of pipework or electrical conduits were once secured to the castle.

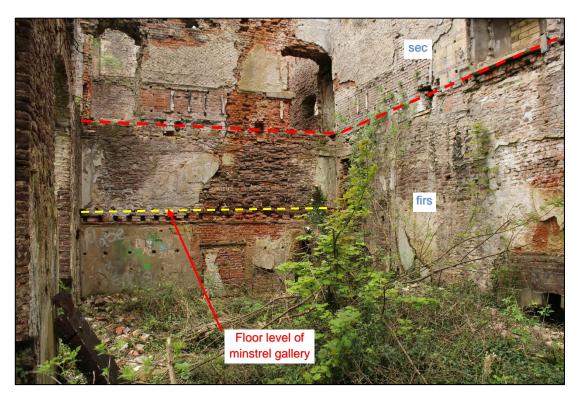
Photo 37: Overview of Cell A, looking north-west

- 4.45. Cell A is located at the south-east corner of the castle and is the largest cell of the building by floor area (Photo 37). According to the 1909 plan this cell formerly incorporated the Dining Hall at first floor level, Drawing Room at second floor level whilst the third floor contained servant accommodation comprising two maid's rooms, the 'White Room' and a passageway. This broad configuration had been maintained without appreciable alteration since at least the 1780s.
- 4.46. As with all internal areas of the building, Cell A was extensively damaged by the fire of 1941; the Cell incorporates no floors, ceilings, decoration or fixtures. The visible fabric comprises exposed masonry walls with portions of surviving plasterwork and the apertures of doors and windows. The floor of the space was piled with debris to

a height appreciably higher than the original floor level. Consequently, the full height of the Dining Room can no longer be appreciated.

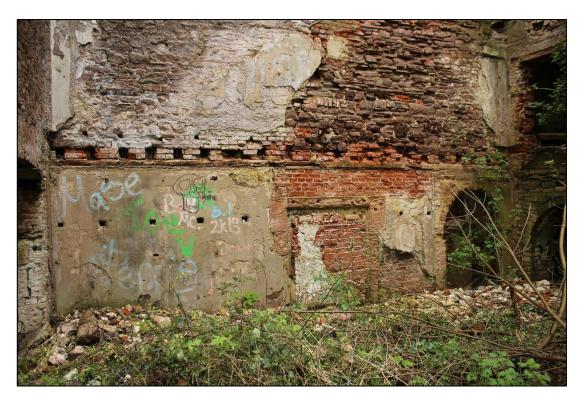
Photo 38: View towards west wall of Cell A, first floor

- 4.50. Whilst the minstrel gallery has now gone, the wall behind survives and evidences various phases of alteration (Photo 38). The wall below the level of the gallery consists of thin, handmade red brick. A central, square framed ashlar doorway, dating to Phase A, survives but is infilled with later red brick. This door formerly led to what is now the Butler's Pantry within Cell G. The door was recorded as open on the 1780s plan (Fig. 30) but was infilled by 1909 (Fig. 31). The character of the infill brickwork, however, suggests that the door was probably infilled soon after the 1780s. Curiously, the surrounding brickwork, above and to the north of the central infilled door, broadly corresponds to the infill brick, suggesting that this was also possibly the result of 1780s repair.

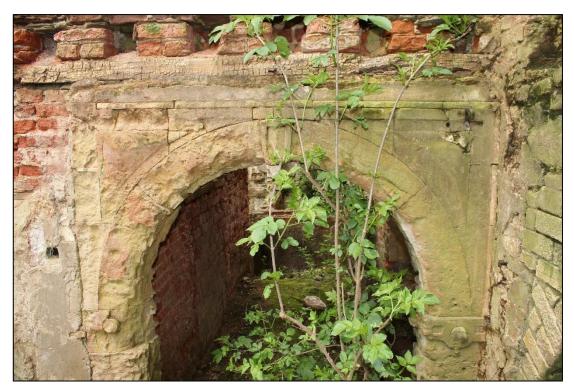
Photo 39: North doorway, west wall of Cell A

- 4.51. A second, grander doorway is positioned at the north extent of the wall and comprises an ashlar frame with semi-circular head (Photo 39). The doorway is similar to several other examples through the castle, all probably contemporary with Phase A of the building. The door was probably the primary access between the Dining Hall, pantry and kitchen. The south portion of the wall is obscured by surviving plasterwork but may have also incorporated a door at one stage, reminiscent of the triple doors at the lower end of a medieval hall (Photo 38).

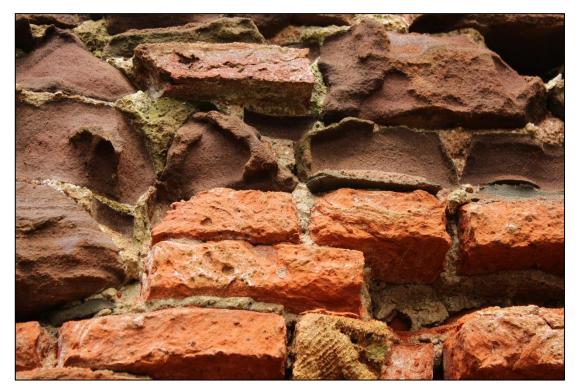
Photo 40: Detail of brick and rubblestone usage, west wall of Cell A

4.52. Above the height of the minstrel's gallery, the wall fabric of the west wall changes to predominantly rubblestone. The bricks and rubblestone appear to share the same type of mortar (Photo 40) and are therefore likely to be contemporary with one

another, forming Phase A of the castle, however, a mortar analysis would aid conclusions in this respect and provide greater evidence one way or another. This view is shared by Morriss (CA 2001) and the integration of the two materials is used throughout the castle, including the towers. The reasons for the varied use of the two materials is not immediately clear but brick appeared to be viewed as more suitable for detailed works such as door jambs, chimney flues, fireplace surrounds and aperture heads whilst the rubblestone was principally used as a possibly cheaper material to infill large areas of blank wall. However, rubblestone was also used in areas where brick would have been expected to be used, such as surrounding the windows in Cell A.

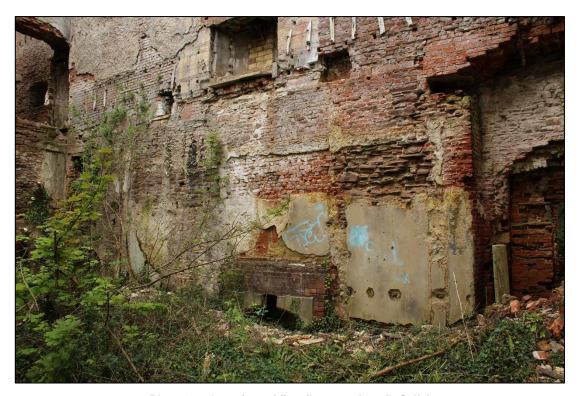
Photo 41: Overview of first floor north wall, Cell A

4.53. The north wall of the Dining Hall also incorporates elements of red brick, laid in English bond, and rubblestone whilst also retaining a large amount of surviving plasterwork (Photo 41). The deterioration of the fabric allows for visibility of multiple layers of lime plasterwork, Illustrating the instances of renovation within the room (Photo 42). The area of exposed brickwork above the fireplace also exhibits a vertical arrangement of Phase A bricks. This was probably employed as a means of supporting the area directly above the centre of the fireplace (Photo 42). As with the west wall, the north wall incorporates a combination of brick and rubblestone, integrated into one another (Photo 43).

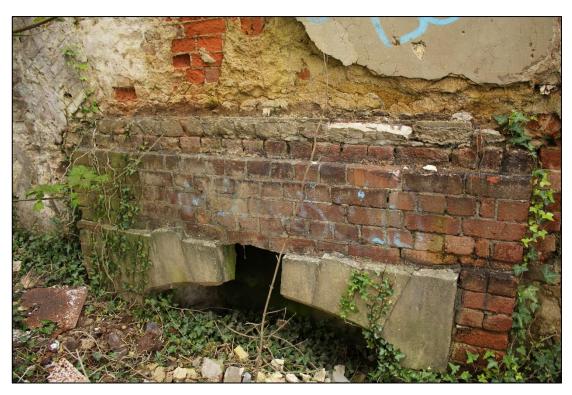
Photo 44: Detail of visible fire surround, north wall of Dining Hall

- 4.54. At the centre of the north wall, at Dining Hall level, are the remains of a fireplace that is clearly a later installation. The visible portions of the fire surround evidence moulded stone dressings within a brick surround (Photo 44). Formerly the fireplace comprised of a double height timber mantle and overmantle, as visible in an early 20th-century photograph (Friend 2018, p 12). Whilst there are several 1913 plans for variations of a new design for the fireplace, the final example captured in the photograph differed from those available at the National Library of Wales. The photograph also evidences that the wall to either side of the fireplace was panelled up to picture rail height (*ibid*). The visible remains of the fireplace can therefore be dated to the 1913 refurbishment.

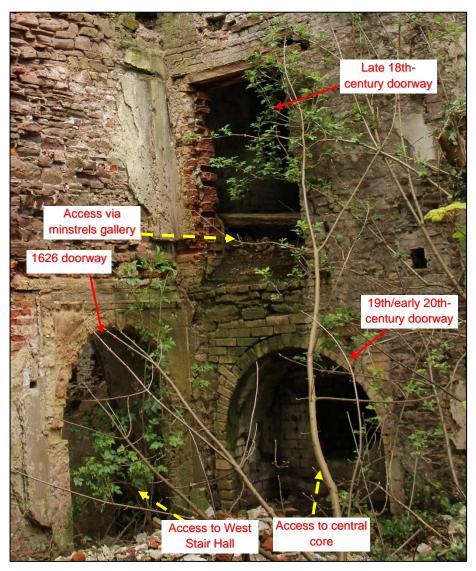
Photo 45: Doorways at west end of north wall, Dining Hall

- 4.55. At the west end of the north wall is a doorway that incorporates a segmental brick head with contemporary brickwork surrounding the frame (Photo 45). The door appears to date to the late 19th or early 20th century and provided access to a space within the core of the first floor, likely a store. Above this door is a square head example, directly accessible from the former minstrel gallery (Photo 45). This appears earlier than doorway below and was likely contemporary with the construction of the gallery following the 1780s fire.

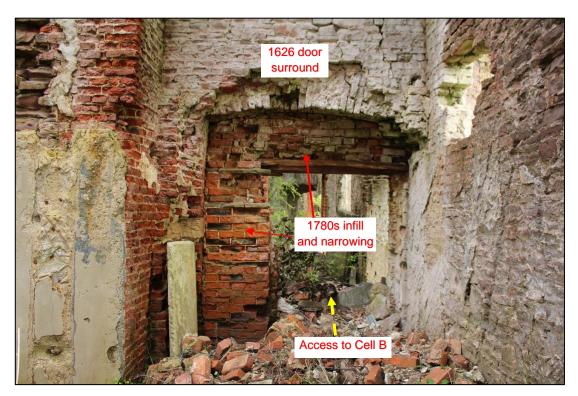
Photo 46: Doorway at east end of north wall, Dining Hall

4.56. At the eastern extent of the north wall is the doorway to access Cell B (the East Stair Hall) (Photo 46). The doorway is positioned at the 'upper' end of the room and has evidently undergone several alterations, principally to narrow the original aperture width. The surrounding fabric of the doorway comprises handmade red brick, of Phase A date, and incorporates a segmental brick arch head. Morriss identified traces of ashlar limestone within the Phase A door surround (CA 2001) and, coupled with the comparatively wide size of the original aperture, the door would have presented as a grand entrance to the Dining Hall. Hardwick's 1780s plan suggests that the door was to be narrowed as part of the repairs at the time and so the infill of red brick probably accords with this period, Phase B. Certainly, whilst the infill brickwork is later than Phase A, it is still handmade in composition, in accordance with a late 18th-

century date. The doorway is recessed behind the main wall plane of the north wall owing to the size of the east chimney stack.

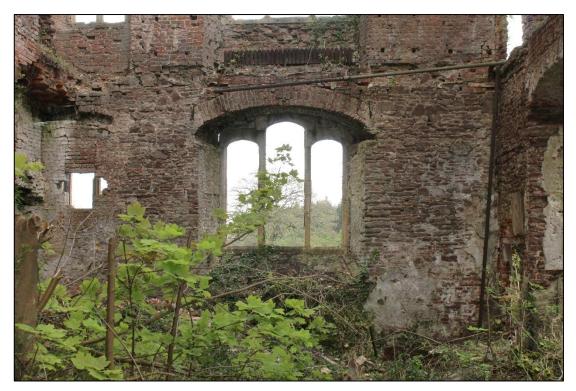
Photo 47: Overview of east wall, Dining Hall

4.57. The eastern wall of the Dining Hall incorporates a single, three-light window within a deep reveal (Photo 47). The surrounding masonry is predominantly rubblestone and features fragments of plasterwork. The window aperture is headed by a large segmental brick arch and comprises part of the original construction of the building (Phase A). To the north of the large window is a smaller aperture that is predominantly blind, save for a small opening (Photo 48). Externally, this smaller window is fully formed (Photo 20) in order to preserve symmetry but the infill brickwork appears part of Phase A, with later infilling to the central portion. Both the 1780s and 1909 plans show this window to be fully enclosed to the internal elevation (Figs. 43 and 44), suggesting that the narrowed window was probably installed at the time of the building's construction but then completely infilled as part of the 1780s works. The aperture has since been opened up slightly, possibly due to collapse following the 1941 fire (Photo 48).

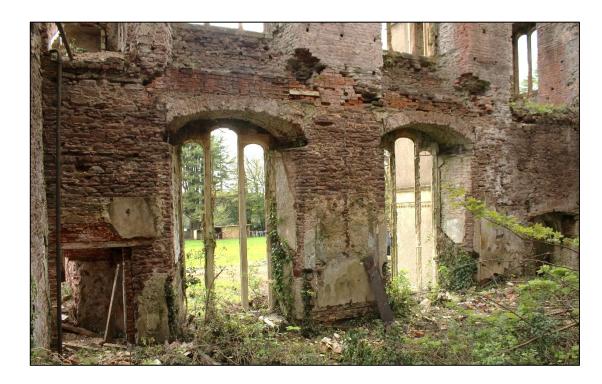
Photo 49: Overview of south wall, Dining Hall

4.58. The south wall of the first floor of Cell A (Photo 49) incorporates the two large three-light windows, which constitute the largest windows within the building and would have provided a large amount of light into the south-facing Dining Hall. The surrounding fabric all dates to Phase A, however, a band of red brick between the window heads and the floor level of the Drawing Room above, of apparently larger and more uniform composition than those use for Phase A, suggests this are may have been subject to repairs, likely following the fire of 1784 (Photo 50). The former Dining Hall retains three fire damaged examples of curtain rail brackets *in situ*, probably installed in 1913 (Photo 51).

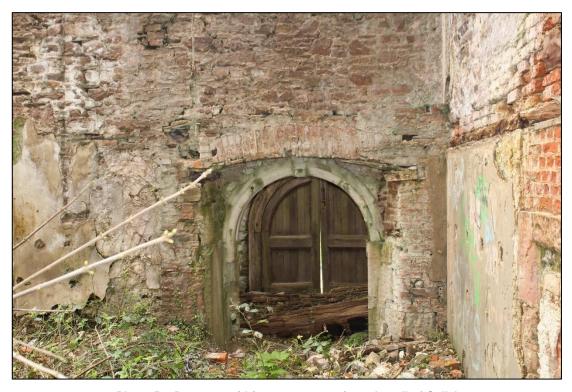
Photo 52: Doorway within west extent of south wall of Cell A

4.59. At the west extent of the south wall is the doorway leading from the South Porch (Photo 52). The door surround is ashlar with a semi-circular head and matches several other Phase A examples throughout the building (e.g. Photo 39). The door sits beneath a segmental brick arch and would have formerly led directly into the screens or cross passage, behind the former screen at the west end of the Dining

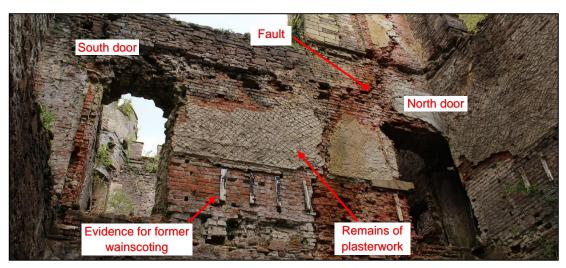
Photo 57: second floor (Drawing Room) of Cell A, west wall

4.61. The second floor of Cell A formerly comprised the Drawing Room, as recorded on 1909 plans but was formerly recorded as the 'Dining Room' on the 1780s plans (Fig. 29). It is likely that the room was originally designated as the parlour or great chamber during the early 17th century, in accordance with societal preferences at the time. By floor area, the Drawing Room comprised the largest room of the castle and extends above the area of both the Dining Hall and minstrels gallery beneath. The west wall of the Drawing Room (Photo 57) is predominantly red brick in composition with an

element of rubblestone at the upper portions of its southern extent, and despite the varying tones of brickwork, it all forms part of Phase A of the building. A large fault in the masonry is evident, stemming from the chimney stack above, and routing through the wall from top to bottom (Photo 57).

- 4.62. The wall incorporates the remains of two doorways at the north and south extents of the wall (Photo 57). The 1780s plan evidences a door at the south extent, but the north door is not accessible. However, the position of the door is represented by a small niche or alcove, possibly suggesting that an earlier aperture was infilled. Certainly, by 1909 the north doorway was open and in use as an access to an adjacent passage to the west side of the building. The north door is also visible in a 1920 photograph of the Drawing Room which shows a six-panelled door within the aperture (Friend 2018, page 13).

- 4.63. Fragments of plasterwork remain on the wall, however, the 1920 photograph also confirms that the room was panelled from floor to ceiling at that time, suggesting that the upper panelling was possibly fixed on top of an earlier, plastered decorative scheme. Whilst the panelling has now gone, a row of timber batons remains affixed to the lower portions of the wall which would have secured the lower part of the panelling. The present appearance of the walls may suggest that an earlier finish comprised of plastered walls with wainscoting beneath, as evidenced by the lack of plasterwork on the lower portions of the wall.

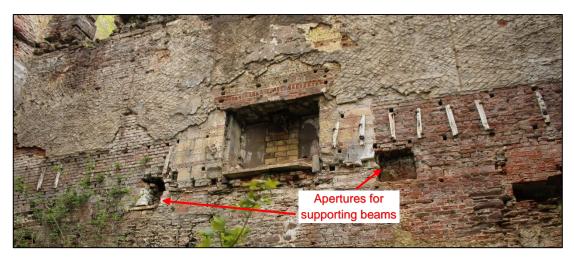
suite of timber panelling at the time of the fire, this may have partially shielded the plaster beneath from the most severe effects of the heat and flames (Photo 58), however, the plaster itself may have incorporated a degree of fire resistance in itself. Consequently, it is not possible to assess all of the masonry beneath, however, it forms part of a core element of the building's fabric and is likely to form part of Phase A. The lower portions of the wall are predominantly red brick and continue the sequence of timber batons as found on the west wall.

Photo 58: second floor of Cell A, north wall

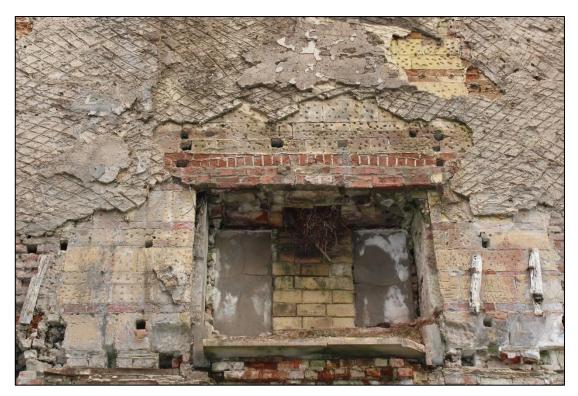
- 4.65. The key feature of the Drawing Room was the central fireplace within the north wall (Photo 59). The fireplace is missing all of its surround, mantle and overmantle features but the removal of these features and the surrounding panelling and plasterwork has revealed elements of ashlar stone above and at either side of the fireplace (Photo 59). The ashlar was later hacked to provide a key for a subsequent plaster finish whilst the square holes evidence an even later fixing for an overmantle.

- 4.66. The ashlar is flush with the surrounding brickwork and likely to be contemporaneous with Phase A of the building. The presence of the ashlar indicates an original fireplace of high status, that would have provided a focal point of the room. To either side of the fireplace, and intersecting the former floor level, are two square apertures (Photo 58). The function of these apertures is unclear, however, their most likely function was to seat a pair of timber beams or, latterly, a pair of rolled steel joists. A corresponding pair of apertures is present within the south wall (Photo 62), corroborating this hypothesis.

- 4.67. The fireplace evidences later alterations such as the addition of cementitious side and back walls, with the additional incorporation of yellow brick within the back wall. The lintel comprises red brick of later appearance to that of Phase A. The appearance of the fireplace is recorded in the aforementioned 1920s photograph of the room (Friend 2018, p13) where the final configuration of the fireplace is composed of a white chimney piece with engaged columns supporting the mantle. Unlike the Dining Hall beneath, there was no elaborate overmantle at that time, probably due to the lower ceiling height and more private nature of the room, by comparison with the Dining Hall.

Photo 59: Detail of fireplace in Drawing Room

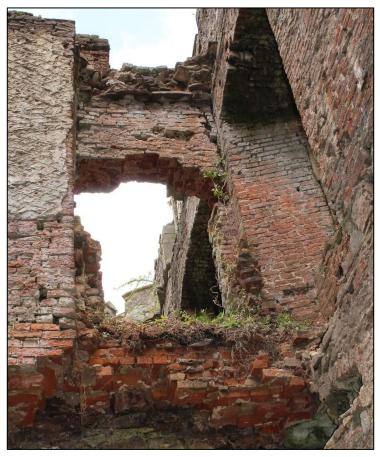
- 4.68. At the east extent of the Drawing Room is a further doorway, providing access to the East Stair Hall (Photo 60). The doorway almost certainly dates to Phase A of the building, but it is likely to have been remodelled over time during the various renovations to the building.
- 4.69. The east wall of the Drawing Room exhibits little in the way of alterations and it is predominantly comprised of coursed brick laid in English bond, which is contemporary with Phase A of the building (Photo 61). The wall incorporates a large, three-light window that is broadly central within the wall, and a further two-light

Photo 60: Doorway at east extent of Drawing Room, second floor of Cell A

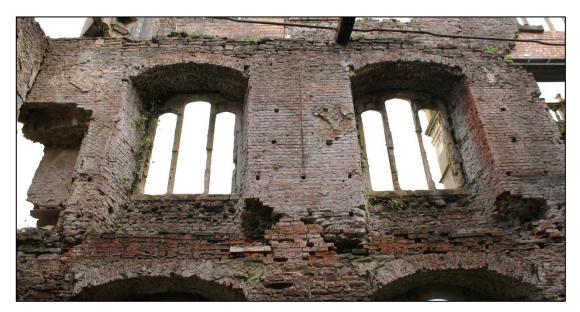
4.70. The south wall of the Drawing Room is also comprised predominantly of coursed brick and evidences very few alterations (Photo 62). The wall incorporates two large three-light windows which, combined with the two within the east wall, would have provided ample light into the very high status room. At the west extent is a doorway providing access into a small chamber above the south porch (Photo 63 and Photo 56). The door is undoubtedly contemporary with the construction of the porch during Phase A, however, during 2018 the masonry above the doorway was assessed to be in a critical condition, necessitating intervention. Subsequently, portions of the original masonry were removed and a Rolled Steel Joist (RSJ) inserted, in conjunction with reclaimed bricks, laid in English bond (Archaeo Domus 2019) (Photo 63).

Photo 62: second floor of Cell A, south wall

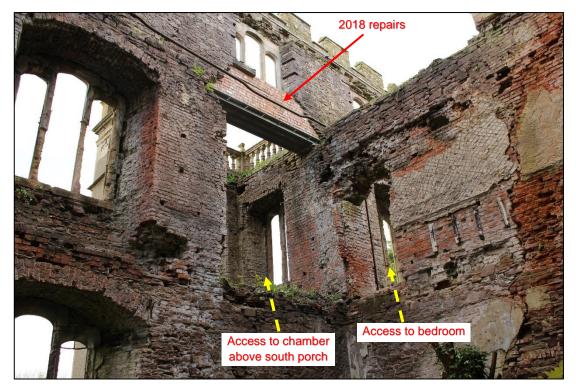
Photo 63: Doorway within west extent of south wall, second floor

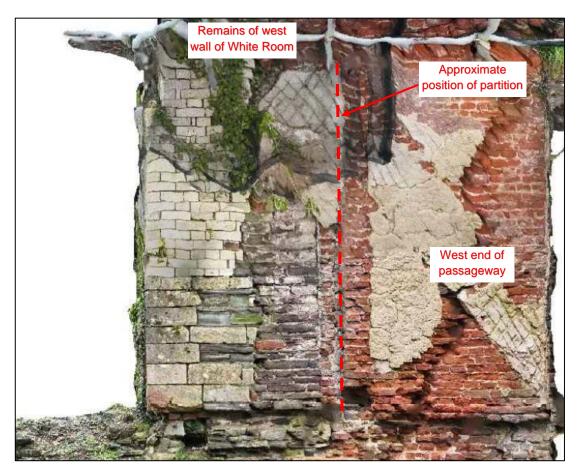
- 4.73. The west wall of the White Room only partially survives as part of the south chimney stack (Fig. 46). There are visible elements of buff or glazed brick above seven courses of ashlar that comprise alterations to a flue that served rooms within Cell G. To the north of the ashlar, and still within the room, the wall changes to rubblestone; there are remains of plasterwork at the upper portions of the wall suggesting at least, that the rubblestone was decorated in this fashion. This change in materials is delineated by a vertical crack along the masonry. This conglomeration of materials evidences multiple layers and alterations that have become visible as a result of the

1785 and 1941 fires. The northern portion of the chimney stack comprises red brick of Phase A.

Fig. 46: Detail of west wall of White Room and adjacent corridor

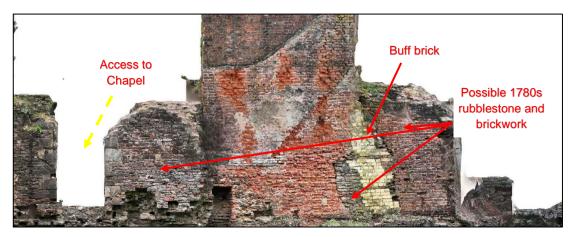
- 4.74. The north passageway on the second floor of Cell A was aligned alongside the northern wall of Cell A. This alignment survives and forms part of the east chimney stack (Fig. 47). The principal, central portion of the wall, incorporating the chimney stack itself, is comprised of red brick dating to Phase A, all laid in English bond. To the east of the chimney stack there is evidence of extensive repairs to the fabric, likely following the 1785 fire. A combination of coursed rubblestone, buff brickwork and later, darker brickwork is incorporated. The two former roof pitches of the 1626 and 1780s roofs are visible as scars on the south side of the east chimney (Fig. 47).

Fig. 47: Detail of northern wall of Cell A, third floor

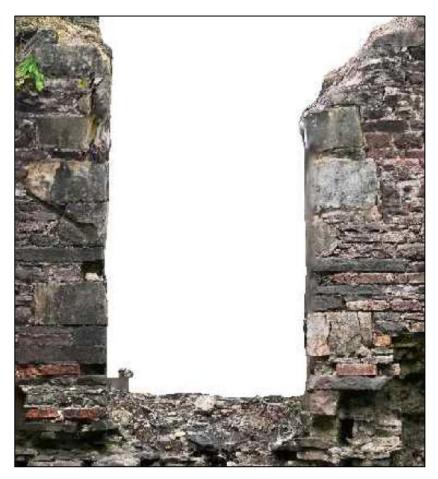
- 4.75. To the west of the chimney stack the wall is principally comprised of roughly coursed rubblestone, possibly erected as part of the 1780s refurbishment works following the fire. Notably, at the west extent of the wall is a doorway to what was labelled as a Chapel on the 1909 plan. The doorway surround incorporates large stones that are arranged akin to quoins (Fig. 48). The Chapel may have incorporated a suitably

gothic aesthetic and these stones may have remained exposed, however, this would appear contrary to the wider decorated scheme of the building. According to the 1780s and 1909 plans, the position of the doorway is suggested to have been moved eastwards during this period, however, the present position accords with the 1780s plan and there is no visible evidence for a later opening to the east.

Fig. 48: Detail of doorway to Chapel, third floor of Cell A

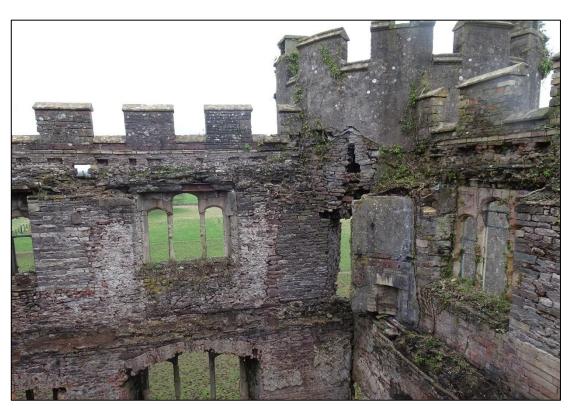
- 4.76. The east and south walls of the third floor of Cell A are set back from the main wall planes and are principally comprised of rubblestone (Photo 64). Above the height of the windows there is evidence for the remodelling work of the 1780s that resulted in the introduction of crenelations to the four principal elevations of the castle. The later roof pitch would have intersected the exterior wall at the point where the rafters would have fitted into visible slots in the masonry (Photo 65). The rubblestone beneath these slots would have been concealed within the roof space, so it may have been thought unnecessary to ensure a flat finish given the walls would not be plastered or decorated at these points. Crenelated portion of the wall acted as a parapet with a valley behind where rainwater would have collected and transferred to the ground through rainwater hoppers, now removed from the building.

- 4.77. A small fireplace survives at the south-east extent of the east Maid's Room (Photo 64). The fireplace, incorporating cementitious surround and a chimney breast with a small grate, was probably installed during the early 20th-century works to the building.

Photo 64: Overview of east and south walls, third floor of Cell A

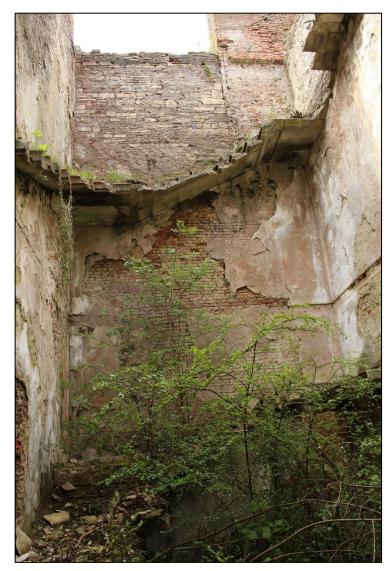
4.80. The west wall of Cell B forms the wall of the stair well and retains portions of plasterwork (Photo 67). The majority of the wall fabric is thin, handmade red brick, dating to Phase A. At the upper portion of the wall, abutted to the south of the north chimney stack, is a portion of roughly coursed rubblestone (Fig. 49) that is also described in previous analyses as part of Phase A (CA 2001). Despite this initial conclusion, the appearance of the rubblestone within this portion is distinctly different to the prevailing Phase A construction found throughout the building. The stone is generally larger, and darker than Phase A elements and exhibits clear evidence that it was inserted alongside the chimney rather than constructed in tandem with it. Accordingly, whilst at other parts of the third floor the later, Phase B rubblestone has been successfully keyed into the Phase A rubblestone, within the upper portions of Cell B, it was probably less feasible to neatly key the stone into the existing, coursed brickwork which is much finer.

Photo 67: Overview of Cell B, looking west

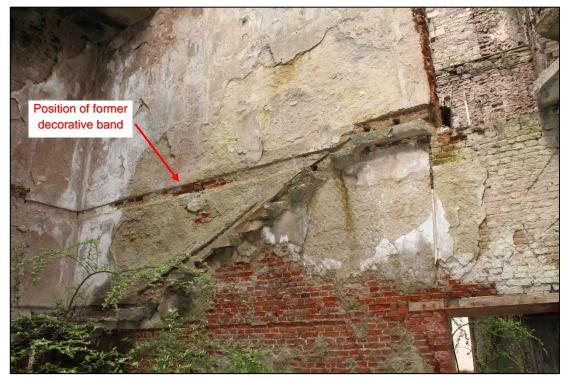
4.82. The north wall of Cell B (Photo 69) incorporates further remains of the former staircase and appreciable amounts of plasterwork. Where masonry is visible this

comprises Phase A red brick at first floor level, whilst rubblestone is evident at second and third floor levels, a sequence that is commonly found throughout the building. The position of a former band of relief work is still visible through the presence of a recessed horizontal band. This decoration is visible in an early 20th-century photograph from the second floor landing of the staircase where two suits of armour were also stationed on the intermediate landings (Moseley 2005, p100).

Photo 69: Overview of north wall of Cell B

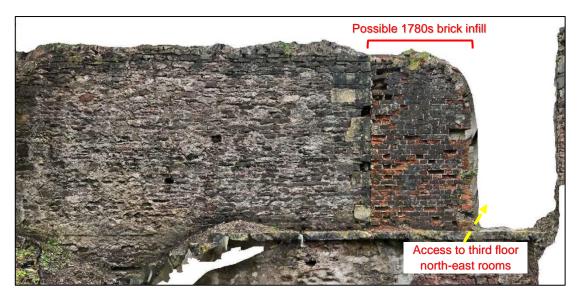
4.83. The east extent of the north wall incorporates doors at each of first, second and third floor level. The presence of doors in these positions is likely in accordance with Phase A, to provide access to the north-east rooms of the building, however, there has clearly been a degree of alteration at third floor level where a portion of later brickwork has been installed, suggesting that the doorway had been moved to the east from its original position (Fig. 52). The brickwork was laid in Flemish bond and its appearance accords with that of the late 18th century. Furthermore, the current position of the doorway is reflected on the 1780s plan, indicating that the change had already been enacted by that time.

Fig. 52: Detail of north wall at third floor level of Cell B

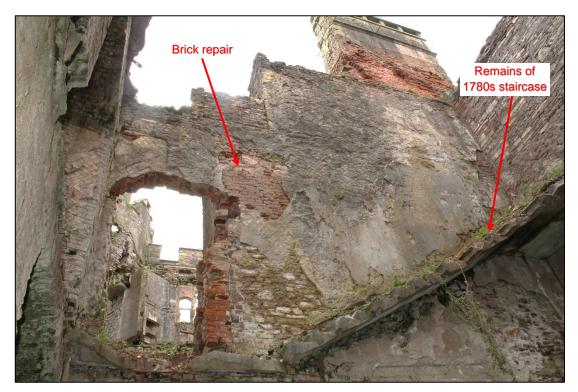
4.85. The south wall of Cell B incorporates a mixture of rubblestone and red brick that predominantly dates to Phase A. Further remnants of the former staircase remain embedded within the wall, and large areas of plasterwork survive in places (Photo

71). In contrast to the extensive use of red brick within the north wall, the south wall appears to be mostly comprised of rubblestone. Brick is used for door surrounds and areas of apparent repair (Photo 71). There are three doorways at the east extent of the north wall, all leading into Cell A and discussed above.

Photo 71: Overview of south wall of Cell B

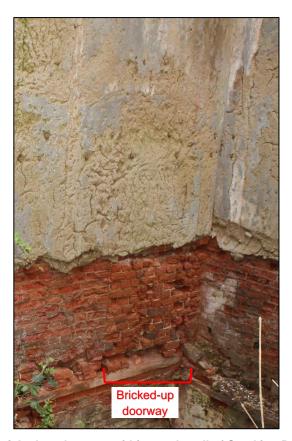
- 4.89. A door is positioned at the north end of the west wall, leading directly into the former Study (Photo 72). This doorway was probably created as part of Phase A, and there is no visible evidence for later alteration beyond perhaps some small repairs above the lintel. Within the west extent of the south wall of the Smoking Room is evidence for a bricked-up doorway that would have formerly led to into the first floor of the Stair Hall (Photo 75). The infill bricks appear handmade and accord with a probable intervention of the 1780s, after the 1785 fire. The doorway is not recorded on the 1780s plans, further strengthening this conclusion. This may be suggestive of an earlier planform that was changed following the reconfiguration of the staircase in the 1780s. There is no visible record for the original staircase so this infilled aperture may

provide an indicative clue as to the access into Cell C. There is no corresponding doorway on the opposite (south) wall, however.

Photo 75: Detail of bricked up doorway within south wall of Smoking Room, first floor of Cell C

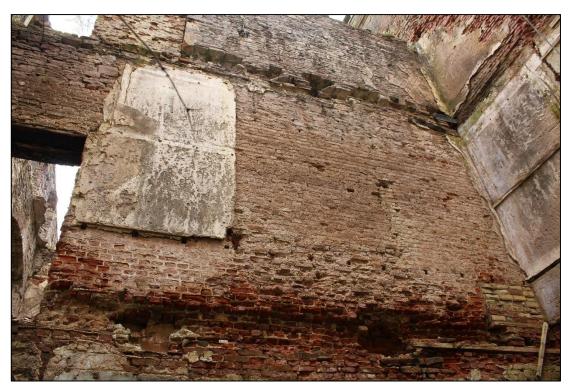
- 4.93. The south wall of the King's Room continues with Phase A red brick and retains a portion of historical plaster with evidence for former timber rails (Photo 78). The upper portion of the wall comprises Phase A rubblestone which then carries up through the third floor of Cell C. A small area of later brick infill is present at the far west extent of the south wall (Photo 78). This is located above the aforementioned bricked up doorway on the first floor, so its former function is unclear as it rises above the floor level of the second floor. The opposite side of the wall would have opened onto an area of the Stair Hall that did not coincide with a halfway landing on the staircase.

Photo 78: South wall of King's Room, second floor of Cell C

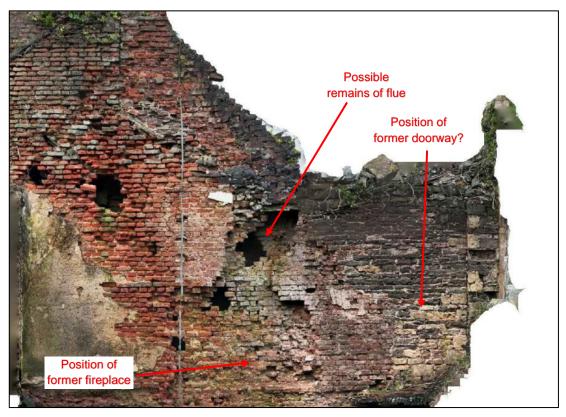
4.96. The west wall of the Flower Room (Fig. 56) is comprised principally of Phase A red brick with a small remnant of plasterwork at its south extent. Whilst both the 1780s and 1909 plans (Figs. 33 and 34) record the presence of a central fireplace within the wall, the present condition of the fabric no longer provides evidence of this feature. The extensive damage to the brickwork likely indicates that the fireplace has been

- removed or collapsed. The vestiges of a former flue are visible within the fabric, further strengthening this interpretaiton.
- 4.97. The aforementioned doorway within the north extent of the west wall, later infilled by 1909, is not apparent (Fig. 56). There are no clear straight joints to evidence such an infilling of the aperture, however, the fabric within this portion of the wall is clearly different, comprising of roughly coursed stonework rather than the adjacent, earlier brickwork. The stonework closely matches the appearance and character of the 1780s alterations to the west wall of Cell B (Fig. 49). Its position toward the north extent of the cell suggests that this area was added in the 1780s as part of the reconfiguration of the roof structure, which was higher than the 1626 predecessor, necessitating this extra partition area.

Fig. 56: Detail of west wall of Flower Room, third floor of Cell C

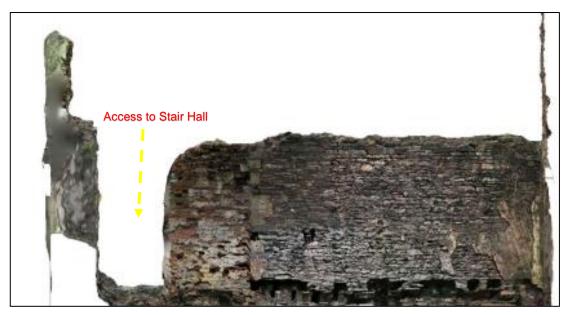
- 4.98. The south wall of the Flower Room is comprised predominantly of rubblestone, as part of Phase A of the building (Fig. 57). The aforementioned altered doorway to Cell B is evidenced through an area of later, recessed, brickwork.

Fig. 57: Detail of south wall of Flower Room, third floor of Cell C

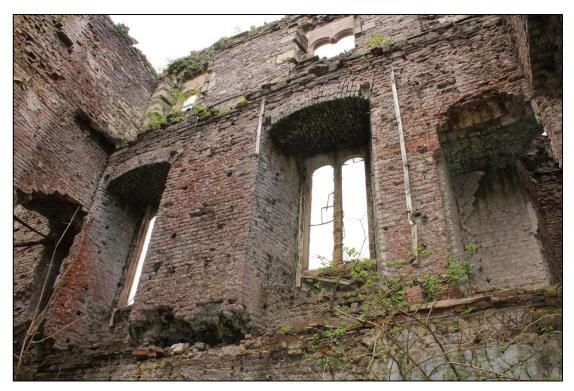
- 4.99. The north and east walls of Cell C (Photos 79 to 81) broadly accord with the Phase A character and fabric of the external walls throughout the building, however, there is a clear straight joint between the rubblestone fabric of the north wall and the brickwork access to the north-east tower, at third floor level (Photo 80). This is most likely suggestive of the works during the 1780s to reconfigure the roof structure and parapets of the castle to introduce battlements and a hipped roof. The tower would have been pre-existing and so the two phases of development are clearly distinguished from one another in this position although it is highly probable that the towers were also substantially repaired/modified at their upper portions. Certainly, as alluded to above, the crenelations of the towers appears to have been renewed at the same time as their addition to the principal wall alignments.

Photo 79: North wall of Cell C, second and third floors

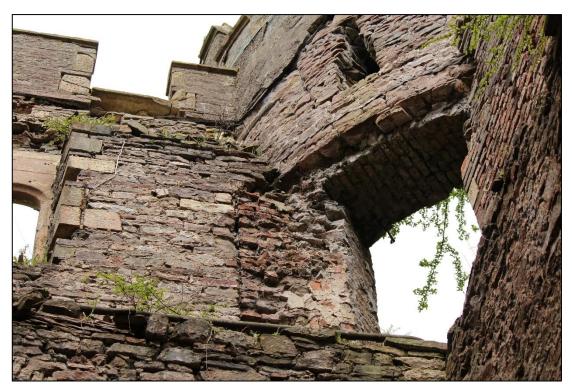
Photo 80: Detail of third floor access to north-east tower

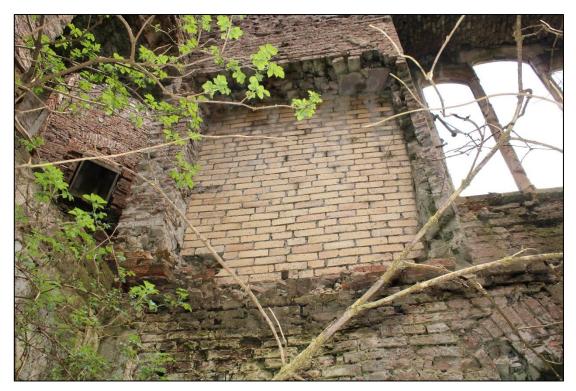
- 4.100. Within the north extent of the east wall, at second floor level, is a large area of later buff brickwork that appears to indicate an area of repair work within the former King's Room. However, this area of wall is recorded as incorporating a wide alcove by 1909 (but not during the 1780s) (Fig. 32), suggesting a purposeful use of the space. The possible function of the alcove is unclear and there are no clear signs of a former flue within the fabric above to suggest a fireplace. Consequently, it is hypothesised that the alcove may have been used as a wardrobe area or dresser which have been known to be recessed into walls. The scale and effort needed to make this intervention into the principal fabric of the building appears disproportionate though and so the former use of the alcove remains inconclusive.

Photo 81: Detail of possible former alcove within east wall of Cell C, second floor

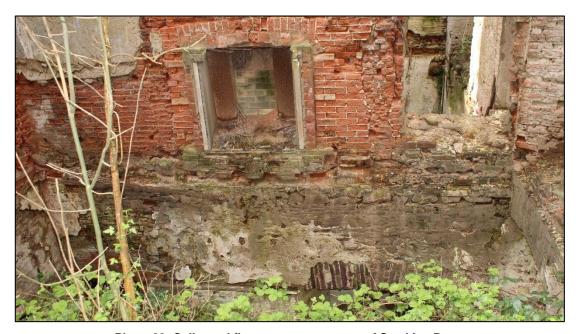
- 4.101. The western half of the first floor Smoking Room has collapsed and reveals part of the West Larder beneath, at ground floor level (Photos 82 and 83). The West Larder was a comparatively small room and was bounded on the west side by the substantial north chimney stack wall (Photo 83). Despite the appreciable obscuration of the room's walls due to fallen masonry, the functional nature of the room is evidenced by the survival of white, glazed tiles that coat the west wall and parts of the window sill within the reveal of the north window, the room's only source of light. The upper portions of the walls were plastered, some of which survives *in situ*. The visible masonry beneath the plaster appears to be mostly rubblestone of Phase A date.

Photo 82: Collapsed floor at western extent of Smoking Room

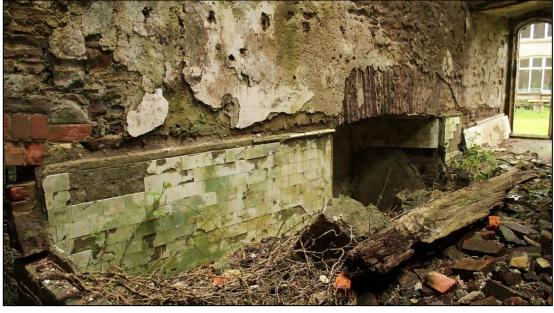
Photo 83: West wall of the West Larder

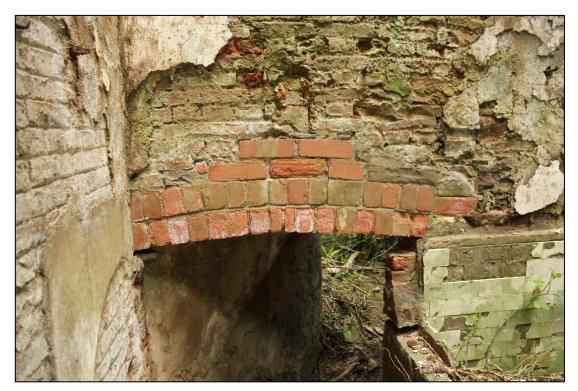
4.103. By 1909 (Fig. 60), the West Larder had been sub-divided to create a new passageway directly from the East Larder to the Scullery, incorporating a separate access from the West Larder into the passageway, and consequent infilling of the Phase A doorway. The door head above the new passageway at the south-west extent of the West Larder evidences brickwork that accords with an early 20th-century date (Photo 84). This route would have presumably been a well trafficked part of the building, perhaps explaining why it was diverted away from routing directly through the West Larder.

Photo 84: Detail of early 20th-century brick segmental head above passageway door

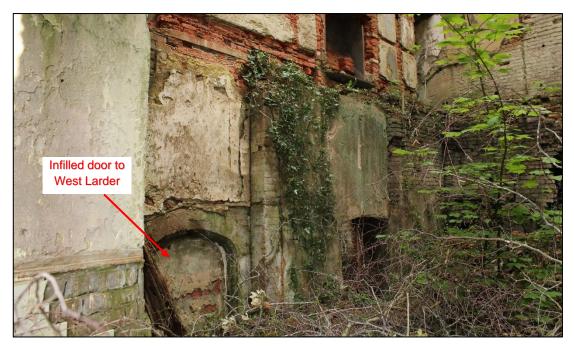
- 4.107. The east wall of the Scullery incorporates the two aforementioned apertures that formerly provided access to the Larders in Cell C (Photo 85). The north door comprises an ashlar doorway with ovolo moulding and an arched head. Whilst almost certainly attributable to Phase A, the arched head incorporates a three-centred arch rather than a four-centred example and is a unique feature within the building in this respect. As discussed above, the door formerly provided direct access to the West Larder in Cell C before it was infilled, likely between 1900 and 1909 as part of the reconfiguration of the ground floor circulation. The south door represents the early 20th-century access to the passageway to the Larders beyond, as discussed above. The east wall of the ground floor is obscured by surviving plaster and later brickwork, pertaining to the early 20th-century alterations. The west wall of the Scullery (Photo 89) retains substantial amounts of plaster and a single Phase A ashlar doorway into the Kitchen, discussed as part of Cell E, below.

Photo 85: Overview of Scullery, east wall

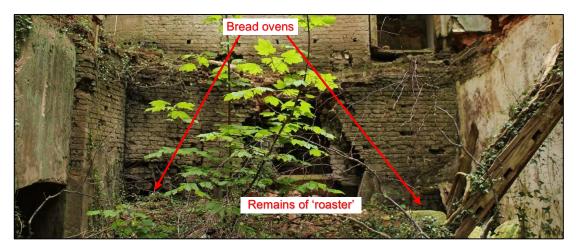
Photo 86: Overview of Scullery, south wall

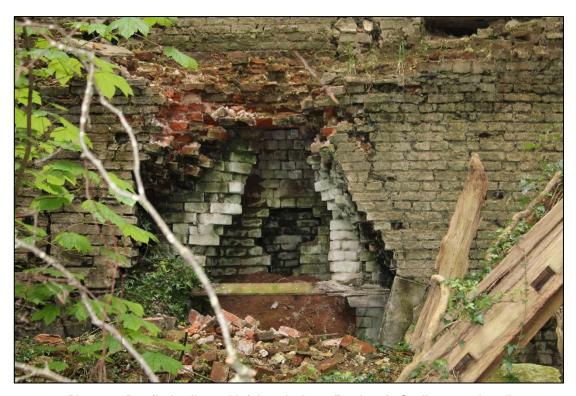
'bakehouse'. The room incorporates the remains of a large fireplace within the south wall, with a partially collapsed area of brickwork above (Photo 87). The fireplace is heavily obscured by debris and vegetation and much of it has collapsed, however, high quality ashlar voussoirs can be identified that once formed a segmental head to the fireplace (Photo 88). The 1909 plan identifies the fireplace as a 'roaster', implying the cooking of large joints of meat in this hearth. The 1780s plan records two elliptical alcoves to either side of the fireplace (Fig. 61), these probably functioned as bread ovens that utilised the heat from the central fire. These features are heavily obscured and not visible, however, the east example appears to be defined by a diagonal slant in the wall, as depicted on the 1780s plan. The angle of the wall for the west bread oven is less clear but the 1780s plan records that it should have mirrored the east example.

Photo 87: Detail of collapsed brickwork above fireplace in Scullery, south wall

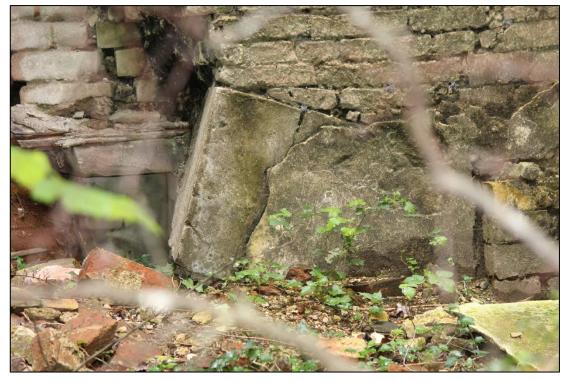
Photo 88: Detail of ashlar voussoir remains forming head of fireplace in Scullery, south wall

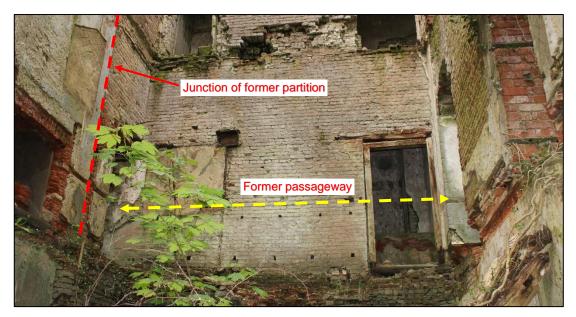
- 4.111. The south door formerly provided access from the passageway to the north-west areas of the castle. Morriss states that this door is a later insertion and incorporates a segmental door head (CA 2001). However, the door head is no longer evident and has likely fallen in the intervening years. Nevertheless, this conclusion contributes to the hypothesis that the passageway was not a Phase A component of the building and was most likely installed as part of the 1780s works.

Photo 90: South wall of passageway, first floor of Cell D
