Ruperra Castle (Castell Rhiw'r Perrai) Caerphilly Glamorgan

Historic Building Recording

CA Project: CR1627

CA Report: CR1627_1

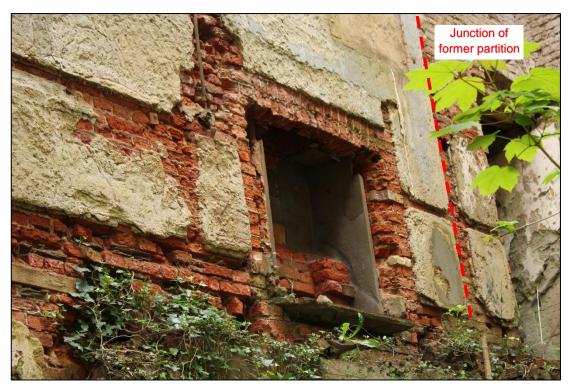
- 4.109. Although the passageway is present as early as the 1780s, the consequence of its existence resulted in an apparently compromised positioning of the fireplace within the adjacent Study (Photo 91). Due to the position of the north doorway to the Smoking Room and that room's fireplace and flue, the fireplace within the Study is located off centre and close to the former partition wall. It may therefore be that the partition was a later insertion, possibly installed as part of the 1780s works. The

Photo 91: Fireplace within east wall of Study, first floor of Cell D

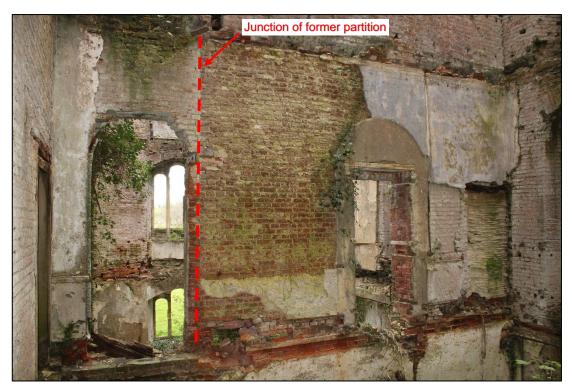
- 4.110. The west wall of the Study and passageway is comprised of Phase A brickwork but evidences multiple alterations (Photo 92). Firstly, a band of later brick has been inserted between the floor of the first floor and the upper portions of the Scullery below. As with the south wall of Cell A, this probably indicates an instance of substantial repair following the 1785 fire.

Photo 92: West wall of Study and passageway, first floor of Cell D

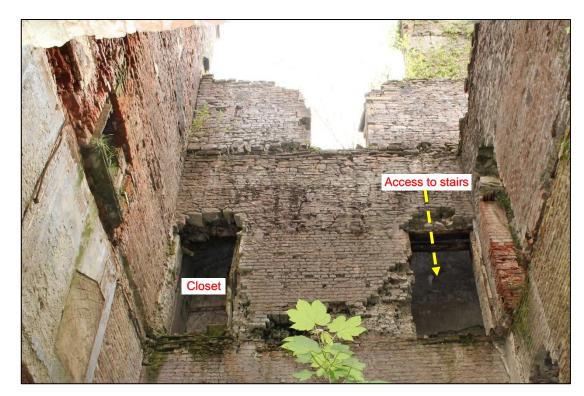
- 4.113. The second floor of Cell D formerly incorporated a single room called, in 1909, the 'Green Room'. The room incorporated direct access from the King's Room through a door within the north extent of the east wall, and towards a passageway through a door at the south extent of the west wall. Two further doors are present within the south wall (Photo 93). The west door led to an apparently inserted staircase that connected with the west stairwell within Cell F (Fig. 63). Morriss concludes that this door must also, therefore, be inserted (CA 2001). The door surround exhibits some possible later brickwork to its west side to corroborate this theory, however, the doorway and intermediate stairs were present by the 1780s (Fig. 62) and so were possibly inserted as part of the works at that time to improve circulation through the building for staff. It was not possible to inspect he present condition or existence of this linking staircase as a part of this survey. The east door provided access to a store or closet (see Figs. 62 and 63); it's age is unclear, however, the door was also present since the 1780s. Much of its lintel fabric has collapsed, however, several larger, flat stones are incorporated amongst the brick, implying a comparatively crude method of adding support above the doorway (Photo 93).

Photo 93: South wall of Green Room, second floor of Cell D

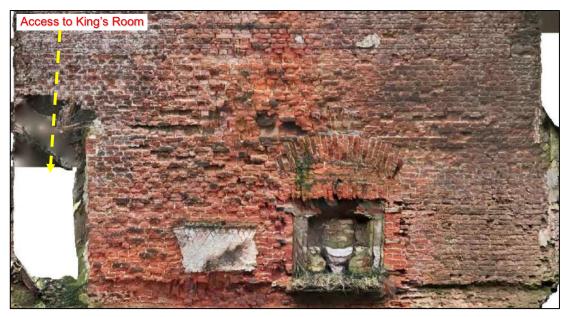
- 4.114. The east wall of the Green Room (Fig. 64) features a fireplace, located broadly in a central position within the wall, whilst a doorway is situated at the north extent and provided access to the King's Bedroom to the east. Whilst the fireplace has clearly

been altered and incorporates a relatively small firebox, typical of a later example, the brick surround and segmental arch above indicate that the fabric is mostly Phase A in date. The doorway to the north of the fireplace is square headed and much eroded. Morriss speculates that this doorway was possibly a much altered original opening (CA 2001). Certainly, it was present on the 1780s and 1909 plans and likely required a manner of direct access to the King's Room next door, for access by house staff, assuming that the latter harboured a degree of status within the castle. The wall is entirely composed of Phase A handmade brickwork.

Fig. 64: East wall of Green Room, second floor of Cell D

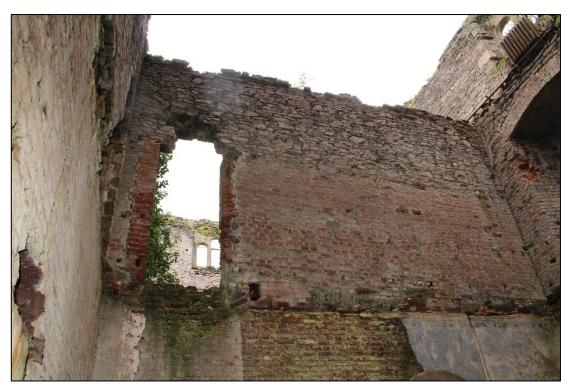
4.115. The west wall of the Green Room incorporates a single doorway at its south extent (Photo 94) that led into a passageway at the north-west extent of the building. The south side of the doorway surround has clearly been altered and includes later brickwork. The door head has collapsed, however the fabric appeared to comprise rubblestone. Given the room's position, it is probable that the door is contemporary with Phase A, to allow for access to north-west areas of the building. It is present on the 1780s plan. The wall masonry is Phase A red brick halfway up the wall, whereupon it then transitions into rubblestone at its upper portions, also likely to be Phase A. The red brick differs in tone to that of the wall below (the Study), however, this is probably due to different wall treatments or plasterwork. The wall of the Green Room retains no evidence of plasterwork, as opposed to the Study, and so this may explain why there is no discolouration of the brickwork. Regardless, the brickwork in both rooms appears contemporary with Phase A, excepting patches of later repair. The north wall retains a large radiator within the window reveal (Photo 95), probably installed in the early 20th century.

Photo 94: West wall of Green Room, second floor of Cell D

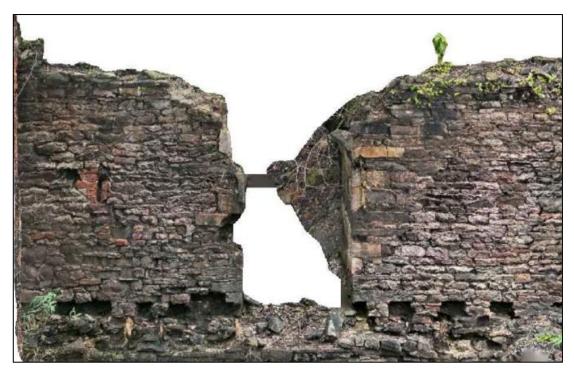
- 4.117. The west partition of the valet's Room has now gone. This was likely comprised of lath and plaster studwork and appears to have perished during the fire of 1941. Formerly, in 1909, the south extent of Cell C at third floor level incorporated a corridor, however, in the 1780s, the corridor terminated further west. The reason for this alteration appears to be the incorporation of a new staircase to provide access to the roof (see Figs. 65 and 66). No such staircase was recorded on the 1780s plan and so this is assumed to be a later alteration, possibly as part of the early 20th-century alterations. Correspondingly, a door within the south wall of Cell D appears to have also been moved as indicated by the plans. The former position of the door, to the west, is not clear from the visible fabric. The wall is entirely rubblestone and so any infill may be less obvious as an alteration due to the lack of clear butt joints. Nevertheless, it may suggest a more wholesale rebuilding of the wall during the 1780s. Most likely, the configuration as shown on the 1780s plan was not in fact enacted and the present door position is consistent with Phase A. Notably, the doorway incorporates some large stones, akin to quoins, as also evident on its south side (Fig. 67).

Fig. 67: South wall of Cell D, third floor

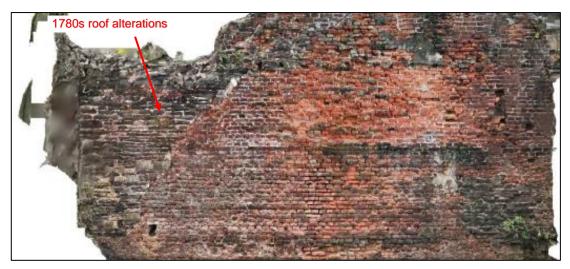
- 4.118. The east wall of the Valet's Room is predominantly comprised of handmade red brick of Phase A date (Fig. 68). Whilst the wall exhibits considerable patina it does not appear to have been appreciably altered and does not incorporate a fireplace for the room, despite forming part of the north chimney stack. The northernmost portion of the wall comprises of roughly course rubblestone, incorporating a broadly 45 degree angle of intersection with the prevailing brickwork. This alteration is probably associated with the substantial roof reconfiguration of the 1780s.

Fig. 68: East wall of Valet's Room, third floor of Cell D

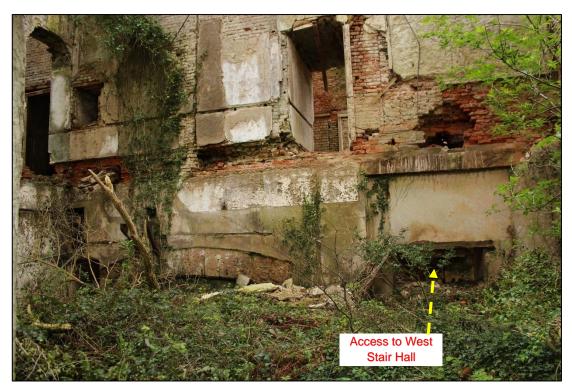
- 4.120. The floor of the cell is filled with substantial amounts of debris and vegetation that prevents a full appreciation of internal elevations at ground floor level (Photos 96 and 98). The key feature of the Kitchen is the substantial hearth within the south wall. The fireplace itself is heavily obscured by debris, however, the wide arched head of the surround is visible and incorporates shaped ashlar stone voussoirs with ovolo chamfer just visible to the lower portion of the arch (Photo 97). The character of the stone, moulding and width of the hearth indicates it was probably constructed as part of Phase A but have been modified over time, probably multiple times, according to developments in cooking appliances and technology. Certainly, the 1909 plan illustrates a considerably subdivided aperture within which a range cooker occupied roughly half of the fireplace, to its north extent.

Photo 96: Visible portion of south wall of Kitchen, ground floor of Cell E

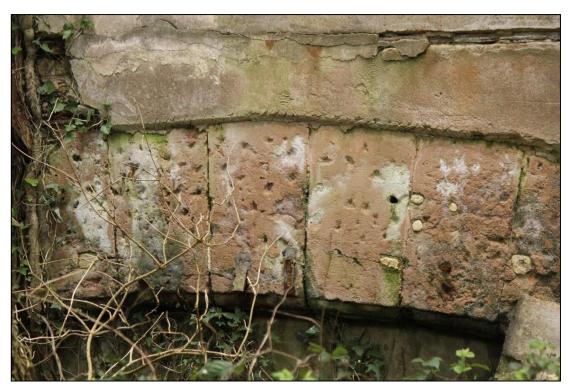
Photo 97: Detail of stone voussoirs above Kitchen hearth

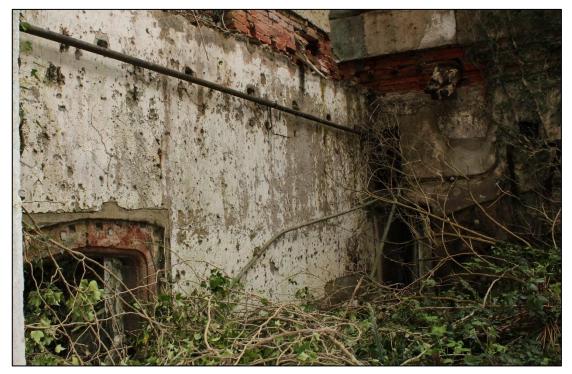
4.122. The east wall of the Kitchen (Photo 98) is comparatively plain and incorporates a surviving white-washed render. The band of later red brick between the ground and first floor is evident and illustrates, probably, a repair during the 1780s following the fire of 1784; this continues along the south wall (Photo 96). The most notable feature is the Phase A doorway at its north extent, allowing access between the Kitchen and Scullery (formerly the bakehouse). The frame comprises of fire-reddened limestone ashlar incorporating a four-centred arch head with ovolo chamfer moulding that echoes that used within the fireplace arch. The lower portions of the wall were not visible for assessment.

Photo 98: Visible portion of east wall of Kitchen, ground floor of Cell E

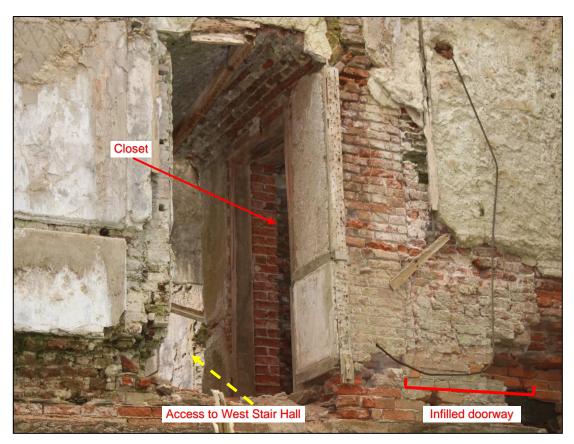
- West Stair Hall. A further, later door opening has since been infilled and plastered over, immediately west of the vaulted tunnel (Photo 100).
- 4.125. The 1780s plan records a possible fireplace within the south wall, however, this is not present on the 1909 plan, nor is there any clear visible evidence for the fireplace within the present fabric (Figs. 69 and 70; Photo 99). To the east of this is a small alcove within the south wall, incorporating a timber ceiling, probably inserted during the early 20th century (Photo 99).

Photo 100: Doorway and tunnel connecting Cells E and F, first floor, looking south

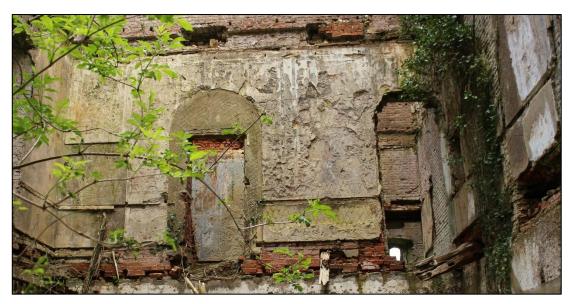
4.127. The east wall of the first floor of Cell E (Photo 101) incorporates the reverse of the two doors accessed from Cell D, discussed above. Otherwise, the masonry fabric of the wall is substantially obscured by multiple layers of plasterwork. Within the latest layer of plaster are the vestiges of studwork for panelling that evidence the former decorative scheme of the room (Photo 102). At the north extent of the west wall is the remains of a fireplace that was probably installed in the 1780s.

Photo 101: East wall of Secretary's Room, first floor of Cell E

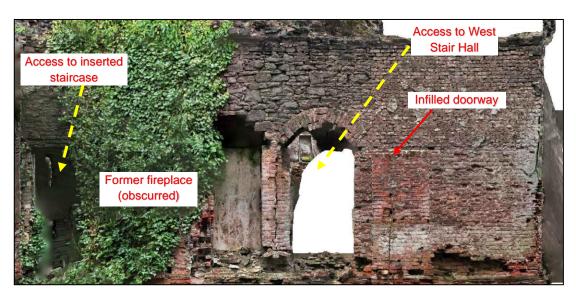
Fig. 71: South wall of the second floor of Cell E

4.128. According to the 1909 plan, the second floor of Cell E formerly incorporated a 'Dark Room', the 'Pink Room' and a passageway leading from the Green Room to the east. The south wall is partially obscured by vegetation, but several apertures can be seen (Fig. 71). As with the first floor, a principal route through the West Stair Hall survived in the form of a brick tunnel through the west chimney stack. This example retains a

visible segmental arch head at the doorway opening. To the immediate west is an infilled doorway that formerly accessed a small store/closet.

4.129. To the east of the principal Stair Hall door is a further doorway that appears little modified and may form part of Phase A. However, the door is not present on the 1780s plans and only appears on the 1909 plan as a small cupboard. It no longer incorporates a coherent lintel and so it is unclear when it was installed. Morriss observed that, to the immediate east of this door, is a remodelled fireplace, however, this was not visible during the present survey due to vegetation coverage. Morriss asserts that the fireplace retains its segmental arch head (CA 2001). To the east of this feature is a further doorway that led into a connecting staircase, leading to an intermediate landing within the West Stair Hall. This feature was not present on the 1780s plan and only appeared on the 1909 plan, it may therefore form part of the early 20th-century refurbishment works. The wall is predominantly comprised of red brick, but upper portions of the wall are composed of rubblestone, in common with other parts of the second floor throughout the building. The brickwork and rubblestone are both Phase A, excepting for patches of repair or alteration.

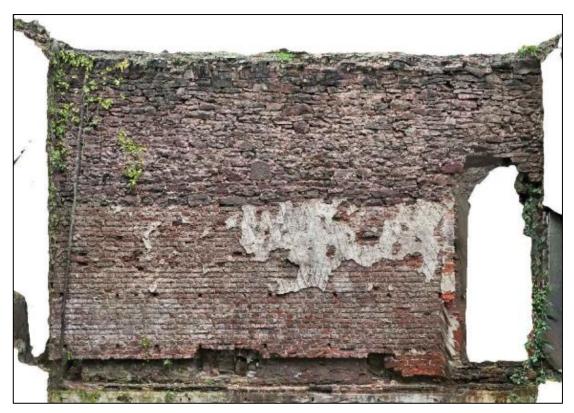
Fig. 72: East wall of the second floor of Cell E

4.130. The east wall of the second floor of Cell E exhibits no appreciable alterations and is comprised or brickwork with rubblestone above, both Phase A (Fig. 72). A single door at its south extent leads from the adjacent Green Room and accesses a passageway within Cell E, the partitions for which no longer exist.

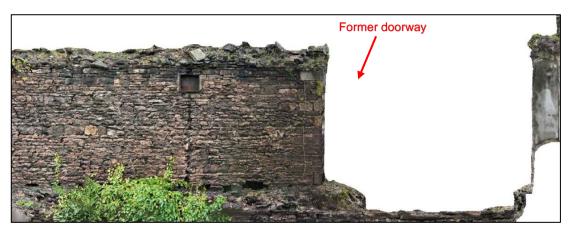
Fig. 73: South wall of the second floor of Cell E

4.131. The third floor of Cell E formerly comprised of the Footman's Room and a Store. A corridor, leading from the Valet's Room in Cell D, routed to the south of these rooms and was present on both the 1780s and 1909 plans. The east wall of the cell no longer exists. The south wall of the cell partially exists as a rubblestone wall of Phase A construction (Fig. 73). The east side of a former doorway survives and incorporates comparatively large stones, matching the configuration of the nearby doorways to the chapel, within Cells A and D, and possibly of 1780s date.

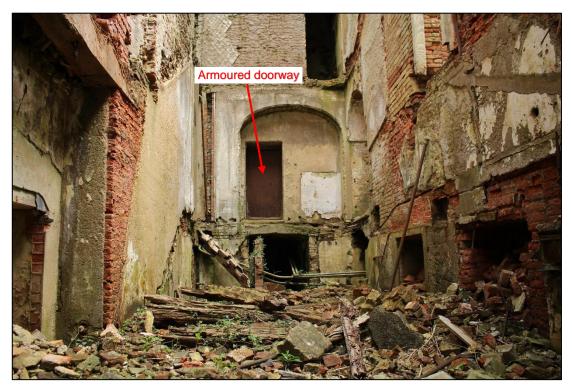
Photo 103: Overview of Cell F, looking west

4.132. Cell F incorporates the West Stair Hall and west porch. The stair hall extends from the ground floor to the third floor of the building and is recorded in the 1780s as the 'Back Stairs' whilst in 1909 the cell was recorded as the 'Back Entrance Hall' (see Figs. 74 and 75). Clearly, this stair hall was secondary in status to the East Stair Hall and principally served the western, service areas of the building. The cell no longer incorporates the staircase structure, which perished during the 1941 fire (Photo 103). Scars within the walls of the cell provide evidence for the staircase's former position. A substantial amount of debris covers the floor, and obscures a considerable area of the ground floor walls.

4.135. The east extent of the ground floor of the West Stair Hall incorporates a single, central doorway to a former coal store, within the very central core of the building (Photo 103). It was not possible to inspect this doorway, however, during the 1780s it would

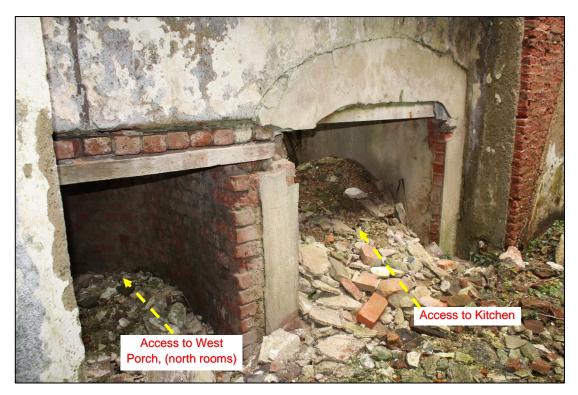
Photo 104: Detail of west extent of north wall, ground floor of Cell F

- 4.133. At ground floor level, the east and central portions of the north wall comprise the west chimney stack, whilst a wide recess occupies the west extent of the wall and incorporates two square headed doorways that lead from the kitchen and west porch respectively (Photo 104). As within the discussion of Cell E, the recessed aperture may have been fully open prior to the refurbishment works of the 1780s. The original, larger proportions of the aperture are hinted at through the incorporation of queen closers to its east extent, clearly suggesting that the east position of the opening, at least, is contemporary with Phase A (Photo 105).

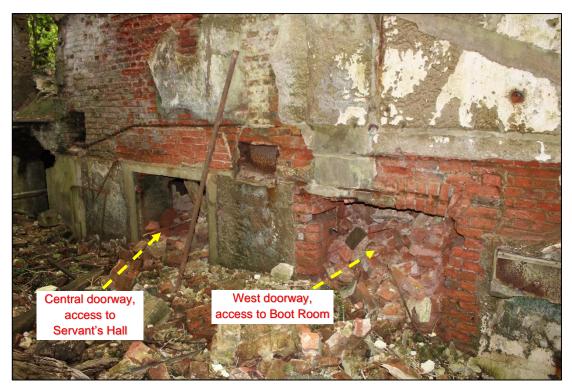
Photo 106: Central and west doorways within south wall of West Stair Hall, ground floor, Cell F

4.136. Despite the aforementioned changes, the south wall of the ground floor of Cell F retains three doorways that were present on the 1780s plan. It was not possible to closely inspect the east doorway as part of the survey, however, it is likely to have been installed alongside the vaults during the 1780s as it provides direct access to these areas at the south-east extent of the building. The central doorway (Photo 106) may originally date to Phase A to provide access to the south-west rooms of Cell G, however, there is clear alteration as evidenced by later brickwork as part of the door's segmental head and areas above, likely of 1780s date (Photo 107). Further alteration is apparent in the form of a cement frame to the doorway, likely installed during the early 20th century, which has partially obscured the earlier segmental arch head (Photo 107). The west doorway most recently provided access to a small Boot Room (see Fig. 28), however, during the 1780s this door was used to access the Servant's Hall prior to its reconfiguration during the early 20th century. The door incorporates an odd segmental arch head that closely resembles a soldier course with shaped bricks (but not voussoirs) evident at its west extent (Photo 106). The brickwork is clearly a later installation and was probably inserted as part of the 1780s refurbishment.

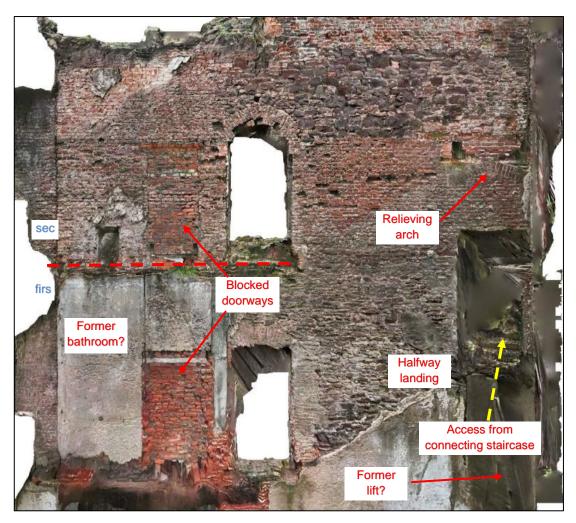
Fig. 76: North wall of first and second floors, Cell F

extent of the staircase and exited from the two inserted connecting staircases that formerly led from the Green Room, and the passageway adjacent to it, on the second floor (Fig. 76). An apparent relieving arch is present above the half landing doorway, the bricks of which appear of larger dimension to those of Phase A. This may therefore represent an alteration of the 1780s to coincide with the insertion of the connecting staircase beneath.

- 4.139. To the west of both the first and second floor doors are two further, blocked doorways (Fig. 76). As with the corresponding examples within Cell E, these doors formerly accessed small store rooms; the first floor example incorporates a surviving limestone lintel. The infill of the first floor door to the store is notable in so far as the infill brick is handmade and somewhat resembles the character of Phase A brickwork used throughout the building. Most likely, the bricks date to the 1780s when the building was refurbished. The 1780s plan shows that this doorway (and the example directly above on the second floor) had already been infilled by this time, indicating that the age of infill brickwork accords with this broad timeframe. At the east extent of the wall, accessed from the halfway landing between the ground and first floors, are the remains of a possible former lift, as indicated on the 1913 plan.

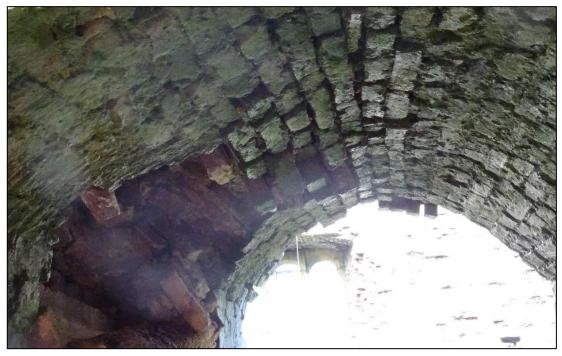
Photo 108: View north through the second floor tunnel from Cell F to Cell E

- 4.138. On the first floor, west extent, the 1909 plans indicate the former presence of a shared bathroom, however, this was absent from the earlier, 1900 plan. The north wall of the room evidences the remains of render, however, this does not provide evidence for the room's former use. Where the render is missing, red brick from Phase A is visible. Towards the centre of the wall is the connecting doorway from the north-west areas of the building which leads through the aforementioned vaulted tunnel through the west chimney stack. The south door surround of this tunnel is positioned between an area of Phase A red brick and rubblestone. The east side of the doorway comprises Phase A brickwork and a segmental brick arch head. Clearly this was an original route through the west side of the castle. This configuration is replicated above, within the south wall of the second floor. The configuration of brickwork that comprises the tunnel is visible (Photo 108).

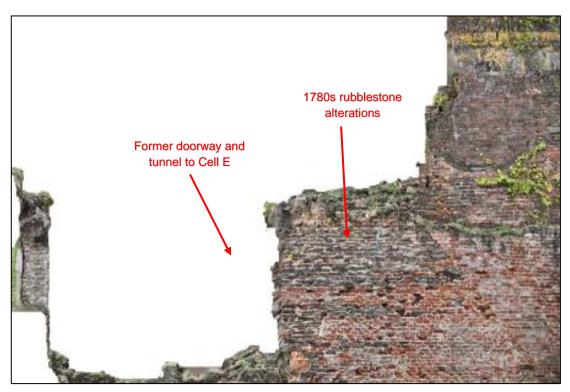
Fig. 77: South wall of third floor, Cell F

- 4.140. The third floor of the north-west corner of Cell F was similarly configured to that of the first and second floor, with a short tunnel leading to Cell E, incorporating a small store to its west extent, however, the masonry of this portion of the building has partially collapsed, eroding the west portion of the Phase A doorway (Fig. 77).

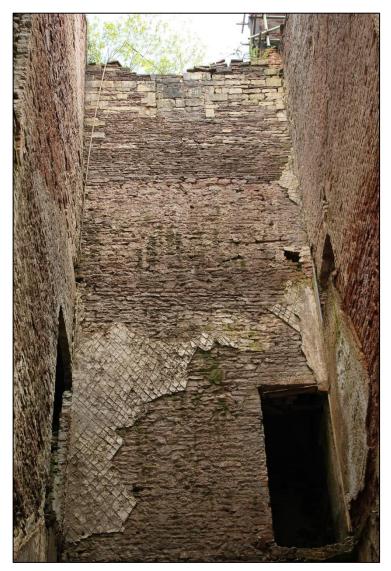
Photo 109: East wall of Cell F, upper floors

4.142. The east wall of Cell F (Photos 103 and 109) incorporates a wide, shallow arch recess between ground and first floor level (Photo 103) which incorporates a square headed doorway that formerly led into the core of the building. The door appears armoured and anecdotal evidence suggest that this area was possibly used during the Second World War for the storage of arms. The doorway is therefore likely to have been inserted during the war as it does not feature on the 1909 plans. Alternatively, the room may have functioned as Lord Tredegar's strongroom, prior to the transfer of the

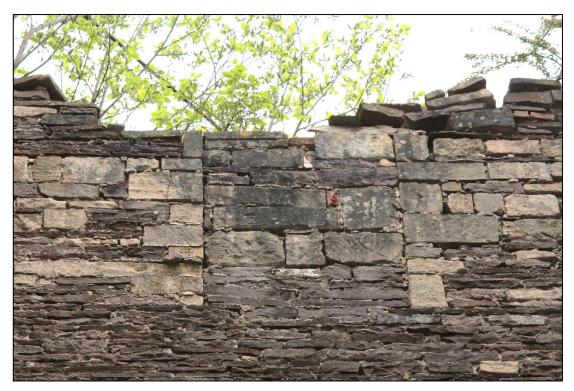
Photo 110: Detail of ashlar at the top of east wall, Cell F

- 4.144. At the very top of the east wall is portion of higher quality ashlar mixed with rubblestone, incorporating an infilled aperture (Photo 110). Morriss speculates that the higher quality stonework is possible evidence of a former embattled tower that would have projected above the gabled roof structure prior to the fire of 1785 (i.e. it was a Phase A feature). Such a tower was present on Lulworth Castle and so it is possible that one existed here too. The infilled aperture appears similar in materials and appearance to the two doorways within Cell A and D that formerly provided access to a chapel.

- 4.145. The high degree of ashlar suggests that the wall is contemporary with other 1780s alterations, such as those at third floor level in Cell B (Fig. 45). The stone infill, however, suggests a subsequent phase of works. Ultimately, the fabric beneath the ashlar section appears Phase A whilst the ashlar itself and infill were possibly of 1780s date with the infill inserted soon after. The suggestion of an earlier tower structure is not conclusively evidenced. If it was the case, then much fabric is now missing and there are no documentary sources to evidence such a structure was ever present. The possibility of an embattled tower is not to be discounted but its form can only be speculated and its relationship with the very large chimneys would be difficult to envisage, unlike the more compact arrangement found at Lulworth.

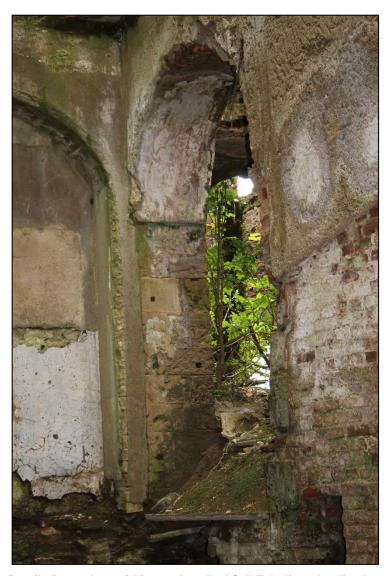
Photo 111: Detail of east door within south wall of Cell F, halfway landing between ground and first floors

4.146. The south wall of Cell F above ground floor height is predominantly red brick in construction and dates to Phase A, with later alterations. The east extent of the wall, at halfway height between the ground and first floors, incorporates a brick arched doorway with ashlar surround, although this could not be closely inspected during the survey. The presence of the ashlar surround perhaps indicates a degree of status and the doorway was part of the circulation route from the kitchen to the Dining Hall to the east. As such, the doorway may have been visible from beneath the nearby minstrel gallery within Cell A and may have occasionally been used by the owners of the building. The presence of the adjacent, aforementioned recessed arch panel within the staircase lends a possible degree of credence to the once higher status of this part of the West Stair Hall (Photo 111). The arch above the doorway has been rendered, possibly contemporaneously with the adjacent recessed panel (Photo 103).

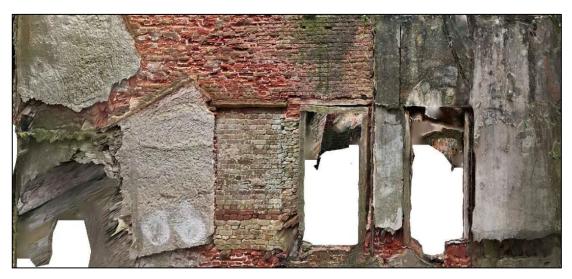
Fig. 78: South wall of first floor of Cell F

4.147. At first floor level there are two extant doorways with a further example that has been infilled with buff brickwork (Fig. 78). The west two doors most recently led into a connecting corridor to the Housekeeper's Room and a small WC lobby respectively. The westernmost door has evidently been inserted at a later date as it does not appear on the 1780s plan (Fig. 79) and appears to have been inserted as a consequence of the installation of a WC within the window reveal of the west wall, likely during the refurbishment of the early 20th century. This coincided with a somewhat awkward arrangement of walls and doors that also accommodated a fire hose device and a bathroom within the former landing area of the Stair Hall, also probably installed in the early 20th century (Fig. 80). By comparison, the 1780s layout in this part of the cell was much simpler and comprised a single doorway into a connecting lobby that in turn allowed access to a small store room and the

Housekeeper's Room beyond (Fig. 79). The eastern (infilled) doorway appears to be curiously placed above the flight of the staircase itself and so would have theoretically been floating above the stairs. This may suggest a much earlier configuration of the staircase itself (the latest version of which was probably installed during the 1780s along with the east staircase). Certainly, the doorway does not appear on either of the 1780s or 1909 floor plans (Figs. 79 and 80), which supports this hypothesis.

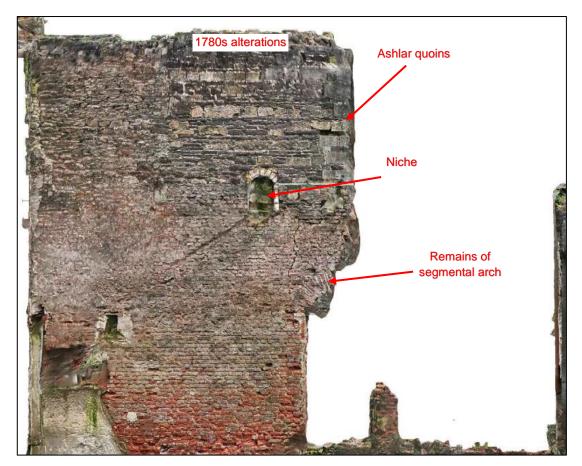
Fig. 81: South wall of West Stair Hall, second and third floors of Cell F

- 4.148. At second and third floor levels of the south wall, the fabric displays a transition from brickwork through to rubblestone, all of apparently Phase A date (Fig. 81). The upper portions of the wall incorporate courses of ashlar stone which follows a trait for use of this material at higher levels of the walls throughout the castle, a possible indication of its use to bear structural elements rather than rely solely on rubblestone. Its position here occurs away from the central core so would not have presumably formed part of an embattled central tower, as speculated above. Its integration with rubblestone may suggest that the material was reused following the dismantling of the tower as part of the roof alterations of the building as there is a clear difference in appearance between adjacent rubblestone sections of the south wall (Fig. 81). This would have represented a comparatively substantial rebuild that extended the entire height of the third floor at this part of the castle.

- 4.149. The west portions of the wall are missing at both second and third floor levels but there is evidence for former openings in the form of a portion of brick segmental arch at second floor level whilst a stack of ashlar quoins at third floor level also suggests a former doorway of the same ilk as found within the central core of the building at this height (Photo 112). Both doorways coincide with positions shown on the 1909 plan, however, the third floor doorway is shown as further west on the 1780s plan, indicating a possible later date for the ashlar quoins and wider wall fabric. A small niche is apparent to the east of the ashlar doorway, at third floor level. The date of this feature is unclear, however, it appears to breach the alignment of the former staircase and may therefore represent a Phase A feature that was formerly accessible via the original staircase configuration.

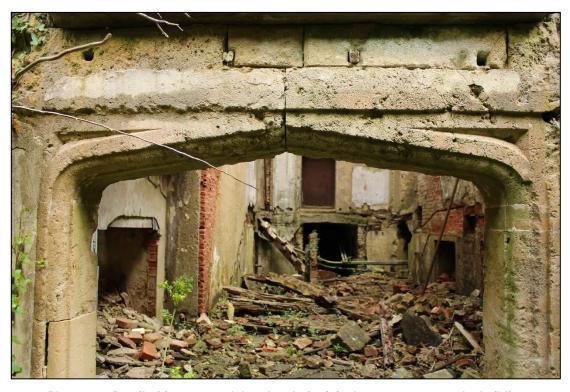
Photo 113: Detail of four-centred door head of original west entrance to the building

- 4.150. The interior of the West Porch comprises an entrance lobby into the west extent of Cell F. From within this space, the original entrance doorway to the building can be seen. The doorway incorporates the same stone dressings as observed elsewhere throughout the building's exterior and features ovolo moulding, a four-centred head and sunk spandrels (Photo 113). The configuration of the flanking rooms is asymmetrical. The south rooms formerly comprised a male WC and separate wash room, both accessible directly from the entrance lobby. The north rooms incorporated a further WC, however, the entrance to this room was through a comparatively convoluted curved passageway, accessed directly from the West Stair Hall (Photo 114; see entrance in Photo 104). As discussed above, the West Porch was constructed during the early 20th-century, likely in tandem with the wider refurbishment works of that time.

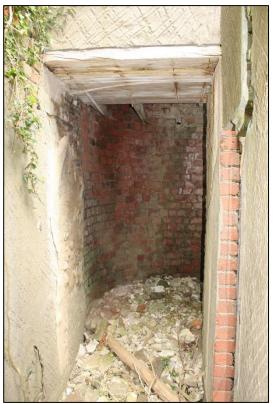
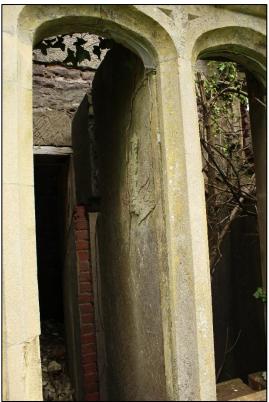
Photos 114 and 115: Detail of passageway entrance to north rooms of West Porch and partition intersection behind two-light window

- 4.151. None of the WC or washroom fittings appear to have survived, however, cementitious partition walls are still in situ and illustrate the comparatively cramped and somewhat convoluted configuration of rooms within the porch, likely created to satisfy a desire or requirement for more WC facilities within the building. Notably, whilst the exterior of the porch incorporates window tracery that accords with the prevailing character of the building (Photo 34), the central mullions of the facing windows accommodate the western intersection of the internal partitions (Photo 115).

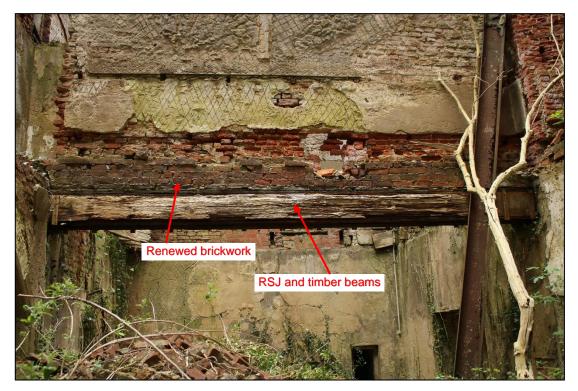
Photo 116: Overview of Servants Hall, viewed from the west

- 4.154. The changes discussed above are evident when assessing the fabric of the building. An early 20th-century combined RSJ and timber beams have been inserted to support the Phase A brick wall above (Photo 116). The beam appears to have been supplemented by five courses of renewed brickwork directly above. This alignment was formerly a partition and clearly necessitated the support of the RSJ once the space was opened up.
- 4.155. At the north-west extent of the room is a wide, shallow arch aperture that incorporates handmade bricks within the segmental arch head (Photo 117). At the time of the 1909 plans (Fig. 83) the arch incorporated a recessed infill. This lighter weight infill,

possibly studwork, had evidently perished in the fire of 1941, leaving the arch open, as it was in the 1780s (Fig. 82). Morriss speculates that this arch may form part of Phase A; the arch certainly incorporates handmade bricks which appear contemporary with those used as segmental heads above all of the principal Phase A windows of the building. However, its position uggests that it may have been created during the 1780s as an original enlargement of the Servants Hall, as it was at that time, necessary to support the weight of masonry above. On balance, the appearance of the fabric indicates a Phase A installation. Ironically, the arch was apparently infilled again, probably during the early 20th century, as part of a further enlargement of the Servants Hall and creation of the separate boot room to the north.

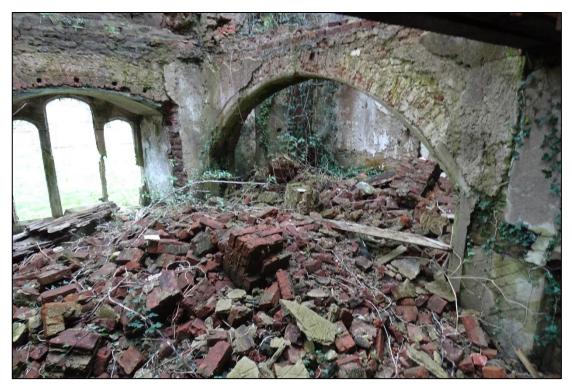
Photo 117: Shallow arch at north-west extent of ground floor of Cell G

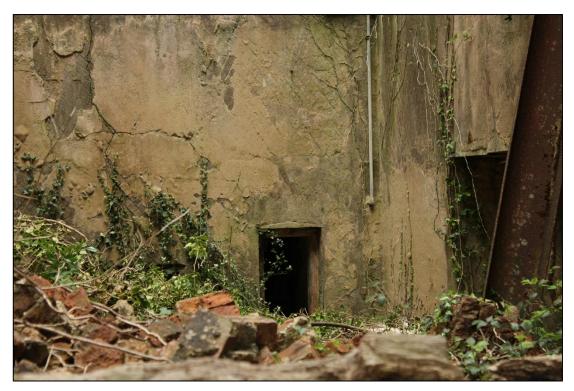
- 4.156. The east extent of the ground floor of Cell G was not physically surveyed, however, client photographs illustrate the present appearance of the space, which is heavily compromised by fallen debris (Photo 118). From a distance, the east extent of the ground floor appears to retain substantial amounts of plasterwork. Morriss states that a large, projecting stone chimney piece is present at the centre of the wall (CA 2001) whilst two openings are present either side and may have functioned as the flow and return apertures that formerly served the boiler.
- 4.157. Morriss reports that the north wall of the Servants Hall retains a Phase A doorway comprising a stone frame, with a three-piece lintel and a four-centred head. It incorporates ovolo moulded chamfer and is rebated on the south side (CA 2001).

Photo 118: View of east wall of Servants Hall, ground floor of Cell G

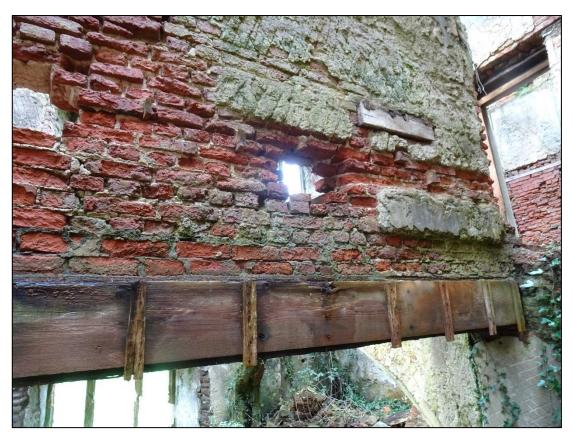
- 4.158. The first floor of the Cell formerly incorporated a Butler's Pantry and Housekeeper's Room, divided by the central partition. The partition (Photo 119) forms part of the Phase A construction of the building and incorporates handmade red brick fabric. The upper portions of the west side of the partition are substantially covered in plasterwork and there are no consequent signs of blocked doorways or other alterations. The east side of the partition also retains appreciable amounts of plasterwork, covering the Phase A brickwork. Also evident are portions of Portland cement mortar that was likely applied in tandem with the installation of the RSJ beam (Photo 119).

Photo 119: East side of partition in Cell G, first floor level

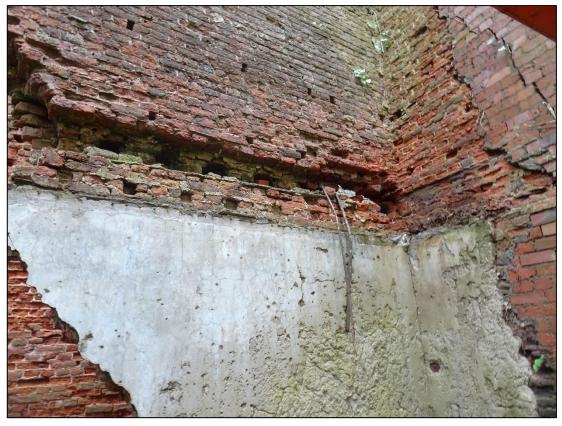
- 4.159. The former north wall above the arch at the west extent of the Servants Hall have fallen or been dismantled. The upper portions of the east extent of the north wall survive and comprise handmade brick of Phase A (Photo 120).

Photo 120: North wall of Butler's Pantry and Bedroom, first and second floors of Cell G

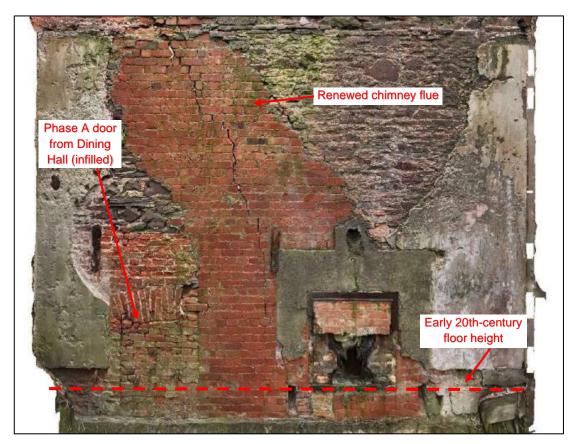
- 4.160. The east wall of the Butler's Pantry, at the first floor level of Cell G, retains a fireplace of early 20th-century character (Fig. 84). This is coupled with an apparent refacing of the associated flue, to its north, which appears contemporary with the fireplace. The fireplace is set within the area of renewed brickwork and incorporates a cementitious fire surround that was applied directly on top of the renewed brickwork. The surrounding wall fabric is predominantly Phase A brickwork and rubblestone, matching that of the reverse of the wall within Cell A (Photo 37).

- 4.164. Whilst the fireplace is much altered and broadly comprises material of early 20th-century date, the position of the fireplace itself is broadly consistent with the 1780s plan, albeit the whole fireplace must have been raised up and moved slightly to the north (Figs. 84 to 86). This was likely to have been the catalyst for the reprofiling of the flue and facing bricks. The late Georgian hob grate may have been retained and moved into the new fireplace position, despite the reconfiguration of its surround.

Fig. 84: East wall of Butler's Pantry, first floor of Cell G

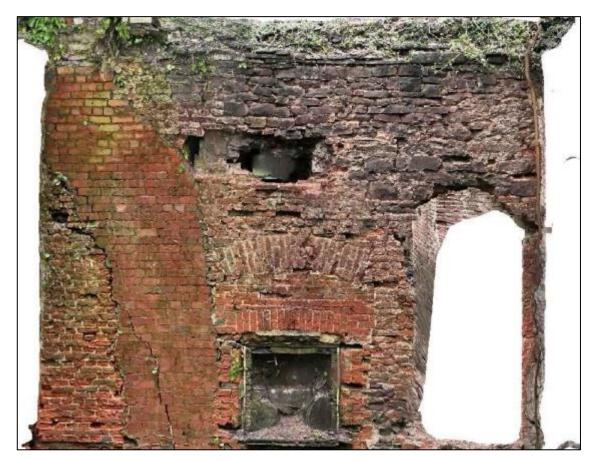
Fig. 87: East wall of Bedroom, second floor of Cell G

4.167. A Phase A fireplace is situated within the middle of the east wall of the reconfigured bedroom and incorporates an arched, segmental head (Fig. 87). This was later altered to a more modest sized fireplace with shallower brick segmental arch and matching brickwork to create a smaller surround. This alteration likely occurred during the 1780s refurbishment works during which the chimneypiece was likely replaced.

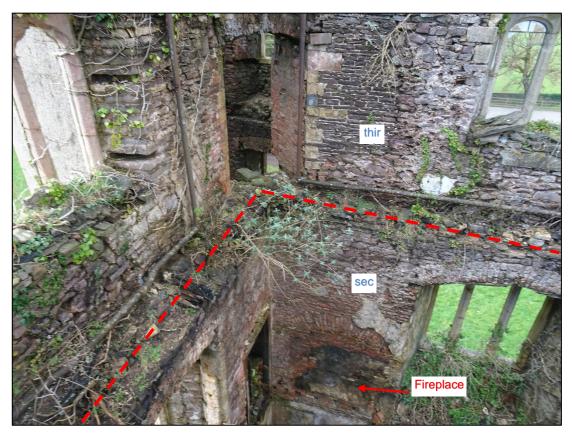
4.166. Within the previous configuration, the west room of the second floor incorporated a fireplace at its south-west extent. This fireplace presumably became redundant at the introduction of the new passageway, but it was evidently not infilled or covered up as it is recorded by the 1909 plan (Fig. 89). The fireplace is still visible within the west wall of Cell G (Photo 122) and incorporates Phase A brickwork surroundings.

Photo 122: South-east corner of Cell G, second and third floors

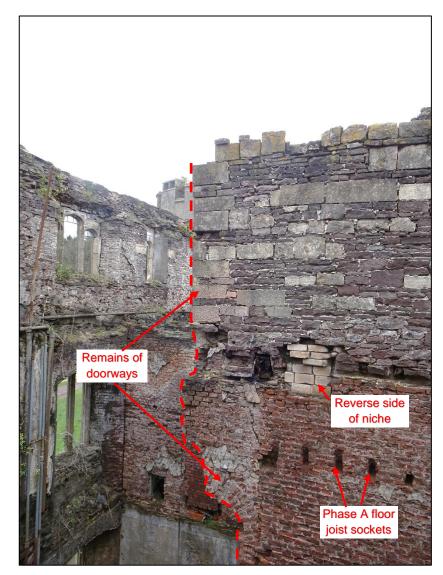
- 4.169. The north wall has survived in part but is precariously hanging without adequate support (Photo 123). At its west extent it incorporates similar ashlar quoins (the reverse of the former doorway discussed in Cell F) to those found elsewhere at third floor level whilst the wall fabric to the east also incorporates a mixture of rubblestone and ashlar. This fabric is placed on top of the red brick wall of the second floor below which also incorporates the remains of an arched doorway that formerly led from Cell G to the landing in the West Stair Hall. The reverse side of the niche identified in Cell F is also evident, incorporating hastily positioned stone infill (Photo 123). A series of floor joist sockets survive within the Phase A brickwork and indicate the former height of the 3rd floor prior to the 1784 fire (Photo 123). The later floor height is represented at the junction between the brickwork and rubblestone.

Photo 123: West extent of north wall at third floor level, Cell G

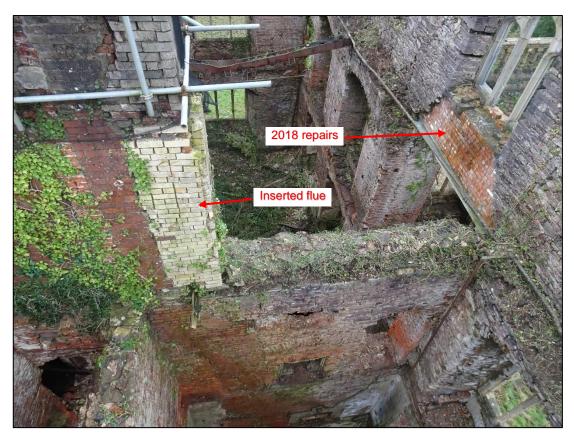
- 4.170. At its east extent, the wall of the third floor is no longer in situ, however, the white brickwork identified in Cell A continues around the south chimney stack and is evidently a later addition and probably the top of the early 20th-century inserted flue, discussed above (Photo 124). At the south extent of the wall are the 2018 repairs to the wall behind the south porch.

Photo 124: East extent of Cell G, third floor level

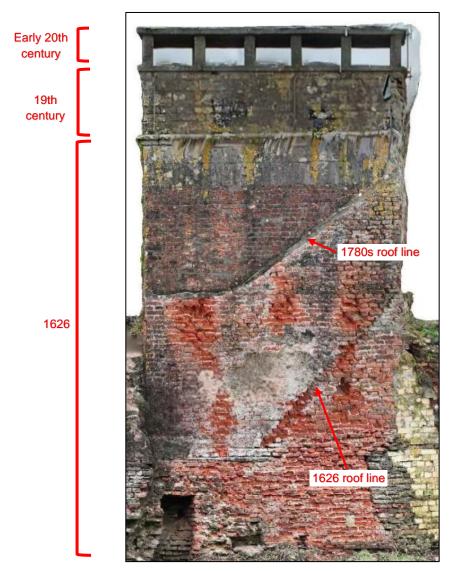
4.173. The east chimney retains much of its form and illustrates the Phase A brickwork that comprises most of the chimney's form (Fig. 90). A notable feature are the two successive roof scars that illustrate both the 1626 and 1780s roof intersections.

Fig. 90: East chimney, south side

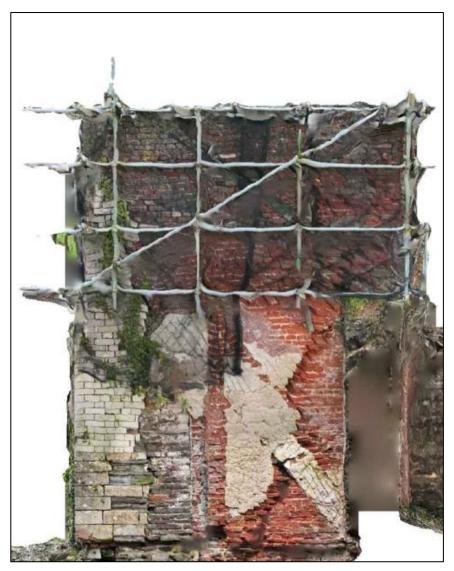
Fig. 91: South chimney, east side

4.174. The south chimney is much degraded and was subjected to a programme of stabilisation during 2018. This included the removal and storage of the uppermost ashlar, cornice and cowl elements from the chimney (Fig. 91).

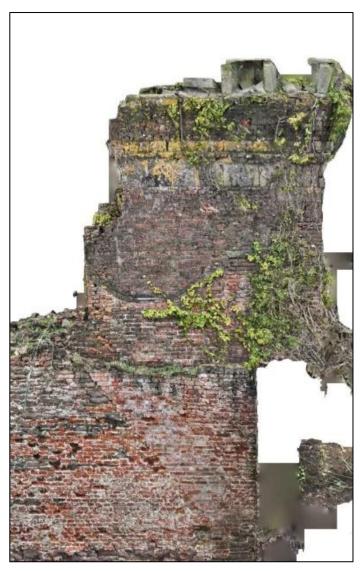
Fig. 92: West chimney, south side

4.175. The west chimney (Fig. 92) is in very poor condition and has experienced the collapse of much of its cowling elements. Elements of the west extent of the chimney also evidence damage and loss.

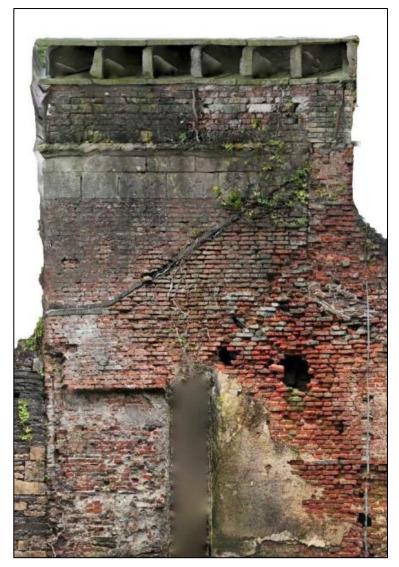
Fig. 93: North chimney, east side

4.176. The north chimney remains in good visible condition and retains all of its principal elements. Once again, the roof lines of the 1626 and 1780s phases (Phases A and B) can be seen via scars within the brickwork (Fig. 93).

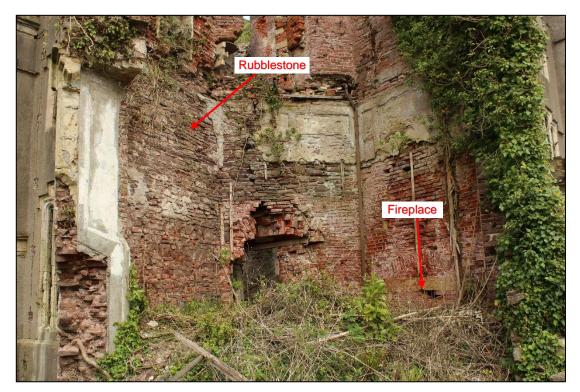
4.177. The south-east tower partially collapsed in 1982. The tower does not incorporate any rooms within the ground floor/vault level. On the first floor (Photo 125), the tower accommodated an ante room, accessible directly from the Dining Room. Accordingly, the room retains elements of decorative plasterwork that exhibits a panelled pattern, apparently shaped into the plaster itself (Photo 126). The collapse of the tower has prompted some consolidation work to stabilise the structure, evidenced by the cementitious coating to its west extent (Photo 125). The remnants of a fireplace are visible within the north-east wall of the room (Photo 125).

Photo 125: first floor of south-east tower

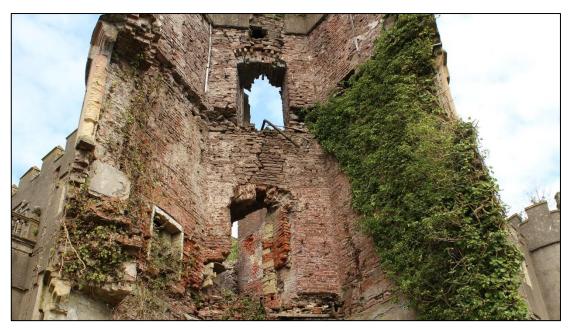
- 4.179. The upper floors of the south-east tower evidence the widespread interspersion of both handmade red brick and rubblestone found throughout the building, evidencing the Phase A date of both materials (Photo 127). On the second floor a further fireplace is evident within the west extent of what was another Ante Room, accessed directly from the Drawing Room. The incorporation of ashlar sandstone within the door surround illustrates the relatively high status of the room in its early incarnation, although this stonework was likely to have been covered in later phases of the building (Photo 128). The fireplace appears to have been altered from its original configuration, with a smaller aperture inserted and buff brickwork used within the fire box (Photo 128).

Photo 127: Remains of second and third floor rooms of the south-east tower

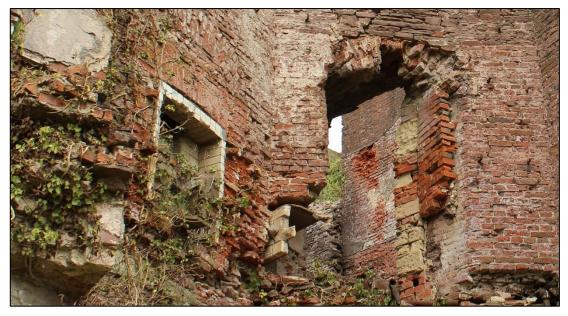
Photo 128: Detail of fireplace and doorway within Ante room on second floor of south-east tower

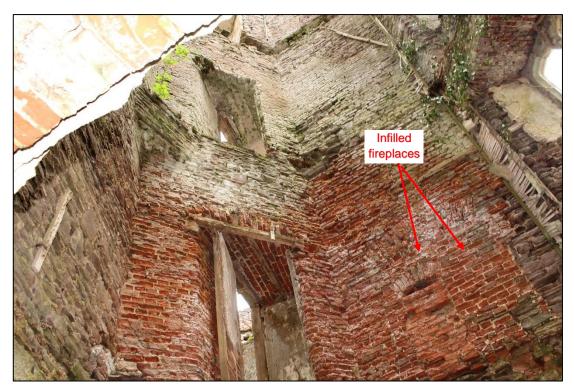
- 4.187. At first floor level, the Workroom incorporates two bricked up features (Photo 135) within the east wall. A small former fireplace with segmental brick head has been infilled, however, this appears to represent a later insertion within the larger aperture of an earlier fireplace. It appears that when the smaller example was inserted, the remaining portion of the earlier firebox was bricked in. Subsequently, the smaller fireplace was also bricked up. The reasons for these transitions are not clear, and neither fireplace appears as a feature on the 1780s, 1909 or 1913 plans. All of the plans show a fireplace on the west wall, however, this fireplace is not evident when observing the wall in its current state, although the remains of the fireplace may exist behind the well preserved lath and plaster wall covering (Photo 136). Fundamentally, it appears that the position of the fireplace was perhaps erroneously omitted on the 1780s plan and the error was carried through subsequent plans.

Photo 135: Overview of first and second floors of south-west tower

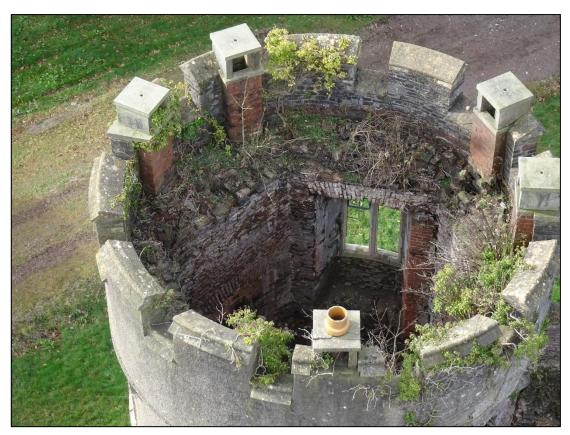
Photo 137: Overview of battlements of south-west tower

4.188. The battlements of the tower incorporate five cowls which suggest that the first floor room perhaps incorporated two hearths, or else the east example was possibly

superseded by a later example. All of the cowls appear contemporary, however (Photo 137). Certainly, the fabric used at the very upper portions of the towers appear to evidence a degree of rebuilding following the 1785 fire as it accords with the prevailing material used for the third storey of the principal elevations. Whilst the lower portions of the towers may incorporate varying degrees of repair or alteration, the substantial form of the towers appears contemporary with Phase A.

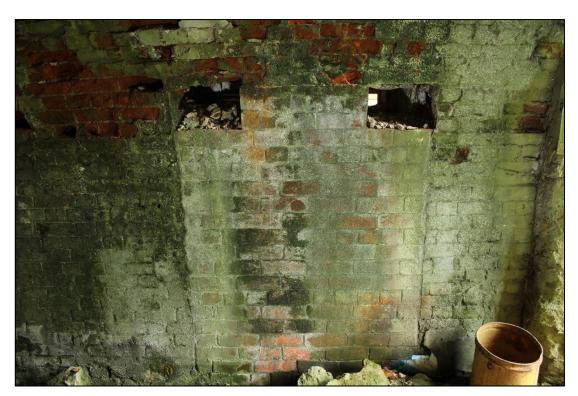
- 4.191. The west wall of the room incorporates a former door to the West Larder (Photo 139). The reconfiguration of this circulation route is discussed as part of Cell D. The door was still open according to the 1909 plans (Fig. 28), however, it would likely have been infilled shortly after. Two cavities have been left open to assist with the circulation of air through what was an area of very low ventilation.

Photo 139: Infilled doorway between West and East Larders

- 4.198. It appears that the East Larder at least existed in some form but may have formed part of a larger room, encompassing the footprint of the West Larder as well (Fig. 23). This is evidenced by the brick partition which comprises later brickwork, likely contemporary with the 1780s works (Photos 138 and 139) By this logic, it is feasible that the lobbies and Wine Store 1 to the south also existed in a form but have been much altered since.
