Ruperra Castle (Castell Rhiw'r Perrai) Caerphilly Glamorgan

Historic Building Recording

CA Project: CR1627

CA Report: CR1627_1

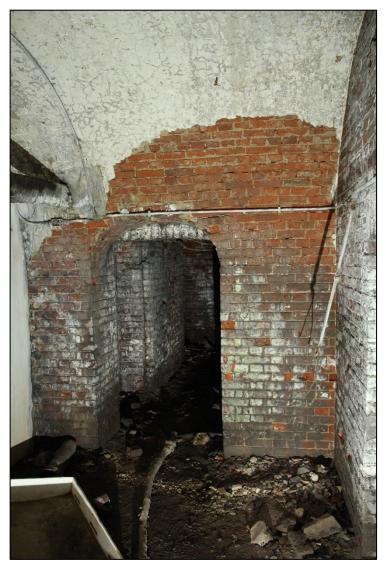
4.192. A short internal lobby (Photo 140), accessed through an arch headed door from the south extent of the East Larder permits access to Wine Store 1 (Photo 141). This is configured in accordance with typical examples of the 19th and early 20th centuries. The ceiling of the store is rendered whilst regular, square brick cavities with limestone shelving would have accommodated stacked bottles of wine on top of cement shelves. Brick dimensions used for the shelves are consistent with standard imperial measurements and are very consistent in dimension, indicating they were created using uniform moulds. The brick shelves were laid half a brick wide, in stretcher bond.

Photo 140: Internal lobby between East Larder, Wine Store 1 and Vault Passage, looking south

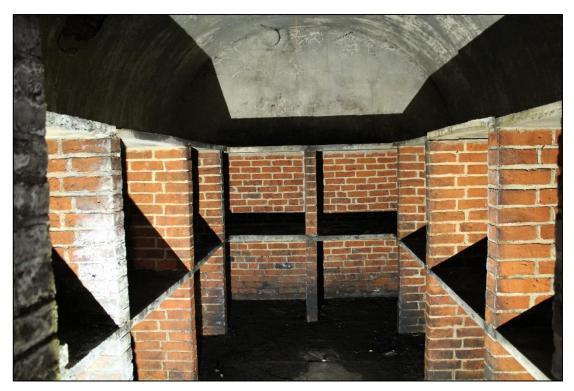
Photo 141: Overview of Wine Store 1, looking west

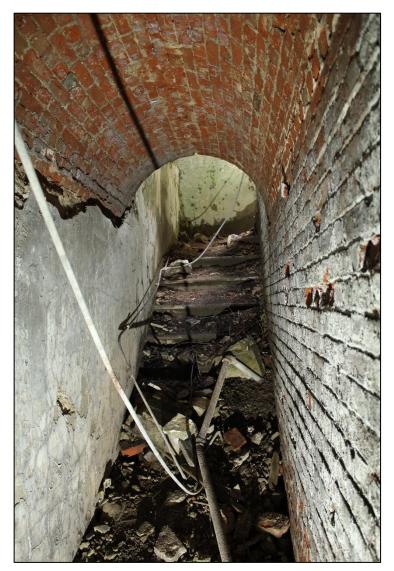
- 4.193. The lobby then leads into a further lobby that provides access to the connecting staircase that leads to the East Stair Hall (Photo 142). This is recorded on the 1780s plan and appears to be contemporary with the creation of the vaults. This lobby also leads south to the long Vault Passage (Photo 143), aligned east to west beneath Cells A and G, providing access to further wine and beer stores and the central heating apparatus. Notably, whilst the entire construction appears contemporary throughout, the north wall is constructed using Flemish bond whilst the south walls consist of English bond. Spot measurements of bricks within both walls indicate a very consistent and narrow range of dimensions, consistently measuring 8^{3/4} x 2^{1/4} inches (approximately 220 x 60mm). The vaulted roof is English bond throughout the entirety of the Vaults.

Photo 142: Access to Vaults from East Stair Hall, looking west

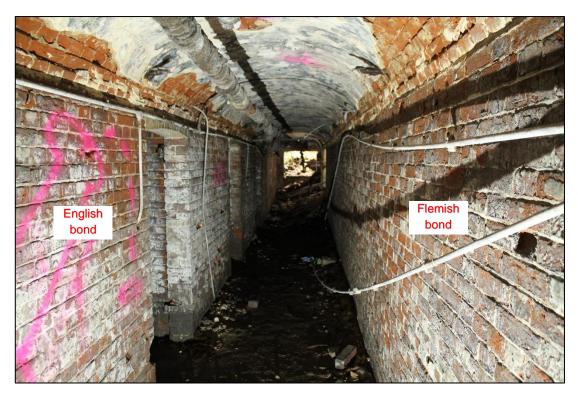
Photo 143: Overview of Vault Passage, looking west

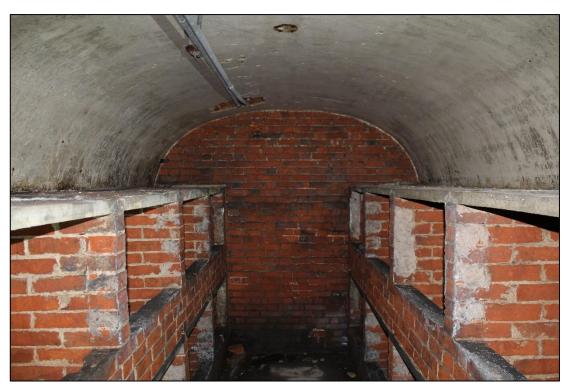
- 4.194. Wine Store 2 (Photo 144), at the east extent of the passage mirrors the configuration of Wine Store 1 except for a brick frontage to the shelves. The brickwork is contemporary with Wine Store 1 and appears to have been installed at the same time. The Beer Store (Photo 145) is positioned to the west of Wine Store 2 and mirrors the shelf configuration of Wine Store 1. The relative configurations of Wine Store 2 and the Beer Store suggest that perhaps these designations should be reversed in accordance with the similarities between Wine Store 1 and the Beer Store.

Photo 144: Overview of Wine Store 2, looking south

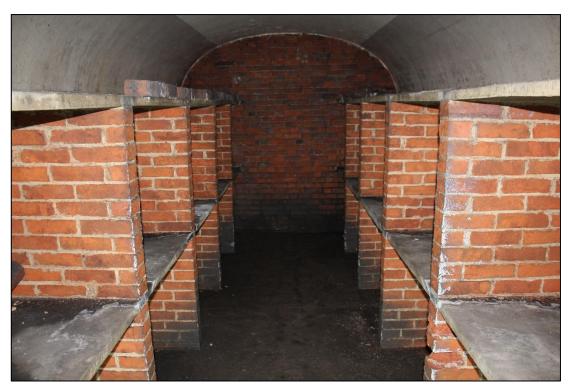
Photo 145: Overview of Beer Store, looking south

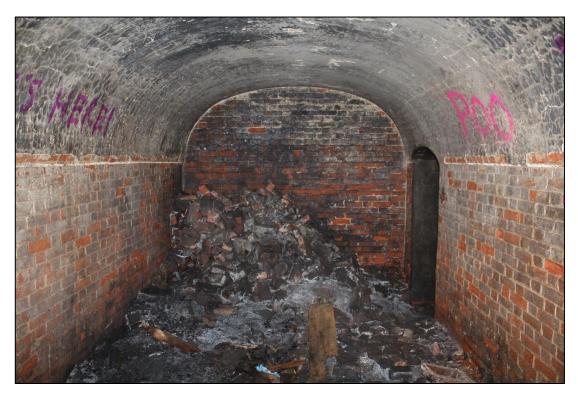
- 4.195. To the west of the Beer Store is the former Coke Storage room (Photo 146). No features remain in the room, however, discolouration of the walls evidences its former function. Two doors are positioned at the south and north ends of the west wall that provide access to the adjacent Central Heating room. The 1909 plans show only the north door within the wall, suggesting that the south door is a later insertion, perhaps correlating with an upgrading of the heating equipment and consequent changes to transfer of coke from one room to the next. The walls of the Coke Storage room are laid in Flemish bond.

Photo 146: Overview of Coke Storage, looking south

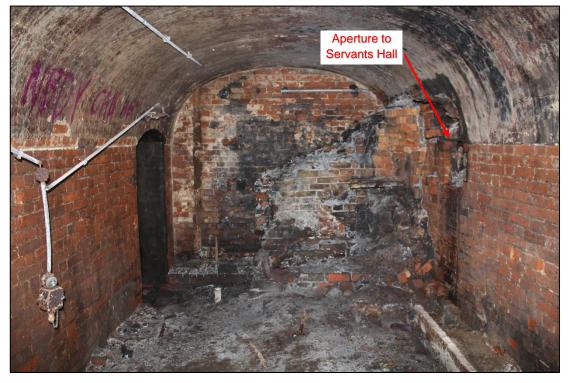
- 4.196. The Central Heating room (Photo 147) is located west of the Coke Storage room and, in 1913, appeared to incorporate a 'hot water boiler' that was fuelled by coal/coke stored in the two nearby stores (Fig. 95) (the second one is located within the central core of the building, accessed via the West Stair Hall (Photo 103)). No trace of the former heating equipment remains, however cement plinths suggest possible seating positions. The 1913 plan indicate it was positioned at the north extent of the room (Fig. 95). Notably, there are two, tapering apertures between the Central Heating Room and the Servants Hall, in Cell G. These apertures are positioned at the north and south extents of the west wall of the Central Heating Room and are recorded on the 1909 plan. They do not appear on the 1780s plan and have clearly been cut into the existing brickwork (Photo 148). The former purpose of these apertures is unclear,

Photo 147: Overview of Central Heating room, looking south

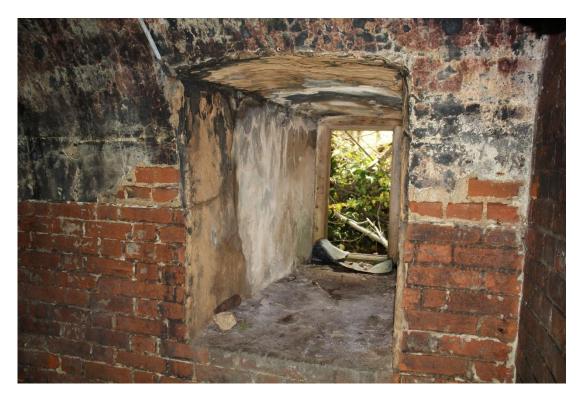
however, they may have been provided to provide a modicum of natural light into the room.

Photo 148: North aperture in west wall of Central Heating Room

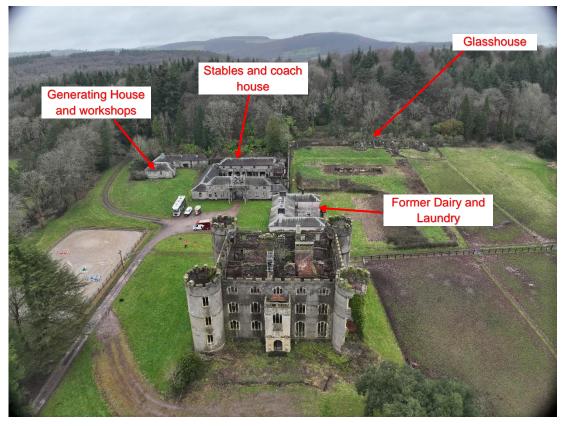
4.201. The castle is positioned within a small group of buildings that all combine to form the Ruperra estate (Photo 149). The north building is the Generating House and attached workshops (Grade II; ref: 18973). This building was constructed in the 1920s and incorporated steam driven generators to provide electricity to the castle. The complex to the immediate south-east of the Generating House is the stables and coach house building and courtyard (Grade II; ref: 18971). This was constructed in 1910 and

Photo 149: Overview of Ruperra Castle and ancillary buildings, looking north

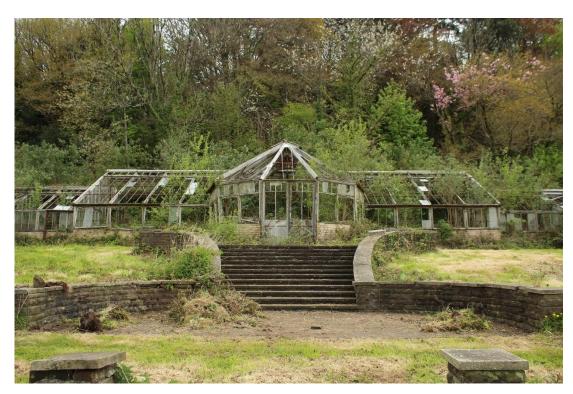
- 4.203. Within the gardens to the north-east of the castle lie the ruins of the former Glasshouse (Grade II; ref: 20144). This building was constructed around 1910 by Mackenzie and Montcur Ltd (Photo 150). The central portion of this building was recorded as a conservatory whilst the side elements were carnation houses (Cadw 2022). A further two free standing glasshouses were positioned to the north of the stables, however, these are largely ruinous.

Photo 150: Remains of former glasshouse, looking north

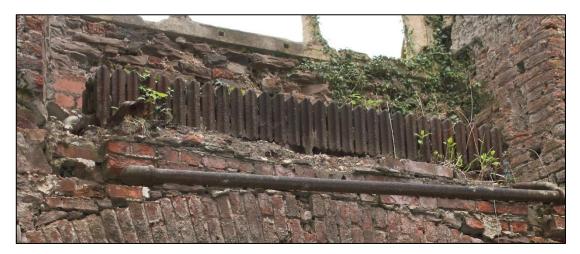
- 5.22. The only visible remains of the former heating system comprise several radiators, located beneath windows, and the remnants of hot water pipes. Of the radiators that are visible, two have been identified by experts at the Heritage Group of the Chartered Institute of Building Services Engineers as part of this survey. The first

radiator, located within the south window reveal in the east wall of the second floor, Cell A (Photo 151) and has been identified as an 'Ideal Window Radiator' from an Ideal catalogue of 1924 (Fig. 96). Ideal was the brand name of the National Radiator Company Limited of Hull (More 2024).

Photo 151: Radiator, Cell A, second floor, east wall

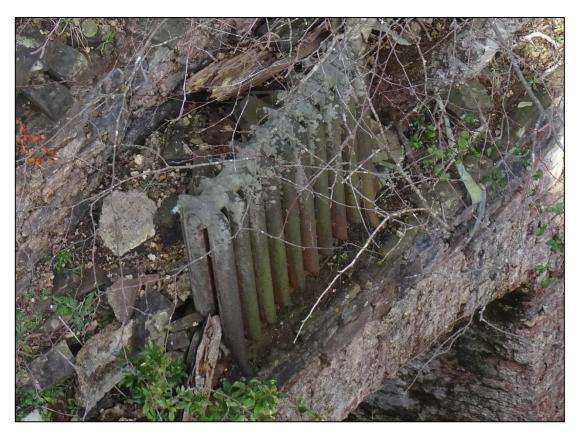
5.23. The second radiator identified is located beneath a window in the north wall of Cell D, third floor (Photo 152). The radiator has been identified as an 'Ideal Plain Two Column Radiator' (Fig. 97), as depicted within the Ideal catalogue of 1924.

Photo 152: Radiator, Cell D, third floor, north wall
