Whitford Point Lighthouse

NPRN 34289

Report on RCAHMW Survey Work, 2023-2024

May 2025

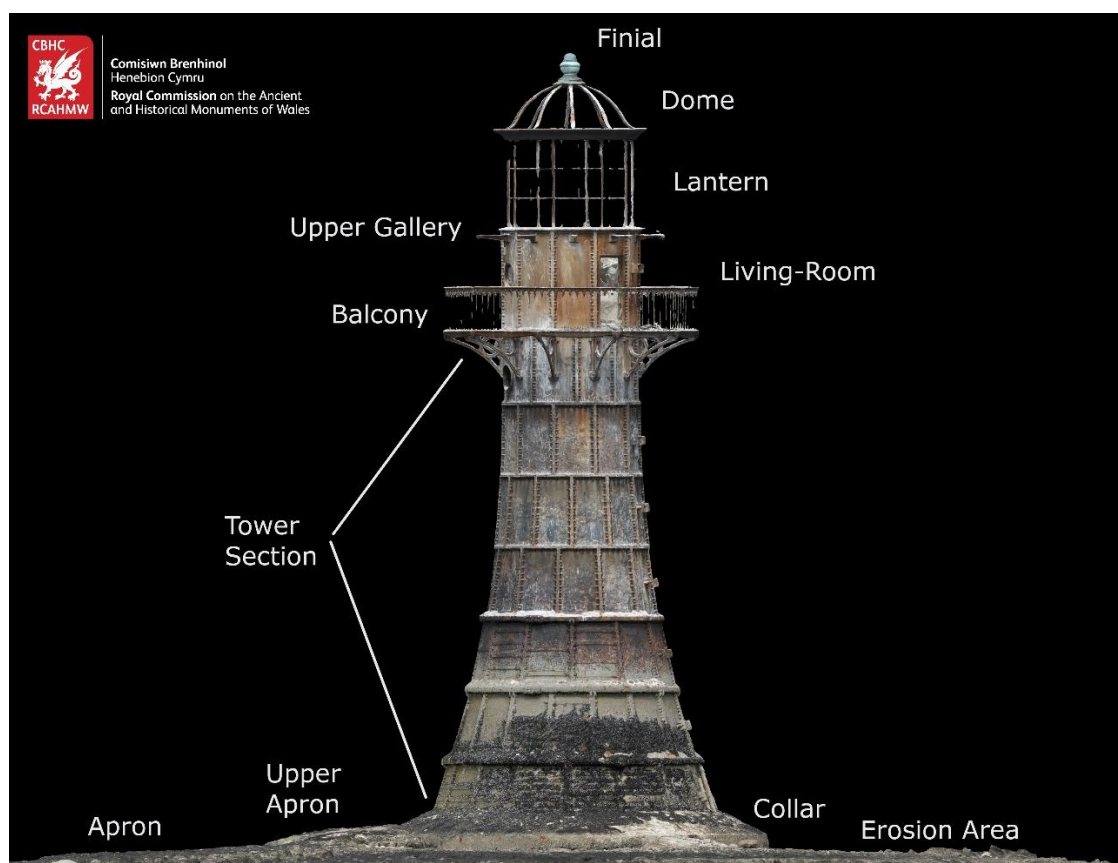
Whitford Point Lighthouse is 19.2m in height, from the base of the lowest cast-iron band to the top of the surviving finial. It is 7.1m in diameter around the lowest part of the cast-iron work, and occupies a footprint some 27.5m in diameter inclusive of the base collar and stone apron. The lighthouse is formed of a main tower section, in turn topped by a living-room, lantern, and domed roof with finial (Figure 2.1).

Figure 2.1. Annotated Orthomosaic of the southern elevation of Whitford Point Lighthouse, derived from RCAHMW survey on 17/08/2023 (© Crown Copyright: RCAHMW).

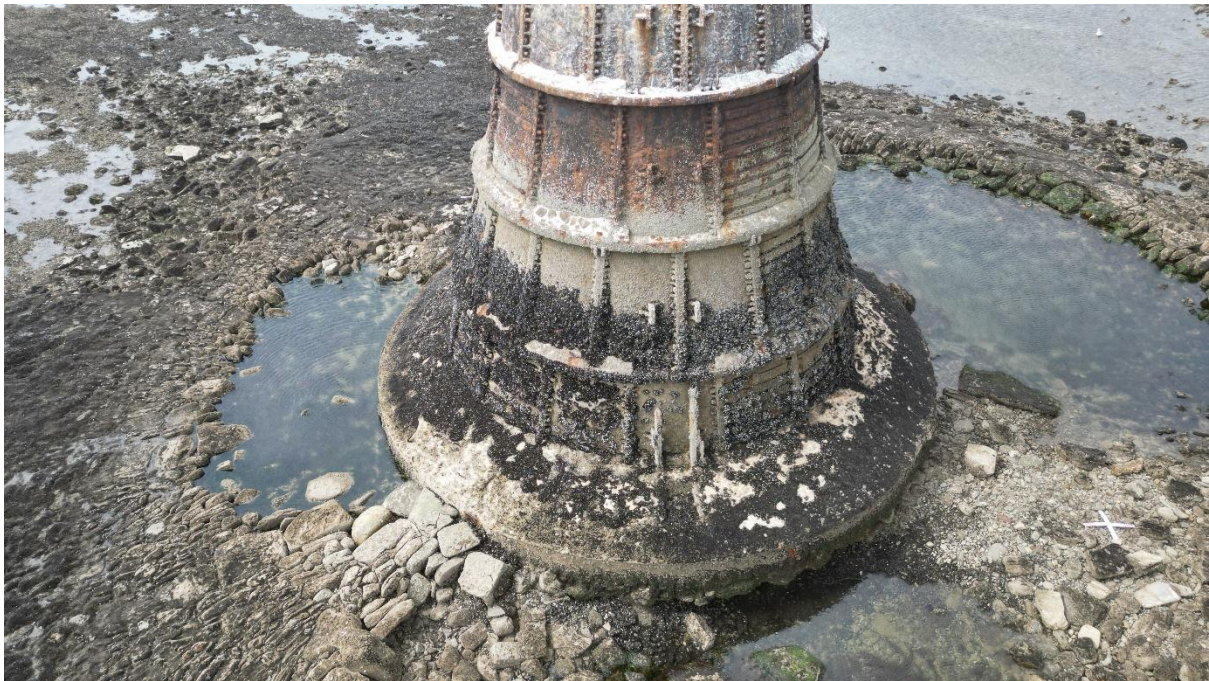
The tower section of the lighthouse has a height of 12.1m and consists of seven rings of heavy cast-iron plates that are bolted together by external flanges (Figure 2.2). Hague (1994: 85) notes that this is in contrast to other cast-iron lighthouses which usually utilised internal flanges, but considers the external method would better facilitate erection of the tower during the limited low water working

Figure 2.2: The lower cast-iron sections, collar and surrounding apron of Whitford Point Lighthouse on 17/08/2023 (© Crown Copyright: RCAHMMW).

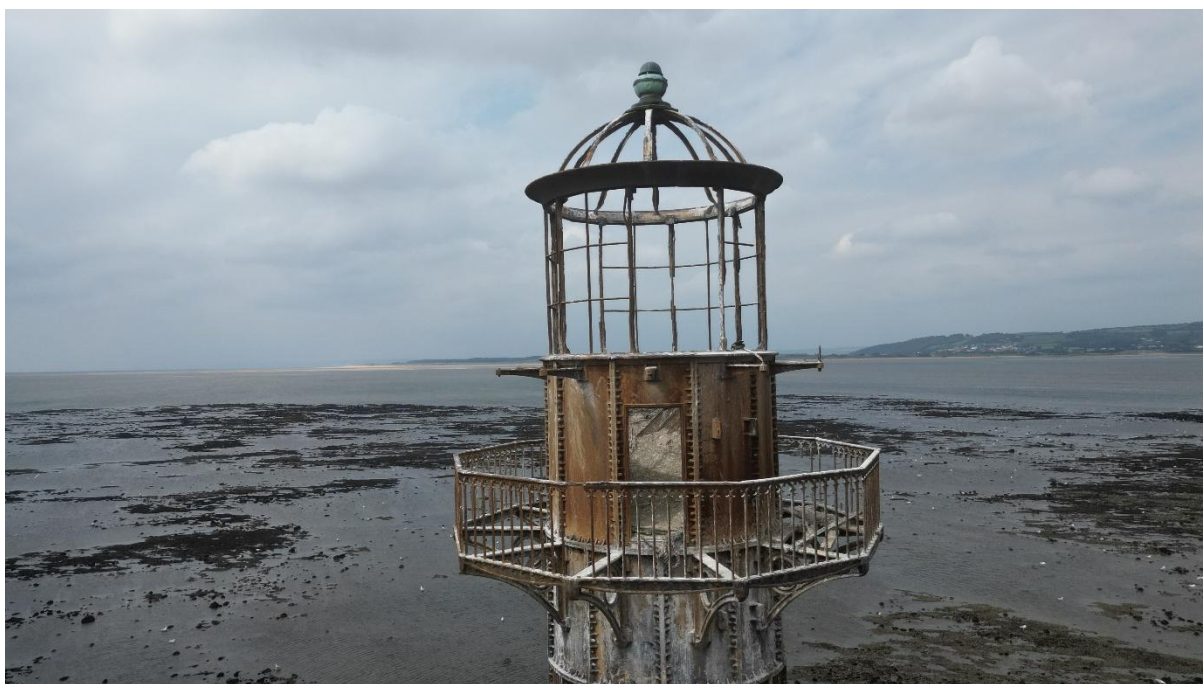
The living-room is formed by an eighth ring of cast-iron plates, 2.6m high, above which is the glazed lantern itself (Figure 2.3). The glazing comprises eight main sections, with six square panes within each section. An increasing number of the secondary glazing bars are now being lost. One section is likely to have been a glazed doorway to allow access to the upper external gallery. The lighthouse roof is domed, the original copper is missing, leaving only ten roof frames visible, the roof is topped with a ball finial (now partially incomplete). The junction between the top of the tower section and the living-room is distinguished by a ten-sided balcony (originally with a wooden floor) and balustrade, supported by ten ornate cast-iron brackets with roundel-decorated spandrels (Hague, 1994: 85). A further, smaller, balcony is arranged around the lantern to facilitate its cleaning. The railings of this are now lost, but the ten support brackets remain in place. When viewed from overhead (Figure 2.4), these are arranged so that they are between the brackets of the main balcony, and in-line with the dome frames.

Figure 2.3: The upper sections of Whitford Point Lighthouse on 17/08/2024, including the living-room, lantern, dome and balustrades (© Crown Copyright: RCAHMW).

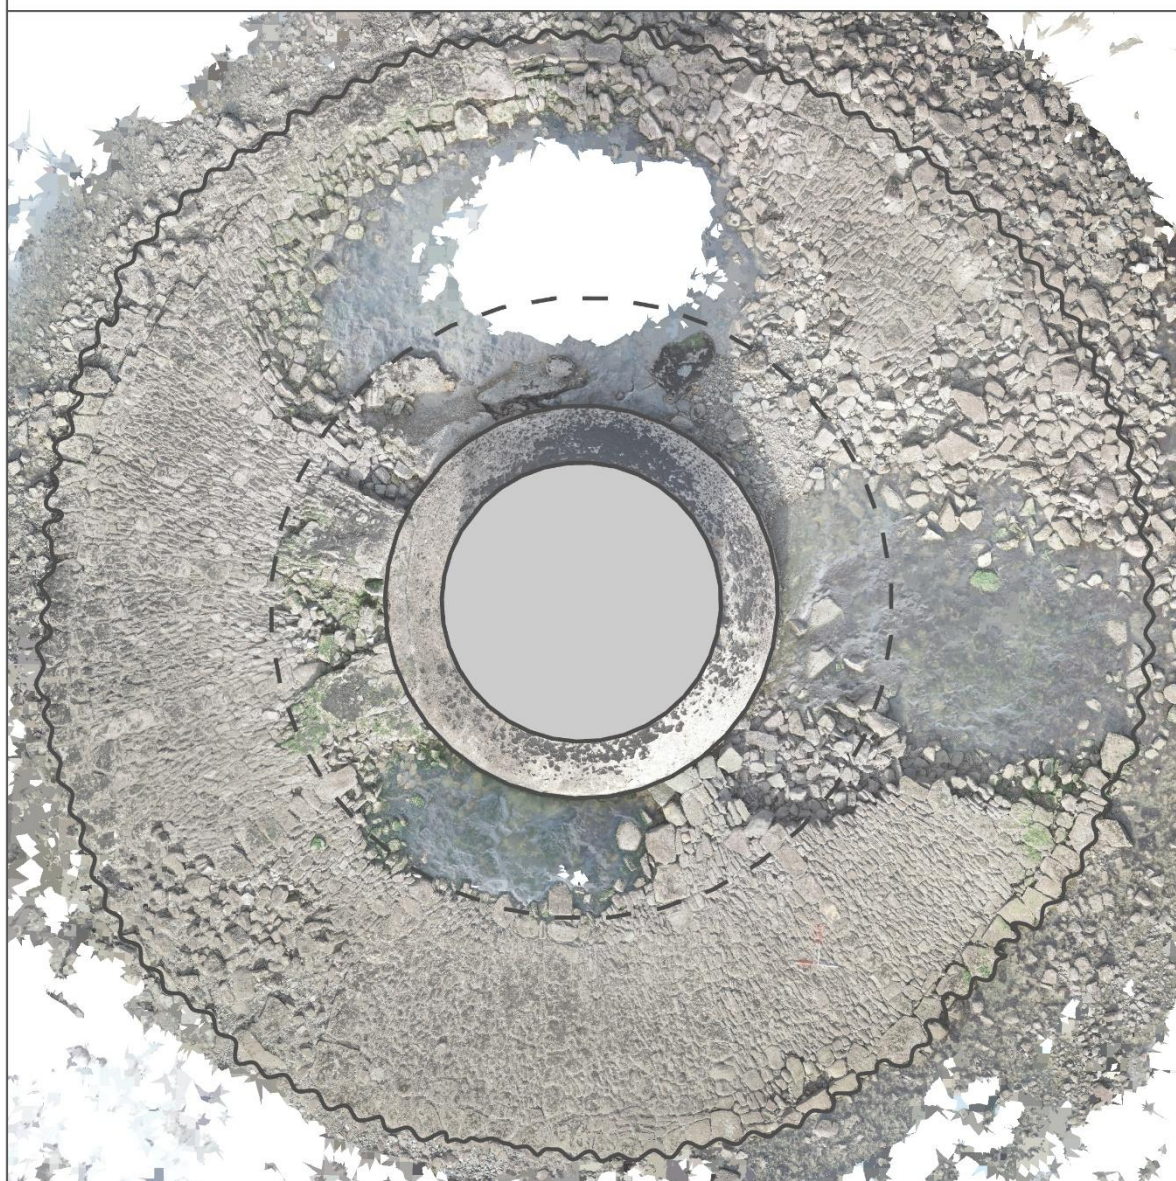
NPRN 34289 Whitford Point Lighthouse **Orthomosaic, October 2024**

As noted, the scour pools and erosion are most extensive on the eastern and northern sides of the lighthouse (Figures 4.1 – 4.6). The eastern scour area is visibly undercutting the collar, potentially by as much as 0.5m from the vertical outer edge of the collar. The same process is evidence on the northern side of the collar where a 0.5m deep undercut is observable. The scour pool on the southern side of the collar has not yet started to undercut the collar, based on the observations in August 2023.

Figure 4.4: Annotated Orthomosaic of Whitford Point Lighthouse derived from a photogrammetry survey on 17/10/2024 (© Crown Copyright: RCAHMMW).

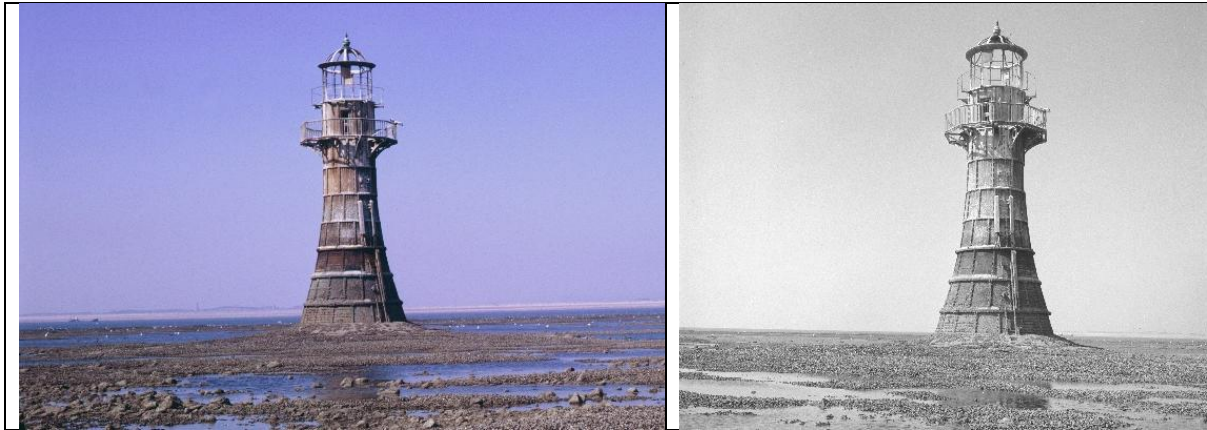
1970s imagery is restricted to ground-level photographs taken in 1971 (Figure 4.7 left) and 1972 (Figure 4.7 right), from the southern side of the lighthouse. It is impossible to assess the extent of any erosion to the apron as only a small part on the southern side is visible. The whole area of the apron does appear to be covered in mussels, consistent with the surrounding intertidal area. These are absent from later images of the apron, so it is possible to surmise that the extent of erosion in the 1970s was very small to non-existent, based on the coverage of mussels over the apron, which decreases, as erosion increases in later years.

Figure 4.7: Ground-level photographs of Whitford Point Lighthouse, viewed from the south (© Crown Copyright: RCAHMMW). Left: 1971, by Dylan Roberts, archive No. 6171738.⁴ Right: 1972, by Douglas Hague archive No.6498731 (© Crown Copyright: RCAHMMW).⁵
