Project PD24-108

Report 2076

# Holt Presbyterian Church

Level 3 Historic Building Recording

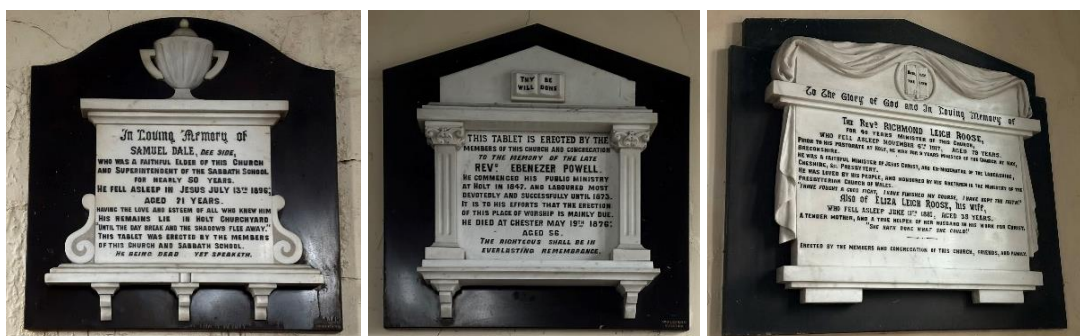
- 1.7. Within the church are three memorial plaques (Figure 2), one to its founder Reverent Ebenezer Powell noting that he was minister of this (and the previous) church from 1847 through until 1873, dying in 1876.

- 1.8. The second commemorates another of the church's ministers Reverent Richmond Leich Roose, former minister to the Church at Hay, Breconshire and an important figure in the Presbytery Church of Lancashire and Cheshire. The plaque also commemorated his wife Eliza Leich Roose. The reverend's son, also a resident of Holt and likely a member of the church congregation, was Leigh Richmond Roose, considered one of the greatest football players of his generation, who played as a goalkeeper for the Welsh national team also playing for Everton, Sunderland, Stoke, and Glasgow Rangers during his career (Richards, 1959).

- 1.9. The third plaque commemorates Samuel Dale, an elder of the church and superintendent of the church Sunday school for nearly 50 years.

Figure 2: Memorial plaque to Samuel Dale, Rev Ebenezer Powell and Rev Richmond Leich Roose (Heneb photo PD24-108\_017, 020, 021)

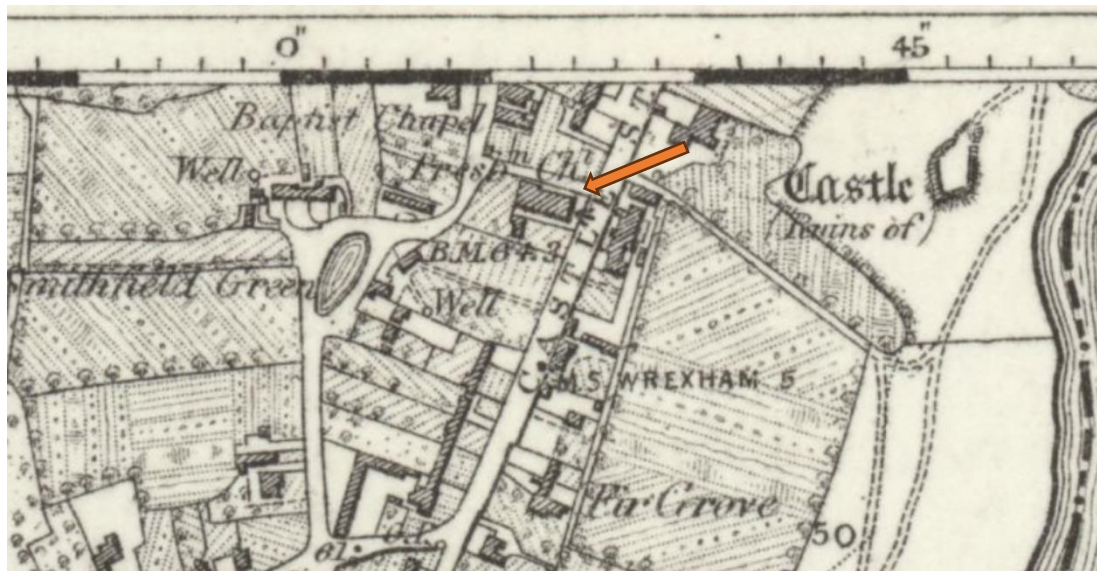
- 1.11. The church first appears on the first edition Ordnance Survey (OS) 6-inch scale map in 1872, 7 years after its construction. It is depicted with both the main church and a schoolroom to the west of it. The Manse (clergy house) is shown directly to the south of the church which shares its rear yard or garden with the church (Figure 3).
- 1.12. The second edition Ordnance Survey 25-inch scale map dating to 1897 is relatively unchanged but also shows the gateway access into the schoolroom from the north (Figure 4).

Figure 3: First edition Ordnance Survey 6 inch to the mile map Denbighshire Sheet XXIX Surveyed: 1872, Published: 1879 (National Library of Scotland)

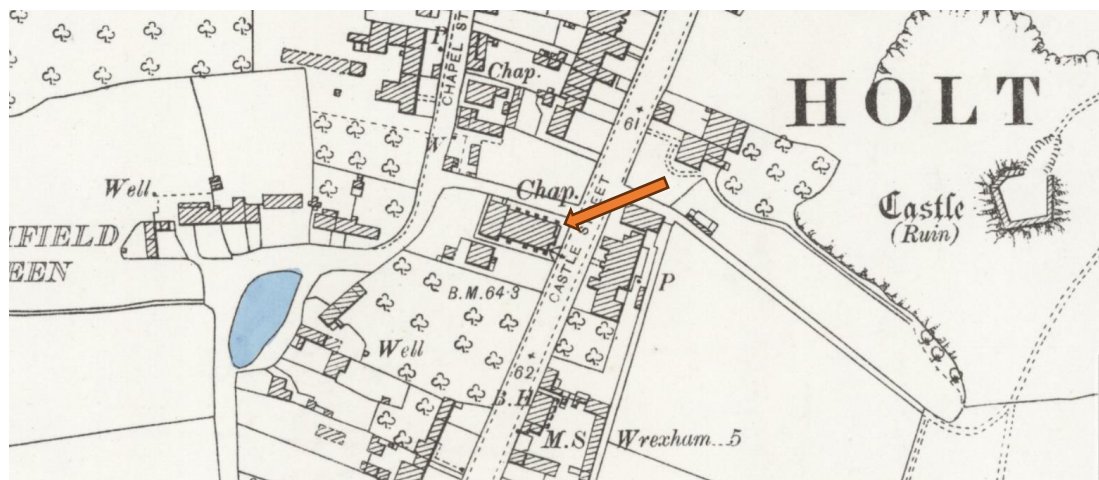
Figure 4: Second edition Ordnance Survey 25 inch to the mile map Cheshire LIII.11 Revised: 1897, Published: 1899 (National Library of Scotland)

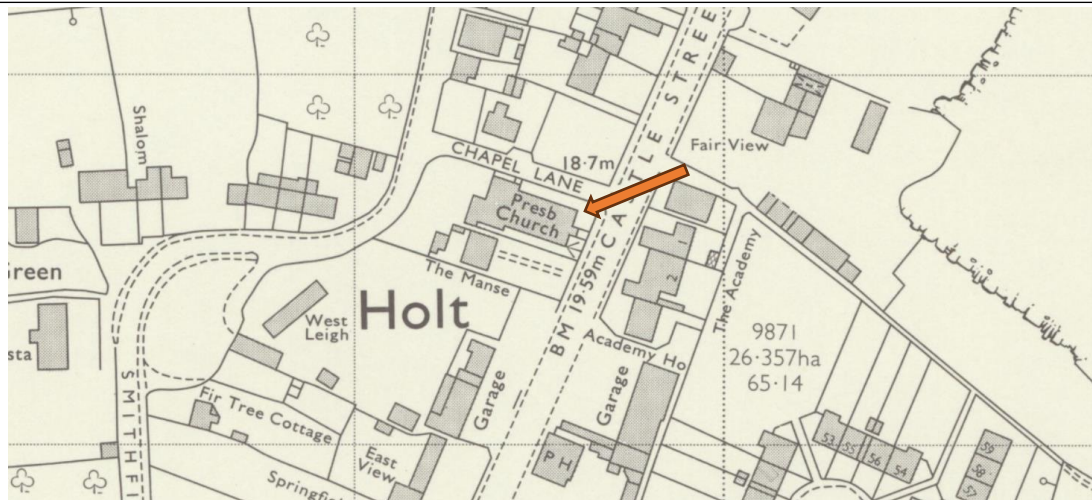
Figure 5: SJ4053-SJ4153 - AA Revised: 1970, Published: 1971 (National Library of Scotland)

- 1.13. By the 1970 National Grid Ordnance Survey Map, the new rear single-story extension is now depicted to the west of the school room. The Manse is also now labelled within this map (Figure 5).
- 1.14. Google Earth archive satellite imagery shows the rear western yard of the still active church joined to the Manse in 2006, but by 2009 it was subdivided to form the present rear western yard and parking spaces.

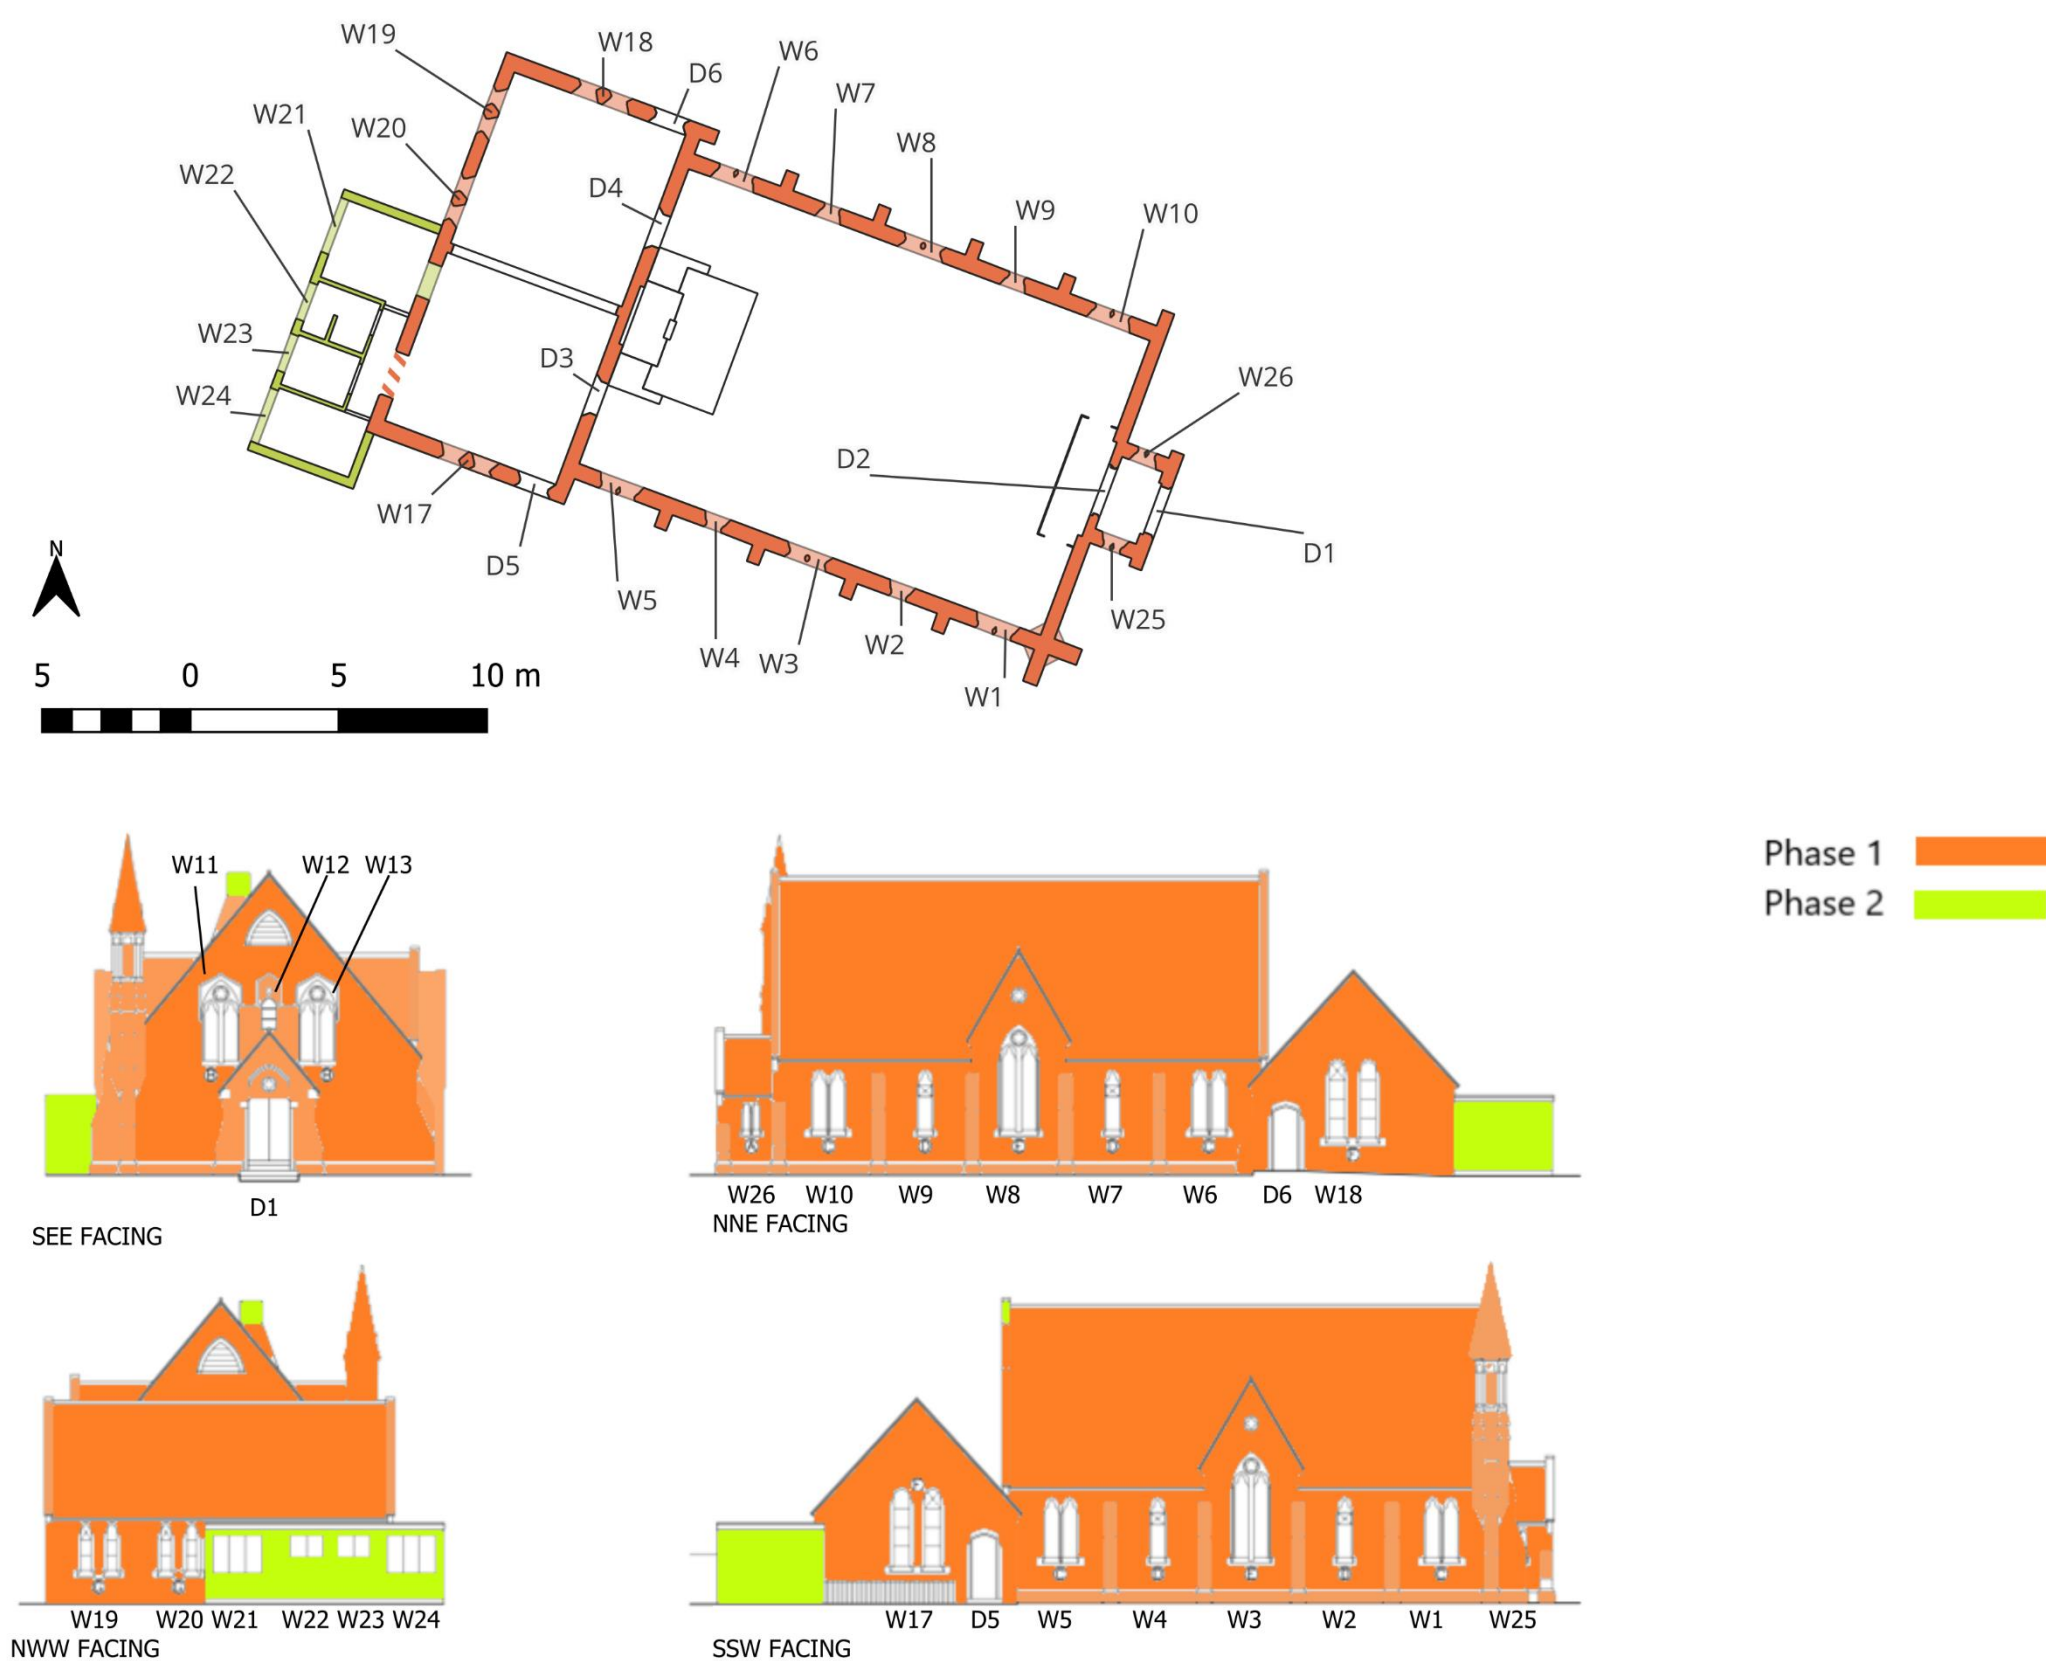
Figure 17: Phasing plan

- 2.4. The following presents the photographic recording and investigation of the structure in order of phasing. The phasing, as identified in this assessment, is illustrated in Figure 17 at the end of this document and includes the labelling of features such as doors and windows that are referred to throughout this assessment. A floor plan is shown in Figure 18.
