Llwyn Celyn Stanton Cwmyoy Crucorney Fawr Gwent

An Architectural & Archaeological Analysis

February 2020 Mercian Heritage Series No. 1517 Llwyn Celyn Stanton Cwmyoy Crucorney Fawr Gwent NGR: SO 309 218

Planning Application: 15/12532/FUL Ref: Condition 7 (Level 4 Buildings survey).

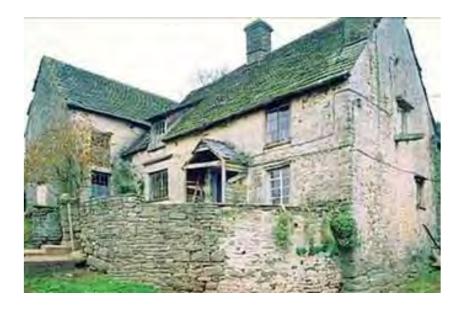
Pl.4: Llwyn Celyn from the south-east, before being swathed in protective scaffolding.

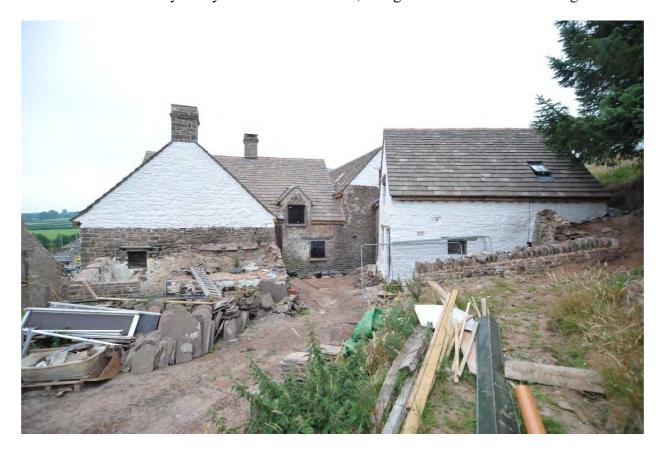
Pl.8: The rear elevations of Llwyn Celyn from the north, during restoration, 2017.

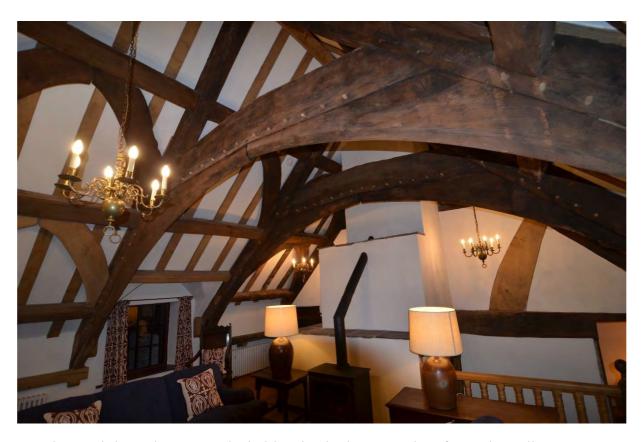
Pl.9: Arch-braced trusses and wind-bracing in the restored roof over the Hall Range.

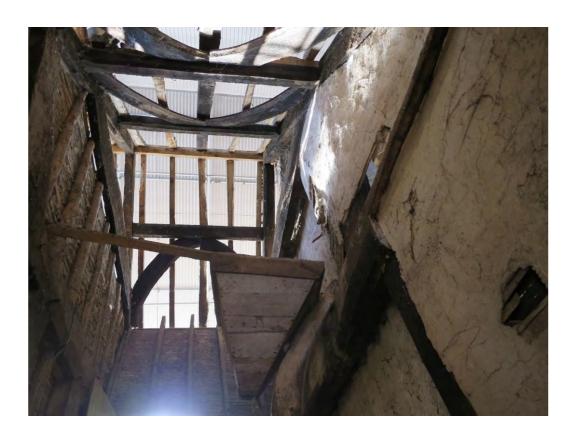
Pl.12: The bay of the roof above the screens passage, spere truss to right.

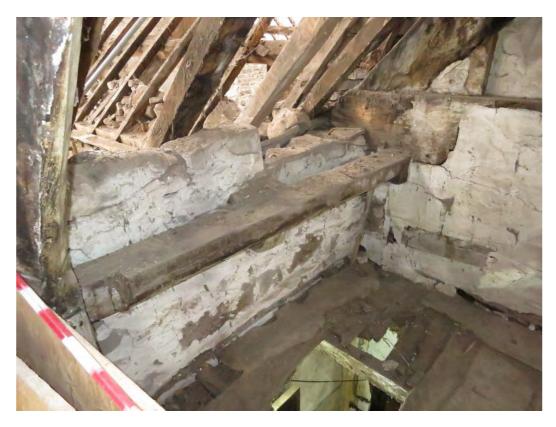
Pl.13: Detail of surviving corbelled inner wall-plate on the north side of the Hall Range.

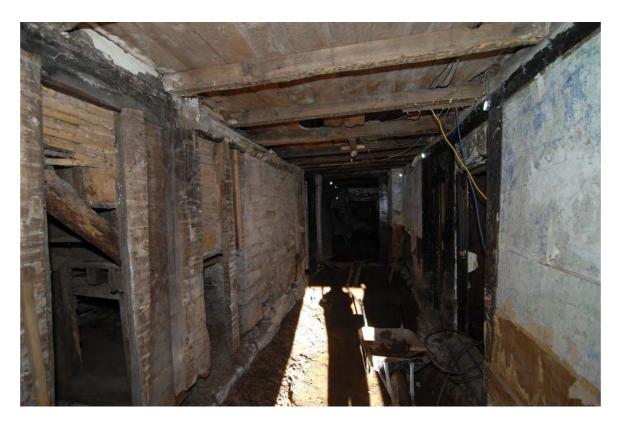
Tenoned between the aisle posts of the spere truss was another long rail which supported the axial joists of the first floor above the screens passage. It is octagonal in section but cannot be original. Apart from interfering with views from the hall to the service doorways, it is also not properly jointed to the spere posts. One side does have a flush mortise and tenon joint; the other is cut into the flank of the post – the rail being slightly too long for the span.

This rail also has a series of cuts in its flanks which were difficult to decipher. It is possible that it was the transom for a wooden mullioned and transomed window – but there is no indication of a window anywhere near as wide in the building that it could have come from. It seems of too great a scantling to have been the mid-rail of some plank-and-muntin wainscot (very rare but not unknown in the sub-medieval period). Another possibility is that it may have been the newel for a small spiral stair.

Pl.15: The screens passage, looking north, during the restoration work. On the left is the back of the stack inserted between the aisle posts of the spere truss.

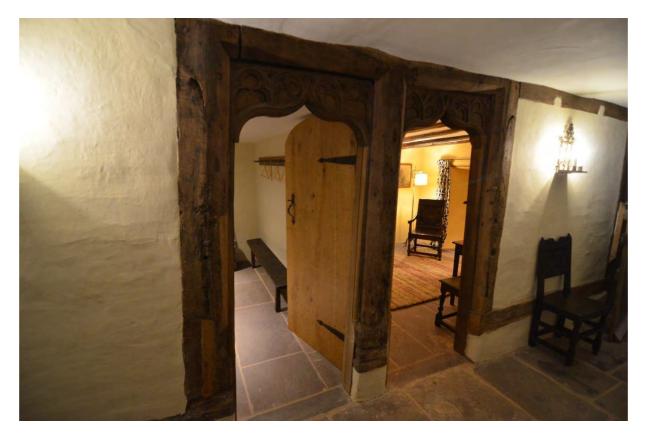
Pl.16: The restored pair of original service doorways in the east wall of the screens passage.

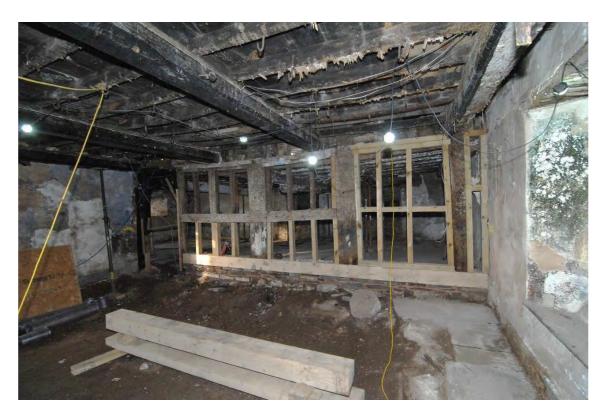
Pl.17: The hall during restoration, looking west; note the timber-framed partition at the dais end and the inserted first-floor; the door on the south wall had yet to be rediscovered.

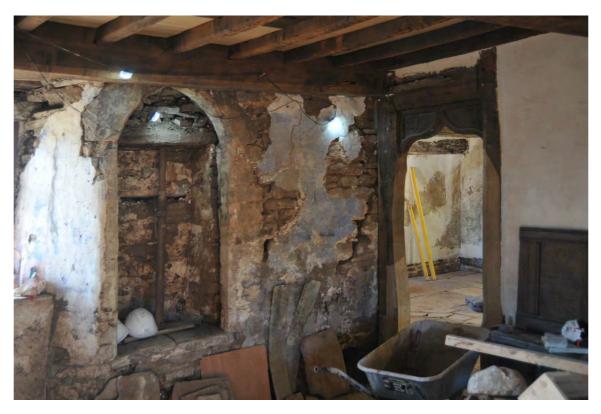
Pl.18: The south-west corner of the hall in 2017, showing the recently re-discovered doorway, left, and its relationship with the door into the Solar wing.

There were two doorways into the Solar at this level, one to either end of the timber-framed partition between the two sections. That towards the northern end was evidently inserted. The one at the southern end is primary and has an ogee head with shields in the spandrels; it was quite deformed but has been carefully restored and brought back more to 'true'. Between the doors is a long dais bench with wainscot back; this is presumably associated with the long table known to have existed in the hall – sold later to the hotel at Llanthony Abbey; it is probably of 17th century date.

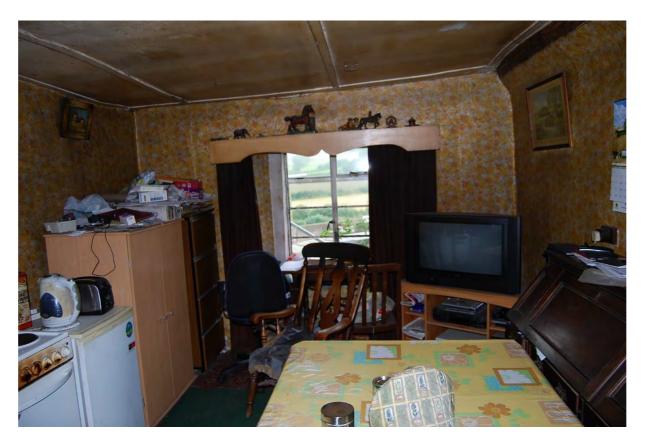
Towards the southern end of the east gable wall the remains of a small blocked fireplace were encountered after the stripping of decorative finishes; this relates to the remnants of a stack on the floor above and a chimney on old photographs. Also within the inner masonry were some odd bricks – perhaps indicating a degree of post-fire repairs to the wall.

Pl.20: The ground-floor of the former services was the main living room in 2009.

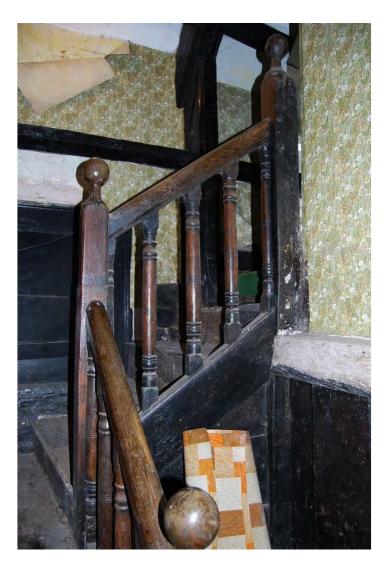
They are of an open well design with three sets of risers and two quarter landings; this allows them to cope with the difference in the first-floor levels. The stairs have square newels with ball finials and the balustrades have solid strings, moulded handrails and turned balusters. The general design is indicative of a date in the later- 17th or early-18th centuries.

Pl.21: Detail of the stairs in 2009, prior to the restoration project.

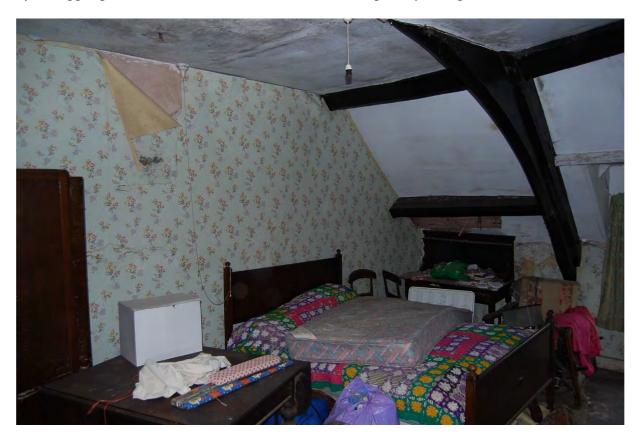
In between these was the main first-floor bedroom, occupying the area between that western corridor and the line of the spere truss and inserted stack. This was ceiled and lit by an inserted dormer window in the north wall. The lath-and-plaster partitions were probably of the 19th century and were removed as part of the recent restoration program to better express the character of the medieval building and its early post-medieval phase.

Pl.22: The first-floor bedroom in the Hall Range prior to restoration.

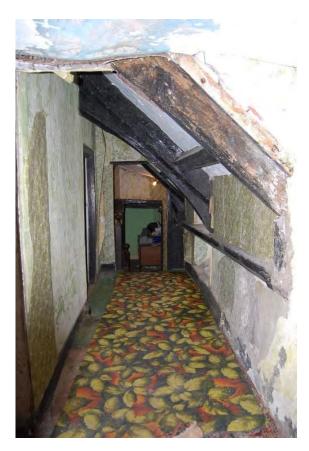
Pl.23: First-floor corridor on south side of Hall Range IN 2009, prior to restoration.

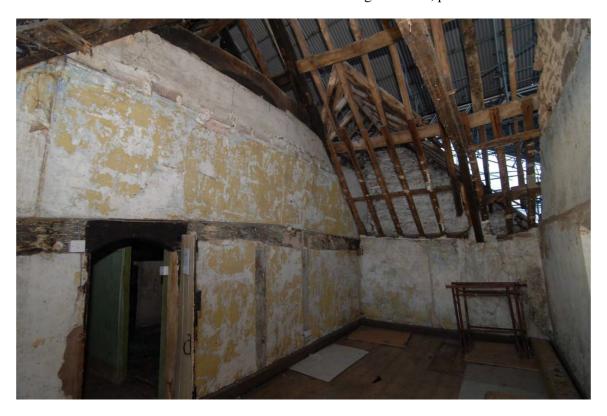
Pl.24: The first-floor room over the services looking north during restoration.

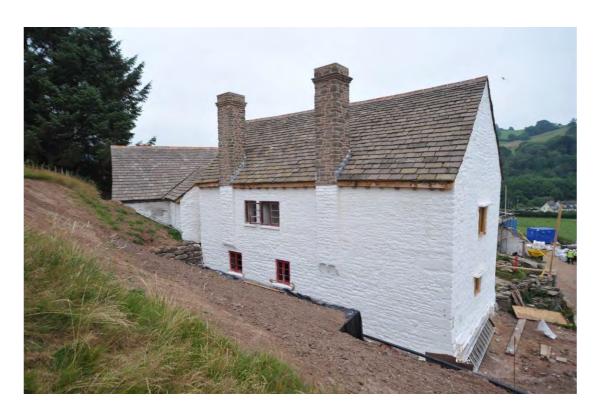
The lower part of the western side elevation of the Solar had been partly buried by the slippage in the adjacent bank and this needed to be excavated for drainage purposes – the work being carried out under archaeological monitoring. That work demonstrated that the wall had been built up from ground level and that the slipping of the soil onto it was much later in date.

Pl.25: The Solar (Building A2) from the south-west during the restoration work.

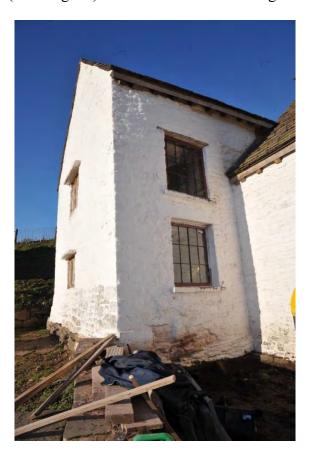
Pl.26: The south-eastern corner of the Solar during the restoration work.

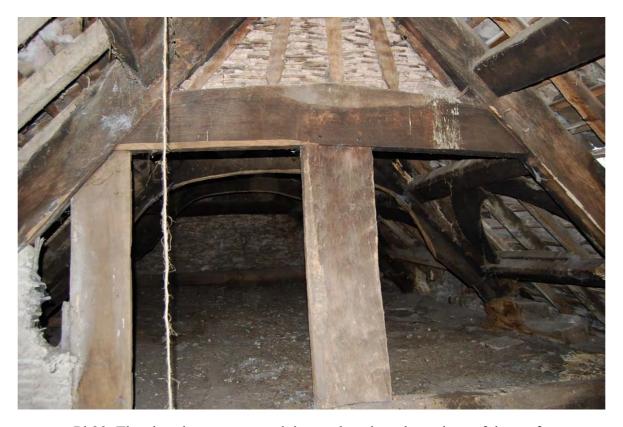
Pl.29: The closed truss separated the south and north portions of the roof.

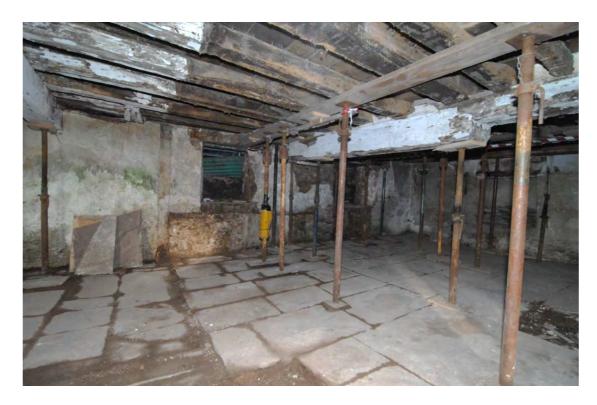
Pl.30: View of the ground-floor of the Solar, looking north-west, after initial strip-out; the large beam to the right forms the remains of the original cross-frame.

In the restoration the original room parameters – of two spaces separated by a timber cross-frame with a single doorway at the eastern end – were restored and the inserted partition and small inserted lobby were both removed. Blocked windows were also re-opened.

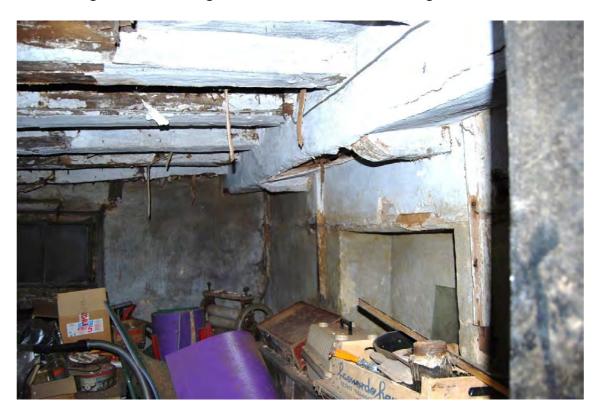
Pl.31: The north end of the ground floor in 2009; note corbel-supported end beam supporting the axial floor joists and blocked window.

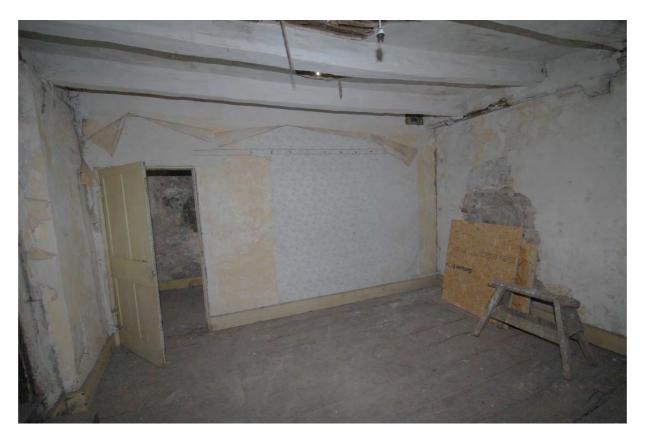
Pl.32: South part of first-floor of Solar looking towards the inserted partition, now removed.

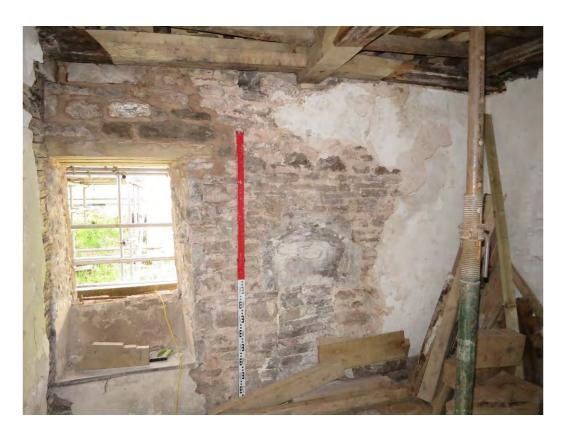
Pl.35: Inner face of the west wall of the north first-floor room of the Solar, showing inserted window and blocked inserted fireplace.

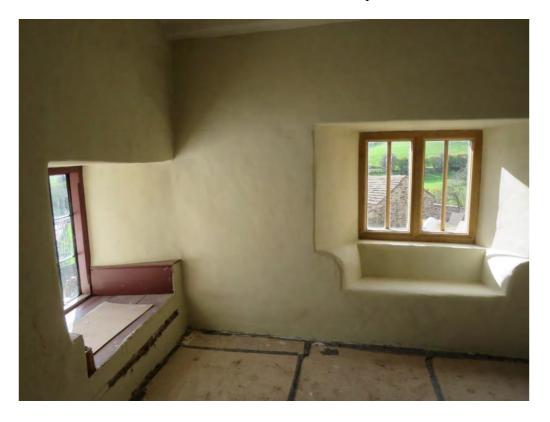
Pl.36: The southern first-floor room of the Solar as restored, with gable window renewed.

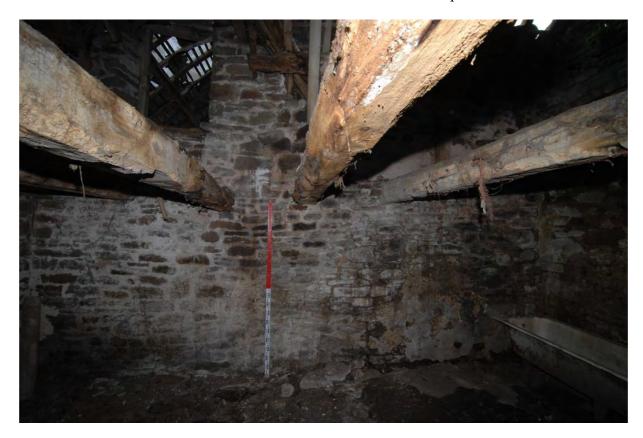
Pl.48: The inner face of the south side wall of the Cider House in 2013.

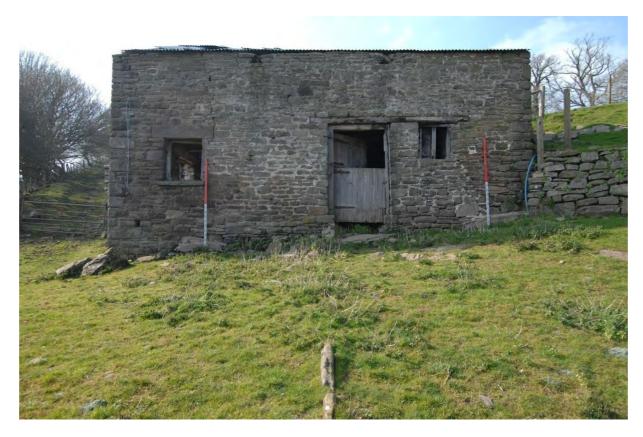
It was considerably altered in the later-20th century by the father of the present owners of the property when the original roof was removed and replaced by a monopitched one. As part of the restoration work, the profile of the earlier roof has been restored.

Pl.50: The front, or east, elevation of the Stable (Building E) prior to restoration.

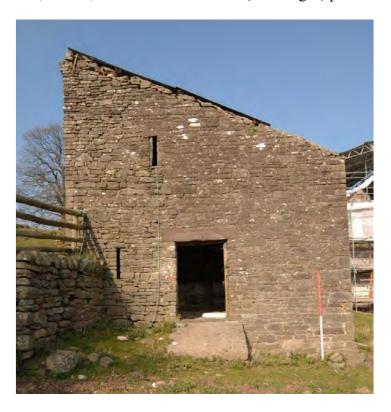
In the south gable wall is a ground- floor doorway towards the right-hand end with a well worked stone lintel – like that of the window at the south end of the east wall - and a narrow loop to the west of it; there is a second loop at first-floor level.

Pl.51: The south gable of the Stable prior to restoration.

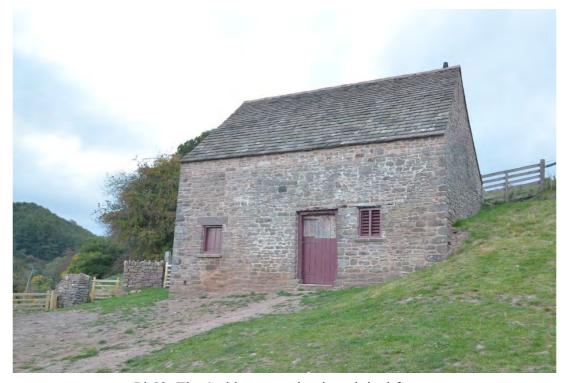
Pl.52: The Stable restored to its original form.

The roof is again plain gabled, its profile based on the visible evidence left when the earlier roof was reduced in height and replaced by a shallow monopitch in the later-20th century.

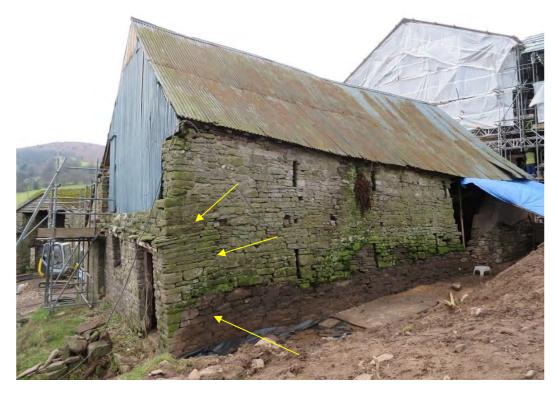
The wall had been suffering from instability for many years and was in imminent danger of collapse – so much so that much of it had to be carefully taken down and rebuilt as part of the restoration project.

Pl.53: The north-east corner of the Beast House (Building F); note how the coursing changes to the left of the arrows, suggesting the gable has been rebuilt.

The potential discrepancy in dates could be explained by the evidence suggesting that the east gable end was rebuilt. This may well have been for structural reasons and may account for the fact that it was either not rebuilt to its original full height in masonry – or it was found necessary to reduce the weight even after rebuilding.

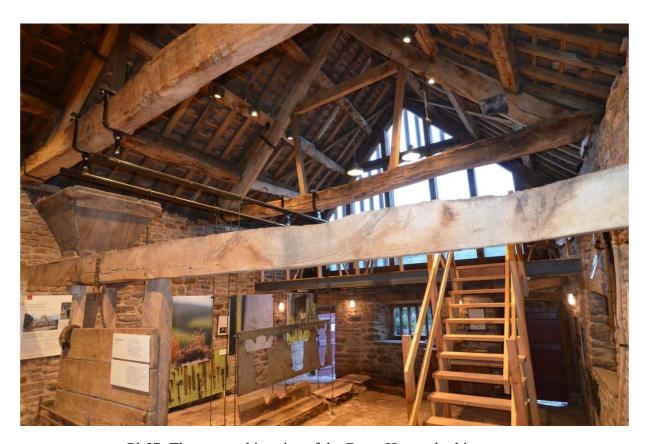
Pl.57: The restored interior of the Beast House, looking east.

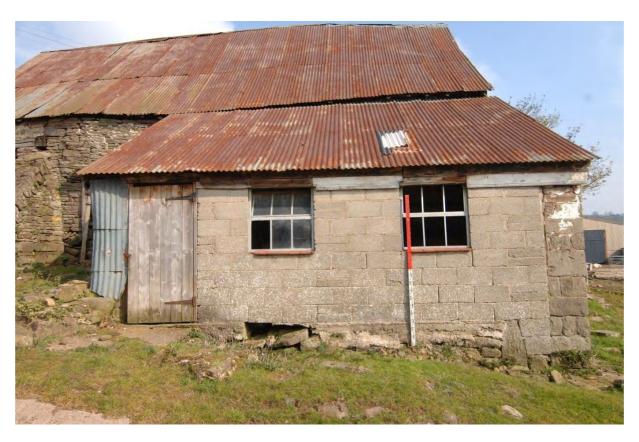
The roof was a simple lean-to covered structure, with rusting sheets of corrugated iron, pierced by a single roof light. However, the purlins supporting the corrugated sheeting had been added above two earlier waney purlins presumed to be associated with a lower roof since removed.

This was clearly a much-rebuilt structure that seems to have started as an open-fronted shelter shed. By the mid-20th century any arcaded opening has been infilled with timber match-boarding, as shown in old photographs of the site. That, in turn, has been replaced in concrete blockwork, leaving only the east gable masonry of the original build.

Pl.58: The south elevation of the Shelter Shed (Building G), 2016.

The building was not considered to be of any great significance and the proposals resulted in a radical rebuilding to meet the requirements of the site. During the works, an ephemeral timber frame was exposed at the western end once modern walling was removed on the inside of it and the corrugated sheeting on the exterior.
