**NORTH WEST WALES DENDROCHRONOLOGY PROJECT 2009-2012**  
**PROSIECT DENDROCHRONOLEG GOGLEDD ORLLEWIN CYMRU**

**Cwm Farm, Cwm Cynfal, Ffestiniog, Gwynedd**

**ARCHITECTURAL RECORD /COFNOD PENSARNIOL**

### Building Record

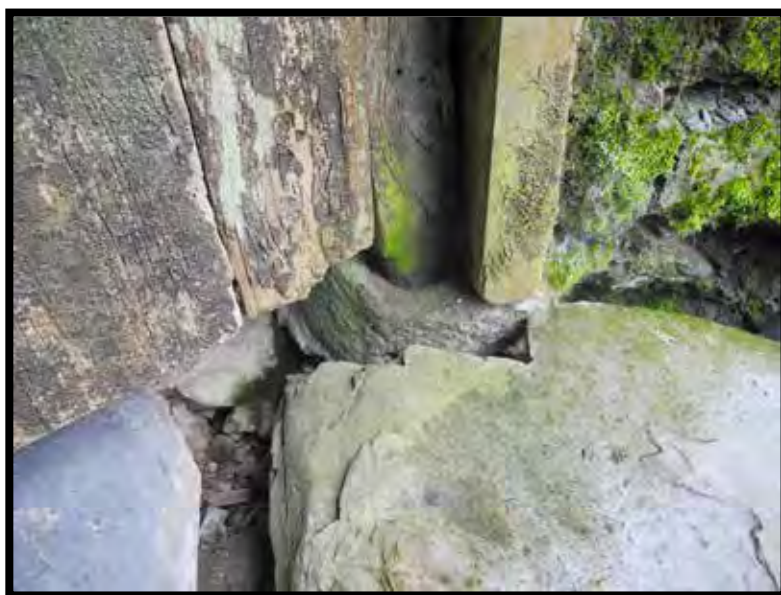
Plate 5: Harr Hung door & socket

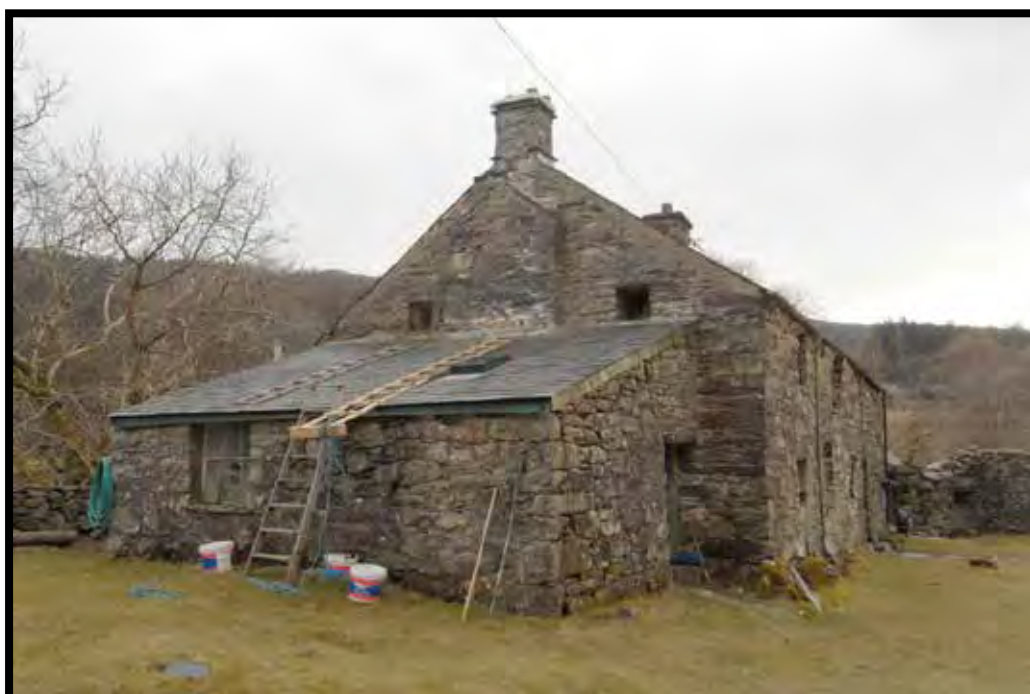
To the right are a ground floor window that lights the hall. The masonry has clearly been altered and reduced in size. (plate 09) Above this a small metal casement window has been inserted into the wall to eave level at a later date. Disturbed masonry and lintel of re-used timber. A small outshut with pitched roof has been added to the south-east corner of the building. A lean to single storey extension was added to the NE gable in the 19<sup>th</sup>C. This partially obscures the external chimney. Above the roof of this outshut are two small windows, original phase, either side of the chimney breast with modern oak casements (Plate 7)

Plate 7: NE gable; external breast & windows

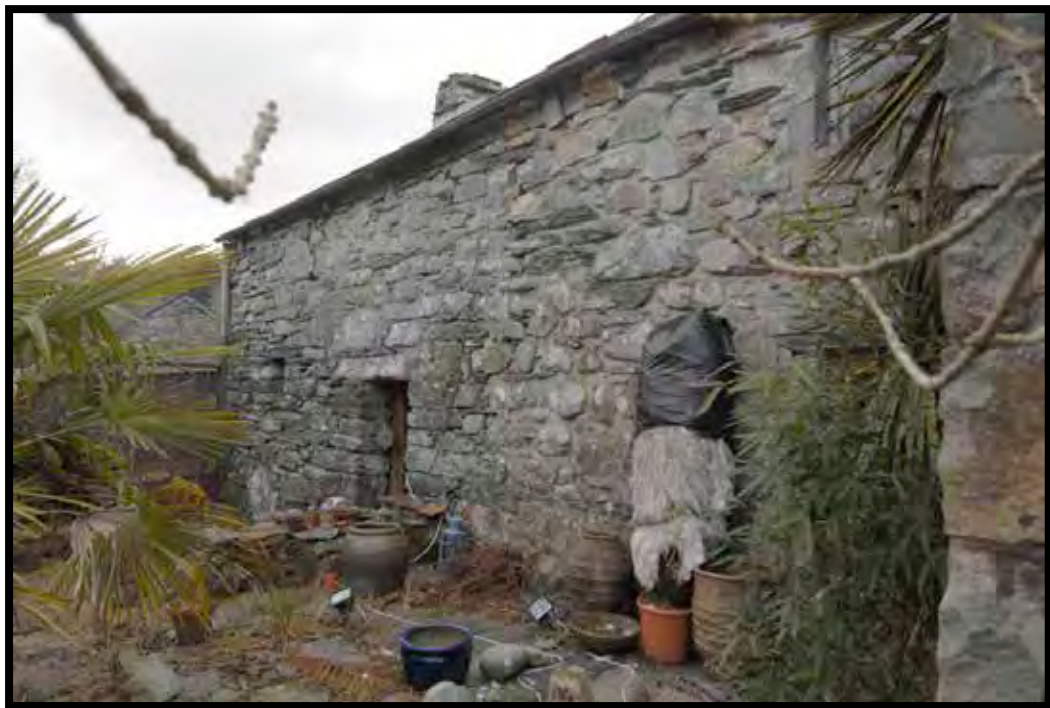
- 4.1.4 The southern elevation shows two alterations and changing window sizes. From the left hand gable facing the wall a small early mullion window lights what was the service room [GF2] (Plate 8). To its right the opposing cross passage doorway has a flat stone lintel and has no decorative features although it shares the chased rebates that are displayed on the 'front' doorway. This doorway had been converted, until recently, to a window, probably 19<sup>th</sup>C.

Plate 8: SW elevation

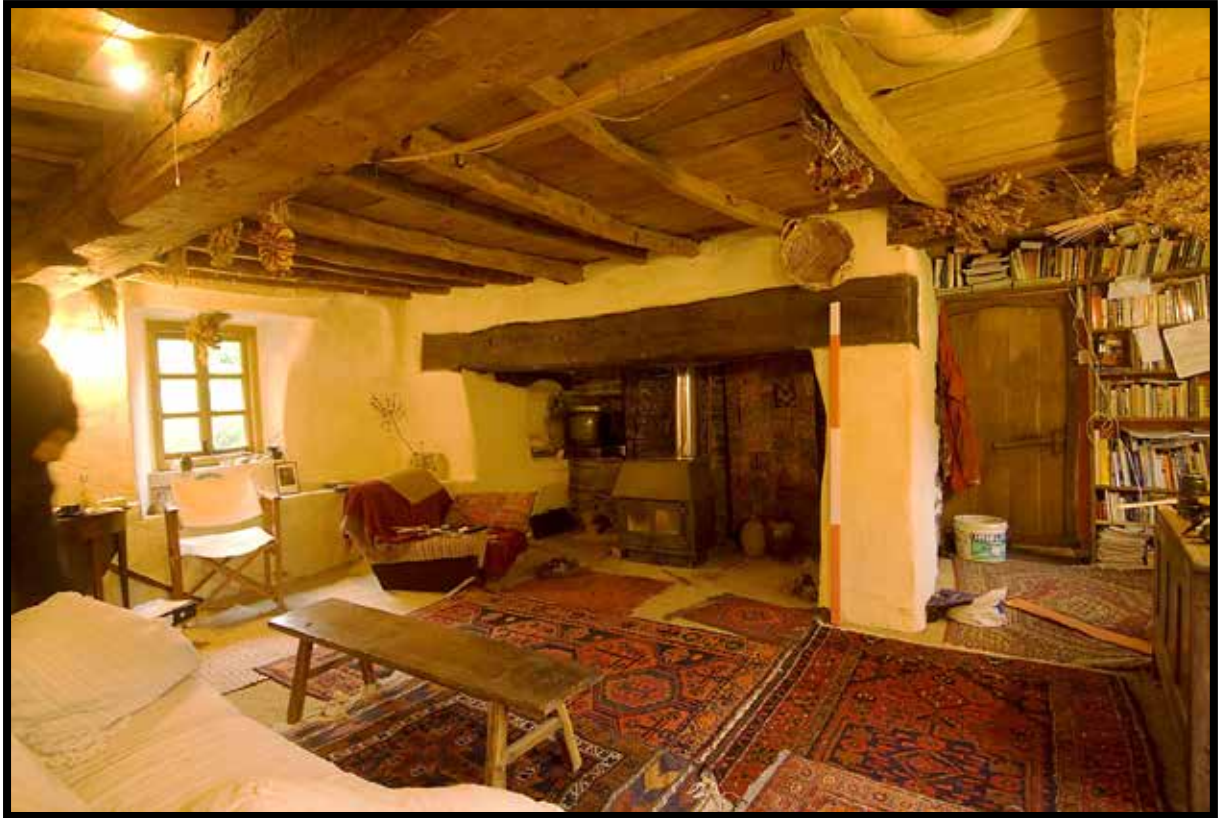
- 4.2.2 Room [GF3] (Plate 11) occupies the hall as floored over with inserted chimney. It is lit by two windows on NW wall. The northernmost with oak lintel (Plate 10) still exposed with mortises to house five mullions now gone. Modern oak casement windows now in situ. Opposite, on southern wall, is a further oak casement. Masonry changes on exterior show window reduced or altered at some time. (Plate 9)
- A fine dais partition to north-eastern end of room in almost complete condition. (Plate 12) (figures 8,9). It is not fixed to the wall at either end and does not retain outer doorposts but clearly had them. It has two shallow round arches formed out of the head beam at either end

Plate 11: Hall and inserted fireplace

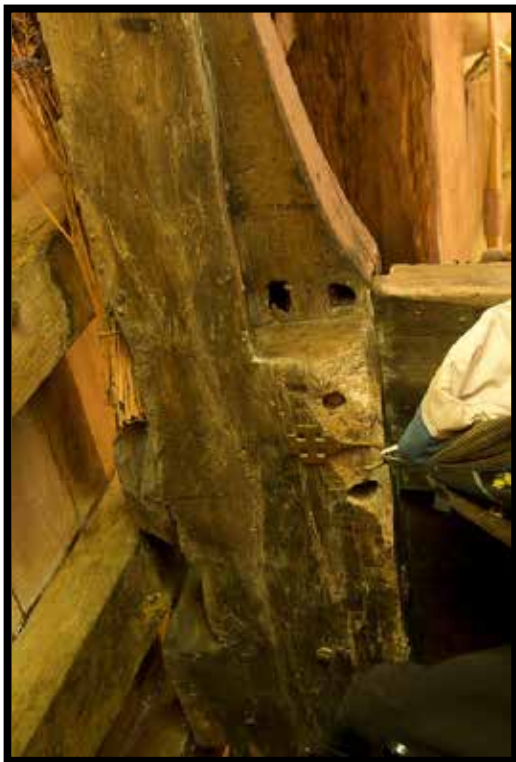
and is fitted with 6 posts and 5 planks/panels. The cill has been crudely truncated at the bottom (Plate 13-16) of the inner door posts of the screen to afford a more convenient circulation. The partition posts are decorated with a plain stopped chamfer while the head beam also has a chamfer interrupted by 'nailhead' bosses. (Plate 16) The head beam and the joists that formerly sat in the housings cut out of the top of the head beam do not now meet, being raised approximately 110mm to sit on later inserted pine beam.) These joists were originally pegged into the head beam and sailed on to meet the bottom of the partition that travelled down from the truss [T1] directly above. This formed a canopy of around 380mm. (Plate 17) A bench was fixed to the partition and is clearly indicated by an arrangement of mortises. The partition has been moved back slightly. The joists over the partitions are now seated into a large, pine beam, squared and chamfered. This beam also supports the widely spaced and rather crude joists of the later floor that divided hall into ground and first floor spaces, running from this beam to the inserted chimney stack.

Plate 13: Rear side of dais partition; door head L

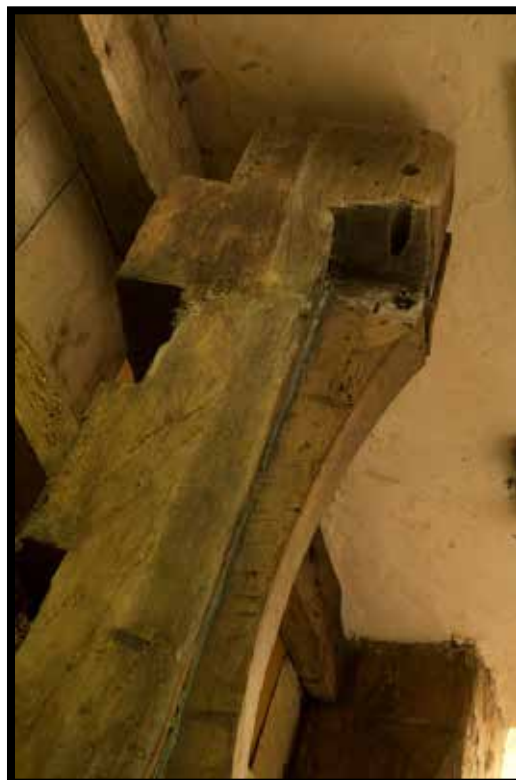
Plate 14: Rear side of dais – door head R

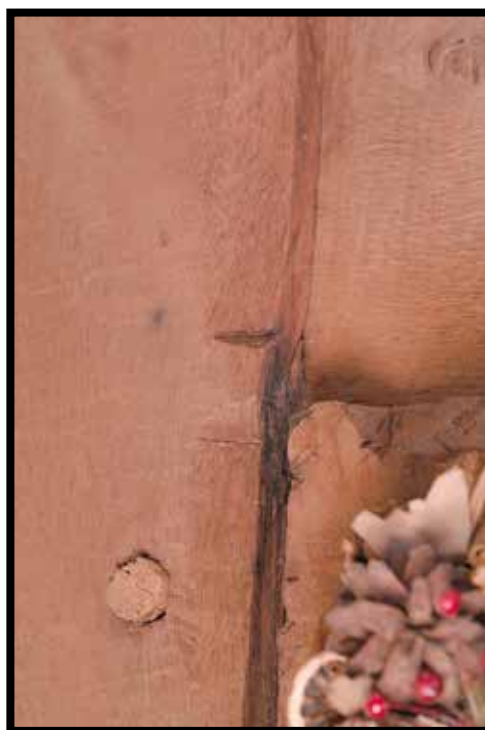
Plate 16: Screen detail – nailhead stop & chamfers

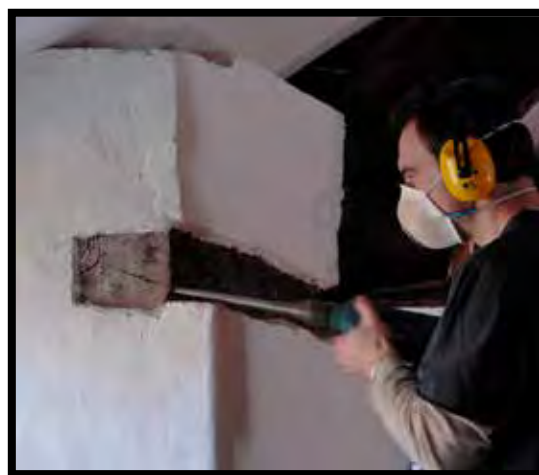
- 5.1.2 Eleven timbers were sampled. A wallplate NW retained complete sapwood and gave a felling date of **Summer 1523**. It is felt that this dates the trusses. Five of the PRs were cut from the same tree. One principal rafter, (T3 W) however, dated to the **winter of 1567/68** and may have been a repair. The head beam for the partition gave a date of **1533-5** and the second sample from the fireplace lintel, which had complete sapwood, dated similarly to **c1535**.

Plate 23: Matt Hurford sampling wall plate. Dated 1523.

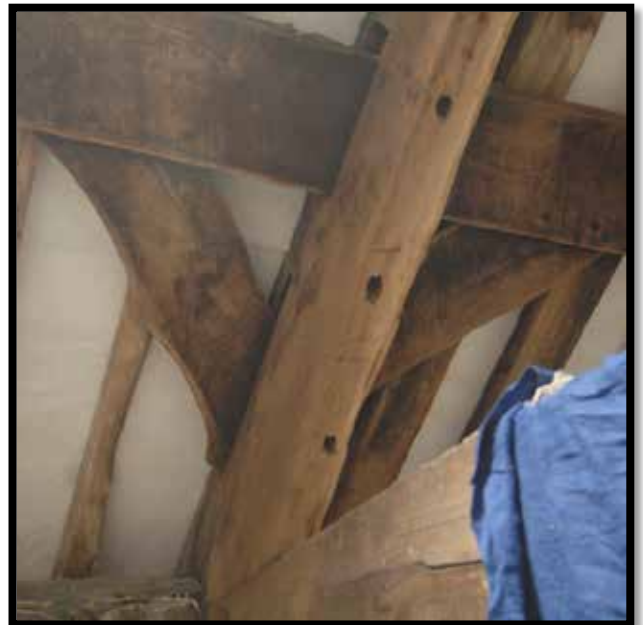
- 4.3.6 Room [FF7] has truss [T3]. Similar to [T1], with collar, post and tie beam but showing considerable signs of wear/ erosion and distortion. (Plates 28, 29) It is holed and grooved in the same way as [T1] for staves and wattle to form another closed screen to ground floor level. It is not clear whether a post and panel or a post and wattle screen dropped below the tie beam. The NW principal of [T3], has dated with dendrochronology, to a precise felling date of the winter of 1567/68. Given the context of the truss and rafters it is probable that this date is explained by a repair/replacement. The rafters have been removed and re-positioned with some replacements. Some rafters 127mm wide.

Plate 30: T3: wind braces and stave holes

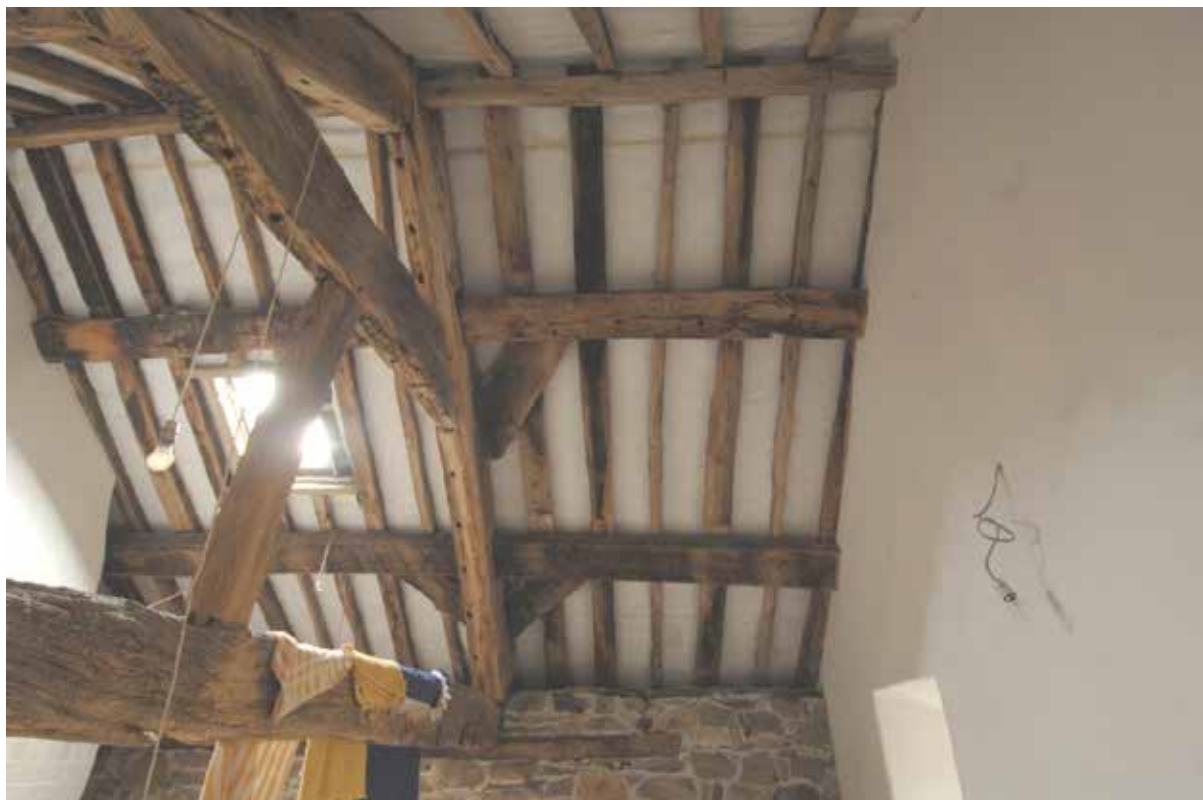
Plate 33: T3: rafters & wind braces
