WAUN HIR, CARMARTHENSHIRE: ARCHAEOLOGICAL EVALUATION

RHIF YR ADRODDIAD / REPORT NO. 2012/28
RHIF Y PROSIECT / PROJECT RECORD NO. 102768

Mawrth 2012
March 2012

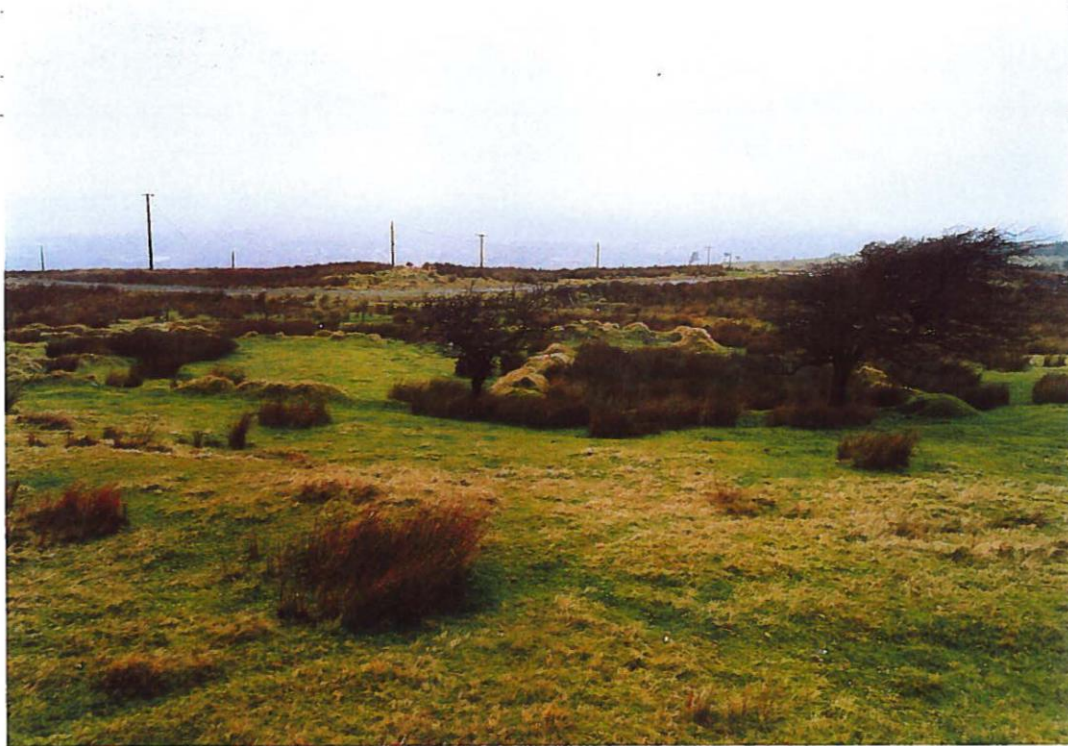
Photo 1: View of the site prior to any unauthorised excavation, facing NW. Photo taken from Cadw Scheduling description (Cm331) 2003.

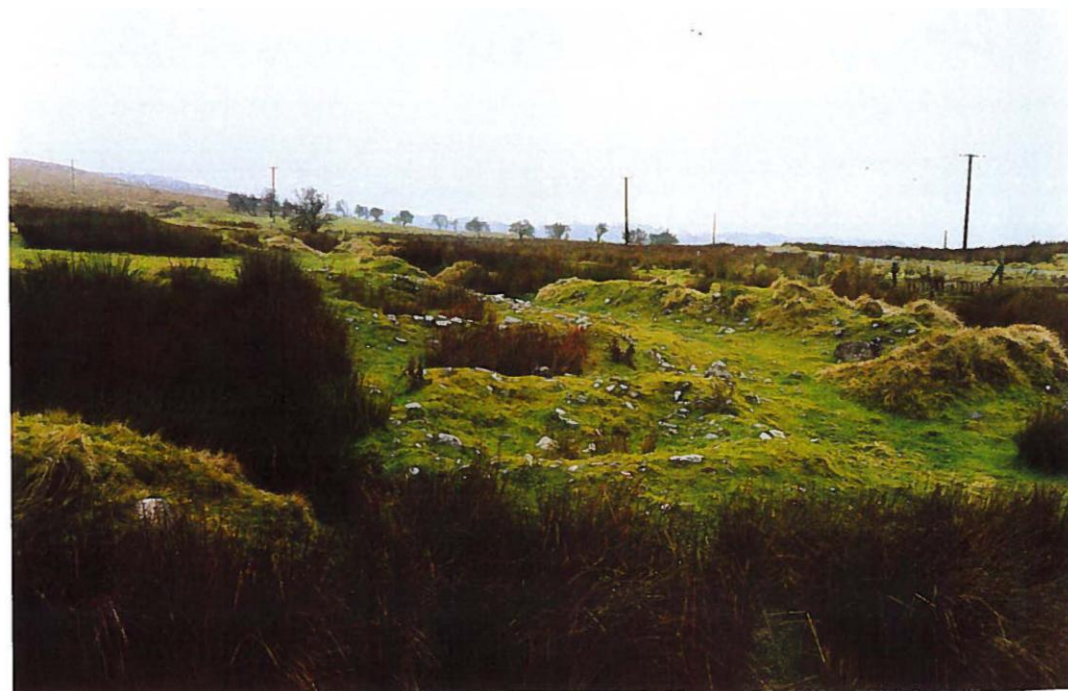
Photo 2: View of the building remains prior to any unauthorised excavation, facing SW. Photo taken from Cadw Scheduling description (Cm331) 2003.

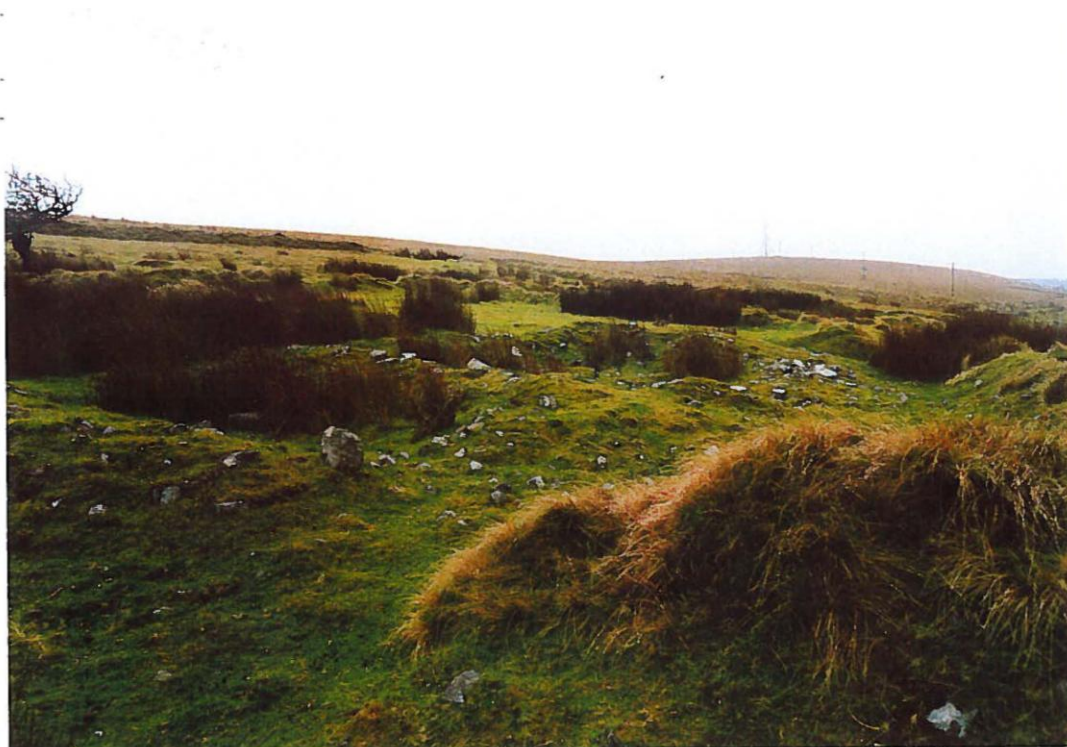
Photo 3: View of the building remains prior to any unauthorised excavation, facing S. Photo taken from Cadw Scheduling description (Cm331) 2003.

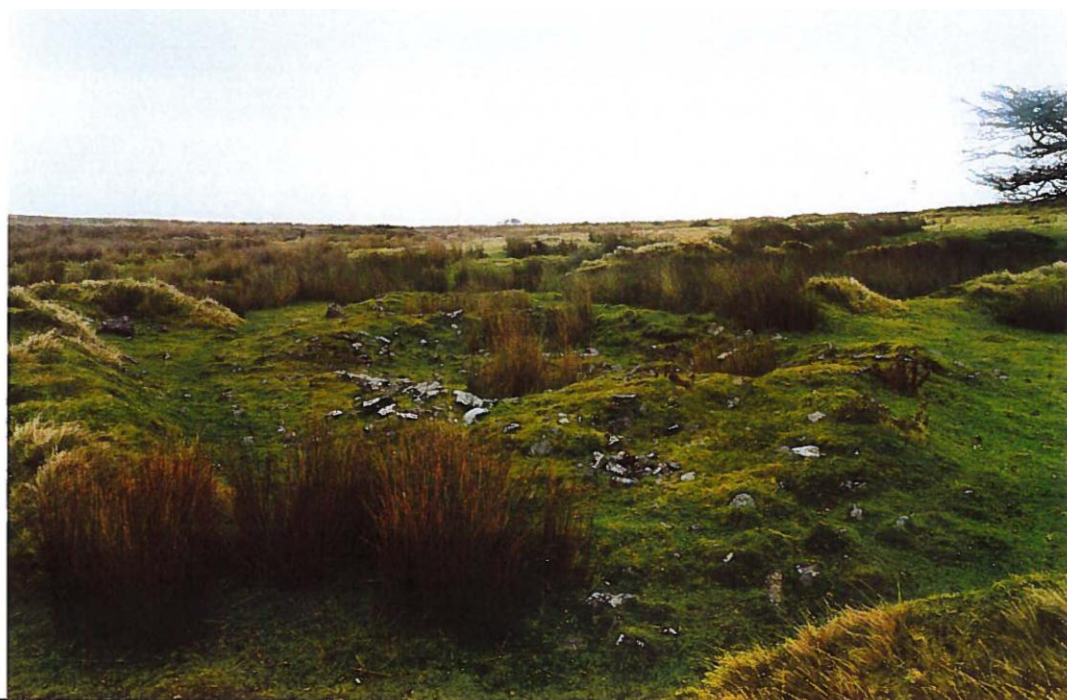
Photo 4: View of the building remains prior to any unauthorised excavation, facing NE. Photo taken from Cadw Scheduling description (Cm331) 2003.

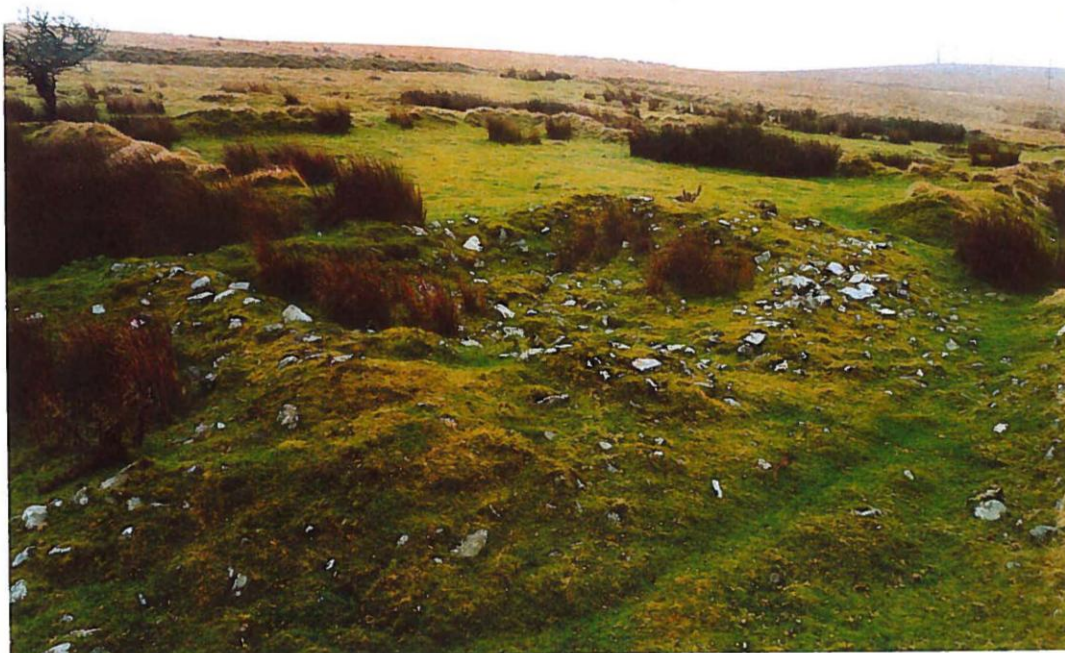
Photo 5: View of the building remains prior to any unauthorised excavation, facing S. Photo taken from Cadw Scheduling description (Cm331) 2003.

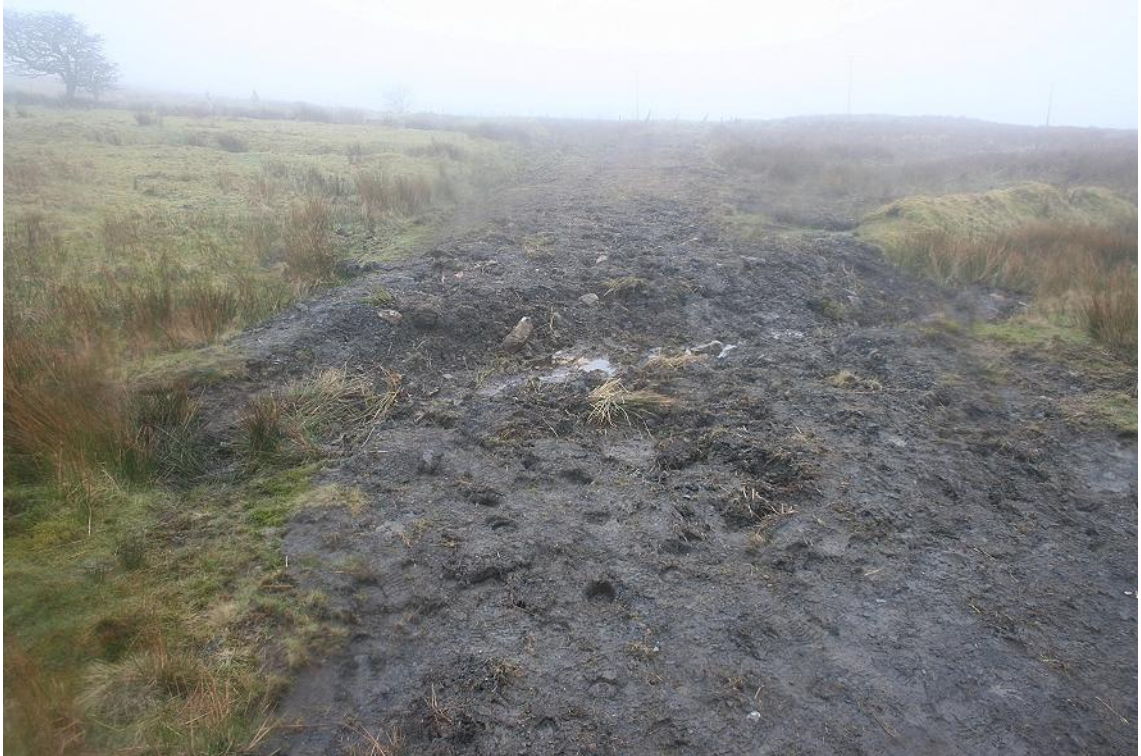
Photo 11: View down the modern trackway across site, facing SW.

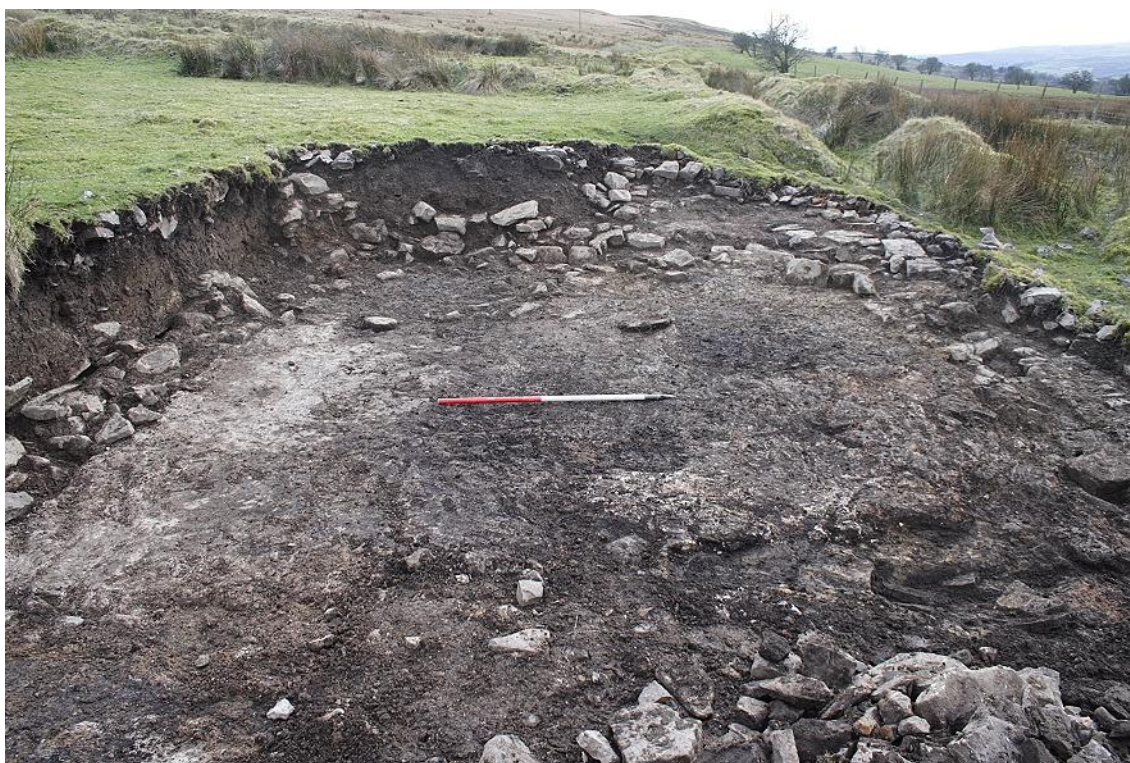
These walls enclosed a rectangular area 6.7m SW - NE by 3.9m NW - SE, with a rounded internal corner to the southeast. A straight linear feature 0.1m wide ran the width of this space that would appear to be the remains of a room partition, the width of the linear suggesting a timber partition. This is borne out by differences in the floor deposits on either side, with an area 4.6m wide to the southwest covered by a relatively well-preserved smooth mortar floor (photo 13), and an area 2m wide to the northeast with the partial remains of a rougher mortar floor (photo 18).

Photo 13: Mortar floor at the southwest end of the building. Facing SW, 1m scale.

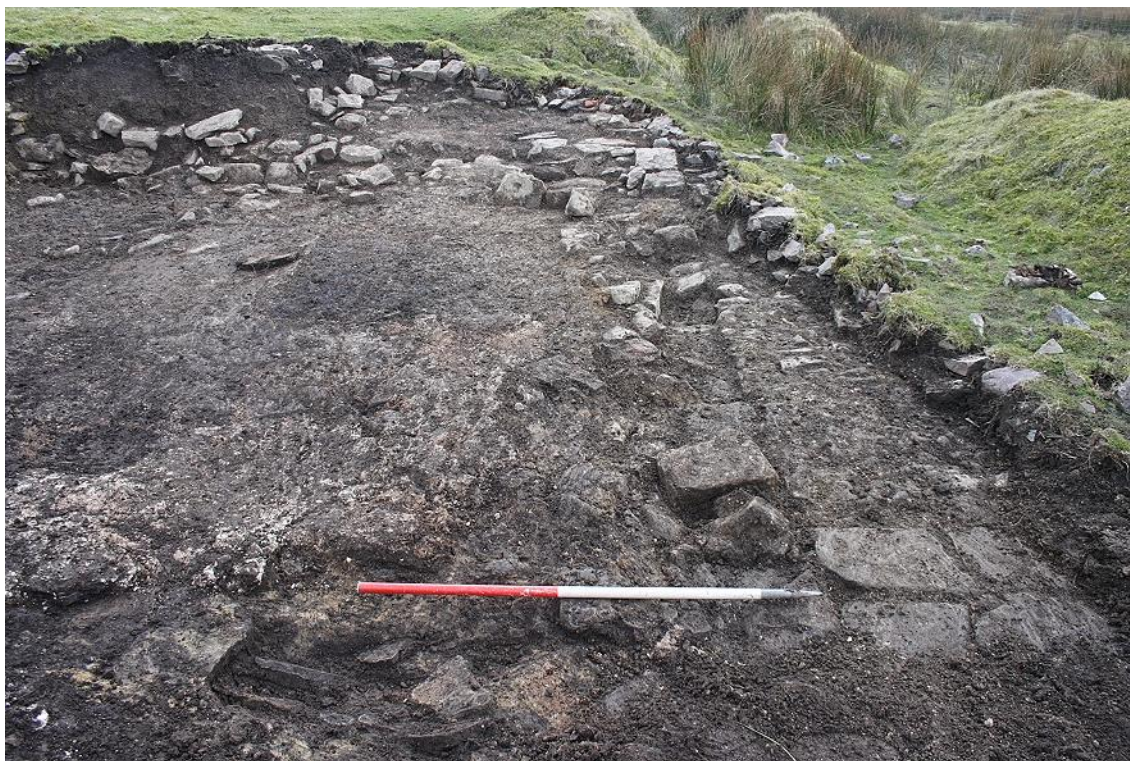
During the course of the project the surrounding field enclosures were also surveyed. In front of the main building, on its north-western side, stands a large bank parallel to the building, with a gap of c.3m between the two. This gap was partially uncovered in front of the main building (photo 15), where it was paved with cobbles. This changed to flagstones to the northeast, possibly in front the main entrance to the building and presumably also covering the point where the under-floor culverts emerge. There was also a step down of 0.08m roughly in line with the cross partition wall. This flagstone and cobbled area leads on to a sunken pathway that runs off to the southwest towards the well (photo 35), as marked on the 1st edition Ordnance Survey map of 1878 (Figure 3).

Photo 15: Looking down the north-western wall line, with the mortar floor to the left, and cobbled exterior to the right. Facing SW, 1m scale.

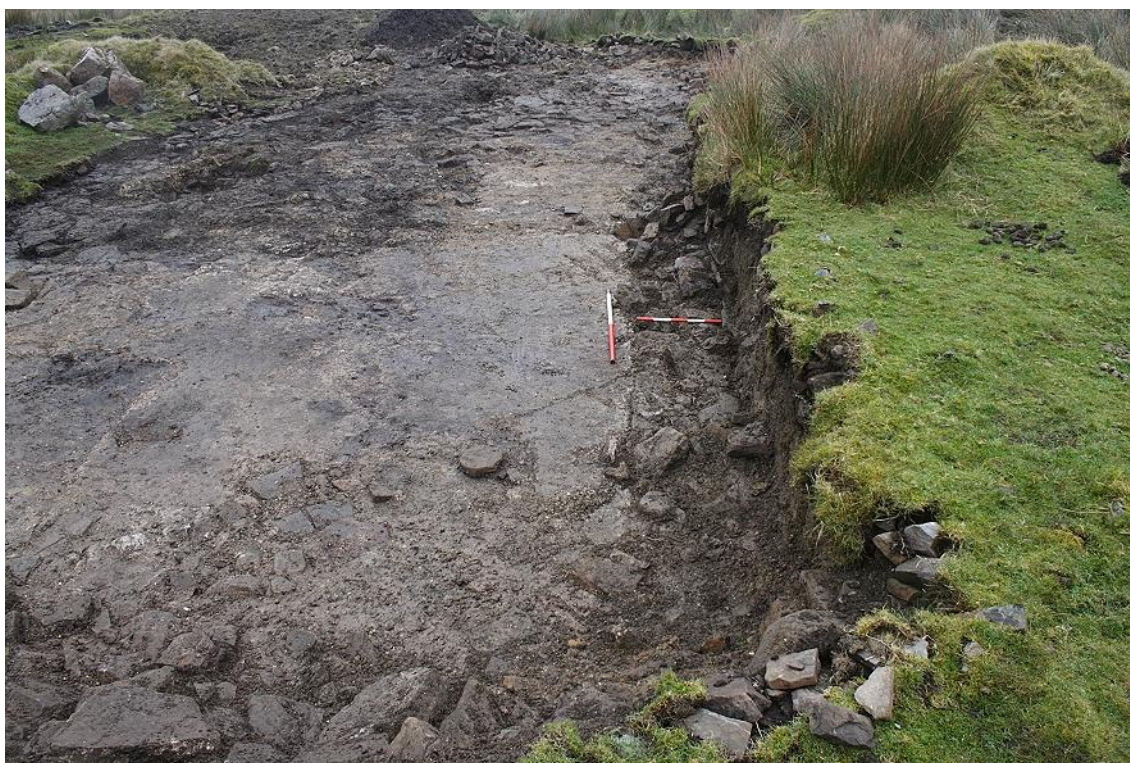
Photo 16: Looking down the south-eastern wall line, with the mortar floor to the left. Facing NE, 1m & 0.5m scale.

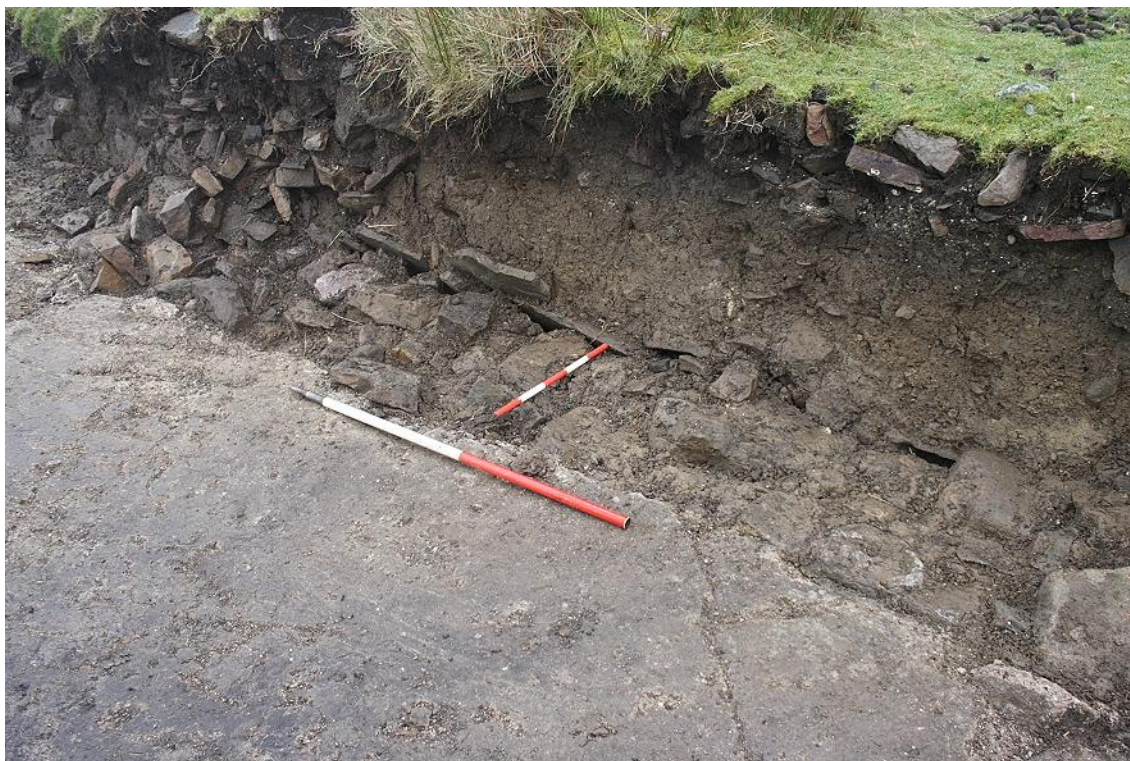
width of this room. However, where it has been removed it has revealed the remains of a stone-lined and capped culvert running underneath the floor (photo 18). This culvert, 0.35m wide, runs SE – NW before curving round to the west, to run out under the outer wall of the building, roughly at the point where the presumed entrance is. Close to this point a second culvert is just visible running underneath the floor of the southwestern room to exit under the wall at the point of the presumed entrance. Both culverts are presumably also linked to the stone-capped drain visible running along the outside of the south-eastern wall (photo 17), helping to drain water running off the higher ground to the southeast.

Photo 17: Looking at the north-eastern wall, remains of the stone-flag covering of an external drainage culvert is visible at the base of the section along the outside of the wall. Facing E, 1m & 0.5m scale.

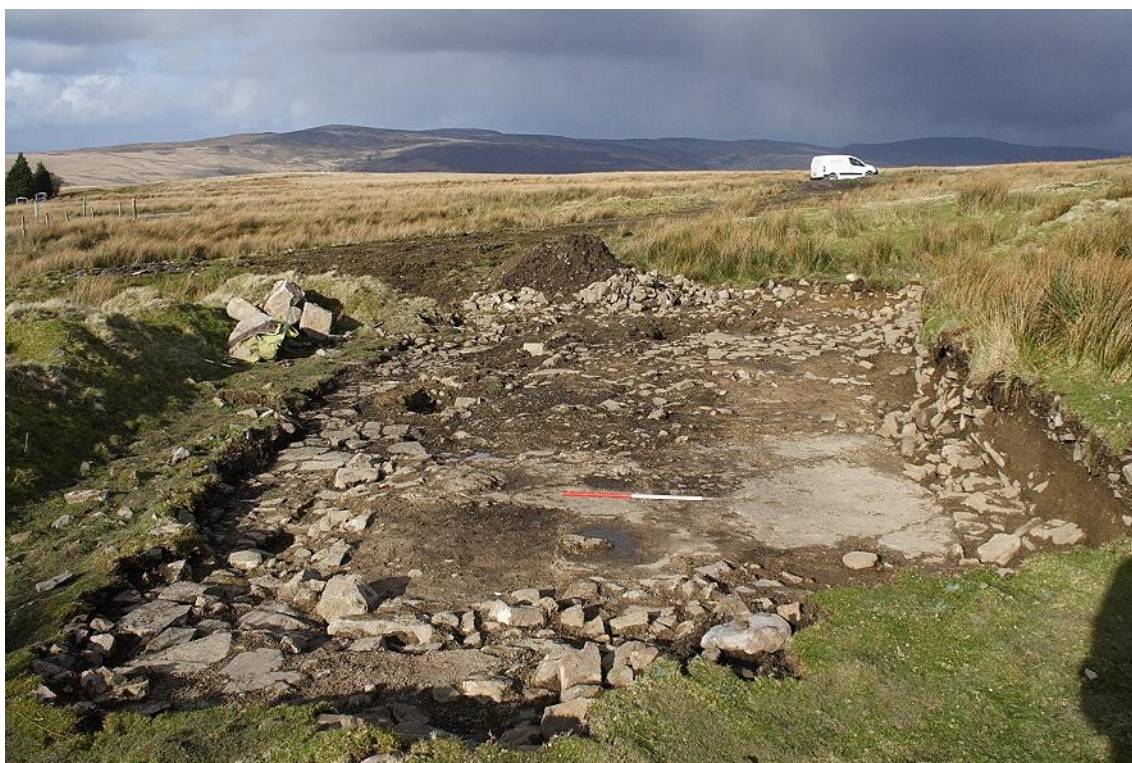
Photo 30: General view of site after archaeological clearance. Facing NE, 1m scale.

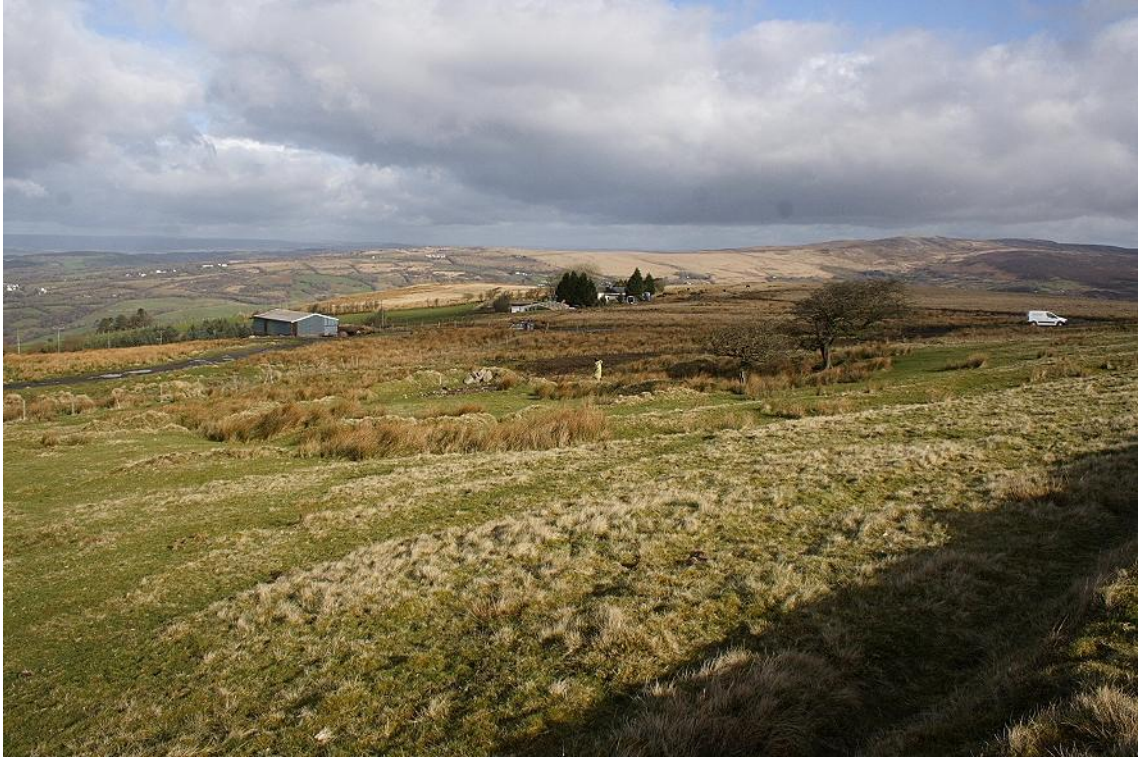
Photo 31: General view across the Scheduled area, facing N.

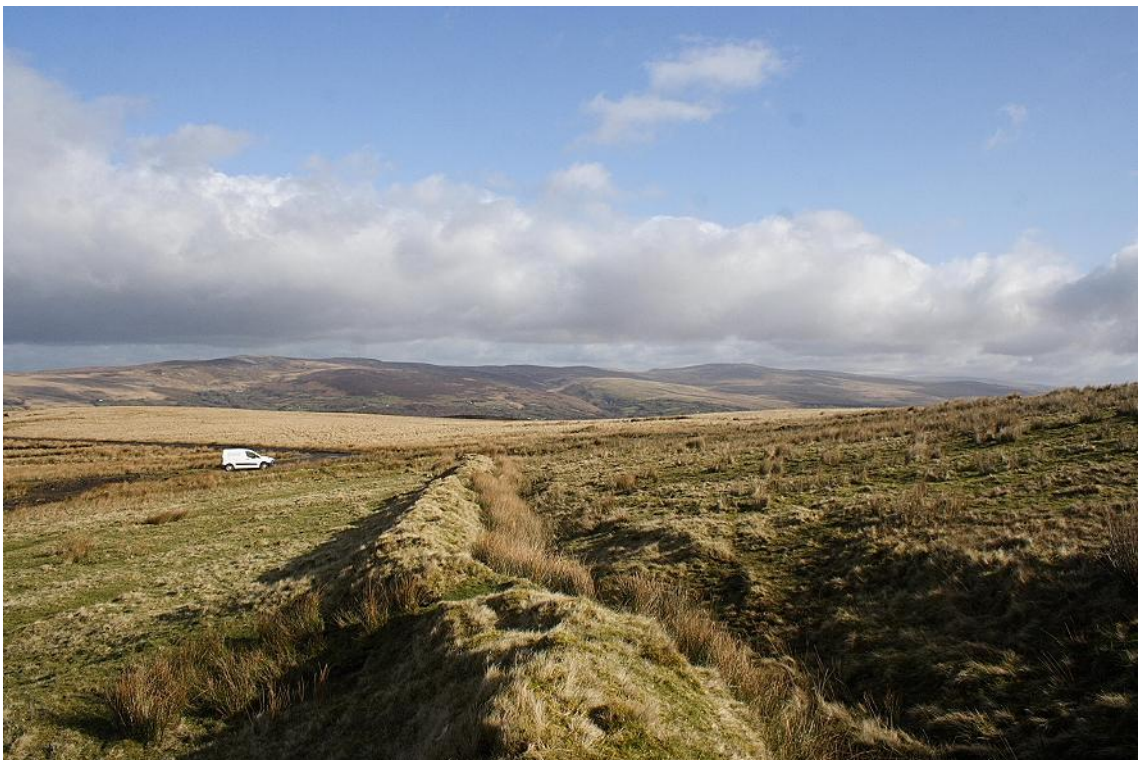
Photo 32: View along the outer field bank to the east, with common land to the right. The kink in the bank is visible, where the possible trackway meets it. Facing NE

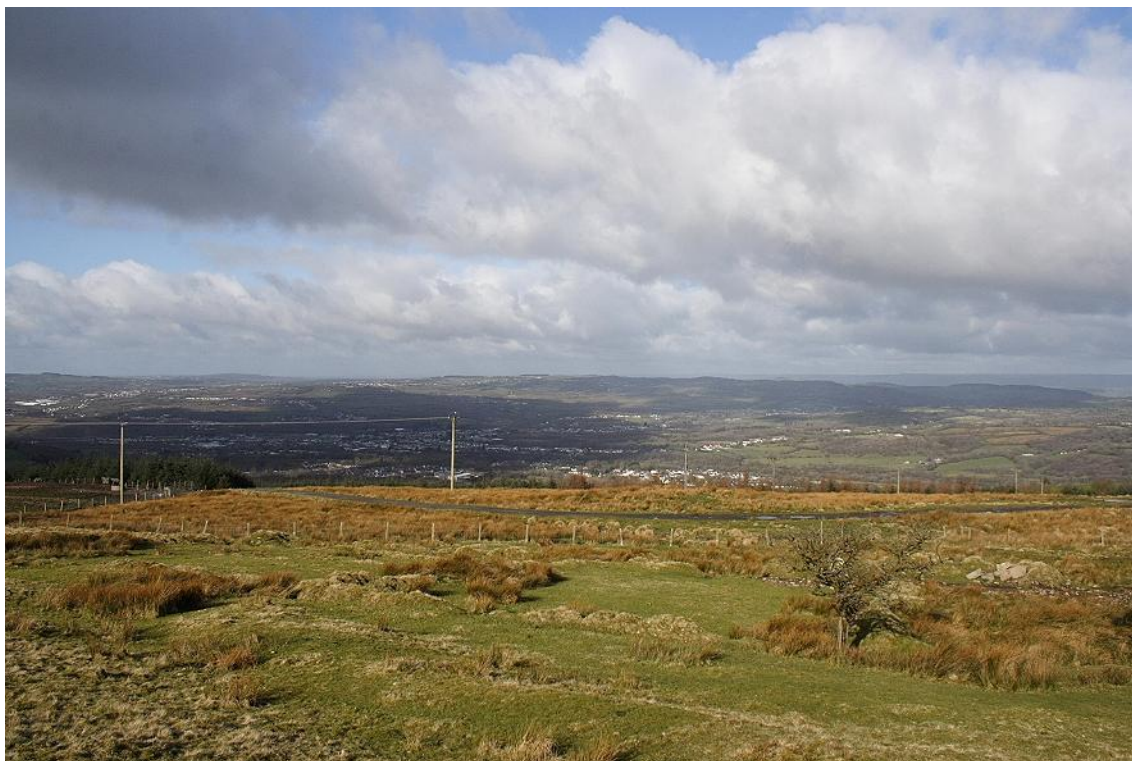
Photo 33: General view across the Scheduled Area towards Ammanford, facing W.

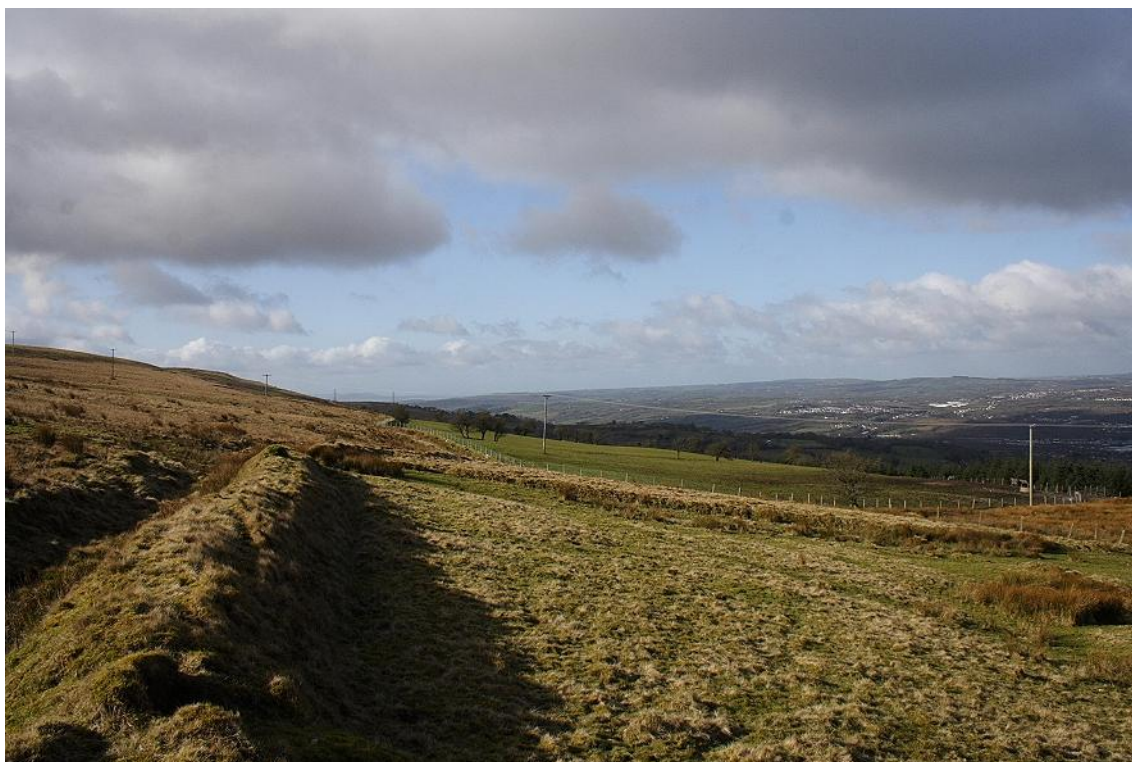
Photo 34: View along the outer field bank, facing SW.

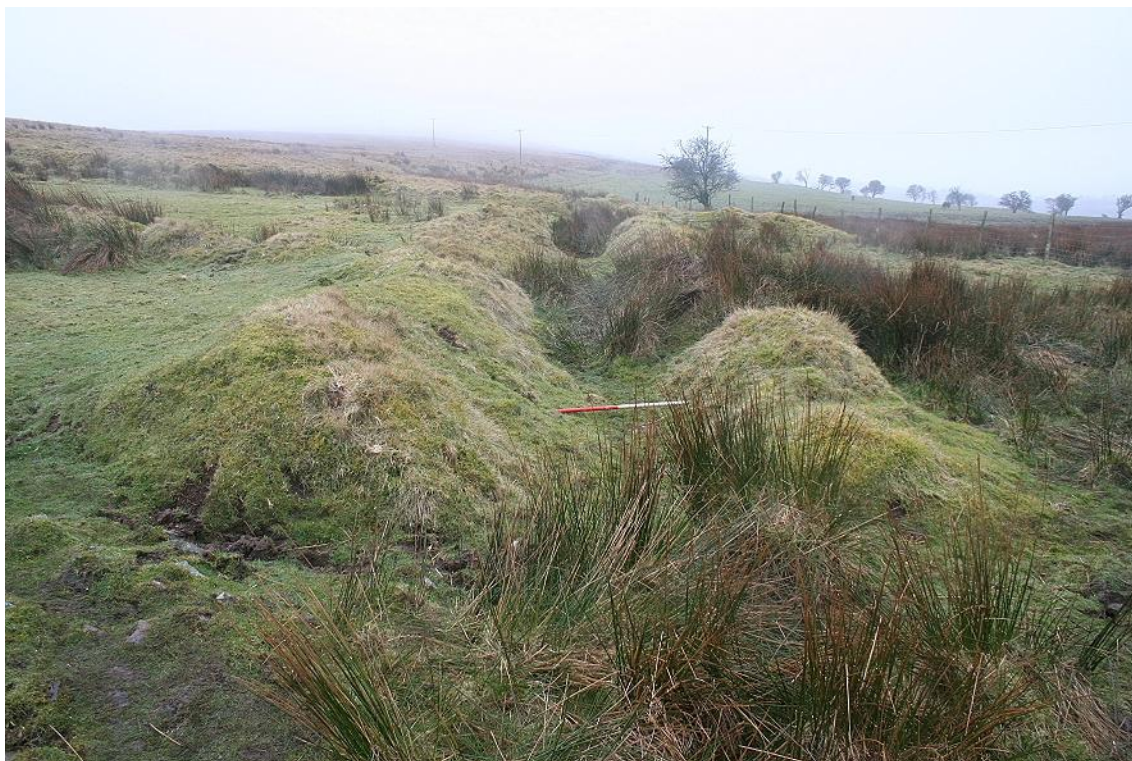
Photo 35: View from the main building along the sunken path towards the well (roughly where the tree stands in the middle distance). Facing SW, 1m scale.

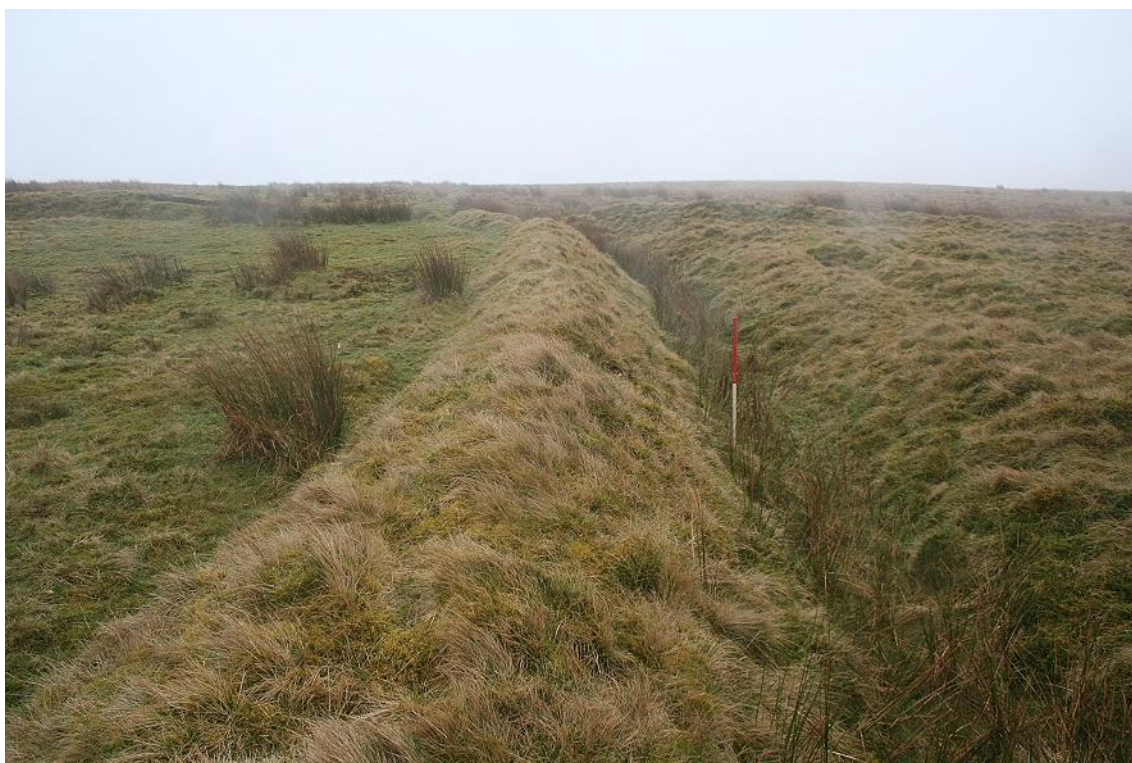
Photo 36: Looking along the outer field bank to the south, showing the bank and external ditch. Facing ENE, 1m scale.
