Gatewen Colliery, Moss Wrexham.

Archaeological Evaluation

Report No. 542

**Gatewen Colliery, Moss
Wrexham**

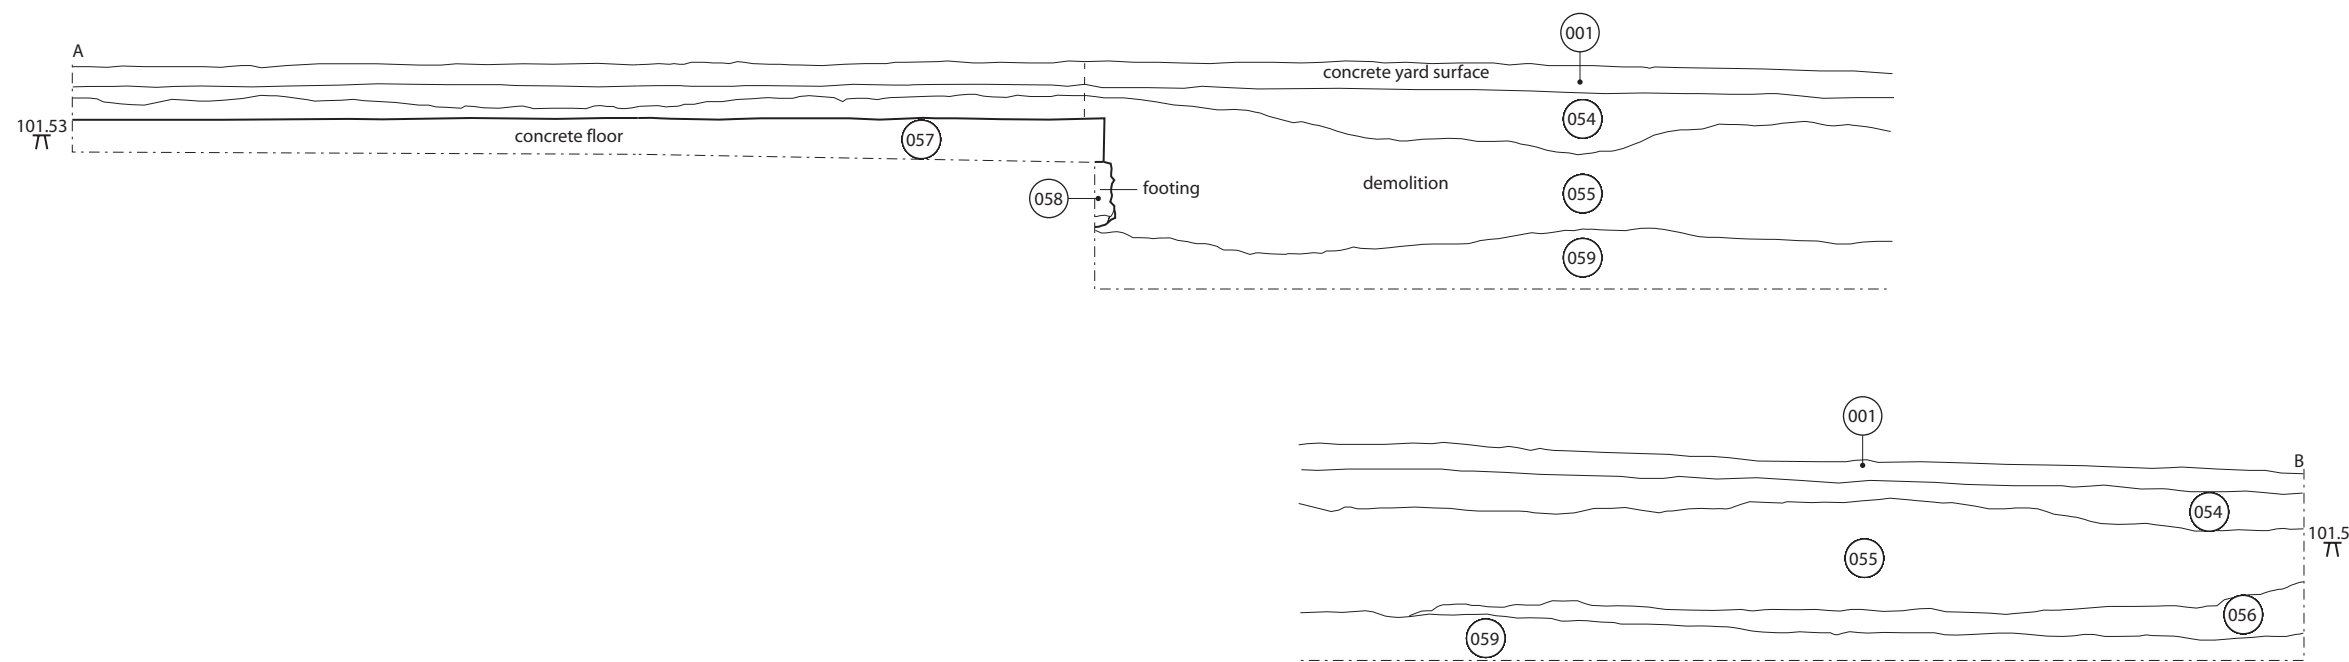
Figure 5

Drawing Title: Trench 1

Trench 1 (Fig.5) (Plate 1) Fan Drift

4.3.1 After the removal of the concrete and tarmac surface (001) the trench was excavated in spits. The layer below the surface was an orangey grey layer with an average depth of 0.30m containing large amounts of crushed brick (054) used for the general levelling of the ground before the laying of the concrete surface. The layer below (054) was a large deposit of demolition material (055) containing broken brick and mortar with a maximum depth of 0.60m. There was a narrow band of sandy clay below the demolition which seemed to be natural (056), below which was a greyish brown silty sand natural (059). These deposits were also located in other parts of the site.

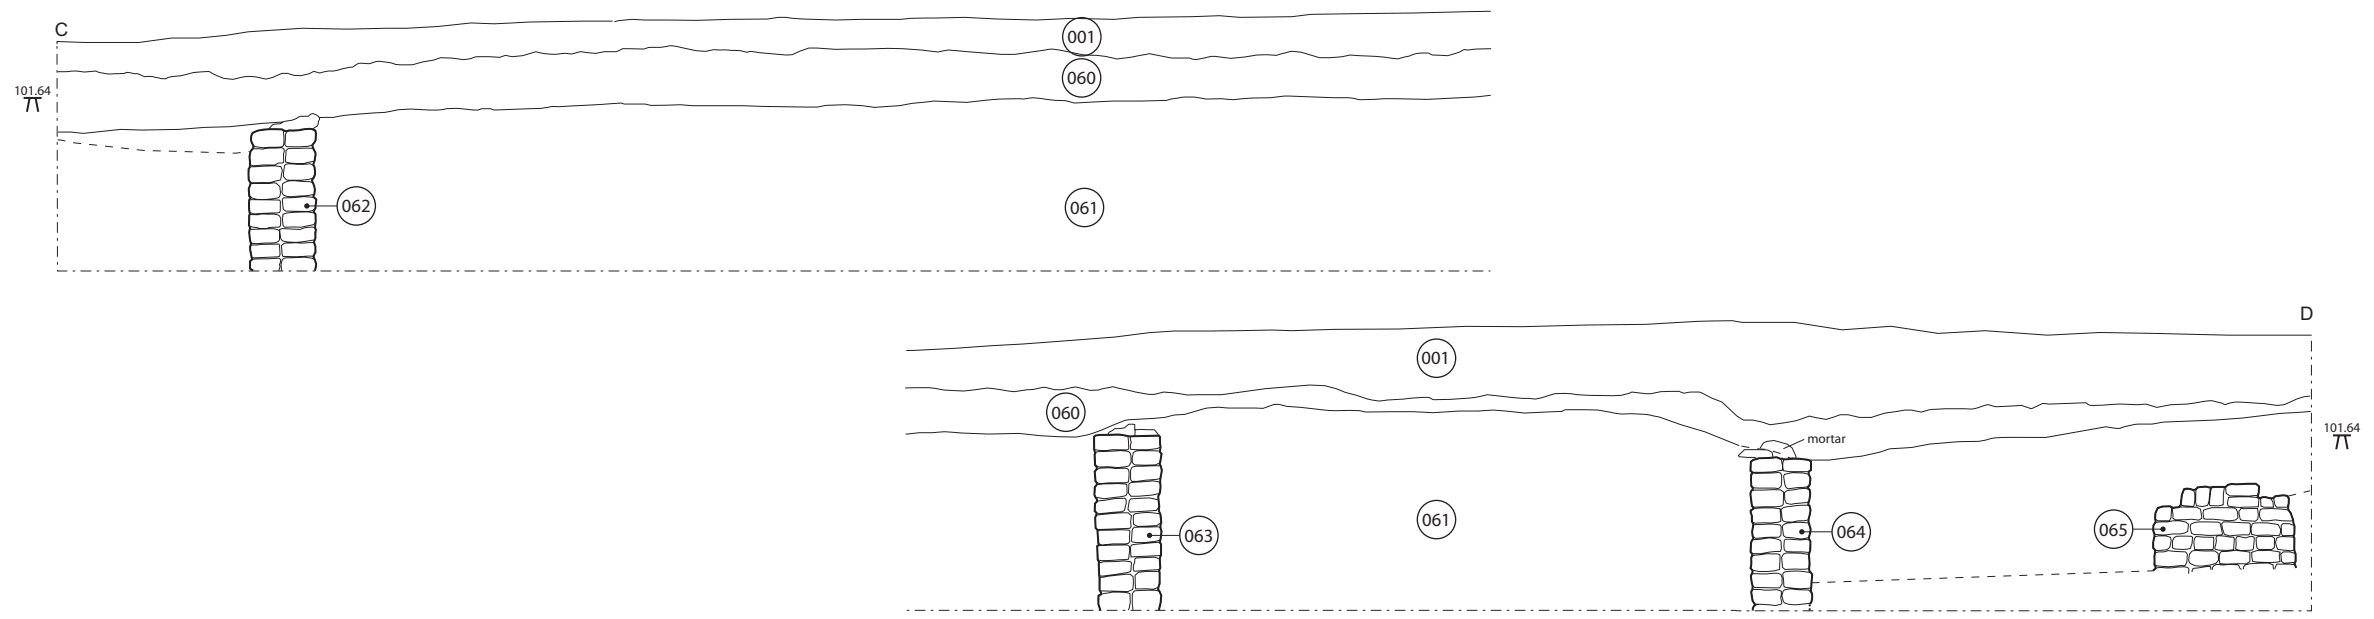
Figure 6

Job Title:	Gatewen Colliery
Drawing Title:	Trench 2
Date:	21/11/2008
Drawn By:	I L Bernardus
Scale:	1:40 @ A3

Trench 2 (Fig.6) (Plates 3+4) Fan and Compressor House

4.3.2 The concrete (001) was removed in this trench to again reveal a crushed brick levelling layer similar to Trench 1 with an average depth of 0.36m (060). After the removal of (060), three brick walls were initially revealed running in a North-South direction. Surrounding these was demolition material very similar to that found in Trench 1, although in this trench the layer contained far more building material, mainly brick (061). This material was excavated for a further 1.50m. With the total depth of the trench now over 2.20m below ground surface, it was decided to cease excavation on safety grounds. The height of the walls at this depth was 1.80m with the demolition material continuing between wall (062) to the East of the trench and wall (063), which was near the centre. Between (063) and wall (064) c.5m to the West the appearance of water within the demolition material at a depth of 1.50m below the surface suggested that there may be a channel or drain within the walls at this point. All the aforementioned walls were 0.38m in width and would have been interior walls within the Fan and Compressor House.

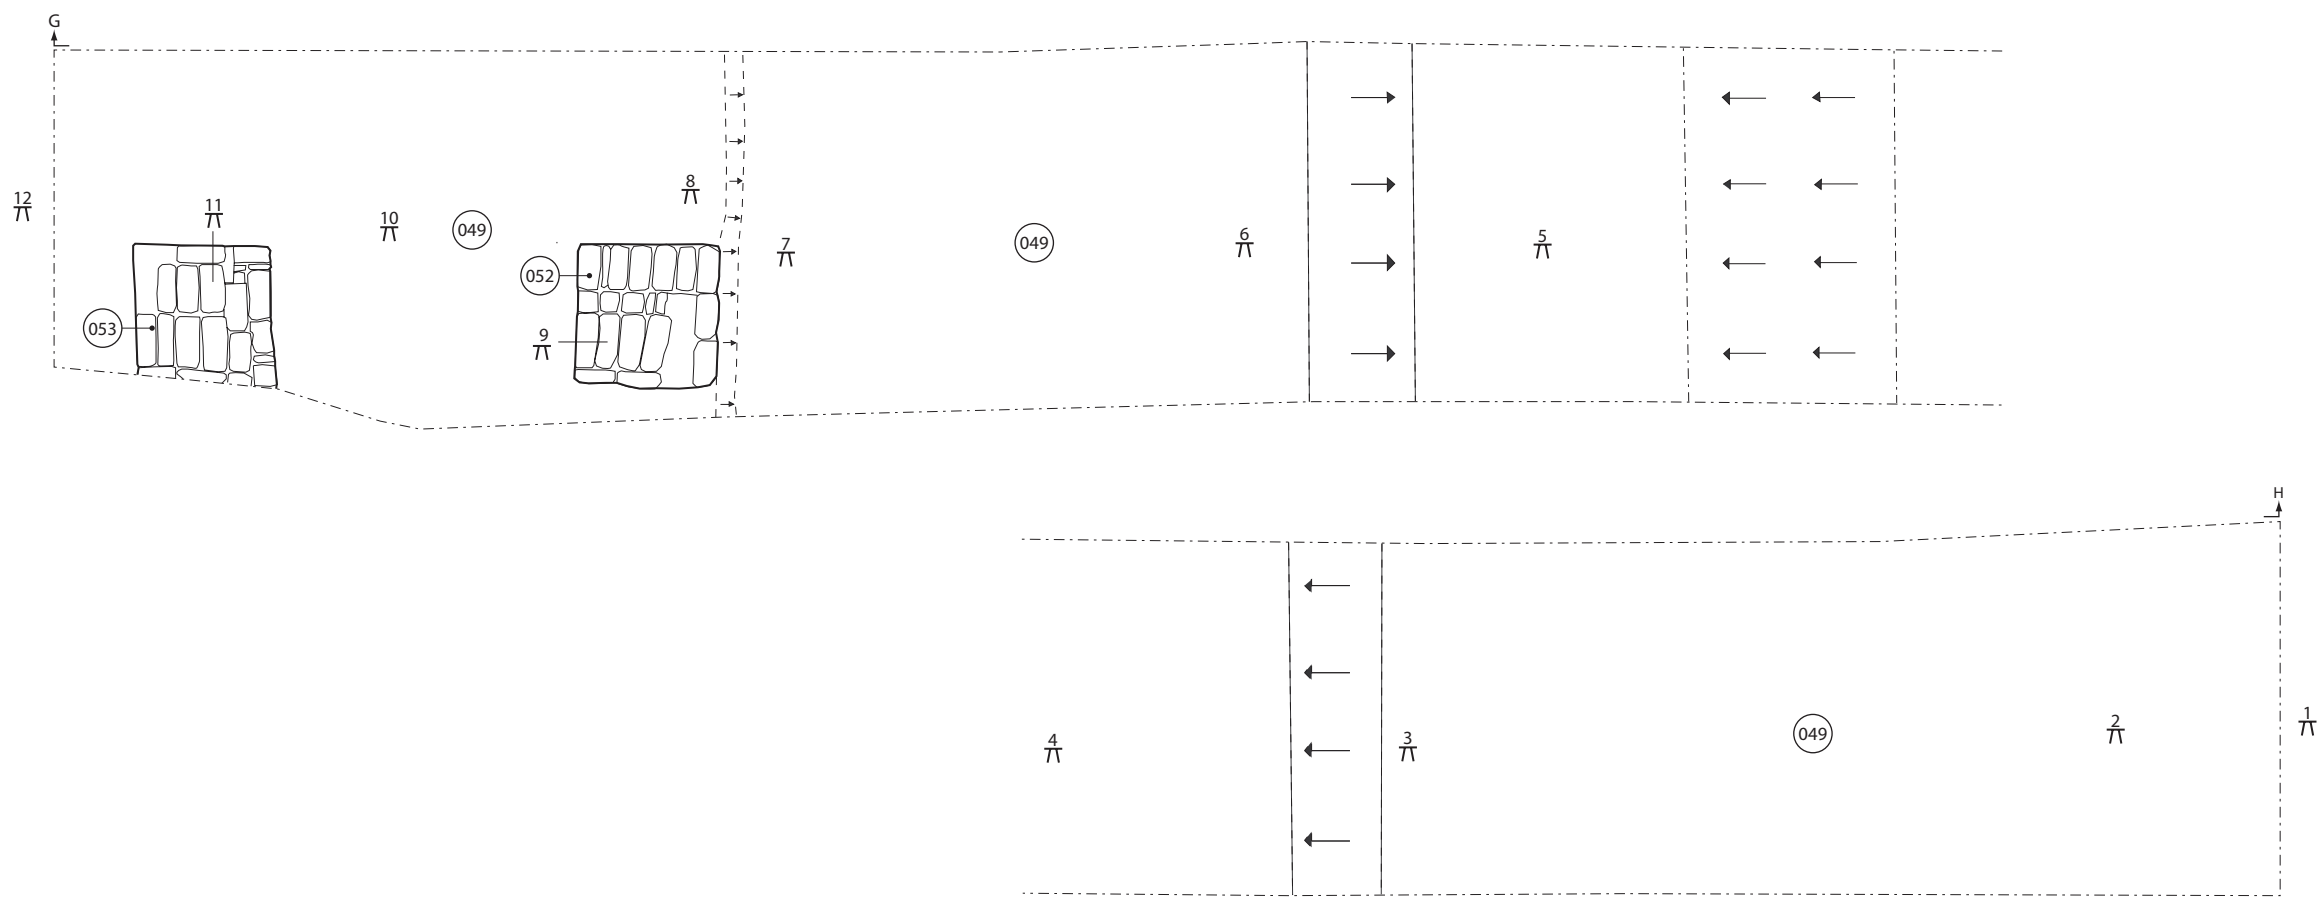
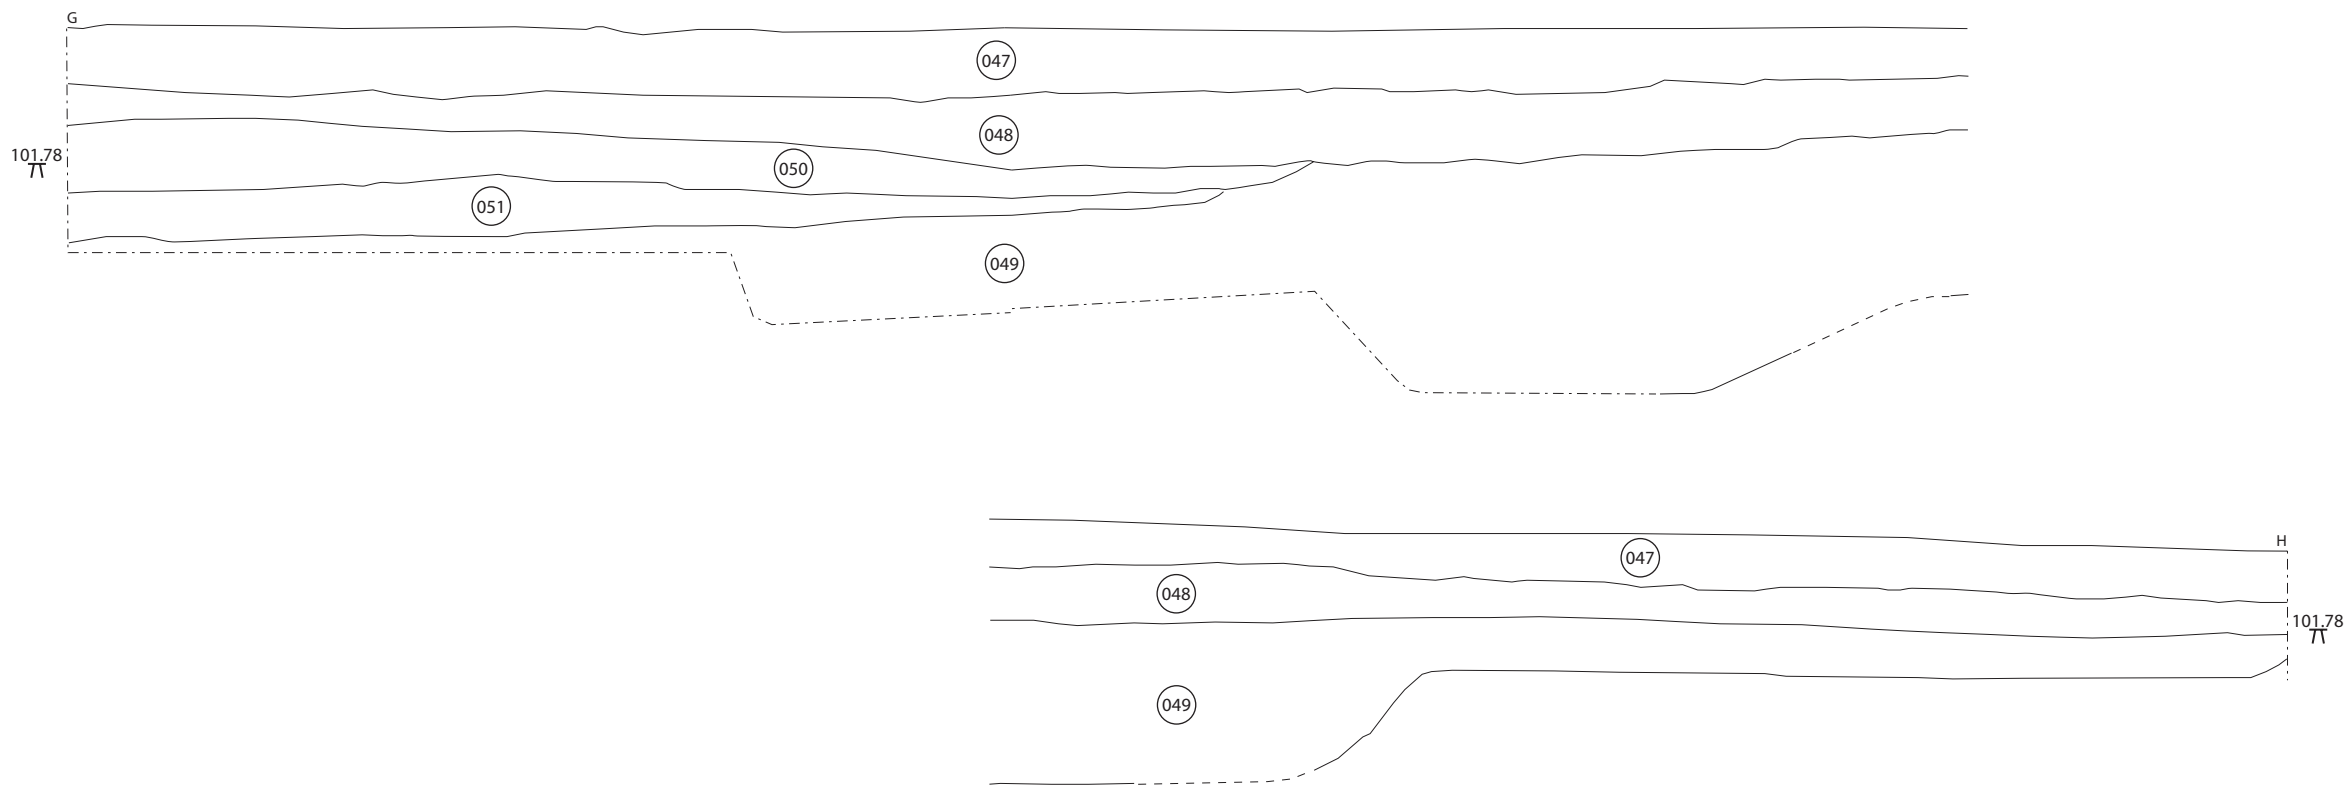
Figure 8

Drawing Title: Trench 4

Trench 4 (Fig.8) (Plate 5) *Former Railway Track/Loading Bay*

- 4.3.4 Trench 4 was located to the West of the other trenches and was orientated North-South within the former railway track. It was also the only trench that did not require concrete to be broken prior to excavation. After removal of the grass and a very thin layer of topsoil there was a layer of ballast (047) with an average depth of 0.32m. Below the ballast was a very dark grey demolition layer containing occasional fragmented brick (048). On the northern side of the trench, natural was reached (049)=(059) at a depth of c. 0.70m. The northern part of the trench was extended to 17m as two brick pillars were found in this area (052)+(053). These pillars were butted by a demolition layer (050), which was only seen in the northern half of the trench. The pillars were cutting into an ash/coke/coal waste (051) deposit with a maximum thickness of 0.30m, which was also only seen at the northern side of the trench.

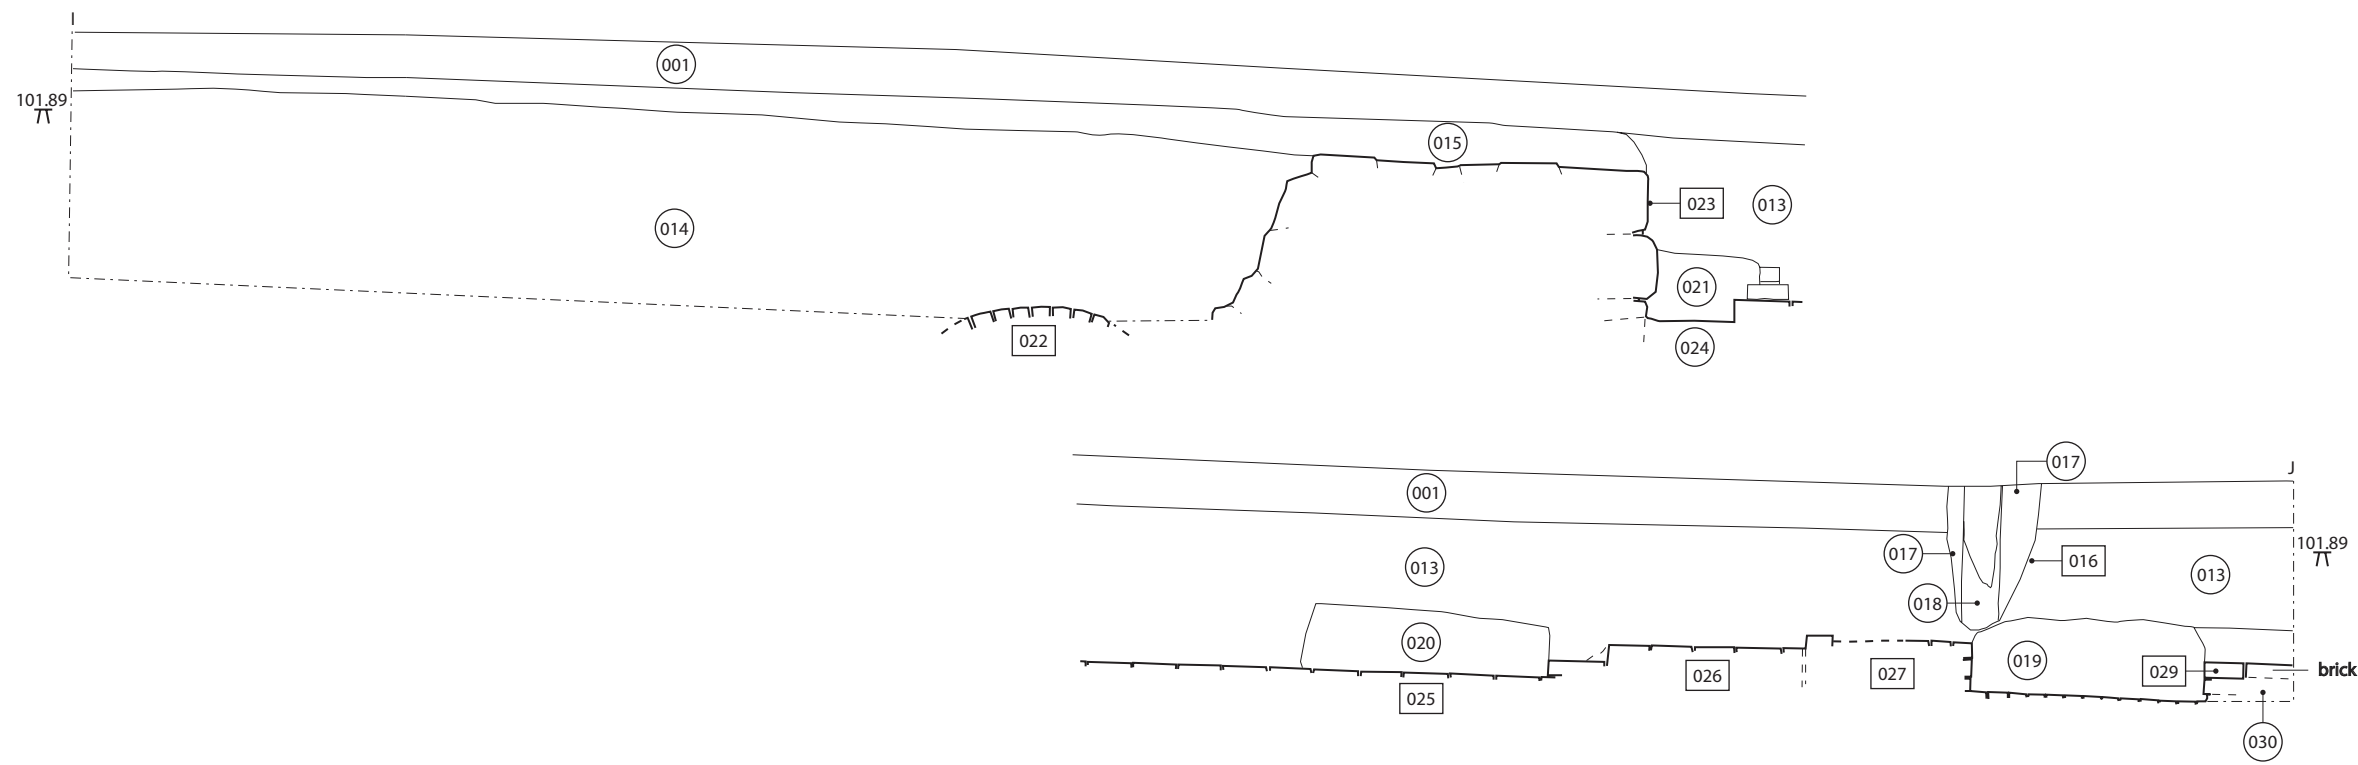
Figure 9

Job Title: Gatewen Colliery
Drawing Title: Trench 5
Date: 26/11/08
Drawn By: I L Bernardus
Scale: 1 : 40 @ A3

Trench 5 (Fig.9) (Plate 7+8) *Winding Engine House (Downshaft)*

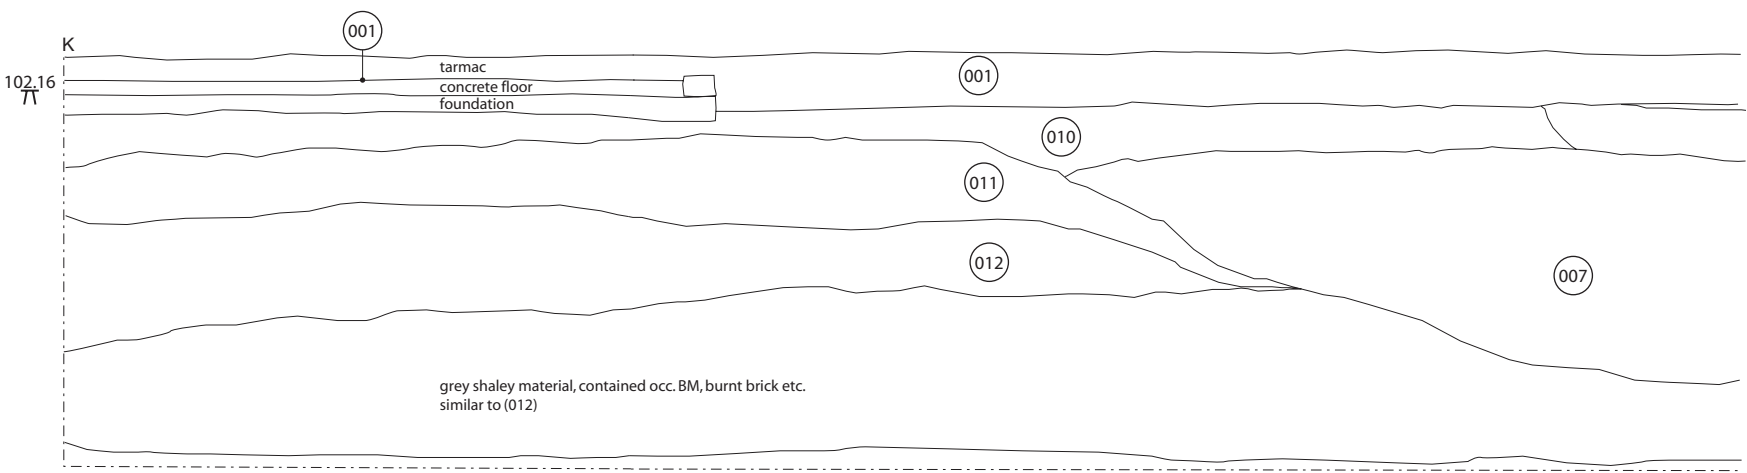
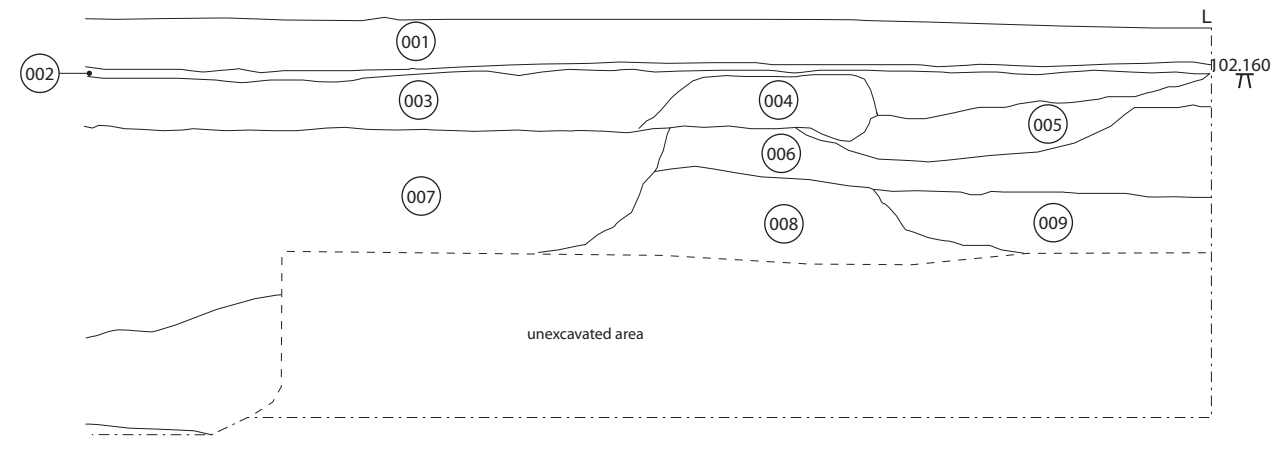
Figure 10

Job Title:	Gatewen Colliery
Drawing Title:	Trench 6
Date:	26/11/08
Drawn By:	I L Bernardus
Scale:	1 : 40 @ A3

Trench 6 (Fig.10) (Plate 6) ***Tramroad***

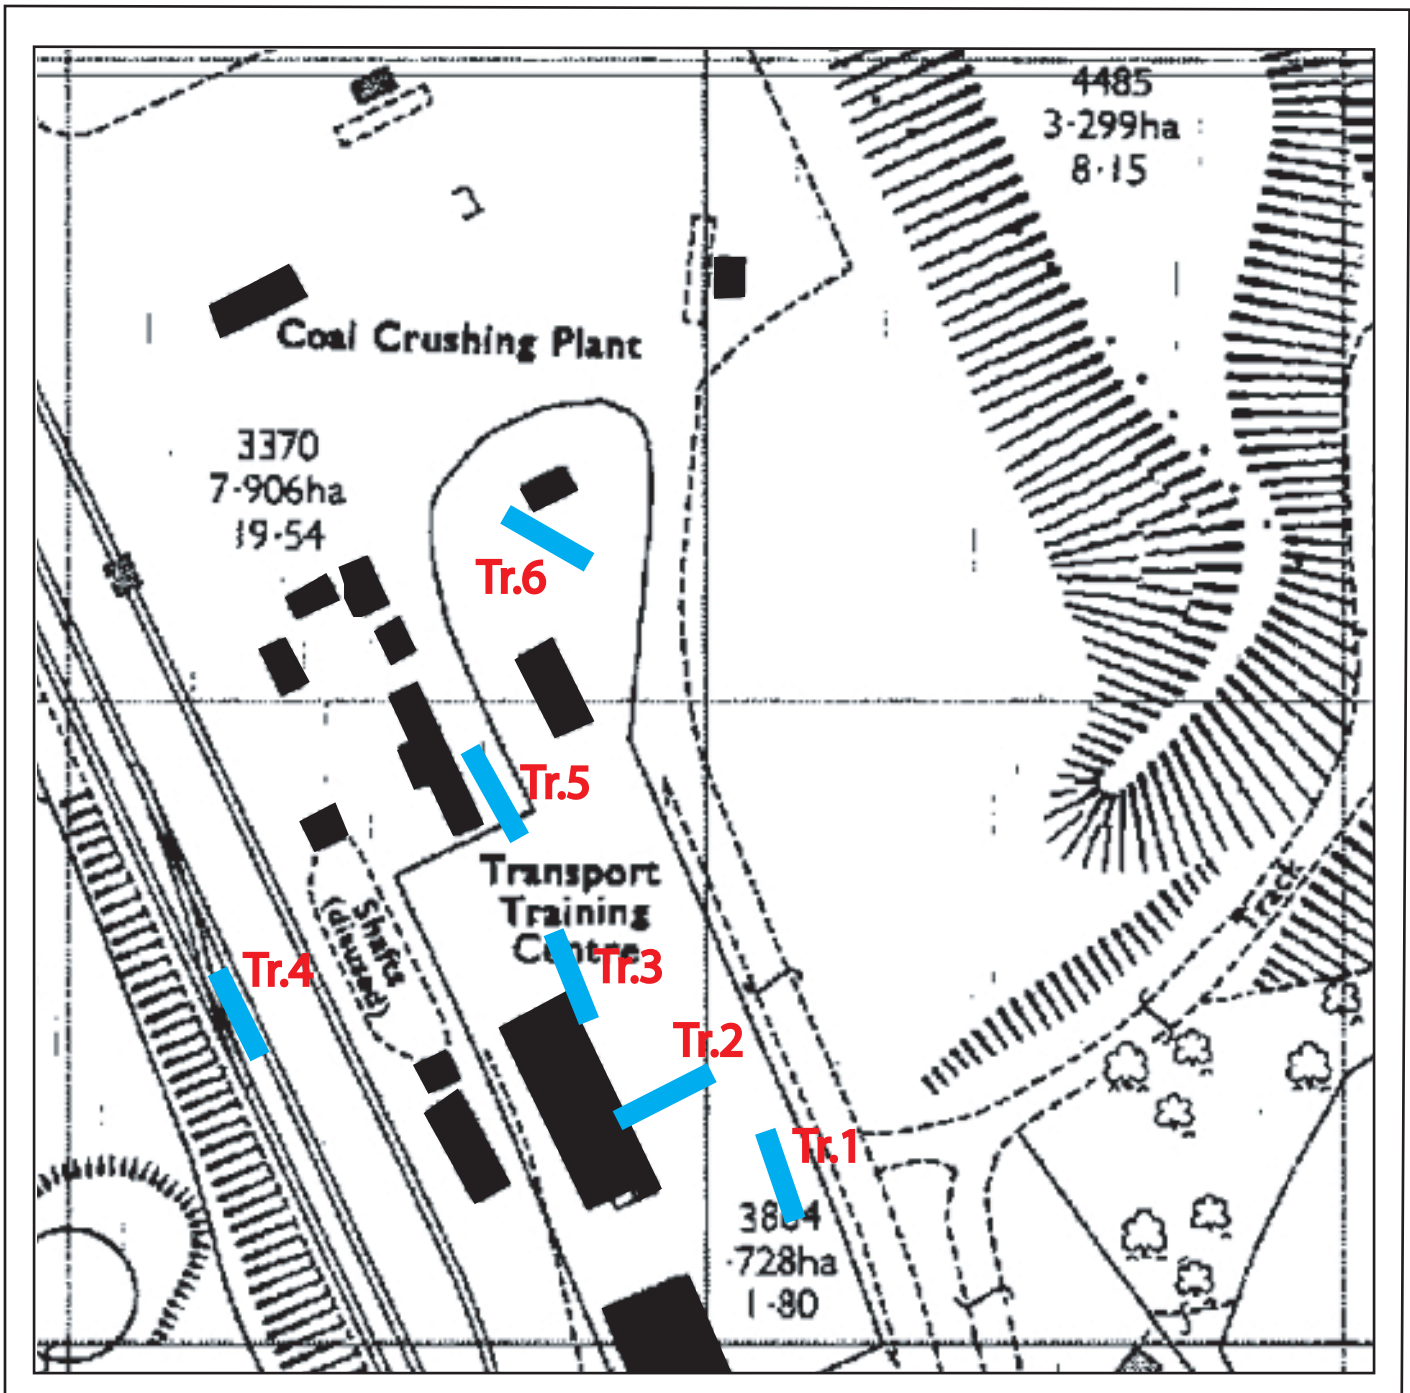
Fig.11 : Location of Evaluation Trenches.

1.1.3 It was proposed by Wardell Armstrong in their report of 2004, 'Specification for Archaeological Excavation', that six evaluation trenches should be excavated each of which would be 15m x 2m in size (Fig.11).

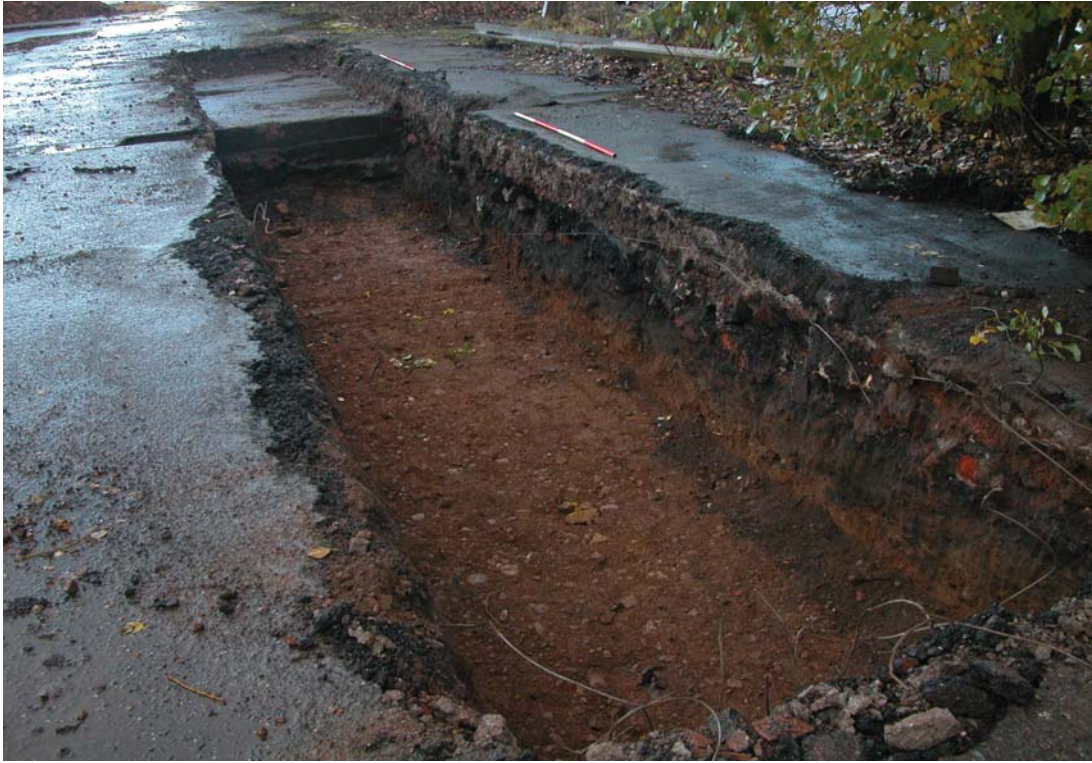
Plate 01: Tr.1, Oblique shot of West facing section showing natural (059) at base.

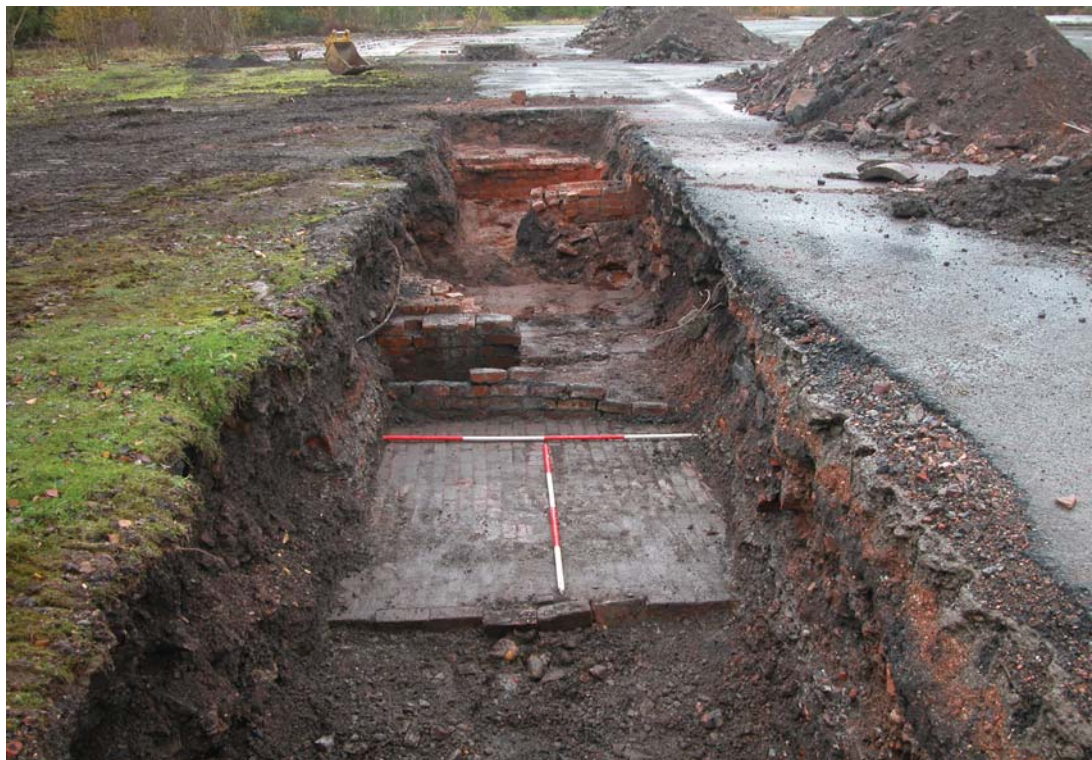
Plate 02: Tr.3, General shot of trench with floor (037) to foreground. CAP Report No. 542

Trench 3 (Fig.7) (Plates 2) *Winding Engine House (Upshaft)*

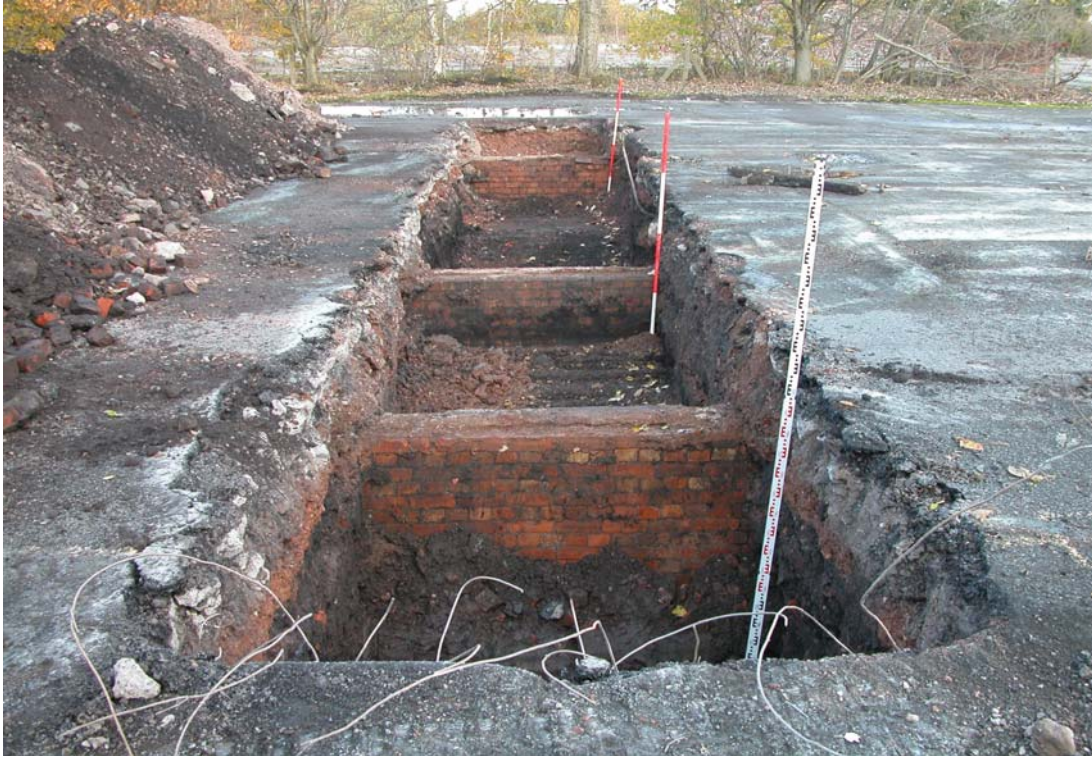
Plate 03: Tr.2, Fan and Compressor House, N-S orientated inner walls.

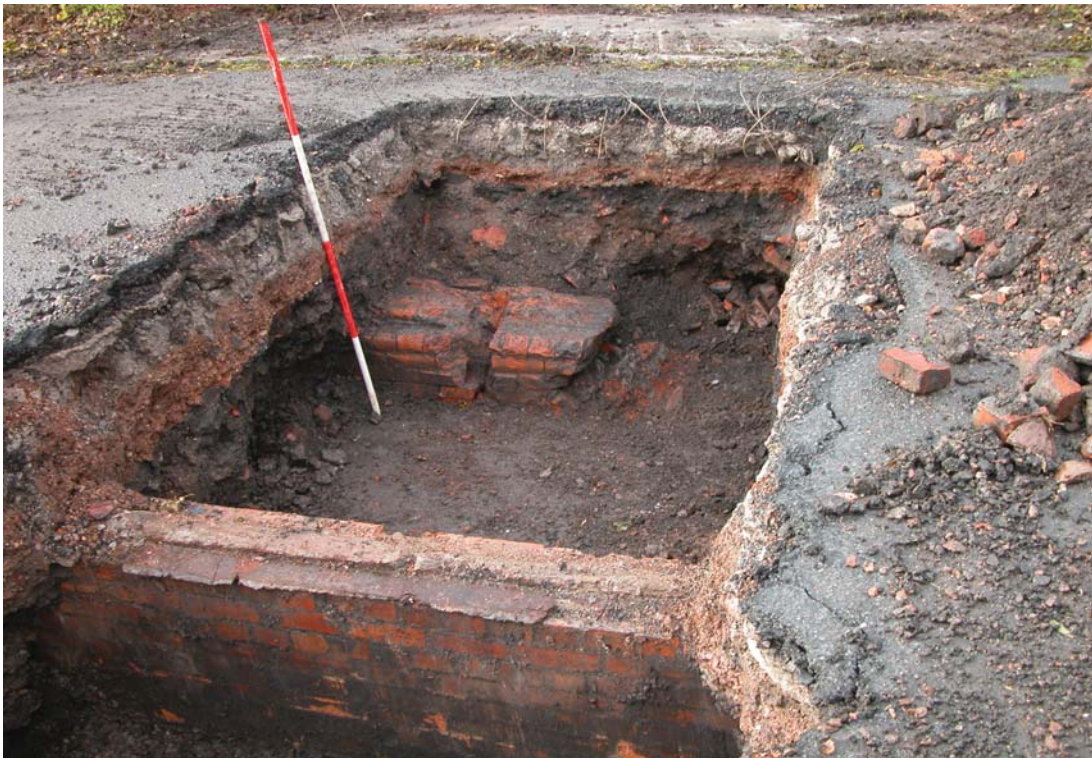
Plate 04: Tr.2, The damaged western wall of the Compressor House. CAP Report No. 542

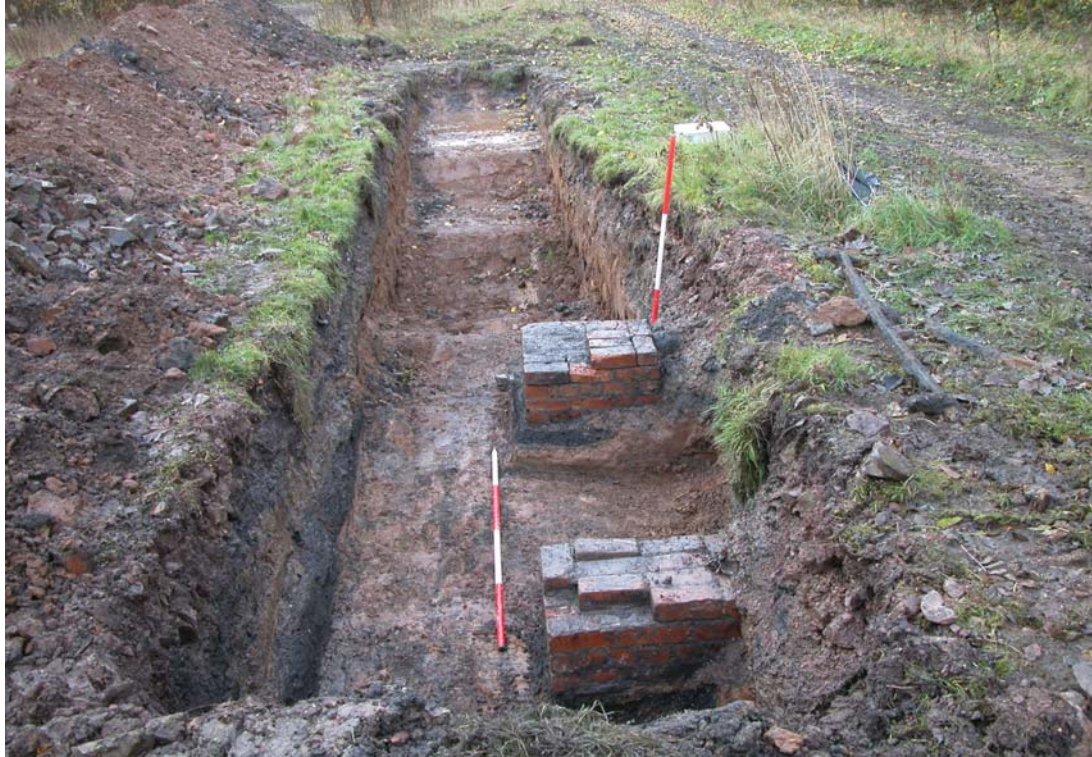
Plate 05: Tr. 5, Excavated to natural (049), brick pillars to North of trench.

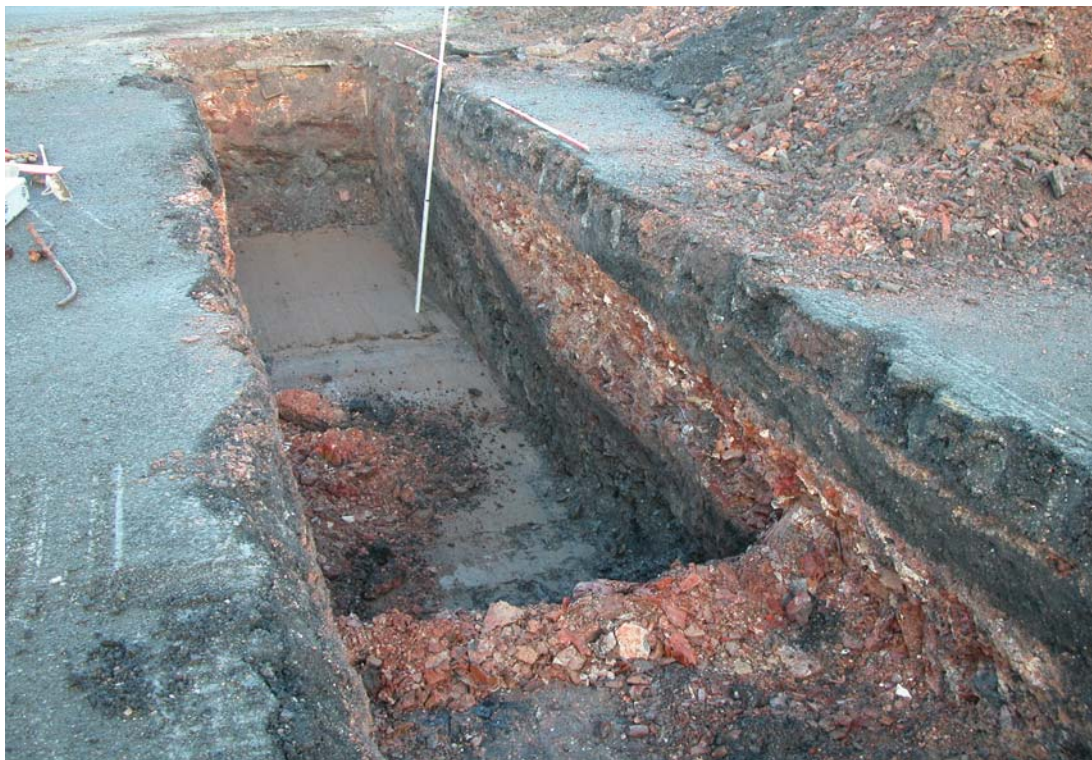
Plate 06: Tr. 6, Trench excavated to natural (059), facing North.

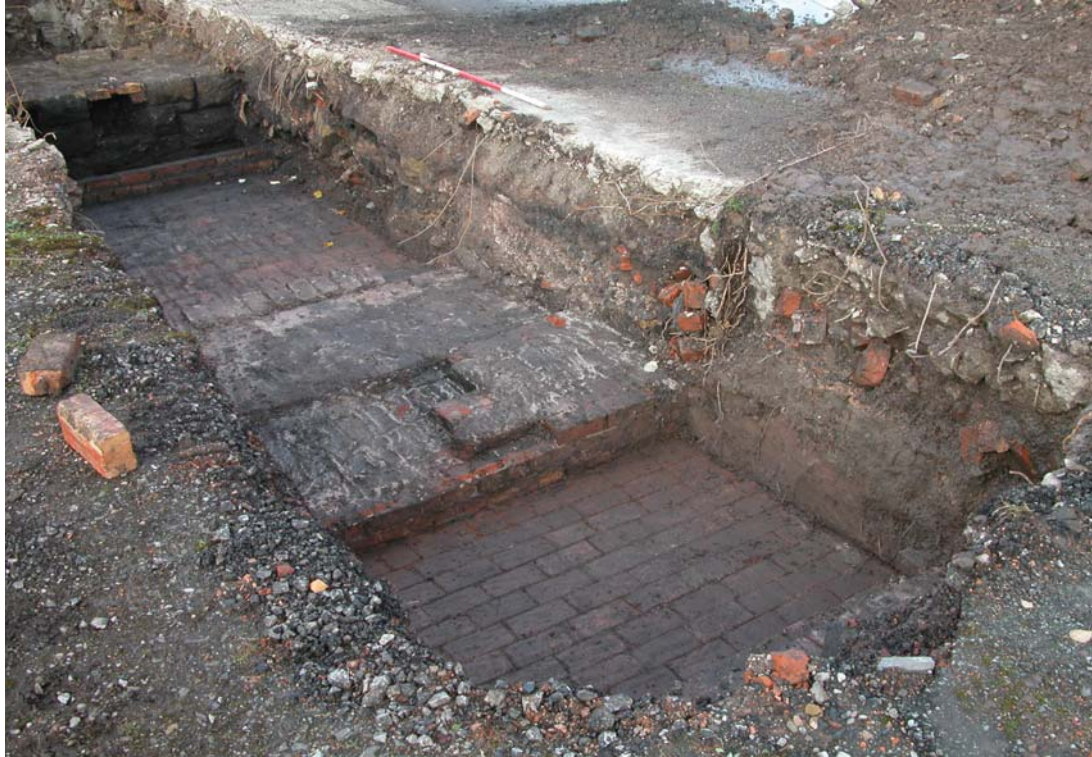
Plate 07: Tr. 5, Brick floors to the South of trench (025) and (028).

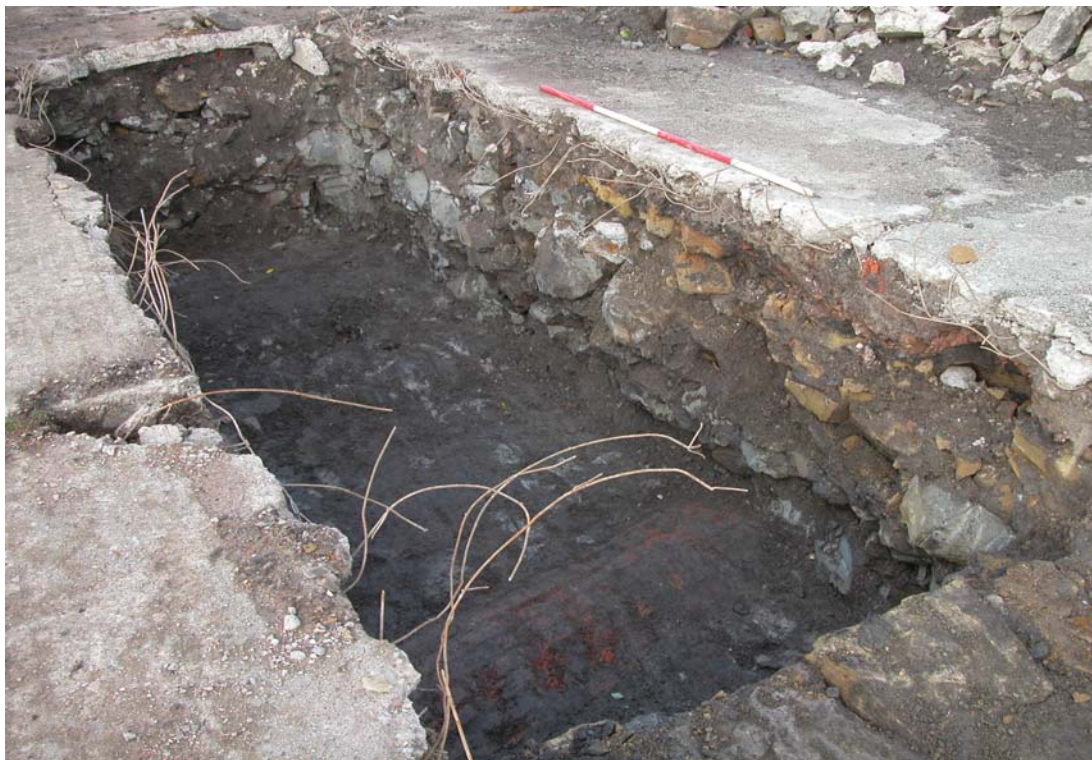
Plate 08: Tr. 5, North of the trench, culvert (022) in foreground.
