GENERAL OFFICES, EBBW VALE
Refurbishment and extension

HERITAGE IMPACT
ASSESSMENT

for
"The Works" Regeneration project, Ebbw Vale

December 2008

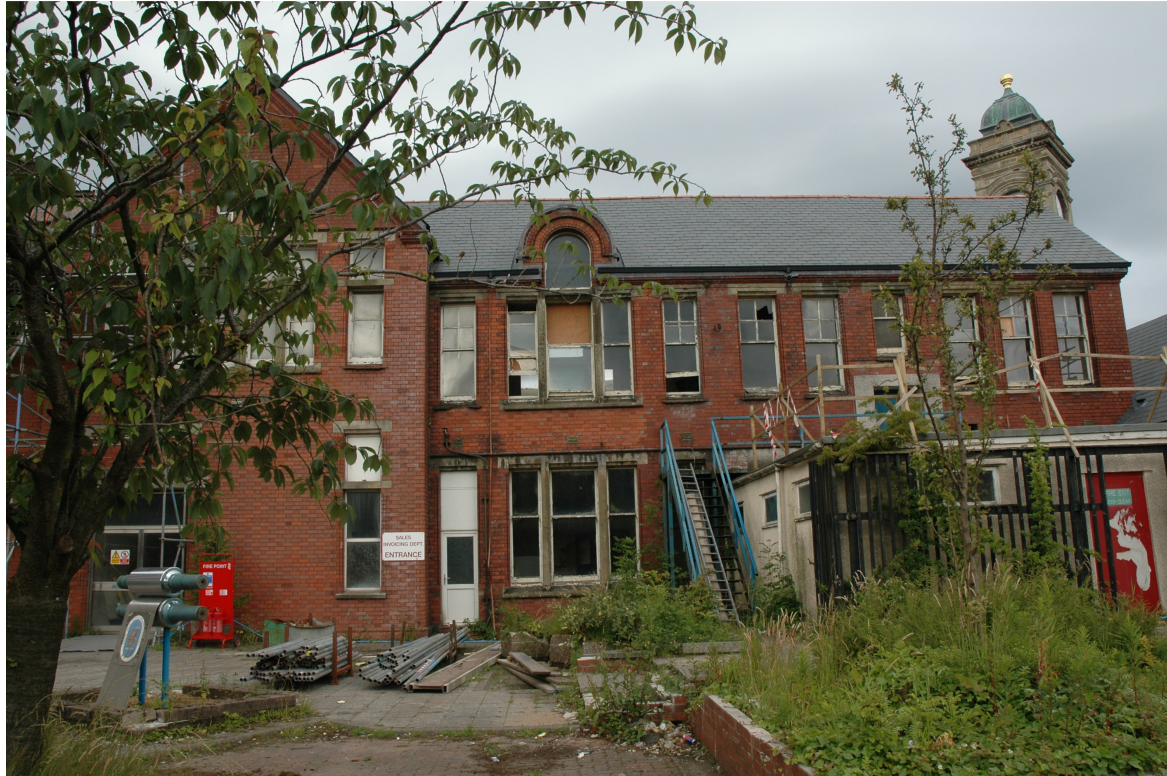
Existing West façade, July 2008

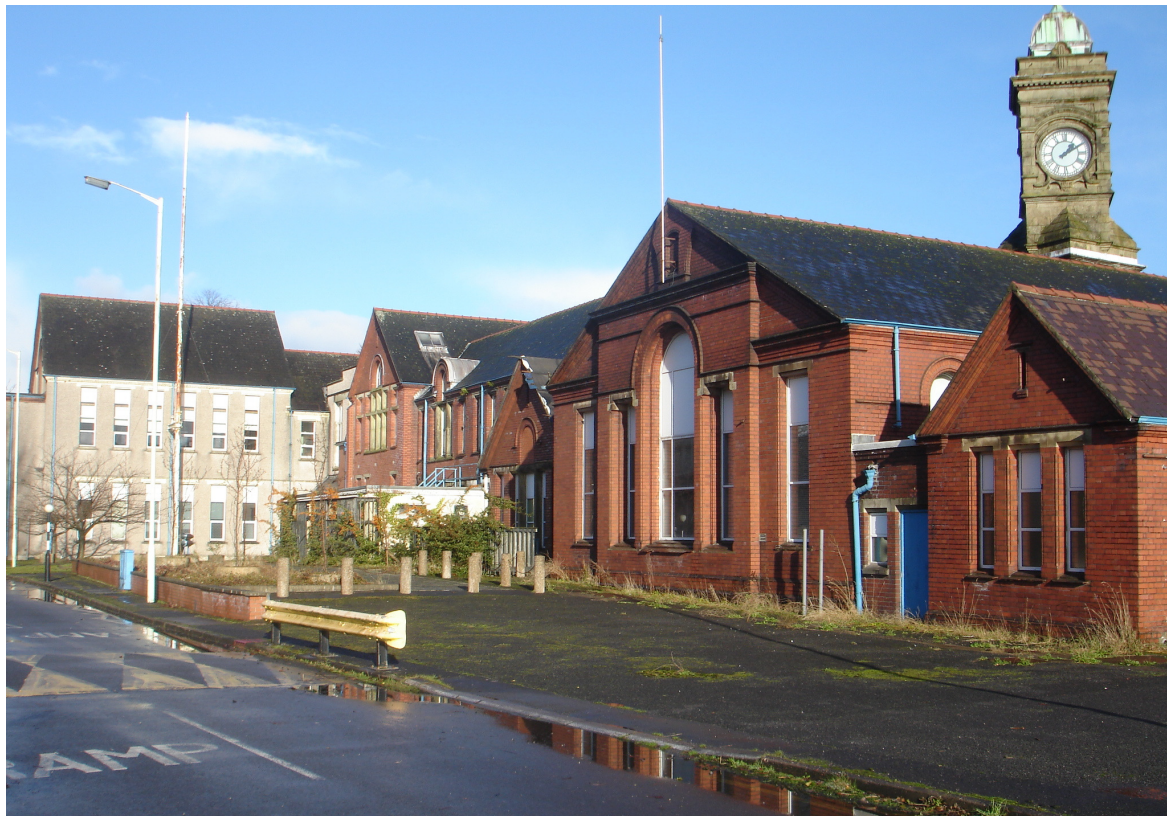
View of west façade and Engineering Drawing Office, July 2008

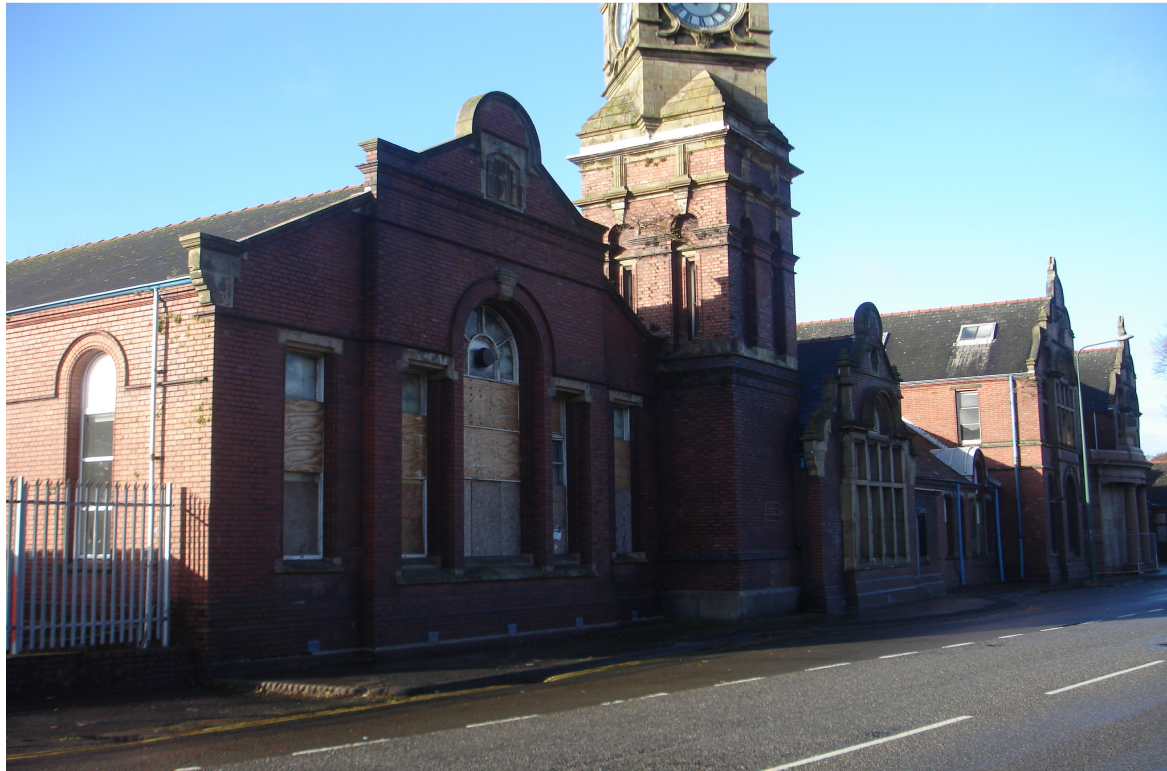
Principal façade onto Steelworks Road July 2008

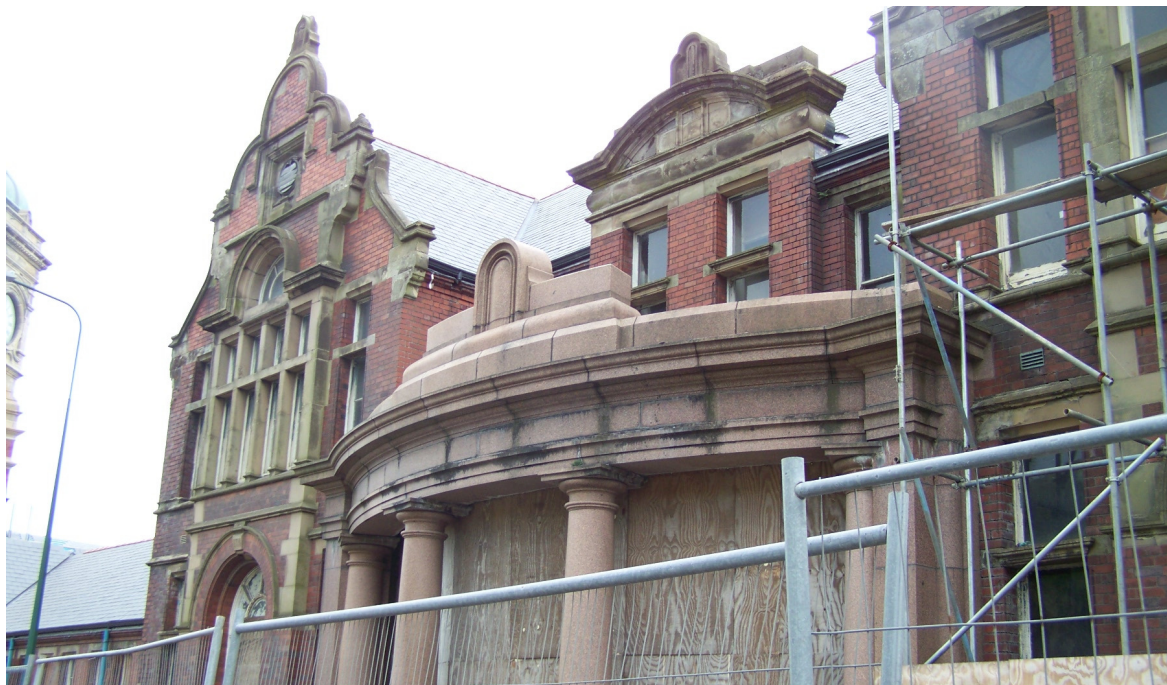
Principal entrance from Steelworks Road June 2008
